Evaluation of Stay-in-Place Metal Forms

for the
Ohio Department of Transportation
Office of Research and Development

State Job Number 134155

Final Report
FHWA/OH – 2006/13
May 2006

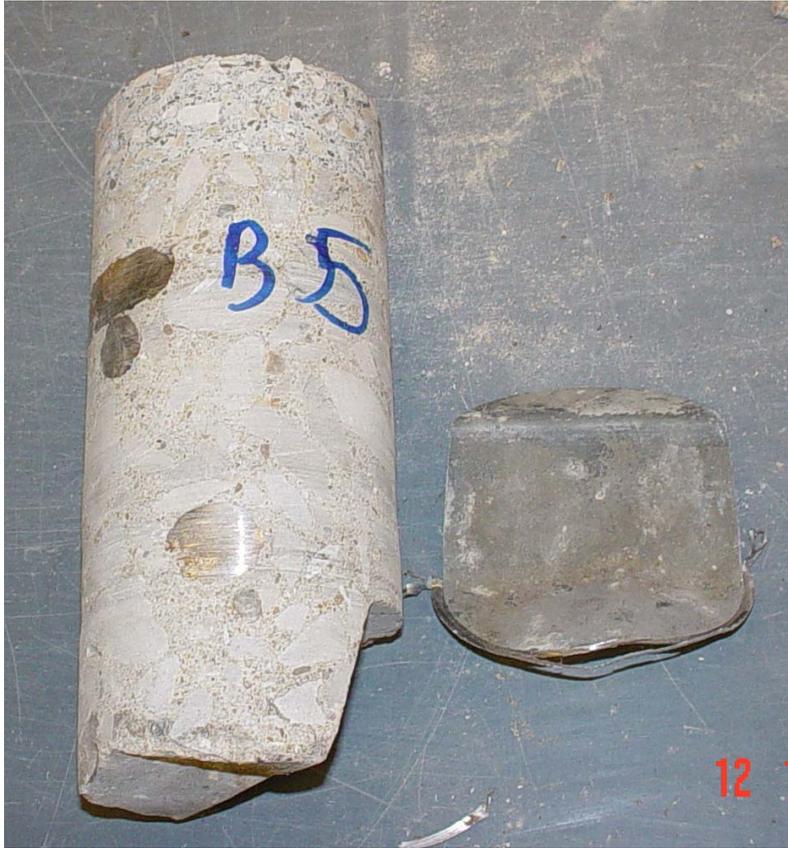
Core Number: B5

- Core height 6.75 inches, 8.75 inches with the concrete in the region of the valley of the SIPMF.
- Area of voids at 3.75 inches from top.
- Two reinforcing bars located at 3.75 inches and 5.5 inches from bottom surface, and show some rust traces.
- Brown and white traces on the SIPMF.

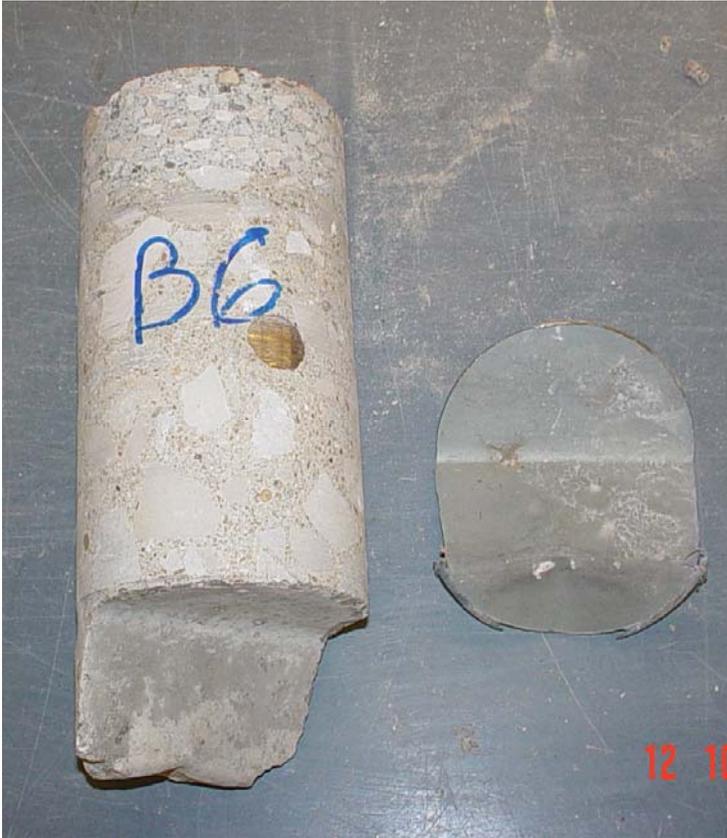
Core Number: B6

- Core length 6.75 – 8.5 inches with 1.5 inch wearing surface.
- No bond between SIPMF and deck. White residue present on SIPMF and concrete.
- Core fractured 2 inches from top due to large amounts of voids. Length of crack 2.5 inches.
- Bottom rebar shows traces of rust.
- Numerous voids in concrete up to 1/4 inch in diameter.

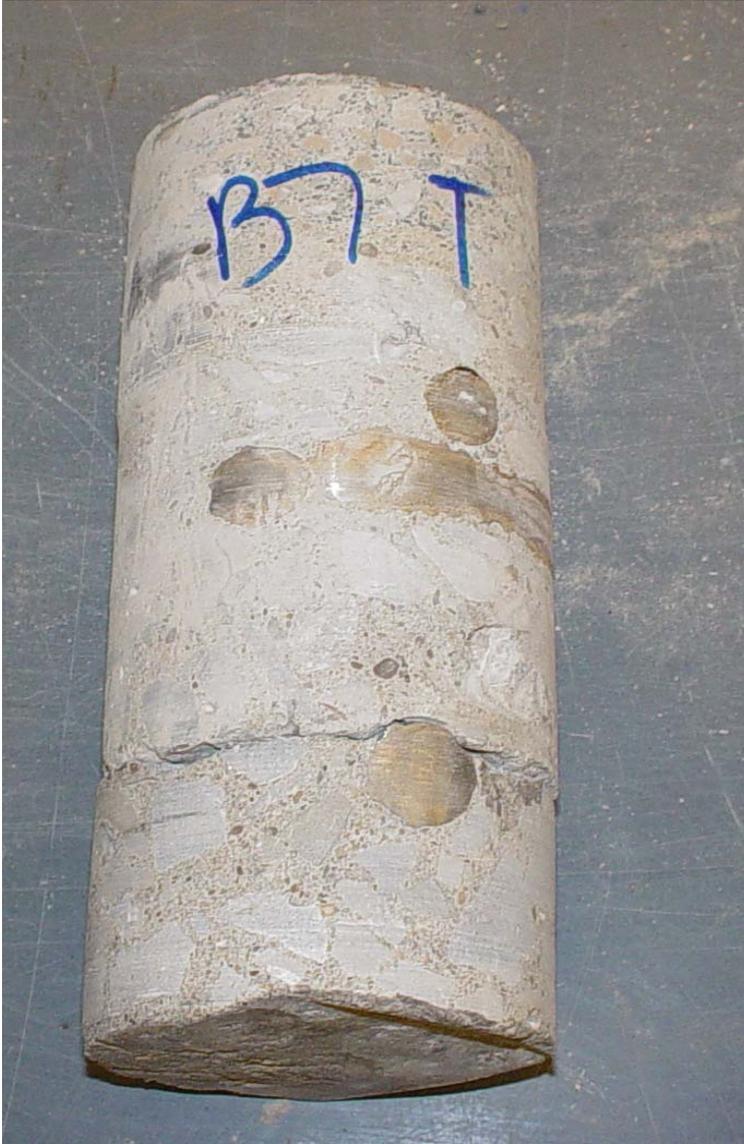
Core Number: B7

- Core length 9 inches with 1.75 inch wearing surface.
- No bond between SIPMF and deck. White residue present on SIPMF and concrete.
- Core fractured 6.5 inches from top due to heavy rusting of rebar.
- Bottom rebar shows traces of rust.
- Numerous voids in concrete up to 1/4 inch in diameter.

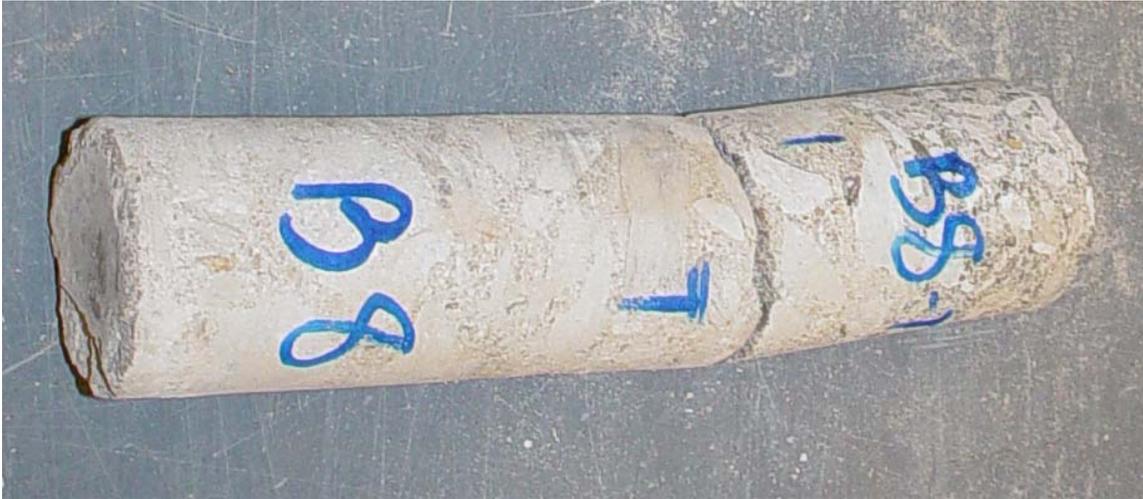
Core Number: B8

- Core length 7.25 inches with 1.75 inch wearing surface.
- No bond between SIPMF and deck. White residue present on concrete
- Core fractured 3.5 inches from top due to excavation of core.

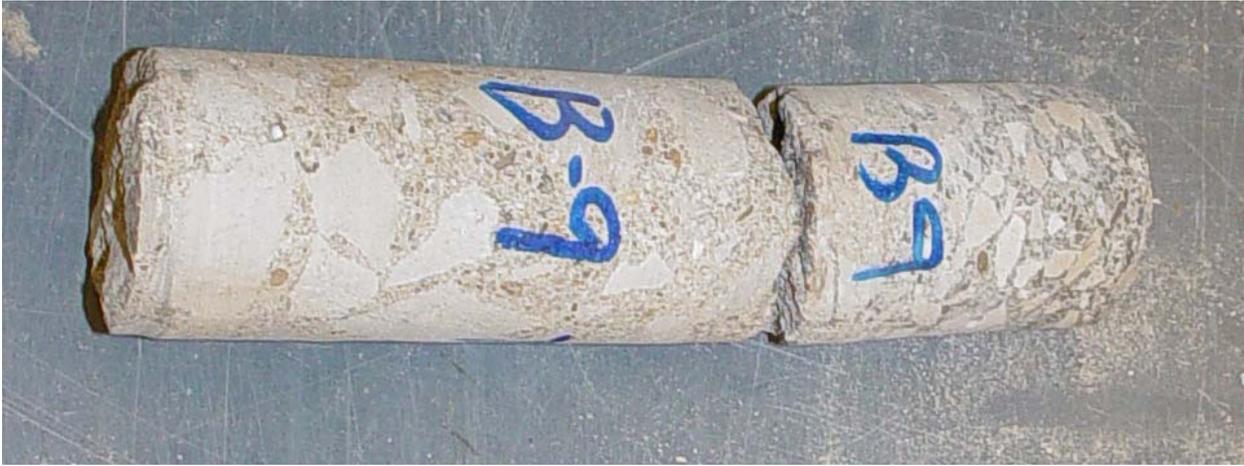
Core Number: B9

- Core length 7.25 inches with 2 inch wearing surface.
- No bond between SIPMF and deck. White residue present on bottom of concrete.
- Core fractured 2.75 inches from top due to heavy rust.

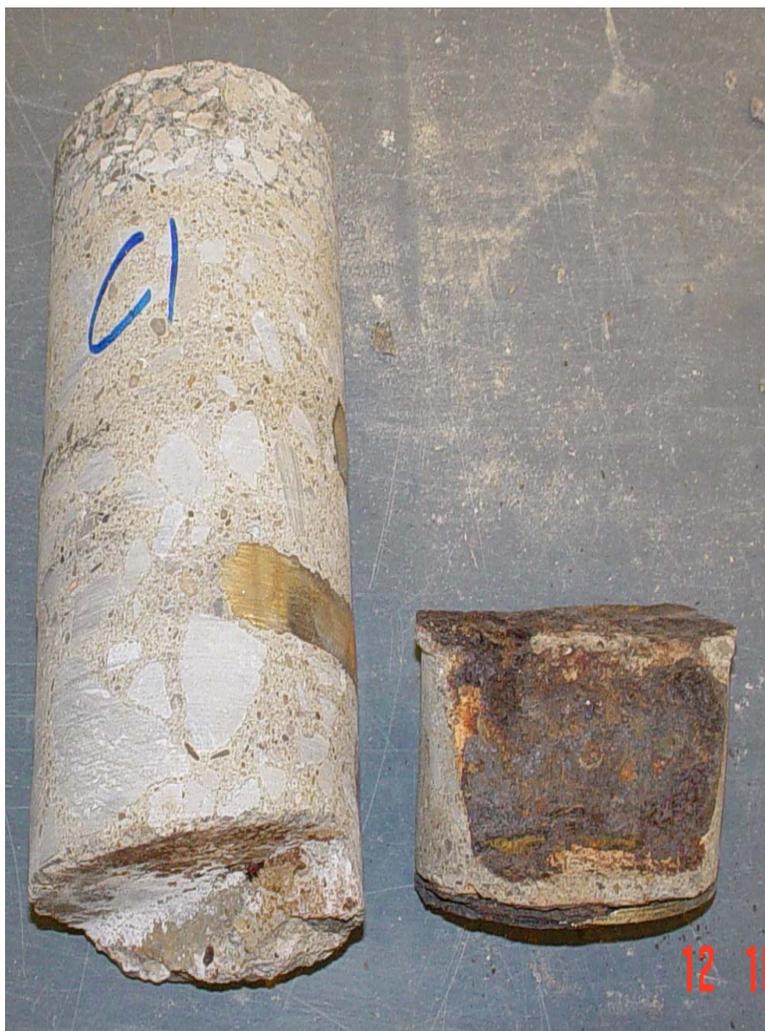
Core Number: C1

- Core length 7.75 – 10.5 inches with 1.5 inch wearing surface.
- No bond between SIPMF and deck. White residue and heavy rust present on bottom of concrete and SIPMF
- SIPMF badly deteriorated.
- Core fractured 8 inches from top due to heavy rusting of SIPMF.
- Rebar badly rusted.
- Numerous amounts of voids present in concrete up to 1/4 inch in diameter.

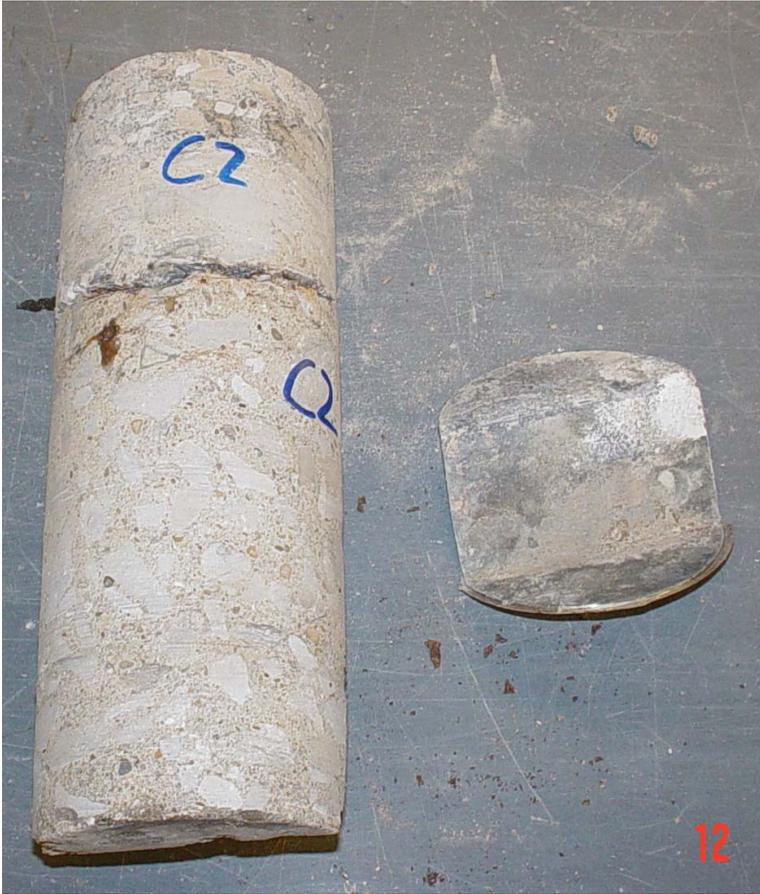
Core Number: C2

- Core length 7.75 – 9.75 inches with 1.5 inch wearing surface.
- No bond between SIPMF and deck. White residue and heavy rust present on bottom of concrete and SIPMF
- Core fractured 2.75 inches from top due to heavy rusting of rebar.
- Rebar badly rusted.
- Numerous amounts of voids present in concrete up to 1/4 inch in diameter.

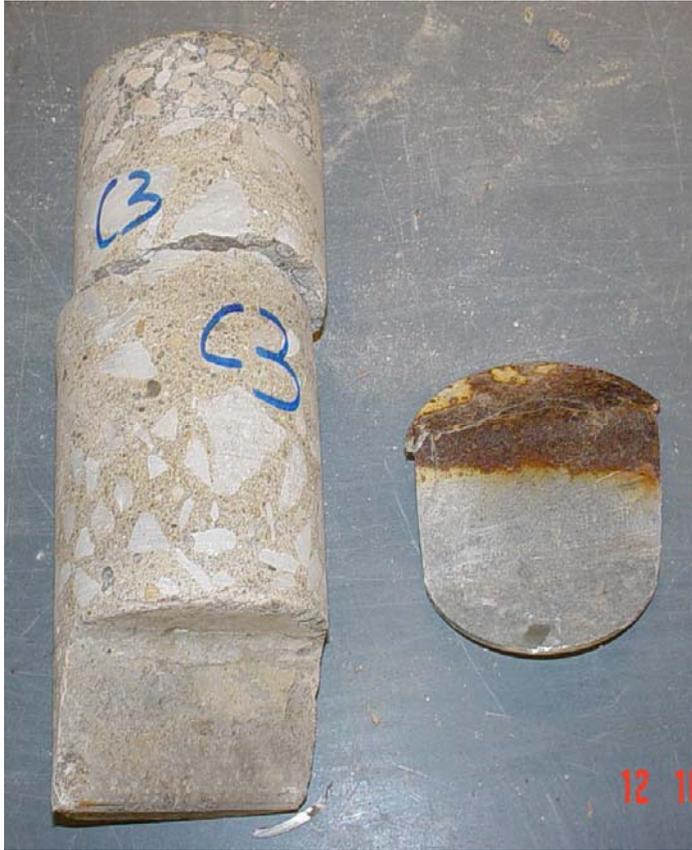
Core Number: C3

- Core height 7.5 inches, 9.5 inches with the concrete in the region of the valley of the SIPMF.
- Core is broken into two parts.
- One reinforcement bar located at 3.75 inches from bottom surface.
- Bar is not coated and shows severe rusting.
- Brown and white traces on the SIPMF.

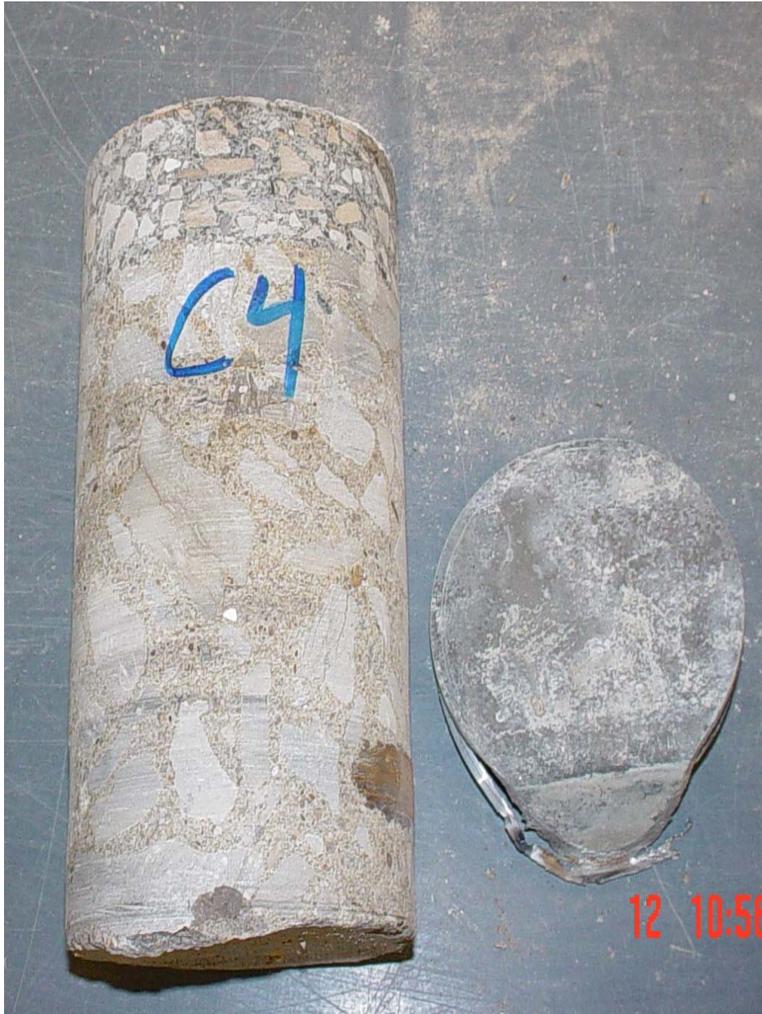
Core Number: C4

- Core length 7.75 – 9.75 inches with 1.5 inch wearing surface.
- No bond between SIPMF and deck. White residue present on bottom of concrete and SIPMF.
- Core fractured 3 inches from top due to large number of voids. Length of crack 2.5 inches.
- Rebar shows traces of rust
- Numerous amounts of voids present in concrete up to 1/4 inch in diameter.

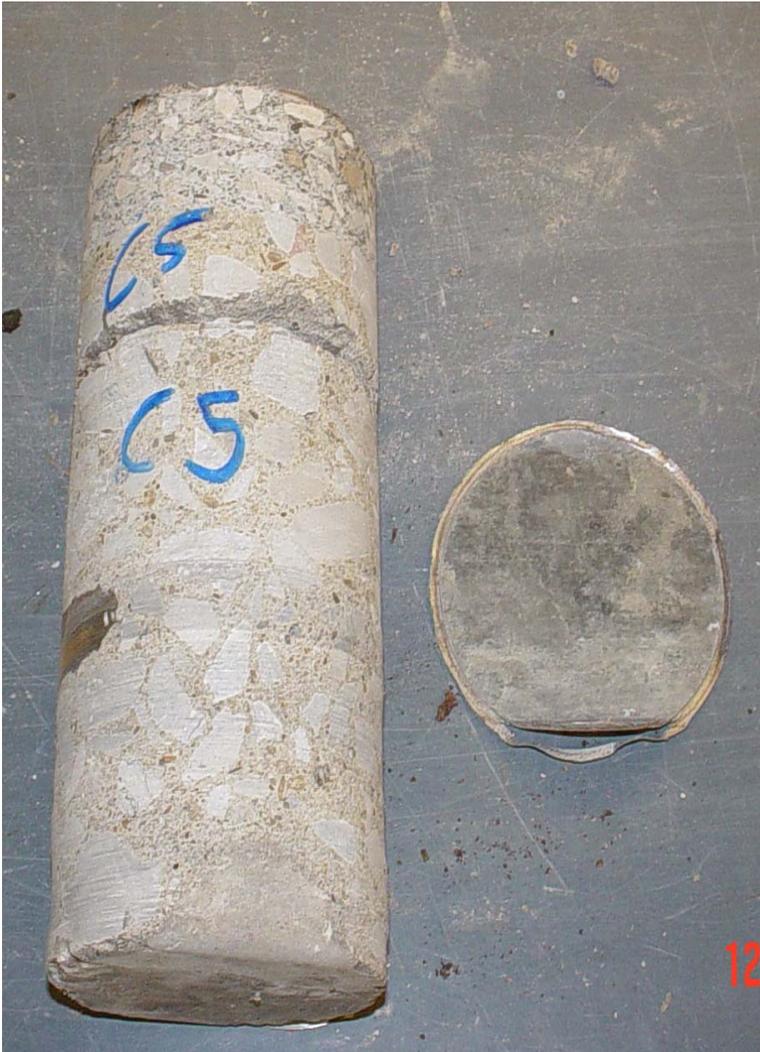
Core Number: C5

- Core length 9 inches with 1.75 inch wearing surface.
- No bond between SIPMF and deck. White residue present on bottom of concrete and SIPMF.
- Core fractured 3 inches from top due to heavy rusting of rebar.
- Rebar severely rusted.
- Numerous amounts of voids present in concrete up to 1/8 inch in diameter.

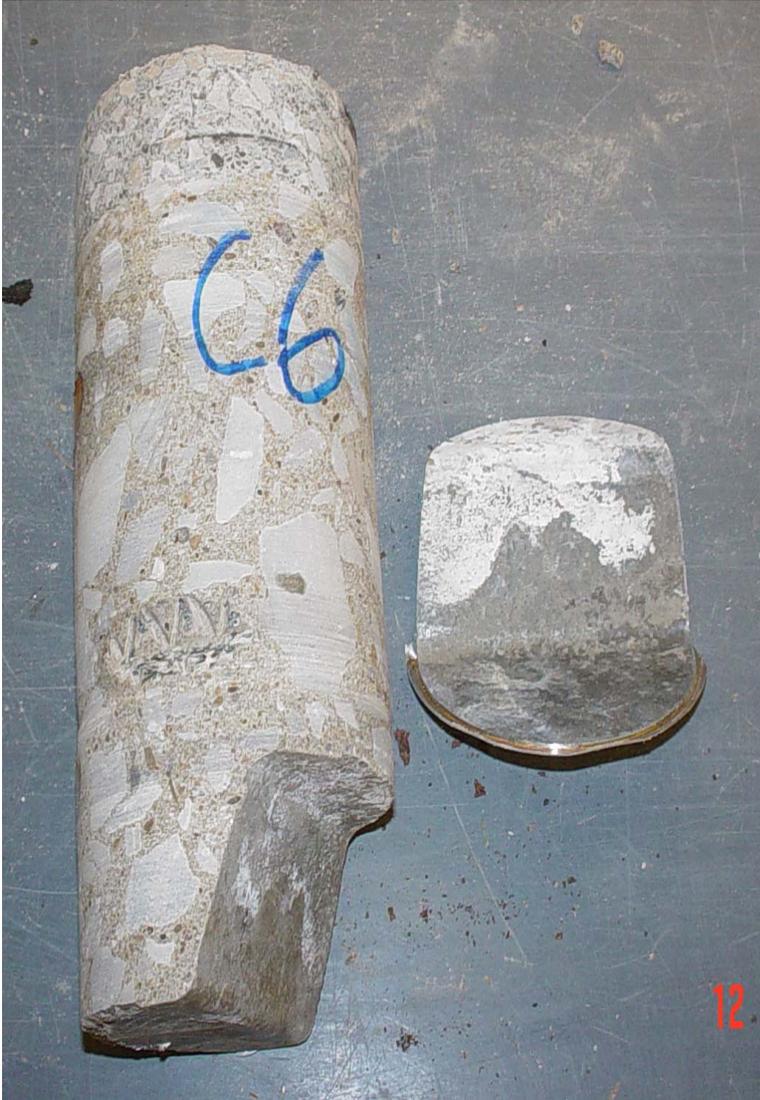
Core Number: C6

- Core length 7- 9 inches with 1.5 inch wearing surface.
- No bond between SIPMF and deck. White residue present on bottom of concrete and SIPMF.
- Rebar traces of rust.
- Numerous amounts of voids present in concrete up to 1/4 inch in diameter.

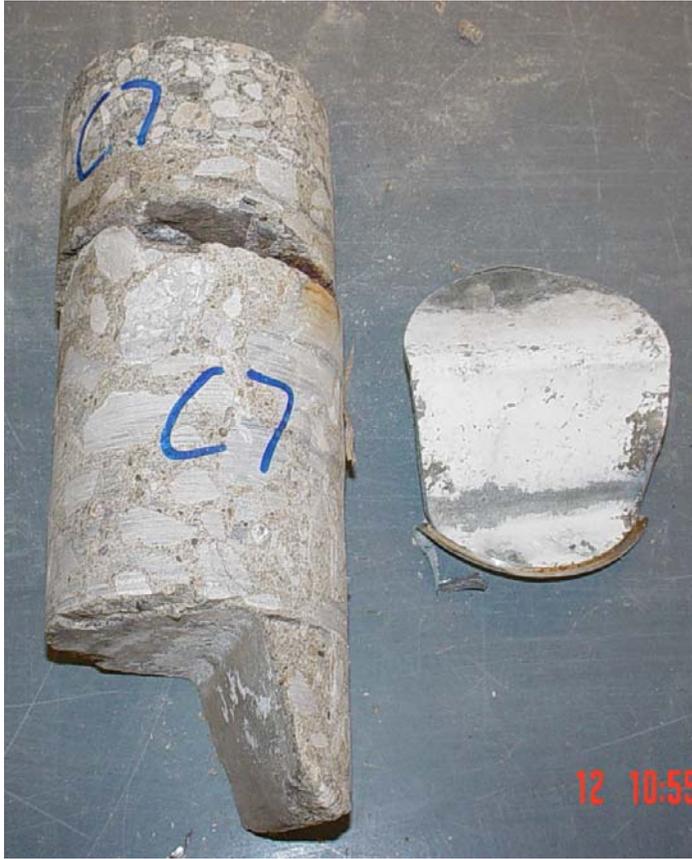
Core Number: C7

- Core height 7 inches, 8.7 inches with the concrete in the region of the valley of the SIPMF.
- Core is broken into two parts.
- One reinforcement bar located at 5.5 inches from bottom surface.
- Bar is not coated and shows some rust traces.
- White traces on the SIPMF.
- Region of small to moderate voids.

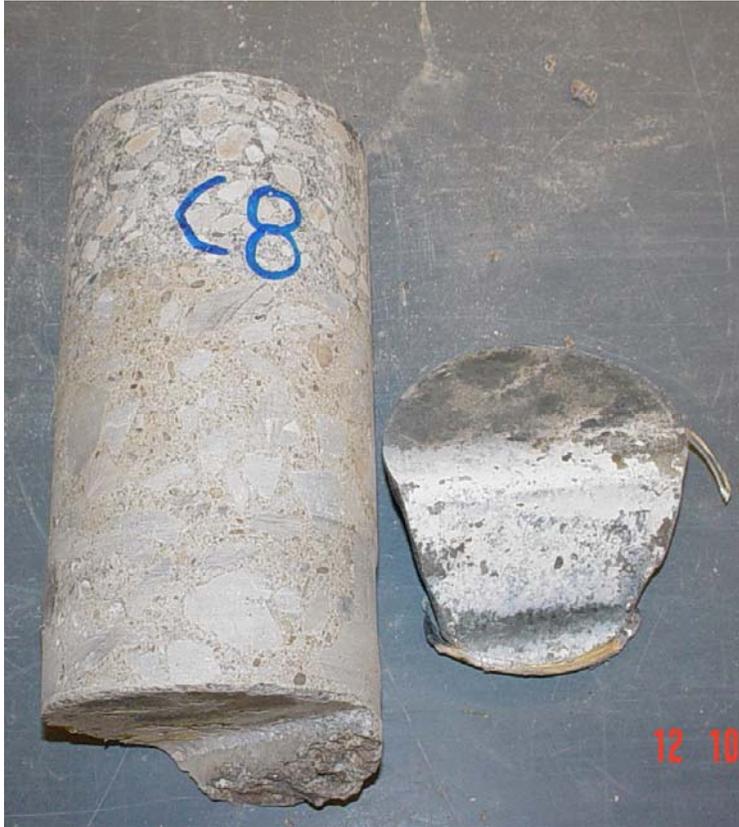
Core Number: C8

- Core length 7 inches with 2.5 inch wearing surface.
- No bond between SIPMF and deck. White residue present on bottom of concrete and SIPMF.
- Rebar traces of rust.
- Numerous amounts of voids present in concrete up to 1/4 inch in diameter.

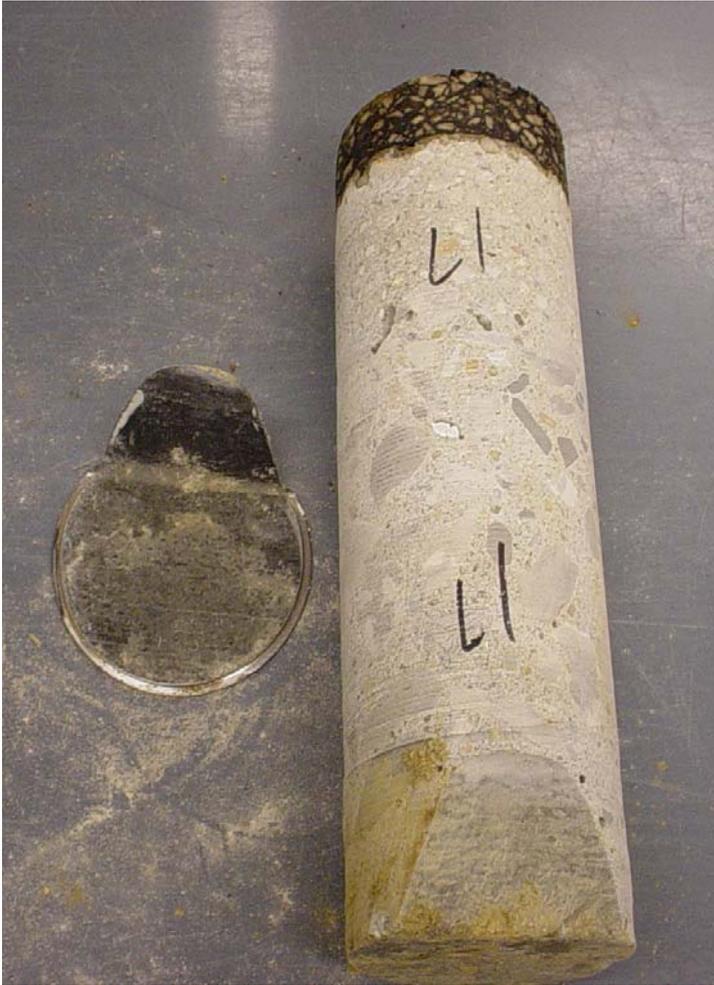
Core Number: L1

- Core length 12 inches with 1 inch wearing surface and 3 inch overlay.
- No bond between SIPMF and concrete. White residue found on SIPMF and concrete.
- Rebar badly corroded.
- Large voids in overlay up to 1/2 inch in diameter.
- Numerous amounts of voids in concrete up to 1/8 inch in diameter.

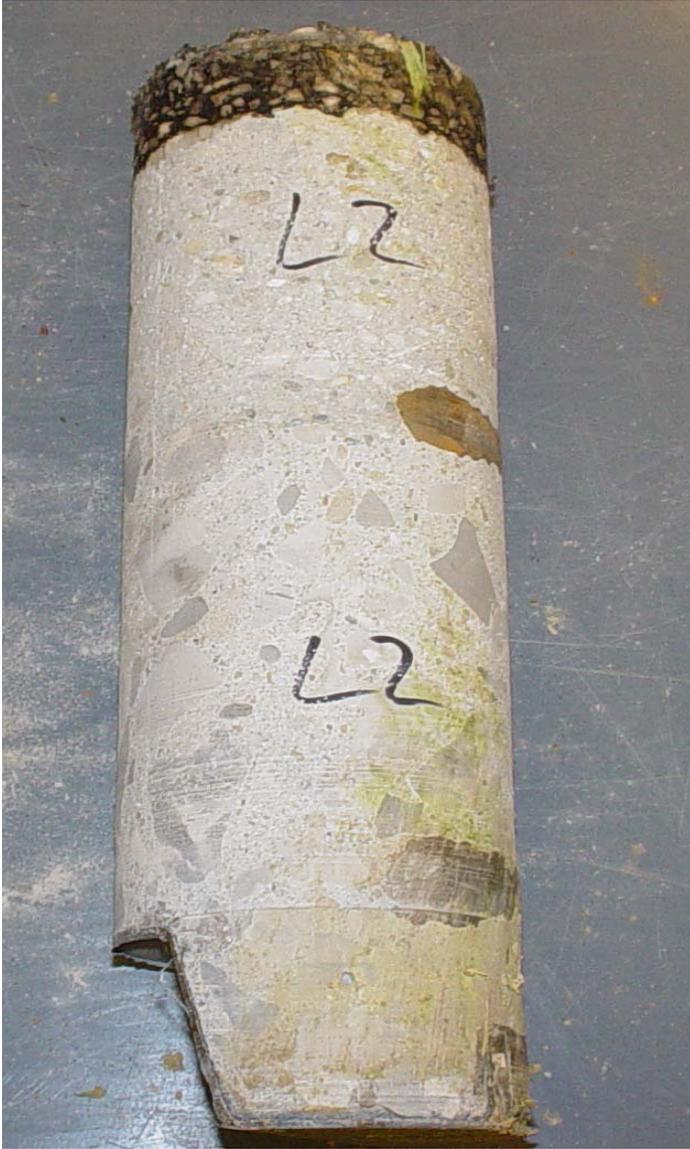
Core Number: L2

- Core length 12.25 inches with 1 inch wearing surface and 3.25 inch overlay.
- Good bond between SIPMF and concrete.
- Rebar badly corroded.
- Large voids in overlay up to 1/4 inch in diameter. Many concentrated where overlay meets concrete.
- Numerous amounts of voids in concrete up to 1/4 inch in diameter.

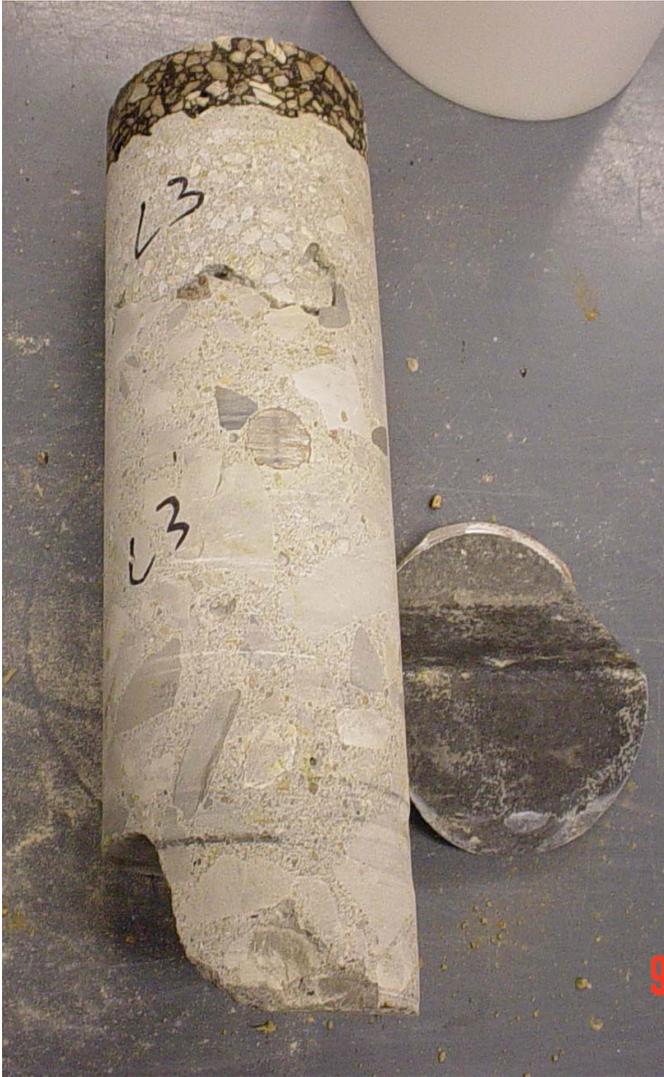
Core Number: L3

- Core height 10.25 inches, 12.25 inches with the concrete in the region of the valley of the SIPMF.
- Regions of large size honeycombing.
- One reinforcement bar located at 6 inches from the top surface.
- Some rust traces on the bar.
- Some cracks existed in the surface between the two concrete layers.

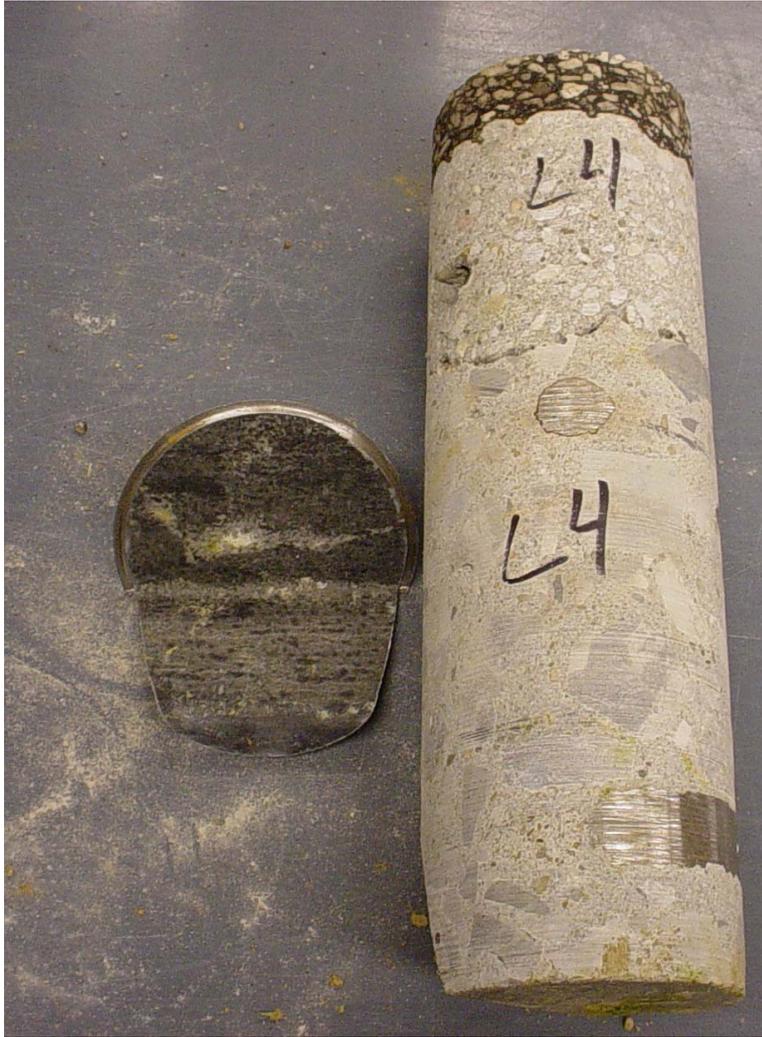
Core Number: L4

- Core length 10 - 12 inches with 1 inch wearing surface and 3 inch overlay.
- No bond between SIPMF and concrete. White residue present on SIPMF and concrete.
- Rebar shows traces of rust.
- Large void in overlay 3 inches from the top. Length of crack is 1.5 inches and 3/4 of an inch deep.
- Large amounts of voids where overlay meets concrete.
- Numerous amounts of voids in concrete up to 1/8 inch in diameter.
- Numerous amounts of voids in overlay up to 1/4 inch in diameter.

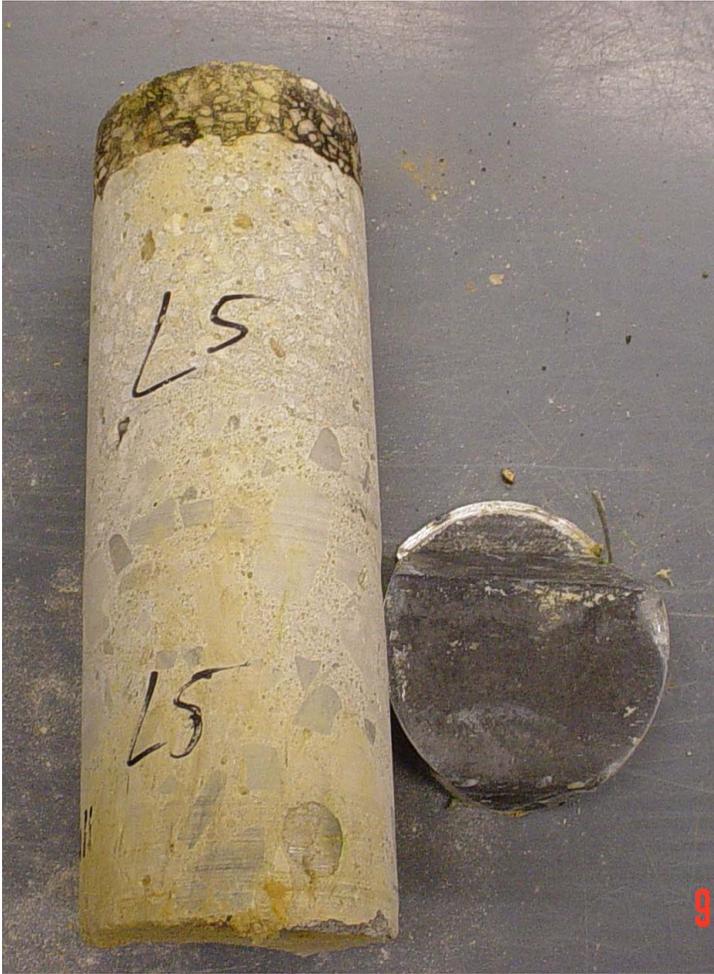
Core Number: L5

- Core length 10.5 inches with 1.5 inch wearing surface and 3.5 inch overlay.
- No bond between SIPMF and concrete. White residue present on SIPMF and concrete.
- Rebar shows traces of rust.
- Numerous amounts of voids in concrete up to 1/4 inch in diameter.
- Numerous amounts of voids in overlay up to 3/8 inch in diameter.

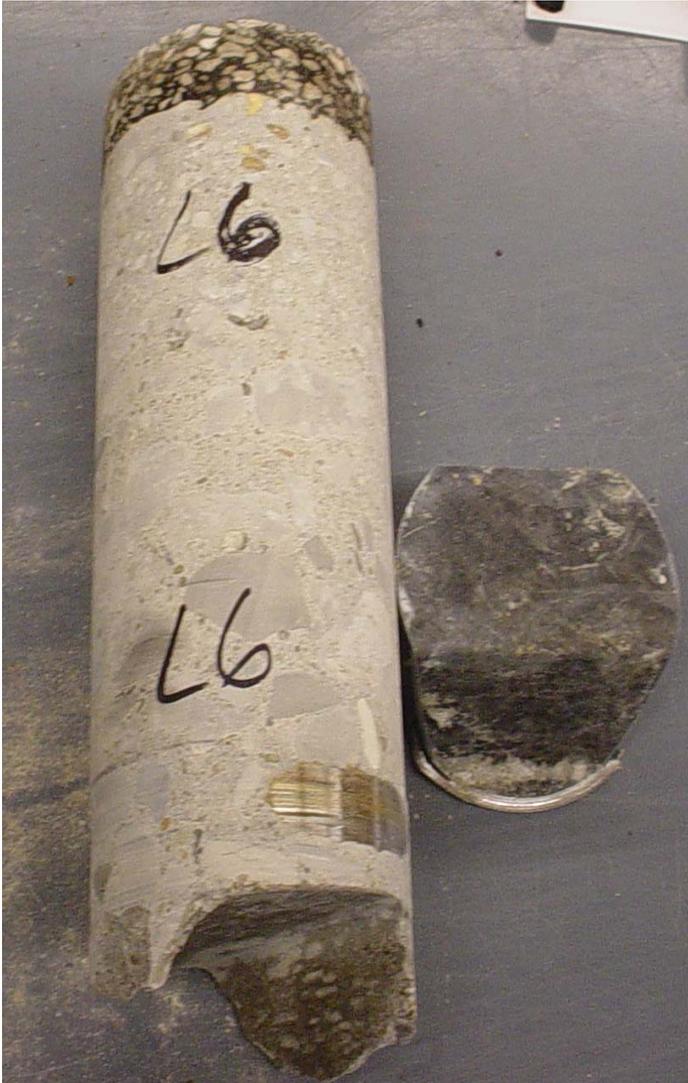
Core Number: L6

- Core height 10.25 inches, 11.75 inches with the concrete in the region of the valley of the SIPMF.
- One reinforcement bar located at 9.5 inches from the top surface.
- Rust traces on the bar.
- Region of small to moderate voids at the top layer of concrete.
- Region of honeycombing at the bottom layer of concrete.

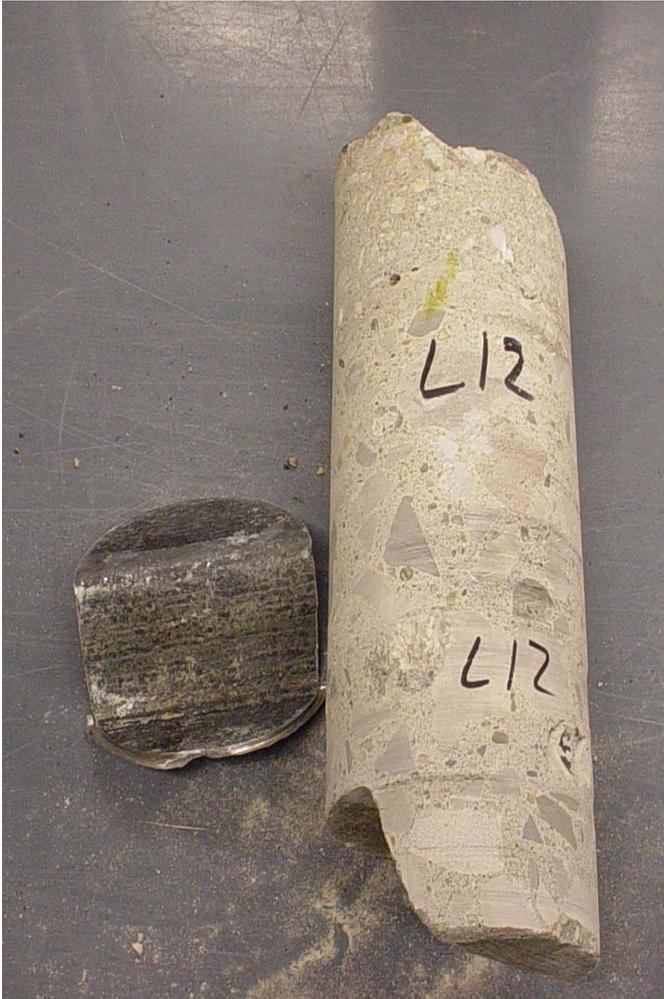
Core Number: L12

- Core height 9.5 inches, 11.5 inches with the concrete in the region of the valley of the SIPMF.
- One reinforcement bar located at 9.0 inches from the top surface.
- Some rust traces on the bar.
- Region of small voids.
- Core is broken at top.
- White traces on SIPMF.

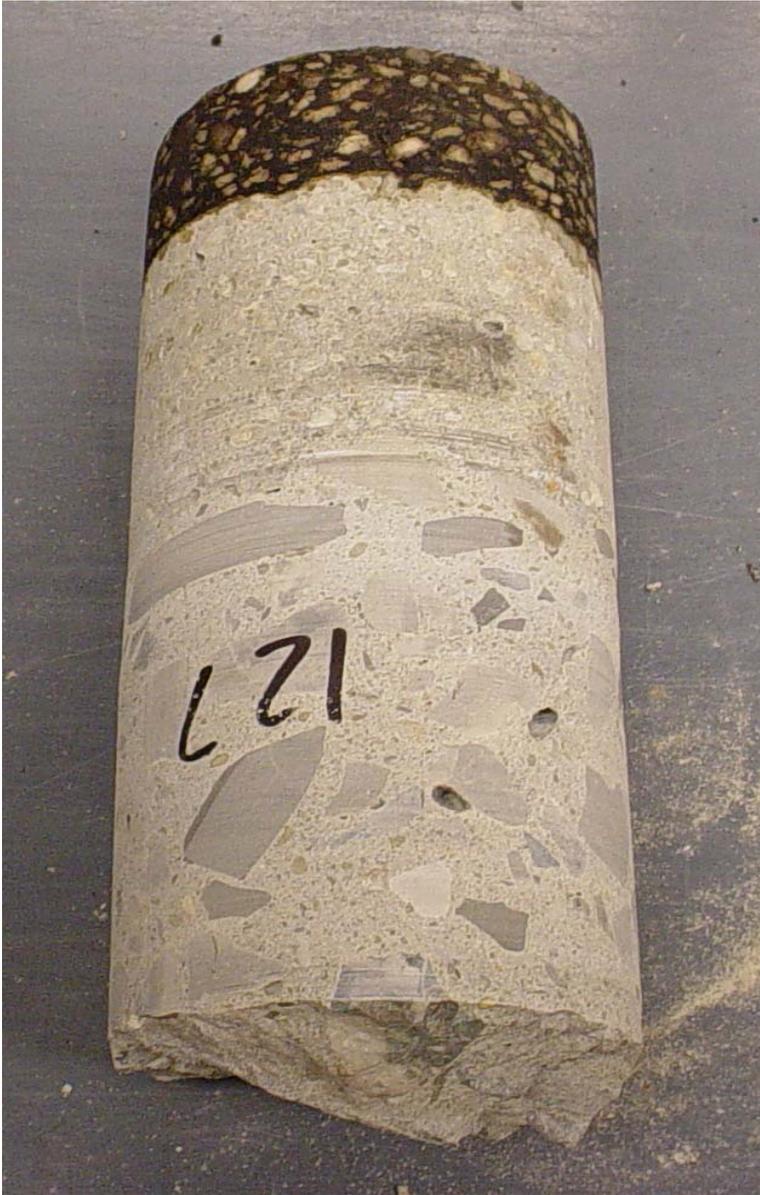
Core Number: L21

- Core length 9 inches with 1.5 inch wearing surface and 3 inch overlay.
- Rebar severely rusted.
- Numerous amounts of voids in overlay up to 1/4 inch in diameter.
- Numerous amounts of voids in concrete up to 1/4 inch in diameter.

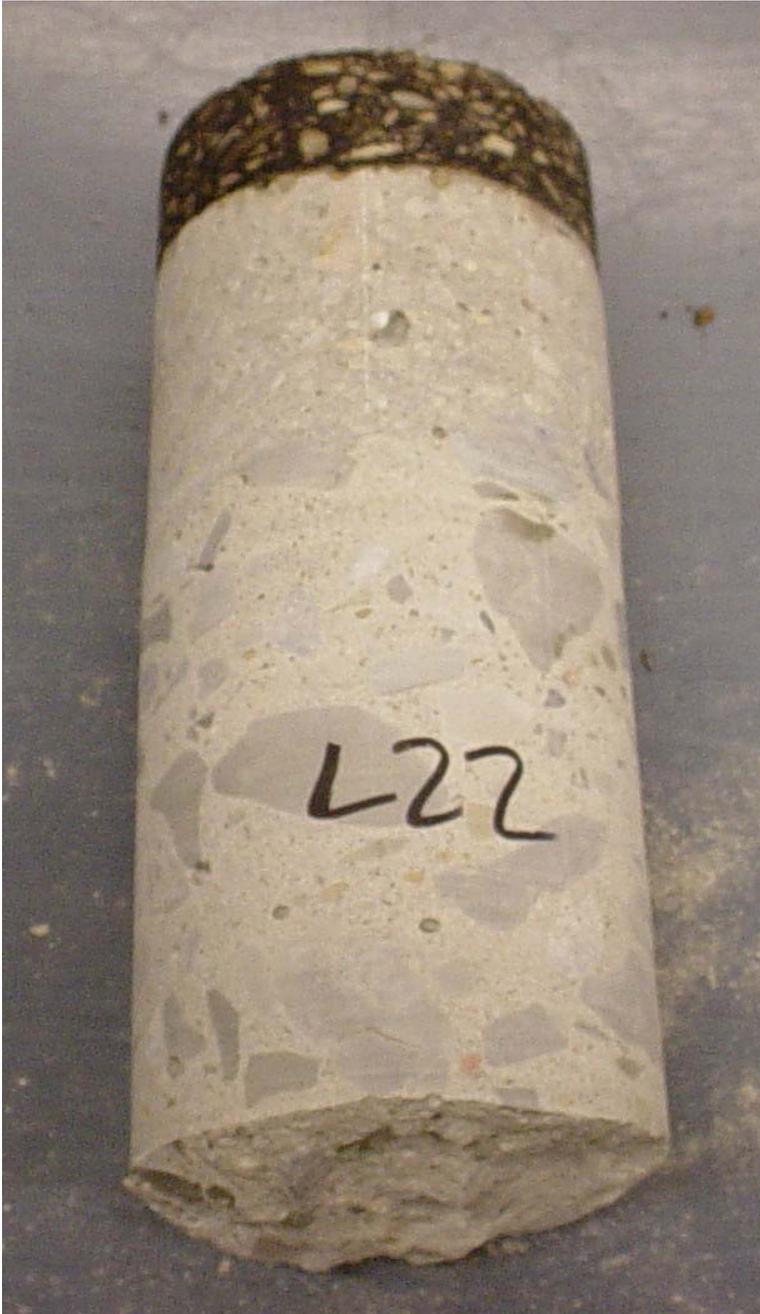
Core Number: L22

- Core length 10 inches with 1.5 inch wearing surface and 3 inch overlay.
- Numerous amounts of voids in overlay up to 3/8 inch in diameter.
- Numerous amounts of voids in concrete up to 1/8 inch in diameter.

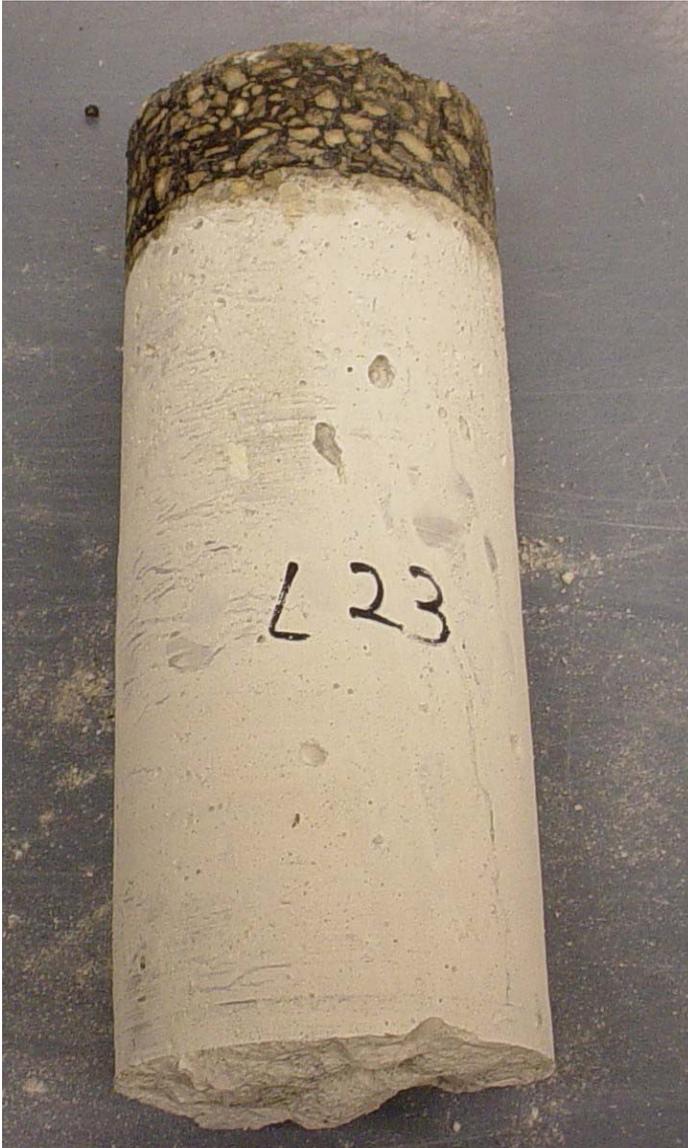
Core Number: L23

- Core height 9.5 inches, 10.03 inches without the wearing surface depth and with the 2 inch imaginary slice.
- One reinforcement bar located at 5 inches from the top surface.
- Bar is not coated and shows rust traces.
- 1.5 inch asphalt wearing surface existed at the top of the core.
- Two different concrete layers.
- The aggregate in the top concrete layer is fine, while it is coarse in the bottom layer.
- Region of moderate voids located at the upper concrete layer.

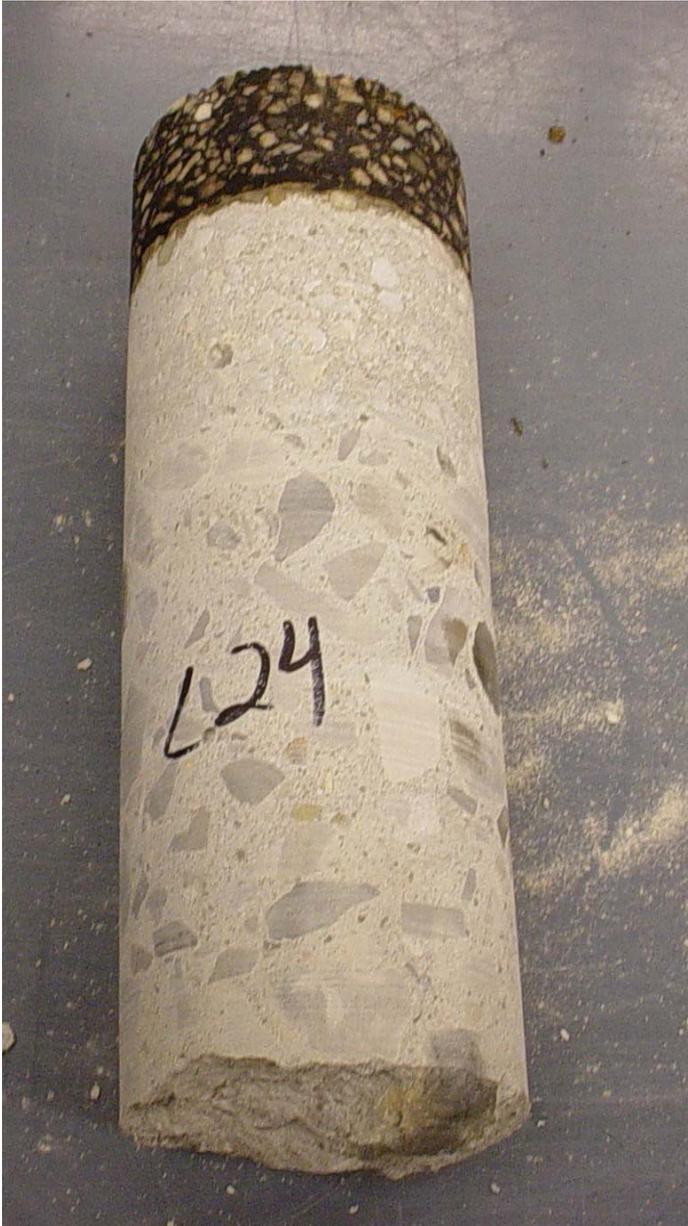
Core Number: L24

- Core height 9.5 inches, 9.97 inches without the wearing surface depth and with the 2 inch imaginary slice.
- 1.5 inch asphalt wearing surface existed at the top of the core.
- Two reinforcement bars located at 5 inches and 6 inches from the top surface.
- Region of moderate voids at upper concrete layer.
- Brown rust traces on bars.

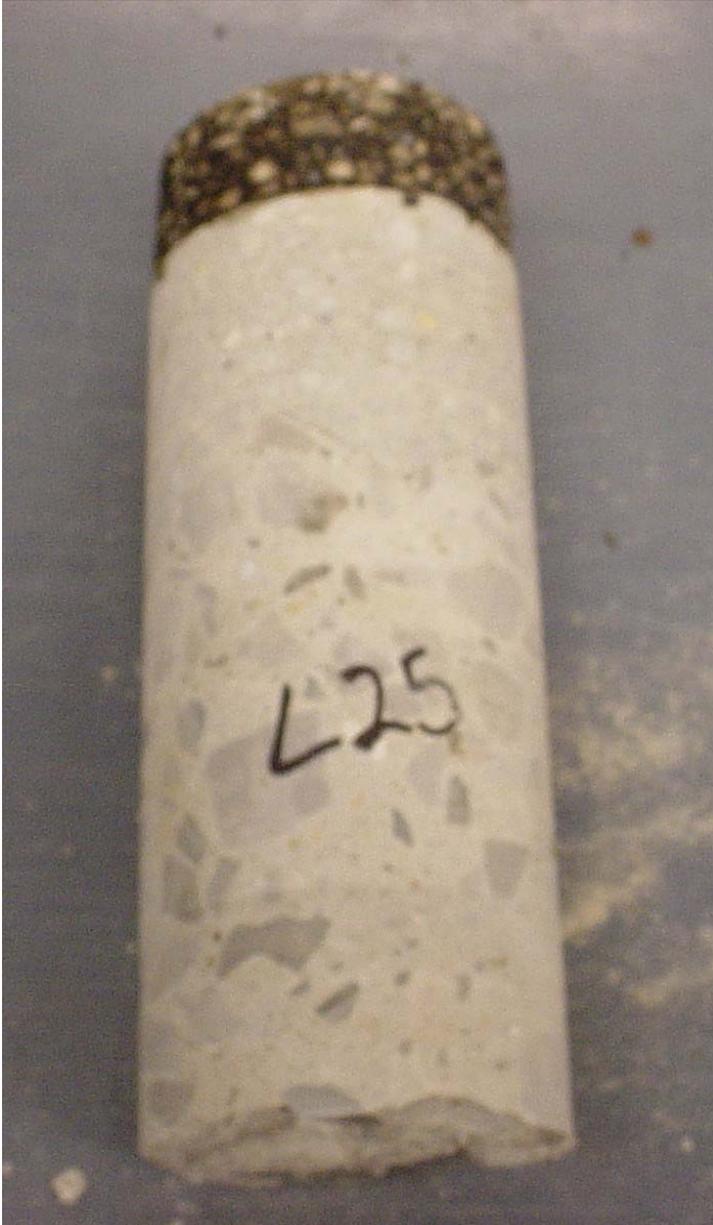
Core Number: L25

- Core length 10 inches with 1.5 inch wearing surface and 3.25 inch overlay.
- Numerous amounts of voids in overlay up to 1/4 inch in diameter.
- Concrete in good condition.

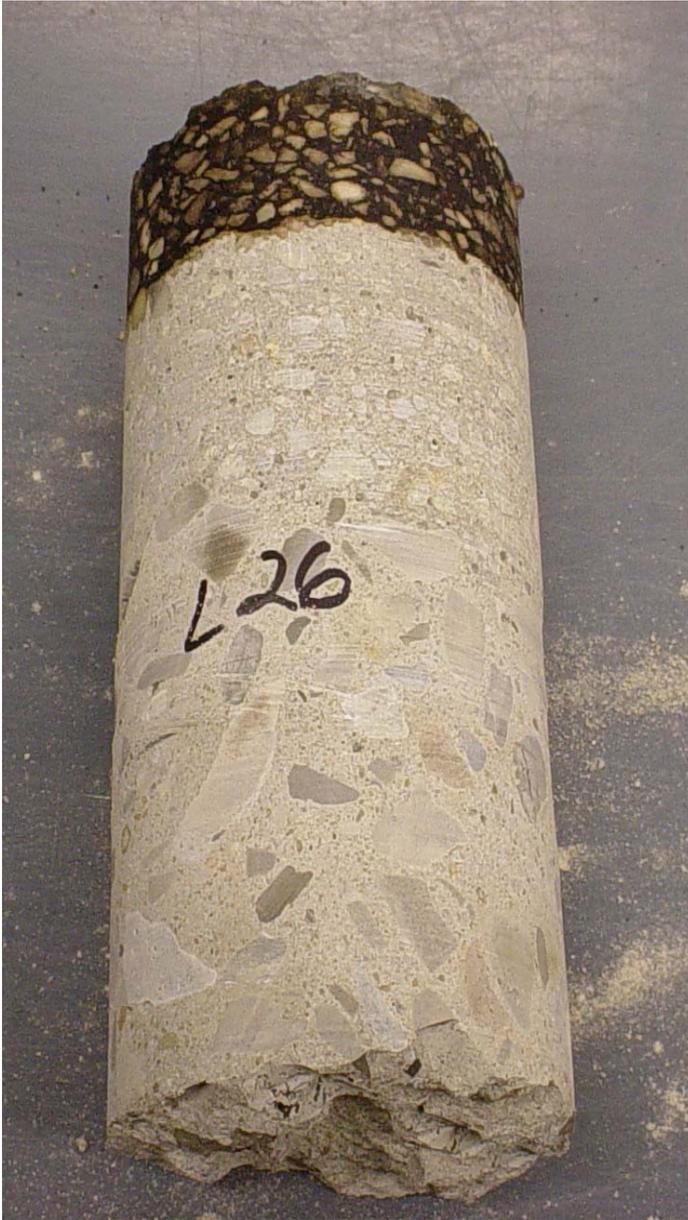
Core Number: L26

- Core height 8.75 inches, 8.97 inches without the wearing surface depth and with the 2 inch imaginary slice.
- 1.5 inch asphalt wearing surface existed at the top of the core.
- Two reinforcement bars located at 5 inches and 6 inches from top surface.
- Some rust traces existed on bars.
- Region of large size honeycombing at top layer of concrete.

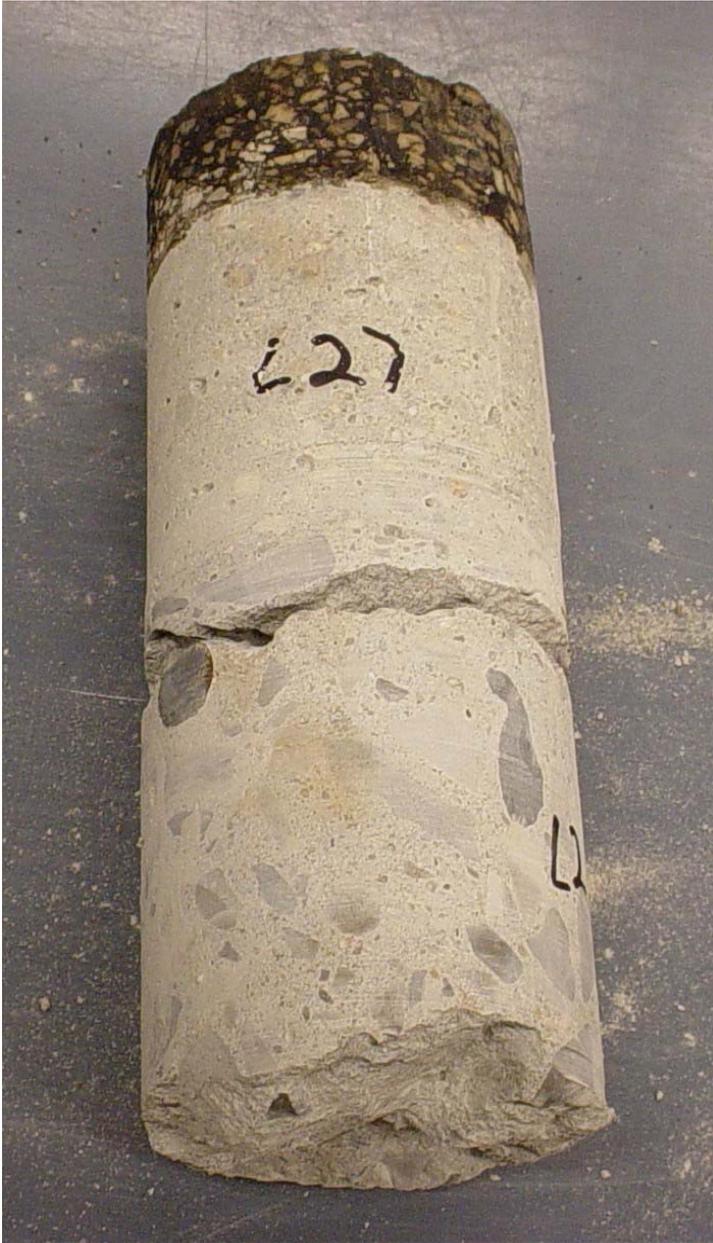
Core Number: L27

- Core length 10 inches with 1.5 inch wearing surface and 3.25 inch overlay.
- Numerous amounts of voids in overlay up to 3/8 inch in diameter.
- Numerous amounts of voids in concrete up to 3/16 inch in diameter.
- Core fractured 5.5 inches from the top due to heavy rusting of rebar and numerous voids.
