Evaluation of Stay-in-Place Metal Forms

for the
Ohio Department of Transportation
Office of Research and Development

State Job Number 134155

Final Report
FHWA/OH – 2006/13
May 2006

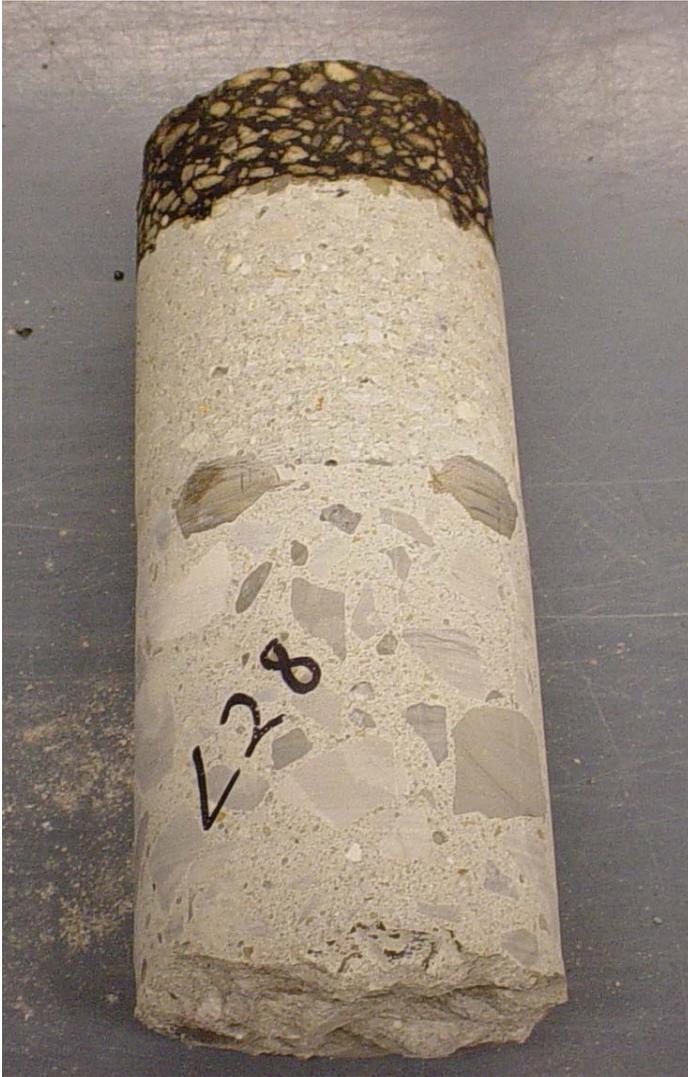
Core Number: L28

- Core height 10 inches, 10.22 inches without the wearing surface depth and with the 2 inch imaginary slice.
- 1.5 inch asphalt wearing surface existed at the top of the core.
- One reinforcement bar located at 5 inches from top surface.
- Bar is not coated and shows some rust traces.
- Region of small to moderate voids at top concrete surface.

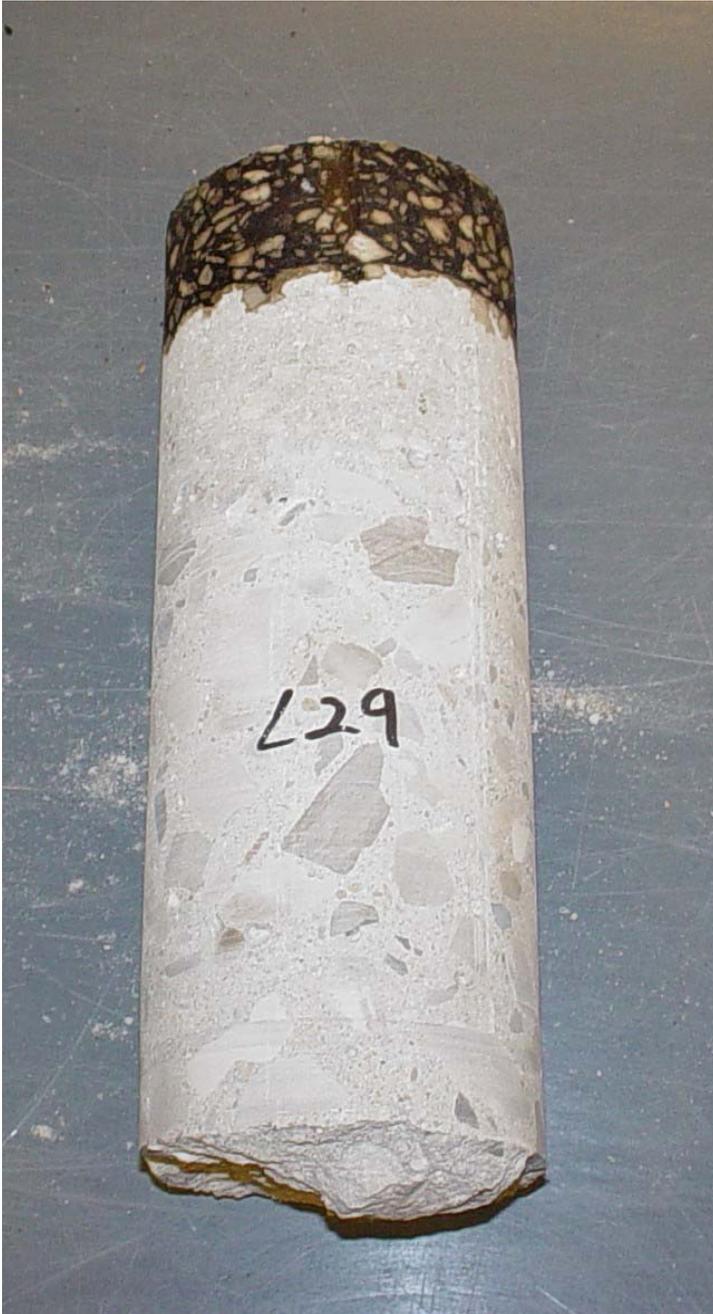
Core Number: L29

- Core length 10.25 inches with 1.5 inch wearing surface and 3 inch overlay.
- Numerous amounts of voids in overlay up to 3/8 inch in diameter.
- Numerous amounts of voids in concrete up to 1/8 inch in diameter.

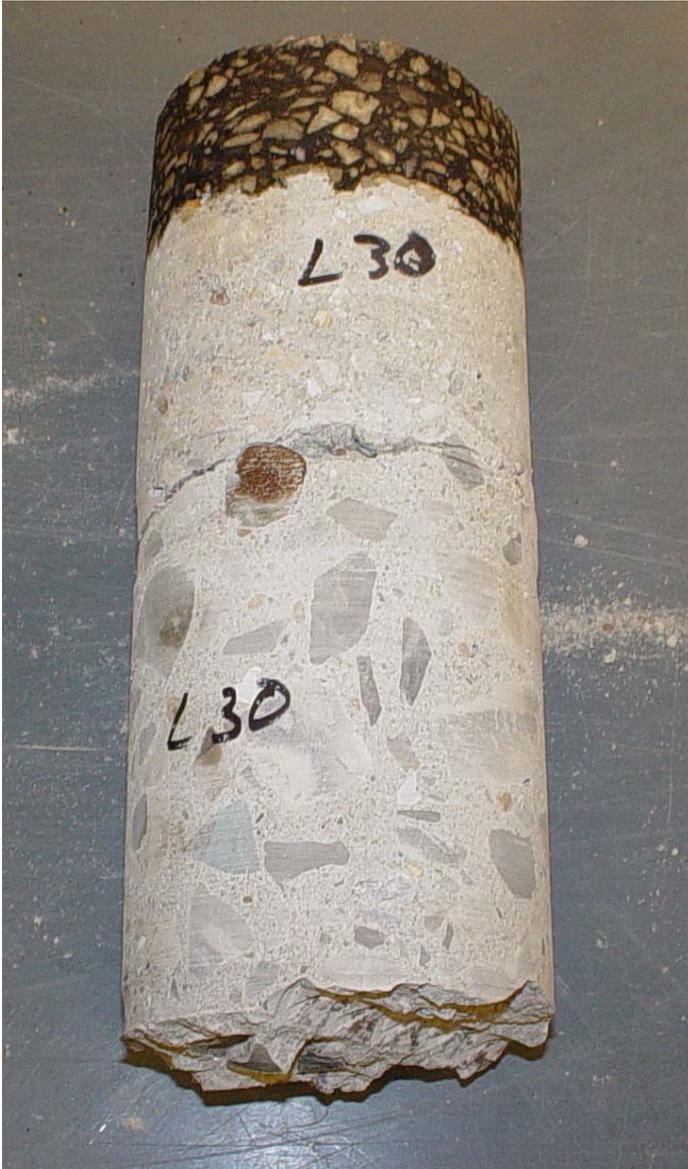
Core Number: L30

- Core length 10 inches with 1.5 inch wearing surface and 3 inch overlay.
- Rebar heavily rusted.
- Core fractured 4.5 inches from the top where the overlay meets the concrete. Fracture due to heavy rusting of rebar.
- Numerous amounts of voids in overlay up to 1/4 inch in diameter.
- Numerous amounts of voids in concrete up to 1/8 inch in diameter.

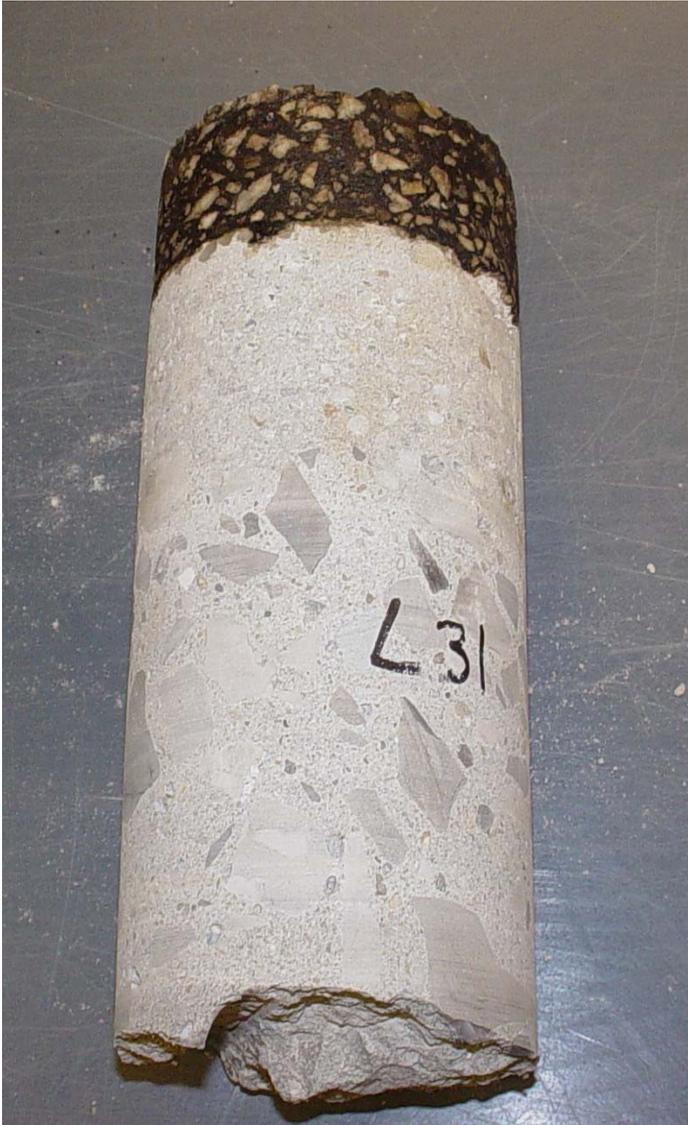
Core Number: L31

- Core height 8.75 inches, 9.15 inches without the wearing surface depth and with the 2 inch imaginary slice.
- Region of small to moderate voids at top concrete surface.
- One reinforcement bar located at 5 inches from the top surface.
- Some rust at edges of reinforcement bars.
- Region of honeycombing.
- Region of small to moderate voids at upper concrete layer.

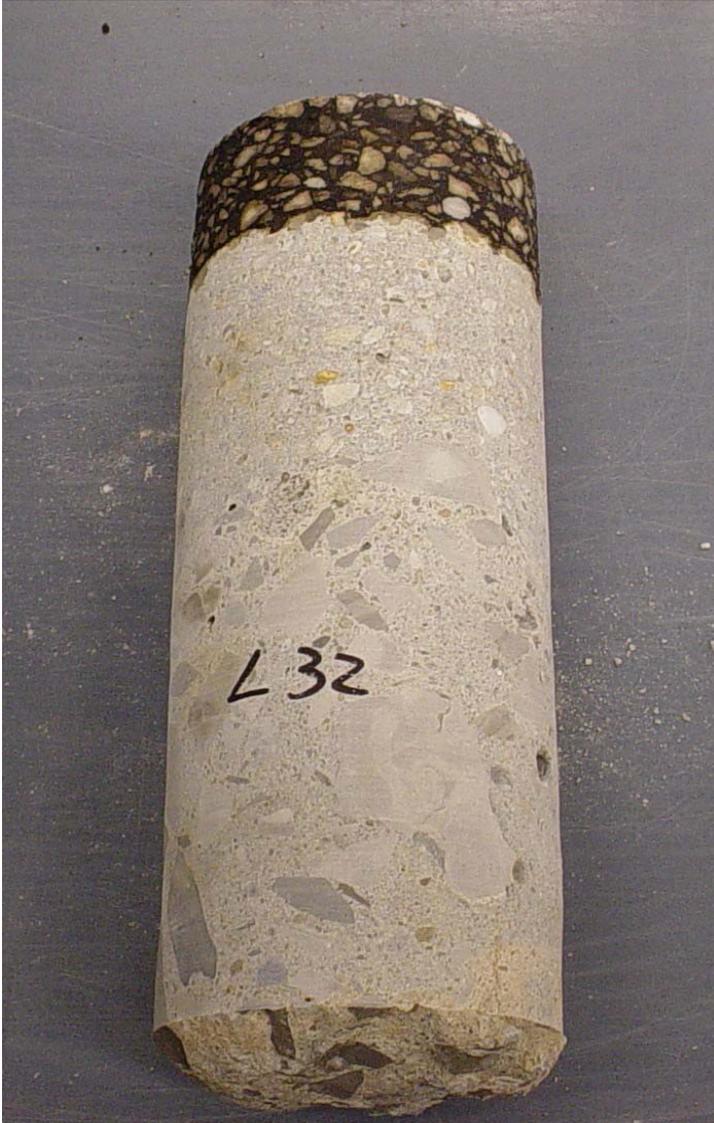
Core Number: L32

- Core length 10.5 inches with 1.5 inch wearing surface and 3.5 inch overlay.
- Numerous amounts of voids in overlay up to 1/2 inch in diameter.
- Numerous amounts of voids in concrete up to 1/4 inch in diameter.

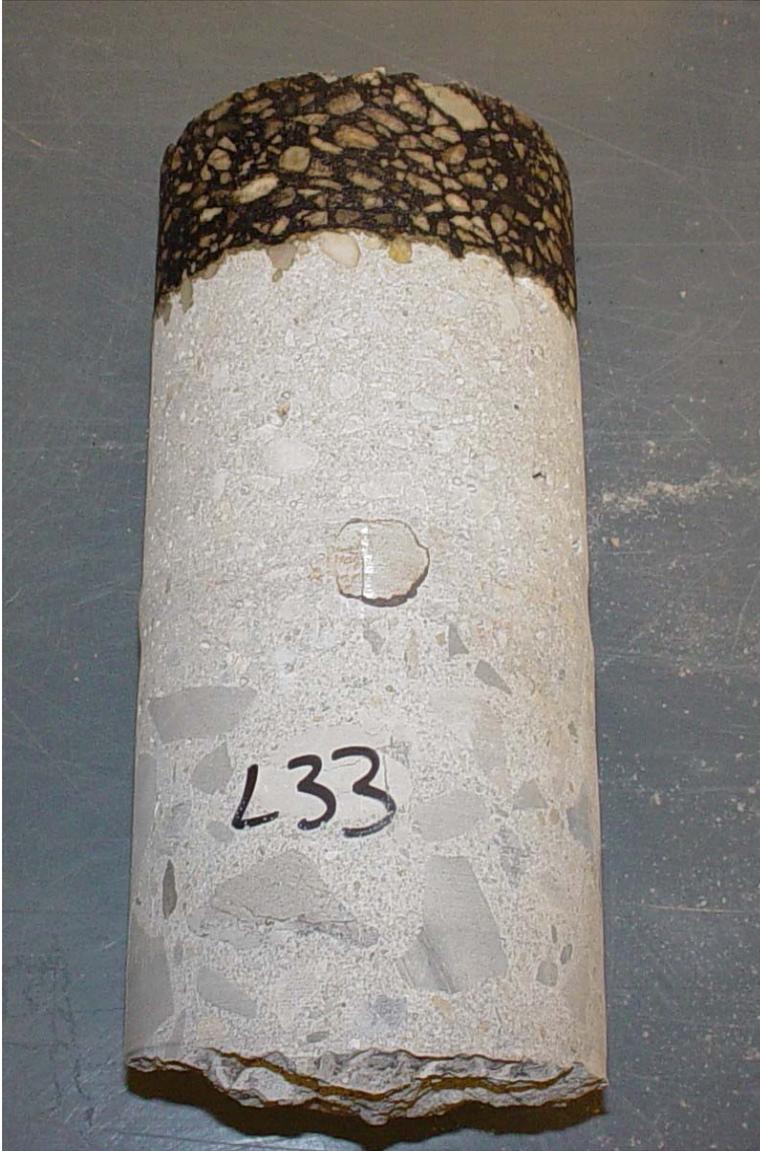
Core Number: L33

- Core length 9.75 inches with 1.75 inch wearing surface and 3.5 inch overlay.
- Rebar shows traces of rust.
- Numerous amounts of voids in overlay up to 5/8 inch in diameter.
- Numerous amounts of voids in concrete up to 1/4 inch in diameter.

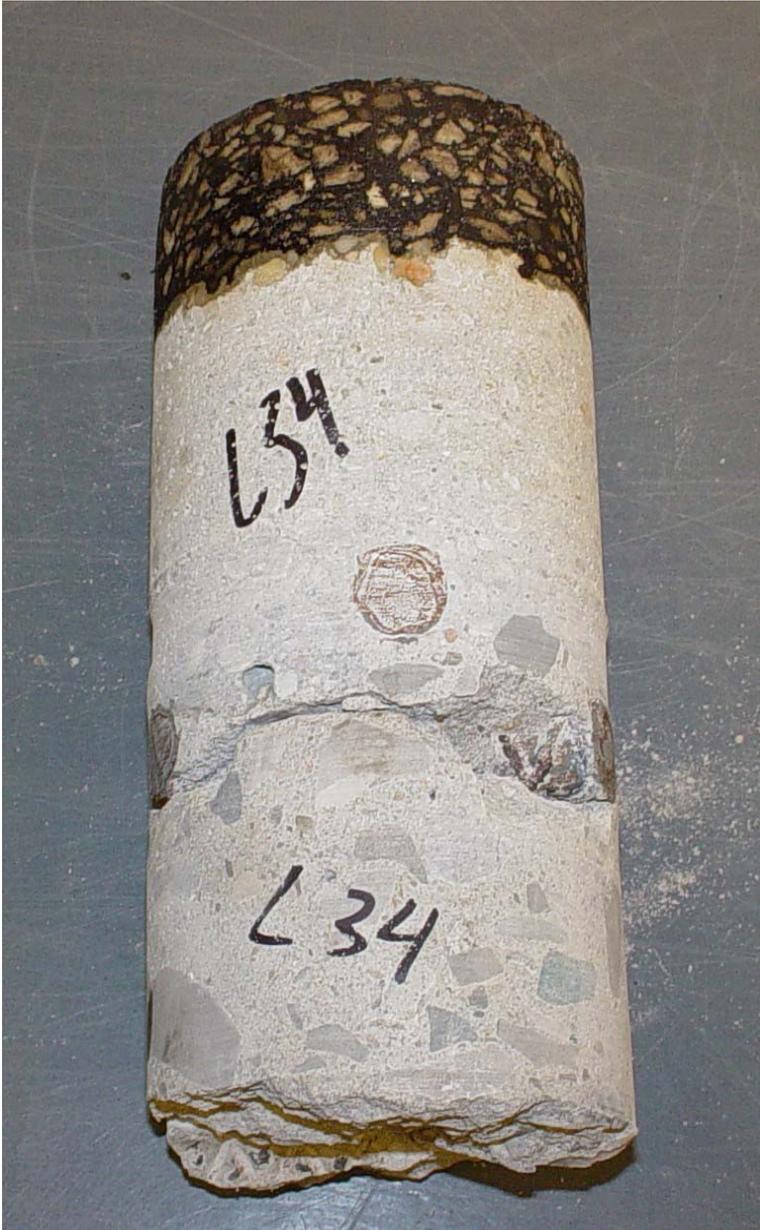
Core Number: L34

- Core length 8 inches with 1.5 inch wearing surface and 3 inch overlay.
- Rebar severely rusted.
- Core fractured 5 inches from the top due to heavy rusting of rebar.
- Numerous amounts of voids in overlay up to 1/8 inch in diameter.

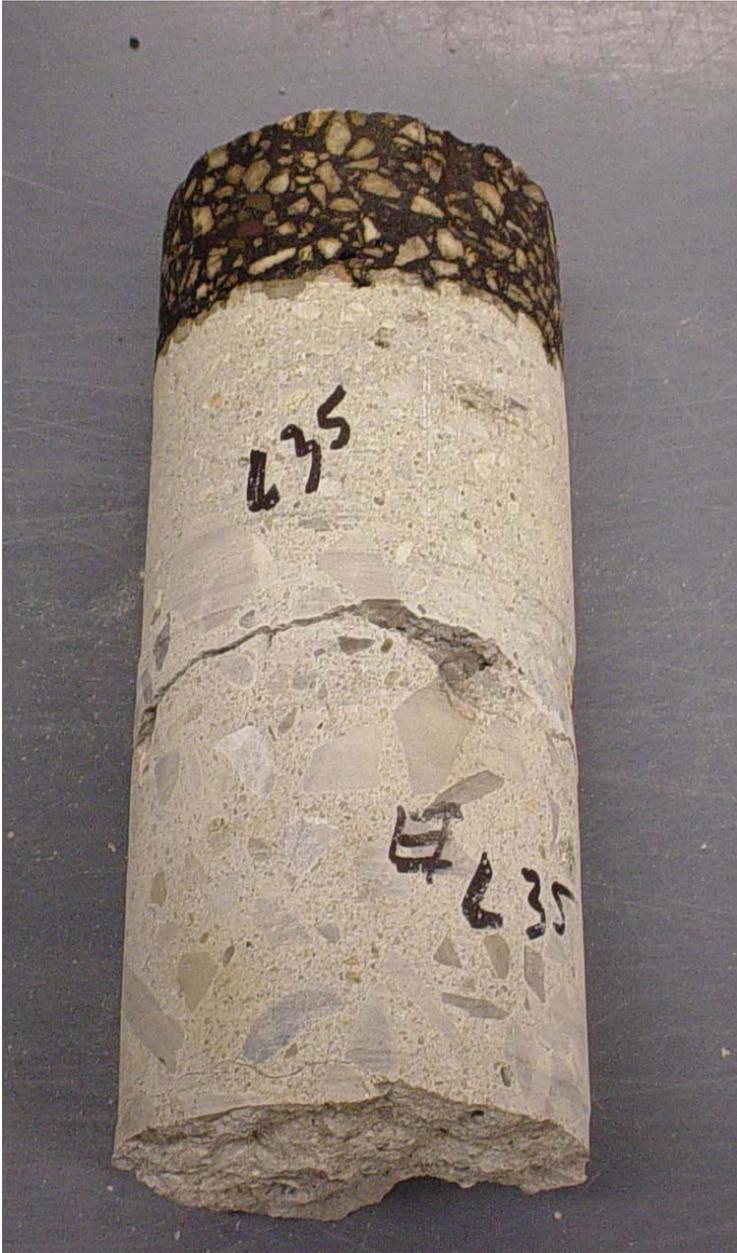
Core Number: L35

- Core length 8.75 inches with 1.5 inch wearing surface and 3 inch overlay.
- Rebar severely rusted.
- Core fractured 5.25 inches from the top due to heavy rusting of rebar.
- Numerous amounts of voids in overlay up to 1/4 inch in diameter.
- Numerous amounts of voids in concrete up to 1/8 inch in diameter.

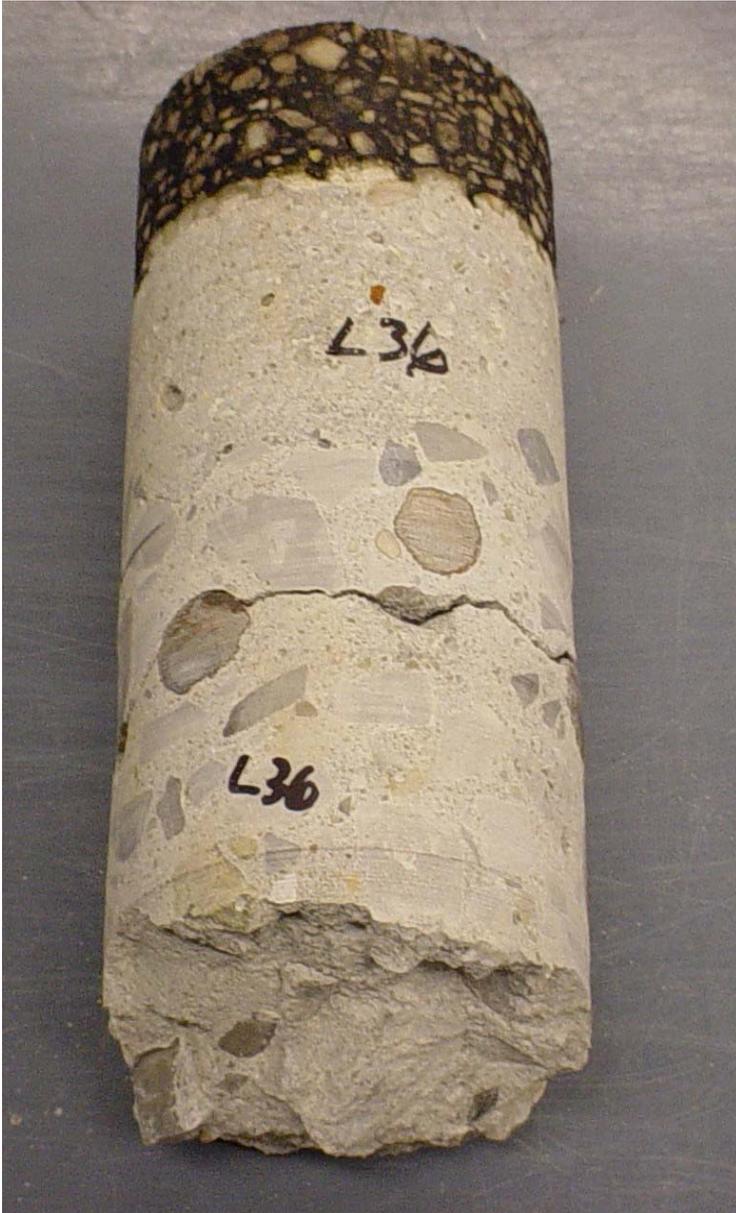
Core Number: L36

- Core length 9 inches with 1.5 inch wearing surface and 3 inch overlay.
- Rebar severely rusted.
- Core fractured 5 inches from the top due to heavy rusting of rebar.
- Large void where overlay meets concrete. Void is 1/2 inch in diameter and 3/4 inch deep.
- Numerous amounts of voids in overlay up to 1/4 inch in diameter.
- Numerous amounts of voids in concrete up to 1/8 inch in diameter.

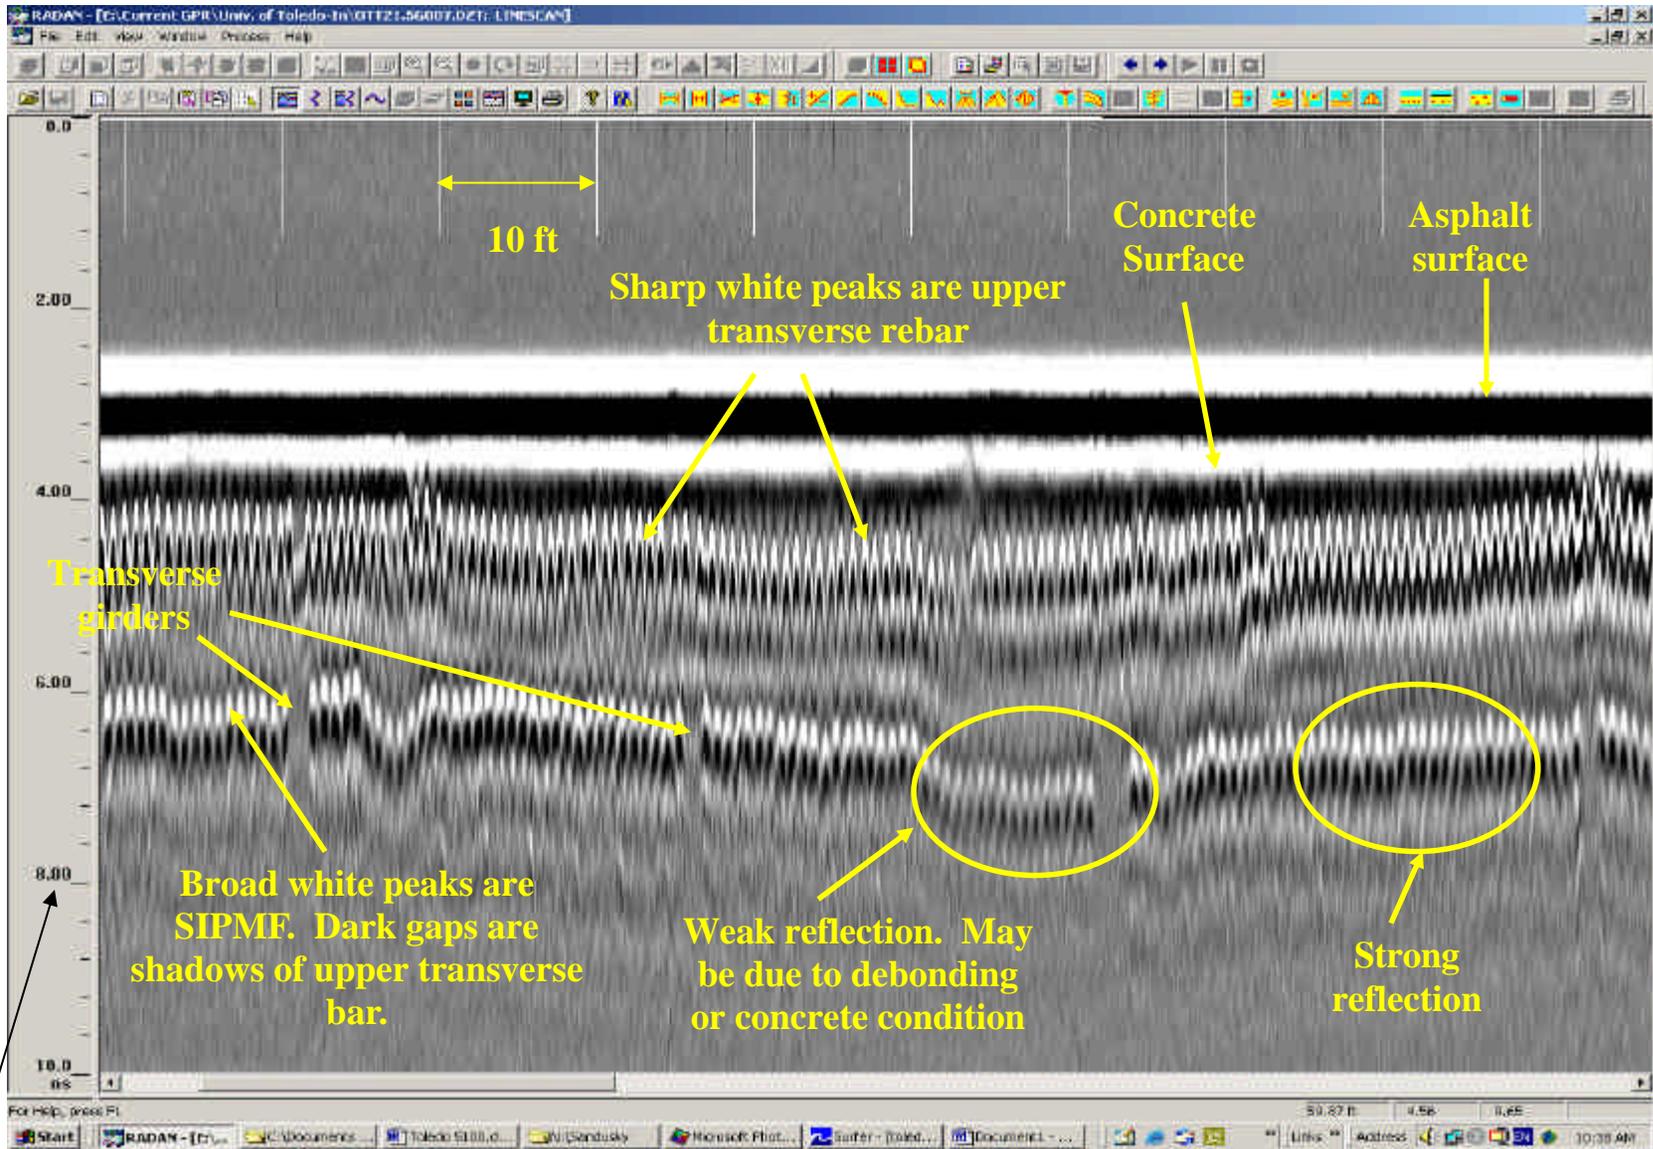
The GPR Scan analysis results shown in Figures 2 and 3 illustrate typical examples of weak and strong signal returns from the SIPMF.

Figure 2. Typical GPR scan showing strong and weak signal returns from the SIPMF (1500 MHz Ground Coupled Antenna)

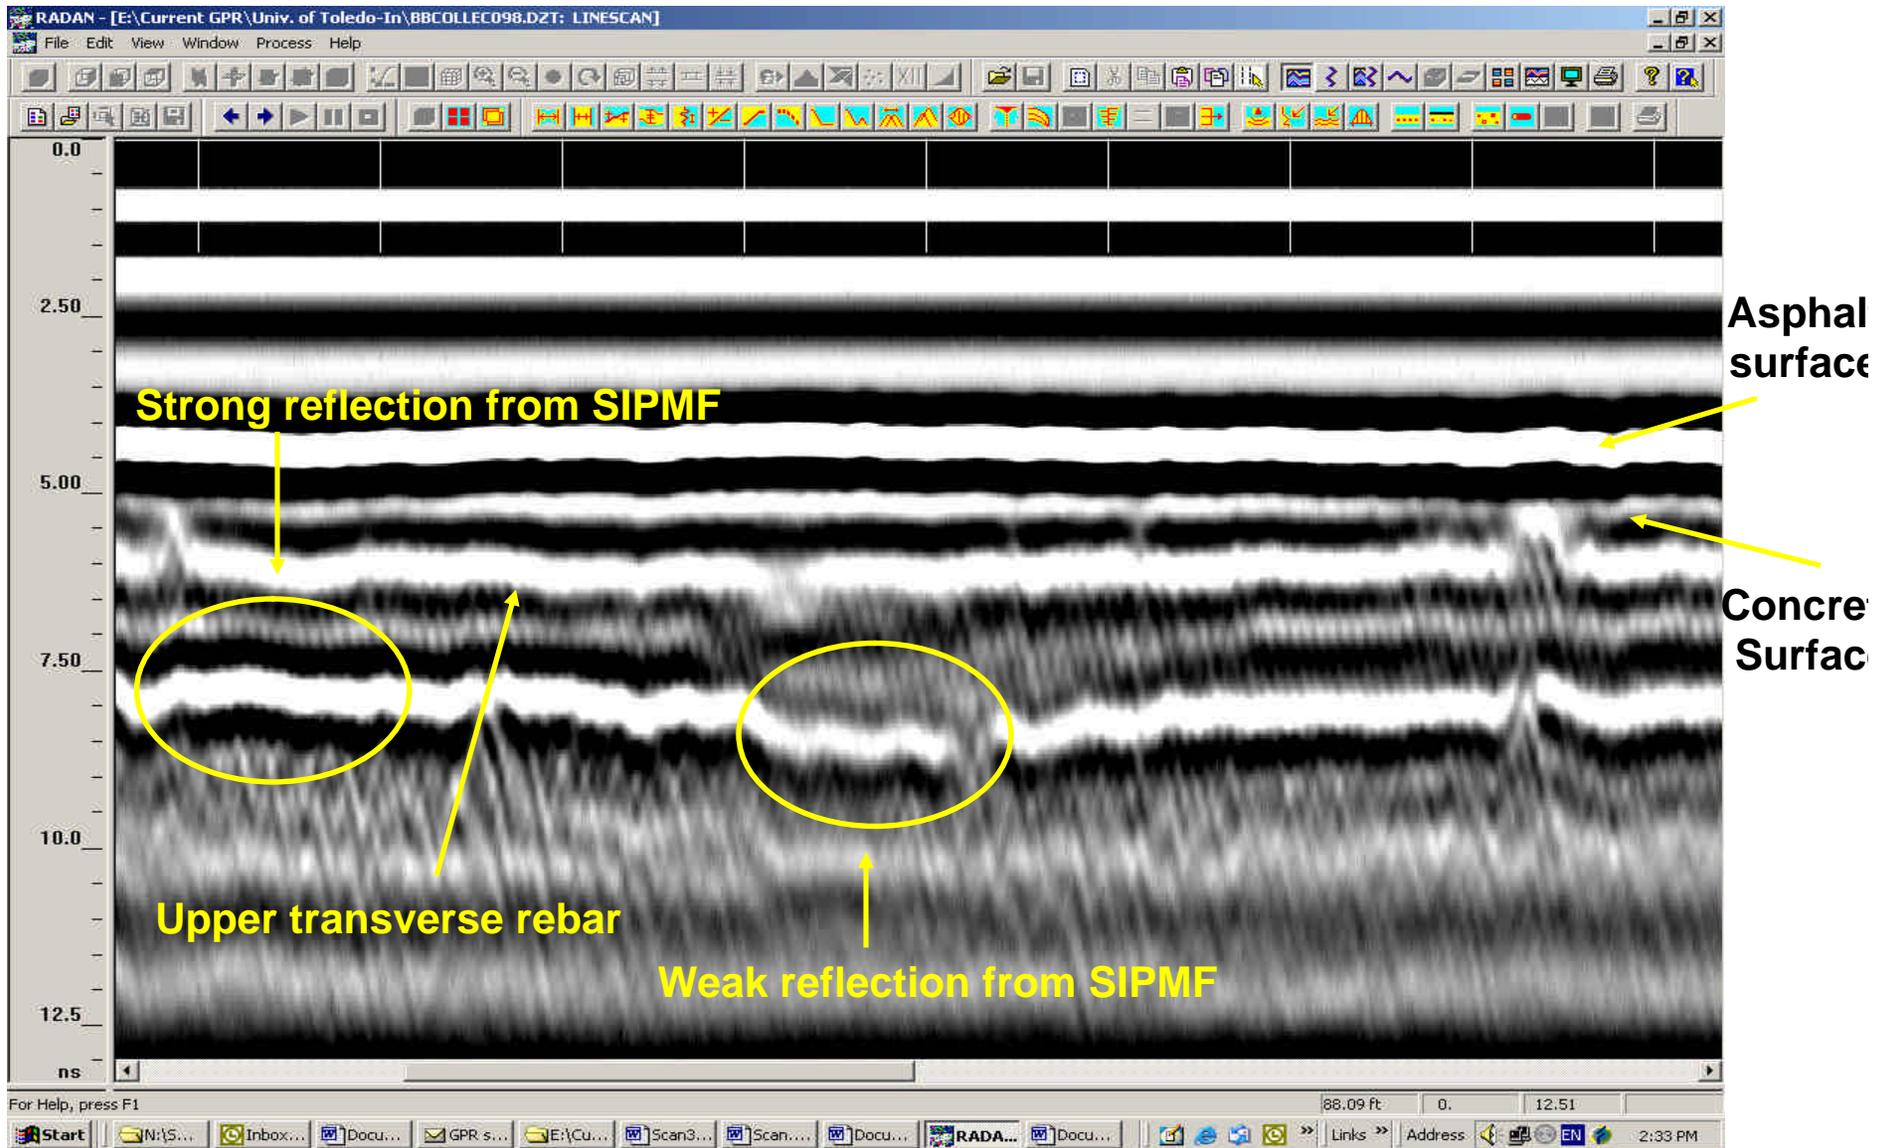
Figure 4. Typical GPR scan showing strong and weak signal returns from the SIPMF (1000 MHz Air Launched Antenna)

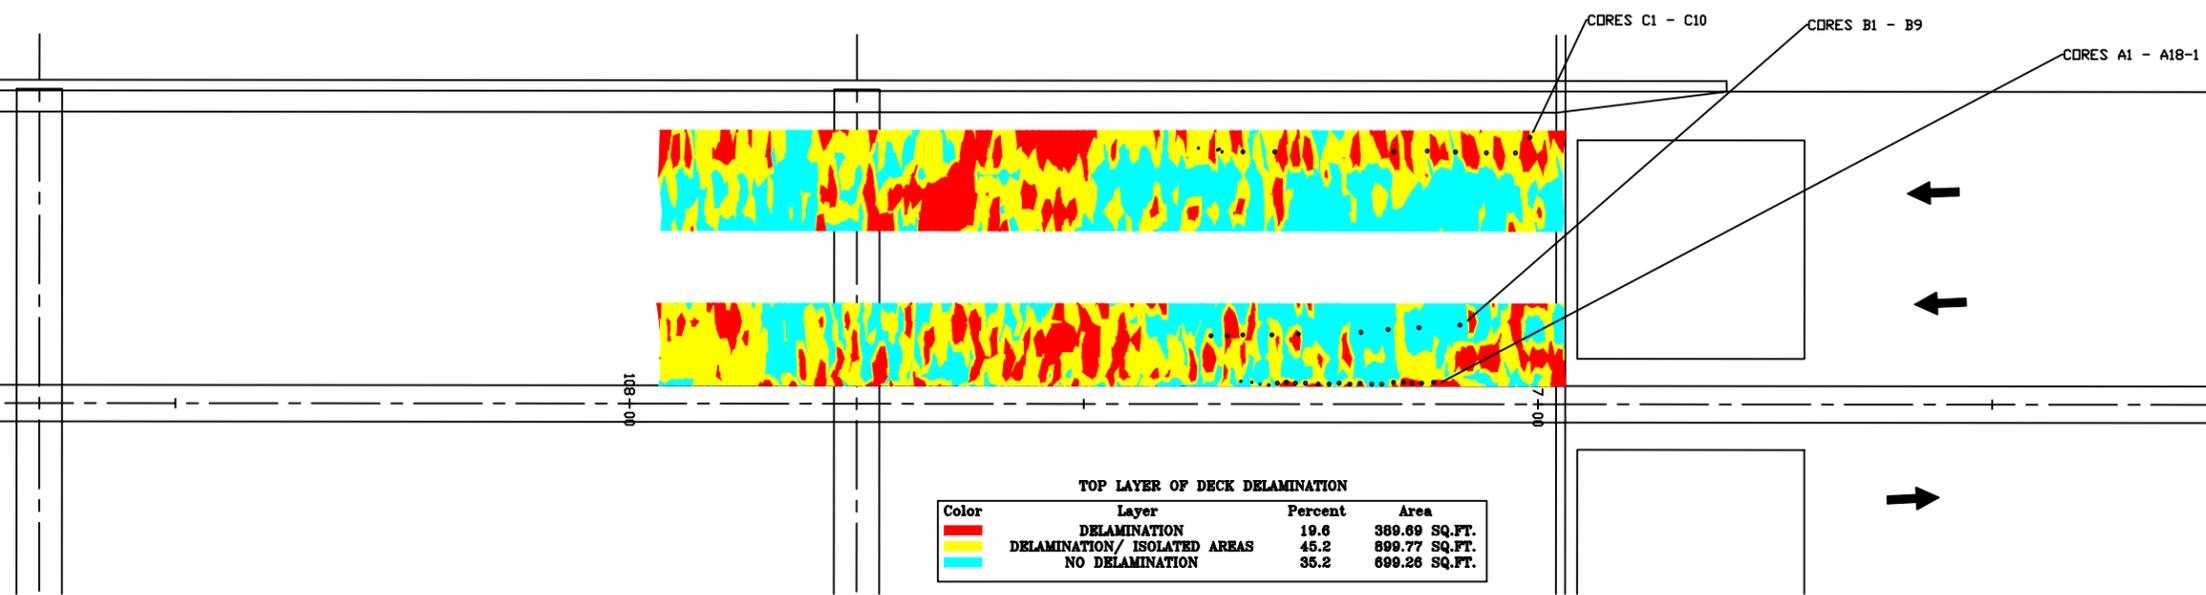
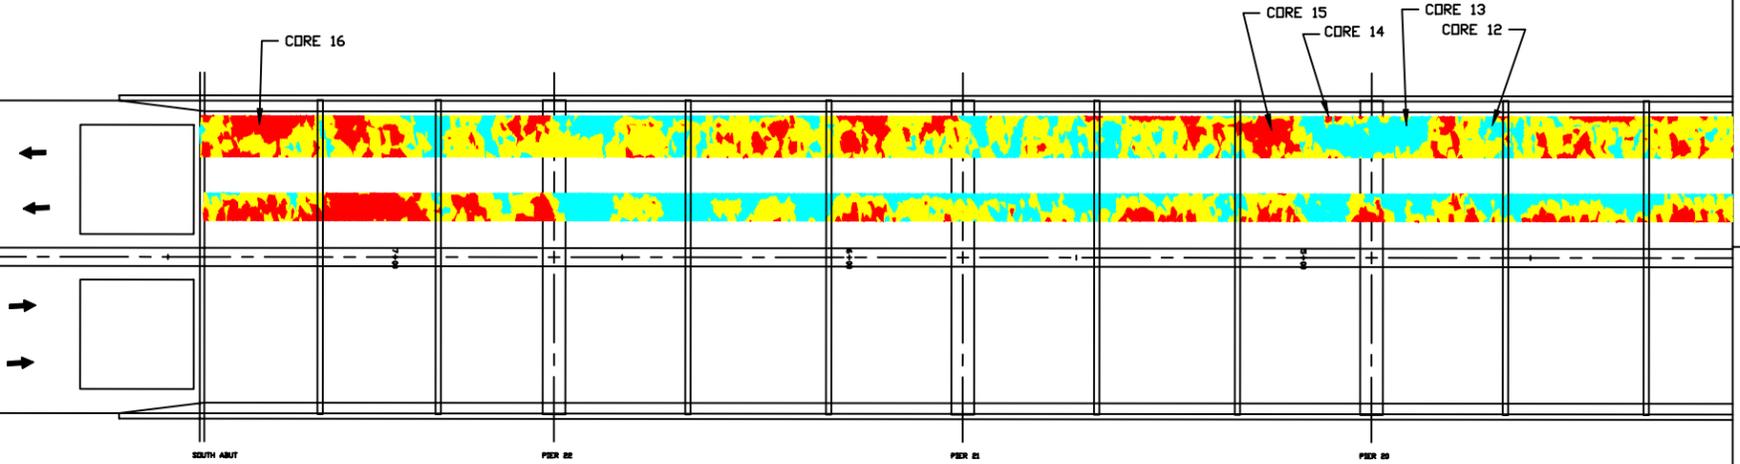
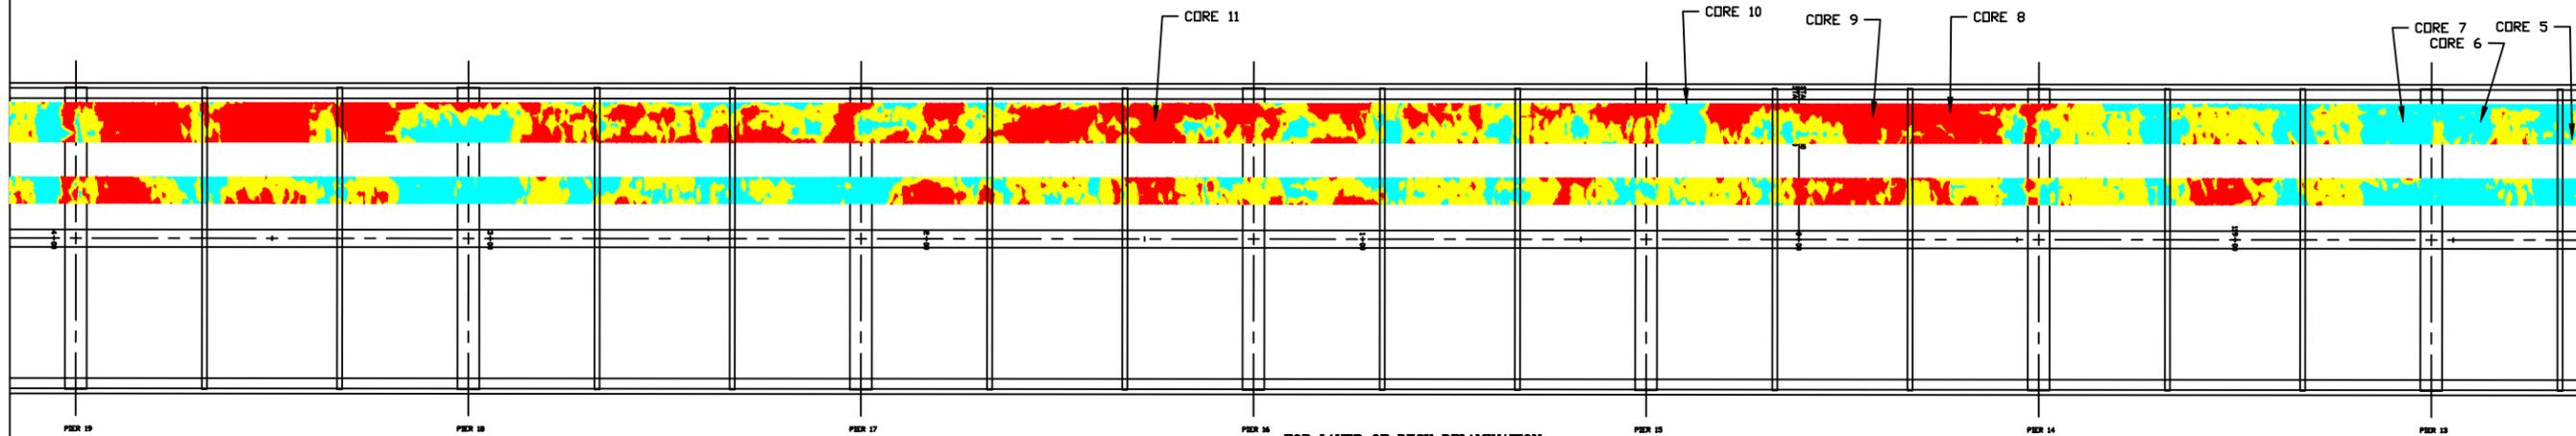
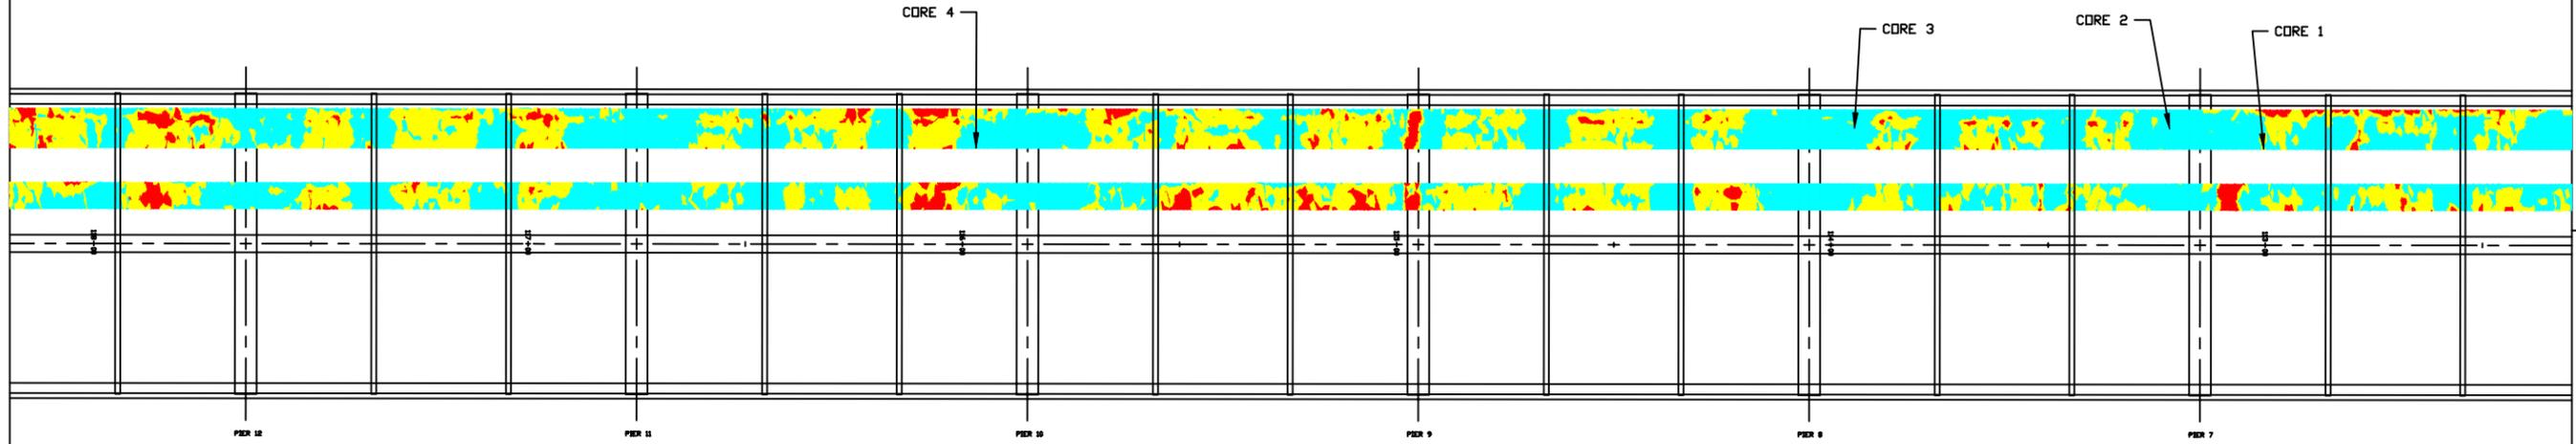
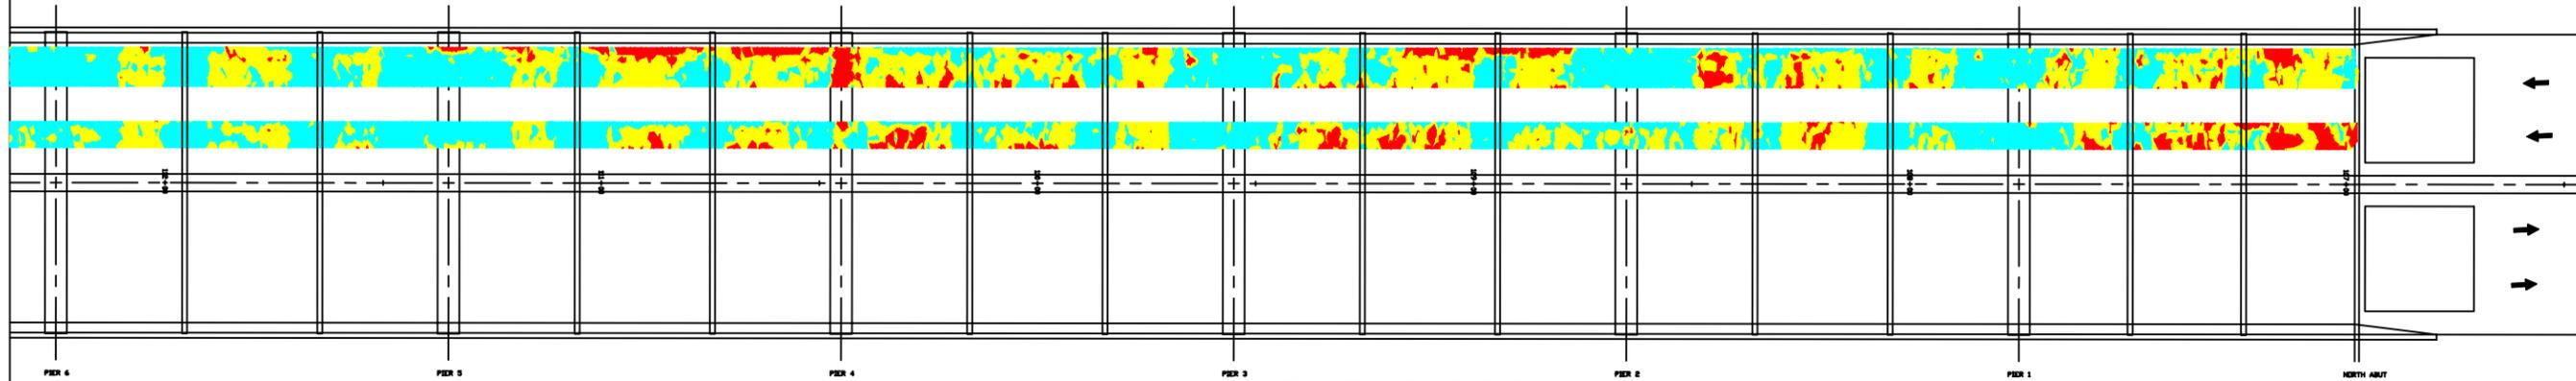
DELAMINATION MAP \ TOP OF DECK

Delamination – the areas of the deck where delamination in the concrete was observed from the GPR data, represented by the areas shaded red.

No Delamination – the areas of the deck where no delamination in the concrete was observed from the GPR data, represented by the areas shaded light blue.

The results of bridge deck evaluation shown in Figures 4, 5a, 5b, 5c and 5d indicate that the percent delaminations of the deck areas are as follows:

Description	Top of Deck
Area of Delamination	15.7%
Area of isolated Delaminations	43.7%
Area of No Delamination	40.6%

Color	Layer	Percent	Area
Red	DELAMINATION	15.7	4808.11 SQ.FT.
Yellow	DELAMINATION/ ISOLATED AREAS	43.7	13398.66 SQ.FT.
Cyan	NO DELAMINATION	40.6	12466.48 SQ.FT.
