Evaluation of Stay-in-Place Metal Forms

for the
Ohio Department of Transportation
Office of Research and Development

State Job Number 134155

Final Report
FHWA/OH – 2006/13
May 2006

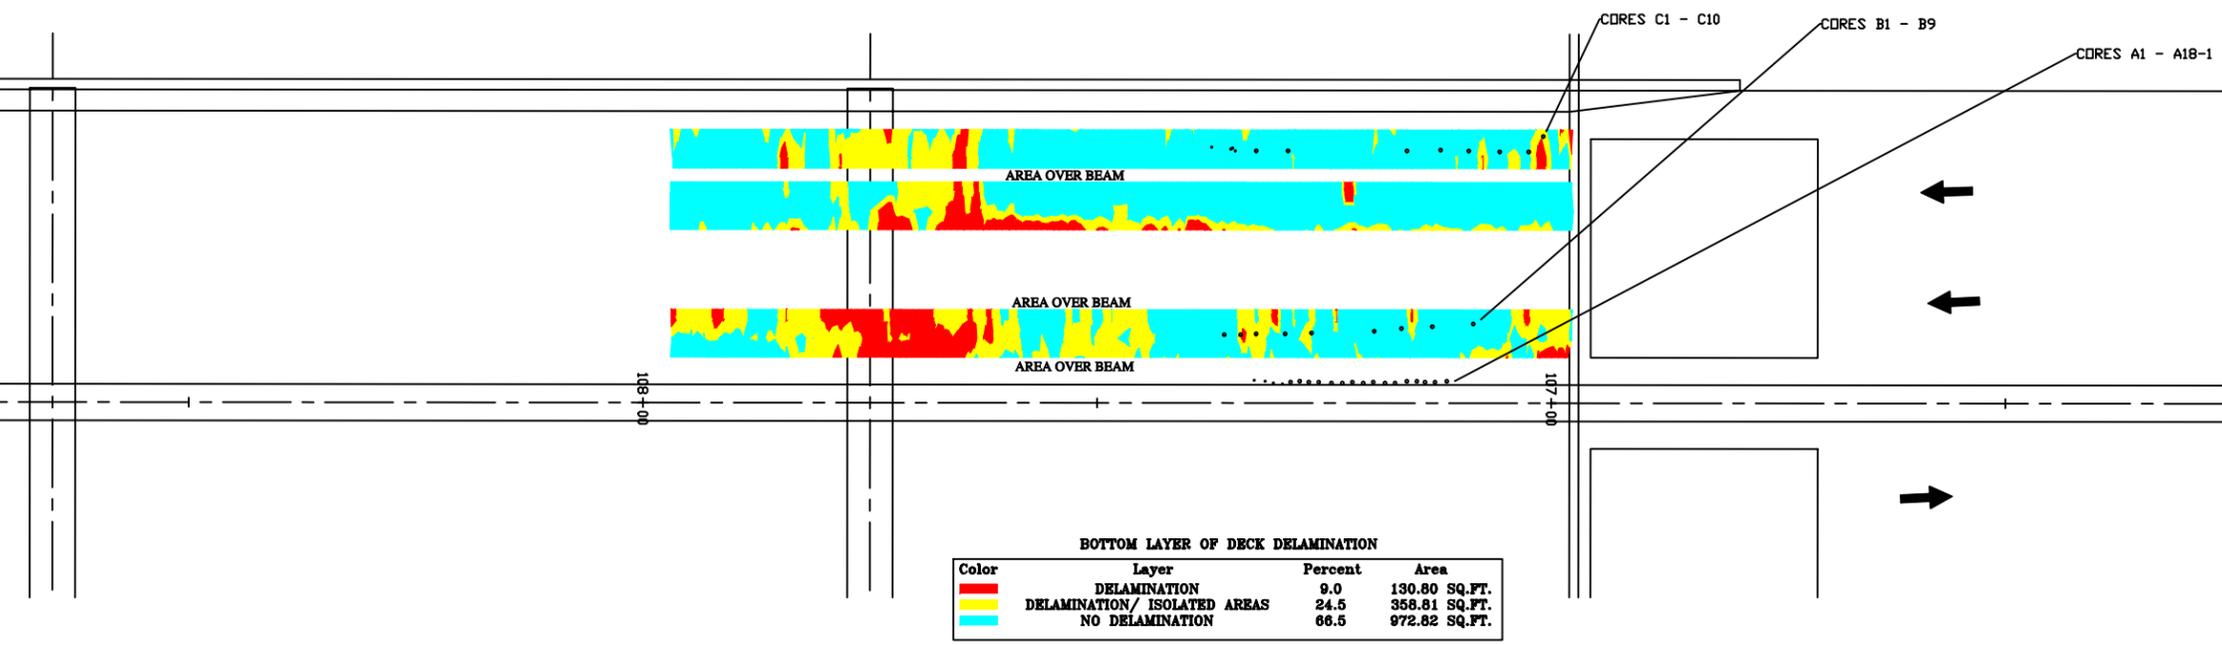
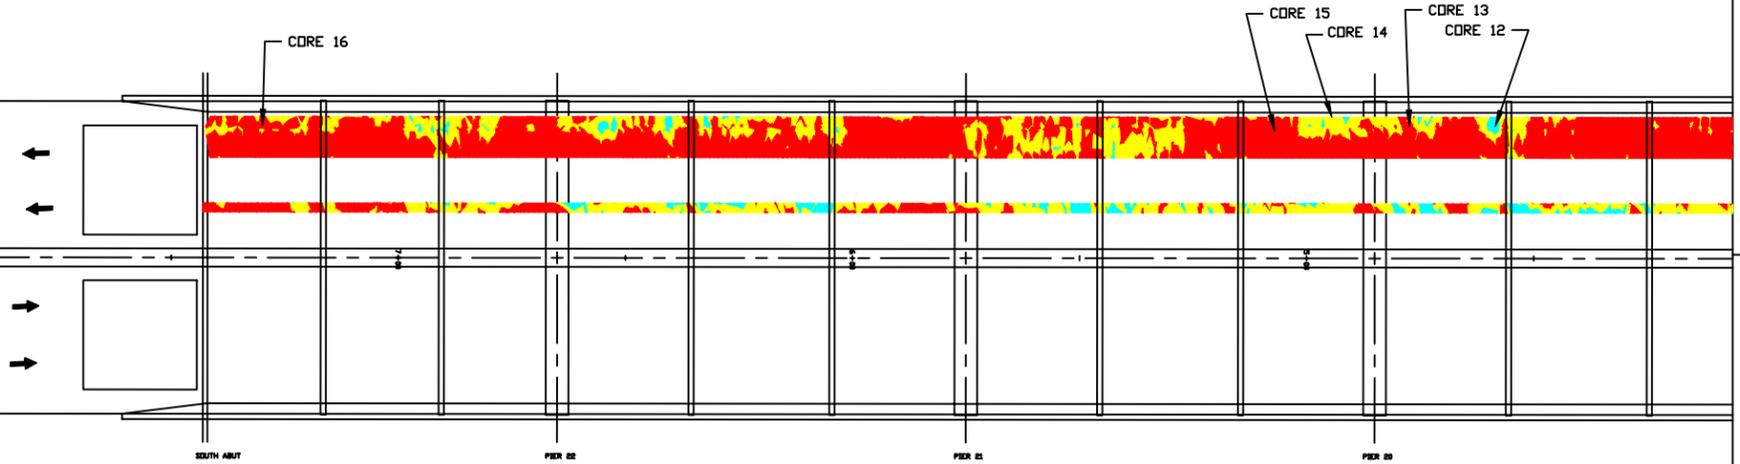
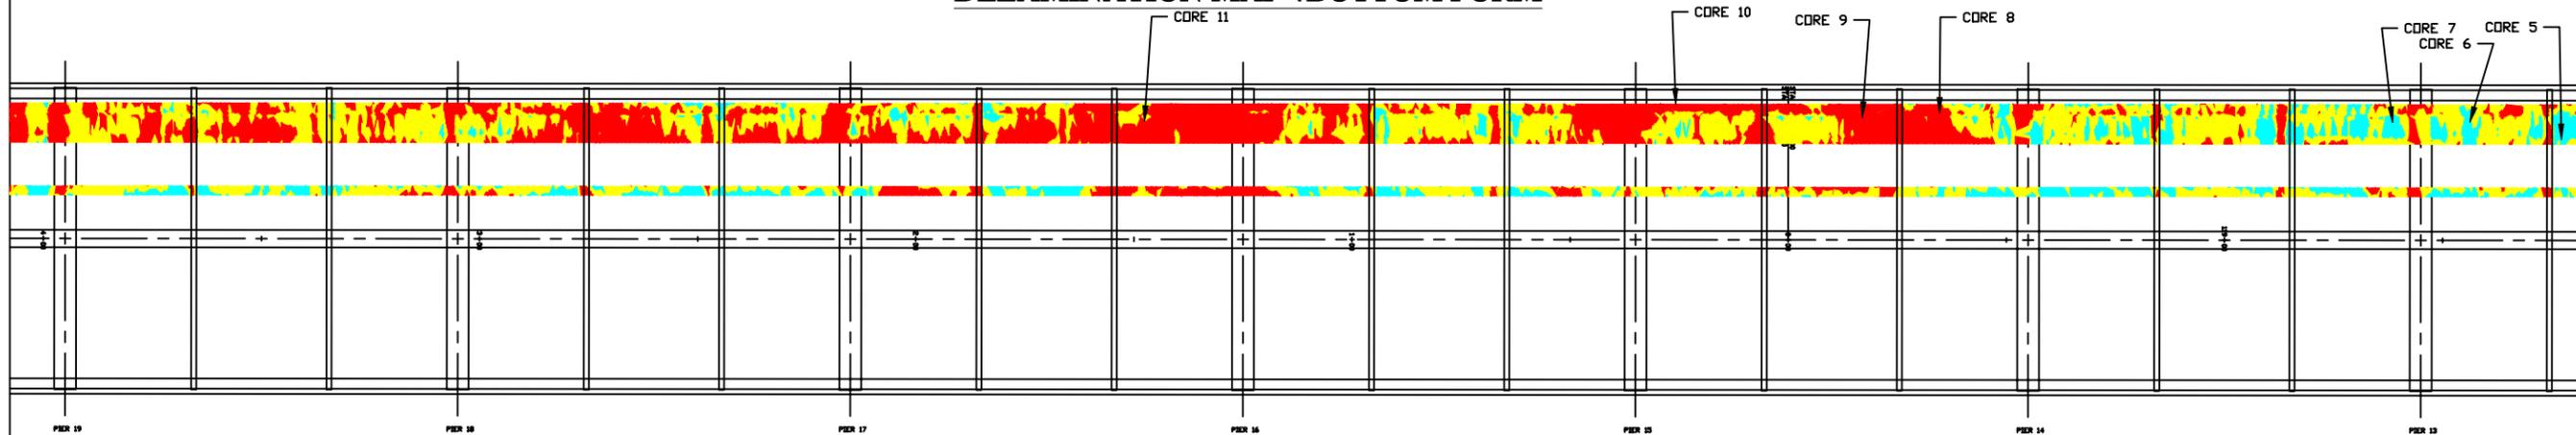
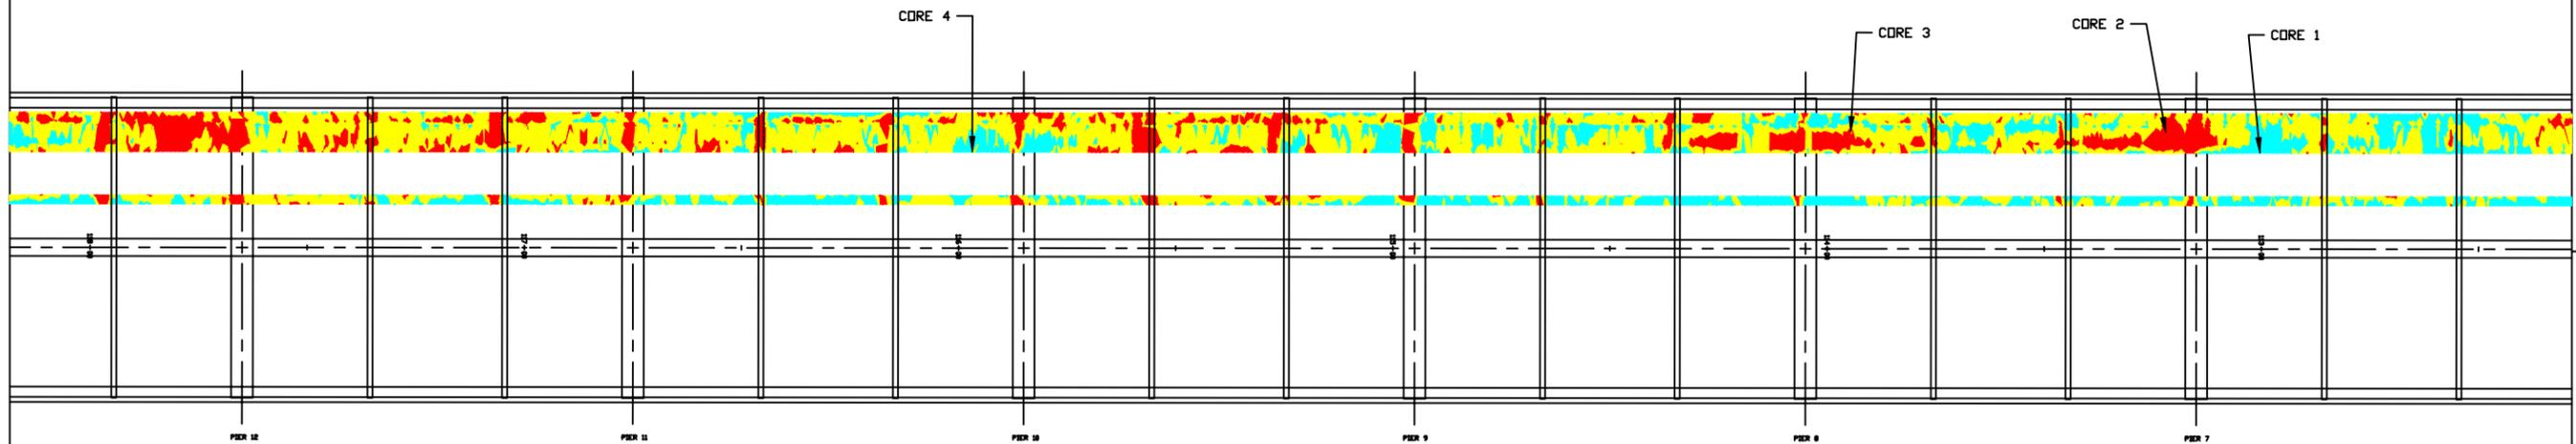
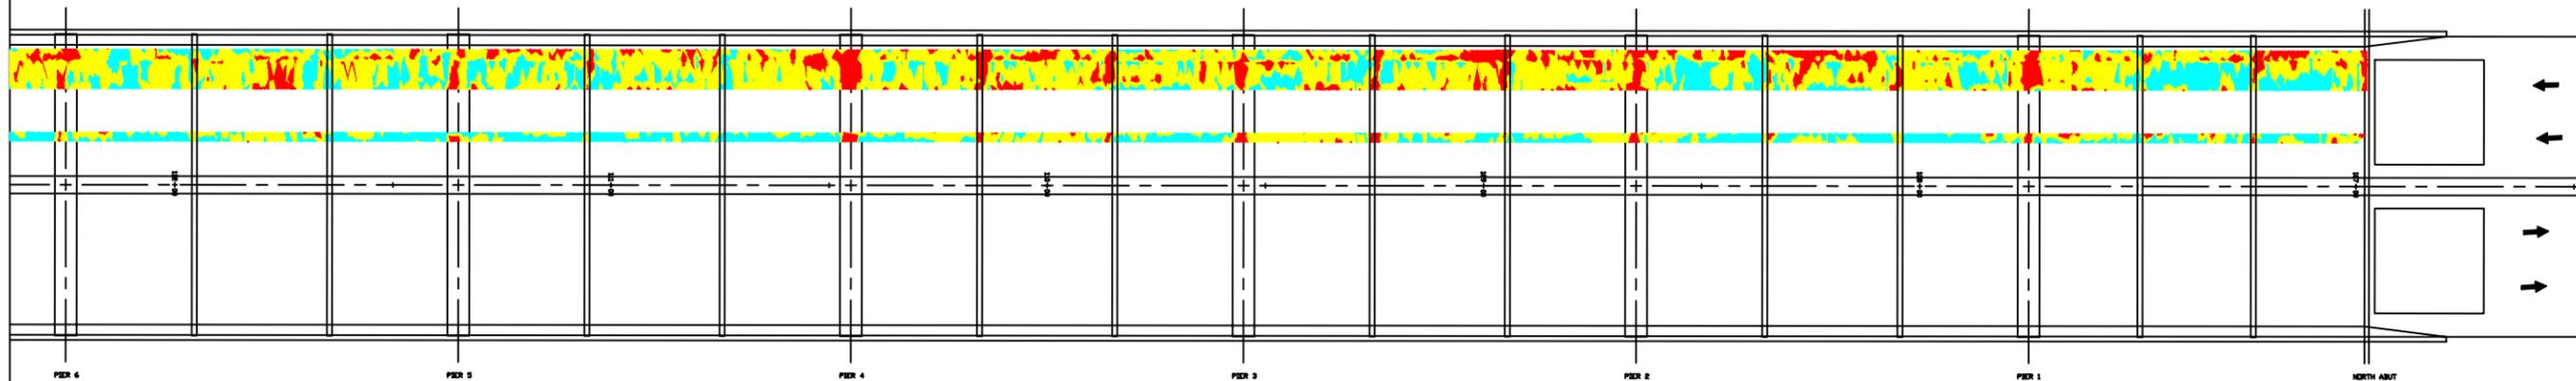
DELAMINATION MAP \ BOTTOM FORM

Description	Bottom form
Area of Delamination	30.8%
Area of isolated Delaminations	51.7%
Area of No Delamination	17.6%

Color	Layer	Percent	Area
Red	DELAMINATION	30.8	6917.53 SQ.FT.
Yellow	DELAMINATION/ ISOLATED AREAS	51.7	11621.48 SQ.FT.
Cyan	NO DELAMINATION	17.6	3949.52 SQ.FT.
