The Ohio Department of Transportation Office of Research & Development Executive Summary Report

Monitoring of Bridge Abutment Walls at SR 33 over East State St. (Athens, Ohio)

Start Date: February 1, 2005
Duration: Approx. 25 months
Completion Date: March 1, 2007
Report Date: March 20, 2007
State Job Number: 505953(0)

Report Number: FHWA-OH-2007/02

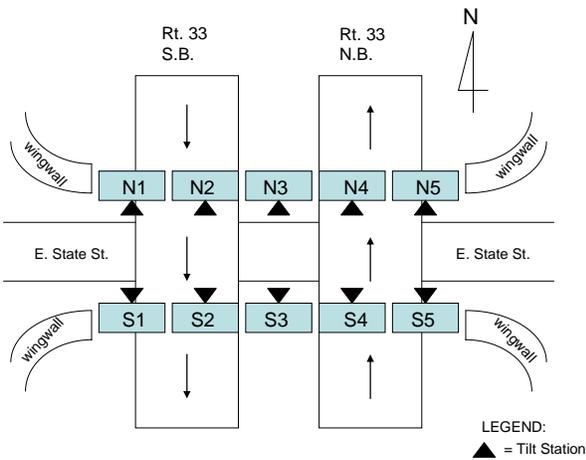
Figure 3: Locations of Tilt Stations

An accelerometer-based tilt measurement system (Digi-Tilt by Slope Indicator, Seattle, Washington; shown in Figure 2) was utilized to measure accurately the degree of tilt of each abutment wall panel. Figure 3 shows the general locations of the ten (10) measurement stations.

The tilt-meter readings collected during the project showed that most of the abutment wall panels had remained stable over the two-year period. Only the abutment wall panels N-1, N-3, and S-1 experienced small rotational movements initially. The manual measurements taken at the top of the abutment walls suggested that the abutment wall panels N-1, N-5, S-1, and S-5 might have moved slightly during the initial period. The visual inspections conducted on April 25 and Aug. 16, 2006 identified no new cracks on the abutment wall panels at the site. These facts point out that these bridge abutment walls have been very stable during the life of the current project (which also included the abutment wall performance in the post-rehabilitation work period).
