Report No. KS-07-5
FINAL REPORT

FINITE ELEMENT ANALYSIS OF FATIGUE PRONE DETAILS OF THE TUTTLE CREEK BRIDGE

November 2007

KANSAS DEPARTMENT OF TRANSPORTATION

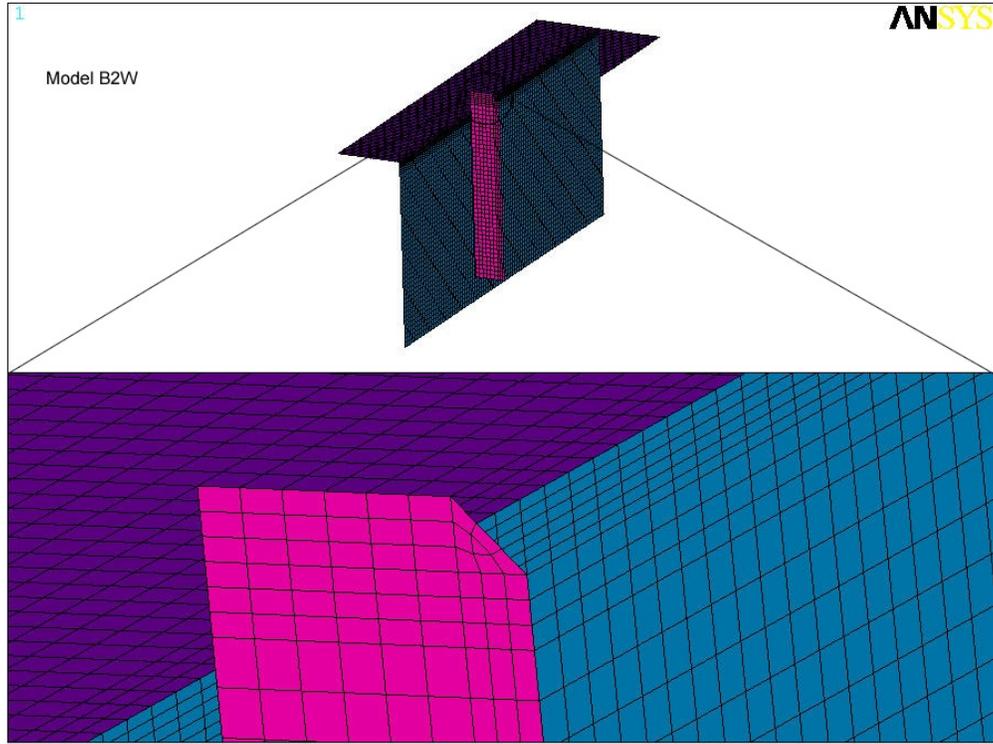
Figure 4.1: Pre-1986 Top Connection Submodel, B2W

to include a 1.5 x 1.5 inch clip, see Figure 4.1, to represent bridge conditions prior to any retrofits. The study indicated that for a west bound truck the most stressed top flange web gap is at connection B2W (see Figure 2.3). So, only the connection at B2W is analyzed in the present study.

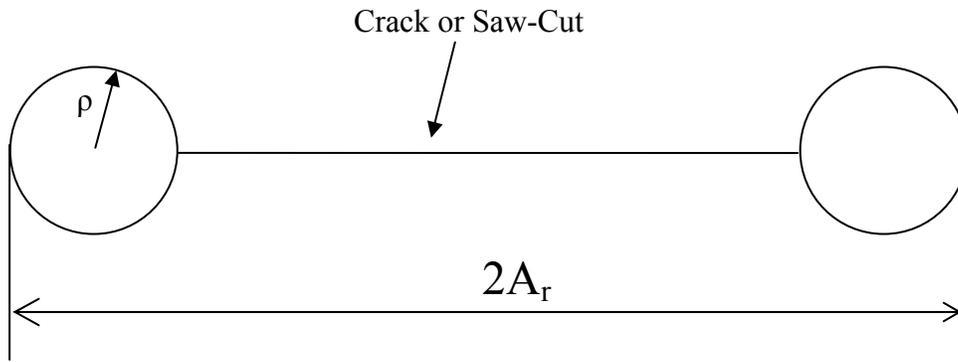
Figure 4.25: Stop Hole Retrofit proposed by Fisher et. al.

A_r = half the equivalent crack length after rehabilitation, see Figure 4.25;

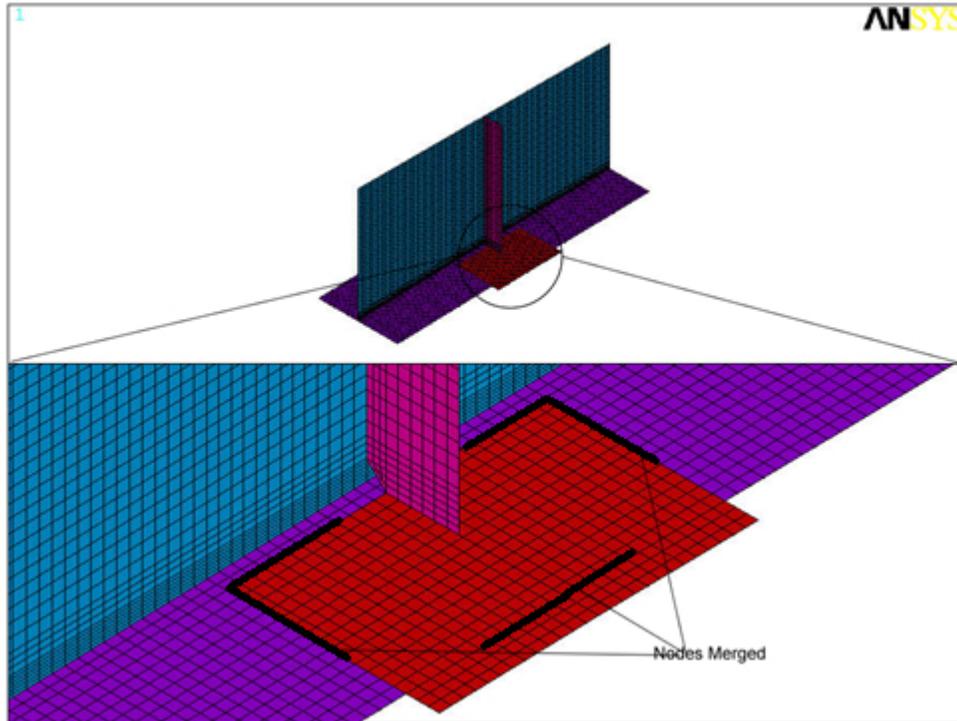
Figure 5.1: Pre Repair Bottom Connection Submodel, BNR

In previous finite element studies [Zhao and Roddis 2004] on Tuttle Creek Bridge detailed analysis of the bottom flange connections at all critical cross frame connections was performed. The study showed that for a westbound truck the critical bottom flange connection is located at cross-frame A2W (see Figure 2.2) and so this connection is chosen for the present study. In this study the gusset plate was not included in the analysis and so the models were modified to include a gusset plate. This model is called model BNR (bottom no repair). The finite element submodel is shown Figure 5.1. In this model the flange-to-gusset connection is modeled by merging coincident nodes along the bold lines shown in the figure.

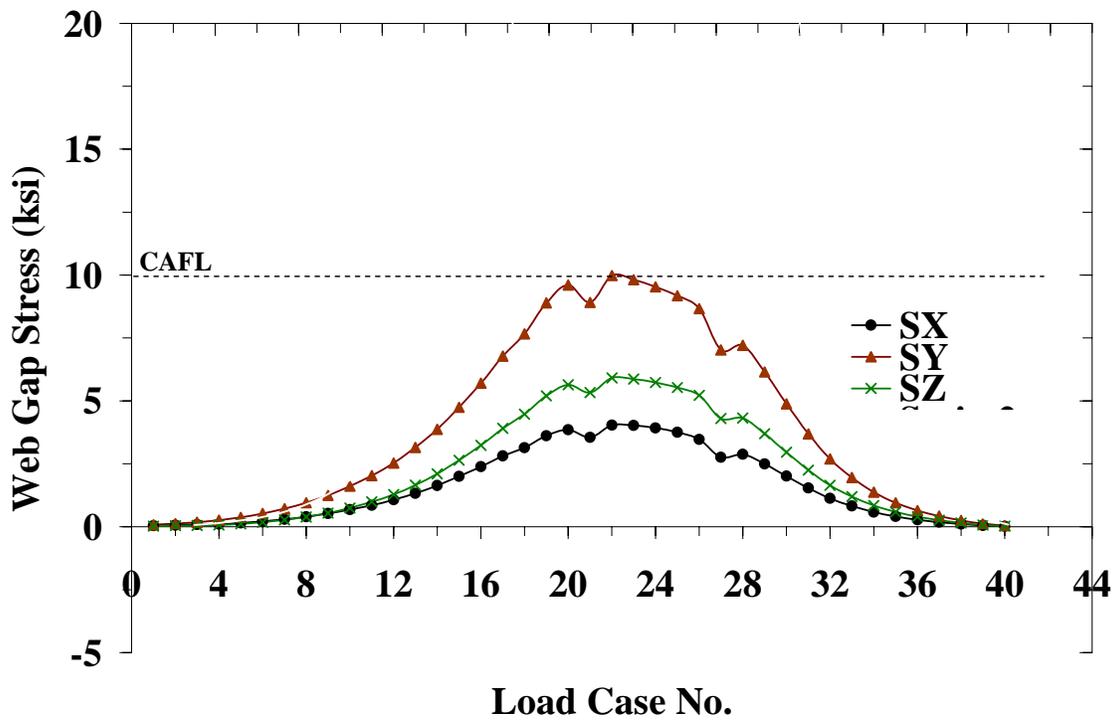
Figure 5.2: Stress Variation in Bottom Web Gap Model (BNR)

Figure 5.2 plots the SX, SY, and SZ stress variation of connection at A2W for the entire truck passage. The peak stresses occur at LC#22 when the truck is close to the mid-span, see Figure 5.3. The results indicate that the peak SX, SY, and SZ stresses

developed in the bottom web gap are 67%, 69%, and 62% lower than the top web gap stresses, respectively. This is because, compared to the top flange, the bottom flange is relatively free to move out-of-plane along with the stiffener plate which results in lesser distortion and hence lower stresses. Figures 5.4 to 5.6 show the web gap SX, SY, and SZ stress contours for bottom web gap at LC#22. Figure 5.7 shows the variation of out-of-plane displacement relative to the bottom flange along the 1.5 in at LC#22. The out-of-plane distortion in the bottom web gap is 67% lower than that in the top web gap (compared with model B2W).

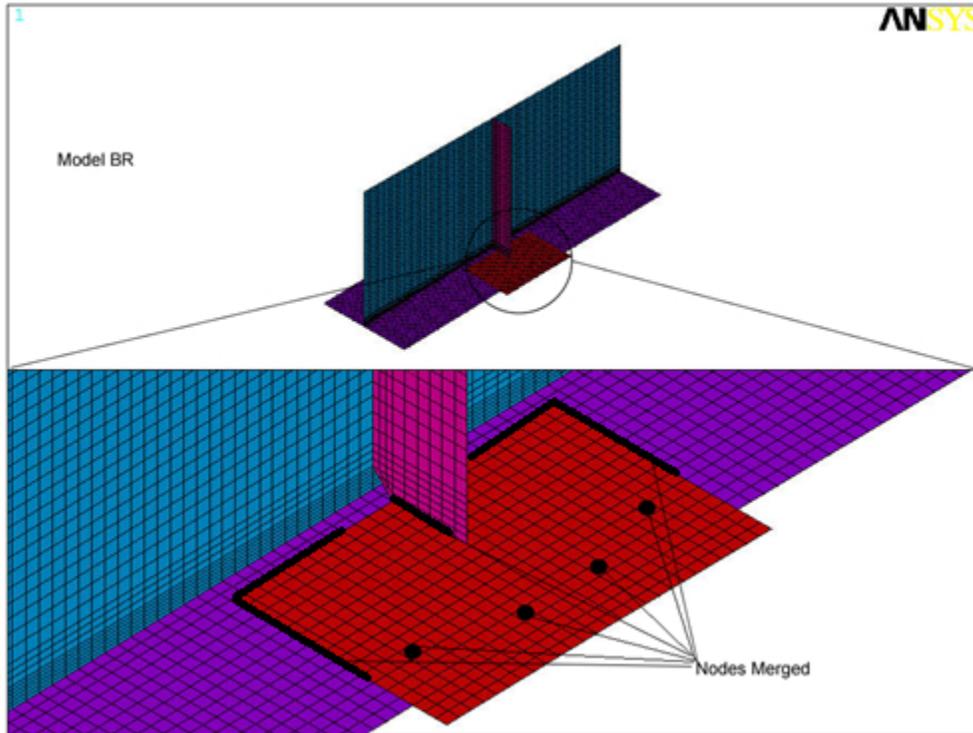
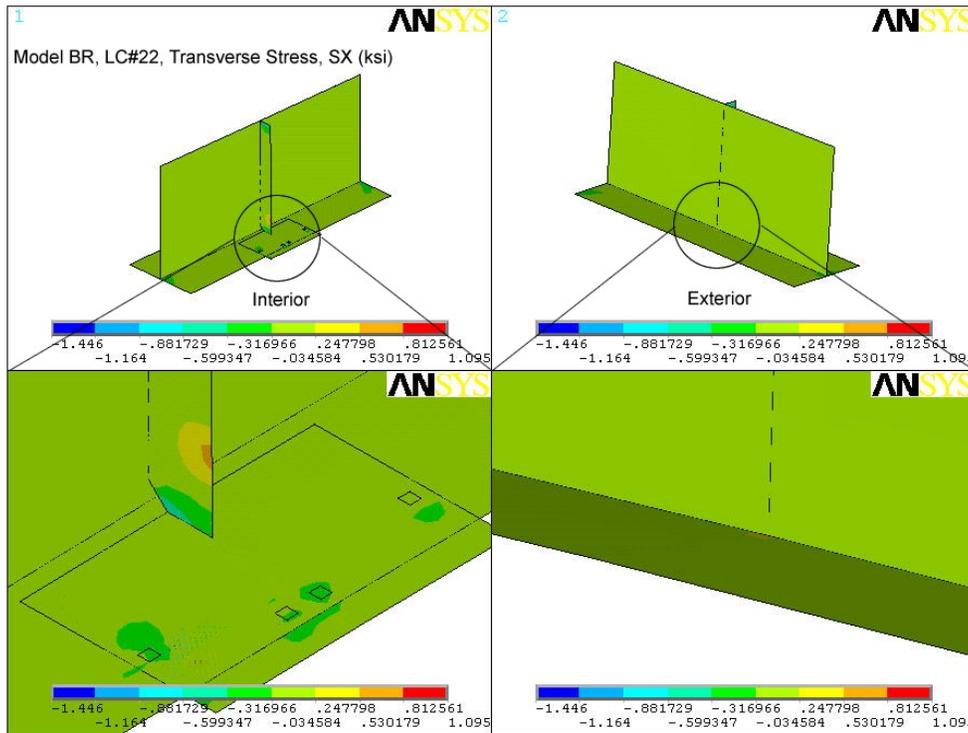
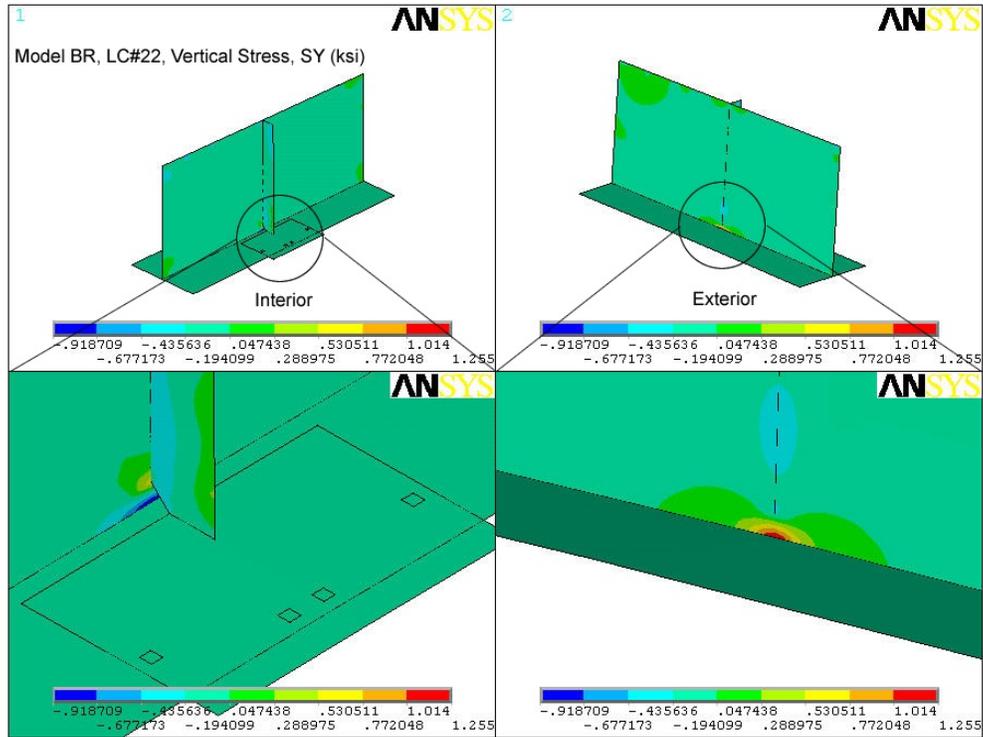
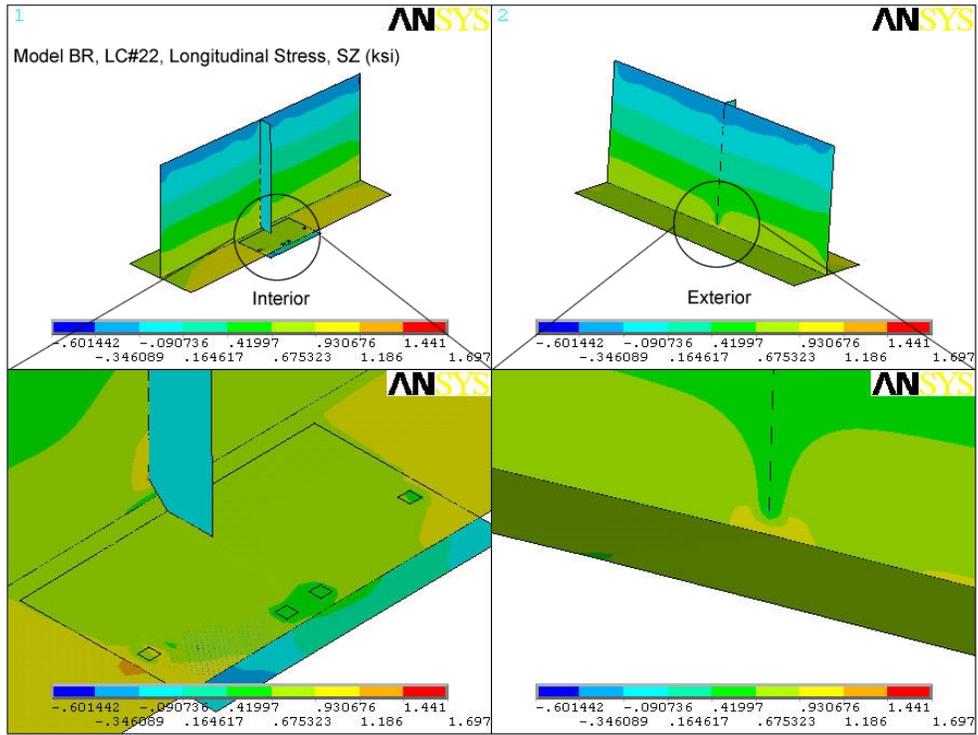
The FE results are conservative and the peak stresses are at least 75% higher than those observed in the field. The stresses are of low magnitudes and are all below the CAFL (10ksi).

In the repair of the bottom connection (Type 'B' repair) the stiffener plate was welded to the gusset plate as shown in Figure 5.8. This will further reduce the lower web gap stresses. In addition to the gusset-to-flange fillet weld, the gusset plate is secured more firmly to the bottom flange by placing four pre-tensioned bolts as shown in Figure 5.8. Since the bottom connection at cross frame A2W was the most stressed, it is used to evaluate the Type 'B' repair. The model BNR is modified to include the positive connection between the stiffener and the gusset plate. The attachment was modeled by coupling all the DOFs of the nodes common to stiffener and gusset plates. The coincident nodes of flange and gusset near the location of the installed bolts are also merged, as shown in Figure 5.9. This modified model is called model BR (bottom repaired). Post retrofit stress distributions and out-of-plane displacements are shown in Figures 5.10 to 5.13. The results indicate a significant reduction in stresses. The out-of-plane displacements both before and after the repair are negligible. Table 5.1

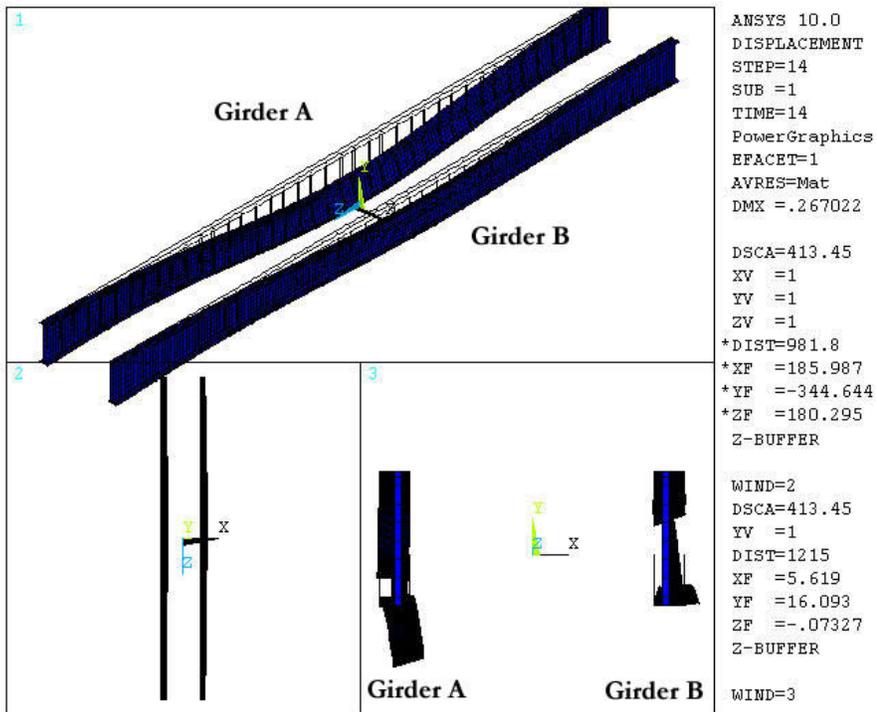
Figure 6.4: Global Deflection at Load Case # 14

For a west bound truck the global analysis indicate that the maximum stress around the cope occurs when the leading axle is close to the mid-span, for LC#14. Figure 6.4 shows the global deflection of the bridge span for this load case. In the figure the displacements are scaled and the solid deck and the frame elements are hidden for clarity. From the isometric and the elevation views in the figure it is clear that the

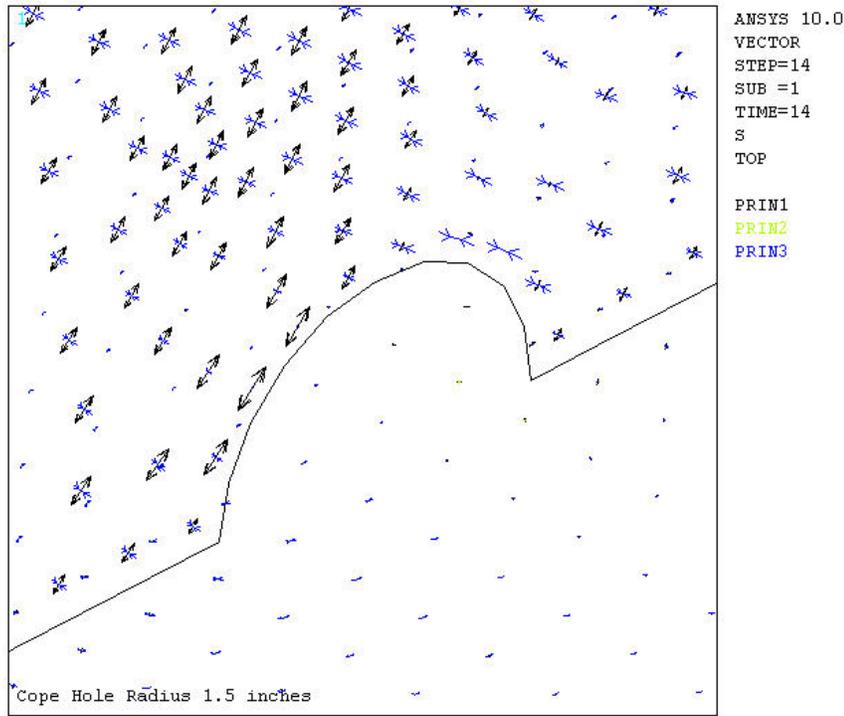
Figure 6.5: Vector Plot of Maximum Principal Stresses for Model CP150 LC#14

Figure 6.5 shows a vector plot of maximum principal stress around the cope. The cracks found near the cope hole originate from the weld toe of the existing field splice and are oriented normal to the direction of the major principal stress, see Figures 6.1 and 6.5. Table 6.1 summarizes the maximum principal stress values for the four models. The maximum in all the models occurs for LC # 14. Figures 6.6 to 6.9 show the principal stress distribution at LC#14 around the cope hole for the four submodels.

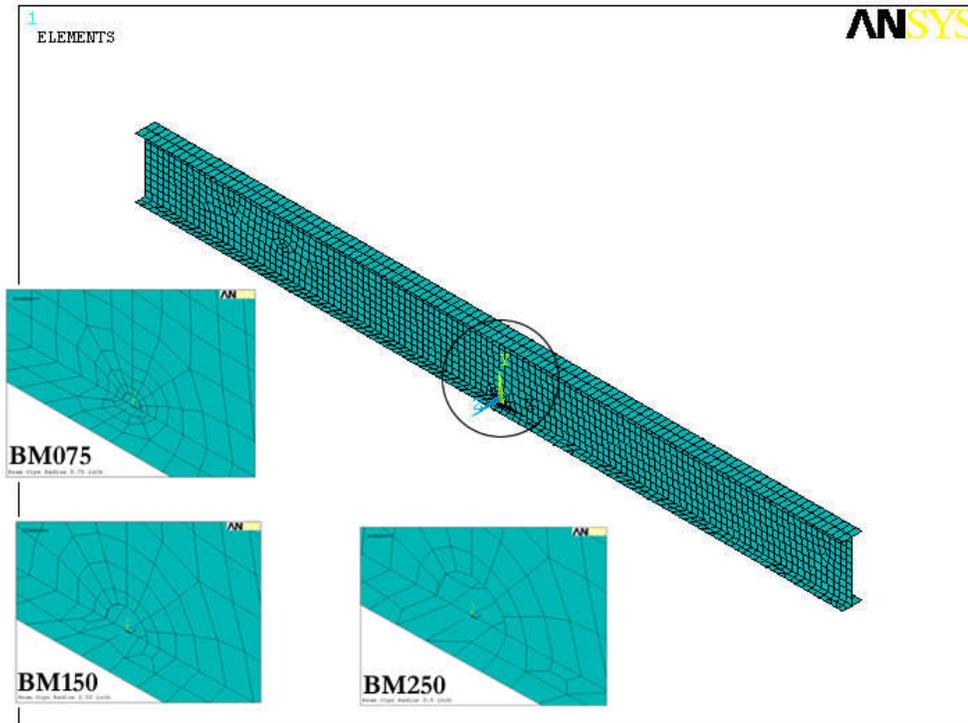
Figure 6.10: FE Models for Simply Supported Beam With a Cope at Mid-Span

The objective of this analysis is to demonstrate that in the absence of any out-of-plane displacement increase in cope radius will reduce the stresses around the rim of the hole. A simply supported beam with a cope mid-span is analyzed for point load at the center. Three FE models analyzed are for cope radius $\frac{3}{4}$, $1\frac{1}{2}$, and $2\frac{1}{2}$ inch, see Figure 6.10. Table 6.2 summarizes the maximum stress values around the cope from these analyses.

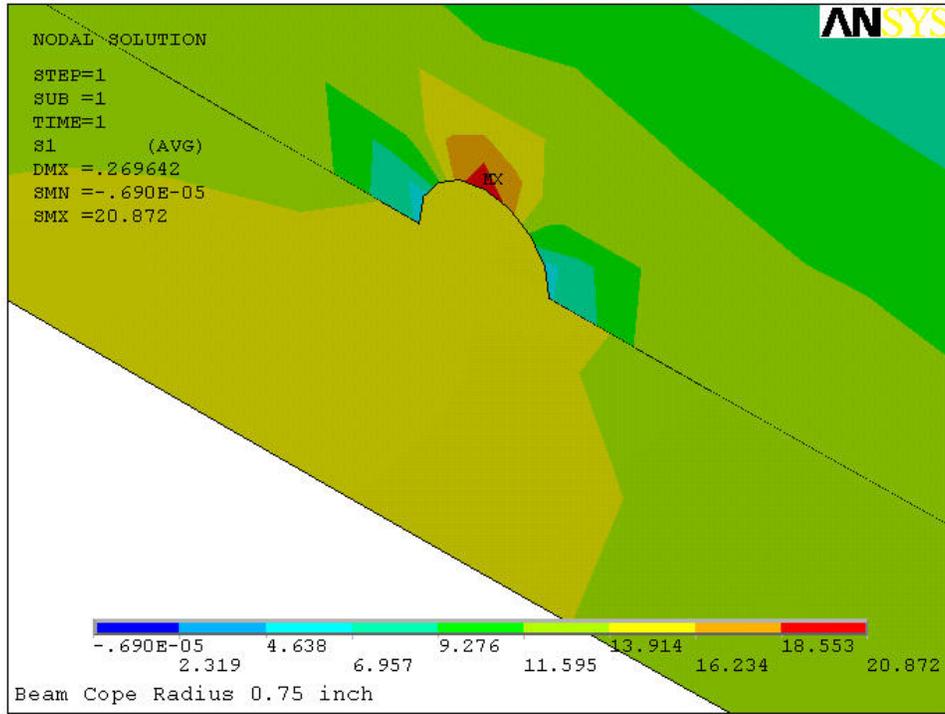
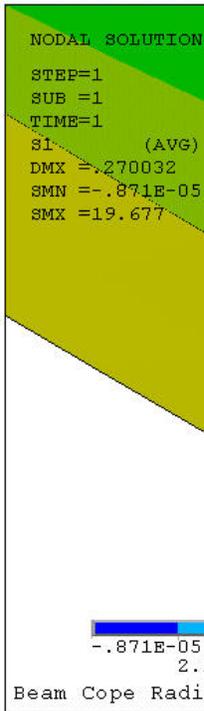
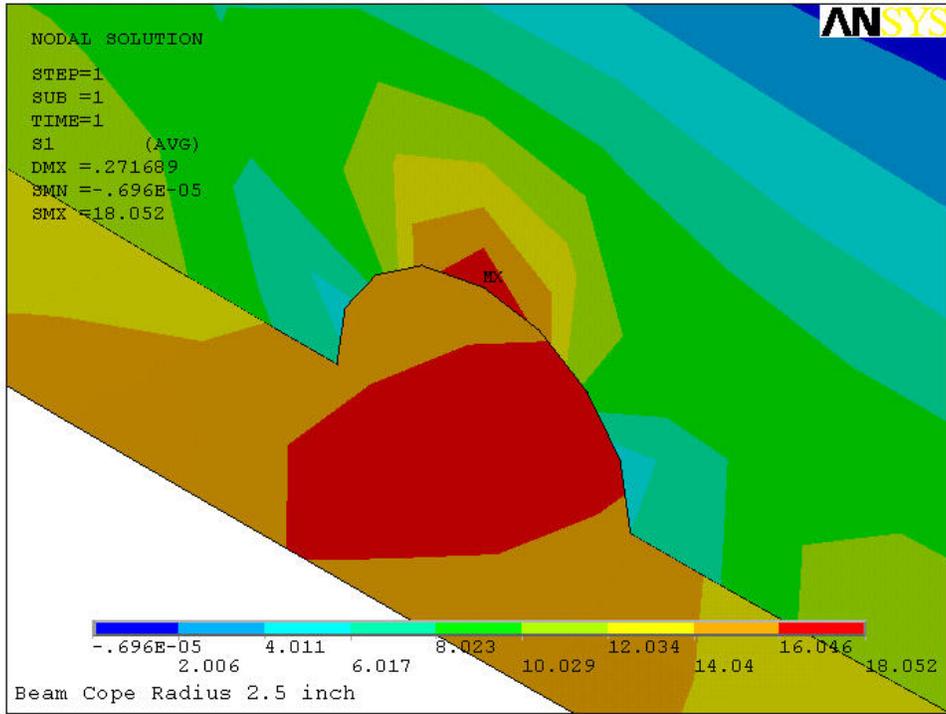
Figures 6.11 to 6.13 show the major principal stress distribution for the three models. In this case when out-plane-movement is not present the stresses decreases with the increase in cope radius. This validates assertion of section 6.2.1.1 that the out-of-plane movement of the bridge girder is the cause of increasing stress with the increase in cope radius.

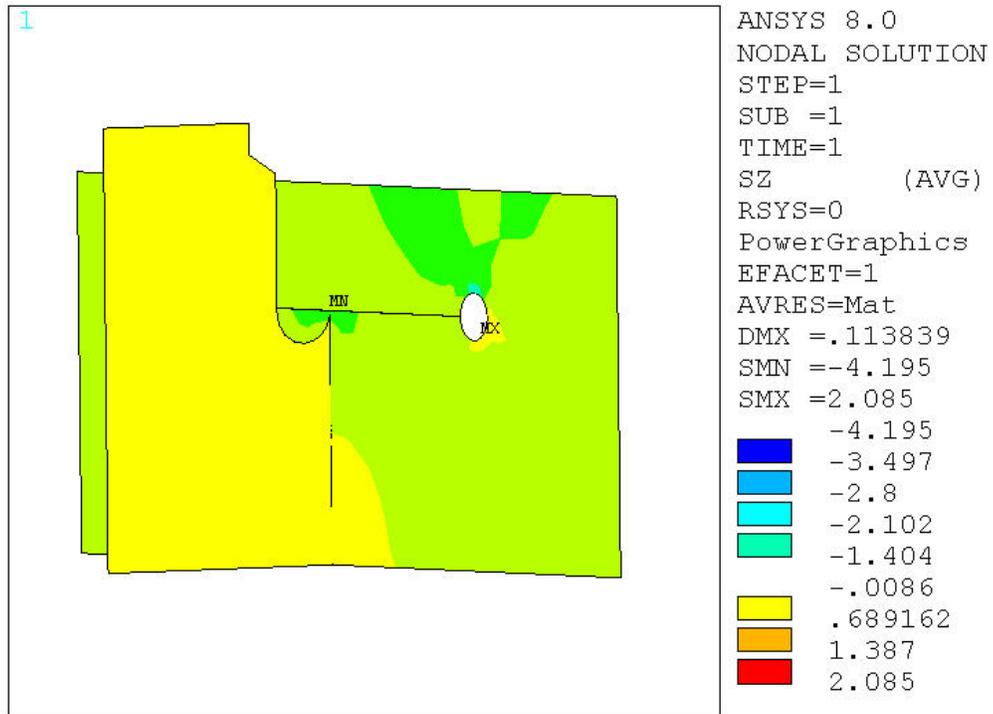
Figure 7.5: SZ Stress Contours in Top Web Gap After Including a 4 inch Through Crack.

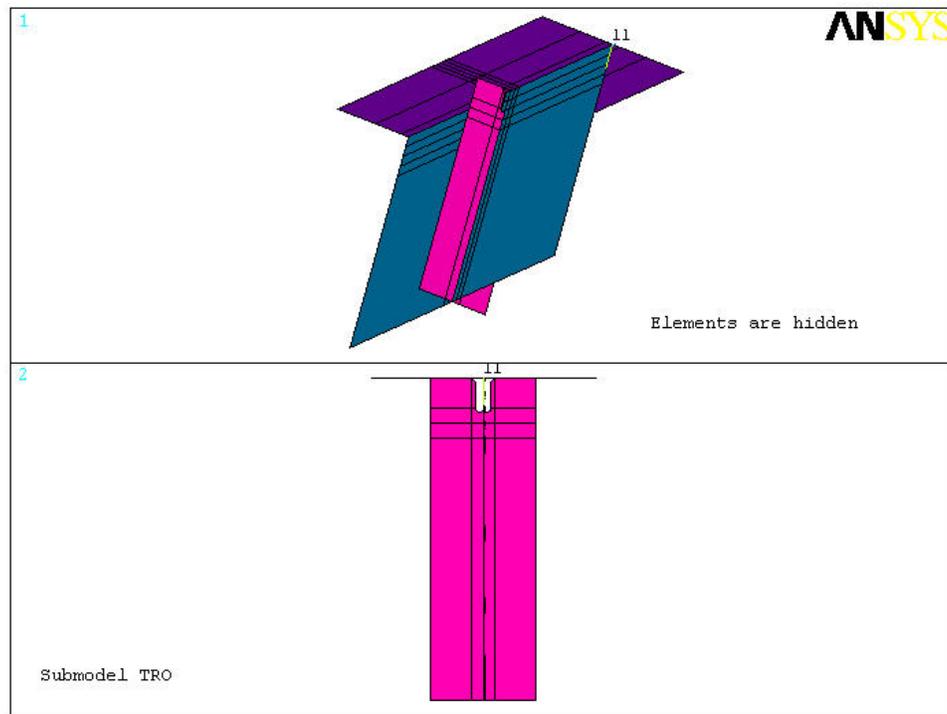
The FE model TR was modified to include an outside stiffener. The connection plate was mirrored to build the TRO (top repaired with outside-stiffener) model, Figure 7.6. The objective of this analysis was to investigate the effect increased stiffness around the region of the observed new crack. The model is first analyzed without including the through crack. The results are compared with the previous results obtained from the TR model (Figures 4.15 to 4.17). The crack will be included in the model only if the stress distribution is significantly modified by adding the outside stiffener plate. Table 7.2 compares the maximum stress results from these models. The stress distributions around the slot end are shown in Figures 7.7 to 7.9. It can be observed that the addition of an outside stiffener has no significant effect on the stress values. Thus, if the crack is included in this model the stress distribution will not be significantly different from that obtained from model TRNC described in section 7.2.1.

Figure 7.6: Top Web Gap Submodel With Outside Stiffener, TRO

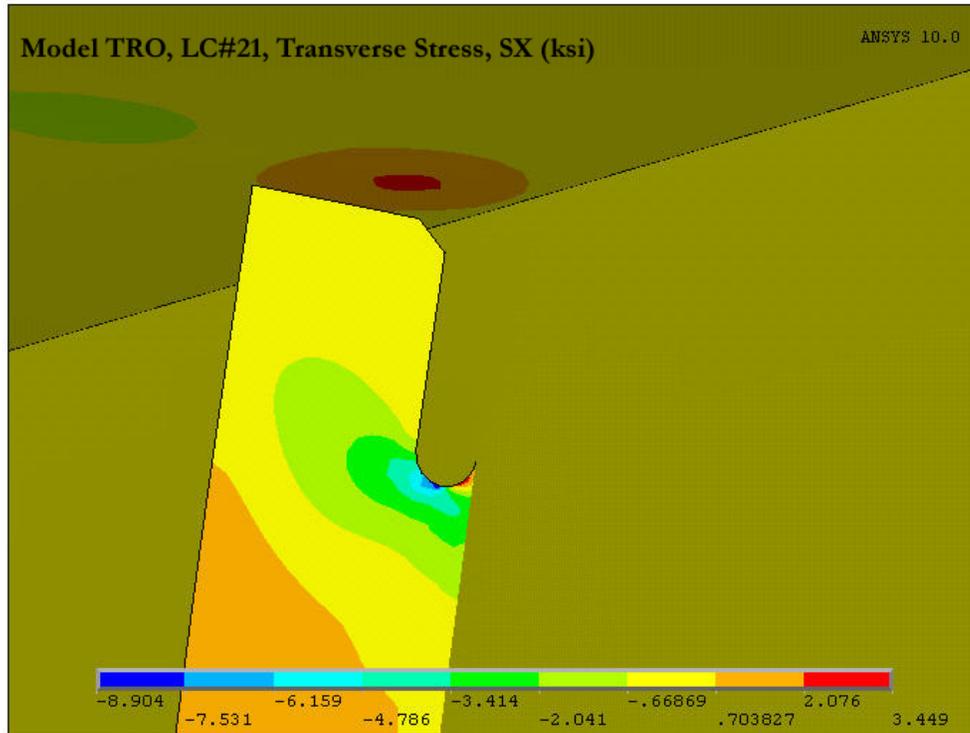
Figure 7.7: SX Stress Contours in Top Web Gap After Including an Outside Stiffener.

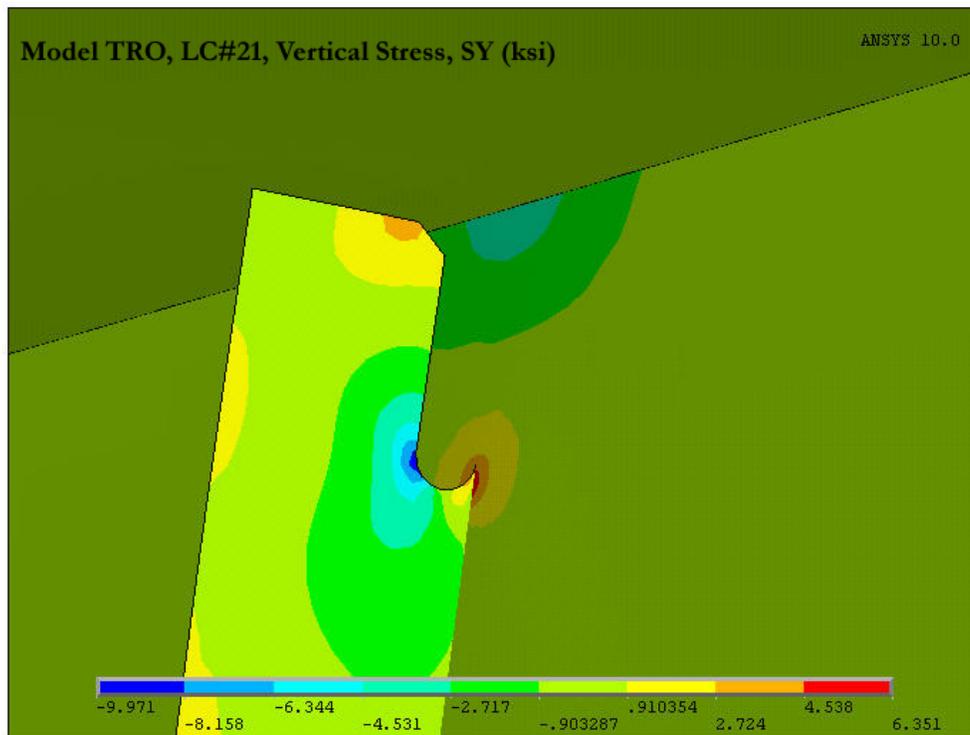
Figure 7.8: SY Stress Contours in Top Web Gap After Including an Outside Stiffener.

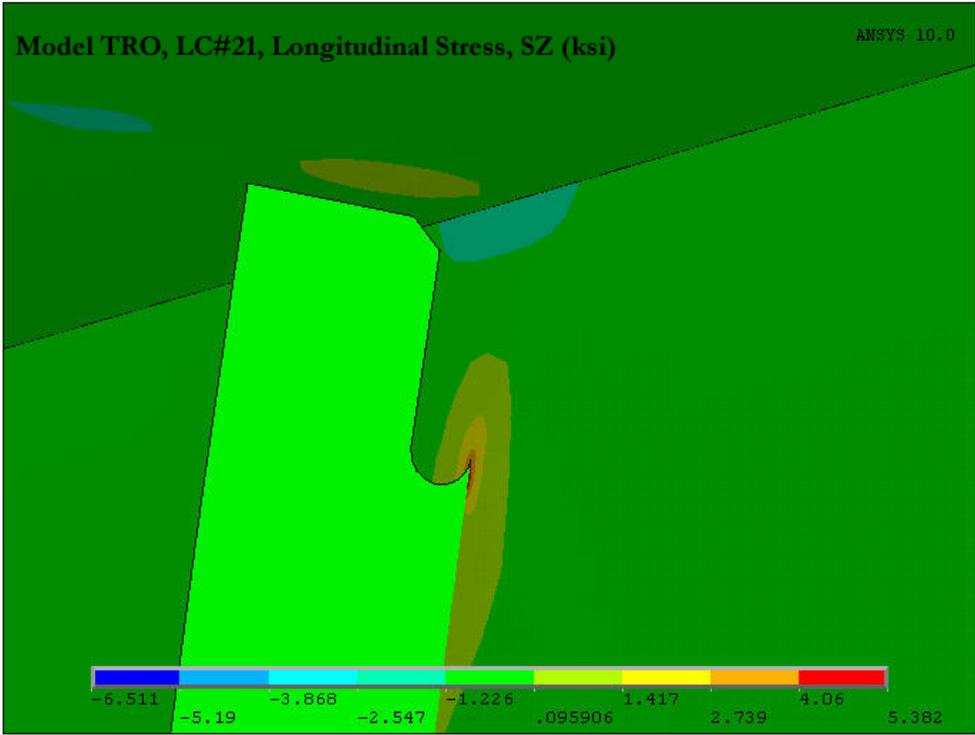
Figure 7.9: SZ Stress Contours in Top Web Gap After Including an Outside Stiffener.
