Report No. K-TRAN: KU-04-5  
FINAL REPORT

## **FIELD INSTRUMENTATION AND ANALYSIS OF THE TUTTLE CREEK BRIDGE**

**Br. No. 16-81-2.24 (017)**

Final Report

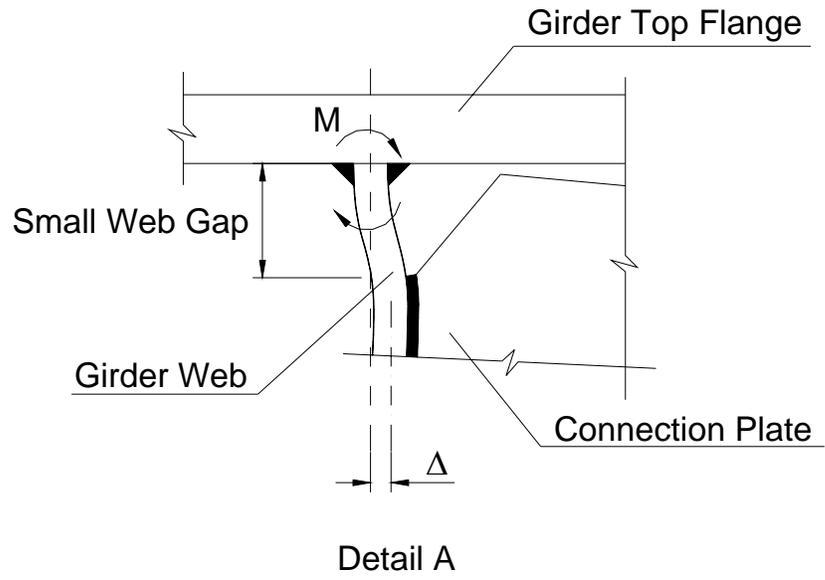
**Figure 2-1 Web-Gap Region**

The web-gap region, found at each diaphragm, was the primary site of crack initiation. The web-gap region is between the girder flange/web fillet weld and the top of the connection stiffener weld. Crack prevention repairs were performed in 1986, however, recent inspection reports have shown continuing crack initiation and propagation. Cracks also have occurred in the weld attaching the lateral gusset plate to the lower flange. Successful repairs were performed on the plates adjacent to the piers, however the remaining unrepaired plates have developed new cracks.

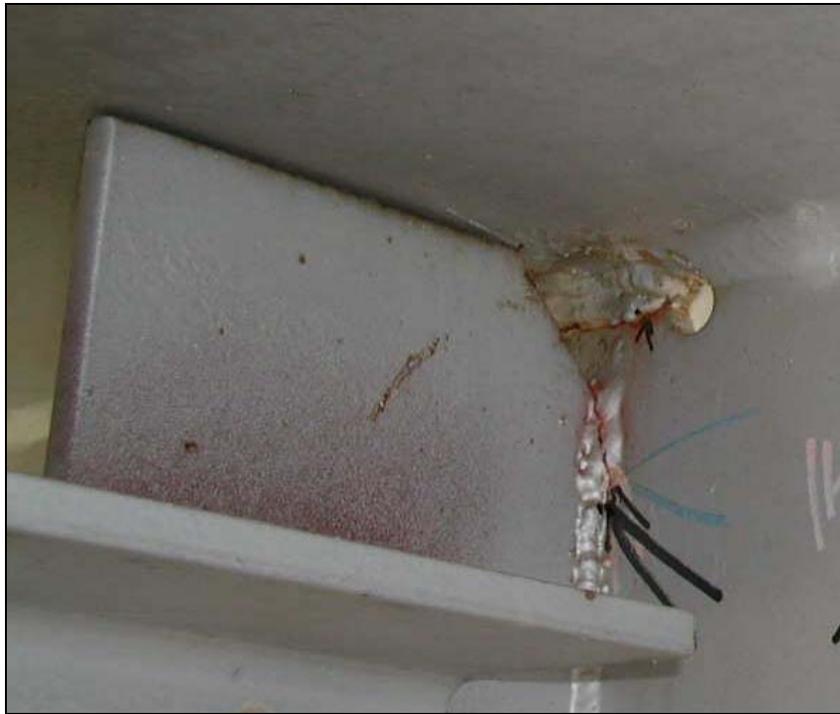
**Figure 2-2 Web-Gap Region (Picture)**

The majority of the cracks on the bridge are found in the upper web-gap region, which lies between the vertical connection stiffener and the upper flange. Cracks also have occurred in the transverse welds attaching the lateral gusset plates to the lower flange. Both these crack types are believed to be caused by differential deflection of the two girders.

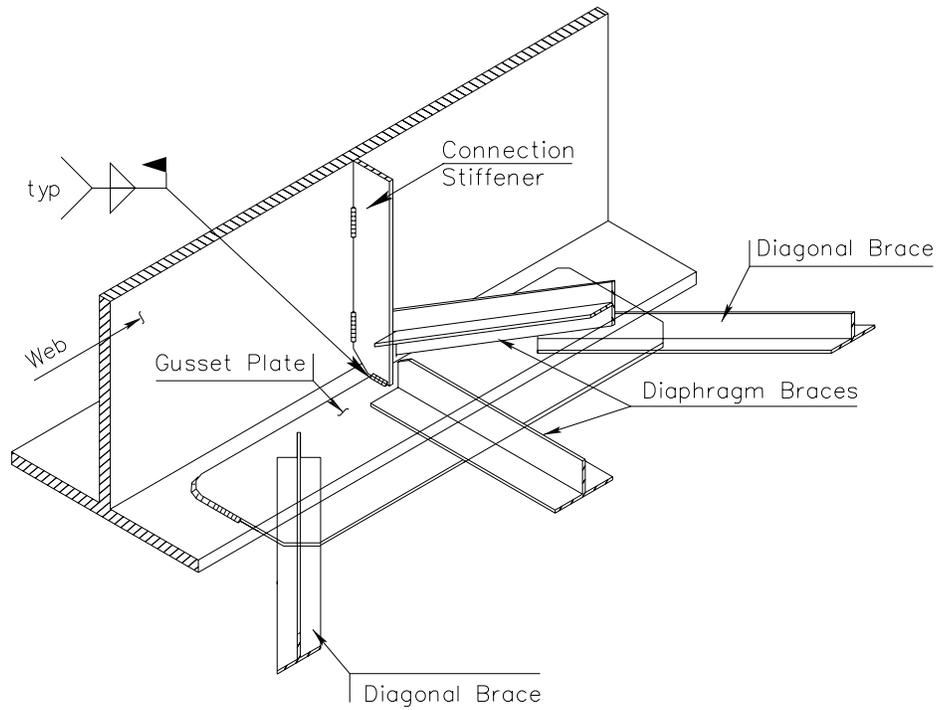
**Figure 5-3 1986 Repair of Lower Web-Gap**

Repairs were also made to the lower web-gap in 1986. An angle bracket was bolted to the connection stiffener and the lower flange, as shown in Figure 5-3. The repairs have been successful, although unretrofitted lower web-gaps have not had any cracks found either. Since this retrofit was only performed on diaphragms labeled F4 in Figure 1-4, additional repairs were necessary for the other diaphragms in order to ensure no new cracks. The lower web-gap region will be repaired by fillet welding the stiffener to the existing gusset plate, as shown in Figure 5-4.

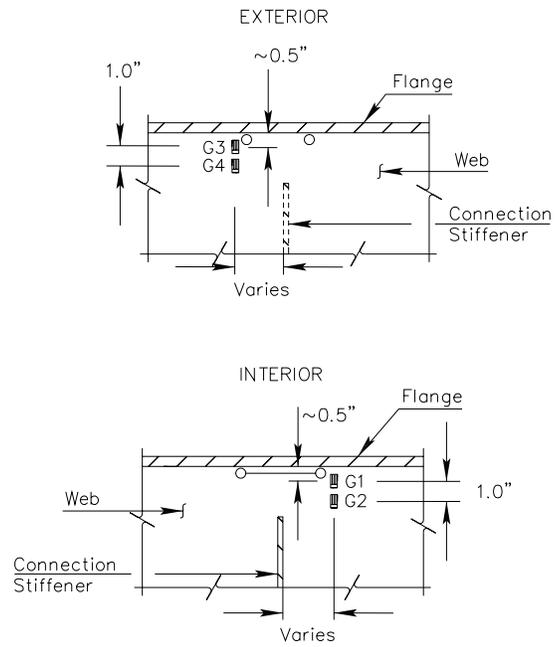
**Figure 5-5 Upper Web-Gap (Diaphragm F2)**

The single-element gages were placed vertically near the tip of the existing horizontal crack, as shown in Figures 5-5 through 5-6. The strain gages were placed as close to the tangent of the drilled hole without overlapping onto the fillet weld. Since the horizontal crack runs along a fillet weld, the gages could not be placed in this high stress region. Due to this restriction, two gages were placed in line with each other. Their values were used to extrapolate the maximum stress near the crack tip. Two sets of gages were used: one on the interior side of the girder and one on the exterior. The gages, in theory, should read equal but opposite strains due to pure bending in the web-gap. Having two sets also provided a backup in case one of the gages did not read strains properly. This gage setup was utilized in similar bridge load testing such as Stallings et al., Jajich and Schultz, and Wpif et al, as summarized in Appendix A.

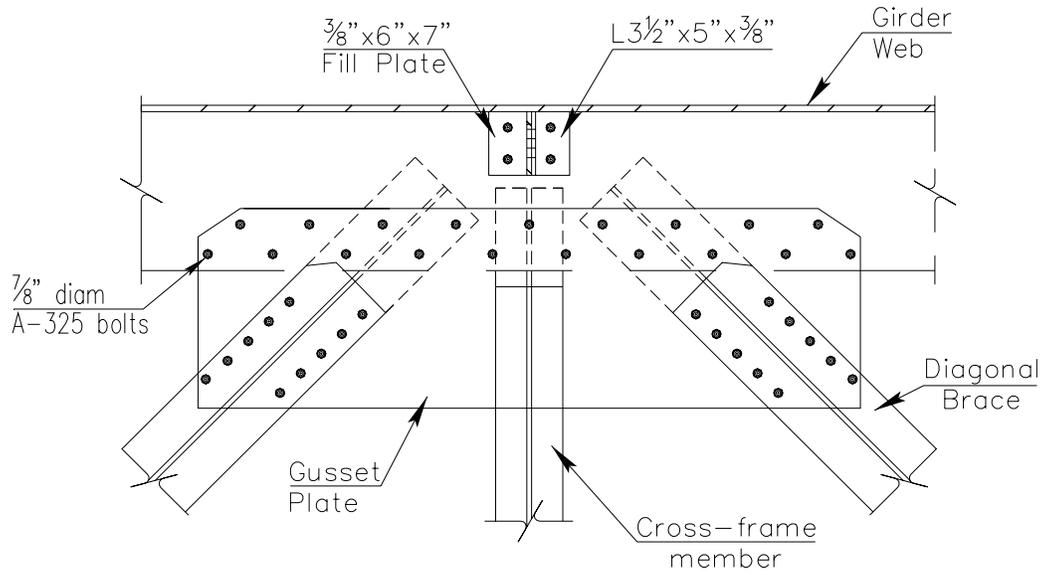
In 1986, repairs were made to gusset plates on the diaphragms located nearest to the piers. These diaphragms are labeled F4 in Figure 1-4. Repairs included bolting a larger gusset plate to the lower flange and eliminating all welds in the connection. The gusset repair can be found in Figure 6-1. To date, the repair has been effective with no new cracks reported.

**Figure 6-1 1986 Repair of Gusset Plate**

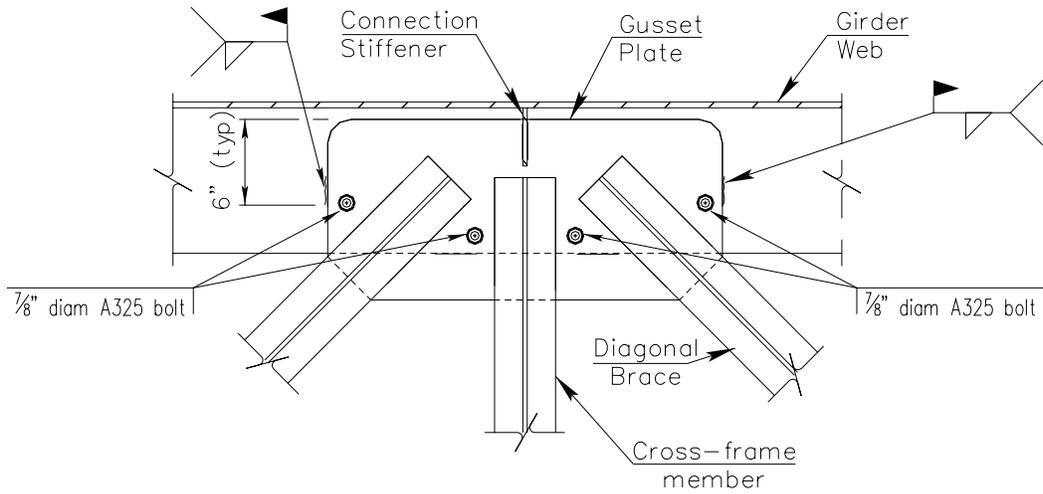
**Figure 6-2 2005 Repair of Gusset Plate**

Although the 1986 retrofit was successful, it only repaired two diaphragm locations per span. New cracks have developed at diaphragms adjacent to the repaired gusset plates. KDOT has decided to repair these diaphragms. However, economic factors have changed the repair plan from the 1986 retrofit design. Figure 6-2 displays the new proposed retrofit. In order to save money, the existing gusset plates will remain on the bridge. The gusset plates will be repaired by first grinding out existing cracked welds and then will be re-welded to the previous dimensions. In addition to welding the gusset plate, four bolts will be placed through the gusset plate and the lower flange. The bolts should prevent any uplift force on the gusset plate. The existing tack welds will also be ground off.

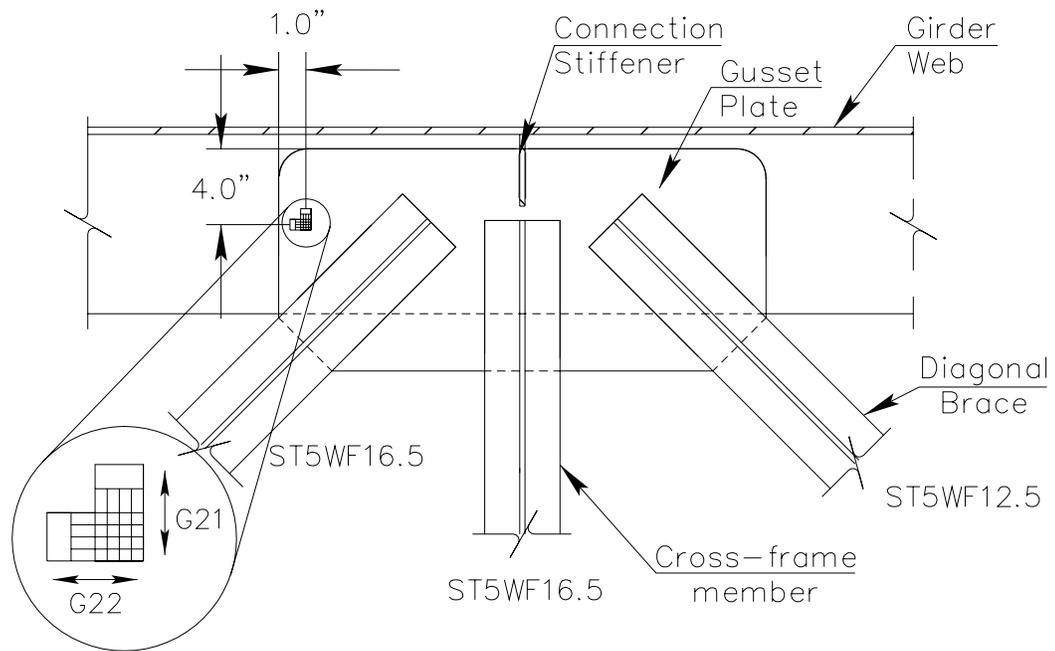
A rosette placed on the gusset plate, as shown in Figure 6-3, was used to measure the magnitude and direction of the forces within the plate. If the measured stresses were primarily parallel with the girder, bending of the girder would be the logical culprit for the cracking. However, if the forces were parallel with the diagonal brace attached to the plate, distortion caused by this brace would be the source of the problem.

The other cracking theory mentioned previously is prying forces from the diagonal bracing. This theory appears logical since the gusset plates with cracks are found in regions of large height transition of the web. The bracing is approaching the gusset plate from an upward angle due to its other end being attached to a gusset plate at a lower elevation. When placed in compression, the bracing will push slightly upward on the gusset plate. The slight upward angle of the bracing could be causing the cracking in the gusset plate.

**Figure 6-3 Gusset Plate Rosette (Diaphragm F3)**

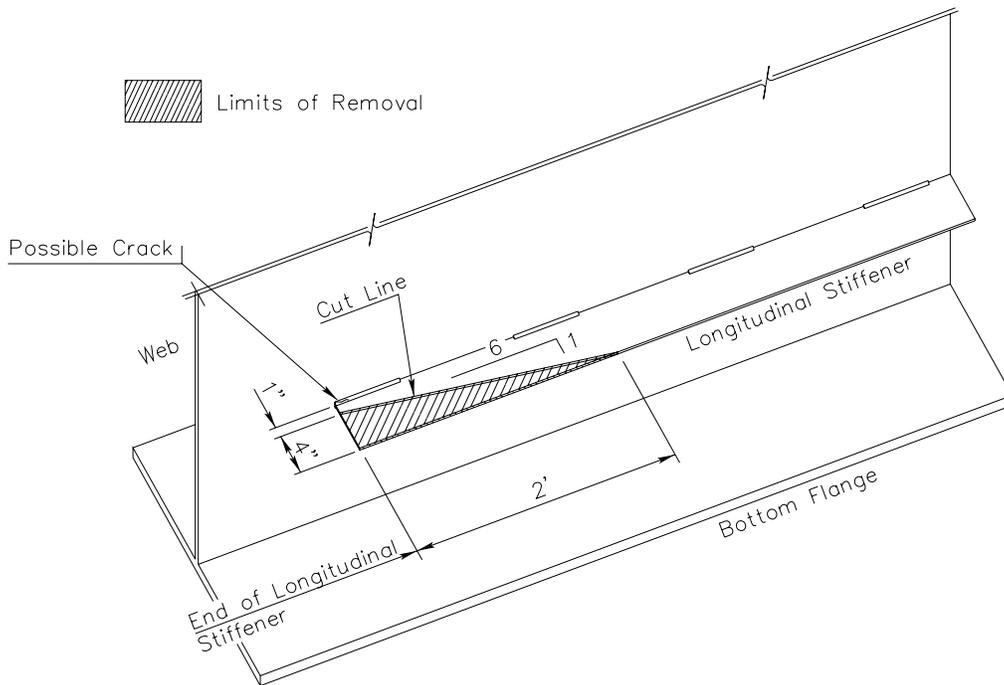
**Figure 7-1 2005 Longitudinal Stiffener Repair**

Two repairs are scheduled for the longitudinal stiffeners. The first repair, re-welding the cracks in the butt welds of the stiffener, is required to fix an existing problem. The other repair, tapering the end of the stiffener, is a preventive measure. For the cracks in the butt welds, the welds will be ground off and re-welded. Although not displaying any fatigue cracking, the termination of the longitudinal stiffener will also be retrofitted since it is a fatigue-prone detail. The repair is a preventive measure to reduce the fatigue category of the design from an E. The ends will be tapered to reduce the stress concentration at the ends, as shown in Figure 7-1. This repair strategy is similar to the tapering of the end of a cover plate welded to a flange. Stress induced by girder bending should gradually enter into the longitudinal stiffener, rather than abruptly at the end.

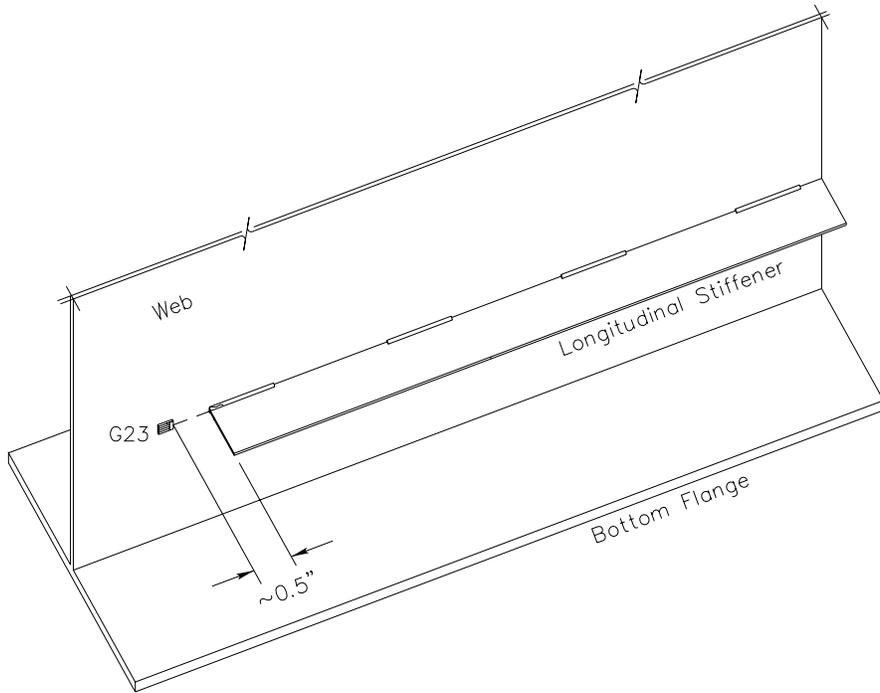
One, single-element gage was used to provide a prior-to-retrofit measurement. Only the tapering repair was investigated, since the butt weld repair was not a new structural configuration. The gage was placed close to the end of the lower longitudinal stiffener, as shown in Figure 7-2. The

Results from the various loadings can be found in Tables 7-1 through 7-4. For the eastbound truck, the average stress cycle was 4.6 ksi, while the westbound truck created a 3.4 ksi cycle. Since the cycle entered into the tensile region, this detail is particularly vulnerable to fatigue. Residual stresses could make this tensile cycle even more damaging. This stress value will be good to compare with the post-retrofit stresses to see the effectiveness of the repair.

**Figure 7-2 Longitudinal Stiffener Gage (Span 29)**

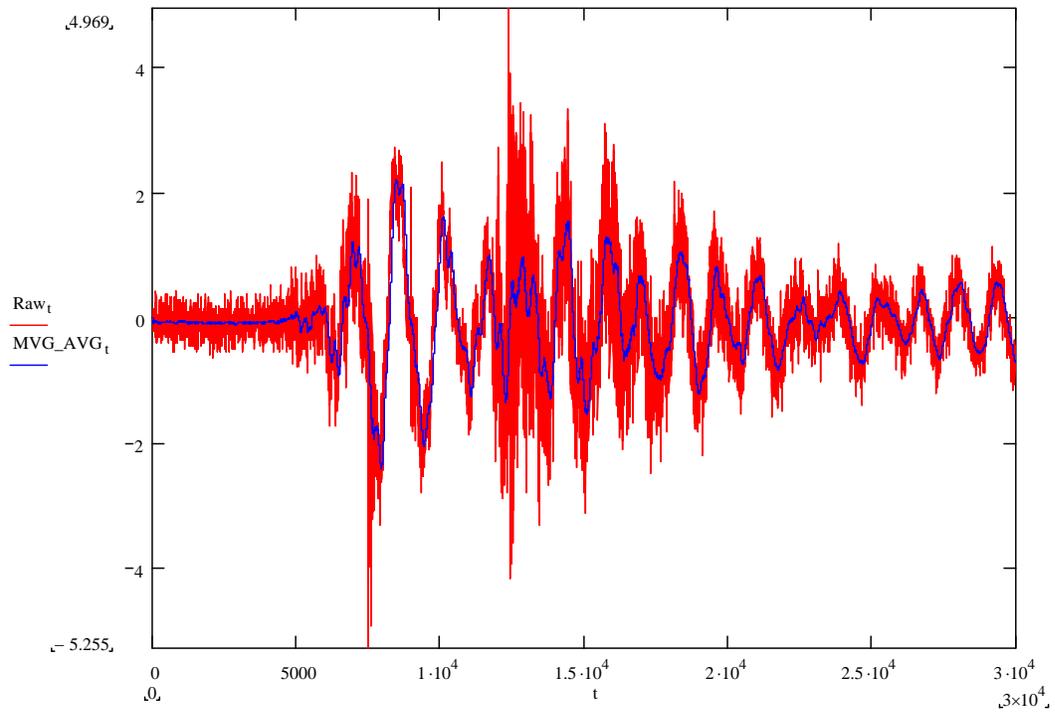
**Figure D-3 Bridge Vibration**

In order to visualize the data collected, an animation of the displacements was created in *MathCAD*. All four displacement readings were placed on a 3D graph. After a time variable was set, *MathCAD* cycled through all the data and created an animation. The 3D model effectively demonstrated the movement of half the span under truck loading. Figure D-5 displays the 3D motion of the bridge under loading. Twisting of the bridge can be observed in the model.

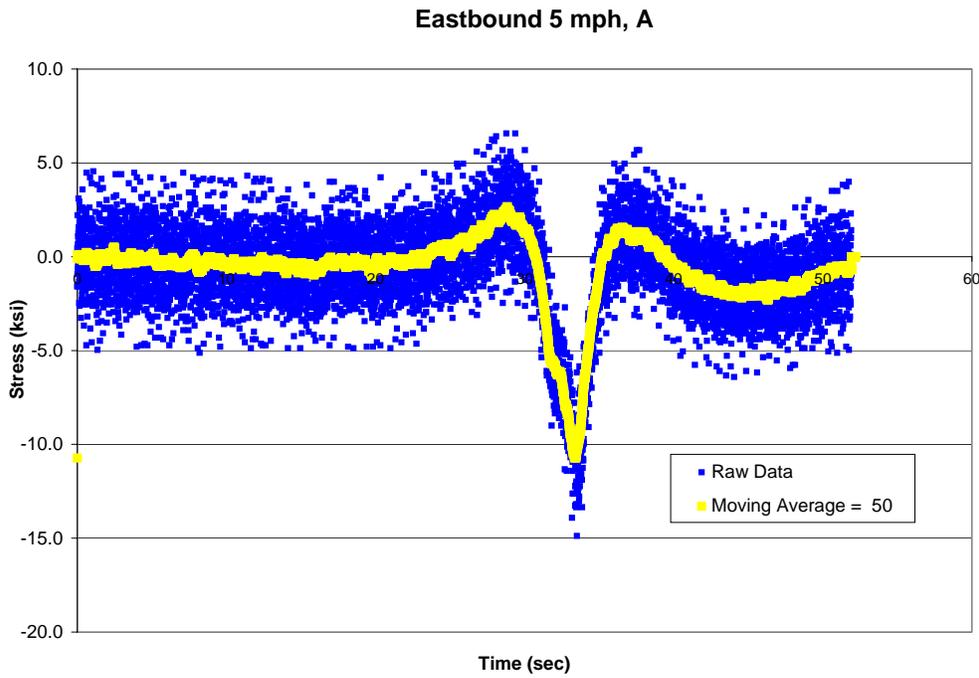
**Figure F-2 Moving Average Graph**

A moving average simply replaces a data point with the average of a specified range of points following it. The moving average formula is shown below.

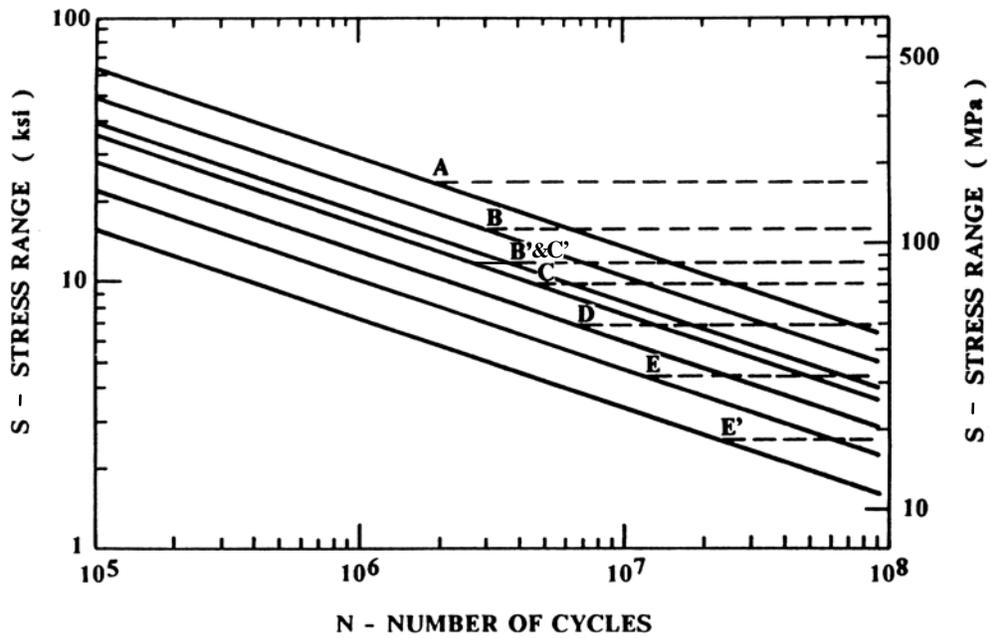
**Figure F-3 AASHTO Fatigue Detail Categories**

Current AASHTO LRFD Specifications place steel bridge details into eight categories of fatigue resistance. The empirical-based categories relate the number of cycles a detail can endure at a particular stress cycle without crack initiation, as shown in Figure F-3. For the field test, a typical truck was used to induce stress cycles. If the amount of truck traffic is known, the fatigue life of the design detail can be estimated. A detail's fatigue resistance is based on the constant amplitude fatigue threshold, CAFT, which is the stress range that the detail can withstand  $2 \times 10^6$  cycles. If the detail's stress cycles are below  $\frac{1}{2}$  CAFT, the design life of the detail is considered to be infinite.
