Report No. K-TRAN: KU-06-2  
FINAL REPORT

**POST-RETROFIT ANALYSIS OF THE TUTTLE CREEK BRIDGE  
(BRIDGE NO. 16-81-2.24)**

March 2008

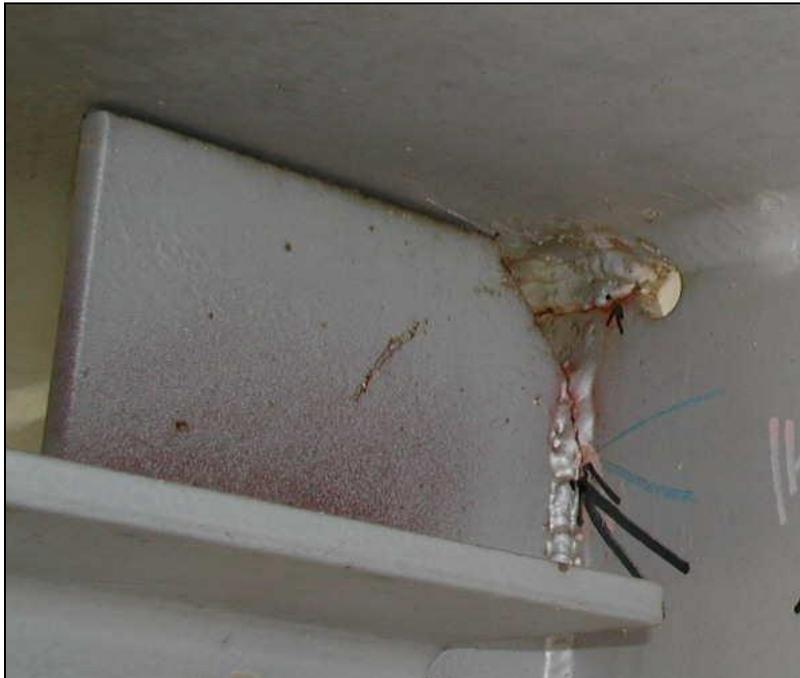
**Figure 2.2: Web-Gap Region Picture.**

The web gap region consisted of a 1"x 1" diagonal cut removed from the top and bottom of the stiffener as shown in Figures 2.1 and 2.2. This cut allowed the fillet weld between the web and flange to be continuous. This gap creates high stress concentrations in the web and creates the potential for fatigue cracks to propagate in this area. Two types of cracks that occurred in the upper web-gap region were designated as either weld tears or horizontal cracks. Figure 2.3 shows the two types of cracks, and Figure 2.4 presents a photograph of actual cracks.

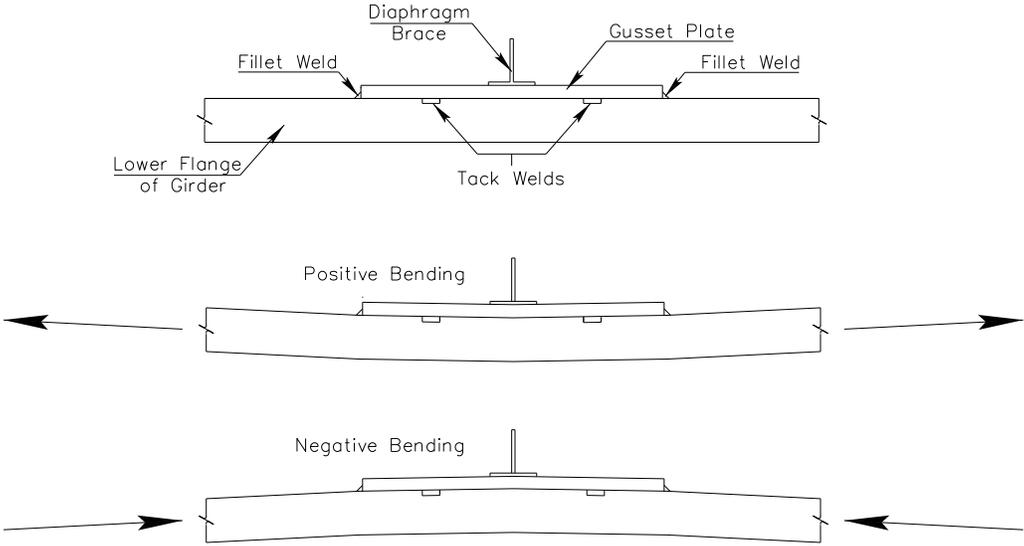
Figure 2.8: Gusset Plate Cracking Source (Bending Stresses).

Fatigue cracking also occurred in the fillet weld between the gusset plate and the lower flange of the girder. Gusset plates connect the girders to the lateral bracing of the girders. As shown in Figure 2.7, three structural tees enter the connection. Loads imposed by the lateral bracing caused cracking of the gusset plate connection.

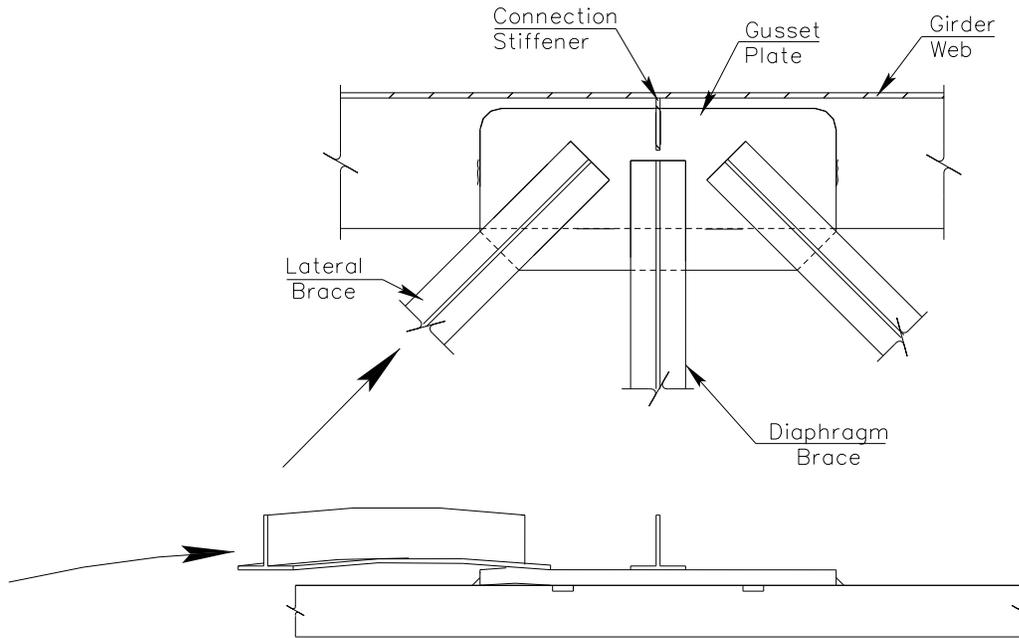
**Figure 2.9: Gusset Plate Cracking Source (Distortion of Lateral Brace).**

the relationship between these gages is of interest because of their location relative to one another. One hypothesis presented in the first field report (Marshall et al., 2005) was that cracking was caused by lateral distortion of the brace. This distortion would induce a prying action in the gusset plate. According to the graphs in Appendix D, the data supports the theory that the gusset plate experienced bending during loading. While this does not prove that this was the only cause of the cracking, it does show that prying action contributed.

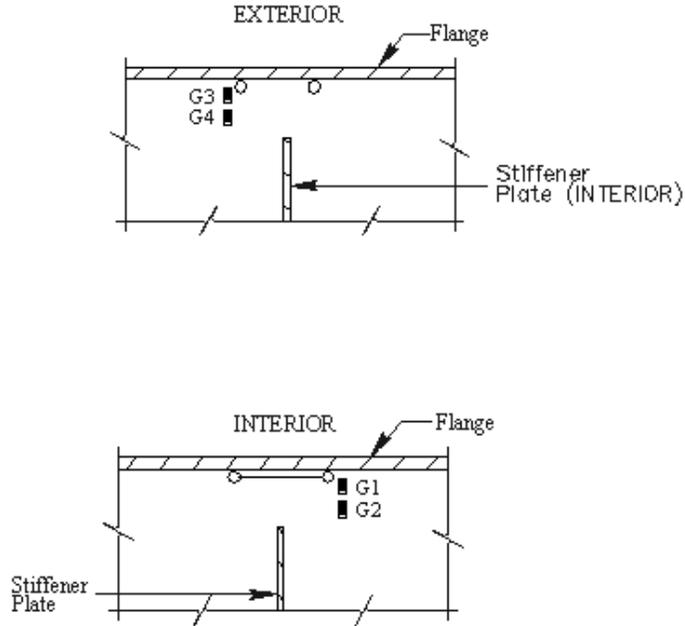
**Figure 5.1: Upper Web Gap Gages.**

According to the results, the retrofit procedure succeeded in reducing the stresses in the web-gap regions. Using absolute stress values, reductions of up to 90 percent were observed for some gage locations. These reductions are consistent with the finite element model created by Dr. Zhao (Zhao and Roddis, 2003). Smaller pre-retrofit absolute stress values generally showed a smaller percent reduction in stress values.

For the upper web-gap extrapolated values with the truck moving westbound, the average maximum stress was reduced from 35.4 ksi to 9.3 ksi. For the truck moving eastbound, the maximum average stress value changed from 12.6 ksi to 6.7 ksi. These values show a significant decrease in stress at the critical point where a crack might form in the upper web gap region. In the lower web gap region, the absolute value of the stress was reduced, but the margin was not as pronounced as in the upper web-gap region.

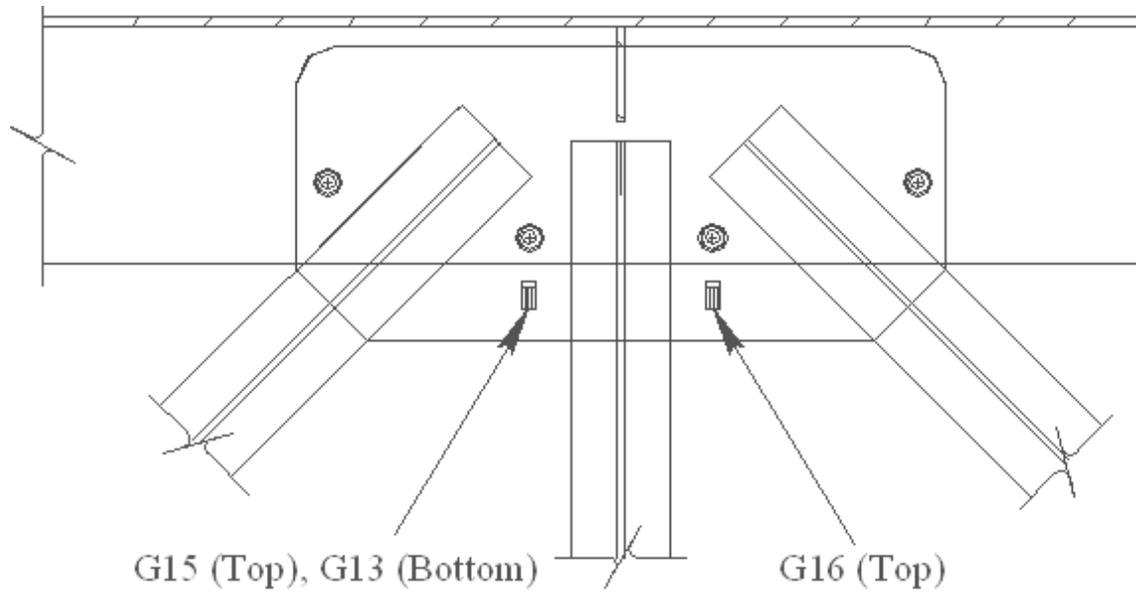
**Figure 6.4: Location of Relocated Gages.**

The exact cause of cracking in the gusset plate was unknown after the first field investigation. In order to help determine why the cracking was occurring, three gages were moved to new locations on the gusset plate. Gage 13 was placed on the bottom side of the gusset plate with gage 15 placed directly above it on the top side. Gage 16 was placed in a similar location as gage 15 on the opposite side of the center brace. The locations are shown in Figure 6.4.

The stress over time for these gages is shown in Figures D.1 through D.11. The majority of the data supports the theory that there is bending force acting on the gusset plate during loading. This is illustrated when gage 13 experiences a stress that is opposite of the stress in gage 15. Gage 16 is also provided as a reference but is not directly related to the position of gage 13. Due to the majority of the tests exhibiting this relationship, prying action is occurring in the plate and is contributing to the formation of cracks.

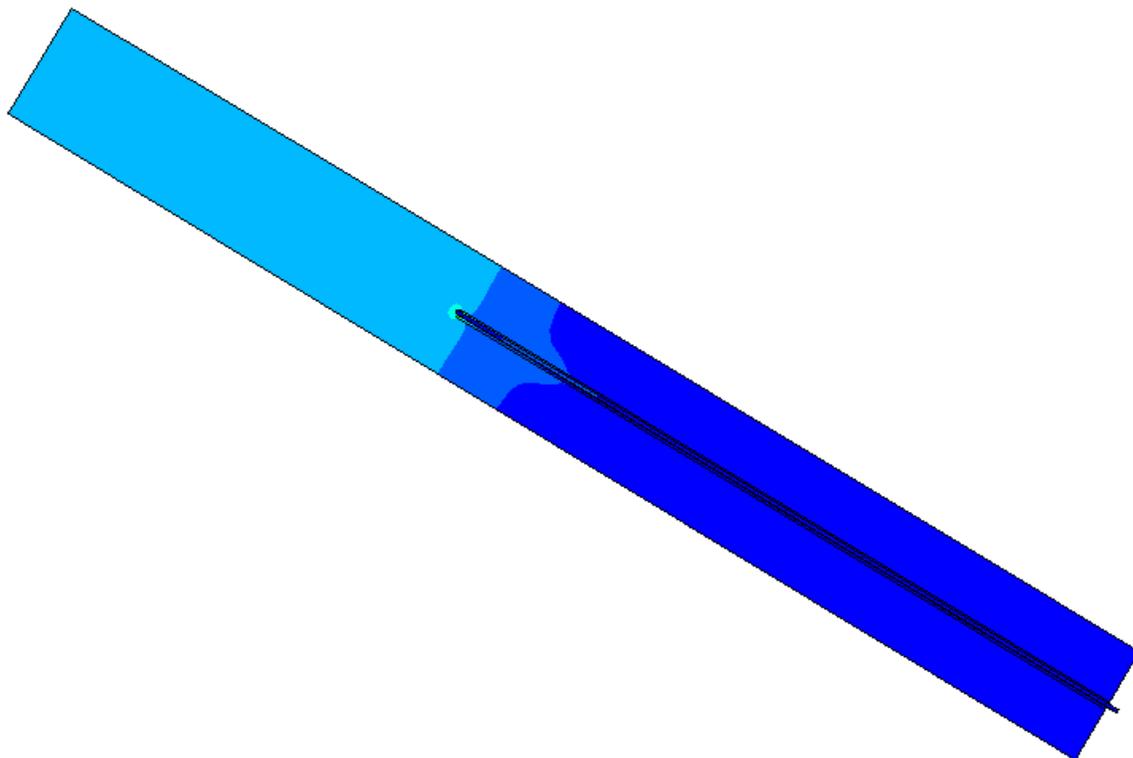
**Figure F.12: Girder web/stiffener (x-y) – before repair.**

Figures F.12 and F.13 show that reduction in the stresses along the girder web caused by the repair was not significant. Although stress concentrations were localized at the tip of the stiffener in both cases, the maximum stress decreased after the repair.

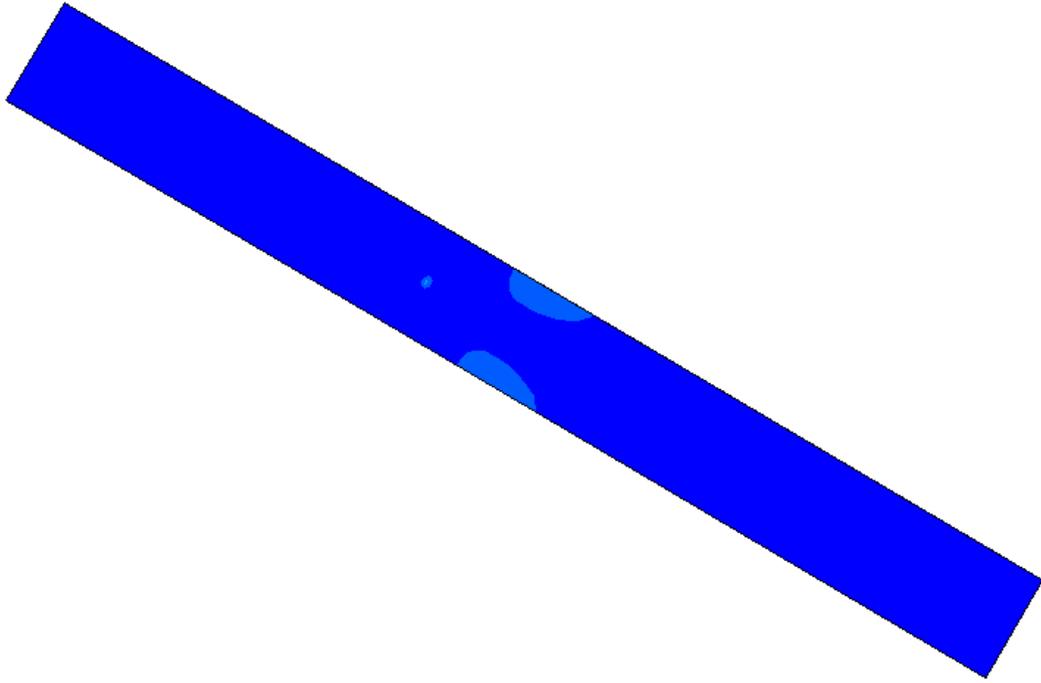
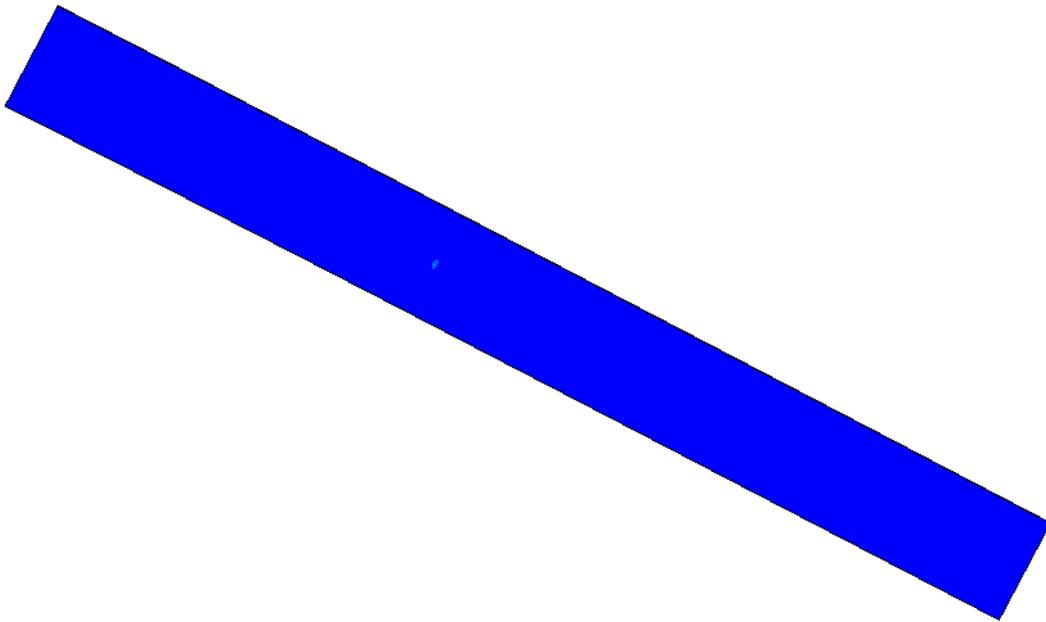
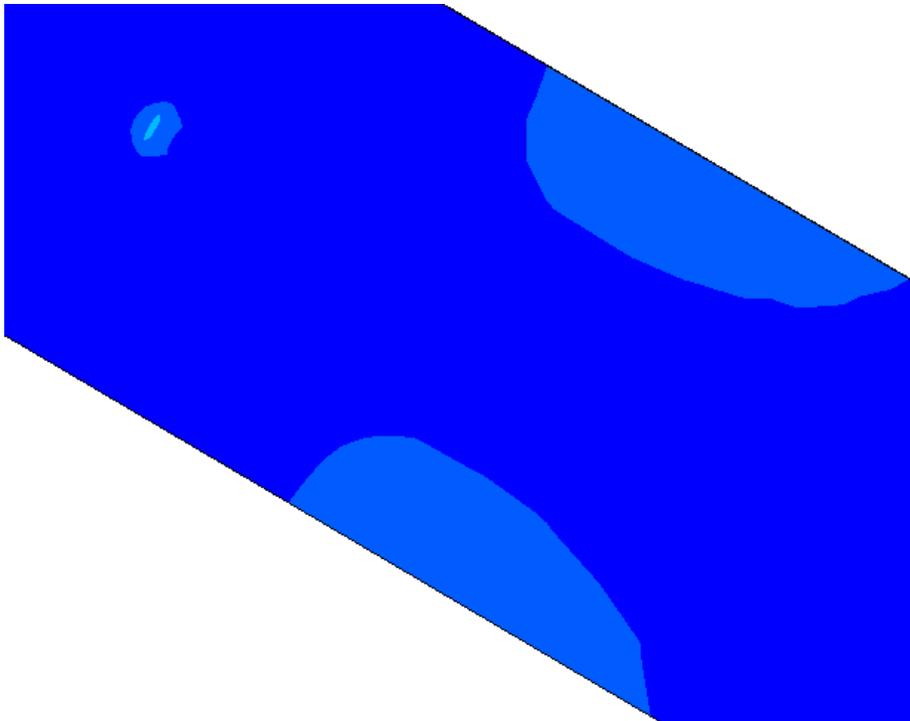
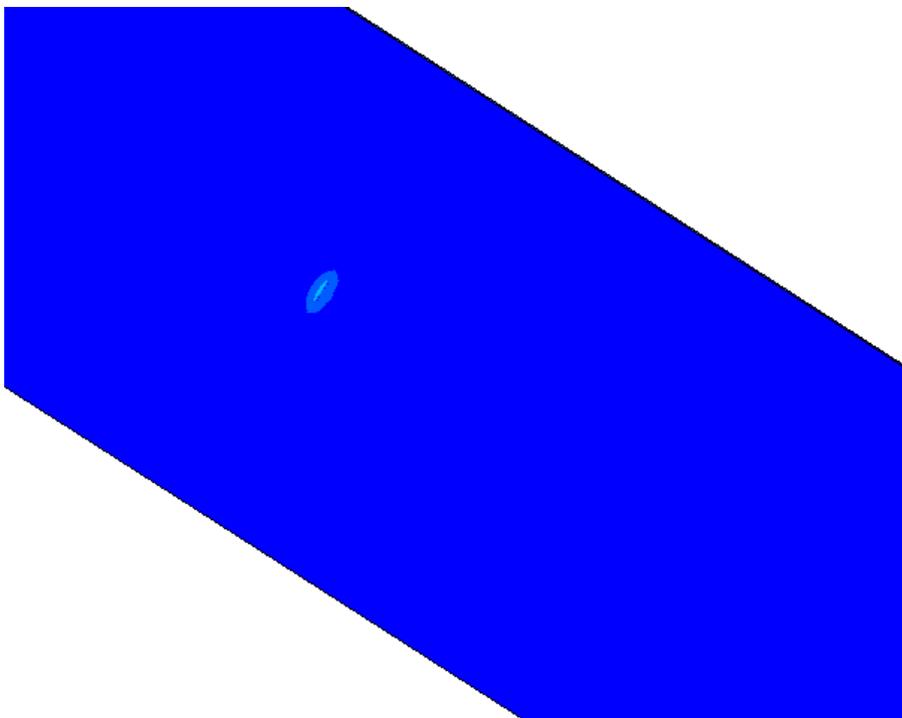
**Figure F.14: Girder web (x-y) - before repair.**

**Figure F.15: Girder web (x-y) - after repair.**

**Figure F.16: Girder web (x-y) - detail 1 - before repair.**

**Figure F.17: Girder web (x-y) - detail 1- after repair.**

Figures F.14 thru F.17 show that on the side of the girder web opposite to the stiffener, stress concentrations were found right at the tip of the stiffener. However, the area over which these stress concentrations were present was very small. The implementation of the proposed repair did reduce the size of the region affected by stress concentrations. The FEM indicate that stress gradients at the sides of the model, near the tip of the stiffener, were eliminated by the repair (Figures F.14 through F.17).

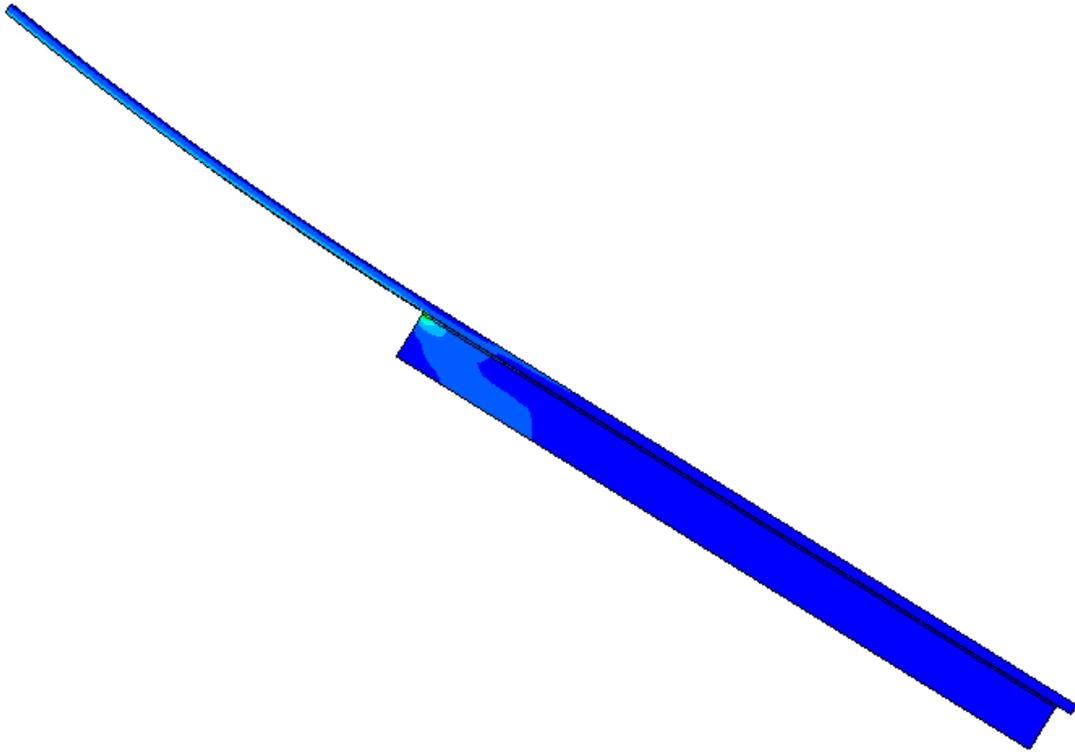
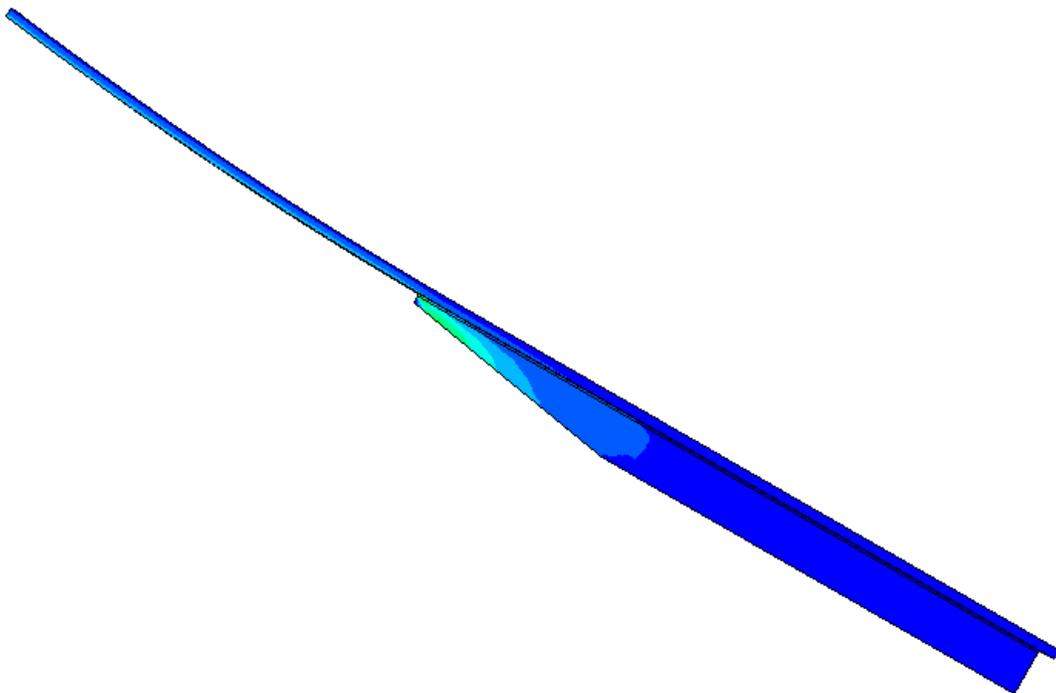
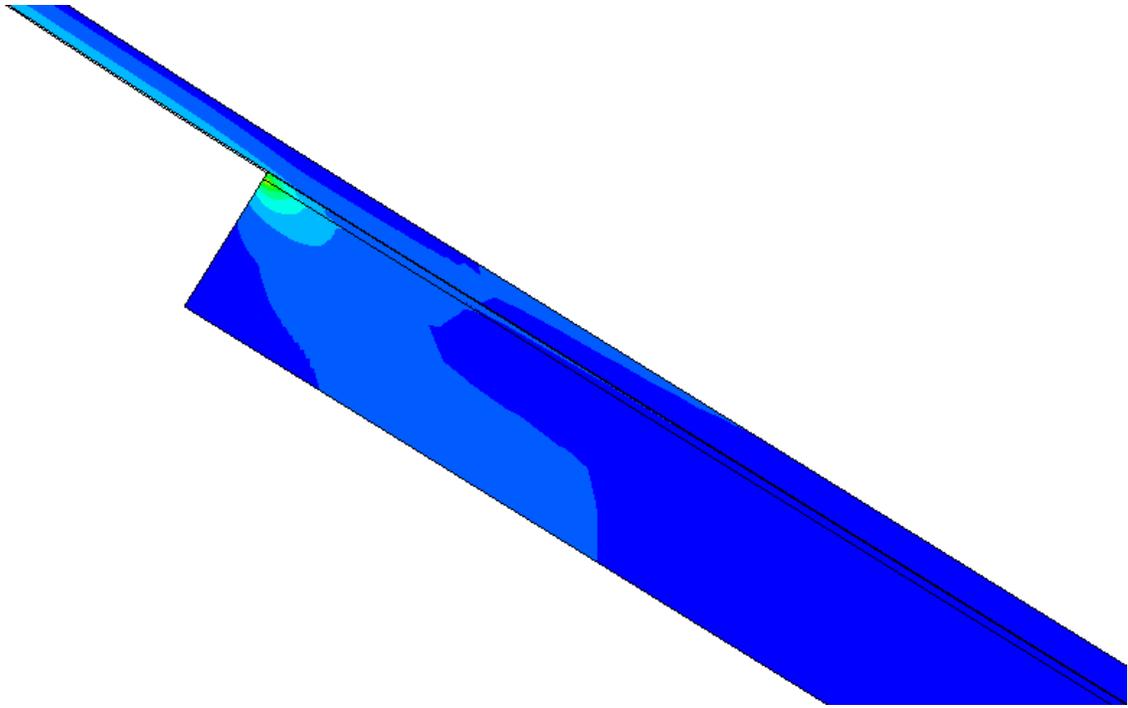
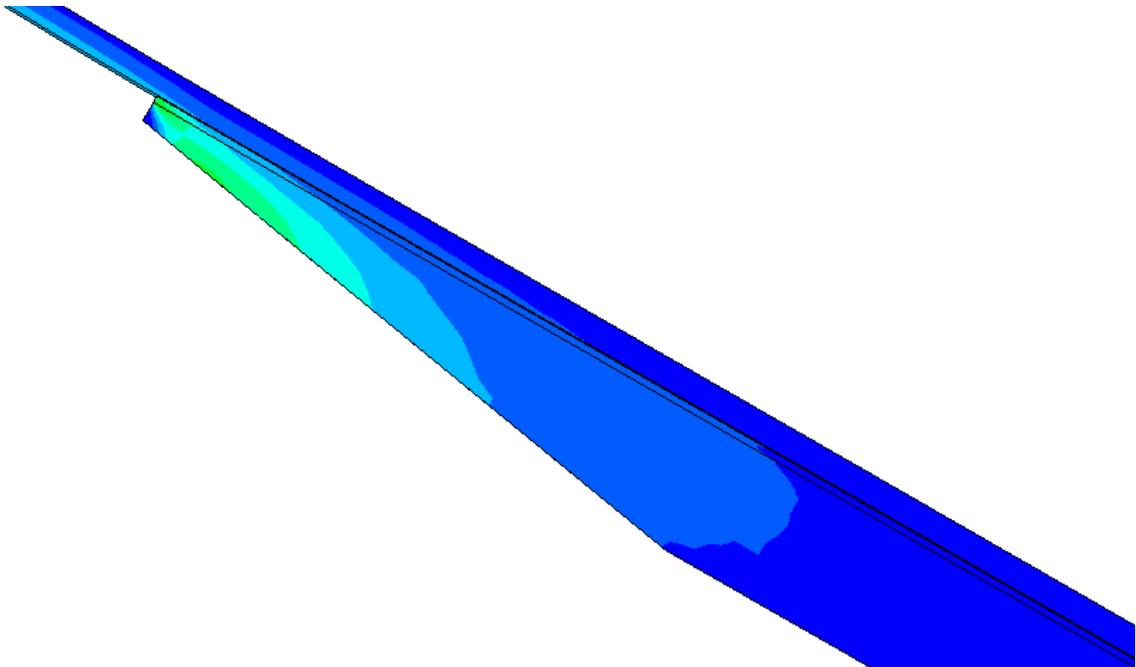
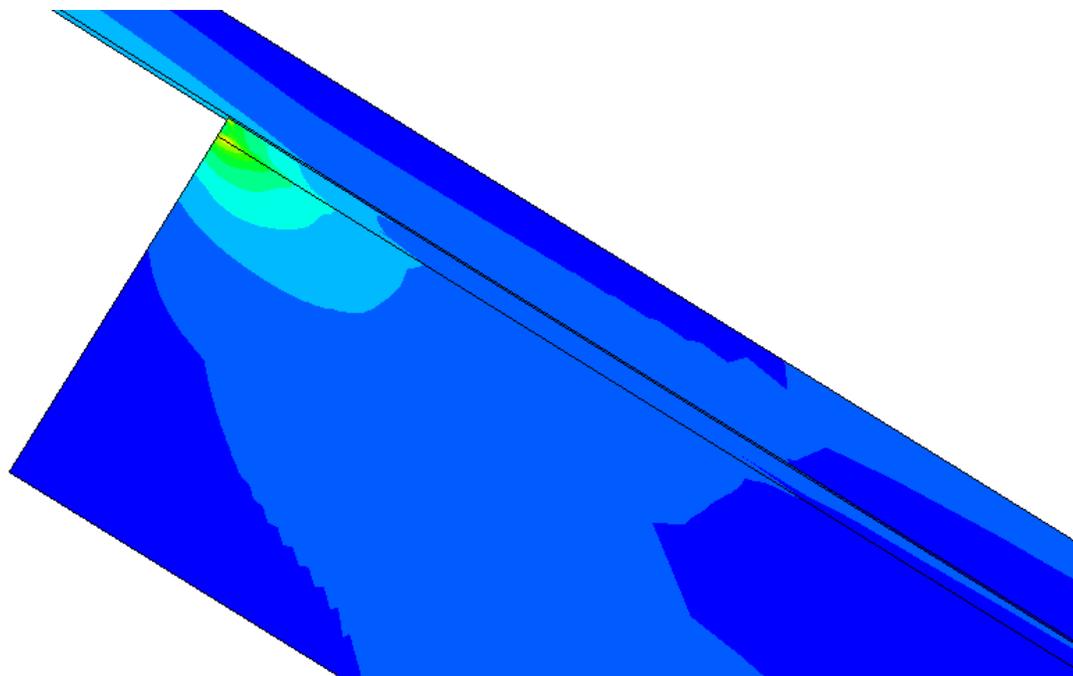
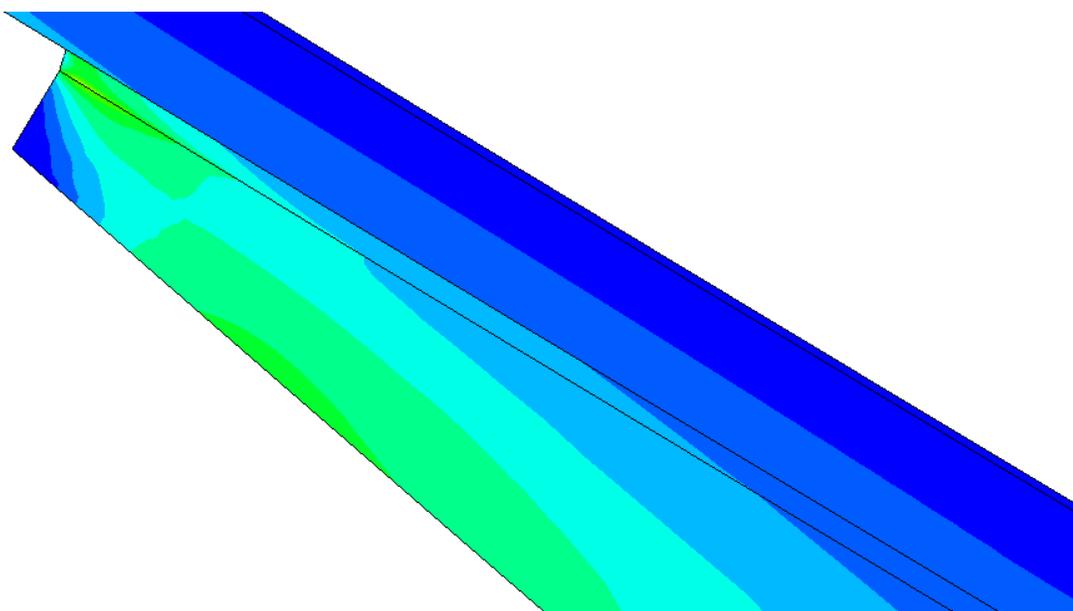
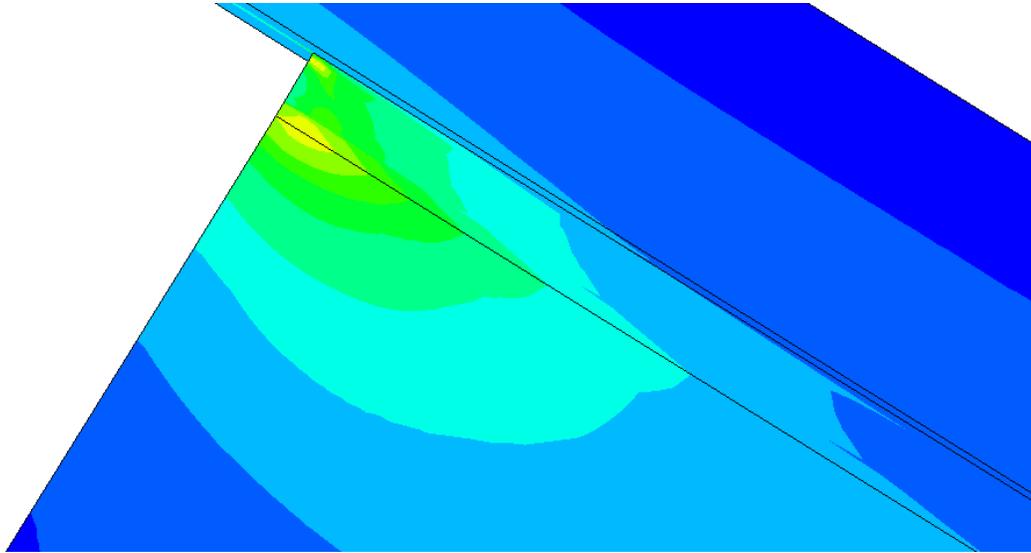
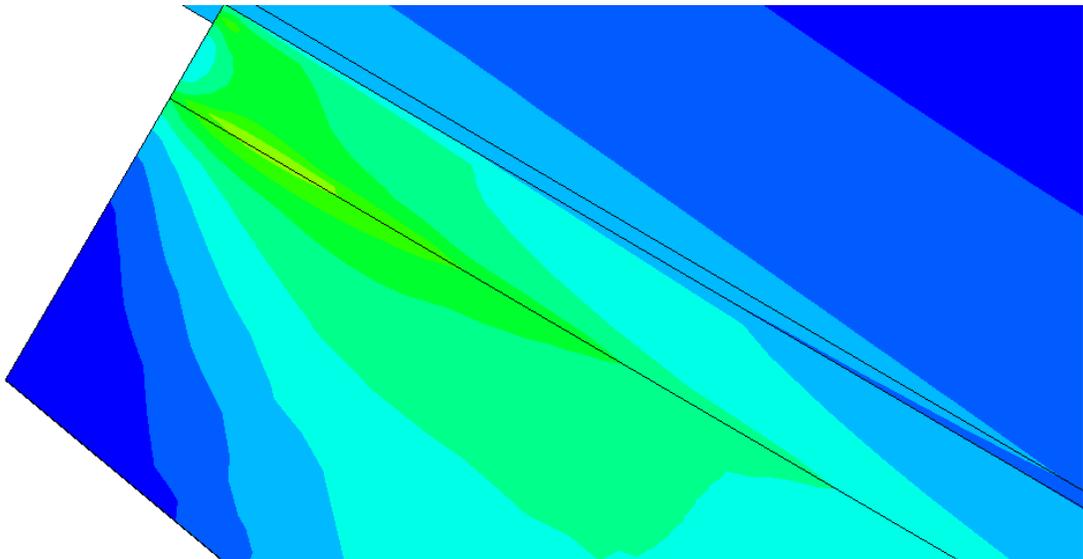
**Figure F.18: Stiffener (x-z) – before repair.**

**Figure F.19: Stiffener (x-z) – after repair.**

**Figure F.20: Stiffener (x-z) – detail 1 – before repair.**

**Figure F.21: Stiffener (x-z) – detail 1 – after repair.**

**Figure F.22: Stiffener (x-z) – detail 2 – before repair.**

**Figure F.23: Stiffener (x-z) – detail 2 – after repair.**

**Figure F.24: Stiffener (x-z) – detail 3 – before repair.**

**Figure F.25: Stiffener (x-z) – detail 3 – after repair.**

Figures F.18 through F.25 show that the longitudinal stresses along the stiffener were similar in magnitude. After the repair, stresses propagated from the tip of the stiffener over a larger area along the stiffener. Also the stress distribution after the repair shows a much more gradual gradient. This can be observed in Figures F.24 and F.25 (detail 3), where areas with higher stresses are shown in yellow.

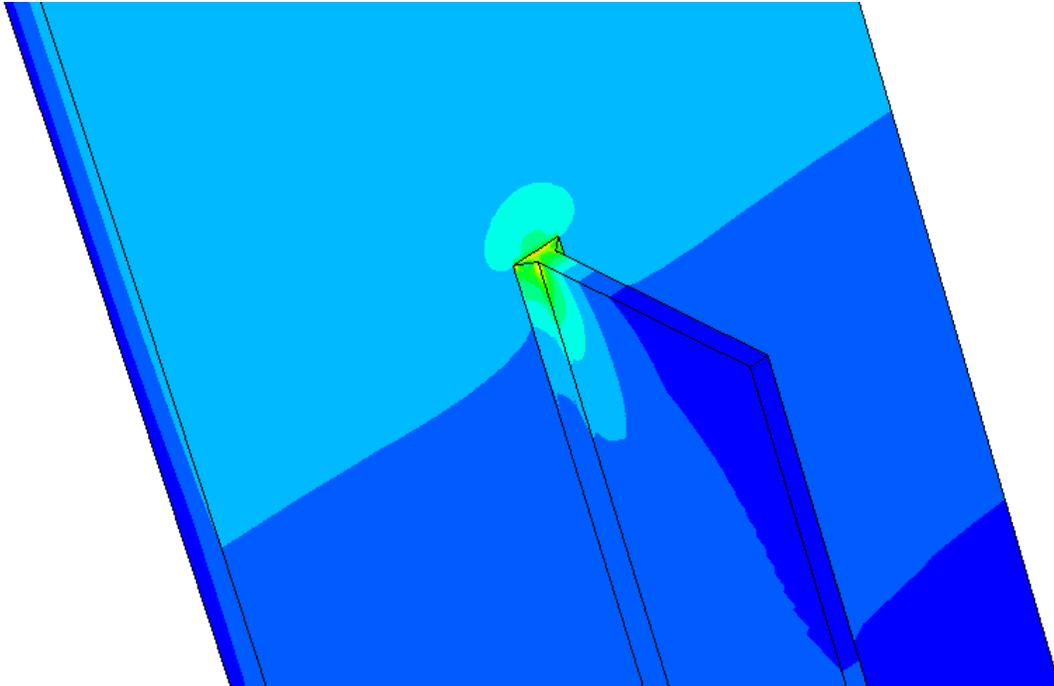
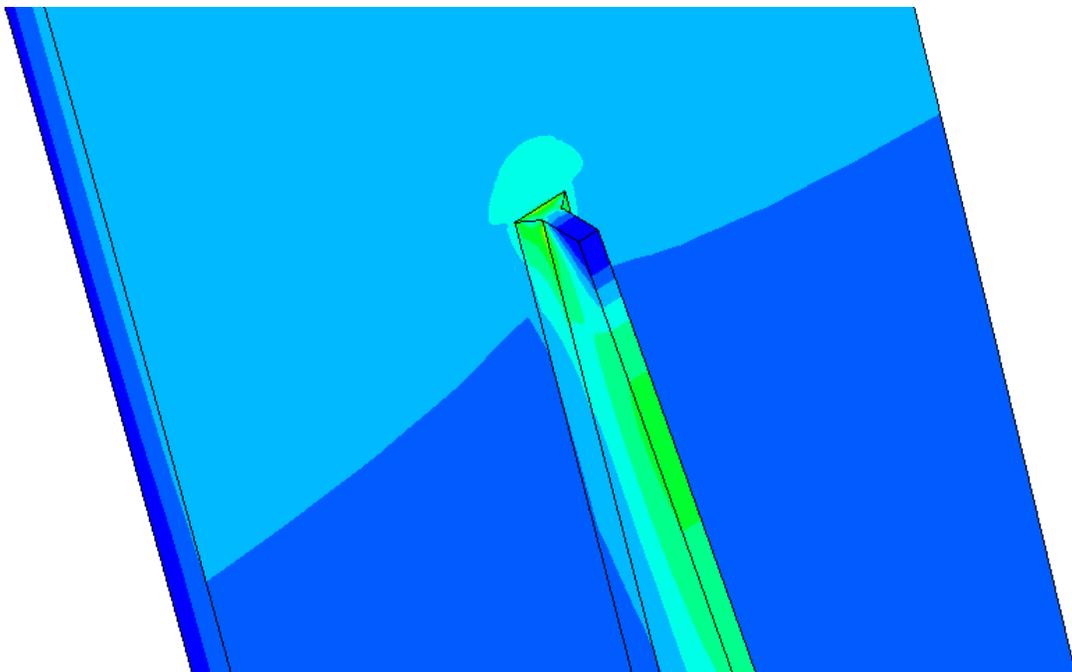
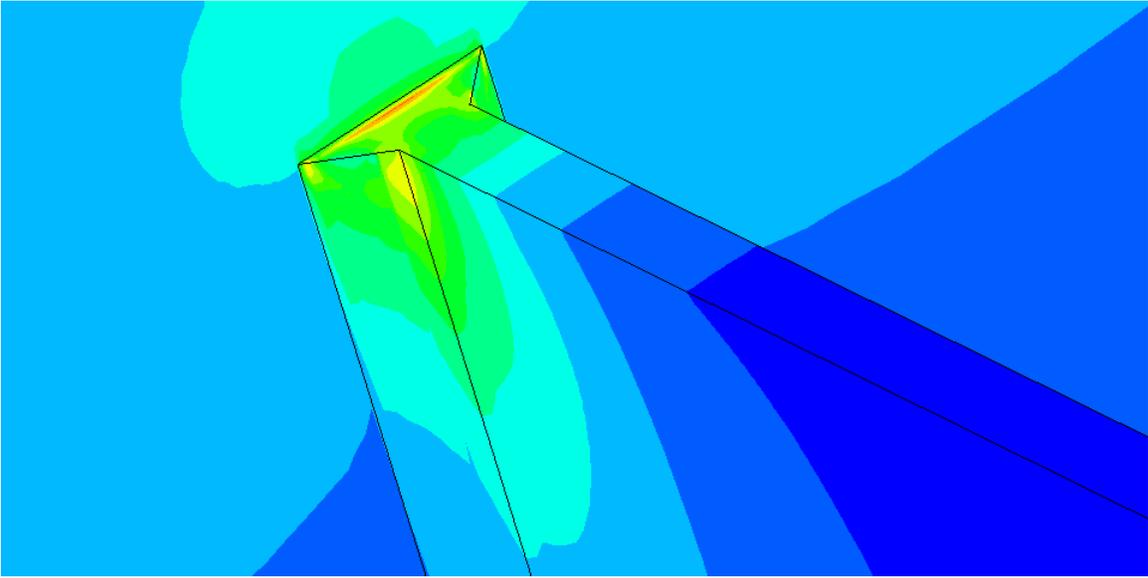
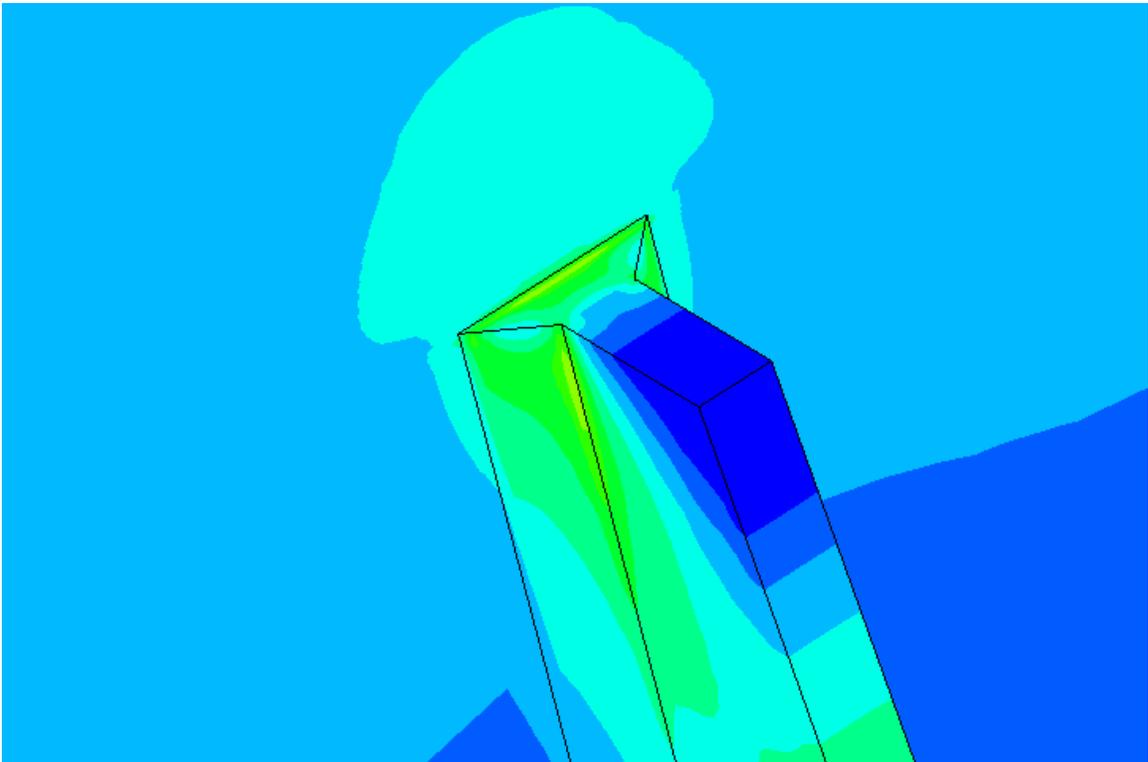
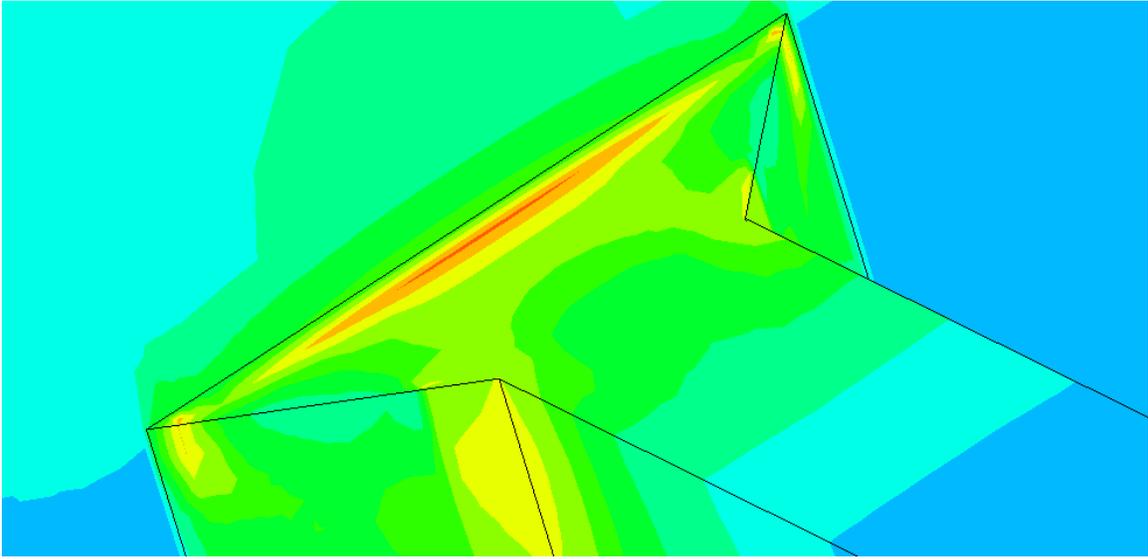
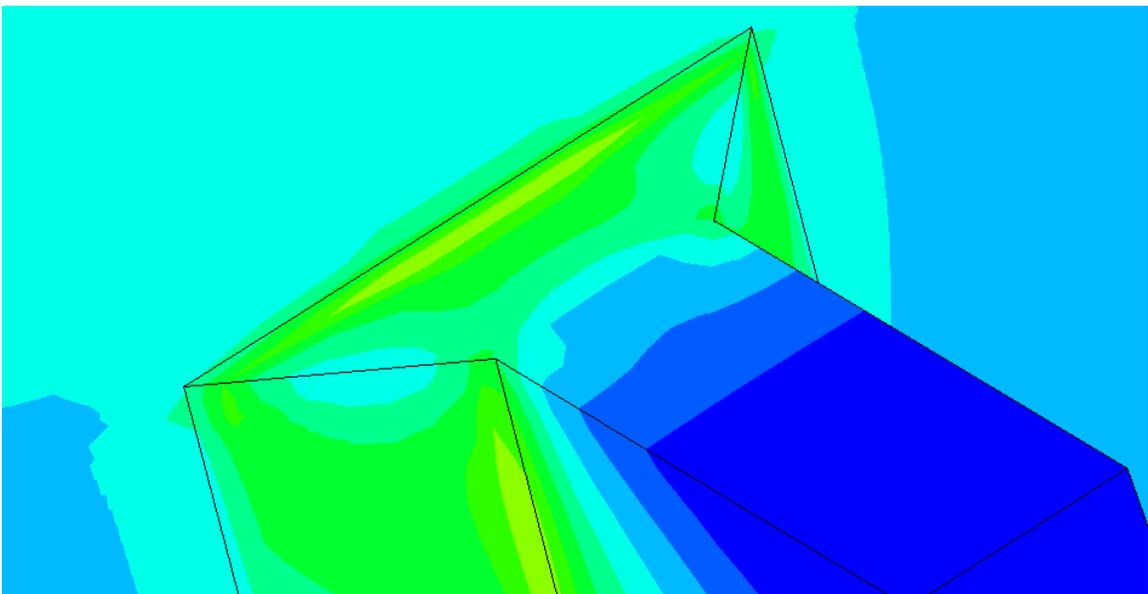
**Figure F.26: Tip of stiffener - detail 1- before repair.**

**Figure F.27: Tip of stiffener - detail 1- after repair.**

**Figure F.28 Tip of stiffener - detail 2- before repair.**

**Figure F.29: Tip of stiffener - detail 2- after repair.**

**Figure F.30: Tip of stiffener –detail 3- before repair.**

**Figure F.31: Tip of stiffener –detail 3- after repair.**

Figures F.26 thru F.31 show that the magnitude of the stresses (shown in increasing order of magnitude as yellow, orange and red) decreased with the repair. Figures F.30 and F.31 show that the front face of the stiffener within the fillet weld region was the area most affected by these stress concentrations. It was found by direct comparison of results from FEMs that after the repair the maximum stresses were reduced by approximately 25%, which would improve the fatigue life.
