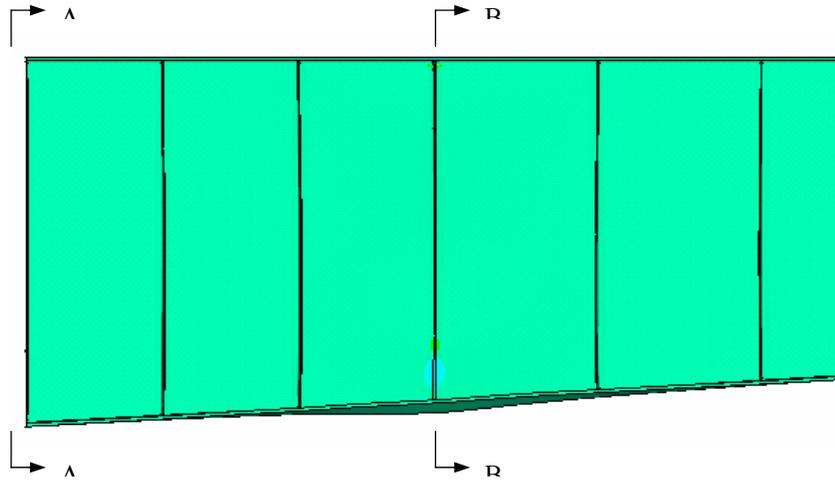
FIGURE 6-39: Model FM3-p Overall Deformation and σ_y Stress Distribution for Load Case No. 6

Since the current repair method does not successfully reduce the secondary stresses to a satisfactory level, truss chord removal is then considered in addition to the already performed repair method, as modeled by FM3-pr shown in Figure 6-36(d). By using this means of retrofit, stresses can be reduced on average by 87%, 69%, and 83%, respectively, for the highest σ_x , σ_y , and σ_z locations in the web gap. Although the percentage reductions of the corresponding stresses are less than those obtained from the chord removal only repair, all of the

stress range magnitudes are successfully controlled below and close to half of the CAFT of fatigue Detail Category C and C'. As a result, the connection stiffener detail should be able to sustain unlimited number of stress cycles and be free from fatigue cracking after the repair is carried out.

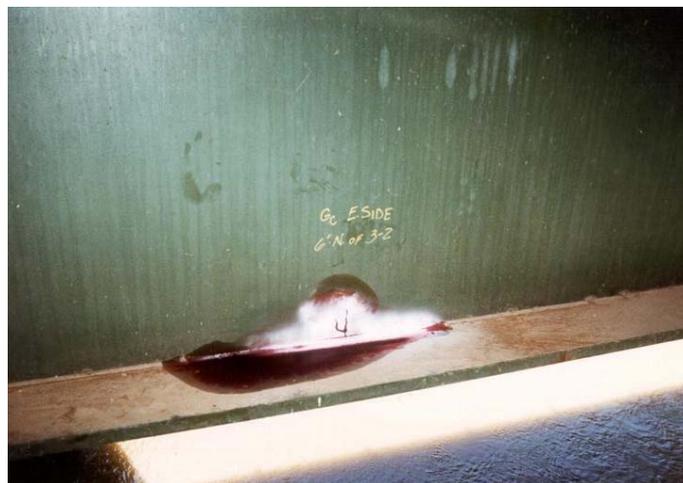
During the 1996 bridge inspection, web gap fatigue cracks were observed at two diaphragm-girder connections in Span No. 3 of the northbound bridge. The framing plan (Figure 7-2) has a staggered diaphragm arrangement. Both Crack Location No. 1 and 2 were located in the mid-span of Girder G3 close to the bottom flange and were thus subjected to high magnitude of both in-plane and out-of-plane bending moments. The connection stiffeners used at these two locations were welded to the top flange, but not to the bottom flange, so cracks were not seen at the top flange web gaps. Figure 7-3 shows the crack exposure on web surfaces at Location No. 1 using dye penetrant. Figure 7-4 shows schematically the observed crack shape and size of the same detail. Both the horseshoe and the horizontal cracks were identified to have gone through the web thickness. Since the cracks were developed at the stiffener to bottom flange connections and at the mid of the longest span of the bridge, the affected web gap areas were exposed to high tensile flexural stresses which could cause the cracks to propagate continuously upward through the girder depth. The cracking condition of this bridge is thus more severe than those found near the girder top flanges such as seen in the Westgate Bridge.

(b) cracks on the exterior girder web side

FIGURE 7-3: Inspection Pictures of Crack Location No. 1

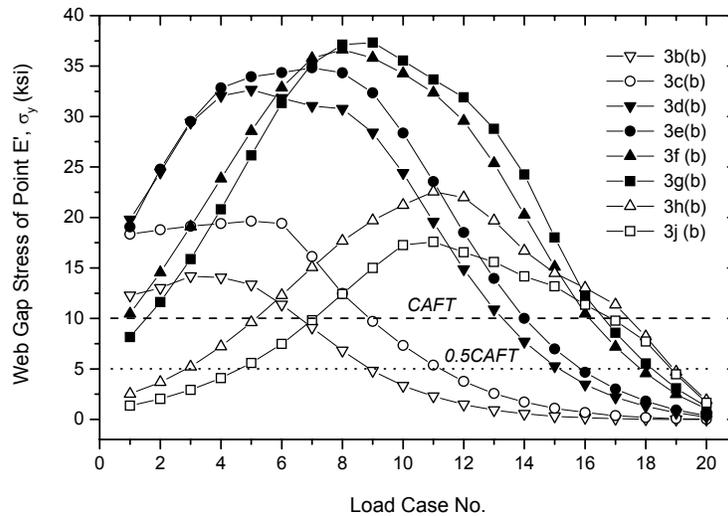
FIGURE 7-20: Point E' σ_y Stress Variation for Girder G3 Bottom Flange Submodels

Girder G3 has eight diaphrag-girder connections with unstiffened web gaps at the bottom flange: connections 3b, 3c, 3h, and 3j in the transition region, and connections 3d, 3e, 3f, and 3g in the positive moment region. For all eight connections and at all major truck locations, the maximum σ_y stress occurs at Point E' and the maximum σ_x and σ_z stresses both occur at Point A. The web gap stresses of those most highly stressed nodes of each submodel are plotted in Figures 7-21 to 7-22 and summarized in Table 7-3. Figure 7-20 shows the variation of Point E' σ_y stress versus load cases. Figures 7-21 and 7-22 show the variation of Point A σ_x and σ_z stresses, respectively. Figure 7-23 shows the variation of the out-of-plane displacement. The fluctuation pattern shown in Figures 7-20 to 7-23 suggests that for each diaphrag-girder connection, the high magnitude stress or out-of-plane displacement in the web gap occurs only when the truck moves close to the diaphrag position. Web gap stresses experienced by the positive moment region connections are much higher than those developed in the transition region connections, which indicates that larger differential girder deflection occurs in the mid-span area. For connections 3b, 3c, 3h, and 3j, the maximum σ_x and σ_z stresses are all close to or lower than $\frac{1}{2}$ CAFT, but the maximum σ_y stresses are higher than the CAFT. For connections 3d, 3e, 3f, and 3g, the maximum σ_x and σ_z stresses are close to the CAFT, but still higher than $\frac{1}{2}$ CAFT. The maximum σ_y stresses are all found close to yield strength, which are much higher the CAFT. So all these eight diaphrag-girder connections may have the chance to develop out-of-plane fatigue cracks in the unstiffened bottom flange web gaps. Connections 3e and 3g had already been identified with fatigue cracks and repaired by KDOT. Connections 3d and 3f may

experience fatigue cracking in the near future as the maximum web gap σ_x , σ_y , and σ_z stress magnitudes developed in these two connections are almost the same as those developed in connections 3e and 3g. Cracks are expected to occur at both the horizontal flange-to-web welds and the vertical stiffener-to-web welds. The maximum σ_y stresses observed in the transition region connections 3b, 3c, 3h, and 3j are much lower than those of the positive moment region connections, but the stress magnitudes are still high enough to introduce horizontal fatigue cracking along the flange-to-web welds. Vertical or horseshoe cracks may not be able to develop in these four connections as the maximum σ_x and σ_z stresses are all of low magnitudes close to $\frac{1}{2}$ CAFT.

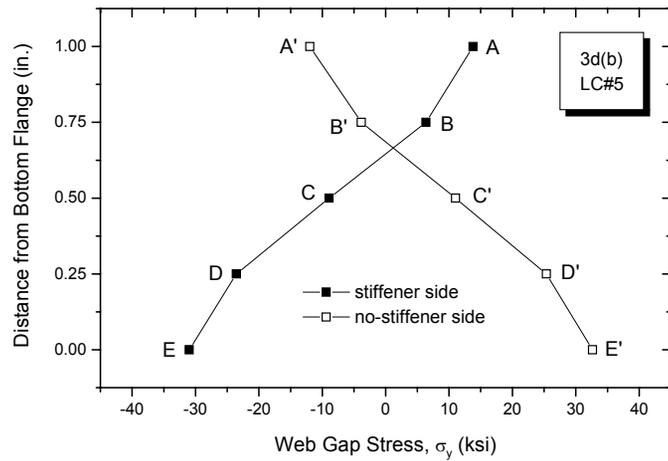
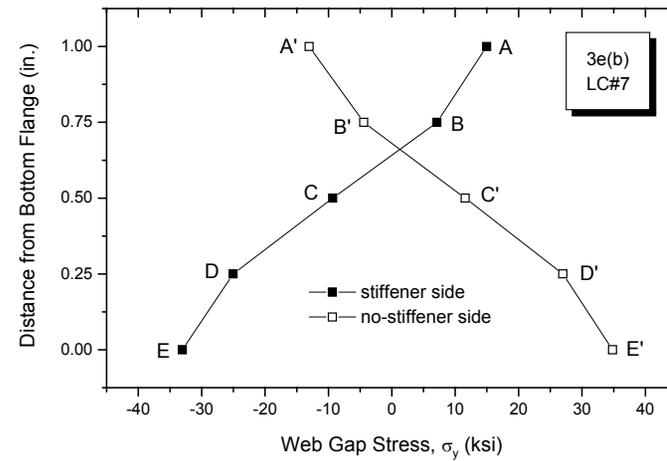
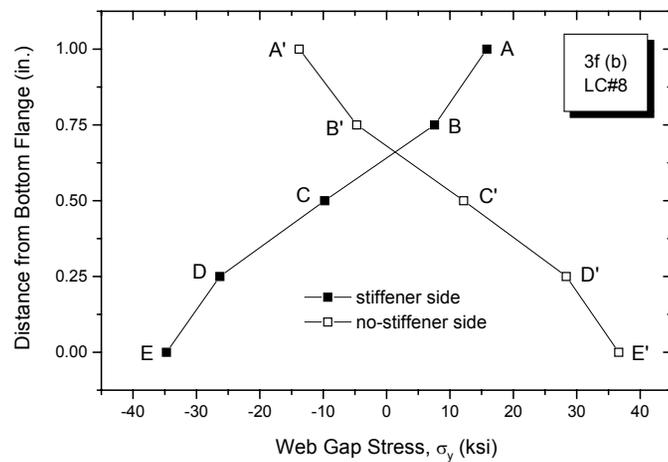
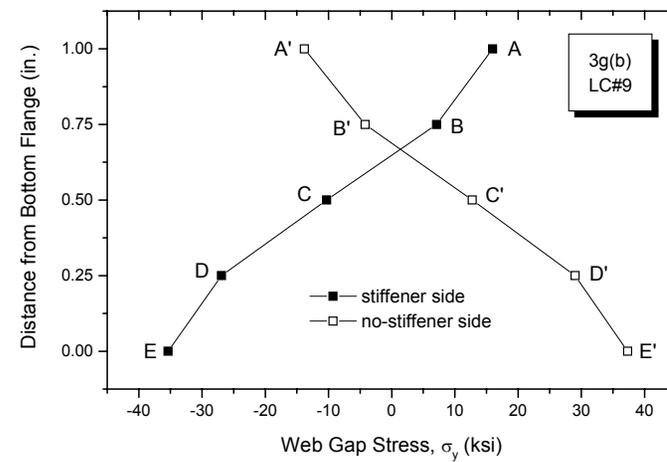
FIGURE 7-24: Web Gap Stress Gradient for Bottom Flange Submodels of Girder G3 Positive Moment

Figures 7-24 and 7-25 show the maximum web gap stress gradient of the diaphragm-girder connections in the positive and transition moment regions, respectively. The effect of out-of-plane distortion is very clear. Connections in the positive moment region are apparently subjected to more dramatic stress variation within the web gap than those in the transition region. For all the eight connections, the σ_y stresses at the bottom end of the web gaps (Points E' and E) are more than two times of those occurring at the top end (Points A and A'). So theoretically, in terms of stress range, the horizontal bottom-flange-to-web welds would develop fatigue cracks at an earlier stage than the vertical stiffener-to-web welds. Symmetry is found about the mid web surface, for the stresses on each side of the girder web, but is not found about the mid web gap length. The locations of zero stresses are about $1/3$ of the web gap length down below the top web gap end (Point A or A').

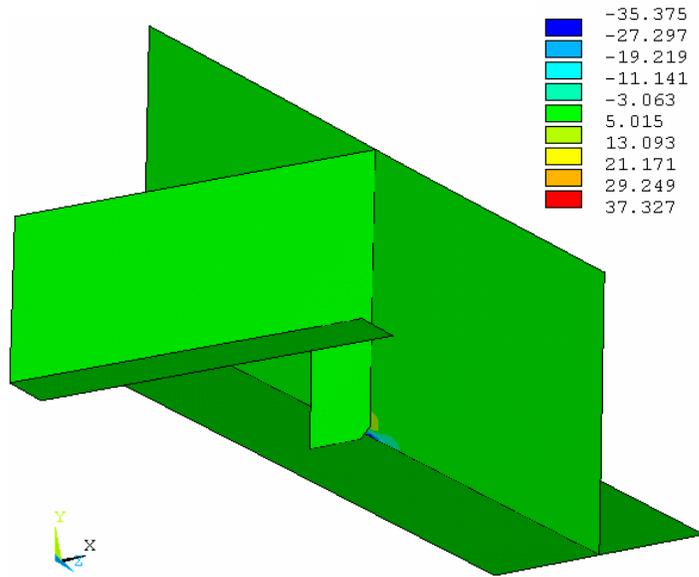
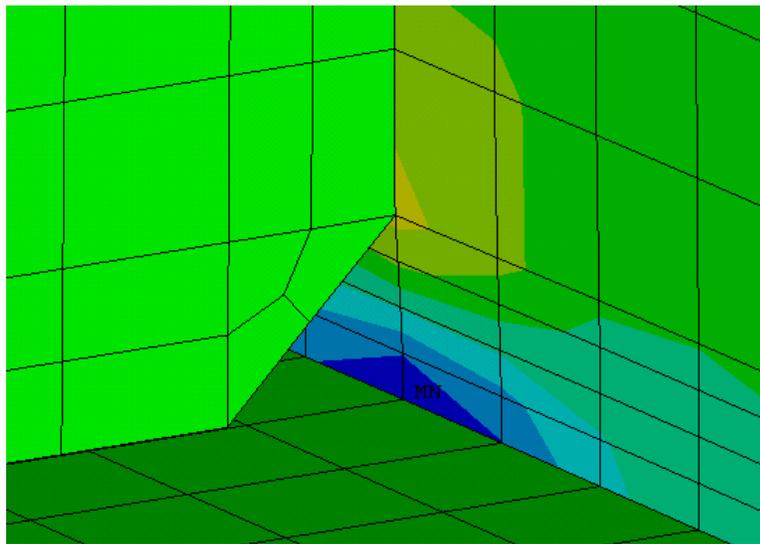
FIGURE 7-26: Load Case No. 9 σ_y Stress Contour of Submodel 3g on the Stiffener Side

Figures 7-26 and 7-27 illustrate, for example, the σ_y stress contour of submodel 3g at Load Case No. 9. The overall stress distribution on both web sides indicates mild, close to zero stress magnitude, but significant stress concentration effect is observed in the small web gap region. The maximum and minimum σ_y stresses at Points E' and E, respectively, are all beyond the yield strength. Figure 7-28 shows the web gap σ_x stress contour of the same connection at Load Case No. 9 and Figure 7-29 shows the corresponding σ_z stress contour. Both have the maximum stresses at Point A on the stiffener side of the girder web. Figure 7-30 shows the σ_y stress distribution along the flange-to-web welds on the no-stiffener side of the girder web. The peak stress occurs at Point E' with an amplitude of 37 ksi. Stress within the next adjacent 3 in. on each side of the stiffener decreases dramatically and in approximately a linear pattern. The σ_y stresses at Points E'3 and E''3 are 4.5 ksi and 5.8 ksi, respectively. From Point E'3 to E'10 and E''3 to E''10, stress decreases gradually in a relatively flat slope. At Points E'5 and E''5, the σ_y magnitudes are 1.3 ksi and 2.5 ksi, respectively. So generally speaking, a total of 10 in. wide area, 5 in. on each side of the connection stiffener, can be defined as the affected zone due to the web gap stress concentration. The other seven Girder G3 connections have the same web gap stress distribution pattern, with similar or lower stress magnitudes. This 10 in. affected zone is thus suggested as a general size for the stress concentration regions of the unstiffened bottom flange web gaps.

(b) web gap σ_y stress distribution (maximum compressive stress at Point E)

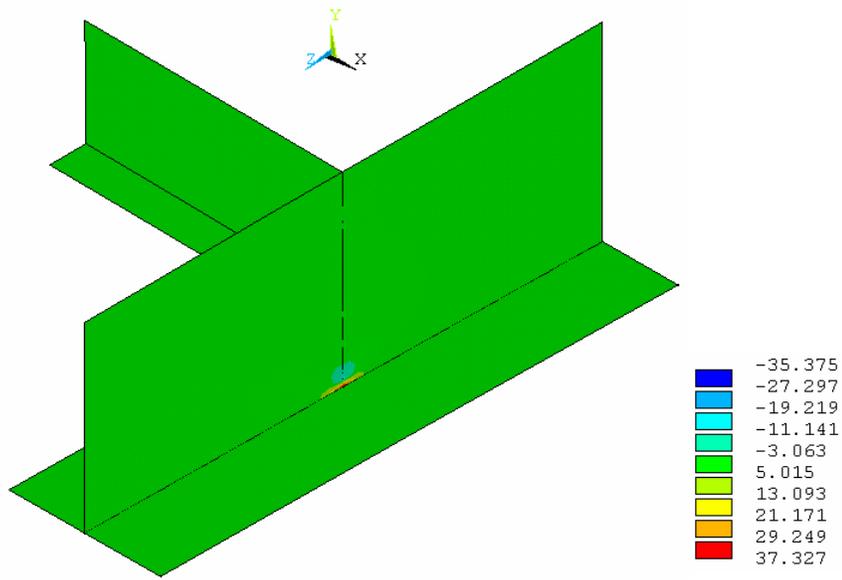
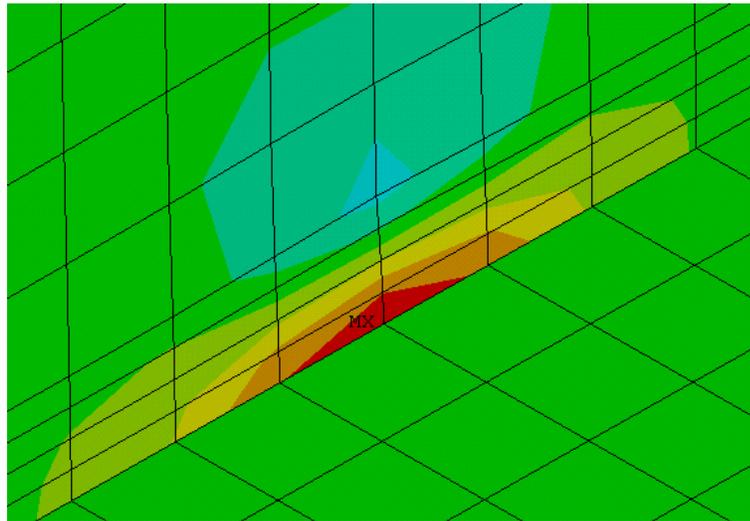
FIGURE 7-27: Load Case No. 9 σ_y Stress Contour of Submodel 3g on the No-Stiffener Side

(b) web gap σ_y stress distribution (maximum tensile stress at Point E')

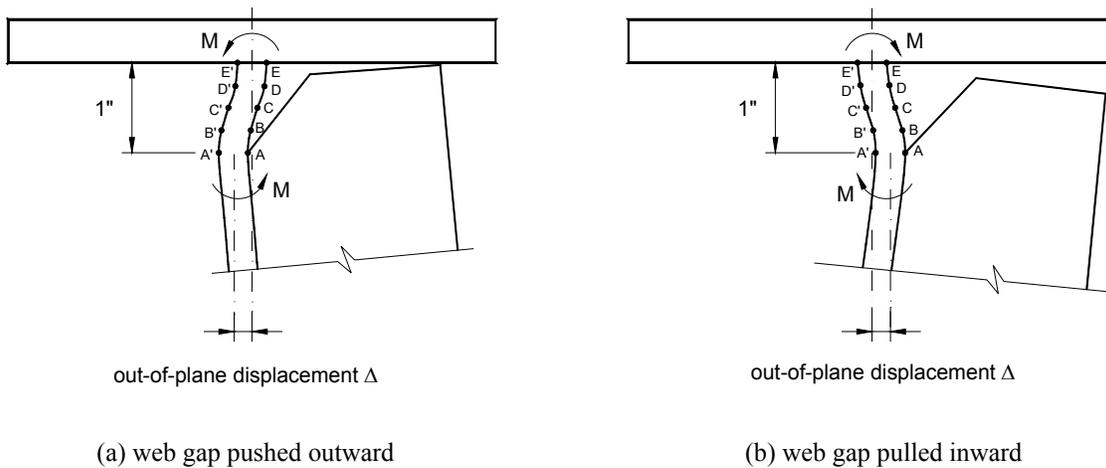
FIGURE 7-31: Schematic of Different Web Gap Distortion Curvature

For all 20 load cases, the web gaps of connections 3a and 3k in the negative moment region are pushed outward and distort in double curvature as shown in Figure 7-31(a). The maximum σ_y stress thus occurs at Point E on the stiffener side of the web and the σ_x and σ_z stresses at Point A are always in compression. For connections 3b, 3c, 3h, and 3j in the transition region, except at a few low stress magnitude load cases where the distortion is found the same as of Figure 7-31(a), for most truck locations the web gaps are pulled inward and deflect in a reversed curvature as shown in Figure 7-31(b). The maximum σ_y stress occurs mostly at Point E' on the no-stiffener side of the web and the maximum σ_x and σ_z stresses occur

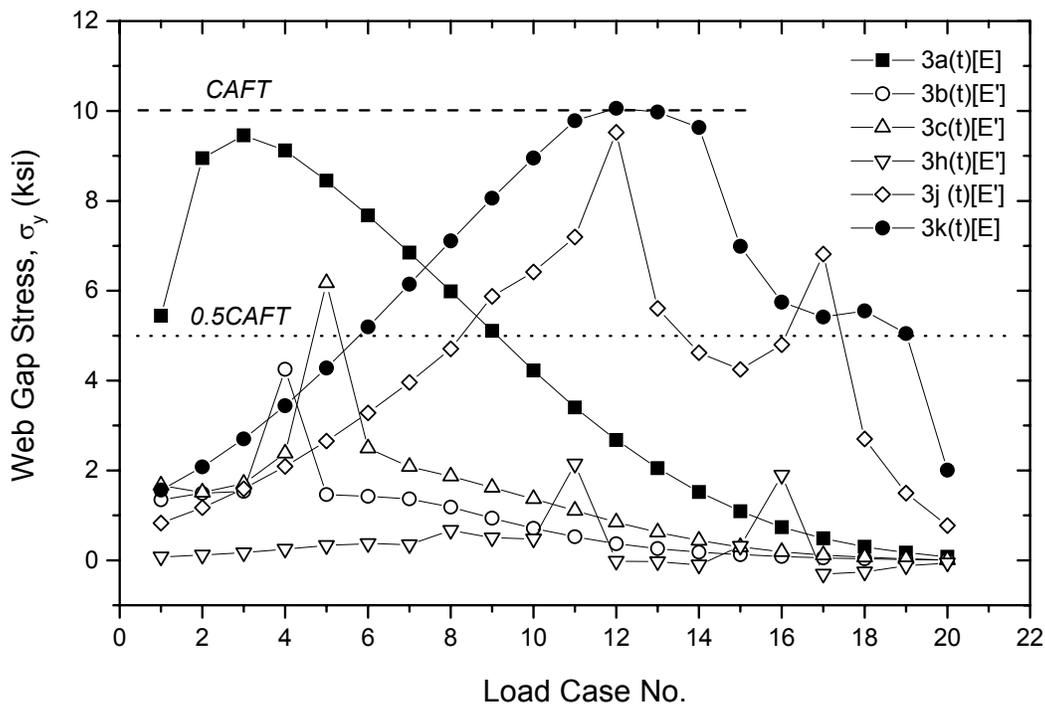
FIGURE 7-32: Web Gap σ_y Stress Variation for Girder G3 Top Flange Submodels

mostly at Point A. Figure 7-32 shows the web gap σ_y stress variation for the six top flange submodels. The data plotted in the diagram are stresses at Point E for connections 3a and 3k and Point E' for connections 3b, 3c, 3h, and 3j. The letter “t” in the parenthesis is added to the legend to make it clear that these submodels are for top flange unstiffened web gaps.

Connections 3a, 3b, and 3c are subjected to only one stress cycle per truck passage, while connections 3h, 3j, and 3k are subjected to two stress cycles per truck passage. The maximum σ_y stresses of connections 3b, 3c, and 3h are below $\frac{1}{2}$ CAFT. Those of connections 3a, 4j, and 3k are close to the CAFT, but still higher than $\frac{1}{2}$ CAFT, so horizontal cracks could develop at the flange-to-web welds. Figures 7-33 and 7-34 show the Point A stress variation for σ_x and σ_z , respectively. Both the maximum σ_x and σ_z stresses of all six connections are below $\frac{1}{2}$ CAFT, so vertical or horseshoe cracks along the stiffener-to-web welds are not likely to occur at these locations. Figure 7-35 shows the variation of out-of-plane displacement for the six top flange submodels. The bridge is skewed at Pier No. 2 and No. 3, so connections 3a and 3k in the negative moment region experience larger out-of-plane displacement than the other four connections in the transition region. Table 7-4 summarizes the maximum out-of-plane displacement as well as the maximum σ_x , σ_y , and σ_z stresses of the six top flange submodels. Compared with the analysis results obtained for the bottom flange submodels (Table 7-3), the fatigue stresses developed in the top flange unstiffened web gaps are much lower. All maximum stresses are below the CAFT and most of them are below $\frac{1}{2}$ CAFT. This is why no cracks have been found in the top flange web gaps of the Winfield Bridge. However, since the maximum σ_y stresses in connections 3a, 3j, and 3k are still higher than $\frac{1}{2}$ CAFT, it is recommended that some repair action also be taken at these unstiffened top flange web gap details, so that possible crack development at these locations can be prevented.

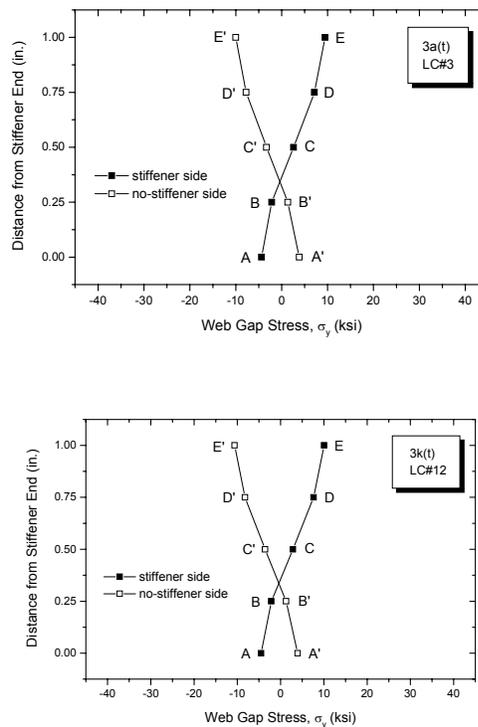
FIGURE 7-36: Web Gap Stress Gradient for Top Flange Submodels of Girder G3 Negative Moment Region Connections

Figures 7-36 and 7-37 show the maximum web gap σ_y stress gradient of the top flange submodels, for connections at negative and transition moment regions, respectively. Compared to those observed in the bottom flange submodels (Figures 7-24 and 7-25), both the stresses and the stress variation amplitudes within the top flange web gaps are of much lower magnitude. For all six connections, stresses on each side of the girder web are symmetric about the web mid surface, but are not symmetric about the mid web gap length. The σ_y stresses at the top, flange end of the web gaps (Points E and E') are at least two times of those occurring at the bottom, stiffener end (Points A' and A). For connections 3a and 3k, the locations of zero stresses are about $\frac{1}{3}$ of the web gap length up above the bottom web gap end (Point A or A'). For connections 3b, 3c, 3h, and 3j, the locations of zero stresses are about $\frac{1}{4}$ of the web gap length up above the bottom web gap end (Point A or A').

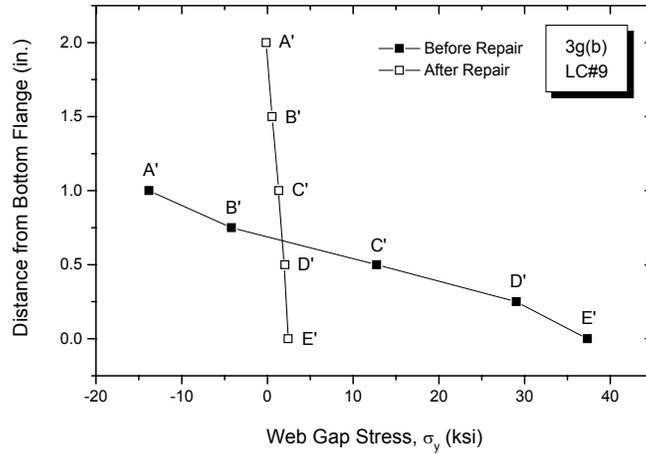
FIGURE 7-46: Connection 3g Web Gap Stress Gradient Before and After the Repair

Figure 7-46 shows the web gap σ_y stress gradient on the no-diaphragm side of the web for Load Case No. 9 both before and after the repair. Significant stress reduction can be observed. The stress variation between Point A' and E' is 51 ksi before the repair, but was decreased to 2.6 ksi after the repair. The σ_x and σ_z stresses at Point A are also decreased to about zero. The web gap region is therefore “cooled” down and fatigue cracking should not occur at this location after the repair.

The two cracked diaphragm-girder connections 3e and 3g were repaired by KDOT using the details shown in Figure 7-6. By changing the model geometries to simulate the repair condition, coarse-to-fine submodel analysis is conducted again for connection 3g, so that the stresses developed before and after the repair can be compared.

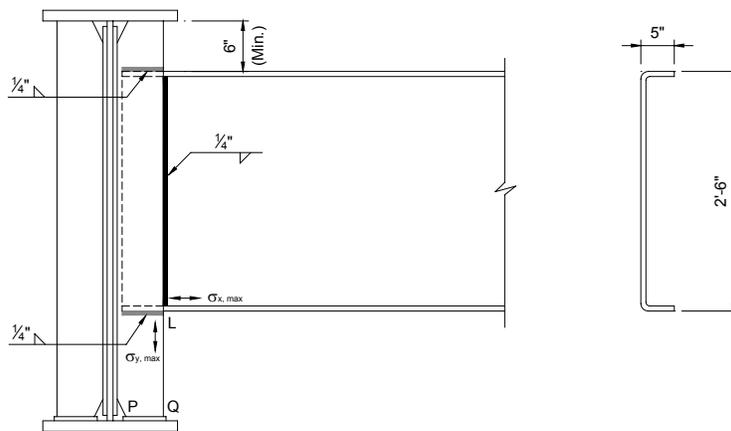
FIGURE 7-47: Locations of Maximum σ_x and σ_y Stresses using KDOT Repair

However, the maximum stresses are noticed to have shifted to the diaphragm-to-stiffener weld ends, as shown by Point L in Figure 7-47. Figures 7-48 and 7-49 show the post-retrofit stress contours of σ_x and σ_y , respectively, for connection 3g at Load Case No. 9. The maximum σ_x stress (10 ksi) and σ_y stress (16 ksi) both occur at Point L and are higher than $\frac{1}{2}$ CAFT. Both the horizontal and vertical diaphragm-to-stiffener welds are considered as Category C details, in terms of the stresses normal to the weld lengths. So the area around the bottom diaphragm-to-stiffener weld junction becomes a new stress concentration zone and fatigue cracking could develop along either the horizontal or the vertical welds.

Another area of interest of the repair model is the bolted attachment between the connection stiffener and bottom flange, as indicated by line PQ in Figure 7-47. Both of the stresses developed in the connection plate (σ_y) and bottom flange (σ_z) normal to this line are found much less than $\frac{1}{2}$ CAFT of Detail Category B, so cracks would not develop at this region after the repair. A summary of the stresses developed at Point L and line PQ is provided in Table 7-5.

A bolted diaphragm-to-stiffener connection could have been used during the retrofit to avoid possible fatigue cracking at the connecting welds. The stress magnitudes of the new concentration area are much lower than those previously developed in the web gap region. The potential crack initiation point is also moved to a location away from the girder web, which gives the inspectors enough time to identify the problem before cracks start to propagate. So in general, the KDOT repair method is acceptable. However, special attention needs to be paid to both horizontal and vertical diaphragm-to-stiffener welds during future bridge inspections. If cracks are found at these locations, it is important that additional retrofit be carried out to prevent cracks from growing into the diaphragm, the stiffener, or even further into the girder web.

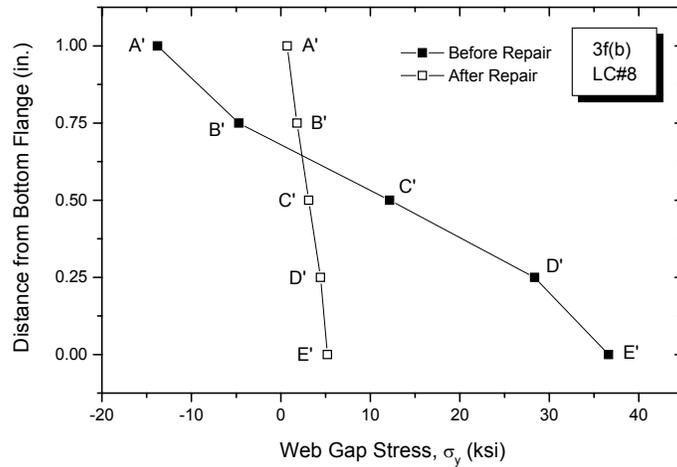
FIGURE 7-50: Connection 3f Web Gap Stress Gradient Before and After the Repair

The geometry of submodel 3f is changed by connecting the stiffener to the bottom flange. The coarse-to-submodel cut boundary DOF interpolation is performed again and the repair model is analyzed for all 20 load cases. Figure 7-50 shows the change of web gap stress gradient on the no-stiffener side of the web at Load Case No. 8. The stress variations between

Nodes A' and E' before and after the repair are 50 ksi and 4.5 ksi, respectively. Table 7-6 summarizes the results of those mostly stressed points within the web gap. The σ_x stress at Point A is always below zero after the connection stiffener is attached to the bottom flange; the σ_y stress at Point E' is reduced to 5.2 ksi; and the σ_z stress at Point A is reduced to 1.7 ksi. The average percentage reductions of all 20 load cases are 102%, 86%, and 91%, respectively, for σ_x , σ_y , and σ_z stresses. Since the stresses at those potential crack initiation points are all decreased to equal or below $\frac{1}{2}$ CAFT, fatigue cracking is not expected to occur at the web gap region after the retrofit.

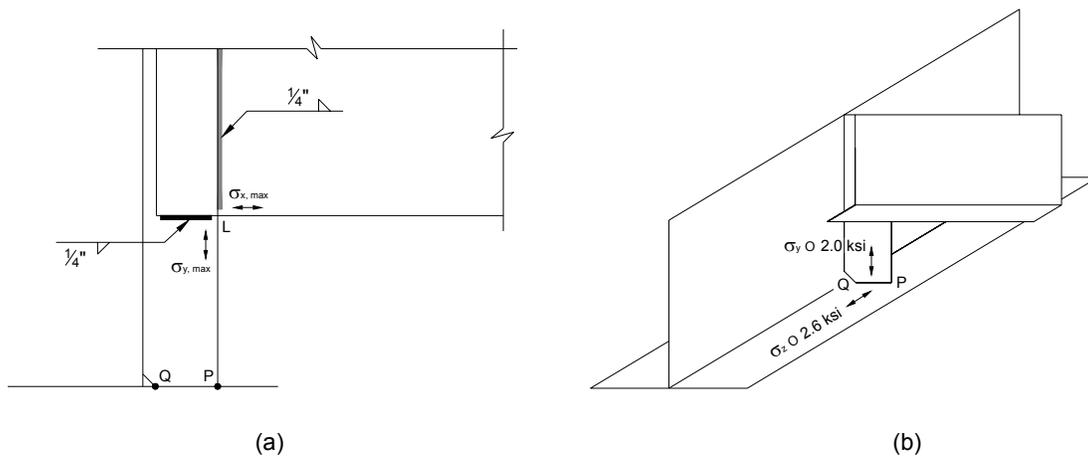
FIGURE 7-51: Areas of Interest in the Connection 3f Repair Model

Figure 7-51 shows schematically the areas of interest in the connection 3f repair model and Table 7-7 summarizes the corresponding stresses developed at these locations. As in connection 3g, the maximum post-retrofit stresses in the model are observed shifting to the vertical and horizontal diaphragm-to-stiffener weld intersection, Point L [Figure 7-51(a)]. The σ_x and σ_y stresses developed at this point are 7.7 ksi and 15 ksi, both higher than $\frac{1}{2}$ CAFT. This new concentration zone, therefore, needs to be checked frequently and carefully during future bridge inspection. As in connection 3g, since the detail is in a relatively low stress range (less than CAFT), the overall performance of the repair at this location is still considered acceptable.

The stresses normal to line PQ are also checked, as illustrated in Figure 7-51(b), because the stiffener is now connected to the bottom flange. For all 20 load cases, the σ_y stresses at the stiffener plate are below 2.0 ksi and the σ_z stresses at the girder flange are below 2.6 ksi. Since the stress magnitudes are lower than $\frac{1}{2}$ CAFT of either a Category B or C' detail, both welded and bolted attachments can be used for the flange-to-stiffener connections without creating a new stress concentration site at this detail after the repair.

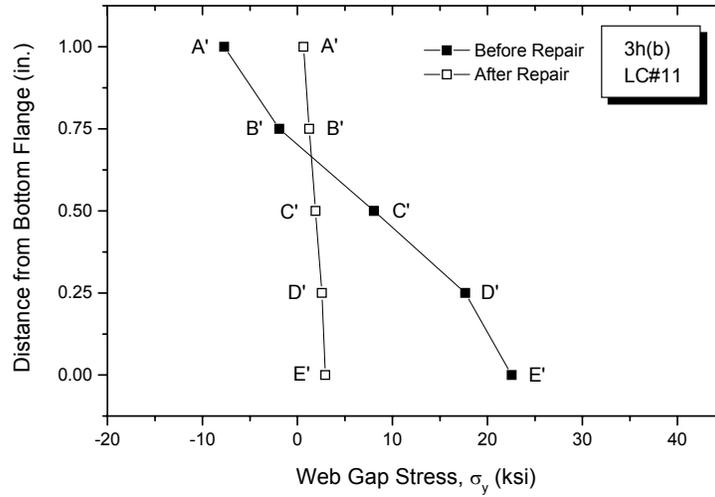
FIGURE 7-52: Connection 3h Web Gap Stress Gradient Before and After the Repair

The repair analysis carried out for connection 3h bottom flange detail yields similar results as those of connection 3f except that lower stress magnitudes are obtained. As tabulated in Table 7-8, all the web gap stresses are decreased to below $\frac{1}{2}$ CAFT and the average percentage reductions for σ_x , σ_y , and σ_z are 102%, 87% and 103%, respectively. Figure 7-52

illustrates the change of web gap σ_y stress gradient before and after the repair at Load Case No.

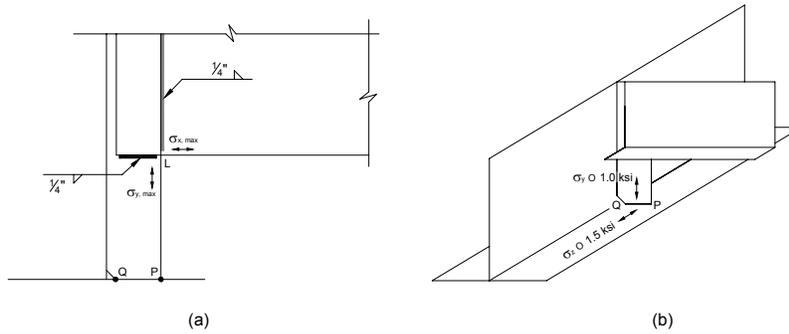
FIGURE 7-53: Areas of Interest in the Connection 3h Repair Model

11. Table 7-9 summarizes the stresses of the areas of interest in the repair model. The maximum σ_x and σ_y stresses again occur at Point L [Figure 7-53(a)]. The maximum σ_x (5.1 ksi) is close to $\frac{1}{2}$ CAFT, but the maximum σ_y (11 ksi) is higher still than $\frac{1}{2}$ CAFT, so cracks may have the chance to develop along the horizontal diaphragm-to-stiffener welds during future service.

Figure 7-53(b) shows the σ_y and σ_z stresses normal to line PQ at the flange-to-stiffener connection. Both are close to zero for all 20 load cases, so fatigue cracks should not occur at this detail no matter a welded or bolted detail is used. Repair analysis for the bottom flange details of the other transition region connections 3b, 3c, and 3j are not conducted, as the fatigue stresses developed in these connections are lower than that of connection 3h.

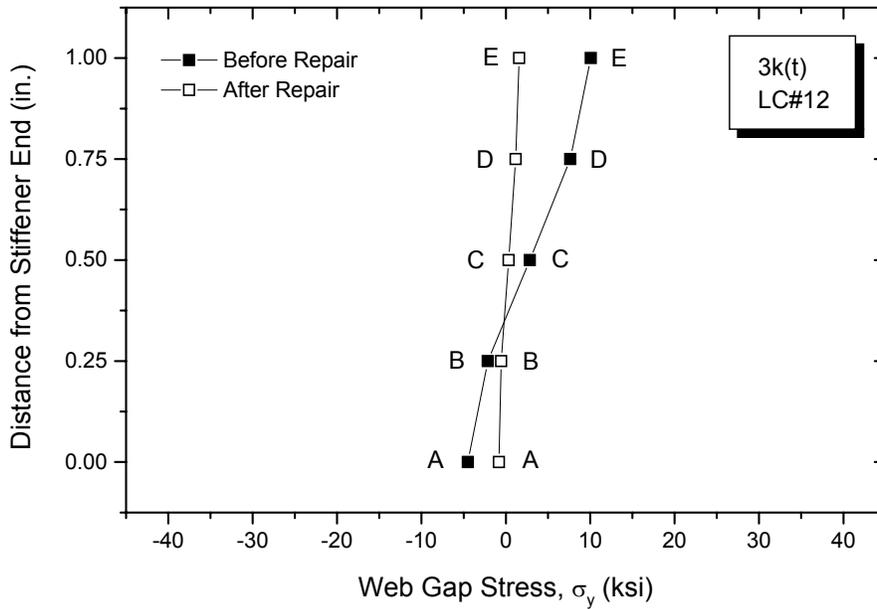
FIGURE 7-54: Connection 3k Web Gap Stress Gradient Before and After the Repair

For those diaphragm-girder connections with unstiffened top flange web gap details, only the flange-to-web welds are subjected to stress magnitudes that can cause fatigue cracking. The crack opening stresses are also much lower than those developed in the bottom flange details. Finite element repair analysis is carried out only for connection 3k, since the web gap stresses developed in this connection are the highest among those of the same group of details. Table 7-10 shows the web gap stresses of connection 3k both before and after the repair. The post-retrofit stresses are all close to zero and the average percentage reductions for σ_x , σ_y , and σ_z stresses are 102%, 85%, and 126%, respectively. Figure 7-54 shows the comparison of web gap σ_y stress gradient before and after the repair on the stiffener side of the girder web at Load Case No. 12. Though the stress variation is not as dramatic as seen in the bottom flange web gap details, the effect of stress reduction after the repair is still obvious. The repair model of connection 3k also indicates a curvature of out-of-plane web gap deflection as of Figure 7-31(a). Though with much less degree of distortion than the unstiffened condition, it still places Point E on the stiffener side of the web in tension and Point E' on the no-stiffener side of the web in compression.

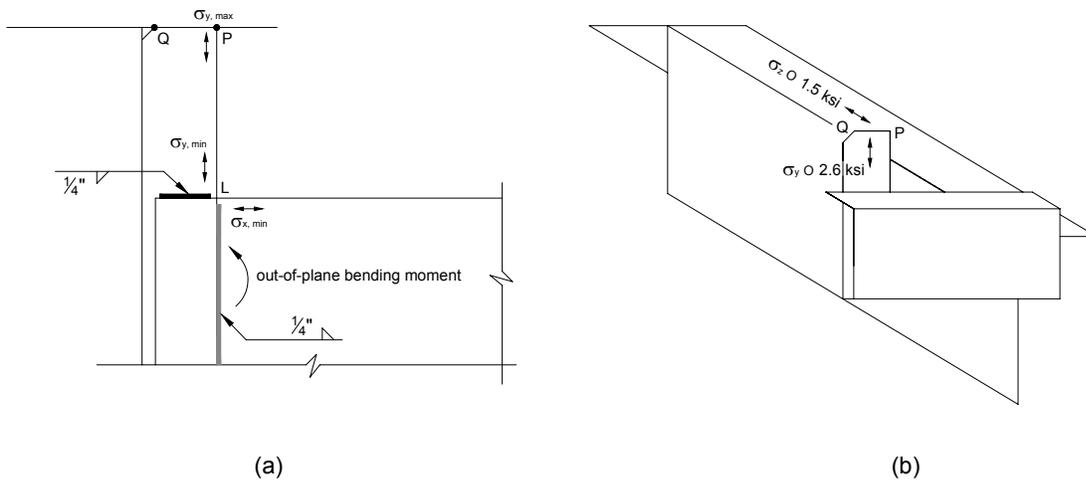
FIGURE 7-55: Areas of Interest in the Connection 3k Repair Model

For all 20 load cases, the end of the diaphragm is subjected to positive out-of-plane bending moment. Therefore, as shown in Figure 7-55(a), Point L at the horizontal and vertical weld intersection is placed in a field of compressive stress. The minimum σ_x and σ_y stresses of

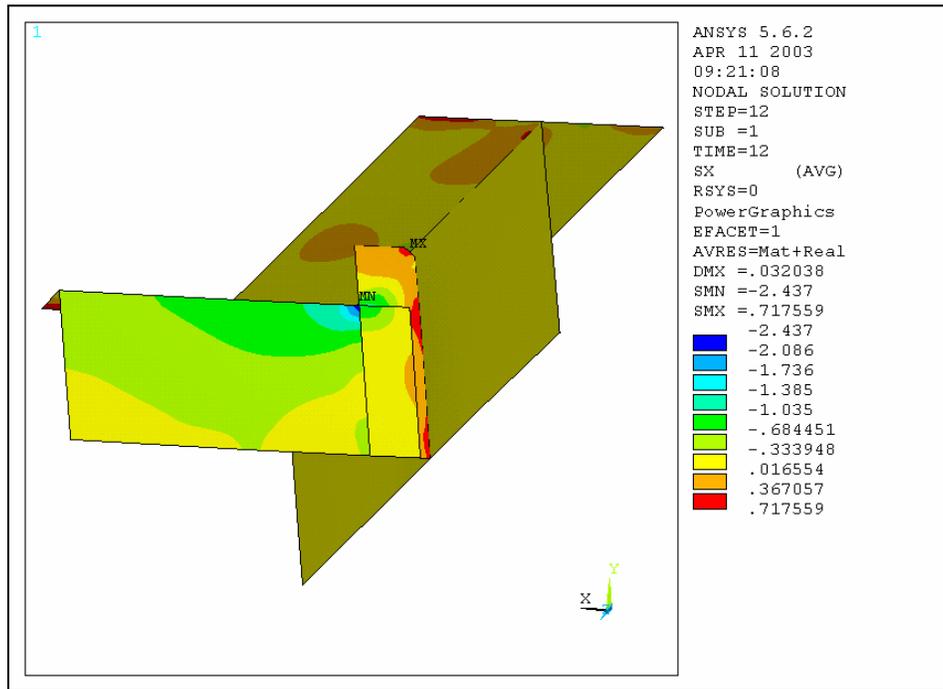
FIGURE 7-56: Post Retrofit σ_x Stress Contour of Connection 3k at Load Case No. 12

the repair model are -2.4 ksi and -4.2 ksi, respectively, occurring at Load Case No. 12. Since both stresses are compressive, fatigue cracking will not occur at the diaphragm-to-stiffener connection welds. Figures 7-56 and 7-57 plot the σ_x and σ_y stress contours of Load Case No 12 for the repair model of connection 3k. The maximum σ_y stress now occurs at Point P, with a magnitude of 2.6 ksi at Load Case No. 14. Figure 7-55(b) shows the stresses along line PQ at the flange-to-stiffener connection. The σ_y stresses are lower than 2.6 ksi and the σ_z stresses are lower than 1.5 ksi for all 20 load cases. Thus, either a bolted or a welded connection can be used for the repair and fatigue cracking will not develop in the flange or the stiffener at the attachment. Table 7-11 summarizes the stresses developed at Point L and line PQ in the repair model.

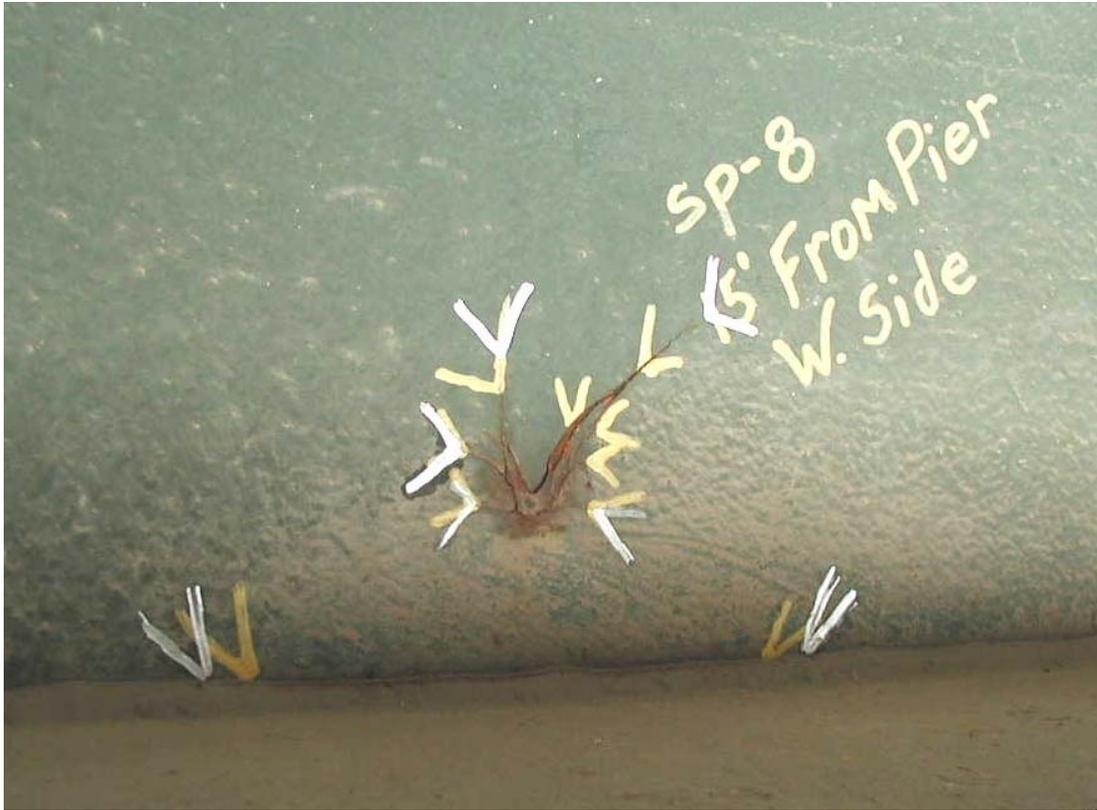
(a) Girder 2-2W

During the 1997 bridge inspection, fatigue cracks were first observed in Span No. 8 of the west bridge at three cross-frame to girder connections. As shown in Figure 8-1, the cracks were identified at the negative moment region close to Pier No. 8 in Girders 2-2W, 2-5W, and 2-8W. All the cracks were found at the small web gaps close to the girder bottom flanges and had propagated through the web thickness. Figure 8-3 shows the inspection pictures of the three locations with the cracks marked by arrows pointing toward the crack tips. The yellow (greyer) arrows were placed during the 1997 inspection. The white (brighter) arrows were placed during a later inspection in 2000. Fatigue crack growth between these two inspections can be noticed clearly by the distance between the ends of the two sets of arrows.

FIGURE 8-3: Inspection Pictures Showing Bottom Flange Web Gap Cracks in Span No. 8

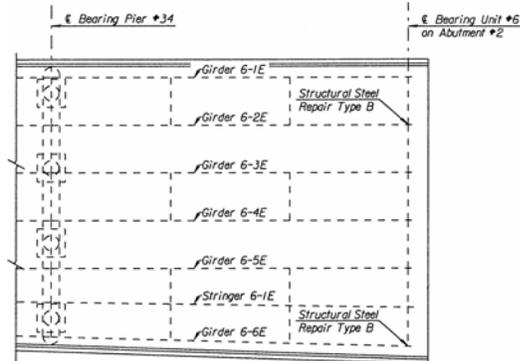
FIGURE 8-7: Type B Crack Locations at Abutment No. 2

- 2) **Type B Repair:** Two new crack details were also found in Abutment No. 2 at the floor-beam to girder connections during the 2000 bridge inspection, as shown in Figures 8-7 and 8-8. The cracks initiated from the top end of the vertical stiffener-to-web welds and then propagated downward into the stiffener plate. The repair method proposed by KDOT is to arrest the crack propagation by drilling holes at the crack tips, increasing the hole size by cold expansion, and installing A325 bolts, as for the Type A repair. Then the cracks will be mended by square-groove welds and the stiffeners will be connected to the top flanges by fillet welds. Repairs applied at these two locations are categorized as Type B repairs. The out-of-plane distortion mechanism at the abutments is due to end constraint of the floor-beams. Type B repairs are discussed briefly below but are not the subject of the finite element study.

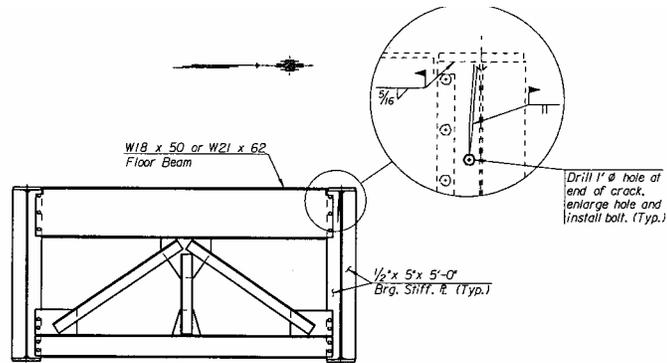
FIGURE 8-8: Type B Repair for Cracks in Bearing Stiffener Plate

TYPICAL ELEVATION OF ABUTMENT NO. 2 CROSS FRAME
(Showing Type B Structural Steel Repair)

Both Type A and B repairs will be accomplished while the bridge is closed to traffic. After reviewing the KDOT repair plan, it is believed that the application of cold expansion in both Type A and B repairs is not appropriate. As previously stated in Section 2.4.2, the existence of a crack on the drilled hole circumference may invalidate the formation of the hoop and radial compressive stress fields in the hole neighborhood, since the crack could open up when the tapered mandrel is pulled from one side of the hole to the other [Figure 2-9(c)]. This concern has been reported to KDOT and an agreement has been reached that cold working will not be used during the actual bridge repair. For the Type B crack, it is believed that the appropriate repair procedures should be to drill a hole at the crack tip, groove-weld the vertical crack, grind the plate surface smooth, and then drill a larger hole or use some other method to remove the end of the welds before the bolt is installed. In fact, bolt installation may not be needed, as the crack path should be eliminated after the repair welding. These suggestions will be submitted to KDOT at a later time together with the finite element analysis results.

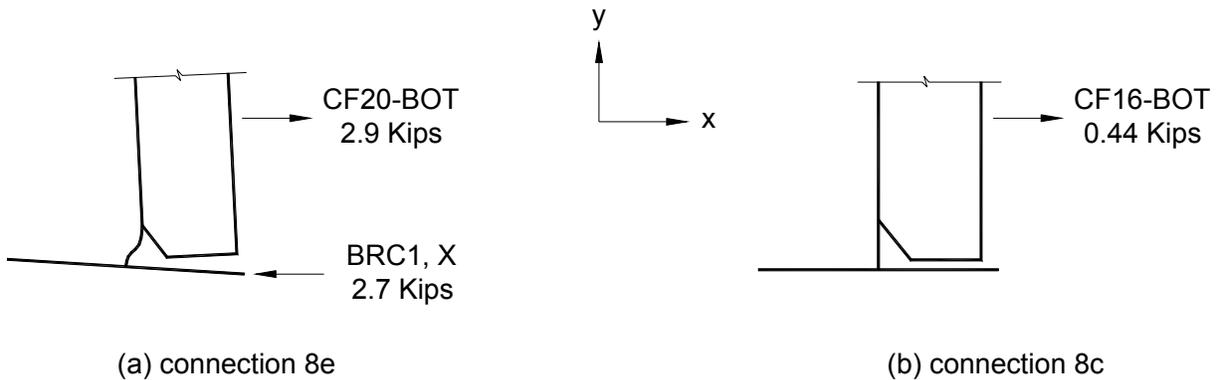
FIGURE 8-24: Load Case No. 21 Bottom Flange Details of Connections 8e and 8c

Other corresponding bottom flange connection details of cross sections C-C and E-E yield similar results. This explains why the web gap cracks in the Hump Yard Bridge developed only in the cross-frame to girder connections with a lateral bracing terminating at the bottom flange. A simple repair method to avoid future crack development could be to remove these bracing members. The detailed web gap stress results presented later in this chapter through submodel investigation support this observation.

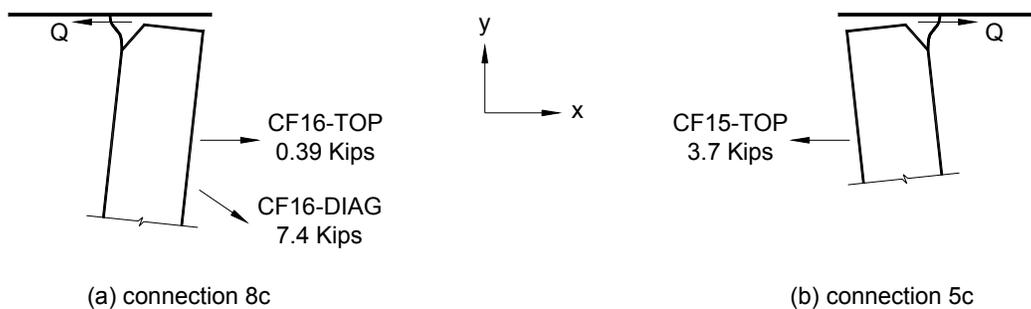
FIGURE 8-25: Load Case No. 21 Top Flange Details of Connections 8c and 5c

Though cracks were not found in the top flange web gaps, the cross-frame member force results of Figure 8-22 indicate that high magnitude fatigue stresses could also develop in these locations. Figure 8-25 shows, for example, the top flange loading diagrams of connections 8c and 5c. In both cases, the X direction components of the cross-frame member forces are larger than those acting on the bottom flange detail of connection 8e, which has already been found with fatigue cracks under the loading condition shown in Figure 8-24(a). Since the bridge top flange is embedded in the concrete slab, the end condition of the web gap is fixed at the top and an equivalent shear force Q can be developed in the direction opposite to the X component of the

cross-frame member forces acting on the stiffener. The top flange connections are more constrained and stiffer than the bottom flange connections, so they can withstand higher magnitude of shear forces and out-of-plane bending moments developed at the web gaps. As a result, the sum of the cross-frame member forces acting on the top flange detail is mostly larger than that acting on the bottom flange detail at the same cross-frame to girder connection, as can be observed from the results of Figure 8-22(a) for cross section C-C. The situation should be the same for the connections of cross sections A-A, B-B, and D-D. For connections of cross section E-E, however, as can be observed from Figure 8-22(b), the cross-frame member force summations are sometimes larger at the bottom flange details, due to the existence of bracing members. Nevertheless, further submodel analysis performed in Section 8.3.2 indicates that stresses developed in the top flange details of cross sections C-C and E-E are both high enough to cause fatigue cracking. Therefore, repair investigations should also be conducted to prevent future crack development at the top flange web gaps.

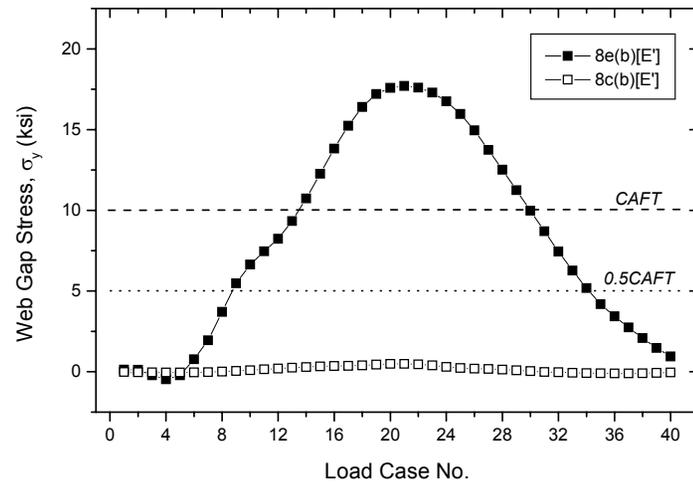
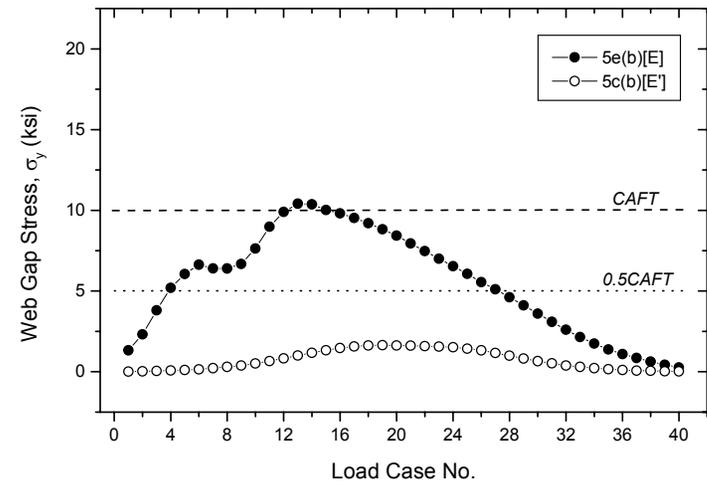
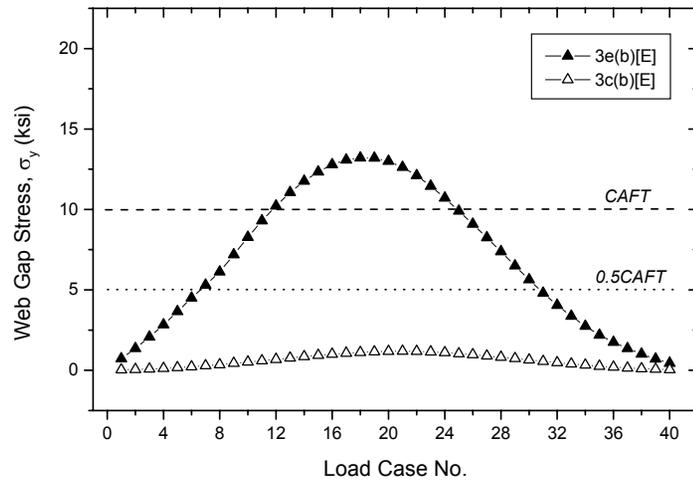
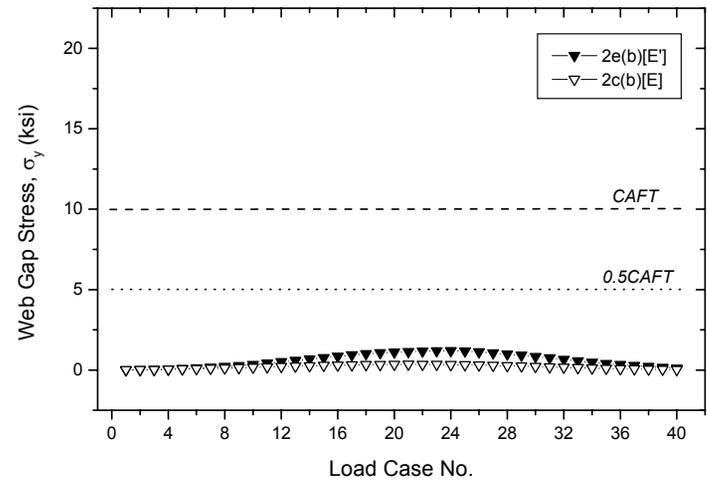
FIGURE 8-29: Maximum Web Gap σ_y Stress Variation of the Bottom Flange Submodels

Submodel analyses are carried out for the bottom flange web gap details of all eight selected cross-frame to girder connections at cross sections C-C and E-E. The results indicate that the maximum web gap stresses all occur when the truck moves close to the mid-span of the bridge. This is true even for the four connections at cross section E-E close to the bridge piers. The maximum tensile σ_y stress always occurs at the flange end of the web gap, either at Point E or E', depending on the curvature of the out-of-plane distortion. The maximum σ_x and σ_z stresses both occur at Point A, either in tension or compression. Figure 8-29 shows the

maximum tensile σ_y stress variation of the corresponding connections in the two cross sections. The information given by the legend includes the designation of the connection, the location of the web gap (“b” for bottom flange and “t” for top flange), and the point where the stress is located (Point E or E’). Except for connection 2e where no significant fatigue stress is observed during the entire truck passage, the other three connections 8e, 5e, and 3e at cross section E-E all experience stress fluctuations higher than CAFT. However, for the entire 40 load cases, stresses developed in the four connections 8c, 5c, 3c, and 2c at cross section C-C are all close to zero. This confirms the coarse model results that bottom flange web gap fatigue cracking could only develop in the connections at cross section E-E with brace intersections. Cracks had already been observed in connections 8e, 5e, and 2e. The stress range experienced by connection 3e suggests that this location will become the next site of bottom flange fatigue cracking if not repaired. The stresses occurring at connection 2e are found close to zero from the submodel analysis. This is because the truck is only placed in Lane 1 (Figures 8-12 and 8-13) during this study, so it has little effect on Girder 2-2W in terms of lateral load distribution. Since this span of the bridge has four southbound lanes, trucks frequently use the other lanes closer to Girder 2-2W, introducing web gap stresses in connection 2e and causing fatigue cracking.
