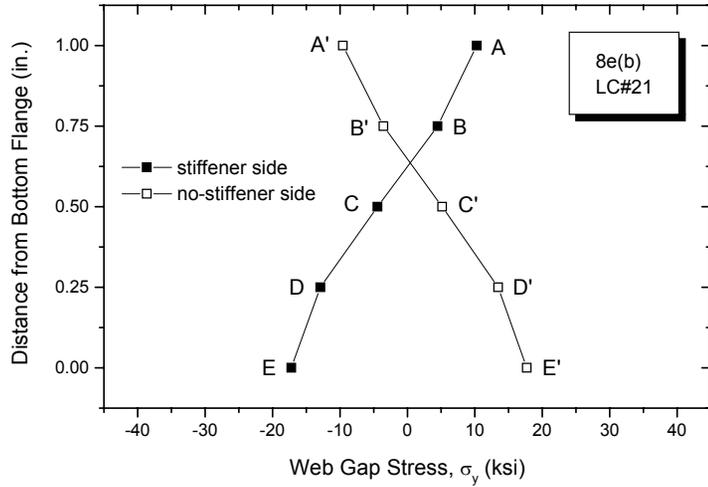
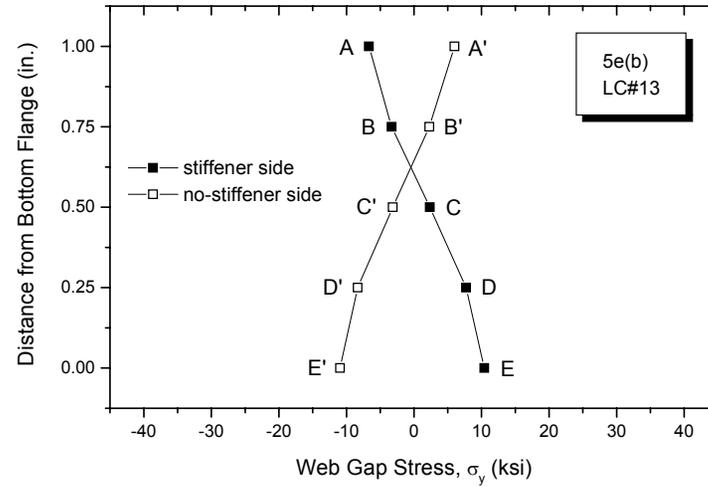
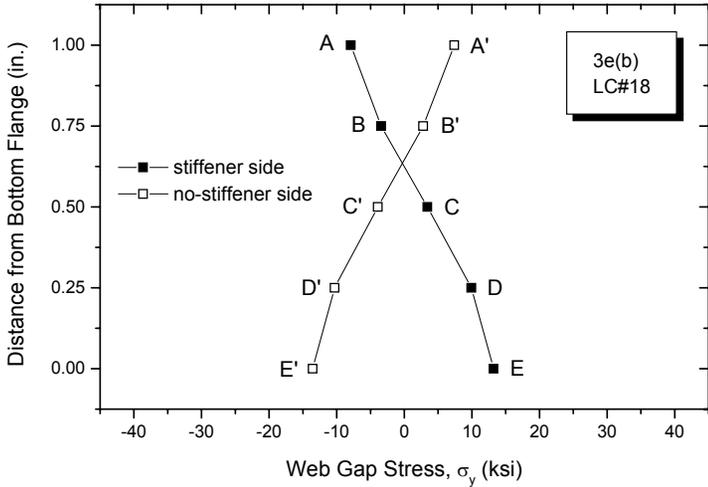
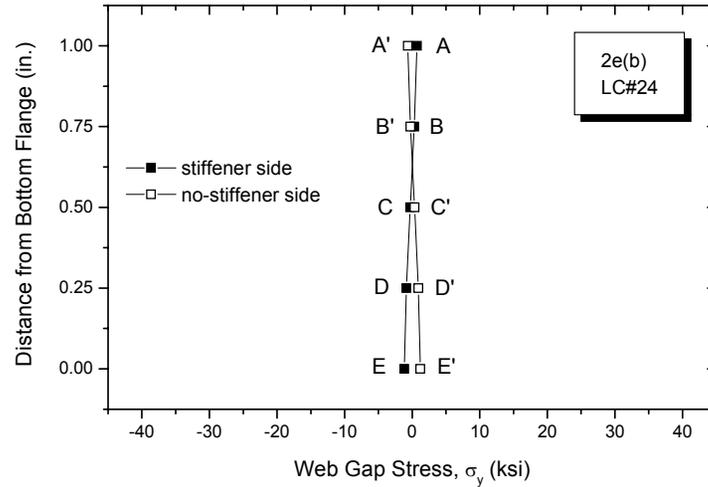
FIGURE 8-30: Bottom Flange Web Gap Stress Gradient of the Connections at Cross Section E-E

Figure 8-30 shows the bottom flange web gap σ_y stress gradient of the four connections at cross section E-E. Stresses on both sides of the girder web are symmetric about the mid web thickness, but are not symmetric about the mid web gap length. The zero stresses are all located at about $3/8$ of the web gap length close to the stiffener ends (Points A or A'). The σ_y stresses developed at the same locations of cross section C-C are all close to zero, so stress gradients are not plotted for these connections.

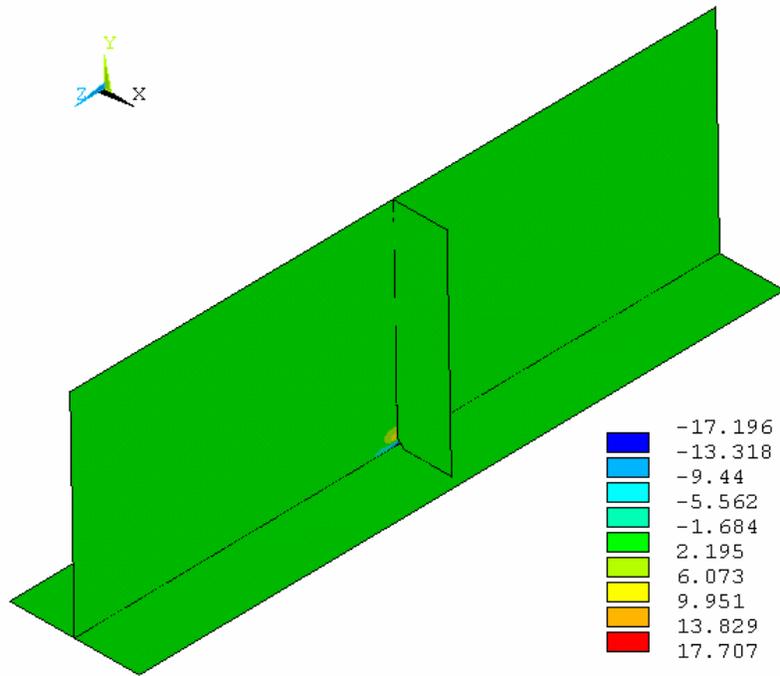
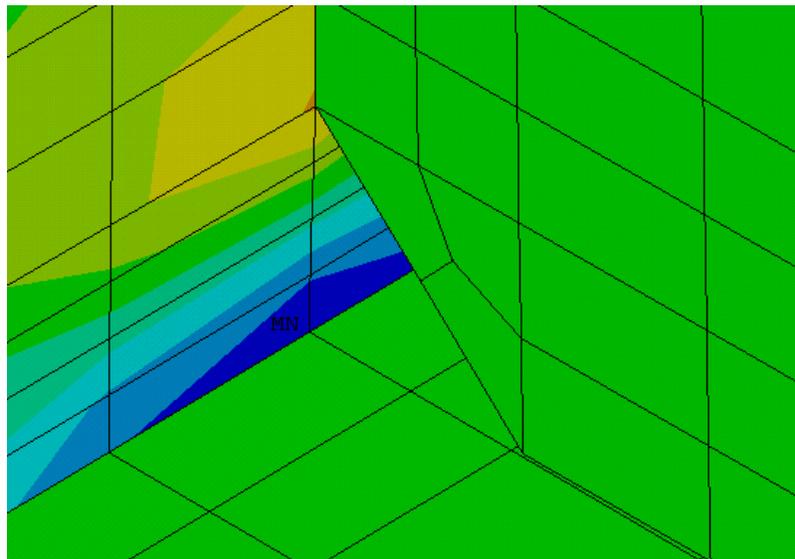
FIGURE 8-31: Load Case No. 21 σ_y Stress Contour of Submodel 8e on the Stiffener Side

Figures 8-31 and 8-32 show the σ_y stress contours of submodel 8e at Load Case No. 21 on both sides of the girder web. Stress concentration is confined to a very small area in the web gap region. The maximum compressive σ_y stress occurs at Point E [Figure 8-31(b)] and the maximum tensile σ_y stress occurs at Point E' [Figure 8-32(b)]. Figures 8-33 and 8-34 show the web gap σ_x and σ_z stress contours of submodel 8e at the same load case. Both indicate maximum tensile stresses at Point A. Figure 8-35 plots the σ_y stress distribution along the flange-to-web welds. A 10 in. affected zone, 5 in. on each side of the stiffener plane, covers the region of stress concentration. Stresses outside this region are close to zero.

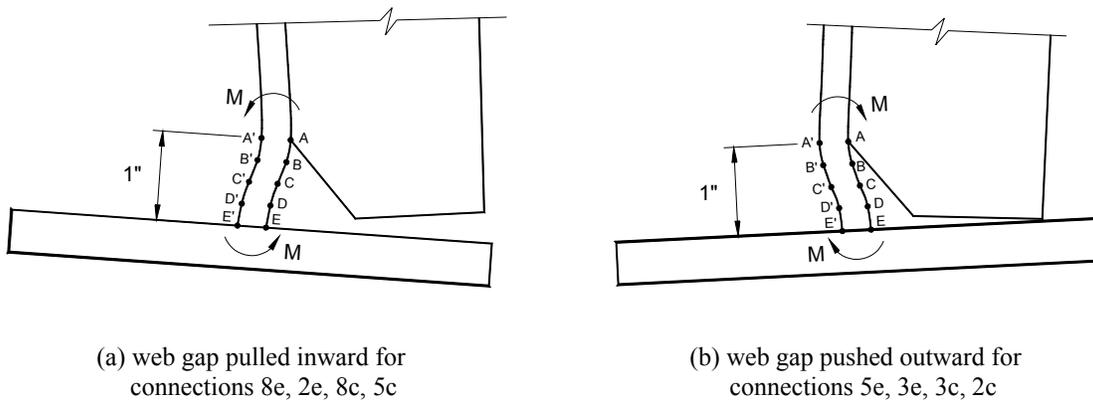
FIGURE 8-36: Connections Subjected to Different Curvatures of Out-of-Plane Distortion

The maximum web gap σ_x , σ_y , and σ_z stresses of the eight bottom flange submodels are summarized in Table 8-2. For connections 8e, 2e, 8c, and 5c, as shown in Figure 8-36(a), the top end of the web gap is deflected towards the stiffener side of the girder web for the most stressed load case, so the maximum σ_x and σ_z stresses occurring at Point A are in tension. For connections 5e, 3e, 3c, and 2c, as shown in Figure 8-36(b), the top end of the web gap is deflected towards the no-stiffener side of the girder web for the most stressed load case, so the maximum σ_x and σ_z stresses occurring at Point A are in compression. In general, for the connections at cross section C-C, the bottom flange web gap σ_x , σ_y , and σ_z stresses are all close to zero. This result can also be extended to the cross-frame to girder connections at cross sections A-A, B-B, and D-D, since the structural layout and web gap detail at these cross sections are the same as those at cross section C-C. For this span of the bridge, only the four connections 8e, 5e, 3e, and 2e at cross section E-E can be exposed to bottom flange web gap stresses higher than $\frac{1}{2}$ CAFT. So structural repair of the bottom flange web gap is only needed at these four locations.

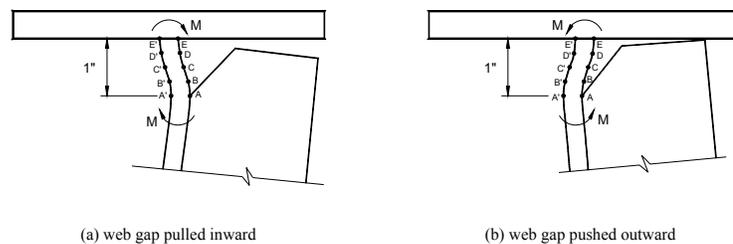
FIGURE 8-37: Variation of Out-of-Plane Displacement for the Top Flange Submodels

Connections 8e and 5e at the first interior cross section E-E and connections 8c and 5c at the mid-span cross section C-C are selected for top flange submodel analysis. Connections 5e, 8c, and 5c experience web gap distortion as shown in Figure 8-37(a) for all 40 load cases. The bottom end of the web gap is pulled towards the stiffener side of the girder web, so the maximum tensile σ_y stress always occurs at Point E'. For connection 8e, the web gap distortion is as Figure 8-37(a) for the first 18 load cases, where the maximum tensile σ_y stress also occurs at Point E'. The curvature of out-of-plane distortion is then changed to that shown in Figure 8-37(b) where the bottom end of the web gap is pushed towards the no-stiffener side of the girder web. The maximum tensile σ_y stress is therefore found at Point E for each of the remaining 22 load cases. However, the maximum σ_y stress of submodel 8e of all 40 load cases is found at Point E' at Load Case No. 6. Thus, Point E' σ_y stress variation is plotted in Figure 8-38 for the four top flange submodels under investigation.

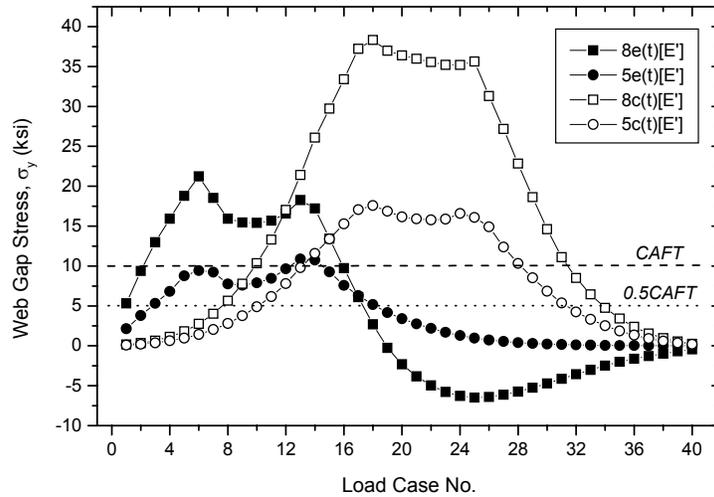
FIGURE 8-38: Point E' Web Gap σ_y Stress Variation of the Top Flange Submodels

Figure 8-38 shows that the highest web gap stress of each submodel occurs at the load case where the truck is close to the connection. Stresses developed in the two mid-span connections 8c and 5c are higher than those developed in the corresponding connections 8e and 5e close to the bridge piers, because the girder differential deflection and out-of-plane distortion

are larger at the bridge mid-span sections. The Point E' σ_y stress of submodel 8e is positive for Load Cases No. 1 to 18 and negative for Load Cases No. 19 to 40, due to the change of web gap distortion curvature. The maximum σ_y stress occurring at Point E' is 21 ksi at Load Case No. 6, but the stress range experienced at this point for the entire truck passage is 28 ksi. Both stress measures are high enough to introduce fatigue cracks along the flange-to-web welds. All four submodels have maximum σ_y stresses or stress ranges higher than CAFT. This indicates that fatigue cracks can develop at the unstiffened top flange web gaps during future bridge service.

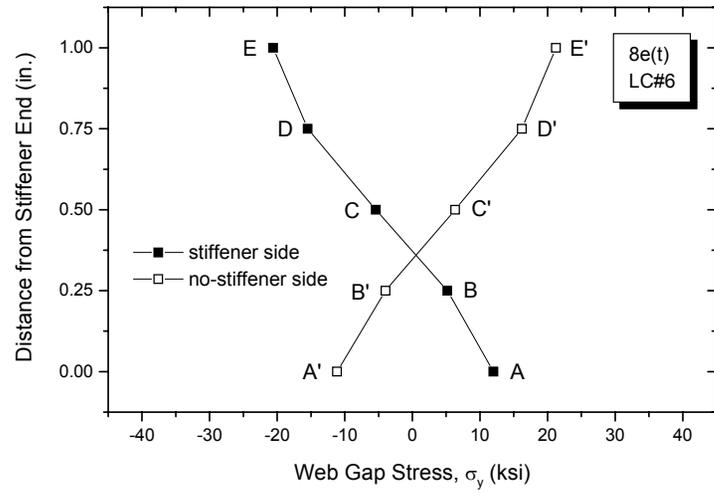
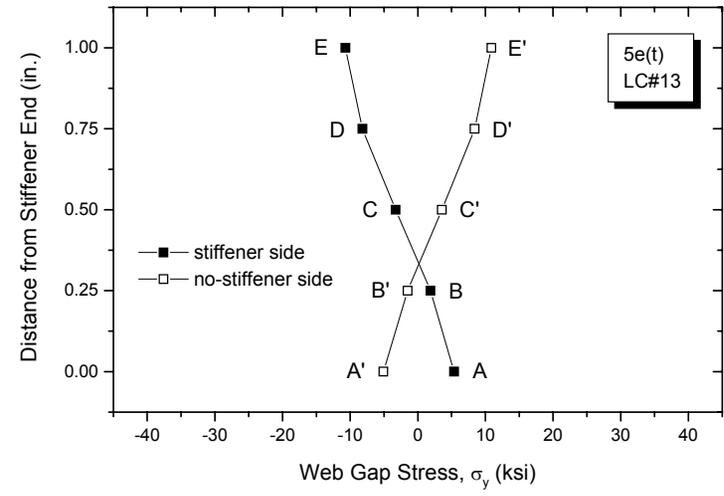
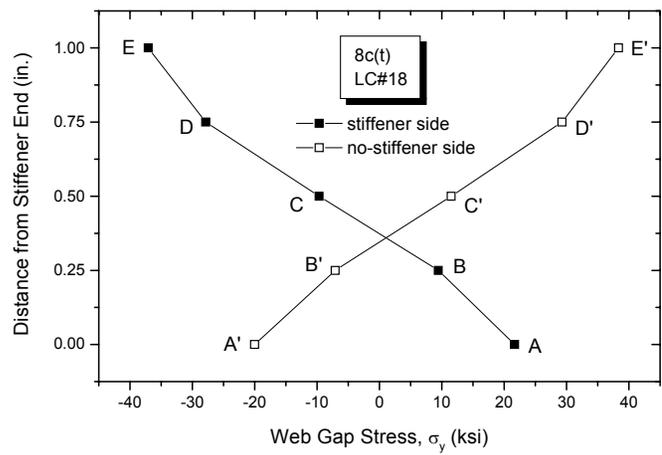
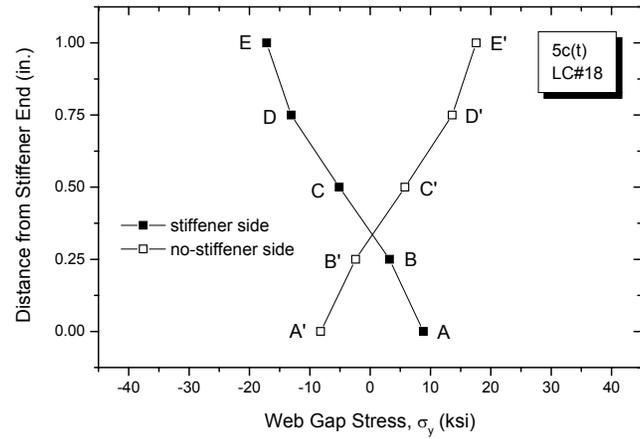
FIGURE 8-39: Top Flange Web Gap Stress Gradient

Figure 8-39 shows the web gap stress gradient of the four top flange submodels. Compared to Figure 8-30, the overall web gap stress magnitude and variation gradient are both higher at the top flange than at the bottom flange. Though the top flange submodel analysis is not performed at the other cross-frame to girder connections, it is expected that stresses higher than the fatigue limit can also develop at these locations when the fatigue truck is in the other lanes or at other load cases. To prevent future crack development, an appropriate repair solution is thus needed for the top flange web gaps of all the cross-frame to girder connections.

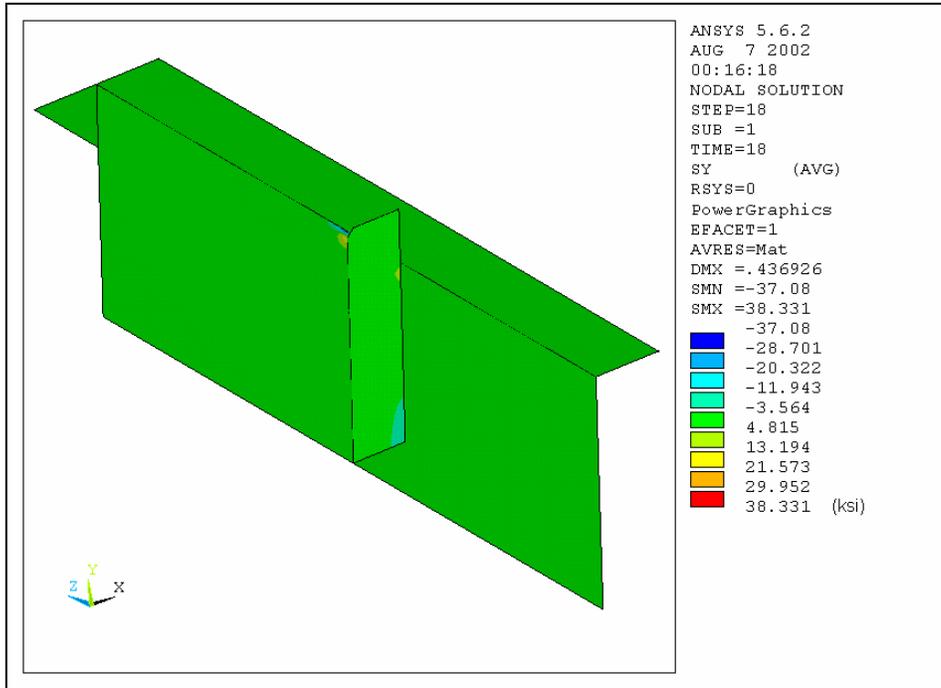
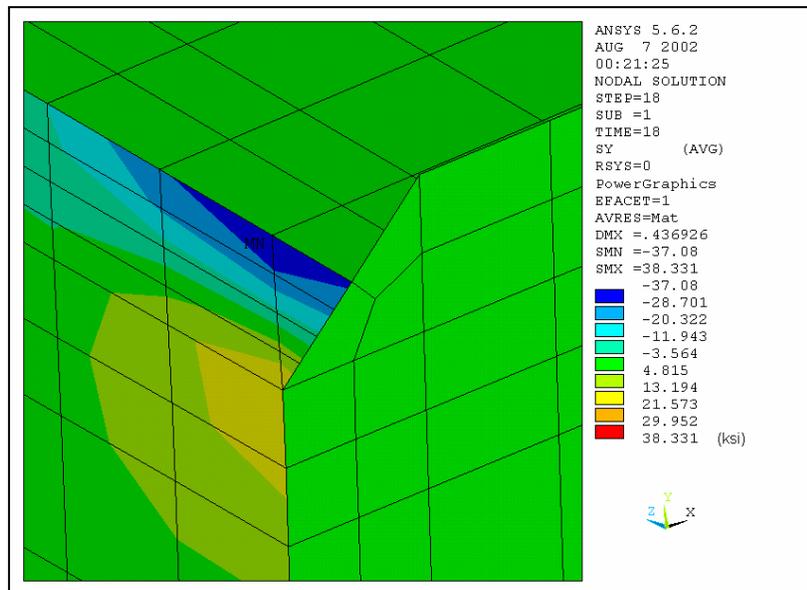
FIGURE 8-40: Load Case No. 18 σ_y Stress Contour of Submodel 8c on the Stiffener Side

Table 8-3 summarizes the maximum web gap stress and out-of-plane displacement results of the four top flange submodels. Connection 8c is the most highly stressed. Figures 8-40 and 8-41 show the σ_y stress contours of submodel 8c on the stiffener and no-stiffener sides of the girder web at Load Case No. 18. The overall stress distribution on both web sides is close to zero, but high magnitude stresses, both in tension and in compression, and dramatic stress variations are observed at the web gap area. The maximum σ_y stress at Point E' is 38 ksi, which has exceeded the yield point. Cracks could develop very soon at the flange-to-web welds when subjected to such a high stress magnitude. Figures 8-42 and 8-43 show the stress contours of the submodel at the same load case for σ_x and σ_z . The maximum σ_x stress is 15 ksi and the maximum σ_z stress is 14 ksi. Both occur at Point A. The combination of these two stresses could cause the cracks to develop in a short time along the stiffener-to-web welds. The same distribution contours are also seen in the other three submodels 5e, 8e, and 5c, but with lower stress magnitude. During the actual bridge service, it is believed that this "hot" stress concentration zone can be found at all the unstiffened top flange web gaps, and the stresses developed at the mid-span positive moment region connections should be higher than those developed at the corresponding transition and negative moment region connections.

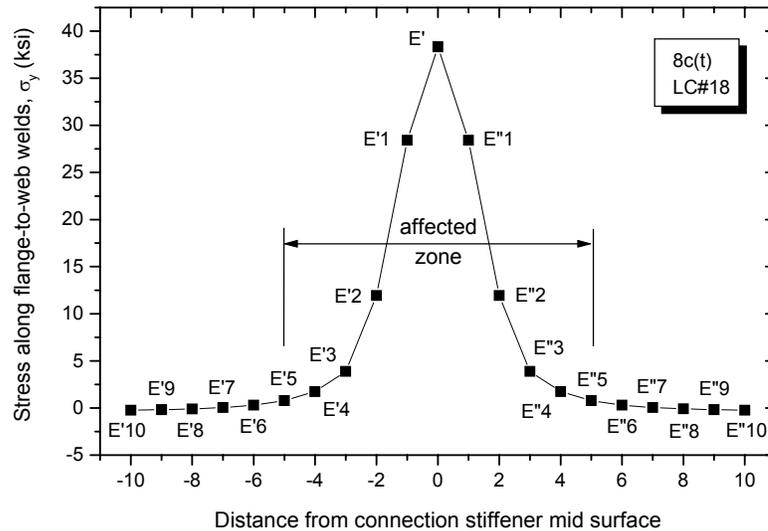
FIGURE 8-44: Load Case No. 18 σ_y Stress Distribution of Submodel 8c along Flange-to-Web Welds

Figure 8-44 plots the σ_y stress distribution along the flange-to-web welds for connection 8c at Load Case No. 18. Compared to the stress condition shown in Figure 8-35 for the bottom flange submodel 8e, the maximum σ_y stress developed at Point E' of the top flange submodel 8c is much higher. However, the 10 in. affected zone for stress concentration is still applicable.

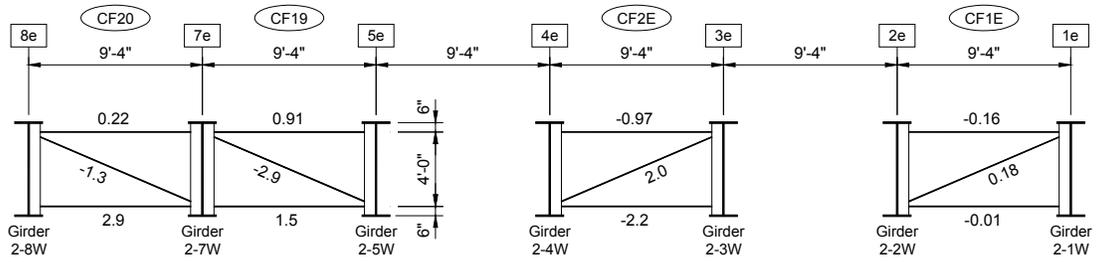
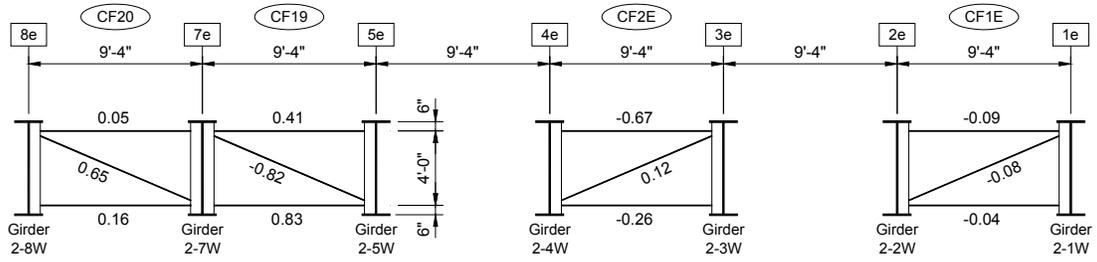
FIGURE 8-45: Load Case No. 21 Section E-E Cross-Frame Member Forces

The first repair option is to remove the horizontal plane of bracing between cross section E-E and Pier No. 8, i.e., members BRC1 to BRC7 shown in Figure 8-12. The coarse model of Figure 8-15 is modified to exclude the brace elements and the analysis is performed again for all 40 truck locations. Figure 8-45 shows the cross-frame member forces of section E-E for Load Case No. 21 both before and after the brace removal. The axial forces all decrease for this load case after the braces are removed. Figures 8-46 to 8-49 show the change in these cross-frame member forces for all 40 load cases. Cross-frames CF20 (Figure 8-46), CF19 (Figure 8-47), and CF2E (Figure 8-48) experience noticeable axial force changes in at least one or two of their structural components, mostly in the diagonal or bottom chords. Forces developed in the cross-frame members of CF1E (Figure 8-49), however, are close to zero both before and after the brace removal. Thus, no further web gap stress evaluation of connection 2e is performed.

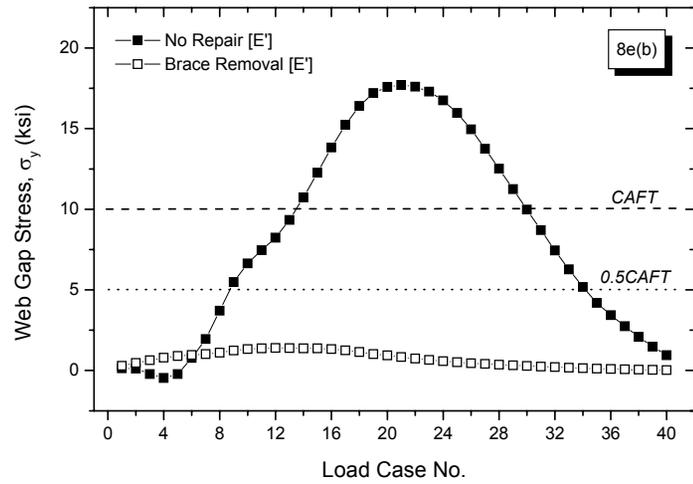
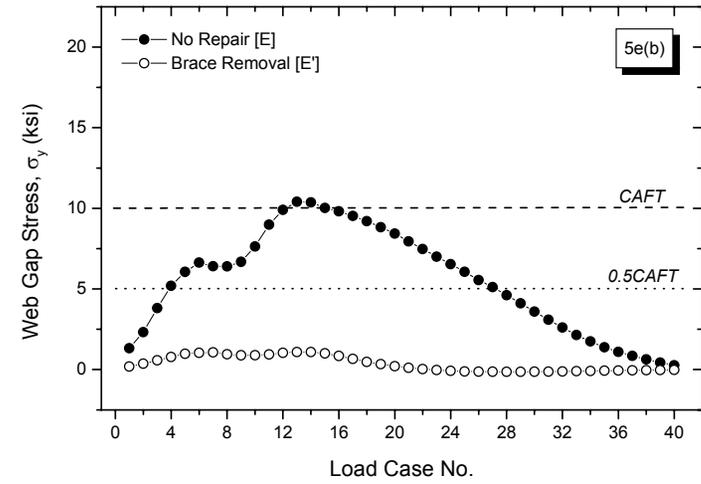
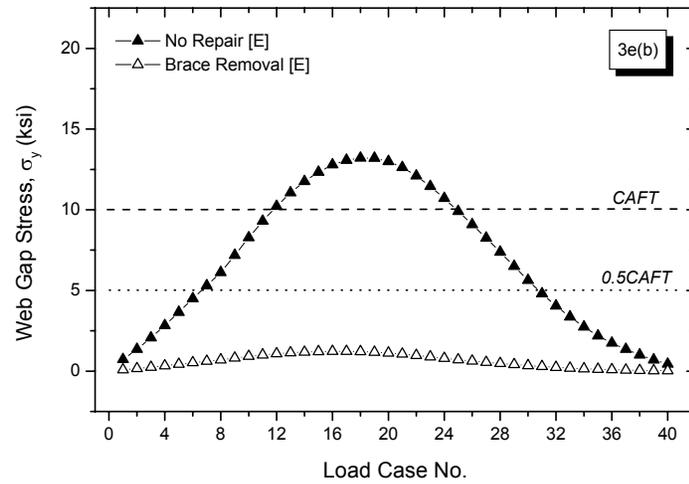
FIGURE 8-50: Bottom Flange Maximum Web Gap σ_y Stress Variation Before and After Brace Removal

The procedures of cut boundary DOF interpolation and cross-frame member force assignment are then carried out for the bottom flange submodels of connections 8e, 5e, and 3e. The maximum web gap σ_y stress solutions obtained from the submodel analysis are plotted in Figure 8-50, together with the corresponding results under the condition of no repair. Significant stress reduction is observed after the brace removal. The maximum σ_y stresses of the three submodels all decrease to below $\frac{1}{2}$ CAFT. Figure 8-51 shows the comparison of web gap σ_y stresses before and after the repair, for the load cases associated with the maximum stress gradient. Stress variation within the web gap length is also greatly reduced after the brace removal. For example, the difference between the σ_y stresses of Point A' and E' of connection 8e is a maximum of 27 ksi with the braces at Load Case No. 21, but is reduced to a maximum of 2 ksi without the braces at Load Case No. 12. The major analytical results of the three submodels are summarized in Table 8-4. The maximum web gap σ_x , σ_y , and σ_z stresses are all reduced to below $\frac{1}{2}$ CAFT by the brace removal. About 90% stress reduction is obtained.

The submodel analysis conducted for the first repair approach again indicates the bracing members as the cause of bottom flange web gap fatigue cracking. Both the out-of-plane bending moments and stresses developed at the web gap ends can be eliminated if the braces are removed. However, lack of bottom flange bracing members could result in lateral torsional buckling of the girder sections at the negative moment region, especially in this span as the bridge is skewed at Pier No. 8. Also, an additional repair approach is needed to prevent the top flange web gap cracking. The welded repair is therefore studied in Section 8.4.2 to see if this method can reduce the web gap stresses to a satisfactory level without removing the lateral braces.

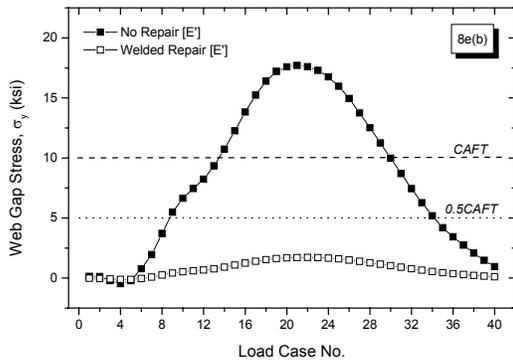
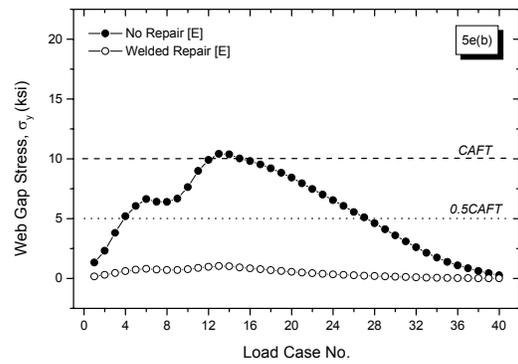
FIGURE 8-52: Bottom Flange Maximum Web Gap σ_y Stress Variation Before and After Welded Repair

The submodels chosen for the welded repair investigations are modified by connecting the stiffener end to the girder flange. The same cut boundary displacements and cross-frame member forces specified in Section 8.3.2 are then applied to the revised models for repair analysis. Figures 8-52 and 8-53 plot the web gap σ_y stress results of the bottom flange submodels in comparison with the data obtained prior to the repair. Figures 8-54 and 8-55 present the same type of curves for the top flange submodels. The maximum web gap σ_x , σ_y , and σ_z stresses of the bottom and top flange submodels are tabulated in Tables 8-5 and 8-6. For the six details under investigation, at least 85% stress reductions are achieved after the repair. The post-retrofit stresses all decrease to below $\frac{1}{2}$ CAFT, so cracks are not expected to occur by the welded repair even for an unlimited number of load cycles.

The second repair option is to stiffen the small web gaps by welding the connection stiffener to the girder flange. Based on the results of Section 8.3.2, the bottom flange web gap cracks could only develop at the cross section E-E brace intersections, while the top flange web gap cracks could develop in any of the cross- frame to girder connections at cross sections A-A to E-E. The welded repair can be used at both the top and bottom flanges to keep the web gaps from deflecting out-of- plane. Finite element studies are conducted for connections 8e and 5e at both the top and bottom flanges and for connections 8c and 5c at the top flange only.

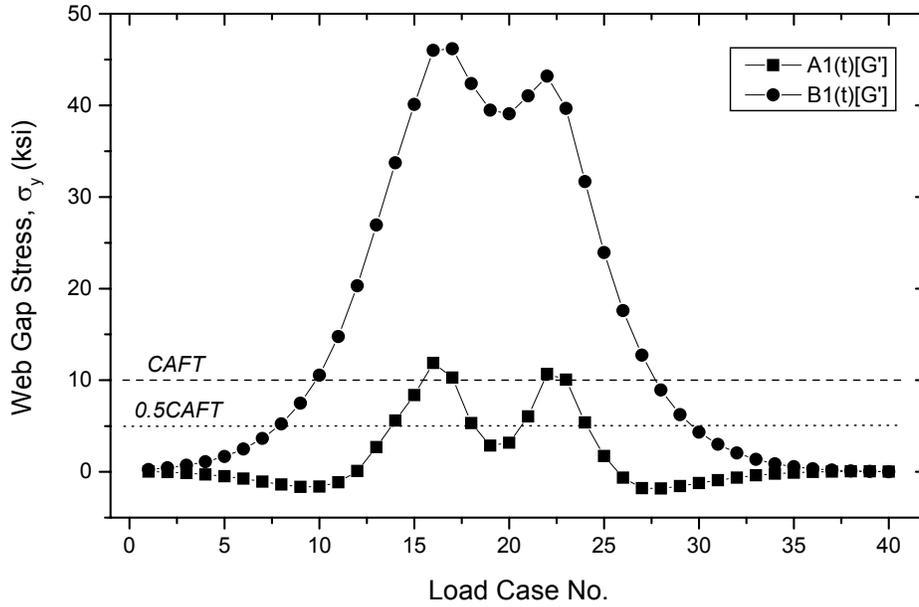
FIGURE 9-12: Top Flange Web Gap σ_y Stress Variation of Mid-Span Connections

Connections A1 and B1 at girder mid-span are investigated first to see which girder details would experience higher fatigue stresses due to the westbound truck traffic. Figure 9-12 shows the top flange web gap σ_y stress variation of connections A1 and B1. The legend in the graph gives information such as the designation of the cross-frame/girder connection, the location of the web gap (“t” for top flange and “b” for bottom flange), and the grid point where the stress is recorded (Point G’ or G in most cases). The maximum σ_y stress of connection B1 is 46 ksi occurring at Load Case No. 17, which exceeds yielding. The maximum σ_y stress of connection A1 is 12 ksi occurring at Load Case No. 16. It is about 25% of the maximum σ_y stress developed in connection B1, but is still higher than CAFT. It is interesting to notice that while the truck moves on the lane close to Girder A, it actually causes much higher top flange web gap stresses in Girder B connection B1 than Girder A connection A1. Figure 9-13 shows the bottom flange web gap σ_y stress variation of the two mid-span connections. This time, stresses developed in connection A1 are higher than those of connection B1. Figure 9-14 shows the σ_y stress gradient of both the top and bottom flange submodels of connections A1 and B1 at their respective load cases with the highest magnitude of fatigue stresses. The maximum out-of-plane displacements and stresses obtained from the submodel analyses of these four details are summarized Table 9-2.

Since both connections are at the girder mid-span cross section, the corresponding stress variation experienced by connection A1 (or B1) due to the westbound traffic should be the same as that experienced by connection B1 (or A1) due to the eastbound traffic. So in general, as can be seen from the results of Figures 9-12 and 9-13, the stress ranges developed in the top flange web gaps are much higher than those developed in the bottom flange web gaps. This is why so many web gap fatigue cracks have already been found in the bridge close to the top flanges, but not yet in the bottom flanges. Based on the above observation, all the Girder B cross-frame connections are chosen for top flange submodel analysis as presented in Section 9.4.2.2 and only half span of the cross-frame connections of Girder A are chosen for bottom flange submodel analysis as presented in Section 9.4.2.3.

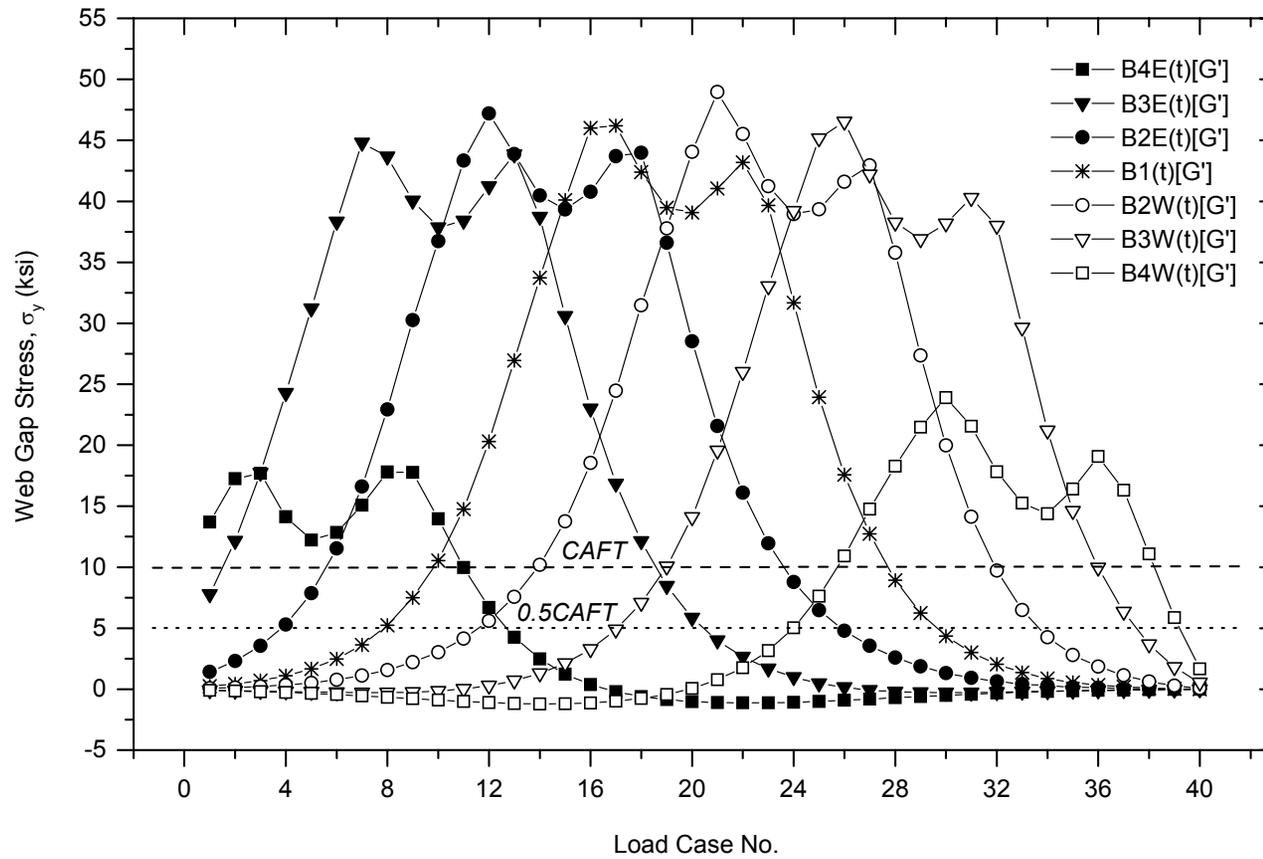
FIGURE 9-15: Web Gap σ_y Stress Variation of Girder B Top Flange Submodels

Submodel analyses are carried out for the top flange web gap details of all the cross-frame to Girder B connections shown in Figure 9-9. From the east to west, these connections are B4E, B3E, B2E, B1, B2W, B3W, and B4W. Figure 9-15 shows the web gap σ_y stress variation of the details under the westbound truck loading. Each detail experiences two stress cycles with the peak stresses occurring about 5 ~ 6 load cases in between. The minimum σ_y stresses of all seven connections are close to zero. The maximum σ_y stresses of the two negative moment region connections, B4E and B4W, are between 15 ~ 25 ksi. The maximum σ_y stresses of the other five connections in the positive and transition moment regions are between 45 ~ 50 ksi. Figure 9-16 shows the top flange web gap σ_y stress contour on both sides of the girder web of connection B2W at Load Case No. 21. Figures 9-17 and 9-18 show the web gap σ_x and σ_z stress contours of the same connection at the same load case on the interior web side. Other connections are found to have the same distribution pattern but with different stress magnitude. The maximum σ_x and σ_z stresses always occur at Point A. The minimum and maximum σ_y stresses always occur at Points G and G'. Table 9-3 summarizes the significant out-of-plane displacements and stresses of the seven top flange submodels under investigation. The maximum σ_x , σ_y , and σ_z stresses developed in these submodels are all higher than $\frac{1}{2}$ CAFT. In particular, stresses developed in the positive and transition moment region connections are of very high magnitude. This is why cracks have been found in high percentage of cross-frame/girder connections in this bridge. Figures 9-19 and 9-20 plot the web gap σ_y stress gradient of the top flange submodels on the east and west half spans of Girder B. The stress gradient of the mid-span connection B1 has been plotted in Figure 9-14. A symmetric stress distribution is observed about the mid web thickness, but not about the mid web gap length. The zero stresses

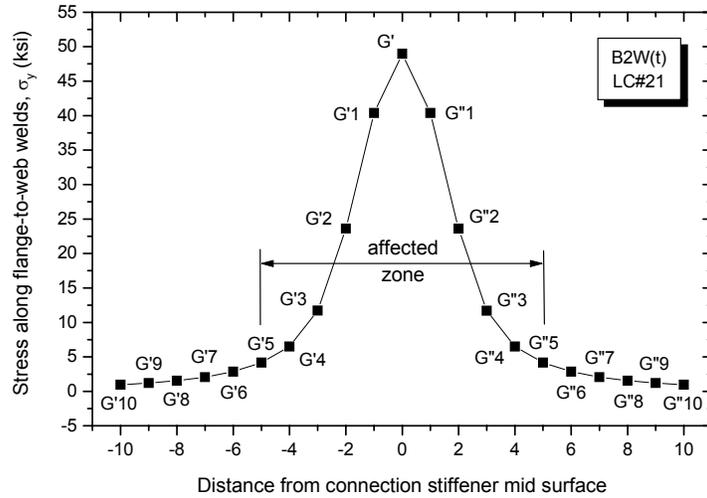
FIGURE 9-21: Load Case No. 21 σ_y Stress Distribution of Connection B2W Along the Top-Flange-to-Web Welds

are located about $\frac{1}{3}$ of the web gap length close to the vertical fillet weld ends. Figure 9-21 plots the σ_y stress distribution along the top-flange-to-web welds of connection B2W, as this is the detail that experiences the highest fatigue stress of the seven top flange connections. Stresses start to drop below $\frac{1}{2}$ CAFT (5 ksi) at 5 in. away from each side of the stiffener plate. So a total of 10 in. affected zone can still be defined for the area of stress concentration.

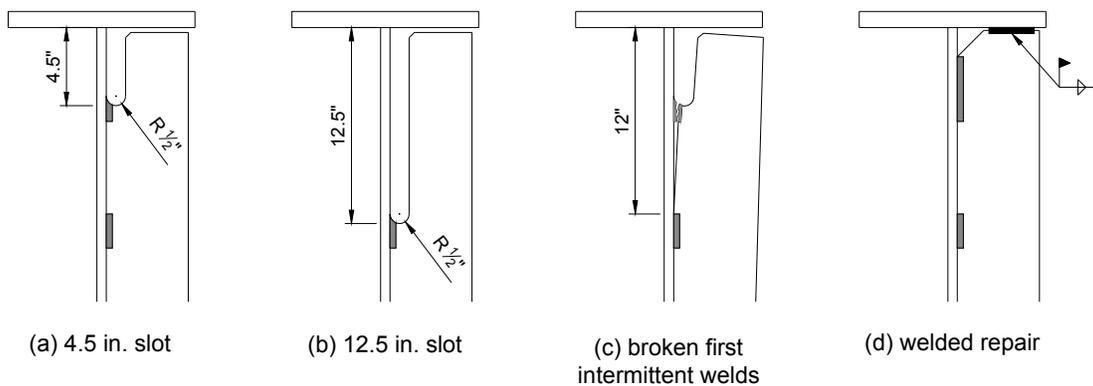
FIGURE 9-28: Repair Schemes Investigated Using Finite Element Methods

Though the out-of-plane displacements, the web gap stress gradient, and the fatigue stresses along the flange-to-web welds are reduced after the repair, the stresses developed at the bottom web gap end are elevated and a new stress riser is formed at the cut-short stiffener-to-web weld termination. So the 4.5 in. slot does not relax the web gap region to a satisfactory level. Contrary to the intent to help release the stress field, this repair actually introduced severer stress concentration at the slot end due to the inadequate loosening length. The newly developed high magnitude fatigue stresses, as well as the possible exposure of weld root defects at the slot end, led to the crack reinitiation and propagation observed in many of the repaired locations of this bridge.

Based on the observed crack condition and the finite element analysis results, it is recommended that all the non-pier cross-frame/girder connections be repaired with welded stiffener-to-flange attachment. In particular, the top flange web gaps should be repaired at the

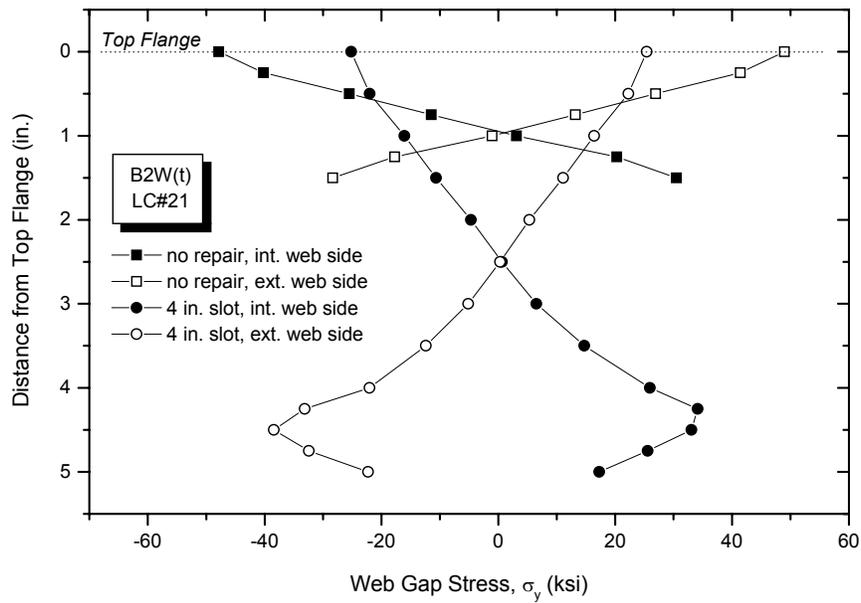
FIGURE 9-32: Comparison of Web Gap σ_y Stress Gradient Before and After the 4.5 inches Slot Repair

is still calculated using the relative X-axis deformation between Points A and G, the top and bottom of the original 1.5 in. web gap depth. As shown in Table 9-5, a 40% decrease of the maximum out-of-plane displacement is resulted due to the 4.5 in. slot repair. However, it should be noted that this is a reference displacement used only for comparison purposes, it is not the actually web gap out-of-plane displacement of the repair model and should not be used in Equation 6-3 (Fisher's $\sigma - \Delta$ expression) for post-retrofit stress evaluation.

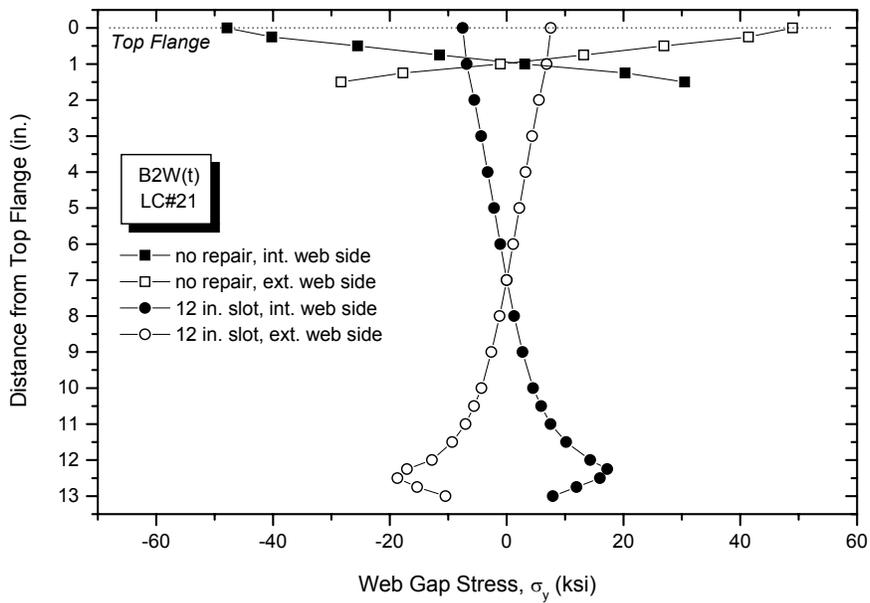
FIGURE 9-36: Comparison of Web Gap σ_y Stress Gradient Before and After the 12.5 inch Slot Repair

The maximum web gap stresses due to the 12.5 in. slot repair are found less than 50% of the corresponding stresses due to the 4.5 in. slot repair, so the 12.5 in. slot repair is apparently more effective in terms of stress reduction. However, the post-retrofit stress magnitude is still higher than $\frac{1}{2}$ CAFT. In addition, the narrow slot is only 1 in. wide, which makes it difficult to achieve a well-finished cut surface, especially at the weld end intersecting with the cut radius. Therefore, fatigue cracks may still be able to reinitiate from the slot end along the vertical welds, even though the web gap stresses have been greatly reduced.

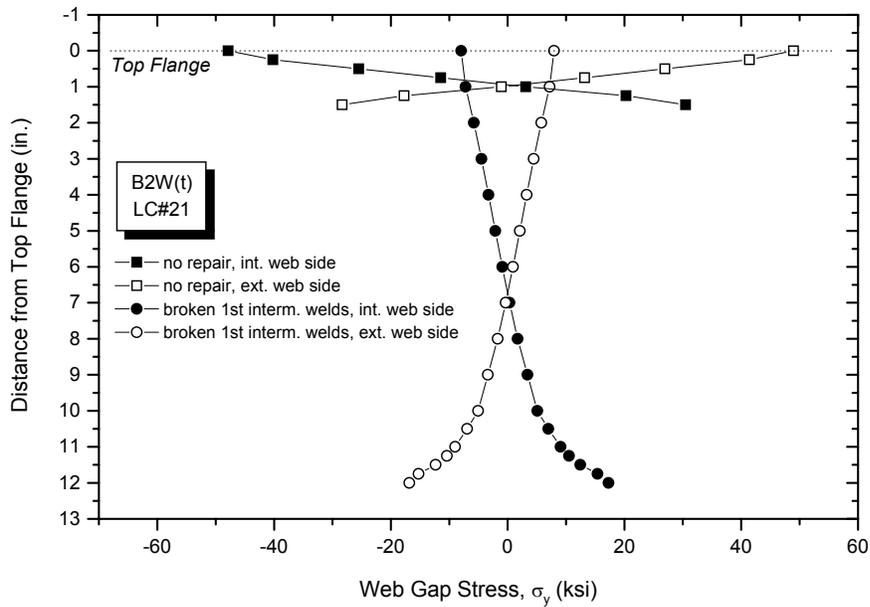
FIGURE 9-40: Change of Web Gap σ_y Stress Gradient Due to Broken First Intermittent Welds

Compared to that of the 4.5 in. slot repair, the web gap stress intensity is greatly reduced after the first intermittent welds are broken. However, the maximum σ_y and σ_z stresses are found higher than $\frac{1}{2}$ CAFT, so cracks may still be able to develop from the top of the second intermittent welds. Additional repair measures are thus needed in order to reduce the secondary stresses to a satisfactory level and to stop crack propagation at those repaired details. In general, the stress condition resulted from the broken first intermittent welds is similar to that of the 12.5

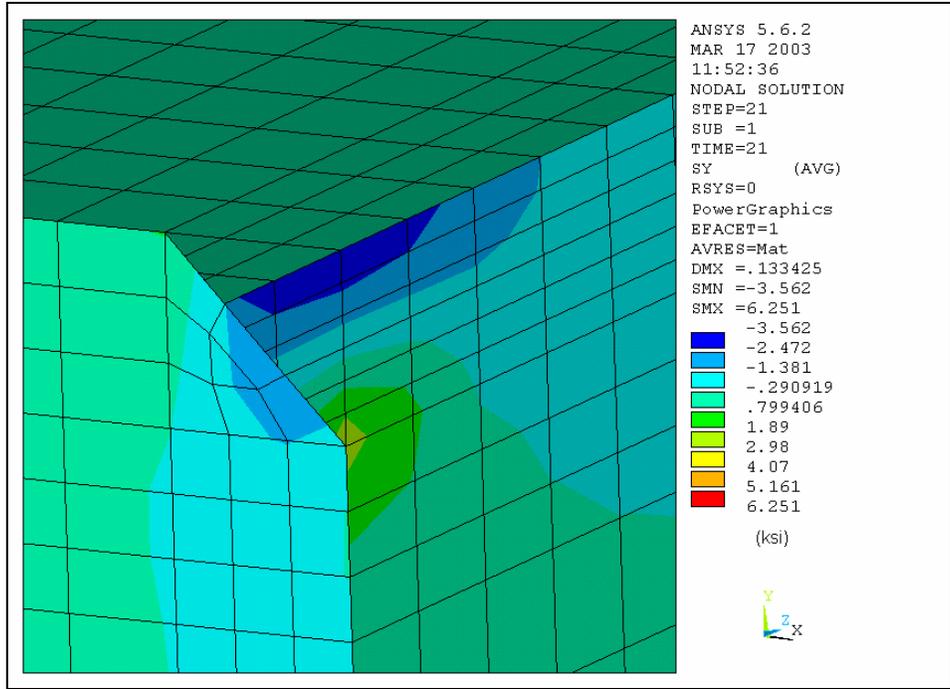
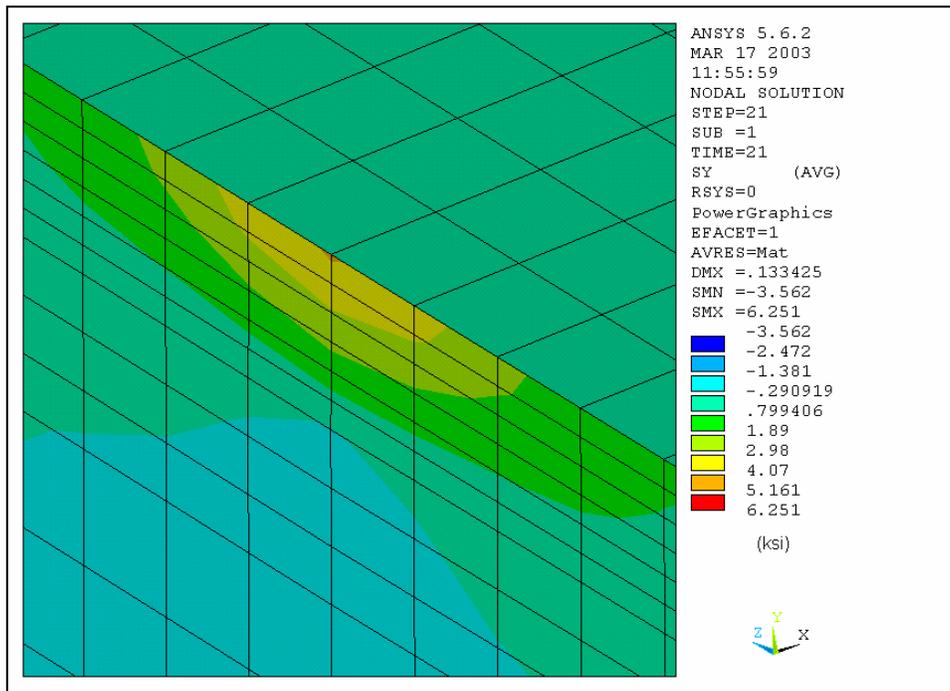
FIGURE 9-41: Load Case No. 21 Web Gap σ_y Stress Contour Due to Welded Repair

The fourth repair scheme, as shown in Figure 9-28(d), is to weld the connection stiffener to girder flange. Figure 9-41 shows the web gap σ_y stress contour of Load Case No. 21 for the repair model. Figure 9-42 shows the σ_x stress contour of Load Case No. 19 and Figure 9-43 shows the σ_z stress contour of Load Case No. 21. For most load cases, the maximum σ_z stress of the submodel still occurs at Point A, but the maximum σ_x and σ_y stresses are not located in the web gap region. Figure 9-44 shows the σ_y stress gradient on the exterior side of the web gap for the conditions without repair and with the welded repair. The stress variation between Points A' and G' drops from 77 ksi to 5.2 ksi after the connection stiffener is attached to the top flange. Table 9-5 shows that the maximum out-of-plane displacement and stresses can be reduced by at least 90% if the welded repair is used. The maximum σ_x , σ_y , and σ_z stresses at Point A are 0.089 ksi, 2.3 ksi, and 0.68 ksi. The maximum σ_y stress at Point G' is 4.2 ksi. So the post-retrofit web gap stresses are all reduced to below $\frac{1}{2}$ CAFT. Compared to the other three repair schemes mentioned above, the welded repair could achieve the highest percentage of stress reduction, decrease the web gap stresses to below the infinite life fatigue limit, and at the same time eliminate the chance of forming new stress risers. This is apparently the most effective repair solution and is thus recommended for future bridge retrofit in order to stop both the initiation of new cracks and the propagation of existing cracks.

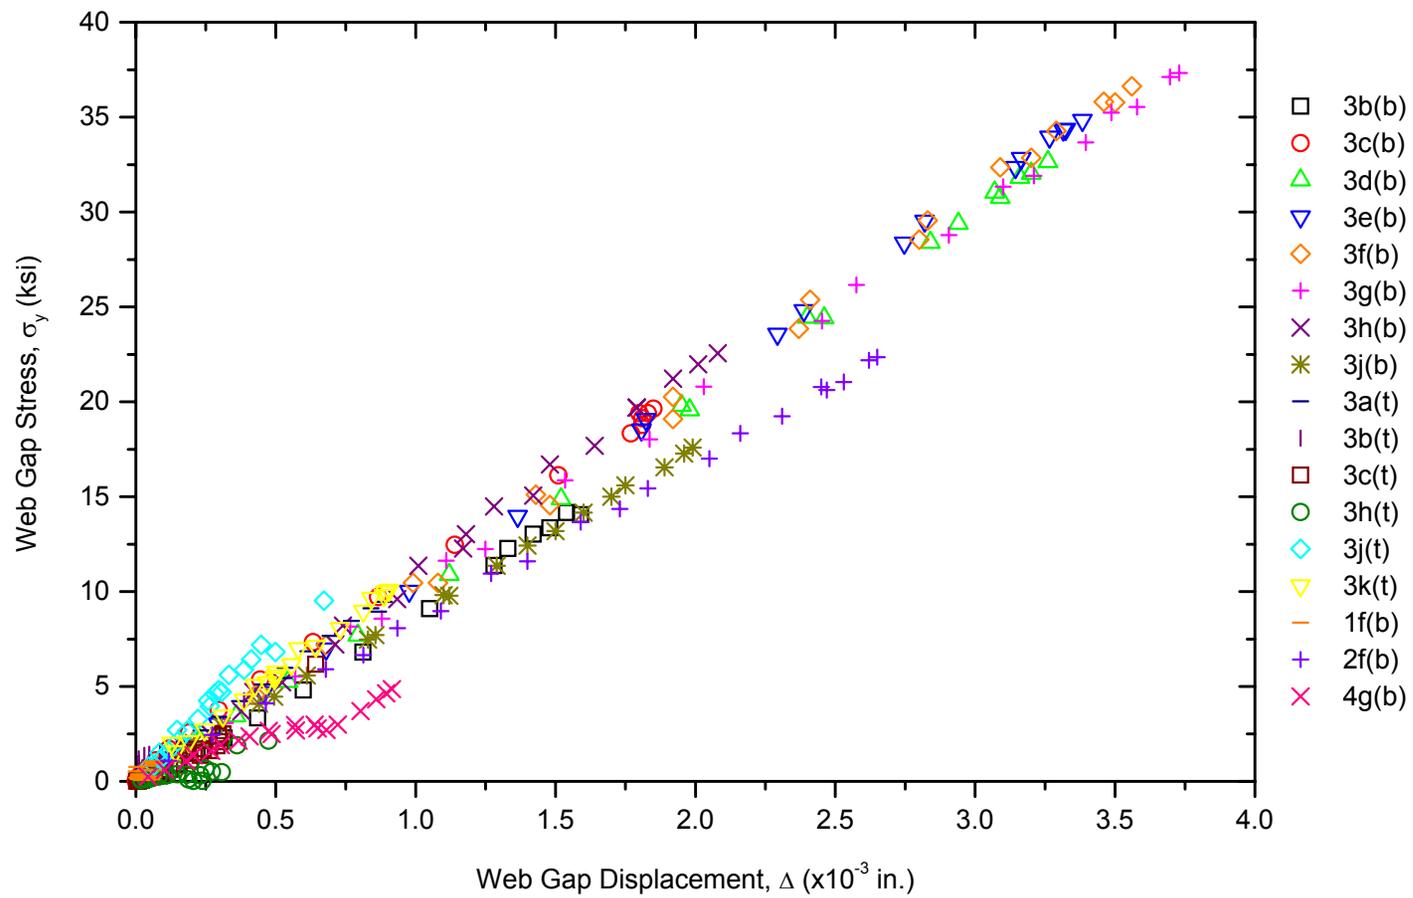
FIGURE 10-2: The Winfield Bridge Web Gap Stress-Displacement Relationship

model analyses may have some influence on the detail behavior. In addition, the Winfield Bridge and the Hump Yard Bridge are both skewed, multi-girder bridges. The Winfield Bridge has staggered diaphragms. The Hump Yard Bridge has different cross-frame type and arrangement in different bays. The skew, the girder location, the connection detail, etc. may also affect the distribution of the stress-displacement data, even for the same type of connections in the same bridge. The Westgate Bridge (Figure 10-1) and the Tuttle Creek Bridge (Figure 10-4) present much more uniform stress-displacement distribution. Both of them are straight, two-girder bridges, so the connection behavior is affected by fewer factors. This is believed to have resulted in the nice grouping of the curves.
