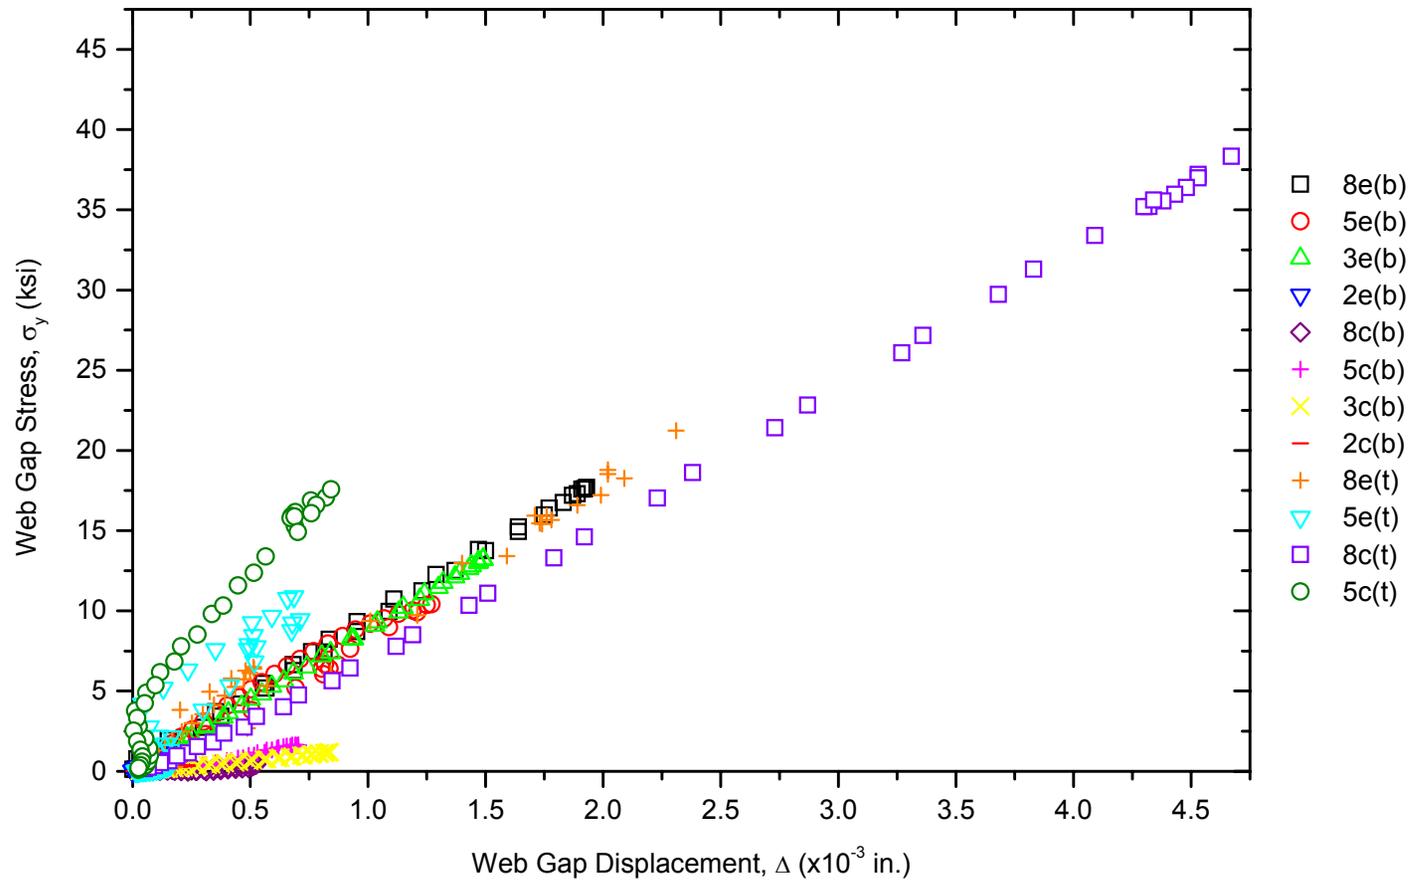
FIGURE 10-3: The Hump Yard Bridge Web Gap Stress-Displacement Relationship

model analyses may have some influence on the detail behavior. In addition, the Winfield Bridge and the Hump Yard Bridge are both skewed, multi-girder bridges. The Winfield Bridge has staggered diaphragms. The Hump Yard Bridge has different cross-frame type and arrangement in different bays. The skew, the girder location, the connection detail, etc. may also affect the distribution of the stress-displacement data, even for the same type of connections in the same bridge. The Westgate Bridge (Figure 10-1) and the Tuttle Creek Bridge (Figure 10-4) present much more uniform stress-displacement distribution. Both of them are straight, two-girder bridges, so the connection behavior is affected by fewer factors. This is believed to have resulted in the nice grouping of the curves.

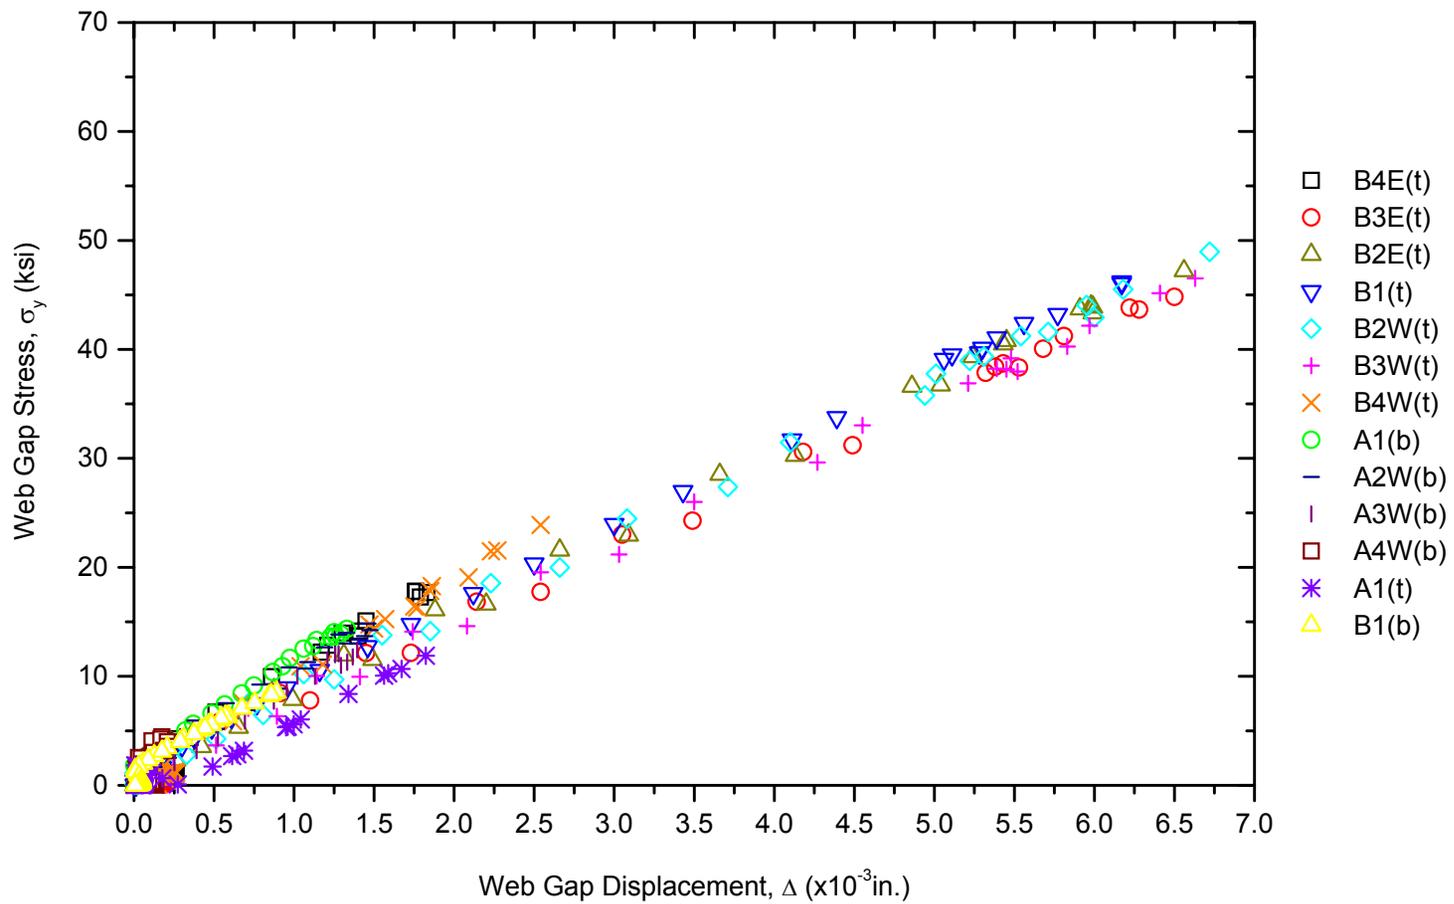
FIGURE 10-4: The Tuttle Creek Bridge Web Gap Stress-Displacement Relationship

Figures 10-1 to 10-4 show the web gap stress-displacement plots of all the bridge connections studied in this research using finite element methods. For most of the details, an almost linear stress vs. displacement relationship can be established when subjected to out-of-plane distortion. The plotted stresses are the higher of the tensile σ_y stresses developed at the flange or the stiffener end of the web gap. For all four bridges, the curves of those details experiencing high-magnitude stress ranges are well grouped with better linearity and less variation in slopes. However, for those details subjected to low stress ranges, the data are in a relatively high degree of scatter with poor linearity and large difference in slopes, as noticed especially in the Winfield Bridge (Figures 10-2) and the Hump Yard Bridge (Figure 10-3). Most of the details experiencing low stress ranges are located close to the bridge piers, so the boundary conditions used in the
