Acoustic Emission Non-Destructive Integrity Assessment of Intermodal Transportation Infrastructure Asset Interactions

Final Report

Multimodal Transportation & Infrastructure
Consortium

January 2016

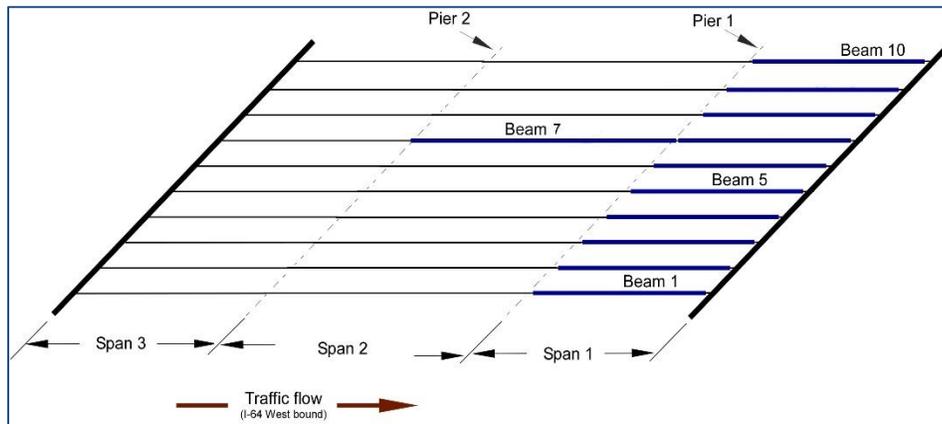
Figure 4: General diagram of the bridge showing the steel girder (beam) layout.

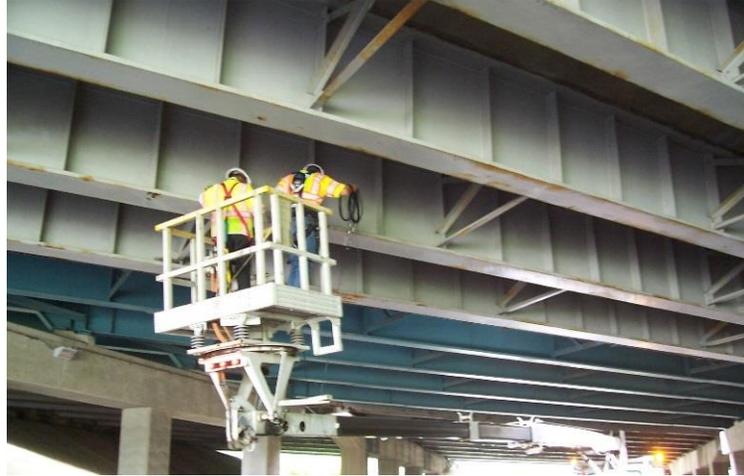
Figure 5: General view of the bridge during AE sensors installation.

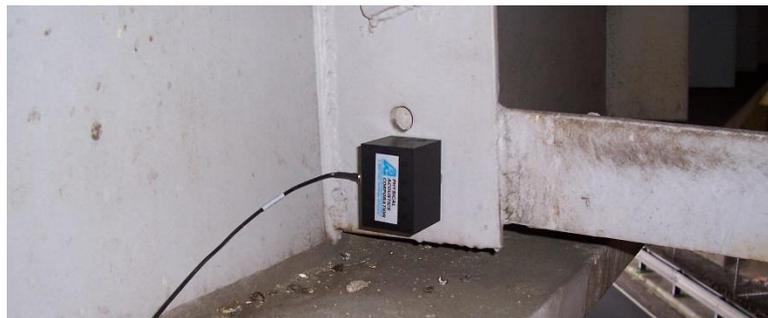
To complete the installation of AE sensors in the middle span of the bridge (span 2), VDOT provided all necessary assistance in the form of lifting equipment, personnel, and road traffic control. Two sensors were installed using magnetic enclosures for sensor attachment to the bridge structure (Fig. 7).

Figure 7: Typical AE sensor installation using the magnetic enclosure.

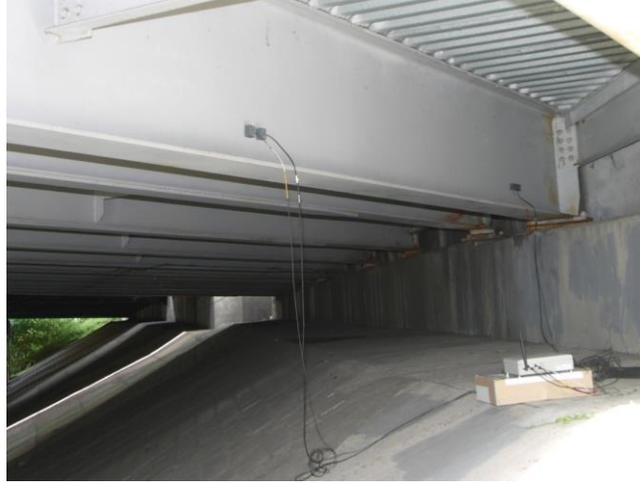
Figure 8: AE sensors mounted onto the steel beams in the northern span of the bridge (span 1).

The work on the northern span of the bridge (span 1) was conducted without VDOT assistance with AE sensors mounting as the relatively low bridge height in those locations allowed AE sensors installation without the use of lifting equipment and did not interfere with road traffic. Four sensors were used to monitor AE activity on each steel girder in this span of the bridge (Fig. 8).

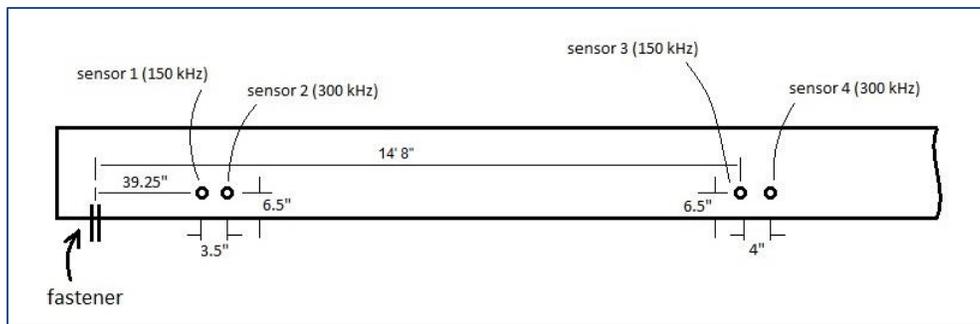
Bridge Span 1: In the northern span of the bridge (span 1), all ten steel girders were subjected to the test. Fig. 4 above shows the arrangement of the girders in this bridge span. On each girder, 4 AE sensors were mounted as shown in the Fig. 11. Two of the AE sensors used have resonant frequency of 150 kHz and the other two 300 kHz. In this bridge span, one end of the steel girder (left side in the Fig. 11) is fastened to the ground and the other end is supported by the concrete pier. Any active crack that is present in the beam will give rise to acoustic emission which can be sensed by the AE sensors. However, the time of travel of the signal reaching the transducer varies according to the distance; this information can be used to locate the active source of the crack.

Figure 11: Arrangement of the 4 AE sensors in each girder.

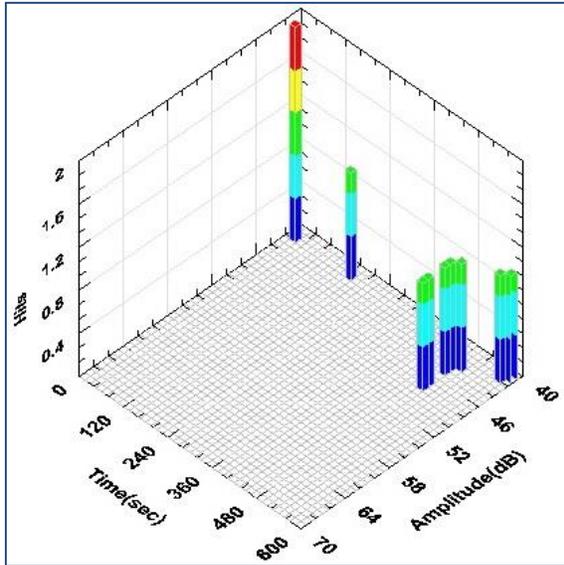
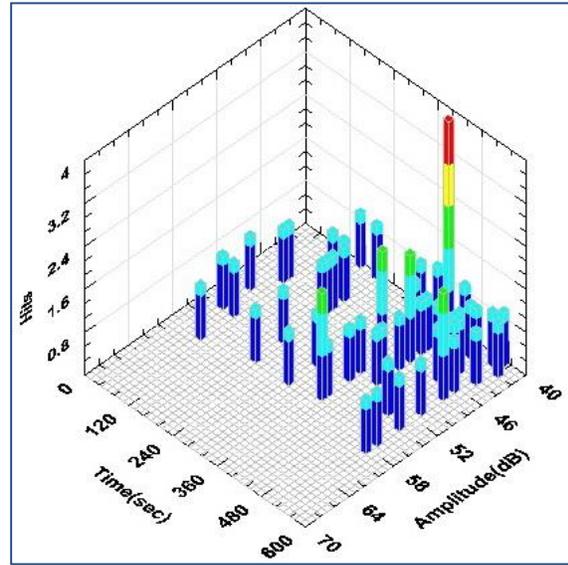
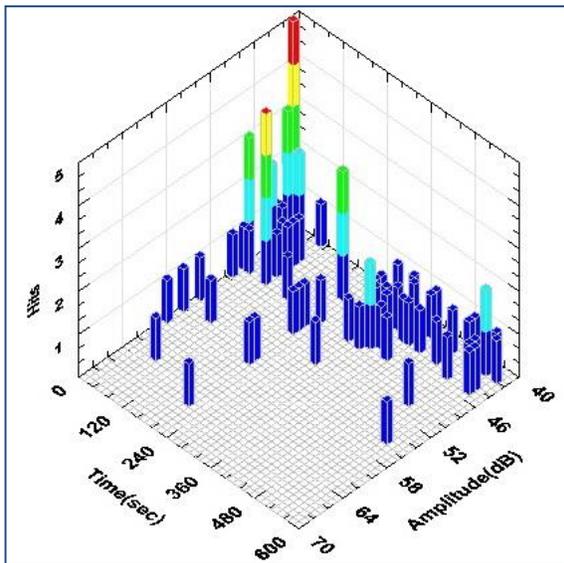
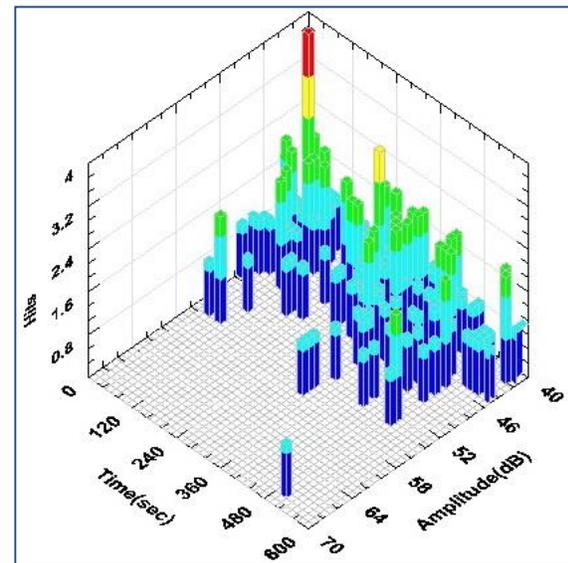
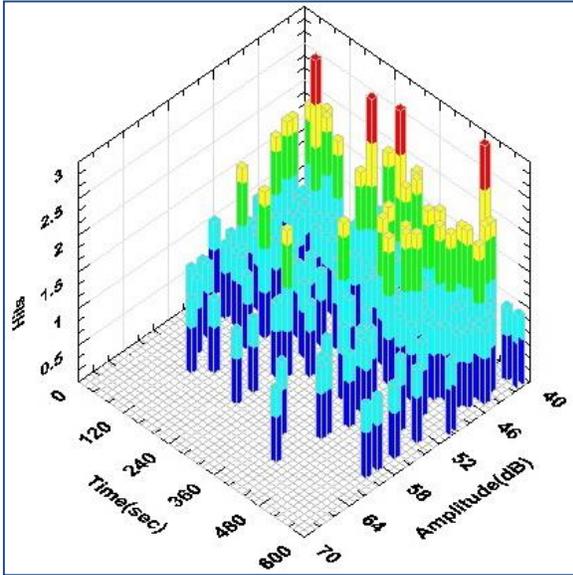
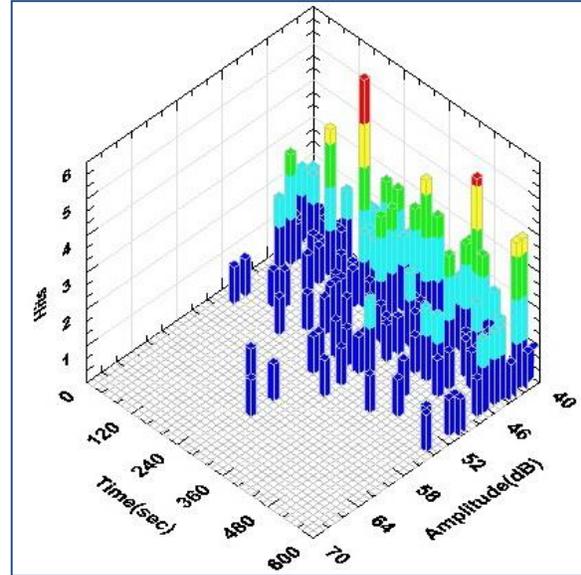
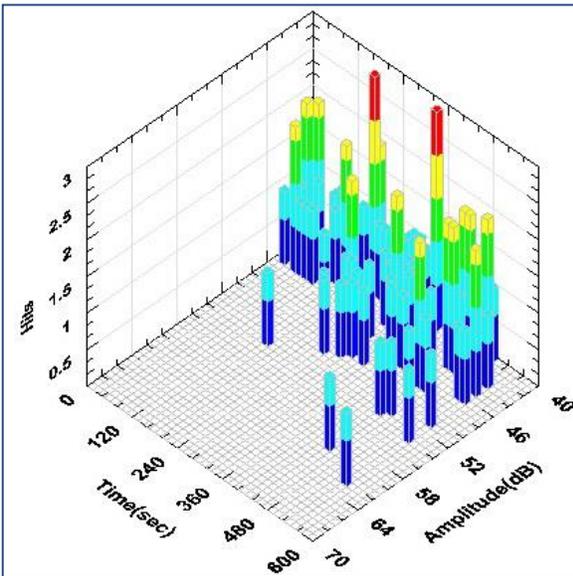
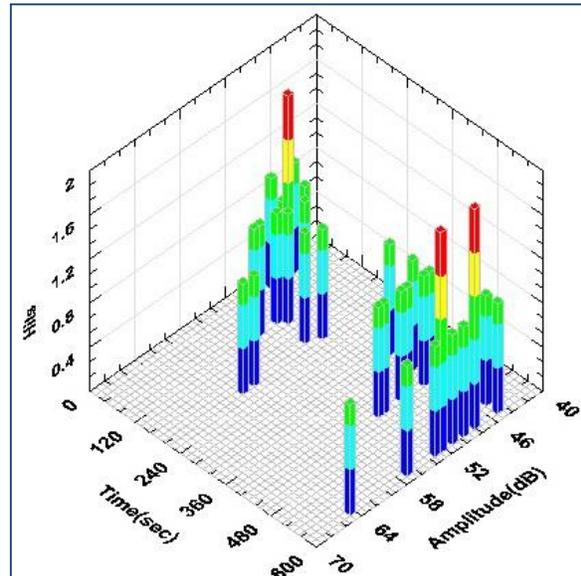
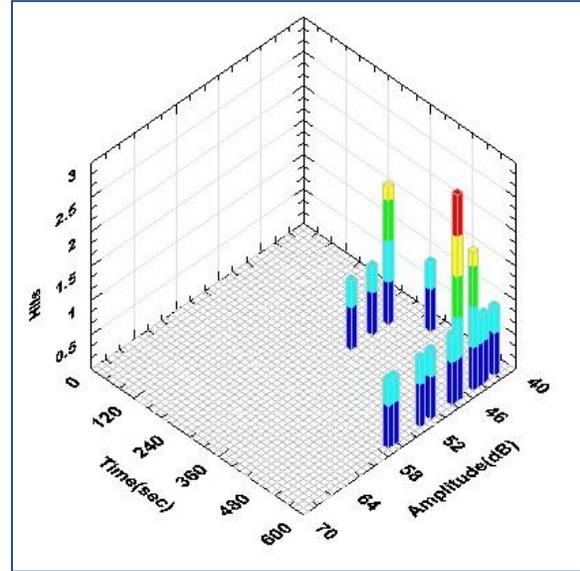
Figure 12: 3D test results using 300 kHz AE transducers.

3D graphs indicating the time, amplitude, and AE hits are given in Figs. 12 and 13. Fig. 12 shows the data on girders #1 to #10 using the 300 kHz AE transducers (Ch. 2 and Ch. 4), with the threshold held at 40 dB. Fig. 13 shows the data on girders #1 to #10 using the 150 kHz AE transducers (Ch. 1 and Ch. 3), with the threshold also held at 40 dB.

This bridge has four travel lanes with two shoulders. It has been observed in all measurements that the AE activity is always greater in the central portion of the road surface. The AE activity is the lowest in the girders #1 and #10, while girders #4, #5, and #6 exhibit more severe AE. This trend has been observed with measurements conducted with both 300 kHz as well as with 150 kHz AE transducers. AE hits acquired from the 300 kHz sensors (Channels 2 and 4) in the ten girders are given in the Fig. 14. Fig. 15 illustrates the same information as a summary, where it is very clear that the AE activity is greater in the middle of the road. However, it can be seen that girder #9 produces much higher level of AE activity, indicating that there is a possibility that this beam may have an active crack. It is

recommended to carry out further detailed studies using visual examination, dye penetrant tests, and ultrasonic tests to check for the presence of defects.

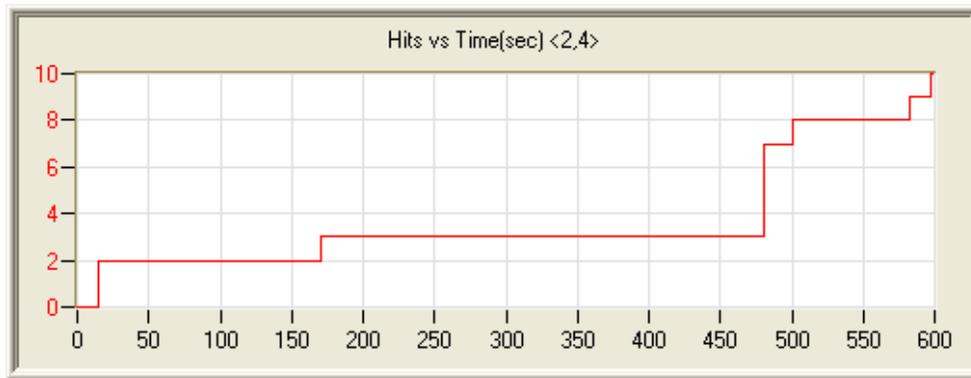
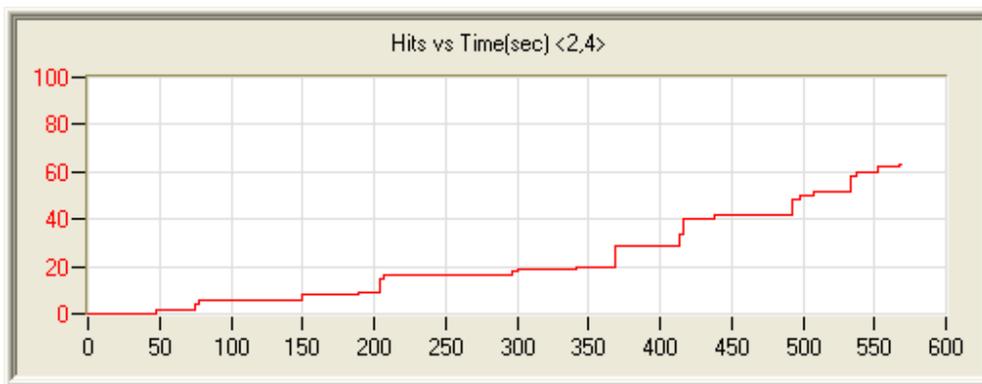
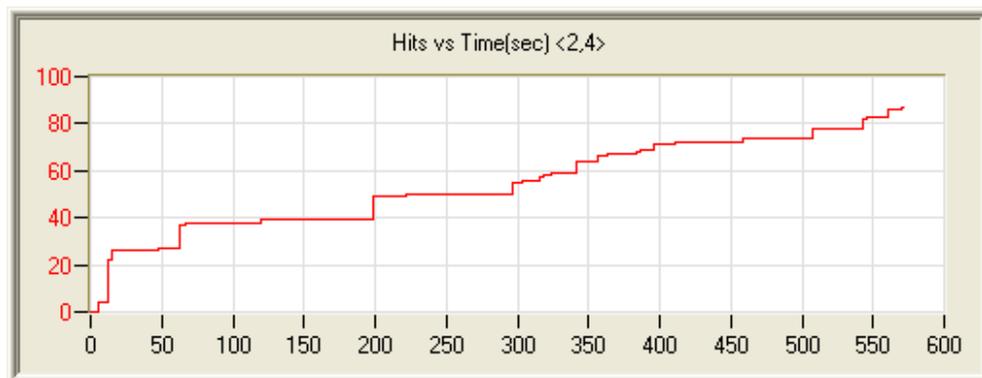
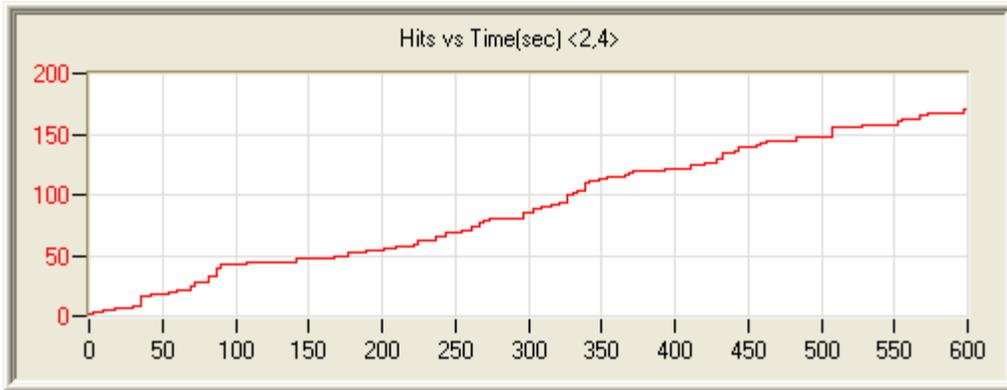
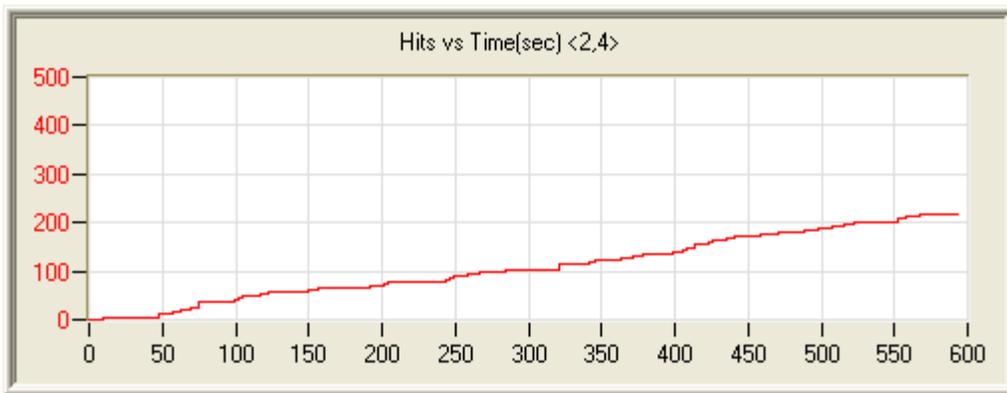
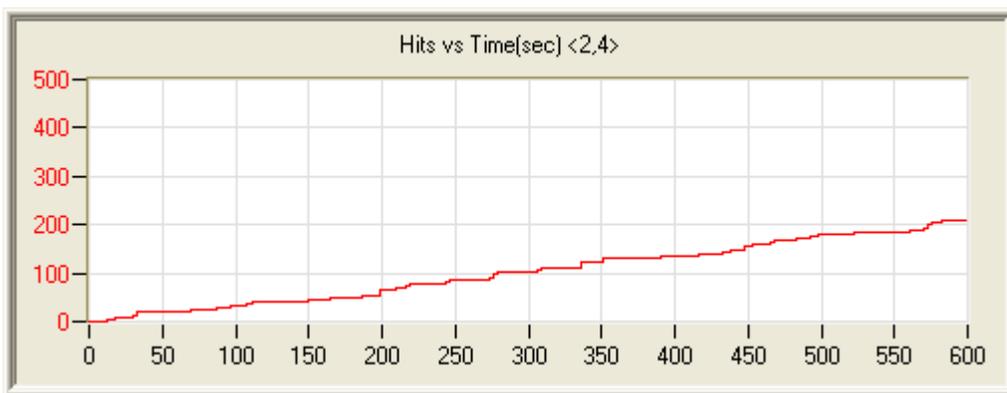
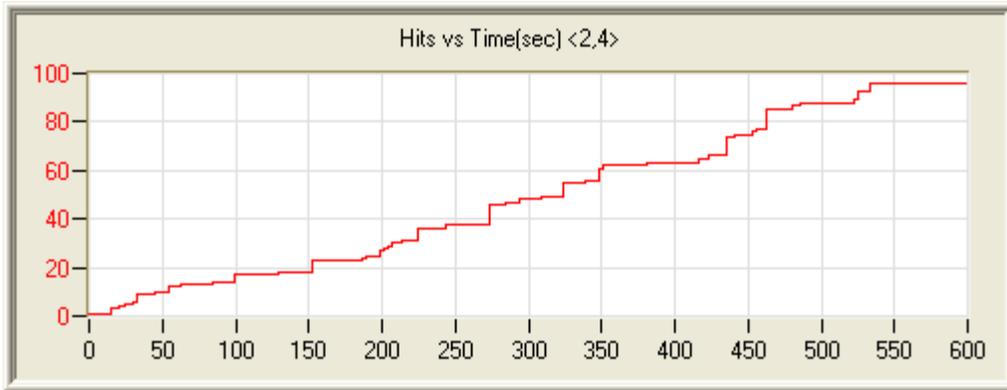
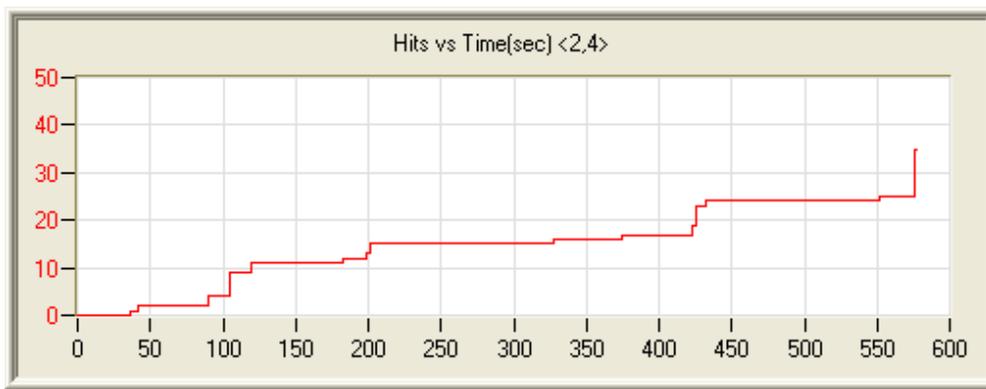
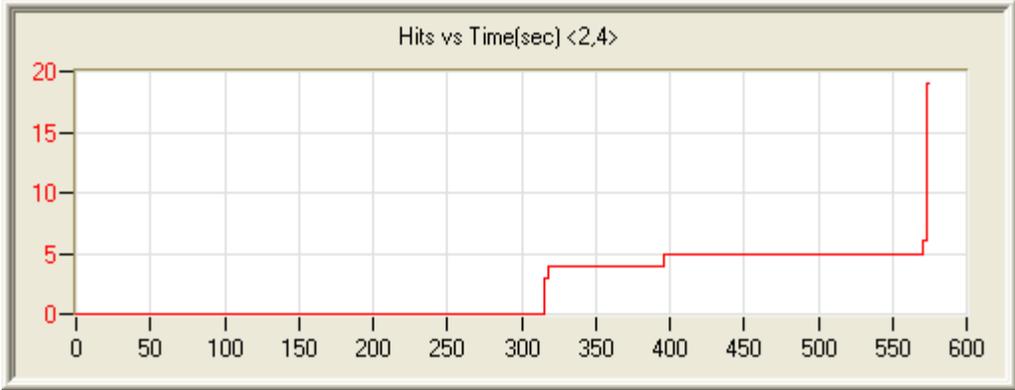
Figure 14: Total hits encountered during 600 seconds of tests using 300 kHz AE transducers.
