REPORT NOS. DOT-TSC-NHTSA-79-48

//  
COMPARISON OF PRE AND POST ROAD TEST  
ULTRASONIC INSPECTION RESULTS ON  
134 PASSENGER TIRES

George Berube

FINAL REPORT

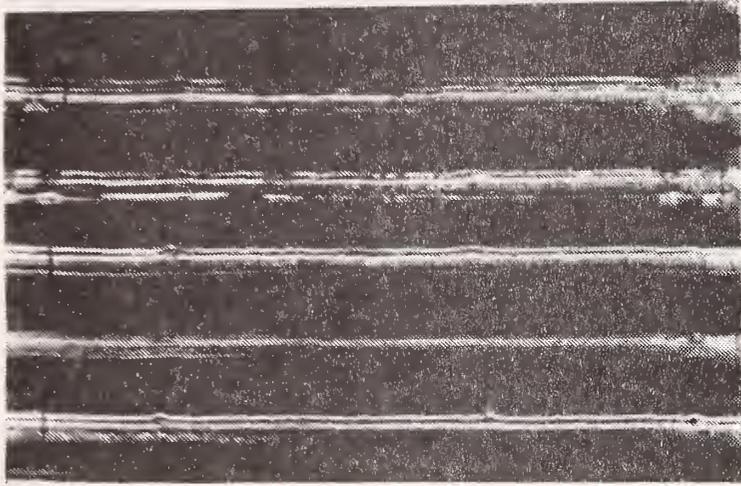
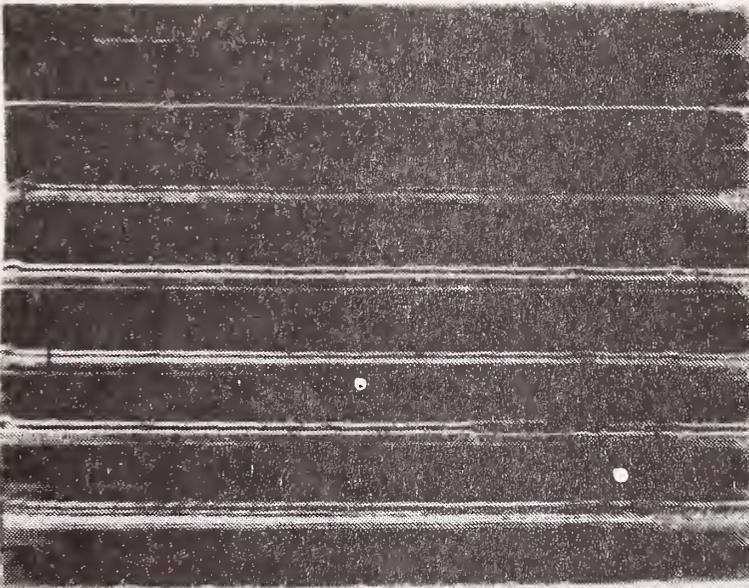
Abrupt brightness change (Figure 3-5). It is caused by overlapping or separation of material near the tire beads.

SEVERE TURNUP  
MODULATION

LITTLE OR NO  
TURNUP MODULATION

FIGURE 3-5. TURN-UP AREA

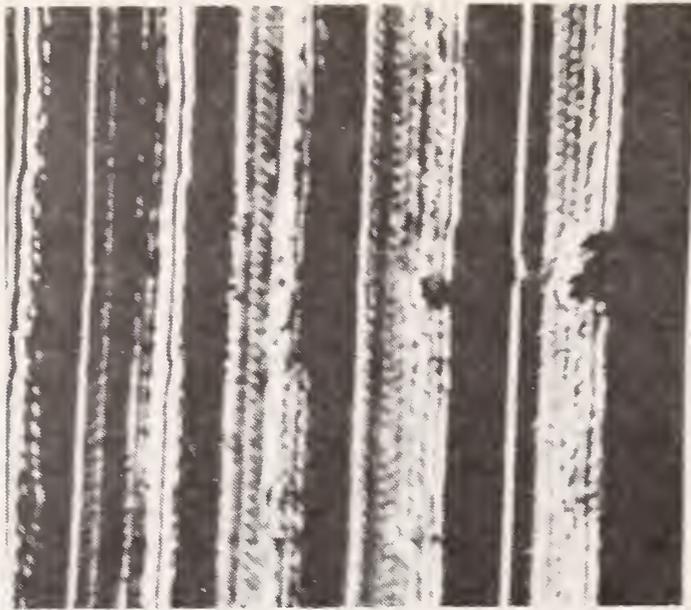
A reflection from several depths and generally present in more than one channel (Figure 3-6), not be confused with a single trace separation or fading of a trace. It is caused by a hole or foreign material in the tire structure.

FIGURE 3-6. EXAMPLE OF INCLUSION

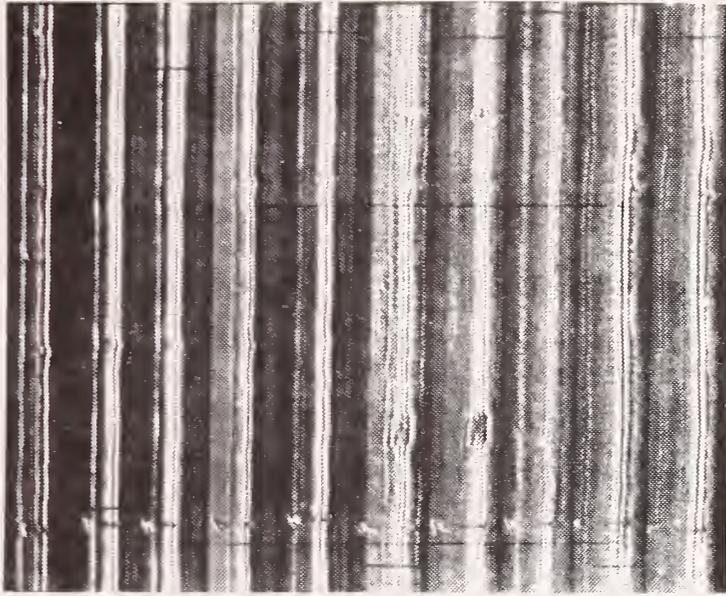
A bright spot adjacent to a shadow (Figure 3-7). It is caused by a separation or other discontinuity.

FIGURE 5-7. EXAMPLE OF SINGULARITY/SHADOW

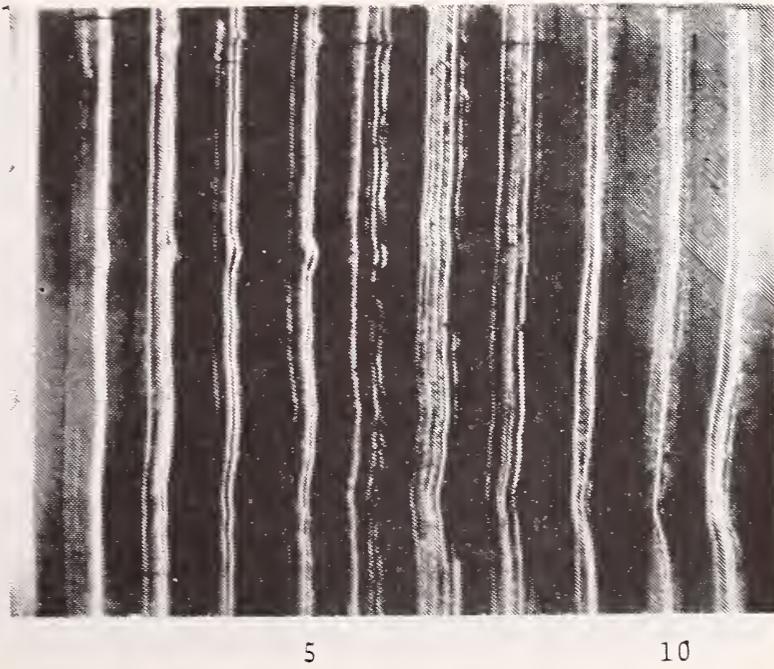
Skewed or wavy trace (Figure 3-8). Caused by "out of roundness": the resulting "high spot" passes closer to transducer #10 than the remainder of the tire scanned in Channel #10.

FIGURE 3-8. RADIAL RUNOUT

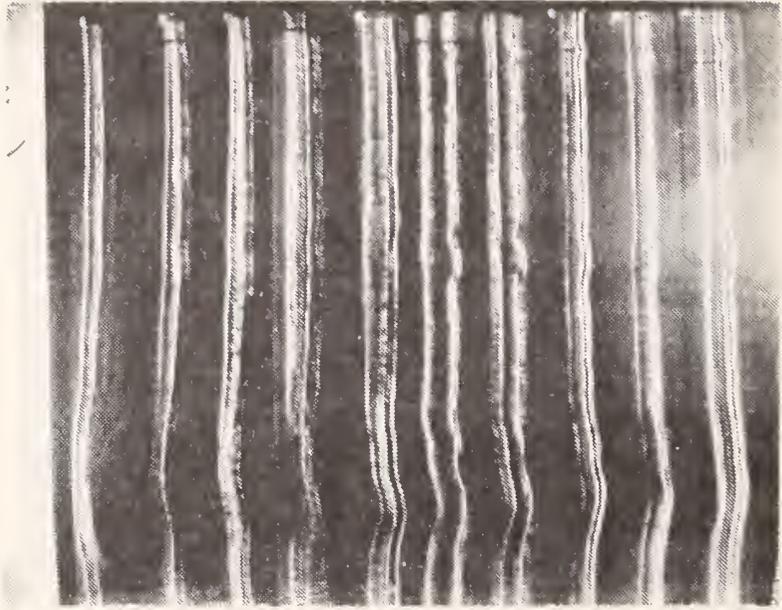
Wavy trace (Figure 3-9). Caused by a change in tire width.

FIGURE 3-9. LATERAL RUNOUT

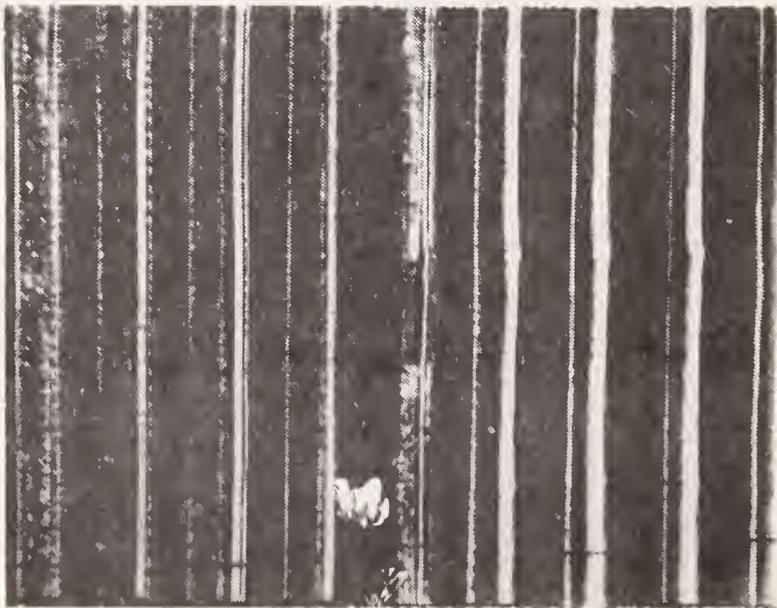
Abrupt brightness change (Figure 3-10). Caused by a change of material thickness.

FIGURE 3-10. INTENSITY CHANGE

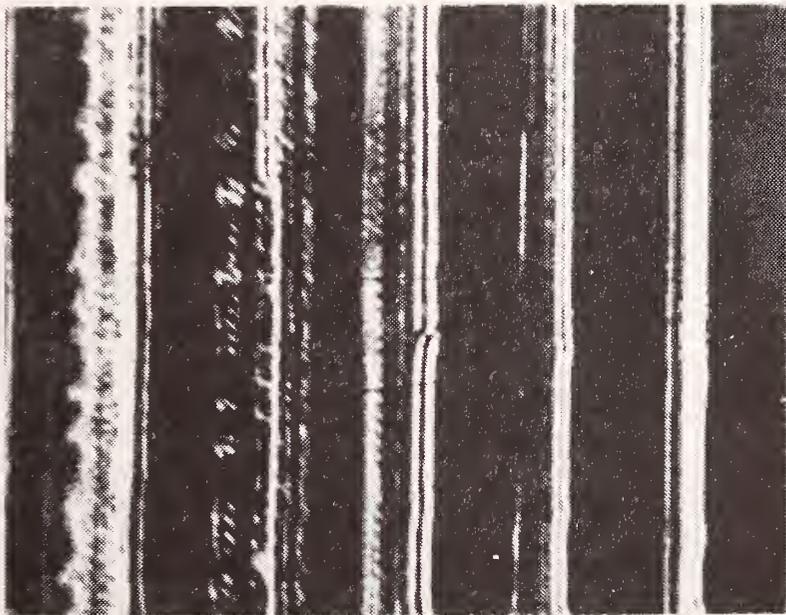
Interruption of a trace (Figure 3-11); not to be confused with an inclusion which is usually indicated in more than one channel. It is caused by abnormal displacement of material.

FIGURE 3-11. TRACE DISCONTINUITY

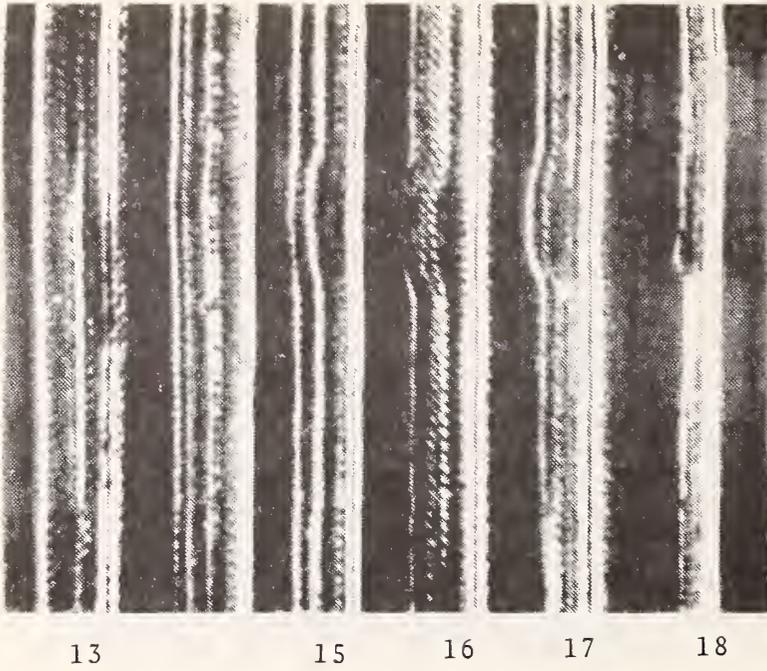
Abrupt change of shape of trace (Figure 3-12). It is caused by excess of material or distorted ply structure.

FIGURE 3-12. SHAPE DISCONTINUITY
