REPORT NOS. DOT-TSC-NHTSA-79-51

✓✓
**CORRELATION BETWEEN ULTRASONIC NONDESTRUCTIVE
INSPECTION AND WHEEL TEST OF 34 RETREADED TIRES**

NOVEMBER 1979

FINAL REPORT

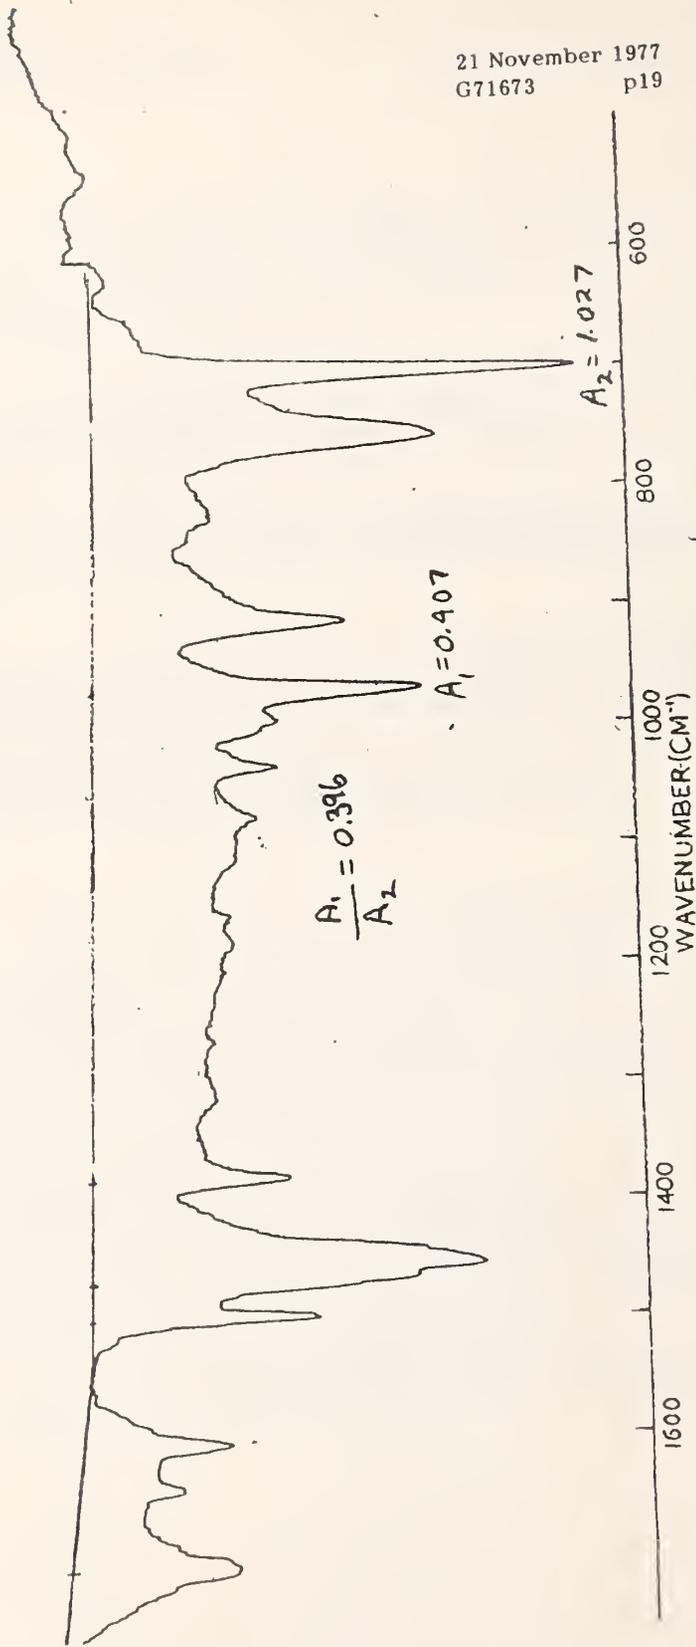
In the case of tread stock the subject tires all used an SBR base rubber. In analyzing for oxidative-degradation (i.e., exposure of the rubber especially to excessive heat), the IR absorbances at 962 cm^{-1} and 698 cm^{-1} are carefully analyzed. Figures 7 and 8 are IR scans of SBR tread stock showing the effect of oxidative-degradation.

Figure 7. IR Scan - Pyrolyzed SBR Tread Rubber - Little Oxidation-Degradation T5X 1161

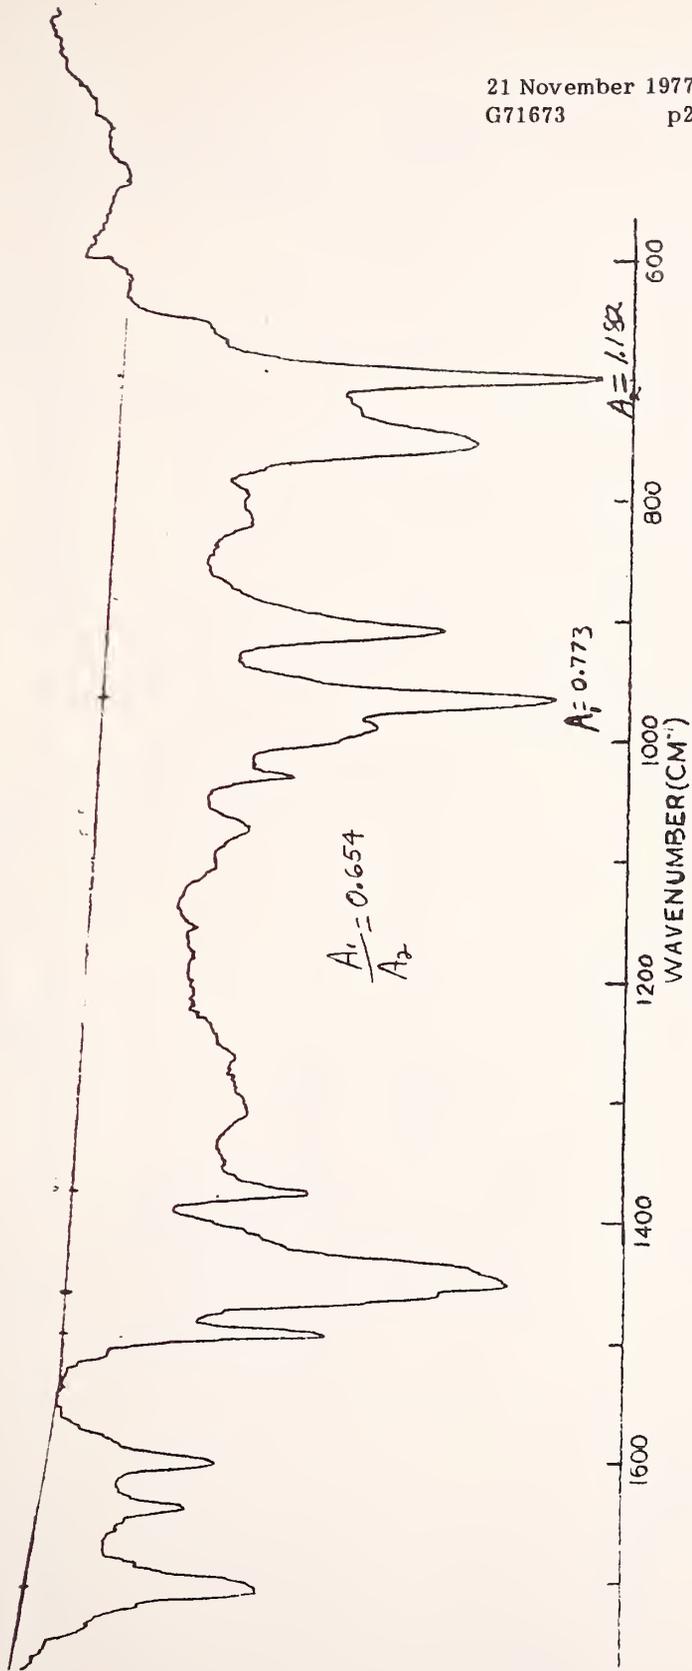
Figure 8. IR Scan - Pyrolyzed SBR Tread Rubber - High Oxidation-Degradation T5X 1223

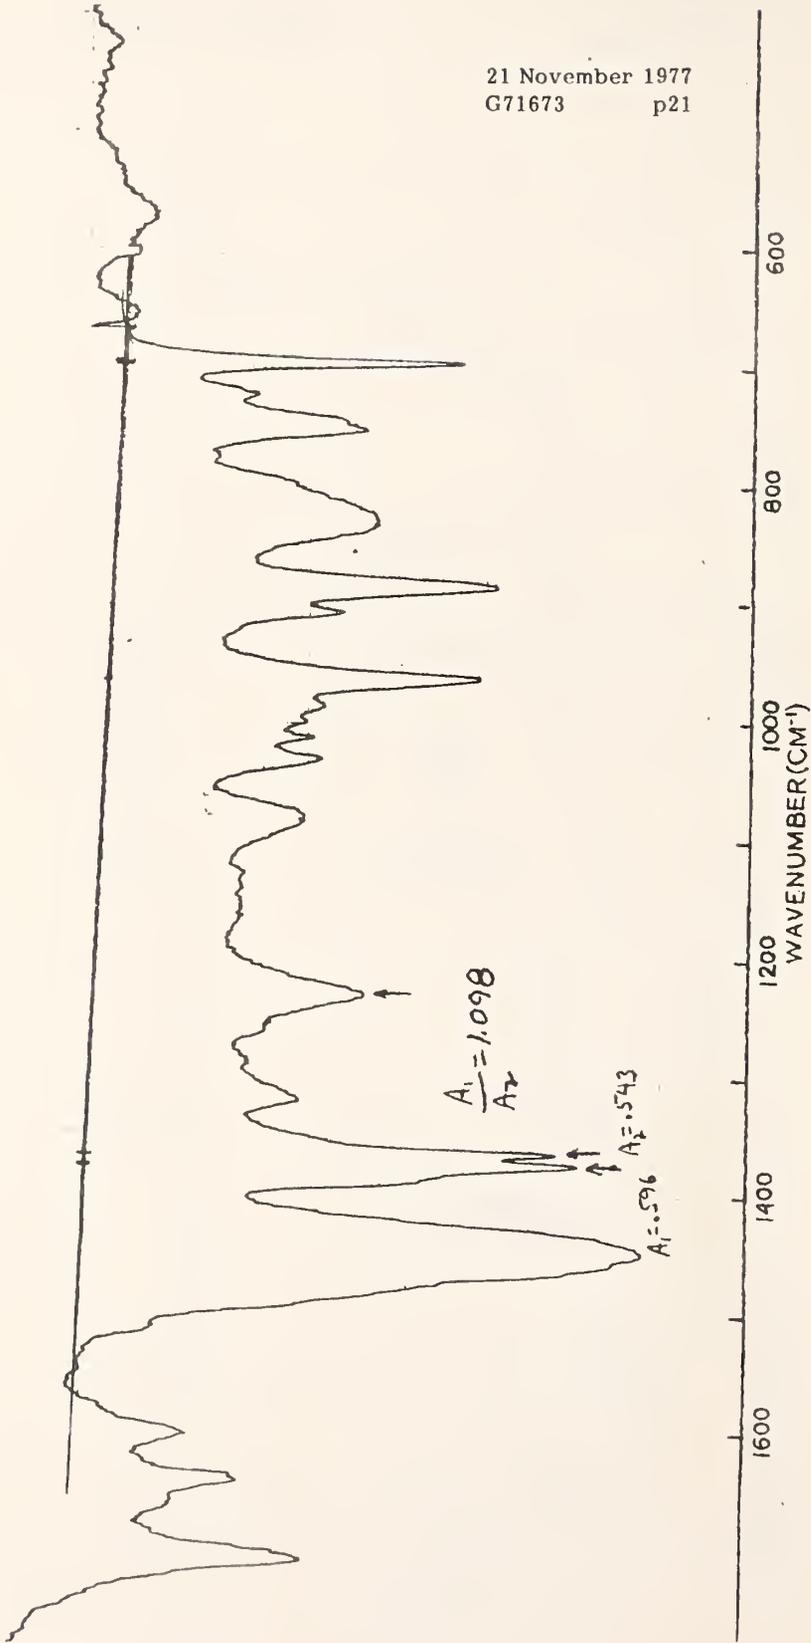
Liner rubber is usually a blend of rubbers of which butyl rubber tends to predominate. The subject tires all contain liners made from blends of butyl rubber. The key characteristic IR absorption band for butyl is a doublet at 1375 and 1365 cm^{-1} which is the deformation of the $\text{CH}_3\text{-C}$ and $(\text{CH}_3)_2\text{-C}$ parts of the polymer chain. Figure 9 illustrates the normal butyl rubber IR scan. Although butyl has good heat resistance, butyl will break down with heat and an oxidizing atmosphere and the band at 1365 cm^{-1} will gradually disappear when the degraded butyl is pyrolyzed. Figure 10 is an IR scan of degraded butyl rubber. The skeletal vibration of the $(\text{CH}_3)_2\text{-C}$ occurs at about 1230 cm^{-1} and also gradually disappears as the butyl polymer degrades and is pyrolyzed. The ratio of the absorbances at 1375 and 1365 cm^{-1} will run between 0.9-1.1 for a normal butyl polymer but as degradation occurs the ratio will increase to about 1.5 or the band at 1365 cm^{-1} will almost disappear after pyrolyzing the degraded butyl.

Figure 9. IR Scan - Pyrolyzed Liner Rubber - Little Oxidation-Degradation (Butyl) T5X 1204

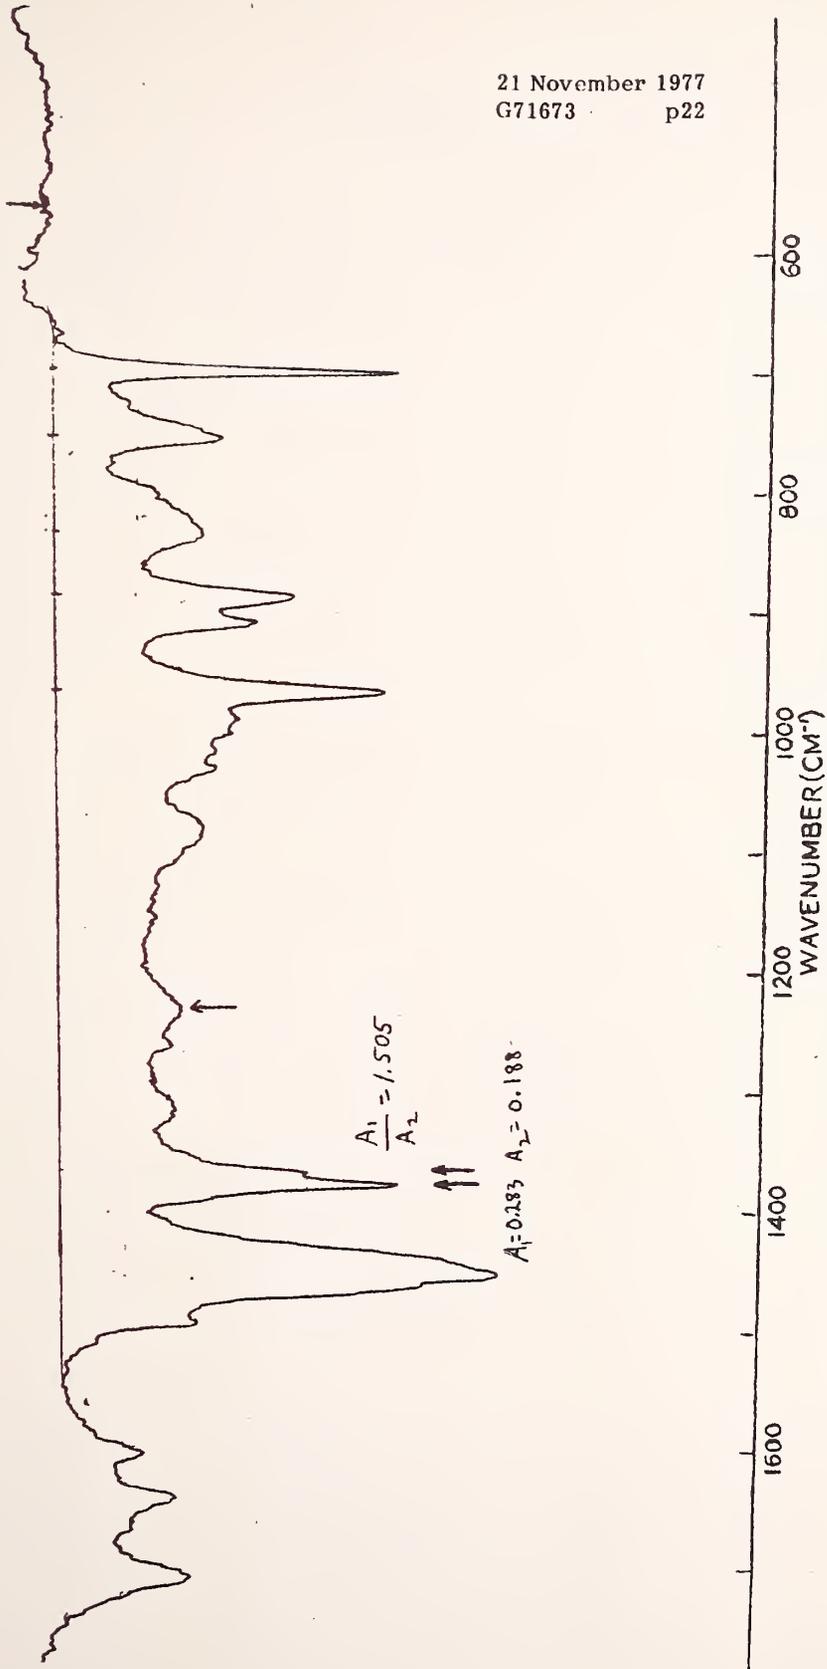
Figure 10. IR Scan - Pyrolyzed Liner Rubber - High Oxidation-Degradation (Butyl) T5X 1223
