✓  
✓  
DETERMINATION OF TIRE QUALITY.  
FROM NONDESTRUCTIVE INSPECTION

S. N. Bobo

U.S. DEPARTMENT OF TRANSPORTATION  
RESEARCH AND SPECIAL PROGRAMS ADMINISTRATION  
Transportation Systems Center  
3 Cambridge MA 02142

NOVEMBER 1979  
FINAL REPORT

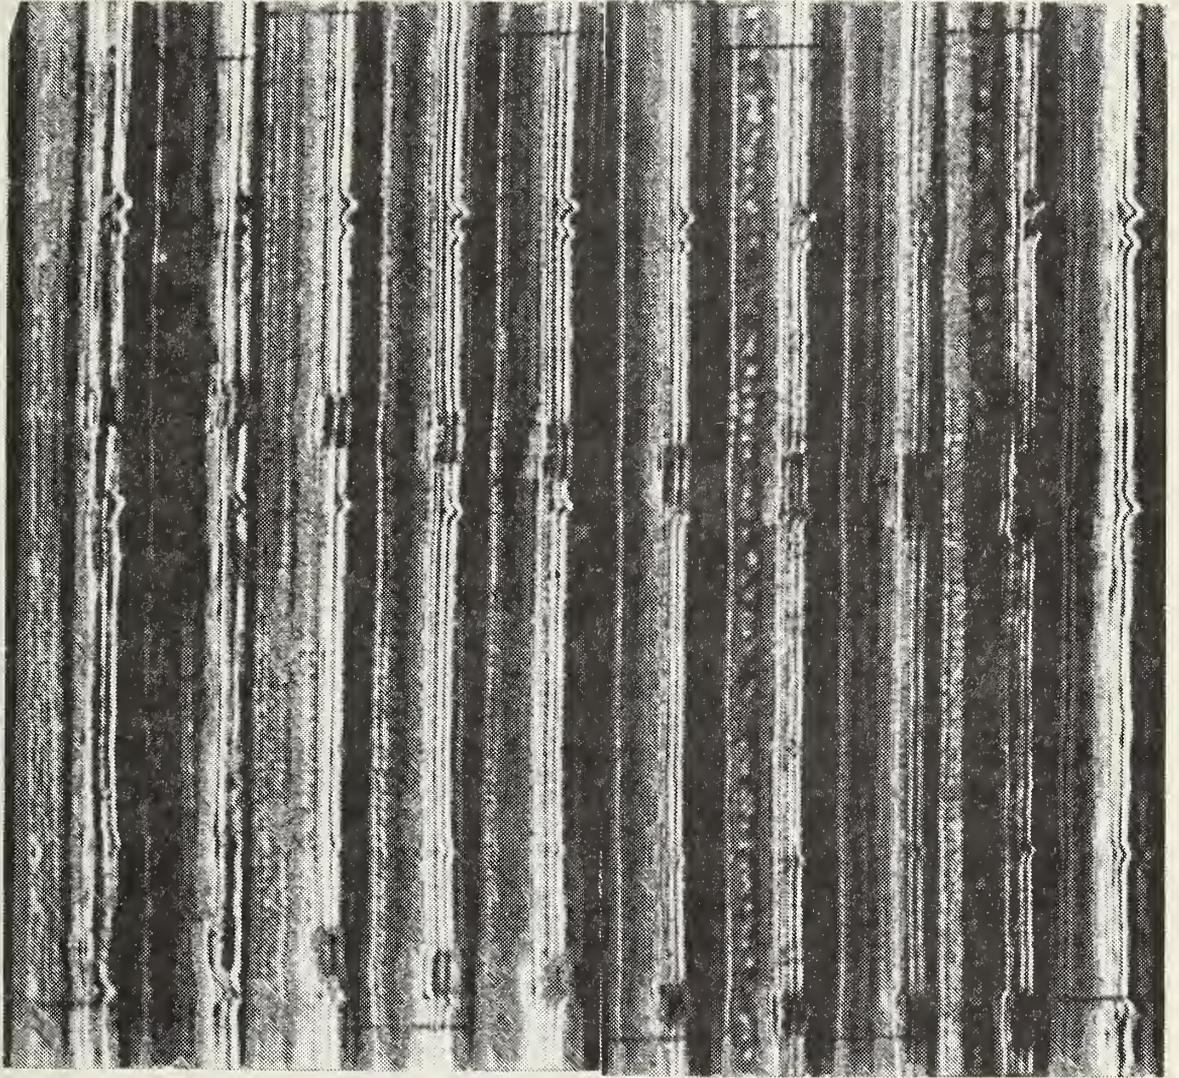
FIGURE 4-1. PRINTOUT OF UNIROYAL

Uniroyal. Construction of Uniroyal and BIG-O (also made by Uniroyal) is two-ply polyester, two steel belts, and a nylon breaker over the belts. The purpose of the breaker is to hold the belt edges down and prevent belt edge separation. This is Uniroyal's premium tire and as far as is known has performed over a number of years in a satisfactory manner on the Compliance Tests and in road service. It is manufactured under a proprietary process involving automatic builders. These builders leave an exceptionally long splice on the belts and this long splice plus the force exerted by the nylon breaker leaves an ultrasonically dense region in the splice area. This region is shown in Figure 4-1 as a typical singularity/shadow system as defined in Appendix A. For this reason the Uniroyal grades are lower than performance indicates.
