UMTA-MA-06-0152-84-3
DOT-TSC-UMTA-84-25

Evacuation and Rescue of Elderly and Disabled Passengers from Paratransit Vans and Buses

Transportation Systems Center
Cambridge MA 02142

October 1984
Final Report

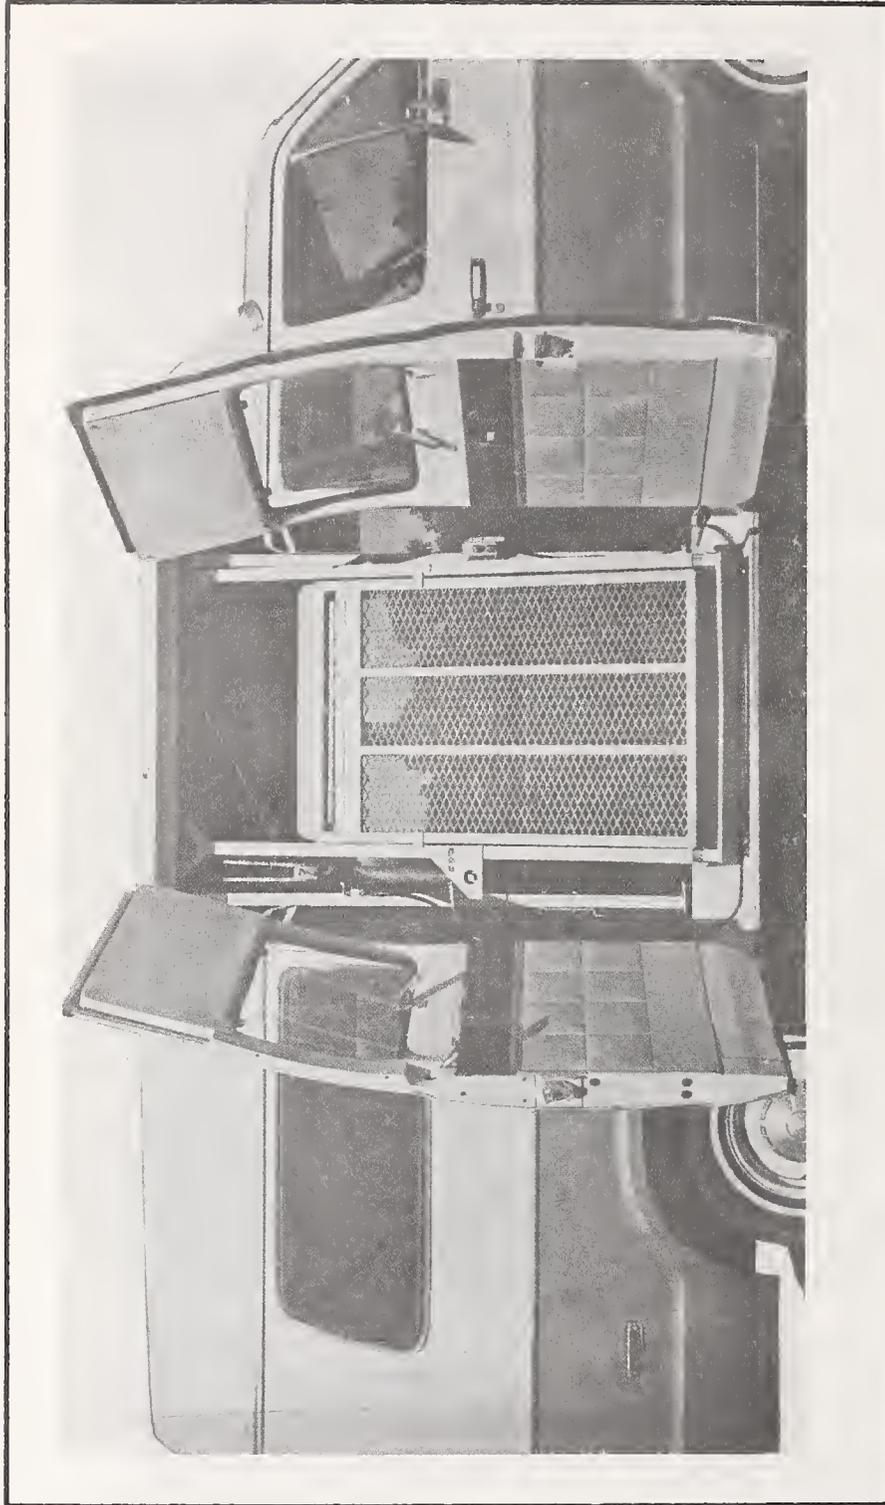
FIGURE 3-5. POWERED WHEELCHAIR LIFT IN ITS STORED POSITION ON A MODIFIED VAN

Figure 3-4 shows a powered lift installed in a modified van and being operated by a wheelchair user. Figure 3-5 shows a lift in its stored position in a van. This typical lift fully blocks the side door while stored and may become inoperative in an accident. Rescue personnel would have to use the rear or cab doors or to cut through the side of the van to gain access. In contrast, another type of side-mounted lift (Figure 3-6) folds in half when stored, thus allowing some access by rescue personnel.

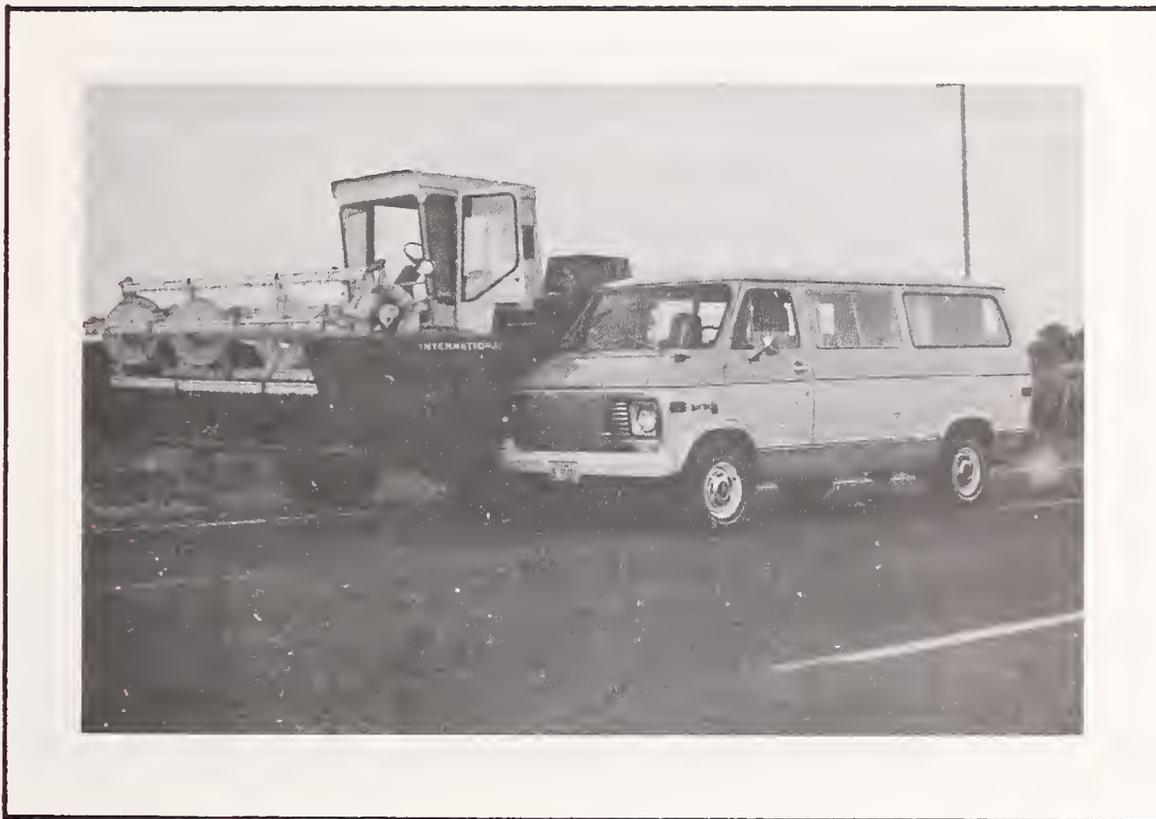
FIGURE 3-7. IMPACT SIMULATION OF DELTA, UTAH, ACCIDENT USING SIMILAR VEHICLES

Paratransit Van/Farm Vehicle Collision. On September 12, 1979, a 1976 standard Dodge paratransit van occupied by 14 elderly persons was traveling on U.S. Route 6/50 near Delta, Utah. About 6:25 A.M., before dawn, it overtook and collided with a poorly-lighted, slow-moving farm vehicle. The van was lifted up on its left wheels, traveled off the right side of the road, and struck a concrete bridge parapet that was approximately 4 1/2 feet beyond the edge of the pavement. Eight of the van's occupants were killed and the remaining six were injured; the operator of the farm vehicle was not injured. Figure 3-7 shows a simulation of the accident using vehicles similar to those originally involved. Figure 3-8 presents the van's seating chart with occupants' ages and injuries and the amount of penetration by the bridge parapet into the passenger compartment of the paratransit van.

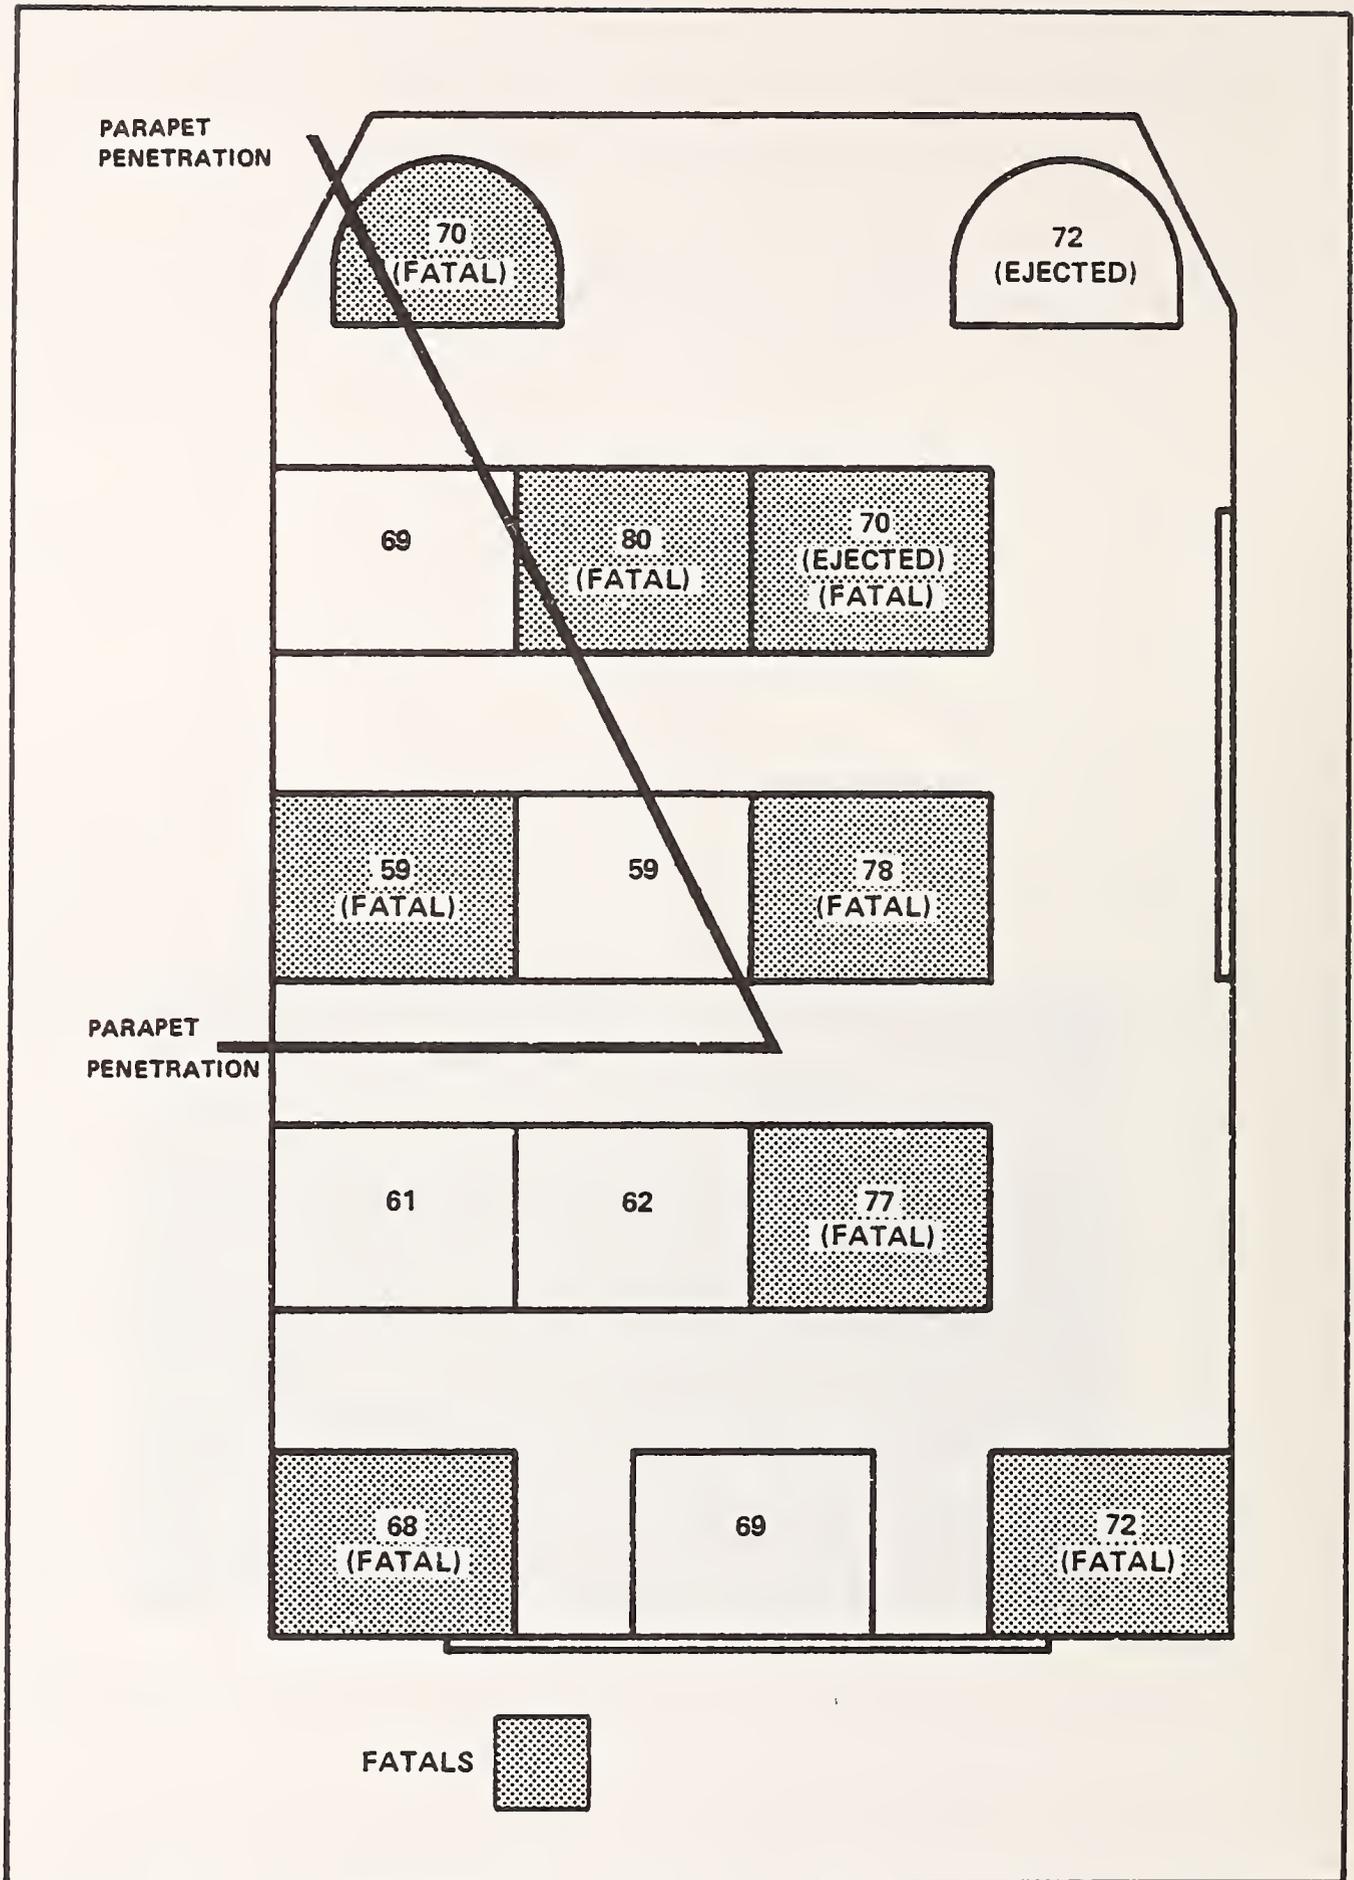
FIGURE 3-8. DELTA, UTAH, VAN SEATING CHART

All of the occupants had to be extricated from the vehicle except the passenger in the right front seat and the passenger on the far right of the first bench seat. (See Figure 3-8.) Both of these passengers were ejected into an irrigation canal. The 72-year-old passenger sustained a shoulder injury but managed to swim to and crawl up the embankment. The other's body was found several hundred feet downstream. An autopsy was not performed.

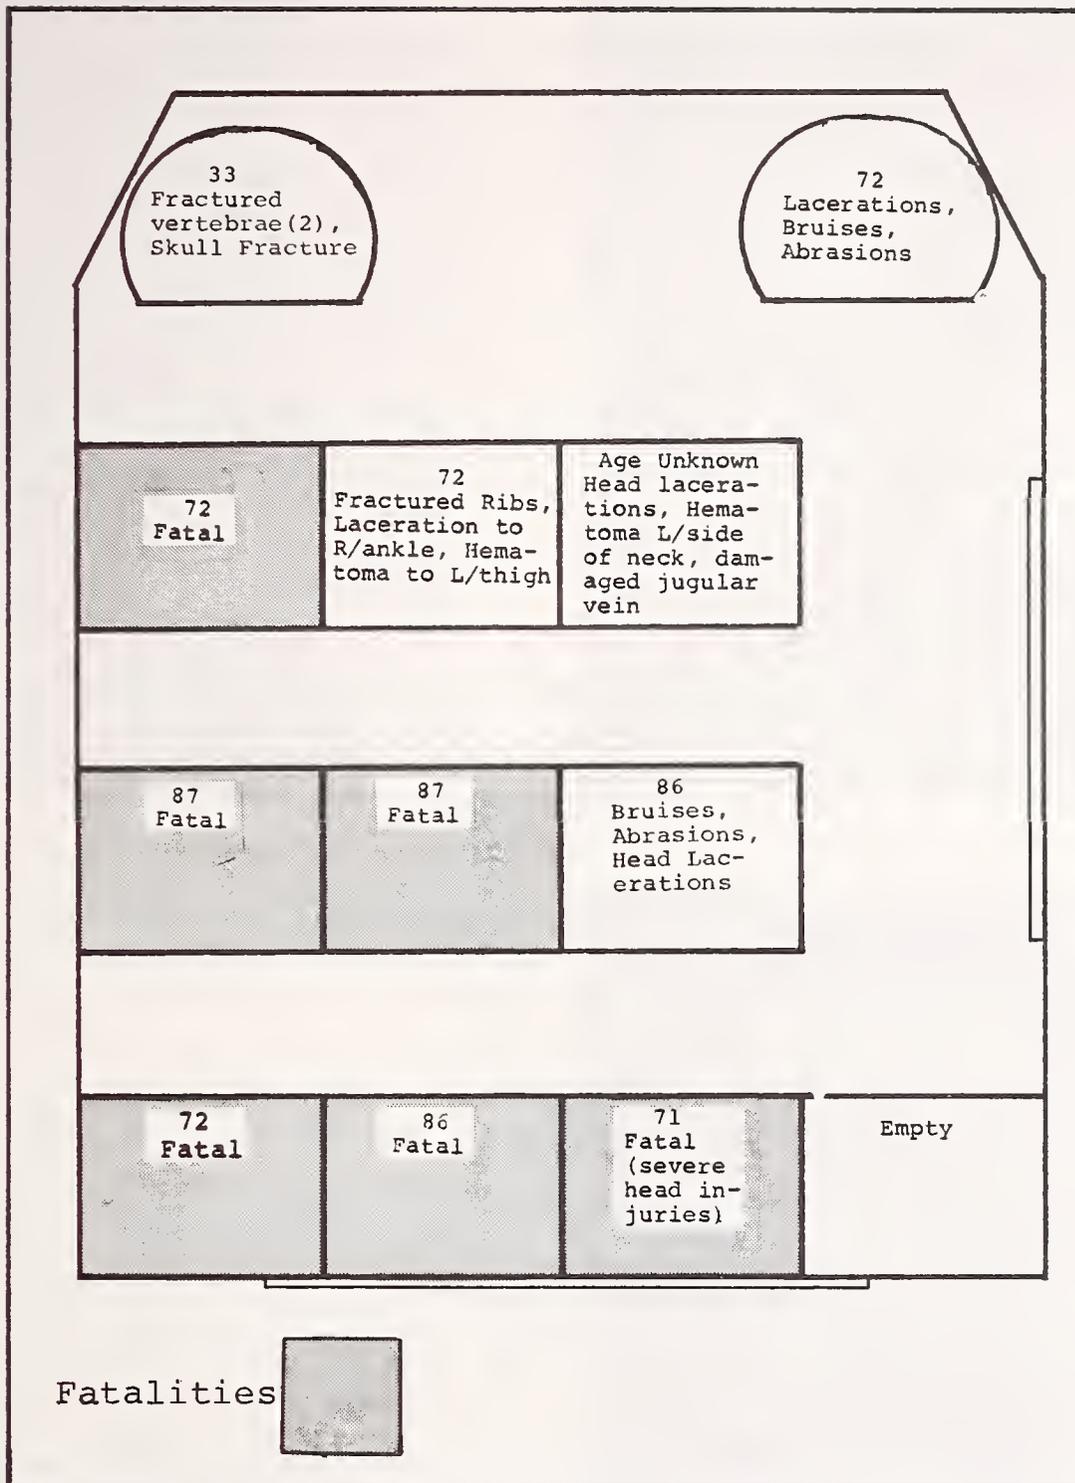
FIGURE 3-10. PARATRANSIT VAN SEATING CHART SHOWING OCCUPANT AGES AND INJURIES: SUSANVILLE, CALIFORNIA, ACCIDENT

Figure 3-10 is the seating chart of the occupants with their ages and injuries. After impact, the van rolled clockwise along its longitudinal centerline. The 72-year-old passenger in the middle of the first bench seat was pinned inside the van and was one of the last to be extricated. The 86-year-old passenger on the second bench seat was also pinned in the wreckage and had to be extricated.

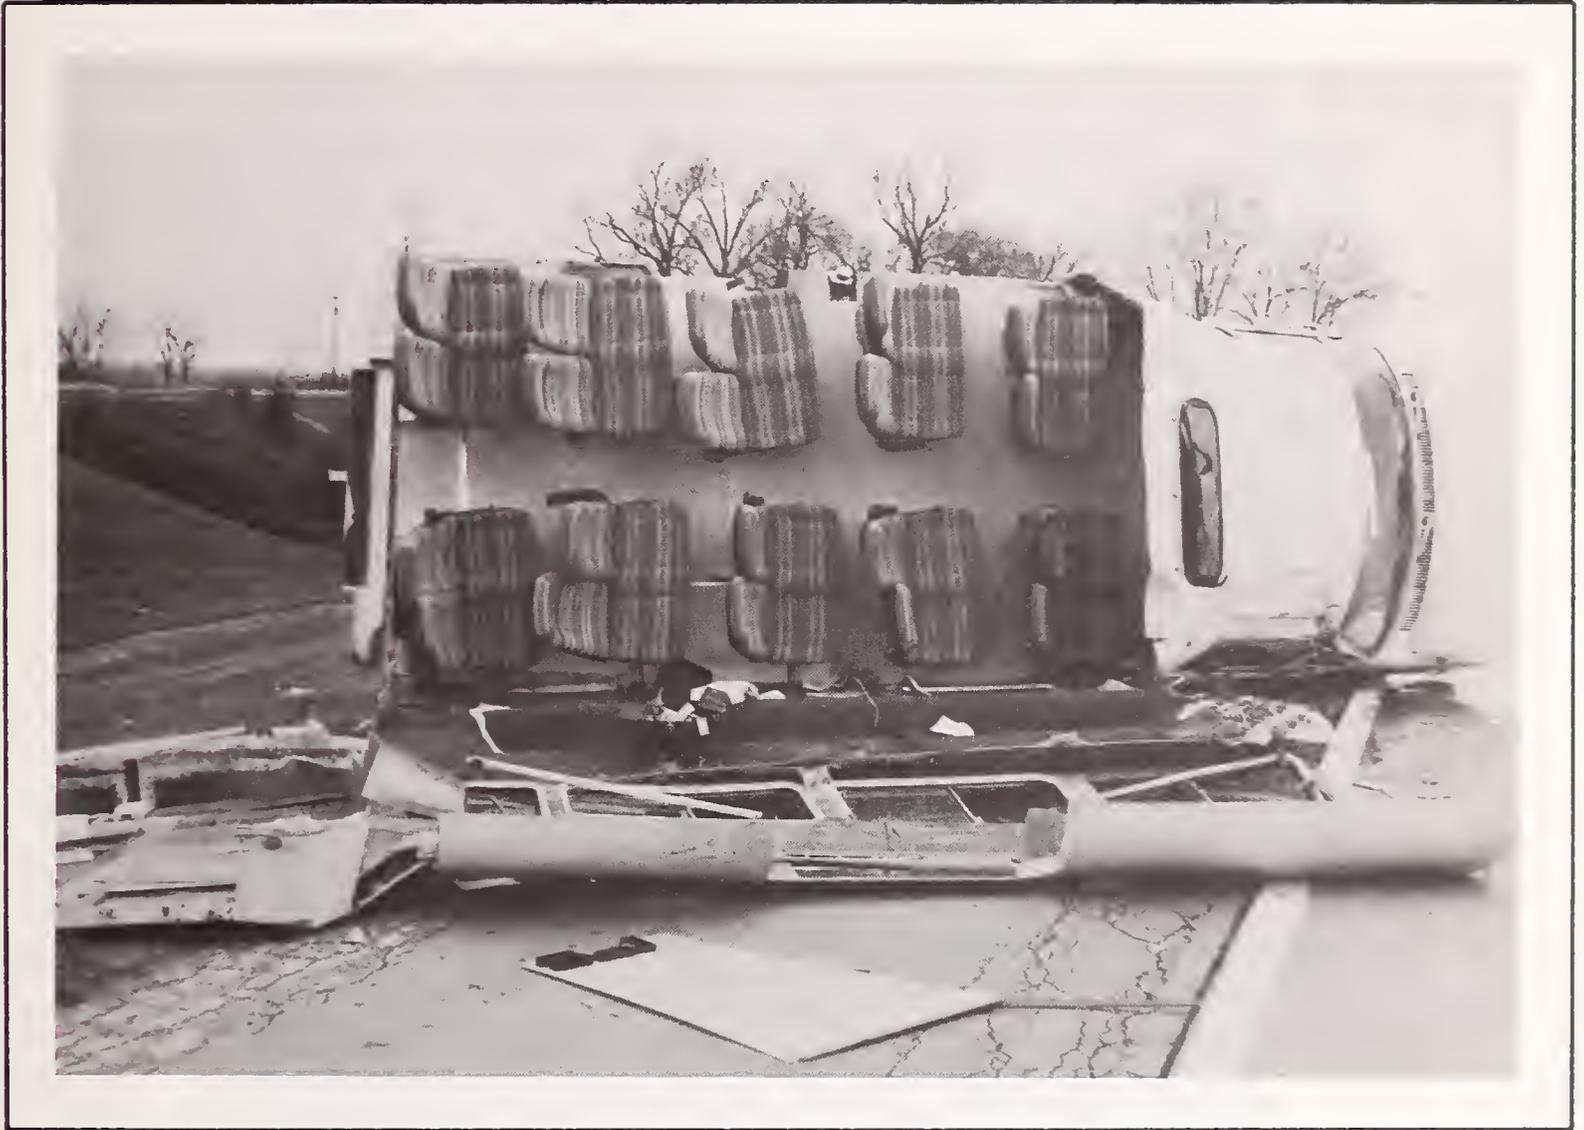
FIGURE 4-13. BODY-ON-CHASSIS SMALL BUS ACCIDENT: SCOTT COUNTY, KENTUCKY

Figure 4-13 shows the bus in its final resting position on its side. Note that the left side wall of the body became detached at the floor line, allowing the side wall and the roof to peel off and unfold onto the pavement. The rear portion of the body also appears to have come away at the floor level and is resting on the shoulder of the roadway. Figure 4-14 shows a front view of the vehicle. It appears that the Ford cab and chassis functioned quite well and demonstrated adequate crashworthiness. Rescue forces experienced little difficulty in gaining access to the victims.

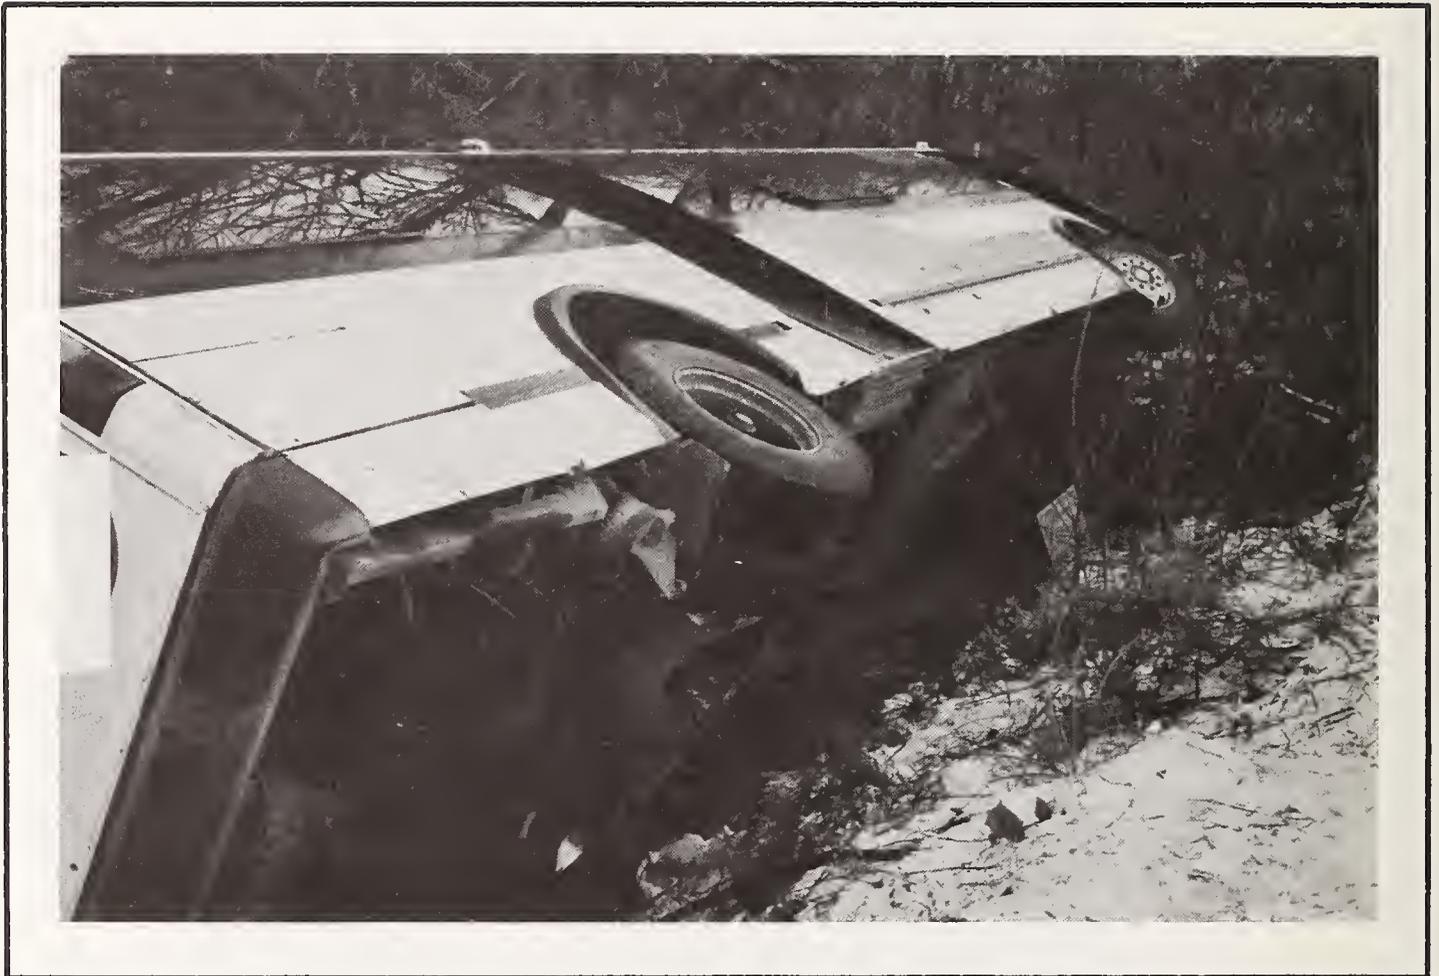
FIGURE 4-15. URBAN TRANSIT BUS ACCIDENT IN MIDWESTERN CITY

Figure 4-15 shows the bus at rest. Note that the front door was still operable and was used in the rescue. Also note, in Figure 4-16, that the last side window on the right side and one of the middle windows are ajar and were presumably used by the passengers or rescuers. It is not known if the escape hatches in the roof were used. Of the 29 passengers on board, 17 were shown in the police report to have had "probable-not apparent" injuries. The passengers ranged in age from 20 to 62.

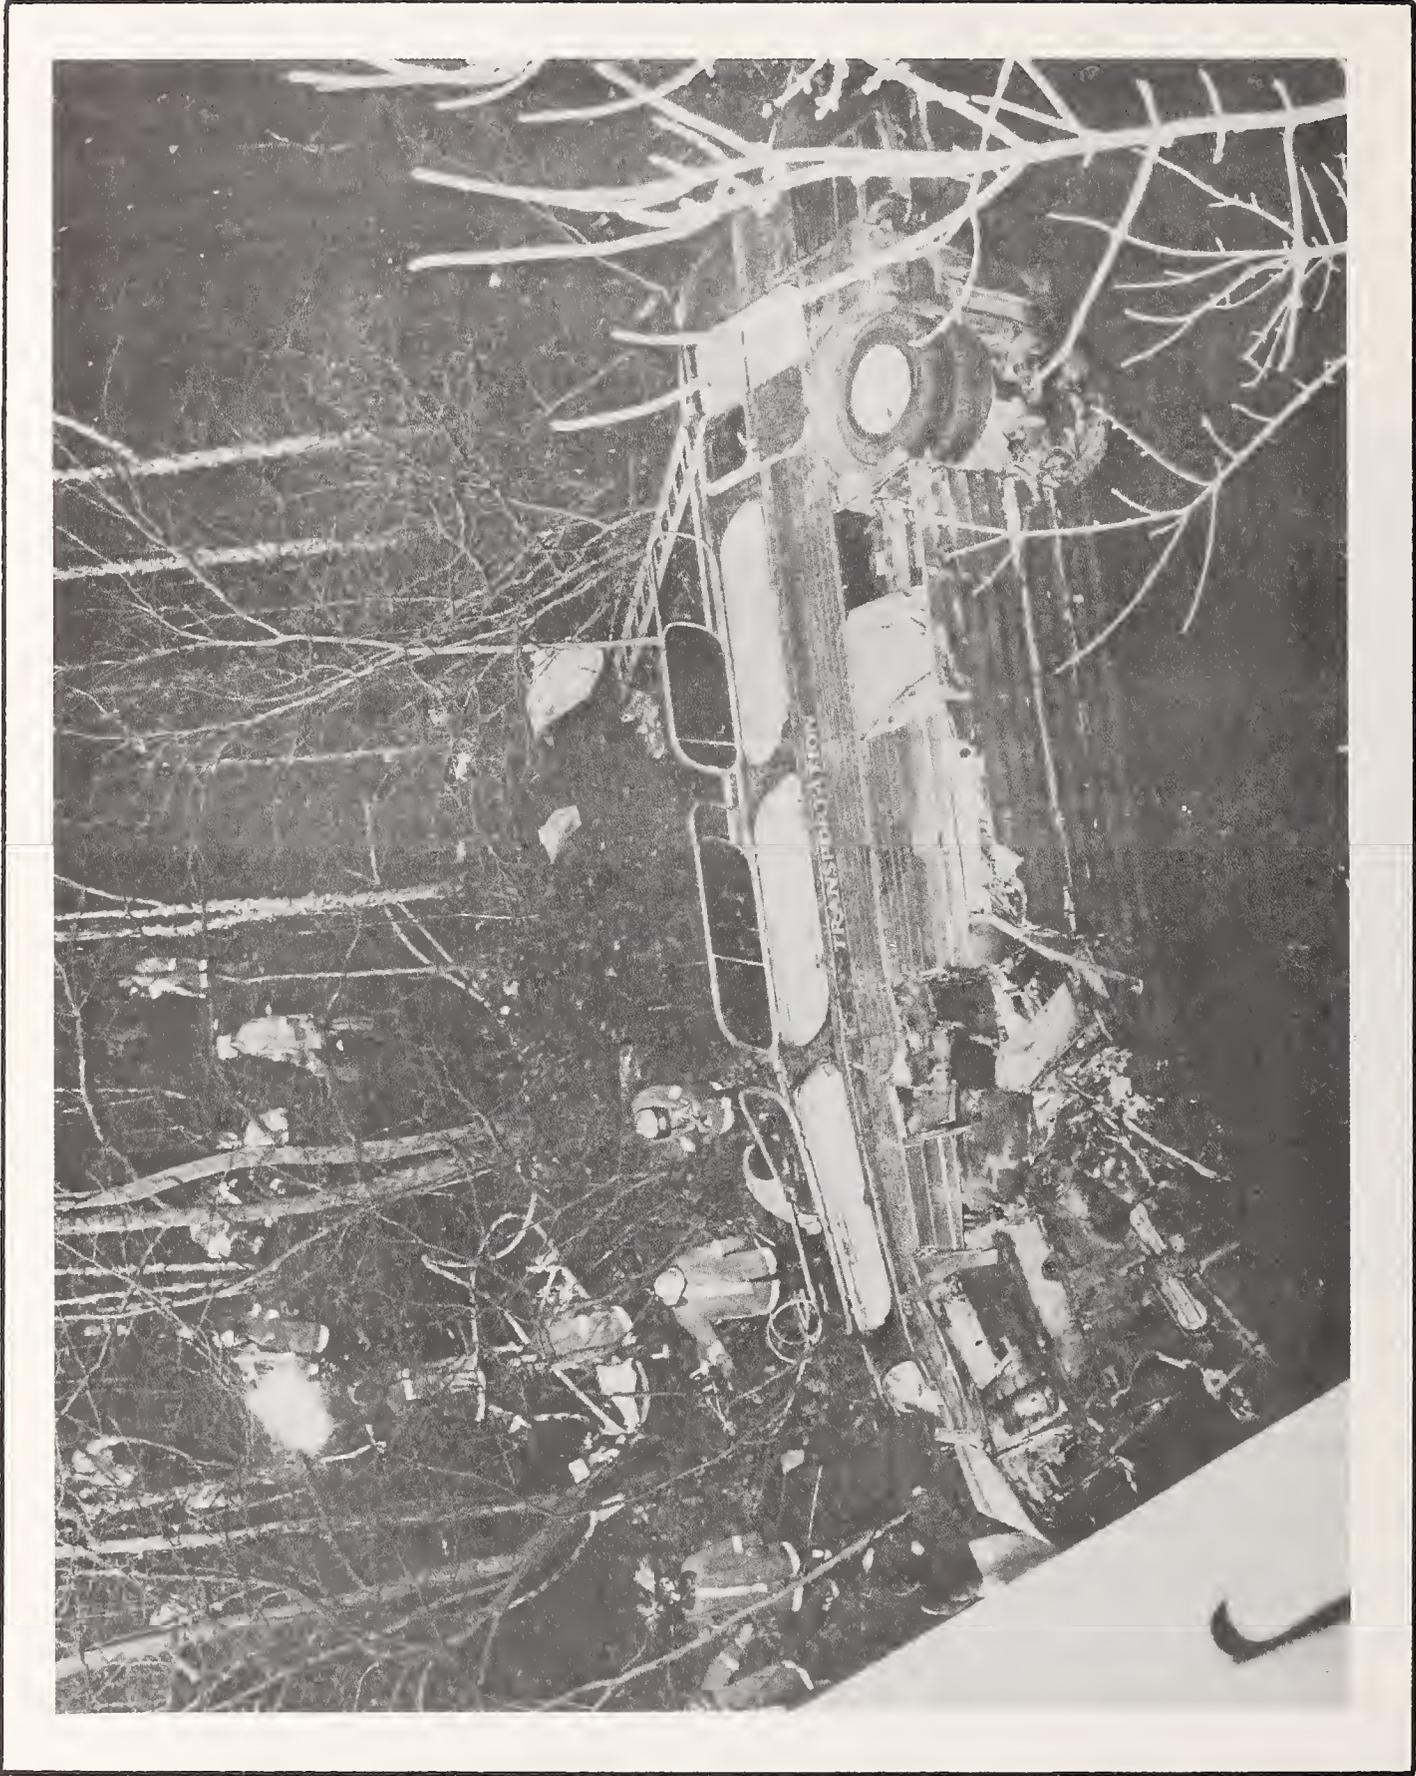
FIGURE 4-17. TRIANGLE, VIRGINIA, TRANSIT BUS ACCIDENT: FINAL RESTING POSITION

Figure 4-17 shows the bus in its final position. Note that access to the interior was gained through the side windows and the left rear emergency door of this rather old bus. Figure 4-18 shows the frontal area of the bus after it had been uprighted. Note the severe crush and damage to the vehicle. The windshield and rear window were missing. There was severe buckling of the roof for the entire length of the bus, but it was less severe toward the rear. The right side panels of the bus buckled and the underfloor cargo loading doors were torn from both sides. Numerous bus seat legs came away from the floor, because their anchor bolts were pulled from the floor pan.

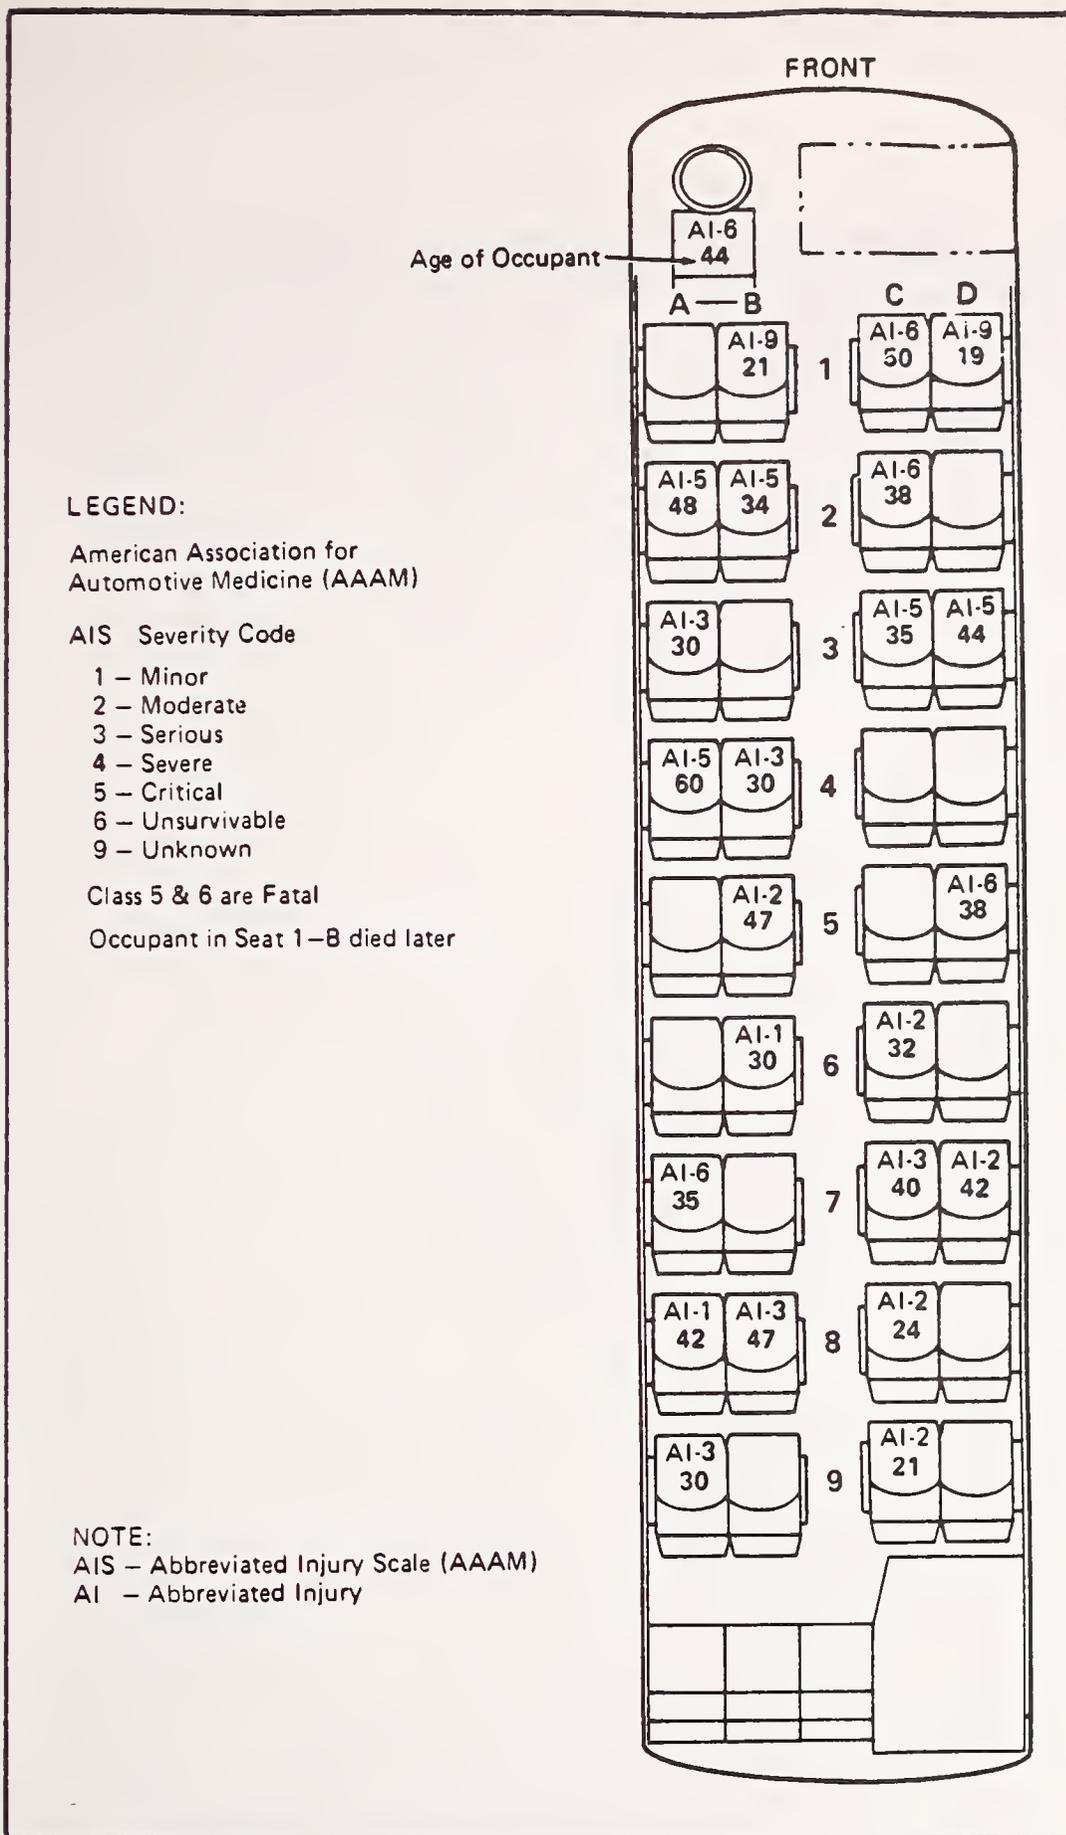
FIGURE 4-19. TRIANGLE, VIRGINIA, TRANSIT BUS ACCIDENT: OCCUPANT SEATING DIAGRAM, INJURY CLASSIFICATION, AND AGE

The ages of the bus occupants ranged from 19 to 60 years. Figure 4-19 shows their age, seat position, and degree of injury.
