Report No. FHWA/RD-80/059

EVALUATION OF HIGHWAY CULVERT COATING PERFORMANCE

June 1980
Final Report

Prepared for
FEDERAL HIGHWAY ADMINISTRATION
Offices of Research & Development
Structures & Applied Mechanics Division
Washington, D.C. 20590

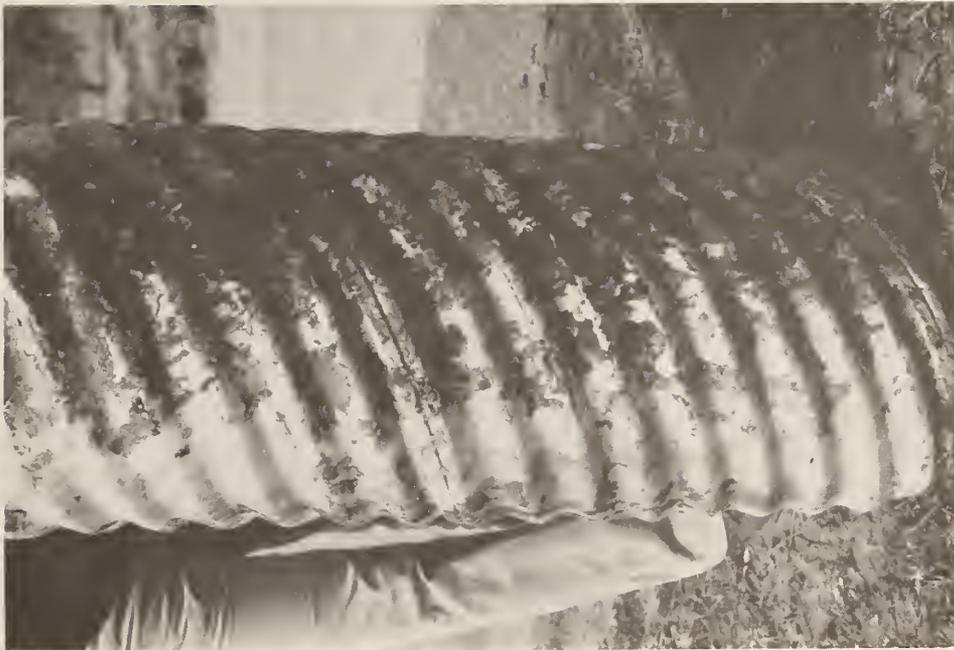
FIGURE 18 - Asphalt Coated Aluminum.
Site No. 25

Inspections included only four asphalt coated aluminum culverts (two at test sites). Figure 18 shows a three year old aluminum coated culvert which was installed with a settling basin at the inlet. Some chipping of the coating is seen on the invert. Coatings on both aluminum culverts examined in field use were in good condition with little coating deterioration and no corrosion of the aluminum. Abrasion and rapid stream flows did not appear to be factors in the two culverts examined. Asphalt exhibits a poor bond to aluminum, being easily removed by prying. Figure 19 shows a test culvert from Louisiana exposed to a moderately corrosive environment in which almost no coating remains. While the condition in Figure 19 could be the result of periodic removals during inspections, it does illustrate the poor adhesion between aluminum and asphalt when conventional application techniques are used.

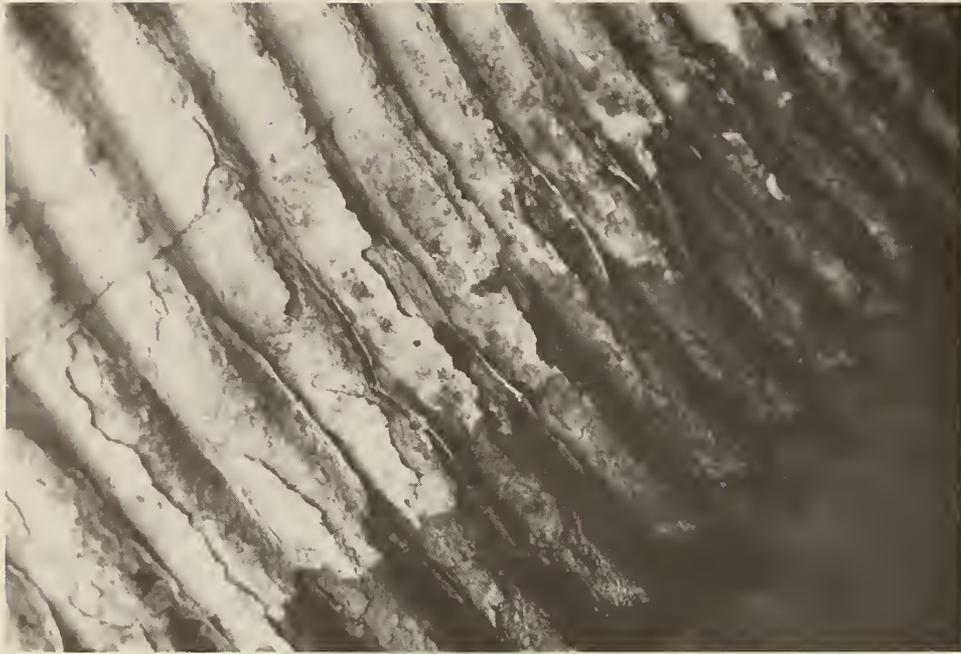
FIGURE 20 - Asbestos Bonded Asphalt.
Site No. 28

Figure 20 shows an unpaved culvert where the coating was removed from the upstream side of the corrugations. Stream velocity was important in coating deterioration as the coating was intact where the stream velocity decreased near the outlet. Figure 21 shows the interior of a culvert exposed to waters with a high salt concentration. The asphalt has delaminated from the saturated asbestos layer at and below the water level. Layer type corrosion is occurring on the steel. In many areas, although the asphalt has been removed, the steel is not corroded, being protected by the asphalt impregnated asbestos and zinc. This observation was made at several other locations. Figure 23 illustrates the asphalt delamination in alkali soil conditions at the Utah test site but no corrosion of the steel. Figure 22 shows an asbestos bonded asphalt coated test culvert exposed to brackish water from Louisiana's Hackberry test site. No significant coating deterioration was observed although asphalt delamination was observed at the Starks test site (number 76). Some of the delamination at the test sites might be the result of periodic removal operations but could also be the result of freeze thaw cycling. Adhesion of the asphalt to the substrate varied, but the mode of failure always consisted of tearing of the asbestos layer.

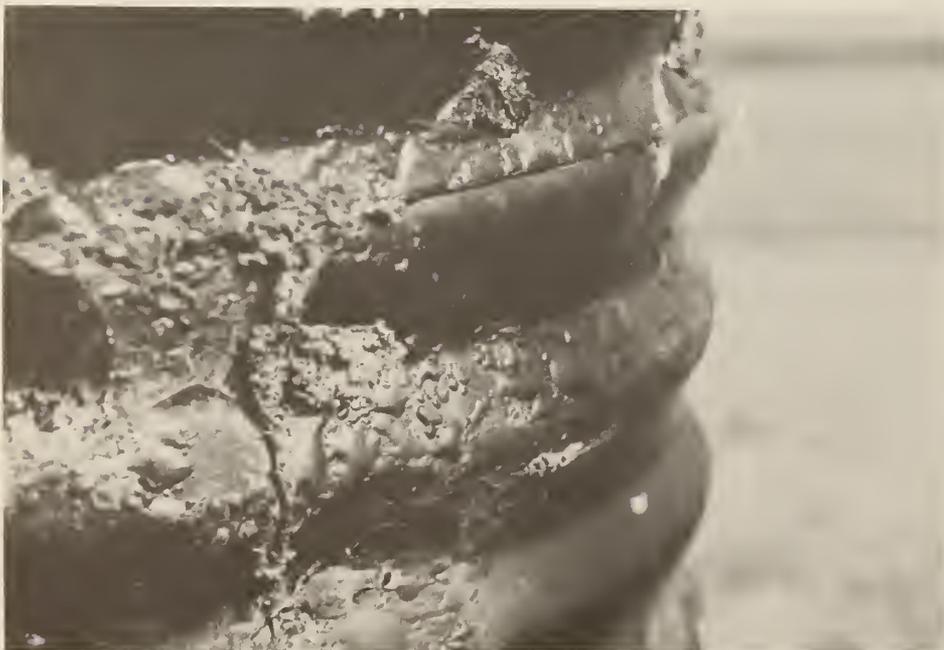
FIGURE 29 - Coal Tar Laminate. Site No. 66

Figure 29 shows a coal tar laminate coated test culvert exposed to brackish waters at the Louisiana Hackberry test site for six years. General blistering is occurring over the entire surface although it is more severe at uncoated cut edges and coating defects. Similar blistering and disbondment at edges and the lock seam were observed in alkali soils at two Colorado test sites (No. 45, 48) but were not observed in the alkali soil of the Utah test site (No. 39). The major difference between the Louisiana, Colorado and Utah test sites is the greater chloride content at the Colorado and Louisiana test sites (see Tables III-IV).

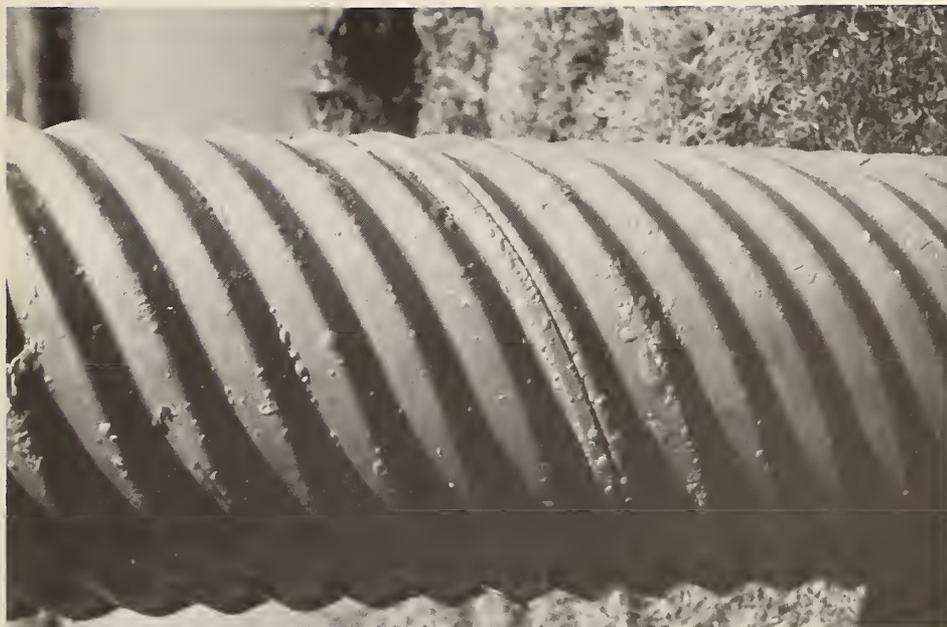
FIGURE 30 - Polyethylene. Site No. 70

Polyethylene (Inland Black Klad) coated culverts were examined at test sites in Colorado, Kentucky and Louisiana. Figure 30 illustrates a sample removed from the brackish Louisiana Hackberry test site (No. 69, 70) and shows extensive general blistering and disbondment. Minor blistering was observed at coating discontinuities at the mildly corrosive test site at Starks (No. 80, 81). No deterioration was noted at the Dillon, Colorado test site (No. 55). Performance in the acidic waters of Kentucky's Mortons Gap test site (No. 94) is satisfactory except for some disbondment at uncoated edges.

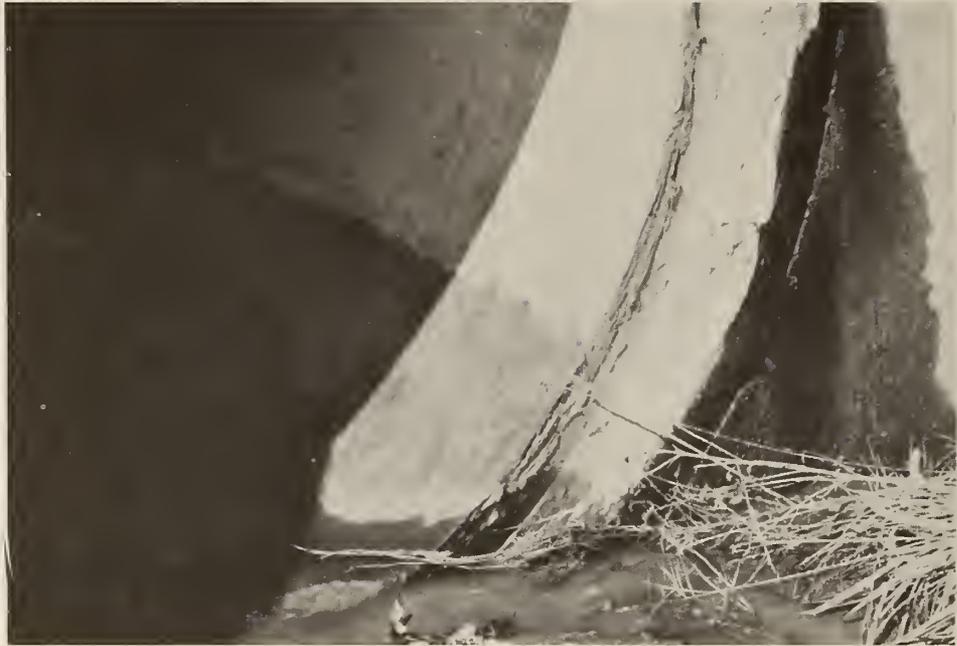
FIGURE 32 - Coal Tar Epoxy on Concrete.
Site No. 1

Epoxy coatings applied to concrete culverts seem to be successful in protecting the concrete substrate. Figure 32 illustrates a culvert with a coal tar epoxy invert coating. A few areas were disbonded on this invert but the coating was otherwise in good condition. Figure 33 shows a polyamide epoxy invert coating which did not exhibit deterioration. This particular coating contains a sand filler which might improve its erosion resistance. The stream can erode the concrete and undercut the coating as in number 87 in Table IV if the paving does not cover a sufficient portion of the pipe circumference to shield the concrete during normal stream flow conditions. The coated concrete culverts examined were not exposed to abrasive flow or rapidly moving water so that performance under these conditions can not be documented here. An epoxy coated culvert exposed to rapid water movement and abrasion (number 31, Table IV) was given only a cursory examination because of rapid water flow and volume. The epoxy appeared to be intact after 3 years.

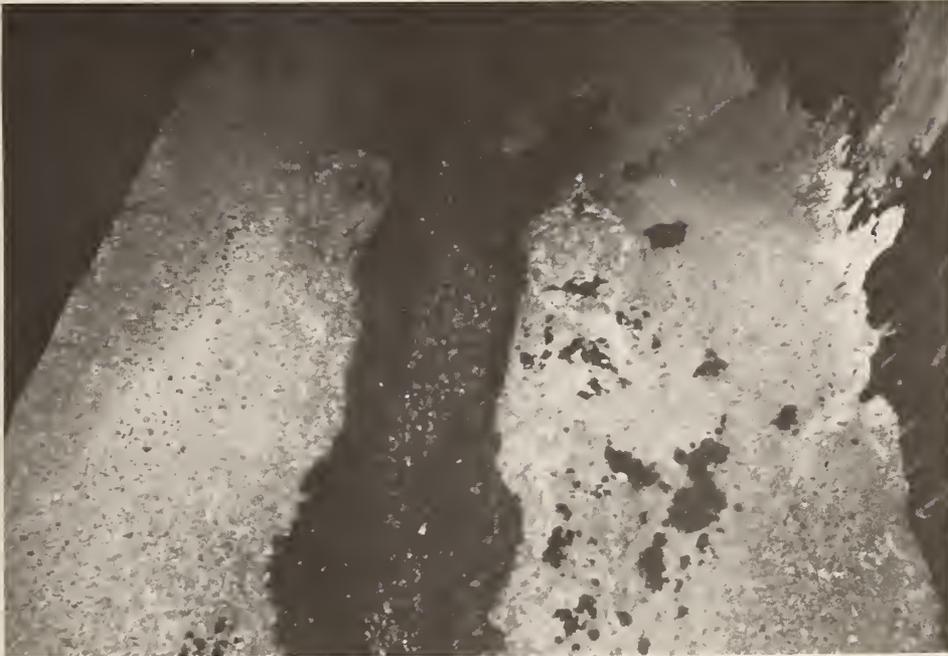
FIGURE 34 - Gunite on Galvanized Steel.
Site No. 92

Gunite paving was found to be unsatisfactory in acidic flows. The gunite paving that we examined appeared to have broken loose from the corrugated steel. There was no reinforcing used and this might have helped retain the paving. Figure 34 illustrates the type of deterioration observed on gunite paving.

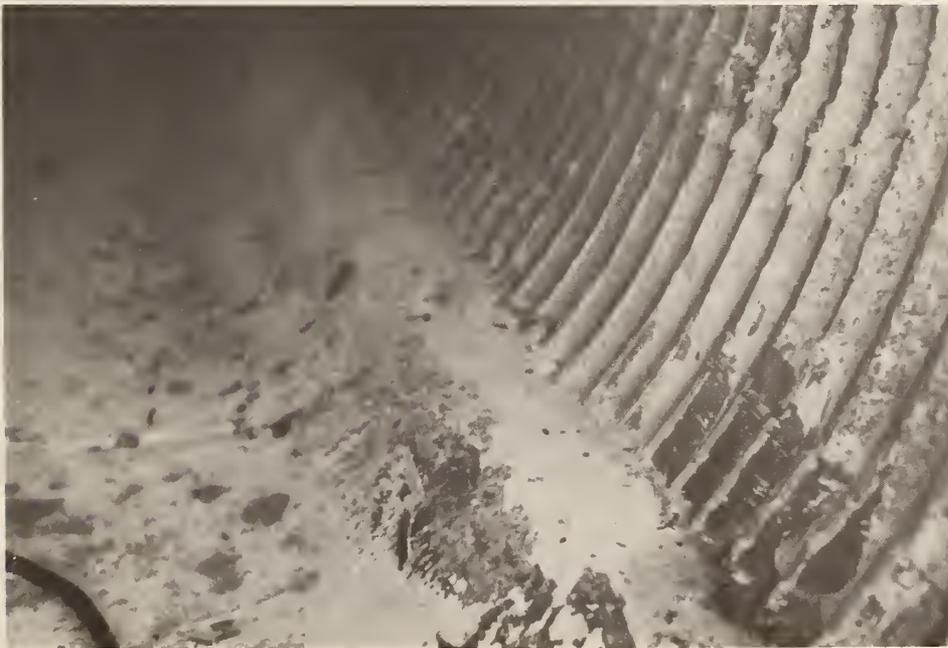
FIGURE 35 - Concrete on Asbestos Bonded Asphalt. Site No. 27

Figure 35 shows a portion of concrete paving applied over asphalt paving which was applied over asbestos bonded asphalt dipped pipe. Although the water pH was neutral at the time of inspection, the concrete was eroded as much as 12.7 cm (5-inches) in the normal flow line. In addition, the water was flowing under the concrete in places.

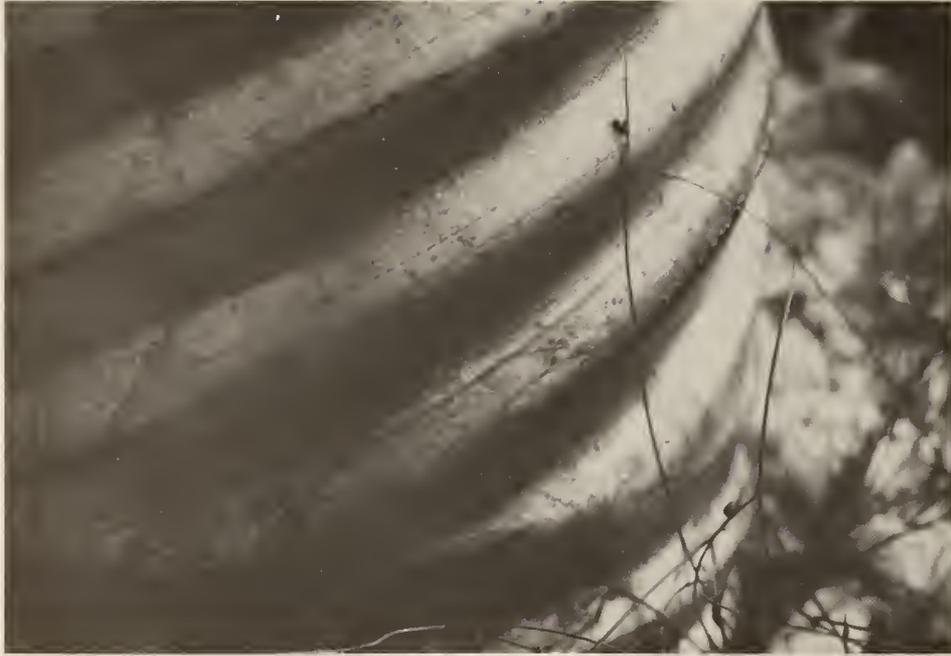
FIGURE 36 - Concrete on Asbestos Bonded Asphalt. Site No. 34

Figure 36 shows a concrete paved culvert applied over asbestos bonded asphalt. The concrete is probably reinforced according to Utah specifications. No deterioration was observed, however, the culvert is exposed to only intermittent flow.
