THE NATIONAL PARTS RETURN PROGRAM

Volume III: PRP News and Program Inputs

1. Report No. DOT HS 805 146		2. Government Accession No.		3. Recipient's Catalog No.	
4. Title and Subtitle NATIONAL PARTS RETURN PROGRAM FINAL REPORT VOLUME 3 PRP NEWS AND PROGRAM INPUTS				5. Report Date 1 July 1979

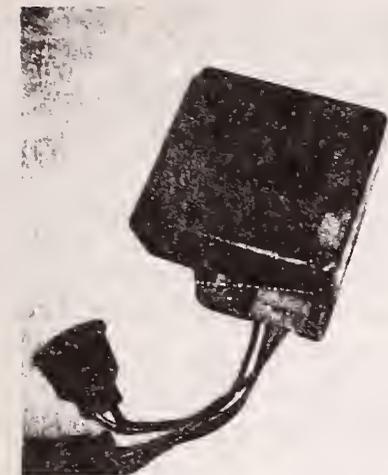
John Shanahan of WASHINGTON GARAGE, Bergenfield, NJ, reports numerous incidents of Ford vehicles with electronic ignitions experiencing intermittent stalling. The problem was reportedly due to failure of the ignition amplifier, shown above. NHTSA is currently looking into this problem and any information you might have will be put to immediate use.

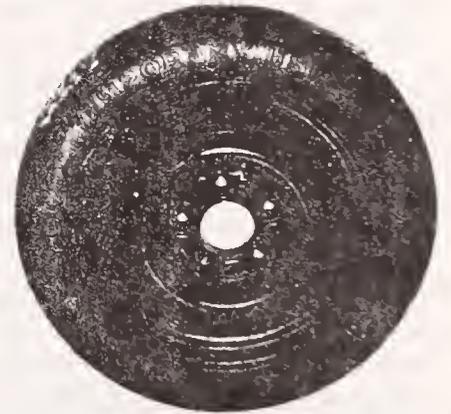
The NHTSA has received reports that some motorists are replacing the T-type spare tire with a conventional, full sized tire, while still using the special, narrow, T-type rim designed only for use with the smaller spare tire. This can be an extremely dangerous practice, since such a mismatch between tire and rim can result in separation of the tire from the rim and possible loss of vehicle control. The T-type tire and its specially designed rim are narrower than other tires and rims supplied on the vehicle.

The T-type tire should be used only until the conventional tire can be repaired or replaced, should not be driven at high speeds, nor should it be rotated with the other tires on the vehicle. If the T-type tire must be replaced, it should be replaced only with a tire designed to be used with the special rim. Full-sized tires must not be mounted on the special rim and vice versa. Please remind your customers of the correct procedure for using these tires.
