## **Final Report**

Concrete Pipe – Electrochemical Cell, Phase II  
BDV27-977-03

Submitted to  
Florida Department of Transportation Research Center  
605 Suwannee Street  
Tallahassee, Florida 32399

August 2016

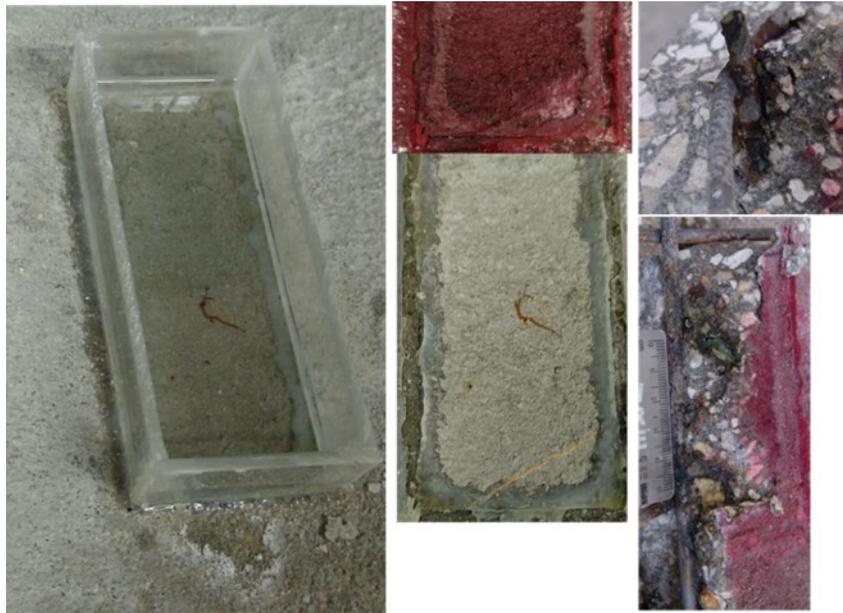
Figure 77 show pictures taken for Specimen F0 before removing the reservoir and for selected locations as the reinforcement was being removed. The pictures in the center show that a thin crack was present (before (top) and after applying a dye-penetrant (bottom picture)). The two pictures on the right show a portion of the reinforcement as the concrete was being removed; the corrosion spots appear to be localized in specimen F0. Figure 78 shows how much the corrosion penetrated into the concrete on specimens F0. The corrosion products penetrated close to 20 mm at various locations as can be observed from the picture. The corrosion sites

Figure 77 – Forensic examination of specimen F0.

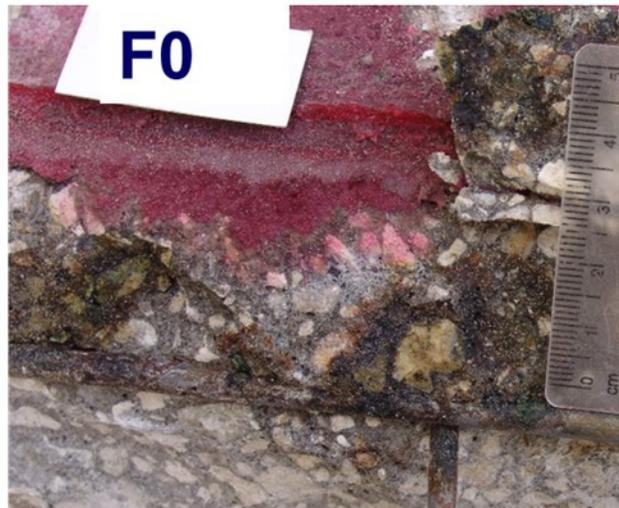
were 5 to 10 mm long and there were several of these spots (see picture shown below after cleaning).

Figure 78 – Corrosion penetration into the concrete for specimen F0.

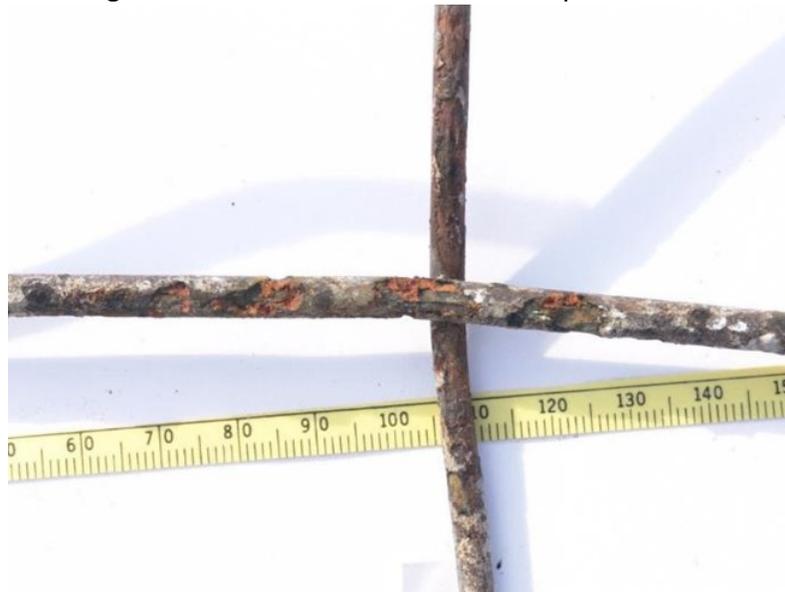
The initial high chloride concentration in the reservoir during chloride migration might explain the significant extent of corrosion observed on the steel wire mesh exposed from F1 specimen, combined with the exposure history of this specimen (See Table 3). Figure 79 shows picture of the several steps followed to obtain the steel wire mesh. The images with exposed steel show significant amount of corrosion under the solution reservoir. The color of the corrosion products were dark green and penetrated the concrete several mm. Figure 80 was taken a few days later and by then the corrosion products have turned to dark brown rust in some areas.

Figure 80 – Section of steel wire with greater cross-section loss of specimen F1.

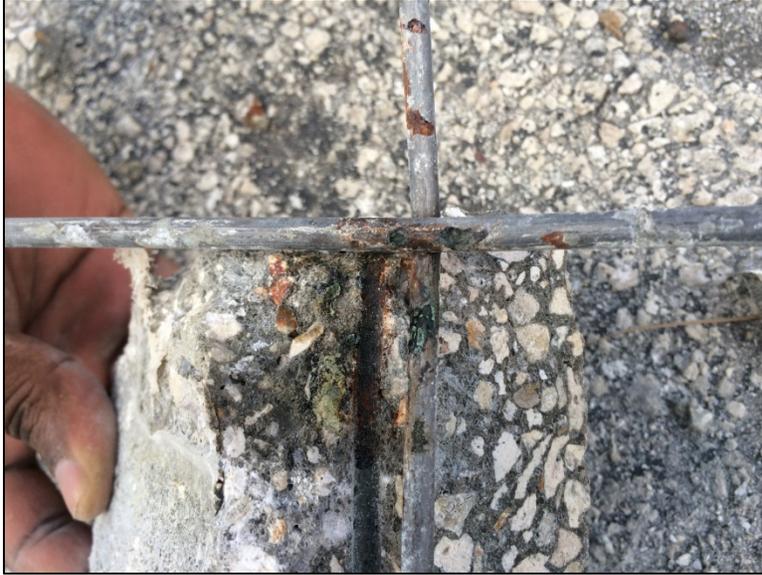
Upon removing some of the concrete on specimen F3, the steel reinforcement's corrosion under the ponding at the reinforcement junction was a mix of red and green/black rust. Corrosion occurred in this region as can be seen in Figure 82. Figure 83 shows black/green rust observed outside of the ponding along of the transverse steel wires. The steel reinforcement of specimen F3 can be seen in Figure 84 displaying the locations where corrosion occurred. As seen in Figure 85, specimen F3 experienced mild corrosion at location 1 under the ponding at the reinforcement junction. Severe cross-section loss can be seen at location 2 along the side of the transverse steel wire (spiral). Corrosion did occur outside the ponding.

Figure 82 – Red and black/green rust observed upon opening specimen F3.

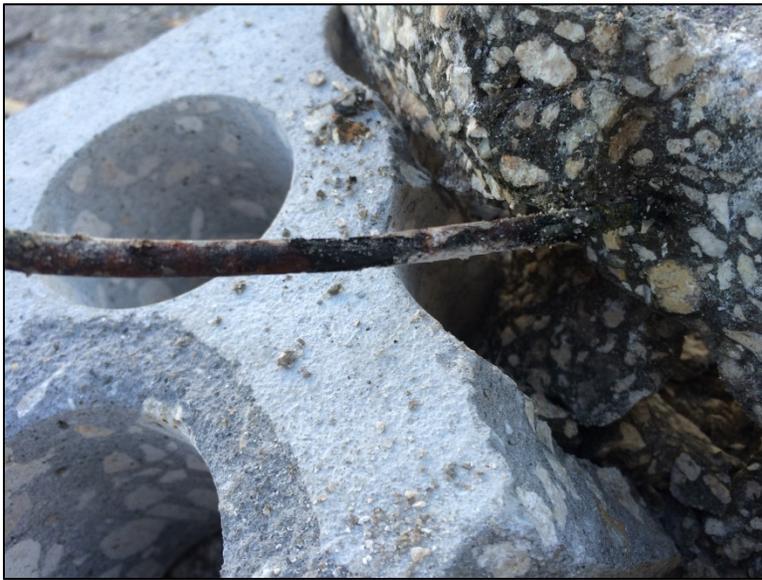
Figure 83 – Black/green rust observed outside the ponding along the transverse reinforcement for specimen F3.

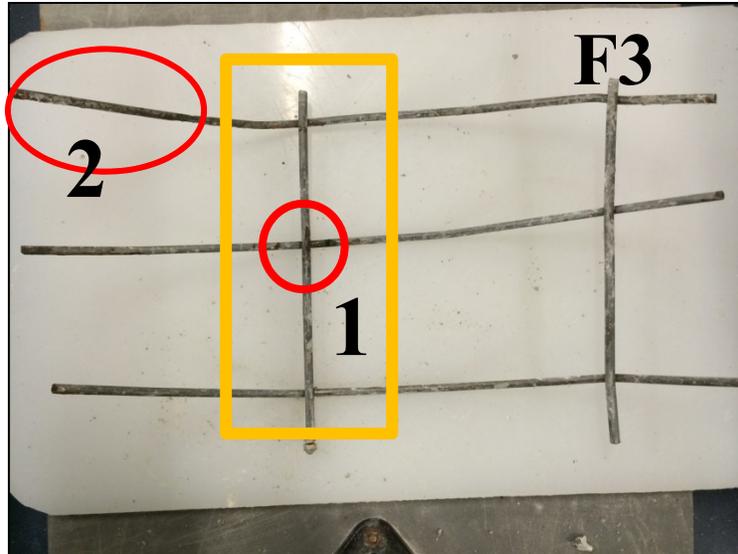
Figure 84 – Autopsy result of specimen F3 – full steel wire mesh.

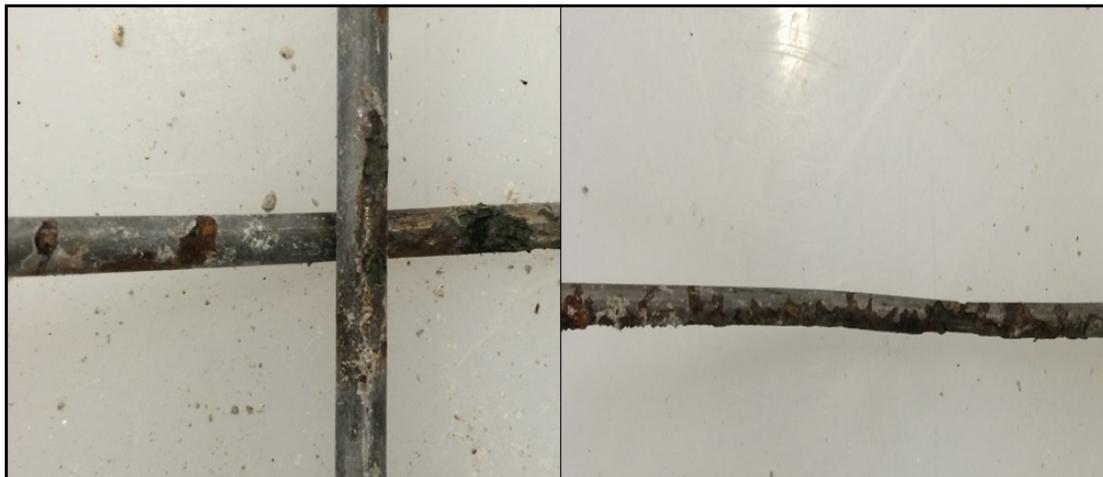
Figure 85 – Autopsy result of specimen F3. Left: location 1. Right: location 2.

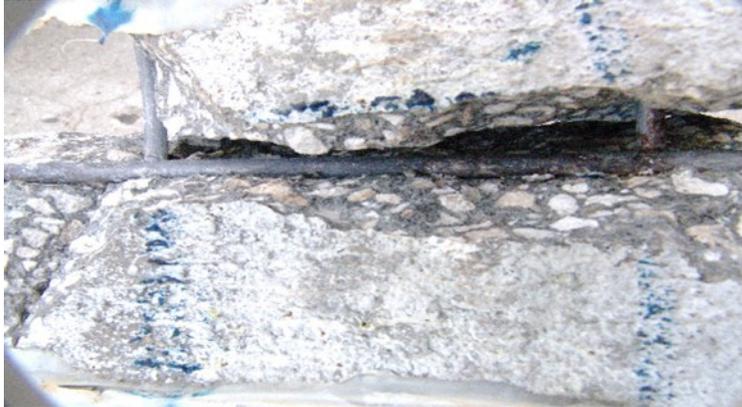
Specimen F11 was oriented vertically and covered with wet sand. Modest corrosion was observed on the area under the solution reservoir as can be observed on Figure 86.

Figure 86 – Specimen F11 while concrete was being removed.

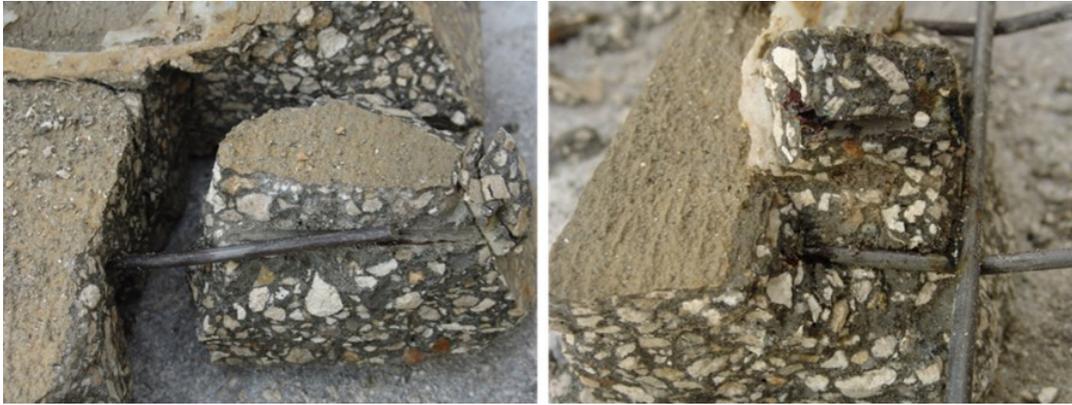
As the concrete was being removed on specimen F21, it was observed (Figure 88) that corrosion took place both outside (left picture) and under (right picture) the ponded section. Two additional pictures are included in Figure 89 that show the whole steel wire mesh after removing the concrete and the section under the ponding that showed the most corrosion. The corrosion products were dark green and became red rust as time passed.

Figure 88 – Concrete removal on specimen F21.

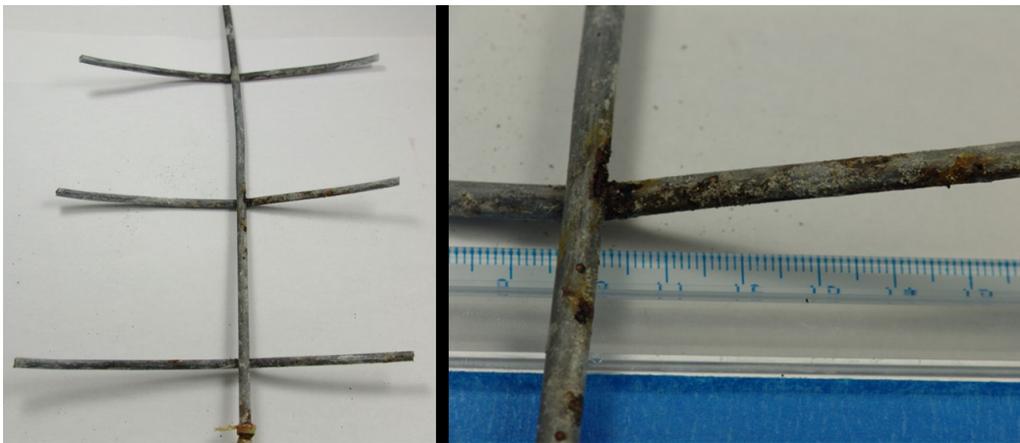
Figure 89 – Steel wire removed from specimen F21.

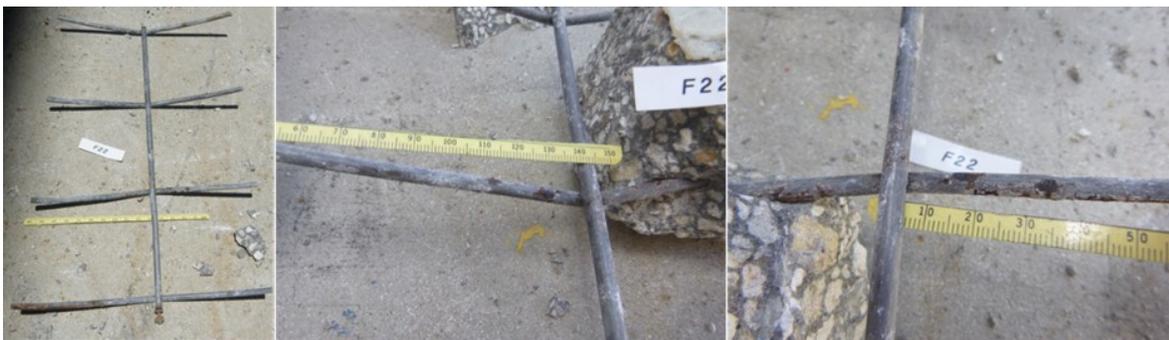
Specimen F22 was exposed horizontally while immersed in water. Figure 90 shows pictures of the steel wire mesh. The picture on the left shows the whole mesh, whereas the picture in the middle shows a close-up of the site with the most corrosion. The steel wire section showing corrosion was below the solution reservoir. On this case, corrosion took place also on the back-side of the steel wire (picture on the right in Figure 90).

Figure 90 – Steel wire removed from specimen F22.

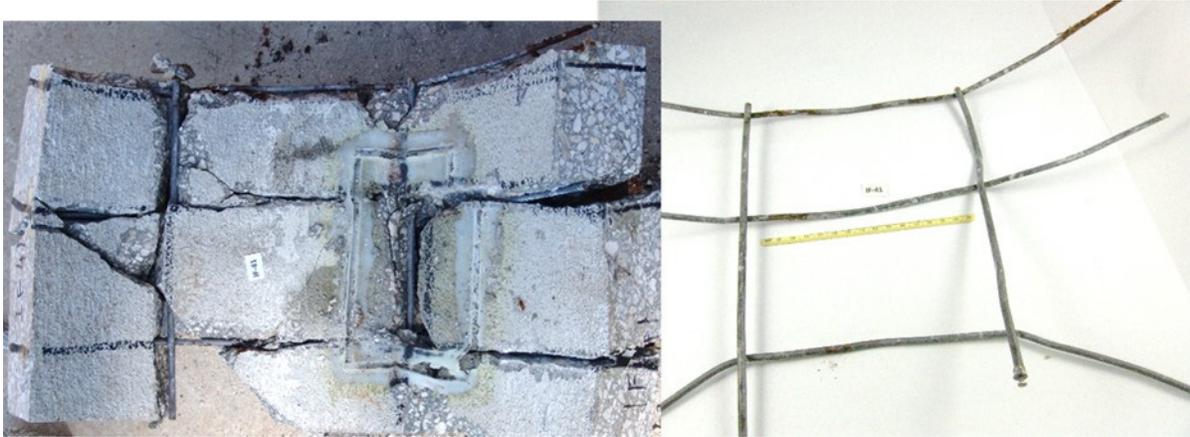
Specimen F41 was obtained from one of the ring specimens. Modest amount of corrosion was found at various locations outside of the solution reservoir. Figure 91 shows a picture on the left while the concrete was being removed and on the right after removing the concrete. Several of the rust spots were outside of the area below the solution reservoir, as can be observed on the transverse steel wires to the right of the longitudinal on the left.

Figure 91 – Specimens F41 prior to and after concrete removal.

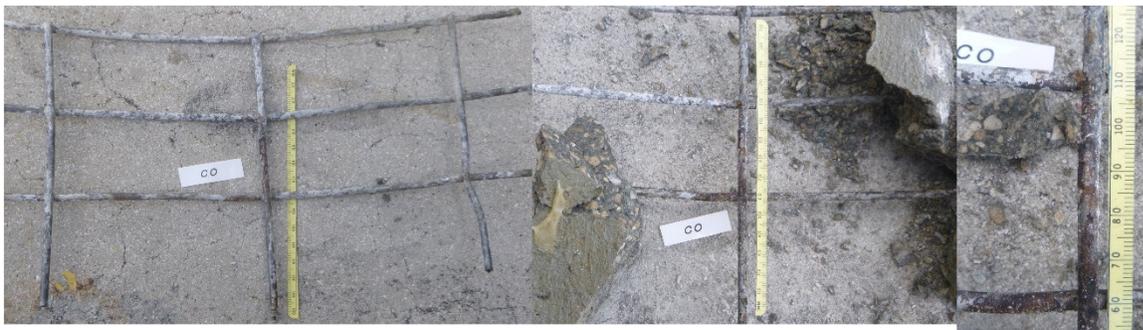
Specimen C0 was exposed horizontally and immersed in water. Figure 92 shows pictures after the concrete had been removed. The picture on the left shows the steel mesh, with rust spot on the center longitudinal (below the reservoir). The pictures on the center and right are close-ups of the section that showed the most corrosion. A white layer (might be calcareous deposits) was found on most of the steel wire surface that was not corroding.

Figure 92 – Steel wire after removing concrete for specimen C0.

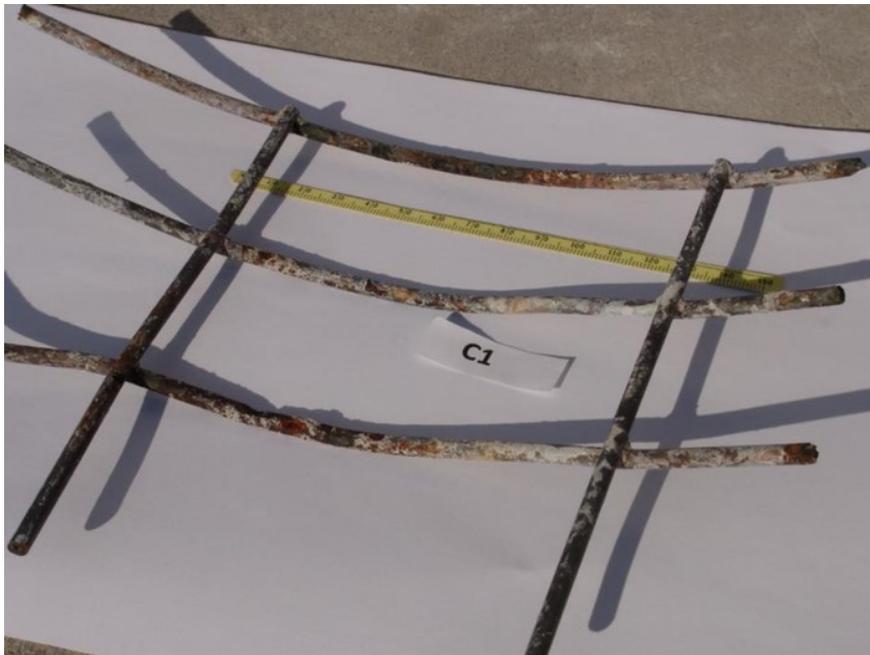
wire obtained after removing the concrete on specimen C1. It is evident that significant corrosion took place at two of the transverse (circumferential) steel wires.

Figure 94 – Steel wire mesh removed from specimen C1.

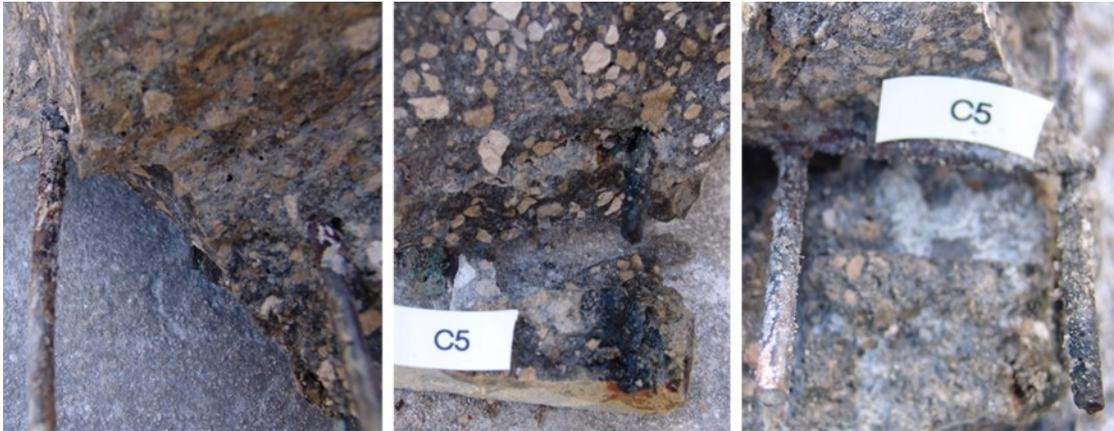
The corrosion extent observed at selected locations of the steel wire embedded on specimen C5 is shown in Figure 95. The center top picture shows corrosion products on the exposed steel and the concrete, a deep dark green (almost black) spot was found for this specimen. This specimen was exposed immersed in water. Figure 96 shows the surface condition upon removing all concrete, a spot with significant corrosion was outside the solution reservoir. Under the solution reservoir, the steel showed some red rust spots and appear to be superficial corrosion. The white products were more dispersed on this reinforcement.

Figure 95 – Steel wire while concrete is removed on specimen C5.

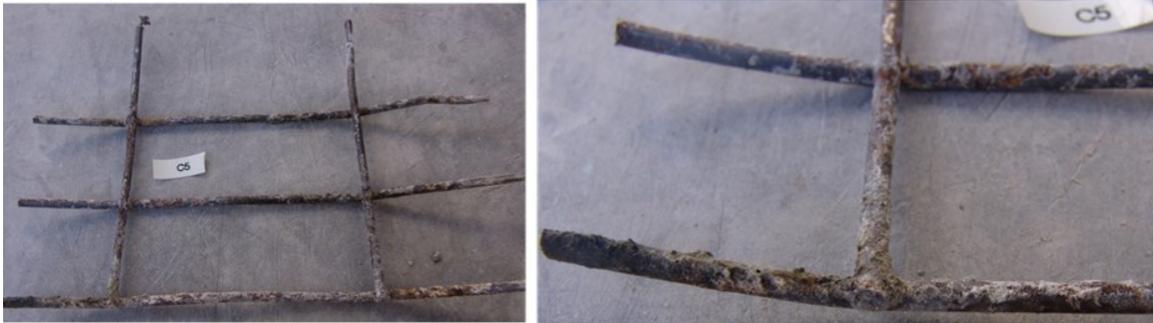
Figure 96 – Steel wire after removing concrete for specimen C5.

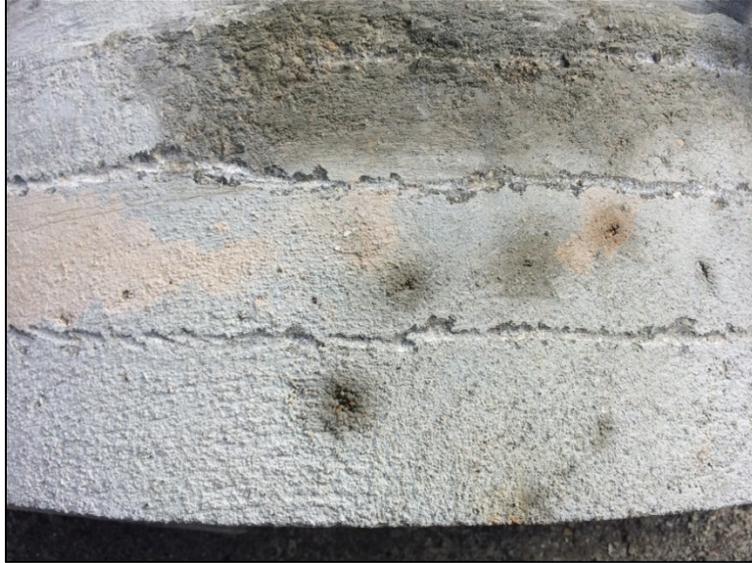
Before opening specimen C7, two dark black/green rust stains were observed on the bottom of the specimen. This can be seen in Figure 97. Upon opening the specimen, the steel reinforcement's corrosion spots observed were above where the black/green rust stains were located. The corroding area can be seen in Figure 98. Specimen C7's steel reinforcement can be seen in Figure 99 displaying the locations where corrosion occurred. Specimen C7 experienced mild to no corrosion. Under the ponding there was mild corrosion at the junction and along the longitudinal reinforcement shown at location 1 in Figure 100. A small amount of corrosion occurred outside the ponding.

Figure 97 – Dark black/green rust stains on the bottom of specimen C7.

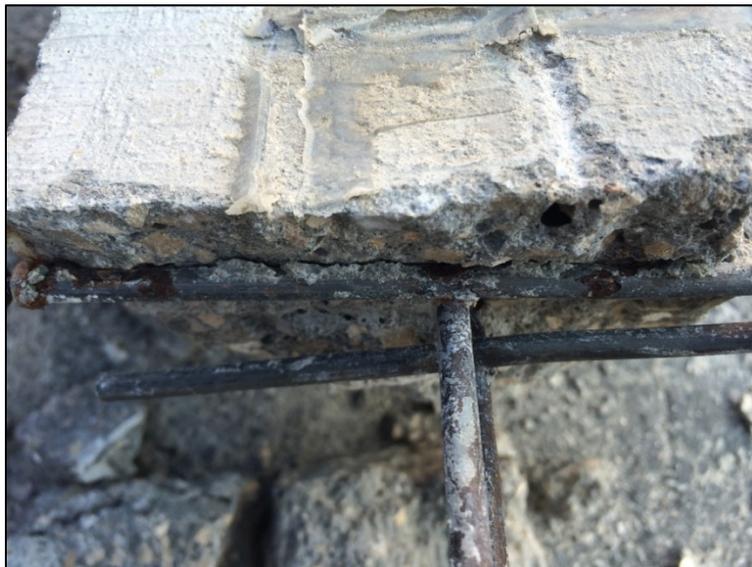
Figure 98 – Corrosion observed under the ponding on specimen C7.

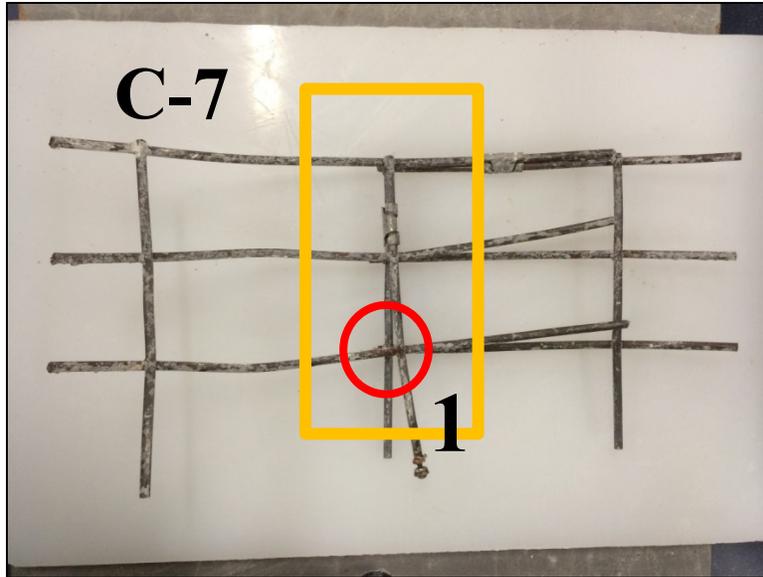
Figure 99 – Autopsy result for specimen C7 – whole steel wire mesh.

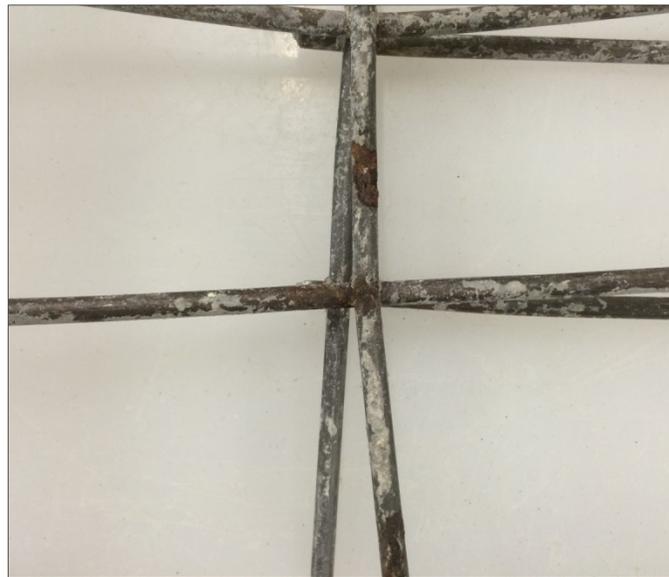
Figure 100 – Autopsy result for specimen C7 (location 1).

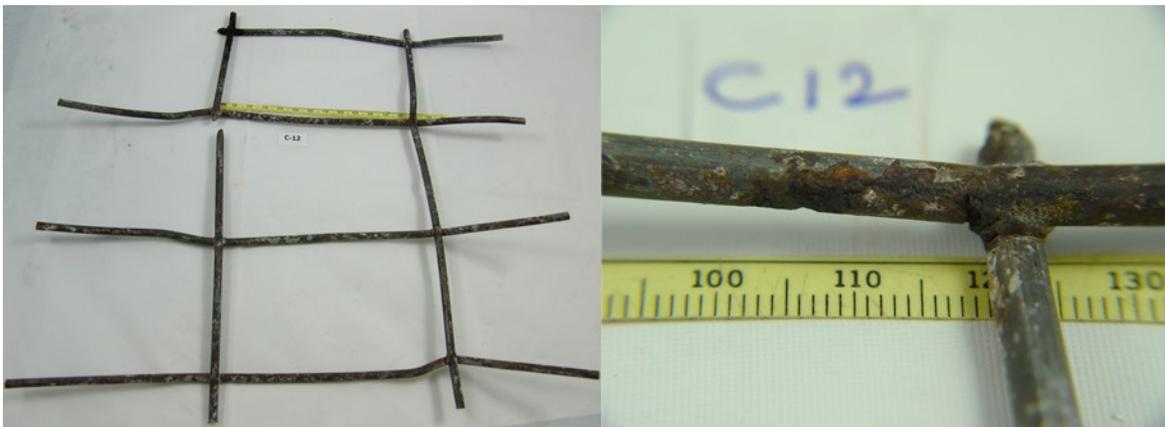
Specimens C12 and C22 were vertically oriented and partially covered with wet sand (1/3rd) and exposed in high humidity. Figure 102 and Figure 103 show the corrosion extent on steel wires removed from Specimens C12 and C22, respectively. Modest corrosion was observed on the steel wire on both specimens. It is interesting to note that corrosion took place on the steel wire some distance above the solution reservoir.

Figure 102 – Steel wire mesh for specimen C12.

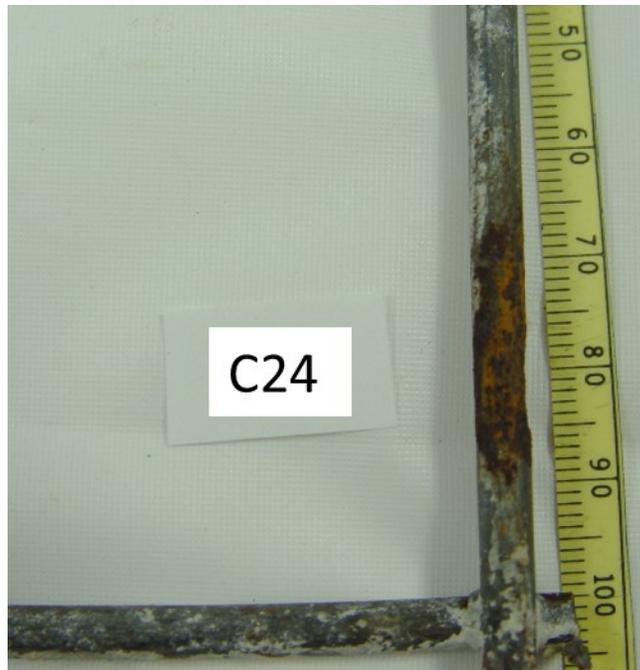
Specimen C24 was oriented vertically and covered with wet sand. A large spot (20 mm long) with modest corrosion was observed above the solution reservoir area (See Figure 104).

Figure 104 – Steel wire area showing significant corrosion from specimen C24.

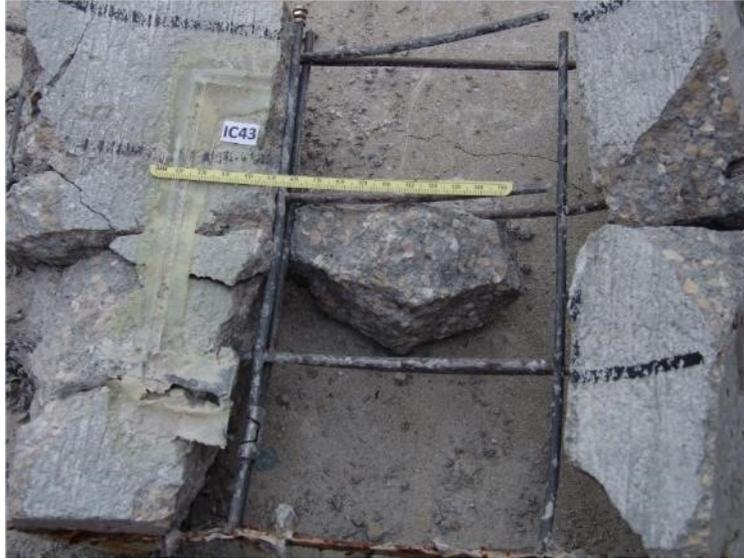
Figure 107 shows a partially exposed steel wire for specimen C43. No corrosion was found under the solution reservoir on the steel wire mesh.

Figure 107 – Partially exposed steel wire on specimen C43.

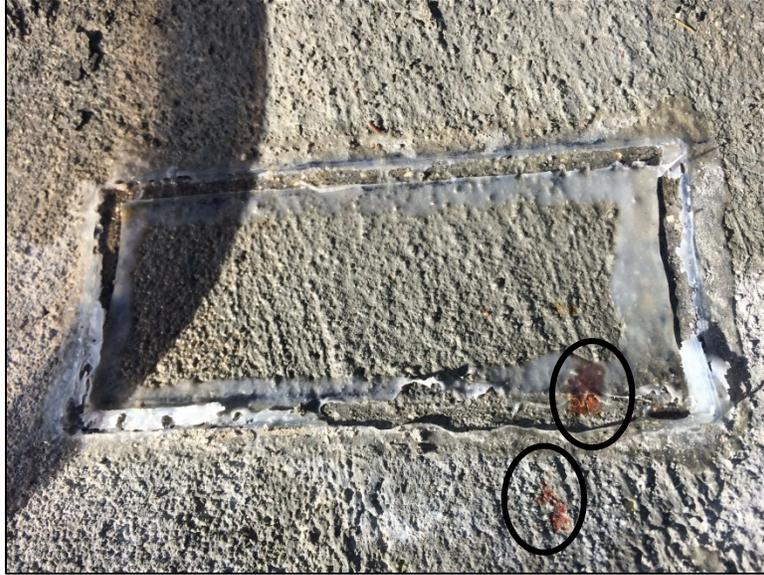
Before cracking the specimen open, two red/orange rust stains were seen located under the ponding and ~0.5 inch from the ponding. The rust stains can be seen in Figure 108. Upon breaking the specimen open, the steel wire's corrosion appeared greenish/black in color. The "green" or "black" color of the corrosion products can be seen in Figure 109 and Figure 110. The steel reinforcement of specimen F7 can be seen in Figure 111 displaying the locations where corrosion occurred the most severe. Specimen F7's applied current was increased to 125  $\mu\text{A}$  before termination. As can be seen in Figure 112, location 1 experienced significant corrosion and occurred under the ponding at the reinforcement junction. Severe cross-section loss can be seen along the transverse reinforcement at location 2 in Figure 108. However, on F7 corrosion did occur outside the ponding as seen at location 3 (Figure 111).

Figure 108 – Rust stains observed near the ponding on specimen F7 before opening.

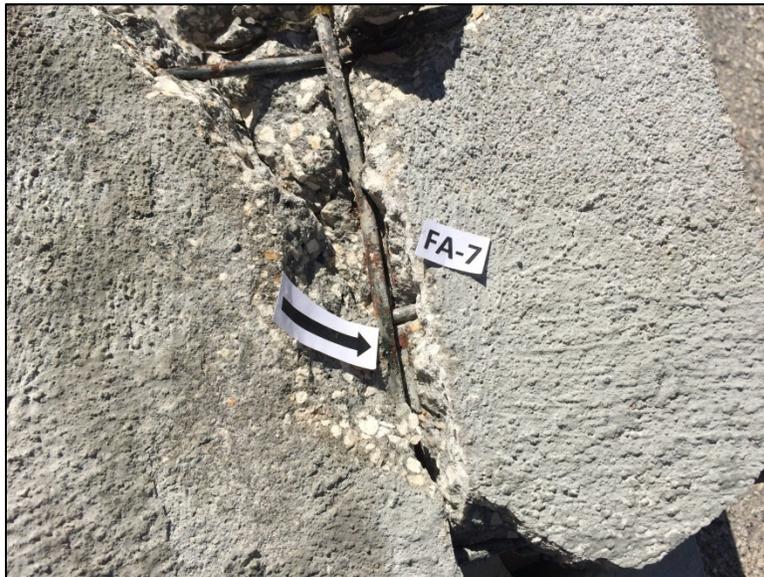
Figure 109 – (1) Black/green rust observed upon exposing steel on specimen F7.

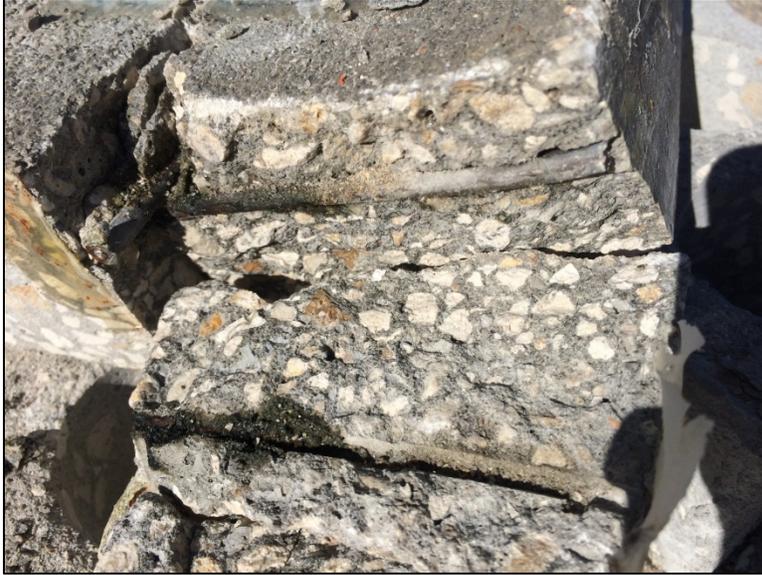
Figure 110 – (2) Black/green rust observed upon cracking open specimen F7.

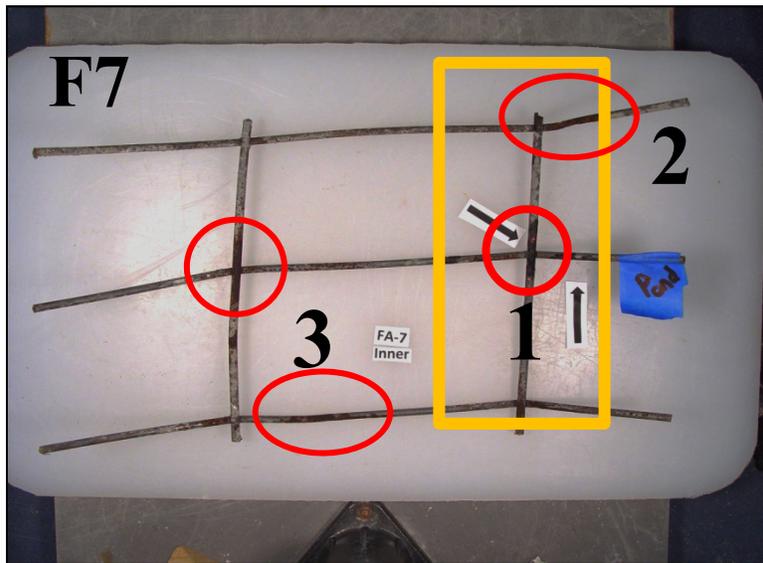
Figure 111 – Autopsy result of specimen F7 – whole steel wire mesh.

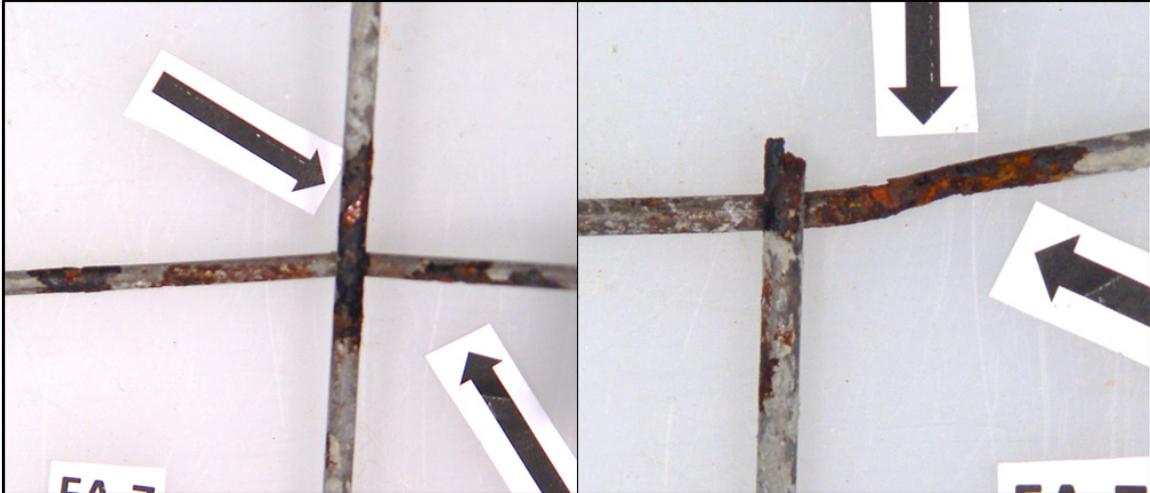
Figure 112 – Autopsy result of specimen F7. Left: location 1. Right: location 2.

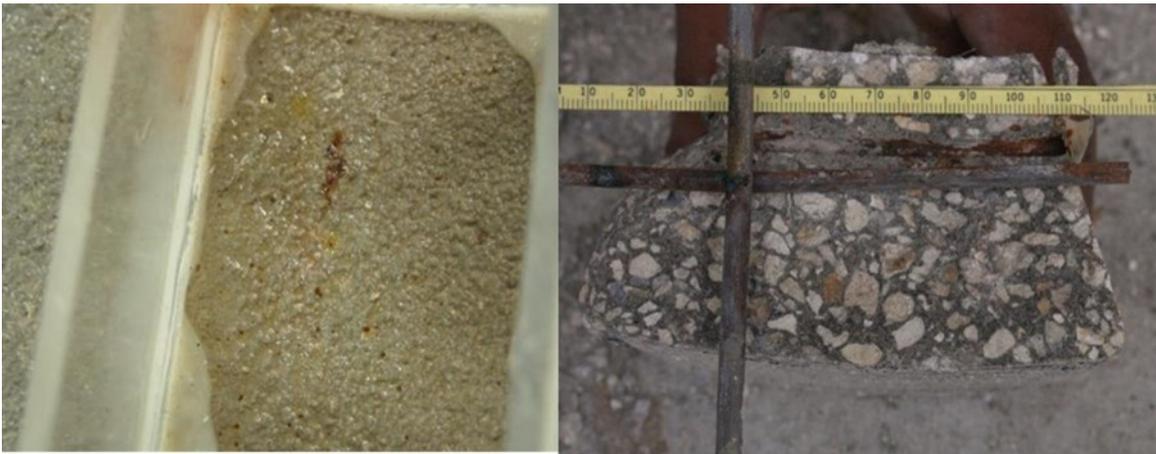
Specimen F18 was subjected first to accelerated chloride transport, at room temperature. Specimen F18 was then exposed to modest galvanic current to accelerate corrosion rate for approx. 365 days, then no additional current was applied and the specimen was exposed in high humidity for additional 300+ days. Figure 113 shows in the left picture that there was a rust-spot on the surface of the concrete inside the reservoir area, the picture on the right shows the extent of corrosion that took place. Some of the corrosion took place outside of the solution reservoir. The corrosion products on the steel under the solution reservoir were dark green/black.

Figure 113 – Surface condition and exposed steel wire from specimen F18.

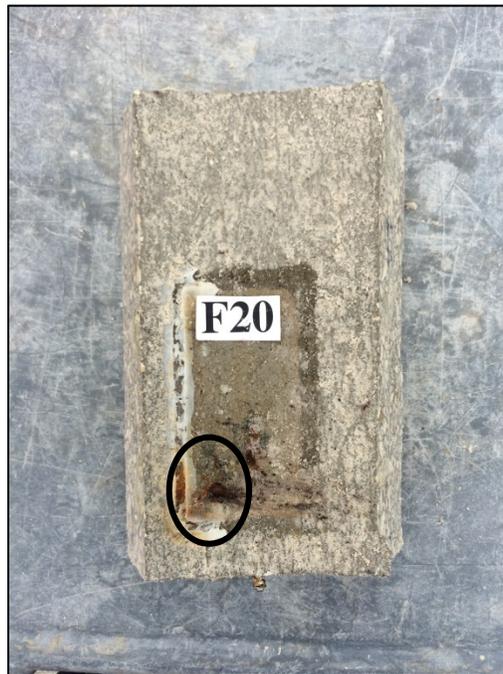
Similar to specimen F7, before cracking the specimen open a red/orange rust stain was seen located under the ponding in the lower left hand corner. The rust stain can be seen in Figure 114. Upon breaking the specimen open, the steel reinforcement's corrosion appeared greenish/black in color. The "green" or "black" rust can be seen in Figure 115 at the rust stain

Figure 114 – Rust stain observed under the ponding on specimen F20 before opening.

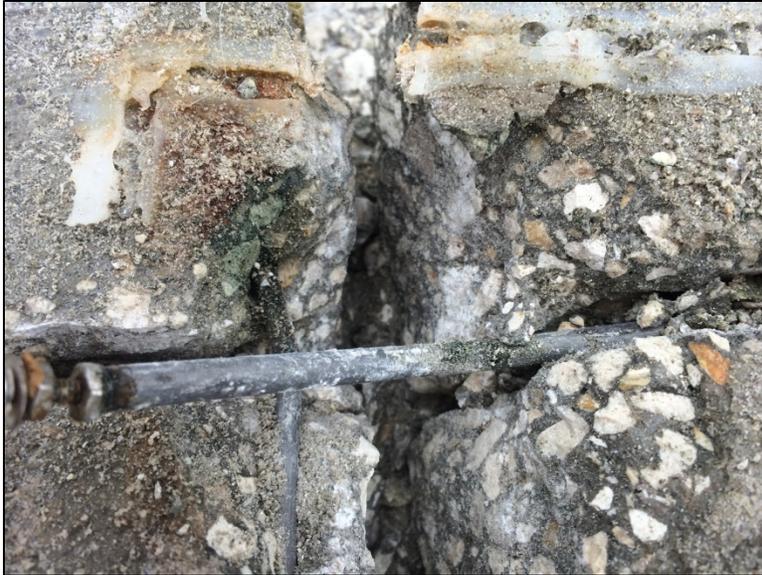
Figure 115 – Black/green rust observed upon exposing steel on specimen F7.

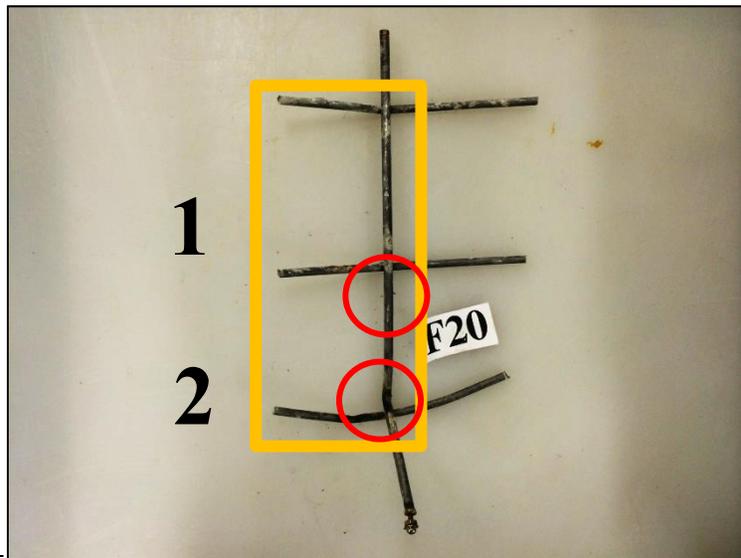
location. The steel reinforcement of specimen F20 can be seen in Figure 116 displaying the location where corrosion occurred. Specimen F20's applied current was increased to 125  $\mu\text{A}$  before termination and also the specimen was covered with saturated sand during latter part of the exposure period. As seen in Figure 117, location 1 experienced significant corrosion occurred under the ponding at the reinforcement junction. Upon exposure the corrosion products were blackish green suggesting that moisture was present. Mild corrosion can be seen along the transverse reinforcement at location 2 in Figure 117. Corrosion did not occur outside the ponding.

Figure 116 – Autopsy result of specimen F20.

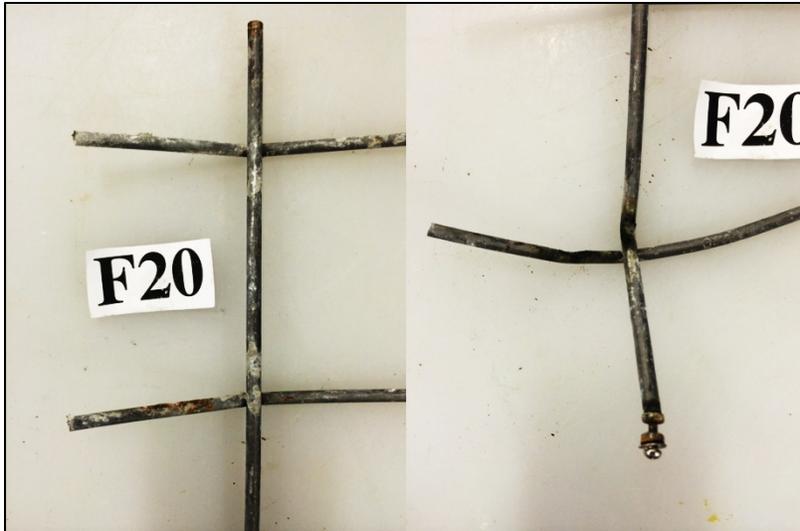
Figure 117 – Autopsy result of specimen F20. Left: location 1. Right: location 2.

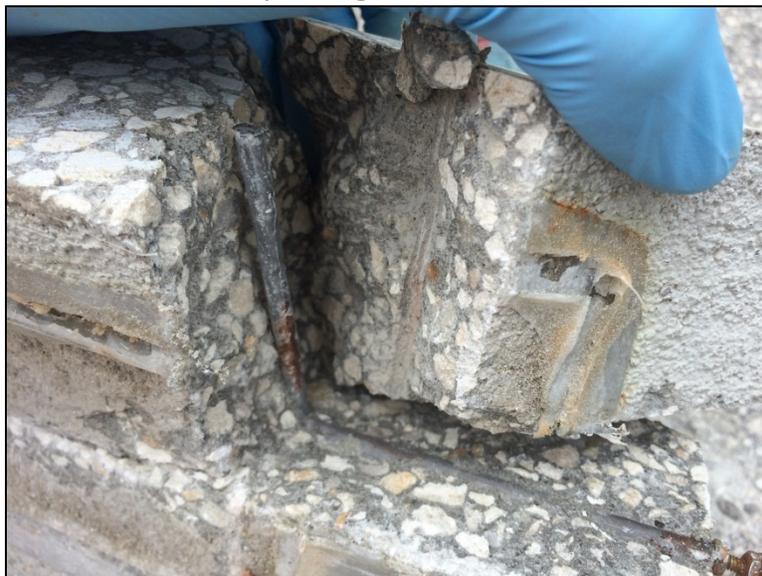
Upon breaking the specimen open, the steel reinforcement's corrosion products were red rust. It is likely that there was plenty of oxygen available at the steel's depth. This can be seen in Figure 118. The steel reinforcement of specimen F23 can be seen in Figure 119 displaying the locations where a small amount of corrosion occurred. In both location 1 and 2 a small amount of corrosion occurred at the steel junction and also extended 1" from the junction along the transverse steel which can be seen in Figure 120. A larger area of the steel reinforcement did not show corrosion which may be due to a smaller chloride concentration at the corroding sites. Corrosion did occur outside the ponding.

Figure 118 – Red rust observed upon explosion steel on specimen F23.

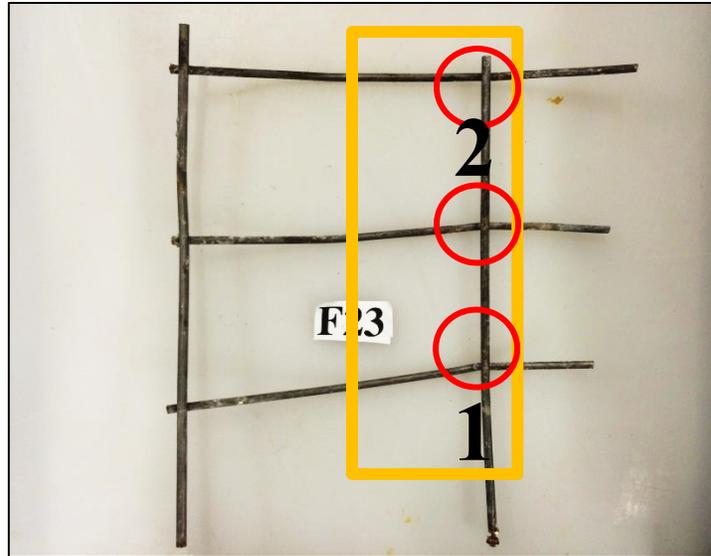
Figure 119 – Autopsy result of specimen F23.

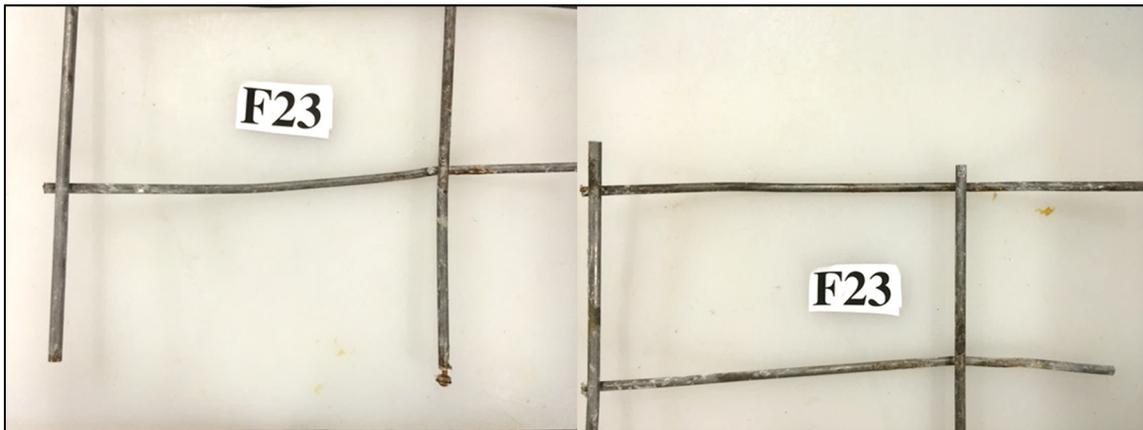
Figure 120 – Autopsy result of specimen F23. Left: location 1. Right: location 2.

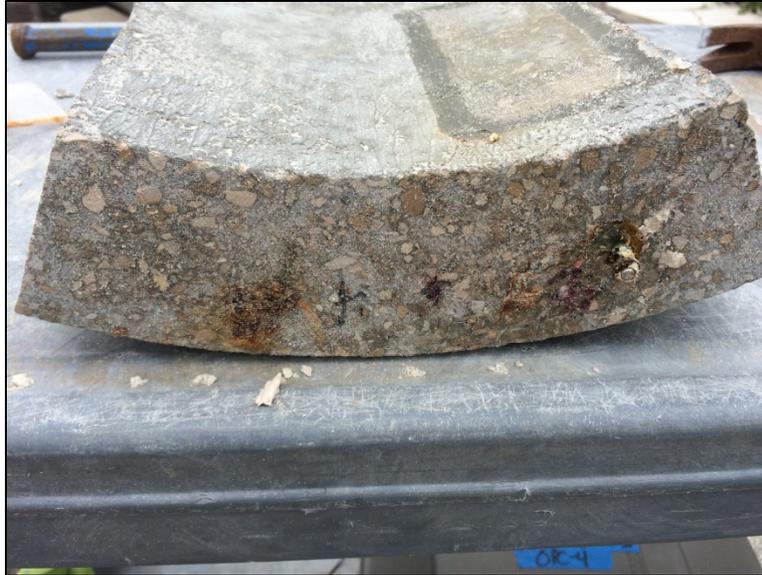
Before cracking the specimen open, the exposed ends of the steel reinforcement were observed to be corroding as seen in Figure 121. Upon breaking the specimen open, the steel reinforcement's corrosion observed was red in some areas and "black" (or "dark green") in other areas as seen in Figure 122. The steel reinforcement of specimen C4 can be seen in Figure 123 displaying the locations where corrosion occurred. Specimen C4's applied current was increased to 125  $\mu\text{A}$  before termination and also the specimen was covered with saturated sand. As seen in Figure 124 corrosion occurred at the steel junction at locations 1 and 2, and also along the transverse and longitudinal wires between the junction. Upon exposure the corrosion products were blackish green suggesting that there was significant moisture at the steel depth. Corrosion did occur outside the ponding at location 3.

Figure 121 – Exposed steel reinforcement ends corroding on specimen C4.

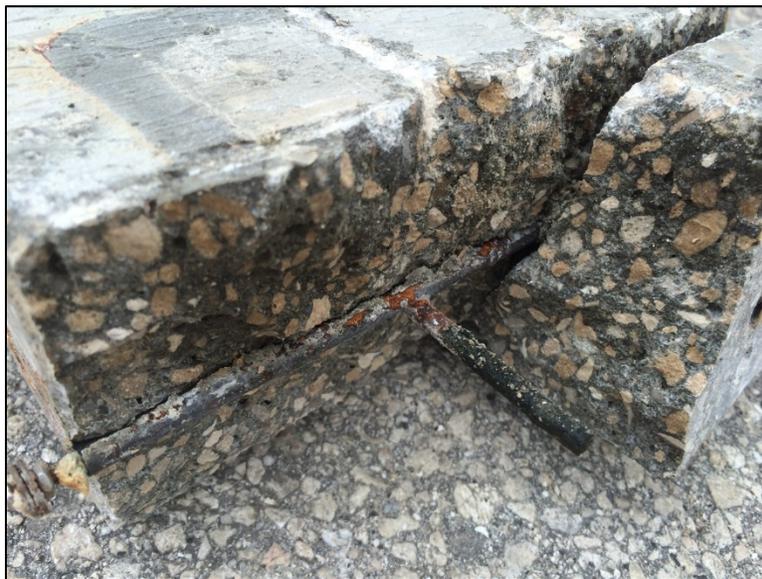
Figure 122 – Red and black/green rust observed on specimen C4 after opening.

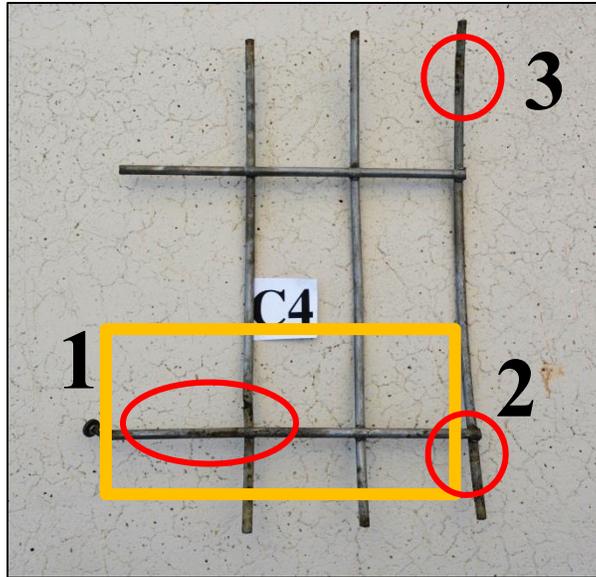
Figure 123 – Autopsy result of specimen C4.

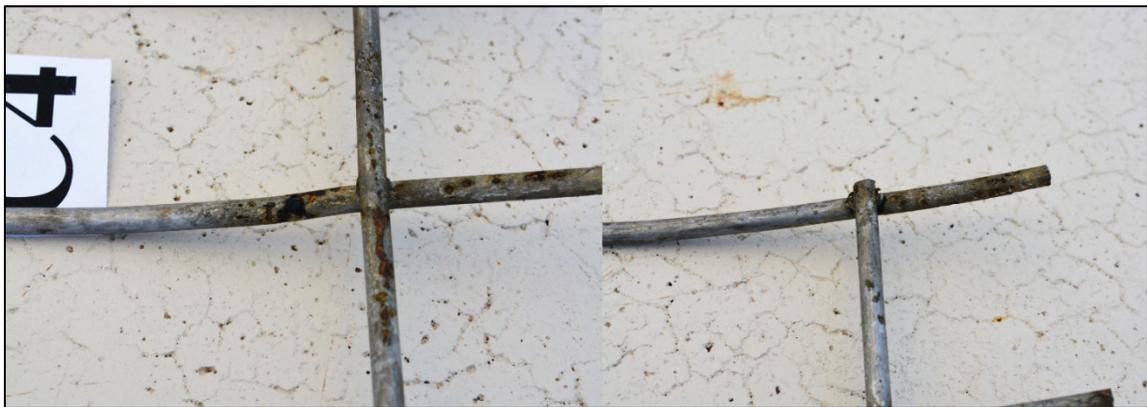
Figure 124 – Autopsy result of specimen C4. Left: location 1. Right: location 2.

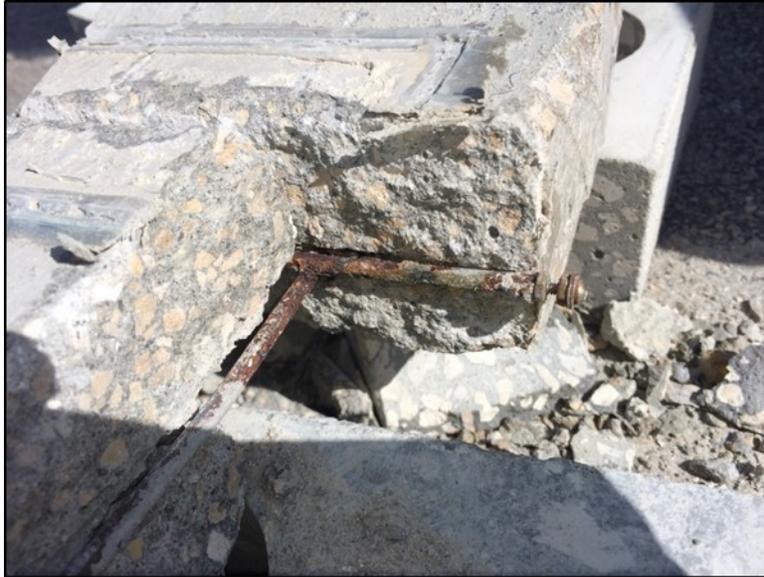
Upon breaking the specimen open, the steel reinforcement's corrosion observed was red rust in some areas as seen in Figure 125. The corrosion products color was "black" (or "dark green") at other locations as seen in Figure 126. The steel reinforcement of specimen C6 can be seen in Figure 127 displaying the locations where corrosion occurred. Specimen C6's applied current was also increased to 125  $\mu\text{A}$  before termination. As seen in Figure 128, location 1 experienced mild corrosion under the ponding at the reinforcement junction. Also, mild corrosion can be seen at the junction along the transverse steel shown in Figure 128. Corrosion did not occur outside the ponding. Specimen C6 experienced more corrosion than C4 which may be attributed to the higher current applied and the fact that specimen C4 was covered with saturated sand for the last 140 days before being terminated whereas specimen C6 was exposed in high humidity.

Figure 125 – Red rust observed under the ponding upon opening specimen C6.

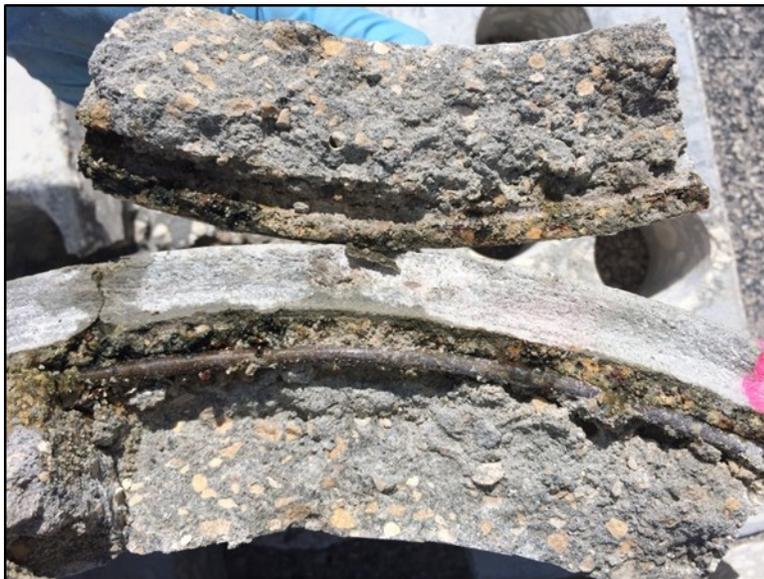
Figure 126 – Black/green rust observed upon opening the end of specimen C6.

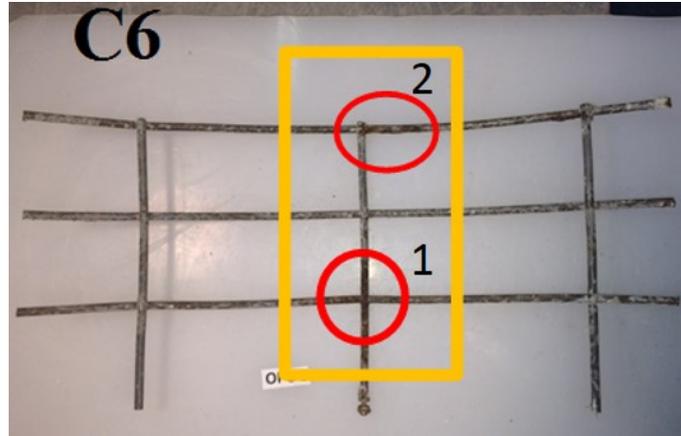
Figure 127 – Autopsy results of specimen C6 – whole steel wire mesh.
