## **Final Report**

Concrete Pipe – Electrochemical Cell, Phase II  
BDV27-977-03

Submitted to  
Florida Department of Transportation Research Center  
605 Suwannee Street  
Tallahassee, Florida 32399

August 2016

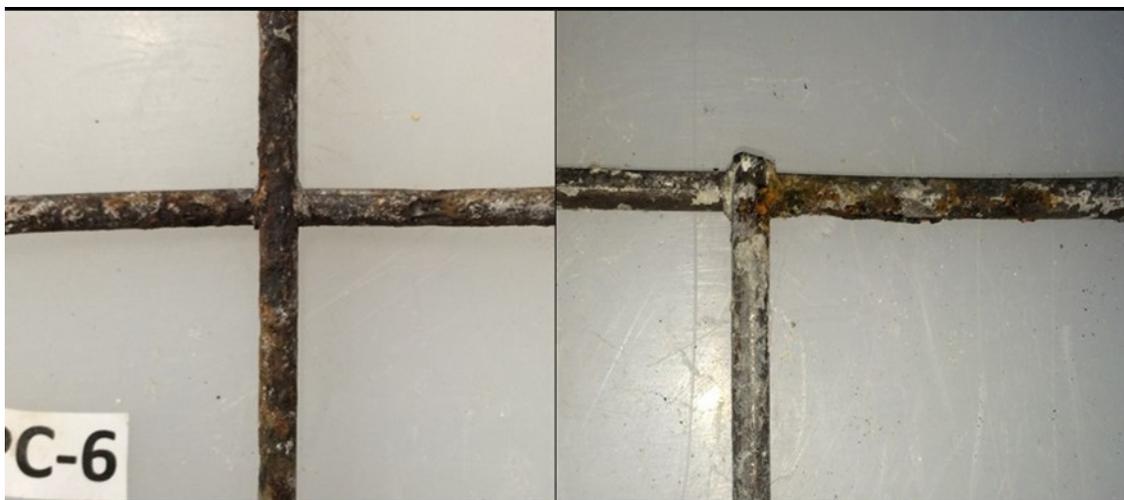
Figure 128 – Autopsy result for specimen C6. Left: location 1. Right: location 2.

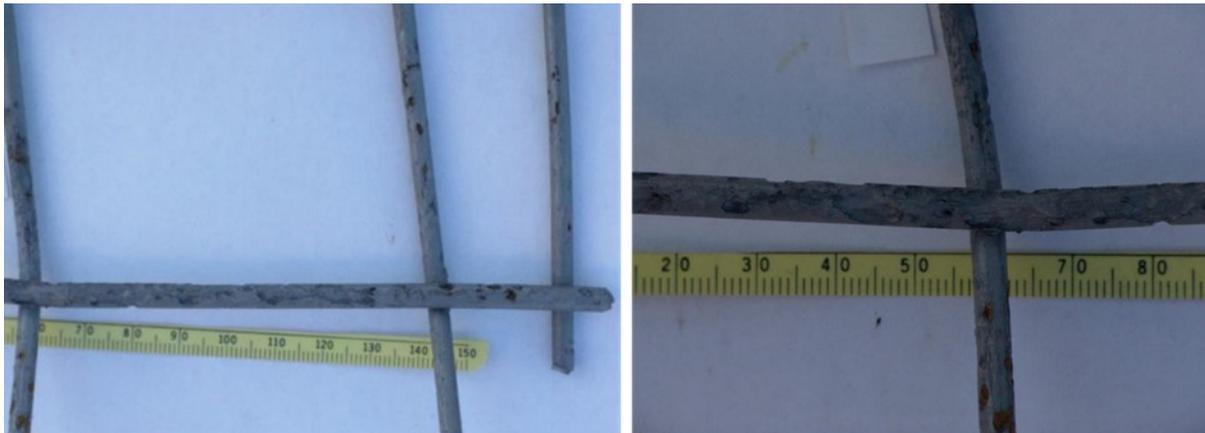
Figure 130 shows the steel wire after cleaning for specimen F1. It is evident that corrosion took place at multiple spots and that the cross-section loss was significant (i.e., more than 1 mm)

Figure 130 – Close up of steel corroding sites after cleaning on specimen F1.

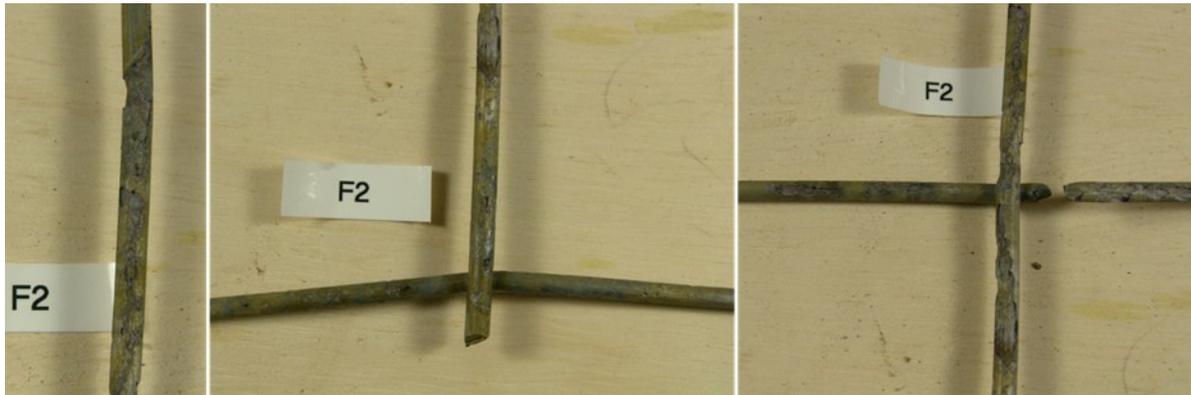
Figure 131 shows three pictures after cleaning steel from specimen F2. The pictures show different locations where corrosion, the pictures on the left and right show the most significant cross-section loss. The picture on the right show a broken wire, the cross-section loss is

significant, but it is not clear if the separation took place during the concrete removal or if this had taken place previously.

Figure 131 – Close-up of corroding sites for specimen F2.

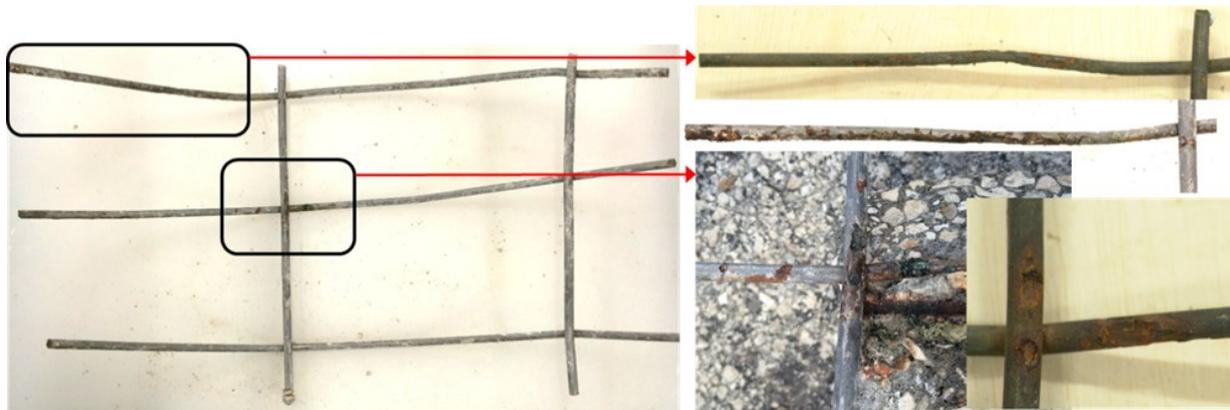
The steel reinforcement of specimen F3 can be seen in Figure 132 displaying the locations where corrosion occurred. Specimen F3 was not polarized. It was exposed in high humidity during the corrosion propagation stage. Specimen F3 experienced corrosion at two locations. One site was under the ponding at the reinforcement junction. Severe cross-section loss can be seen at one other location along the side of the transverse steel. Corrosion did occur outside the ponding. However, the corrosion observed did not spread from the reinforcement junction as compared to specimens subject to applied current during the propagation stage.

Figure 132 – Autopsy result of specimen F3. Left: after opening. Right: close-ups.

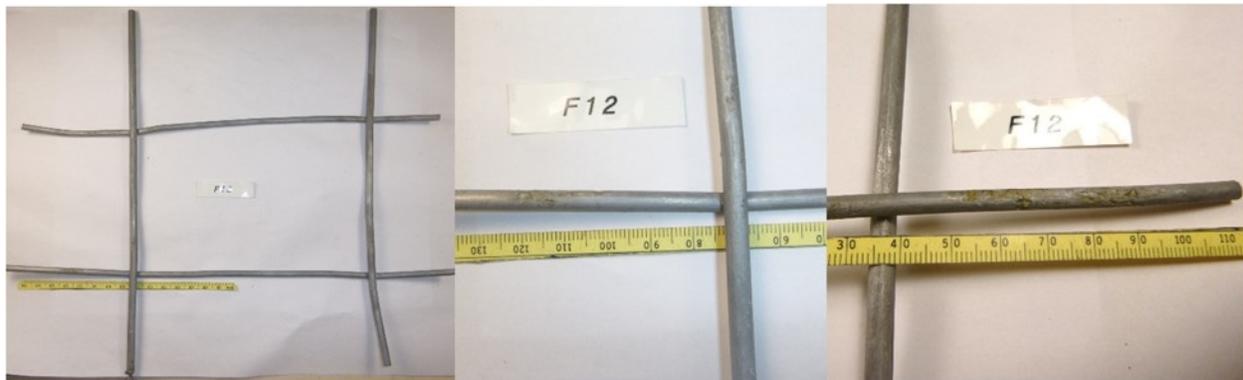
Figure 135, Figure 136 and 137 show pictures of the cleaned steel wires for specimens F9, F12 and 21 respectively. Significantly less cross-section loss and corrosion extent was observed on these specimens.

Figure 136 – Steel wire mesh specimen F12 after cleaning.

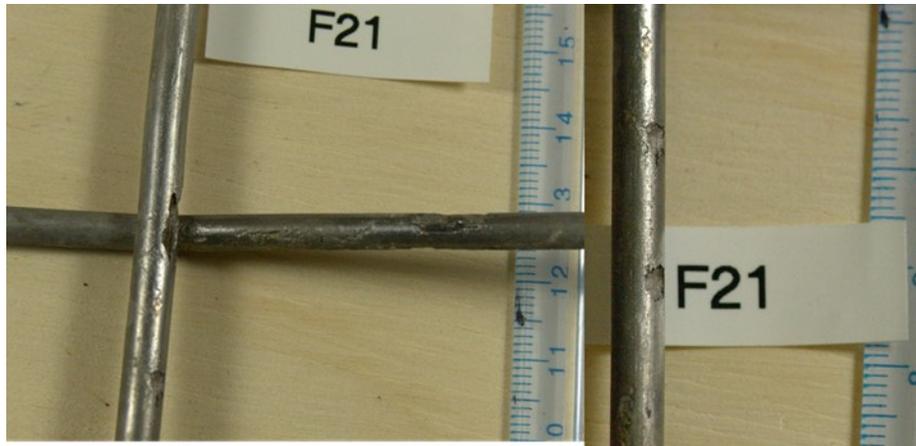
Figure 137 – Steel wire mesh specimen F21 after cleaning.

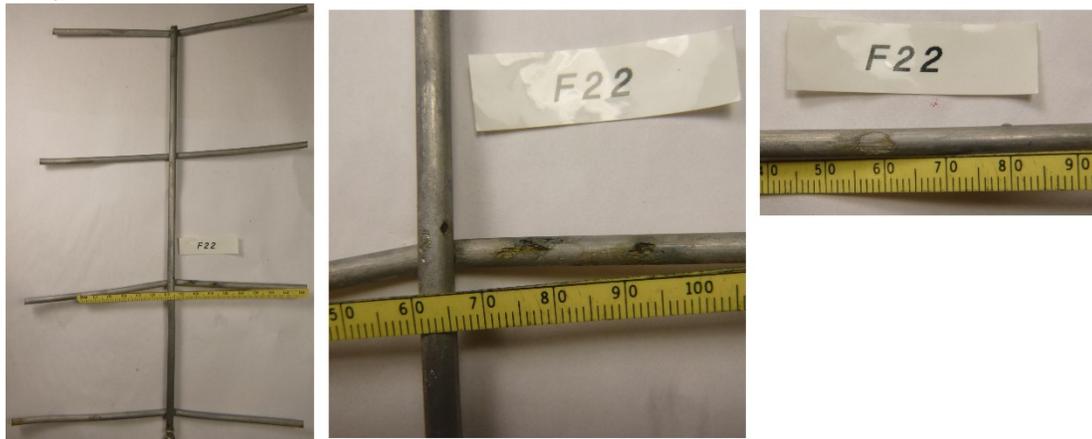
Figure 138 shows the steel wire removed from specimen F22 after cleaning. The close-up picture in the center shows that there were two spots with significant cross-section loss (spiral) and a small corrosion spot  $\sim 2$  mm diameter (longitudinal) that looked like a deep pit. The inset on the right show that at a location away from the reservoir: corrosion also took place (about 5 mm wide), but the cross-section loss was modest.

Figure 138 – Steel wire mesh specimen F22 after cleaning.

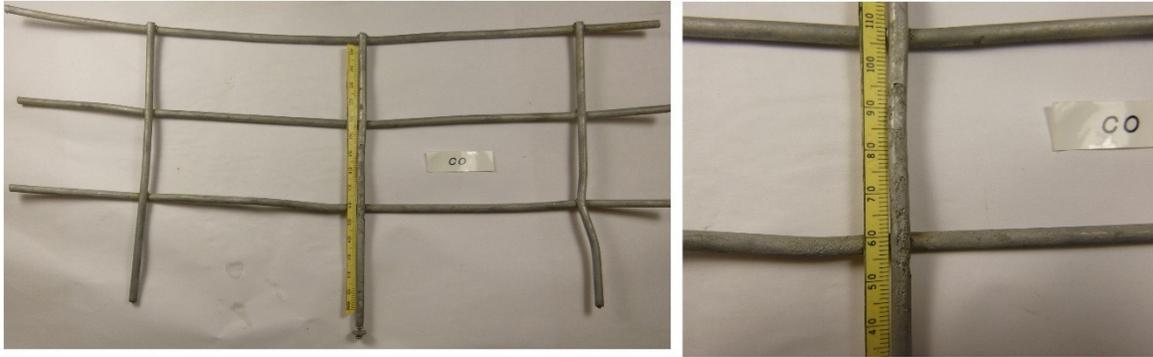
Figure 139 shows on the left the wire mesh from Specimen C0 after chemical cleaning. The picture on the right shows a close up of the region that suffered significant cross-section loss. Several spots 10 mm long (or more) are easy to identify.

Figure 139 – Steel wire mesh specimen C0 after cleaning.

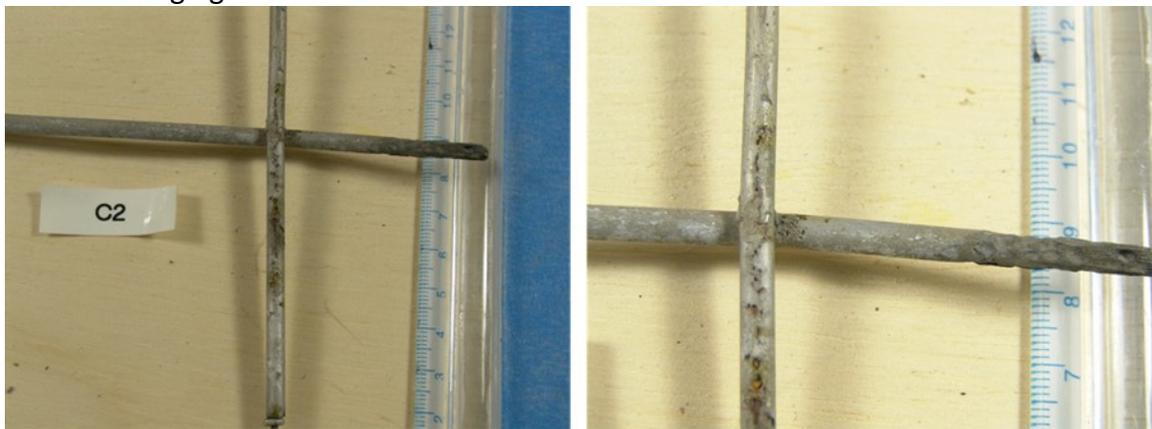
Significant corrosion took place along one of the longitudinal steel wires on Specimen C2 as can be seen on the pictures on Figure 140. The picture on the left shows that corrosion took place also on one of the transverse steel wires a certain distance from where the multiple corrosion spots were present on the longitudinal steel wire. The corrosion spots are pit like shape of various sizes ranging from less than one mm to several mm in diameter.

Figure 140 – Steel wire mesh specimen C2 after cleaning.

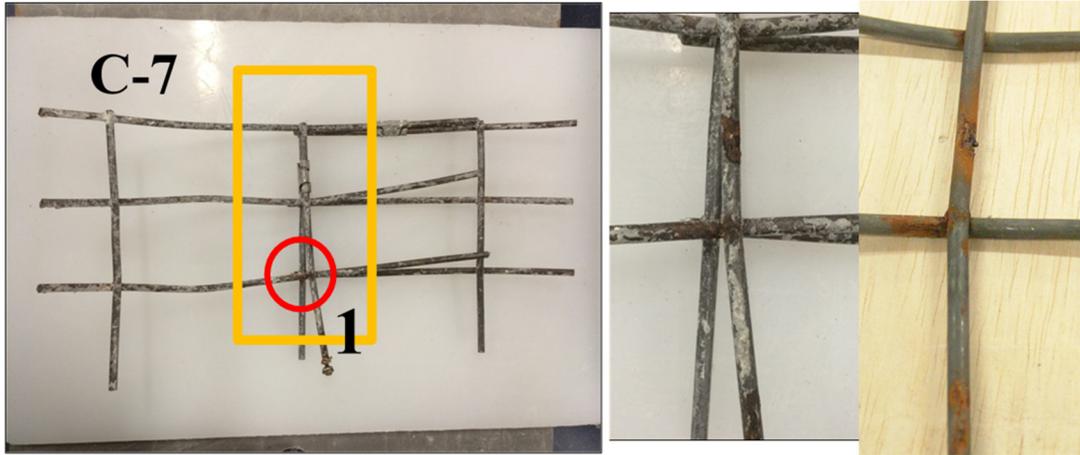
Specimen C7's steel reinforcement can be seen in Figure 141 displaying the locations where corrosion occurred. Like specimen F3, specimen C7 was not polarized when placed in high humidity during the corrosion propagation stage. Specimen C7 experienced mild to no corrosion. Under the ponding there were two spots with corrosion at the junction and along the longitudinal reinforcement shown by the close-up pictures on the right. A small amount of corrosion occurred outside the ponding.

Figure 141 – Autopsy result for specimen C7 – Left: full wire mesh. Right: close-up.

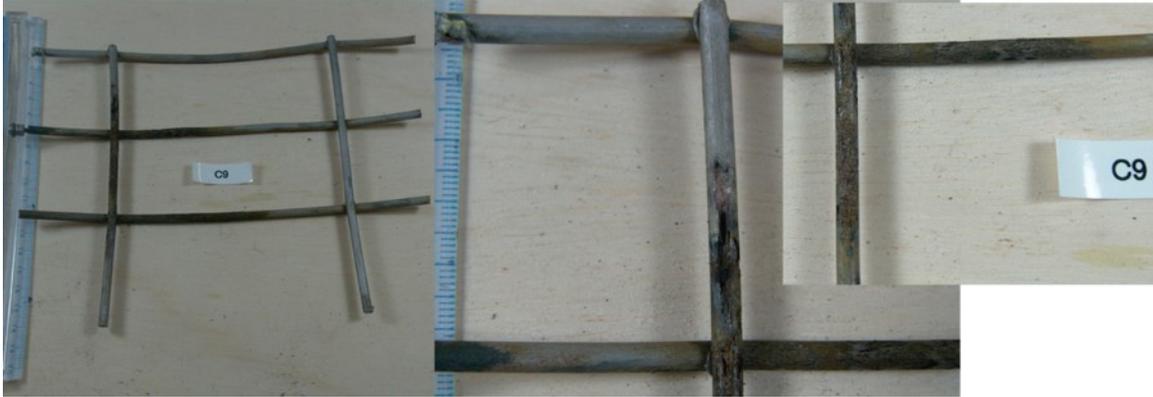
Figure 143 shows on the left the whole steel mesh after cleaning and the pictures on the right show a couple of close ups of sites where corrosion was the most significant. One of the corrosion sites along the longitudinal was longer than 15 mm long and with a significant cross-

section loss. The smaller inset shows additional section of the longitudinal wire that goes below the larger inset. The cross-section can be observed both on the longitudinal and the transverse direction.

Figure 143 – Steel wire mesh specimen C9 after cleaning.

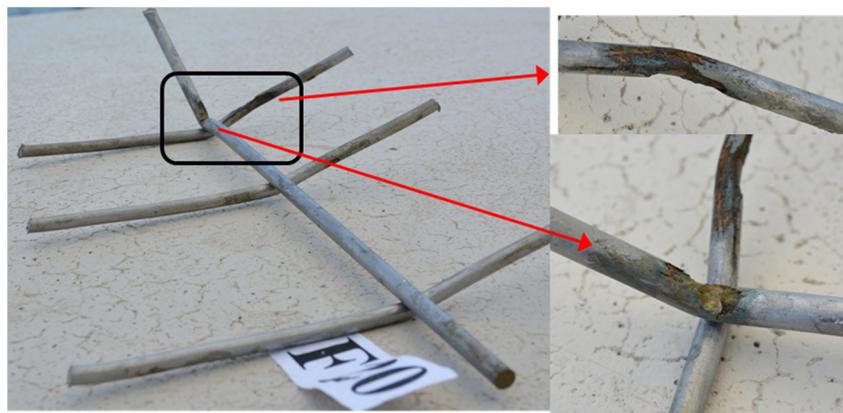
The steel reinforcement of specimen F20 can be seen in Figure 148 displaying the location where corrosion occurred (pictures taken after cleaning). Specimen F20's applied current was increased to 125  $\mu$ A before termination and also the specimen was covered with saturated sand. As seen in the Figure 148 picture on the right, the steel experienced significant corrosion occurred under the ponding at the reinforcement junction. Upon exposure the corrosion products were blackish green suggesting that there was very little oxygen at the steel depth (not shown). Corrosion did not occur outside the ponding. Figure 149 shows pictures of the reinforcement in Specimen F19. Corrosion occurred under the ponding, but the cross-section loss was not as significant.

Figure 148 – Autopsy result of specimen F20. Left: all reinforcement 1. Right: corroding sites.

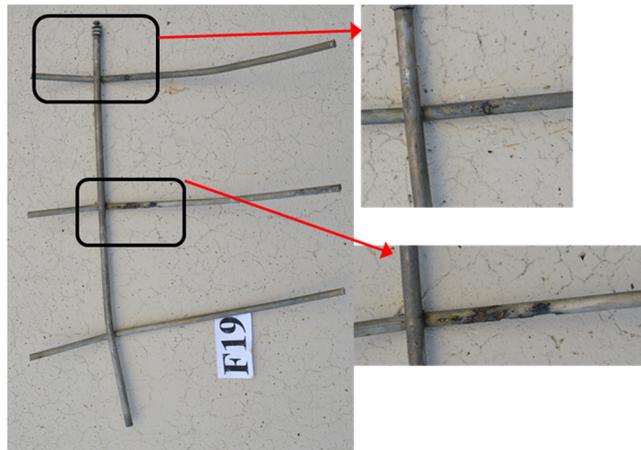
Figure 149 – Autopsy result of Specimen F19: Left: all reinforcement, Right: corroding sites.

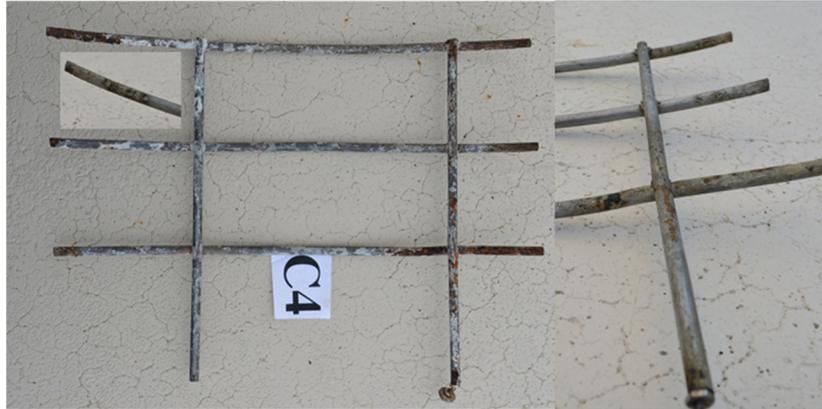
The steel reinforcement of specimen C4 can be seen in Figure 151 displaying the locations where corrosion occurred. The picture on the left shows the reinforcement shortly after exposing the

steel. Specimen C4's applied current was increased to 125  $\mu\text{A}$  before termination and the specimen was covered with saturated sand, as well. As seen in the Figure 151 picture on the right (after cleaning), corrosion occurred at the steel junction, and also along the transverse and longitudinal steel between the junctions. Upon exposure the corrosion products were blackish green suggesting that there was very little oxygen at the steel depth (Not shown in here). Corrosion did occur outside the ponding. See inset on picture on the left column.

Figure 151 – Autopsy result of specimen C4. Left: after opening. Right: close-up after cleaning.

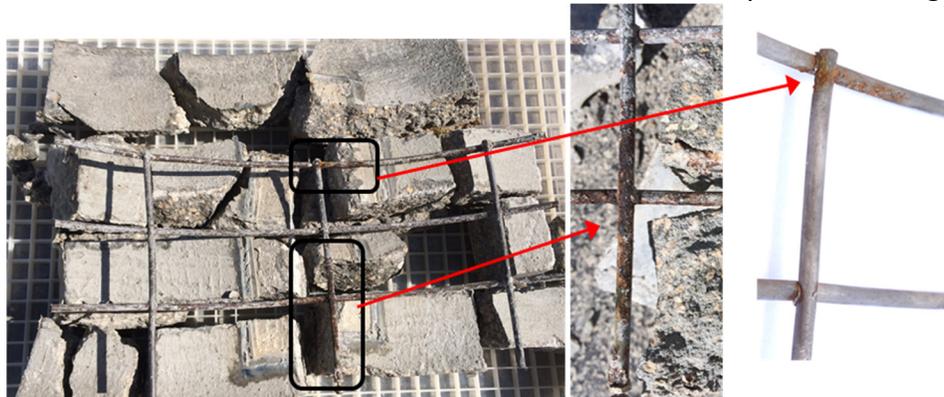
The steel reinforcement of specimen C6 can be seen in Figure 152 displaying the locations where corrosion occurred. Specimen C6's applied current was also increased to 125  $\mu\text{A}$  before termination. As seen in the Figure 152 pictures on the right, the reinforcement experienced corrosion under the ponding at the reinforcement junctions. Also, mild corrosion can be seen at the middle junction along the transverse steel shown. Corrosion did not occur outside the ponding. Specimen C6 experienced more corrosion than C4 which may be attributed to the fact that specimen C4 was covered with saturated sand for the last 140 days before being terminated.

Figure 152 – Autopsy result of specimen C6. Left: after opening. Right: close-ups of corroding sites.

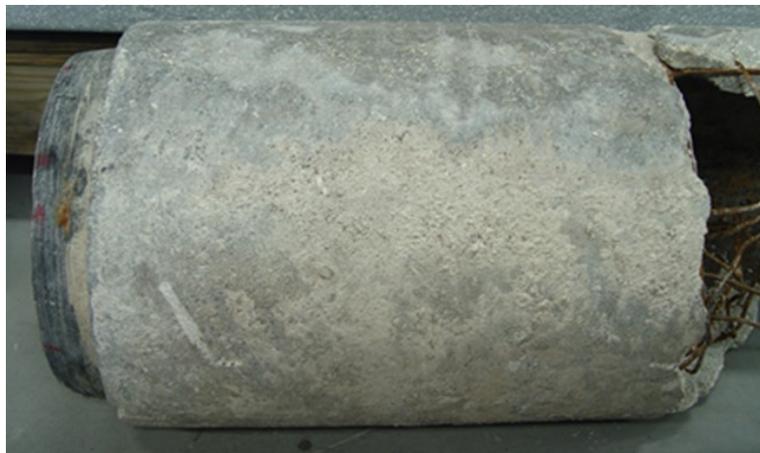
Figure 154 shows the 12 inch inside diameter pipe segment obtained during the site visit to Alton Road in Miami Beach. Figure 155 shows the potential profiles measured along each of the longitudinal steel wires. The potential values (measured against an Ag/AgCl electrode) measured along three of the longitudinal steel wires (L1, L7 and L8) suggest that corrosion was taking place. After additional exposure to the lab humidity the potential on all longitudinal steel wires shifted toward more positive values.

Figure 154 – Reinforced concrete pipe removed from Miami Beach (Alton Road).

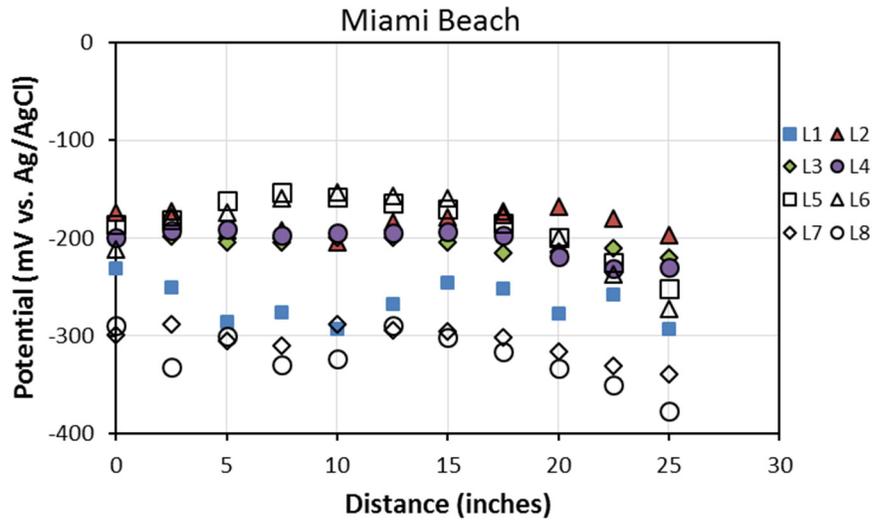
Figure 155 – Potential profile along longitudinal.

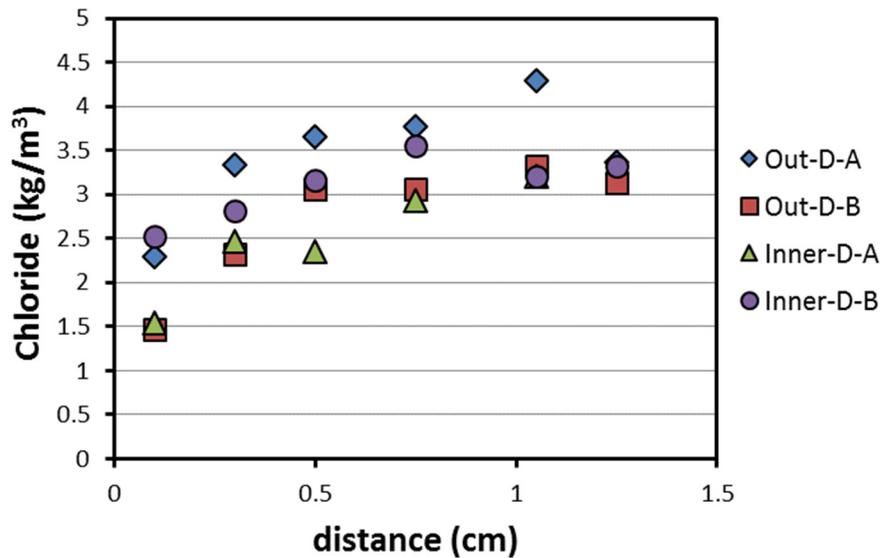
Figure 156 shows the chloride concentrations measured from both sides on two concrete pieces that were milled. The chloride concentration at 1.25 cm from the surface ranged between 3 and 3.5 kg/m<sup>3</sup>.

Figure 156 – Chloride profile for Miami Beach specimen.

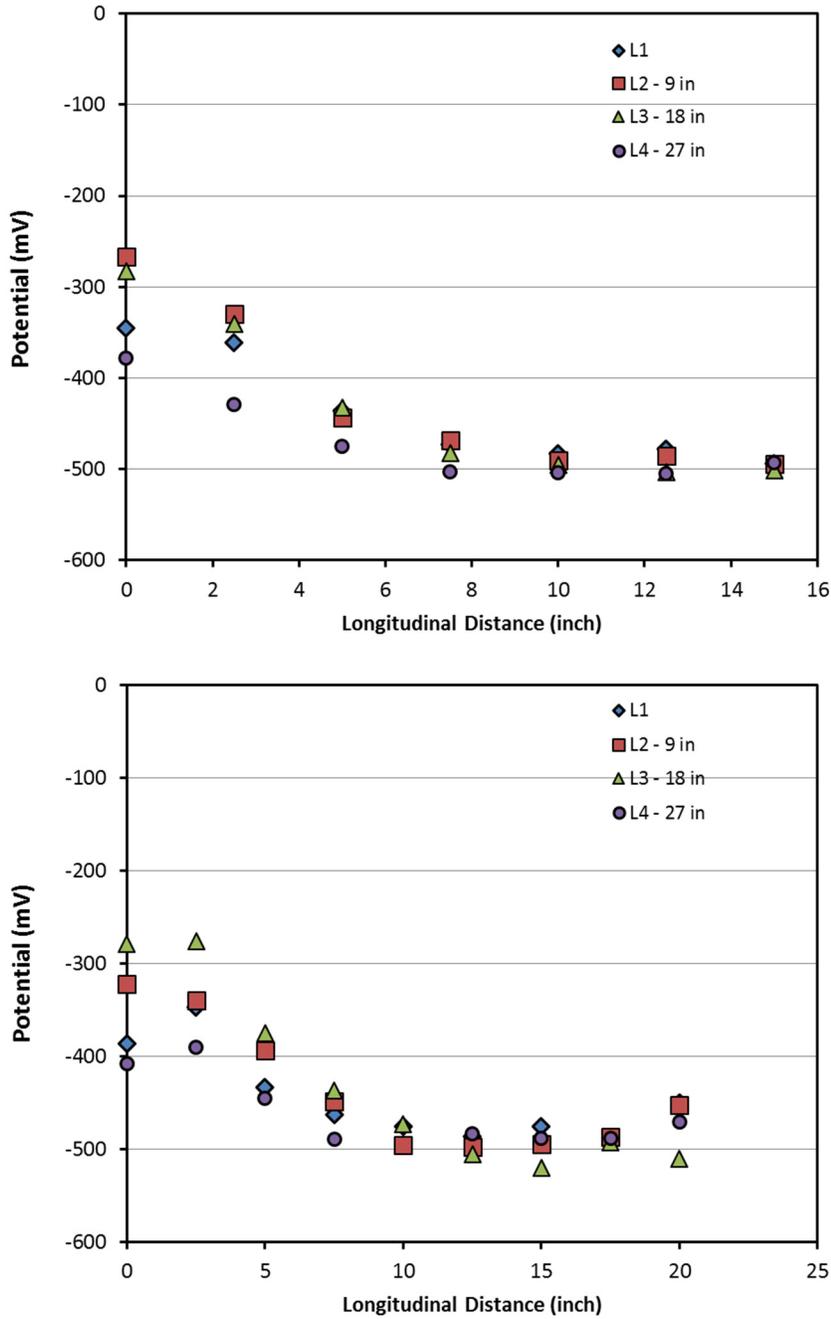
exposed steel wires were used to check continuity and as electrical connections. Figure 157 shows the potential profiles measured along the longitudinal reinforcements. Several small pieces were brought into the lab for forensic examination. Concrete was milled from the surface of both the inner and outer side of a pipe concrete piece. Chlorides were measured from the pulverized concrete. Figure 158 shows the chloride profiles obtained. At a depth of 1.4 cm the chloride concentration ranged between 6 and 7.5 kg/m<sup>3</sup>.

Figure 157 – Potential profiles measured along longitudinal wires (Dania Beach Marina).

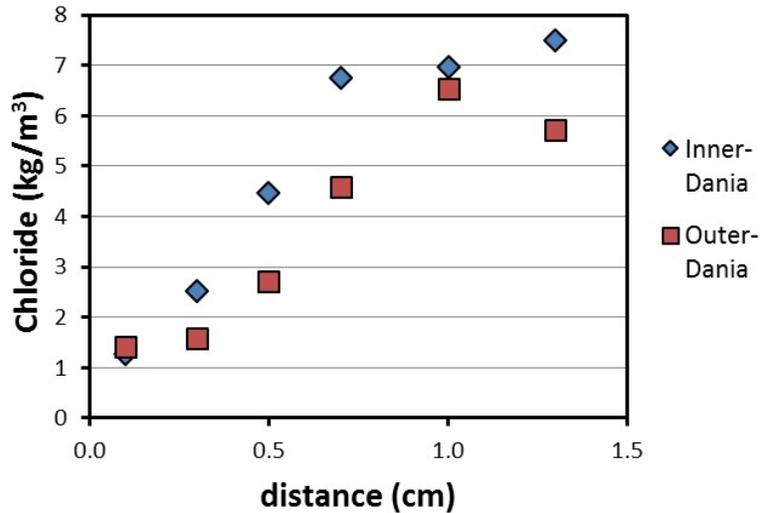
Figure 158 – Chloride profile from RCP at Dania Beach Marina.

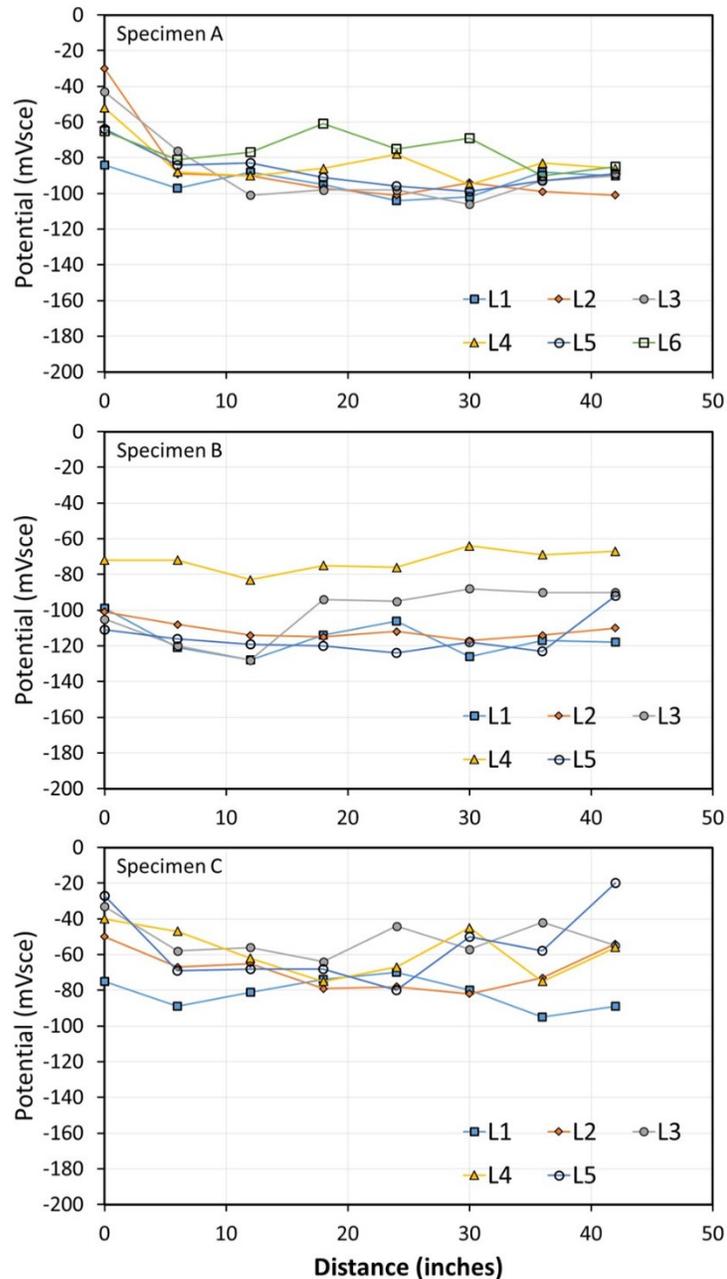
The potentials of the reinforcing steel were measured vs. a saturated calomel values, and all measured values were made along several of the longitudinal reinforcements. The potential values measured ranged between -30 mV<sub>sce</sub> and -130mV<sub>sce</sub>. The average values for specimen

A was -85 mVsce, B was -103 mVsce, and C was -63 mVsce. The plots on Figure 159 display the potential profiles measured on each pipe. All measured values suggest that either there is no on-going corrosion or that there is a very low probability that corrosion is taking place.

Figure 159 – Potential profiles measured on pipes taken from the Titusville Airport.

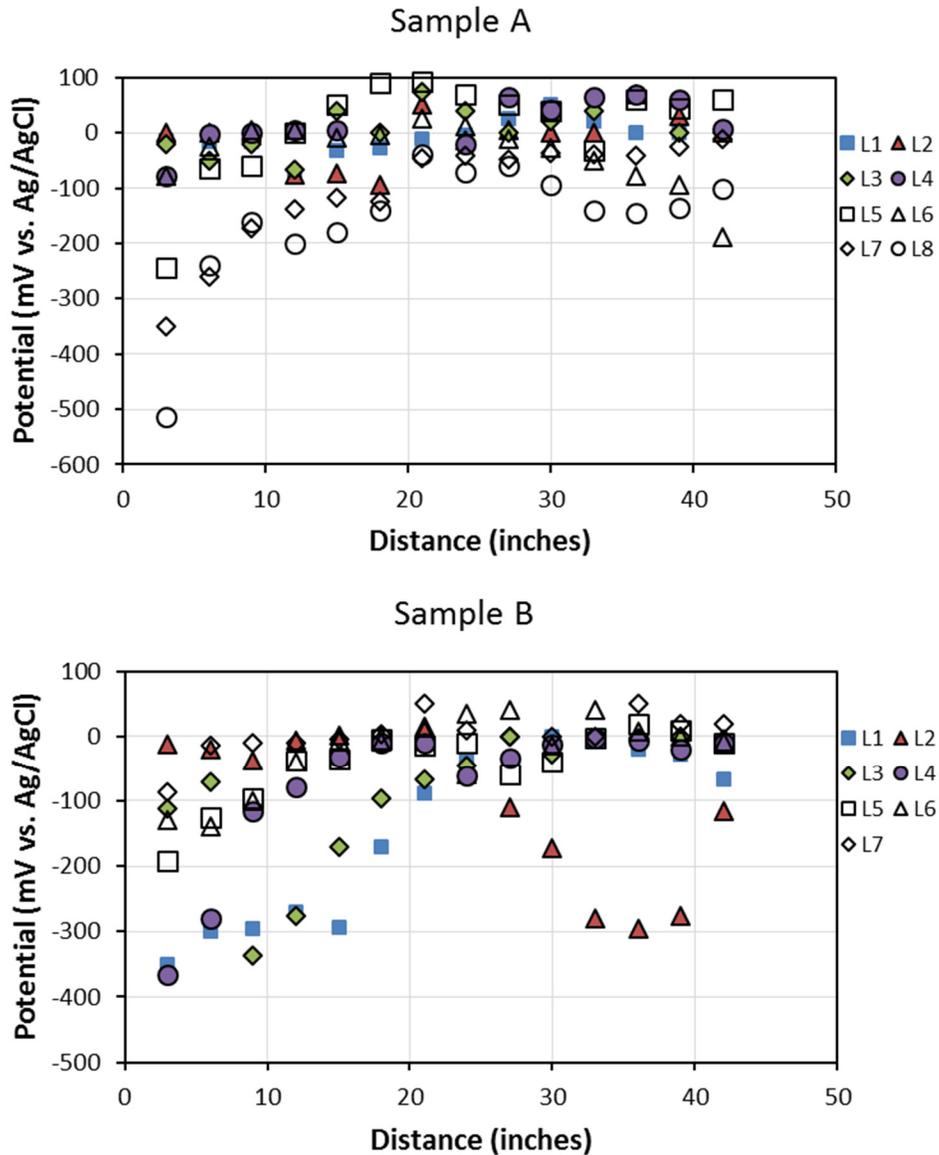
Figure 160 show plots of the potential values measured along selected longitudinal reinforcements on the RCPs at Indian Rock Beach (Largo FL). The reference electrode used during this visit was an Ag/AgCl reference electrode. Based on the measured values two

longitudinal reinforcements (L7 and L8) appear to be active on sample A; whereas on Sample B four longitudinal reinforcements appear to be active (Along L3, L4 and L5 on the left side and L2 on the right side) based on the steel potential. Several concrete pieces were cut-off from the latter pipe (Sample B).

Figure 160 – Potential maps along the longitudinal reinforcements on samples at Indian Rock Beach.

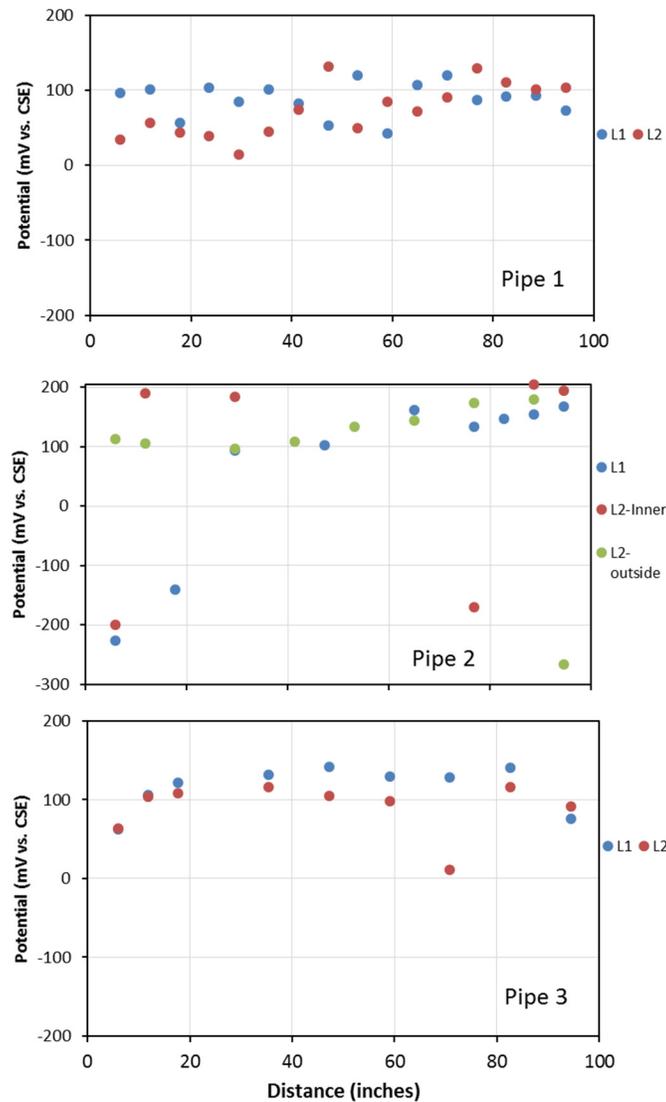
The steel potential values were measured along several longitudinal strands on three different pipes during the visit to the Tallahassee site. The steel potentials were measured against a copper sulfate electrode (CSE). Figure 3 below shows plots of the potential profiles measured

along the selected steel strands. Only pipe 2 appear to have a few active spots. A segment was cut off from pipe 2 for forensic analysis in the laboratory.

Figure 161 – Potential values along the longitudinal reinforcements on RCP (Tallahassee).

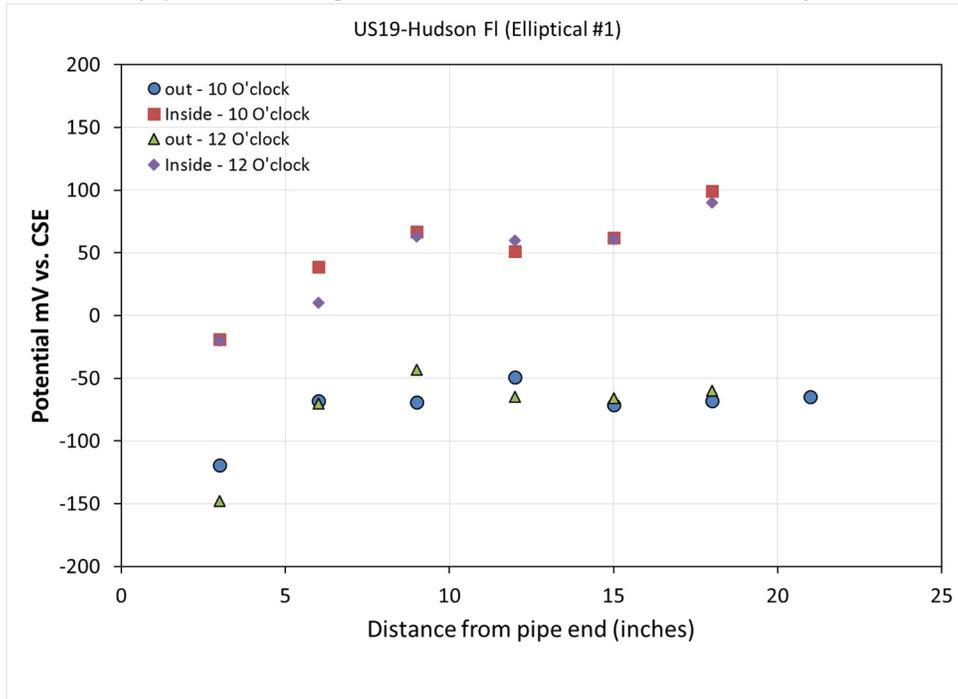
This section describes the reinforcement potential values measured along selected longitudinal wires on pipes found during the visit to Hudson, FL. The potential values shown are vs. CSE in mV. Figure 162 shows a plot with the values measured on one of the elliptical RCPs named elliptical #1. The reinforcement potential values measured on the outside surface were 100 to 150 mV more negative than those measured inside the pipe. The visit took place in July during the rainy season, which might in part explain the potential difference. Figure 163 shows the potential values measured on a pipe labelled elliptical #2, and Figure 164 shows the potential values measured along the longitudinal on a round RCP pipe found a few miles from the two

Figure 162 – Reinforcement potential along longitudinal wires (Elliptical 1).

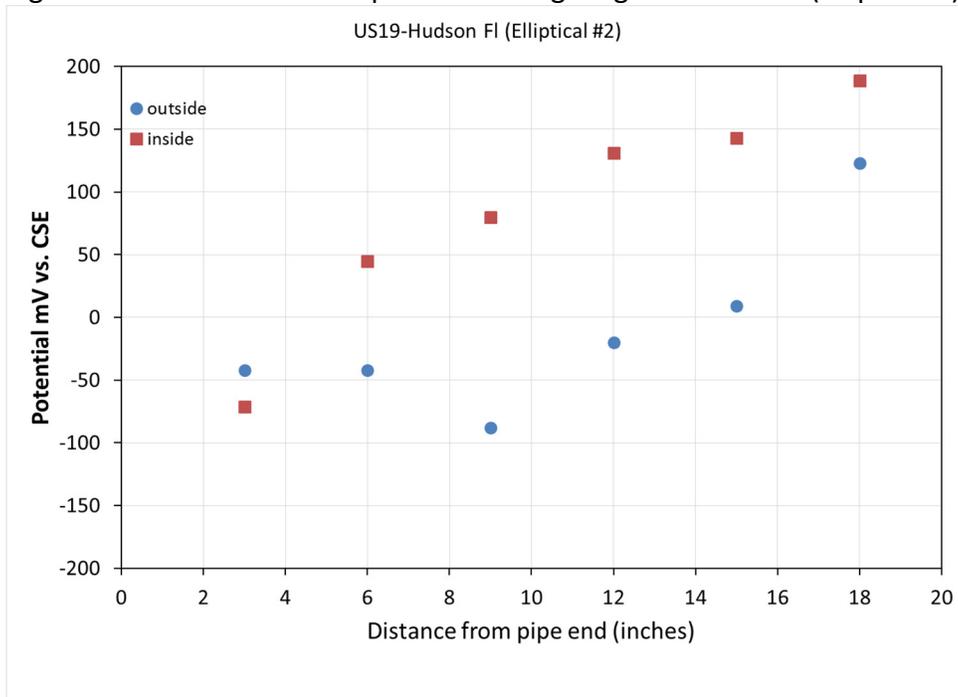
Figure 163 – Reinforcing wire potential along the top longitudinal wire (Elliptical 2).

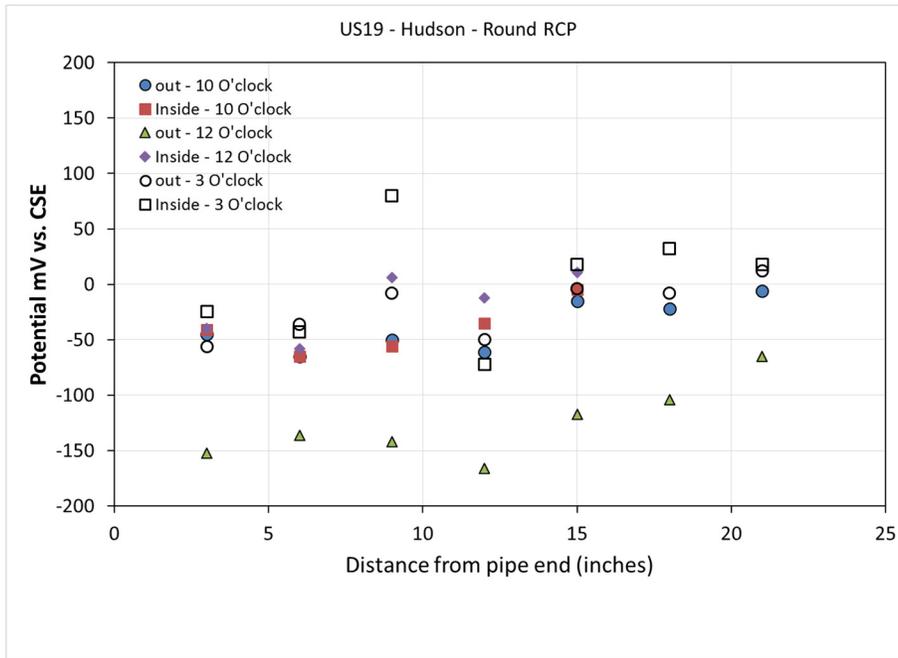
elliptical pipes measured. Most potential values measured were more positive than -150 mVcse, which suggest that the reinforcing wire was likely not corroding. Segments were obtained from three pipes and brought to FAU SeaTech for forensic analysis.

Figure 164 – Reinforcing wire potential along three longitudinal wires, on a round RCP.

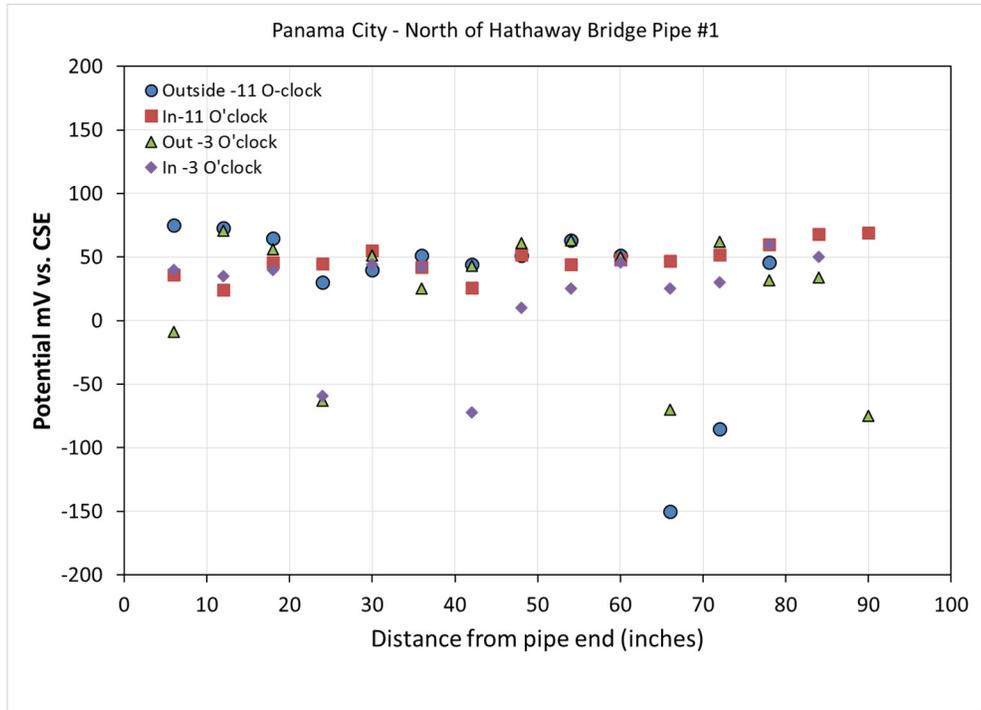
A good number of RCPs were found just before reaching the Hathaway Bridge (from land side). Two of the several pipes already removed were selected to characterize the steel potential along selected longitudinal reinforcements. The pipe inside diameter was 4 ft wide. These pipes have two wire meshes (inner and outer), similar to those found at Zolfo Springs. The potential series marked as in correspond to values measured on inner longitudinal reinforcements and out refers to values measured along a longitudinal reinforcement wire of the outer mesh. Figure 165 and Figure 165 show the potential profiles measured on two different pipes. The magnitude of the potential values suggest that corrosion is not taking place. A CSE reference electrode was used.

Figure 165 – Potential values along longitudinal wires on pipe #1 north of Hathaway Bridge.

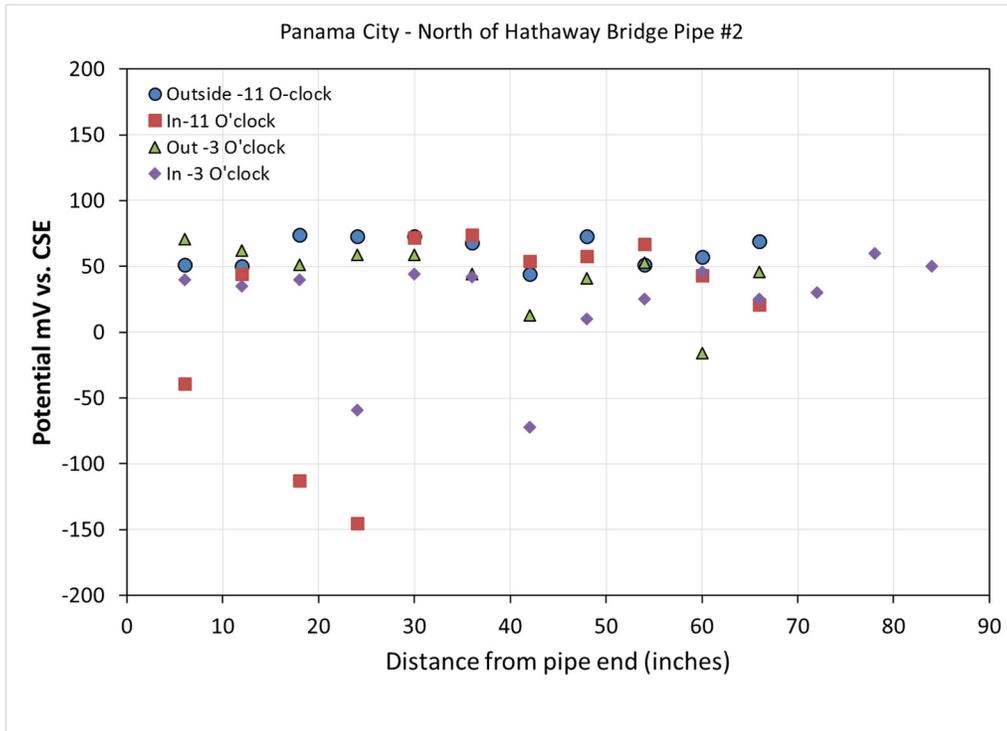
Figure 166 – Potential values along longitudinal wires on pipe #2 north of Hathaway Bridge.

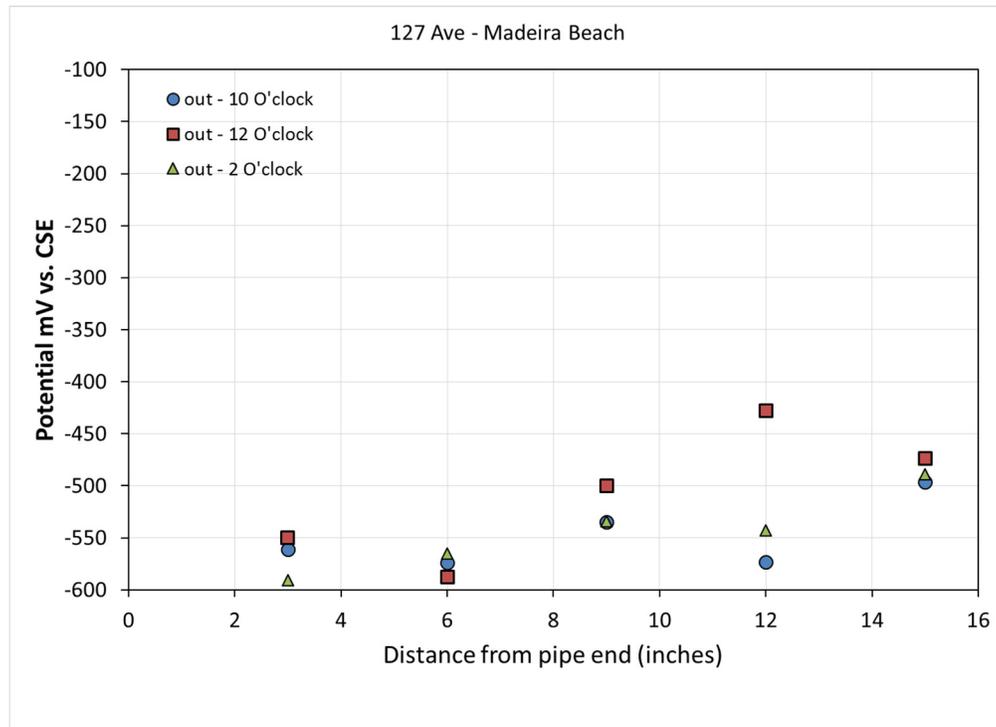
Reinforcement potential values along three longitudinal wires were measured for the RCP on 127<sup>th</sup> Ave, Figure 168 shows the measured potential values. The magnitude of the potential values suggest that corrosion is taking place, and possibly under mass transport (as at some locations the potential was more negative than  $-0.6$  Vcse). The water level was quite high due to seasonal high king tide and covered a good portion of the pipe. Thus, oxygen concentration might be low at the reinforcement depth for the portion of the pipe where the concrete is highly moist. A crack was observed on this pipe along one of the longitudinal steel wires (above water). This pipe was previously visited in 1999 and was reported to be in good condition. A core was obtained during the previous visit that was not filled (see pictures). Other than the visible crack the pipe appears to be in good condition.

Figure 168 – Potential values along longitudinal wires measured on pipe at 127<sup>th</sup> Ave. Madeira Beach, FL.

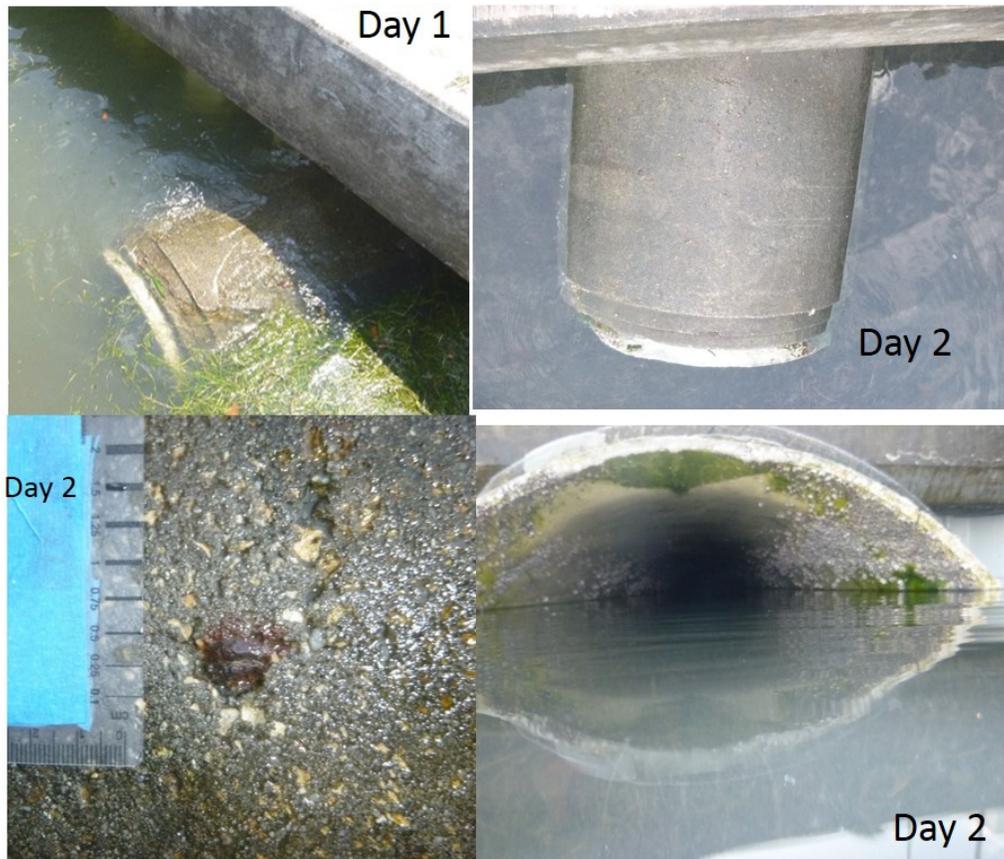
Figure 169 – RCP located at San Jose Park (Dunedin, FL).

One pipe is located on St. Jose Park (end of San Jose St.) and during day one was fully covered with water due to high tide. During day 2, reinforcement potential measurements were performed. This pipe had the most amount of damage during the previous visit. A liner has now been installed on this pipe, and the average resistivity measured from the outer surface was 29 kΩ-cm. An electrical connection was made to the reinforcing steel. See Figure 169. The measured steel potential values (shown in Figure 170) suggest that the reinforcing wire mesh continues to corrode.

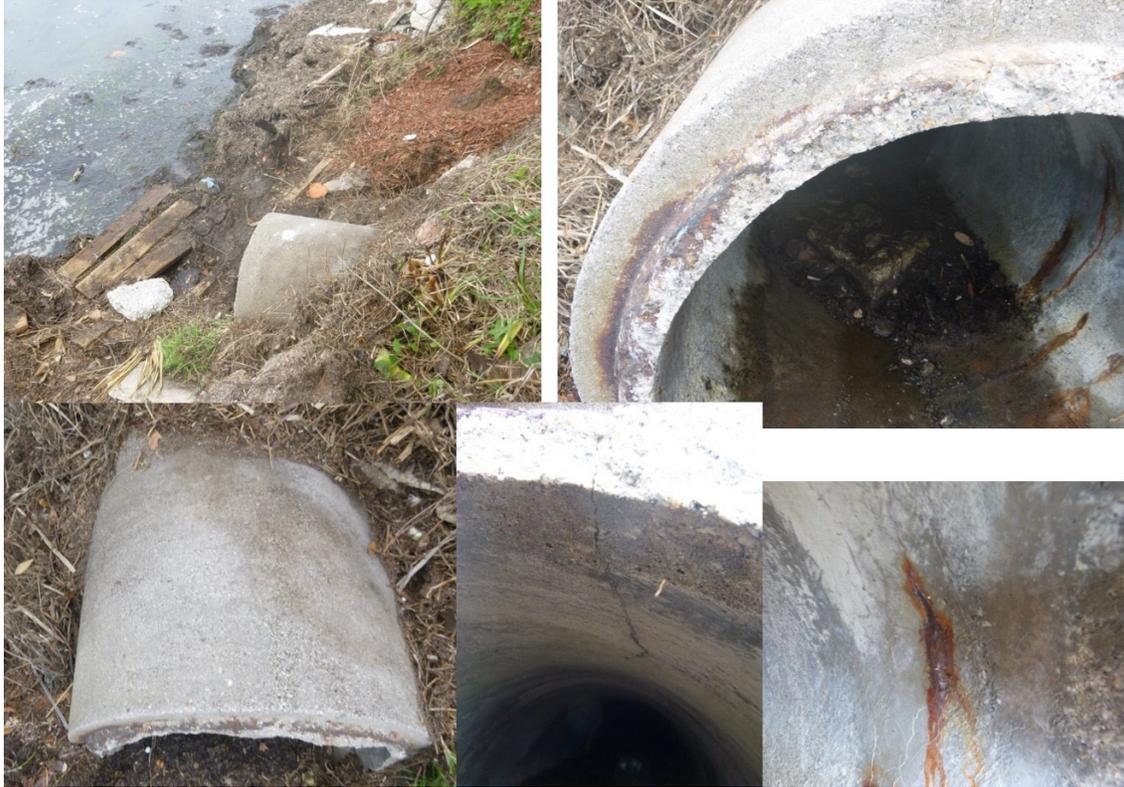
Figure 171 –RCP found at Tilden Street (Dunedin, FL).

Figure 171 shows the pipe condition for the RCP located at Tilden St. Some of pictures show red rust stains inside of the pipe, and one of the inset pictures show that there is a crack several cm long. Figure 172 shows the potential values measured along the longitudinal wires on the pipe located at Tilden St. The measured values suggest that the reinforcing steel mesh is likely undergoing corrosion. No portion of this pipe was immersed during the visit. The resistivity measured on the inside of the pipe range between 1 kΩ-cm and 6 kΩ-cm.
