## **Final Report**

Concrete Pipe – Electrochemical Cell, Phase II  
BDV27-977-03

Submitted to  
Florida Department of Transportation Research Center  
605 Suwannee Street  
Tallahassee, Florida 32399

August 2016

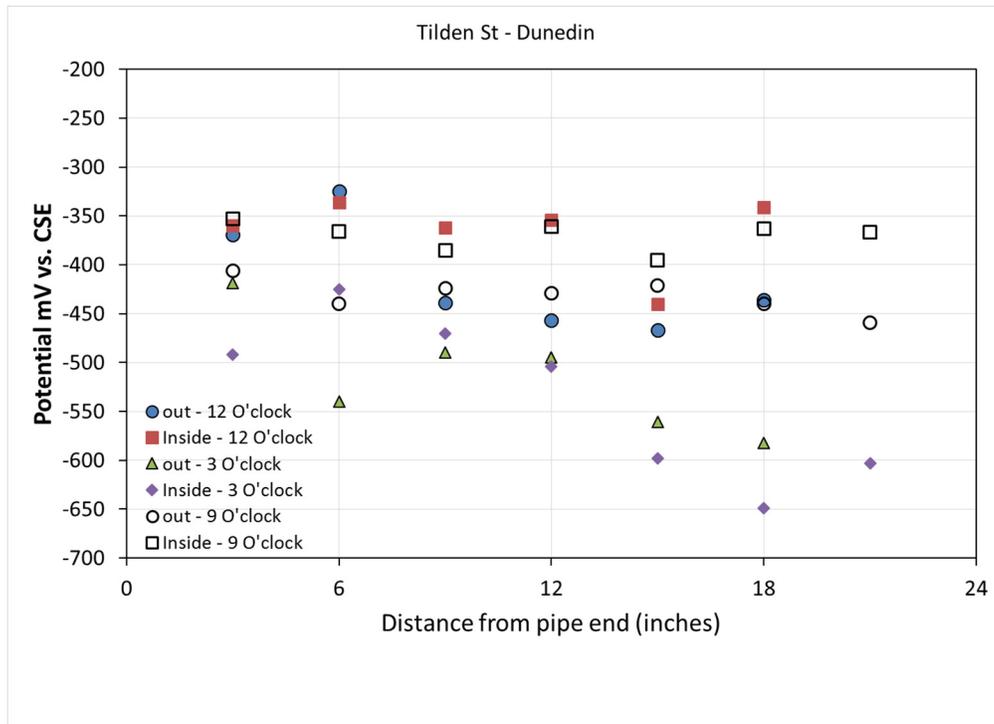
Figure 172 – Potential values along longitudinal wires at Tilden St. pipe (Dunedin, FL).

Figure 171 shows the pipe condition for the RCP located at Tilden St. Some of pictures show red rust stains inside of the pipe, and one of the inset pictures show that there is a crack several cm long. Figure 172 shows the potential values measured along the longitudinal wires on the pipe located at Tilden St. The measured values suggest that the reinforcing steel mesh is likely undergoing corrosion. No portion of this pipe was immersed during the visit. The resistivity measured on the inside of the pipe range between 1 kΩ-cm and 6 kΩ-cm.

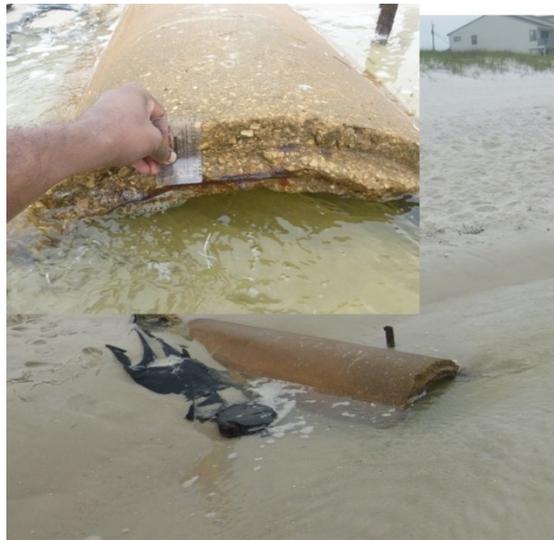
Figure 173 – RCP found at location close to Sugar Sands Inn.

A 24" diameter pipe discharging into the Gulf of Mexico was found at this site. Figure 173 shows a couple of pics of the RCP found at this location. Reinforcement potential values were measured along two longitudinal wires. The resistivity measure on the top side of the pipe was 14 k $\Omega$ -cm. One of the spiral wires closest to the surface was exposed and at some location had lost significant section and was now 2 mm. This exposed wire was used to do the electrical connection. The reinforcement potential values range between -450 and -550 mVcse. Figure 174 shows the potential profile. The potential values suggest that corrosion is on-going.

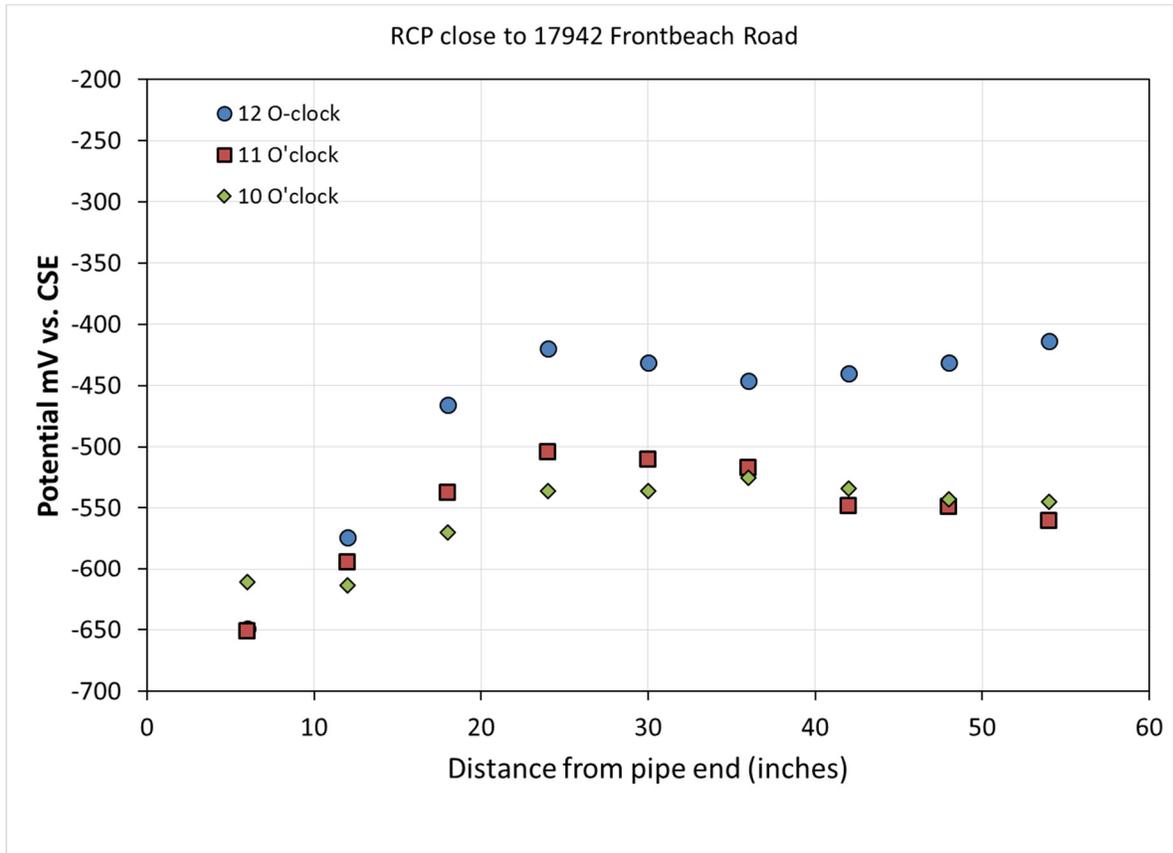
Figure 175 – Potential values measured along longitudinal wires on RCP close to 17942 Front beach Road Site.

A 36" diameter pipe was found at this site. A liner is installed on the inside of this pipe. The concrete cover was 1.5" from the inside and 2.5" cover measured from the outside. Figure 175 show the potential profiles measured along selected longitudinal wire reinforcements. The potential values were more negative than -400 mVcse, suggesting that corrosion of the steel is taking place. The lower resistivity measured on this pipe was 12.6 kΩ-cm and the largest measured value was 40 kΩ-cm.

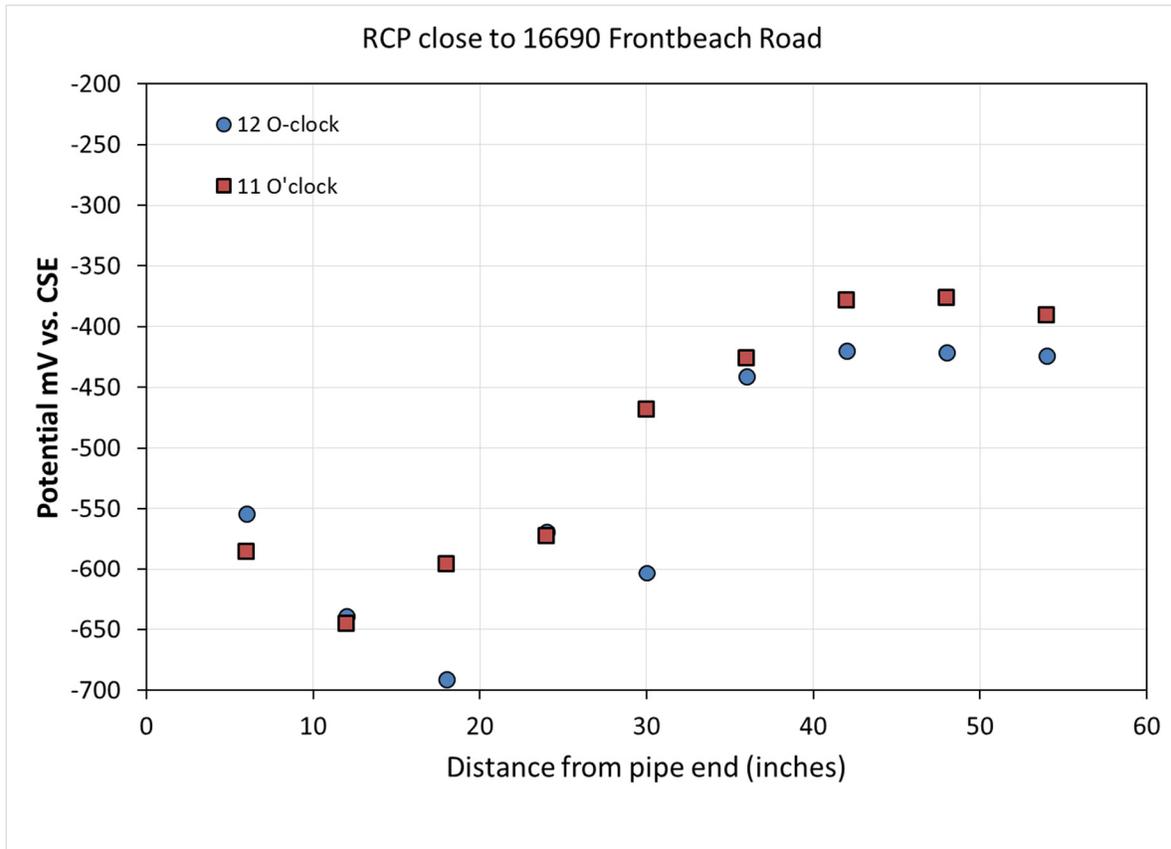
Figure 176 – Potential values measured along longitudinal wires on RCP close to 16690 Front Beach Road Site.

The RCP found at this site was 4 feet in diameter. This RCP has a dual wire cage. The cover from the inside to the inner cage was two inches and the concrete cover from the outside surface to the outer cage is one inch. The potential profile corresponds to values measured along a couple of the outer longitudinal wires. A concrete resistivity of 2.5 kΩ-cm was measured at a few location and was the lowest measured value. At a different location the concrete resistivity was 30 kΩ-cm. Figure 176 shows that all potential values measured were more negative than -350 mVcse, suggesting that the steel wire mesh is undergoing corrosion.

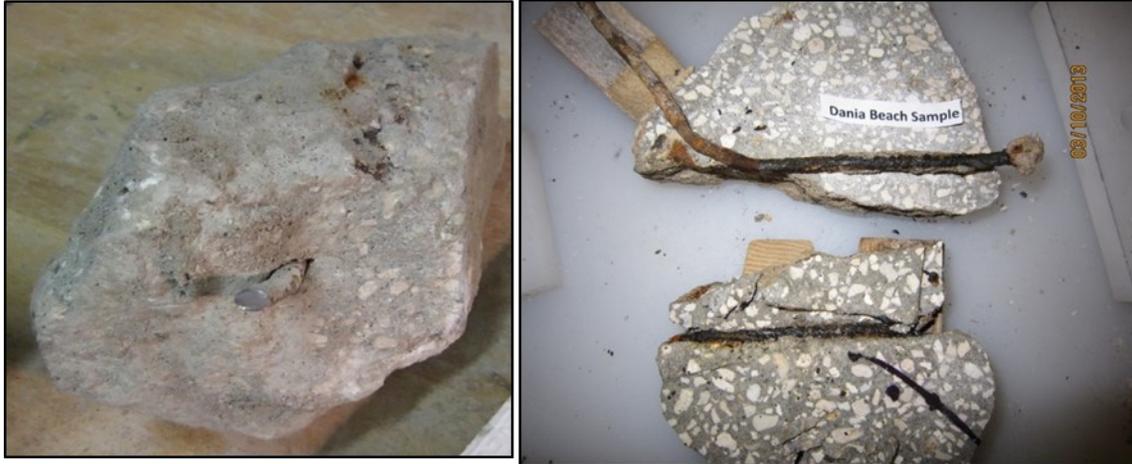
Figure 178 – Reinforcement exposed from a small segment obtained from Dania Beach Marina site.

During Fall/2013, two small RCP pieces were obtained from the removed pipes. The concrete was removed and the reinforcing steel exposed. Figure 178 and Figure 179 show the reinforcement surface condition. Figure 2 shows that the reinforcing wire had undergone significant corrosion. Figure 3 shows that the steel wire had only a couple of superficial rust spots.

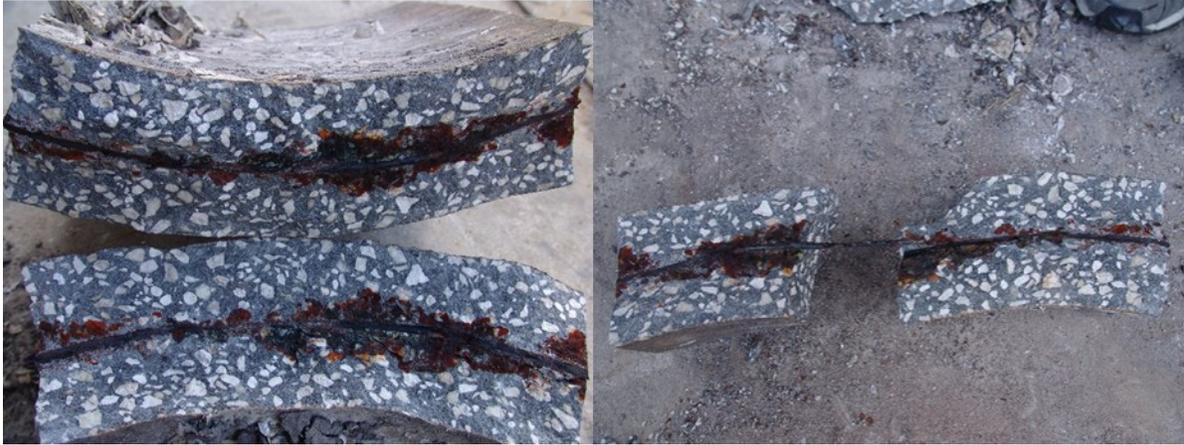
Segments terminated during April 2015 are shown in Figure 180, Figure 181 and Figure 182. Figure 180 and Figure 181 shows that the reinforcement corroded completely on some areas and on other areas a significant cross-section had taken place. Figure 182 shows that the steel reinforcement had corroded significantly along one of the longitudinal wires, but not on the rest of the steel mesh.

Figure 180 – After breaking the segment in two pieces. Significant cross-section loss observed on wire.

Figure 199 to 202 show certain similarity with what was observed on a couple of the forensically analyzed sections obtained from the Indian Rock site (Figure 180 to 182). The corrosion was not as severe/advanced on specimen FS2 when compared to the steel removed from the segment shown in Figures 180 to 182 (Indian Rock pipe), which was not longer there at some locations.

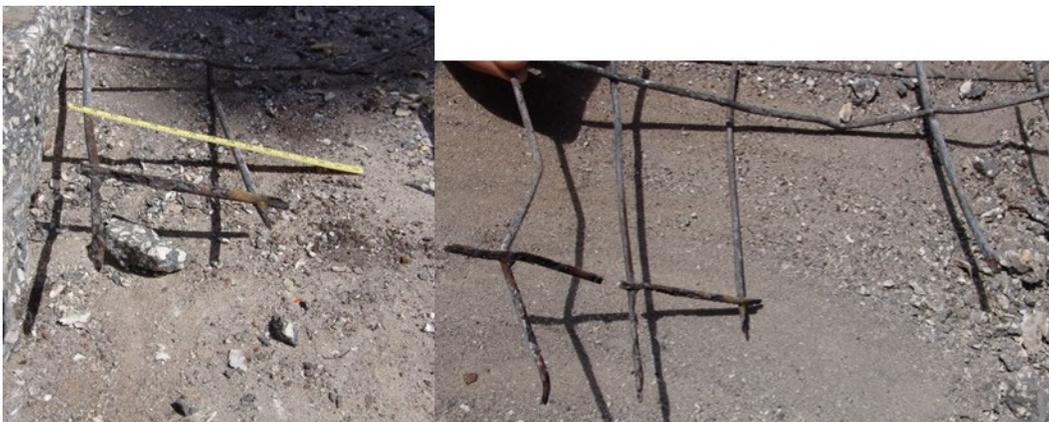
Figure 182 – Steel wire mesh removed from a different concrete segment from the same pipe

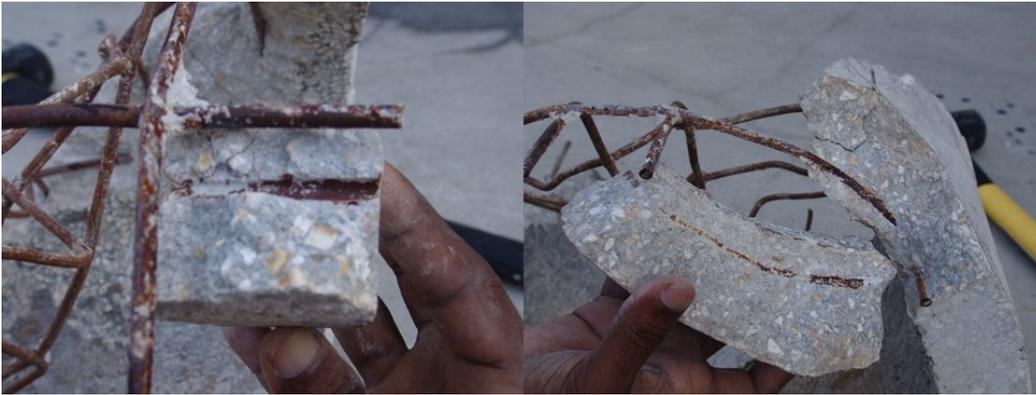
A small pipe (12 inches internal diameter) segment was obtained from a Miami Beach project during summer 2013. Most of the pipe removed at the site was not RCP. The pipe was stored (exposed to lab humidity and room temperature) after removal from the site at the marine materials lab for more than a year. The segment had a portion of the mesh exposed to the lab environment. A piece of the RCP was cut-off. The steel wire was exposed for a portion of the mesh covered with concrete (i.e., the concrete was removed). Figure 183 shows the surface condition after removing the concrete. It is evident that corrosion took place, but no significant cross-section was observed.

Figure 183 – Removed concrete revealed that only surface rust was observed.

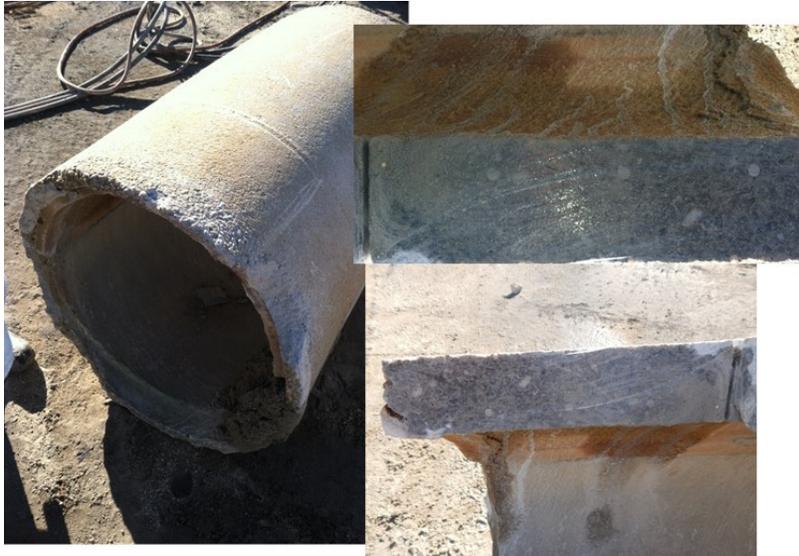
Pre-World War II RCP 24-inch diameter pipes were removed during the re-construction of the Space Coast Regional Airport Taxiway B, Titusville, Florida, during 2013. Selected pipes were moved to Rinker concrete pipe plant in Apopka. The pipes were 4-ft. long, with mortar joints. It is estimated that the pipe segments are ~75 years young. Potential measurements were performed on these pipes during a site visit that took place December 2014. Rinker provided the picture shown below after a cut was made on one of these pipes. No signs of corrosion are observed from the cross-sections shown on Figure 184.

Figure 184 – Cross-section shortly after wet cut. No signs of corrosion are visible.

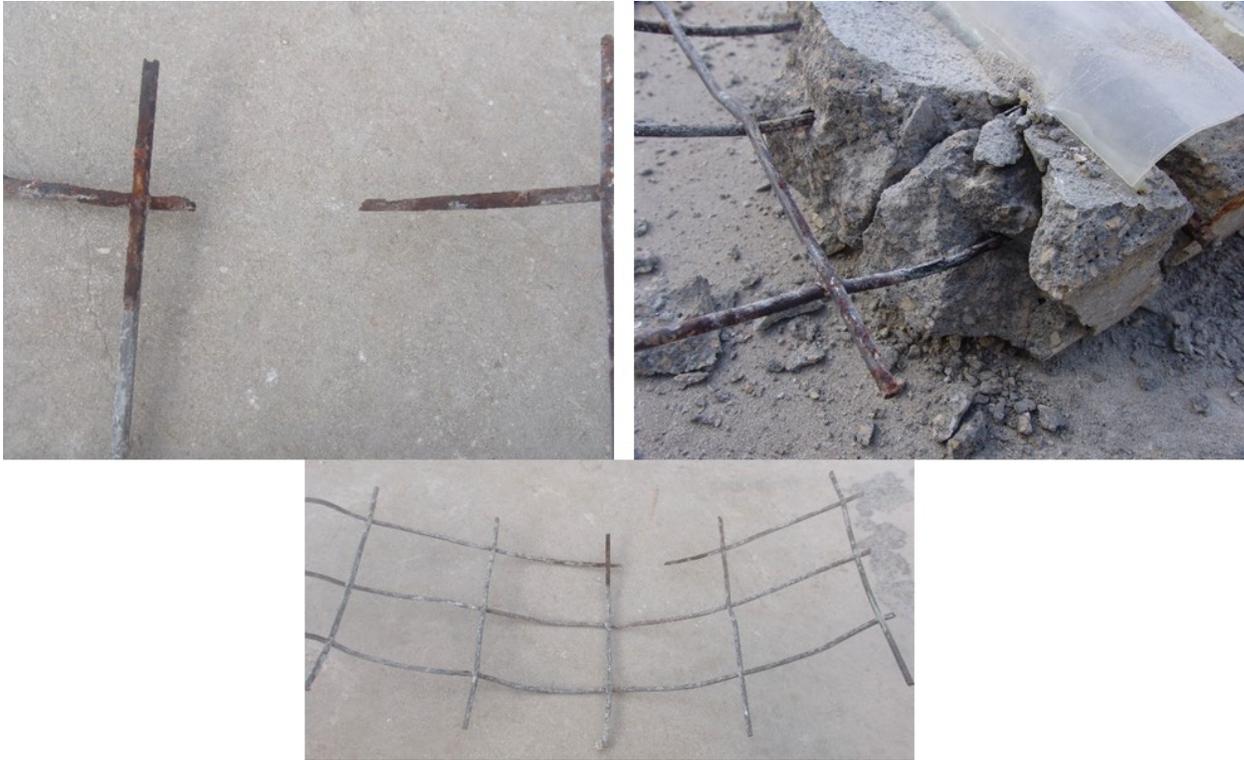
Figure 189 – Pictures were taken after removing and while removing the concrete.

Figure 188 shows on the right a picture of the corrosion extent that took place close to the solution reservoir, shortly after the 3EB load test was performed and after removing some of the concrete covering the steel wire. The picture on the top left corner of Figure 189 shows that a section of the steel wire corroded away. The picture on the top right shows that at areas away of the solution reservoir there was no corrosion or a very modest amount. The picture on the bottom shows the steel wire after removing the concrete for the segment brought back to the lab.

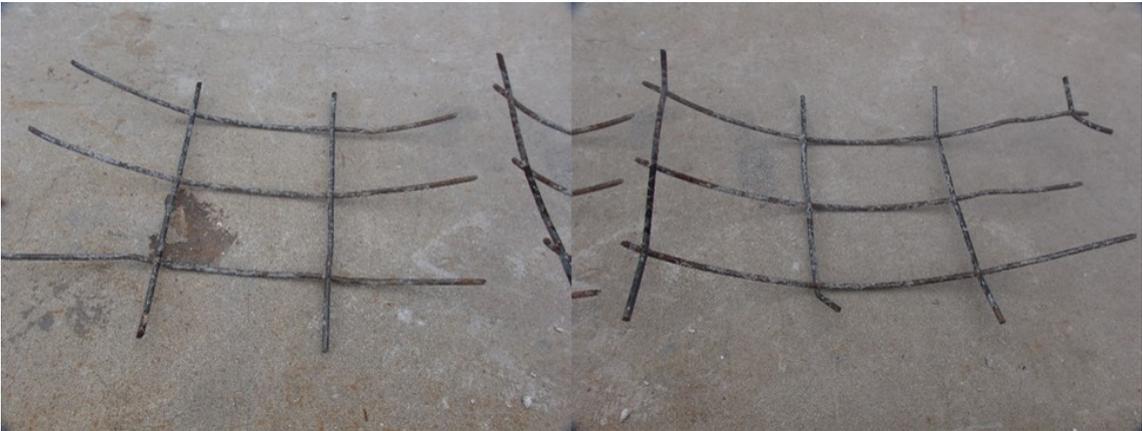
Figure 190 – Steel wire mesh after removing concrete on two pieces from CI2 specimen.

Corrosion initiated after a few months of applying a galvanostatic hold on this specimen, and then it was immersed for over a year in tap water, then covered with sand for one year. A month before the 3EB load test, corrosion was accelerated by immersing about half of the specimen in sodium chloride and applying an electric field to drive additional chlorides into the concrete. Based on the pictures shown in Figure 190 and Figure 191 corrosion did initiate outside of the solution reservoir, but a moderate cross-section loss was observed. (It is possible that a section with more corrosion than that shown in here was not brought back to the lab)

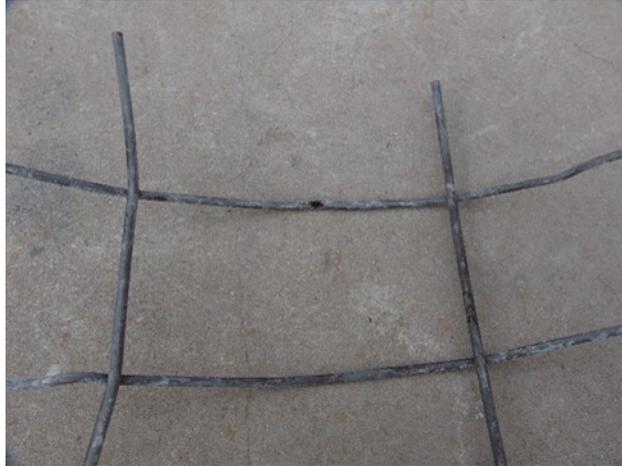
Figure 195 – Steel wire after removing concrete on segment 2 of FI1 specimen.

Specimen FI1 was first exposed for 400 days immersed in water and then exposed outdoors covered with sand. Two segments were selected for forensic analysis from this ring specimen. Figure 194 shows that some corrosion took place on two of the longitudinal wires. Figure 195 shows a small spot where corrosion took place on the second steel wire mesh.

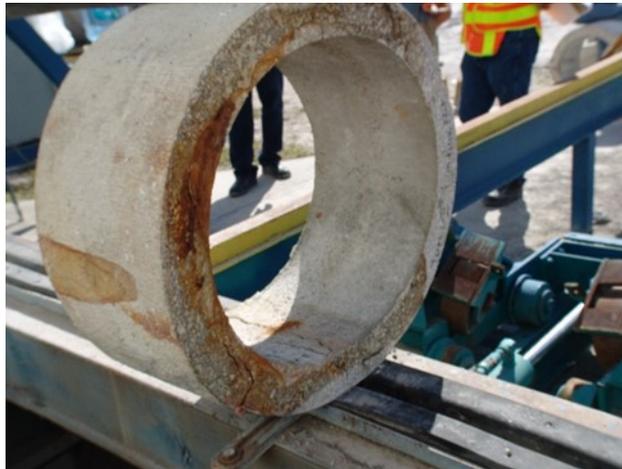
Corrosion initiated under the reservoir after a few weeks on Specimen FS3. This specimen was subsequently covered with wet sand for about two years, during this time corrosion likely continued. Specimen FS3 and specimen FS2 were selected for exposure to additional chlorides via electromigration (via an electric field), followed by applying a constant small current directly to the steel wire mesh to accelerate corrosion. Figure 196 shows specimens FS3 upon completing the 3EB load test. Figure 197 shows the corrosion extent on a segment selected to expose the wire mesh. A moderate amount of corrosion took place on a portion of steel reinforcement.

Figure 196 – Specimen FS3 after 3EB load test. Note the various rust spots.

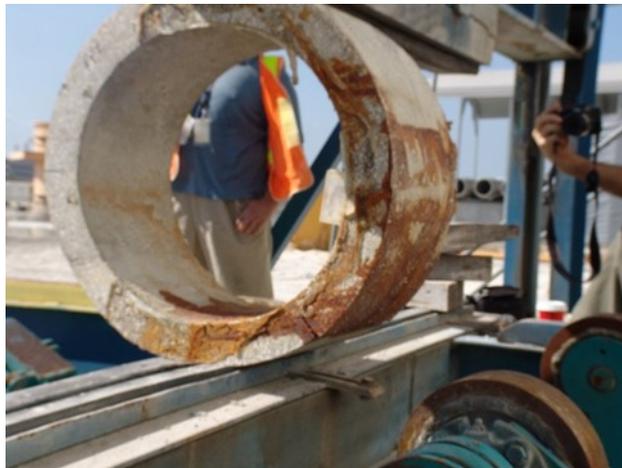
Figure 198 shows that corrosion products bleed/reached a significant surface area on Specimen FS2. After the 3EB load test part of the concrete was removed to assess the steel wire condition. Figure 199 shows dark green corrosion products at the reinforcement and concrete reinforcement trace upon removing the concrete, and some areas showing red rust. Figure 200 show significant penetration into the concrete of the corrosion products that did not cause cracks. Figure 201 and Figure 202 showed that red (dark or light) color was observed upon removing all the concrete and allowing for a few days to pass.

Figure 198 – Specimen FS2 prior to 3EB load test. Note the various rust spots.
