Long-Term Performance of a Hot In-Place Recycling Project – Final Report

WA-RD 738.2

Long-Term Performance of a Hot In-Place Recycling Project Final Report

Contract 7648
SR-542
Britton Road to Coal Creek Bridge Vicinity
MP 3.38 to MP 19.27

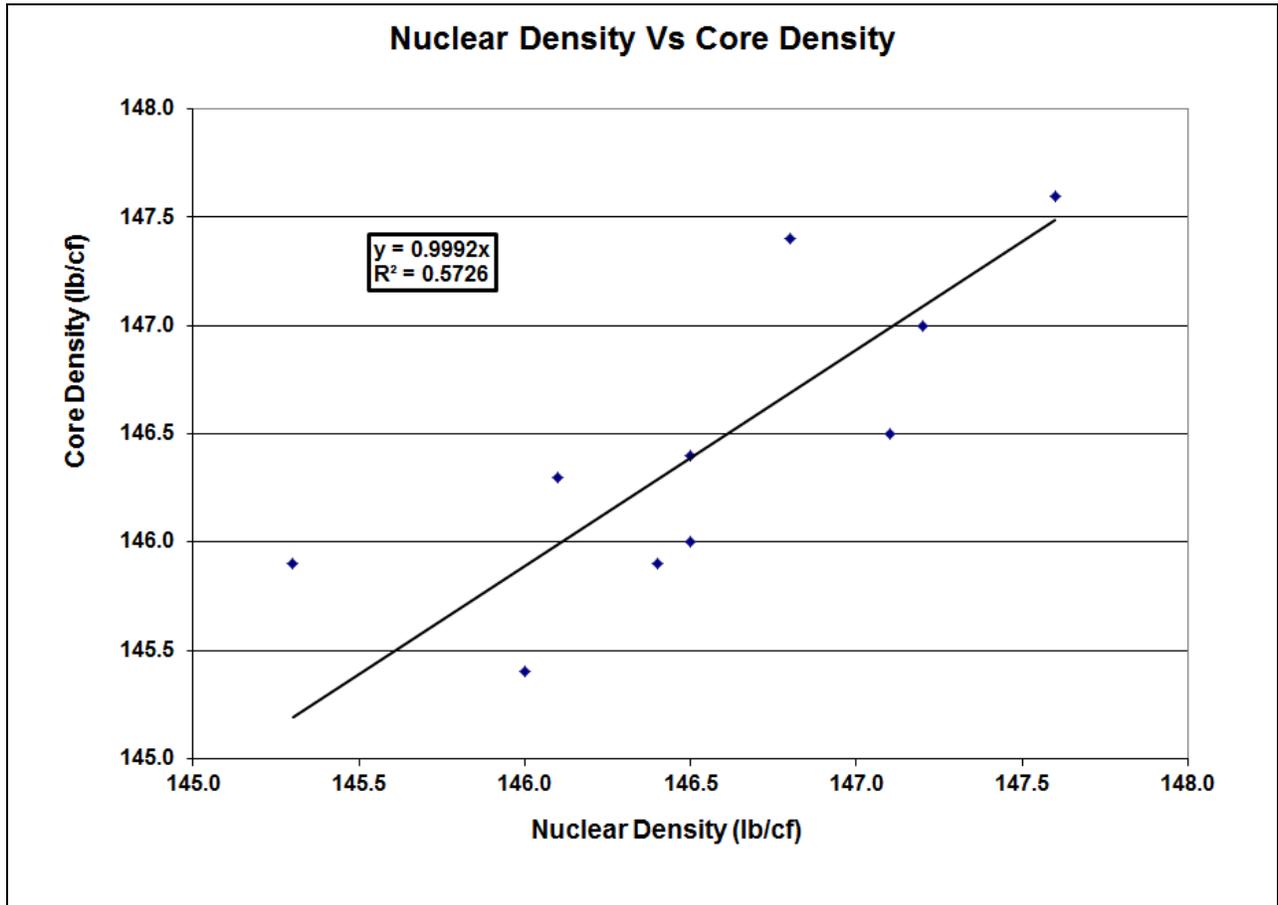
Figure 16. Plot of nuclear density gauge readings vs. core density results.

Although WSDOT did informational density testing on the entire project, the only HIPR pavement correlated to the nuclear density gauge was the section of existing HMA pavement paved under contract 3455. Figure 16 shows a plot of the nuclear density gauge readings compared to the corresponding core density used to correlate the nuclear density gauge. The plot shows a fair correlation ($r^2 = 0.57$) between the two test methods indicating a linear relationship between the nuclear density gauge and core density.

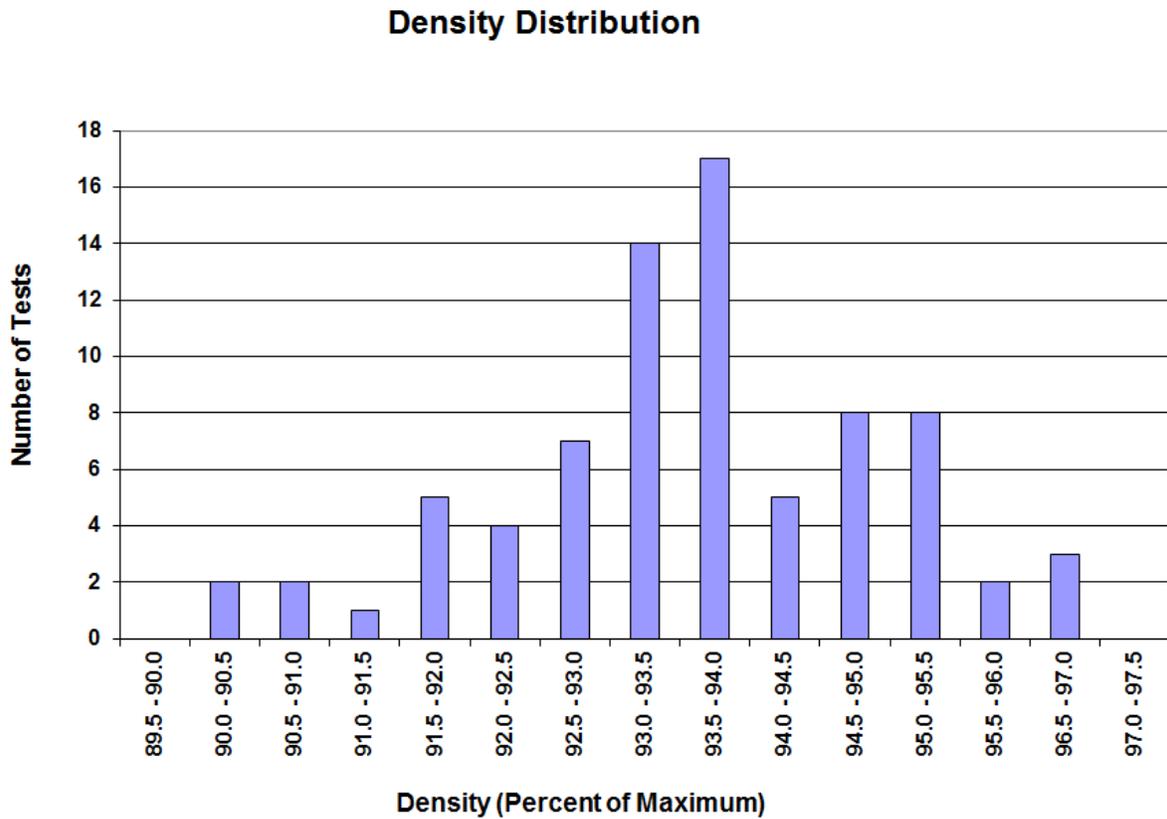
Figure 17. Distribution of corrected nuclear density test results for milepost 14.09 to 19.27.

Within the limits of contract 3455, milepost 14.09 to 19.27, the average density from the corrected nuclear density gauge was 93.5 percent of theoretical maximum with a standard deviation of 1.37. The percentage of tests below WSDOT's 91.0 percent minimum density requirement was 4.7 percent. Figure 17 shows the distribution of test results. Appendix E includes complete density testing results.

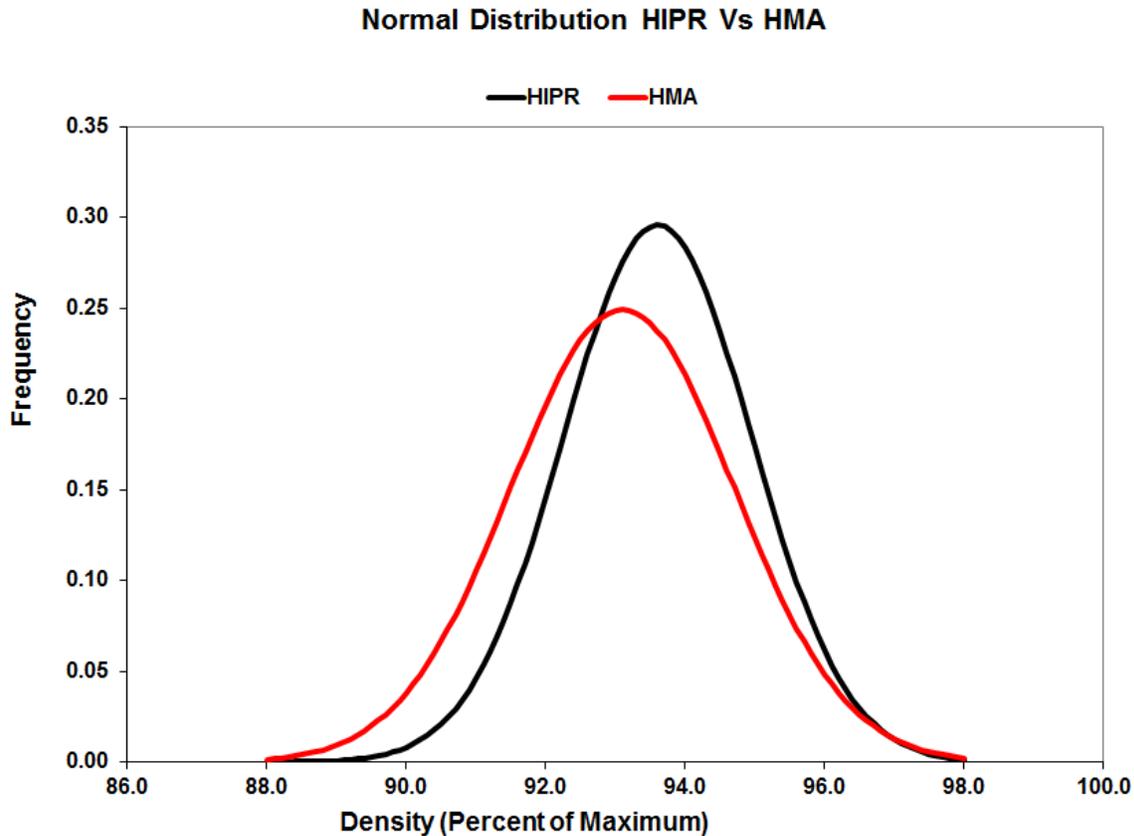
Figure 18. Normal distributions of HIPR density test results vs WSDOT HMA.

Figure 18 compares the normal distribution of HIPR density tests between milepost 14.09 and 19.27 with that of WSDOT HMA density tests taken between 1990 and 2005. The similarity of the two distributions suggests that HIPR is capable of achieving in place densities comparable to HMA paved on WSDOT projects.

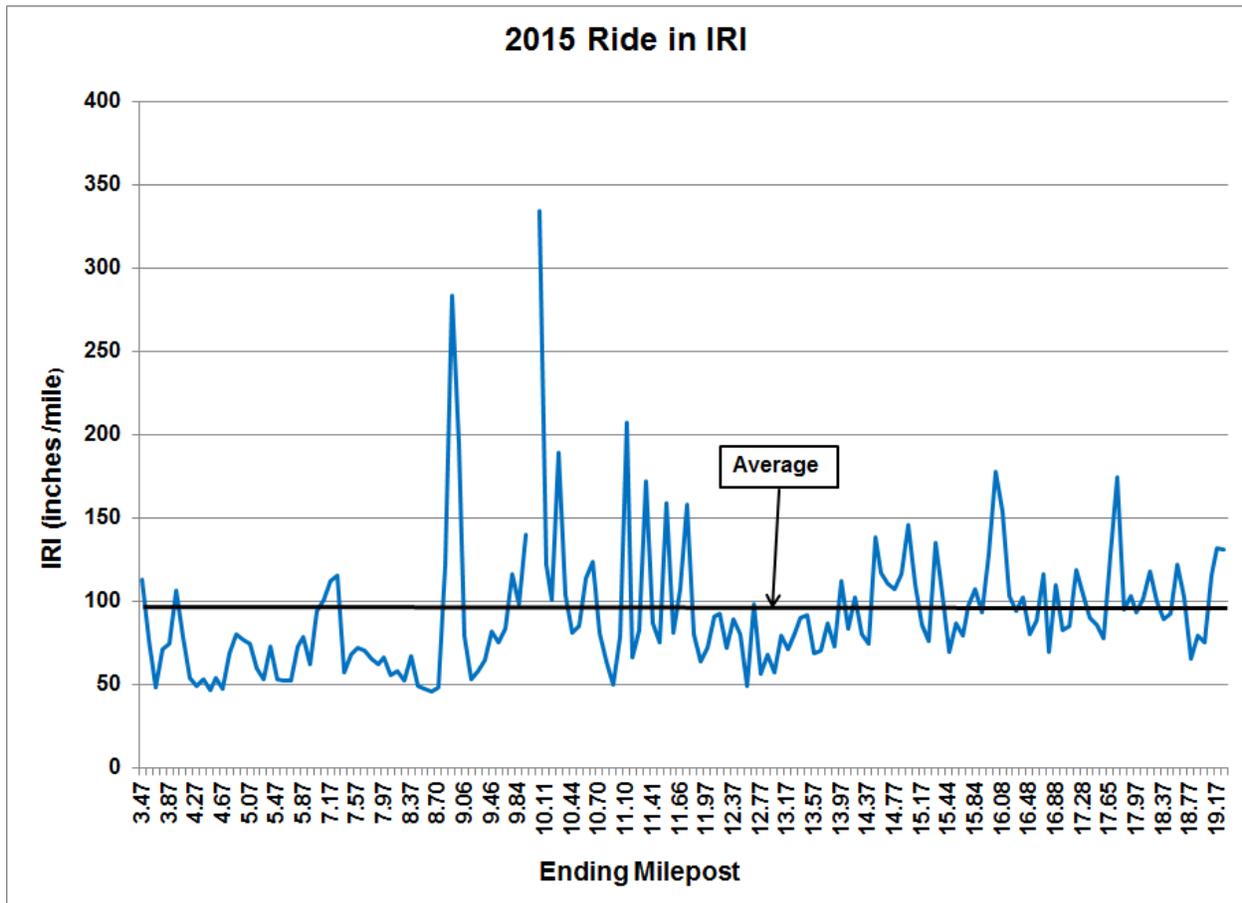
Figure 19. Ride measurements for 2015 showing average of 93 inches/mile.

The ride measurements in International Roughness Index (IRI) units of inches per mile are listed in Table 12 and shown graphically in Figure 19. The average IRI of 93 is high for a new pavement and the spikes in roughness at various locations throughout the length of the project indicate that this particular HIPR process did not produce the smoothest profile.

Year	2015
Average	93
Maximum	335
Minimum	46

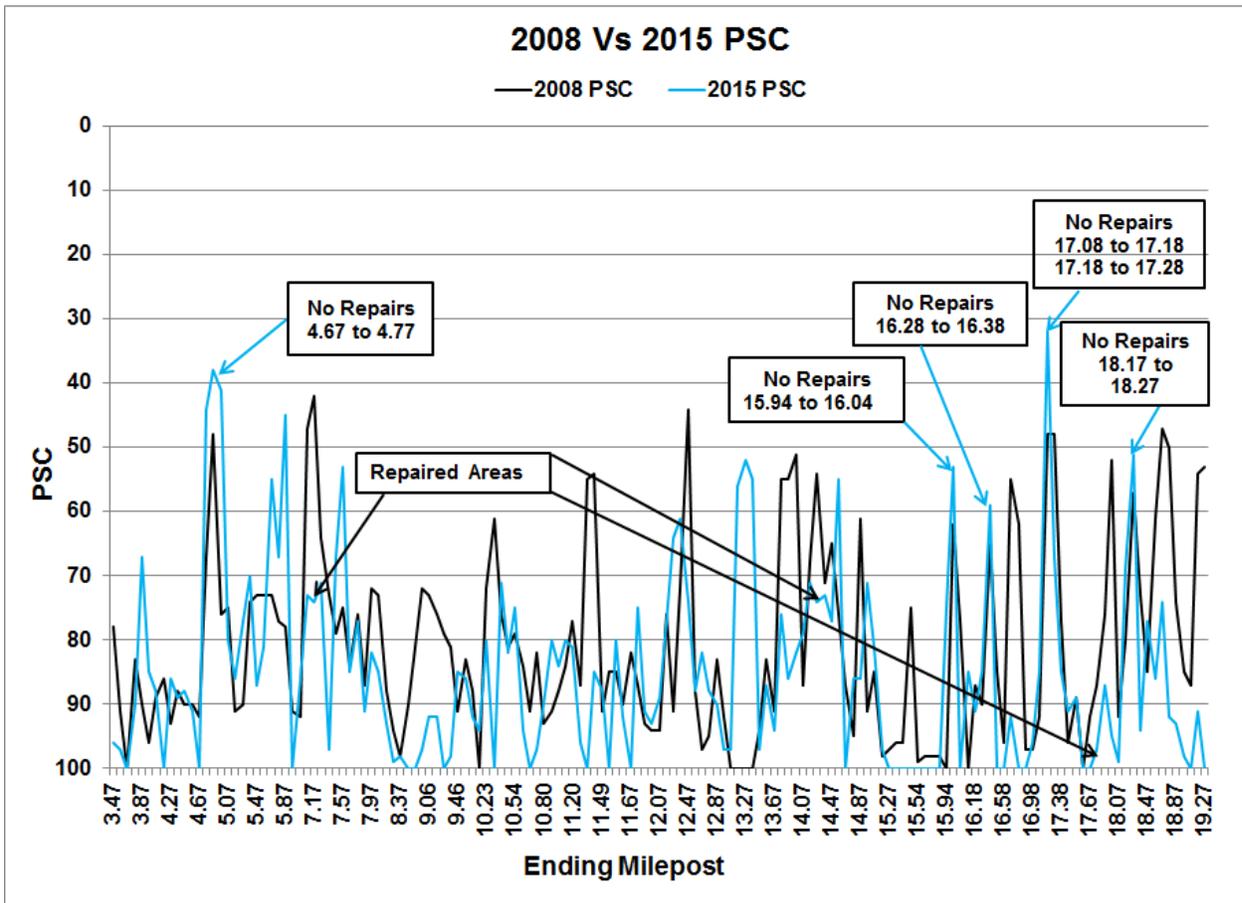
Figure 20. PSC readings from 2008 and 2014.

The underlying structure of the roadway appears to be the source of some of the cracking noted in the HIPR pavement at locations other than those repaired prior to the construction of the HIPR pavement. The WSPMS pavement structural condition (PSC) ratings for 2008 (black line) and 2015 (blue line) are compared in Figure 20. The repaired areas from Table 13 are noted. Areas noted with blue arrows have low PSC's (less than 70) in both 2008 and 2015 surveys indicating the possibility that the underlying pavement structure is having a negative effect on the performance of the HIPR pavement. Table 14 lists the segment locations and the 2008 and 2015 PSC's. The possibility exists that additional full depth repairs in these segments may have improved the cracking performance of the HIPR pavement.

Table 14. Segments with low PSC values in both 2008 and 2015 surveys that did not receive repairs prior to the HIPR.				
Segment	Beginning Milepost	Ending Milepost	PSC	
			2008	2015
1	4.67	4.77	44	67
2	4.77	4.87	48	58
3	15.94	16.04	53	62
4	16.28	16.38	65	59
5	17.08	17.18	32	48
6	17.18	17.28	67	48
7	18.17	18.27	51	57
