### 4.3 Analytical Methods and Results

**4.3.6 Span Condition Ratings**

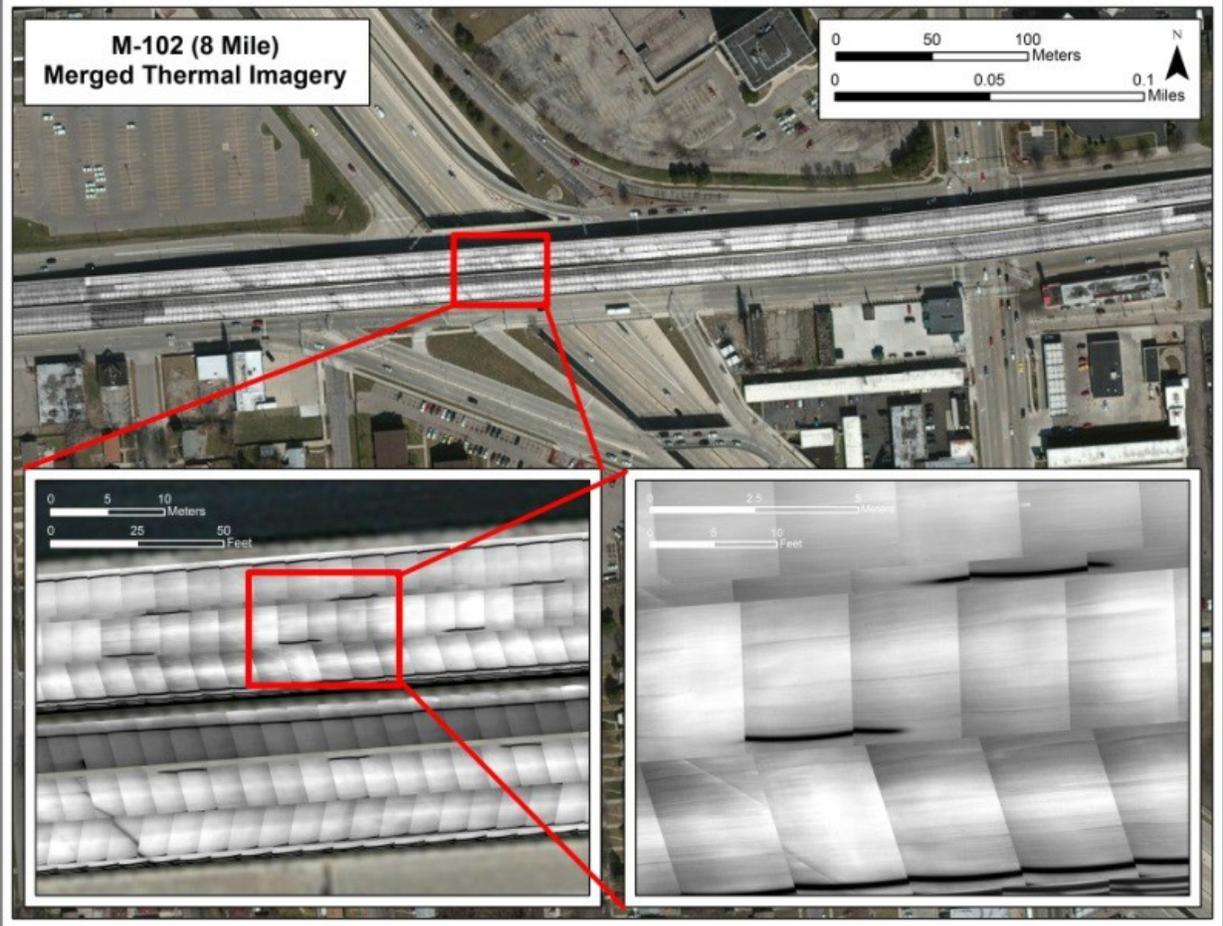
Figure 24: Merged thermal imagery merged of M-102 (8 Mile) eastbound and westbound bridge decks.

Similarly, the thermal imagery was also merged together through the same automated script. Individual frames were cropped and placed end-to-end, resulting in a single image for subsets of the bridge deck. The subsets were then merged together and georeferenced to ESRI base maps to create a single image per pass over the bridge (Figure 24). GS Infrastructure, Inc. inspected the thermal imagery and indicated any location that appeared to have a potential delamination. The merged optical and thermal images can then be placed on top of another and by using transparent layers in the GIS software; a better overview of where potential delaminations exist on the bridge deck can be seen (Figure 25). In total, 398 potential delaminations were identified by GS Infrastructure, Inc., totaling an area of 2,942 ft<sup>2</sup>, or approximately 1.73% of the entire bridge deck.

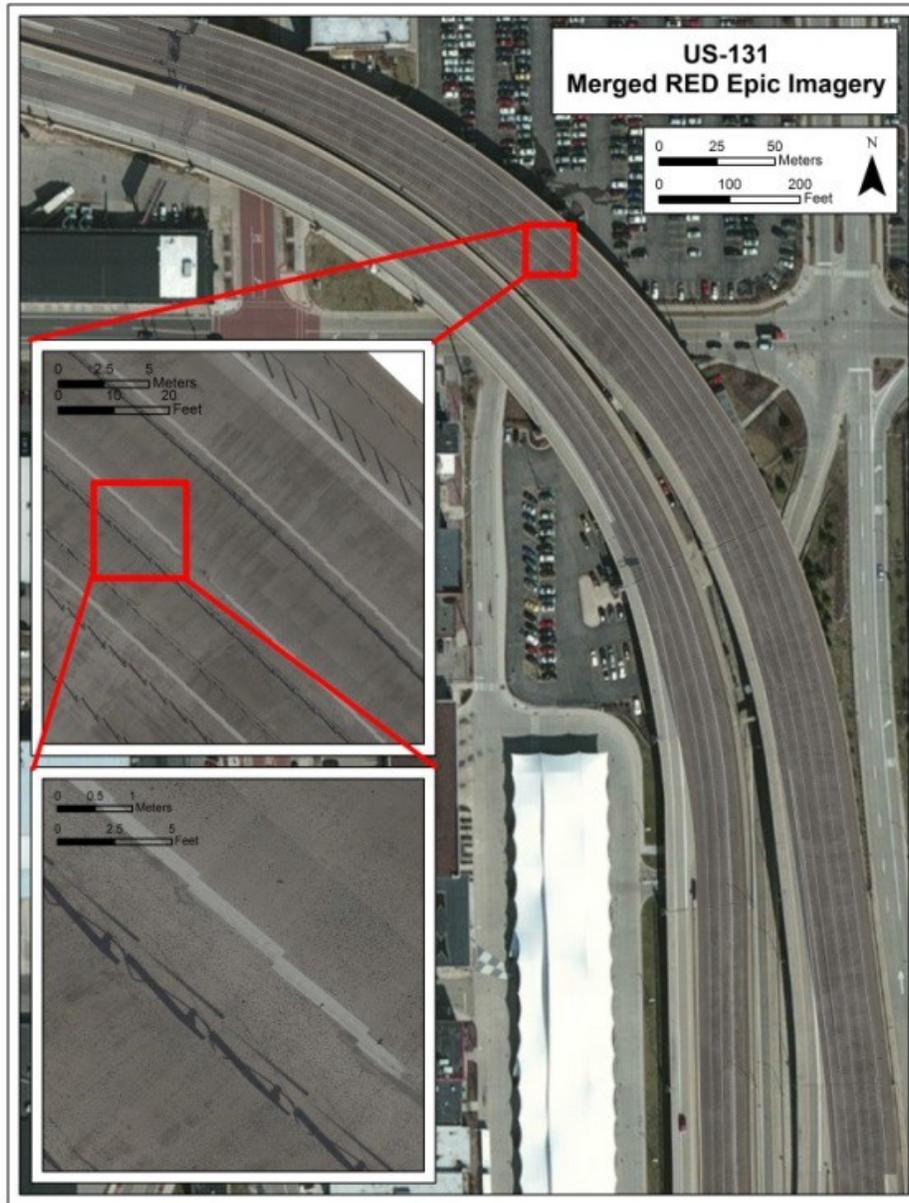
**Figure 26: RED Epic imagery merged together to form the US-131 northbound and southbound bridge decks.**

By using the same script that automated the merging of each individual frames extracted from the RED Epic video imagery for the M-102 (8 Mile) bridge deck, a single merged image of US-131 north and southbound bridge decks were created (Figure 26). Similar to the M-102 (8 Mile) bridge deck, the optical image was created though the merging of imagery from the different vehicle passes over each lane. The separate passes over the bridge deck did not line up perfectly with one another, resulting in slight distortion of pavement markings and bridge joints. However, the merged optical imagery proved useful as it provided an overview of how the bridge deck appeared during data collection.

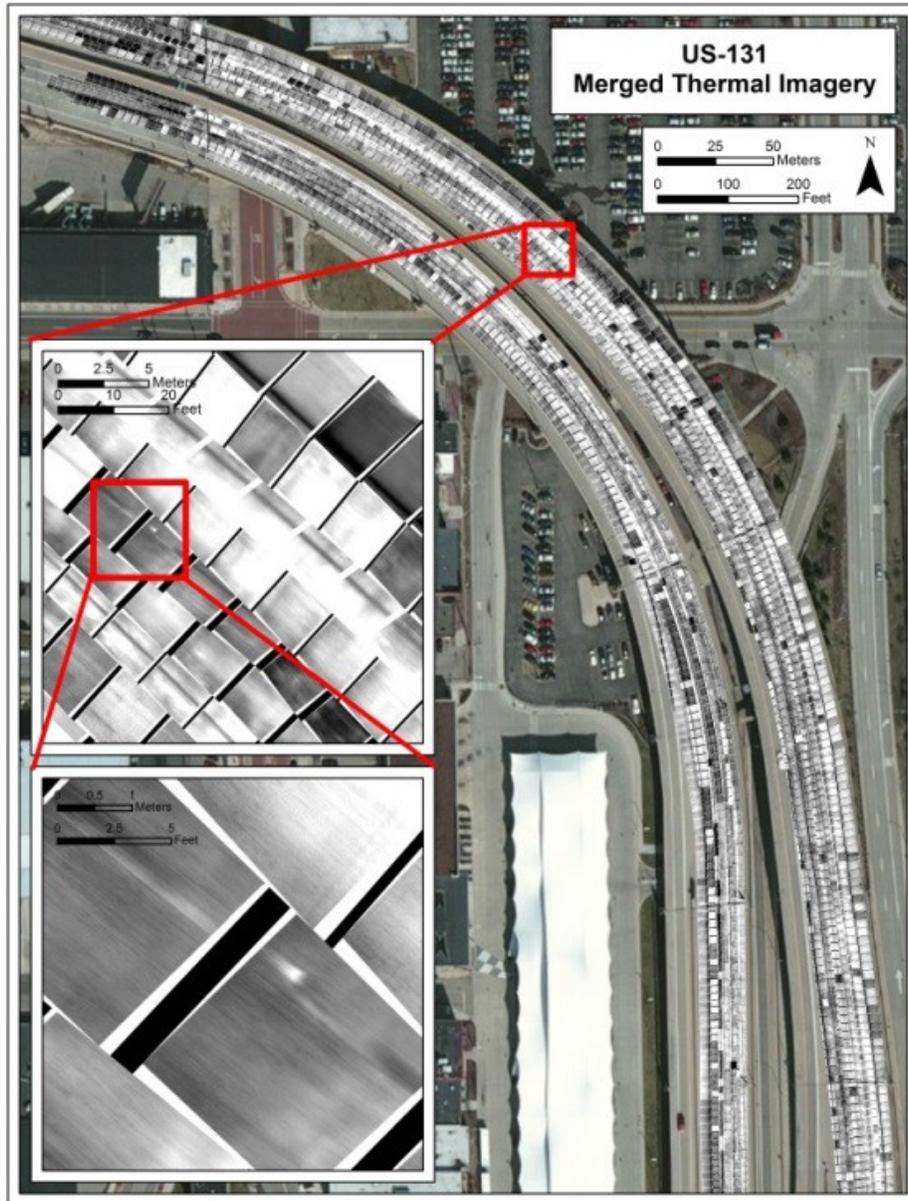
Figure 27: Merged thermal imagery of US-131 northbound and southbound bridge decks.

After merging the thermal imagery from US-131 through the use of the automated merging script, the merged output was georeferenced to ESRI base maps (Figure 27). GS Infrastructure, Inc. inspected the thermal imagery and indicated any location that appeared to have a potential delamination. The merged optical and thermal images were then placed on top of one another and through the use of transparent layers in the GIS software, an overview of potential delaminations and spalls appear on the bridge deck (Figure 28). In total, 133 potential delaminations (34 northbound and 90 southbound) were identified by GS Infrastructure, Inc. totaling an area of 532 ft<sup>2</sup>, or approximately 0.25% of both bridge decks combined. For the overall summary of each span's condition, please reference figures 41 and 42 and tables 9 and 10 in Section 4.3.6.

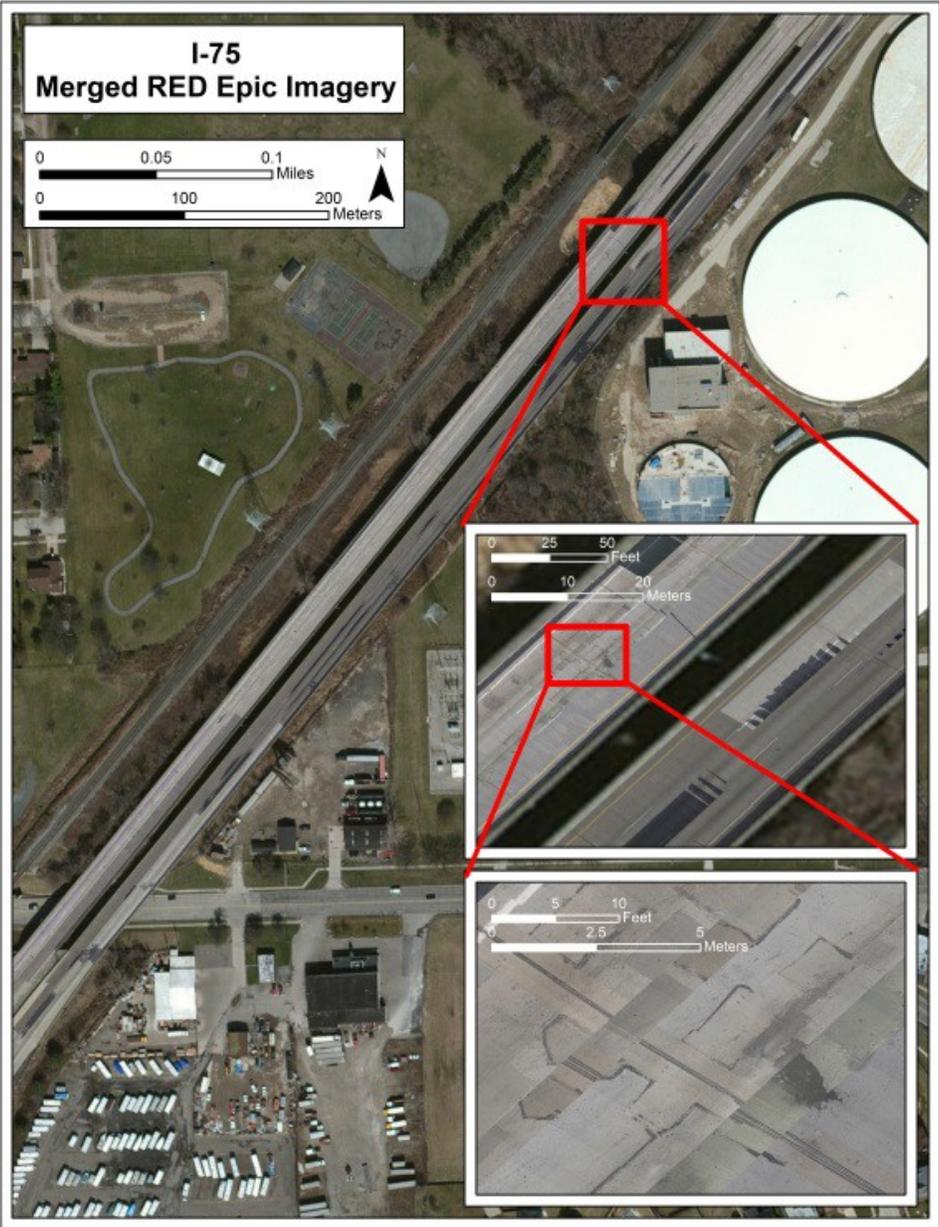
Figure 29: RED Epic imagery merged together to form I-75 northbound and southbound bridge decks.

Upon merging the individual frames from the RED Epic for each separate pass over the bridge decks, a single merged image of the I-75 north and southbound bridge decks was created (Figure 29). Imagery from separate passes over the bridge deck did not line up perfectly with one another, resulting in slight distortion of pavement markings and bridge joints. However, the merged optical imagery proved useful as it provided an overview of how the bridge deck appeared during data collection.

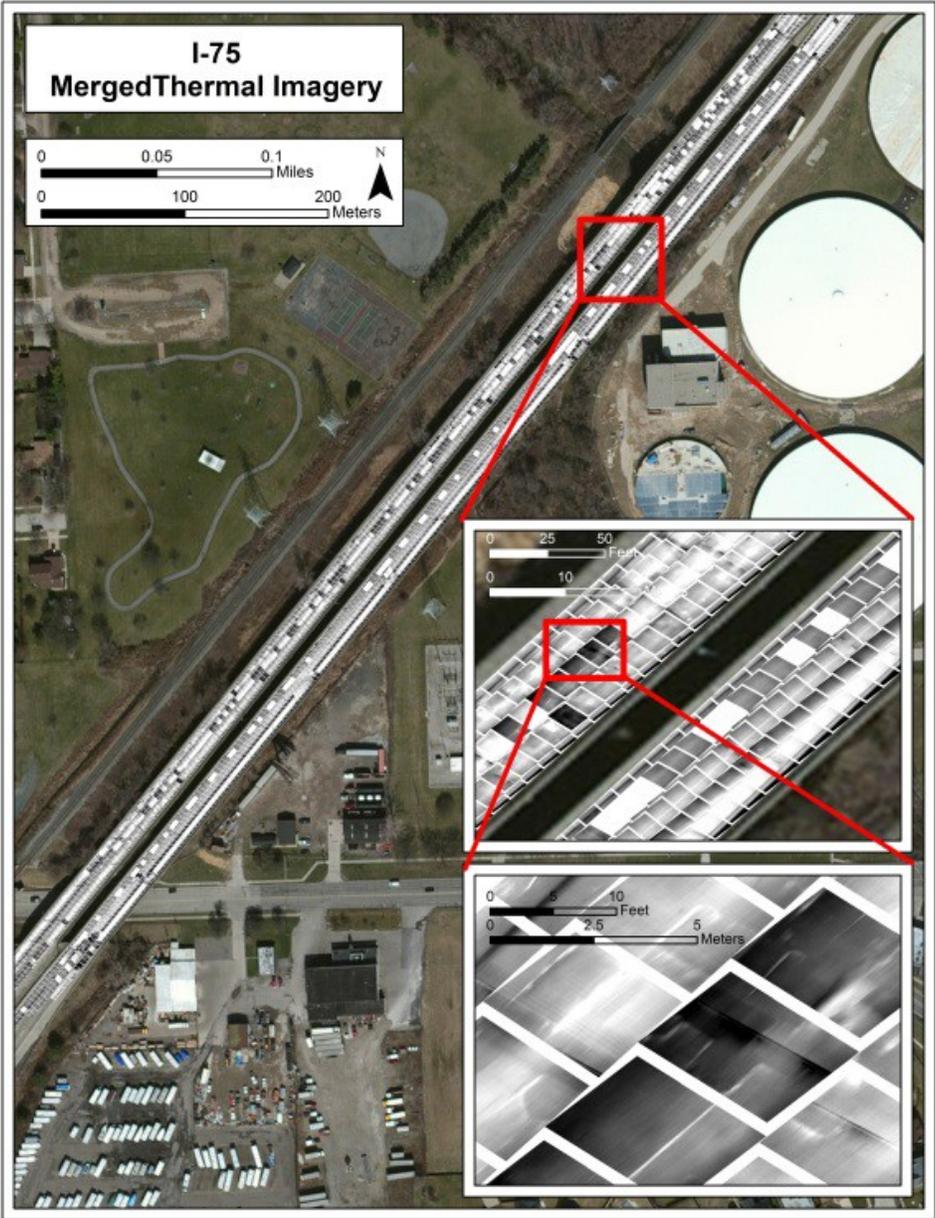
Figure 30: Merged thermal imagery of I-75 northbound and southbound bridge decks.

through the use of the automated merging script, the merged output was georeferenced to ESRI base maps (Figure 30). GS Infrastructure, Inc. inspected the thermal imagery and indicated any location that appeared to have a potential delamination. The merged optical and thermal images were then placed on top of one another and through the use of transparent layers in the GIS software, an overview of potential delamination locations and spalling appear on the bridge (Figure 31). In total, 1,877 potential delaminations (515 northbound and 1,362 southbound) were identified by GS Infrastructure, Inc. totaling an area of 16,328 ft<sup>2</sup>, or approximately 8.50% of both bridge decks combined. As previously noted, spalls and delaminations are color-coded by condition state as noted in AASHTO BEIM (2015). For the overall summary of each span's condition, please reference figures 43 and 44 and tables 11 and 12 in Section 4.3.6.

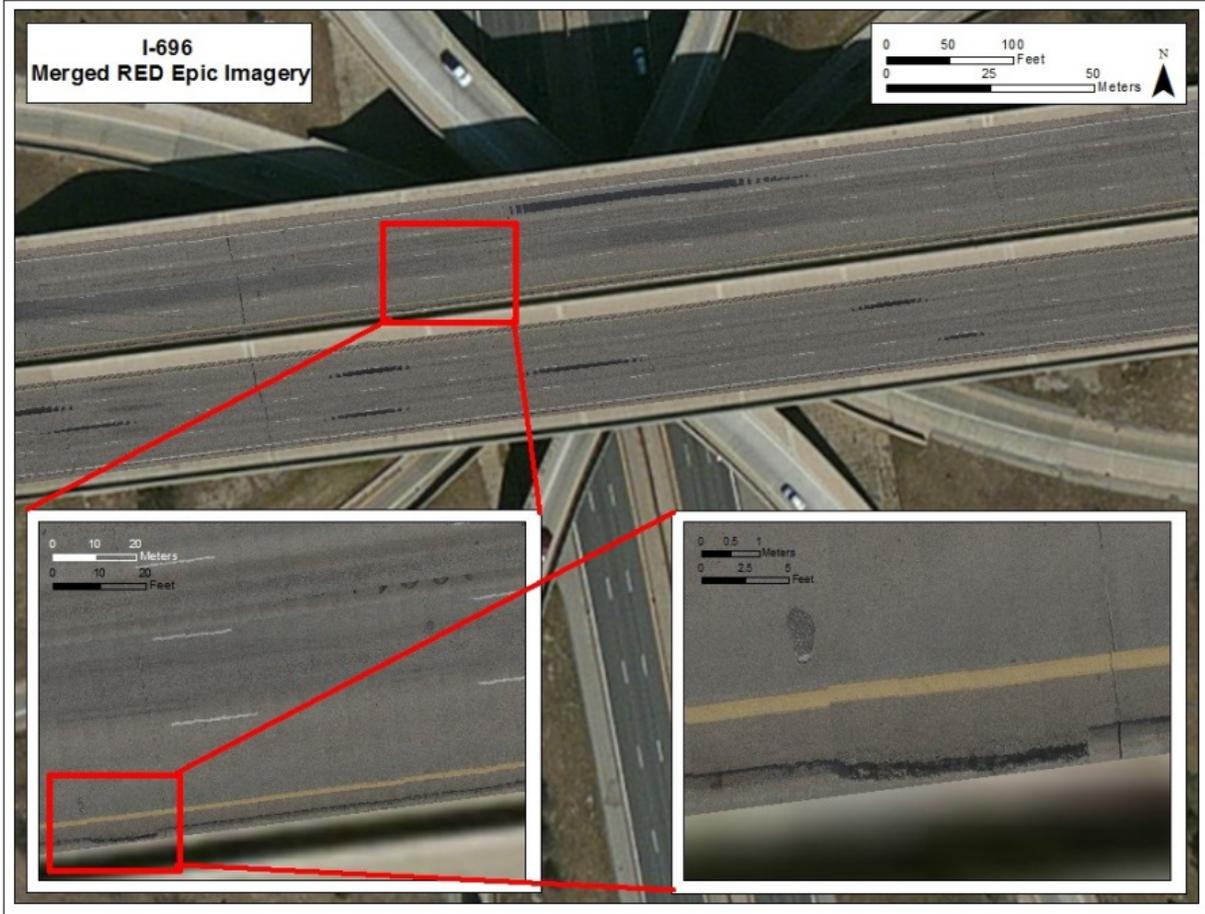
Figure 32: RED Epic imagery merged together to form I-696 eastbound and westbound bridge decks.

Upon merging the individual frames from the RED Epic for each separate pass over the bridge decks, a single merged image of the I-696 west and eastbound bridge decks were created (Figure 32). The imagery from the separate passes over the bridge deck did not line up perfectly with one another, resulting in slight distortion of pavement markings and bridge joints. However, the merged optical imagery proved useful as it provided an overview of how the bridge deck appeared during data collection.

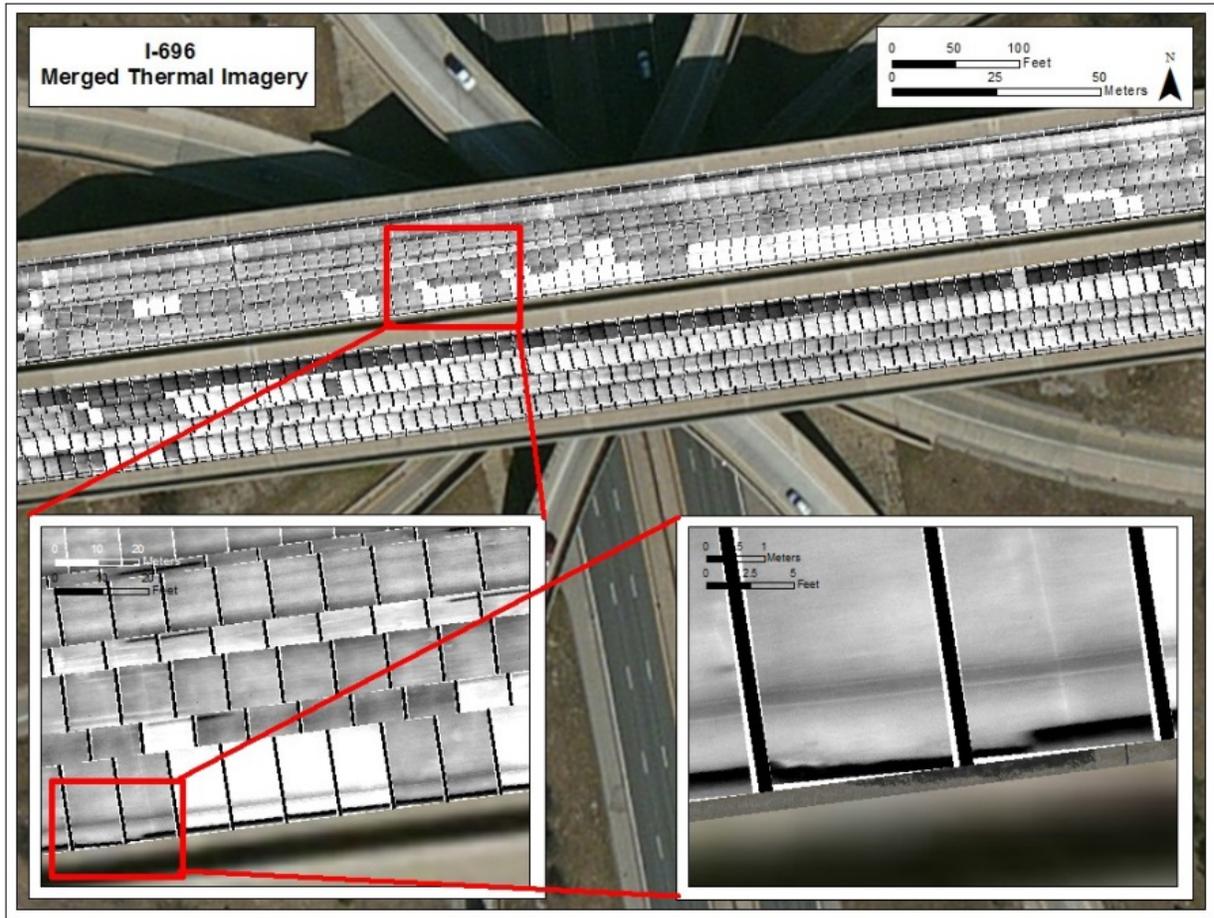
Figure 33: Merged thermal imagery of the I-696 bridge deck.

delamination. The merged optical and thermal images were then placed on top of one another and through the use of transparent layers in the GIS software, a better overview of where potential delaminations exist and how it appears on the bridge deck can be seen (Figure 34). In total, 203 potential delaminations were identified by GS Infrastructure, Inc., totaling an area of 1,125 ft<sup>2</sup>, or approximately 1.10%. For the overall summary of each span's condition, please reference Figure 45 and Table 13 in Section 4.3.6.

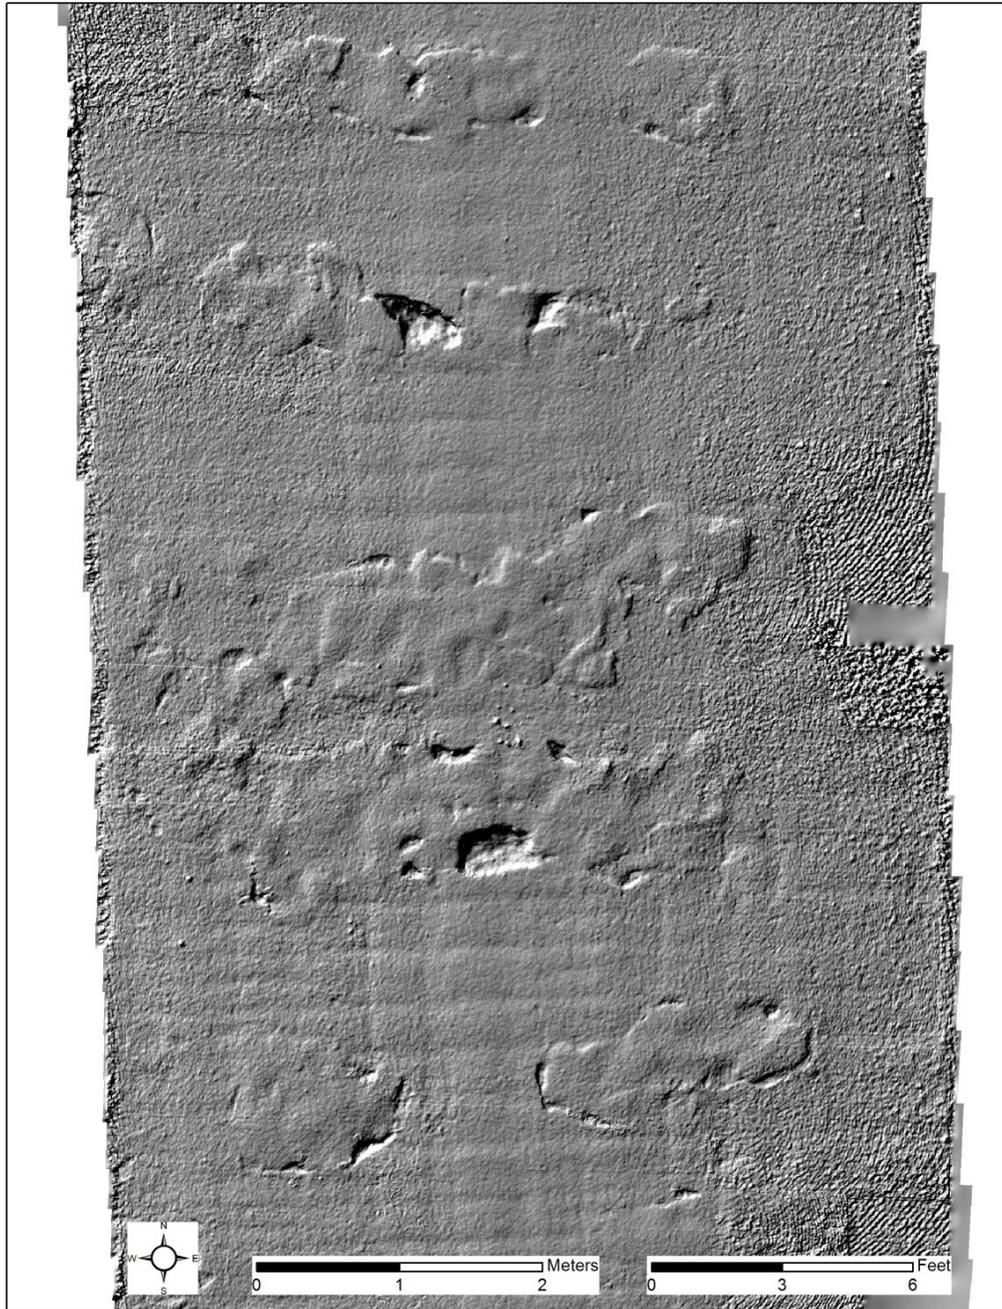
**Figure 38: Zoomed in portion of the Hillshade view of northbound Lake Nepessing Rd. bridge deck.**

Figure 37 shows a zoomed in section of the northbound lane of Lake Nepessing Rd. bridge deck. With a high-resolution orthoimage model, spalls and patches can be located and measured to compare to the in situ measurements. The hillshade of the DEM was reconstructed to show the detail of the patches and spalls (Figure 38). The increased noise on the right and left sides of the hillshade is a result of those areas being mostly flat and with less imagery overlap. There is less overlap on the sides than the center of the model. The edges were reconstructed from a single pass resulting in a point on the ground being represented in five frames. The center of the model was reconstructed from the overlap of both passes of the data collection resulting in a point on the ground being represented in at least 10 frames. The noise in the z-axis, or the amount of random error in the model reconstruction, in the center of the model is 0.16 in. (4.2mm) while on the sides of the model is up to 1.79 in. (4.5cm). Features such as spalls cannot be distinguished if they are less than this error.
