DOT/FAA/AM-98/19

Analysis of Ditching and Water Survival Training Programs of Major Airframe Manufacturers and Airlines

Final Report

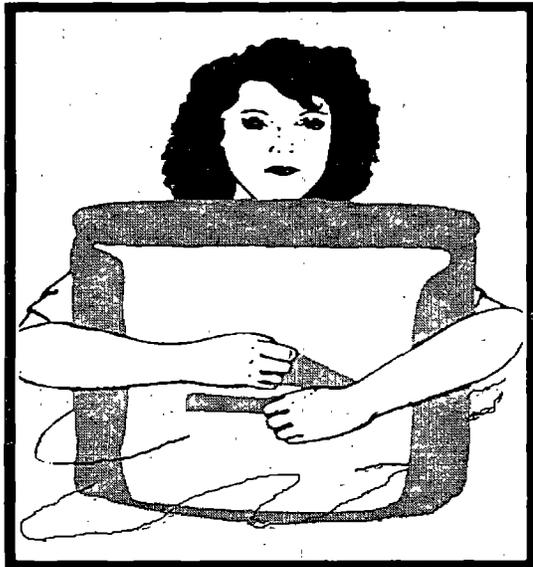
FIGURE 1
Vertical Flotation

advise passengers to hold the cushions in front of their bodies, to rest their chins on the cushions, to wrap their arms around the cushions with their hands grasping the outside loops, and to float vertically in the water (Figure 1). Others suggest that passengers lie forward on the cushions, grasp and hold the loops beneath them, and float horizontally (Figure 2).

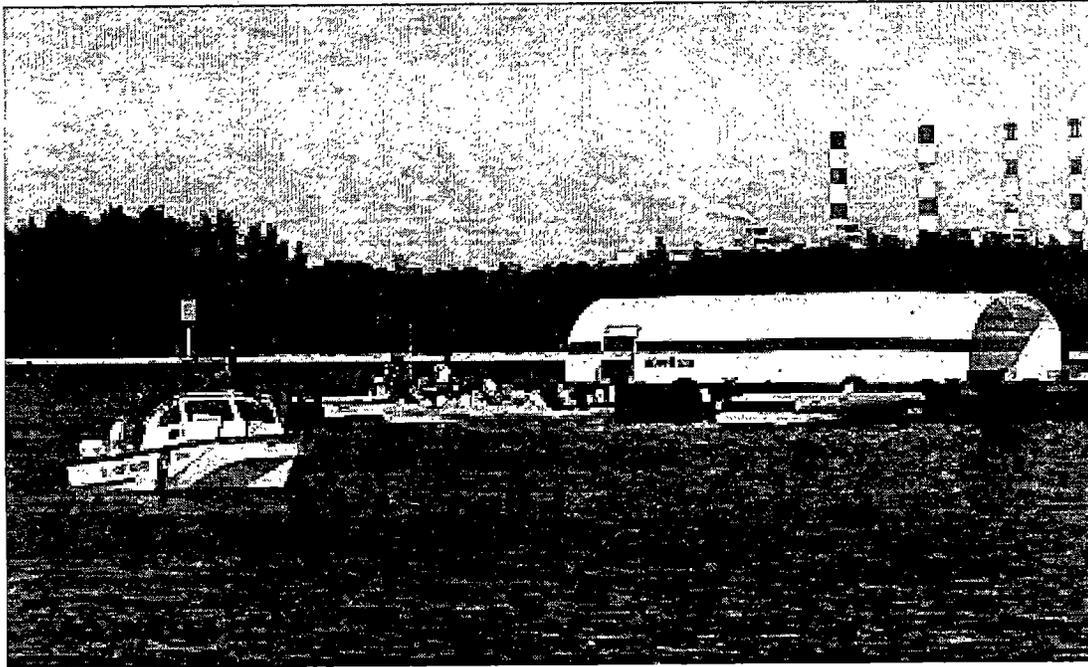
FIGURE 3
EMERGENCY DISASTER DRILL

The exercise began with pilots and flight attendants from the participating airlines, along with other designated victims, stationed on the L-1011 mockup positioned in the middle of the waterway (see Figure 3). Upon command, these *passengers* evacuated the aircraft. Some passengers exited directly into the water while others boarded the slide/raft and waited to be rescued. After being rescued, the *survivors* were taken to a triage station where the severity of their injuries was determined and emergency treatment administered.

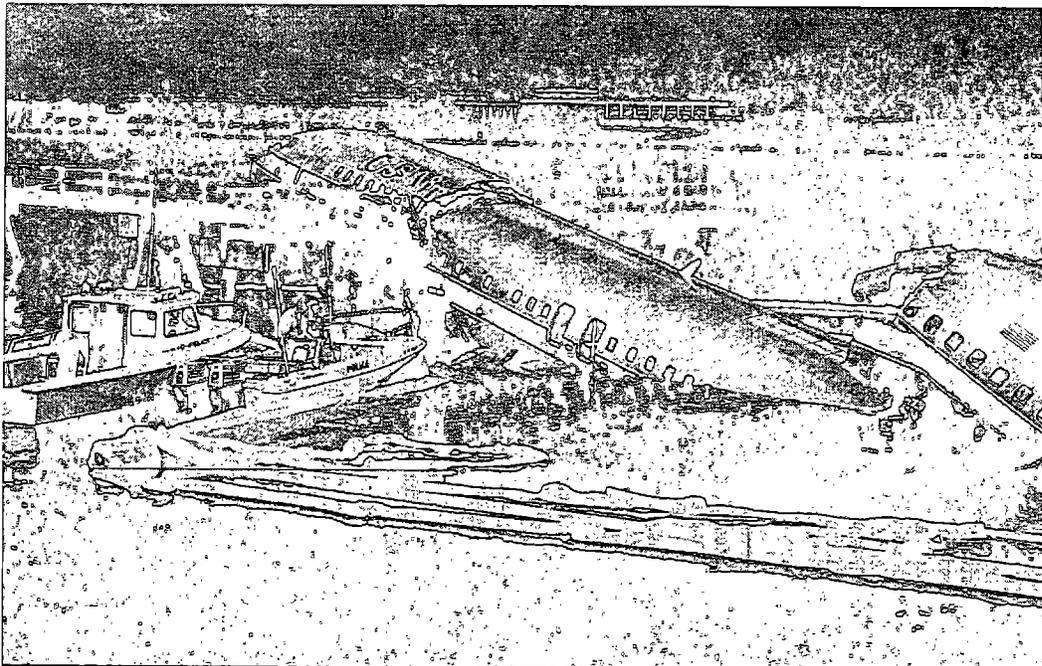
FIGURE 5
Us Air Flight 5050

On September 20, 1989, USAir Flight 5050 was an "extra section" passenger flight to replace the regularly scheduled, but canceled, flight 1846 from New York City's LaGuardia Airport to Charlotte Douglas Int. Airport, Charlotte, North Carolina. Instrument conditions prevailed, and the runway was wet. The accident occurred in darkness. As the first officer began the takeoff roll on runway 31, the airplane drifted to the left, and the captain used the nosewheel steering tiller to correct the drift. Later in the takeoff, the flight crew heard a "bang" and a rumbling noise. The captain then took control from the first officer and rejected the takeoff. The airplane did not stop on the runway, crossing the end of the runway at a ground speed of 34 knots. It came to rest in Bowery Bay on a pier that supports the approach lights for runway 13 (Figure 5).

On January 23, 1982, World Airways, Inc. Flight 30H, a McDonnell Douglas DC-10-30, was a regularly scheduled passenger flight from Oakland, California to Boston, Massachusetts, with an en route stop at Newark, New Jersey. Following a non precision instrument approach to runway 15R at Boston Logan International Airport, the airplane touched down about 2,500 feet beyond the displaced threshold of the 9,191 foot usable part of the runway. When the captain realized that he could not stop the airplane on the runway, he steered it to the left to avoid the runway 33L approach light pier. Four seconds later, at 1936:40, during the hours of darkness, Flight 30H inadvertently went over the sea wall and into Boston Harbor (Figure 5).
