An Analysis of Runway Incursion “Hot Spots” Incidents

With Deidentified Reports Excerpts

October 24, 2002

Aviation Safety Reporting System
625 Ellis St. Suite 305 Mountain View California 94043

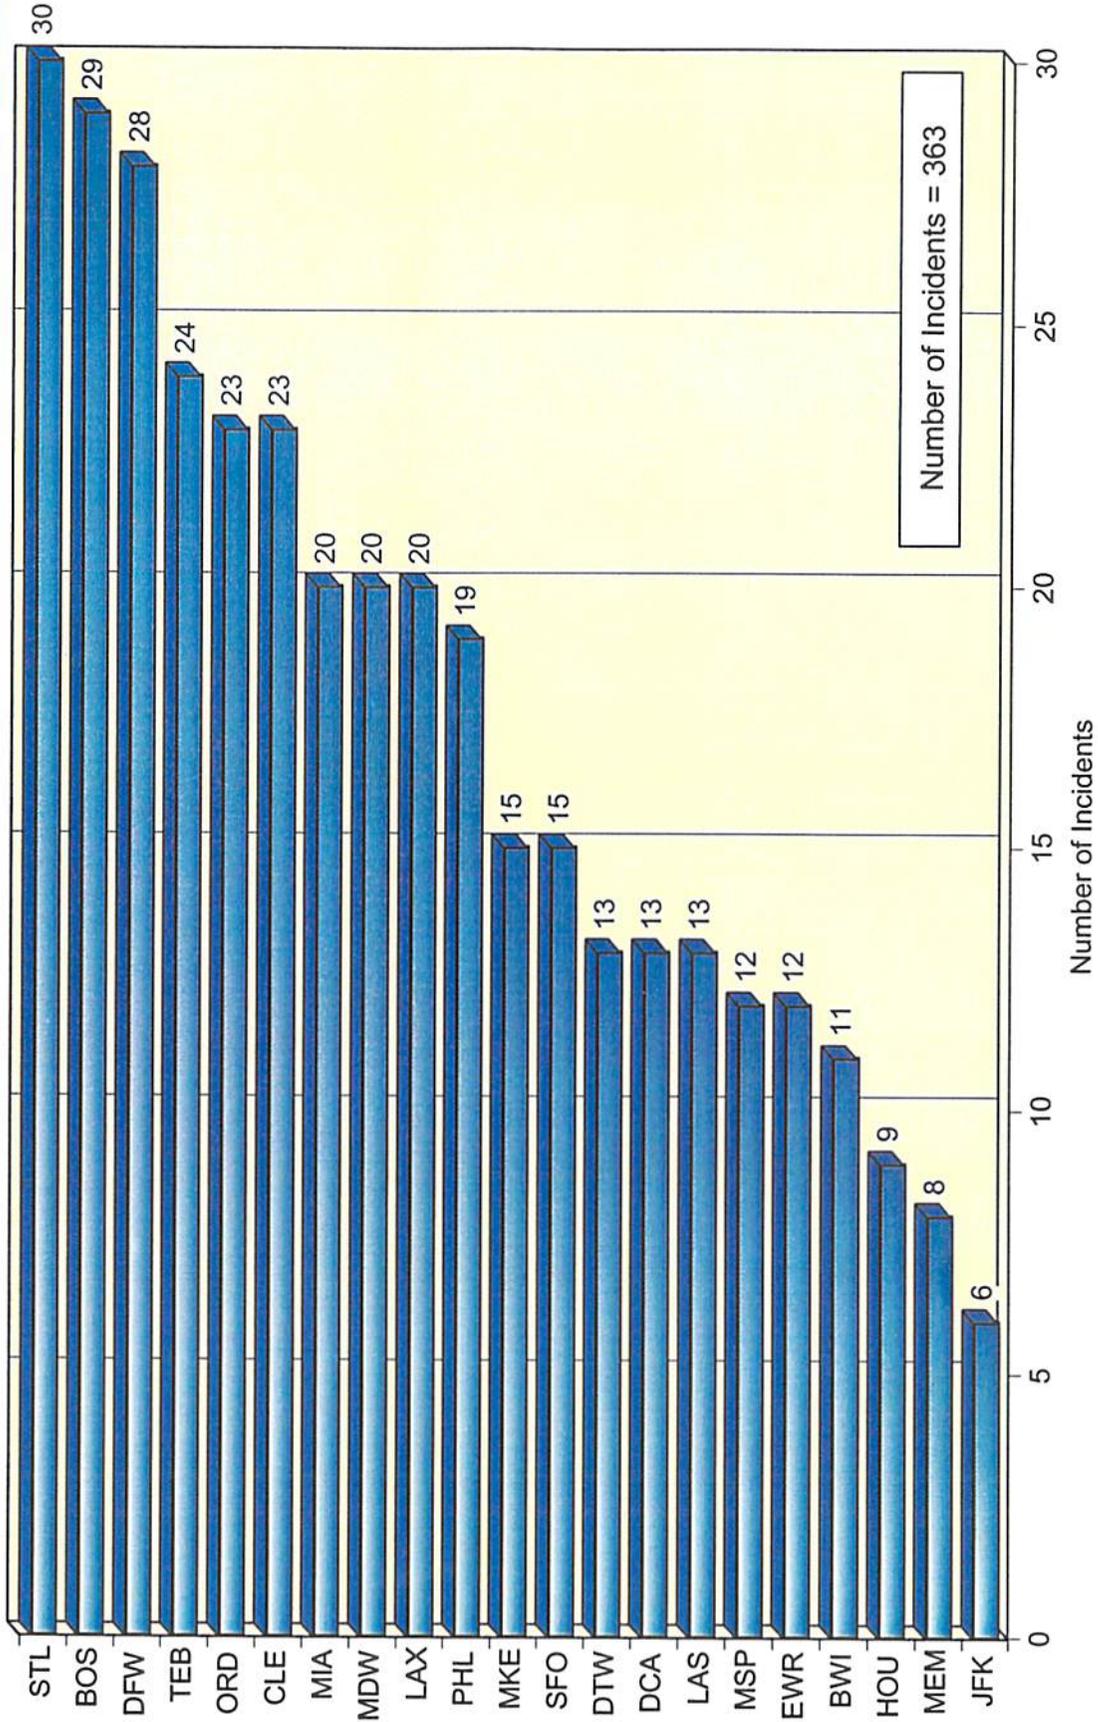
Runway Incursion "Hot Spots" – Top 21 Major Airports

Data references ASRS reports that have received full-form analysis and include the reporters' narrative. Runway incursions include incidents where an aircraft crossed a Hold Line or penetrated an active runway.

Where location information was provided in the reporter's narrative, the specific location of each runway incursion was subsequently plotted by an ASRS analyst on the airport diagram charts. The following observations were noted in the analysis of the runway incursion incidents:

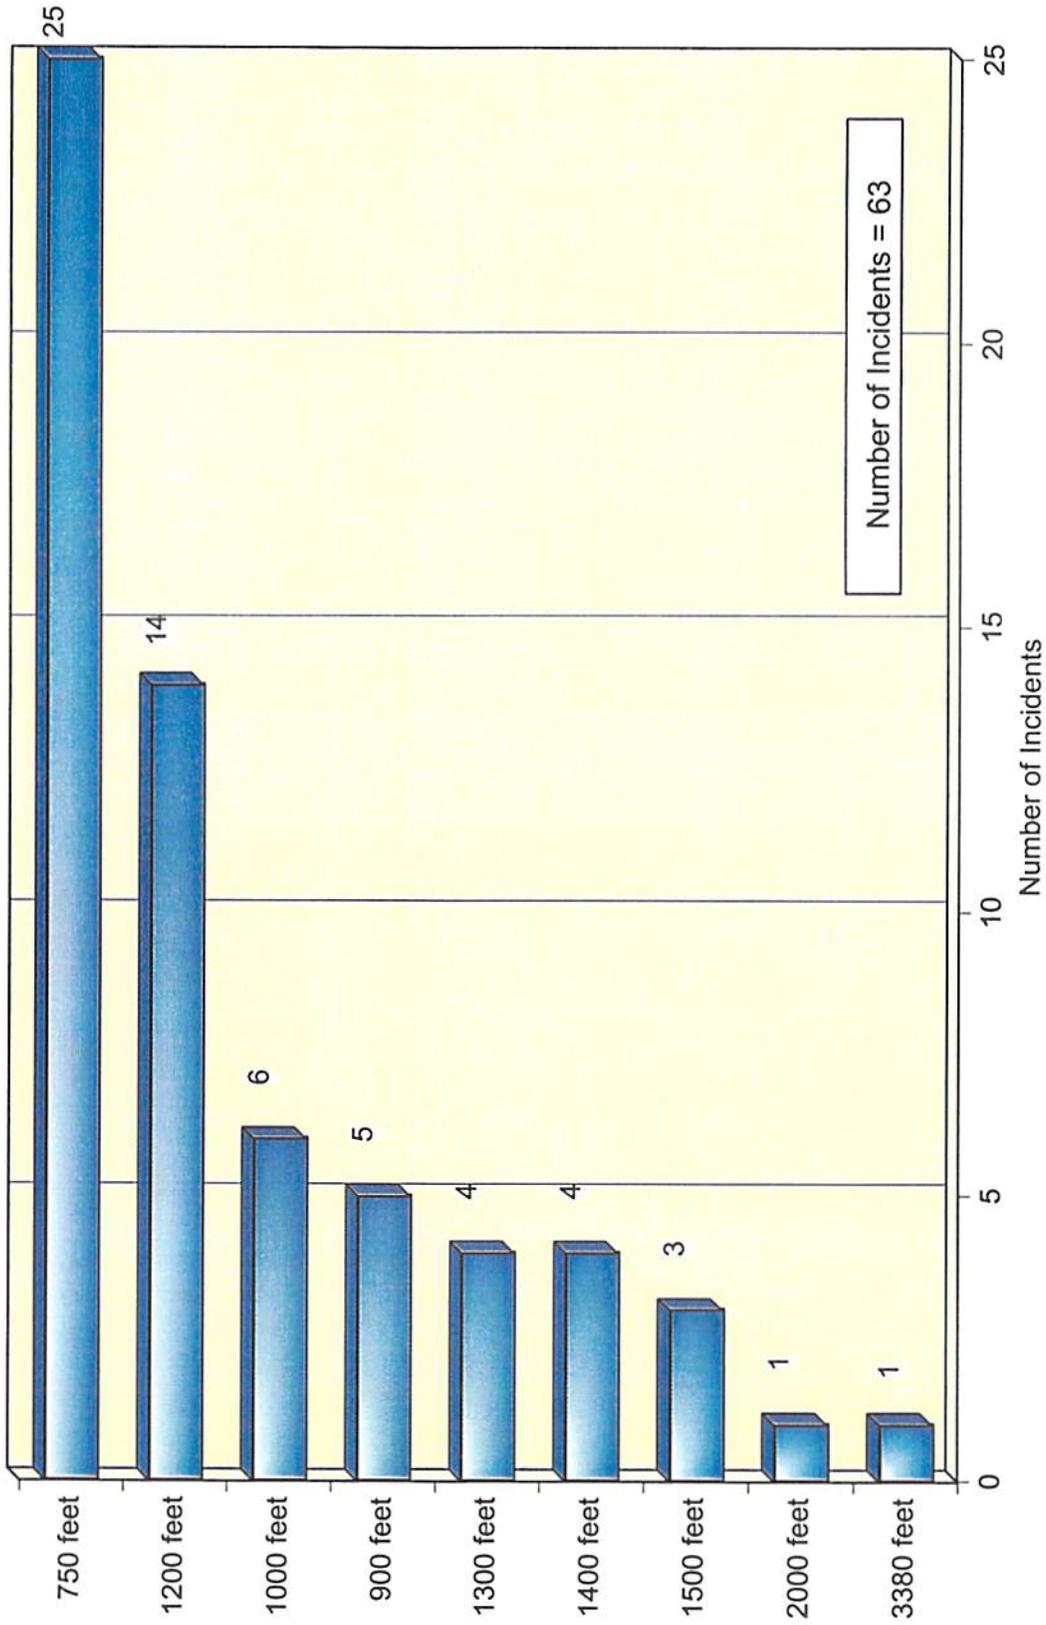
Runway Incursion "Hot Spots" – Distances Between Parallel Runways* January 2000 - April 2002

*Parallel runway operations were determined to be factors in the incident. Data references ASRS reports that have received full-form analysis and include the reporters' narrative.

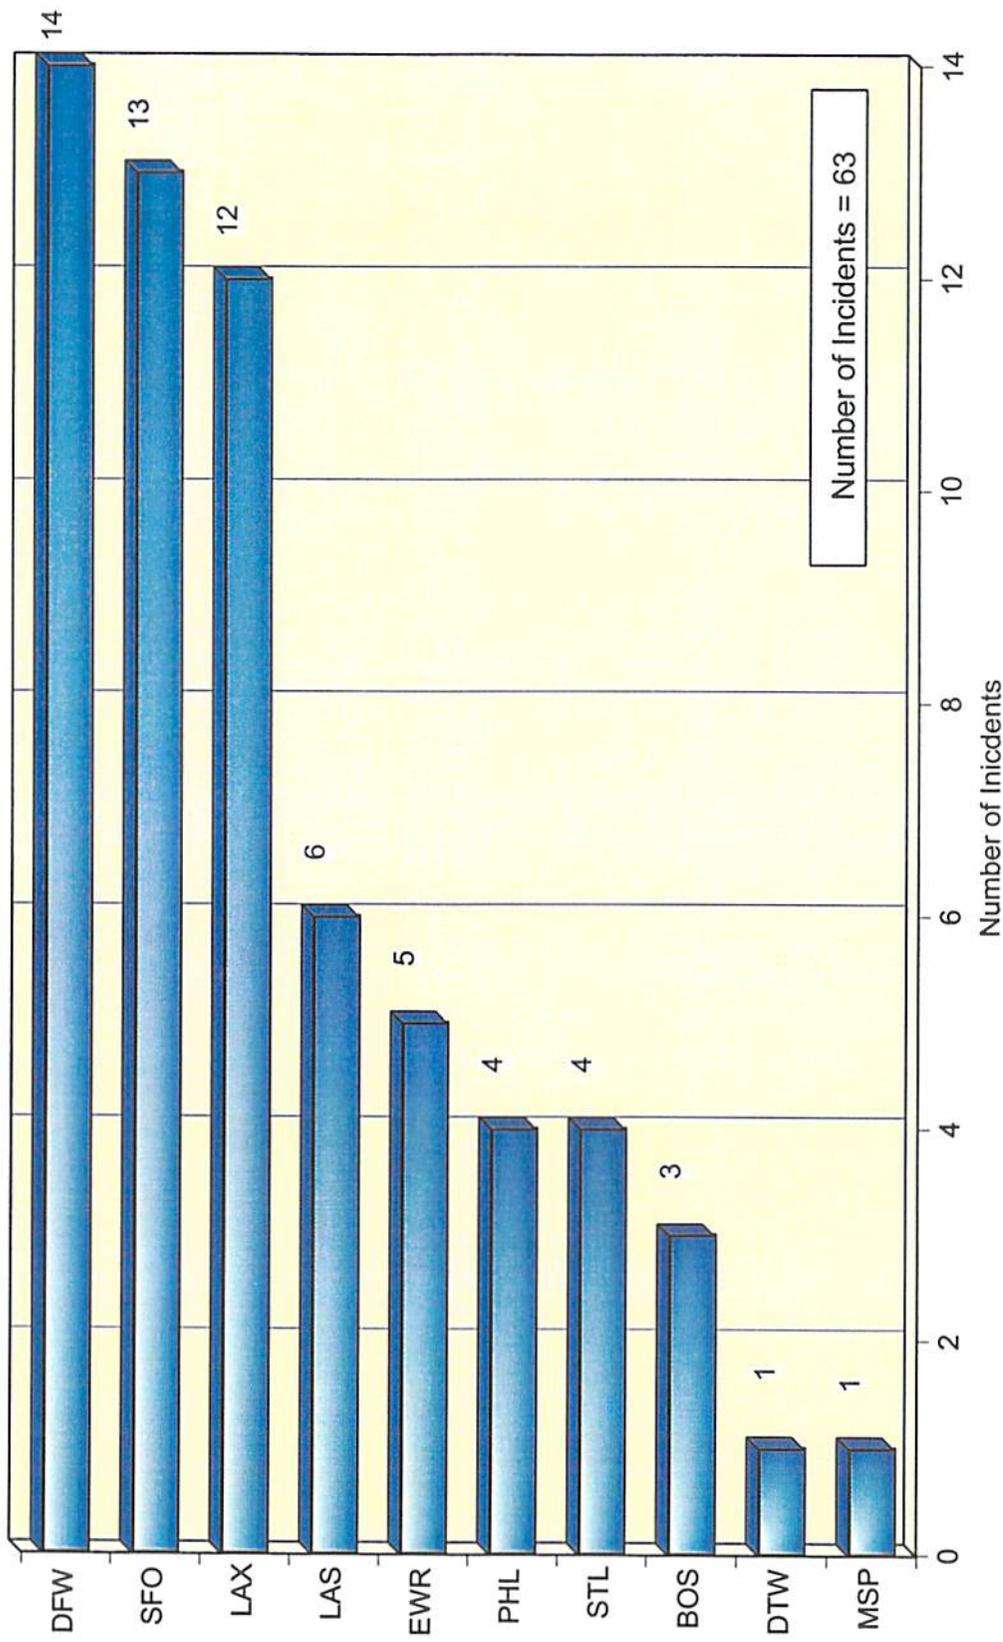
Runway Incursion "Hot Spots" – Parallel Runway Airports*

*Parallel runway operations were determined to be factors in the incident. Data references ASRS reports that have received full-form analysis and include the reporters' narrative.

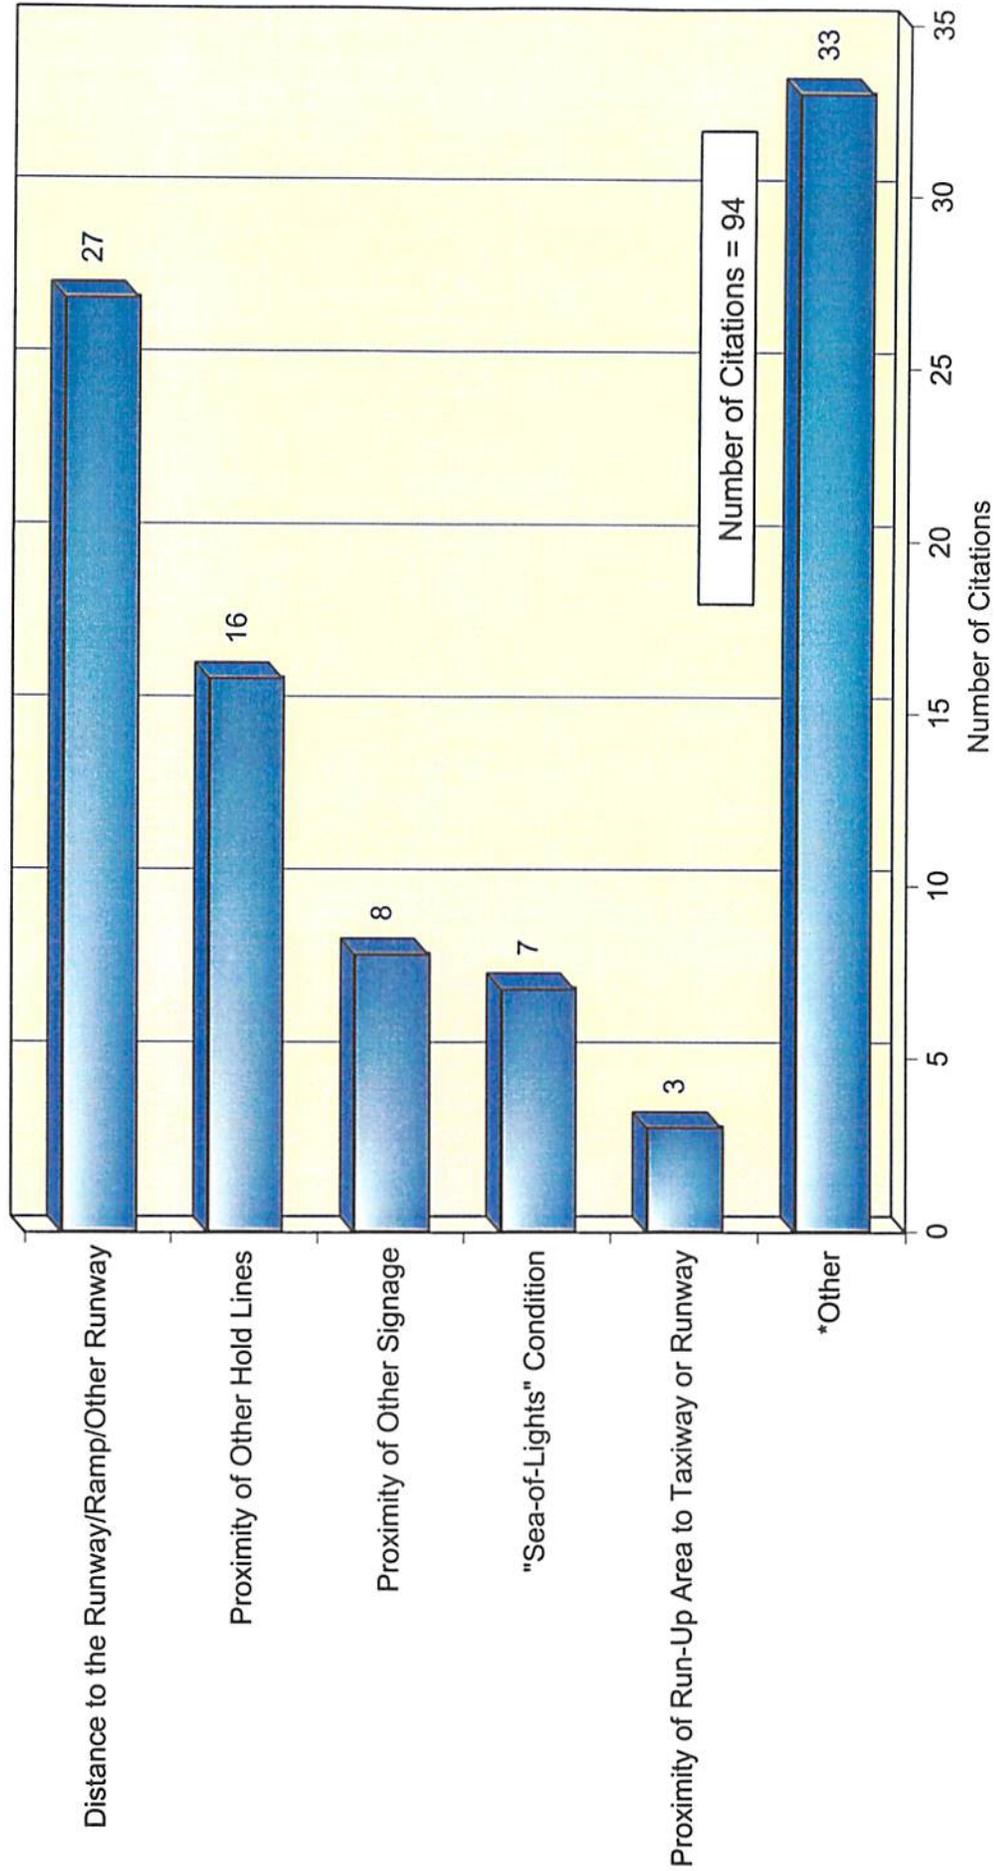
Runway Incursion "Hot Spots" – Airport Layout Factors

*Others include references to "Airport Construction," "Spacing on Taxiways Between Runways," and "Proximity of Hold Line From Runway." Data references ASRS reports that have received full-form analysis and include the reporters' narrative. Categories are not mutually exclusive. Therefore, a single incident may be coded by ASRS analysts as involving more than one citation.

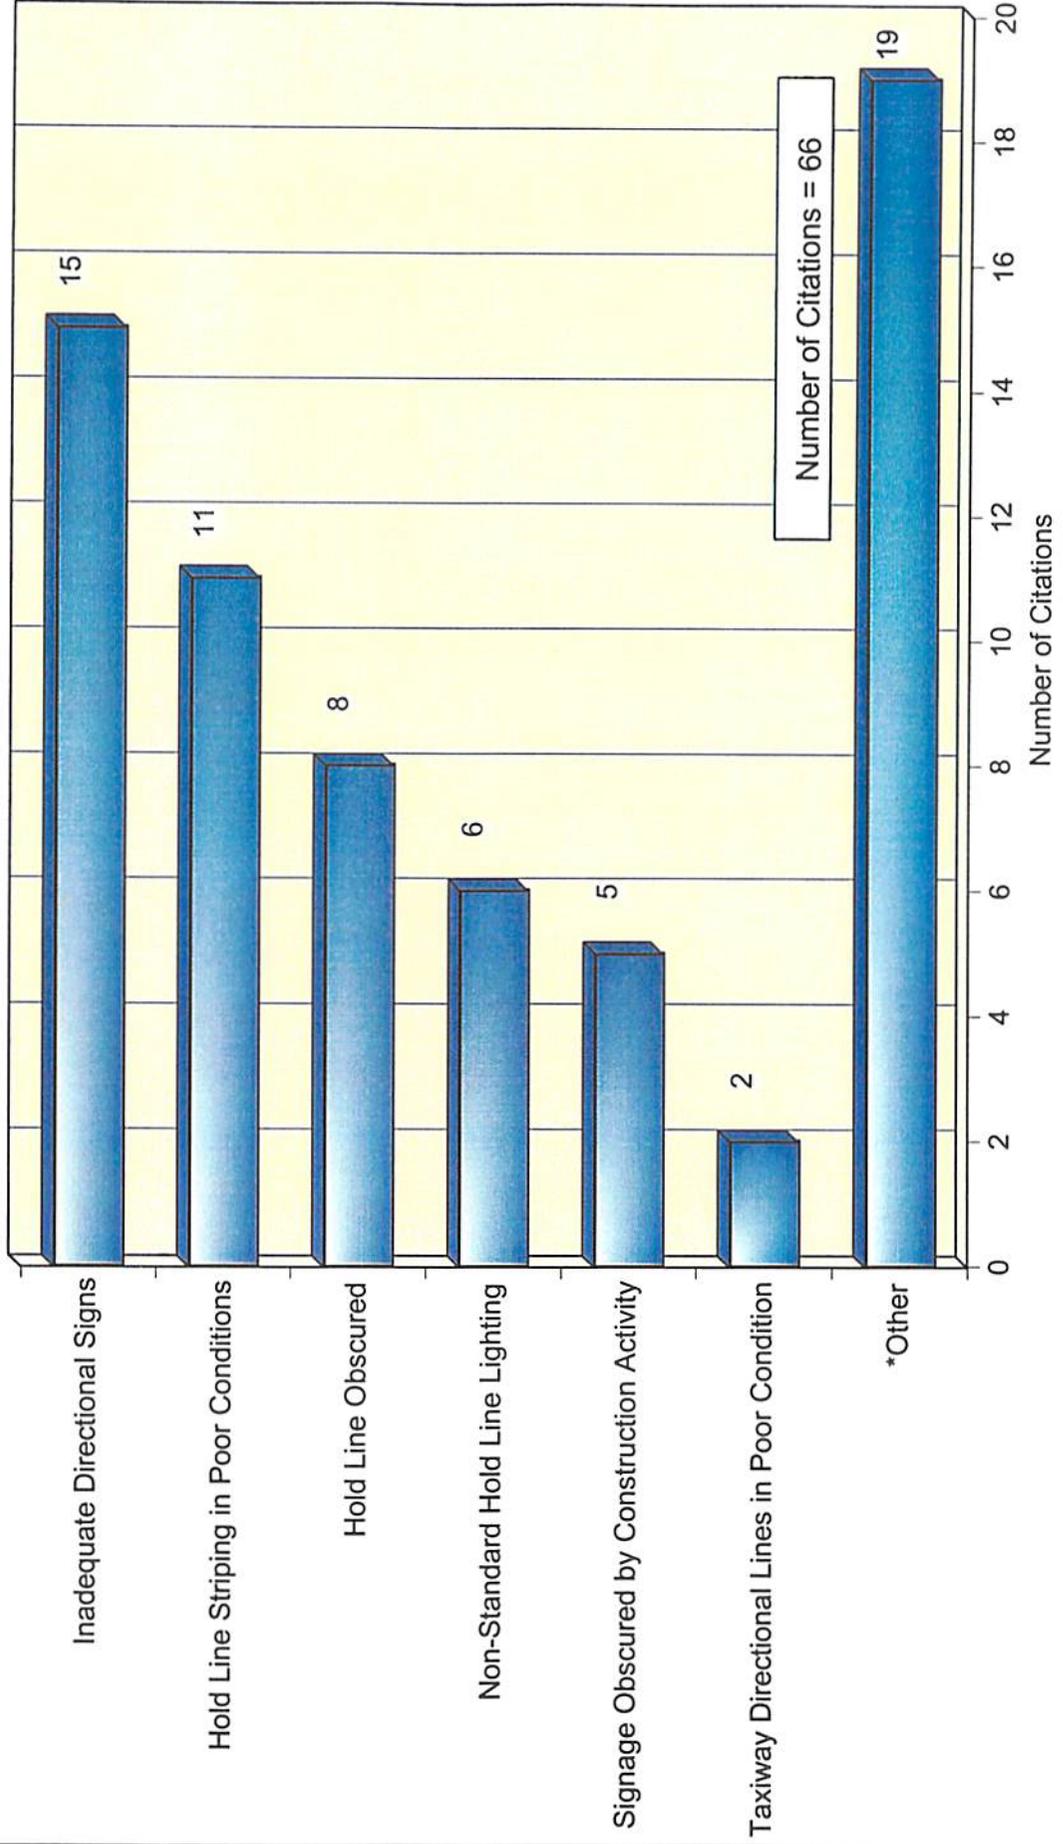
Runway Incursion "Hot Spots" – Airport Aids Factors January 2000 - April 2002

*Others include references to "Non Standard Hold Line," "No Wig Wag Lights," "Location of Hold Line," "Hold Line at Oblique Angle," and "Hold Line Shared with Other Runway." Data references ASRS reports that have received full-form analysis and include the reporters' narrative. Categories are not mutually exclusive. Therefore, a single incident may be coded by ASRS analysis as involving more than one citation.

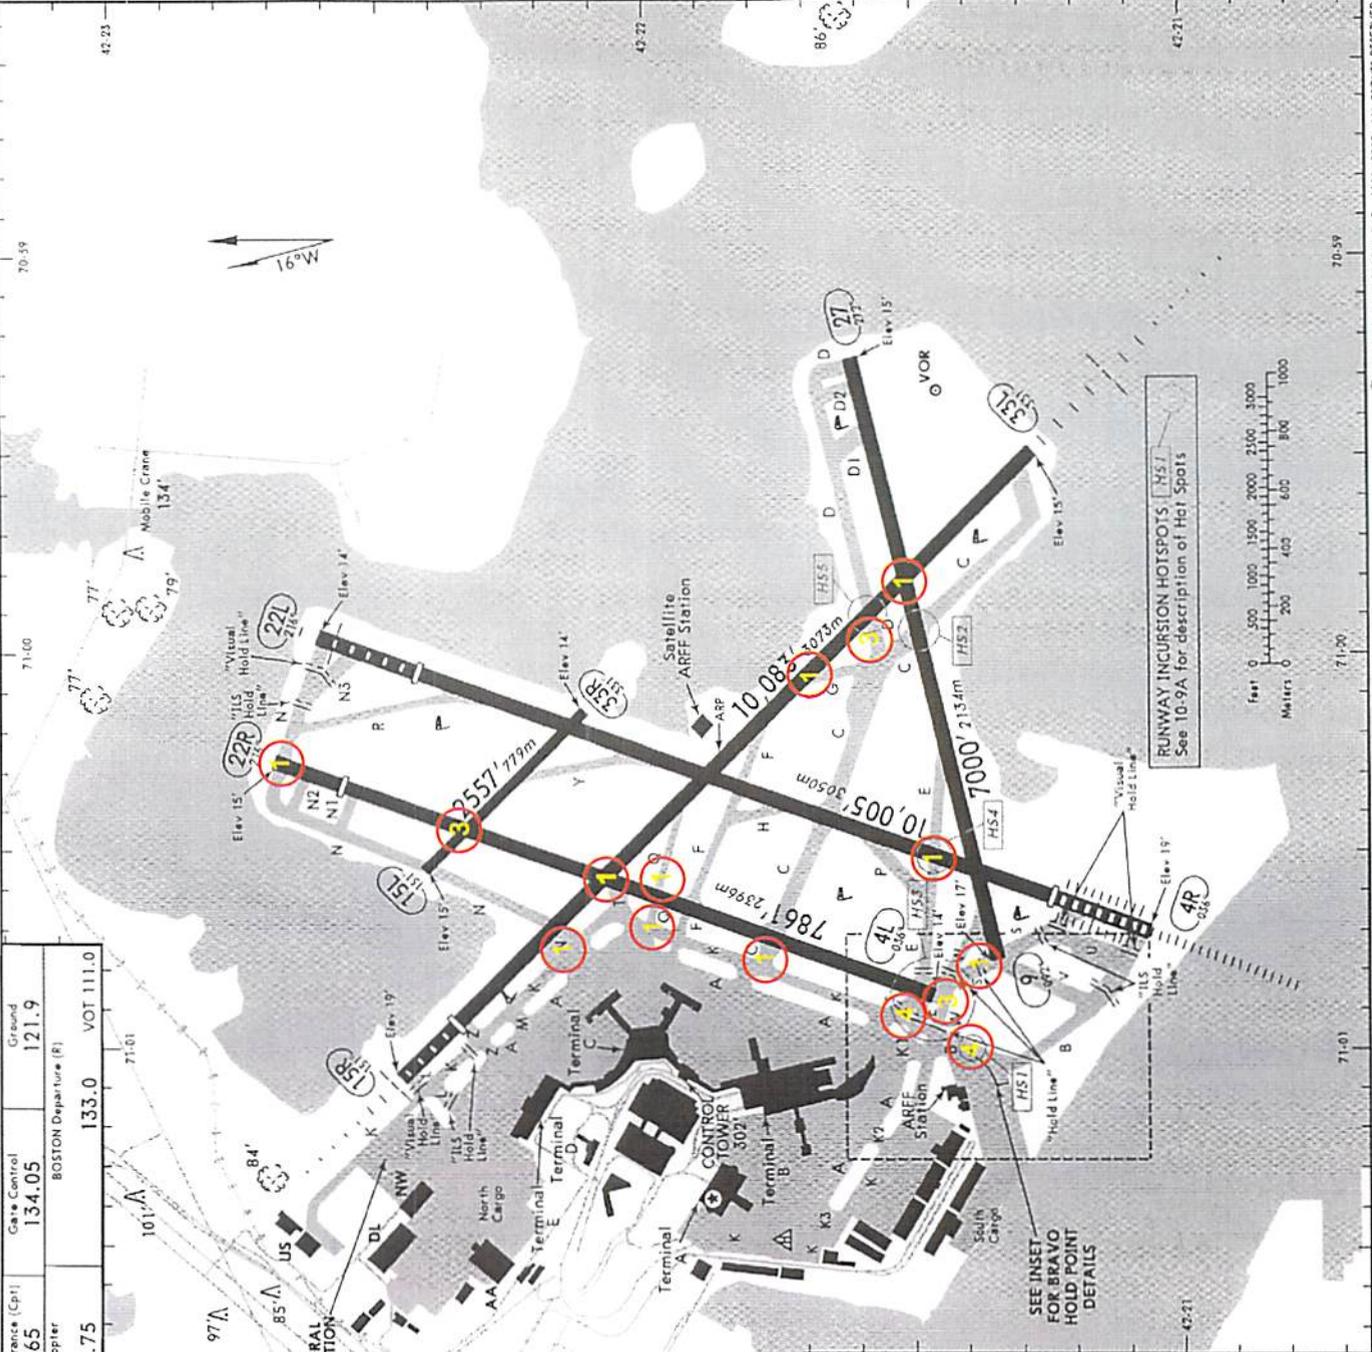
CAUTION: Be alert to runway crossing clearances. Readback of all runway holding instructions is required.
INTL Terminal, and north and south cargo arrivals contact Massport Gate Control on 131.1 before entering/departing ramp area.

RUNWAY INCURSION HOTSPOTS (HS) / See 10-9A for description of Hot Spots

Runway 27	ACN 510140 "Cleared to land... Runway 27... landing flare... saw... air carrier... lifting off Runway 15R... Controller said... 'go around.'"
Taxiway N	ACN 517967 " ...cleared... via Taxiways K, N... about to cross Runway 15R when... DC8 passed by... on... takeoff roll."
Runway 22R	
Taxiway C	ACN 482412 " ...told... 'hold short'... Runway 22R, but were across the hold short line..."
Taxiway N	ACN 484633 " ...no contact... made with Logan Tower prior to entering Runway 22R."
Taxiway S	ACN 501540 " ...at S... cleared to cross Runway 22R... as we crossed the runway... other aircraft rotated and passed overhead."
Runway 22L	
Taxiway E	ACN 470084 " ...cleared Runway 27 on Taxiway E... advised to hold short of Runway 22L... crossed the hold short... saw... aircraft crossing... runway 1500 feet ahead of us."

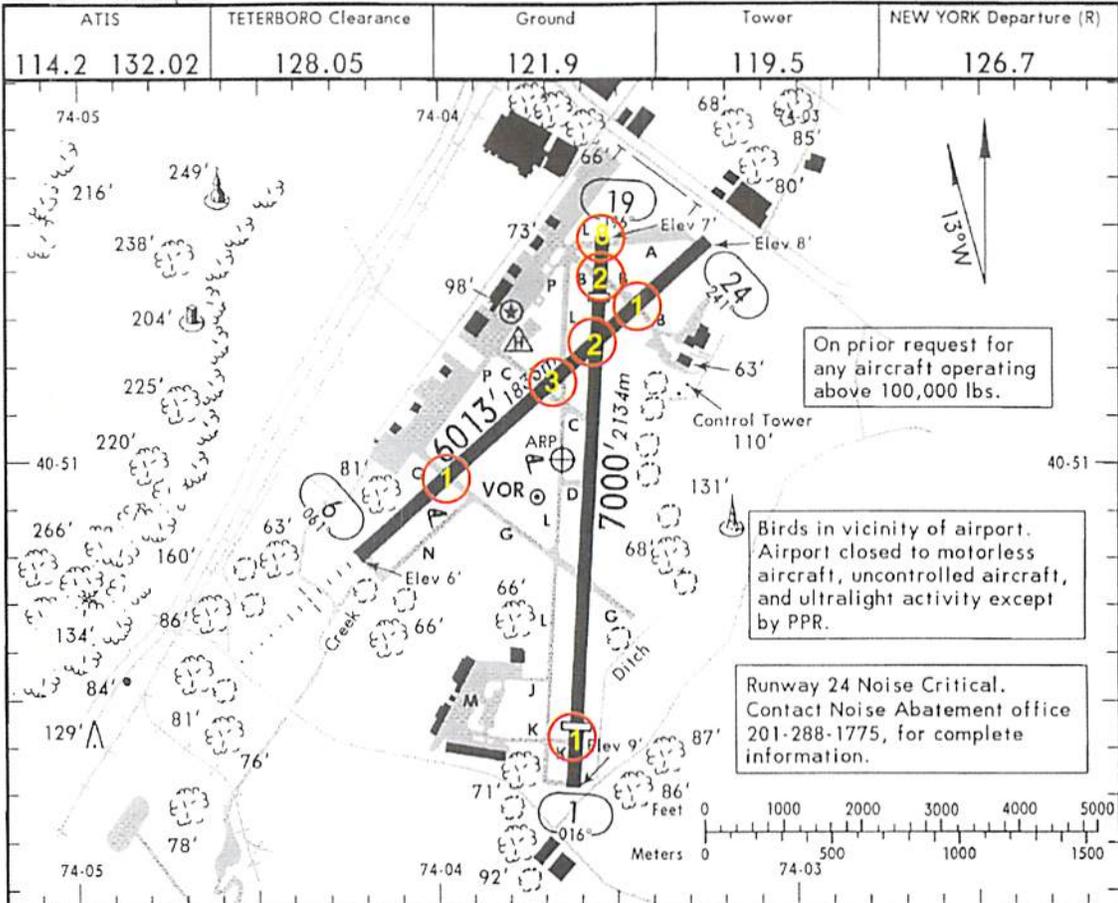
**TEB Runway Incursion
“Hot Spots” Incidents**

On prior request for any aircraft operating above 100,000 lbs.

Birds in vicinity of airport. Airport closed to motorless aircraft, uncontrolled aircraft, and ultralight activity except by PPR.

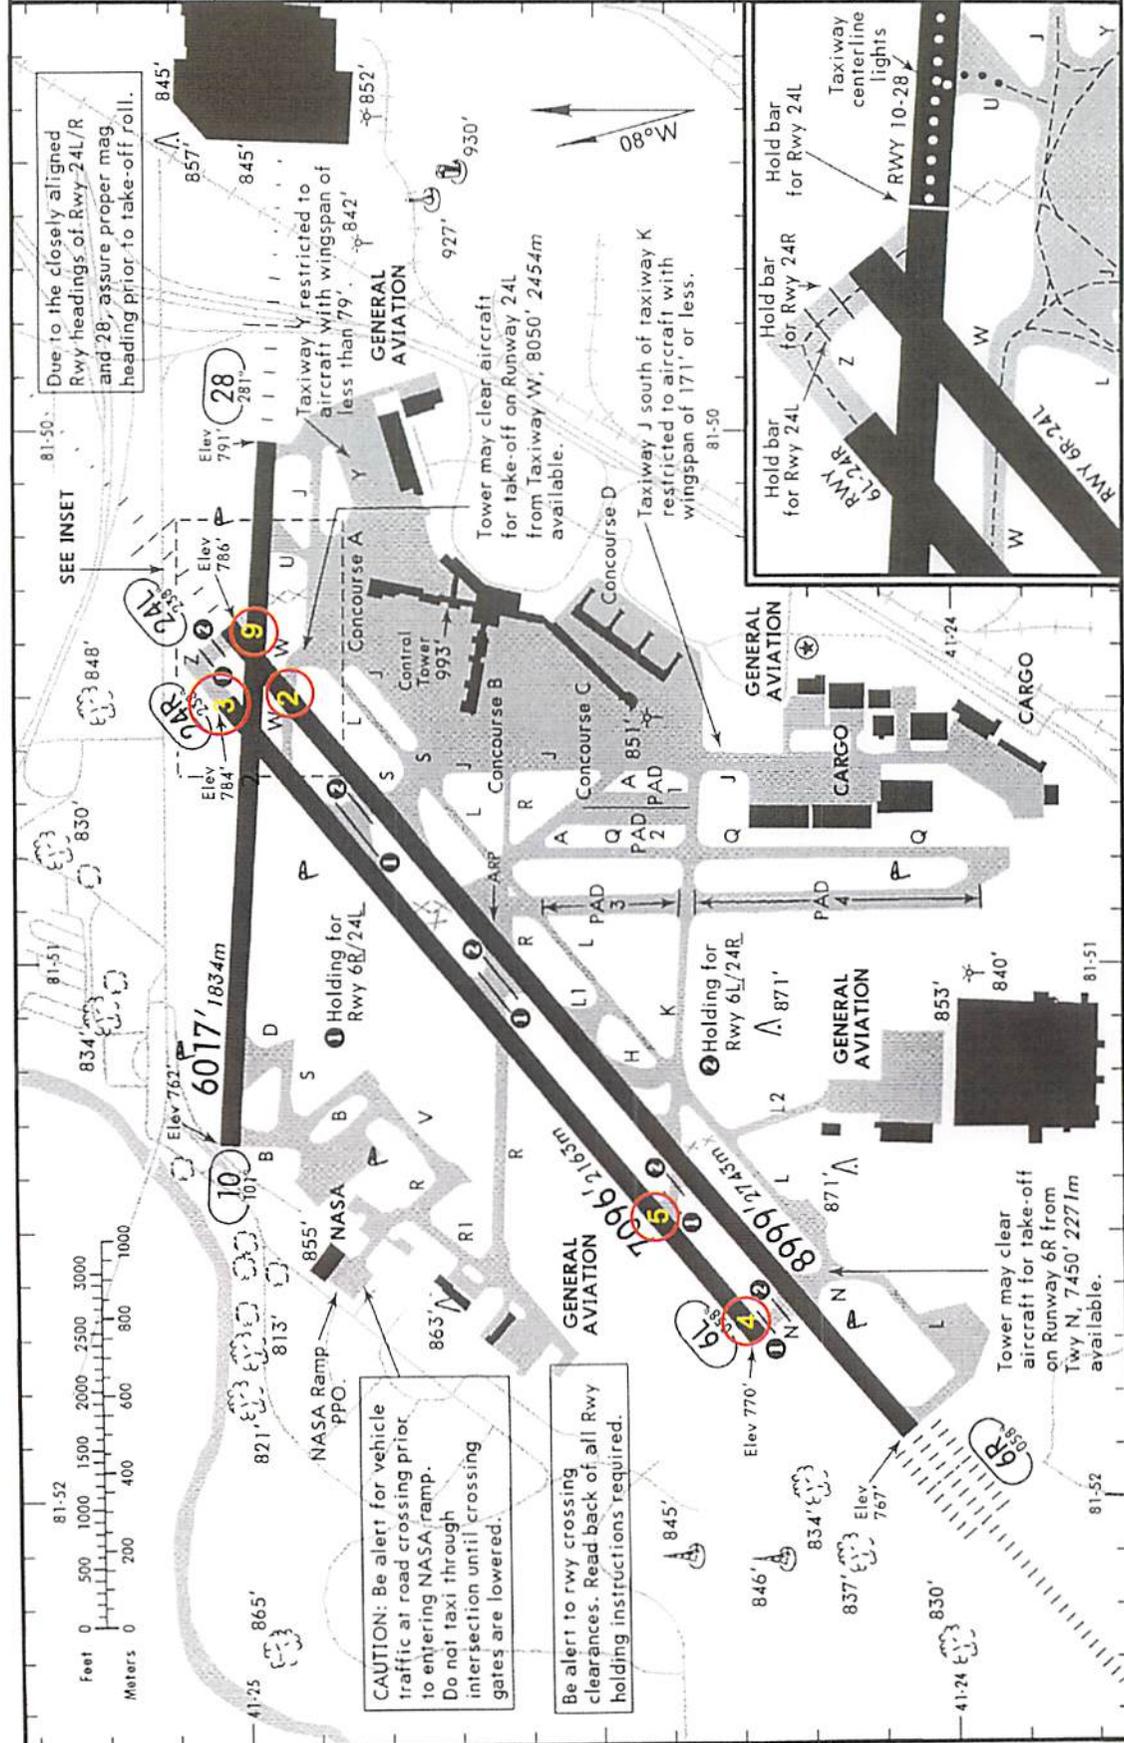
D-ATIS 127.85 VOT 110.4	ACARS: D-ATIS TWIP PDC	CLEVELAND Clearance (Cpt) 125.05	Ground 121.7	Tower 120.9	CLEVELAND Departure (R) 234°-053° 054°-233° 128.25 118.15
----------------------------	---------------------------------	-------------------------------------	-----------------	----------------	---

CHANGES: Runway 18/36 removed, ramp & taxiways.

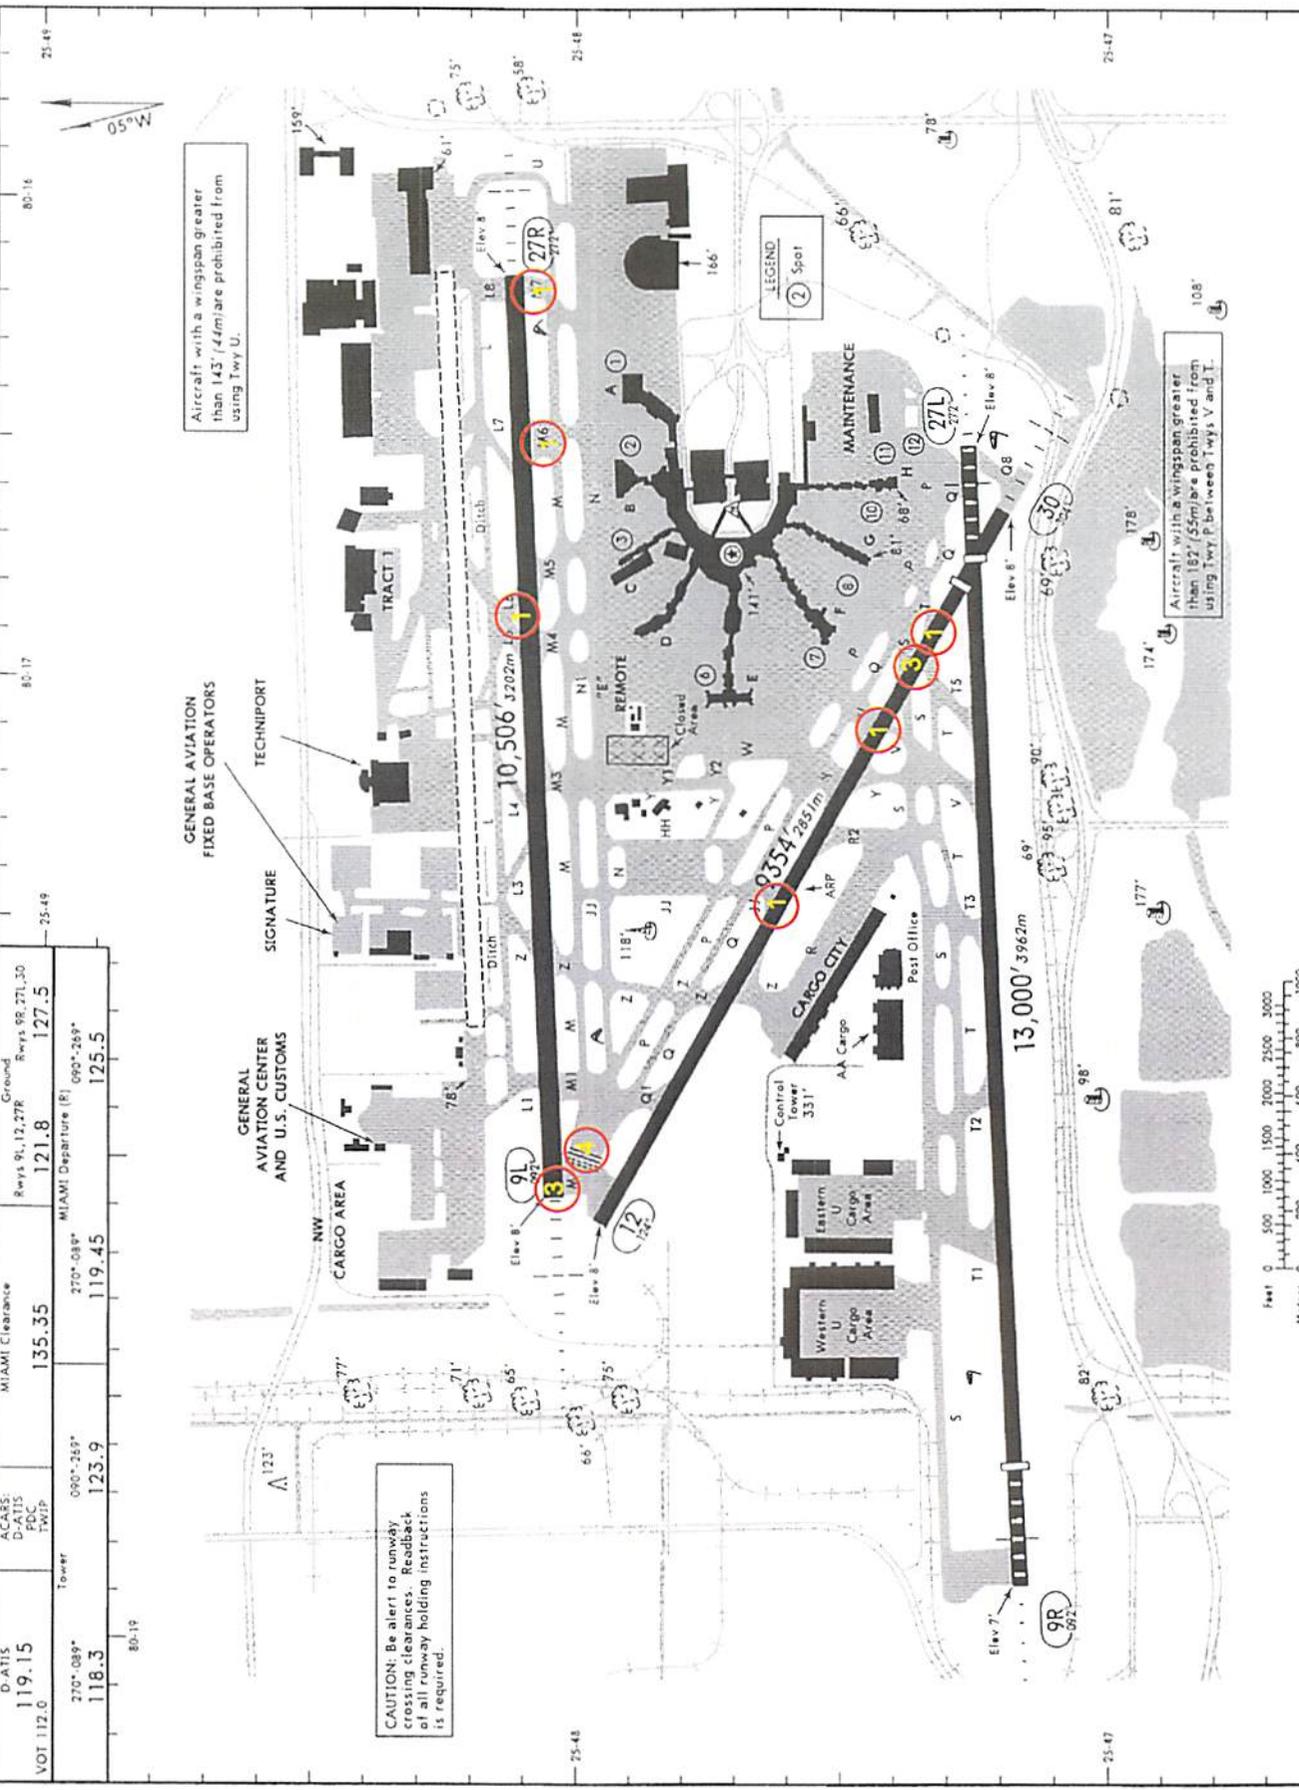
ACARS: D-ATIS D-ATIS D-ATIS D-ATIS D-ATIS	MIAMI Clearance	Ground
119.15	135.35	Rwys 9L, 12, 27R Ewys 98, 27L, 30
112.0	121.8	127.5
Tower	MIAMI Departure (R)	090°-268°
270°-089°	270°-089°	
118.3	123.9	119.45
80-19		125.5

Aircraft with a wingspan greater than 143' (44m) are prohibited from using Twy U.

Aircraft with a wingspan greater than 182' (55m) are prohibited from using Twy P between Twys V and T.
