An Analysis of Runway Incursion “Hot Spots” Incidents

With Deidentified Reports Excerpts

Volume 2

October 24, 2002

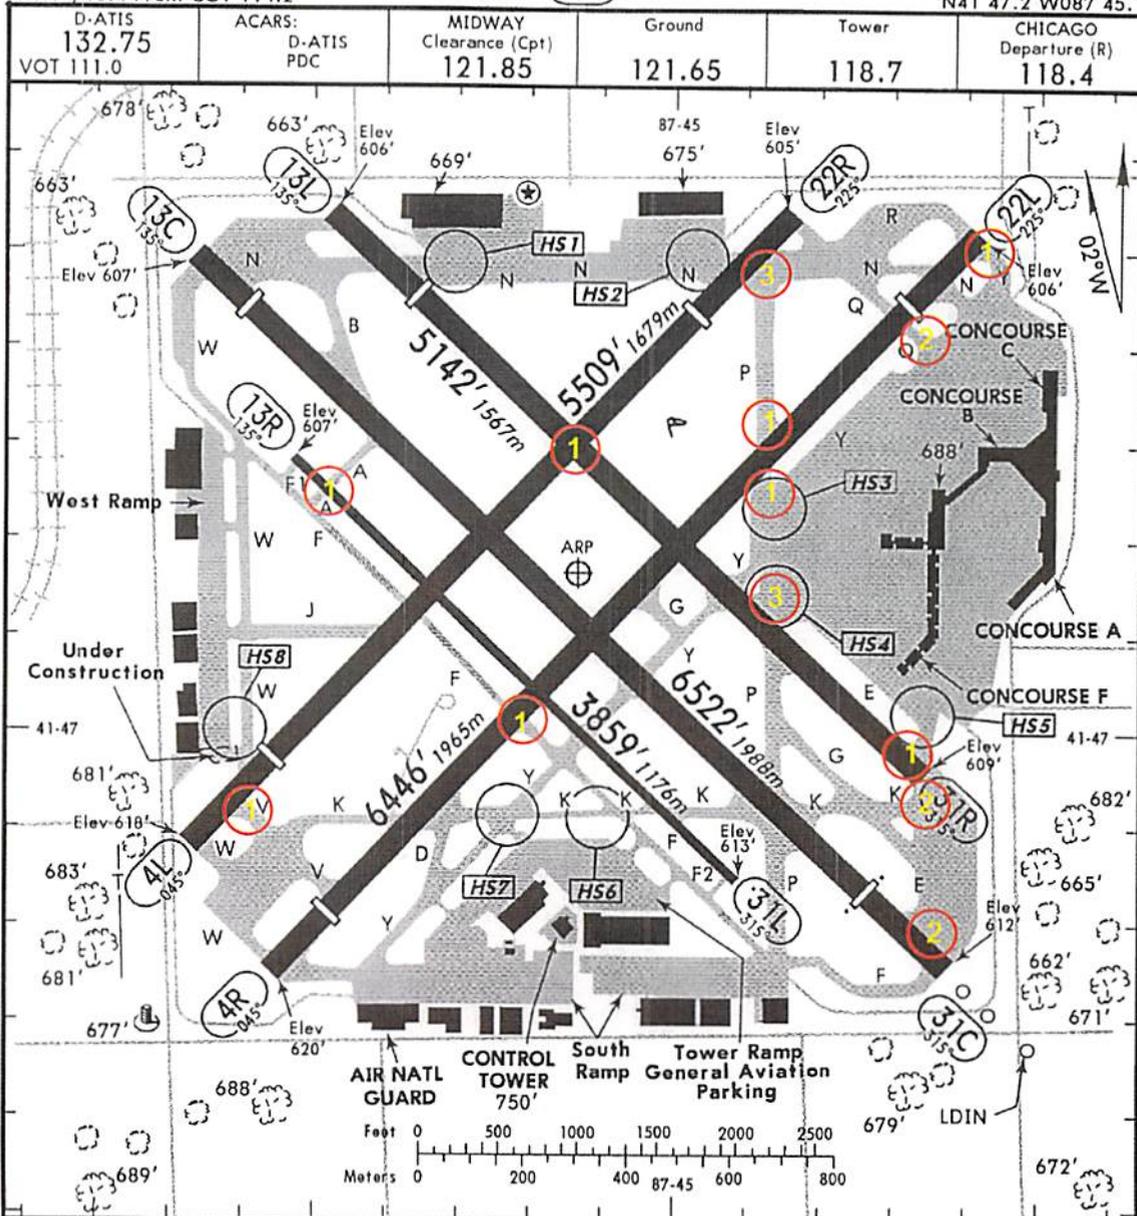
**MDW Runway Incursion
“Hot Spots” Incidents**

RUNWAY INCURSION HOT SPOTS

- HS1** When approaching Runway 13L from November Taxiway, pilots should be aware of the following:
 1. The taxiway is not the standard 90° angle to the runway.

2. Runway 13L has a displaced threshold.
- HS2** When approaching Runway 22R from November Taxiway, the pilot should be aware of the following:
 1. The taxiway is not the standard 90° angle to the runway.

2. Runway 22R has a displaced threshold.
- HS3 & HS4** When approaching Runway 22L or 31R from Papa Taxiway, the pilot should be aware of the following:

1. The hold bar for 22L is 180' from the runway and the hold bar for 31R is 200' from the runway instead of the standard 257'.
- HS5** When approaching Runway 31R on Echo Taxiway from F Concourse area, pilots should be aware that the hold bar is immediately adjacent to the F Concourse apron.

- HS6** If right turn onto Foxtrot Taxiway from Kilo taxiway is missed, the hold bar for Runway 31L is directly after Foxtrot Taxiway intersection.
- HS7** When approaching Runway 4R from Kilo Taxiway, pilots should be aware that the hold bar for the runway is directly after the Yankee Taxiway intersection and before the Delta Taxiway intersection.

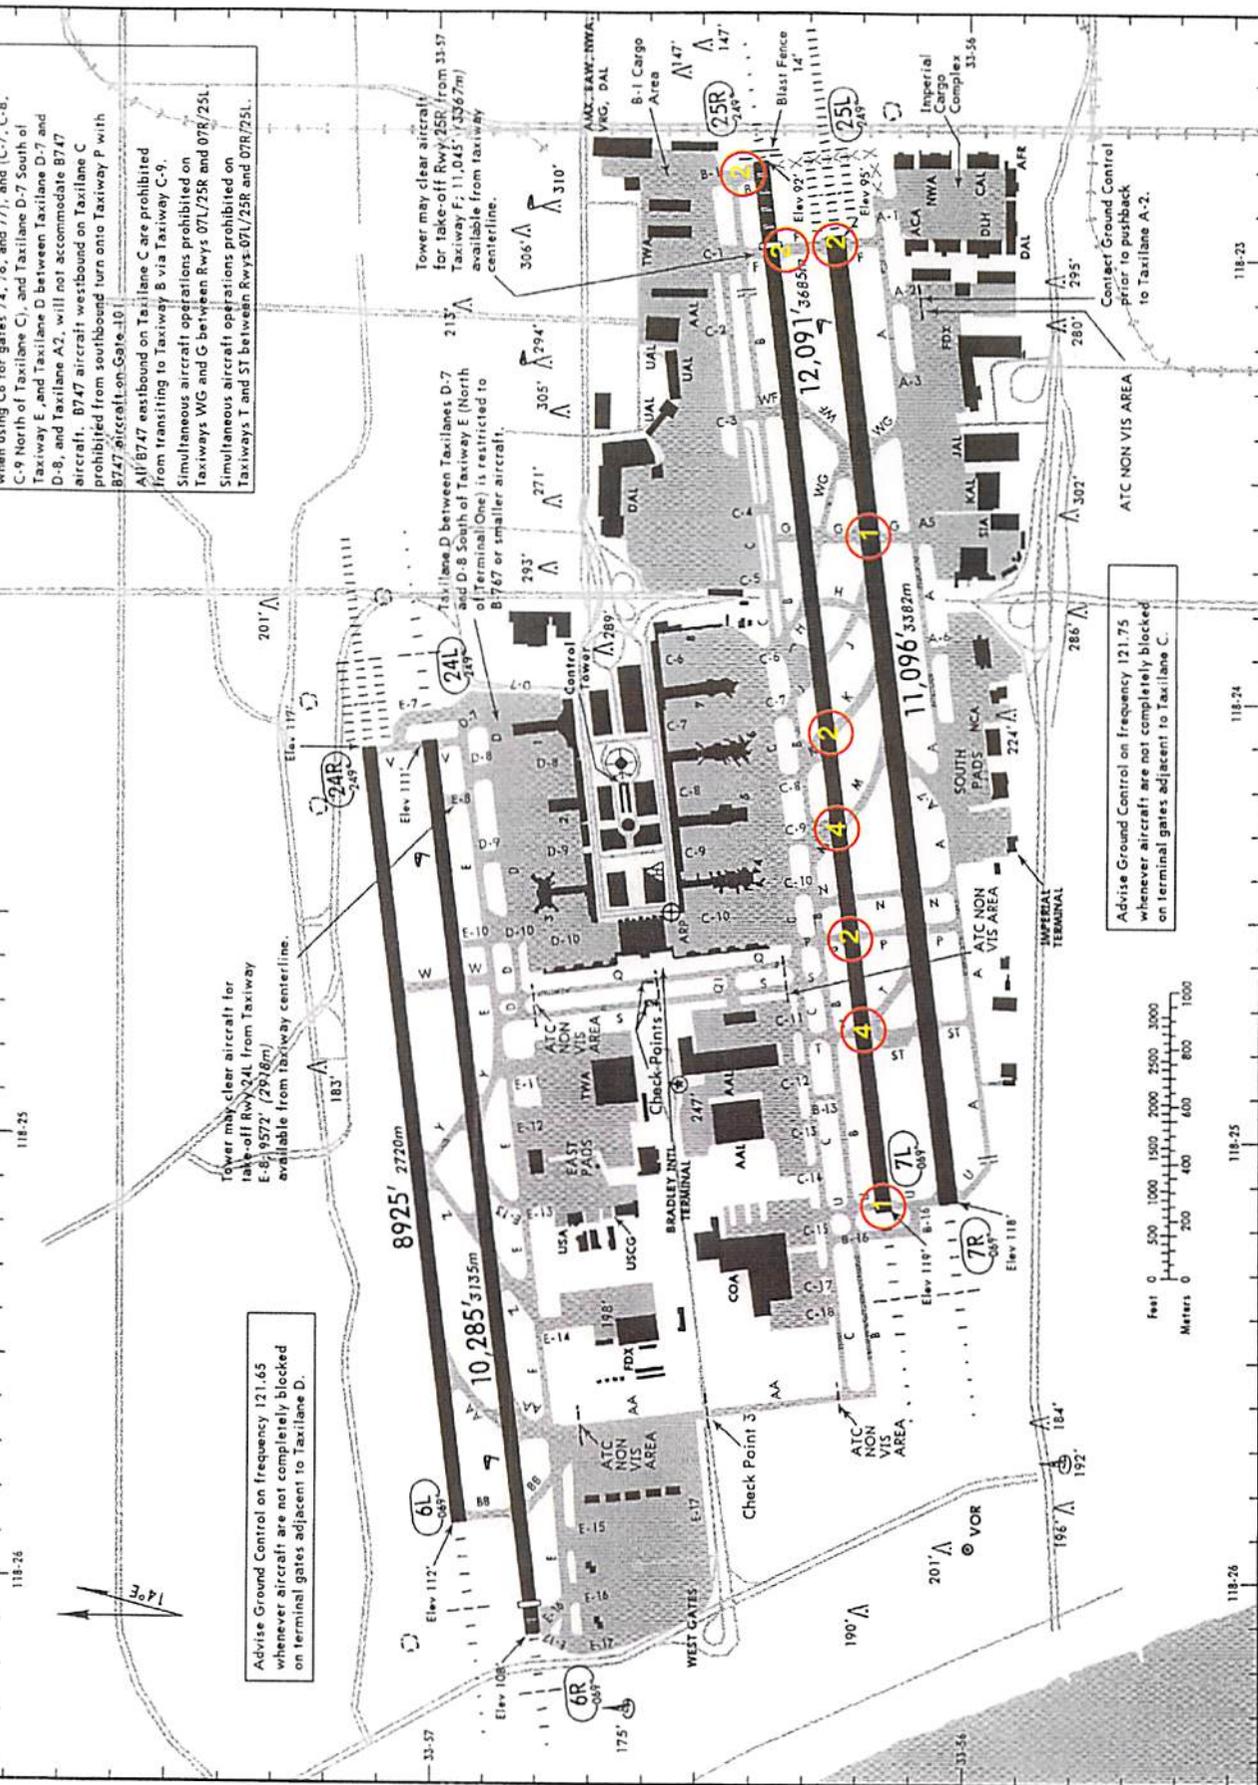
KLAX 126'
 Apt Elev
 045.8°/1.3 From LAX 113.6

Turbulence may be deflected upward from blast fence 180' (55m) east of Rwy 25R.

Taxilanes C-1 North of Taxiway C, Taxiways C6 (except when using C6 for gates 74, 76, and 77), and (C-7, C-8, C-9 North of Taxiway C), and Taxiway D-7 South of Taxiway E, and Taxiway D between Taxiway D-7 and D-8, and Taxiway A2, will not accommodate B747 aircraft. B747 aircraft westbound on Taxiway C prohibited from southbound turn onto Taxiway P with B747 aircraft on Gate 10.

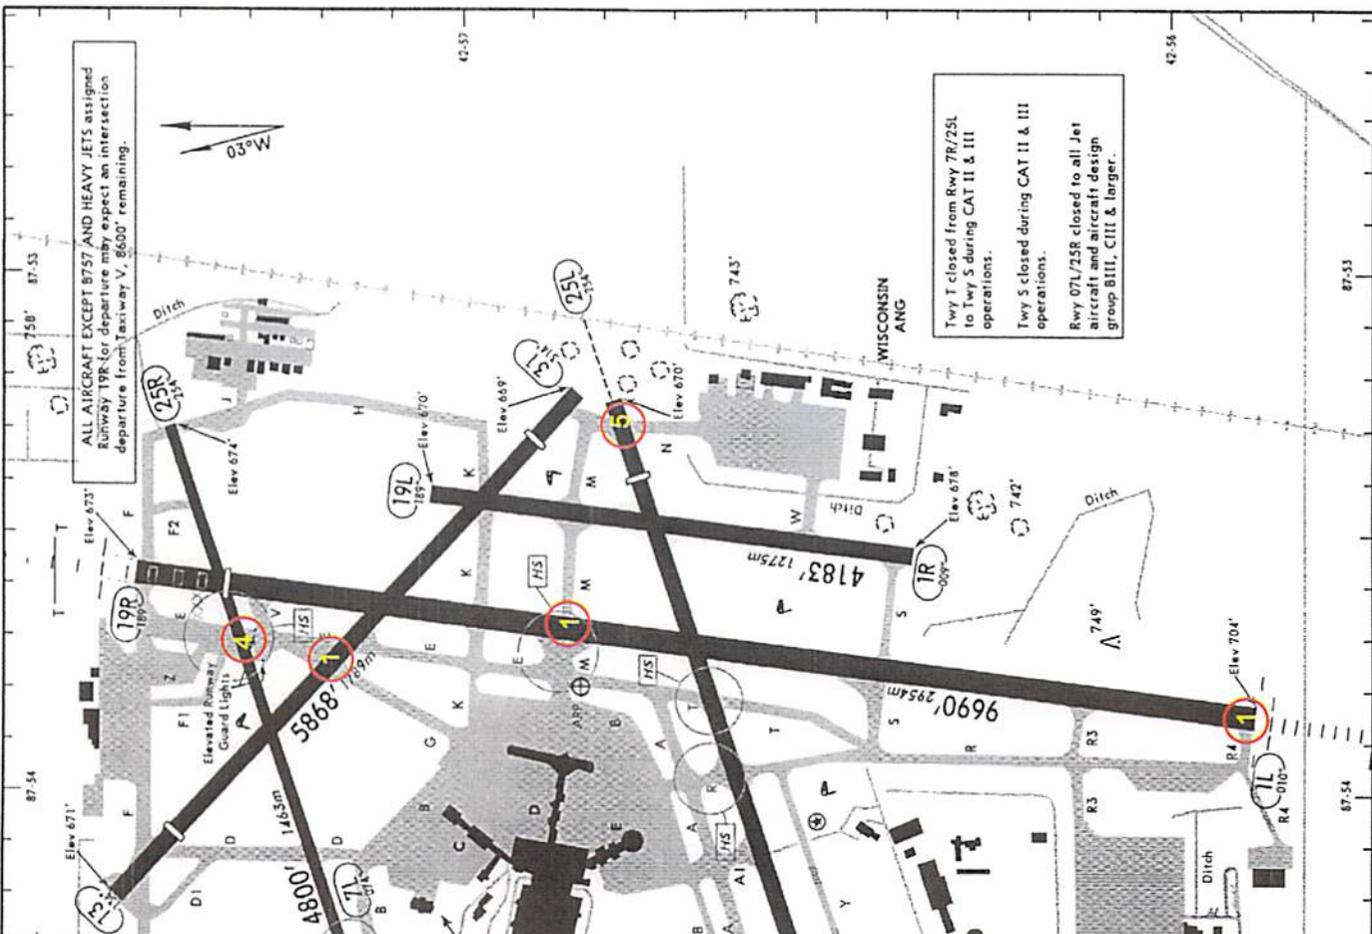
Twy P closed to aircraft with wingspan greater than 79' except with prior permission.

Twy V closed to aircraft with wingspan greater than 118'.

Twy T closed from Rwy 7R/25L to Twy S during CAT II & III operations.

Twy S closed during CAT II & III operations.

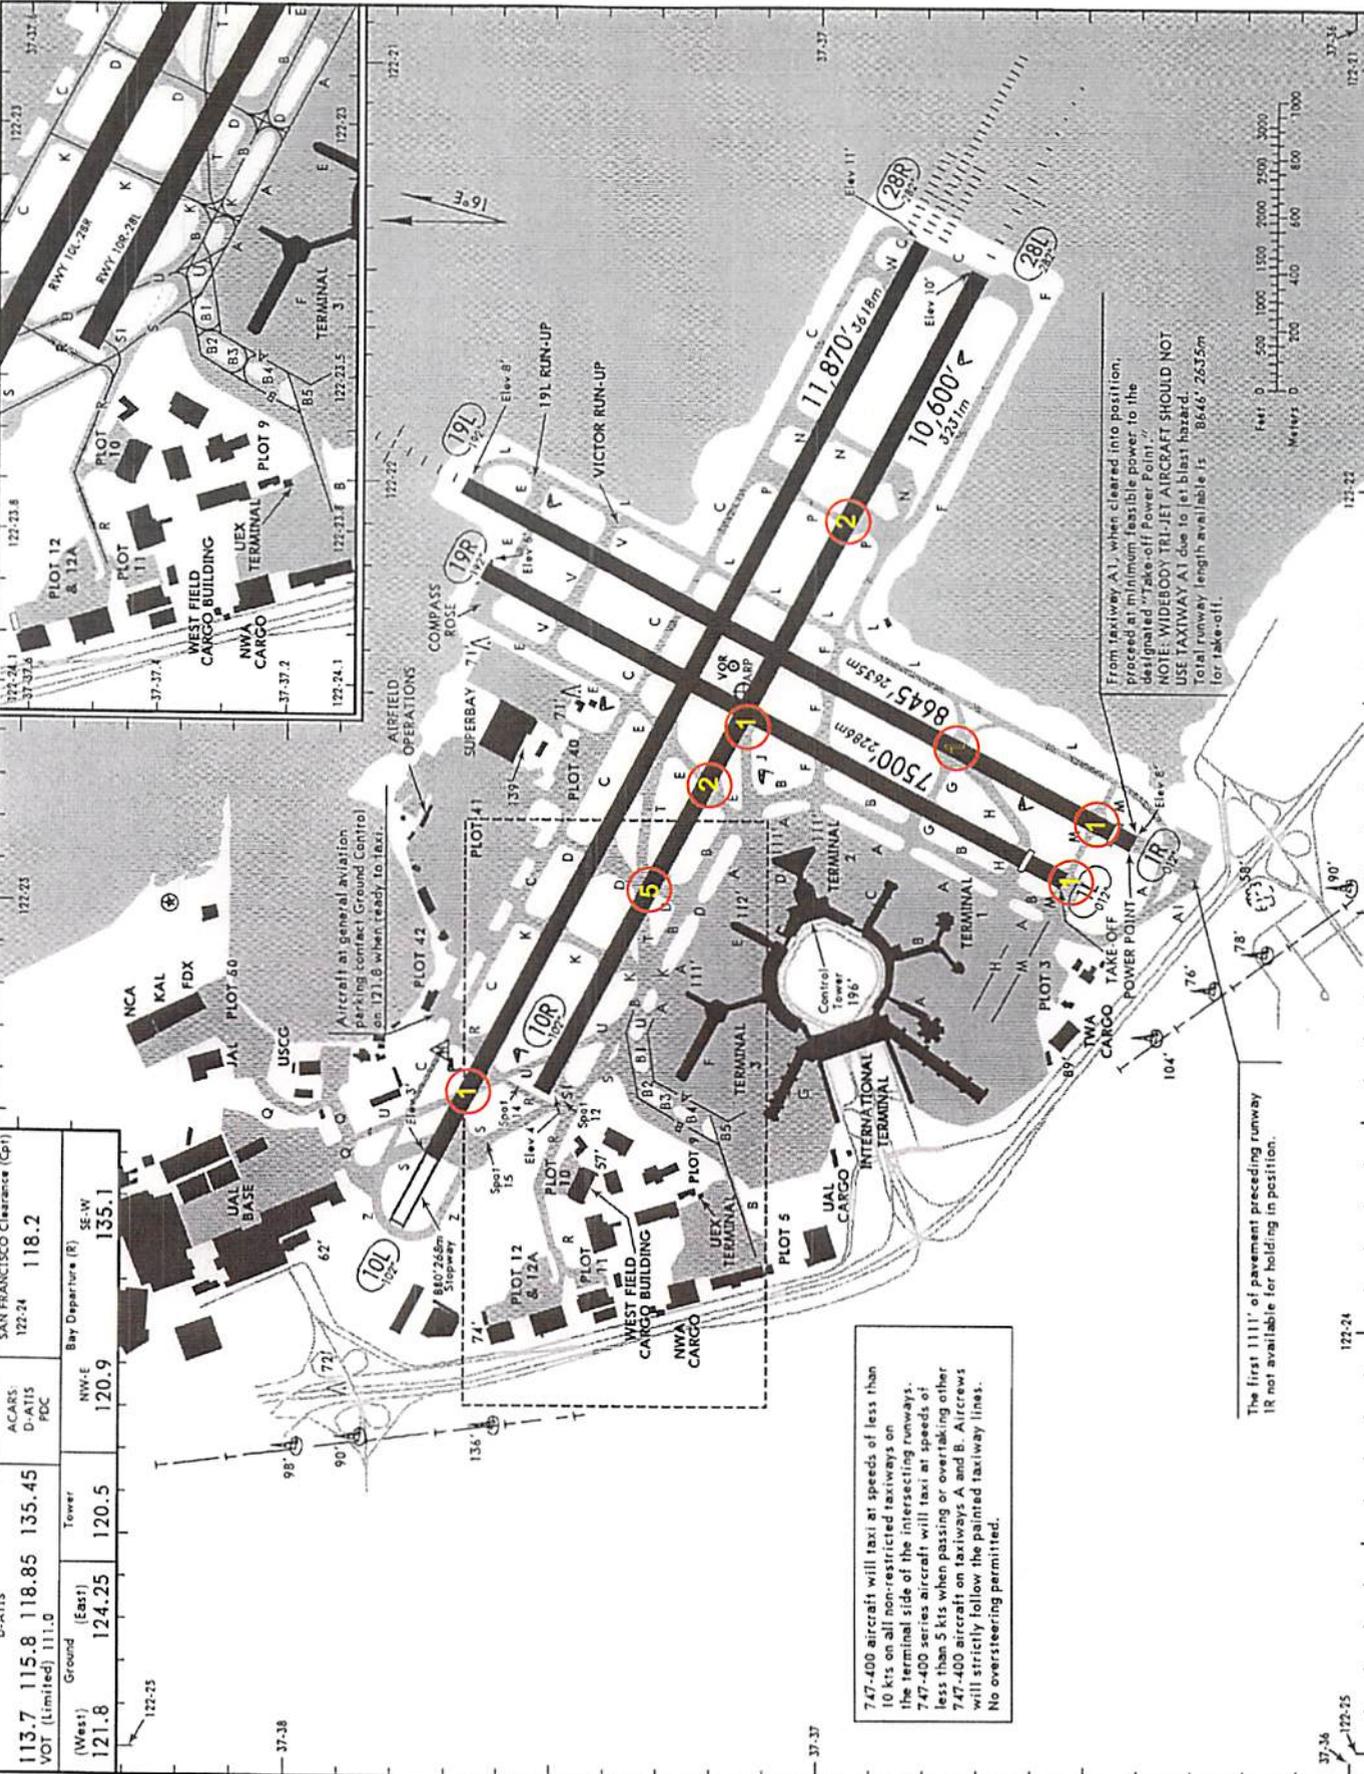
JEFFESEN SAN FRANCISCO CALIF
 SAN FRANCISCO INTL
 N 37° 37' 1" W 122° 22' 5"

From taxiway A1, when cleared into position, proceed at minimum feasible power to the designated "Take-off Power Point."
 NOTE: WIDEBODY TRI-JET AIRCRAFT SHOULD NOT USE TAXIWAY A1 due to blast hazard.
 Total runway length available is 8645' 2635m for take-off.

747-400 aircraft will taxi at speeds of less than 10 kts on all non-restricted taxiways on the terminal side of the intersecting runways. 747-400 series aircraft will taxi at speeds of less than 5 kts when passing or overtaking other 747-400 aircraft on taxiways A and B. Aircrews will strictly follow the painted taxiway lines. No oversteering permitted.

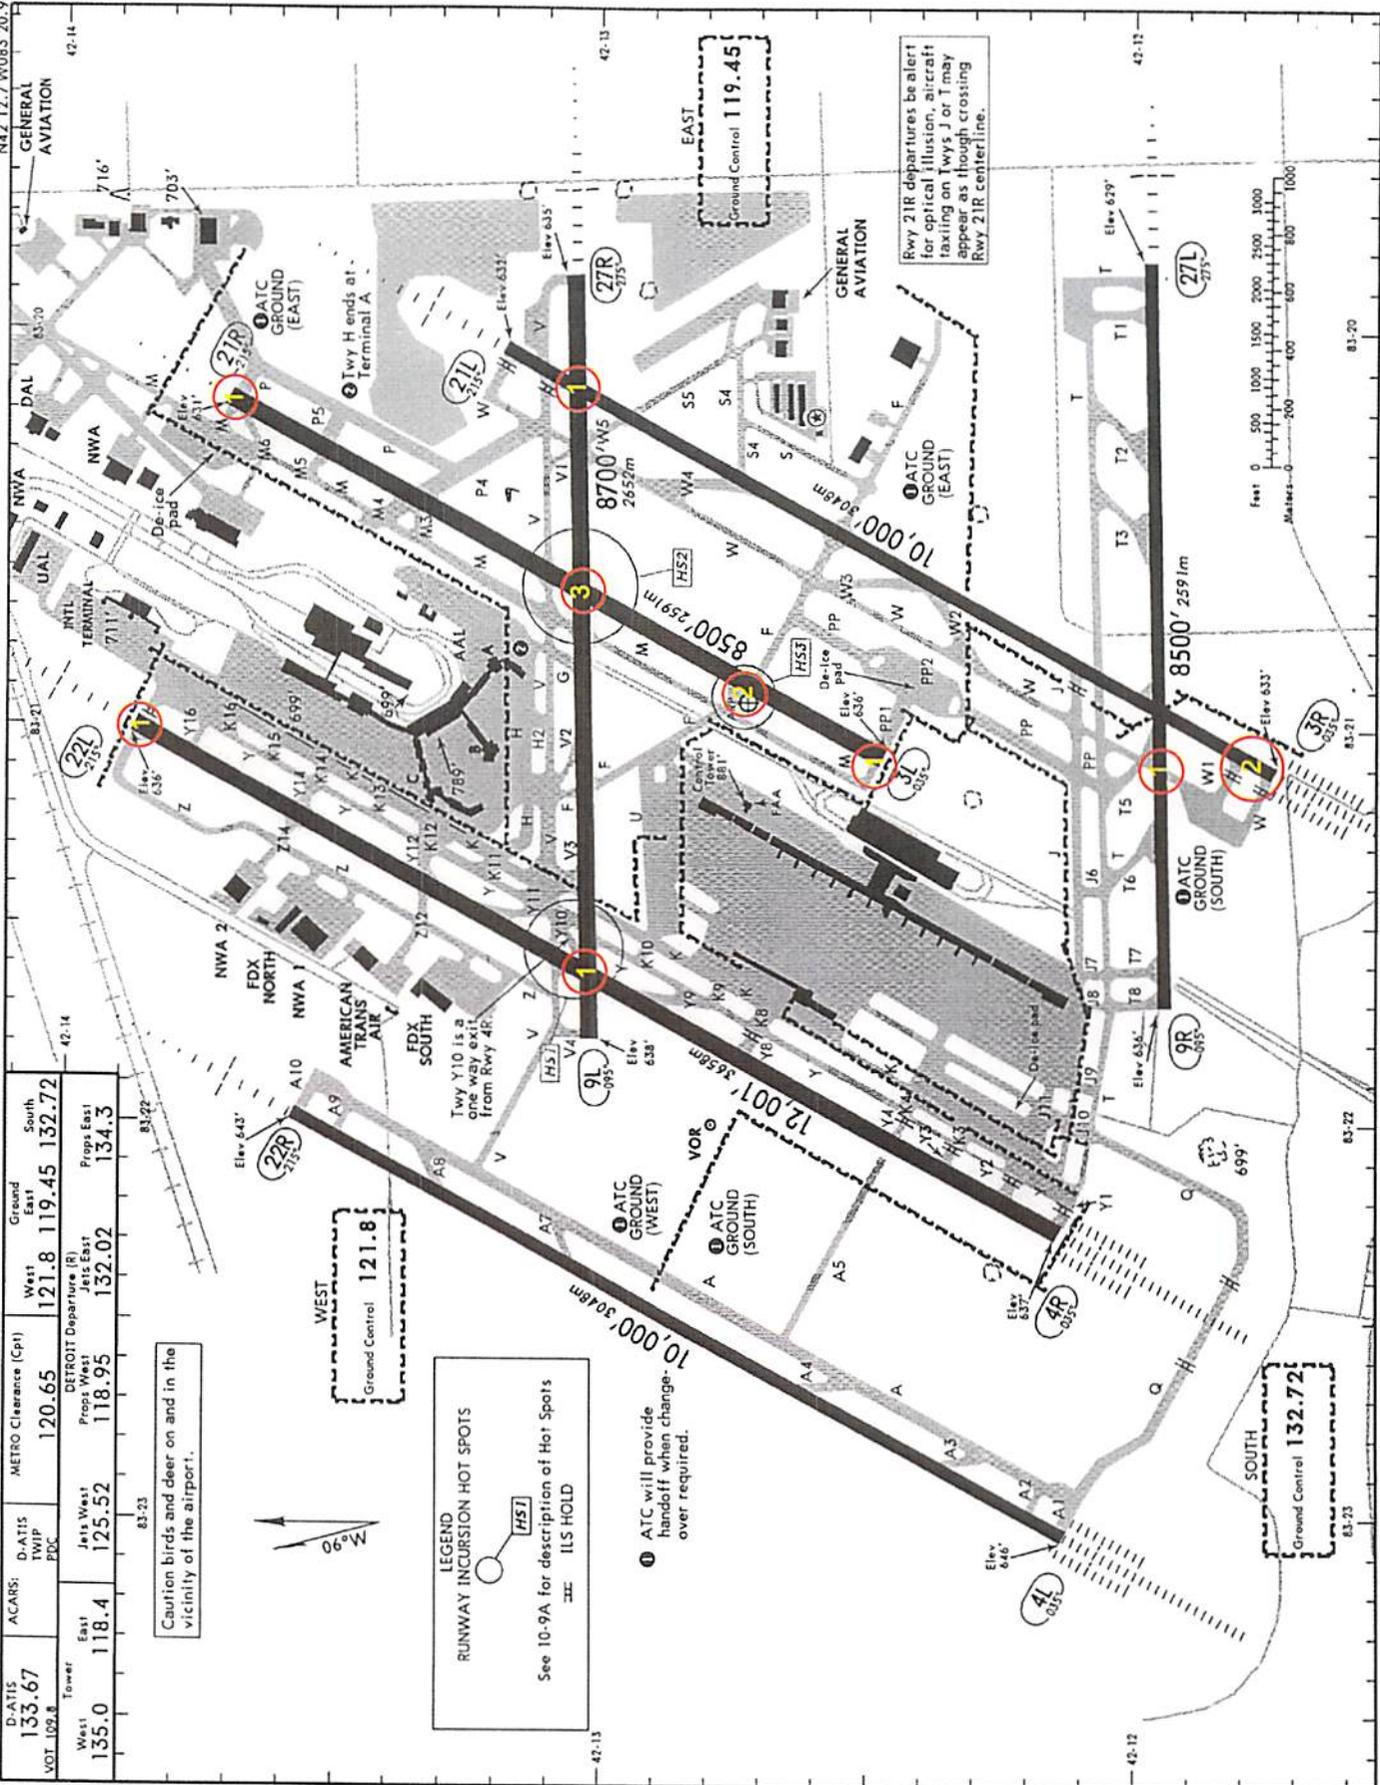
LEGEND
RUNWAY INCURSION HOT SPOTS
See 10-9A for description of Hot Spots
ILS HOLD

CHANGES: Concourses D, E, F, and G removed, control tower, taxiway G added.

All 13 runway incursion incident locations were identified.

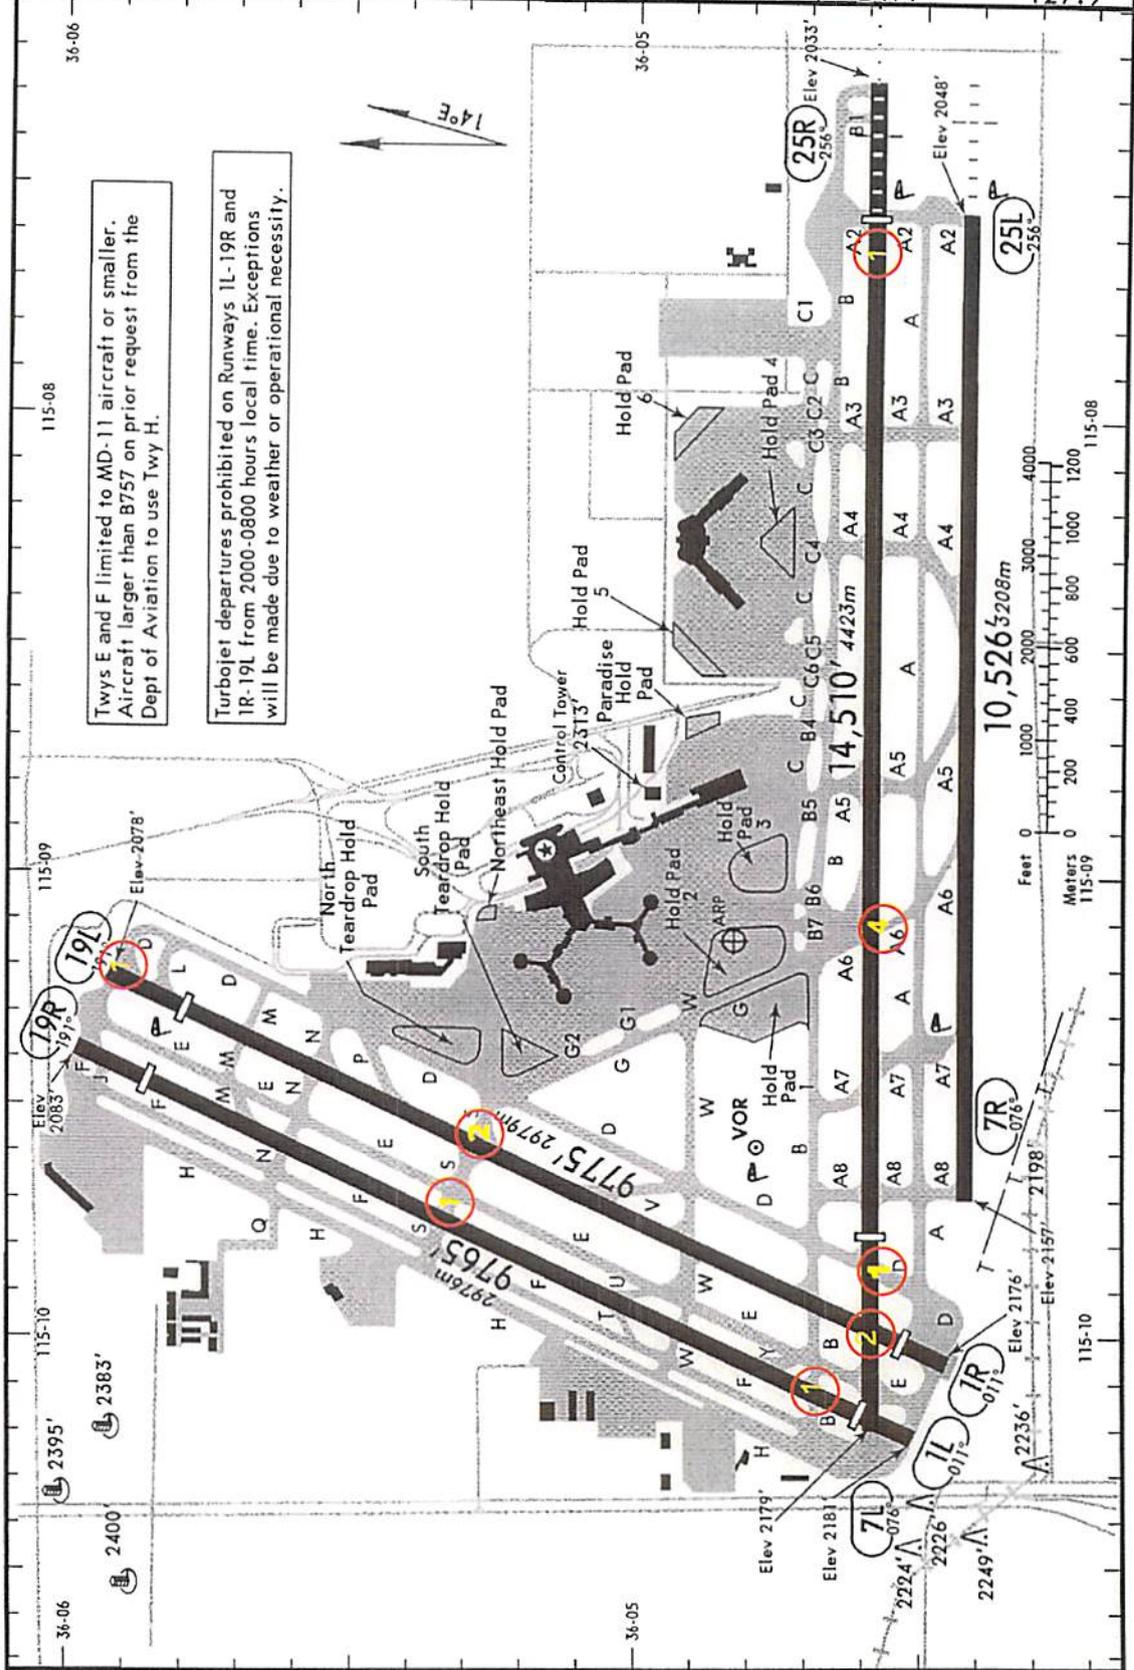
McCARRAN INTL
N36 04.8 W115 09.1

Twys E and F limited to MD-11 aircraft or smaller. Aircraft larger than B757 on prior request from the Dept of Aviation to use Twy H.

Turbojet departures prohibited on Runways 1L-19R and 1R-19L from 2000-0800 hours local time. Exceptions will be made due to weather or operational necessity.

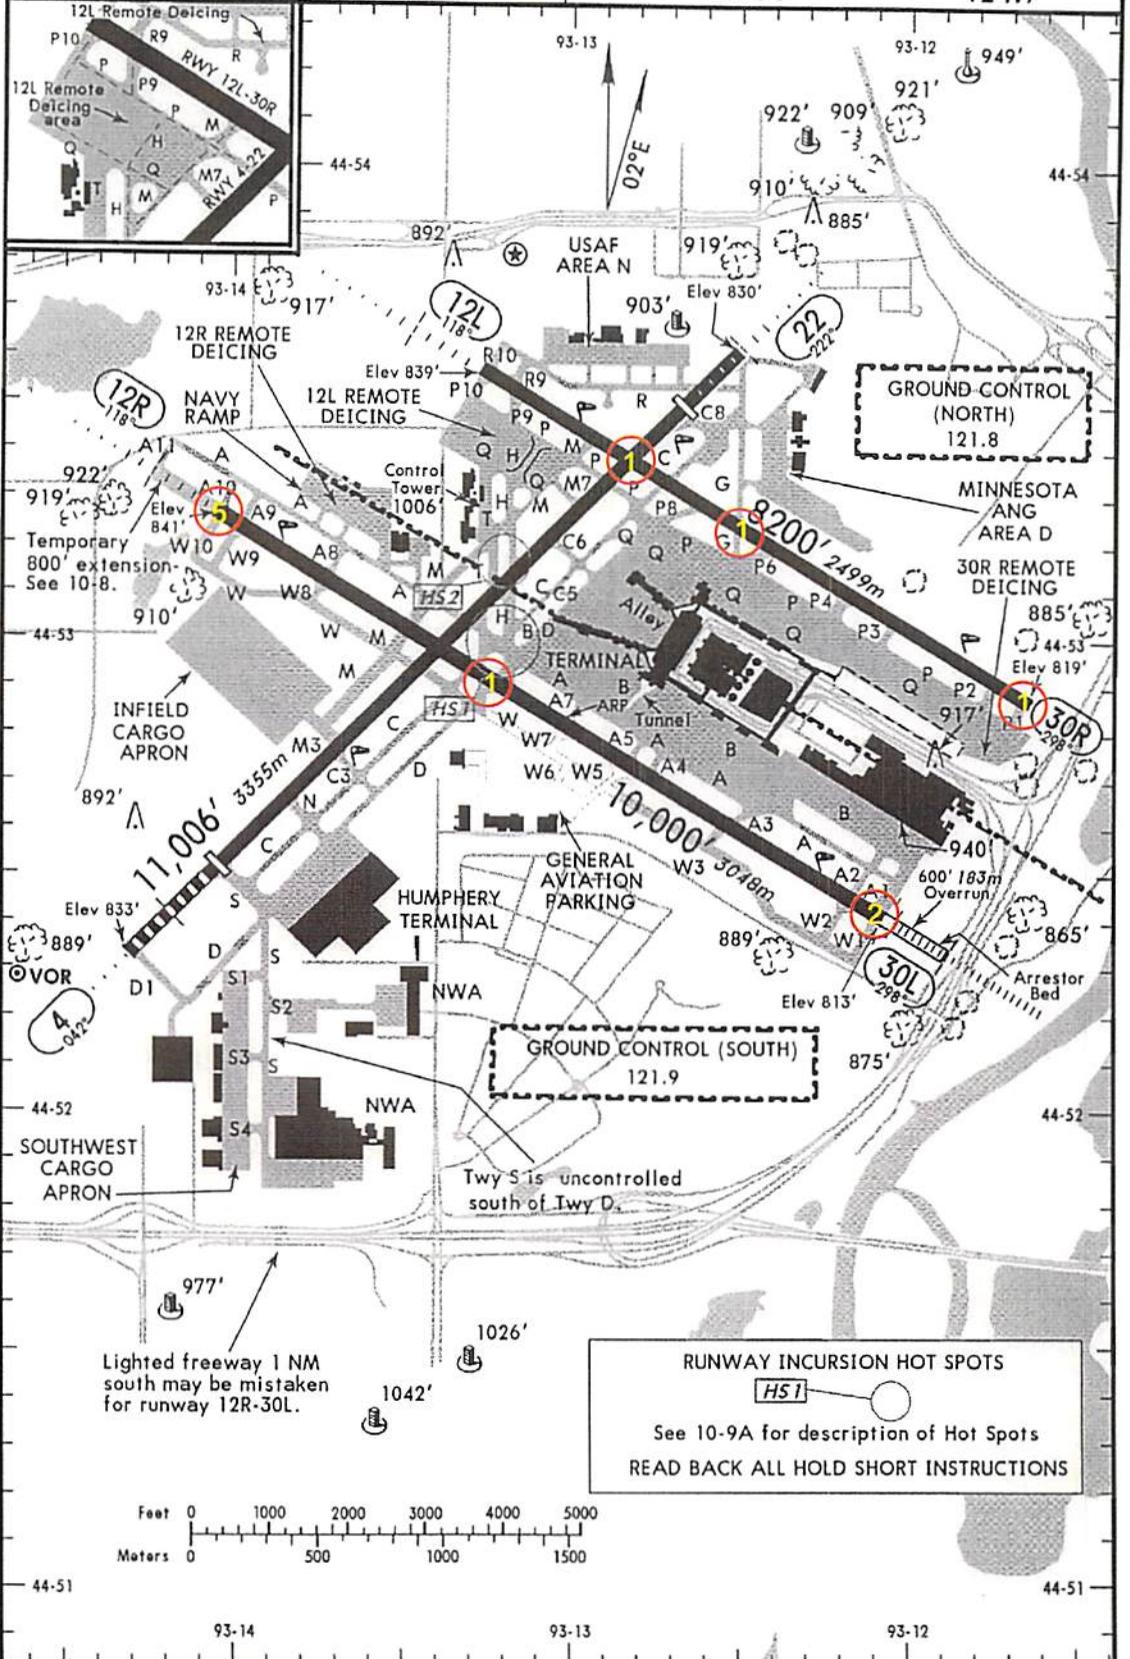
Minneapolis-St. Paul International Airport (MSP)

12 Runway Incursion Incidents

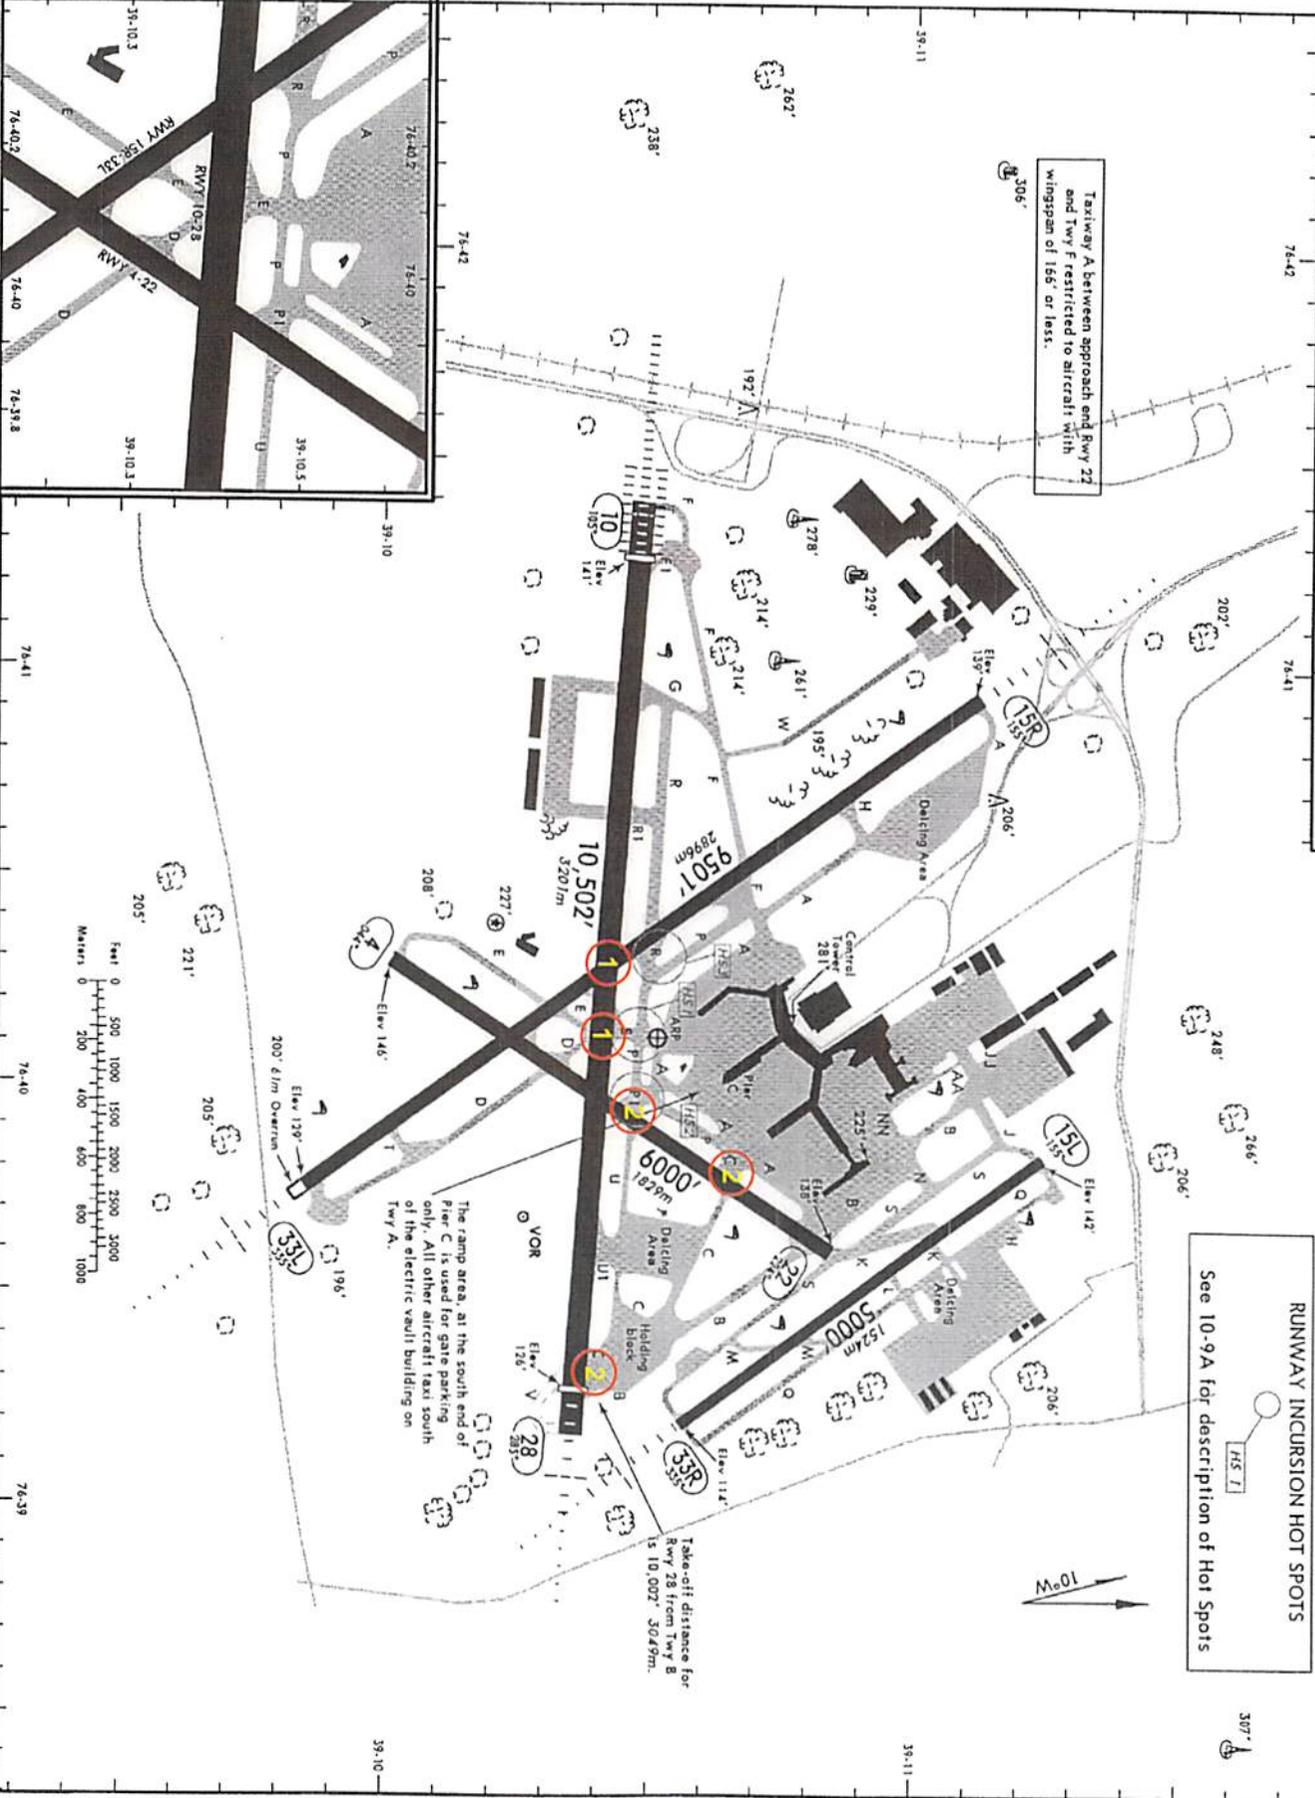
See 10-9A for description of Hot Spots

Taxiway A between approach end Rwy 22 and Twy F restricted to aircraft with wingspan of 165' or less.

CHANGES: Ramp depiction, HOT SPOTS

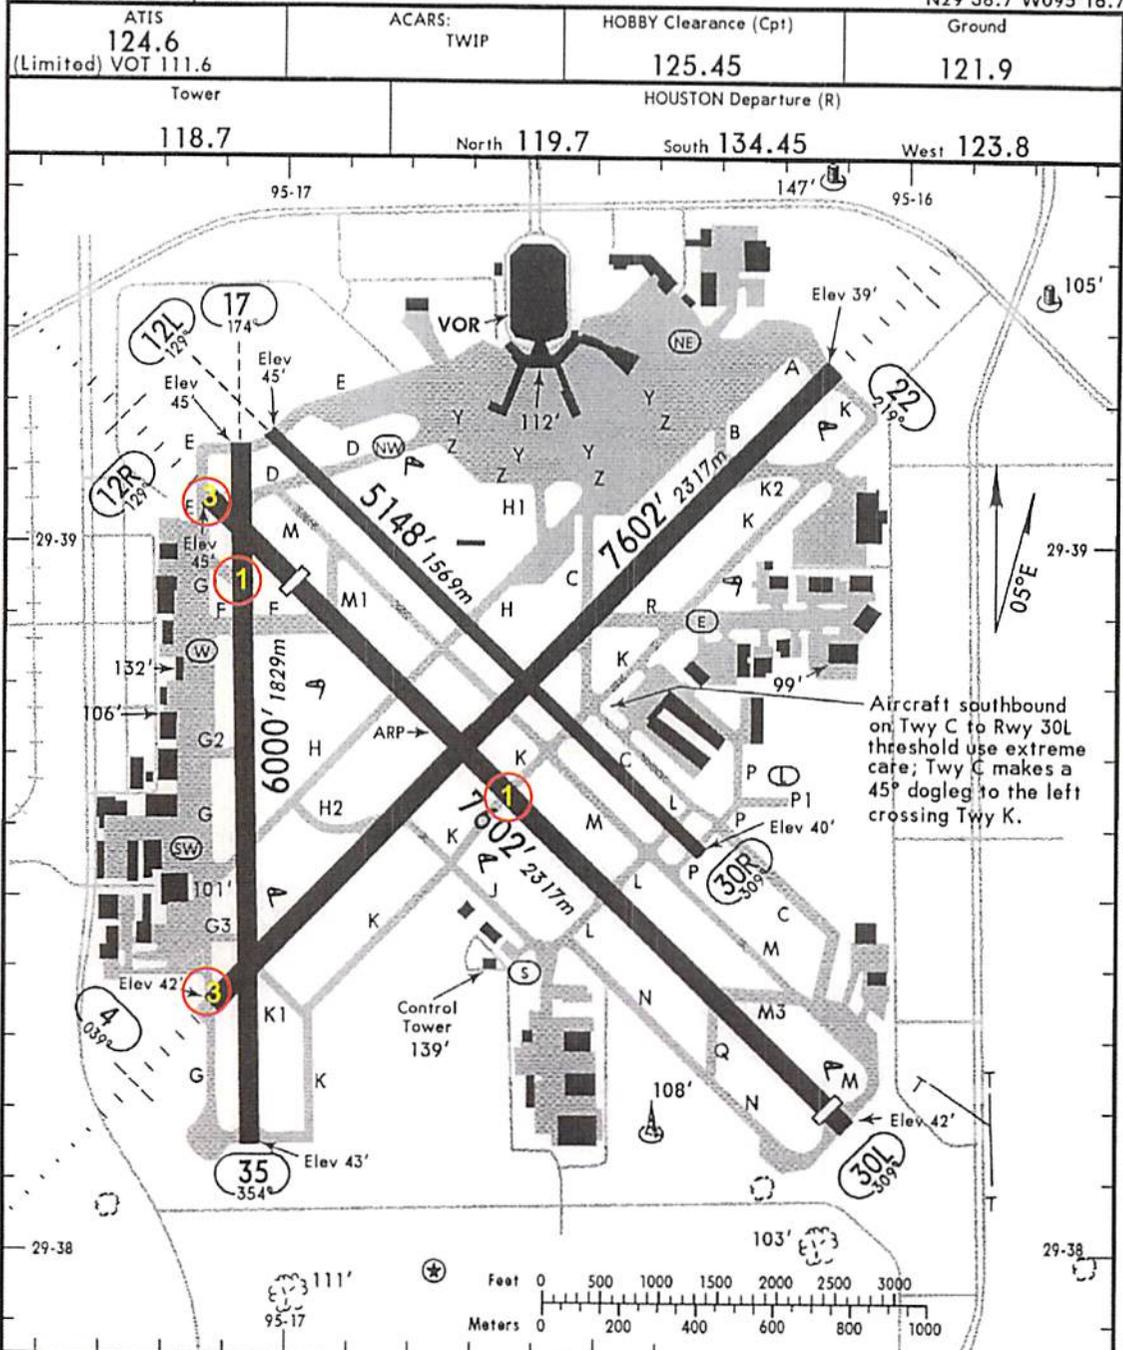
HOUSTON, TEXAS
 HOBBY
 N29 38.7 W095 16.7

Aircraft southbound on Twy C to Rwy 30L threshold use extreme care; Twy C makes a 45° dogleg to the left crossing Twy K.

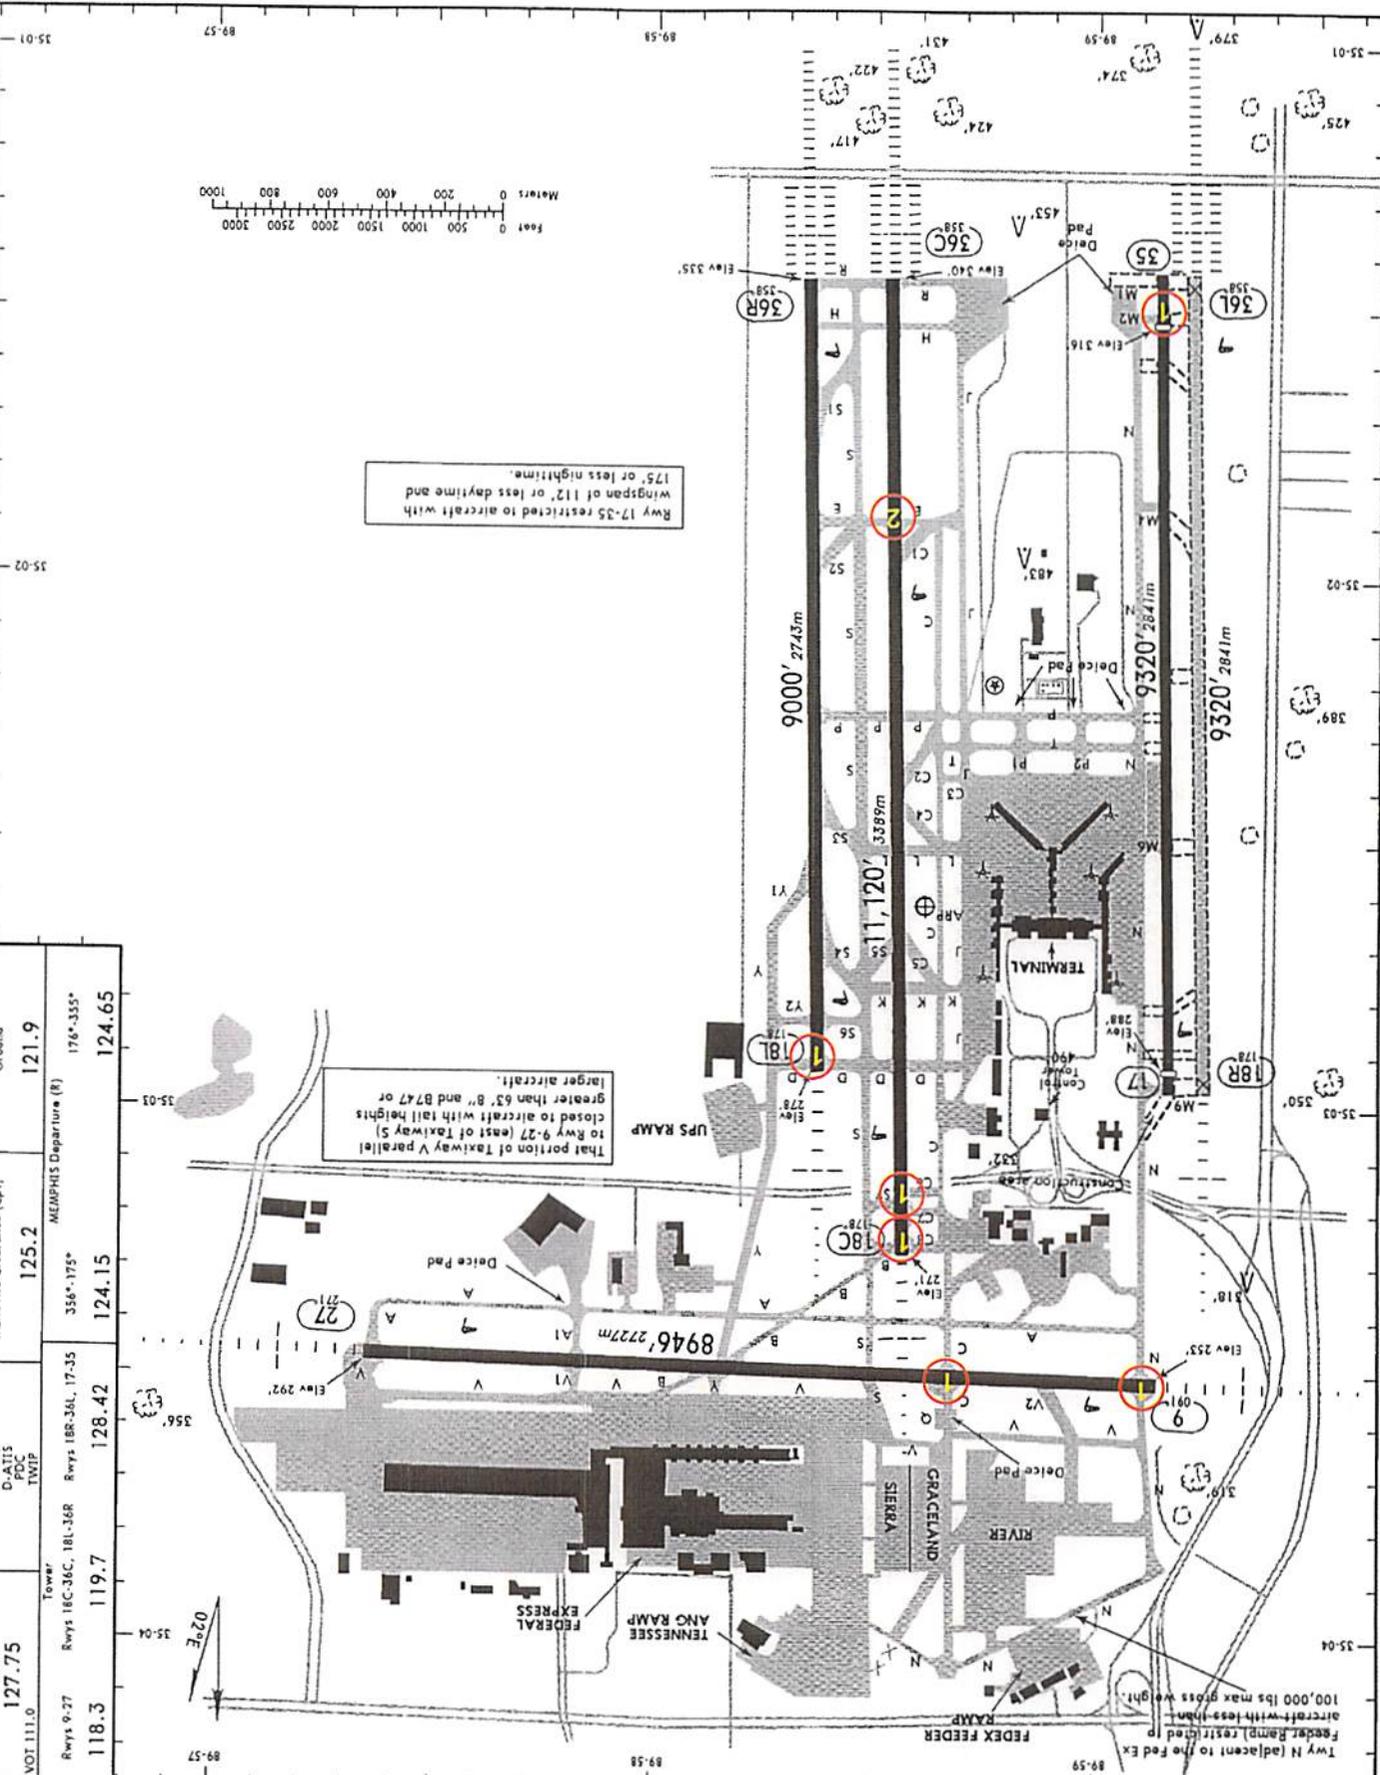
Rwy 17-35 restricted to aircraft with wingspan of 112' or less daytime and 175' or less nighttime.

That portion of Taxiway V parallel to Rwy 9-27 (east of Taxiway S) closed to aircraft with tail heights greater than 63' 8" and 87.47 or larger aircraft.
