An Analysis of Runway Incursion “Hot Spots” Incidents

With Deidentified Reports Excerpts

Volume 2

October 24, 2002

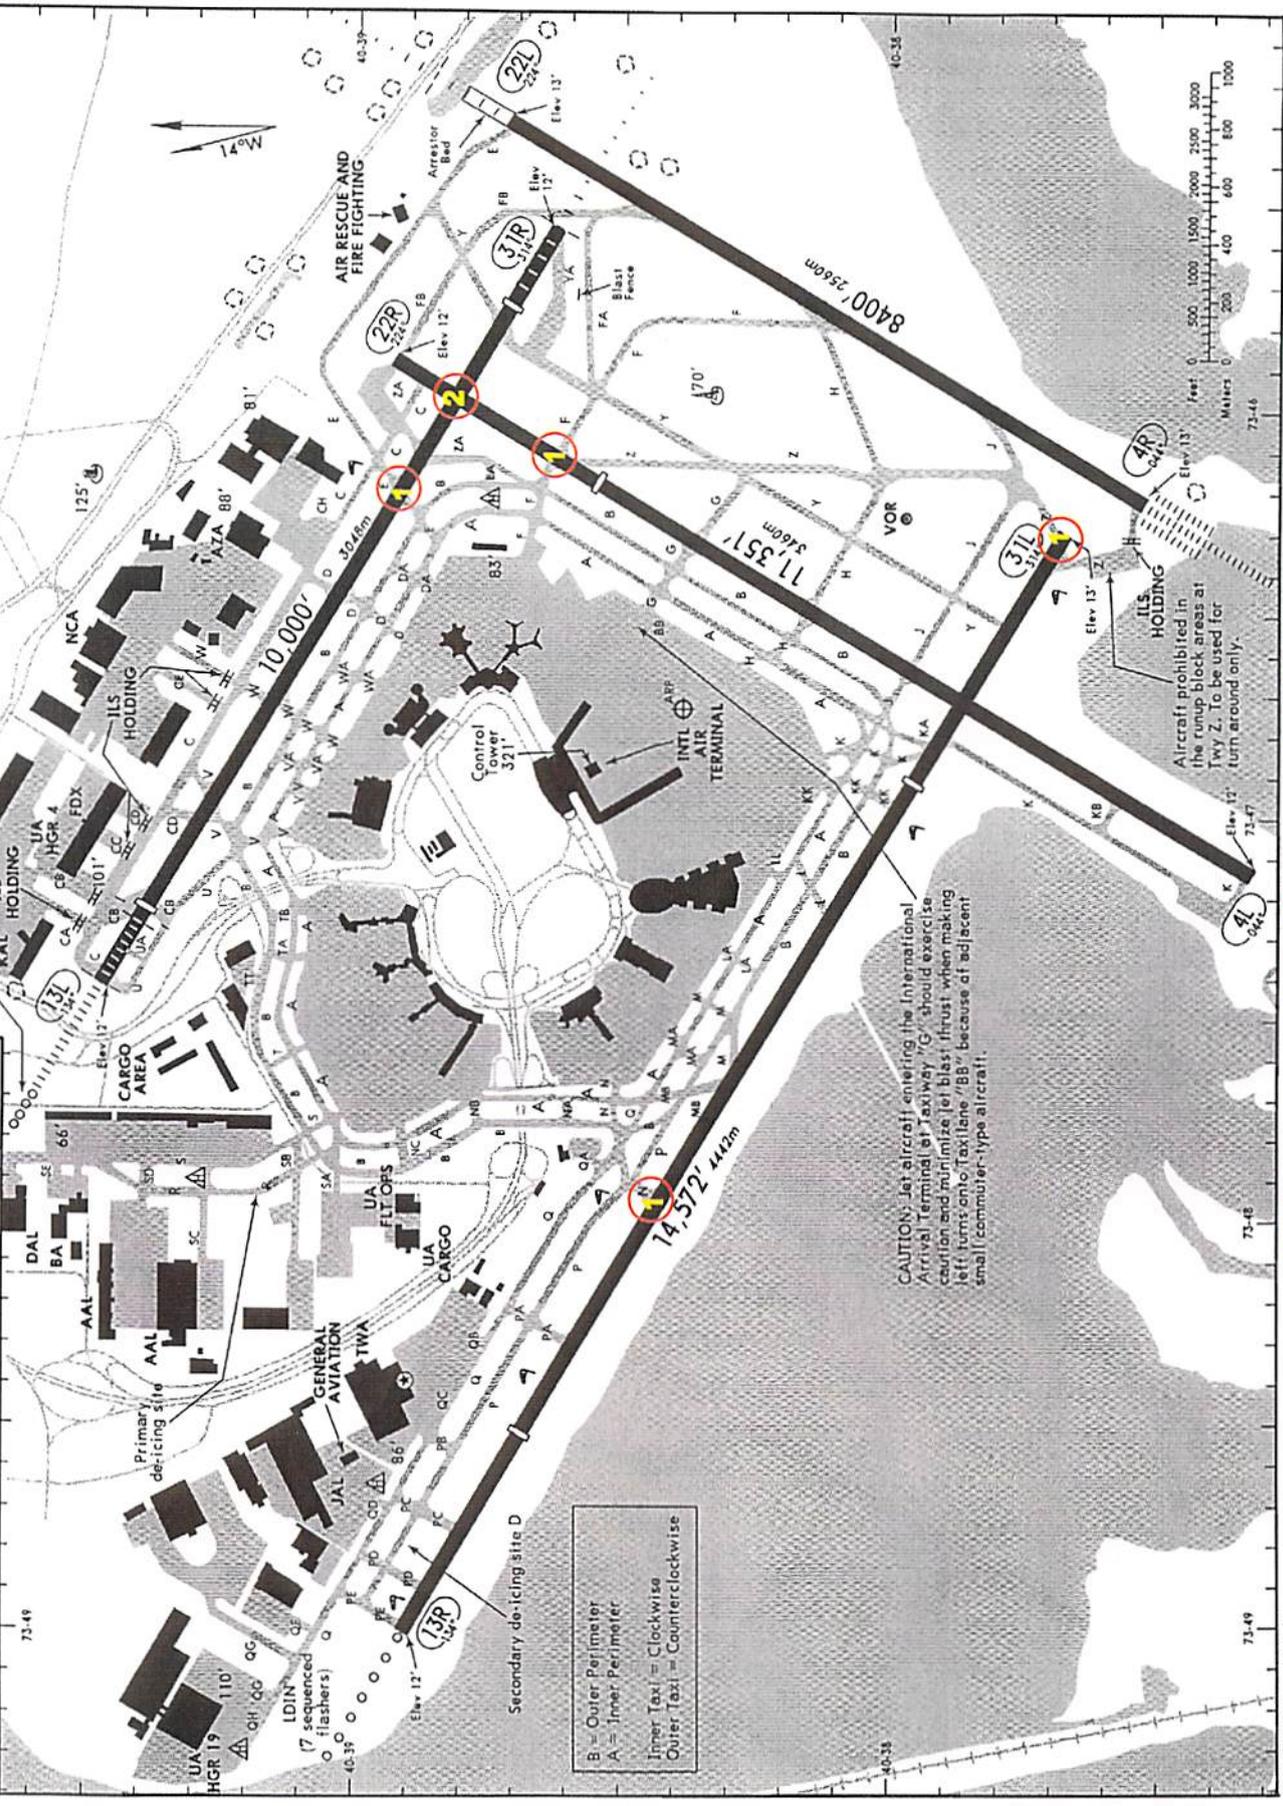
**JFK Runway Incursion
“Hot Spots” Incidents**

CAUTION: Jet aircraft entering the International Arrival Terminal at Taxiway "G" should exercise caution and minimize jet blast thrust when making left turns onto Taxiway "BB" because of adjacent small/commuter-type aircraft.

ILS HOLDING
 Aircraft prohibited in the ramp block area at Twy Z. To be used for ILS 13' turn around only.
