Bus Support Facilities: Conditions and Needs

Final Report
January 1993

ATE Management and Service Company, Inc.
1911 North Fort Myer Drive
Arlington, VA 22209

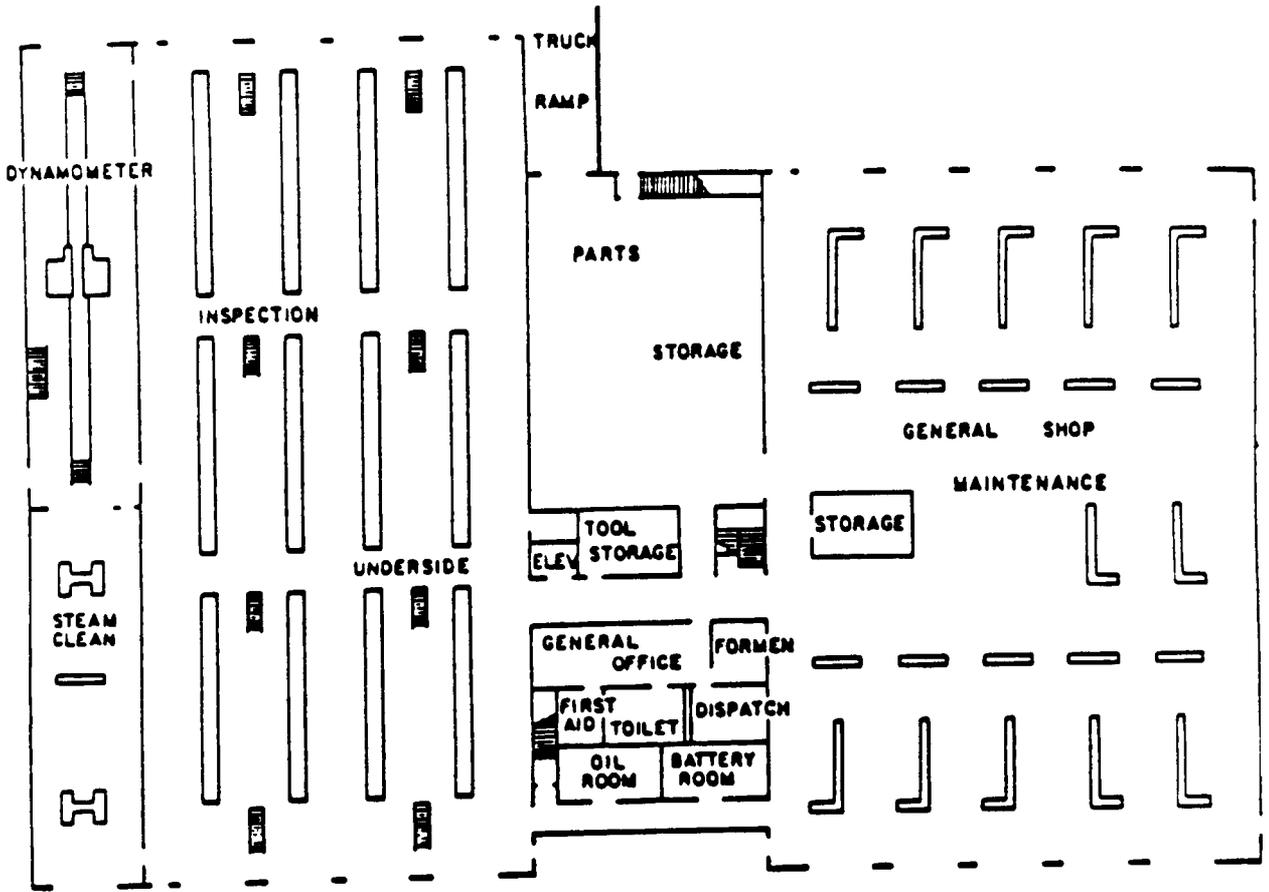
**EXHIBIT C-4
GARAGE PLAN
FOND DU LAC
MAINTENANCE BUILDING**

FIRST FLOOR

Milwaukee County Transit System (MCTS) in Milwaukee, Wisconsin has three operating bus garages. The Fond du Lac garage is one of these garages and it is 10 years old and its bus storage building is over 30 years old. Exhibit C-3 provides a lot plan for the facility and Exhibit C-4 provides a plan for the garage. It was reported that the local community was supportive of the establishment of the bus garage in this location because it has existed there for many years and because it offers another employer in a poorer neighborhood. The location was also chosen because it is centrally located within the structure of passenger routes served. The central location reduces the number of deadhead miles and is a nominal distance from freeway access. Another factor in the decision making process was the land parcel size. To acquire a parcel large enough to meet its needs would have probably required exercising the "right of eminent domain" (condemning land adjacent to a desired parcel in order to have enough land to meet the needs of the location). MCTS strongly

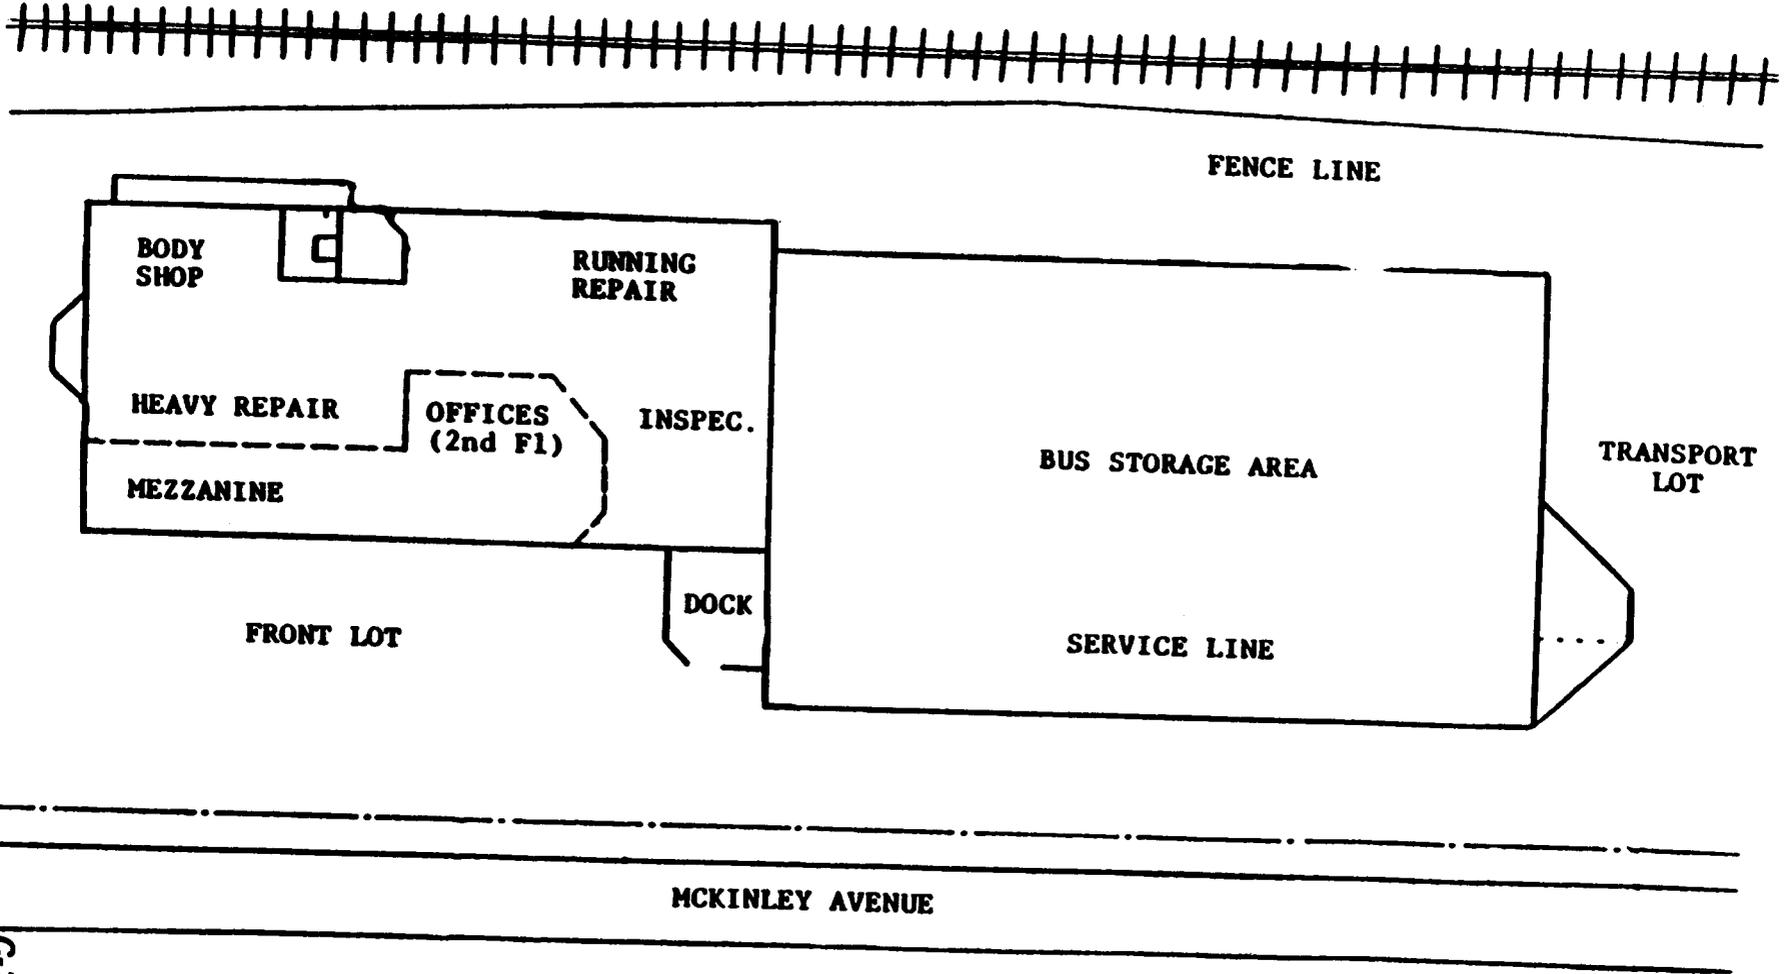
Central Ohio Transit Authority (COTA) is located in Columbus, Ohio. The McKinley facility is a relatively new facility, built in 1980, which supports the operation by providing an operating garage and a central overhaul operation. A site plan is included as Exhibit C-6.

The physical configuration of the facility is along the lines of a large rectangle with the bus parking, servicing, maintenance, overhaul, administration and general offices all interconnected and under roof.

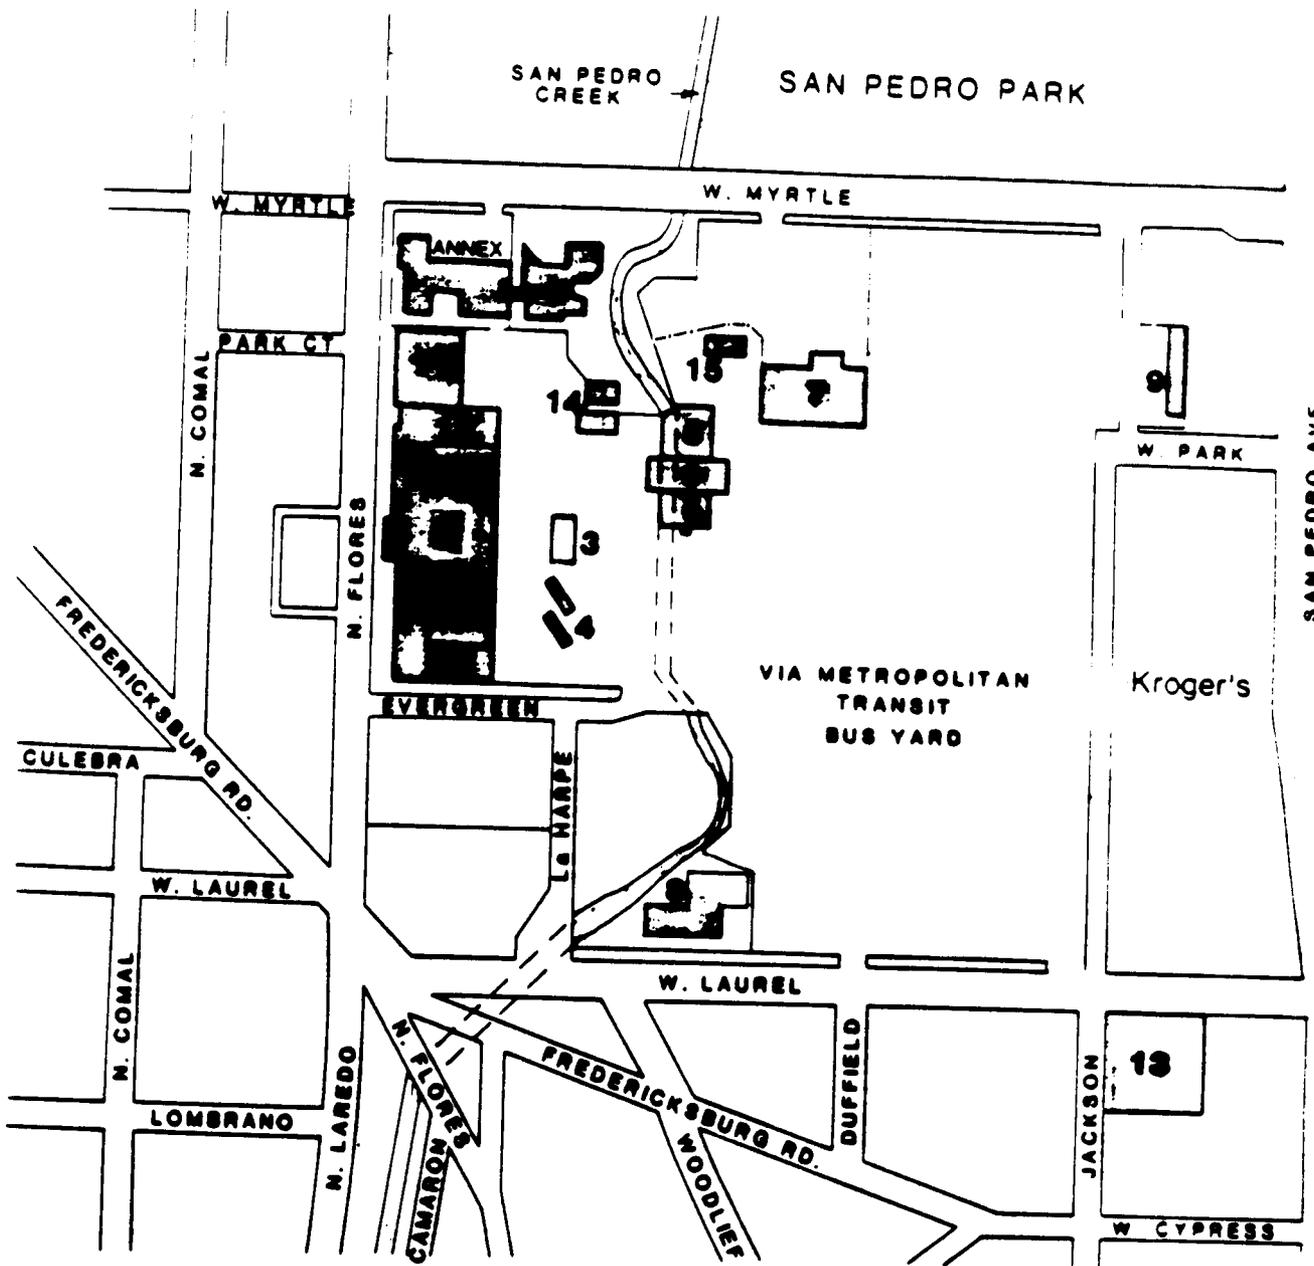
EXHIBIT C-10

VIA Headquarters Site
