Effects of Realistic Heat Straightening Repair on the Properties and Serviceability of Damaged Steel Beam Bridges

JOINT TRANSPORTATION RESEARCH PROGRAM

INDIANA DEPARTMENT OF TRANSPORTATION
AND PURDUE UNIVERSITY

1. Report No. FHWA/IN/JTRP-2013/03	2. Government Accession No.	3. Recipient's Catalog No.	
4. Title and Subtitle Effects of Realistic Heat Straightening Repair on the Properties and Serviceability of Damaged Steel Beam Bridges		5. Report Date February 2012

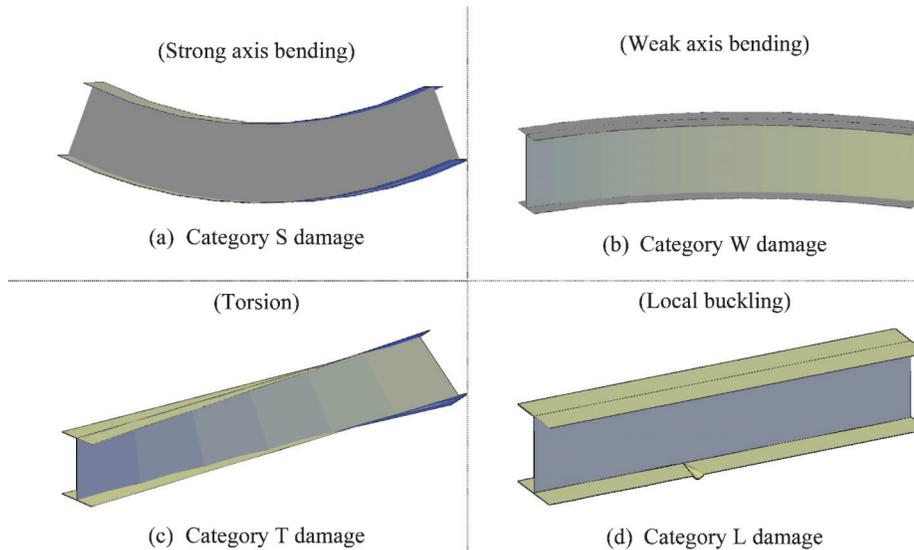
Figure 1.1 Fundamental damage categories for steel beams.

The permanent plastic deformations produced by a collision can be described using the damage characterization scheme developed by Avent and Mukai (1,2), which includes strong axis (S), weak axis (W), torsional (T), and local buckling (L) damage shown in Figure 1.1.

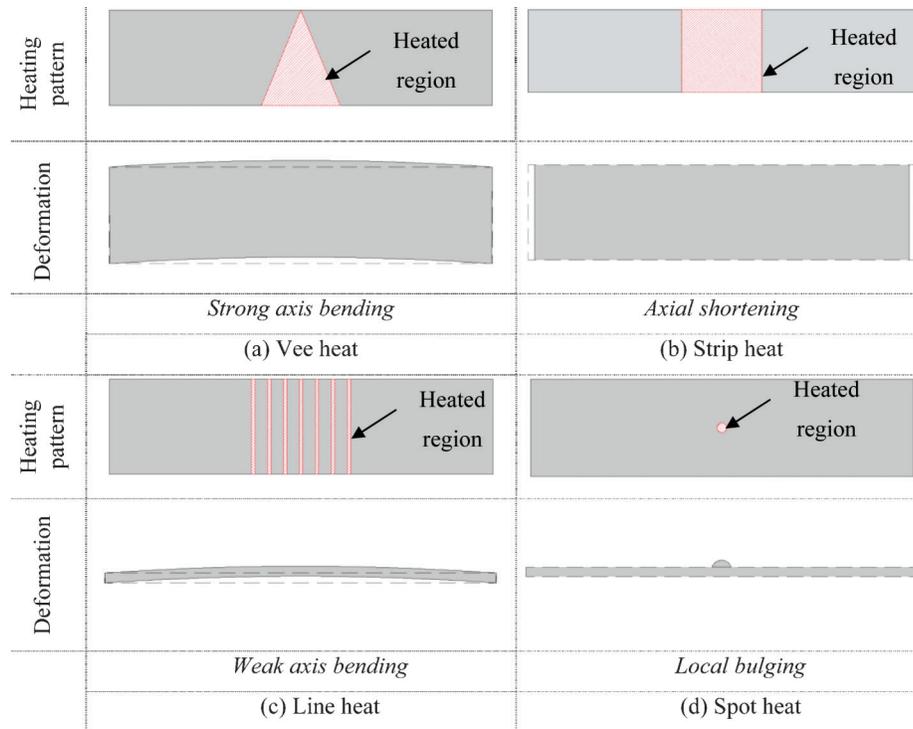
Figure 1.2 Typical heating patterns used for heat straightening repair.

Typical heating patterns used for conducting repair are shown in Figure 1.2. Vee heats are used to repair out-of-plane deformations of the flange, strip heats are used to repair web lateral deformations, line heats are used to repair weak axis deformations, and spot heats are used to repair the flange local buckling.

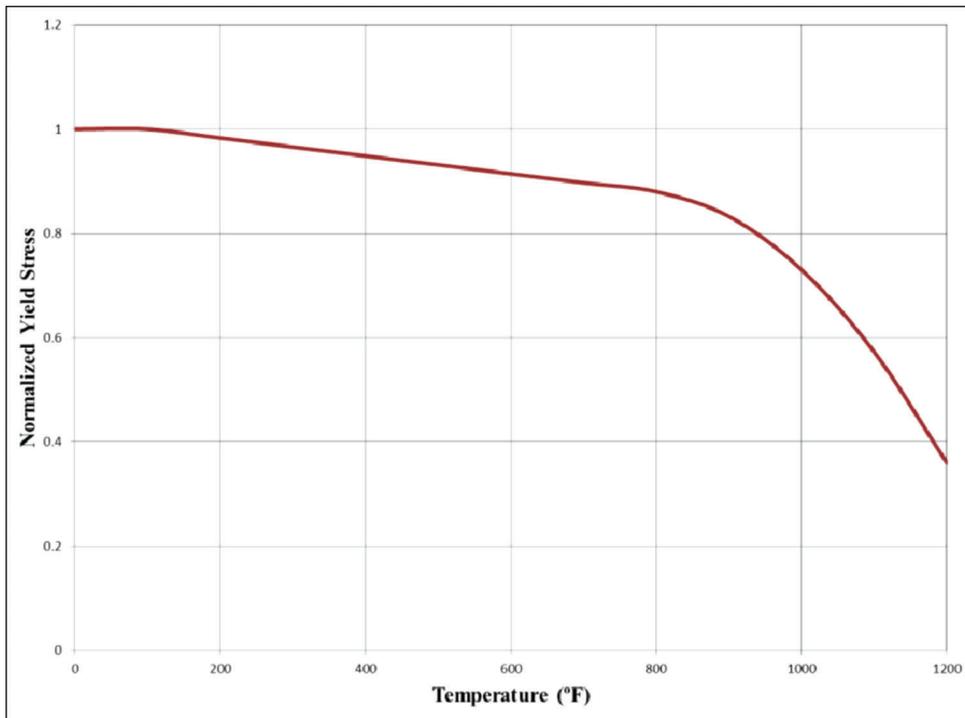
Figure 2.1 Normalized yield stress vs. temperature (22).

Yield stress. The yield stress of steel was influenced by the heat straightening in two ways. First, the yield stress of the steel reduces as the temperature of the steel increases. Figure 2.1 shows this relationship between the yield stress and steel temperature. In Figure 2.1, the relationship between the normalized yield stress and steel temperature is plotted using Equations 2.1–2.3 (22).

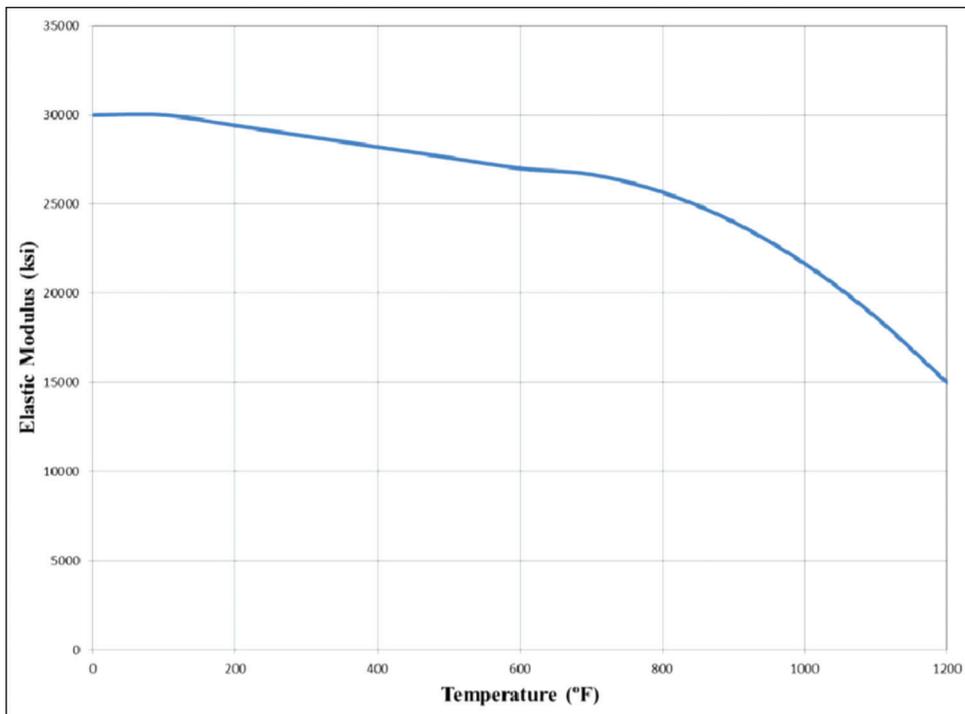
Figure 2.2 Modulus of elasticity vs. temperature (3).

Modulus of elasticity. As the temperature increases, similar to the yield stress described in the previous section, the modulus of elasticity decreases. Figure 2.2 shows this inverse relationship between the temperature and the modulus of elasticity. Equations 2.4–2.6 (22) are used for Figure 2.2 with an assumption that E_o is 30000 ksi. As shown in Figure 2.2, the modulus of the elasticity of steel at 1200 °F is close to half of its typical value (28).

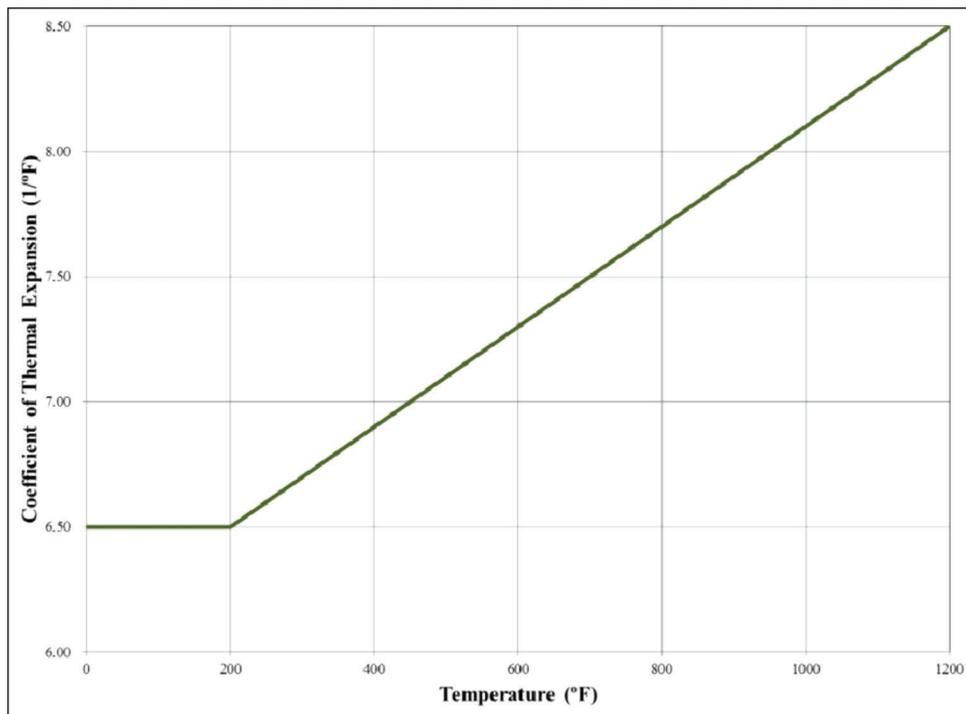
Figure 2.3 Coefficient of thermal expansion vs. temperature (3).

Thermal expansion. Thermal expansion enables the steel member to expand and contract in the desired direction. The coefficient of thermal expansion is described in the measure of the rate of strain per degree of temperature. The relationship of the coefficient of thermal expansion vs. temperature (22) for low carbon steel is shown in Figure 2.3. Roeder (22) has revealed that the coefficient of thermal expansion for Vee heats is increased up to 1600 °F for carbon steels. In the range of 250–1200 °F, the coefficient of thermal expansion has a linear relationship with the steel temperature (3,11,26,29).

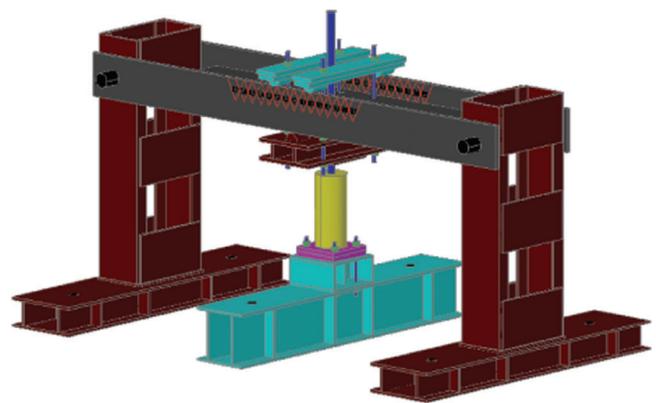
Figure 3.1 Small scale test setup.

The small scale test setup focuses on the damage and repair of the bottom flange of steel beam girders. Figure 3.1 shows a schematic drawing of the small scale test. Six built-up section specimens were prepared and tested. A hydraulic actuator placed at the midspan shown in Figure 3.1 applies damage and restraining force to the test specimen. After the damage, Vee heat is applied on the plastically deformed region to repair the damage with restraining force. This damage and repair behavior is simulated by taking beam specimens with comparable flanges and subjecting them to weak axis bending.

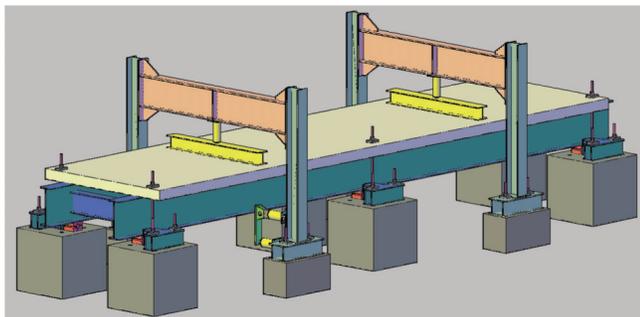
Figure 3.2 Large scale test setup.

Figure 3.2 shows the large scale test setup for conducting the experimental investigations. As shown, the test setup represents a large scale model of steel beam bridges damaged and repaired most frequently in Indiana. The test bridge is composed of two steel rolled beams and concrete slab deck. Two main girders were placed over six abutment blocks and will include four composite beam specimens like Figure 3.2.

After the specimens were subjected to damage and heat straightening repair, the serviceability performance of the repaired bridge was determined by subjecting static loads simulating the AASHTO (40) live loading. As shown in Figure 3.2, two hydraulic actuators were attached to the midspan loading frames over the bridge specimen to apply concentrated loads to the bridge.

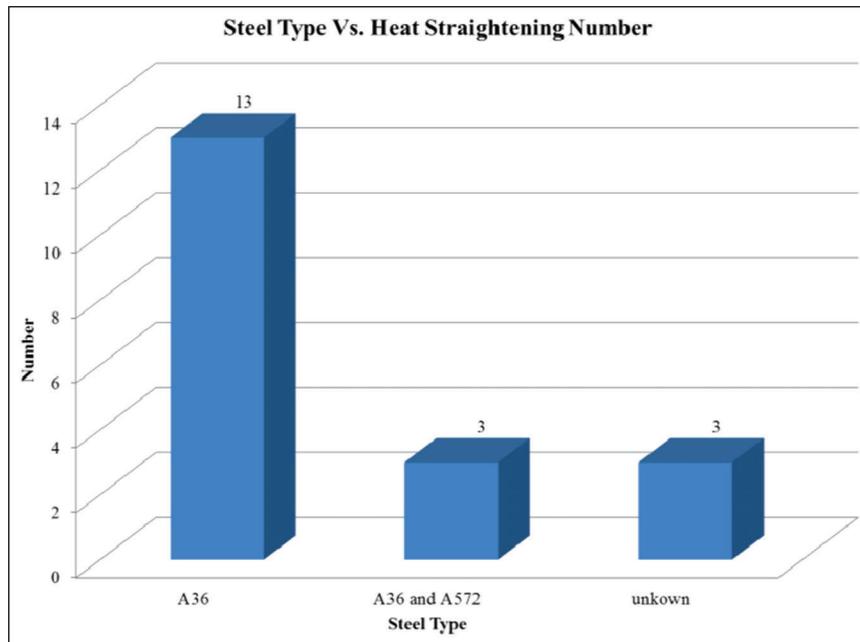
Figure 4.1 Steel type vs. number of heat straightening repairs.

As seen in the Figure 4.1, sixteen out of nineteen damaged and heat straightened bridges in the database were made of A36 steel.

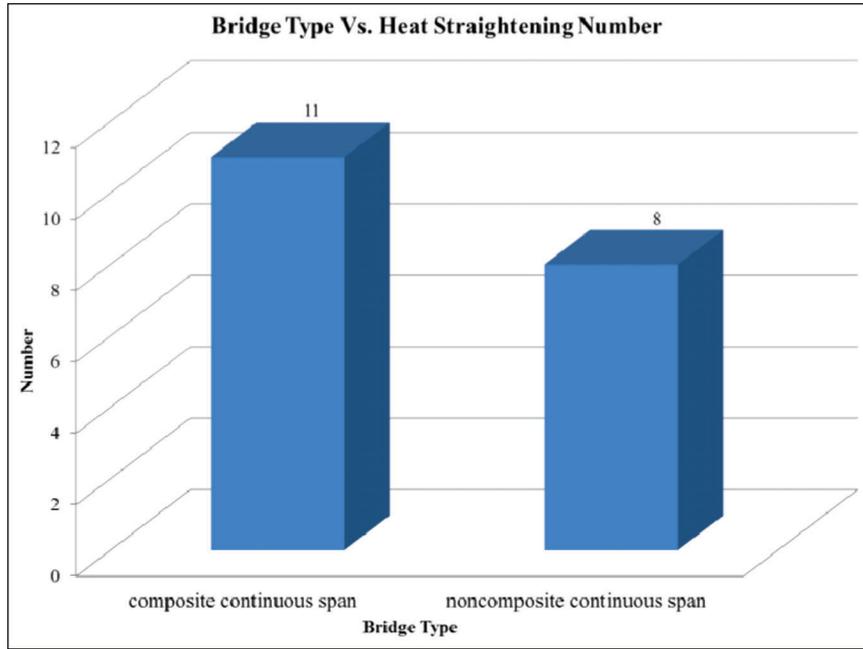
Figure 4.2 Bridge type vs. number of heat straightening repairs.

The composite continuous bridge was the most frequently damaged bridge type in the database. As shown in Figure 4.2, eleven bridges in the database were composite continuous bridges. The second most frequently damaged bridge type in the database was the non-composite continuous bridge.

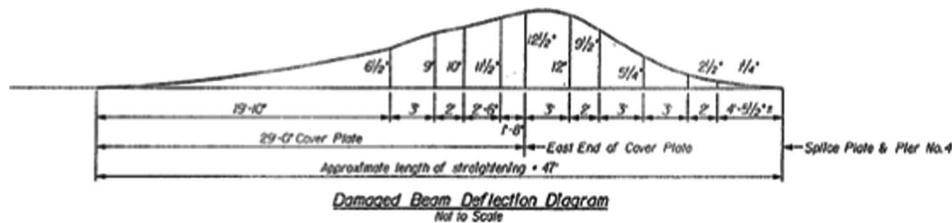
Figure 4.3 Damage diagram of I65-261-4904B bridge.

The maximum damage strain (ϵ_{max}) of each damage case was presumed using deformation diagrams from the drawings in the database. Twenty-four heat straightening cases from thirteen damage-repaired bridges presented a damage diagram to estimate the maximum damage strain (ϵ_{max}) of each case. Figure 4.3 shows one sample damage diagram from the I65-261-4904B bridge.

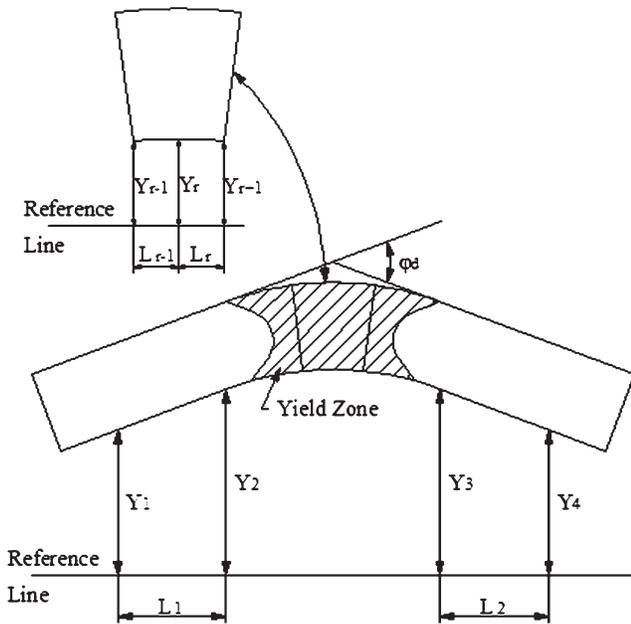
Figure 4.4 Offset measurements to calculate degree of damage and radius of curvature.

The offset method in the FHWA 1998 guidelines (28) was used to estimate the maximum damage strains (ϵ_{max}) in each damage case. Equation 4.2 ~ 4.4 with variables described in Figure 4.4 and 4.5 were used to determine the maximum damage strain.

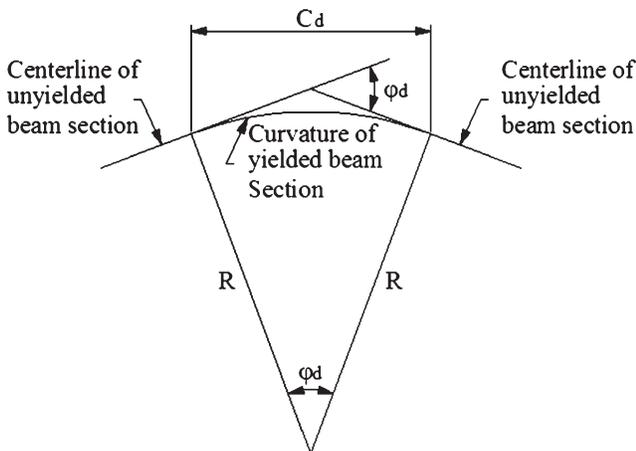
Figure 4.5 Relationship of degree of damage to radius of curvature and cord length.

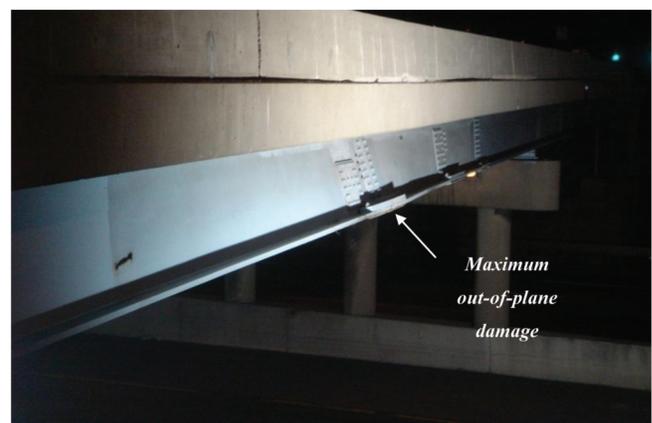
Figure 4.6 Damage on Allisonville Road bridge.

As shown in Figure 4.6, the east-end composite beam was hit by an over-height truck at 37 ft. from the south

abutment and various types of damages were found around the impact point. These damages included a 6 in. out-of-plane displacement (combined with distortion) of the bottom flange, formation of the web yield line, and the girder-to-diaphragm connection failure (including bolt fracture and bearing shear failure of the crossbeam).

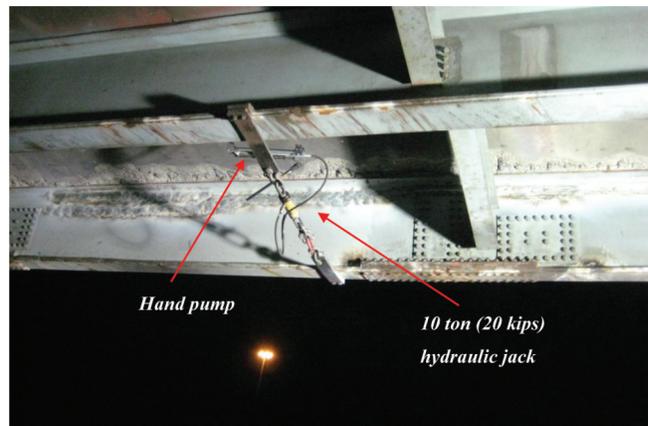
Figure 4.8 Hydraulic jack system for restraining force.

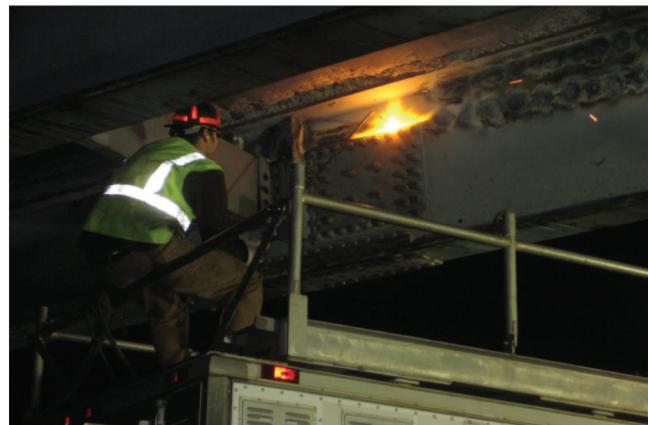
Figure 4.9 Line heat on the web of the girder.

A oxygen-propylene torch was used for the heating process. Initially, line heats were applied on the web of the girder close to the concrete slab. Figure 4.9 shows the line heat process being applied by a technician. After the line heat, Vee heats were applied on several damaged points of the beam as shown in Figure 4.10. As seen in Figure 4.10, half-depth and full-depth Vee heats were properly applied following the deformed shape of the bottom flange. The Vee angle was computed to be approximately 55°.

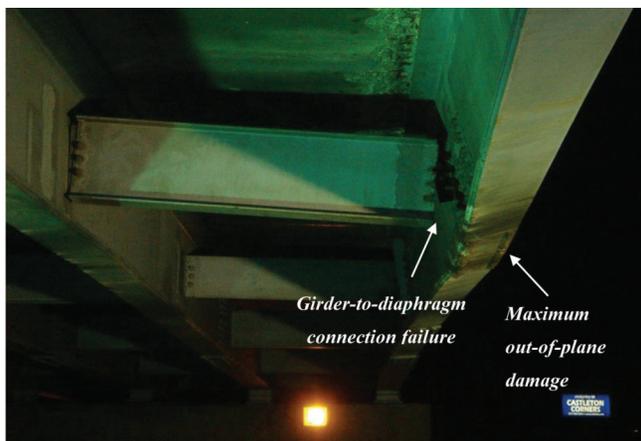
Figure 4.7 Close-up view of damaged region.

The maximum out-of-plane damage occurred at the location with an additional cover plate, which was added in the previous damage-repair process. This is seen more clearly in Figure 4.7. Bearing shear failure that occurred in the end connection of one diaphragm is also shown in Figure 4.7. Yield lines also formed in the girder web close to the concrete slab following the girder direction. (See Damaged Girder video: <http://dx.doi.org/10.4231/D3X63B541>)

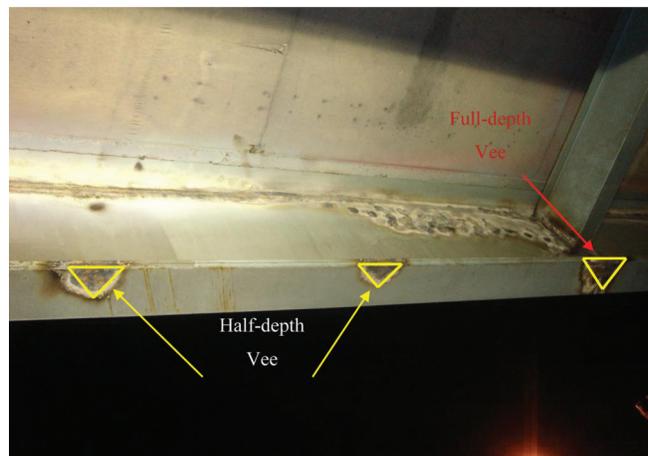
Figure 4.10 Vee heat locations of the bottom flange.

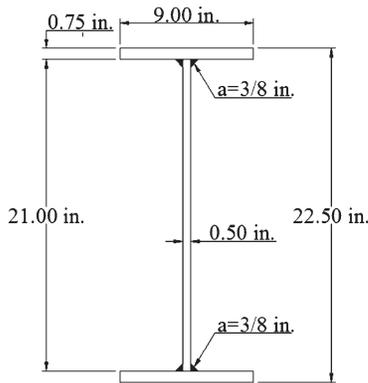
Figure 5.1 Small scale beam section.

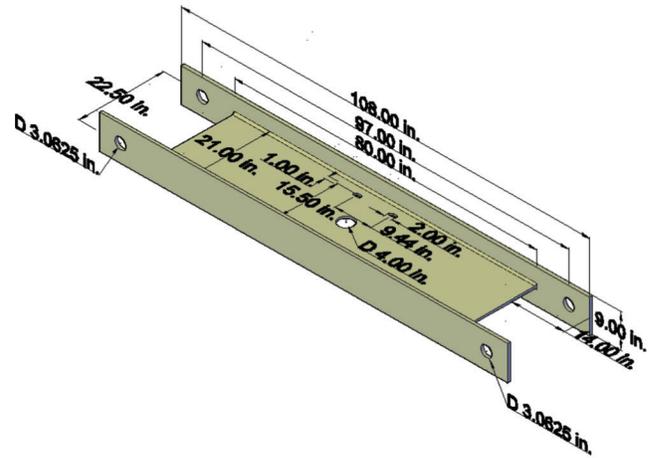
Figure 5.2 Small scale beam specimen dimension.

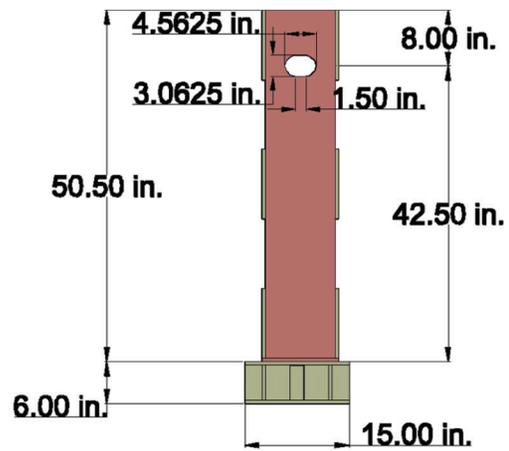
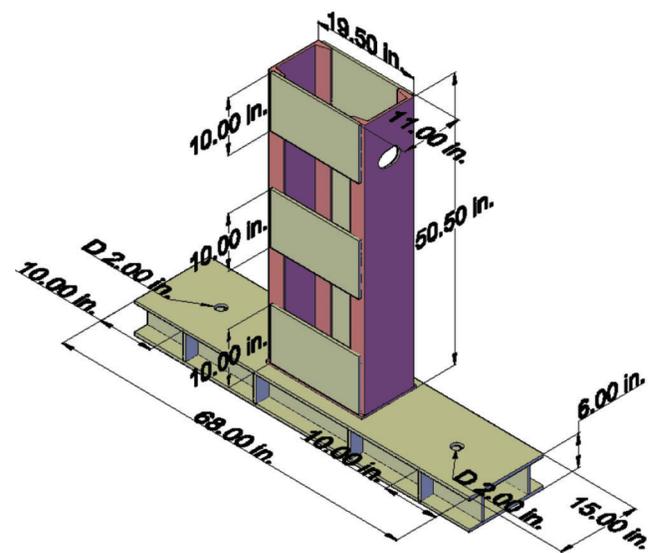
(a) Side view

(b) Detailed dimension

Figure 5.3 Support column details.

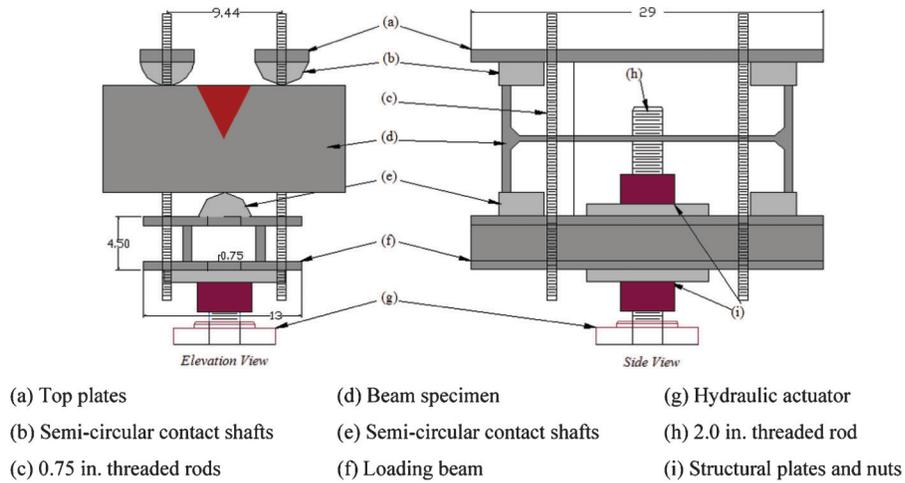
Figure 5.4 Loading beam details.

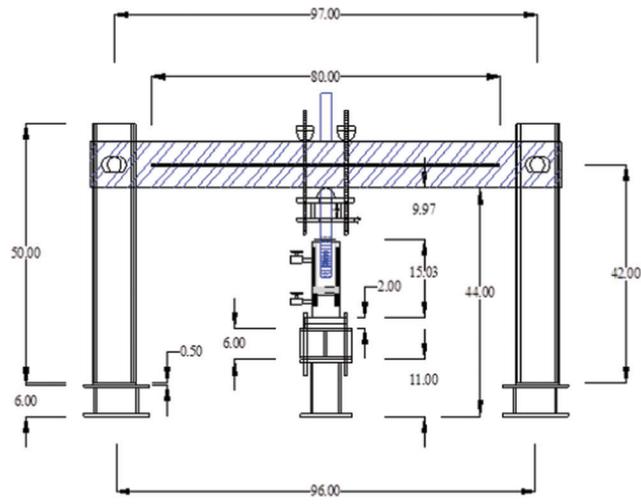
Figure 5.5 Detailed drawing of small scale test setup.

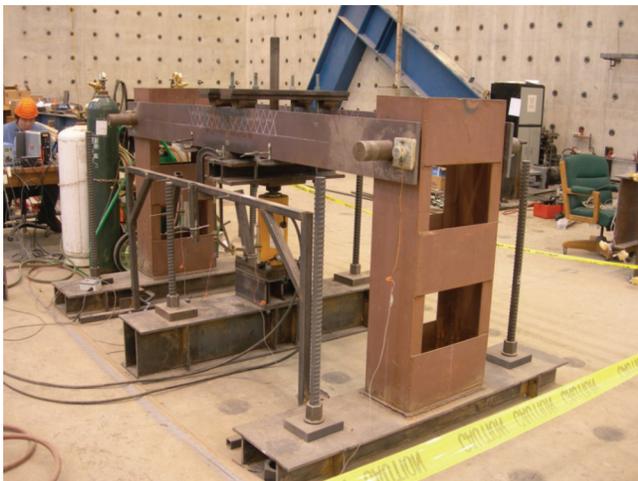
Figure 5.6 Photo of small scale test setup.

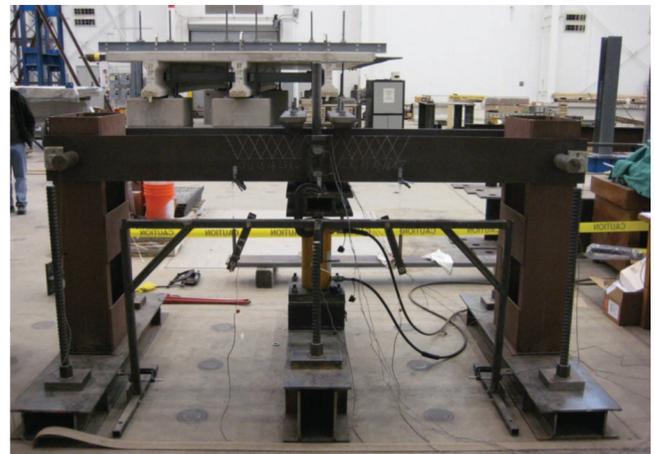
Figure 5.7 Photo of the front side of the small scale setup.

Figure 5.7 shows the front (flange A side) of the small scale test setup where the sensors were attached and Figure 5.8 shows the back (flange B side) of the setup. The left and right sides are decided from the frontal view (flange A side) of the test setup. The top of the beam specimen is the region where the Vee-heats are

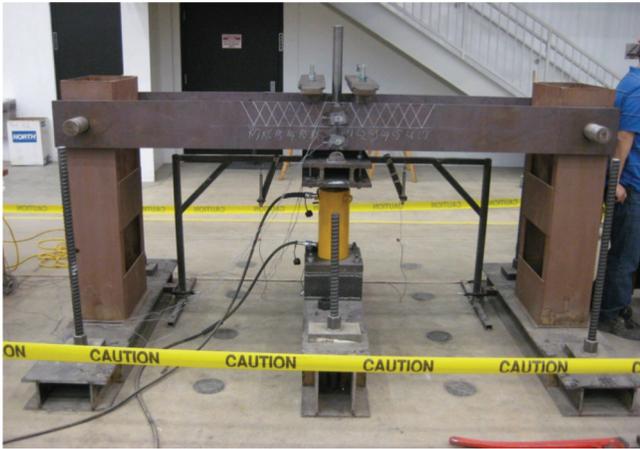
Figure 5.8 Photo of the back side of the small scale setup.

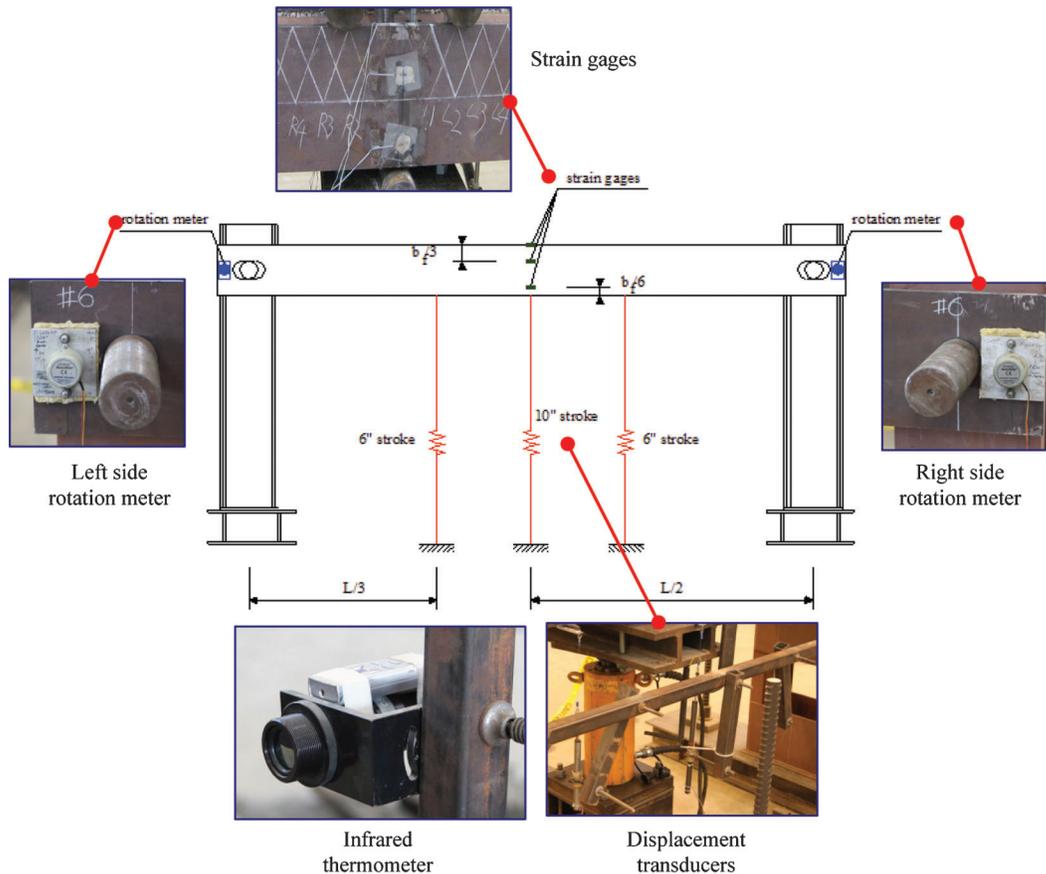
Figure 5.9 Small scale test sensor layout.

Deflections of each small scale test specimen were measured by displacement transducers located at the beam midspan and at the one-third points along the length of the beam, located 33 in. from the end supports.

- The deflection at the beam midspan was measured using a 10 in. stroke displacement transducer that was connected to the front flange (flange A).
- The one-third point deflections were measured using two 6 in. stroke displacement transducers that were connected

to the front flange (flange A). Figure 5.9 shows the location of these displacement transducers.

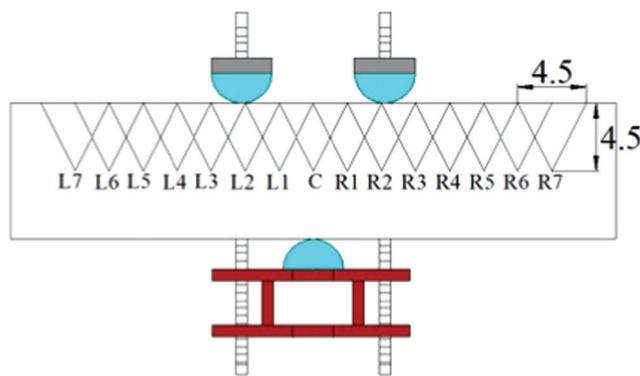
Figure 5.10 Vee heat locations and nomenclature.

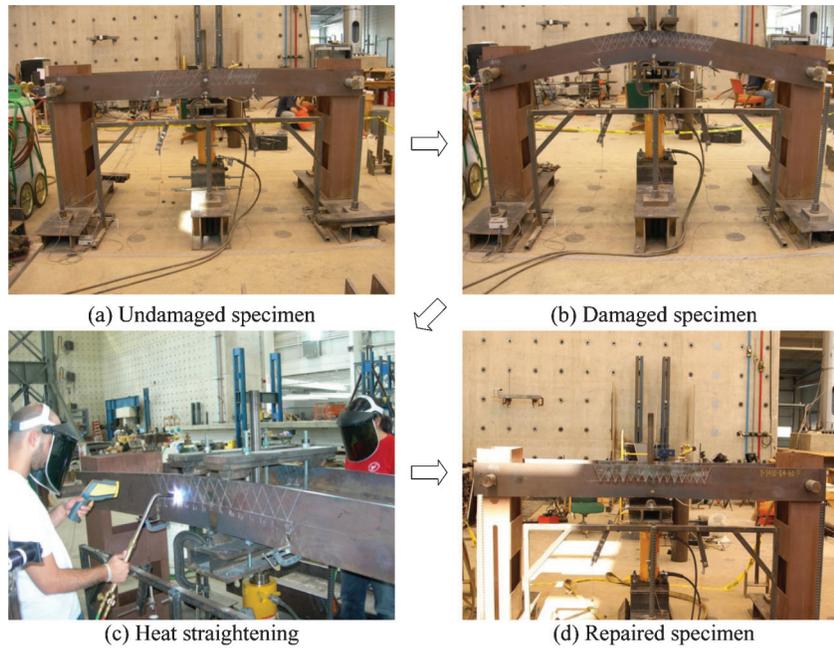
Figure 5.11 Heat straightening repair procedure of small scale test.

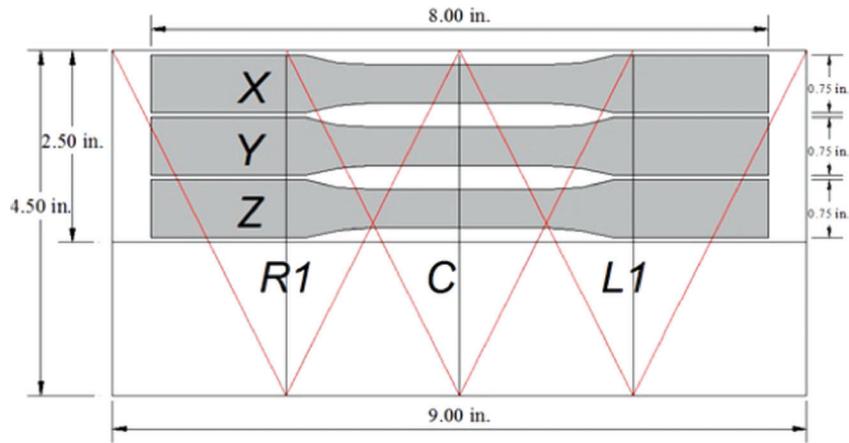
Figure 5.12 Nomenclature and location of damaged-repaired uniaxial tension coupons.

As shown in Figure 5.12, three uniaxial tension coupons were taken from the flange B of each specimen. Figure 5.13 shows the dimensions of the uniaxial tension coupon. All tension coupons were extracted from the central Vee regions (L1, C, and R1) of each back flange. The actual location and the nomenclature of each tensile coupon are also shown in Figure 5.12. Uniaxial tension specimens taken from the undamaged steel plate are shown in Figure 5.14. Figure 5.14 also shows the actual location and the nomenclature of each undamaged tensile coupon.

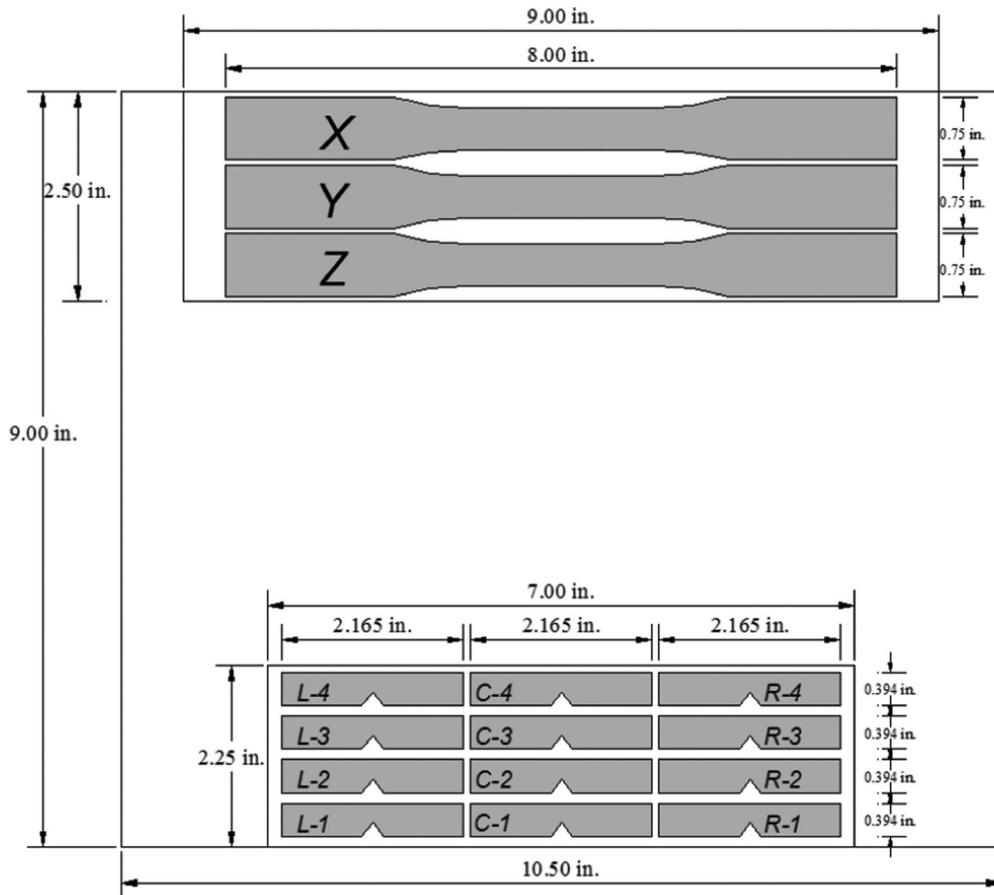
Figure 5.14 Material test coupons from the undamaged steel plate.

v-notches of the Charpy coupons were fabricated facing the edge of the flange plate. The location and the nomenclature of each Charpy coupon are also shown in Figure 5.15. The Charpy specimens from the undamaged steel plate are shown in Figure 5.14. Figure 5.14

also shows the actual location and the nomenclature of each undamaged Charpy coupon.

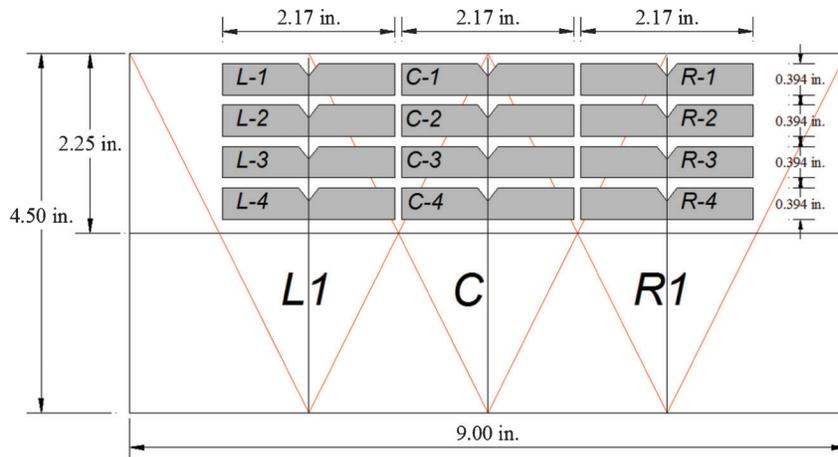
Figure 5.15 Nomenclature and location of damaged-repaired fracture toughness coupons.

Fracture toughness tests, Rockwell hardness tests, and microstructure investigations were conducted on the Charpy coupons of each small scale specimen. The Charpy coupons of the small scale test specimens are shown in Figure 5.15. As seen in Figure 5.15, the

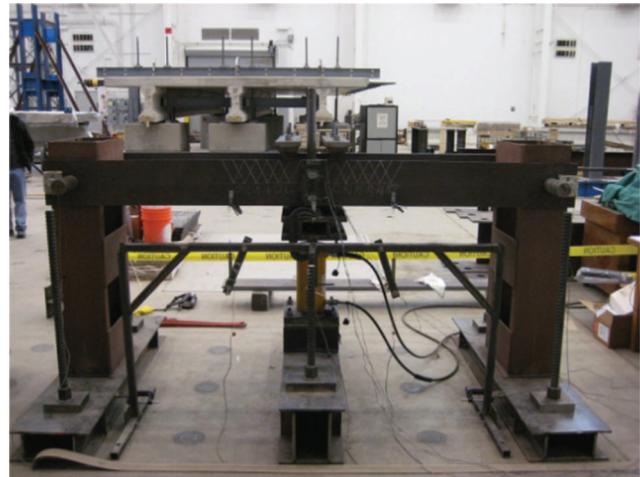
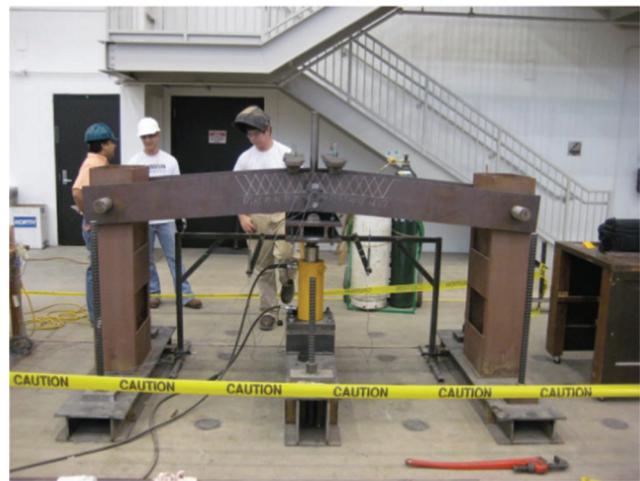
(a) Undamaged specimen

(b) Damaged specimen

Figure 6.1 Photographs of Specimen #1 before and after the damage.

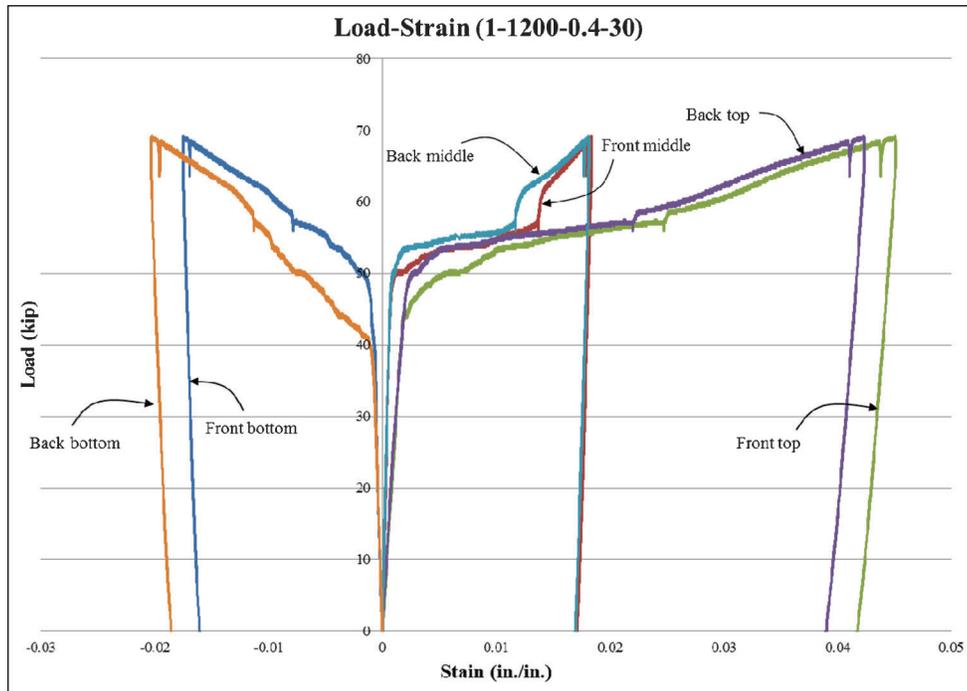
Figure 6.2 Load-strain diagram of Specimen #1 (1-1200-0.4-30).

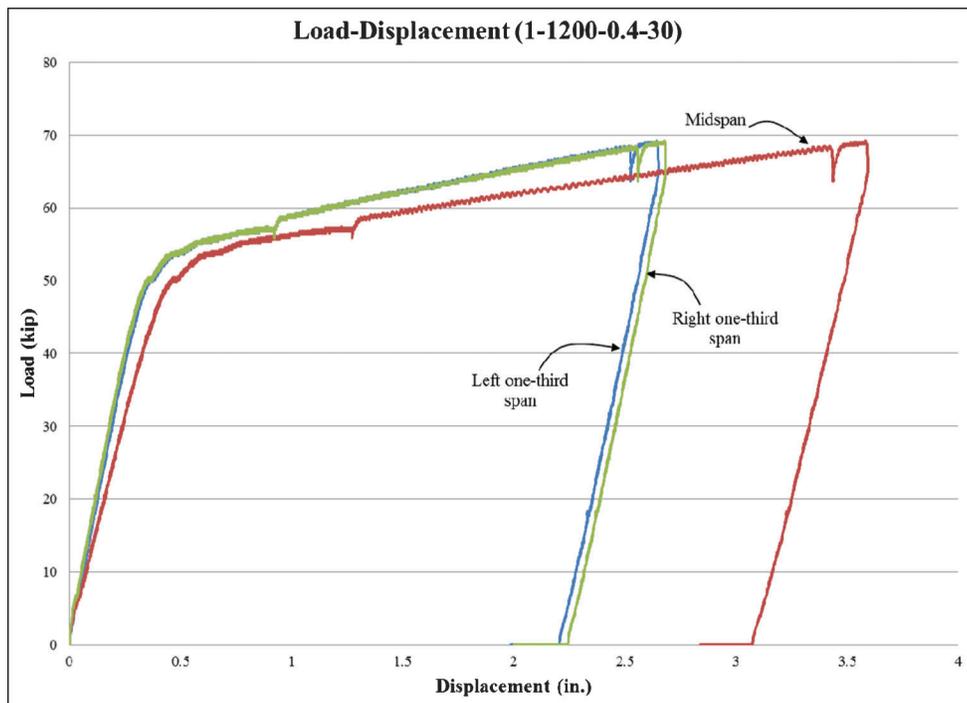
Figure 6.3 Load-displacement diagram of Specimen #1 (1-1200-0.4-30).

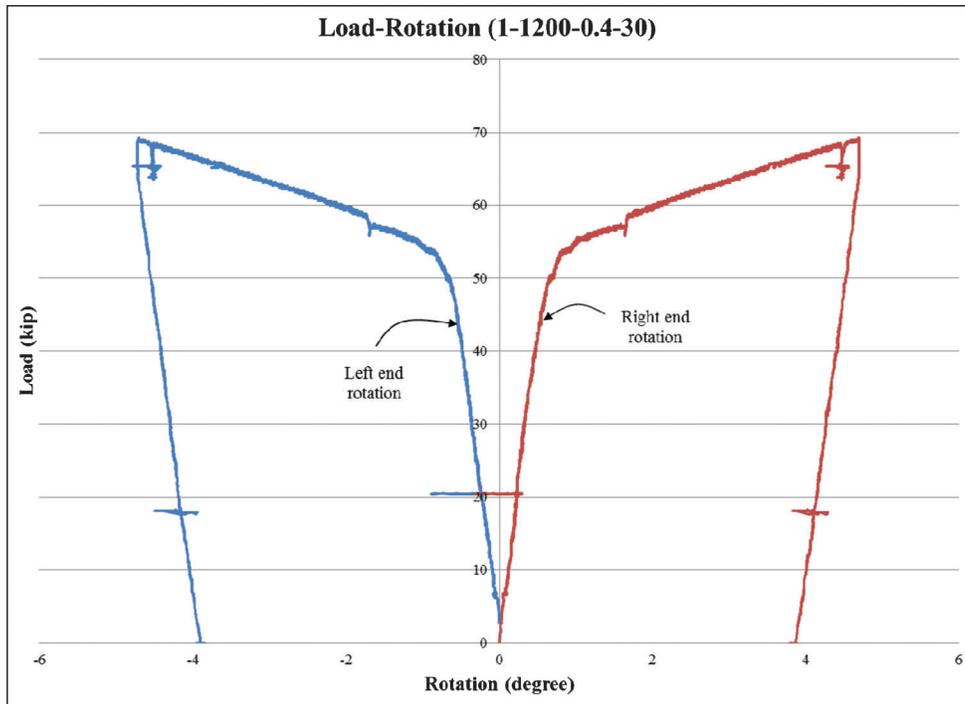
Figure 6.4 Load-rotation diagram of Specimen #1 (1-1200-0.4-30).

Figure 6.4 shows the $P-\theta$ relationship of Specimen #1. The rotation angle of θ was measured close to the end point of the specimen following Section 5.4.

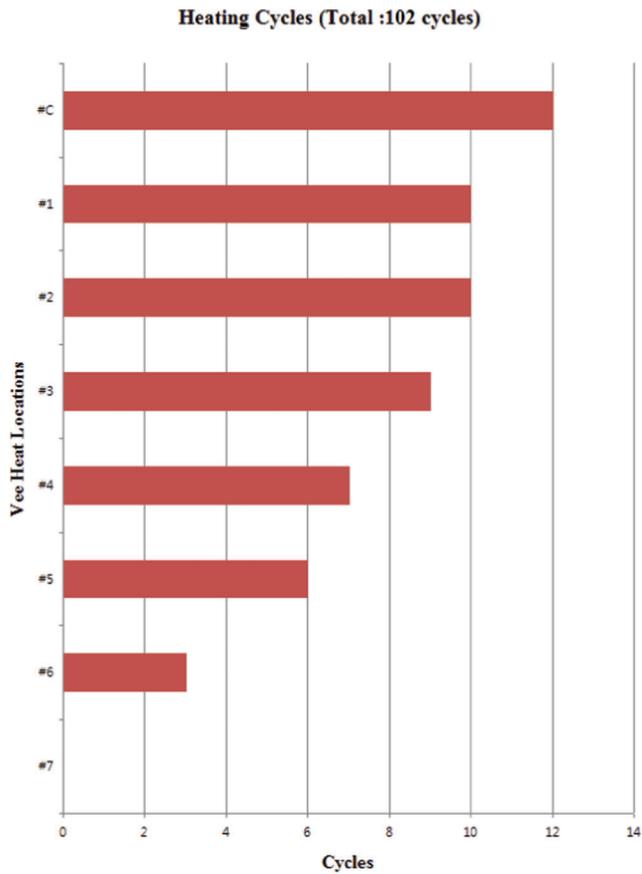
Figure 6.5 Vee heat frequency chart of Specimen #1.

One hundred two (102) Vee heats were required to complete the repair cycle of Specimen #1. The frequency chart indicating the number of Vee heats applied to each location is shown in Figure 6.5. The photograph of the repaired beam is shown in Figure 6.6. After the final Vee heat repair, less than $\frac{1}{8}$ in. of the midspan deflection was left.

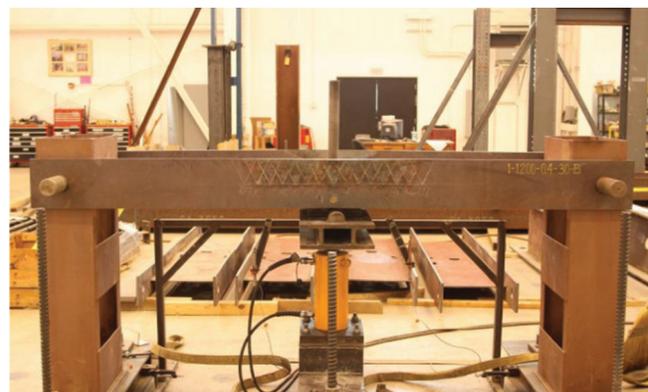
Figure 6.6 Photograph of Specimen #1 after the heat straightening repair.

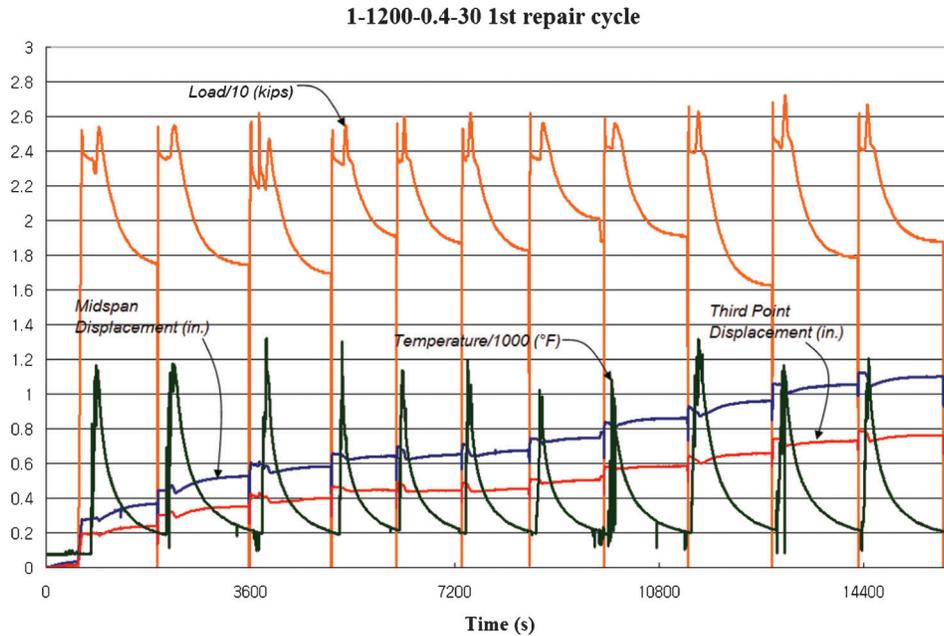
Figure 6.7 Instrument data during the repair cycle of Specimen #1.

actuator in kips, which is divided by 10 (i.e., 1.0 on the graph shows 10 kips of force), and (c) the temperature of the steel in F, which is divided by 1000 (i.e., 1.0 on the graph corresponds to 1000 °F).

Figure 6.7 shows the data of the initial eleven Vee heat repair cycles. This figure includes: (a) the displacements from three displacement transducers in inches, (b) the restraining force in the hydraulic

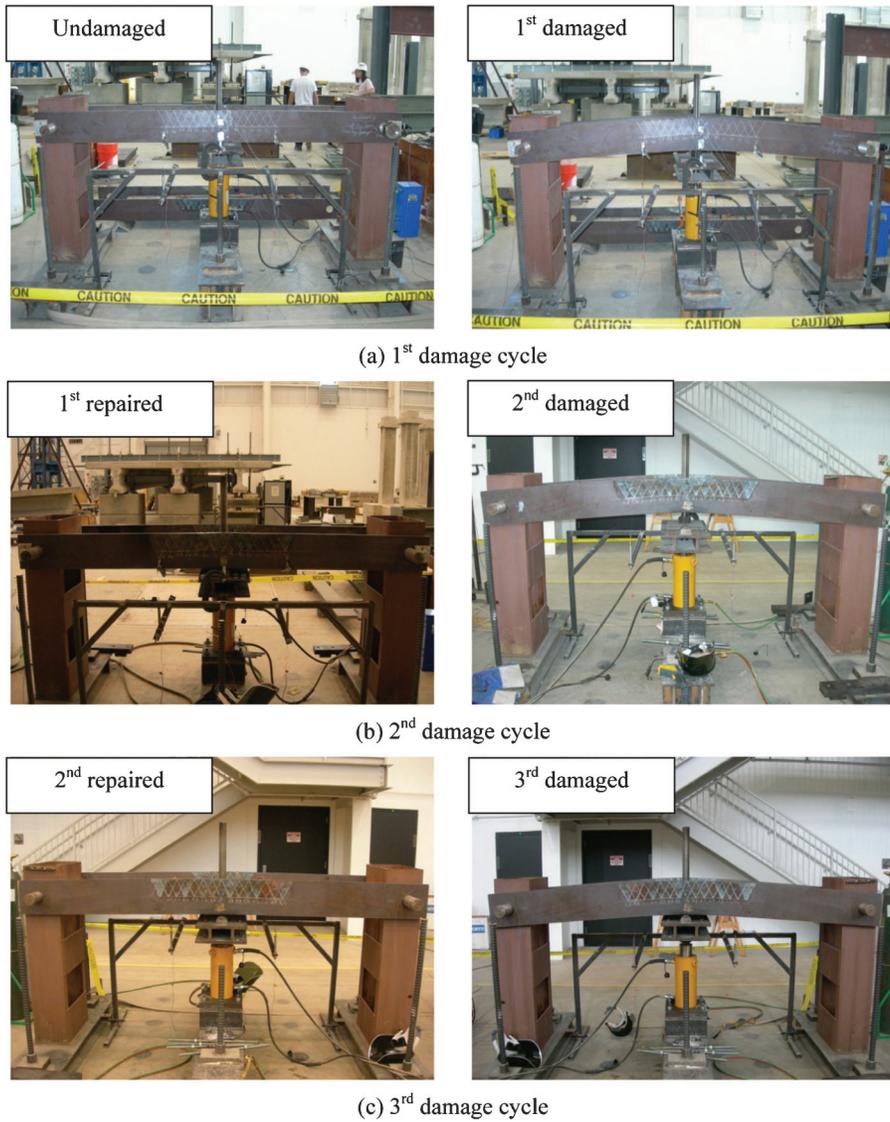
Figure 6.8 Photographs of Specimen #2 before and after the damage.

Specimen #2 was subjected to three damage-repair cycles to determine the effect of multiple damage-repair cycles. Figure 6.8 shows the photographs of the beam specimen before and after each damage cycle. Each damage cycle corresponded to the damage strain of $30 \epsilon_y$ (0.045 in./in.) at top strain gage. The damage strain in the first cycle was measured using the strain gage layout described Section 5.4. The strain gage data from the first damage cycle is provided in Figure 6.9.

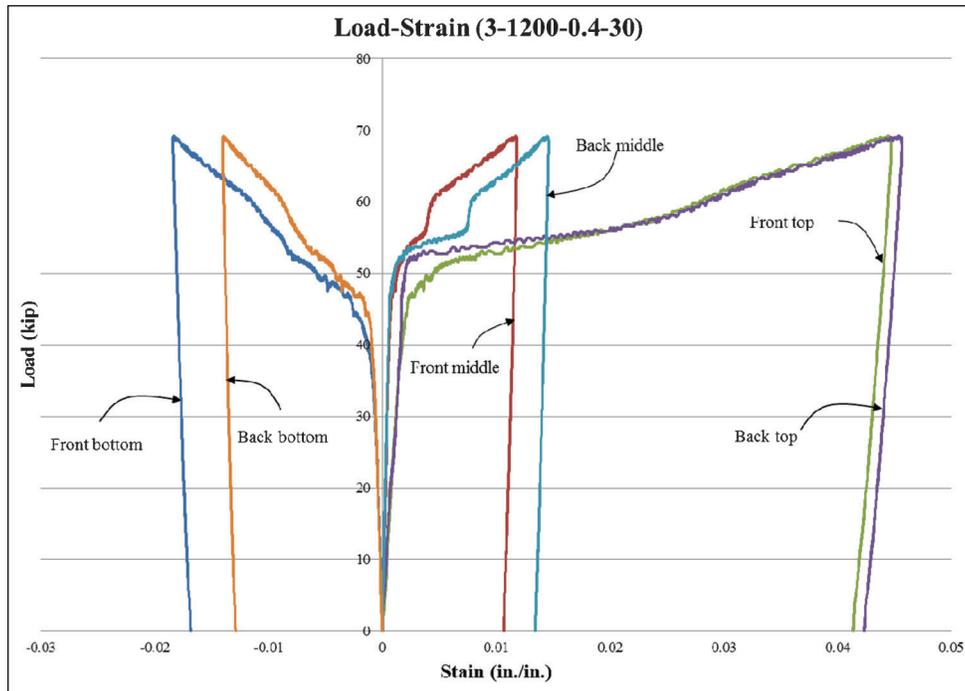
Figure 6.9 Load-strain diagram of Specimen #2 (1-1200-0.4-30).
