Effects of Realistic Heat Straightening Repair on the Properties and Serviceability of Damaged Steel Beam Bridges

JOINT TRANSPORTATION RESEARCH PROGRAM

INDIANA DEPARTMENT OF TRANSPORTATION
AND PURDUE UNIVERSITY

1. Report No. FHWA/IN/JTRP-2013/03	2. Government Accession No.	3. Recipient's Catalog No.	
4. Title and Subtitle Effects of Realistic Heat Straightening Repair on the Properties and Serviceability of Damaged Steel Beam Bridges		5. Report Date February 2012

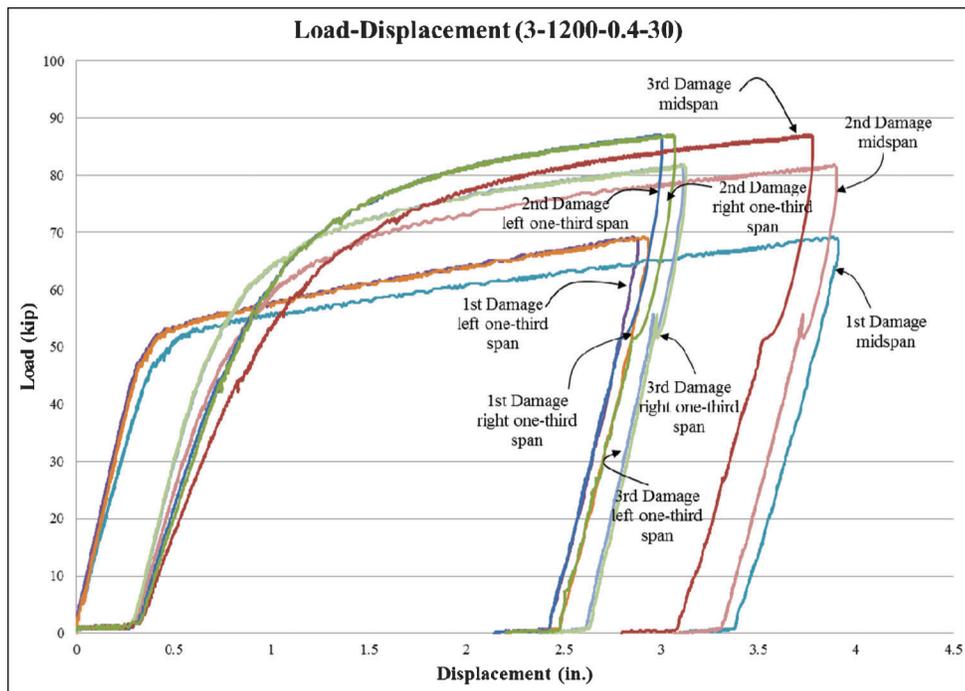
Figure 6.10 Load-displacement diagram of Specimen #2 (3-1200-0.4-30).

Damage cycles 2 and 3 were conducted under displacement control, where the displacement at the midspan reached the required magnitude close to the result of the first damage cycle. Figure 6.10 compares the P- Δ behavior of all three damage cycles of Specimen #2. Figure 6.11 compares the P- θ behavior of all three damage cycles of Specimen #2.

As shown in Figures 6.10 and 6.11, the initial stiffness of the beam changed slightly after the first damage-repair event. The material became stronger after damage-repairs, which is clearly seen in Figures 6.10 and 6.11.

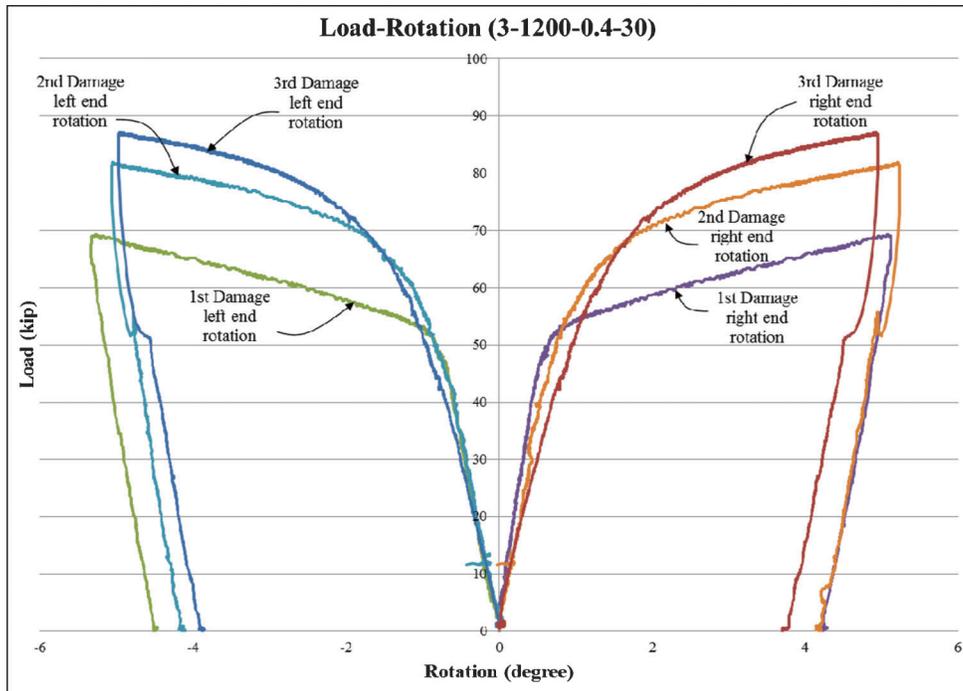
Figure 6.11 Load-rotation diagram of Specimen #2 (3-1200-0.4-30).

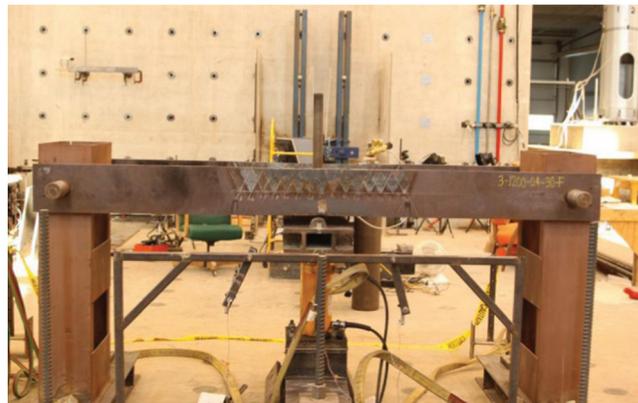
Figure 6.12 Photograph of Specimen #2 after the 3rd heat straightening repair.

The total numbers of Vee heats required to straighten the specimen in each damage-repair cycle are shown in Figure 6.13. One hundred eighteen Vee heats on both flanges were required to complete the first repair cycle. The second repair cycle took one hundred and forty six Vee heats to complete. The third repair cycle needed two hundred eleven Vee heats to complete. Required numbers of the Vee heats to fully straighten the specimen were increased following the damage cycles. The final deflection at midspan after the third damage-repair cycle was less than $\frac{1}{8}$ in. The final photograph of Specimen #2 after all repair cycles is shown in Figure 6.12.

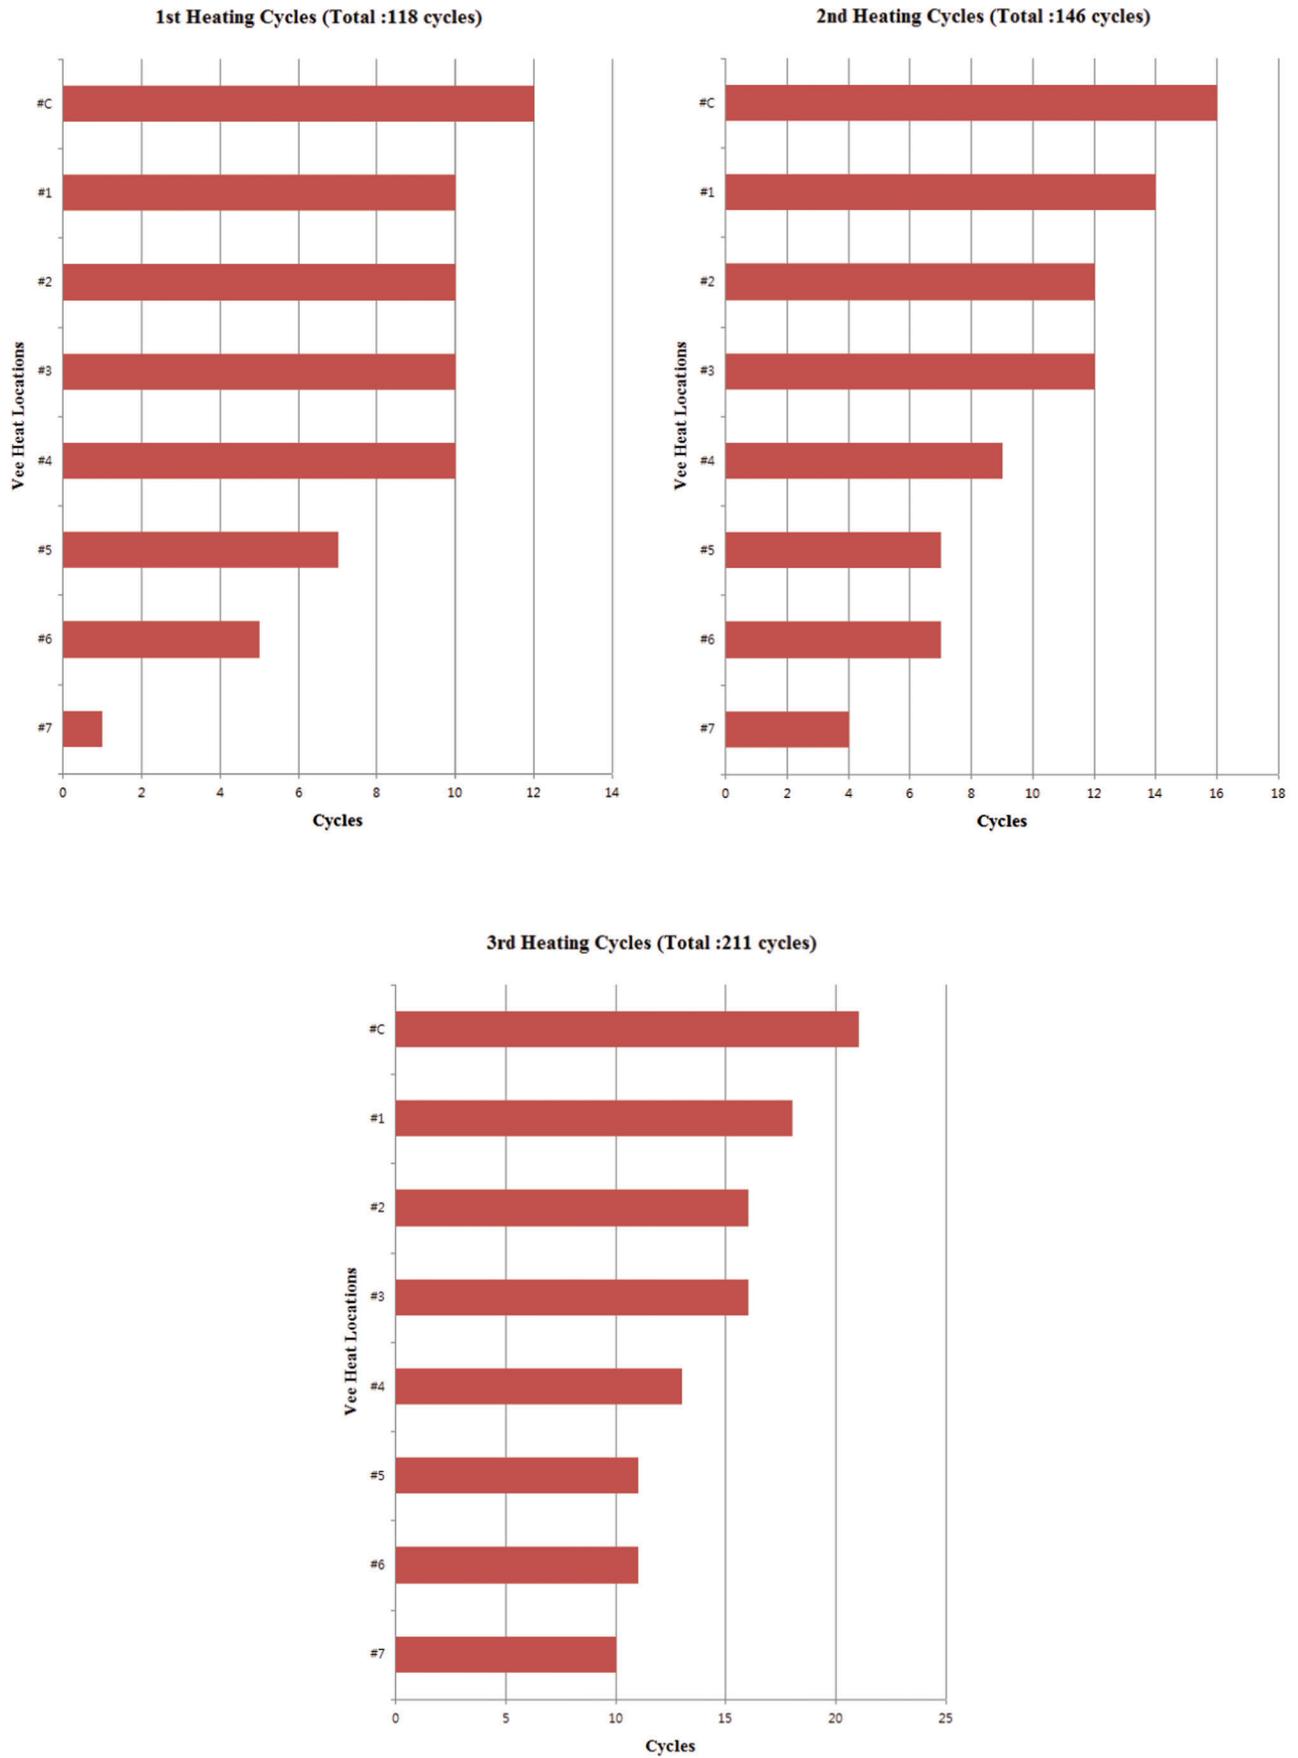
Figure 6.13 Vee heat frequency chart of Specimen #2.

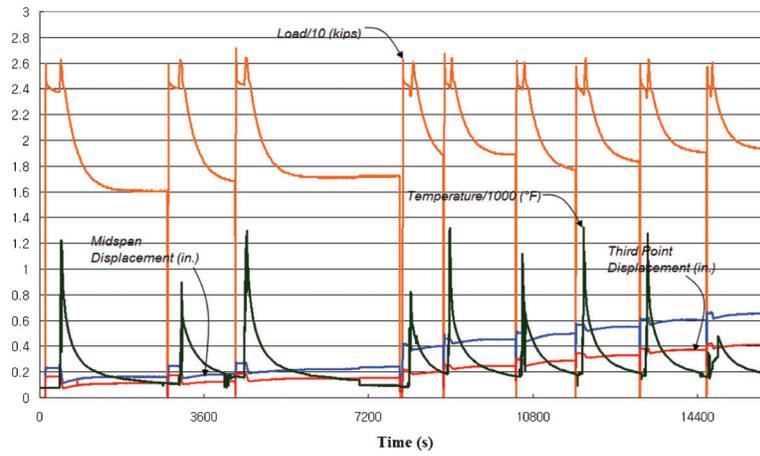
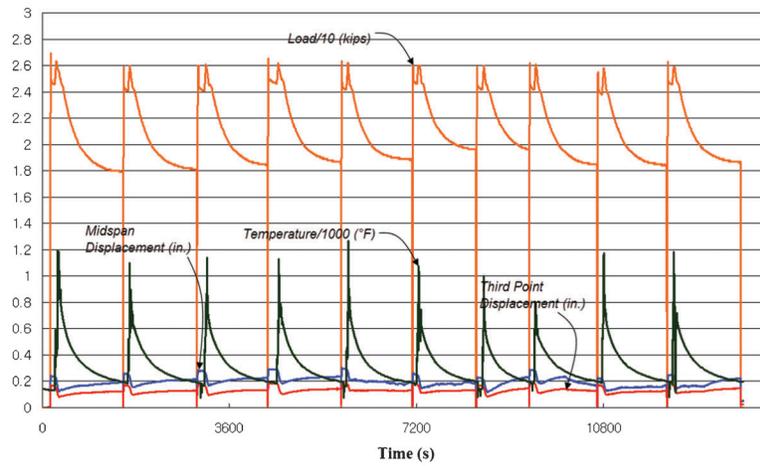
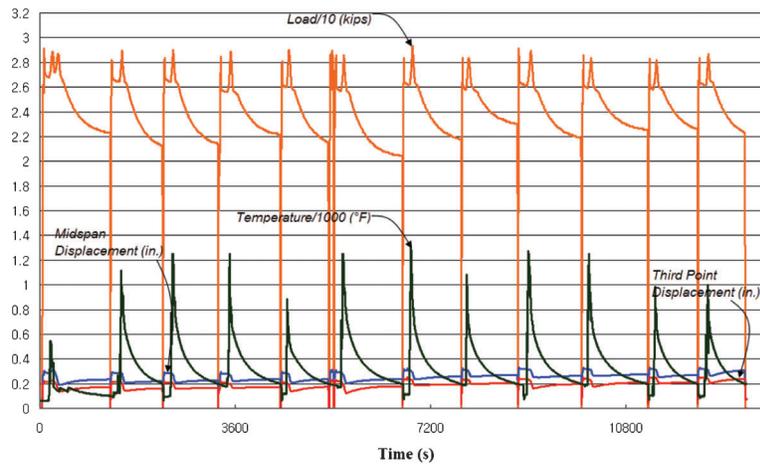
(a) 1st repair cycle

(b) 2nd repair cycle

(c) 3rd repair cycle

Figure 6.14 Instrument data during the repair cycle of Specimen #2.

Figure 6.14 shows the behavior of Specimen #2 in the initial several steps of each repair cycle. This figure includes: (a) the displacements from three displacement transducers in inches, (b) the restraining force in the hydraulic actuator in kips, which is divided by 10 (i.e., 1.0 on the graph shows 10 kips of force), and (c) the temperature of the steel in F, which is divided by 1000 (i.e., 1.0 on the graph corresponds to 1000 °F).

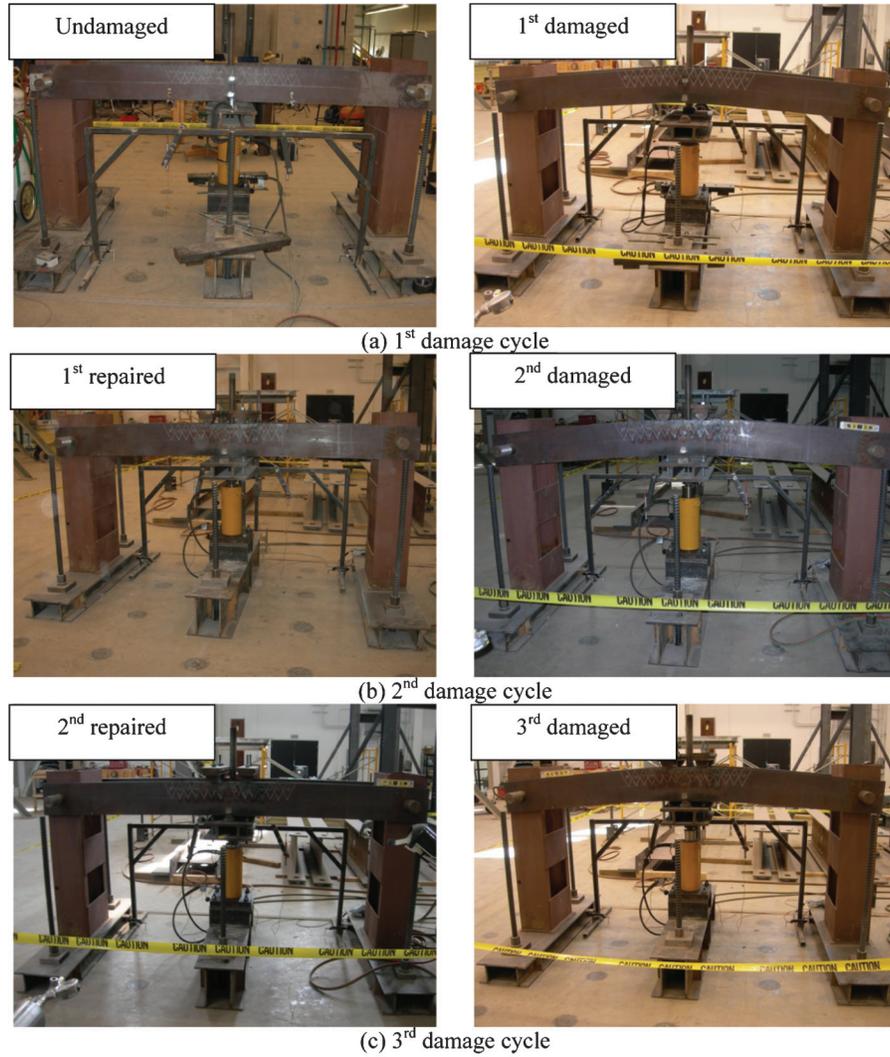
Figure 6.15 Photographs of Specimen #3 before and after the damage.

Specimen #3 was subjected to three damage-repair cycles with a heating temperature of 1400 °F to determine the effect of overheating and multiple damage-repair cycles. Figure 6.15 shows the photographs of the beam specimen before and after each

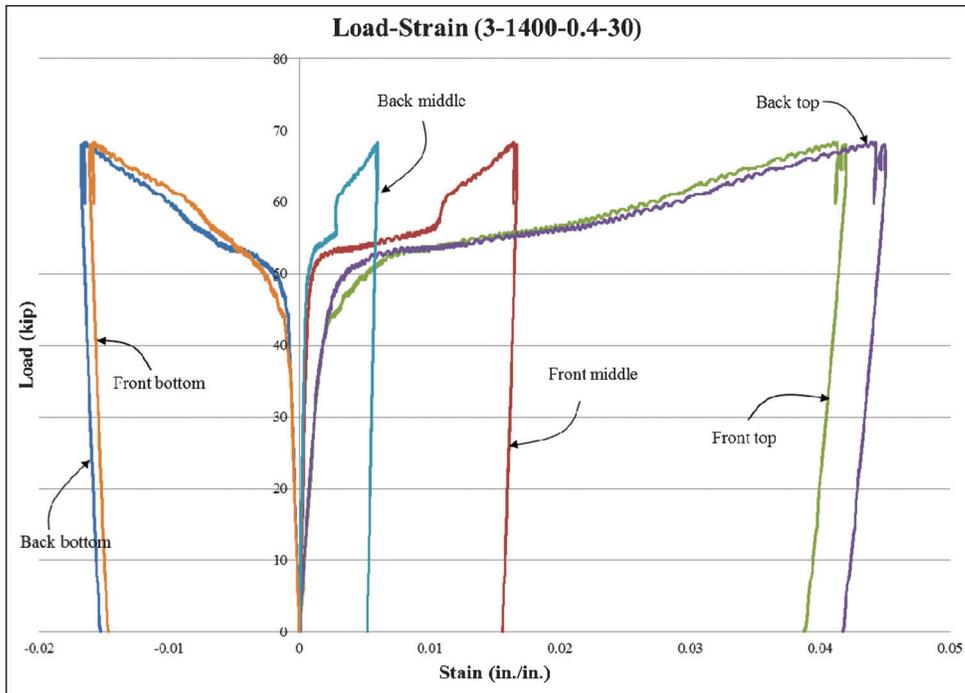
Figure 6.16 Load-strain diagram of Specimen #3 (1-1400-0.4-30).

damage cycle. Each damage cycle corresponded to the damage strain of $30 \epsilon_y$ (0.045 in./in.) at the top strain gage. The damage strain in the first cycle was measured using the strain gage layout described Section 5.4. The strain gage data from the first damage cycle is provided in Figure 6.16.

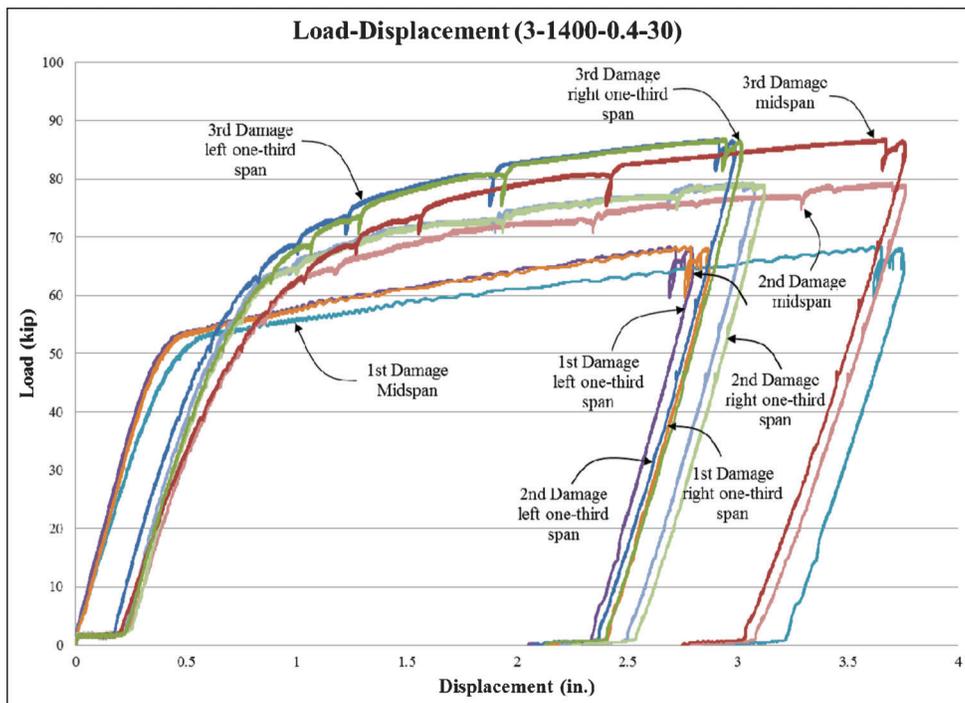
Figure 6.17 Load-displacement diagram of Specimen #3 (3-1400-0.4-30).

Damage cycles 2 and 3 were conducted under displacement control, where the displacement at mid-span reached the required magnitude close to the result of the first damage cycle. Figure 6.17 compares the P- Δ behavior of all three damage cycles of Specimen #3. Figure 6.18 compares the P- θ behavior of all three damage cycles of Specimen #3.

As shown in Figures 6.17 and 6.18, the initial stiffness of the beam changed slightly after the first damage-repair event. The material became stronger

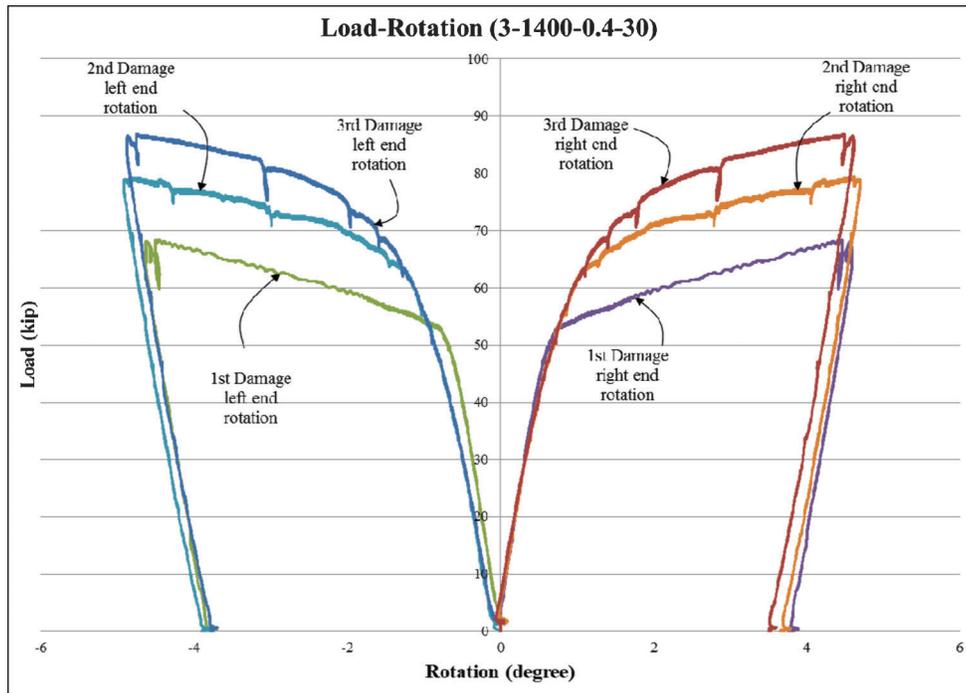
Figure 6.18 Load-rotation diagram of Specimen #3 (3-1400-0.4-30).

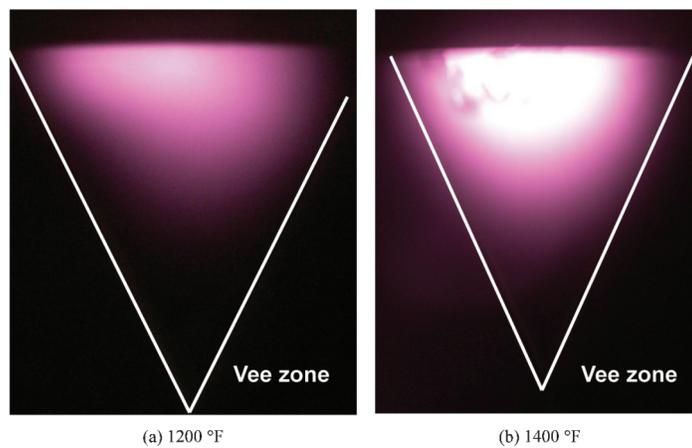
Figure 6.19 Color of A36 steel at the maximum heating temperatures.

Repair cycles of Specimen #3 were conducted by applying external force corresponding to the restraining moment of $0.4 M_p$ which is similar to Specimen #2. The difference was that each Vee heat was subjected to a maximum temperature of 1400°F . The color of the Vee at the maximum temperature of 1400°F is shown in Figure 6.19 (b). For comparison, Figure 6.19 (a) shows the color of the Vee at the maximum temperature of 1200°F .

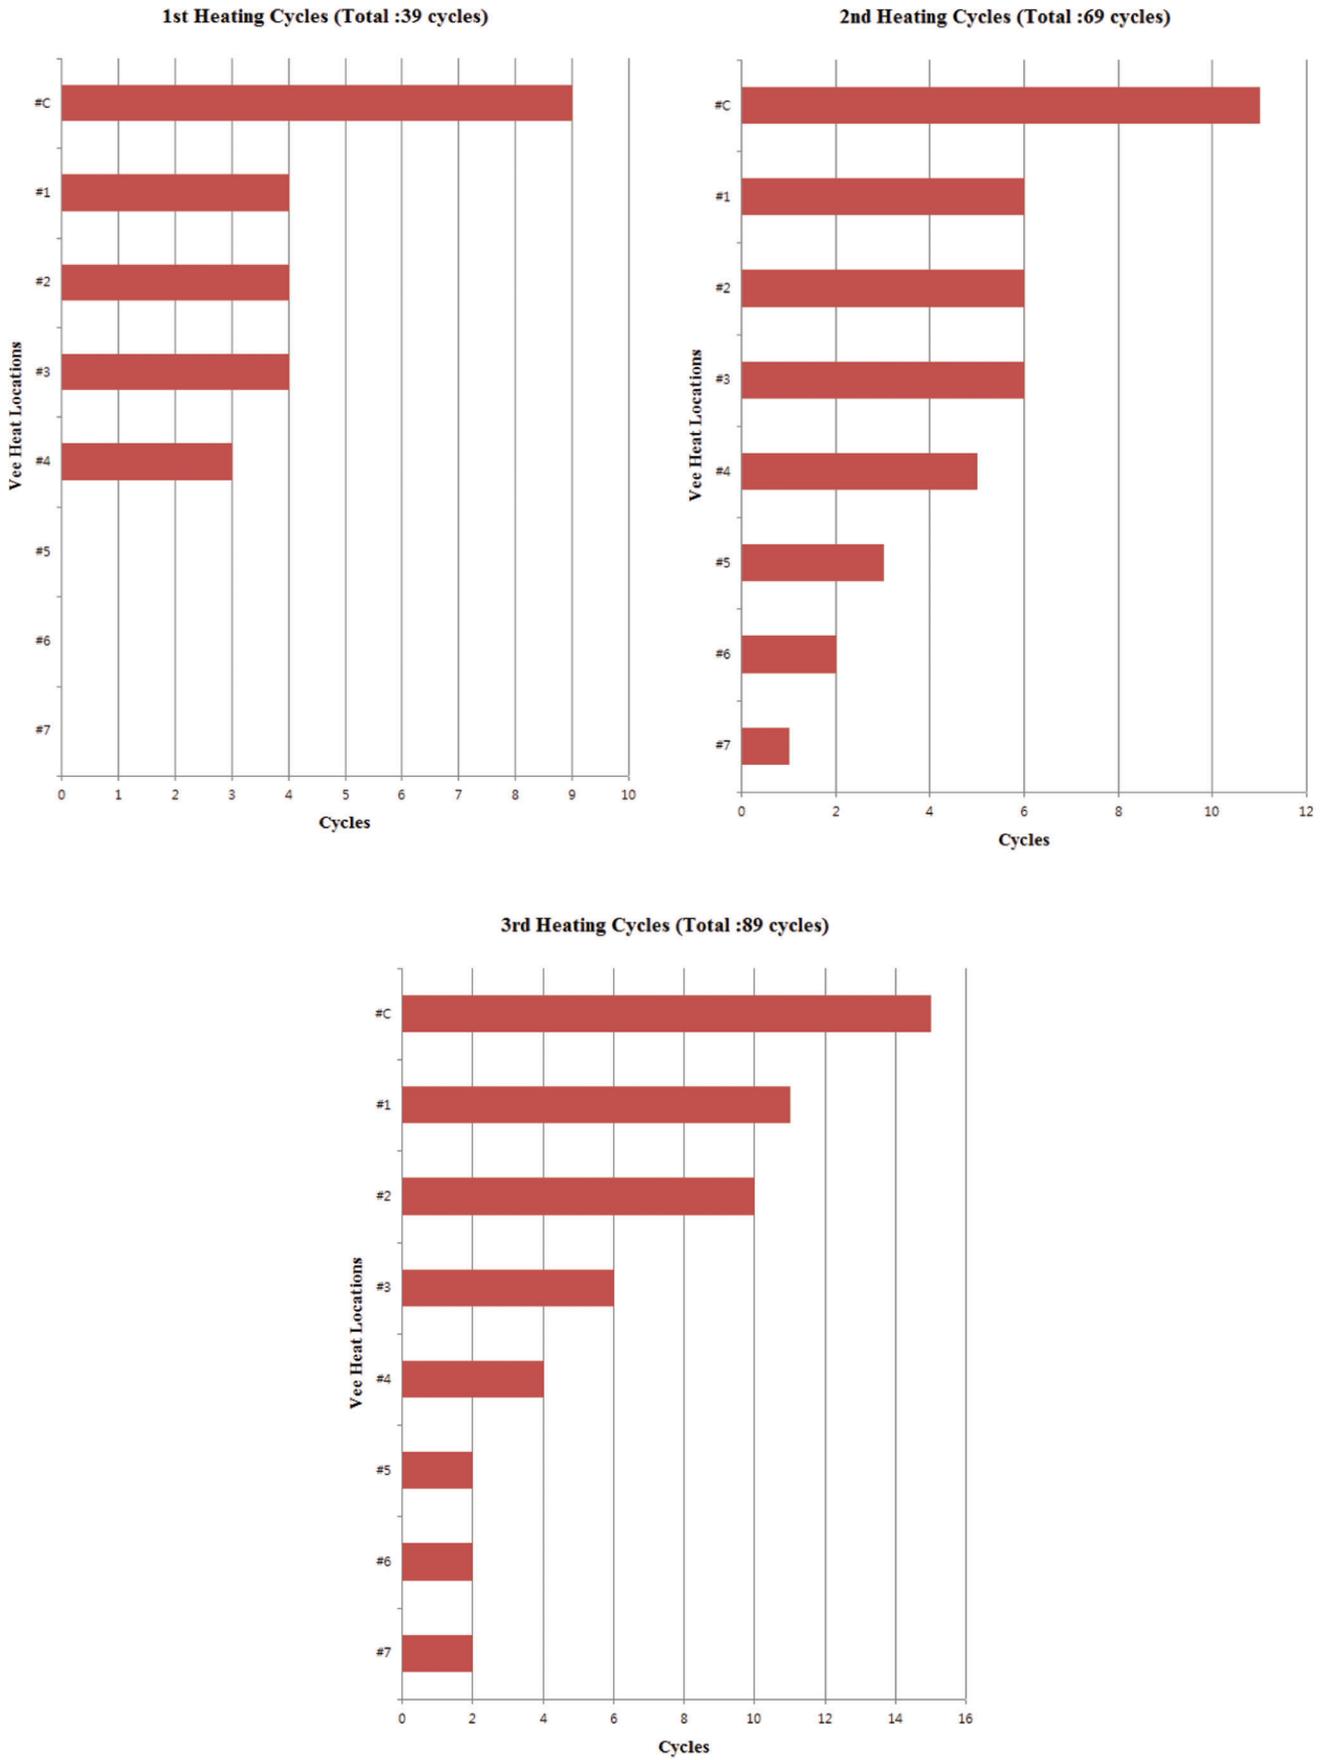
Figure 6.20 Vee heat frequency chart of Specimen #3.

The total numbers of Vee heats required to straighten the specimen in each damage-repair cycle are shown in Figure 6.20. Thirty nine Vee heats on both

flanges were required to complete the first repair cycle. The second repair cycle took 69 Vee heats to complete. The third repair cycle needed 89 Vee heats to complete. Required numbers of Vee heats to fully straighten the specimen increased following multiple damage cycles, which was similar to Specimen #2. But the total numbers of Vee heats required in each damage-repair cycle reduced significantly as compared to Specimen #2. The final photograph of Specimen #3 after all repair cycles is shown in Figure 6.21.

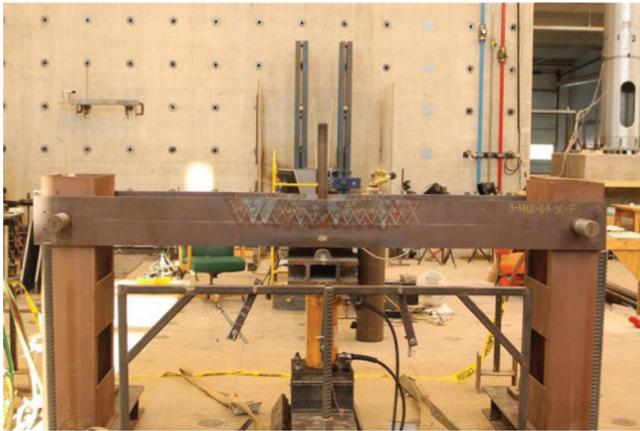
Figure 6.21 Photograph of Specimen #3 after the 3rd heat straightening repair.

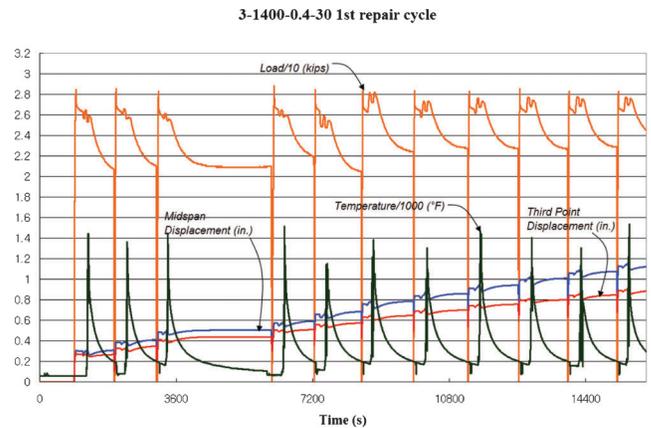
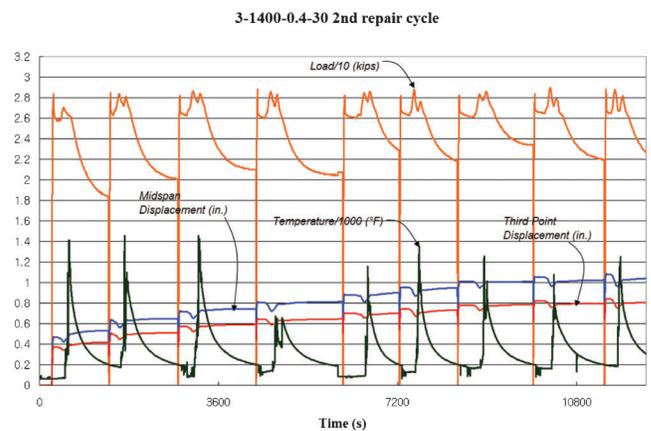
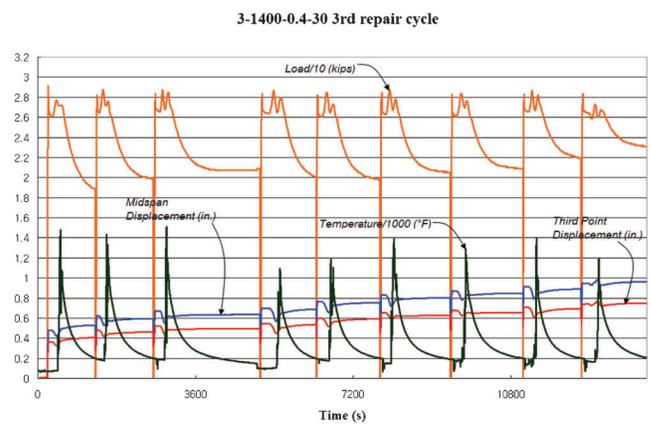
(a) 1st repair cycle

(b) 2nd repair cycle

(c) 3rd repair cycle

Figure 6.22 Instrument data during the repair cycle of Specimen #3.

Figure 6.22 shows the behavior of Specimen #3 in the initial several steps of each repair cycle. This figure includes: (a) the displacements from three displacement transducers in inches, (b) the restraining force in the hydraulic actuator in kips, which is divided by 10 (i.e., 1.0 on the graph shows 10 kips of force), and (c) the temperature of the steel in F, which is divided by 1000 (i.e., 1.0 on the graph corresponds to 1000 °F).

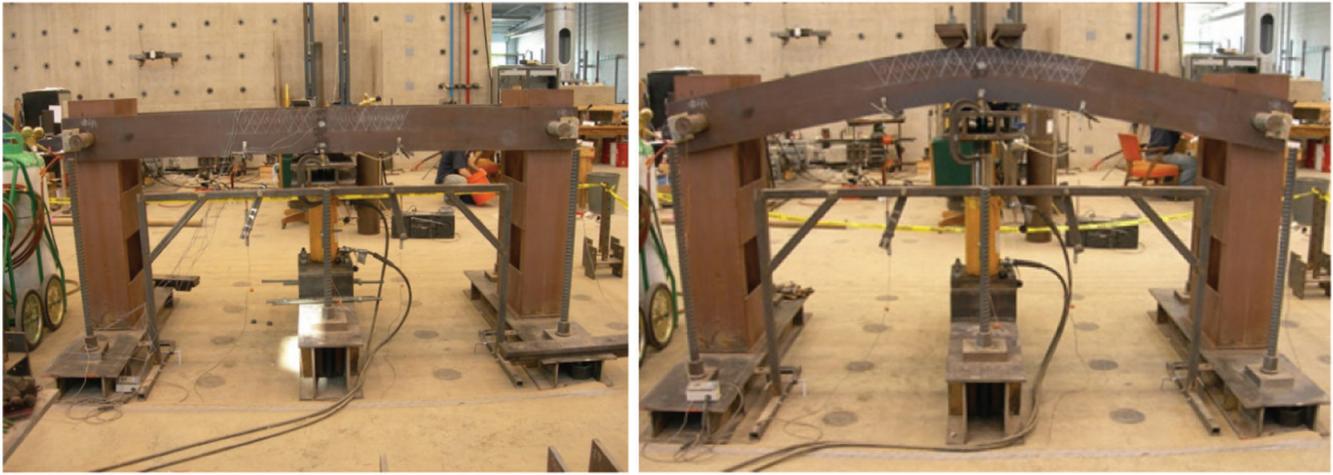
(a) Undamaged specimen

(b) Damaged specimen

Figure 6.23 Photographs of Specimen #4 before and after the damage.

Figure 6.23 shows the photographs of the beam specimen before (a) and after (b) the damage cycle. The beam specimen was damaged by monotonically increasing the concentrated force at the midspan. The damage was monitored using the longitudinal strain gages. The test was considered complete when one of the values of the front top and back top strain gages reached $60 \epsilon_y$. The complete strain gage data for the damage cycle is shown in Figure 6.24.

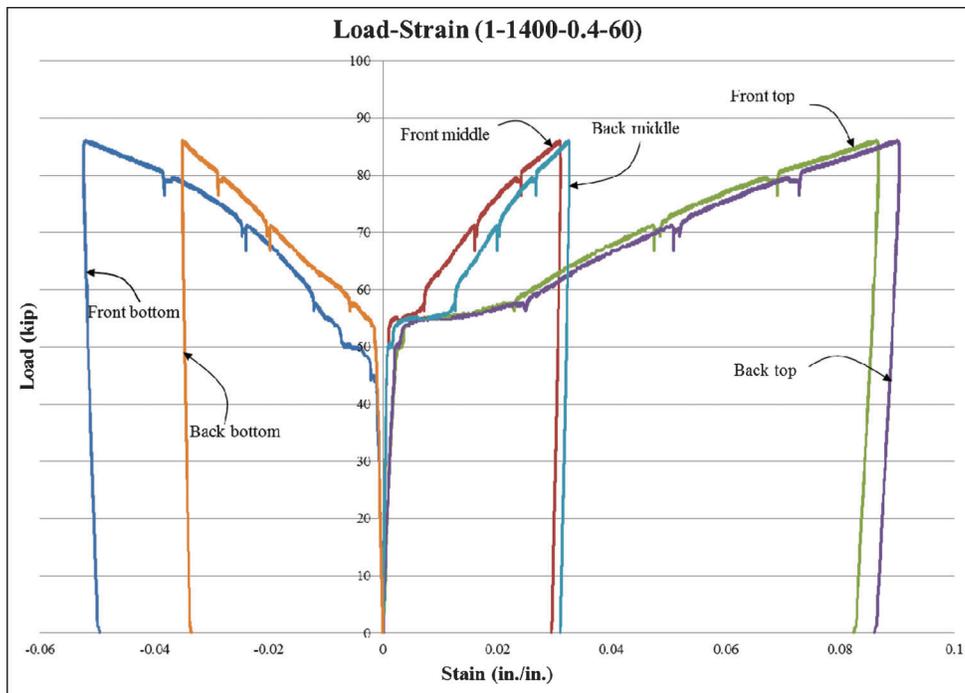
Figure 6.24 Load-strain diagram of Specimen #4 (1-1400-0.4-60).

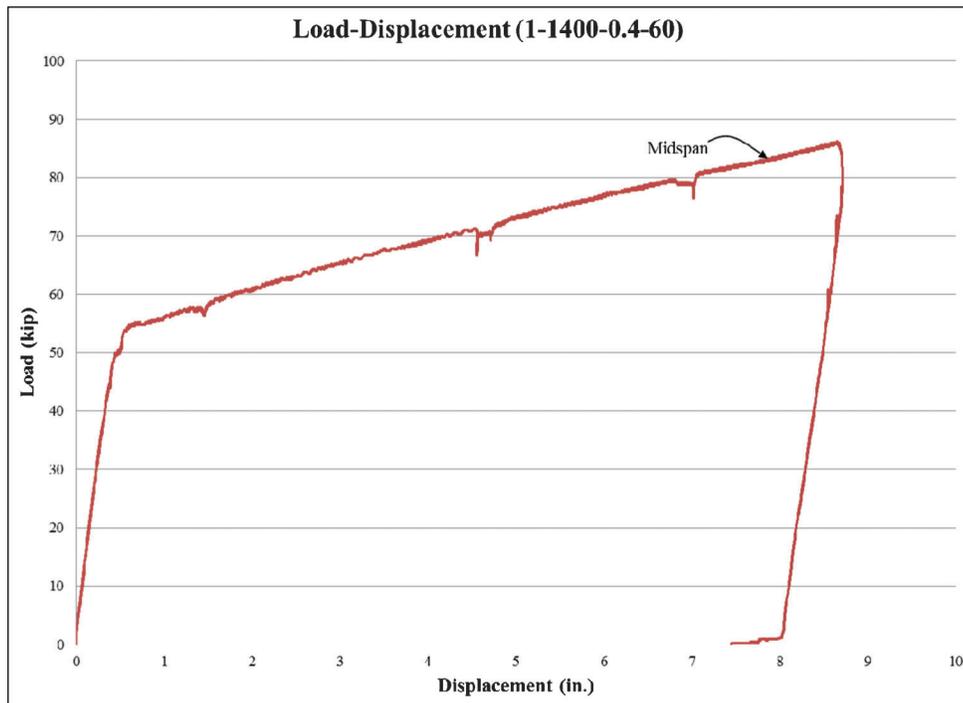
Figure 6.25 Load-displacement diagram of Specimen #4 (1-1400-0.4-60).

The P-Δ relationship for Specimen #4 is shown in Figure 6.25. The maximum midspan plastic displacement at the damage process was measured as 8.7 in. The final

damage displacement after elastic rebound was 7.5 in. at the midspan. Two displacement sensors located at the one-third point of each side were disconnected during the test because the displacements of the one-third point exceeded sensor capacity. Figure 6.25 shows only the

midspan deflection behavior of Specimen #4 during the damage process.

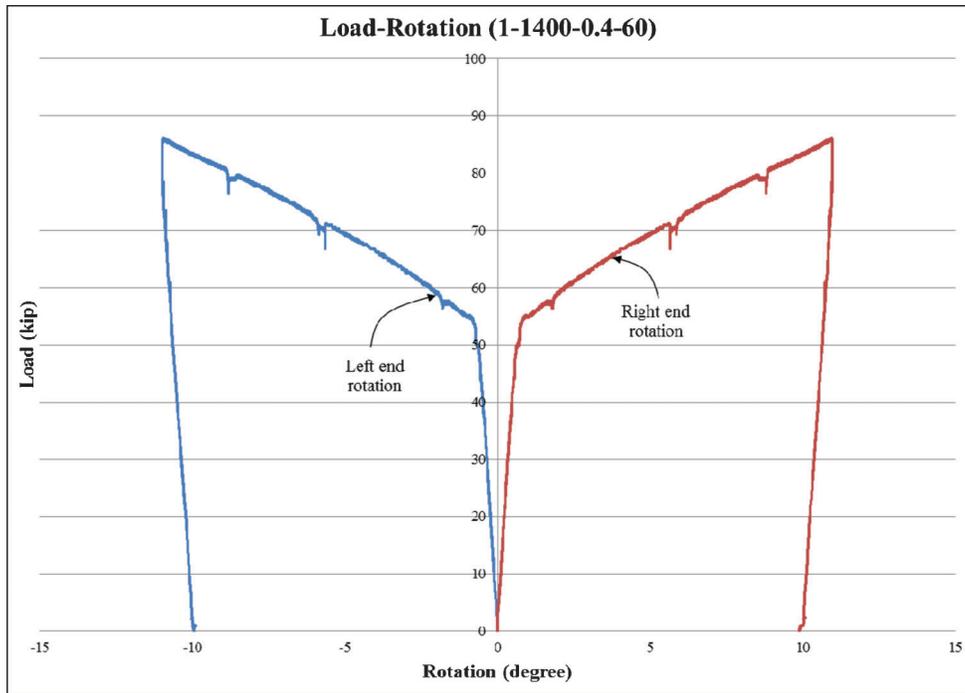
Figure 6.26 Load-rotation diagram of Specimen #4 (1-1400-0.4-60).

Figure 6.26 shows the P- θ relationship of Specimen #4.

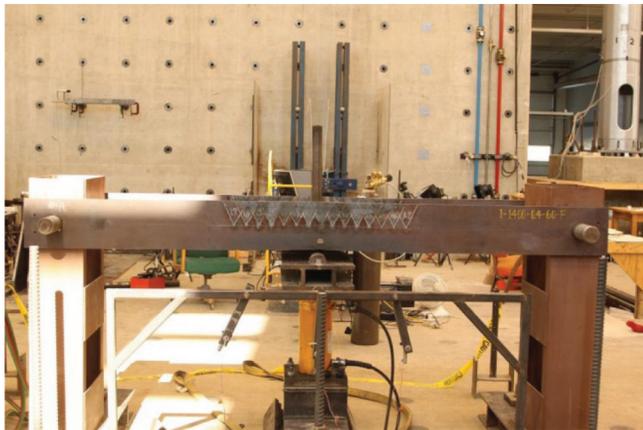
Figure 6.27 Photograph of Specimen #4 after the heat straightening repair.

The photograph of the repaired beam is shown in Figure 6.27. After the final Vee heat repair, the remaining midspan deflection was less than $\frac{1}{8}$ in. Two hundred seventy six Vee heats were required to complete the repair cycle of Specimen #4. The frequency chart indicating the number of Vee heats applied to each location is shown in Figure 6.28.

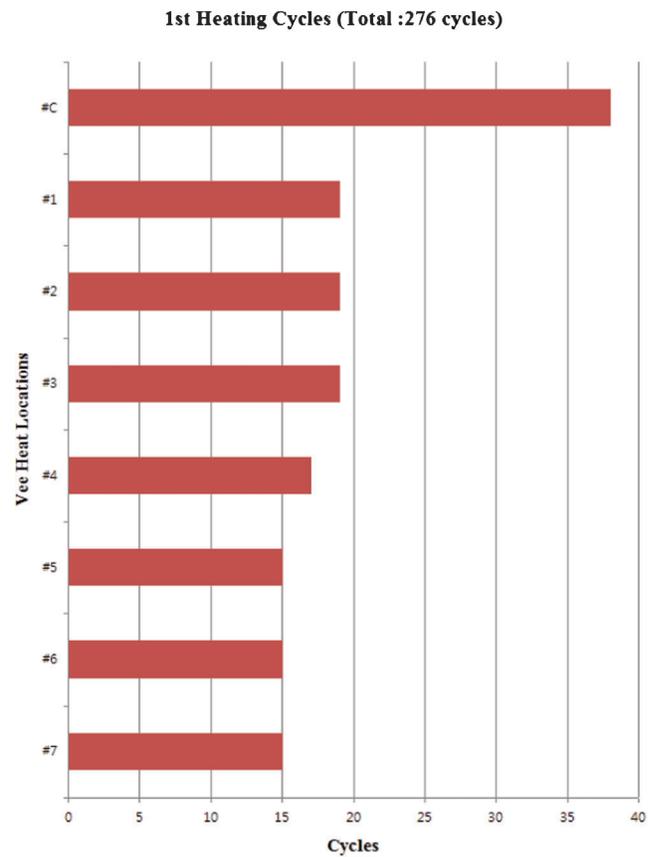
Figure 6.28 Vee heat frequency chart of Specimen #4.

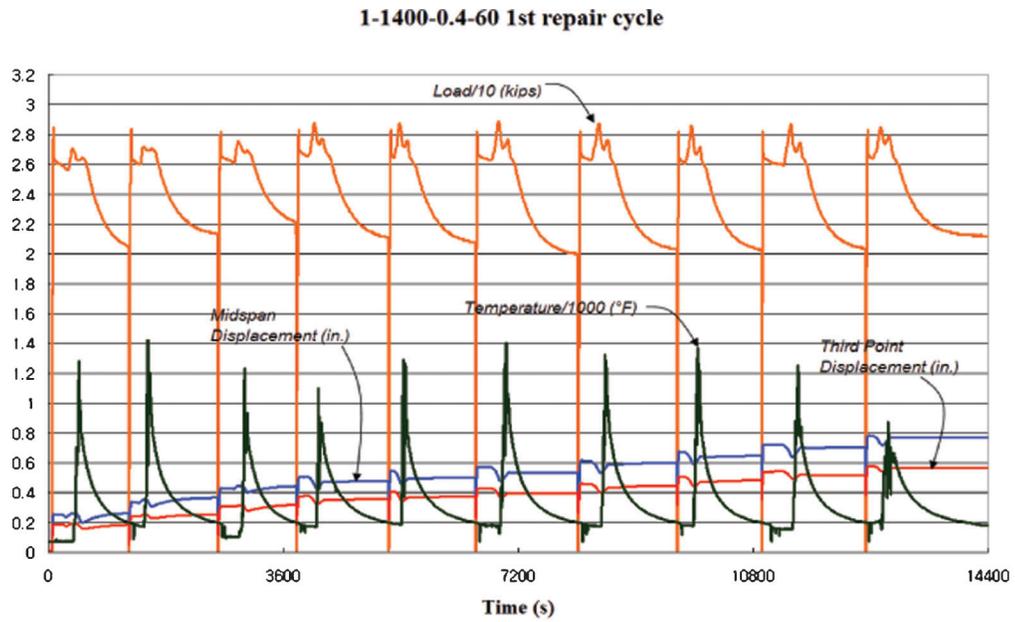
Figure 6.29 Instrument data during the repair cycle of Specimen #4.

Figure 6.29 shows some of the initial data of the Vee heat repair cycles. This figure includes: (a) the displacements from three displacement transducers in inches, (b) the restraining force in the hydraulic actuator in kips, which is divided by 10 (i.e., 1.0 on the graph shows 10 kips of force), and (c) the temperature of the steel in F, which is divided by 1000 (i.e., 1.0 on the graph corresponds to 1000°F).

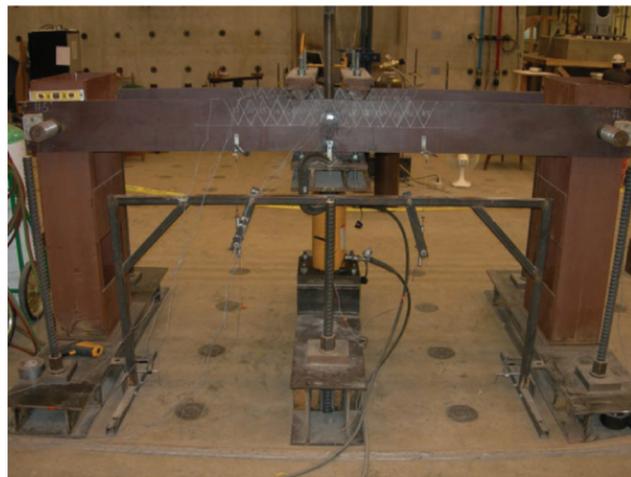
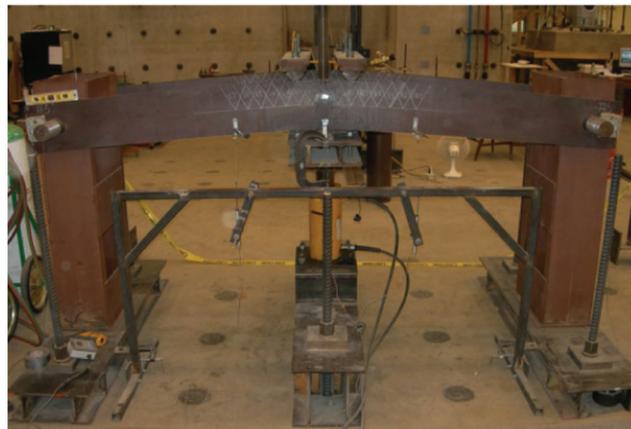
(a) Undamaged specimen

(b) Damaged specimen

Figure 6.30 Photographs of Specimen #5 before and after the damage.

Figure 6.30 shows the photographs of the beam specimen before (a) and after (b) the damage cycle. The beam specimen was damaged by monotonically increasing the concentrated force at the midspan. The damage was monitored using the longitudinal strain gage. The test was considered complete when one of the values of the front top and back top strain gages reached $30 \epsilon_y$. The complete strain gage data for the damage cycle is shown in Figure 6.31.

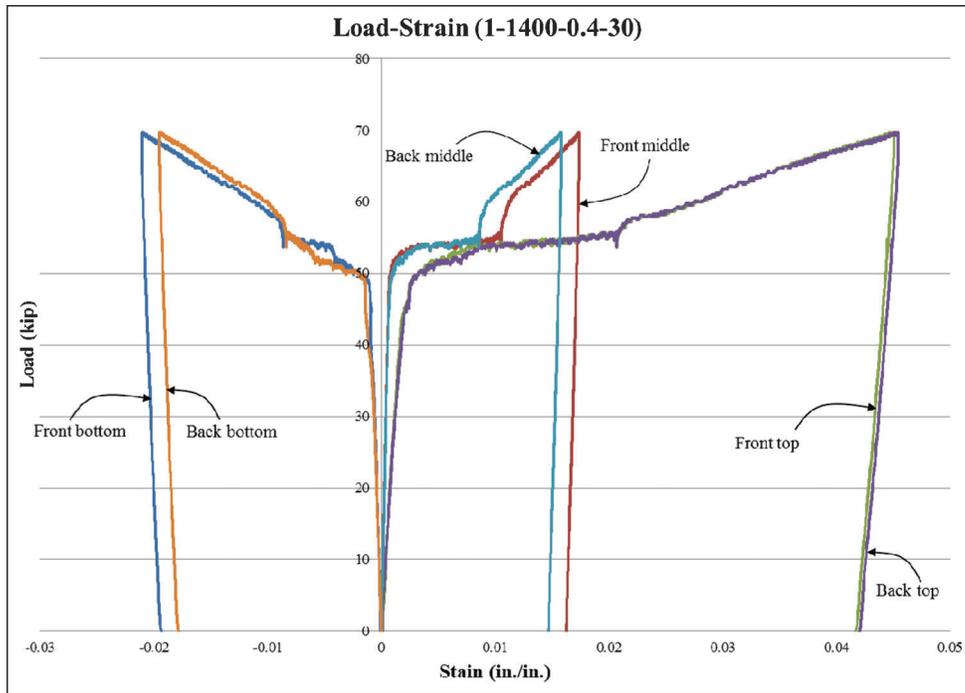
Figure 6.31 Load-strain diagram of Specimen #5 (1-1400-0.4-30).

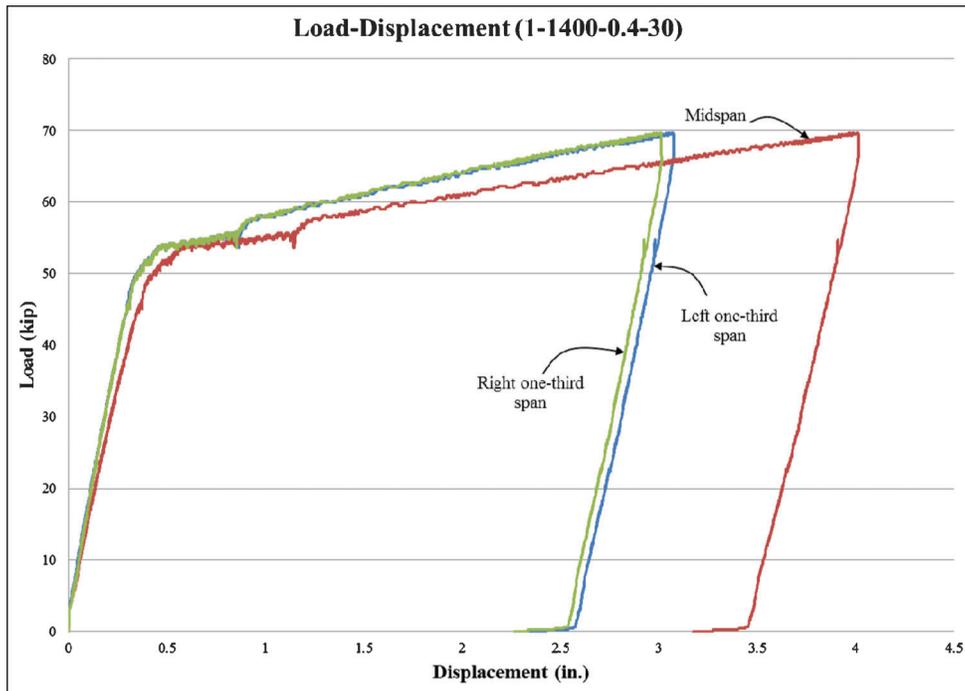
Figure 6.32 Load-displacement diagram of Specimen #5 (1-1400-0.4-30).

P- Δ relationships for Specimen #5 is shown in Figure 6.32. Figure 6.33 shows the P- θ relationship of Specimen #5.

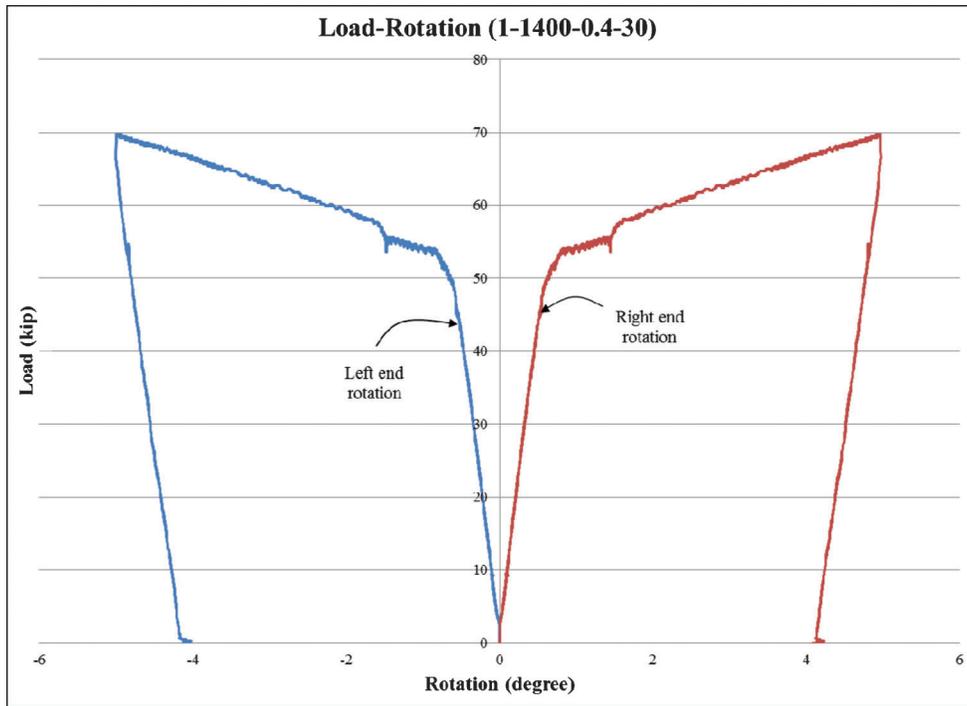
Figure 6.33 Load-rotation diagram of Specimen #5 (1-1400-0.4-30).

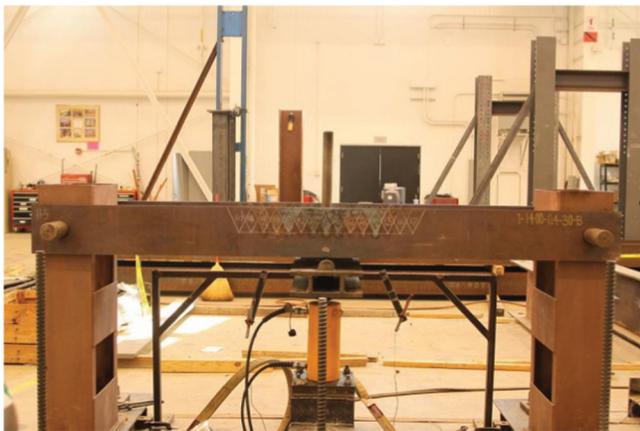
Figure 6.34 Photograph of Specimen #5 after the heat straightening repair.

Fifty four Vee heats were required to complete the repair cycle of Specimen #5. The photograph of the repaired beam is shown in Figure 6.34. After the final Vee heat repair, the remaining midspan deflection was less than $\frac{1}{8}$ in. The frequency chart indicating the number of Vee heats applied to each location is shown in Figure 6.35.

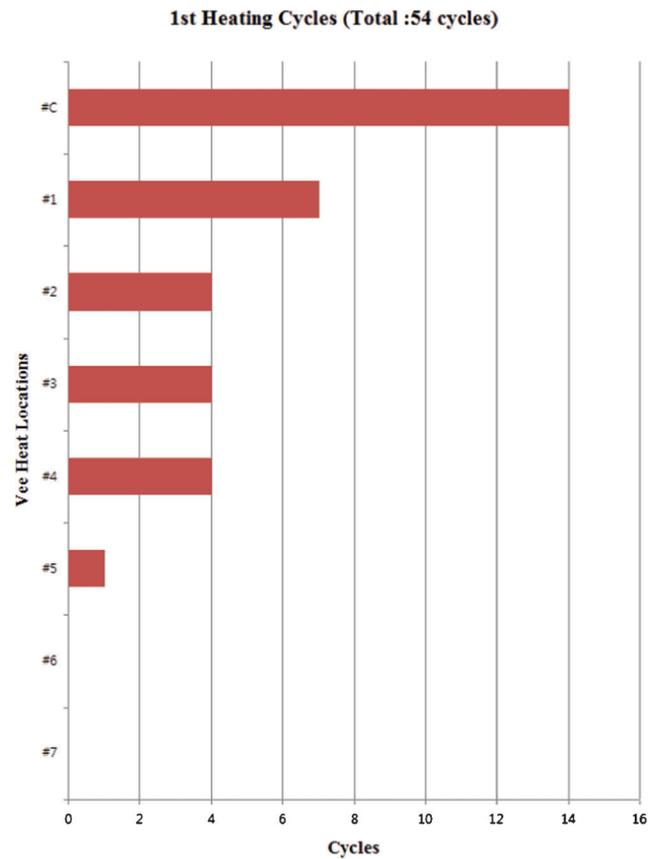
Figure 6.35 Vee heat frequency chart of Specimen #5.

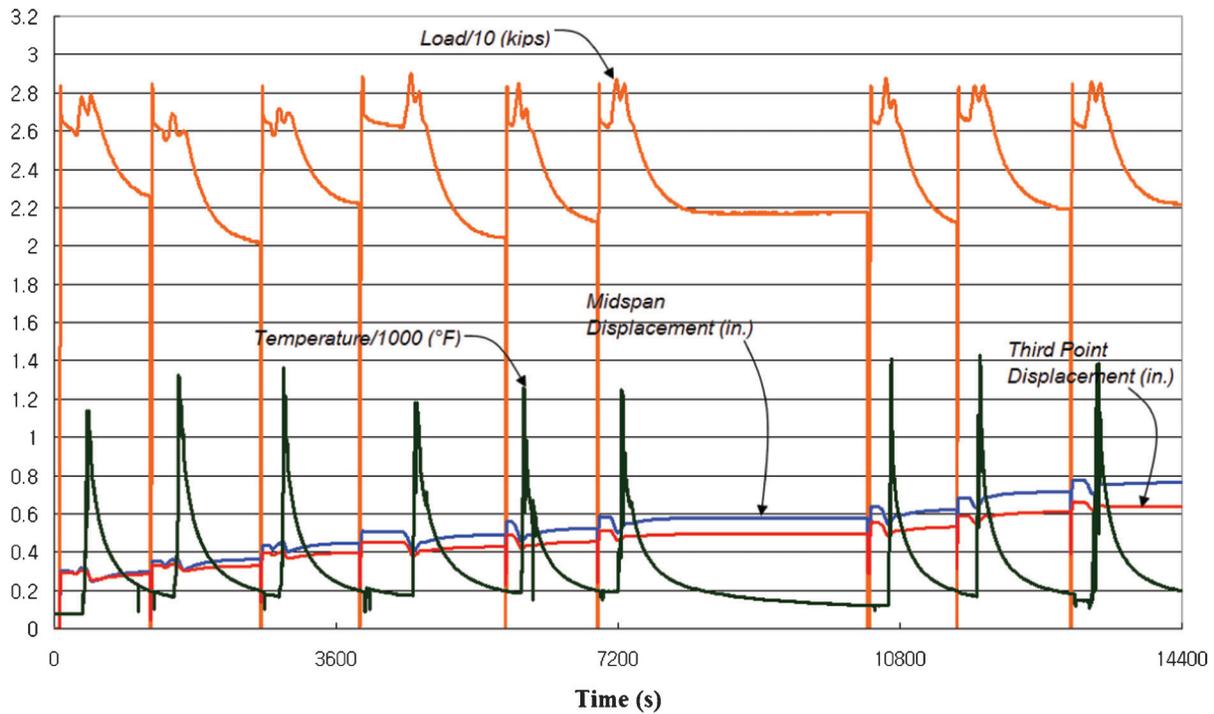
Figure 6.36 Instrument data during the repair cycle of Specimen #5.

Figure 6.36 shows some of the initial data of Vee heat repair cycles. This figure includes: (a) the displacements from three displacement transducers in inches, (b) the restraining force in the hydraulic

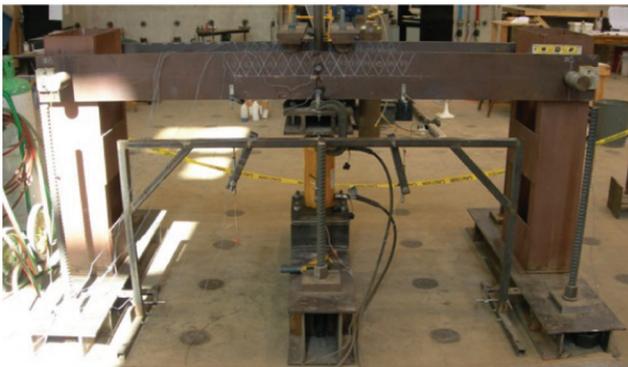
(a) Undamaged specimen

Figure 6.37 Photographs of Specimen #6 before and after the damage.
