Effects of Realistic Heat Straightening Repair on the Properties and Serviceability of Damaged Steel Beam Bridges

JOINT TRANSPORTATION RESEARCH PROGRAM

INDIANA DEPARTMENT OF TRANSPORTATION
AND PURDUE UNIVERSITY

1. Report No. FHWA/IN/JTRP-2013/03	2. Government Accession No.	3. Recipient's Catalog No.	
4. Title and Subtitle Effects of Realistic Heat Straightening Repair on the Properties and Serviceability of Damaged Steel Beam Bridges		5. Report Date February 2012

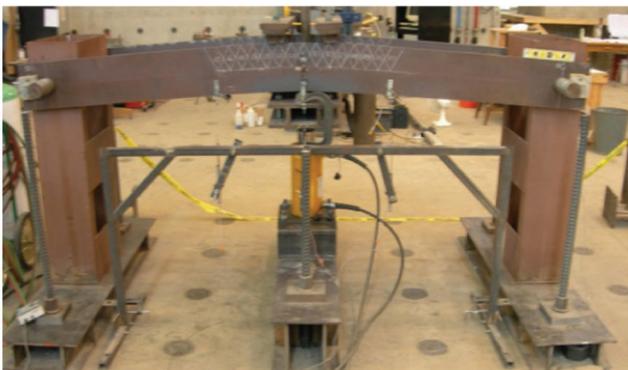
Figure 6.37 Photographs of Specimen #6 before and after the damage.

(a) Undamaged specimen

(b) Damaged specimen

Figure 6.37 shows the photographs of the beam specimen before (a) and after (b) the damage cycle. The beam specimen was damaged by monotonically increasing the concentrated force at the midspan. The damage was monitored using the longitudinal strain gage. The test was considered complete when one of the values of the front top and back top strain gages reached $30 \epsilon_y$. The complete strain gage data for the damage cycle is shown in Figure 6.38.

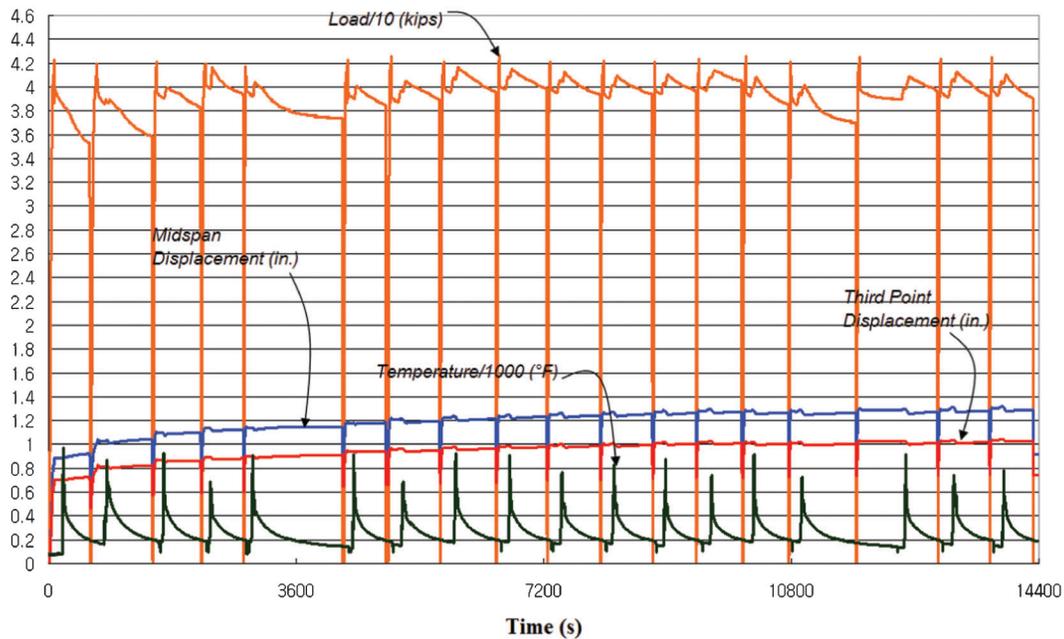
Figure 6.43 Instrument data during the repair cycle of Specimen #6.

1-800-0.6-30 1st repair cycle

Figure 6.43 shows some of the initial data of the Vee heat repair cycles. This figure includes: (a) the displacements from three displacement transducers in inches, (b) the restraining force in the hydraulic actuator in kips, which is divided by 10 (i.e., 1.0 on the graph shows 10 kips of force), and (c) the temperature of the steel in F, which is divided by 1000 (i.e., 1.0 on the graph corresponds to 1000 °F).

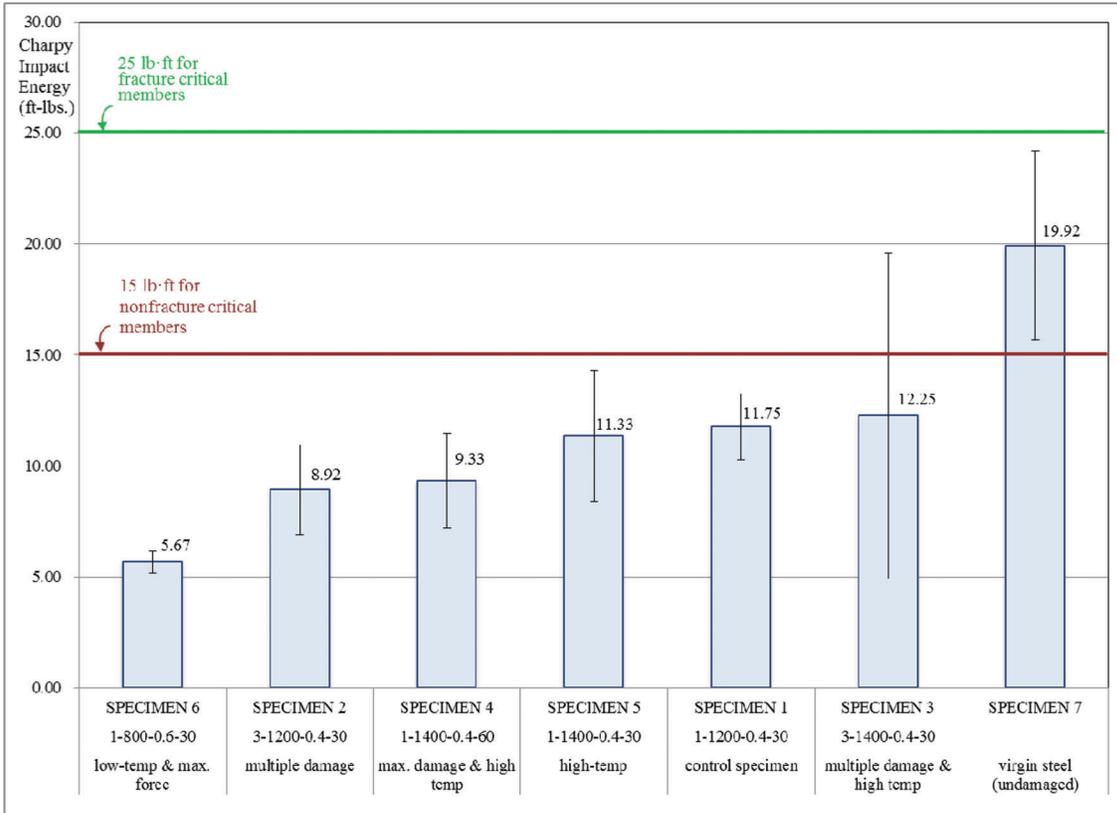
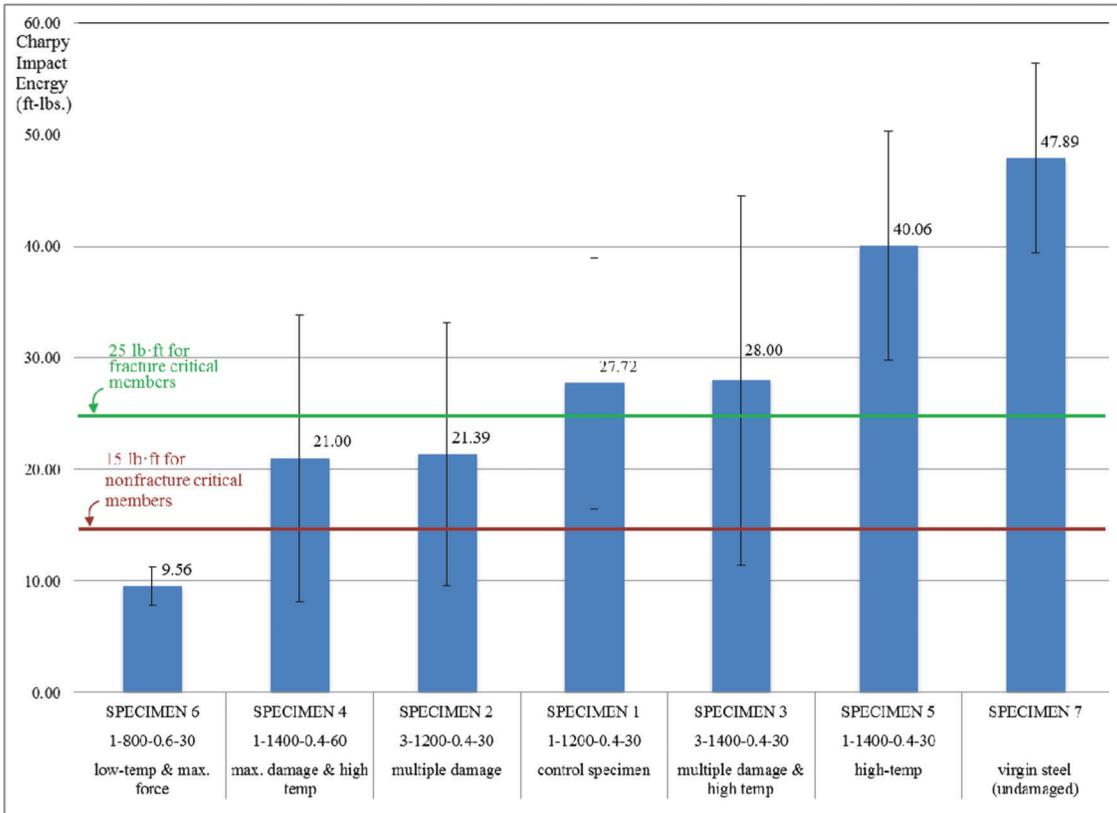
Figure 7.3 Initial and new Charpy impact results comparison.

(a) Initial Charpy impact results

(b) New Charpy impact results

New Charpy V-notch test results are shown in Table 7.2. The comparisons of the averaged fracture toughness of all small scale test specimens at 40 °F and 70 °F of the test temperature are shown in Figure 7.3. The results are shown in the order of the fracture toughness magnitude with standard deviation error bars.

As seen in Table 7.2 and Figure 7.3, Charpy V-notch test results at 70 °F were considerably higher than the 40 °F results.

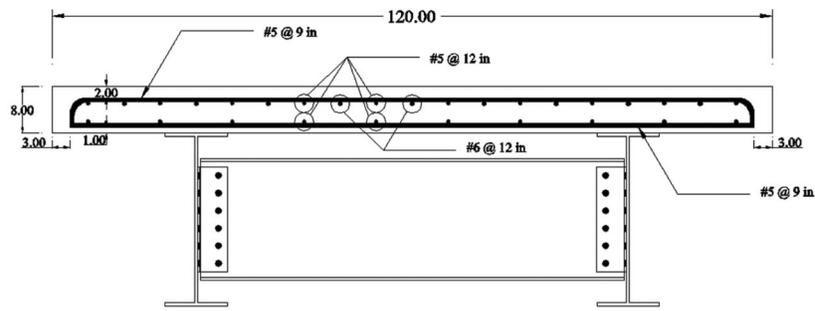
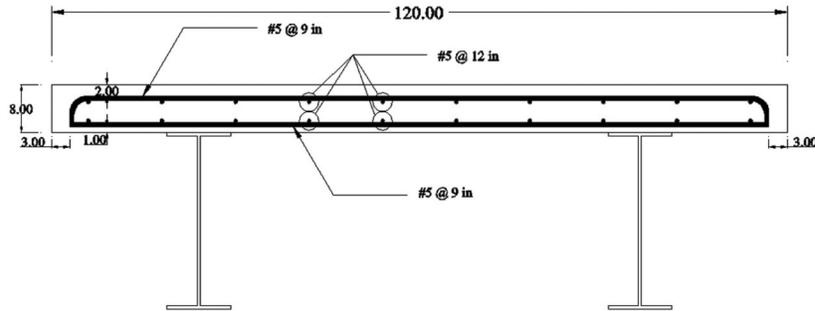
Figure 8.2 Slab reinforcements and shear stud drawings.

(a) Negative region reinforcement drawing

(b) Positive region reinforcement drawing

Figure 8.2 shows reinforcement drawings at the positive and negative moment regions and the drawing

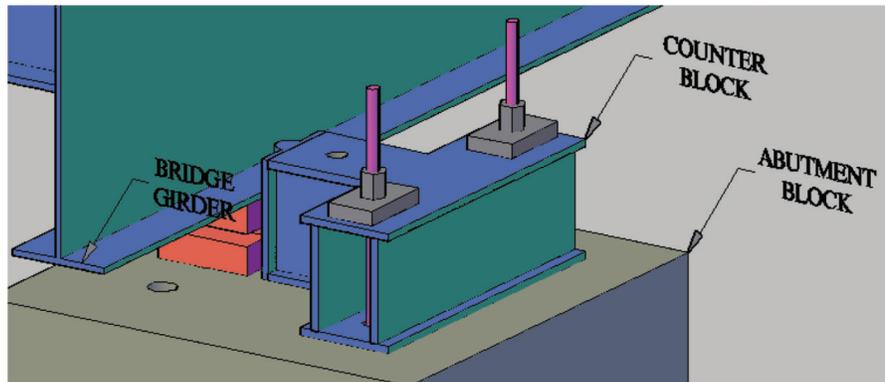
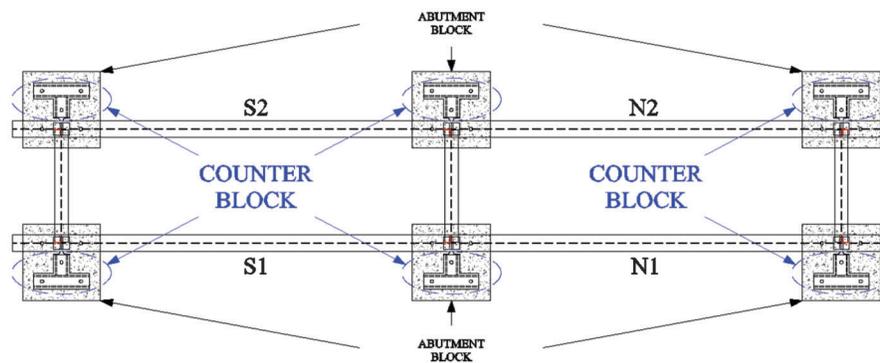
Figure 8.8 Plan of the counter block.

(a) Counter block detail

(b) Counter block location

and post-tensioned to the laboratory floor with a total force of 240 kips. Assuming that the friction coefficient (μ) between the concrete and steel is 0.3, each counter block could provide 72 kips of the lateral reaction force. Figure 8.8 shows the detailed drawing and the location of the counter blocks.

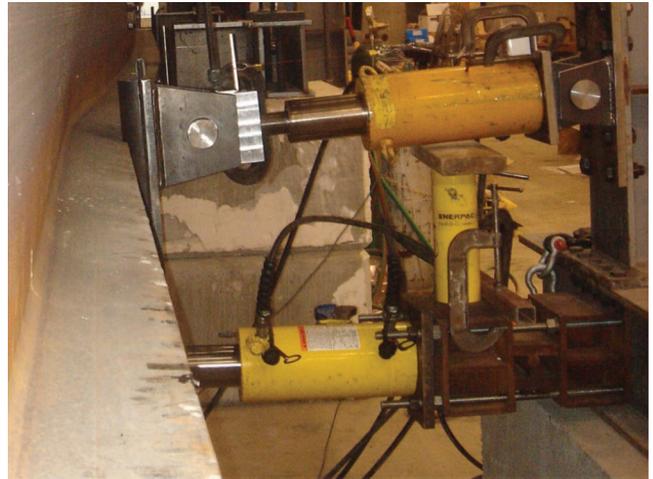
Figure 8.13 Actual damage of large scale specimen.

The damage of the bridge specimen during the first damage cycle was carefully monitored using a strain gage and displacement transducer attached to the midspan of each specimen. The damaging force applied at the midspan by the hydraulic actuators was slowly increased until the targeted damage strain at the midspan was reached.

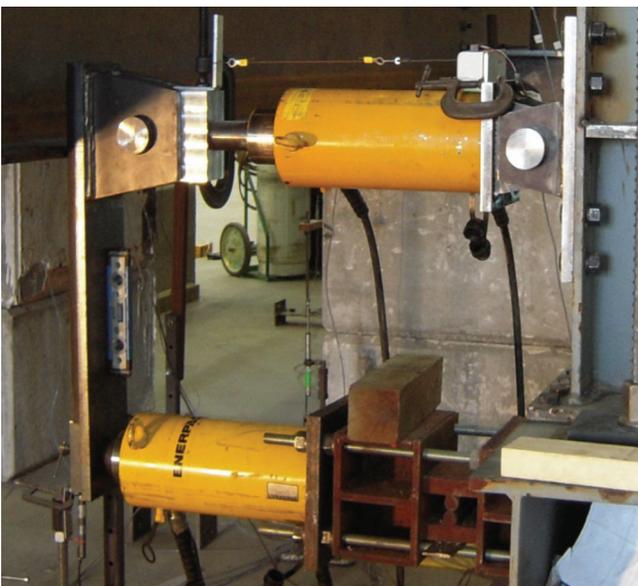
Figure 8.12 Damaging system.

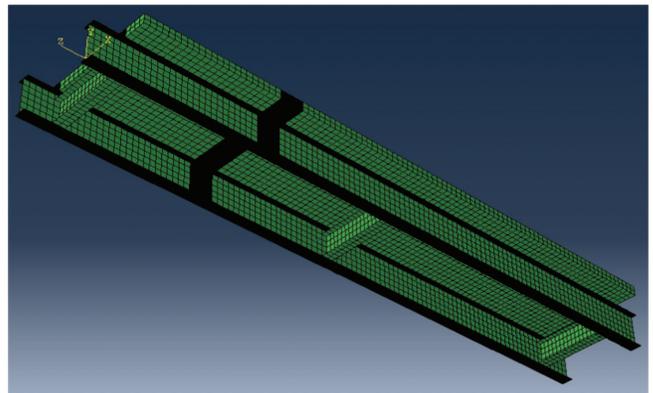
Figure 8.14 Finite model of the large scale test bridge.

A finite element model of the test bridge was developed by using the ABAQUS 6.10 analysis program to calculate the restraining force which could lead to 50 percent of yield stress at the maximum compression point of the bottom flange. Figure 8.14 shows the ABAQUS bridge model to determine the maximum restraining force. Figure 8.15 shows the

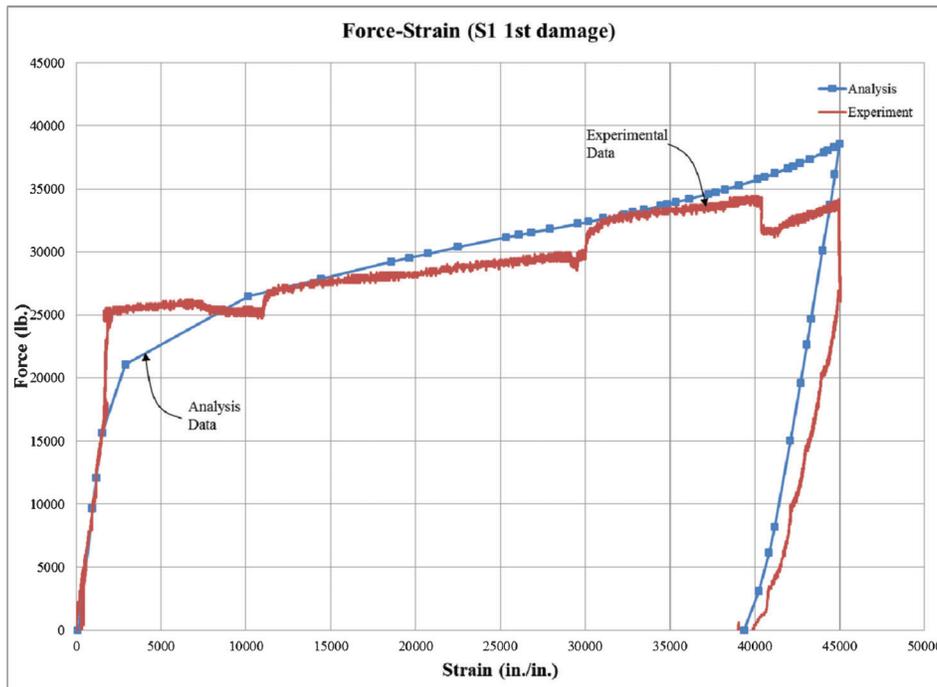
Figure 8.15 Analysis and experimental data comparison (S1 damage).

comparison of the finite element model prediction with the experimental result for S1 specimen (Force-Strain relationship of the 1st damage cycle). As shown in Figure 8.15, the experimental data compares reasonably well with the finite element model.

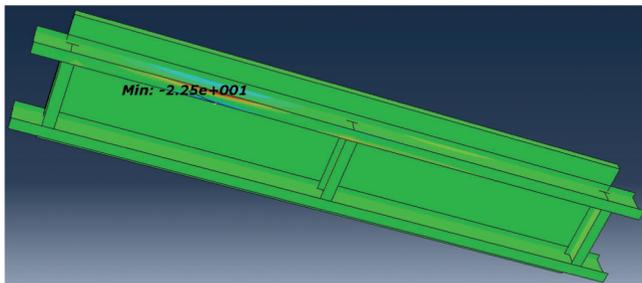
Figure 8.16 Maximum compression stress when applying 0.5 M_p of restraining force.

Assuming the steel yield stress to be 45 ksi, the ABAQUS model was used to determine that 7.9 kips of restraining force produces 22.5 ksi of maximum compressive stress. Figure 8.16 shows the results of the ABAQUS model. 7.9 kips of restraining force was selected as the maximum restraining force producing approximately 0.5 M_p on the whole damaged section. The restraining forces that can cause 0.4 M_p and 0.6 M_p were determined using the ABAQUS model as 6.32 kips and 9.48 kips respectively (80 percent and 120 percent of 7.9 kips).

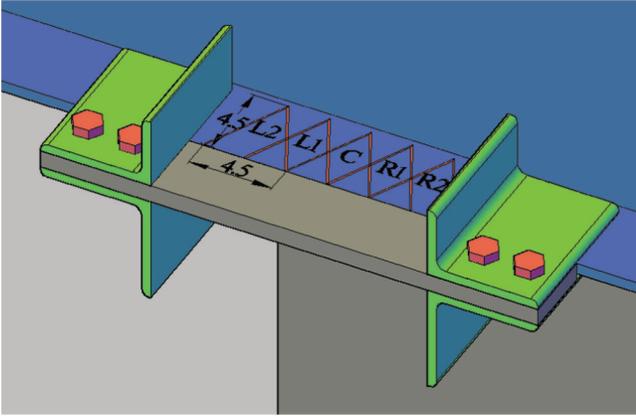
Figure 8.17 Vee heat locations and nomenclature.

Vee heat regions of the large scale test specimens are shown in Figure 8.17. These Vee zones were located within the central plastic strain region of the bridge specimen. The nomenclature of each Vee region is also shown in Figure 8.17. As seen in Figure 8.17, the Vee angle used for the small scale test was about 53°. This angle was similar to the Vee angle used in the heat straightening field visit in Section 4.3.

Repair cycles of the S1 specimen were conducted by applying external force corresponding to the restraining moment of $0.4 M_p$ described in Section 8.5. Vee heats were initially applied at the center (C) Vee region of the bottom flange shown in Figure 8.17. After that, other Vee regions (L1, R1-L2, R2) were heated to minimize out-of-plane distortion of the damaged flange. Each Vee region was heated to a maximum temperature of 1400°F to see the overheating effect.

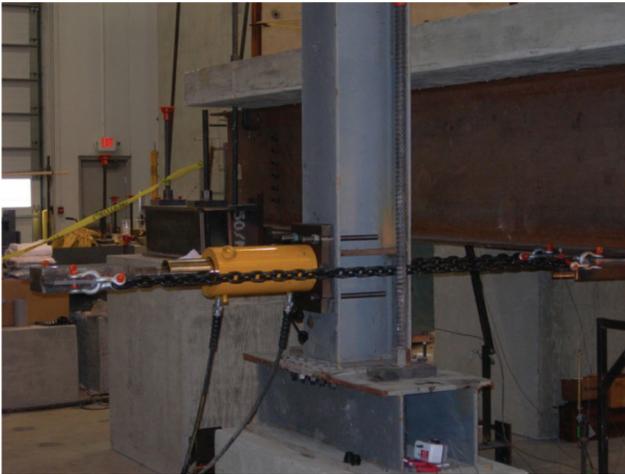
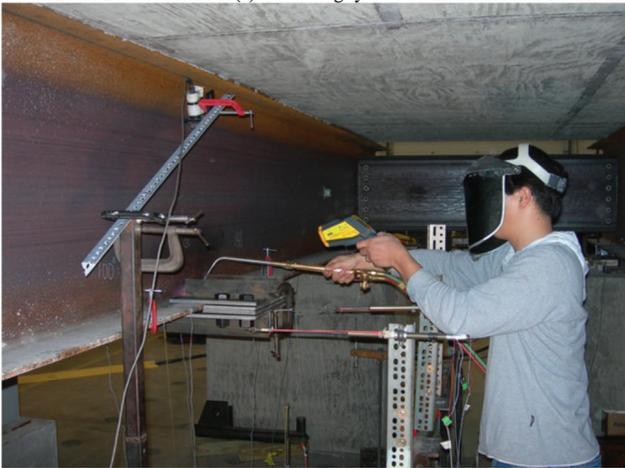
(a) Restraining system

(b) Vee heat application

Figure 8.18 Heat straightening application (Vee heat).

The actual Vee heat application is shown in Figure 8.18. Figure 8.18 (a) shows the actual restraining system used to apply restraining force to the damaged specimen. Figure 8.18 (b) shows the Vee heat application

using the oxygen-propylene heating torch. A non-contact infrared thermometer gun to check the applied temperature during the Vee heat application is shown in Figure 8.18 (b).

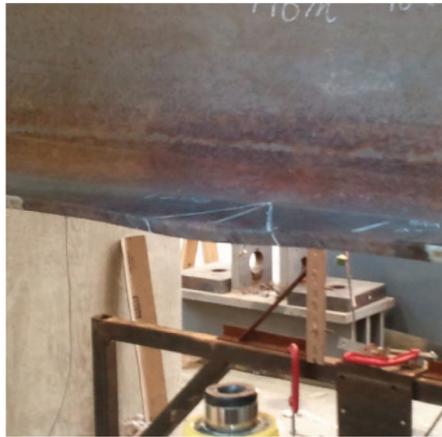
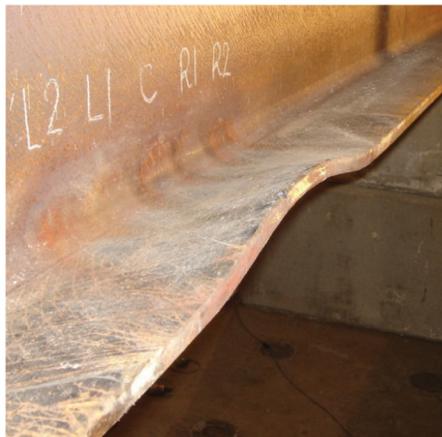
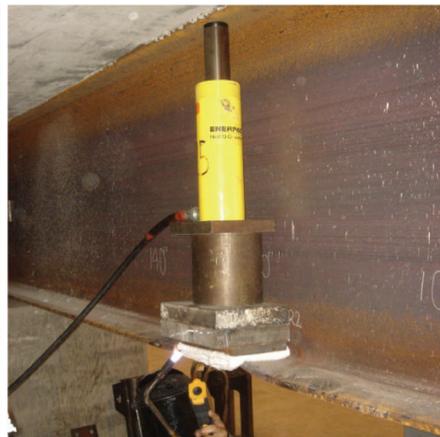
(a) Outside local damage

(b) Line heat application (outside)

(c) Inside local damage

(d) Line heat application (inside)

Figure 8.19 Heat straightening application (Line heat).

(L category damage: localized damage) remained in and outside of the bottom flange. The outside bulge was caused by the damaging force at the contact point with the loading beam, and the inside bulge was initiated from the Vee heat application. Figure 8.19 shows an actual photo of the localized bulge damage on the bottom flange of the bridge specimen and line heat repair. All localized damages were also fixed by using the localized line heat repair method.

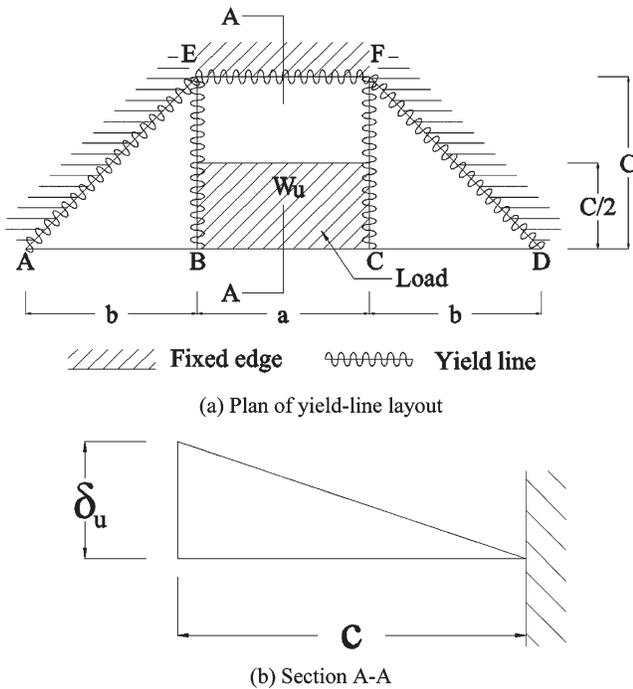
Figure 8.20 Yield line analysis for idealized flange bulge geometry.

The required restraining force for the line heat repair process was computed from the yield line analysis method in the FHWA heat straightening guidelines (28). Figure 8.20 shows the yield line analysis for the idealized flange bulge geometry. Equations 8.1–8.5 were used to find out the required jacking force (P_j) of each test specimen.

The internal work done, W_I , is computed from the following equation using the geometry coming from Figure 8.20 (a).

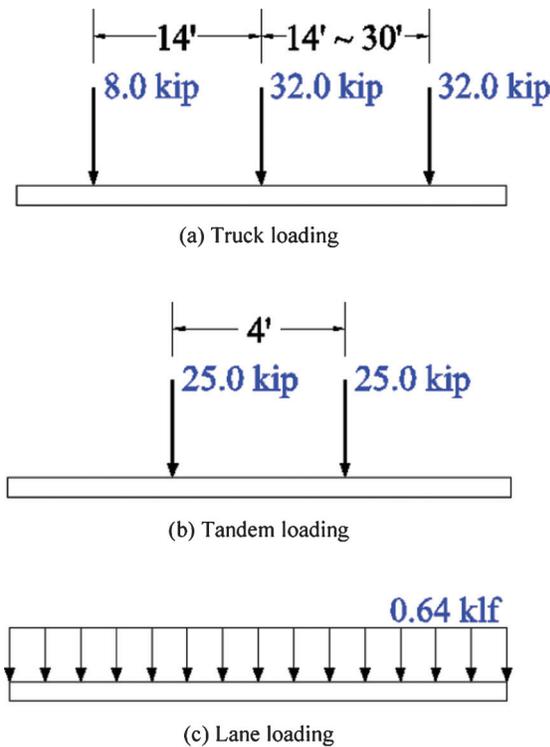
Figure 8.21 HL-93 live loadings of the AASHTO 2007 specification.

SAP 2000 structural analysis program was used to determine the maximum live load effect on the test bridge. A 20 ft. two-span frame model was developed to apply the AASHTO 2007 HL-93 live load. HL-93 truck loading, tandem loading, and lane loading described in the AASHTO 2007 specification were applied on the analysis model. Details of these live loads are shown in Figure 8.21.

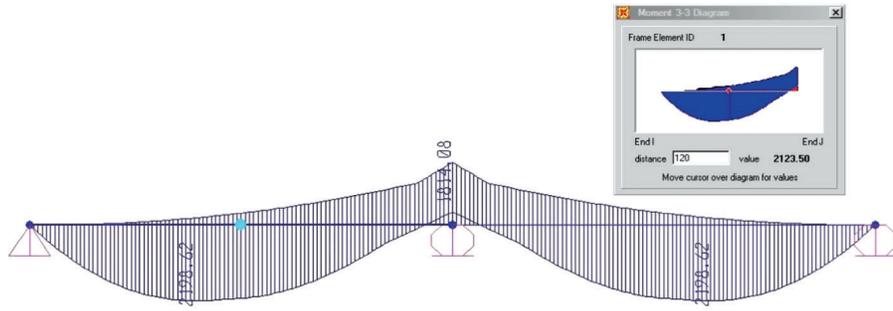
Figure 8.22 Bending moment diagram of HL-93 live load analysis.

Following the AASHTO 2007 design procedure, the truck loading or tandem loading was combined with the lane loading and applied on the bridge model. The maximum HL-93 live load moment diagram obtained from the SAP 2000 linear analysis is shown in Figure 8.22. As seen in Figure 8.22, the maximum moment at the midspan by the applied HL-93 live load was 2123.5 kip-in.

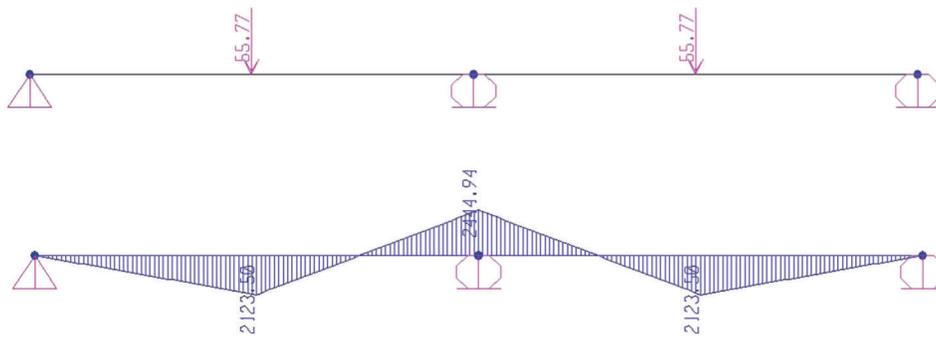
Figure 8.23 Static load and bending moment diagram for serviceability checkup.

A static load which can cause 2123.5 kip-in moment at each midspan was also determined by the SAP 2000 analysis program. Figure 8.23 shows 55.8 kips of static load applied at each midspan and a corresponding bending moment diagram of the analysis model. As seen in Figure 8.23, 2123.5 kip-in of the moment value was developed at each midspan by 55.8 kips of static load. Therefore, 55.8 kips of static midspan load was decided as the maximum live load to determine the serviceability performance of the test bridge.

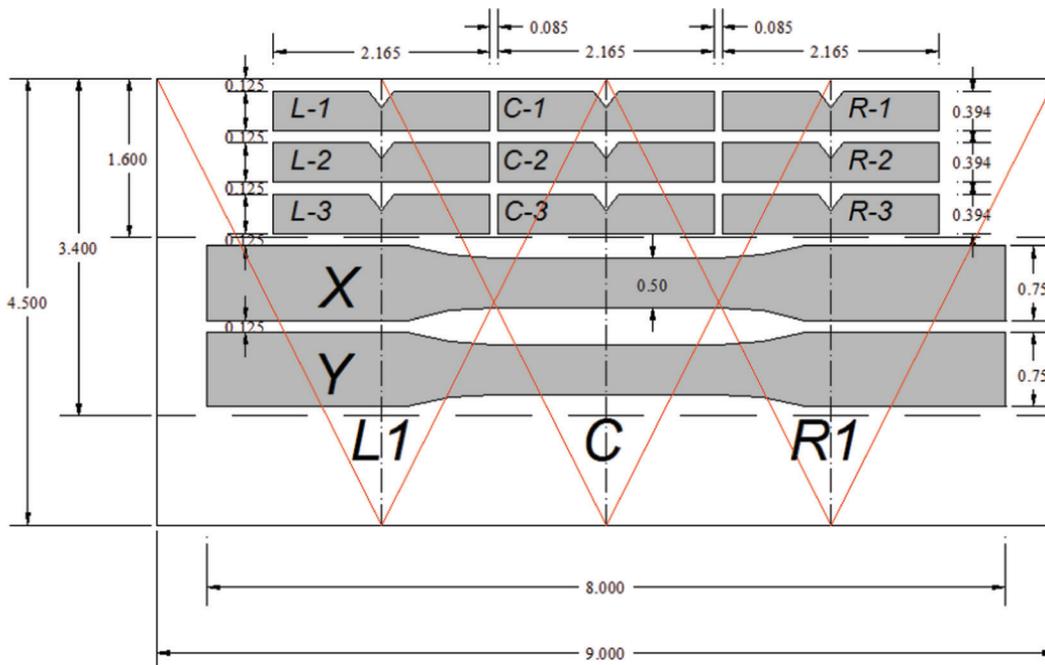
Figure 8.24 Nomenclature and location of large scale material coupons.

As shown in Figure 8.24, two uniaxial tension coupons were taken from the midspan of each test specimen. The dimensions of the uniaxial tension coupons are shown in Figure 5.13. All tension coupons were taken from the Vee heated regions at the midspan (L1, C, and R1) between 1.6 in. and 3.4 in. from the outer surface of the bottom flange. The actual location and the nomenclature of each tensile coupon are also shown in Figure 8.24.

Fracture toughness tests, Rockwell hardness tests, and microstructure investigations were conducted on the Charpy coupons of each large scale specimen. The Charpy coupons of the large scale test specimens are shown in Figure 8.24. The Charpy specimens were removed within a distance of 1.6 in. of the flange edge. As seen in Figure 8.24, the v-notches of the Charpy coupons were fabricated facing the edge of the bottom flange plate. The location and the nomenclature of each Charpy coupon are also shown in Figure 8.24.

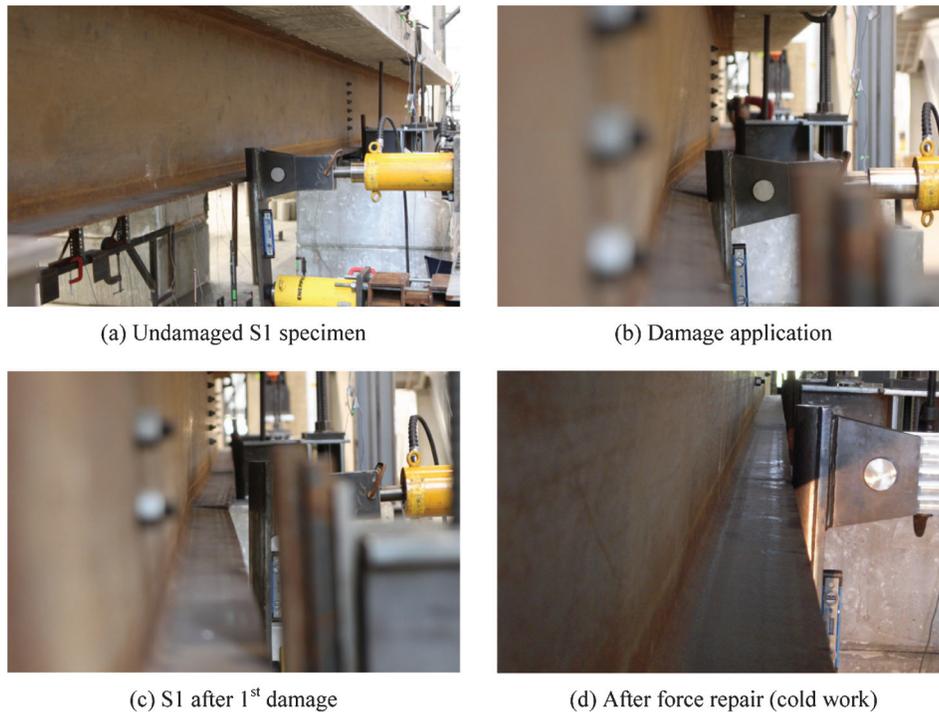
Figure 9.1 Photographs of 1st damage-repair cycle (S1 specimen).

Figure 9.1 shows photographs of the beam specimen before and after the first damage cycle. As mentioned previously, the first damage was repaired by excessive restraining force which was close to 70 kips. Three

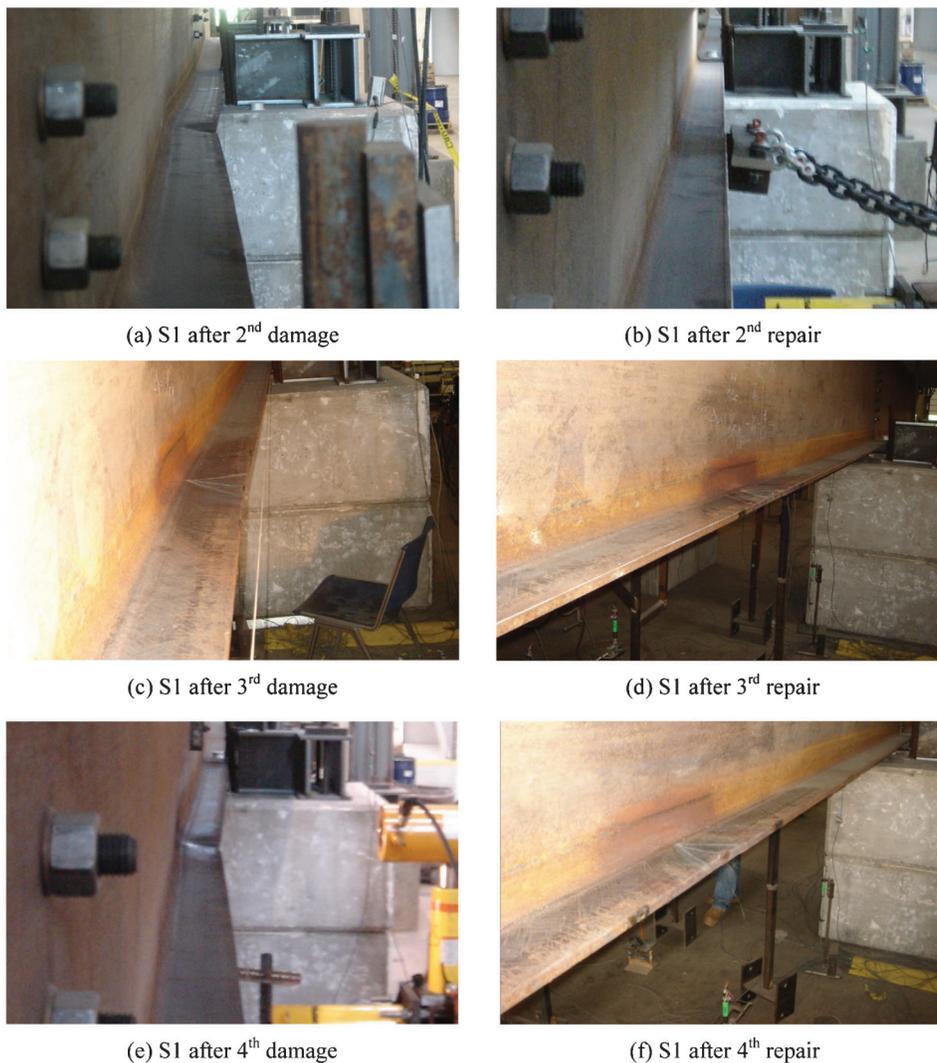
Figure 9.2 Photographs of S1 specimen before and after the damage.

additional damage-heat straightening repair cycles were applied on the S1 specimen after the first force repair as shown in Figure 9.2.

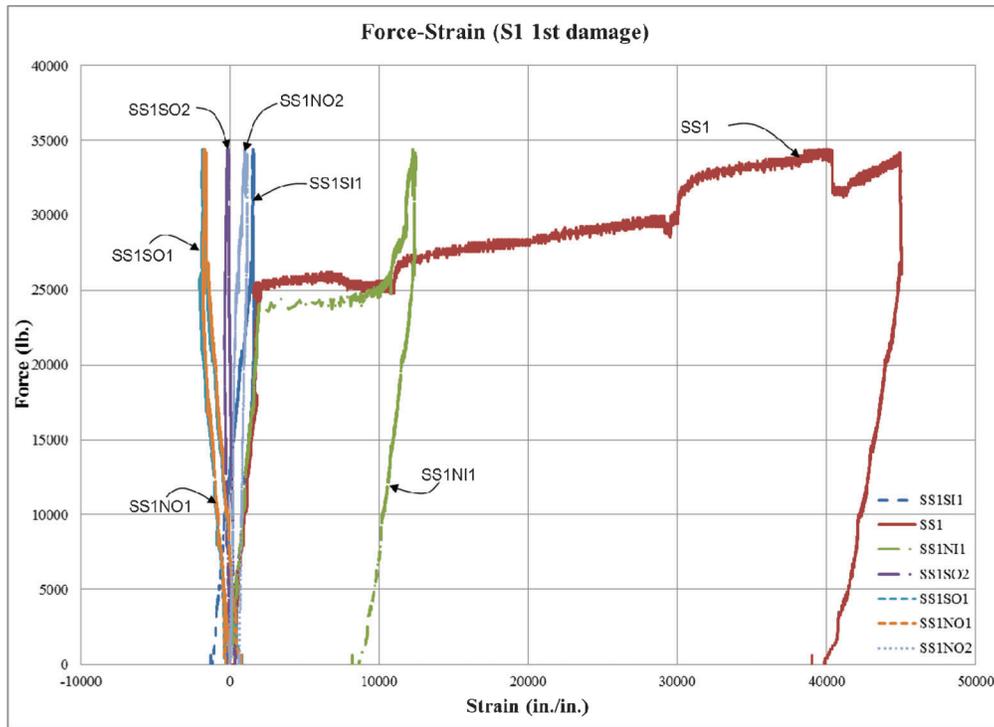
Figure 9.3 Load-strain diagram of S1 specimen.

Each damage cycle corresponded to the damage strain of $30 \epsilon_y$ (0.045 in./in.) at the midspan strain gages. The damage strain in the first cycle was measured using the strain gage layout described in Section 8.4. The strain gage data from the first damage cycle is provided in Figure 9.3.

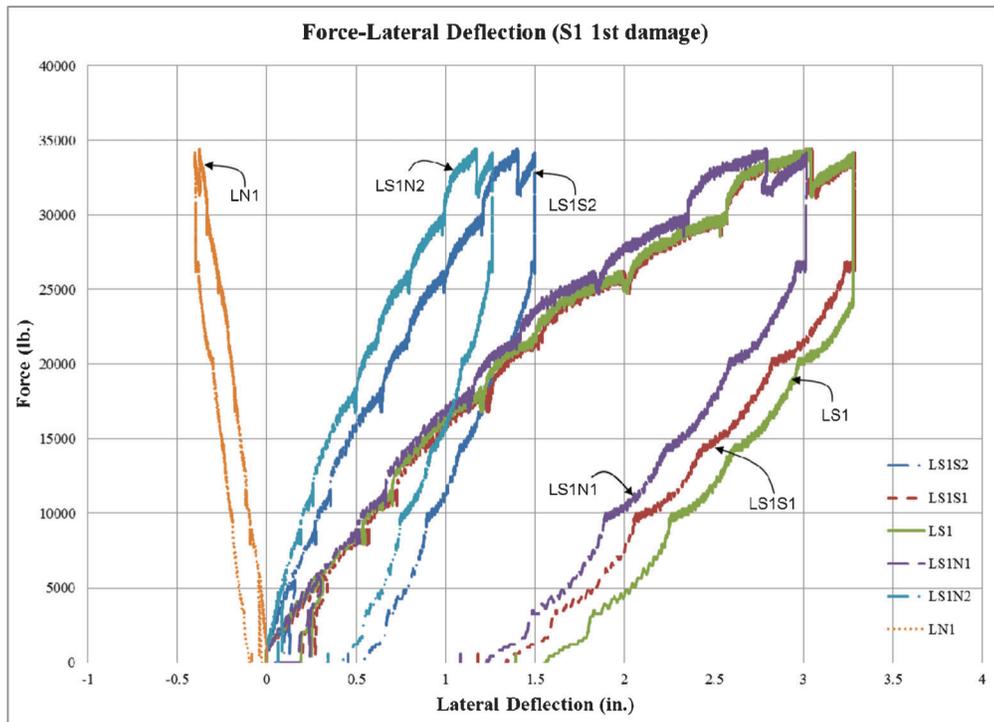
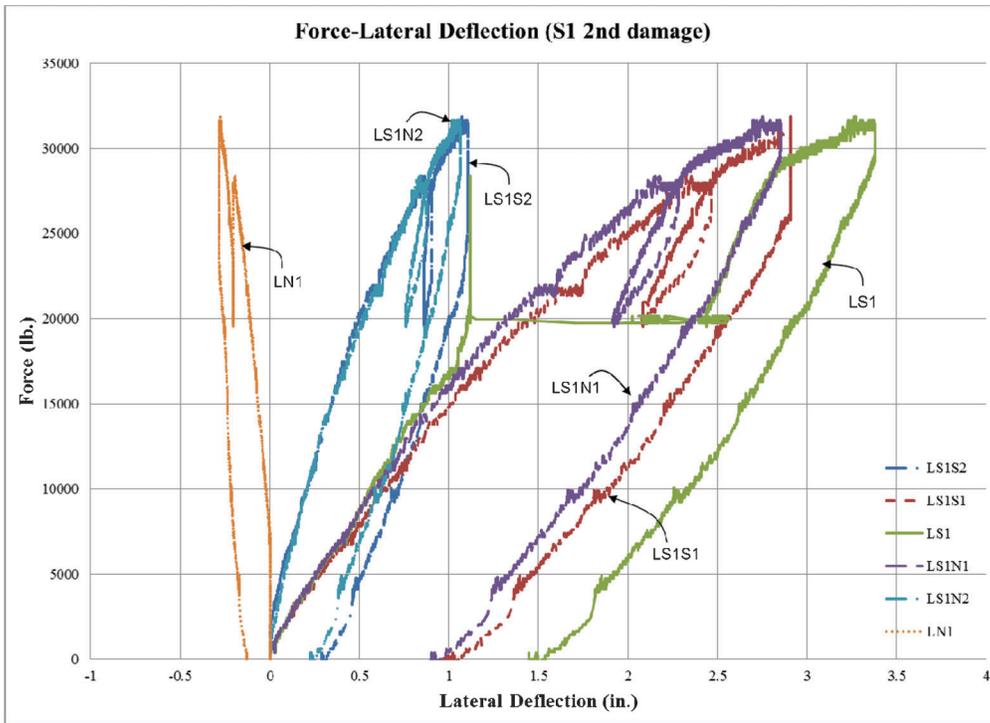
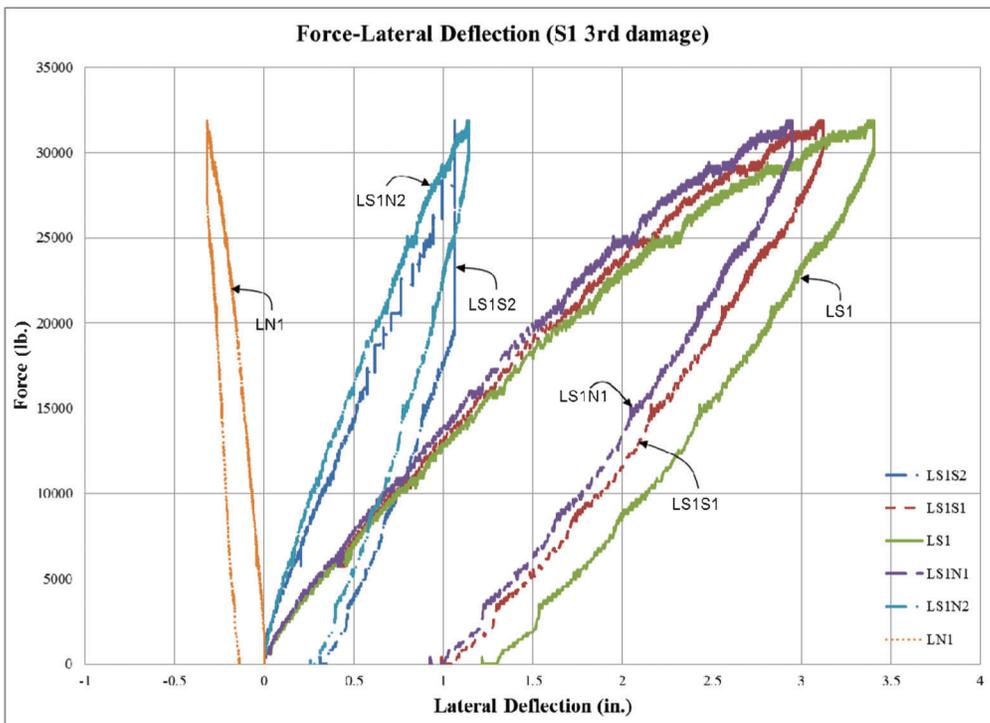
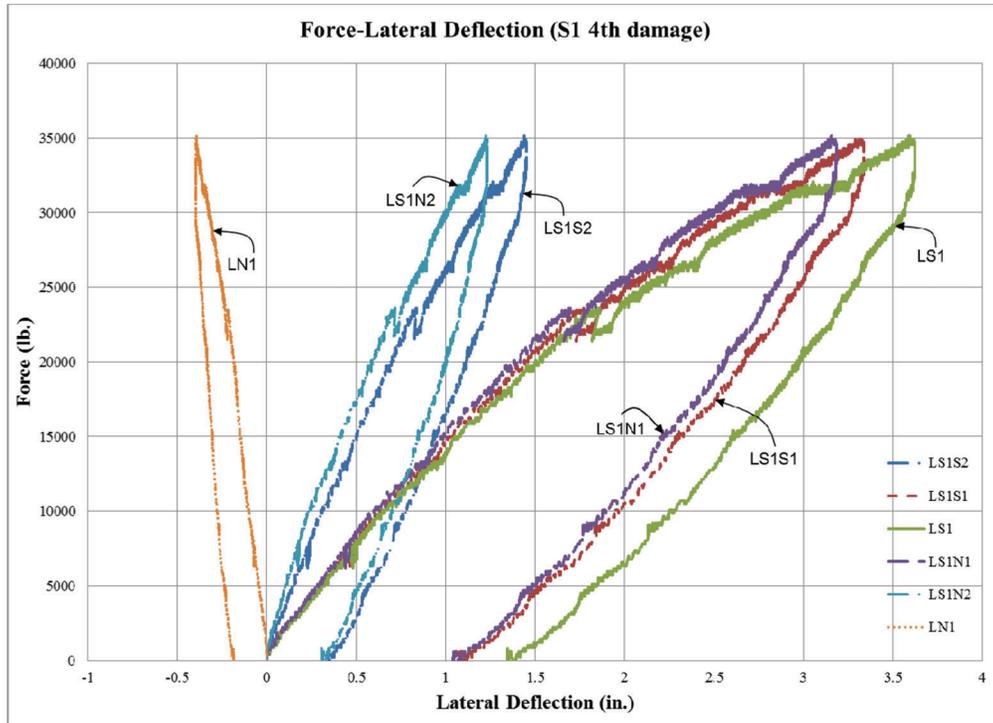
Figure 9.4 Load-displacement diagram of S1 specimen (1st damage).

Figure 9.5 Load-displacement diagram of S1 specimen (2nd damage).

Figure 9.6 Load-displacement diagram of S1 specimen (3rd damage).

Figure 9.7 Load-displacement diagram of S1 specimen (4th damage).

Damage cycles 2, 3 and 4 were conducted under displacement control, where the displacement at the midspan was monitored and controlled to reach the displacement from the first damage cycle. Figures 9.4–9.7 show the lateral displacement behavior in each damage cycle. The maximum lateral displacements at each damage cycle corresponding to the maximum damage strain of $30 \epsilon_y$ are shown in Table 9.1. The permanent deformations left in S1 specimen after elastic rebound are also presented in Table 9.1. These permanent deformations were the final damage magnitude to be fixed by the heat straightening process.

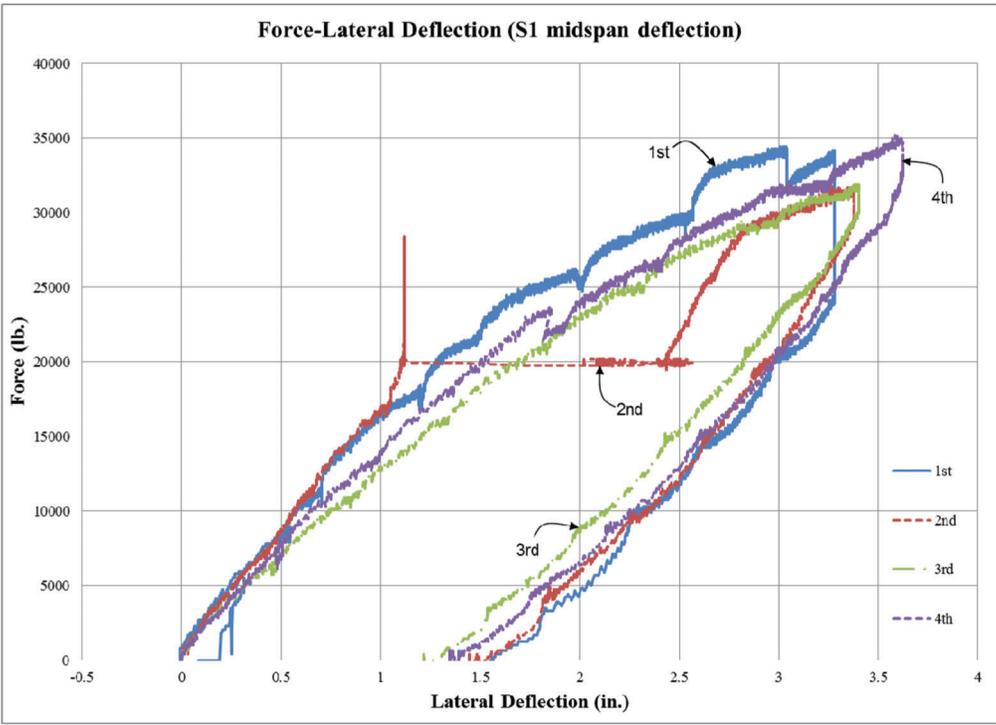
Figure 9.8 Midspan load-displacement diagram of S1 specimen (all damages).

Figure 9.8 compares the P- Δ behavior of all four damage cycles of the S1 specimen. All four graphs in Figure 9.8 show similar P- Δ behavior in all damage cycles. Therefore, the stiffness of the S1 specimen in each damage-repair cycle was not affected significantly by the damage-repair process. (See S-1 Span Damage video: <http://dx.doi.org/10.4231/D3RJ48V2G>)

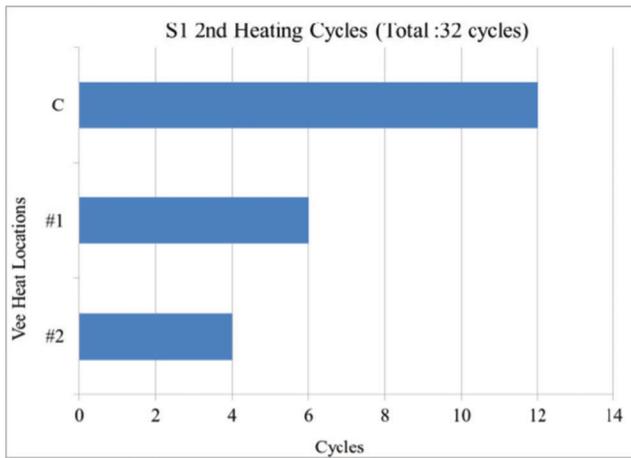
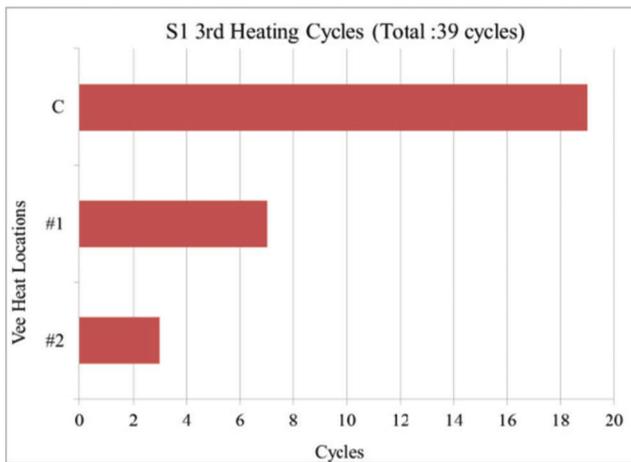
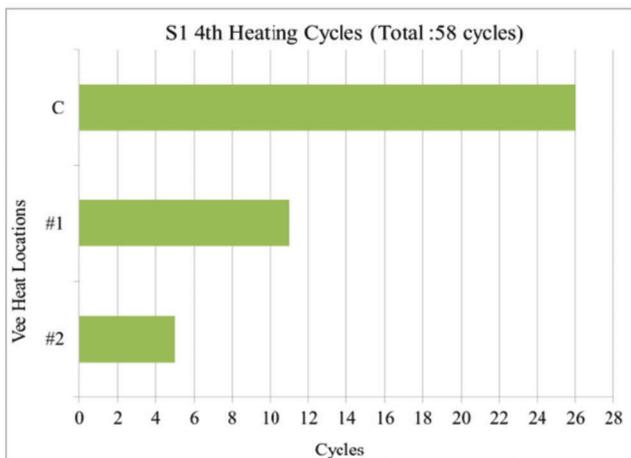
(a) Vee heat frequency of 2nd repair cycle

(b) Vee heat frequency of 3rd repair cycle

(c) Vee heat frequency of 4th repair cycle

Figure 9.9 Vee heat frequency chart of S1 specimen.

are shown in Figure 9.9. Thirty-two Vee heats on the bottom flange were required to complete the first repair cycle. The second repair cycle took 39 Vee heats to complete. The third repair cycle needed 58 Vee heats

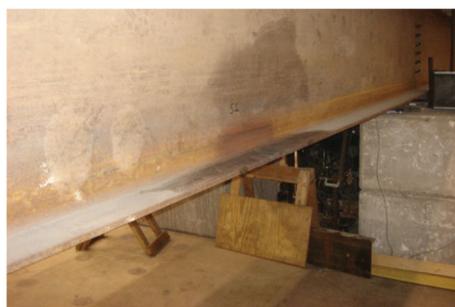
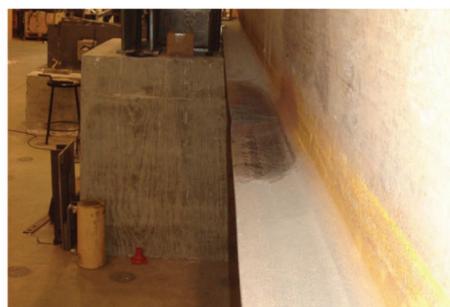
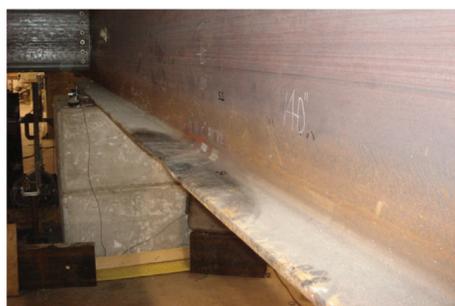
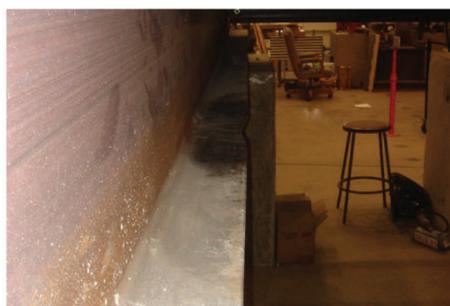
(a) Outside photo of S1 after repair (1)

(b) Outside photo of S1 after repair (2)

(c) Inside photo of S1 after repair (1)

(d) Inside photo of S1 after repair (2)

Figure 9.10 Photographs of S1 specimen after all repair processes.

The final photographs of the S1 specimen after all repair cycles are shown in Figure 9.10. As seen Figure 9.10, the specimen was fully straightened after all repair processes. The surface of the repaired region was ground smoothly to deter undesired stress concentrations.

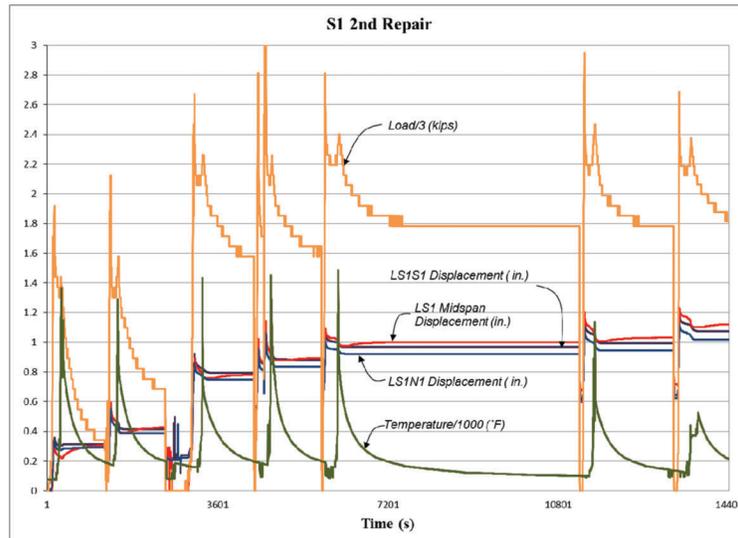
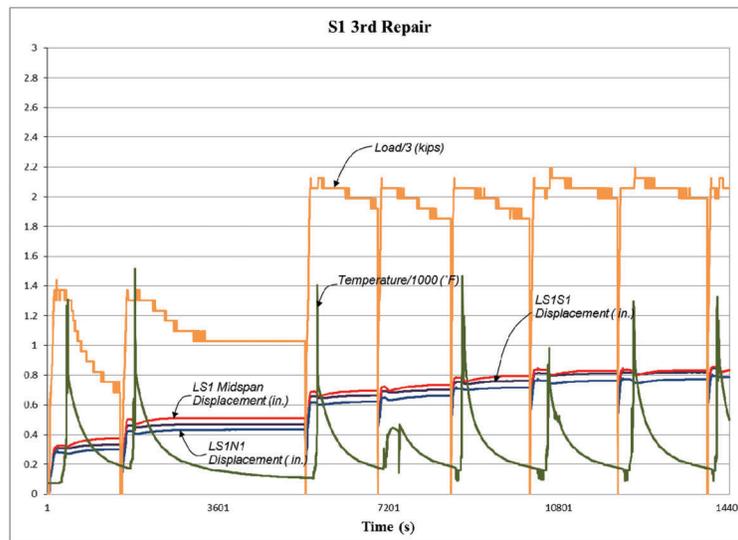
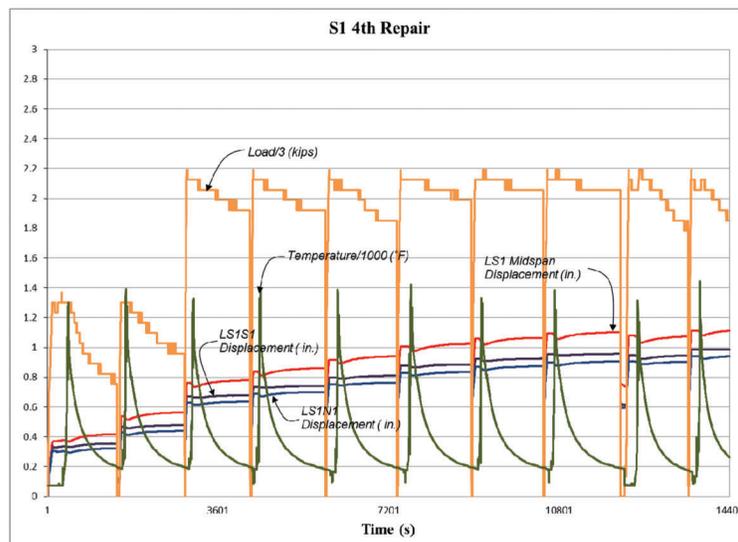
(a) 2nd repair cycle

(b) 3rd repair cycle

(c) 4th repair cycle

Figure 9.11 Instrument data during the repair cycles of S1 specimen.

Figure 9.11 shows the behavior of the S1 specimen in the initial several steps of each repair cycle. These figures include: (a) the displacements from three inside displacement transducers in inches, (b) the restraining force in the hydraulic actuator in kips, which is divided by 3 (i.e., 1.0 on the graph shows 3 kips of force) and (c) the temperature of the steel in °F, which is divided by 1000 °F (i.e., 1.0 on the graph corresponds to 1000 °F).

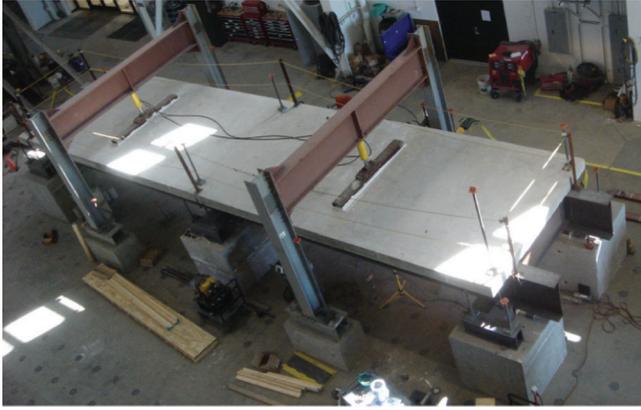
Figure 9.12 Photograph of serviceability test.

The serviceability performance of the test bridge during the S1 damage-repair process was determined by simultaneously subjecting each midspan of test bridge to 56 kips of static loading. All vertical midspan displacements of the test bridge were measured and compared to determine the serviceability difference between each damage-repair cycle. Figure 9.12 shows the serviceability test using two 50 ton capacity hydraulic actuators attached to the midspan loading frames.
