Effects of Realistic Heat Straightening Repair on the Properties and Serviceability of Damaged Steel Beam Bridges

JOINT TRANSPORTATION RESEARCH PROGRAM

INDIANA DEPARTMENT OF TRANSPORTATION
AND PURDUE UNIVERSITY

1. Report No. FHWA/IN/JTRP-2013/03	2. Government Accession No.	3. Recipient's Catalog No.	
4. Title and Subtitle Effects of Realistic Heat Straightening Repair on the Properties and Serviceability of Damaged Steel Beam Bridges		5. Report Date February 2012

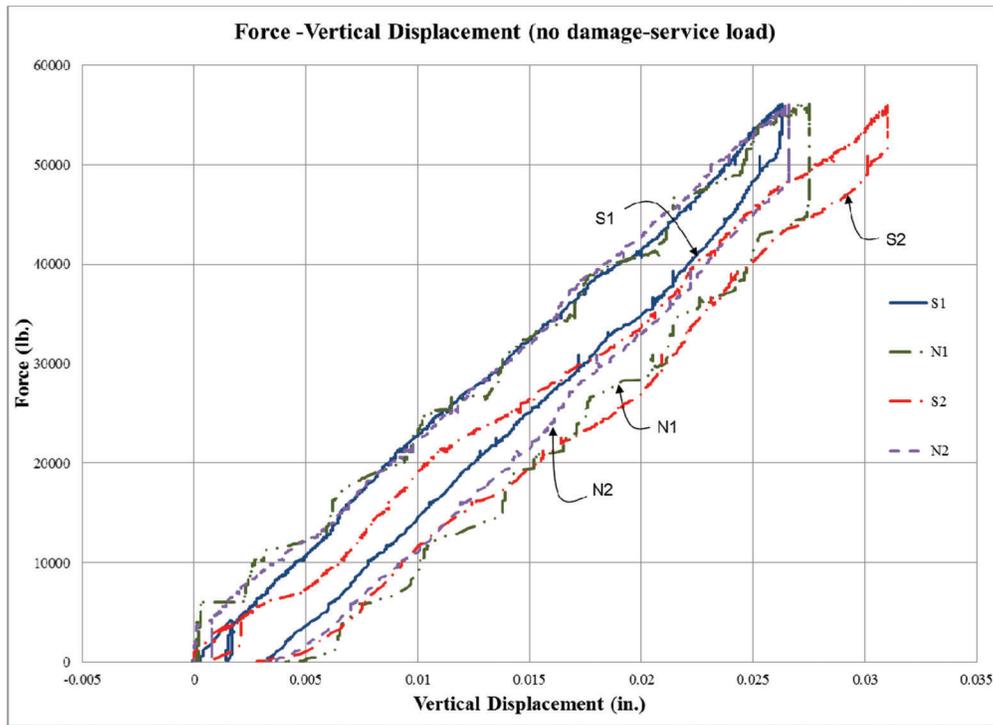
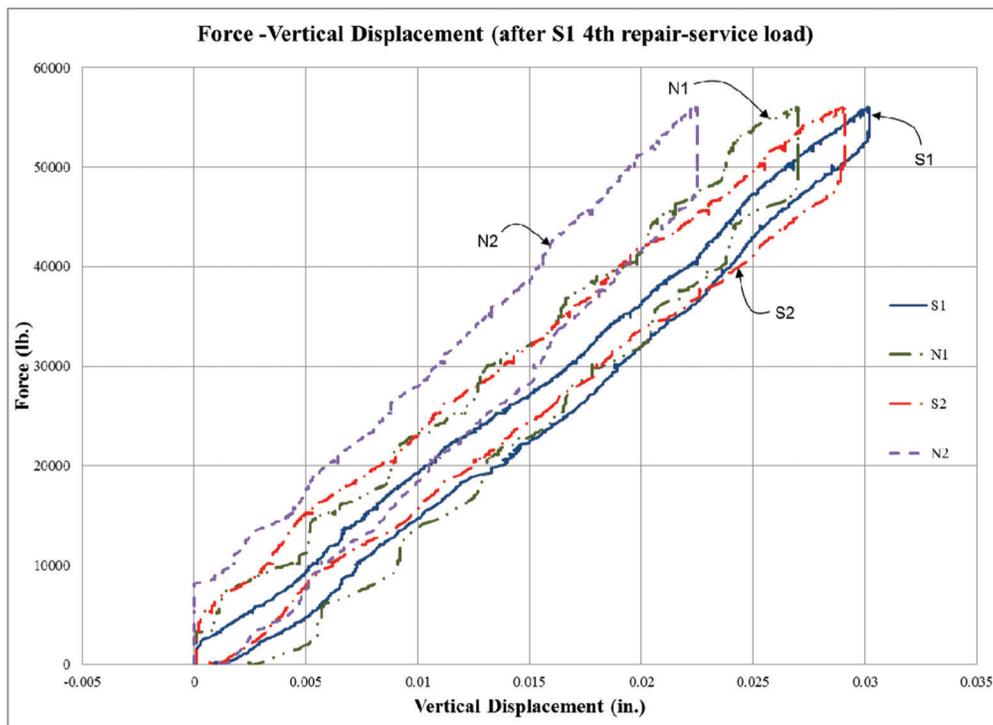
(a) Force-vertical displacement of undamaged bridge

(b) Force-vertical displacement of S1 4th repaired bridge

Figure 9.13 Service load-vertical displacement behavior of S1 test.

Figure 9.13 shows the serviceability behavior of the test bridge before and after the S1 damage-repair process. The maximum midspan deflections in all cases were not bigger than 0.035 in. which is much smaller than the AASHTO deflection limit of 0.3 in. or 0.24 in. Therefore, the maximum midspan deflection after the S1 damage-repair process was within the AASHTO specification deflection limit.

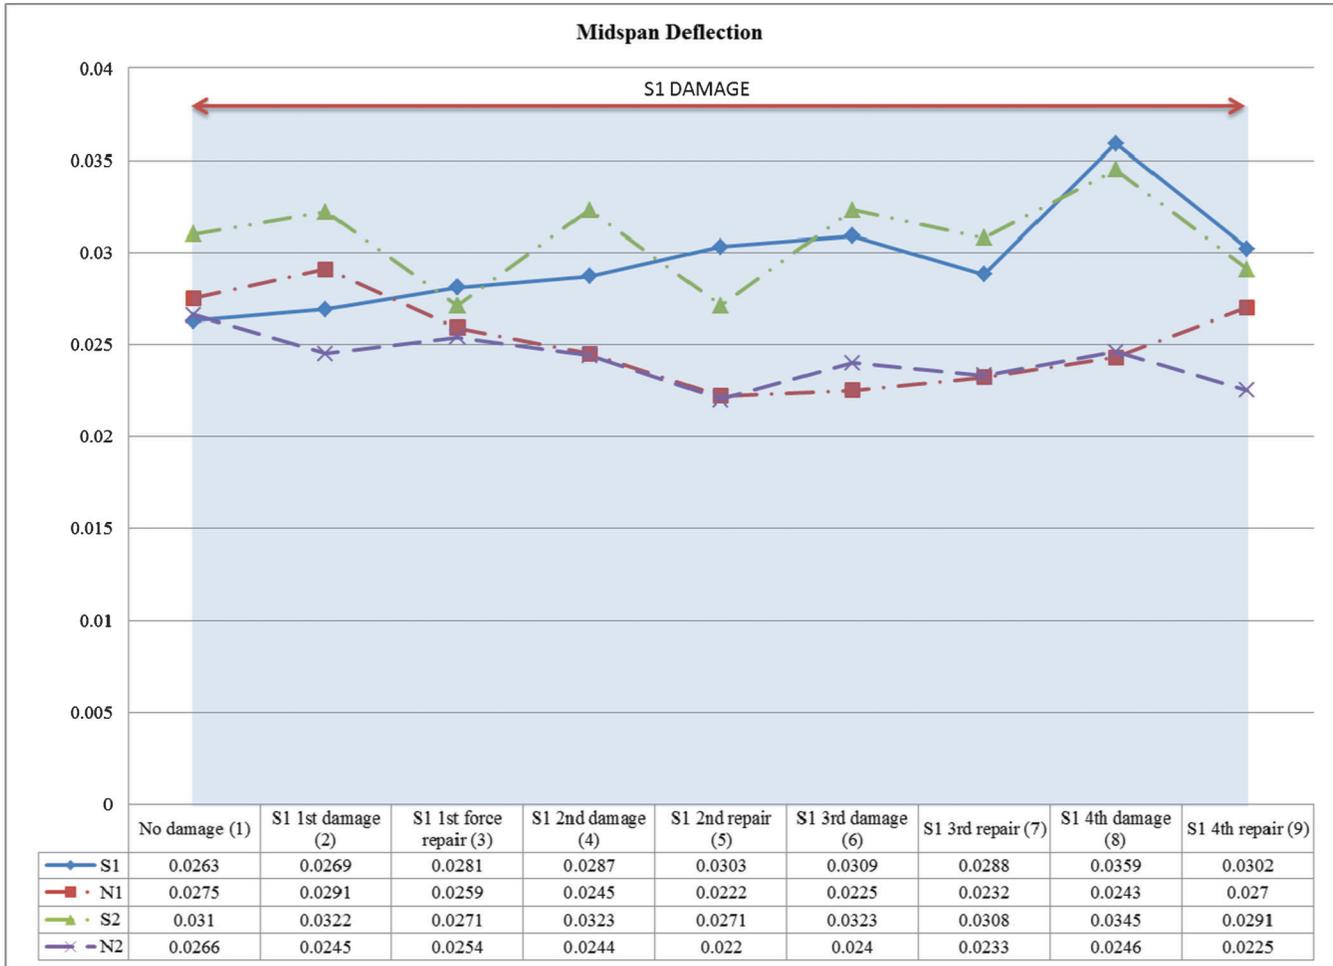
Figure 9.14 Midspan displacements of S1 test.

Figure 9.14 shows the measured maximum midspan deflection values after each damage-repair cycle. All the maximum deflections were within the AASHTO specification deflection limit. The final serviceability deflections of the S1 repair were not changed significantly from the undamaged serviceability deflection.

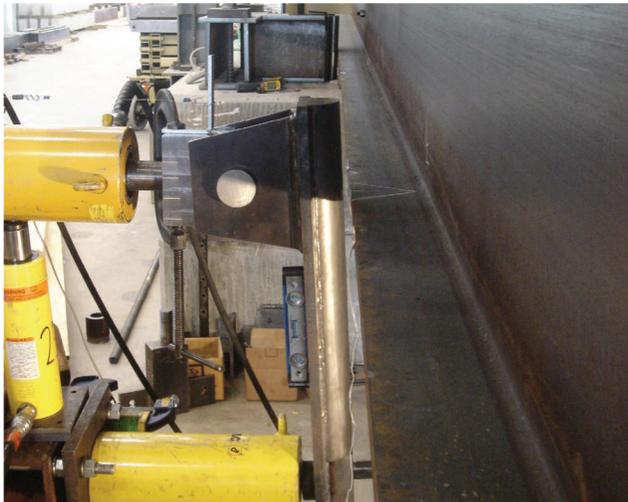
(a) Undamaged S2 specimen

Figure 9.15 shows the photographs of the beam specimen before and after the damage cycle. The beam specimen was damaged by monotonically increasing the concentrated force at the midspan. The damage was monitored by using the longitudinal strain gages. The test was considered complete when the strain gage located at the midspan of the specimen reached $30 \epsilon_y$. The complete strain gage data for the damage cycle is shown in Figure 9.16.

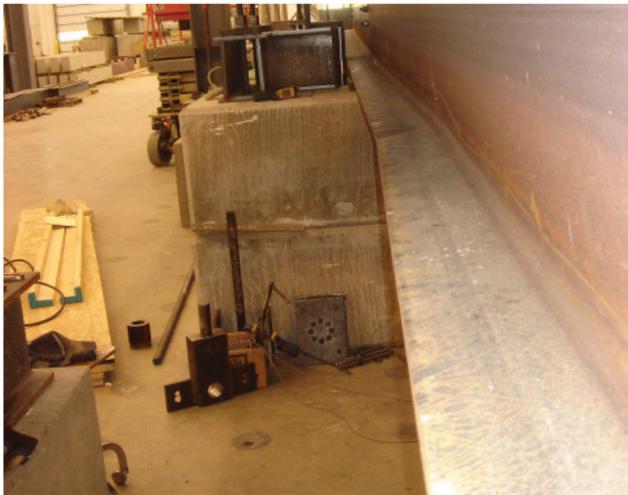
(b) Damaged S2 specimen

Figure 9.15 Photographs of S2 specimen before and after the damage.

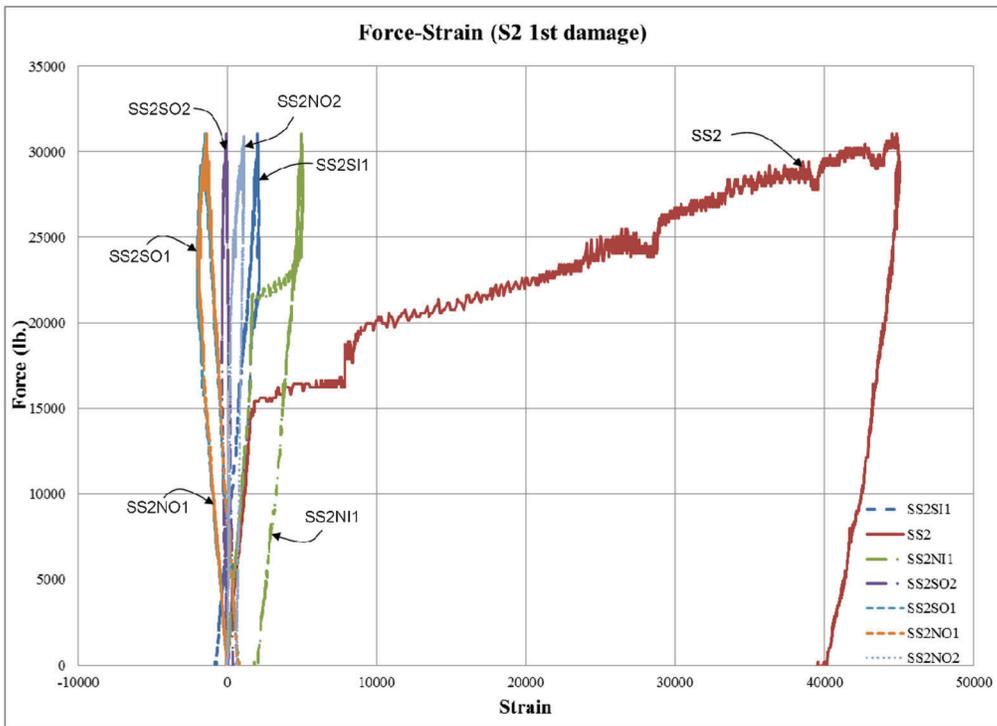
Figure 9.16 Load-strain diagram of S2 specimen.

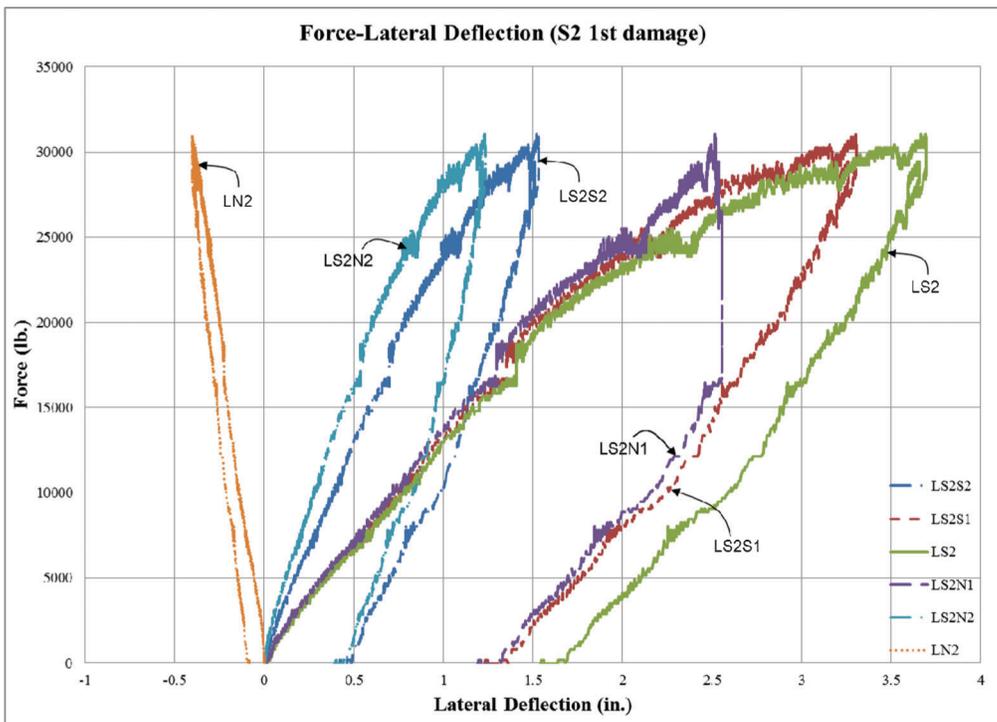
Figure 9.17 Load-displacement diagram of S2 specimen.

P- Δ relationships for the S2 specimen are shown in Figure 9.17. The plastic displacement at the maximum damage was found to be 3.70 in. The final damage displacement after elastic rebound was 1.54 in. (See S-2 Span Damage video: <http://dx.doi.org/10.4231/D34Q7QQ3T>)

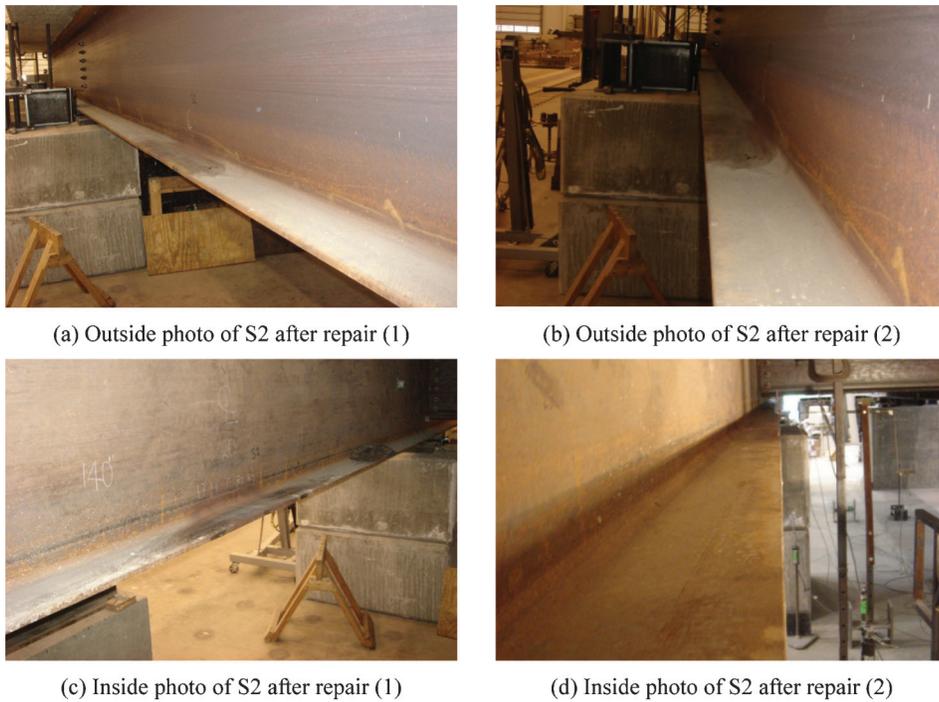
Figure 9.18 Photographs of S2 specimen after the repair process.

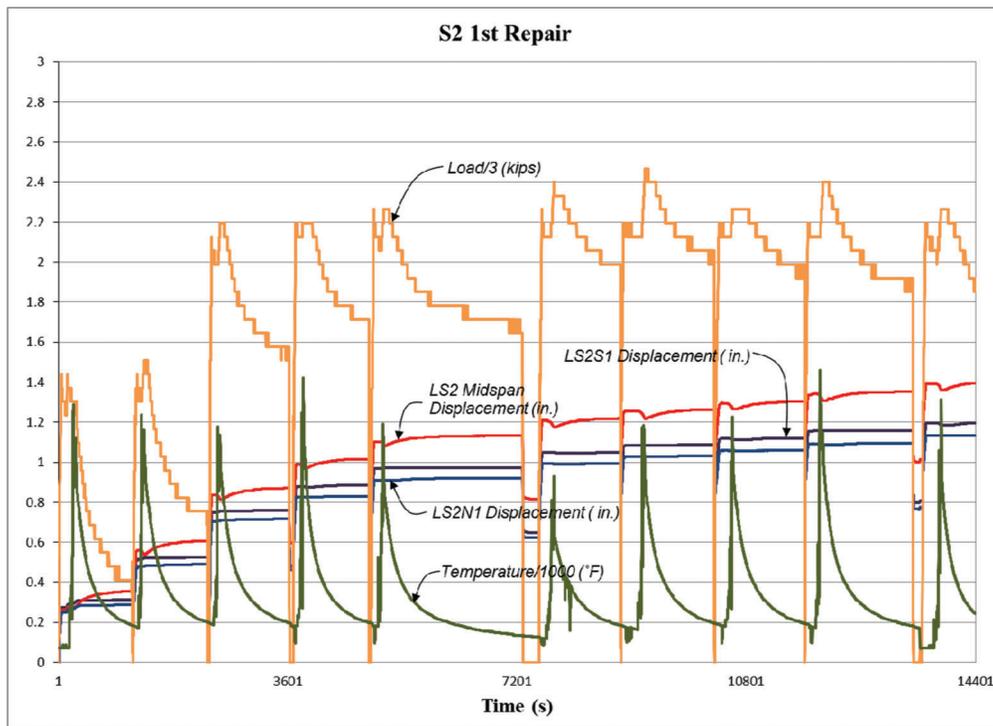
Figure 9.20 Instrument data during the repair cycle of S2 specimen.

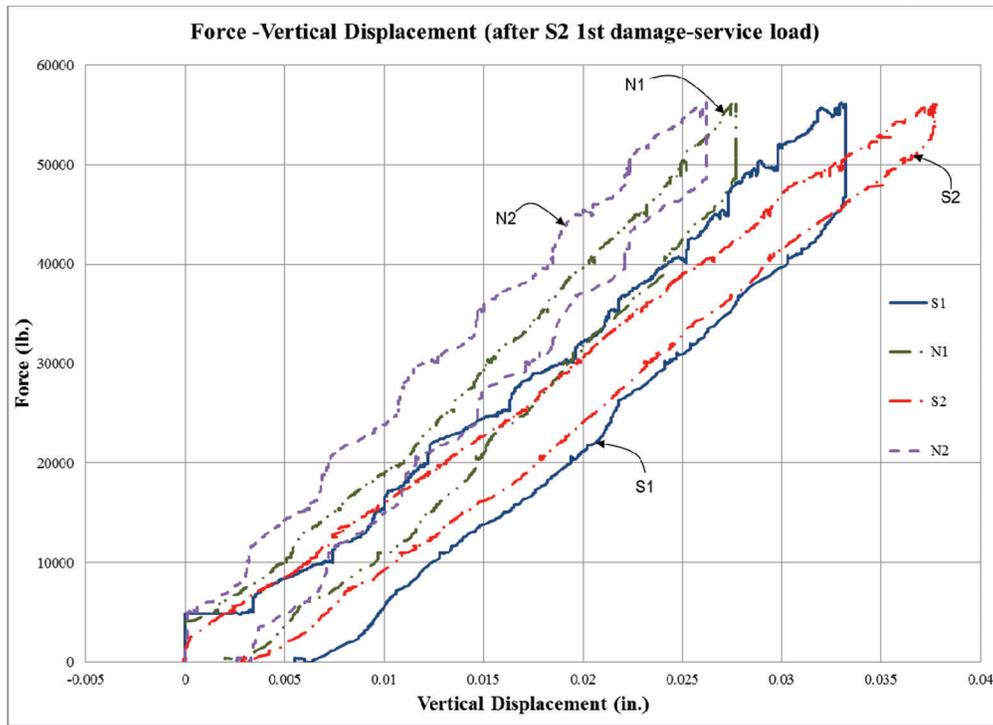
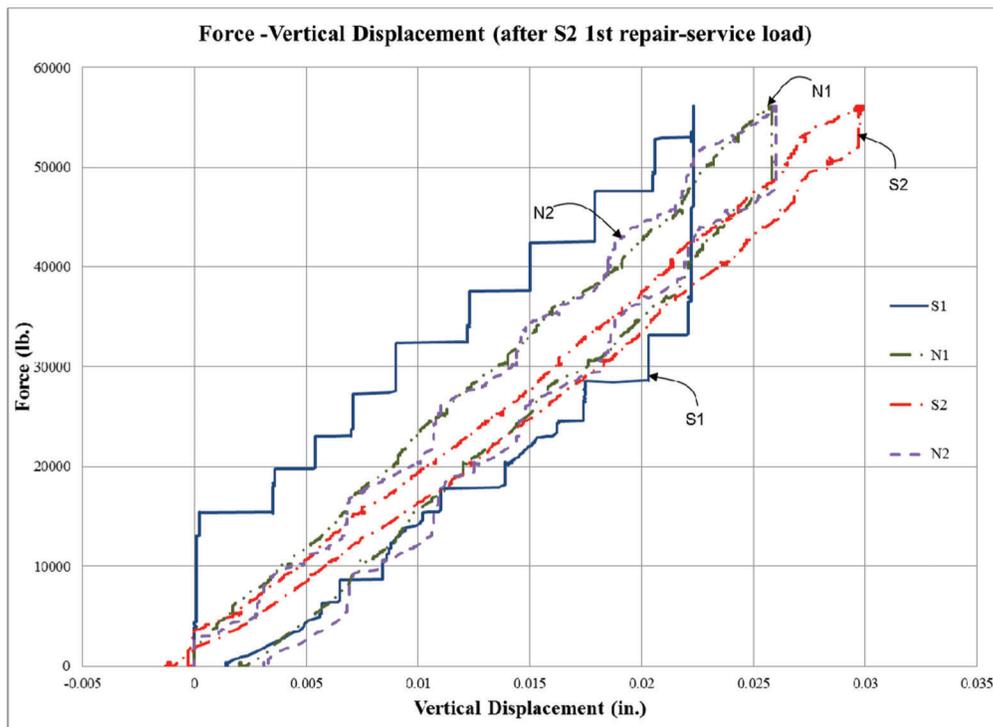
(a) Force-vertical displacement after S2 damage

(b) Force-vertical displacement after S2 repair

Figure 9.21 Service load-vertical displacement behavior of S2 test.

Figure 9.21 shows serviceability behavior of the test bridge after the S2 damage and the S2 repair process. The maximum midspan deflections in all cases were not bigger than 0.035 in. which is much smaller than the AASHTO deflection limit of 0.3 in. or 0.24 in. Therefore, the maximum midspan deflection after the S2 damage-repair process was within the AASHTO specification deflection limit. However, the S1 deflection in Figure 9.21 (b) shows unreliable behavior. It is presumed that an error occurred in the measurement of the S1 displacement transducer at the serviceability test of the S2 repair.

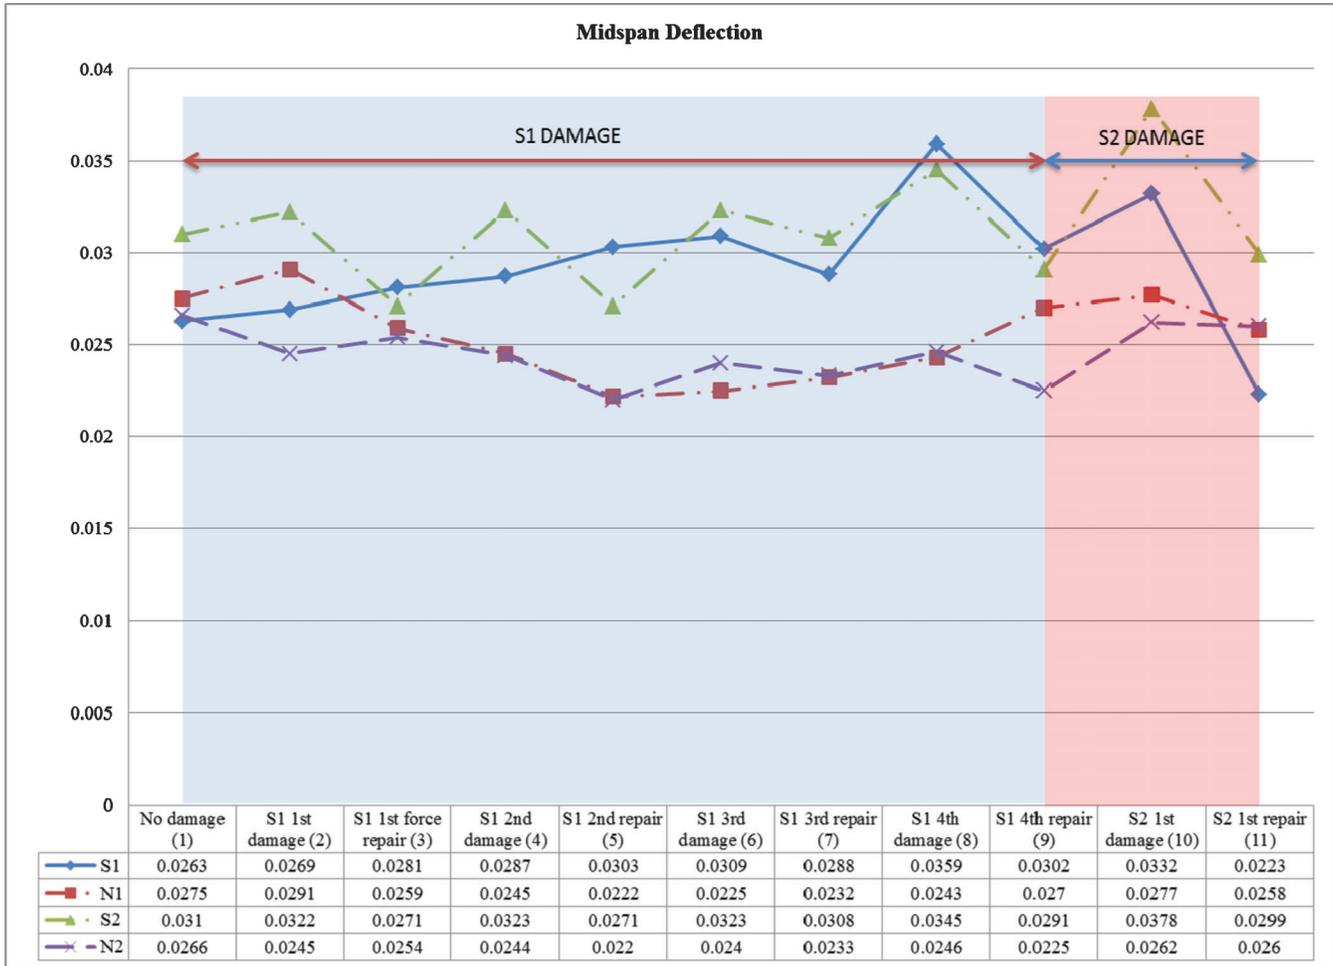
Figure 9.22 Midspan displacements of S1 and S2 test.

Figure 9.22 shows the measured maximum midspan deflection values after each damage-repair cycle. The final serviceability deflections of the S2 repair (except for the S1 deflection) were not changed significantly from the undamaged serviceability deflection.

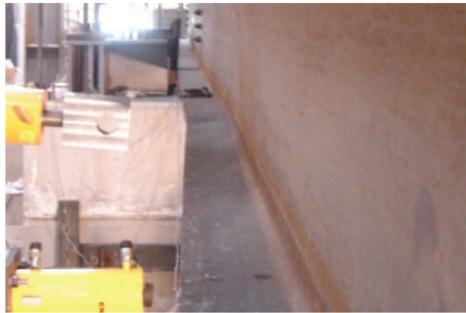
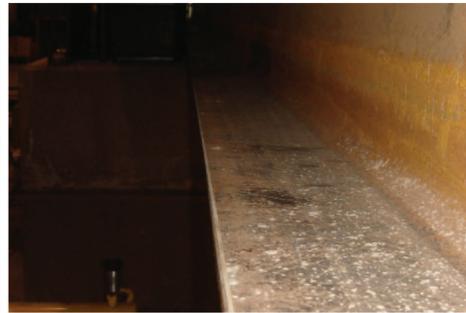
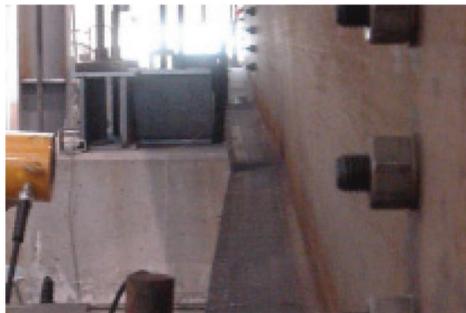
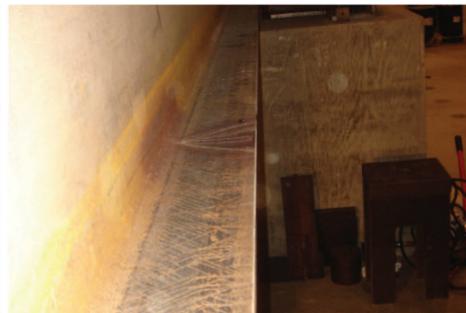
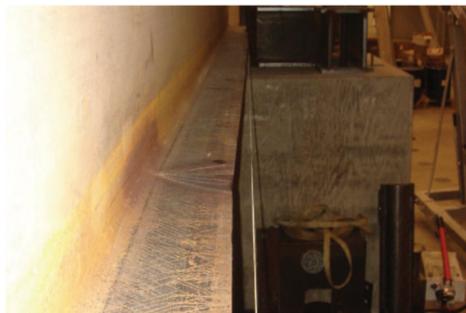
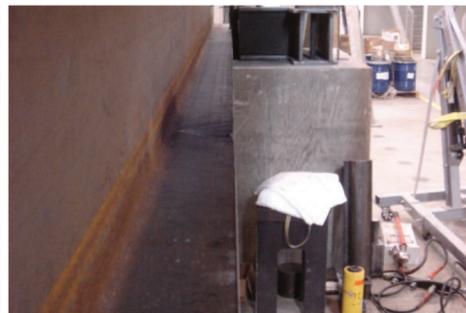
(a) N1 after 1st damage

(b) N1 after 1st repair

(c) N1 after 2nd damage

(d) N1 after 2nd repair

(e) N1 after 3rd damage

(f) N1 after 3rd repair

Figure 9.23 Photographs of N1 specimen before and after the damage.

Several sensors were used to monitor specimen behavior during the first damage procedure of the N1 specimen (3-1200-0.4-30). Strain gages were located at the planned location shown in Section 8.4. After the first damage cycle, all the sensors except for the strain gages were reattached to the test bridge specimen to monitor the behavior of the following cycles. Figure 9.23 shows photographs of the bridge specimen before and after each damage cycle.

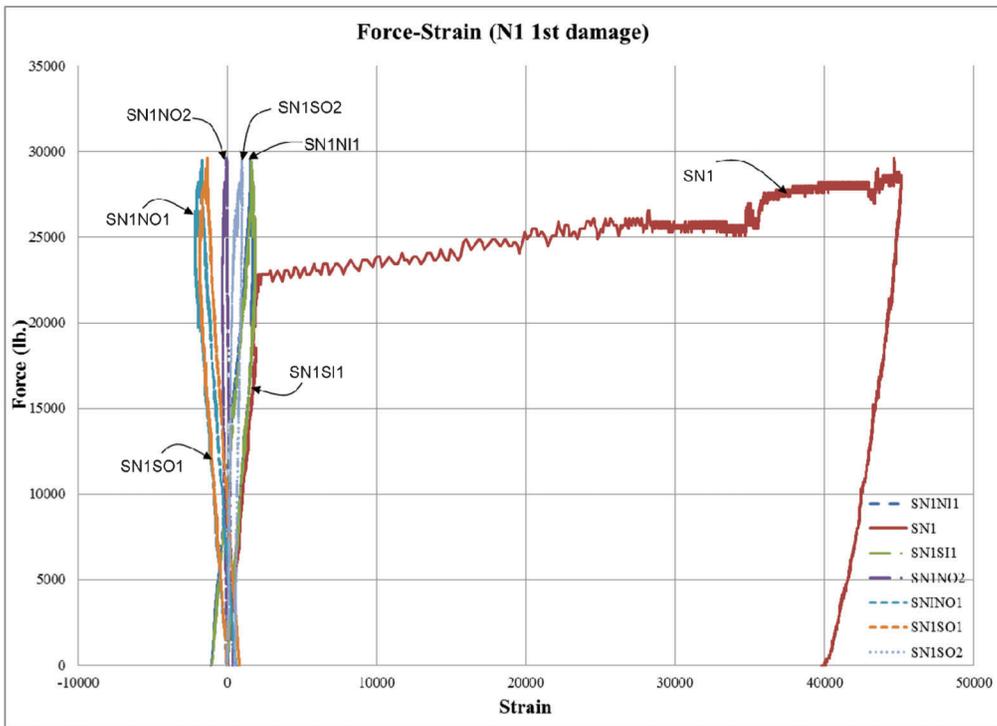
Figure 9.24 Load-strain diagram of N1 specimen.

cycle was measured using the strain gage layout described Section 8.4. The strain gage data from the first damage cycle is provided in Figure 9.24.

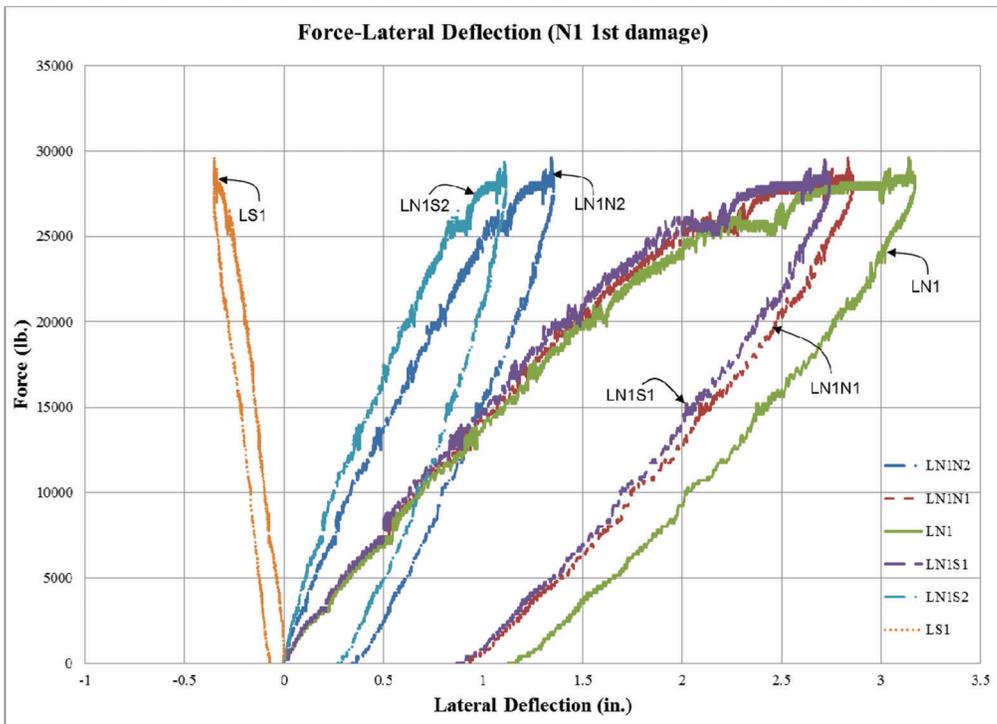
Figure 9.25 Load-displacement diagram of N1 specimen (1st damage).

Damage cycles 2 and 3 were conducted under displacement control, where the displacement at the midspan was monitored and controlled to reach the displacement from the first damage cycle. Figures 9.25–9.27 show the lateral displacement behavior in each damage cycle. The maximum lateral displacement at each damage cycle corresponding to the maximum damage strain of $30 \epsilon_y$ is shown in Table 9.4. The permanent deformations left in the N1 specimen after elastic rebound are also presented in Table 9.4. These permanent deformations were the final damage magnitude to be fixed by the heat straightening process.

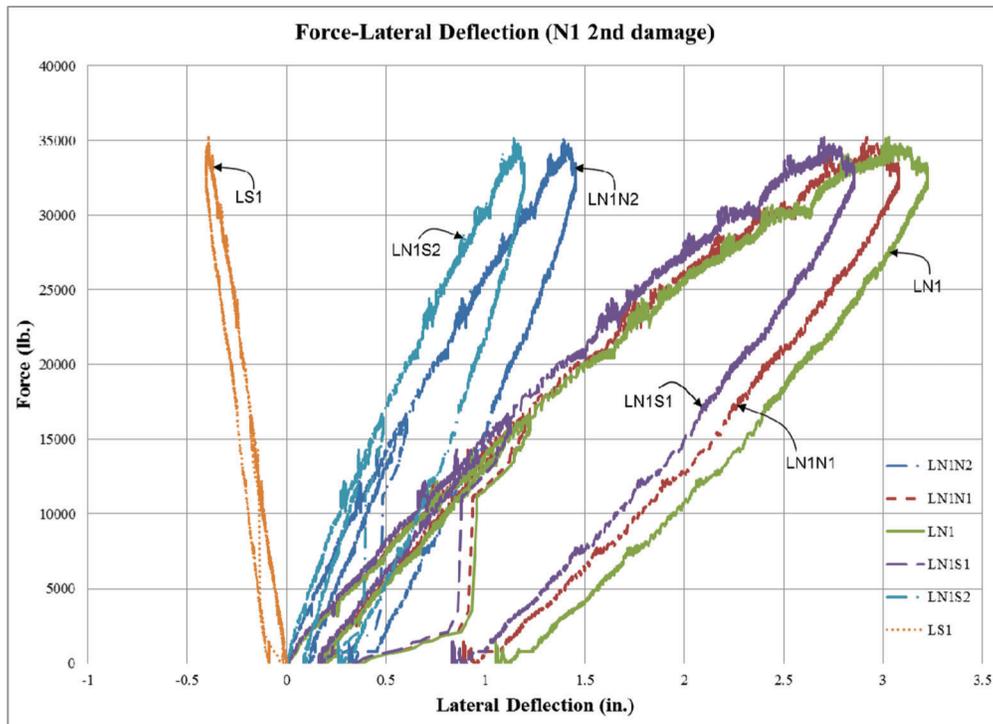
Figure 9.26 Load-displacement diagram of N1 specimen (2nd damage).

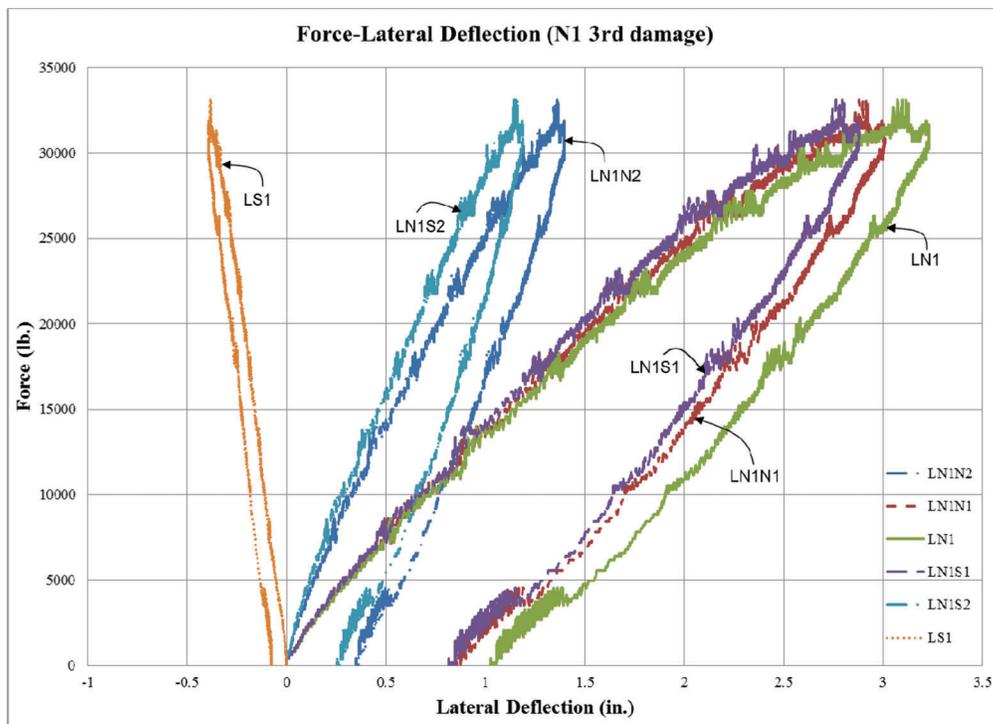
Figure 9.27 Load-displacement diagram of N1 specimen (3rd damage).

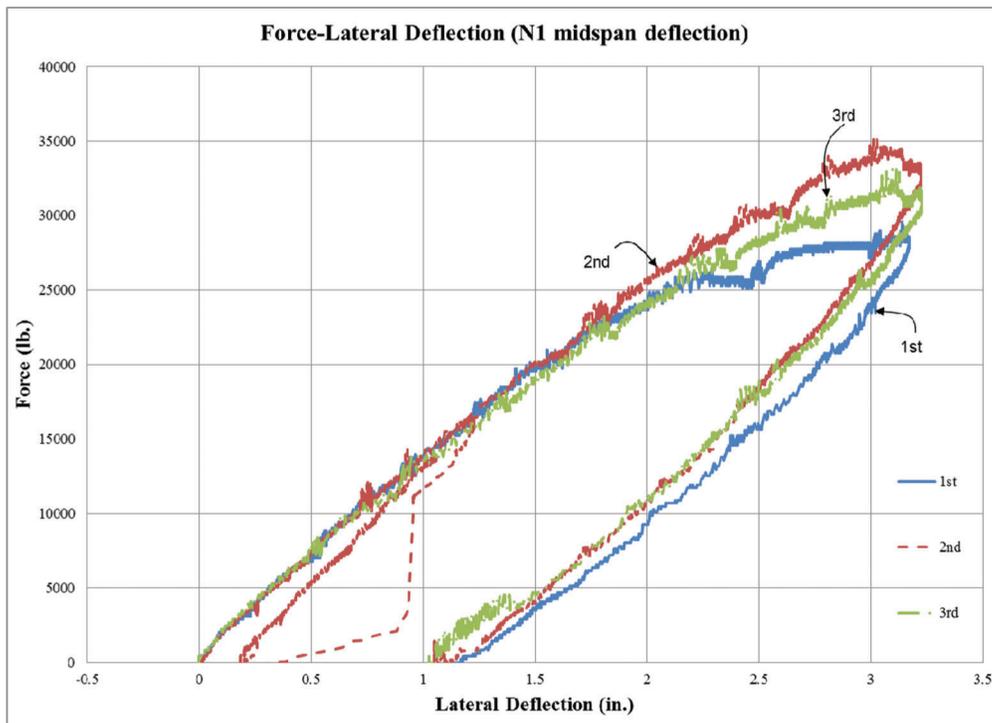
Figure 9.28 Midspan load-displacement diagram of N1 specimen (all damages).

Figure 9.28 compares the P- Δ behavior of all three damage cycles of the N1 specimen. All three graphs in Figure 9.28 show similar P- Δ behavior in all damage cycles. Therefore, the stiffness of the N1 specimen in

each damage-repair cycle was not affected too much by the damage-repair process. (See N-1 Span Damage video: <http://dx.doi.org/10.4231/D3W66984S>)

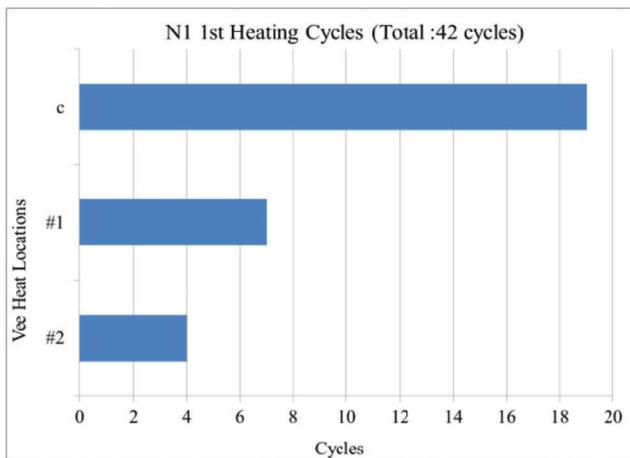
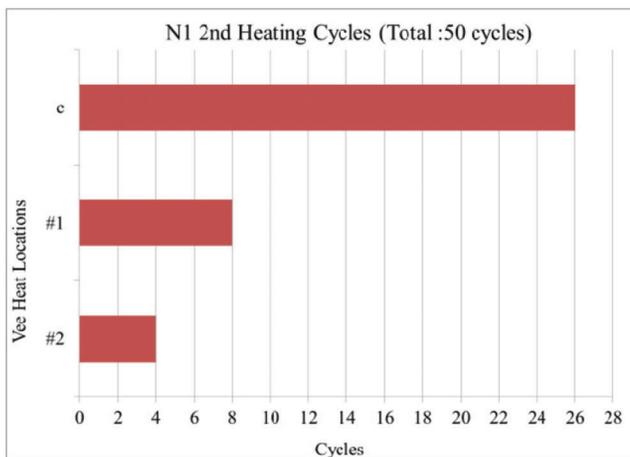
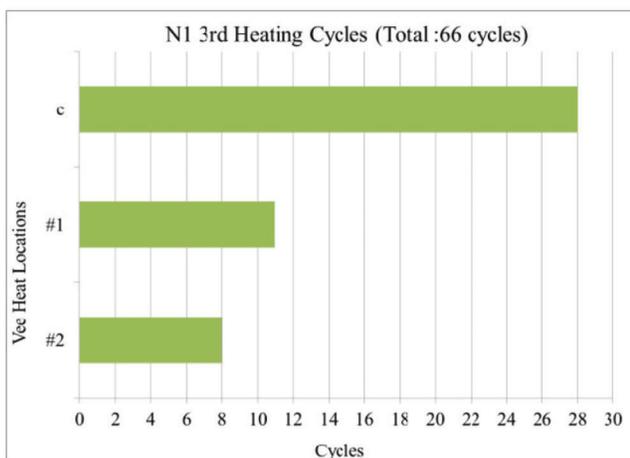
(a) Vee heat frequency of 1st repair cycle

(b) Vee heat frequency of 2nd repair cycle

(c) Vee heat frequency of 3rd repair cycle

Figure 9.29 Vee heat frequency chart of N1 specimen.

The total numbers of Vee heats required to straighten the specimen in each damage-repair cycle are shown in Figure 9.29. Forty-two Vee heats on the bottom flange were required to complete the first repair cycle. The second repair cycle took 50 Vee heats to complete. The third repair cycle needed 66 Vee heats to complete. The required numbers of Vee heats to fully straighten the specimen were increased following multiple damage cycles.

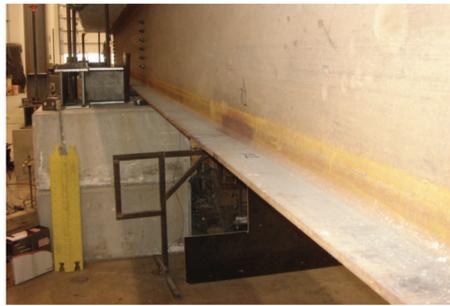
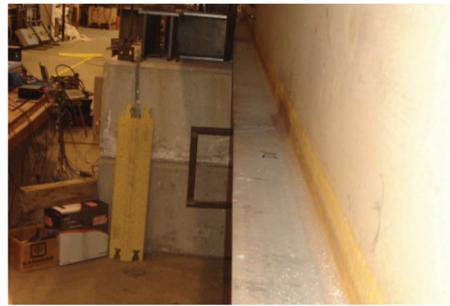
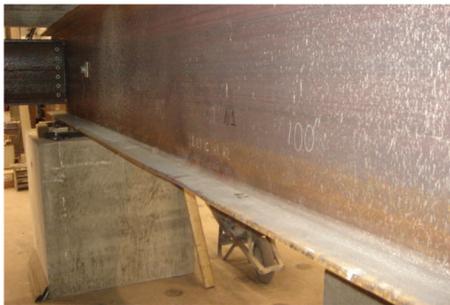
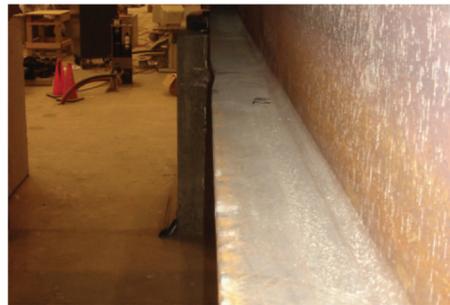
(a) Outside photo of N1 after repair (1)

(b) Outside photo of N1 after repair (2)

(c) Inside photo of N1 after repair (1)

(d) Inside photo of N1 after repair (2)

Figure 9.30 Photographs of N1 specimen after all repair processes.

The final photographs of the S1 specimen after all repair cycles are shown in Figure 9.30. As seen in Figure 9.30, the specimen was fully straightened after all repair processes. The surface of the repaired region was ground smoothly to deter undesired stress concentrations.

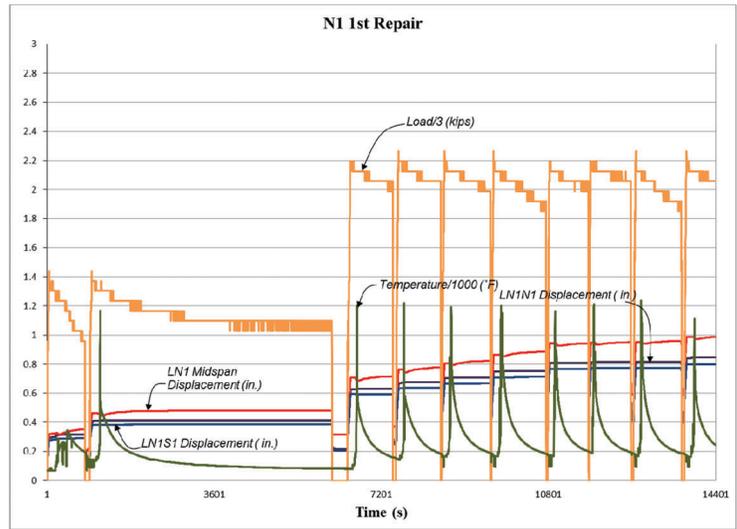
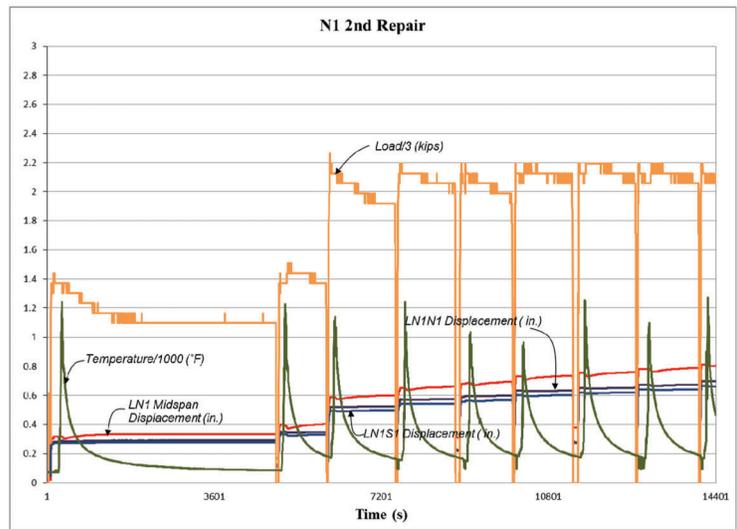
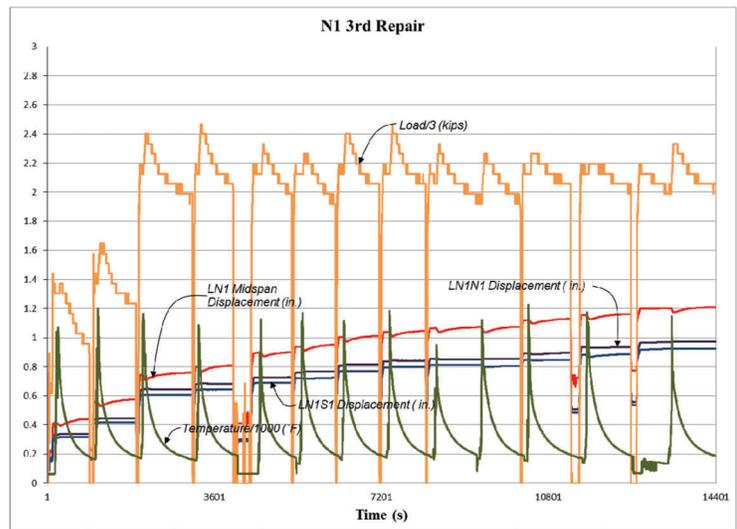
(a) 1st repair cycle

(b) 2nd repair cycle

(c) 3rd repair cycle

Figure 9.31 Instrument data during repair cycles of N1 specimen.

Figure 9.31 shows the behavior of the S1 specimen in the initial several steps of each repair cycle. These figures include: (a) the displacements from three inside displacement transducers in inches, (b) the restraining force in the hydraulic actuator in kips, which is divided by 3 (i.e., 1.0 on the graph shows 3 kips of force), and (c) the temperature of the steel in $^\circ\text{F}$, which is divided by 1000 $^\circ\text{F}$ (i.e., 1.0 on the graph corresponds to 1000 $^\circ\text{F}$).

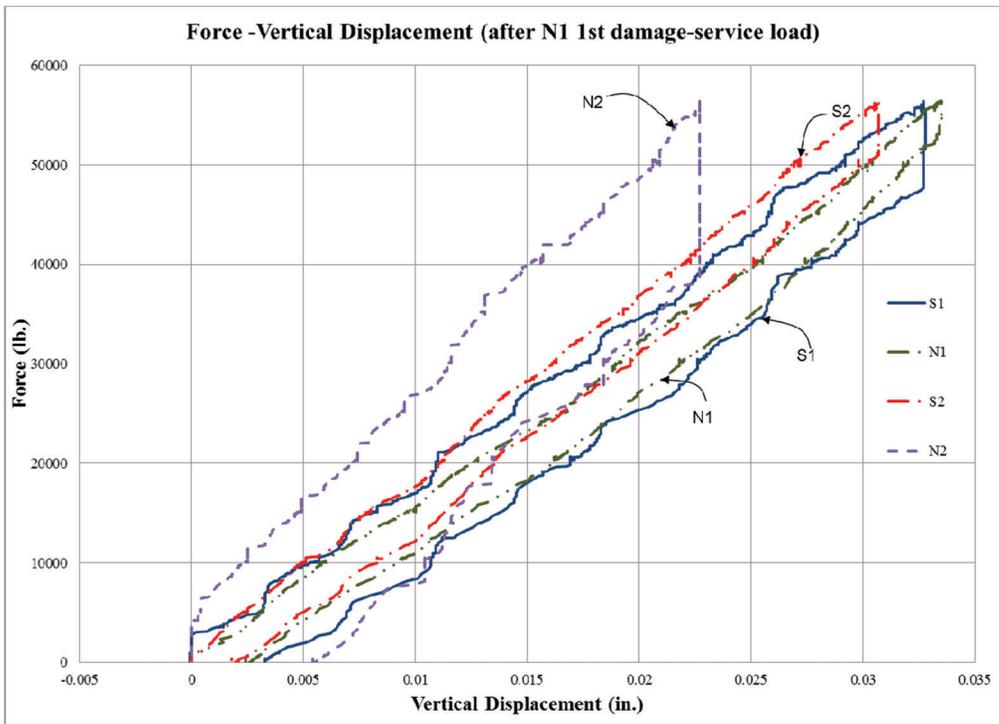
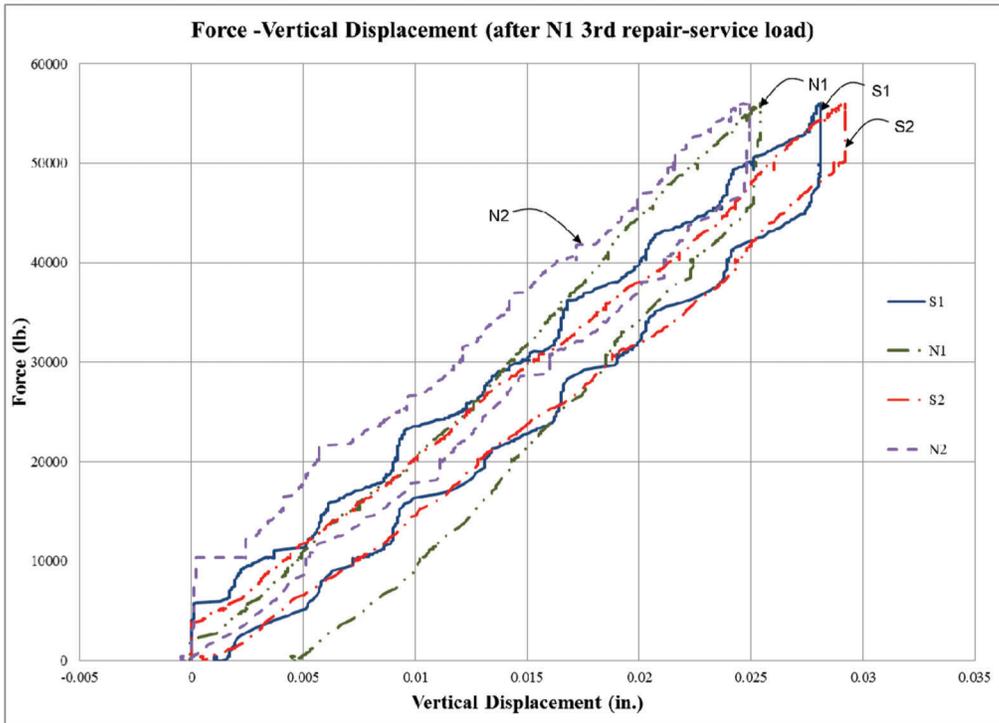
(a) Force-vertical displacement after N1 1st damage

(b) Force-vertical displacement after N1 3rd repair

Figure 9.32 Service load-vertical displacement behavior of N1 test.

Figure 9.32 shows the serviceability behavior of the test bridge after the N1 1st damage and the N1 3rd

repair process. The maximum midspan deflections in all cases were not bigger than 0.035 in. which is much smaller than the AASHTO deflection limit of 0.3 in. or 0.24 in. Therefore, the maximum midspan deflection

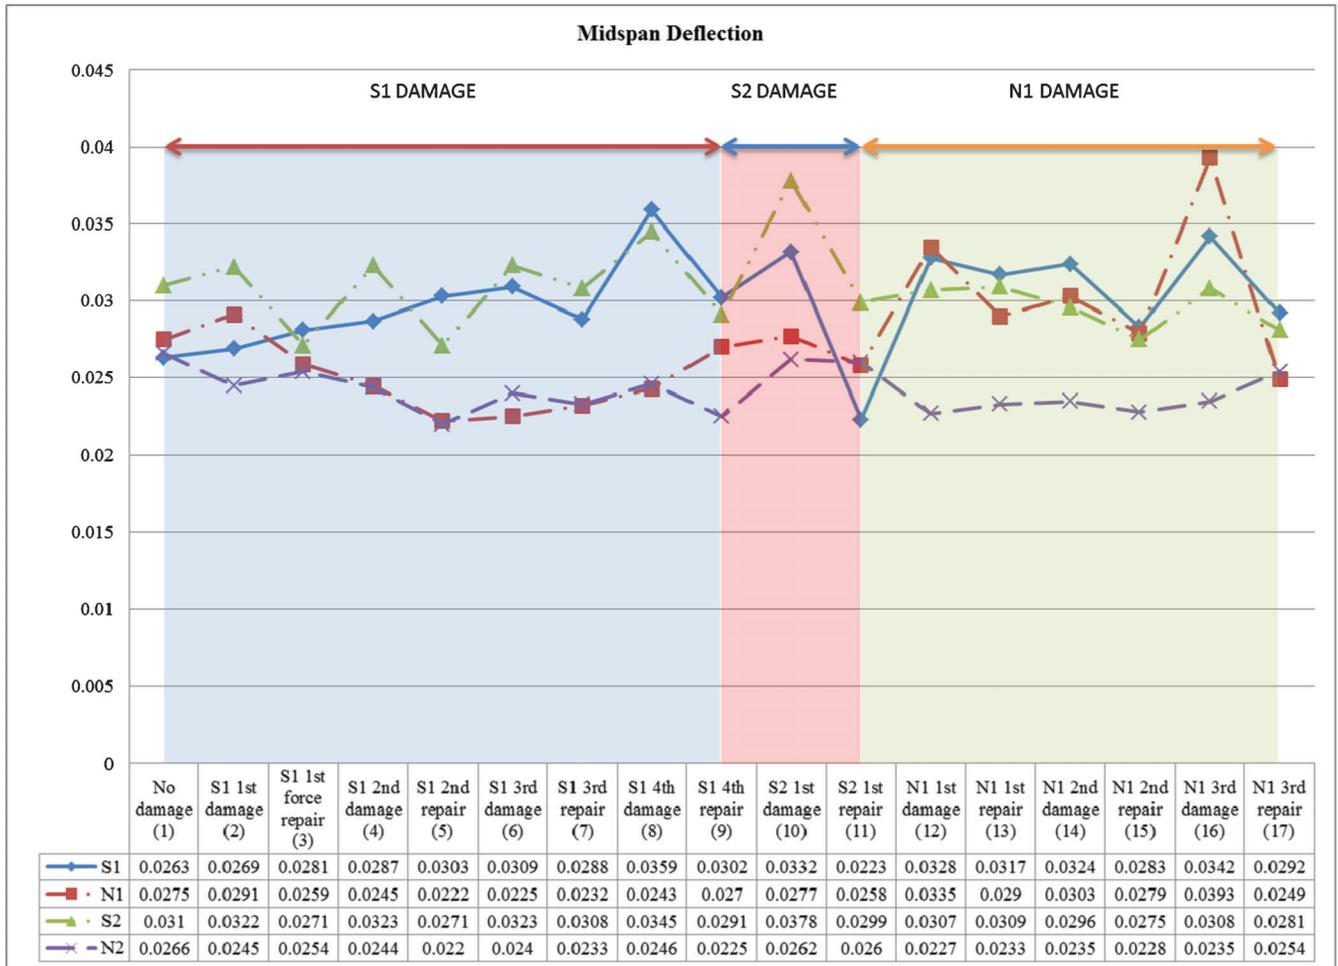
Figure 9.33 Midspan displacements of S1, S2, and N1 test.

Figure 9.33 shows the measured maximum midspan deflection values after each damage-repair cycle. The final serviceability deflections of N1 repair were not changed significantly from the undamaged serviceability deflection.

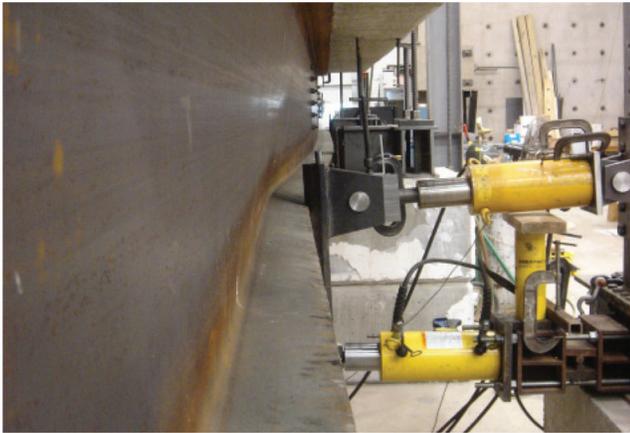
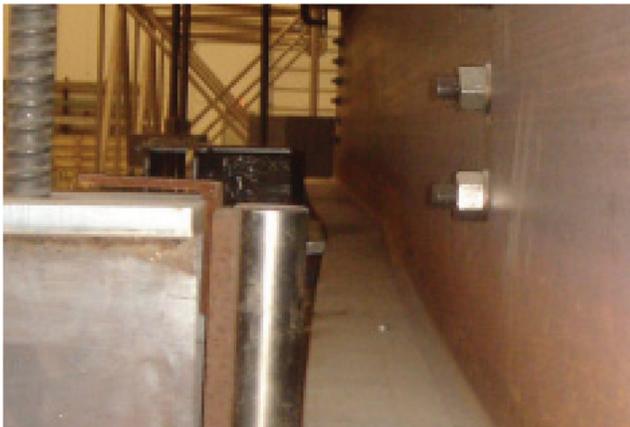
(a) Damage application of N2 specimen

(b) Damaged N2 specimen

Figure 9.34 Damage photographs of N2 specimen (1-800-0.6-30).

Figure 9.34 shows the photographs of the beam specimen during the damage cycle. The beam specimen was damaged by monotonically increasing the concentrated force at the midspan. The damage was monitored using the longitudinal strain gages. The test was considered complete when the strain gage located at the midspan of the specimen reached $30 \epsilon_y$. The complete strain gage data for the damage cycle is shown in Figure 9.35.

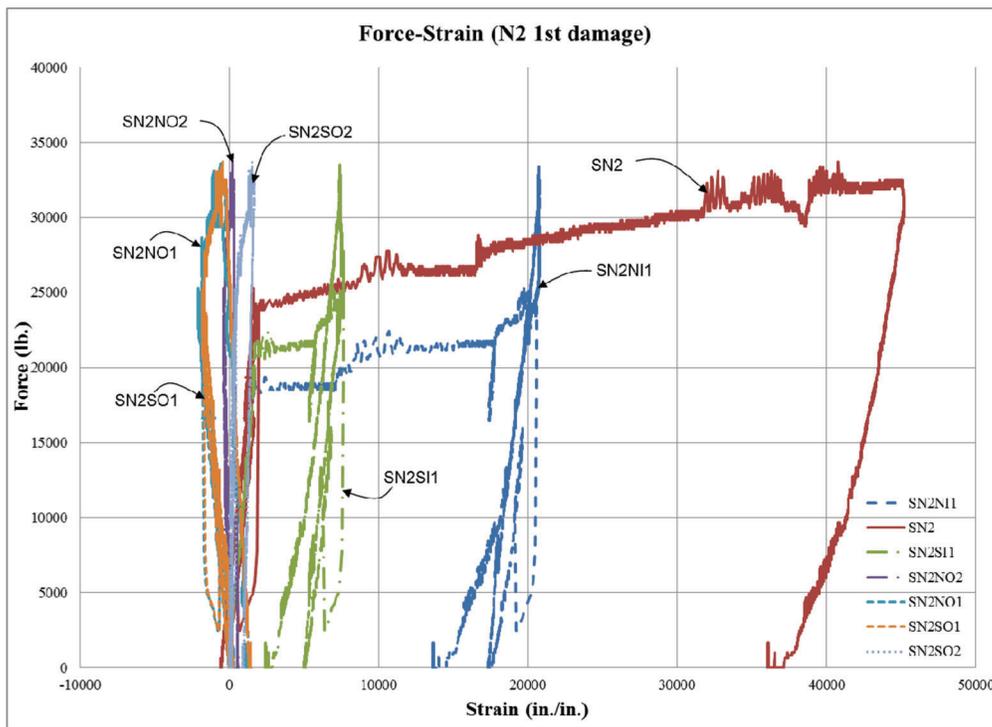
Figure 9.35 Load-strain diagram of N2 specimen.
