Effects of Realistic Heat Straightening Repair on the Properties and Serviceability of Damaged Steel Beam Bridges

JOINT TRANSPORTATION RESEARCH PROGRAM

INDIANA DEPARTMENT OF TRANSPORTATION
AND PURDUE UNIVERSITY

1. Report No. FHWA/IN/JTRP-2013/03	2. Government Accession No.	3. Recipient's Catalog No.	
4. Title and Subtitle Effects of Realistic Heat Straightening Repair on the Properties and Serviceability of Damaged Steel Beam Bridges		5. Report Date February 2012

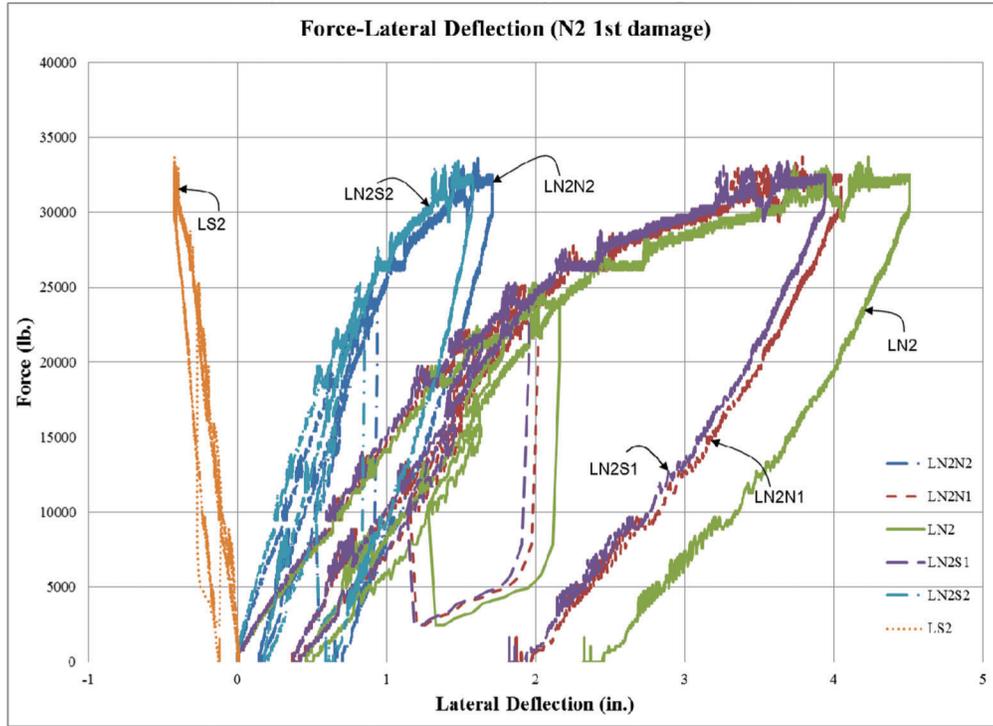
Figure 9.36 Load-displacement diagram of N2 specimen.

P- Δ relationships for the N2 specimen are shown in Figure 9.36. The plastic displacement at the maximum damage was found to be 4.51 in. The final damage displacement after elastic rebound was 2.32 in. (See N-2 Span Damage video: <http://dx.doi.org/10.4231/D38G8FH7Z>)

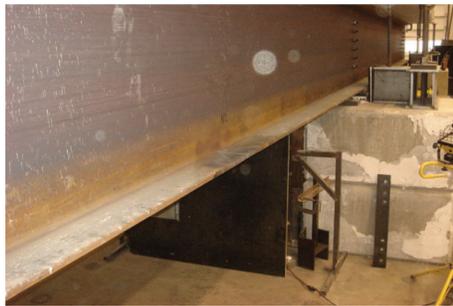
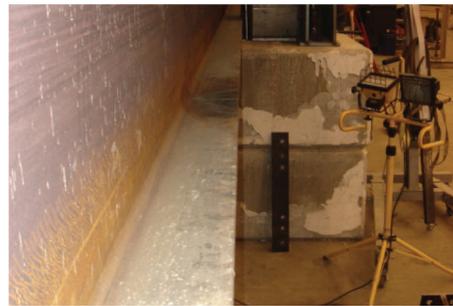
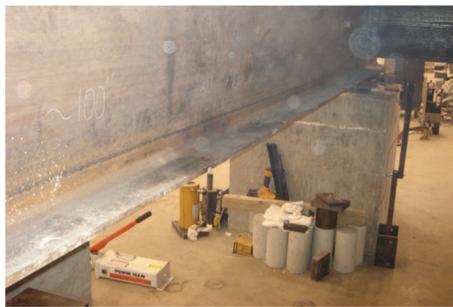
(a) Outside photo of N2 after repair (1)

(b) Outside photo of N2 after repair (2)

(c) Inside photo of N2 after repair (1)

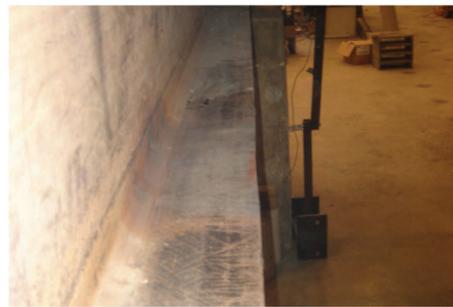
(d) Inside photo of N2 after repair (2)

Figure 9.37 Photographs of N2 specimen after the repair process.

Four hundred and ten Vee heats were required to complete the repair cycle of the N2 specimen. The photographs of the repaired beam are shown in Figure 9.37. The surface of the repaired region was ground smoothly to deter undesired stress concentrations. The specimen straightness was confirmed by the tout line method which used a tout line to measure the gap distance from the specimen to the tout line. The frequency chart indicating the amount of Vee heats applied to each Vee location is shown in Figure 9.38.

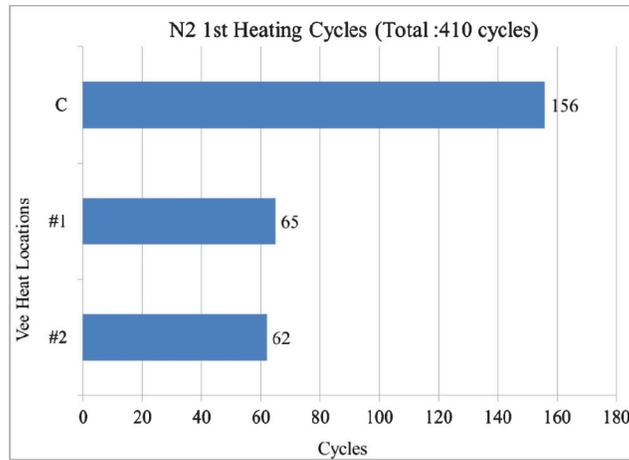
Figure 9.38 Vee heat frequency chart of N2 specimen.

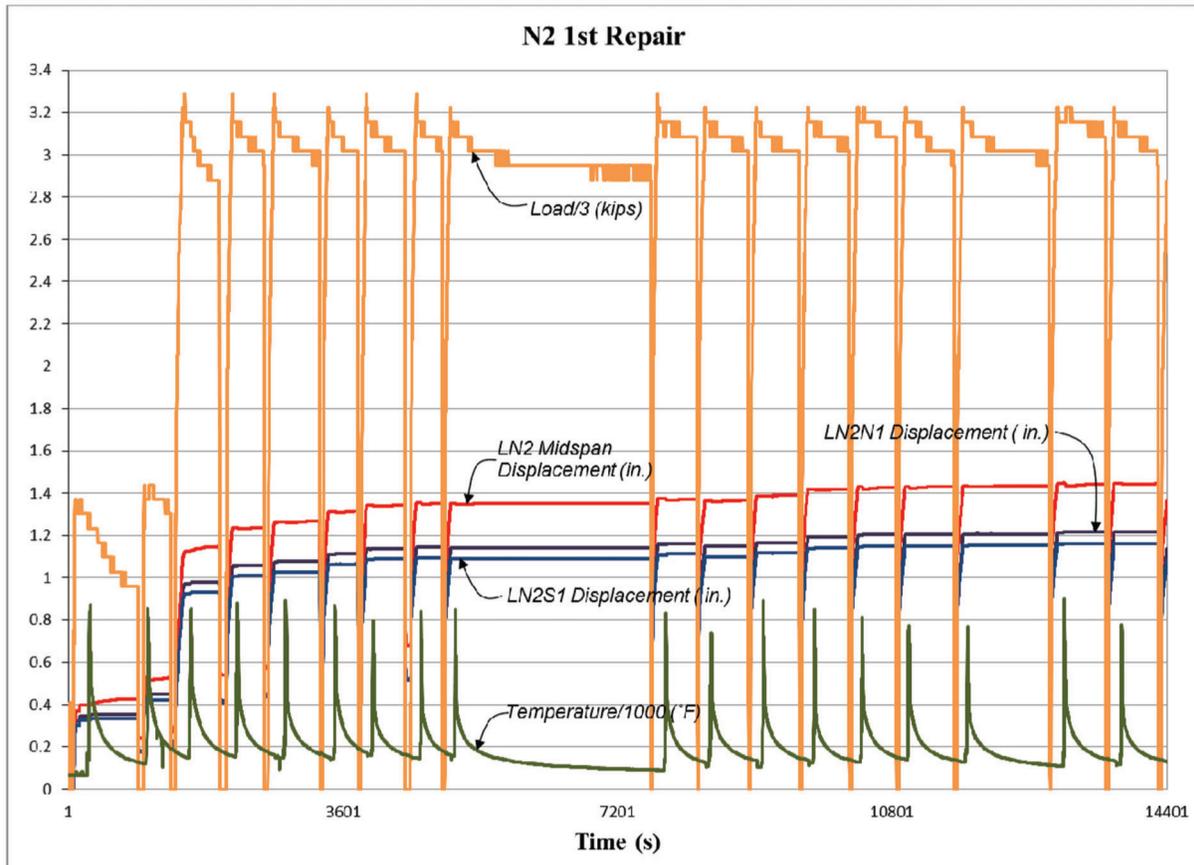
Figure 9.39 Instrument data during the repair cycle of N2 specimen.

Figure 9.39 shows the behavior of the N2 specimen in the initial several steps of the repair cycle. This figure includes: (a) the displacements from three inside displacement transducers in inches, (b) the restraining force in the hydraulic actuator in kips, which is divided by 3 (i.e., 1.0 on the graph shows 3 kips of force), and (c) the temperature of the steel in °F, which is divided by 1000 °F (i.e., 1.0 on the graph corresponds to 1000 °F).

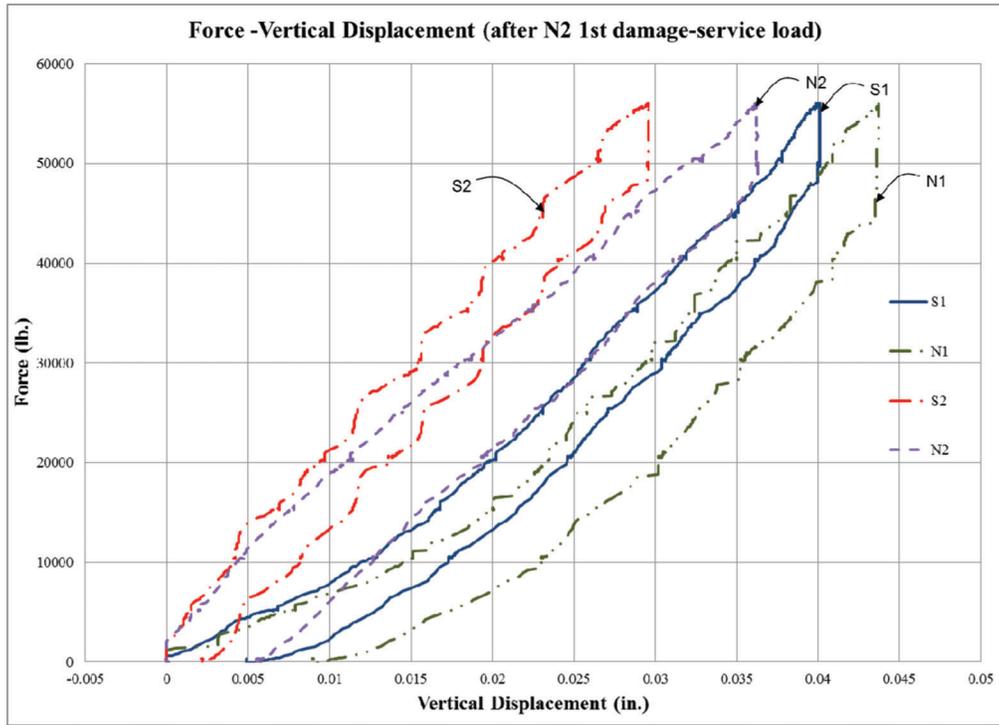
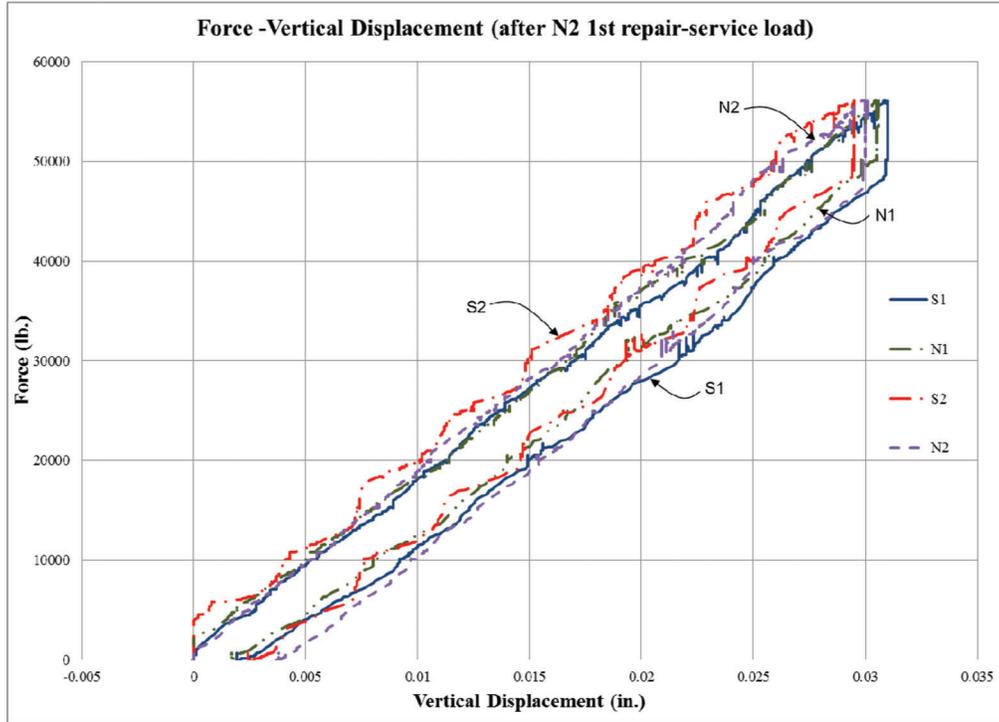
(a) Force-vertical displacement after N2 damage

(b) Force-vertical displacement after N2 repair

Figure 9.40 Service load-vertical displacement behavior of N2 test.

Figure 9.40 shows the serviceability behavior of the test bridge after the N2 damage and the N2 repair process. The maximum midspan deflections in all cases were not bigger than 0.045 in. which is much smaller than the AASHTO deflection limit of 0.3 in. or 0.24 in. Therefore, the maximum midspan deflection after the N2 damage-repair process was within the AASHTO specification deflection limit.

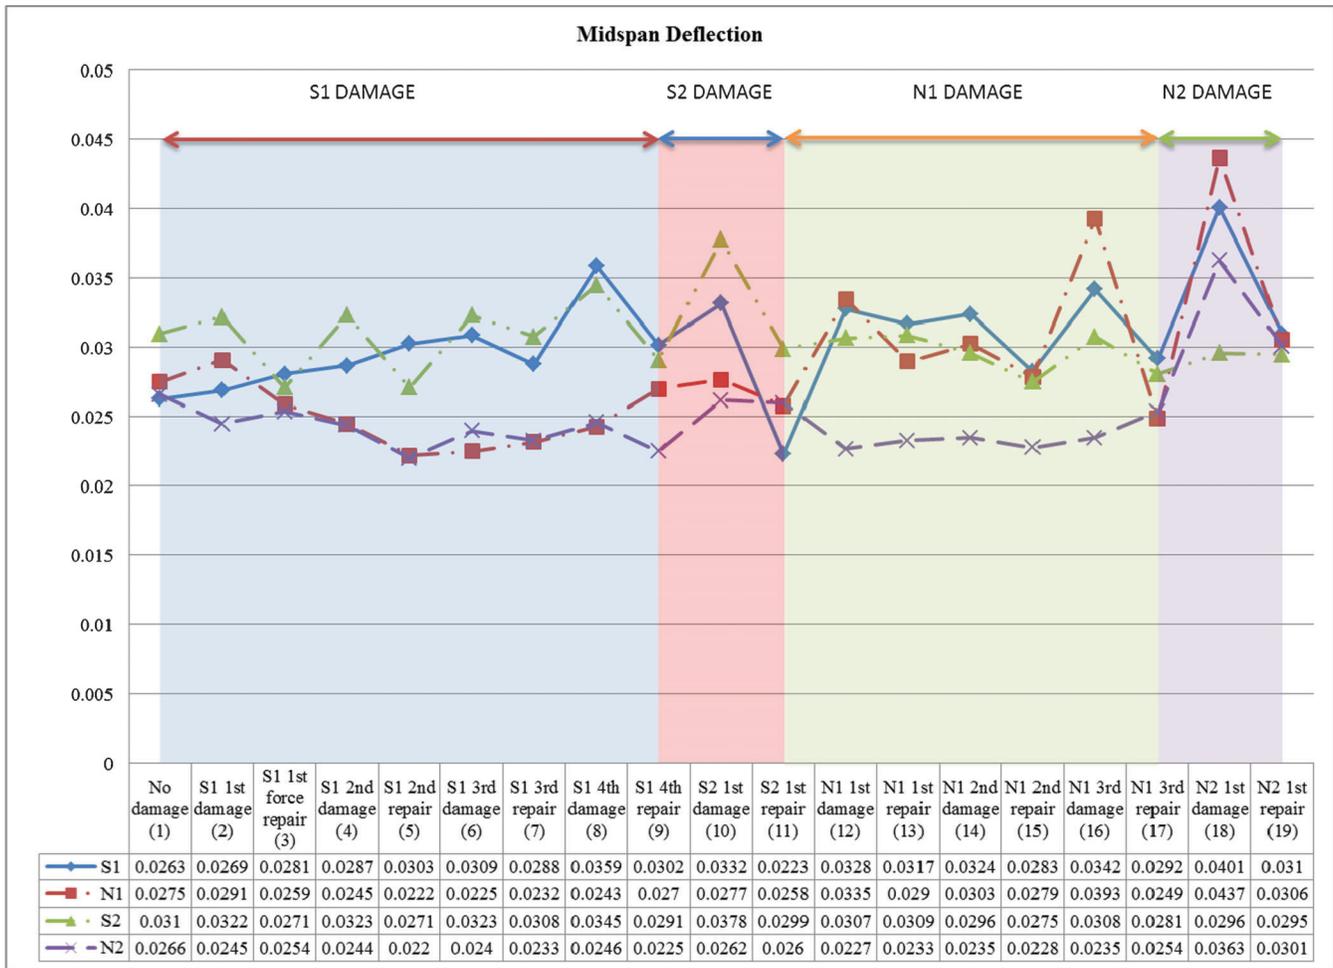
Figure 9.41 Midspan displacements of S1, S2, N1, and N2 test

Figure 9.41 shows the measured maximum midspan deflection values after each damage-repair cycle. The final serviceability deflections of the N2 repair were not changed significantly from the undamaged serviceability deflection.

Vertical deflections at the midspan of all specimens were measured and compared to evaluate the difference of the serviceability performance at each test procedure. The midspan vertical deflections for all specimens are presented in Figure 9.41.

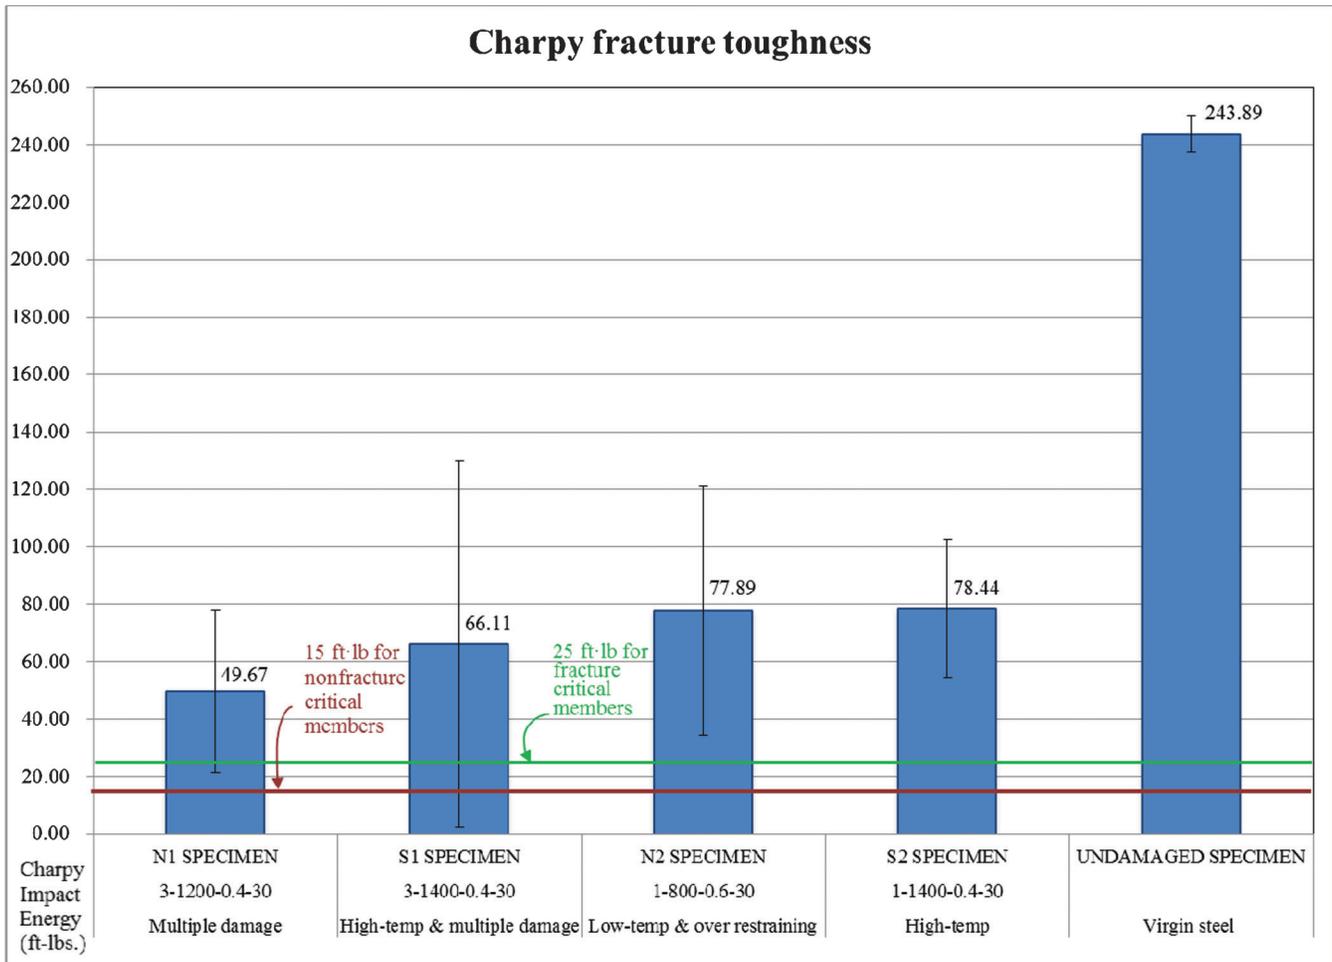
Figure 10.1 Charpy fracture toughness of large scale specimens.

Figure 10.1 shows the average Charpy fracture toughness test results of all specimens with standard deviation error bars. The results are shown in the order of the magnitude of fracture toughness values. The AASHTO requirements for Zone 2 fracture critical (25 ft·lb @ 40 °F) and nonfracture critical members (15

ft-lb @ 40 °F) are also shown in Figure 10.1. Figure 10.2 shows the normalized fracture toughness of the Charpy specimens from the damaged-repaired beams. As seen in the graph, the N1 specimen shows the lowest average Charpy fracture toughness values.

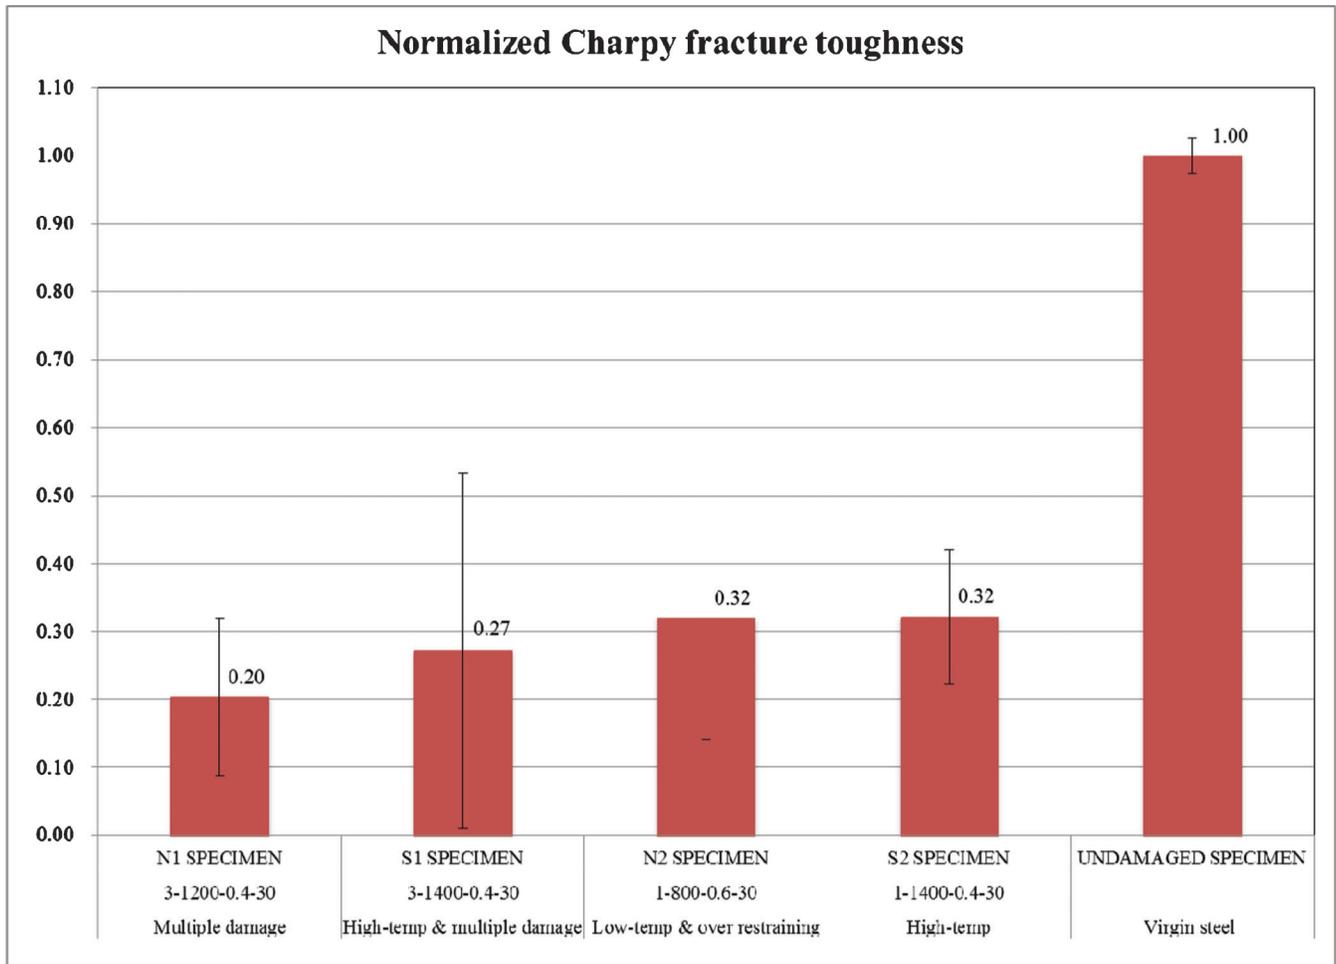
Figure 10.2 Normalized Charpy fracture toughness of large scale specimens.

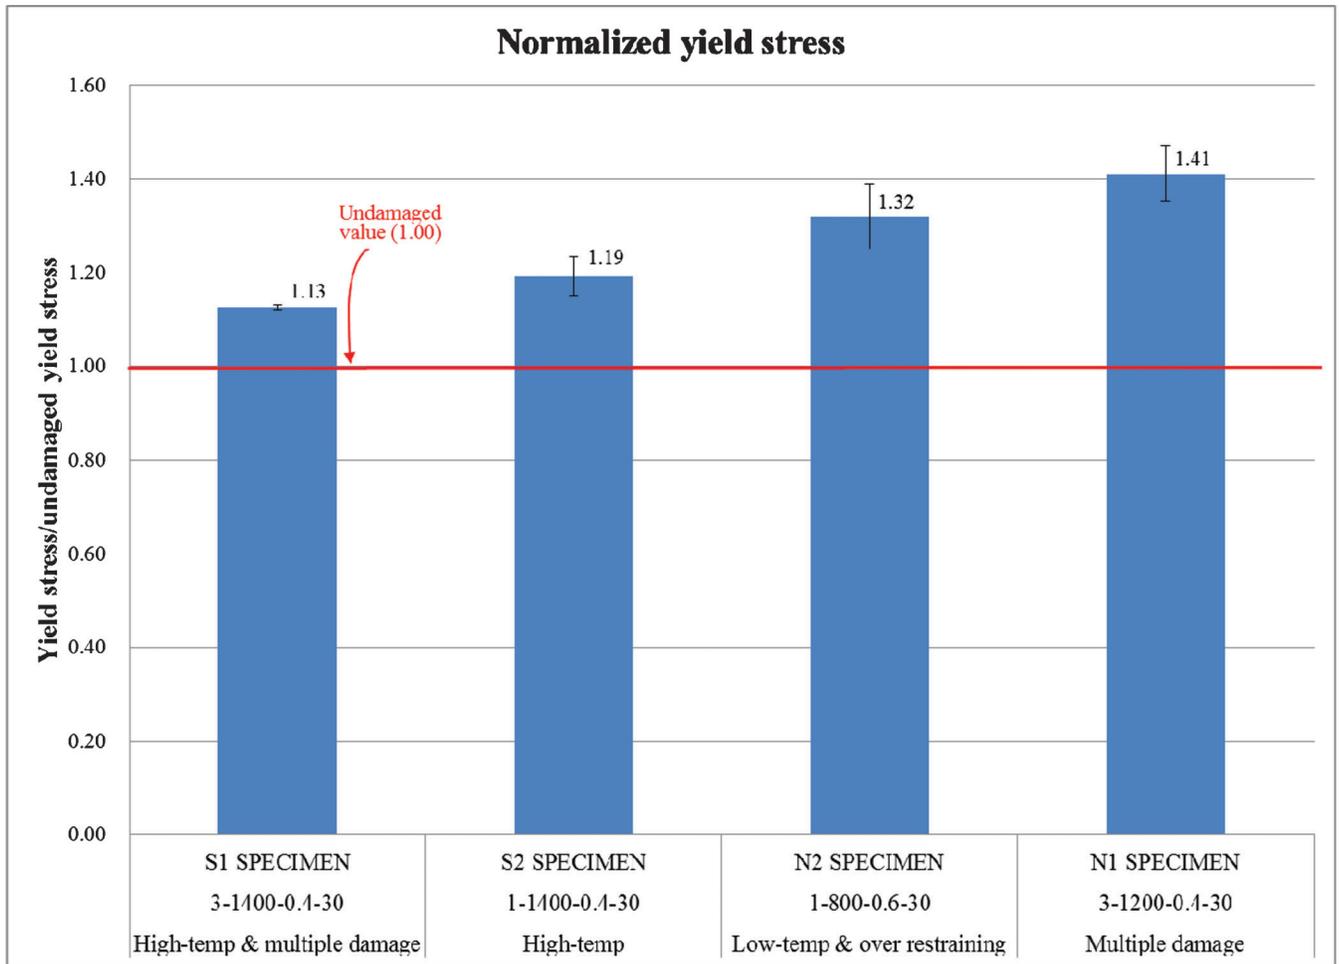
Figure 10.3 Normalized yield stresses of large scale specimens.

Figures 10.3–10.6 show the normalized steel material properties (σ_y , σ_t , % elongation, and reduction in area) with respect to the corresponding undamaged steel material properties. Standard deviation error bars are also shown in Figures 10.3, 10.4, 10.5, and 10.6.

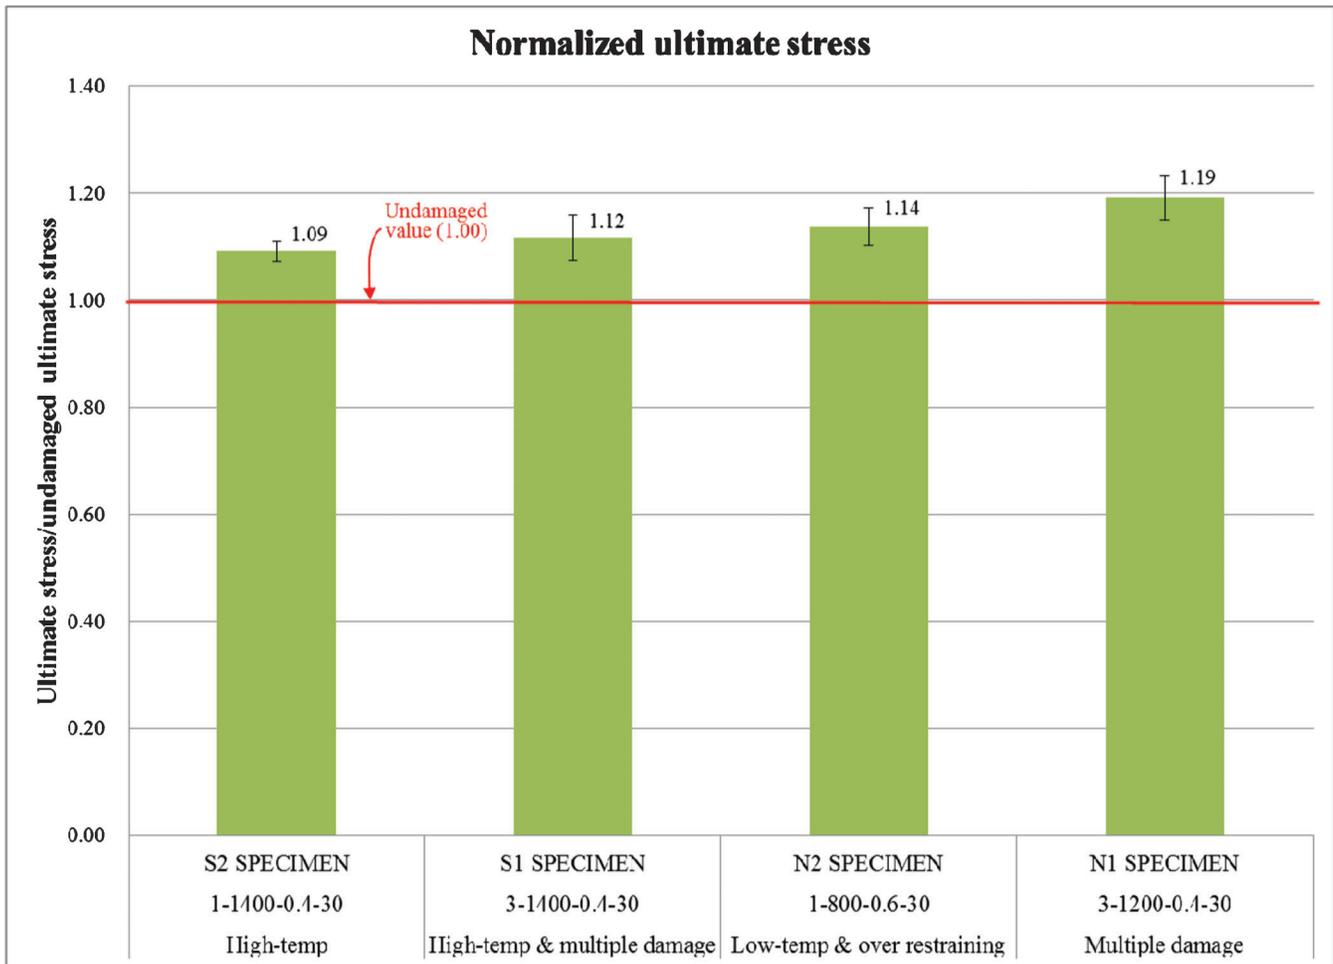
Figure 10.4 Normalized ultimate stresses of large scale specimens.

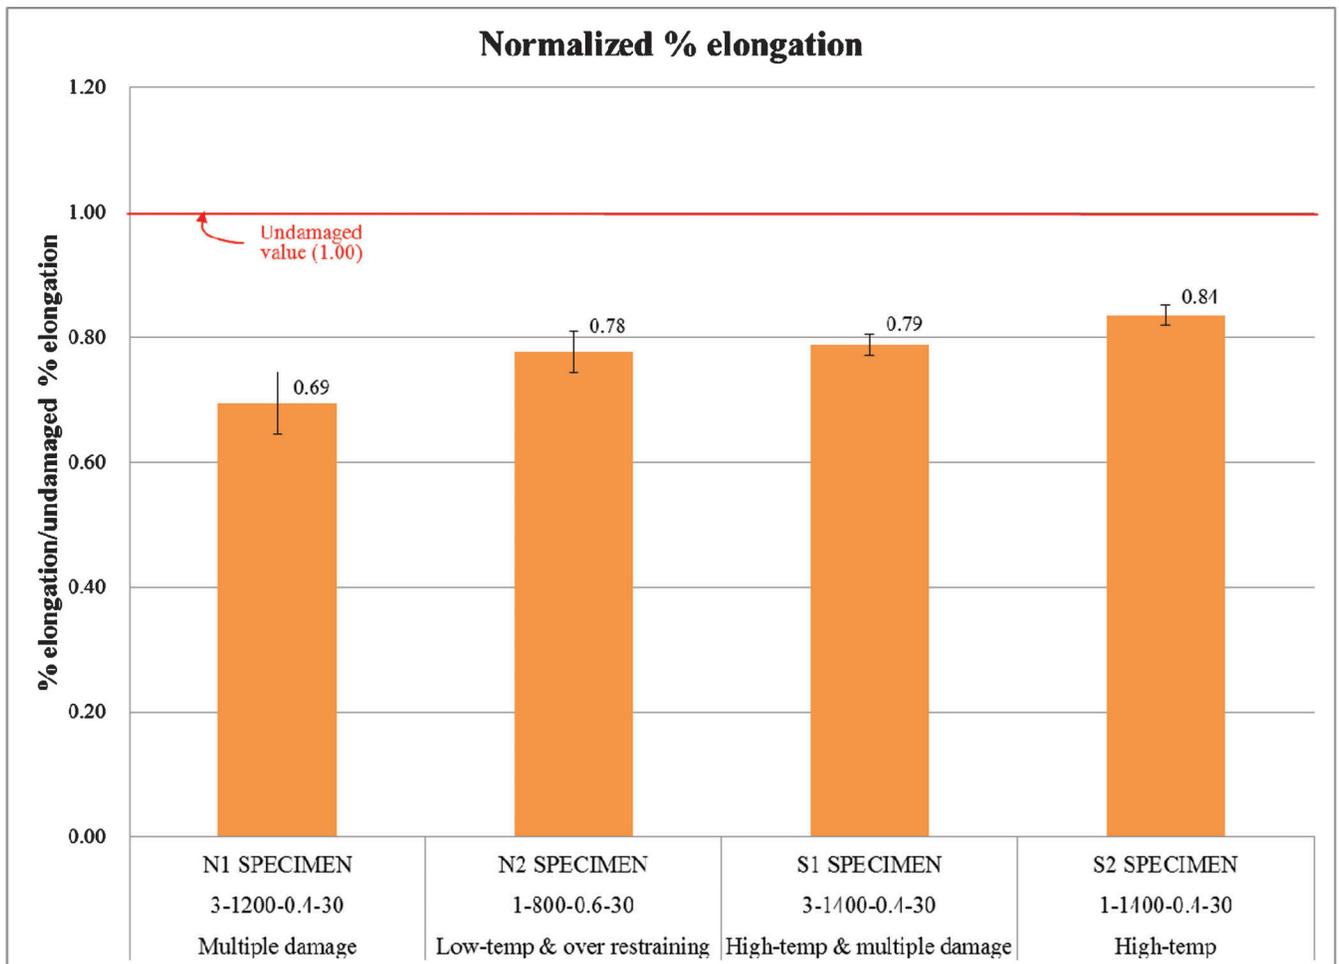
Figure 10.5 Normalized % elongations of large scale specimens.

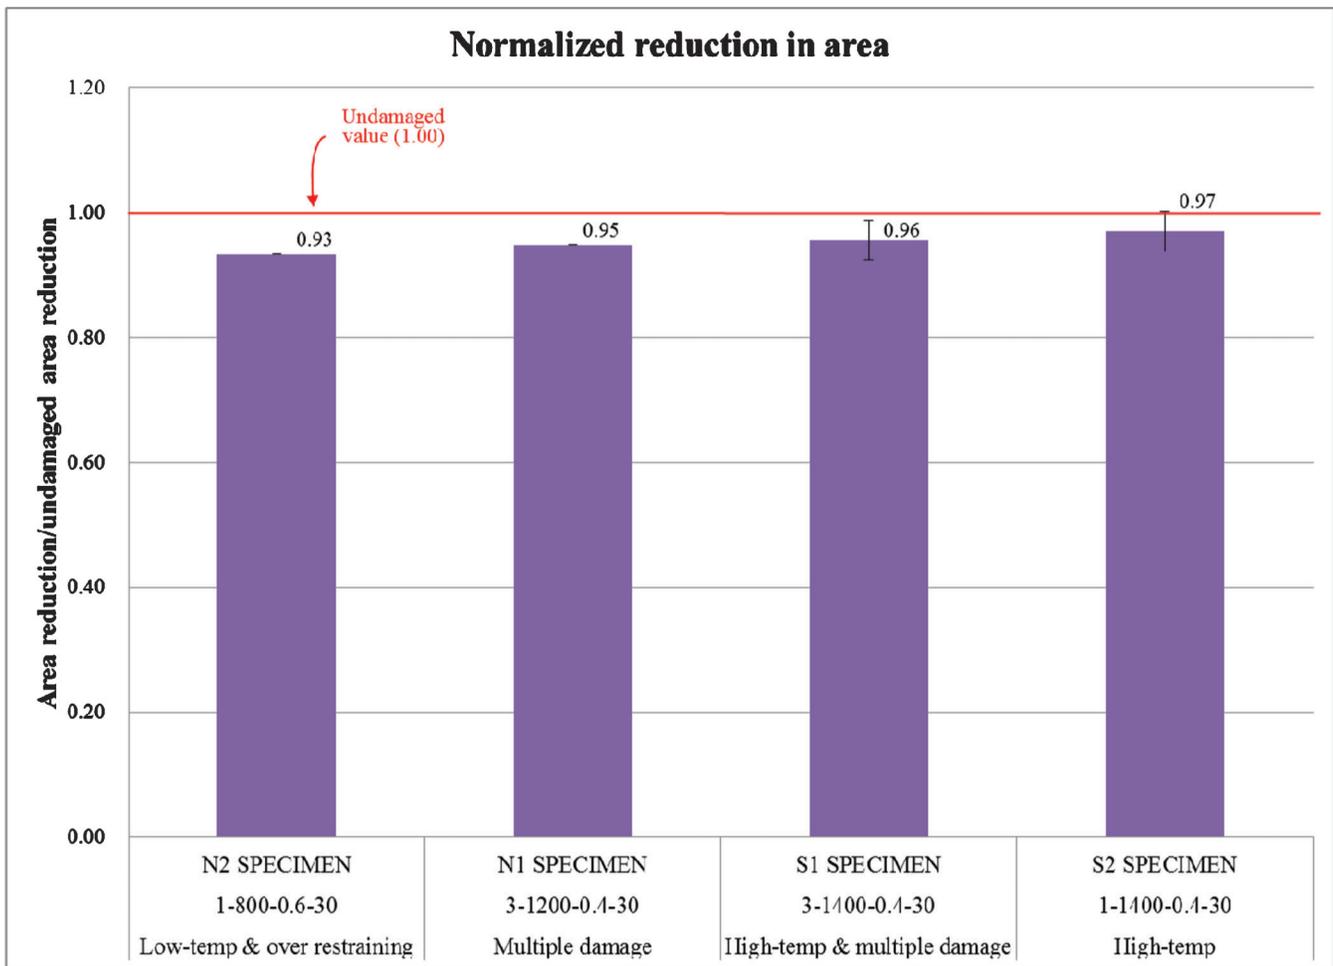
Figure 10.6 Normalized area reductions of large scale specimens.

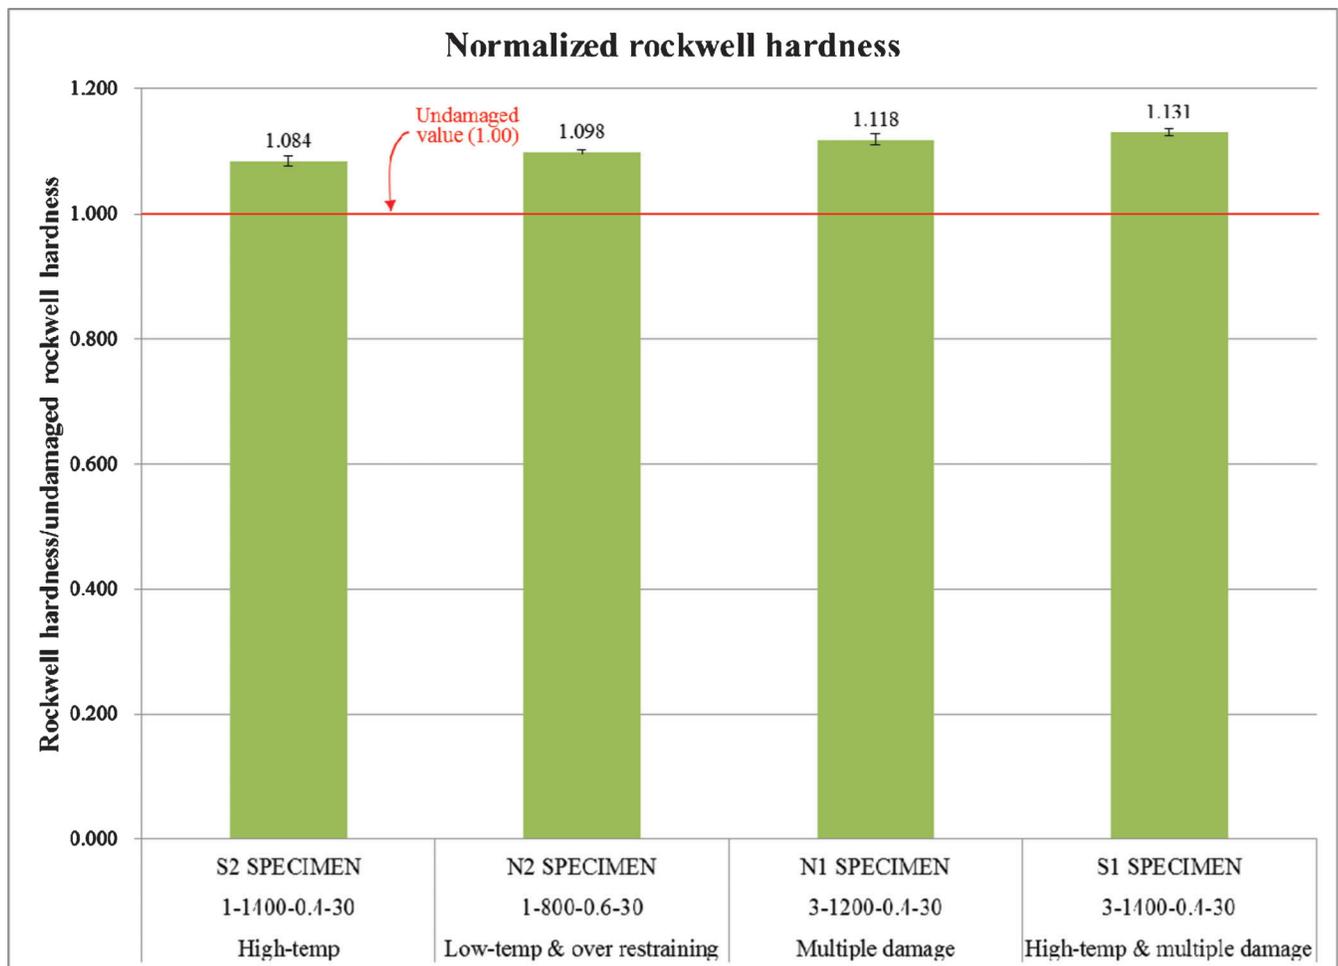
Figure 10.7 Normalized Rockwell hardness results of large scale test.

V-notch specimen. Table 10.7 shows the Rockwell hardness test results and normalized values. Figure 10.7 shows the normalized value comparison.

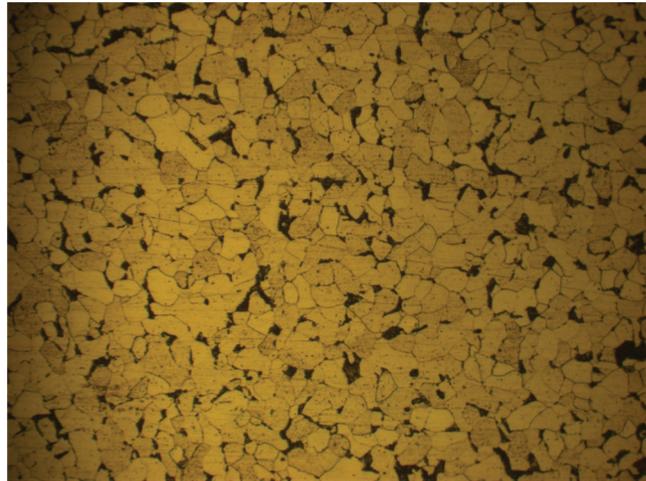
Figure 10.10 Microstructure of N1 specimen (3-1200-0.4-30)—300x.

Microstructures of all specimens are shown in Figures 10.8–10.12. Table 10.8 shows the grain size and percent pearlite of each specimen. Normalized values of all specimens compared with the undamaged specimen are also shown in Table 10.8. Normalized values with standard deviation error bars are also compared in Figures 10.13 and 10.14.

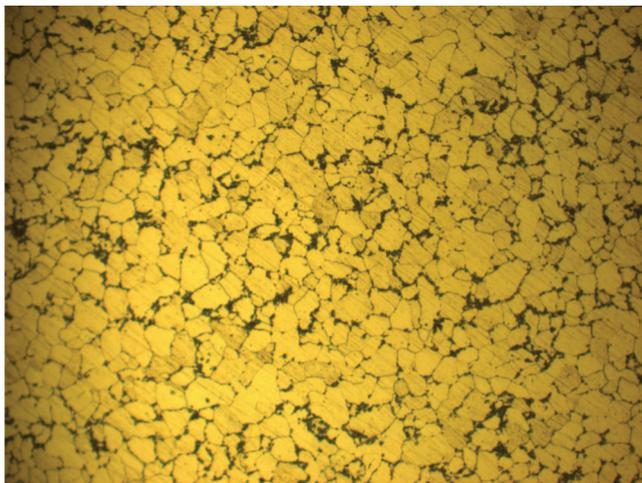
Figure 10.8 Microstructure of S1 specimen (3-1400-0.4-30)—300x.

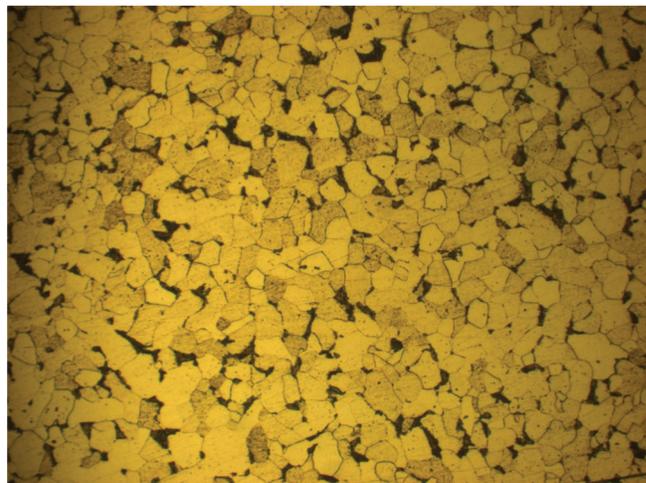
Figure 10.11 Microstructure of N2 specimen (1-800-0.6-30)—300x.

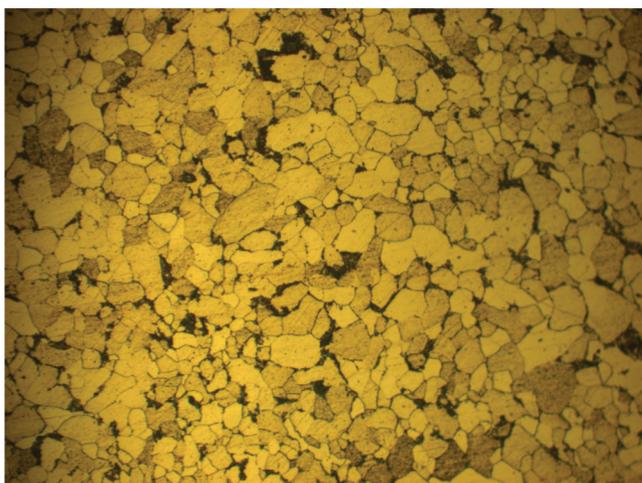
Figure 10.9 Microstructure of S2 specimen (1-1400-0.4-30)—300x.

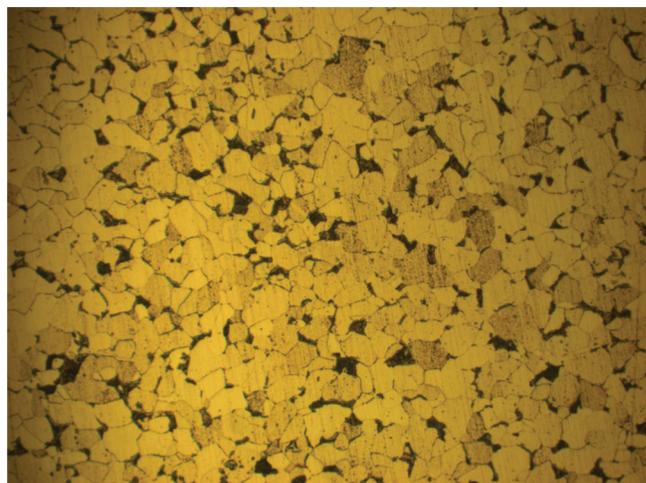
Figure 10.12 Microstructure of undamaged specimen—300x.

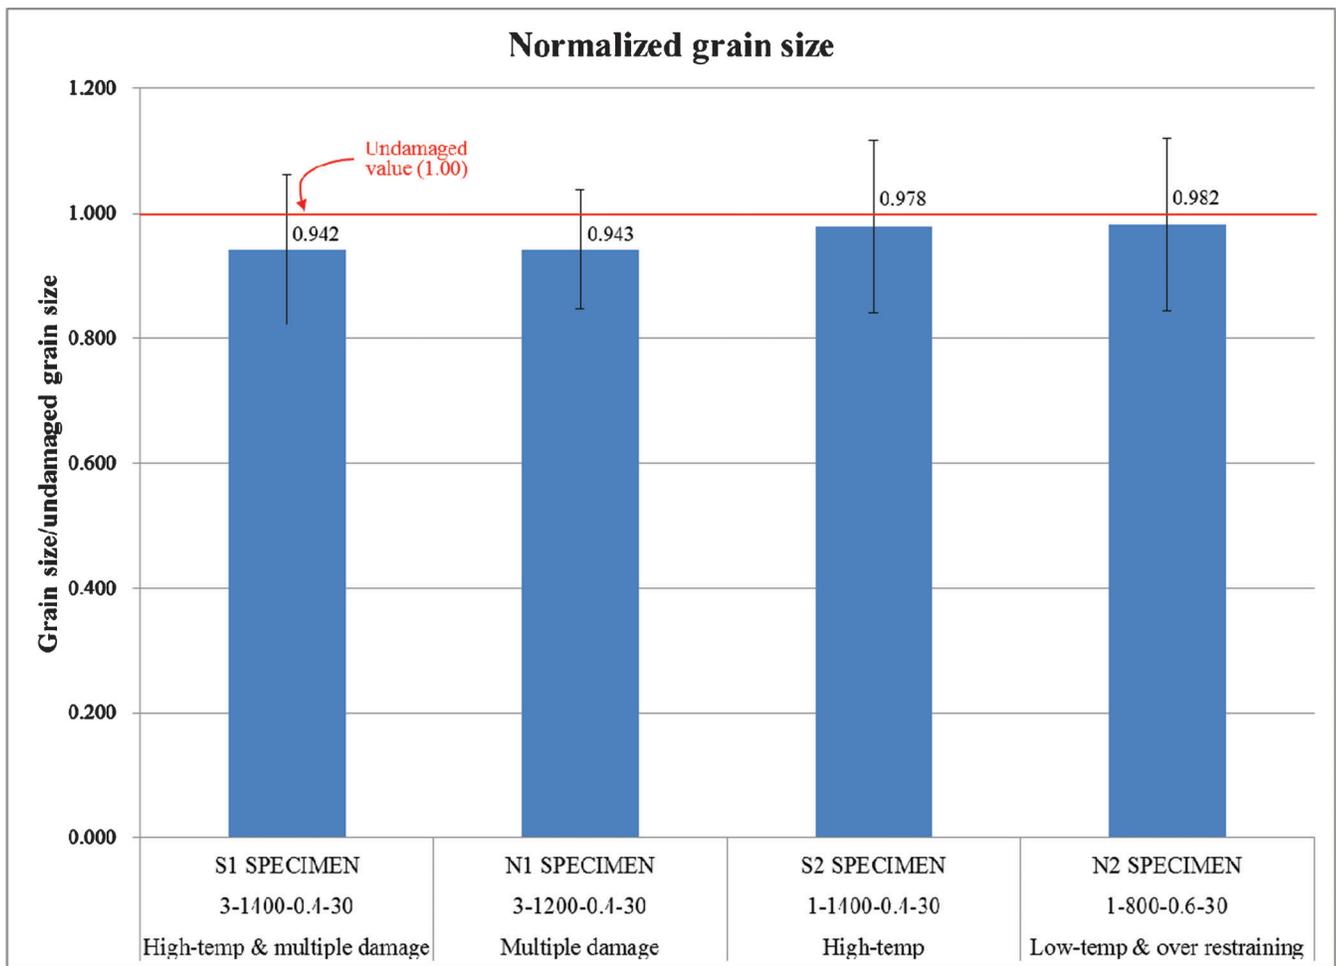
Figure 10.13 Normalized grain size of large scale test.

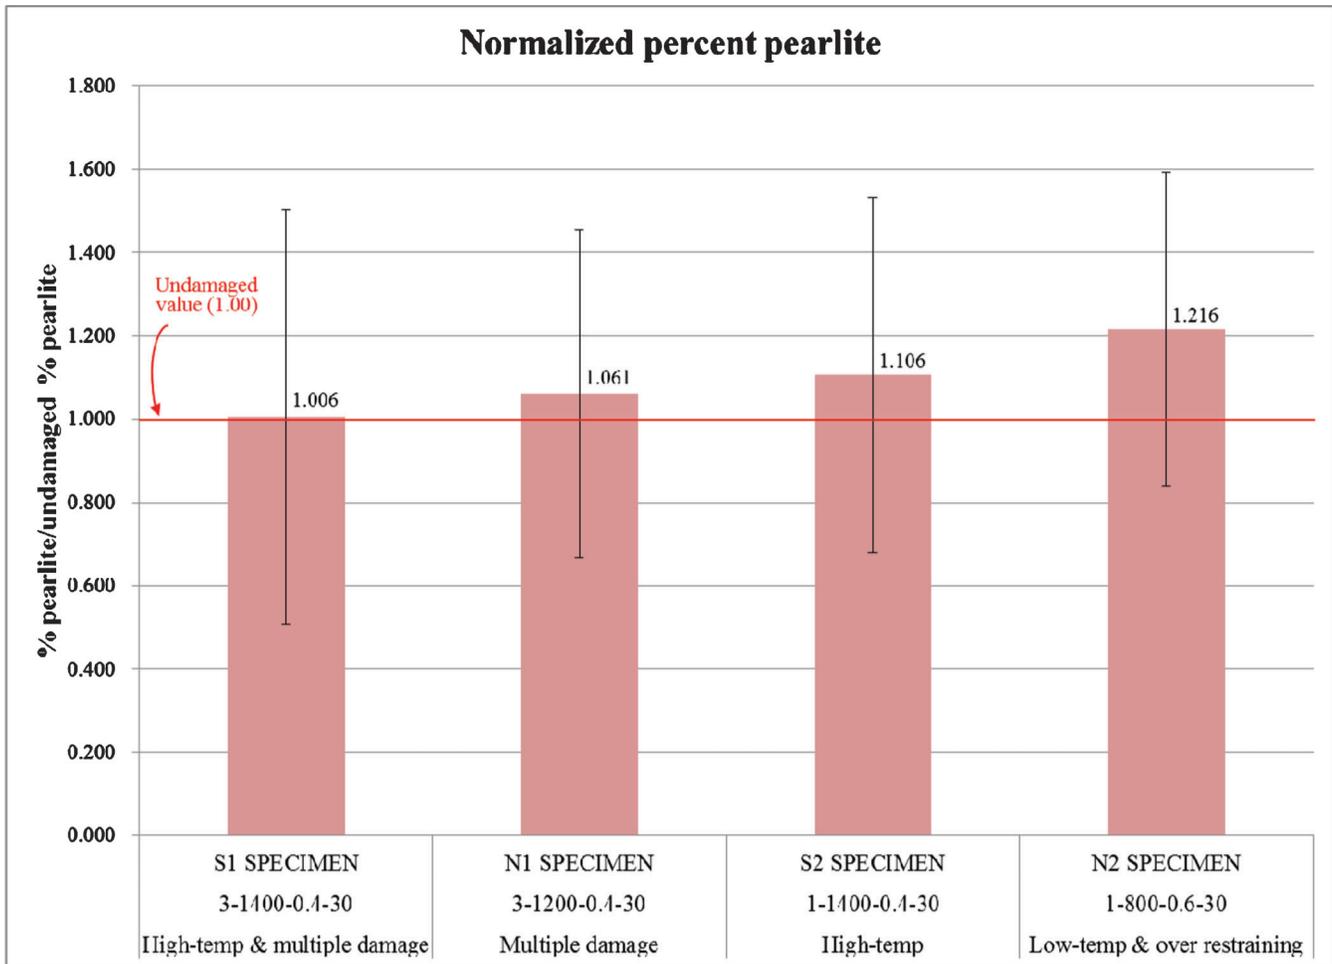
Figure 10.14 Normalized percent pearlite of large scale test.

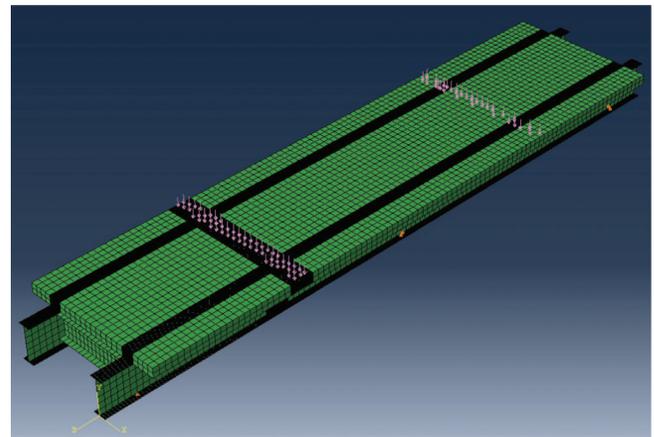
Figure 11.1 Service load conditions of the FEM analysis model.

The finite element bridge model, which was developed in Chapter 8, was used to predict the bridge midspan deflections caused by the static service load. Figure 11.1 shows the service loading conditions of the FEM bridge model. As seen in Figure 11.1, 56 kips of concentrated service load was evenly distributed at around the midspan region of the solid slab elements.

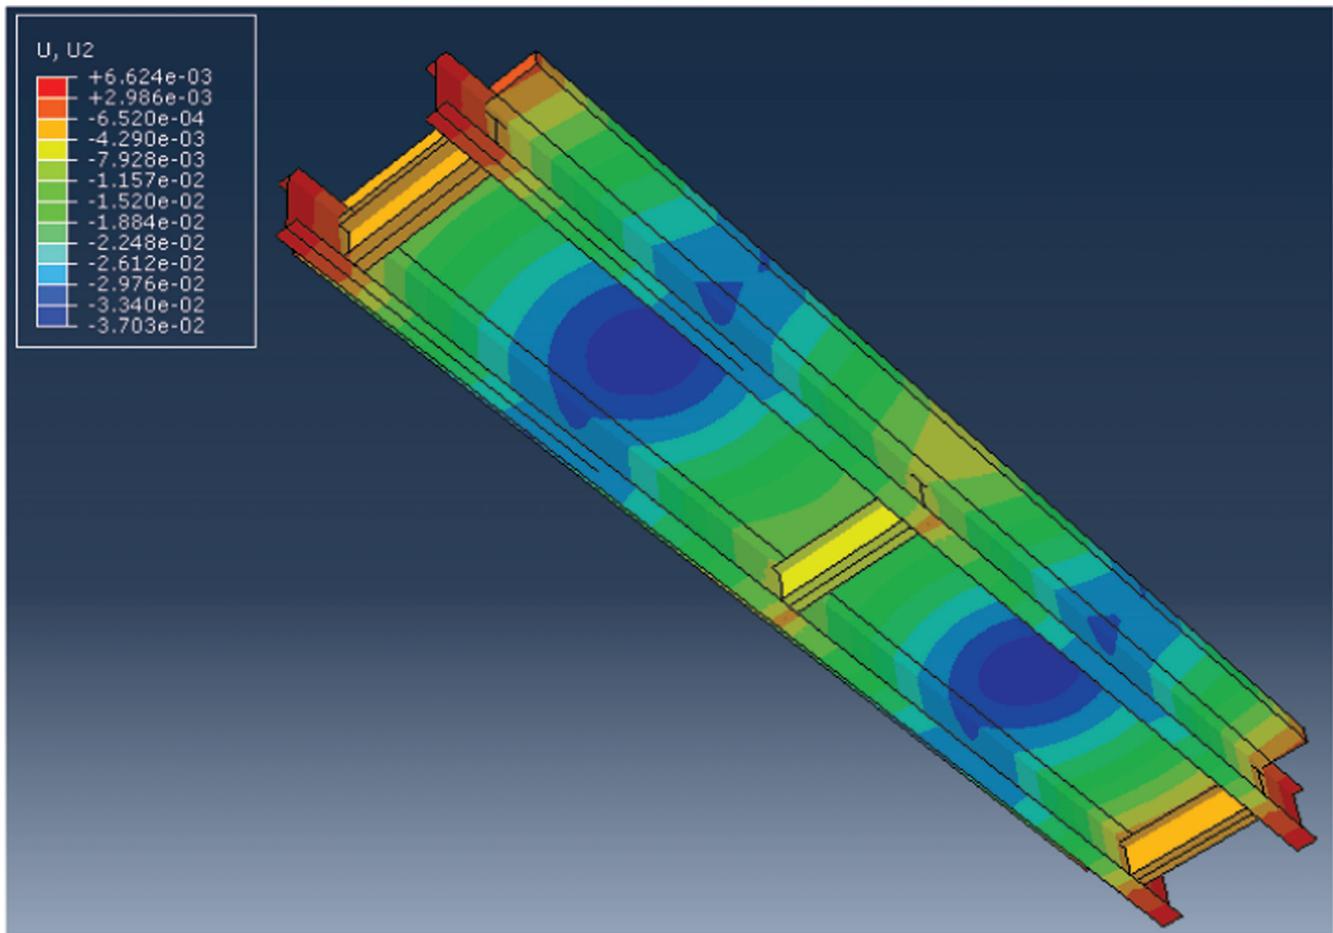
Figure 11.2 Vertical deflection result of the FEM serviceability analysis.

From this FEM analysis model, the maximum midspan deflections of the test bridge were measured at actual vertical midspan sensor locations (inside edge of the bottom flange). The vertical deflection result of the FEM bridge model is shown in Figure 11.2. The maximum midspan deflection measured in the FEM analysis model was 0.0291 in.

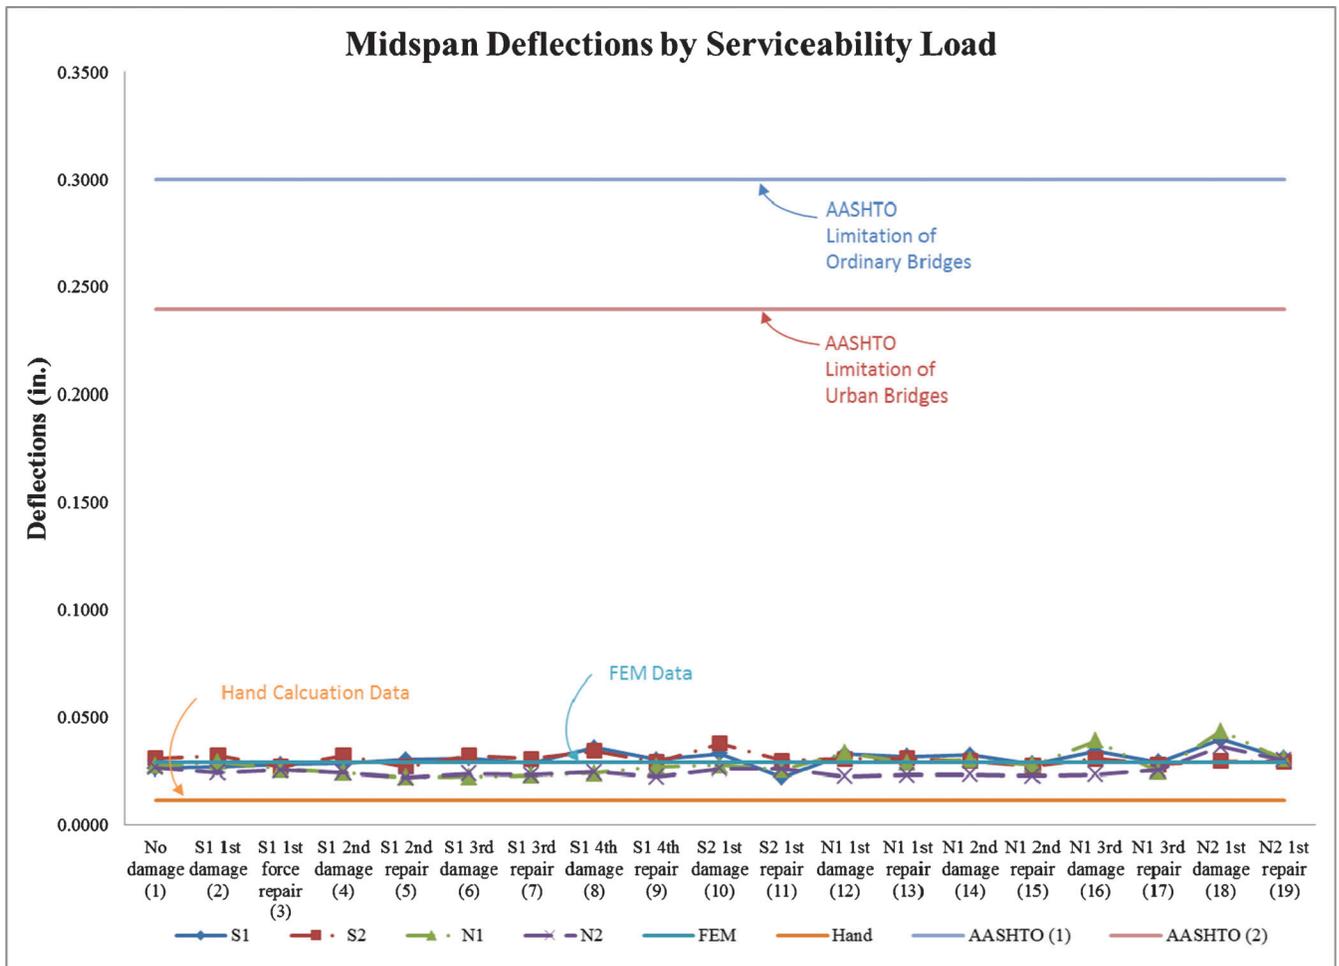
Figure 11.3 Serviceability deflection data and the AASHTO deflection limit.

Figure 11.3 shows all serviceability deflection data and the AASHTO specification deflection limit. All of the midspan deflection data from the test and analysis were much smaller than the AASHTO deflection limit.
