Effects of Realistic Heat Straightening Repair on the Properties and Serviceability of Damaged Steel Beam Bridges

JOINT TRANSPORTATION RESEARCH PROGRAM

INDIANA DEPARTMENT OF TRANSPORTATION
AND PURDUE UNIVERSITY

1. Report No. FHWA/IN/JTRP-2013/03	2. Government Accession No.	3. Recipient's Catalog No.	
4. Title and Subtitle Effects of Realistic Heat Straightening Repair on the Properties and Serviceability of Damaged Steel Beam Bridges		5. Report Date February 2012

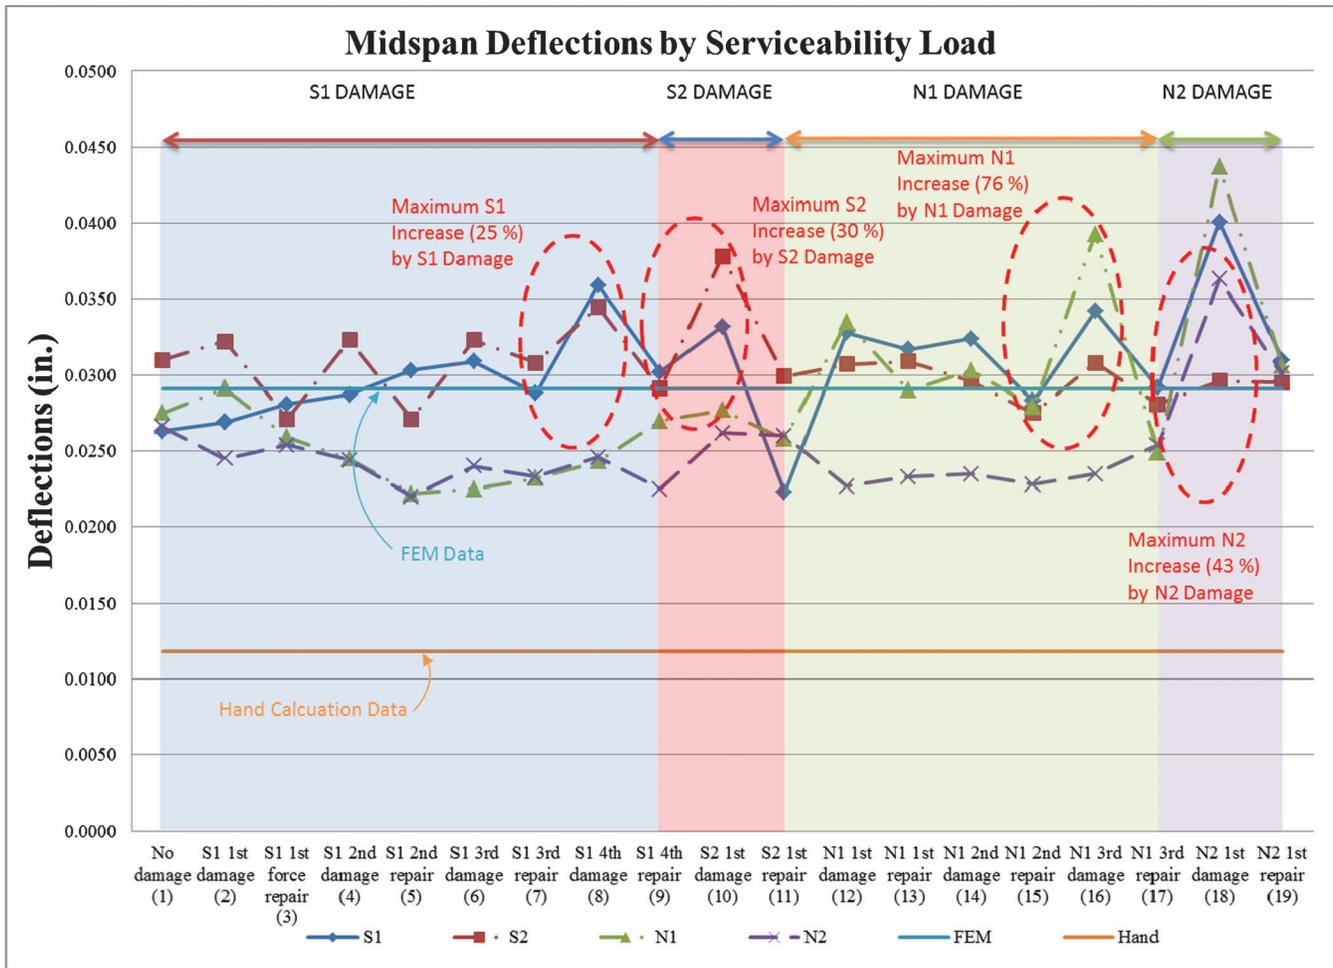
Figure 11.4 Midspan deflections by service load.

Detailed graphs of the midspan deflection during all the stages of testing are shown in Figure 11.4. One notable feature in the graph was the sudden increase of the midspan deflection right after each damage process. As seen in the graph, S1, S2, N1, and N2 midspan
