# Rapid Stabilization of Thawing Soils for Enhanced Vehicle Mobility

## A Field Demonstration Project

Maureen A. Kestler, Sally A. Shoop, Karen S. Henry,  
Jeffrey A. Stark, and Rosa T. Affleck

CRREL Report 99-3

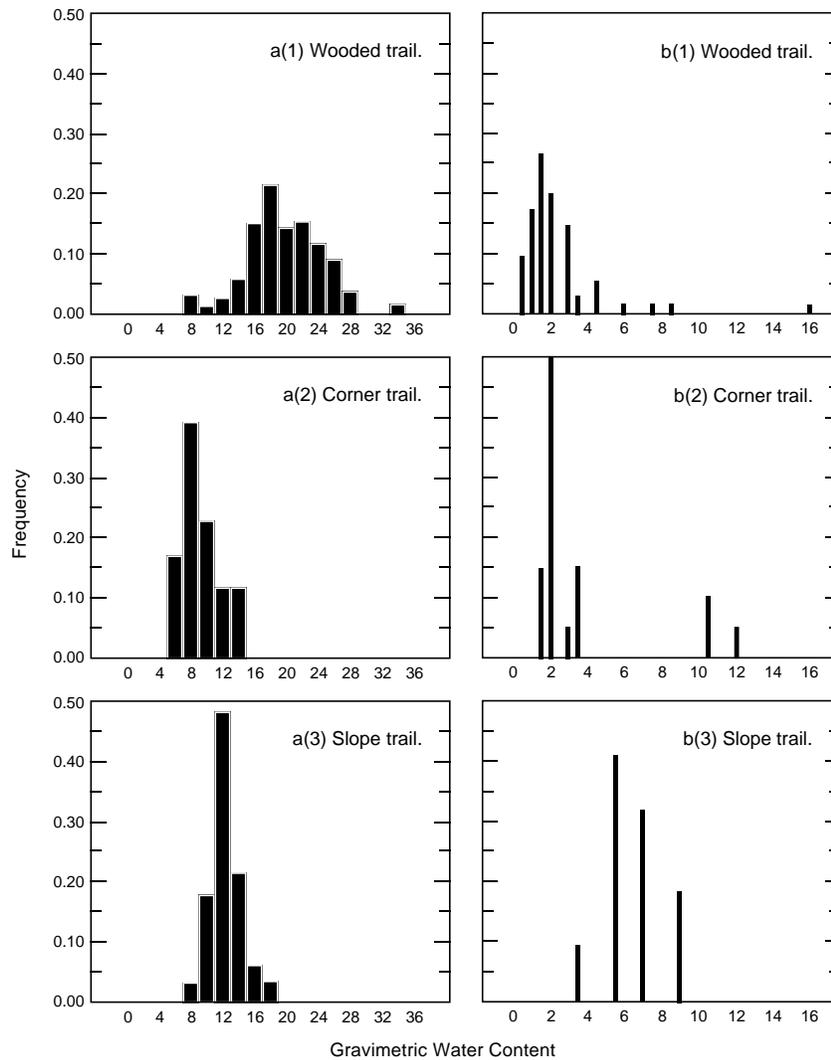
Figure 1. Water content and CBR.

a. Gravimetric water content histograms.

b.  $CBR_{CLEGG}$  histograms.

Based upon  $CBR_{CLEGG}$ , the material in the wheel paths was slightly stiffer than that along the centerline. This is probably a result of compaction due to past use/trafficking. Histograms showing the distribution of gravimetric water content and CBR are shown in Figures 1a–d. Typical  $CBR_{DCP}$  profiles for stations 6+00 and 18+00 at left, right, and center of the travelway are shown in Figure 1c. CBR in this figure was calculated using DCP values, and plotted using the Pavement-Transportation Computer Assisted Structural Engineering (PCASE) program “DCP” (U.S. Army 1995). The figure shows substantial strength variability both horizontally and vertically. Again, this provides additional evidence pointing toward a possible unequal frame of reference for test section performance evaluation.

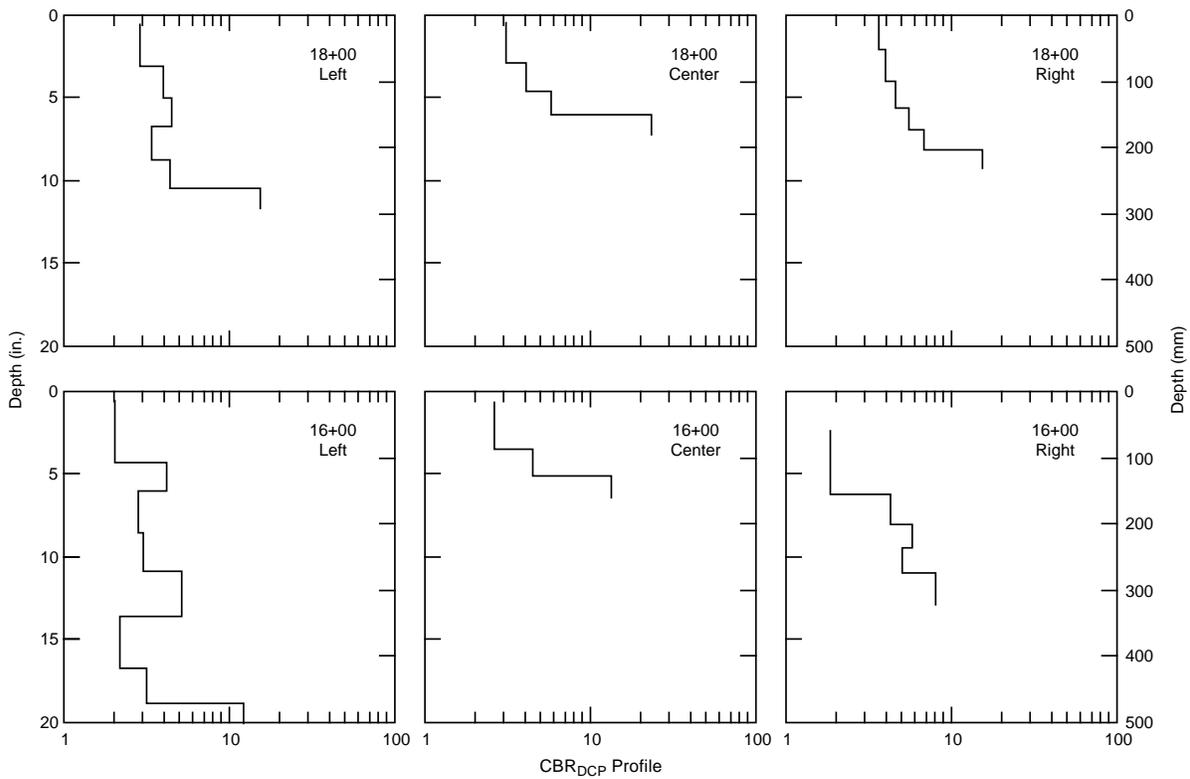
c. Typical  $CBR_{DCP}$  profiles—wooded trail.

Figure 1 (cont'd). Water content and CBR.

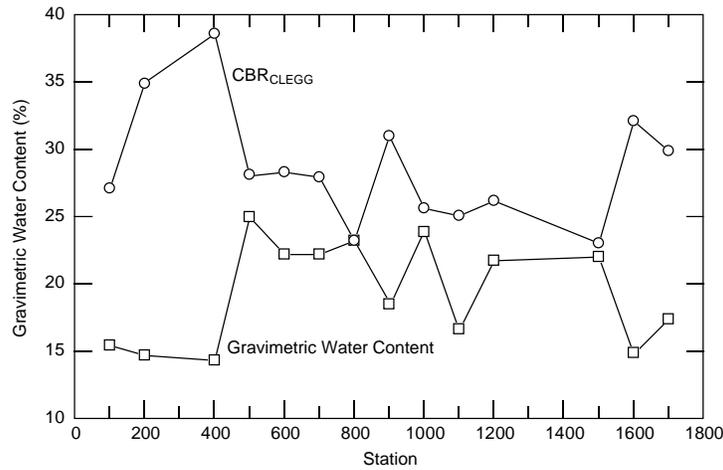
d. Gravimetric water content and  $CBR_{CLEGG}$ —wooded trail.

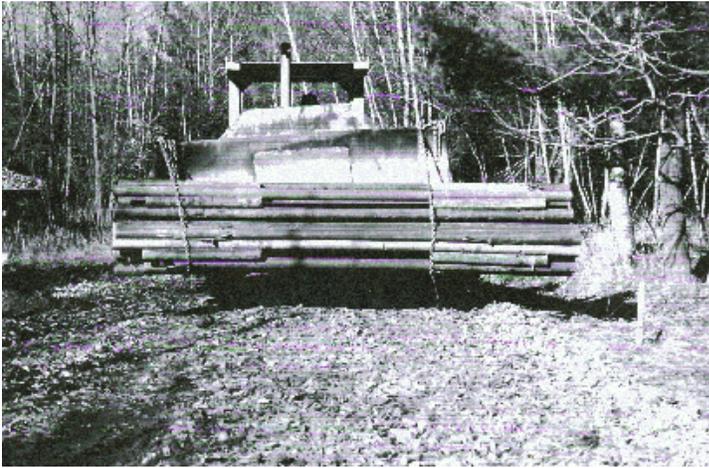
Figure 6. PVC fascine.

a. Fascine.

A fascine is a series of parallel pipes placed to fill a ditch that allows traffic to travel across (Fig. 6a). In contrast to a typical military fascine, the fascine mats used for this demonstration project were constructed of materials similar to those used by the USFS (Mason 1990), e.g., 6-m-(20-ft-) long schedule 80 PVC pipe, 1.6 cm (5/8 in.) steel cable and cable clamps. Two 4.6-m-(15-ft-) long by 4.9-m-(16-ft-) wide fascines were constructed.

The second location was another area where water was flowing across the trail. The HEMTT was used to transport the fascine to this test section. The fascine was unrolled so it was only one pipe thick (Fig. 6), and covered with tire mats.

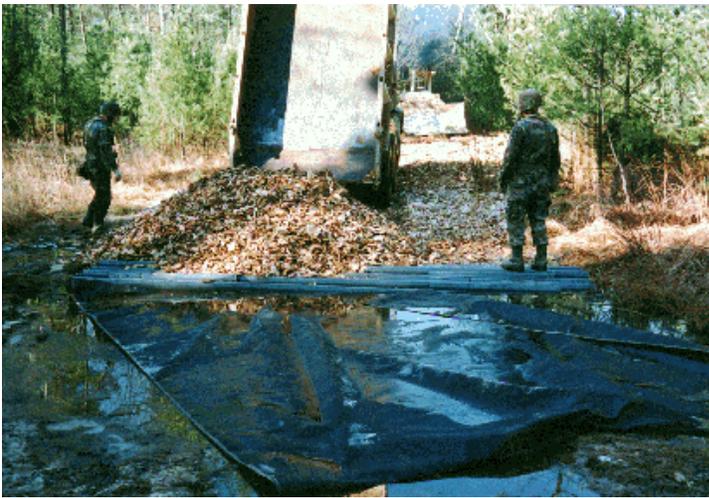
b. Covered with chunkwood.

prior to the demonstration. Water, approximately 10–20 cm (4–8 in.) deep, was flowing across the trail. By use of a D7 bulldozer, the fascine was moved into place, placed on top of a geotextile, and covered with chunkwood.

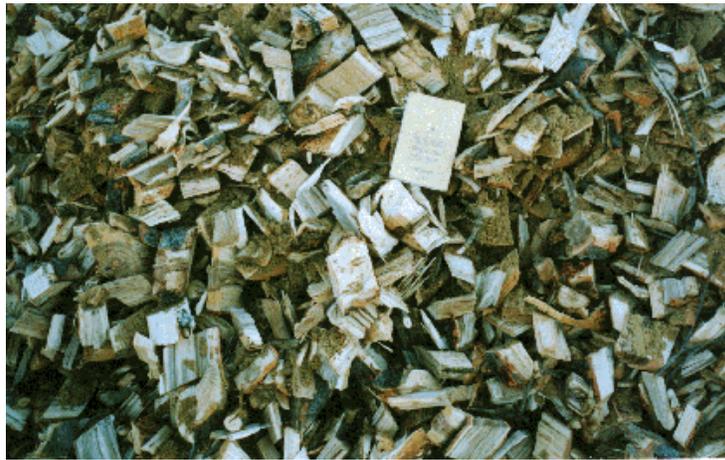
*Figure 8. Chunkwood.*

*a. Chunkwood fill.*

The chunkwood was produced by shredding whole trees with a USFS prototype wood chunking machine. The resulting wood chunks were approximately 3.8 cm (1.5 in.) thick and were well graded, ranging from 1 to 20 cm (0.5 to 8 in.) in diameter. The chunkwood was mixed with sand in the approximate ratio of three parts chunkwood to one part sand. The density of the chunkwood/sand mix was approximately 796 kg/m<sup>3</sup> (50 lb/ft<sup>3</sup>). The bulking factor appeared to be low. Although testing by the USFS has shown a sheepsfoot or padfoot roller improves compaction, the chunkwood compacted easily with construction vehicle traffic. The compacted surface was relatively smooth and provided a good wear surface (Fig. 8).

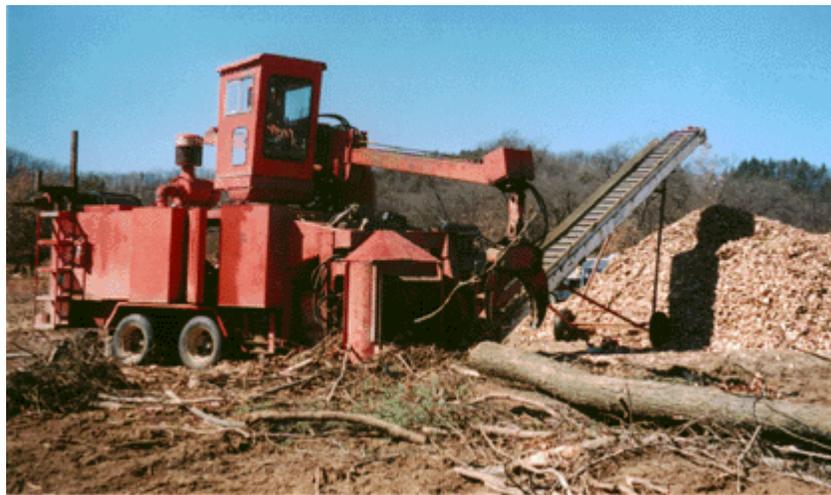
*b. USDA Forest Service wood chucker.*

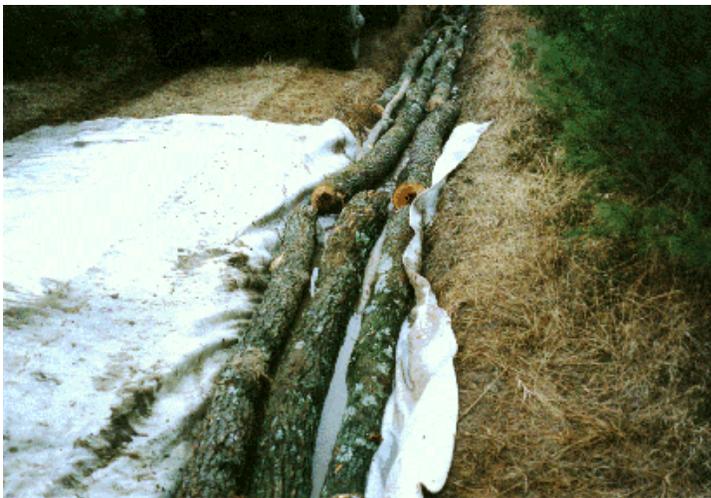
b. Larger diameter logs used to fill large rut.

Figure 9. Slash.

The slash test section on the wooded trail was 30 m (100 ft) long; the southern 15 m (50 ft) was covered with a geotextile before construction began. There was a large rut in the easterly wheel path in the slash test section. This rut was filled with logs (approx. 15 cm [6 in.] in diam.), running parallel to the rut (Fig. 9b). It took about five rows of logs to fill the rut. Next the slash was delivered. In this test section, the maximum diameter slash allowed was 8 cm (3 in.). The first few truckloads had trees that were larger than 8 cm (3 in.) in diameter. These trees were delivered to the site, cut up on site, and placed. The remaining trucks

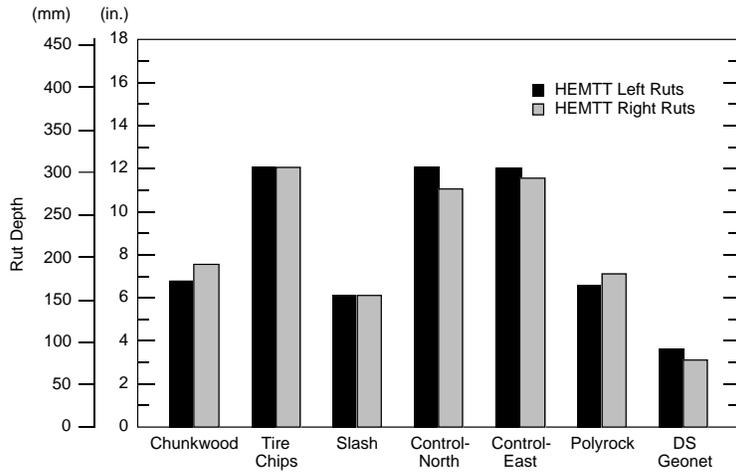
a. Sloped trail.

Figure 11. Rut depths.

Table E1 summarizes observations and test section performance and briefly discusses how each technique could be improved for future testing and use. Detailed observations of each test section are contained in Appendix E. Left and right rut depths for each trail after HEMTT trafficking are shown in Figure 11. As discussed in the site characterization section, in most instances, stabilizing techniques cannot be ranked by directly comparing rut depths, as stabilization techniques separated by any appreciable distance were constructed on virtually different subgrades. Just one of the many factors influencing rut depth is shown

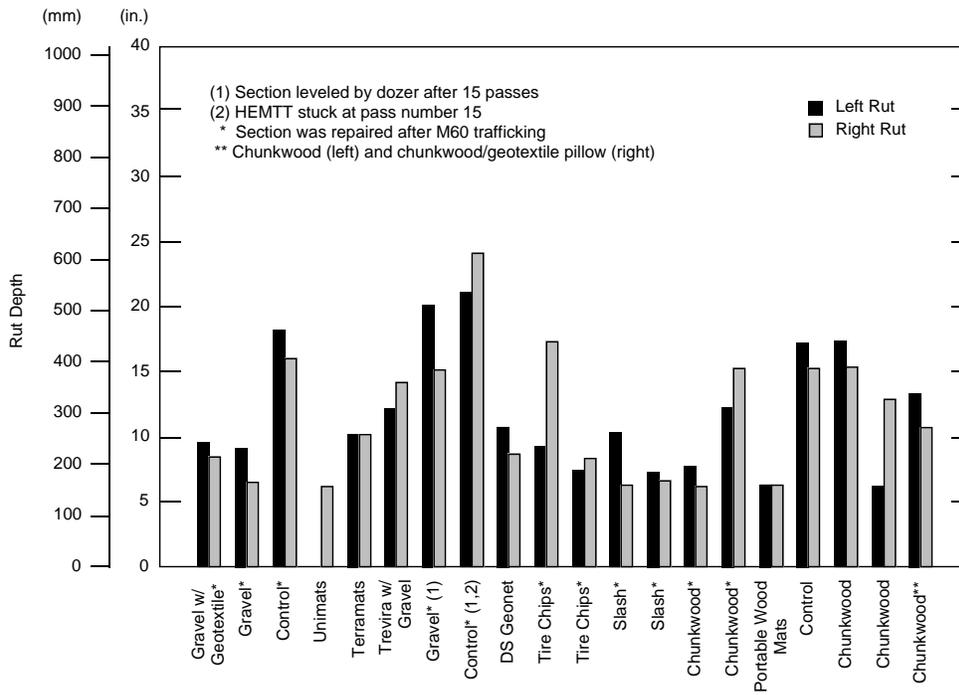
b. Wooded trail.

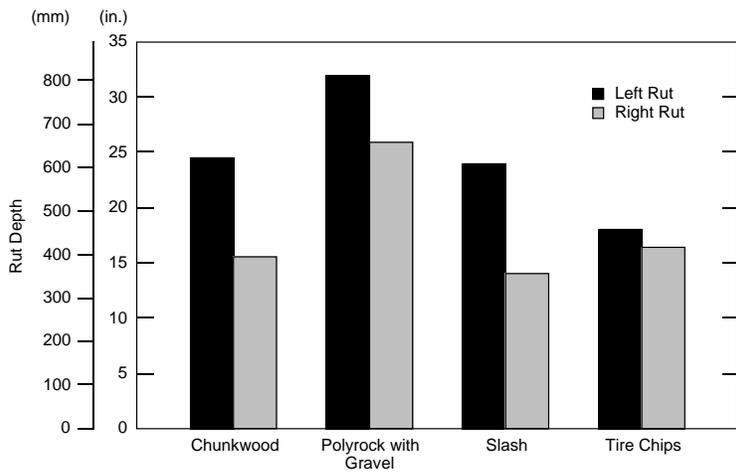
c. Pentagonal loop trail.

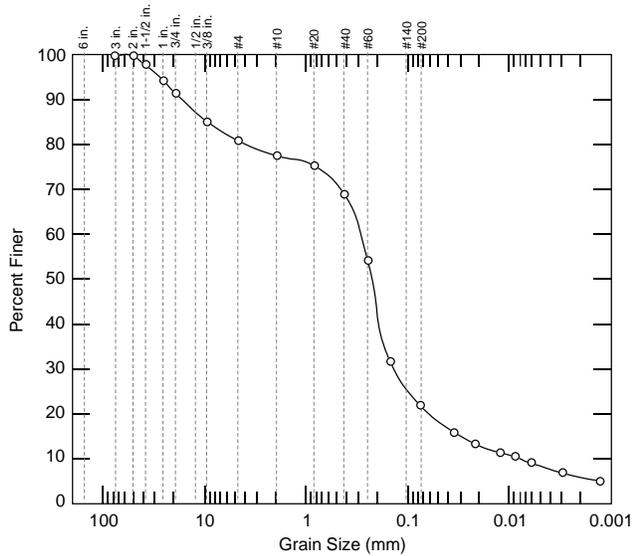
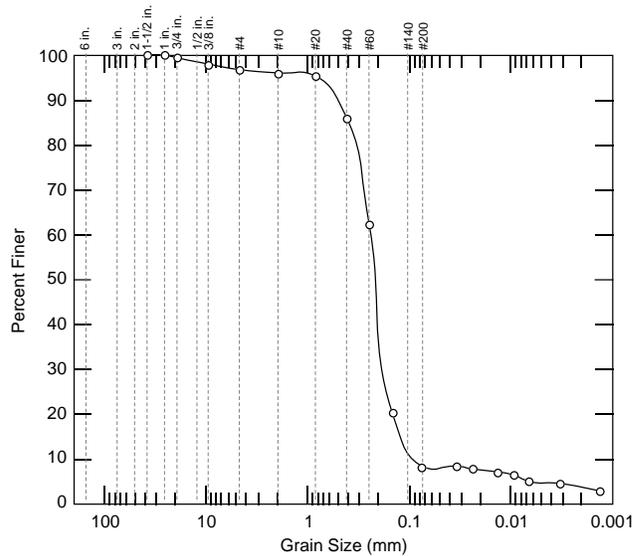
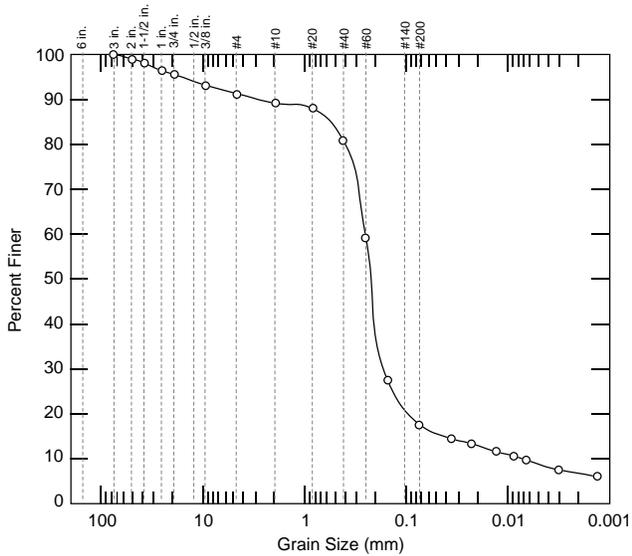
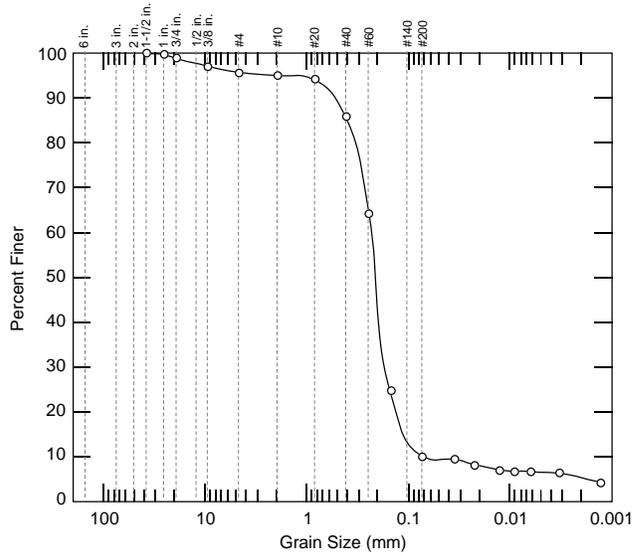
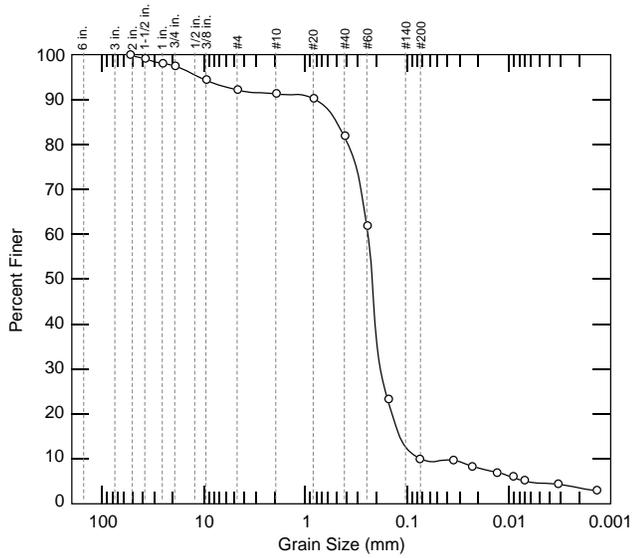
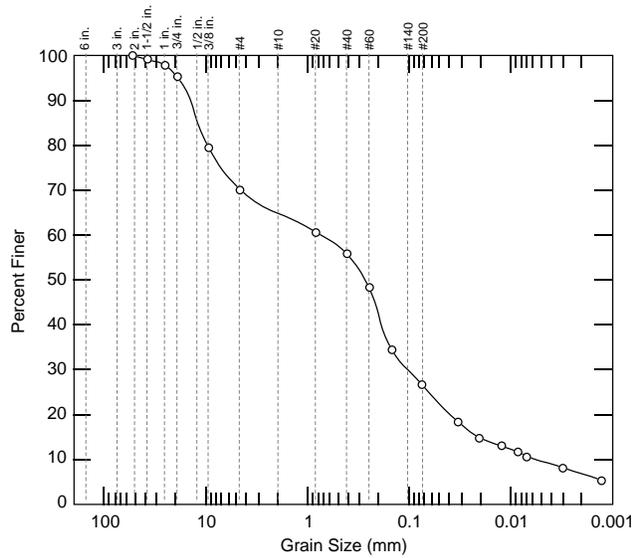
Figure A1. Wooded trail.

Material Description		USCS	AASHTO
○ Wooded Trail Station 8+25		SM	A-2-4

Material Description		USCS	AASHTO
○ Poorly Graded Sand with Silt		SP-SM	A-3
○ Wooded Trail Chunkwood Station

Material Description		USCS	AASHTO
○ Wooded Trail Station 16+50		SM	A-2-4

a. Gradation curves—wooded trail.

Material Description		USCS	AASHTO
○	Poorly Graded Sand with Silt	SP-SM	A-3
○	Wooded Trail Control Station 5+00

Material Description		USCS	AASHTO
○	Silty Sand with Gravel	SM	A-2-4
○	Wooded Trail Station 5+00, West Side Road

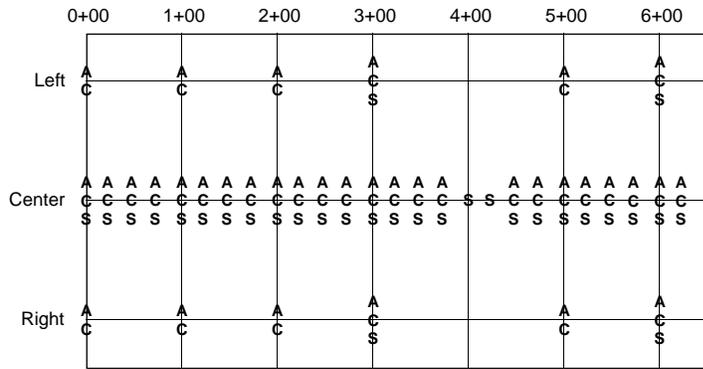
*c. Typical sampling and testing grid.*

A = Dynamic Cone Penetrometer (DCP)  
 C = Clegg  
 S = Static Cone

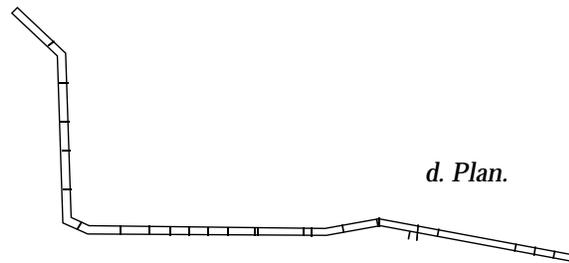
*d. Plan.*

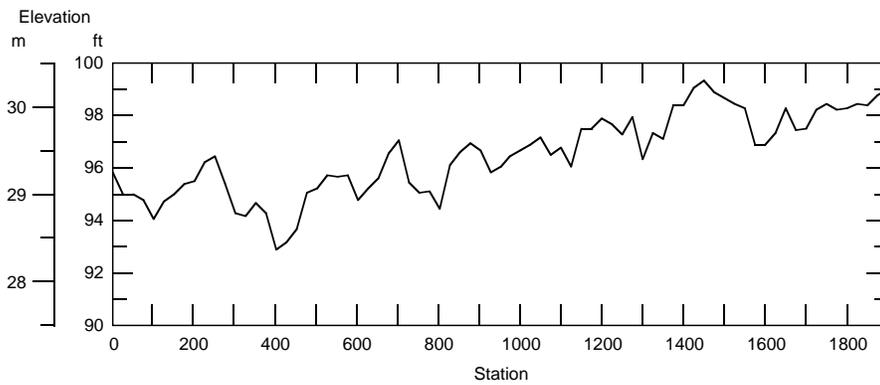
*e. Profile.*

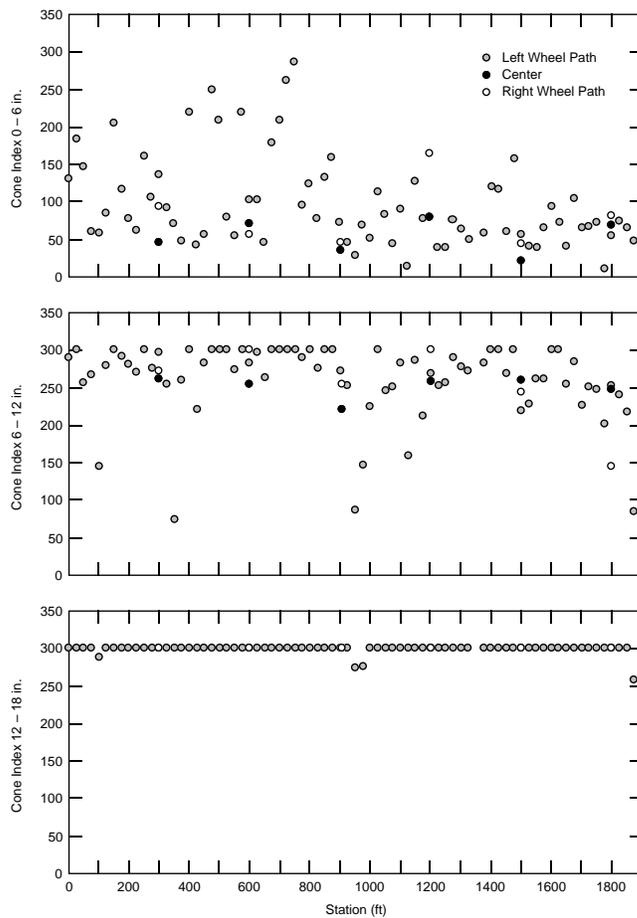
*g. Cone index for wooded trail.*

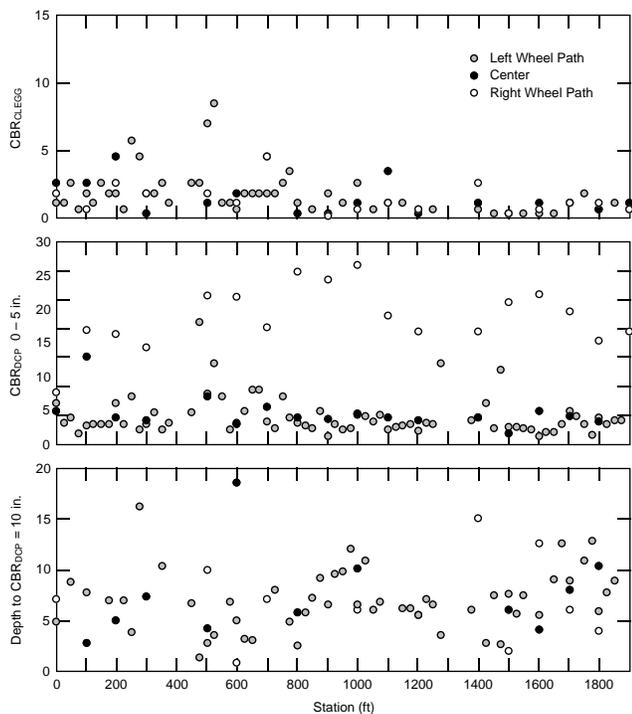
*h. CBR values for wooded trail.*

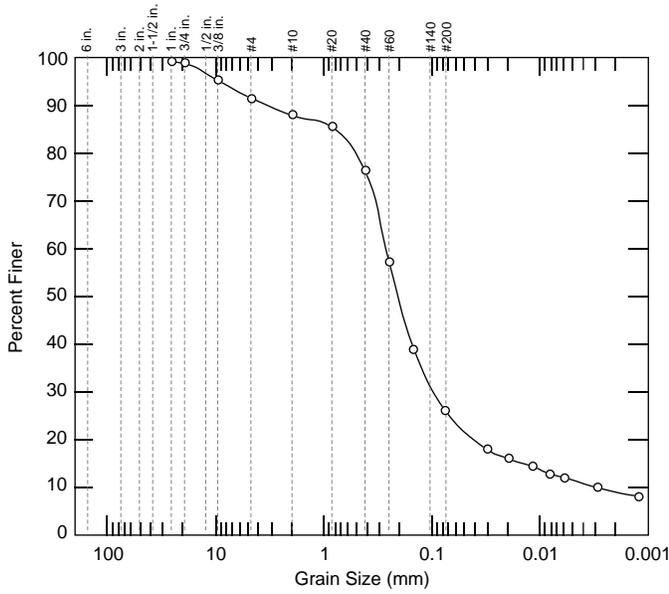
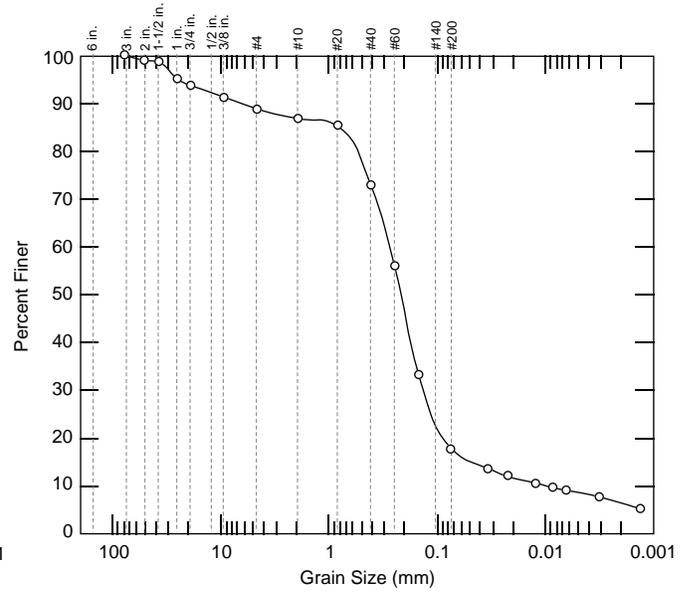
% +3"	% Gravel	% Sand	% Silt	% Clay
○	0.0	7.9	66.0	14.7	11.4

% +3"	% Gravel	% Sand	% Silt	% Clay
○	0.0	11.1	70.9	9.3	8.7

Material Description	USCS	AASHTO
○ Slope Trail, North Slope, East Side	SM	A-2-4

a. Gradation curves.

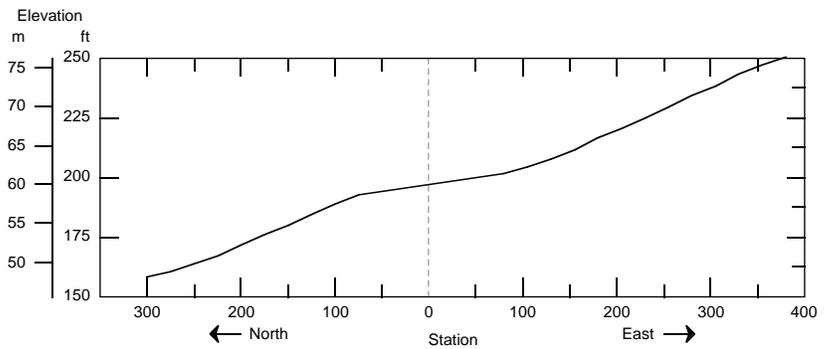
d. Profile.

Figure A2. Sloped trail.

The sloped site consisted of sections of two intersecting trails. Both trail sections (collectively termed the sloped trail) had erosion gullies. Prior to site characterization and construction, the sloped trail was both graded to remove the erosion gullies and filled to yield a relatively uniform 16 to 18% grade. The corner was incorporated as a control section. Because of recent use, the sandy travel surface was not covered with an organic layer as were the wooded and pentagonal loop trails. The gradation of the sandy material is shown in Appendix A, Figure A2a. The sloped trail site is shown in Figure A2b, and the plan and profile are shown in Figures A2c and A2d, respectively.

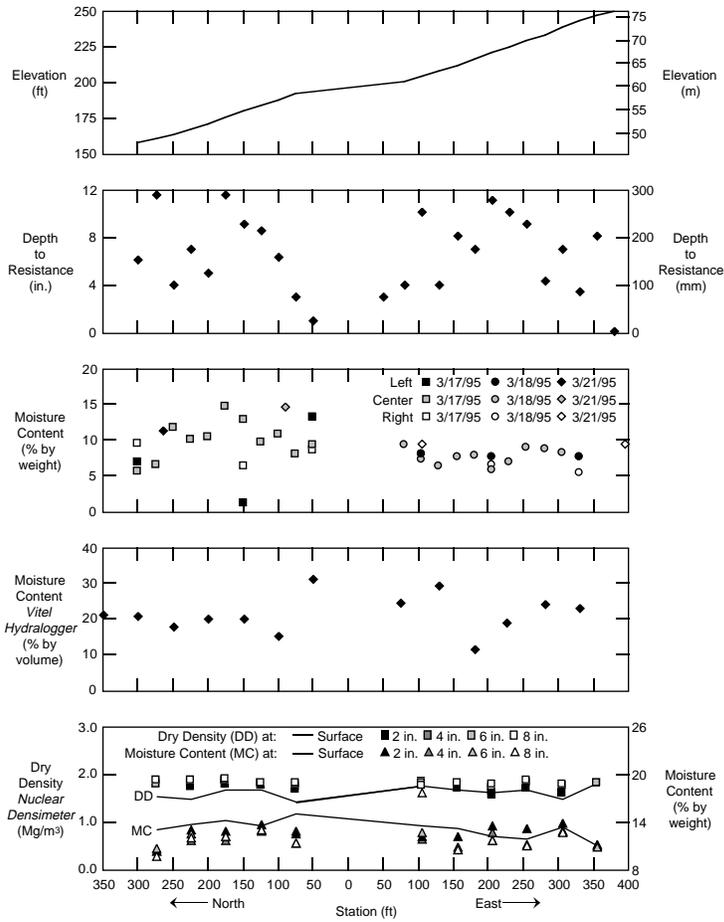
*e. Slope trail.*

Based upon soil sample tests, gravimetric water contents ranged from 6 to 16%, and averaged 11% with a standard deviation of 1.9. Figure A2e shows

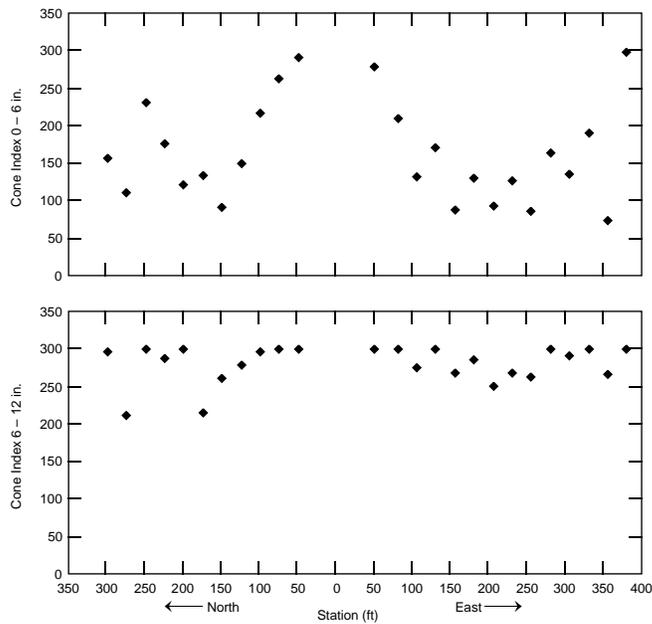
*f. Cone index for slope trail.*

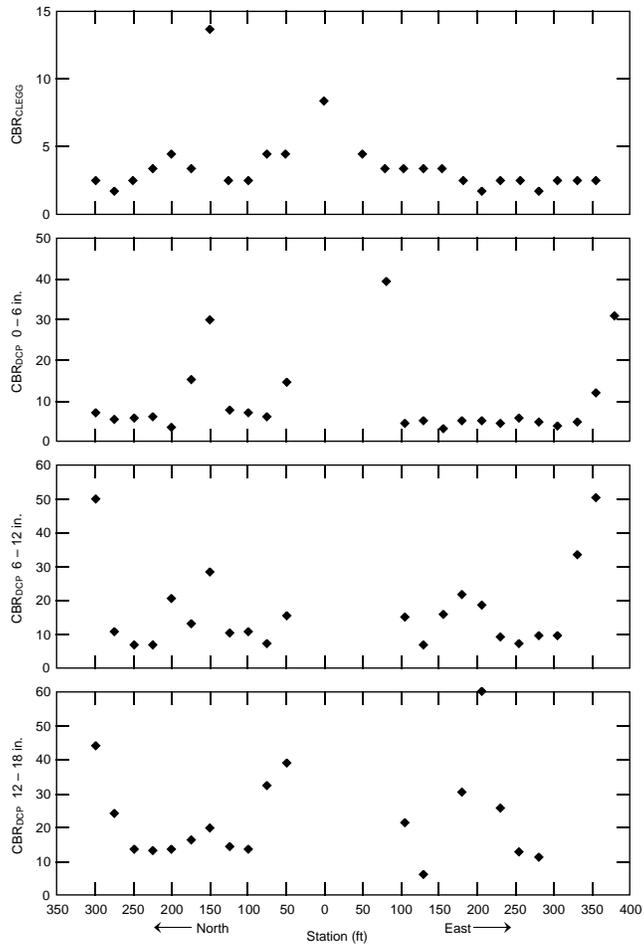
*g. CBR values for slope trail.*

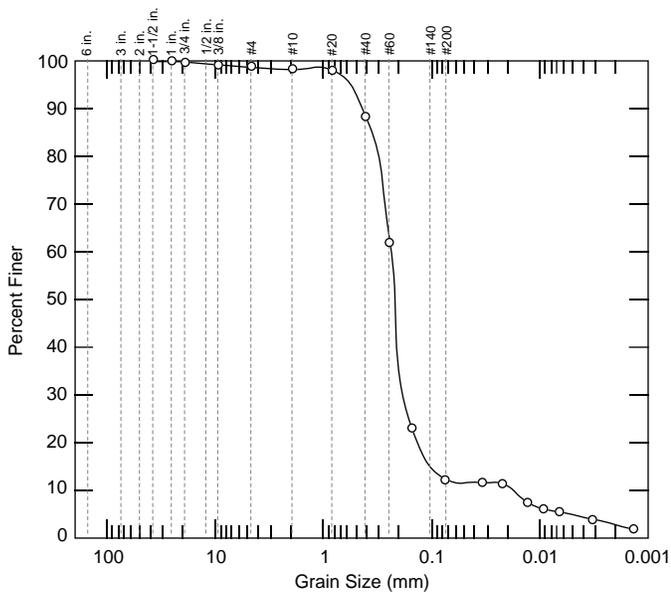
% +3"	% Gravel	% Sand	% Silt	% Clay
○	0.0	1.5	86.8	6.3	5.4

LL	PI	D <sub>85</sub>	D <sub>60</sub>	D <sub>50</sub>	D <sub>30</sub>	D <sub>15</sub>	D <sub>10</sub>	C <sub>c</sub>	C <sub>u</sub>
○			0.376	0.244	0.216	0.168	0.125	0.0167	6.99	14.6

Material Description	USCS	AASHTO
○	Pentagon Trail	SP-SM	A-2-4

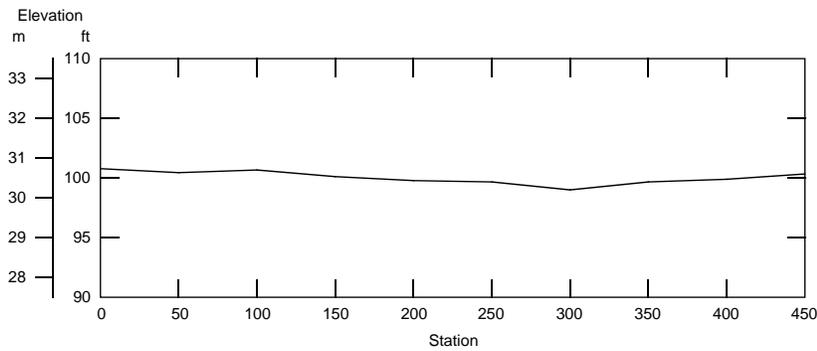
d. Profile.

Figure A3 (cont'd). Pentagonal loop trail.

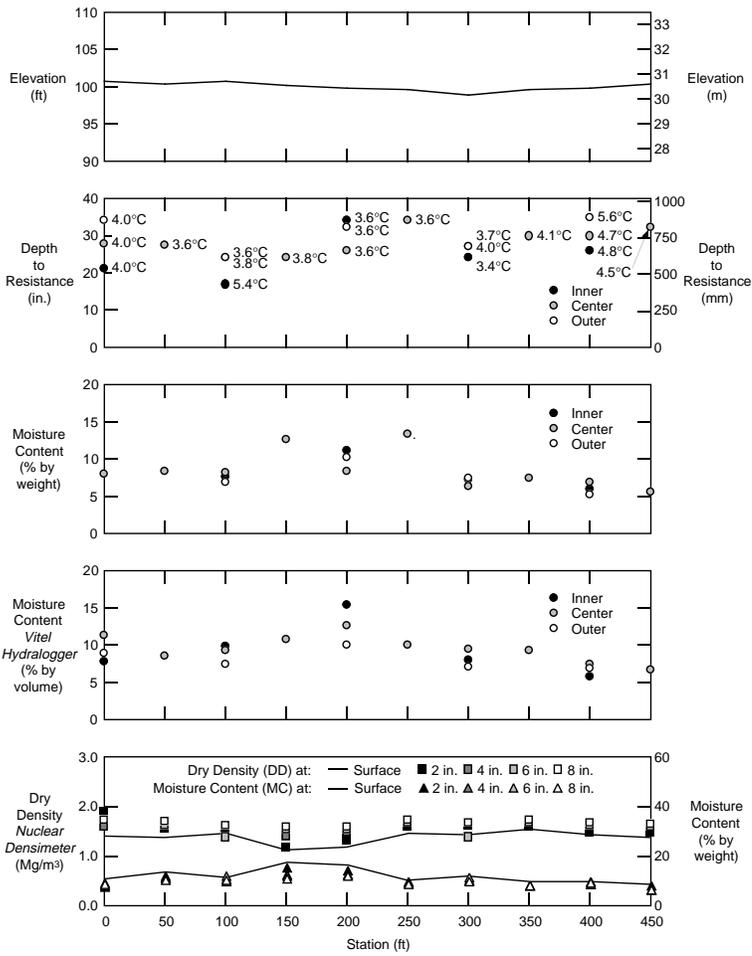
e. Pentagonal loop trail.

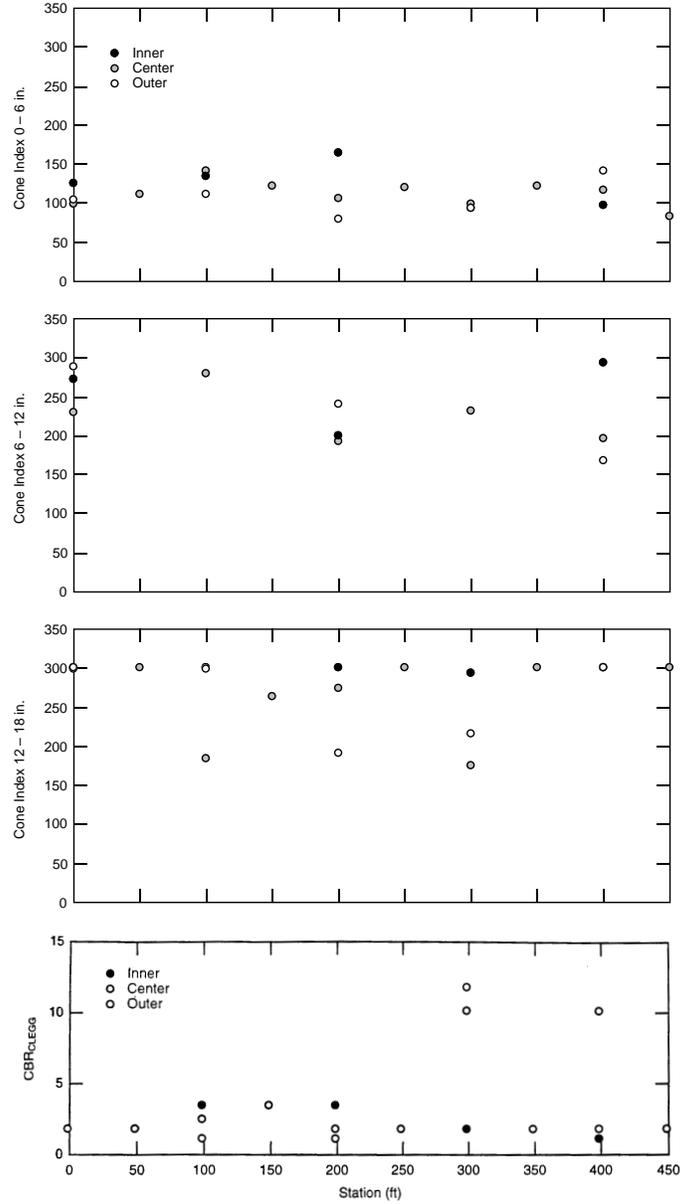
f. Cone index and CBR values, pentagonal loop trail.

Figure A3 (cont'd).

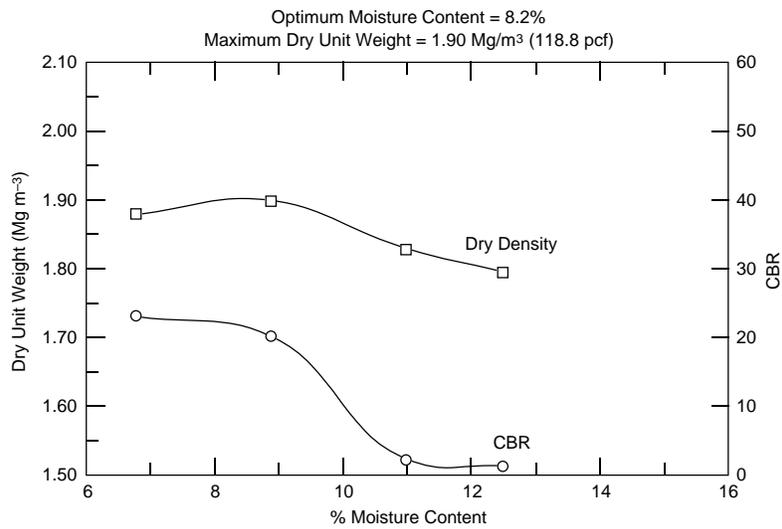
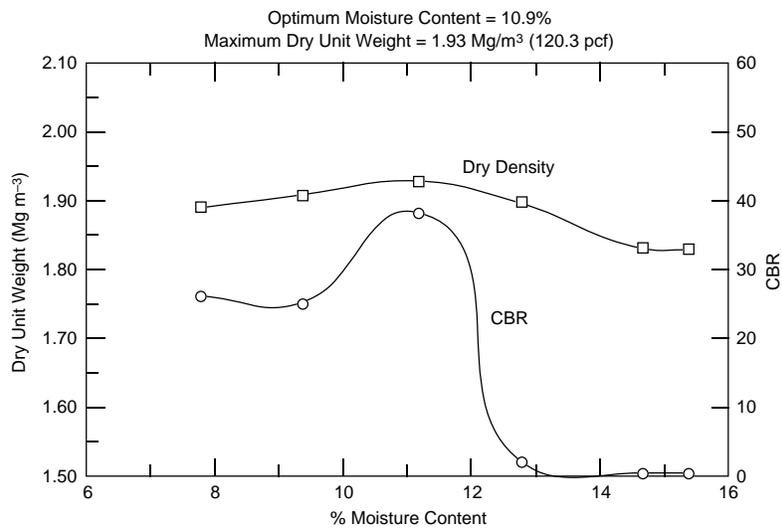
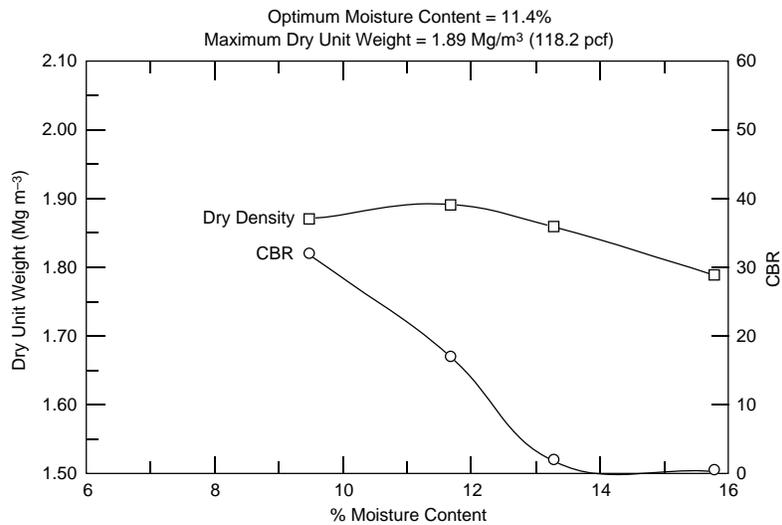
Figure B1. Wooded trail stations 1+50 (top), 8+25 (middle), and 16+50 (bottom).

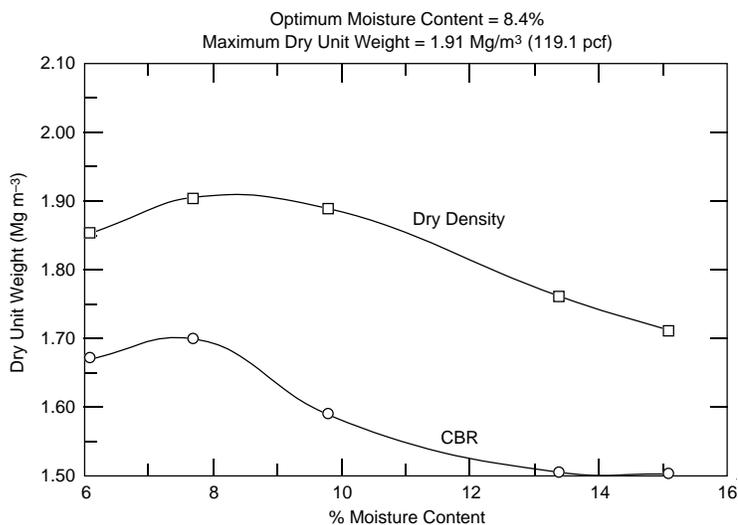
Figure B2. Pentagonal loop trail.

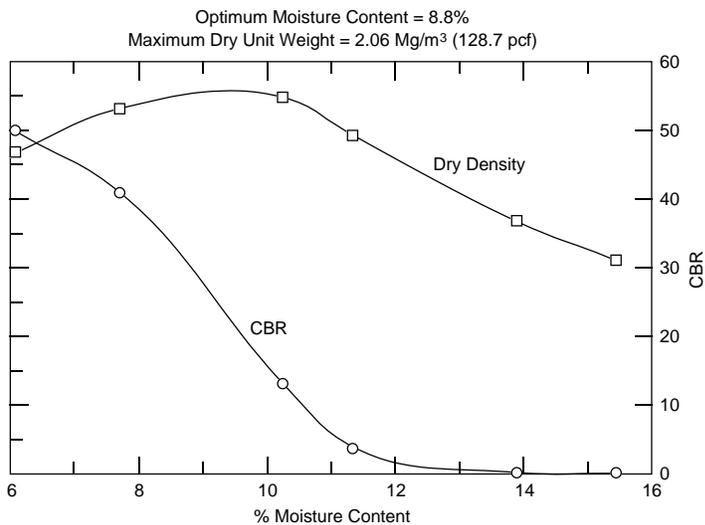
Figure B3. Slope trail.

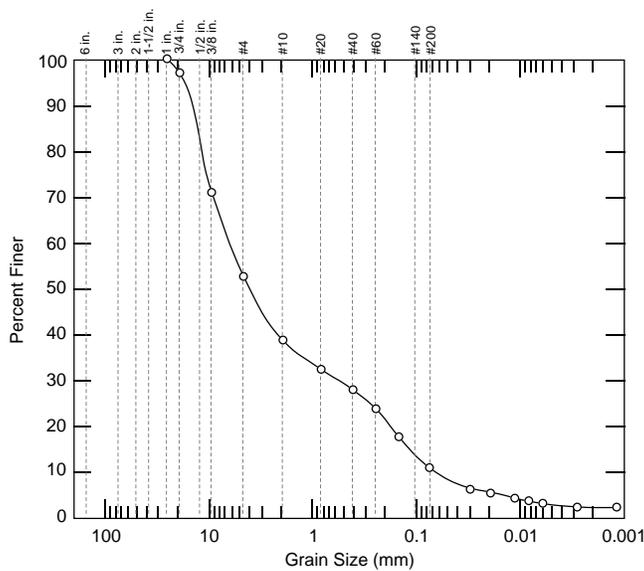
% +3"	% Gravel	% Sand	% Silt	% Clay					
○	0.0	47.0	41.7	8.3	3.0					
	LL	PI	D <sub>85</sub>	D <sub>60</sub>	D <sub>50</sub>	D <sub>30</sub>	D <sub>15</sub>	D <sub>10</sub>	C <sub>c</sub>	C <sub>u</sub>
○	none	none	13.9	6.38	4.07	0.512	0.112	0.0595	0.69	107.2
Material Description				USCS	AASHTO					
○ Gravel				GP-GM	A-1

Figure B4. Typical grain size distribution.

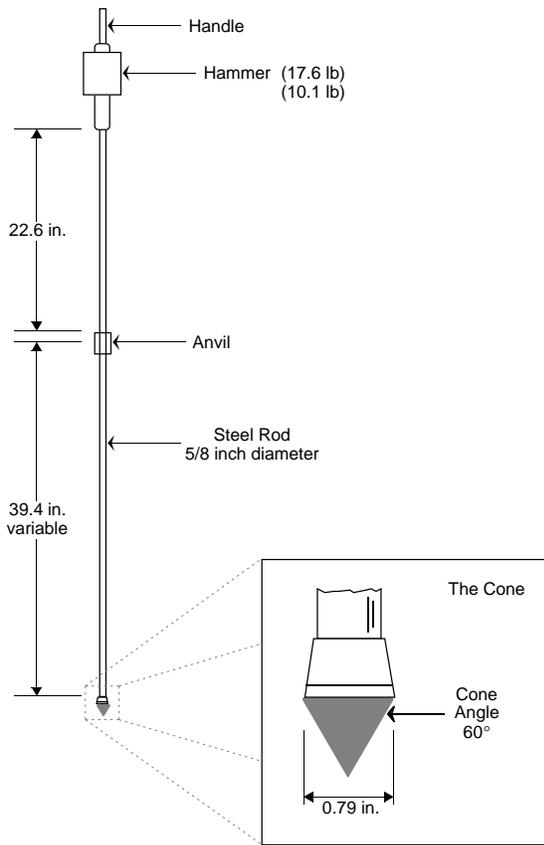
a. Dynamic cone penetrometer (DCP).

Figure B5. Sampling and testing devices.

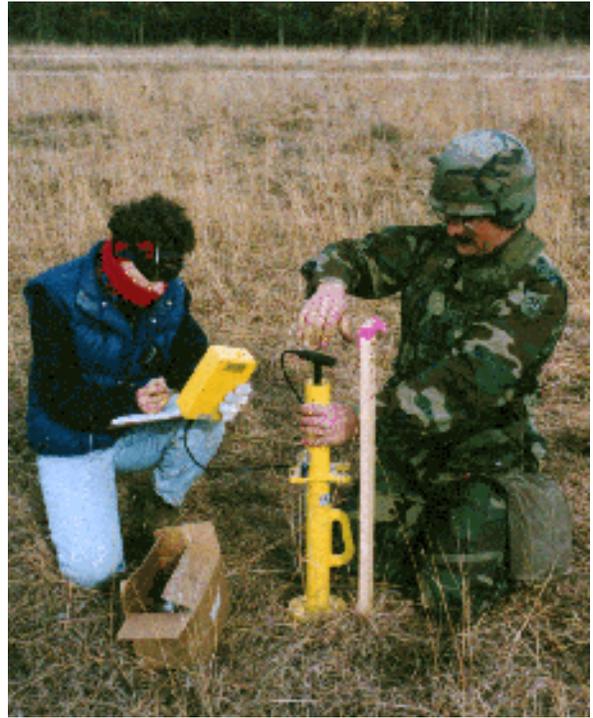
b. Clegg impact tester (CIT).

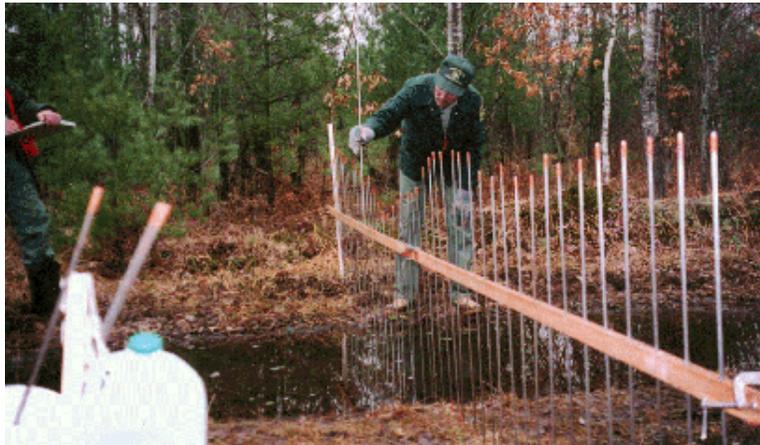
c. Measuring rut depths manually.

Intermediate rut depths can be measured by laying a straight rod or level across the rut and measuring the distance from the rod to the bottom of the rut. Final rut depths will be more thoroughly characterized by measuring the road profile using the profilometer (Fig. F5). CRREL will provide two profilometers which must be shared by the evaluators (one person can call the depth while the other records data).

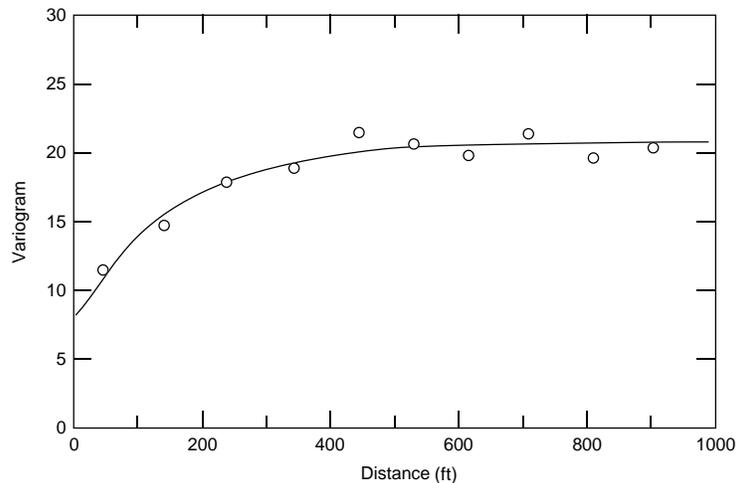
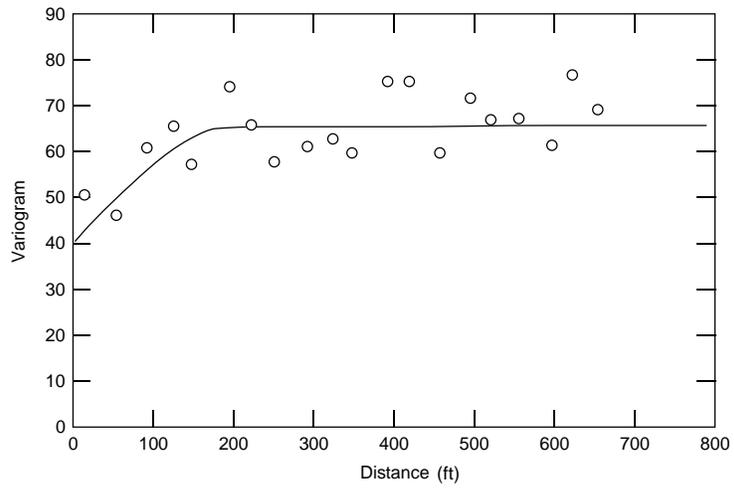
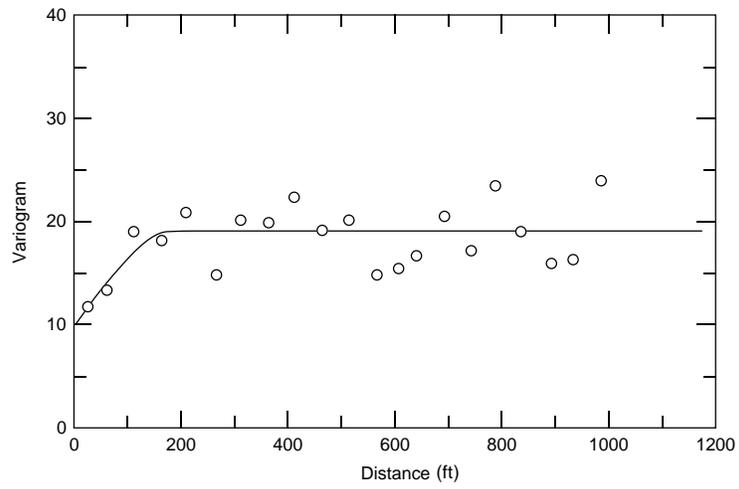
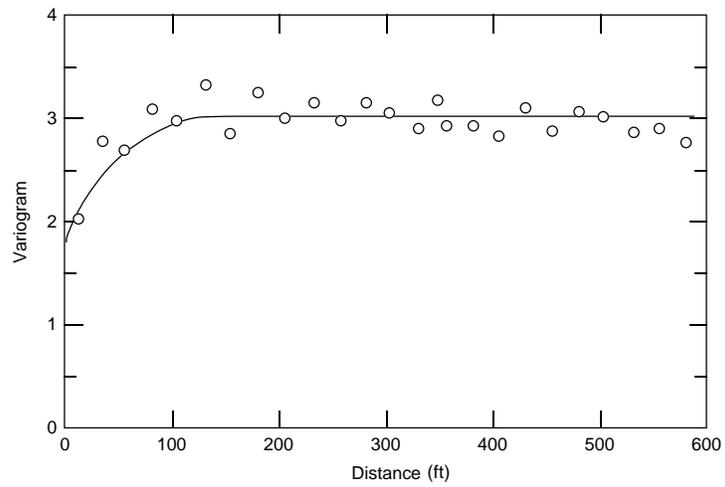
a. Gravimetric water content.

Figure C1. Experimental variogram—wooded trail subgrade.

Figures C1a–C1d show variograms with correlation ranges of 125, 67, 61, and 40 m (410, 220, 200, and 130 ft) corresponding to gravimetric water content,  $\ln CBR_{CLEGG}$ ,  $\ln$  thaw depth, and percentage of initial standing water. As stated above, these variograms indicate the distance over which any one parameter is correlated. The water content variogram, for instance, shows that wooded trail water contents are correlated for up to a distance of approximately 125 m (410 ft).

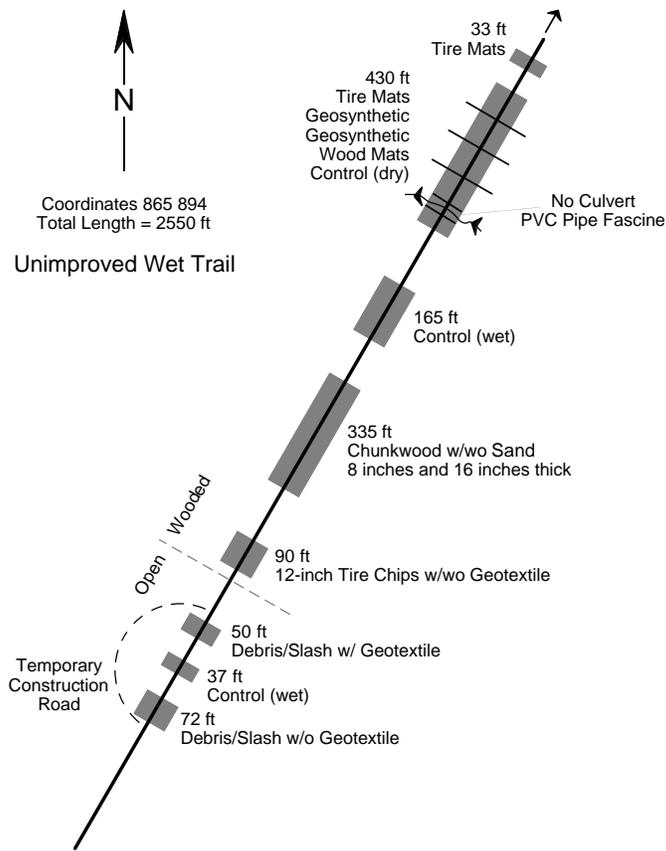
Figure F2. Wooded trail test sections.

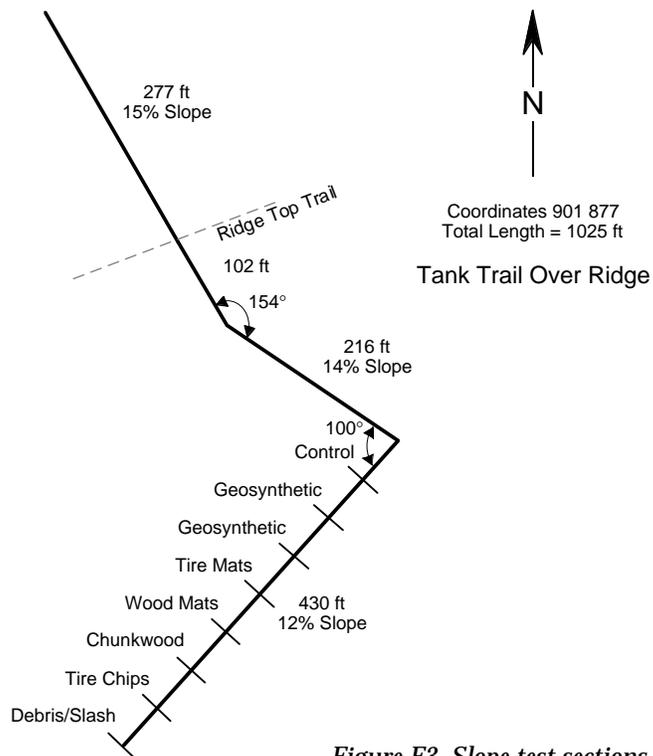
Figure F3. Slope test sections

The test sections will be laid out as in Figure F3. **The road grade should be made as uniform as possible prior to building the test sections.** This may involve grading or bulldozing to cut high spots and fill low areas.

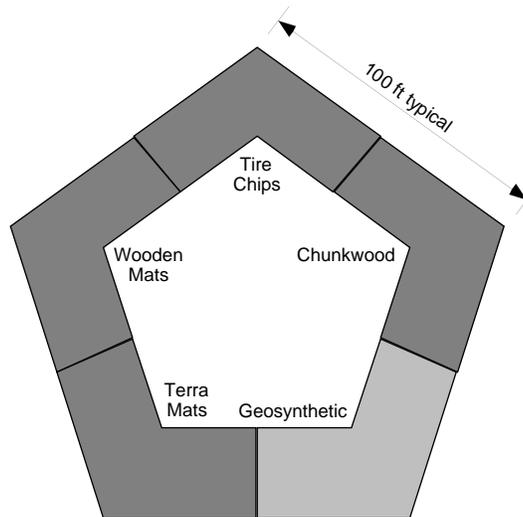
*Figure F4. Corners test section.*

The construction and performance of 5 of the test sections will be evaluated by building a pentagonal test section of 100-ft sides with the test sections centered on the corners as shown in Figure F4.
