# Rapid Stabilization of Thawing Soils for Enhanced Vehicle Mobility

## A Field Demonstration Project

Maureen A. Kestler, Sally A. Shoop, Karen S. Henry,  
Jeffrey A. Stark, and Rosa T. Affleck

CRREL Report 99-3

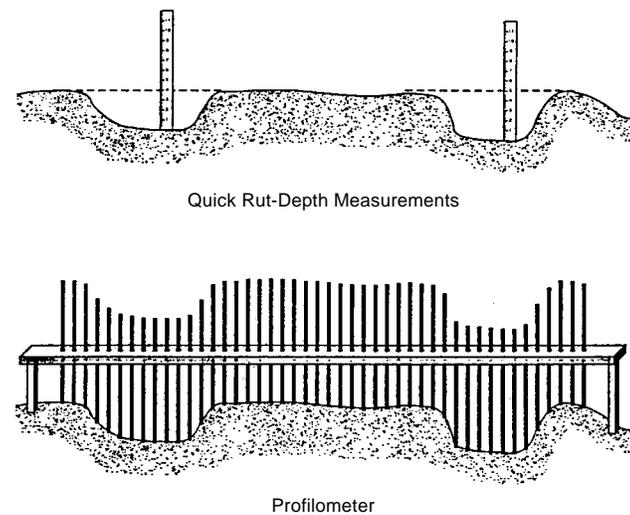
*Figure F5. Rut-depth measurements.*

Intermediate rut depths can be measured by laying a straight rod or level across the rut and measuring the distance from the rod to the bottom of the rut. Final rut depths will be more thoroughly characterized by measuring the road profile using the profilometer (Fig. F5). CRREL will provide two profilometers which must be shared by the evaluators (one person can call the depth while the other records data).

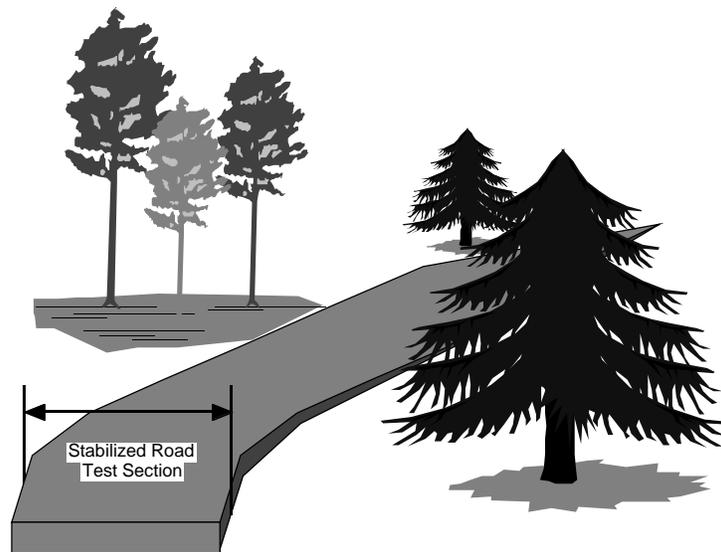
*Figure F6. Lateral expansion of test section.*

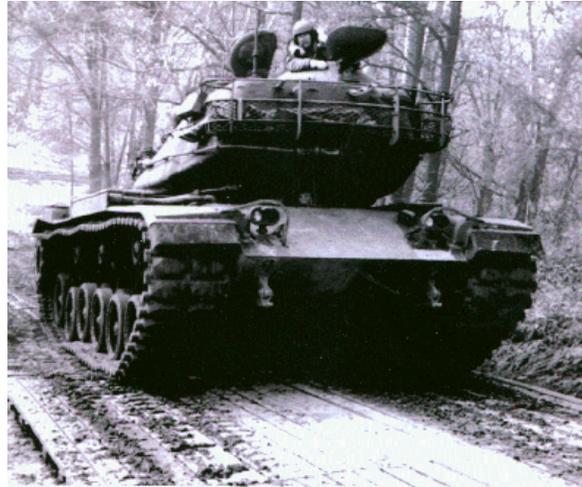
Specifications for the M60A3 Tank	
Crew	4
Combat weight	51,500 kg
Unloaded weight	47,500 kg
Power-to-weight ratio	14.56 bhp/tonne
Ground pressure	0.85 kg/cm <sup>2</sup>
Length gun forwards	9.436 m
Length hull	6.946 m
Width	3.631 m
Height	3.27 m
Firing height	2.095 m
Ground clearance	0.45 m
Track	2.921 m
Track width	711 mm
Track adjustment	Hydraulic
Track type	T142 replaceable pads
Length of track on ground	4.235 m
Max road speed	48.28 km/h
Fuel capacity	1420 liters
Max road range	480 km
Fording	1.22 m
Fording with preparation	2.4 m
Gradient	60%
Side slope	30%
Vertical obstacle	0.914 m
Trench	2.59 m
Engine	AVDS-1790-2D
Suspension	Torsion bar

*a. M60A1 Tank.*

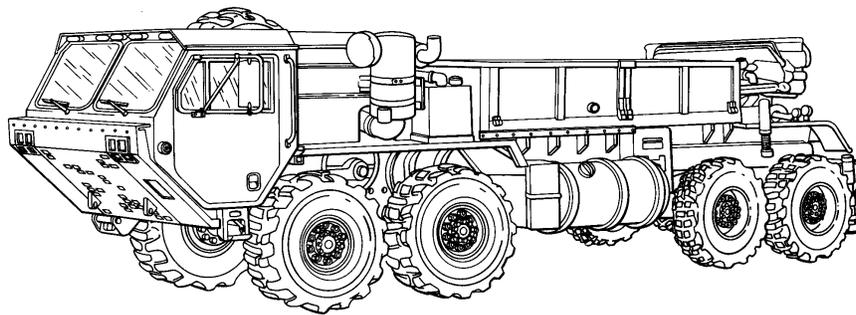
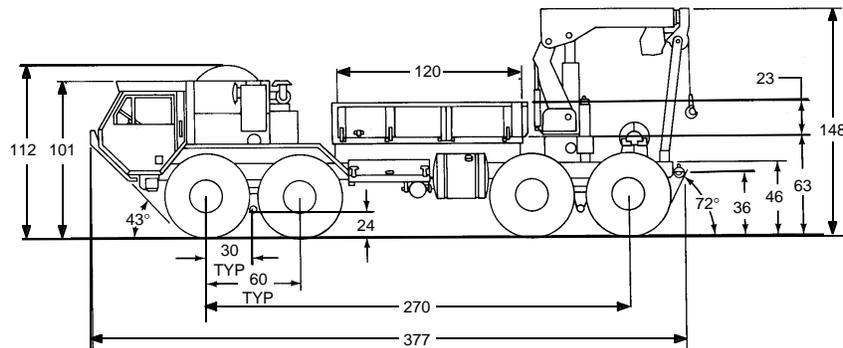
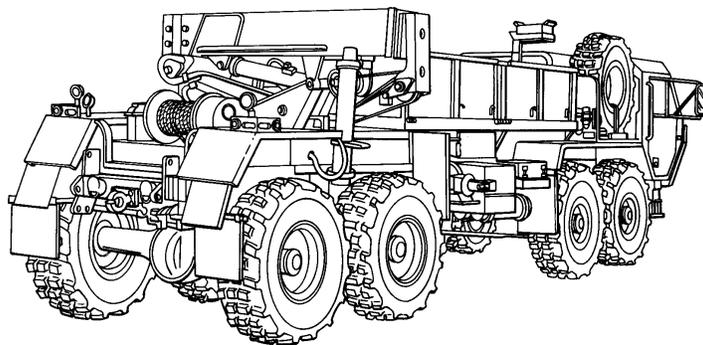
General Information	Performance data	Vehicle data
Nomenclature: 10 ton, recovery, 8x8, HEMTT, w/winch Model number: M984 Crew/cab capacity: 2 NSN: 2320-01-097-0248 LIN: T63093 SSN: D162030 TM: 9-2320-279-Series	Forging: w/kit: wo/kit: 48 in. Approach angle: 43 degrees Departure angle: 62 degrees Cruising range: 300 mi Maximum: Sustained forward speed (@ 2,100 rpm) 4th Gear: 57 mph 3rd Gear: 41 mph 2nd Gear: 28 mph 1st Gear: 15 mph Speed on 3 percent grade: 40 mph 30 percent grade: 5 mph Grade: Side slope w/adequate tractive Surface: 30% Towed speed (ref. FM 20-22): 15 mph	Type classification and date: Std A, 1980 Replaces/replaced by: Augments Goer Life Expectancy: 20 years Payload: 31,000 lb Towed load allowance: 20,000 lb Air transportability: C5, C141, & C130 aircraft
<b>Characteristics</b> Horsepower: 445 bhp @ 2,100 rpm Transmission: Automatic; Allison 740-HD Electrical system: 24 V, 12 pin Tires: Michelin 16:00 x R20XL Brakes: Air, 16.5 x 5F, 16.5 x 7R Blackout lights: Yes		<b>Equipment options</b> Kits: Arctic, alternator, GPFU, radio, M8 alarm machine gun Winch: Self recovery

<b>Shipping data</b> Weight: 41,574 lb Cube: 2,340 cu ft Ground clearance: 24 in.

All dimensions are in inches

*b. M984E1 wrecker/recovery HEMTT.*

*Figure 26 (cont'd). Vehicles used for trafficking Fort McCoy test sections.*
