FHWA/IN/JTRP-99/6

## LANDSLIDE REMEDIATION USING UNCONVENTIONAL METHODS

Joint Highway Research Program  
Project Number: C-36-34 CC  
File Number: 6-14-28

Purdue University  
West Lafayette, IN 47907  
September 1999

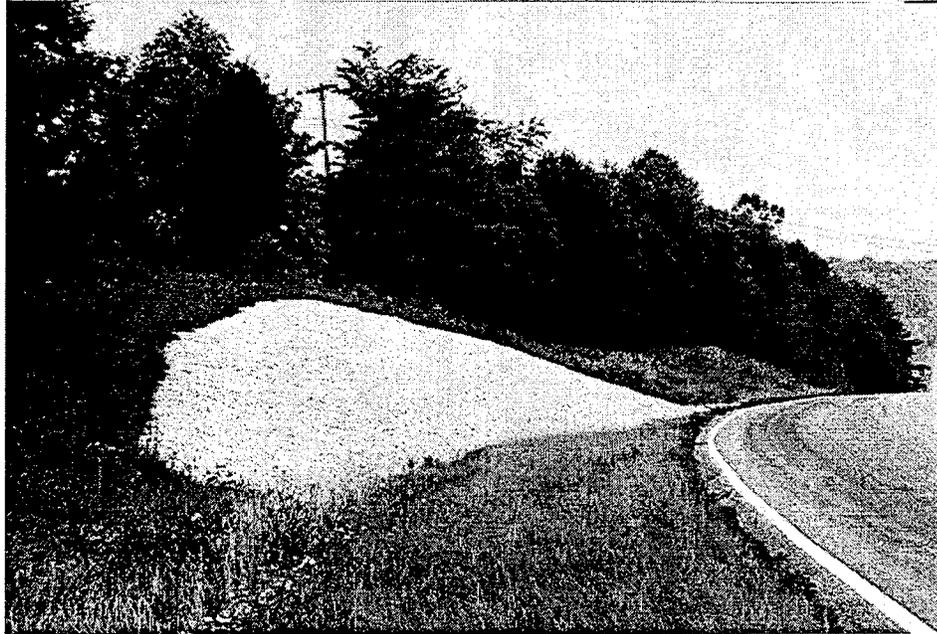
**Figure 1.** Landslide remediated using the excavation and backfill method on SR 64 in Crawford County.

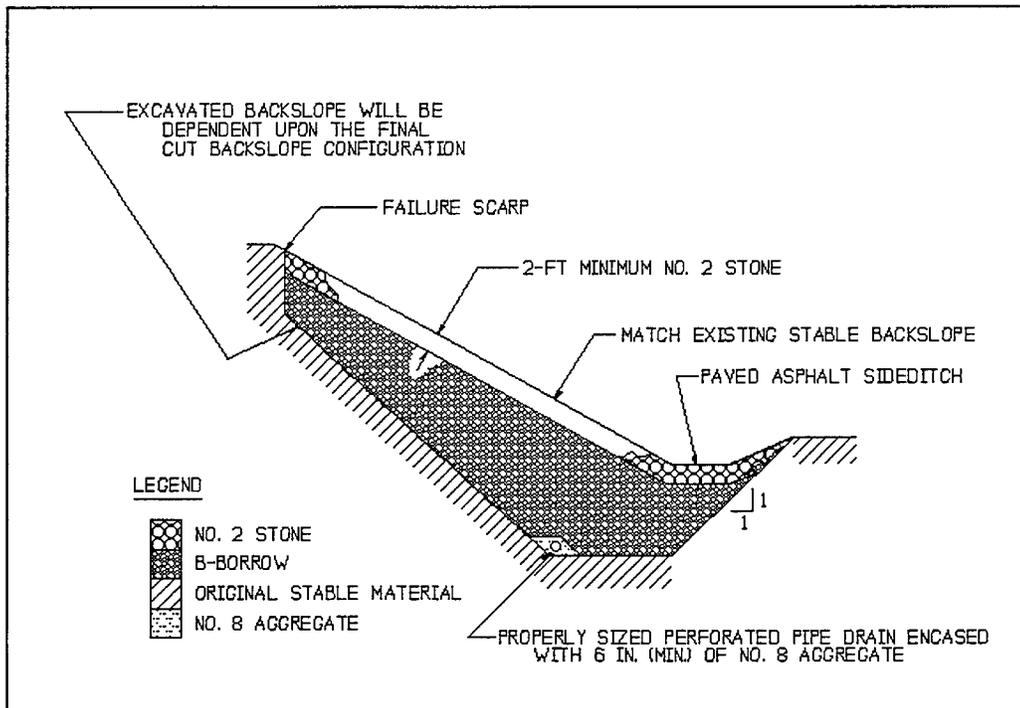
**Figure 2.** Cross-section view of typical excavation and backfill treatment. 'B'-Borrow is optional and may be replaced with stone.

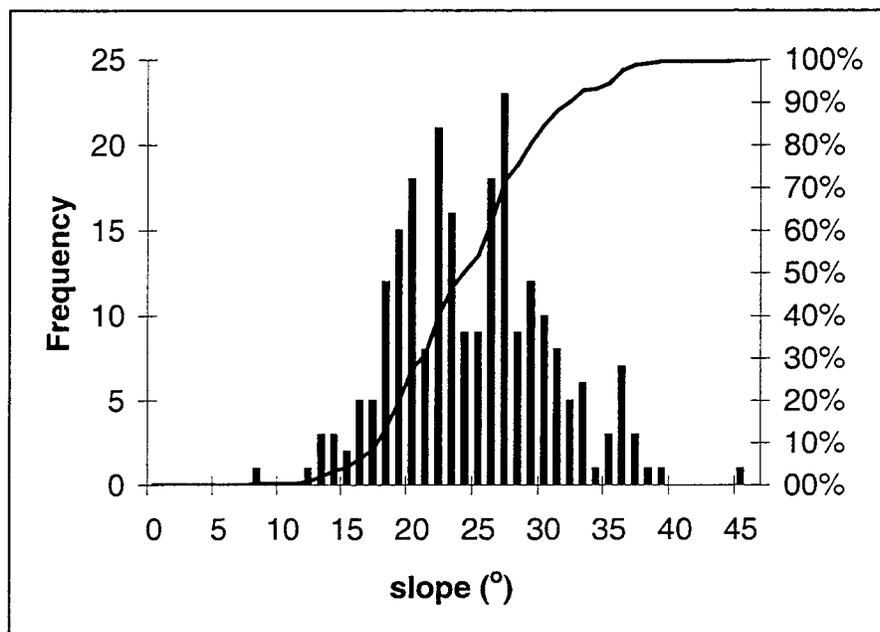
Figure 3. Slope Distribution.

A histogram of slope severity calculated from profile data of landslides is illustrated in Figure 3. Three distinct peaks occur at approximately 18, 22, and 26 degrees, which correspond to 3:1, 2.5:1 and 2:1 horizontal to vertical slopes: so it is observed that many landslides occur within engineered embankments and cut slopes.

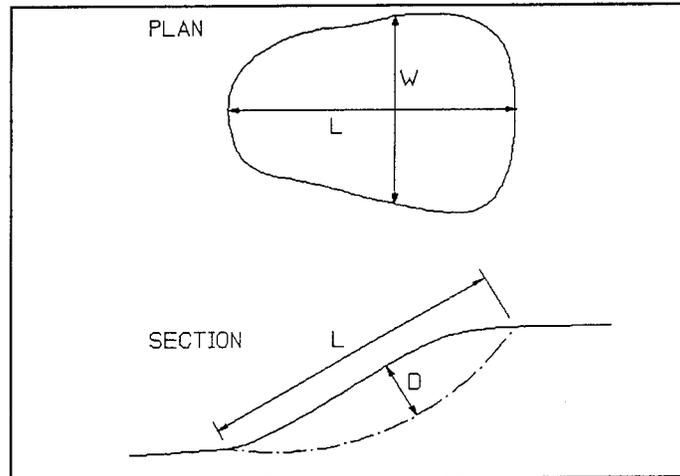
**Figure 4. Landslide Dimensions.**

The length (L), width (W), and depth (D) quantify the landslide geometry. These dimensions are illustrated in Figure 4. The depth to failure surface (D) is defined as the maximum depth from the ground surface to the surface of rupture (Varnes, 1978). D is approximated from either borelogs or slope inclinometer data if such information is available. For earth slump on bedrock landslides, D is assumed to be the average depth of overburden within the site. If borelogs are not available, the depth of overburden is that estimated in INDOT landslide field investigation forms.

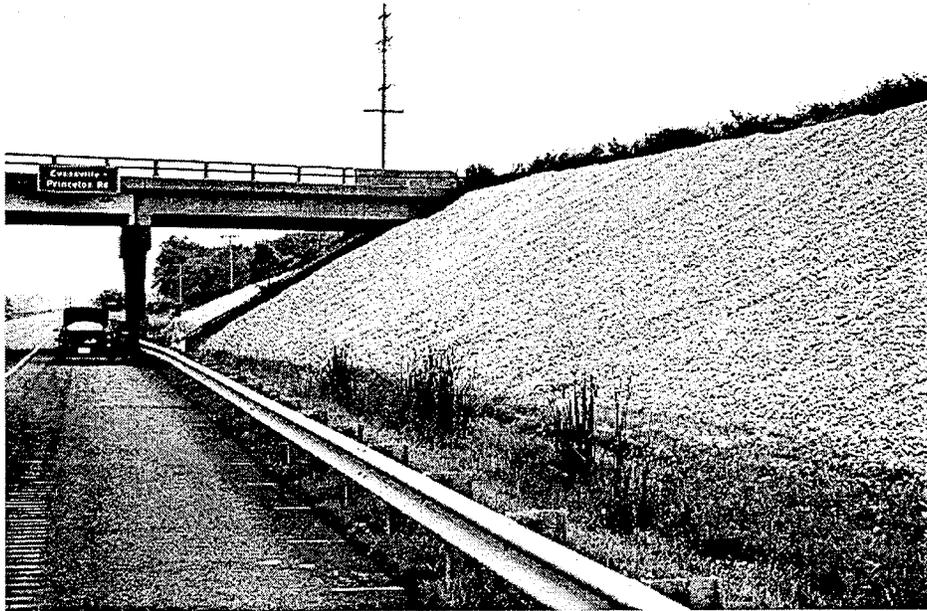
**Figure 5.** Cattails in ditch near toe of remediated landslide adjacent to I-64 in Vanderburgh County.

Vegetative cover was observed during field surveys and is described qualitatively within the inventory. Notice was taken to the presence of cattails, which are inherent in very wet areas where the groundwater table is high or perched water exists, indicating that the cause may likely be attributed to groundwater, and therefore, subsequent remedial action should incorporate subsurface drainage. Figure 5 is a photograph showing cattails in the ditch line at the toe of a corrected landslide.

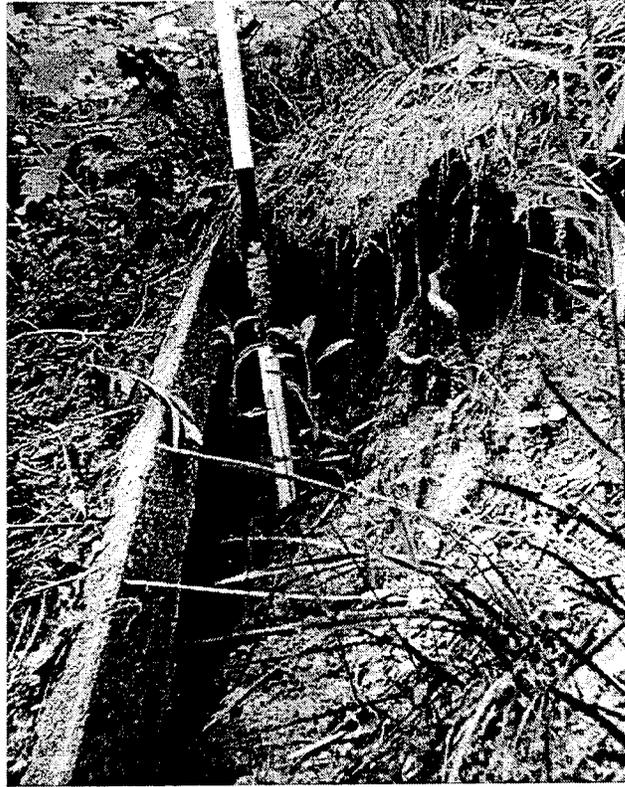
**Figure 6.** CPID at head scarp of landslide on SR 37 2.1 miles north of SR 54 in Lawrence County.

Twelve landslides are thought to have occurred due in some part to concrete paved interceptor (CPID) ditches that failed. Severe erosion often occurs parallel to the ditches between the edge of the CPID and the soil. Erosion opens channels for surface water to infiltrate into the subsurface, which may eventually cause failure. Figure 6 is a photograph showing erosion along a CPID that may have contributed to slope failure.

External drainage systems act indirectly to reduce groundwater levels by reducing infiltration, and are especially effective in reducing short-term infiltration during periods of intense and/or consistent precipitation. External drainage systems include interceptor and diversion ditches, and vegetation. INDOT often installs a concrete paved interceptor ditch (CPID) near the crest of cut slopes to divert overland flow from the slope crest. Erosion parallel to CPID's between the drainage structure and soil often occurs and may open infiltration paths within the soil mass acting counter to the intention of the design and thereby reduce stability. Figure 6 is a photograph showing erosion along a CPID that likely contributed to instability.

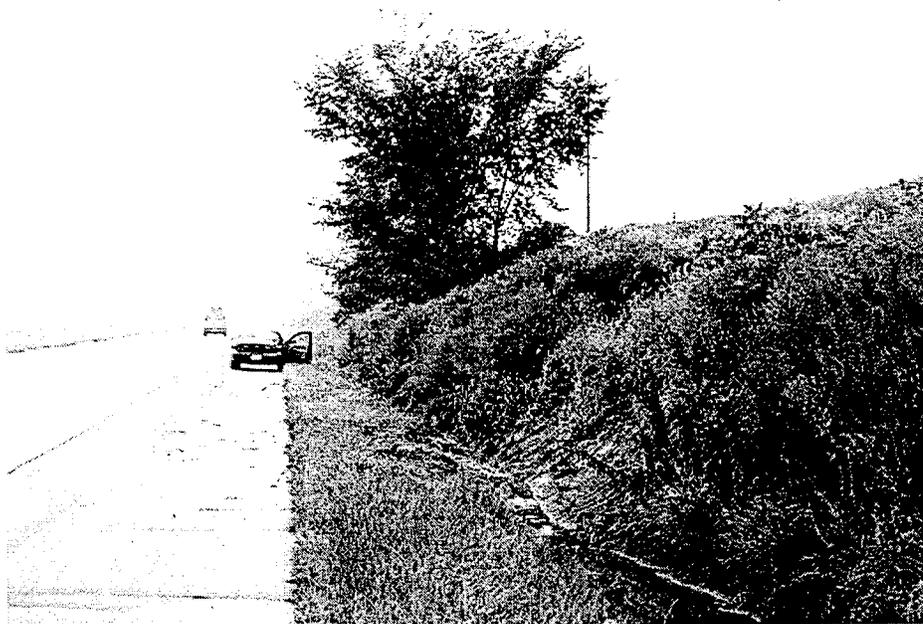
**Figure 7.** Fresh ditching at the toe of an active landslide adjacent to I-64 in Vanderburgh County.

Finally, for seven landslides it is thought that routine ditch maintenance may have caused instability, which removed needed toe support from the slope. Figure 7 illustrates recent ditching near the toe of an active landslide.

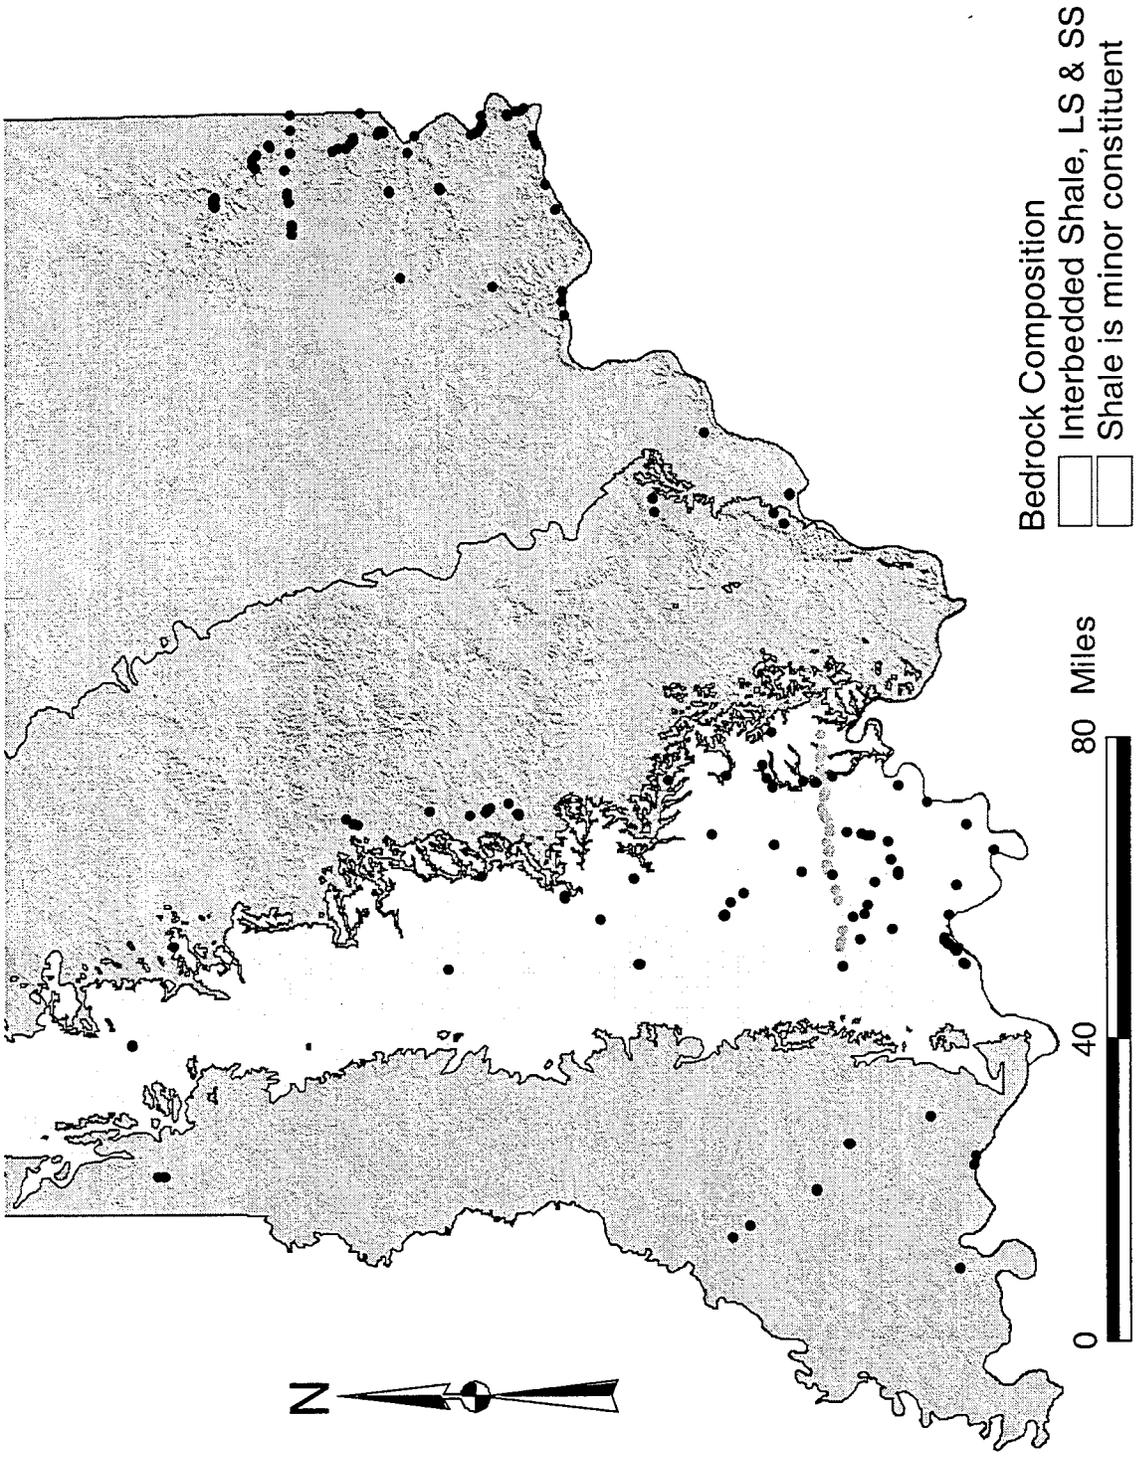
**Figure 13.** Landslide Occurrence within South Central Indiana Relative to Bedrock Composition.

Clearly landslide occurrence is not just a function of topography. Considering bedrock geology of the physiographic regions, the Crawford Upland Region is composed of the Raccoon Creek, Stephensport, West Baden, Buffalo Wallow and Blue River bedrock groups. These bedrock groups are composed of alternating layers of shale, limestone and or dolomite, with shale being a significant constituent. The Norman Upland Region is composed of the Sanders and Borden bedrock groups. These groups contain mostly siltstone and limestone, with shale as a minor constituent. Figure 13 illustrates this fraction in bedrock composition respective of landslide occurrence.

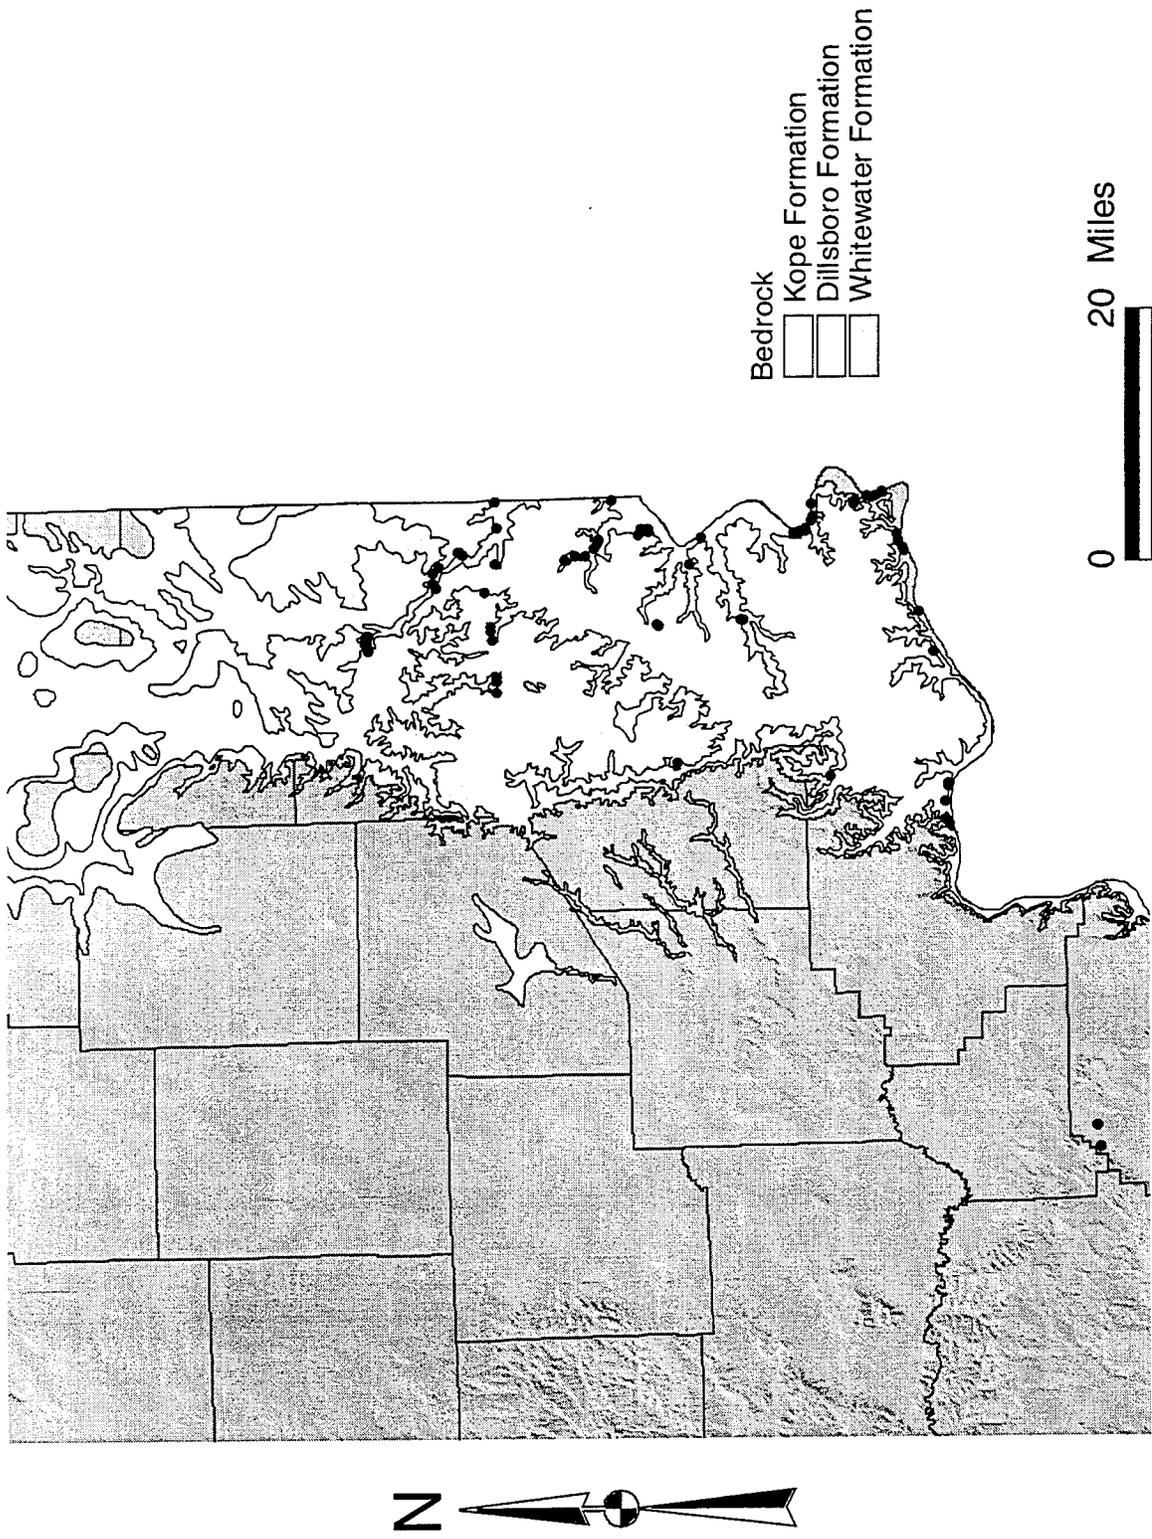
**Figure 14.** Landslide Occurrence within Southeast Indiana Relative to Bedrock Formation.

Figure 14 illustrates landslide occurrence in Southeast Indiana within the Dearborn Upland Region respective of bedrock geology. Landslides within the Dearborn Upland Region occur primarily within the Kope and Dillsboro Formations, which are composed mostly of shale. The Kope Formation is predominately composed of clay shale, containing about 5 percent fossiliferous limestone, and the Dillsboro Formation is composed of about 30 percent argillaceous limestone and 70 percent shale (Shaver et al., 1970). The Kope Formation is notorious for the occurrence of landslides in and around Cincinnati, Ohio and is also responsible for many failures within Southeast Indiana and Northern Kentucky. Therefore, landslide occurrence within Southeast Indiana is also function of both bedrock geology and topography. Landslides within the Kope Formation have never been known to penetrate into the bedrock. Failure within this formation usually occurs along the soil-bedrock interface (Gray, 1985).

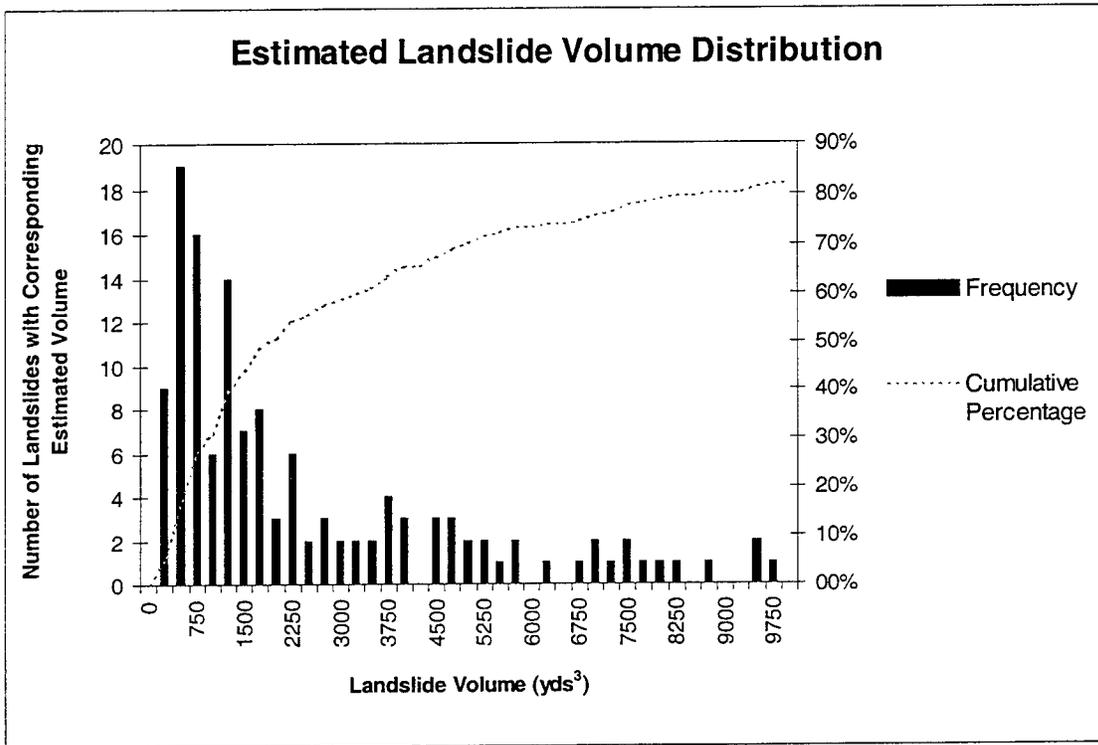
**Figure 15.** Histogram of Estimated Landslide Volume.

The volume of the idealized landslides are not arbitrary, they are reflective of the range of landslide volumes estimated in the inventory. It was only possible to estimate the volume for 163 landslides in the inventory. The average estimated landslide volume of these landslides is about 6400 yd<sup>3</sup>, and ranges from about 100 to 84,000 yds<sup>3</sup>. Figure 15 is a histogram of estimated landslide volumes and illustrates that approximately 80% of the estimated landslide volumes are below about 9000 yds<sup>3</sup>, and 50% are below 2000 yds<sup>3</sup>. Case II is thought to represent the average estimated landslide volume, while Case I is significantly below this average and Case III is significantly above this average.

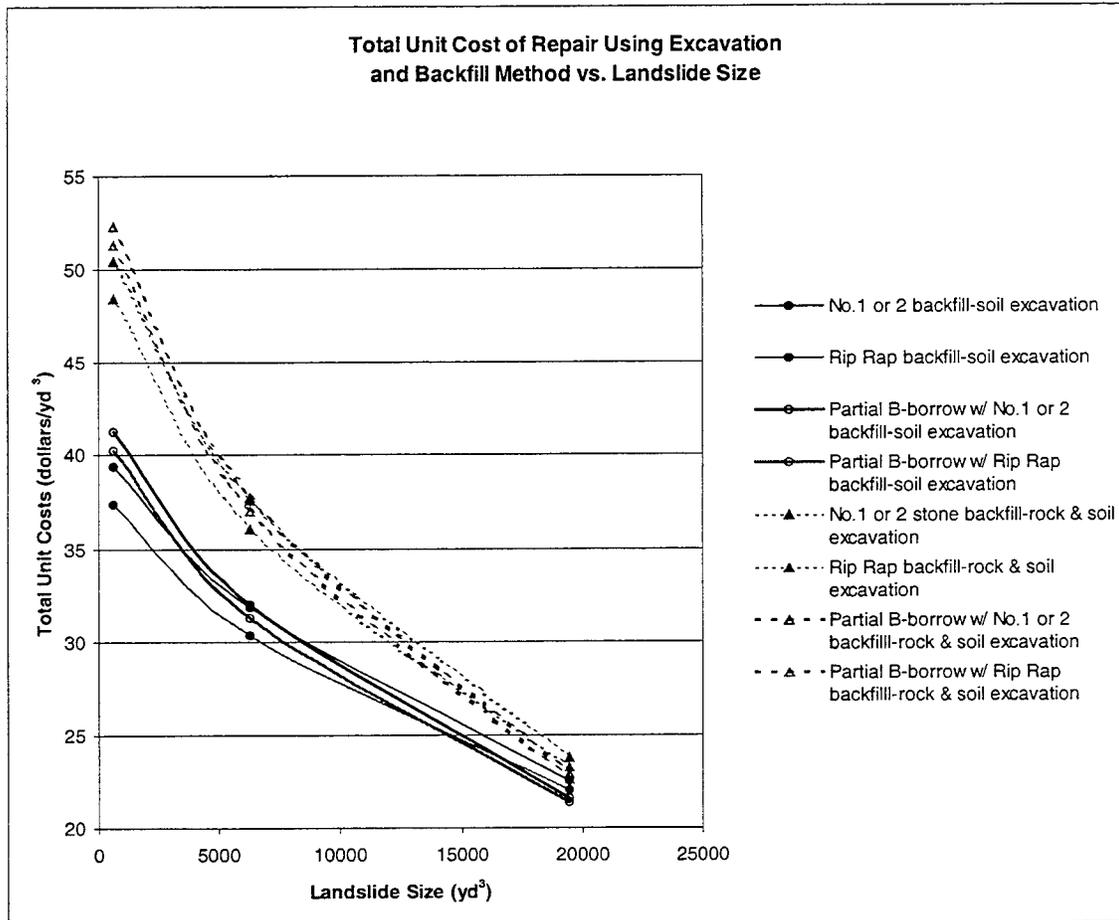
**Figure 16.** Unit Cost of Repair Using Excavation Backfill Method vs. Landslide Volume.

Figure 16 summarizes the unit cost of each scenario relative to the landslide size. As observed, unit cost of repair significantly decreases with increasing landslide volume. Excavation within rock significantly increases the costs of repair for smaller slides, but does not increase the cost of repair for larger landslides. This is due to two reasons; the unit cost for excavating rock decreases with increasing volume of excavated rock, and the percentage of excavation required within rock decrease with increasing total excavated volume. Many slope failures are believed to occur at the soil-bedrock interface, not within the rock mass. As such, ideally bedrock excavation will be required to remove only the weathered, degraded veneer on the top of the bedrock surface.

As observed in Figure 16, cost savings using 'B borrow' material is not realized until the excavated volume exceeds approximately 6,000 yd<sup>3</sup>. This may be because 'B-borrow' material must be compacted much more thoroughly compared to granular backfill. The time and equipment costs required to properly compact 'B-borrow' material exceeds costs required to import granular fill until the volume of fill exceeds approximately 6,000 yds<sup>3</sup>.

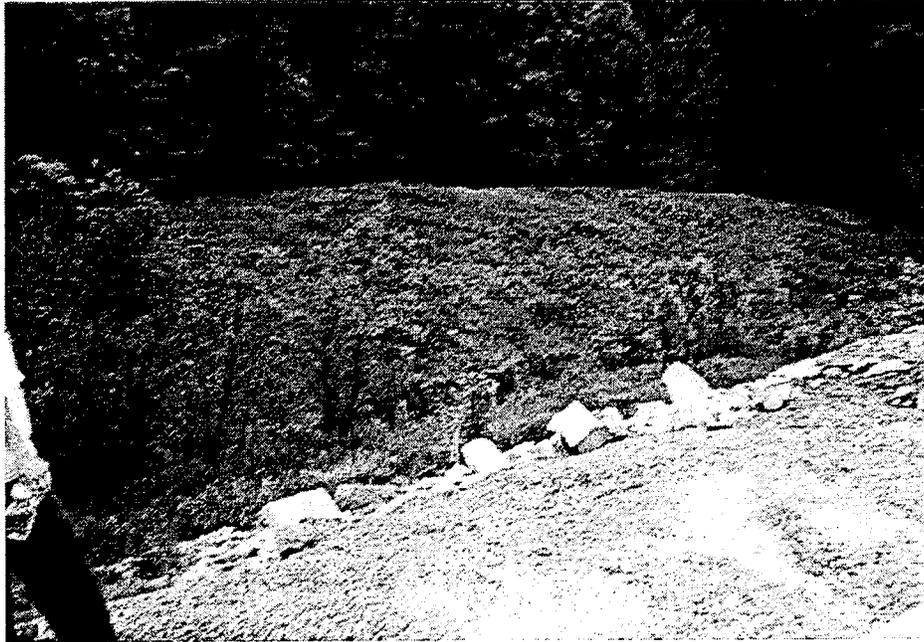
**Figure 17.** Erosion along riprap lined drainage ditch at toe of landslide on SR 450, 8.6 miles northeast of US 50 in Martin County.

Erosion can also occur near the toe of a landslide due to natural or man made drainage features. Whether a perennial stream, intermittent stream, or drainage ditch, during periods of intense or continuous precipitation, water flowing at the toe of a landslide may erode soil, which may lead to instability. Figure 17 is a photograph showing erosion at the toe of a landslide due to a small ditch running parallel to the base of the slope.

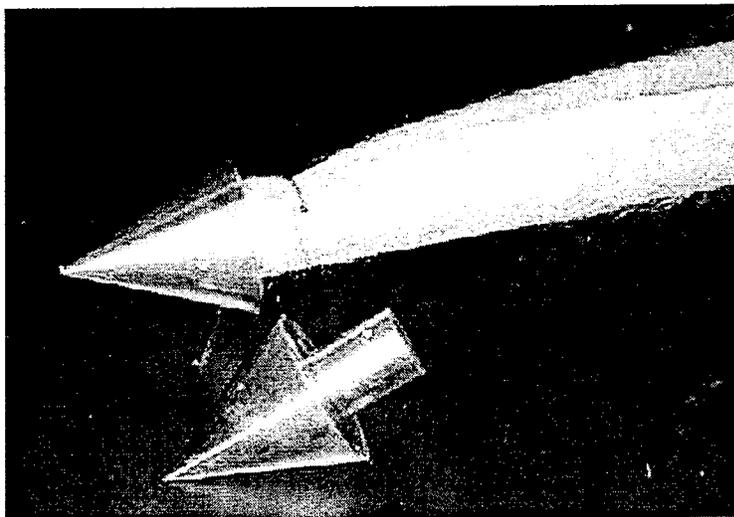
**Figure 18.** Disposable drive cone and wick drain (Santi, 1999).

The installation technique is as follows: a jackhammer, hydraulic shovel, bulldozer or trackhoe works from a prepared platform cut in the slope to push small diameter steel pipe into the slope. The annulus of the steel pipe is preloaded with wick drain, which is attached to a disposable drive cone at the advanced end of the pipe. Figure 18 is a photograph showing the disposable drive cone and wick drain. After the loaded steel pipe is pushed or driven to target depth, the steel casing is removed, abandoning the disposable drive cone and leaving the wick drain.

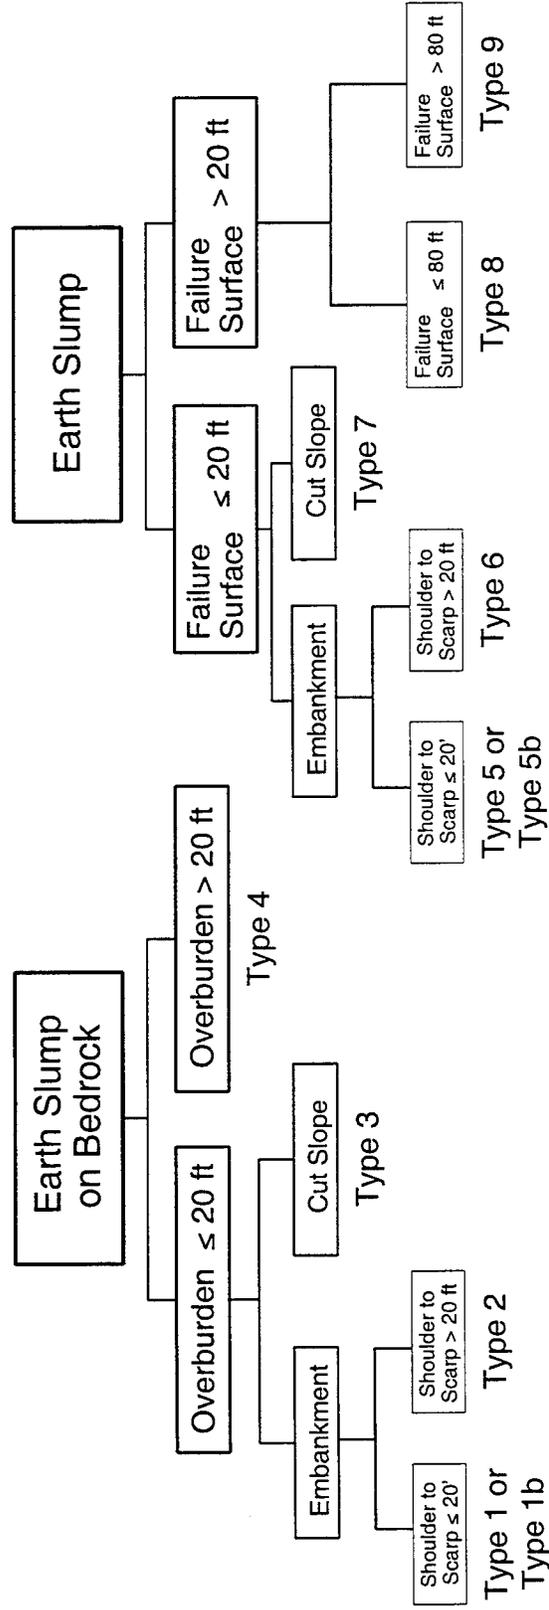
Figure 20. Landslide Classification Flowchart

The classification scheme is represented by the flowchart illustrated in Figure 20. Eleven landslide types are defined from the following four landslide attributes included in the landslide inventory.

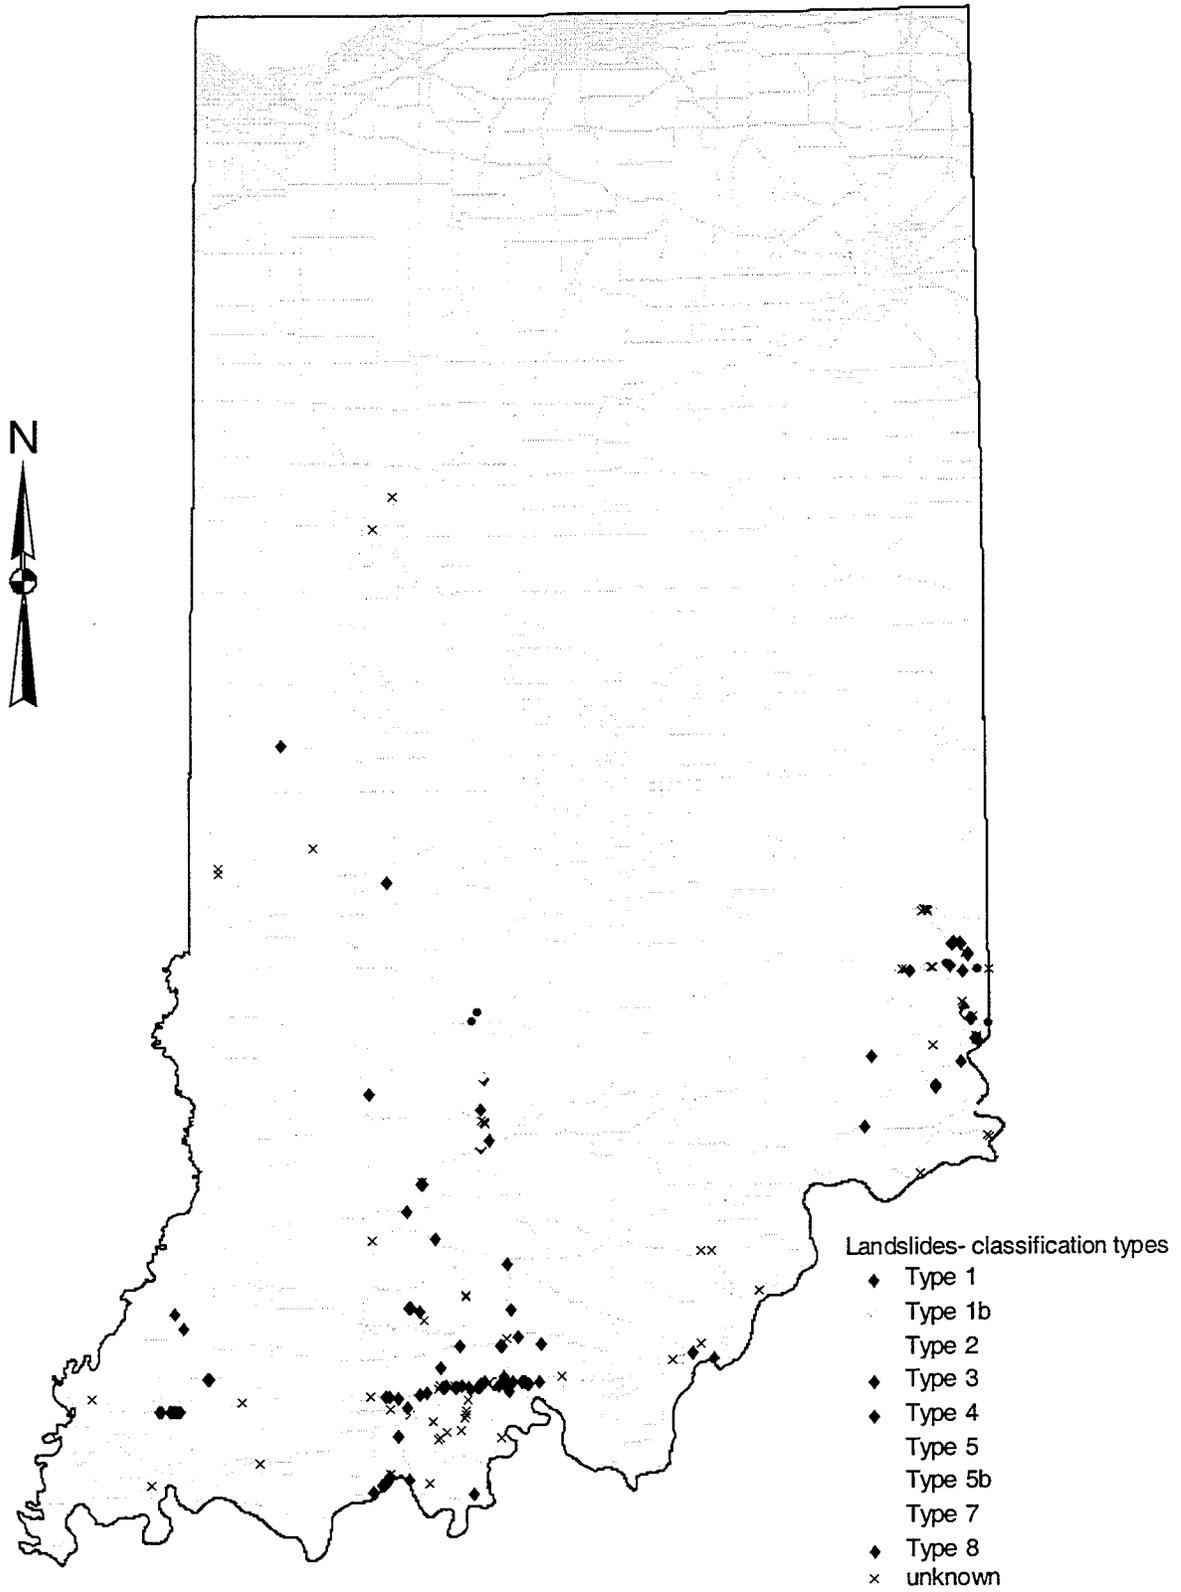
**Figure 21.** Aerial Distribution of Landslide Type.

Figure 21 illustrates the aerial distribution of the landslide types. The most common landslide types (Type 1, 3, 4 and 8) are represented as various colored triangles and other landslide types are represented as various colored dots.

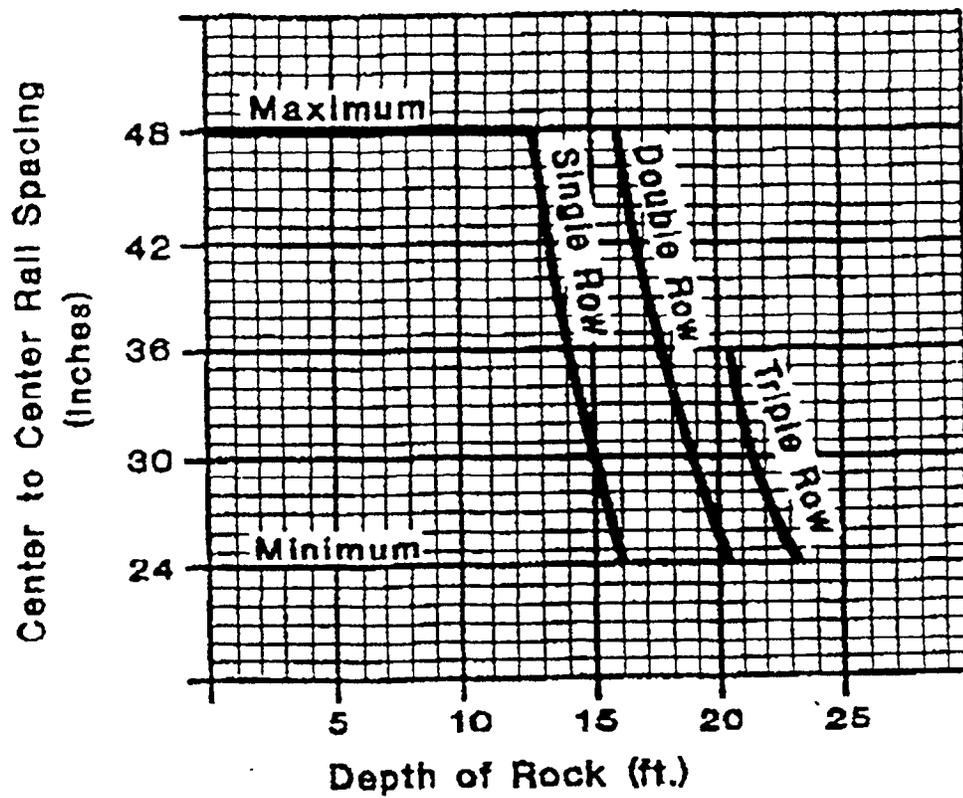
### Design Chart for 130 to 133 lb./yd. Rails

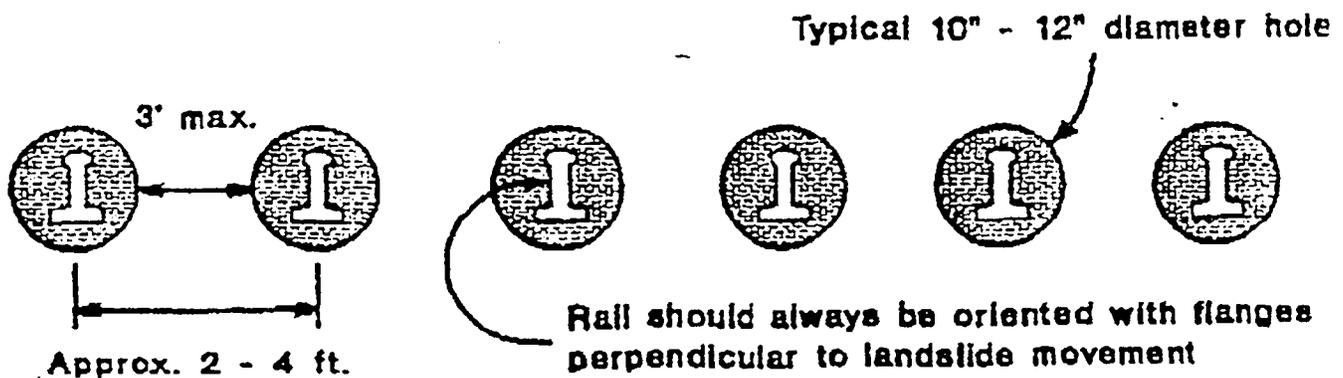
## Scheme I

# ALTERNATE SCHEMES FOR INSTALLING RAILROAD RAILS PLACED IN DRILLED SOCKETS

One row may be used when the effective spacing varies from approximately 2 - 4 ft.
