Effects of Fire Damage on the Structural Properties of Steel Bridge Elements

FINAL REPORT

University of Pittsburgh

1. Report No. FHWA-PA-2011-009-PIT011		2. Government Accession No.		3. Recipient's Catalog No.	
4. Title and Subtitle Effects of Fire Damage on the Structural Properties of Steel Bridge Elements				5. Report Date April 30, 2011

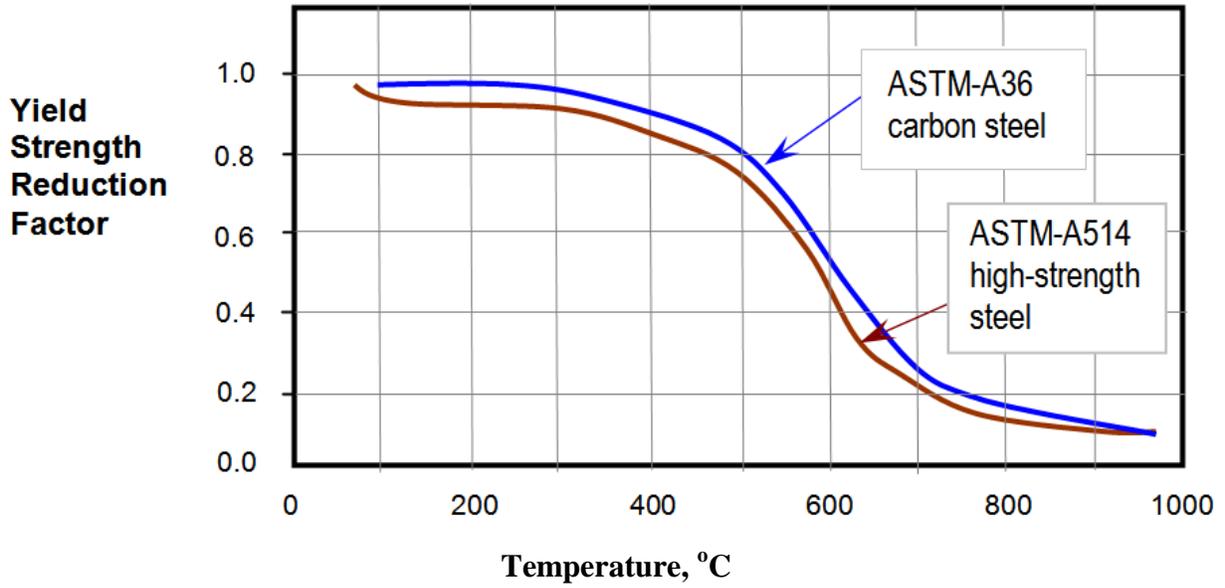
Figure 2.1. Reduction of steel yield strength with temperature (Astaneh-Asl et al. 2009)

Astaneh-Asl et al. (2009) discuss the effects of elevated temperatures due to fire on the material properties of steel bridges. As shown in Figure 2.1, the tensile yield strength of the steel decreases gradually up to 500°C (932°F). It is reduced to about 50% of its nominal yield strength at 600°C (1112°F). This essentially eliminates any factor of safety, which is usually between 1.5 and 2.0 for bridge calculations. The steel yield strength decreases more rapidly for temperatures greater than 500°C (932°F), and failure may be inevitable if temperatures keep increasing while the loading is sustained.

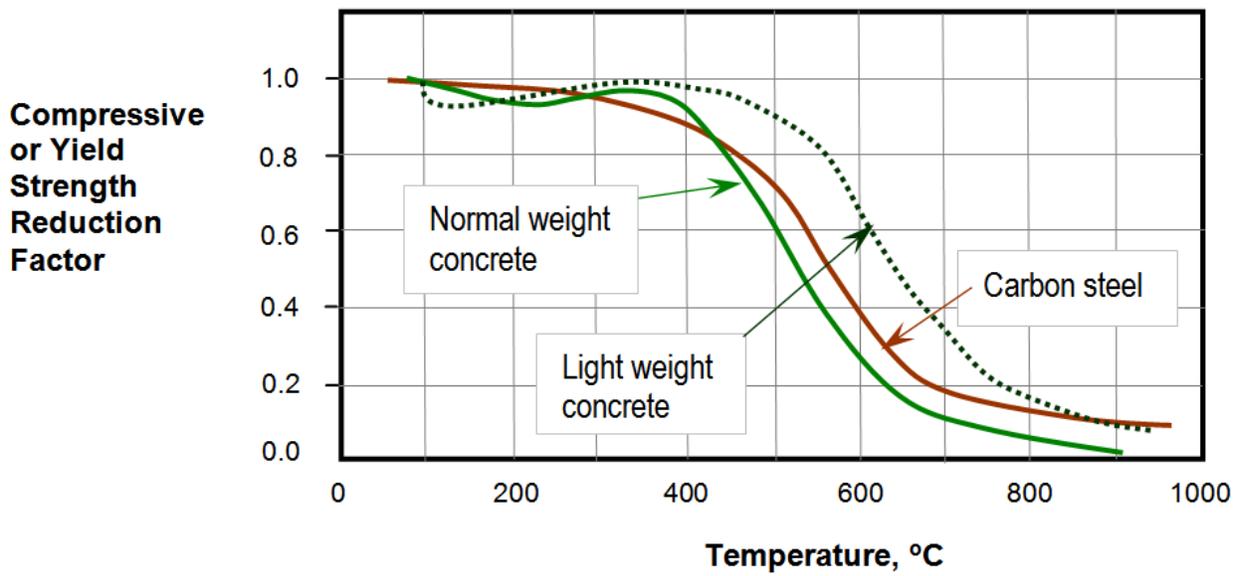
Figure 2.2. Reduction in concrete compressive strength with temperature (Astaneh-Asl et al. 2009)

Astaneh-Asl et al. (2009) also discuss the effects of elevated temperatures due to fire on the material properties of concrete. Concrete undergoes cracking, spalling, and experiences a decrease in stiffness and strength as the temperature increases. Concrete has low thermal conductivity, which allows it to undergo heating for longer durations before the temperature increases significantly and damage occurs. As shown in Figure 2.2, the concrete compressive strength starts decreasing rapidly after its temperature reaches approximately 400°C (750°F). At temperatures of around 500°C (932°F), the concrete compressive strength is reduced to 50% of its nominal strength.

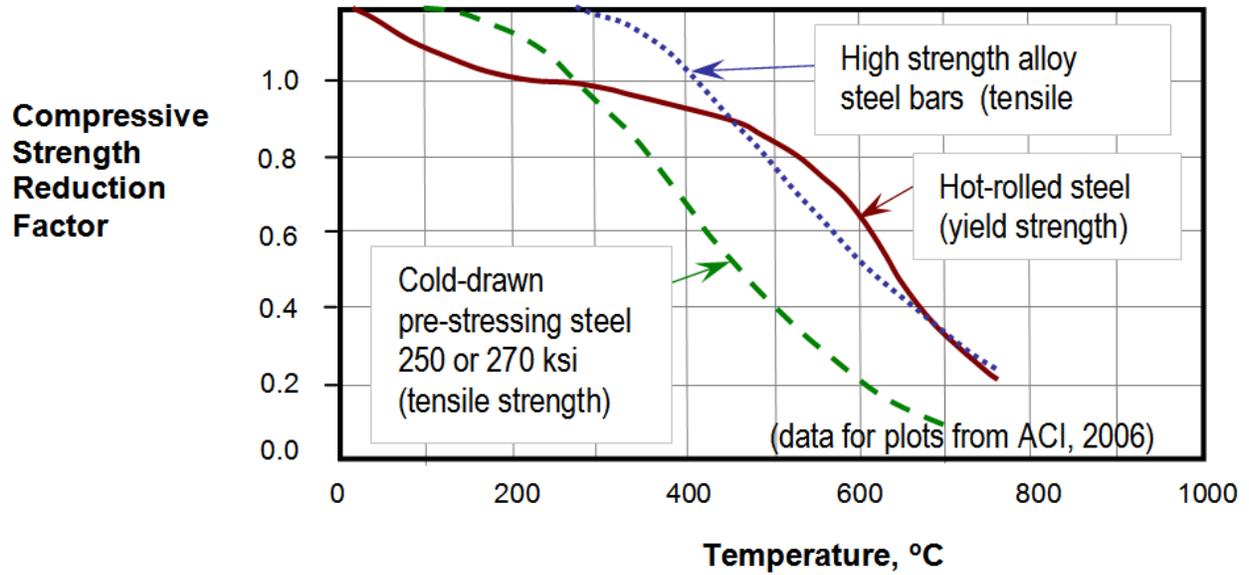
Figure 2.3. Reduction in strength of prestressing steel and high strength alloy bars with temperature (Astaneh-Asl et al. 2009)

Figure 2.3 shows the reduction in the tensile strength of high strength low alloy (HSLA) reinforcing steel and prestressing steel with elevated temperatures. As shown, the tensile strength of prestressing steel reduces steadily for temperatures greater than 300°C (570°F), and the tensile strength of HSLA bars reduces steadily for temperatures greater than 400°C (750°F). Figure 2.4 shows the reduction in the tensile strength of high strength bolt and weld material at elevated temperatures. As shown, these strengths reduce gradually up to 400°C (750°F), and then reduce more rapidly and steadily for temperatures greater than 400°C (750°F).

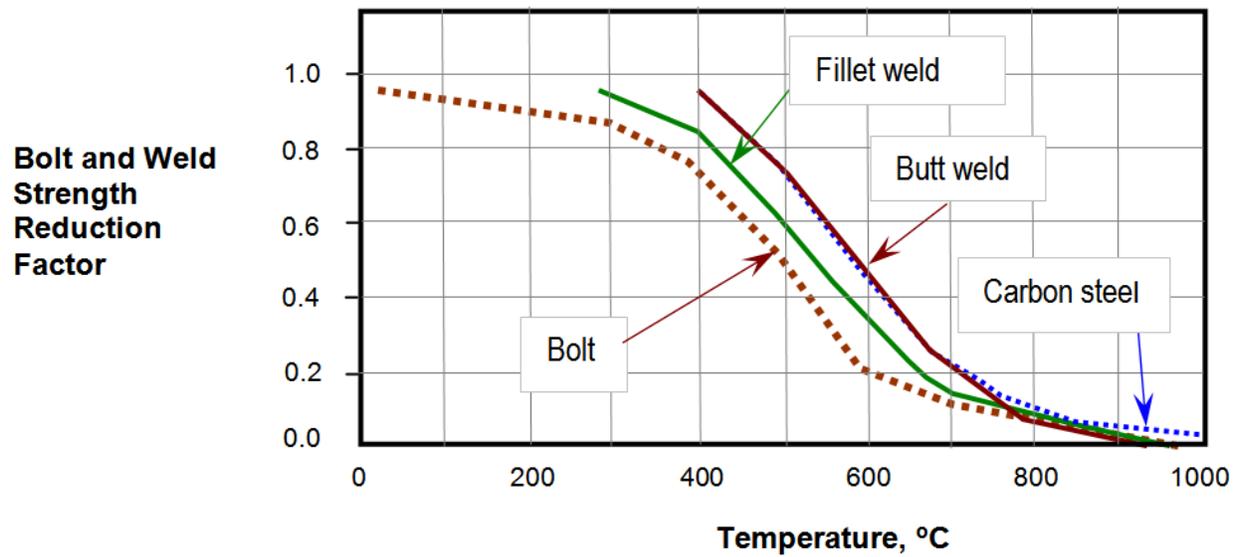
Figure 2.4. Reduction in strength of bolts, welds, reinforcing bars with temperature (Astaneh-Asl et al. 2009)

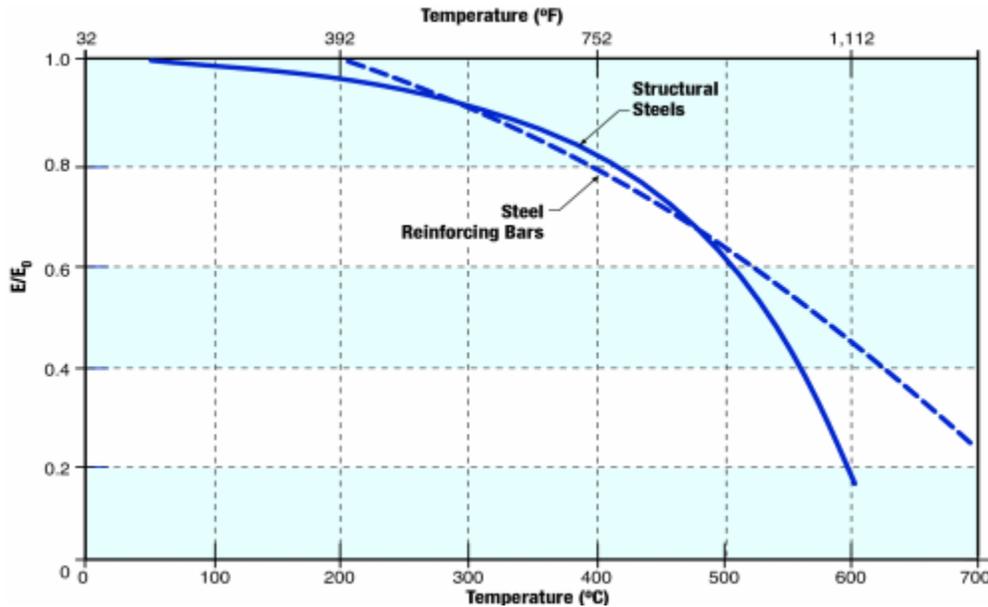
Figure 2.5. Reduction in modulus of steel with respect to temperature (SFPE 2000).

Figure 2.5 shows reduction in modulus with increase in temperature. As shown, the modulus reduces gradually up to 400°C (750°F), and then reduces more rapidly for temperatures greater than 400°C (750°F).

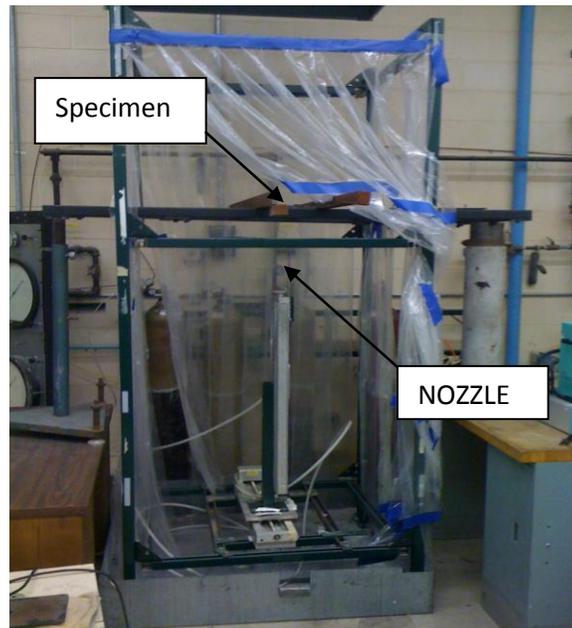
The controlled fire exposure tests were conducted at Zukrow Laboratory, which is an indoor fire testing laboratory at Purdue University in West Lafayette, Indiana. A steel frame superstructure with a flame jet setup within the fixture was used to apply controlled fire exposure to the steel bridge elements (plates). A photograph of the flame jet setup in Zukrow laboratory is shown in

Figure 4.1. At the top of the setup is an exhaust fan that discharges the soot and smoke from flame safely to the outside of the laboratory.

Figure 4.1. Photograph of jet flame test set up.

The flame jet consisted of an 8 mm nozzle connected to an adjustable meter, which allowed calibrated mass flow rates to be achieved. Ethylene gas (C_2H_4) was used to simulate the fire exposure. This is a sooting fuel with adiabatic flame temperature of $2900^{\circ}C$ ($5252^{\circ}F$). This temperature assumes a pre-mixed flame and no heat loss. However, in the tests there was heat loss to the specimen and cooling from the ambient surroundings, which was also representative of real bridge fire exposures.

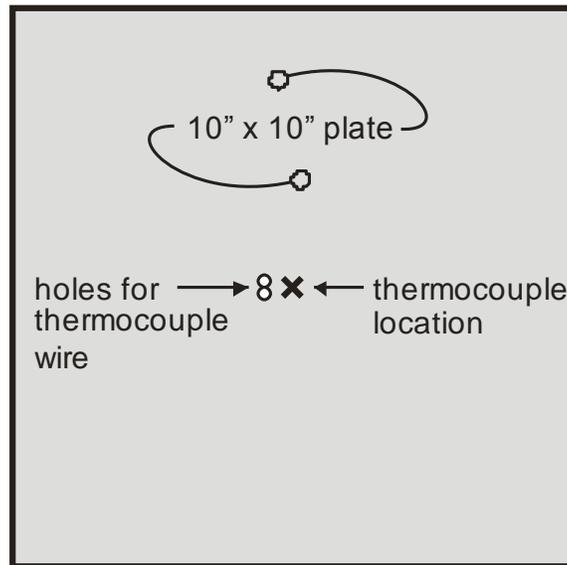
As shown in Figure 4.3, each plate specimen was approximately 10 x 10 in., and was instrumented with two thermocouples. The thermocouples were attached to the center of the specimens on both sides, i.e., (i) the flame side or bottom, and (ii) the non-flame side or top. Two 1/16" holes were drilled just off center in order to allow the thermocouple wires to pass through the plate from the top to minimize flame disturbance on the plate. For the same reason, the holes and the thermocouples are covered with a smooth layer of fiberglass paste.

Figure 4.3. Plate Specimen with Thermocouples.

The thermocouples were connected to a data acquisition unit which recorded temperatures of the surfaces of the plate at user defined time intervals. A thermal imaging camera was also used to visualize the heat intensities in the flame and on the plate surface. The intensity could also be used to determine the highest temperature in the flame and the difference in temperatures in the specimens. An infrared temperature gun was also used to take spot readings of specimen temperatures and compare it with thermocouple measurements.

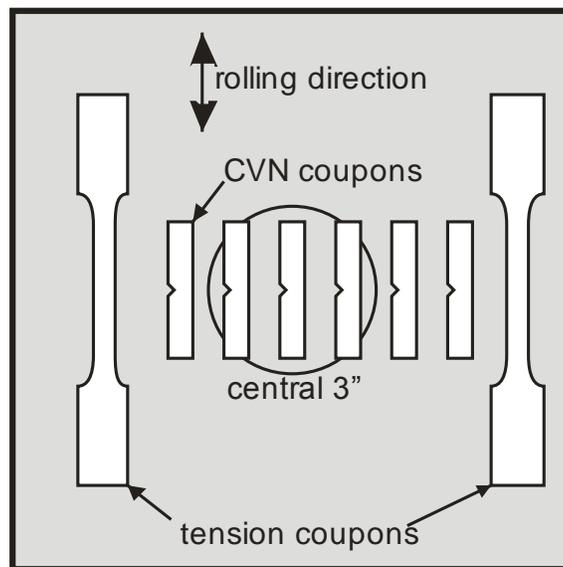
Figure 4.4. Layout of Material Coupons Taken From Plate Specimens

After subjecting the plate specimens to controlled fire exposures, material tests were conducted on coupons fabricated according to applicable ASTM standards. As shown in Figure 4.4, from each plate specimen, three Charpy V-notch (CVN) coupons (ASTM E23) were fabricated from the central 3 in., and another three CVN coupons were fabricated from outside the central 3 in. These six CVN coupons were fabricated parallel to the rolling direction with the CVN notch oriented as shown in the Figure. One tension coupon (ASTM E8) is taken from either end of the specimen parallel to the rolling direction. Figure 4.4 shows a drawing of the locations of the material coupons as they were taken from the 10 x 10 in. plate specimens.

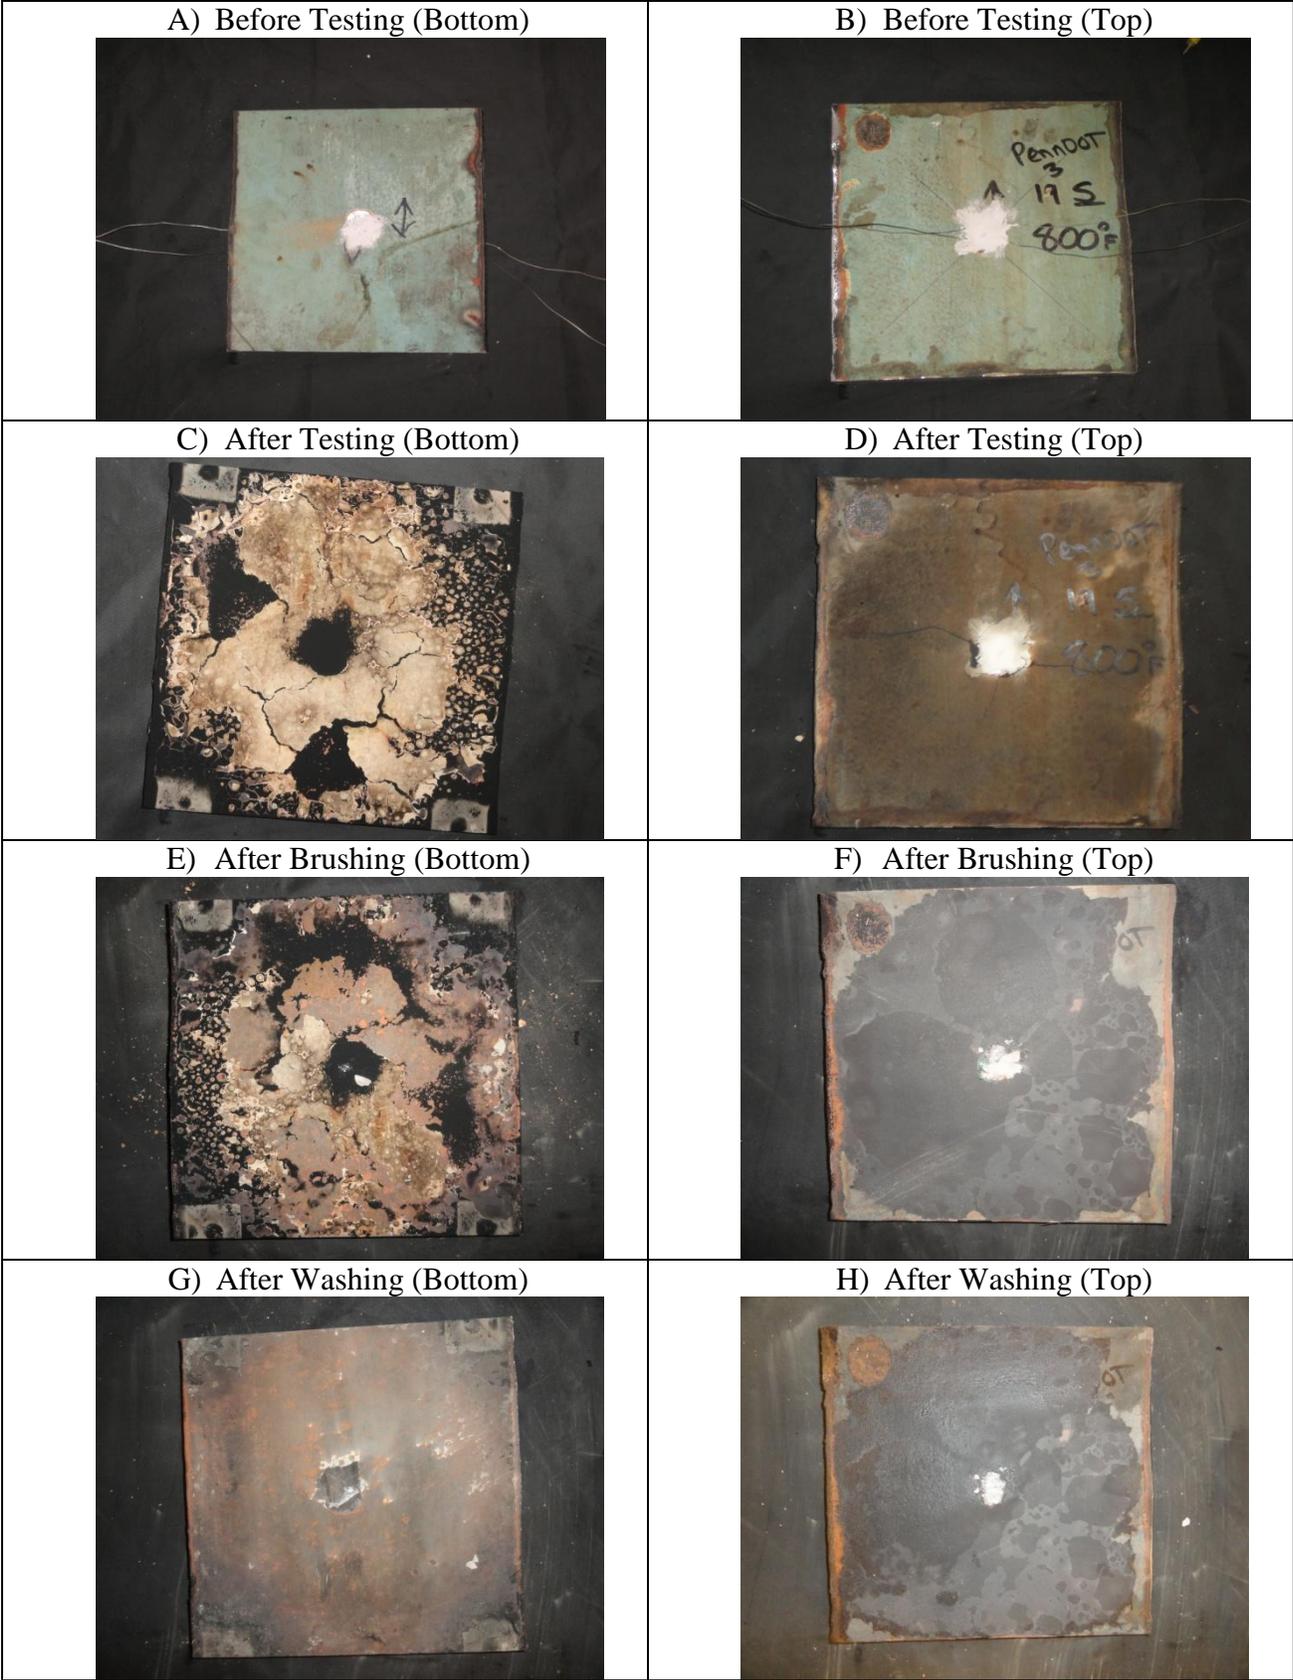
Figure 5.1-1. Post-Fire Evaluation of Penn DOT 3 S (19) 800°F

Figures 5.1-1 to 5.1-4 show photographs of the post-fire evaluation of the plate specimens (Part 1) identified in Table 4.2-1 and listed below. These include photographs taken as described in Section 4.4.

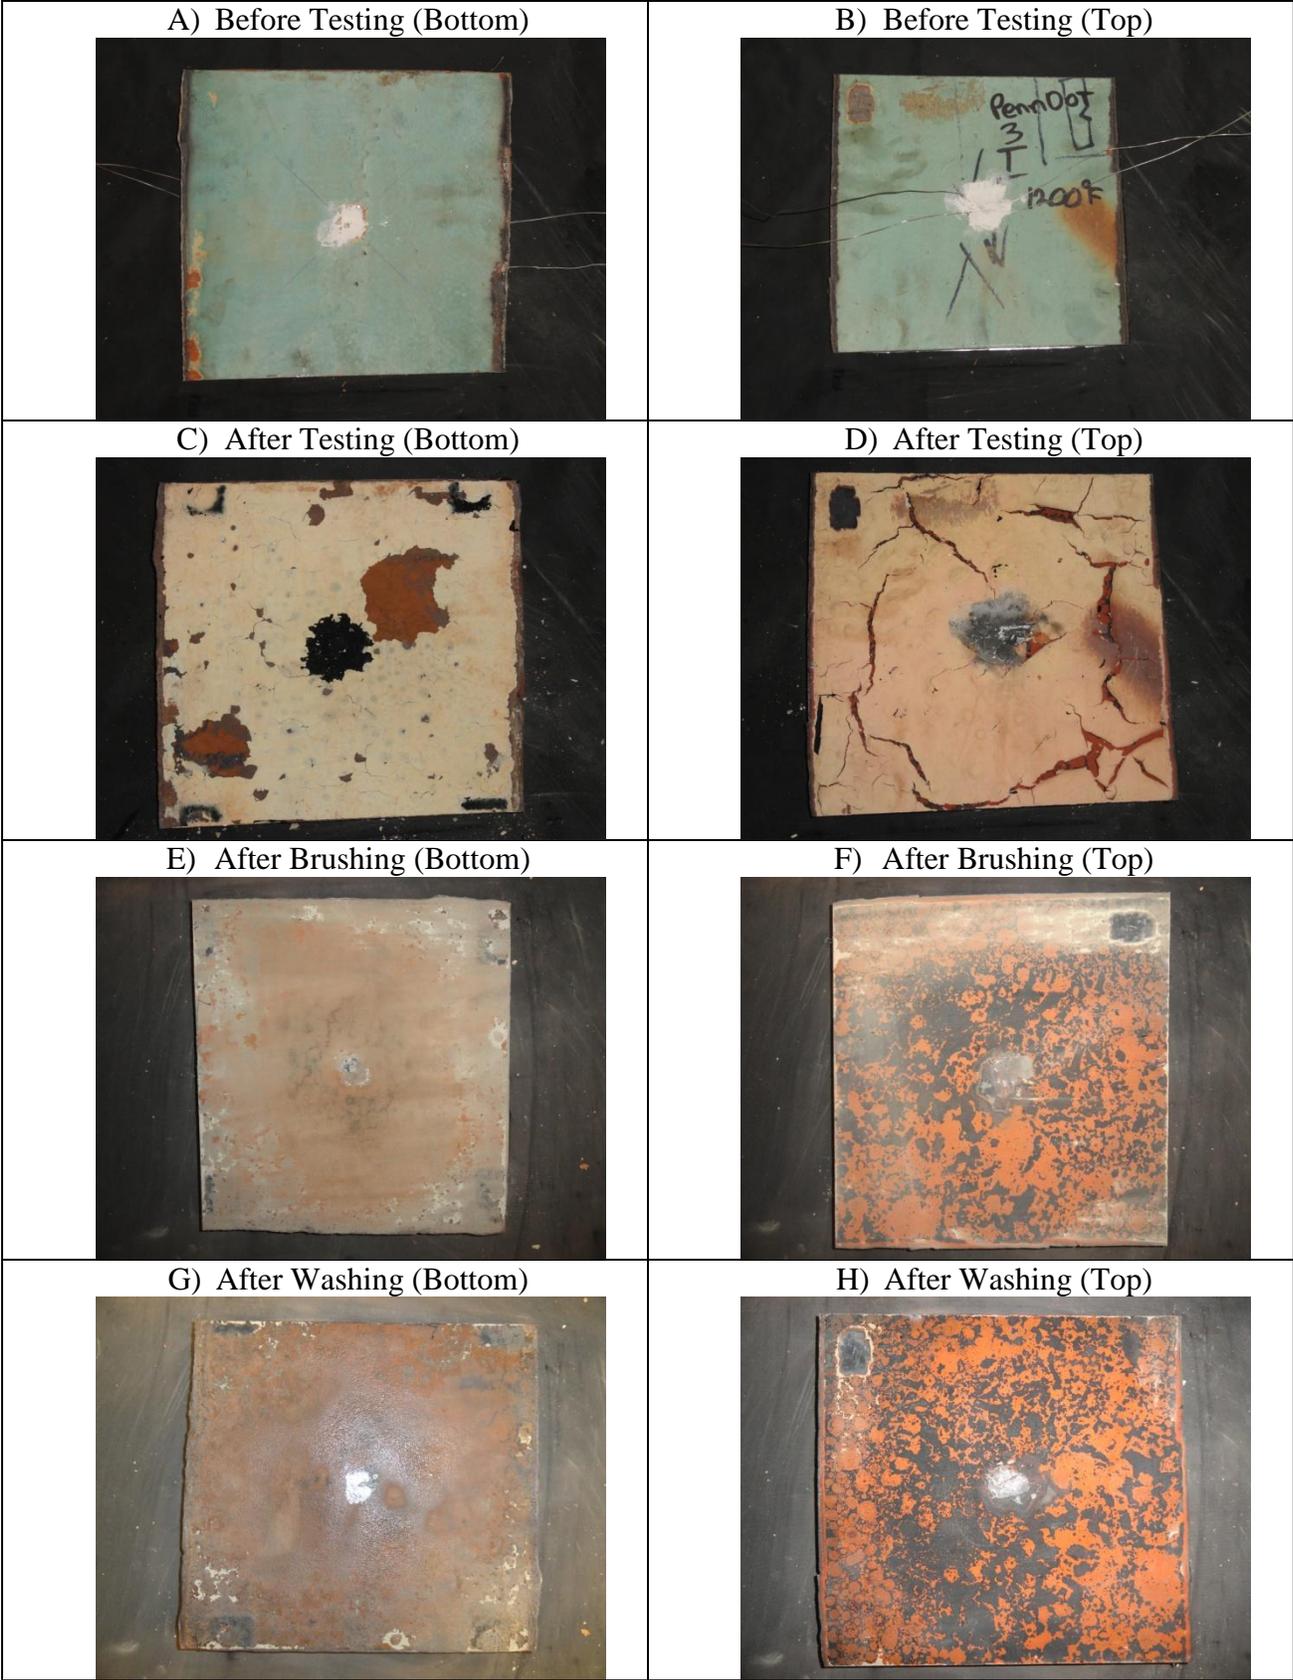
Figure 5.1-2. Post-Fire Evaluation of Penn DOT 3 T (20) 1200°F

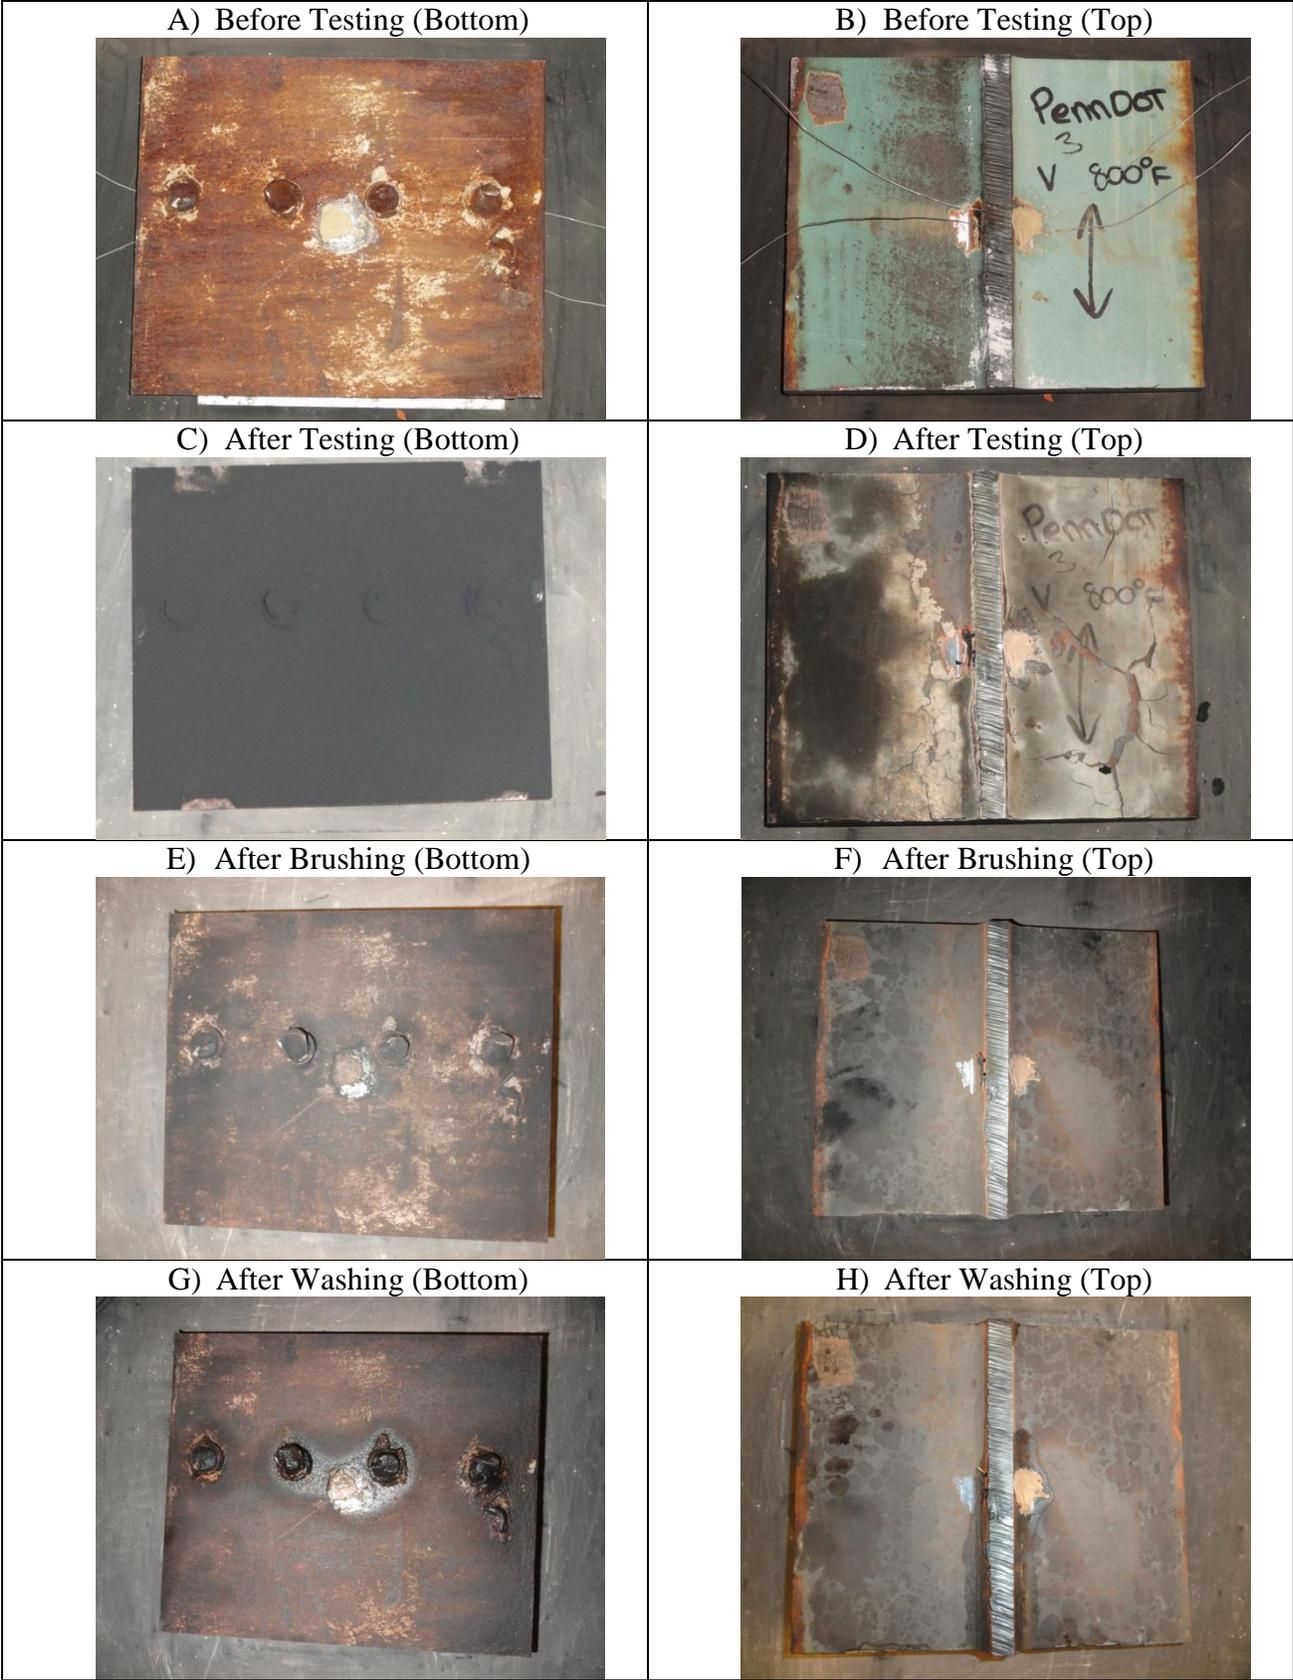
Figure 5.1-3. Post-Fire Evaluation of Penn DOT 3 V (22) 800°F

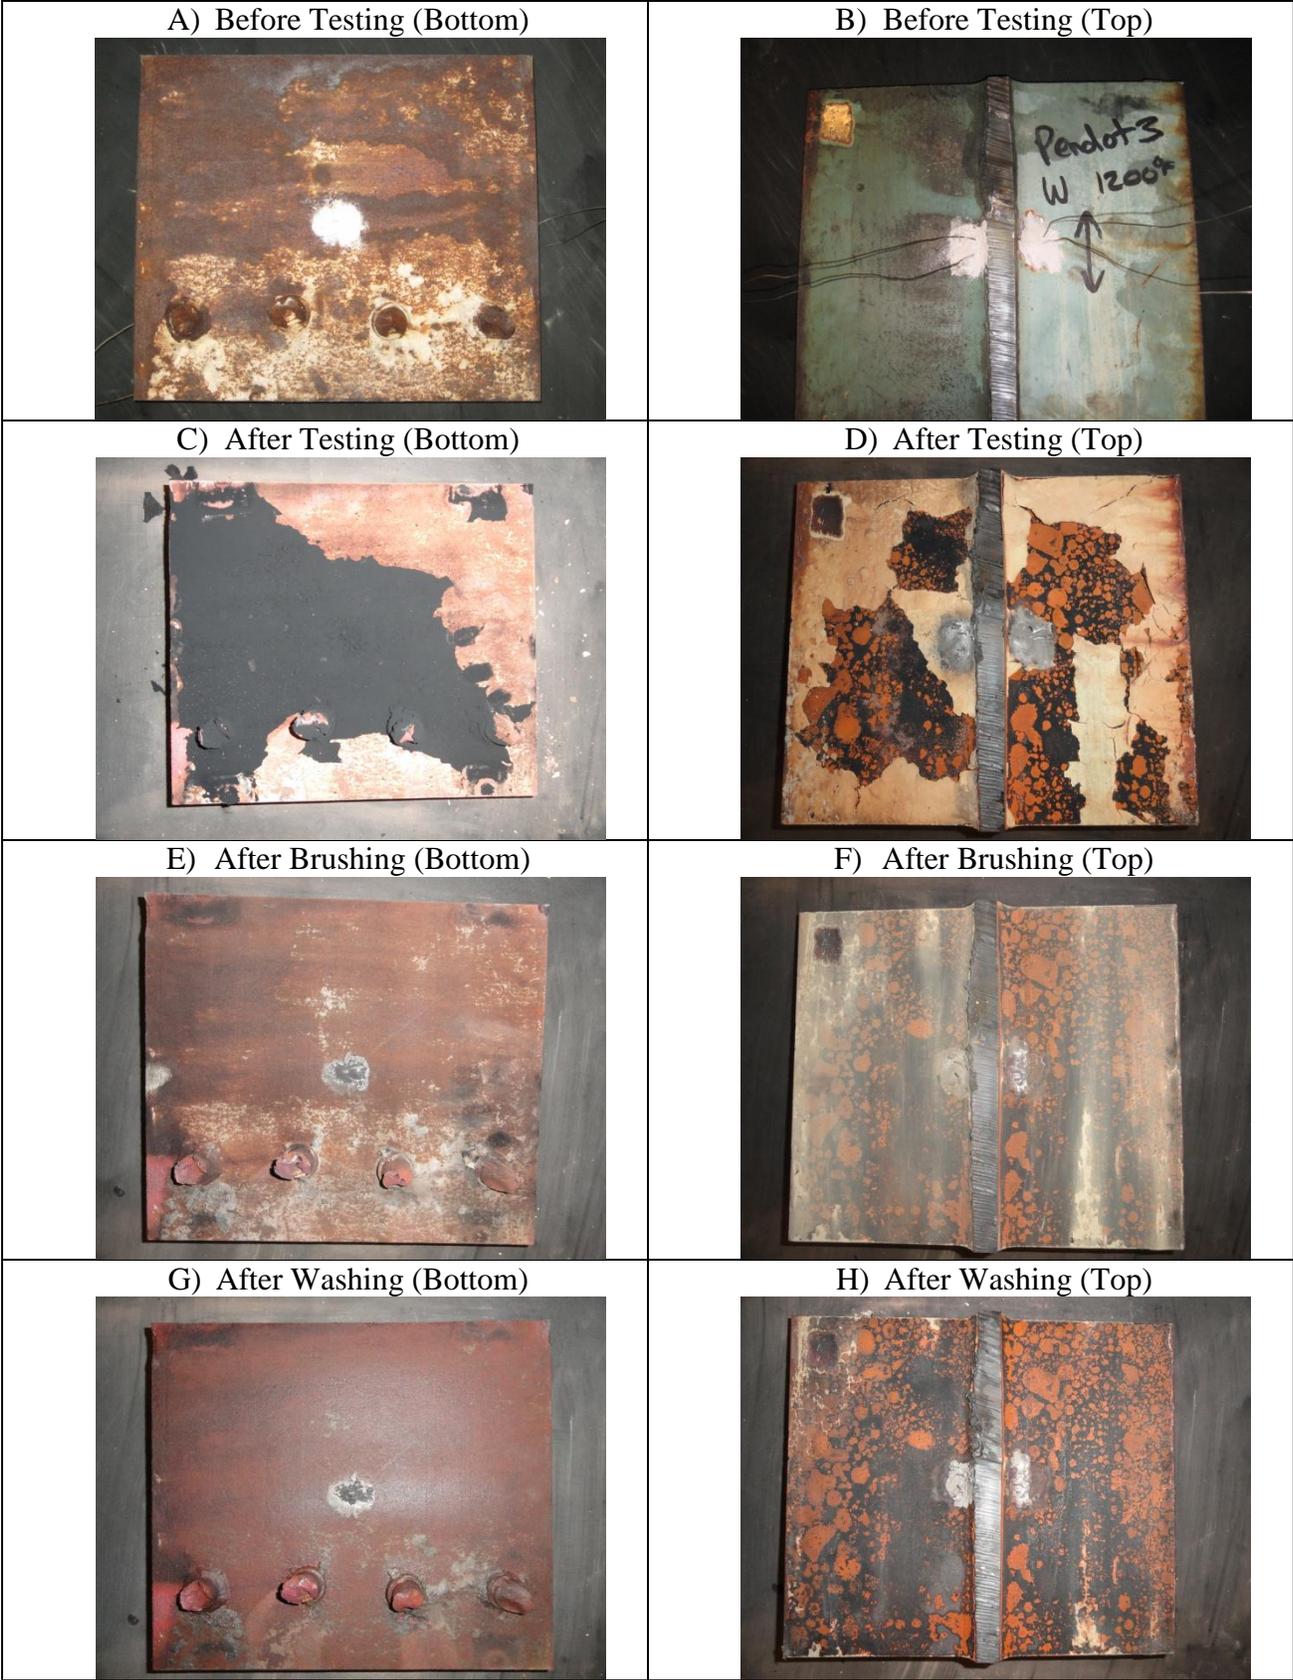
Figure 5.1-4. Post-Fire Evaluation of Penn DOT 3 W (23) 1200°F

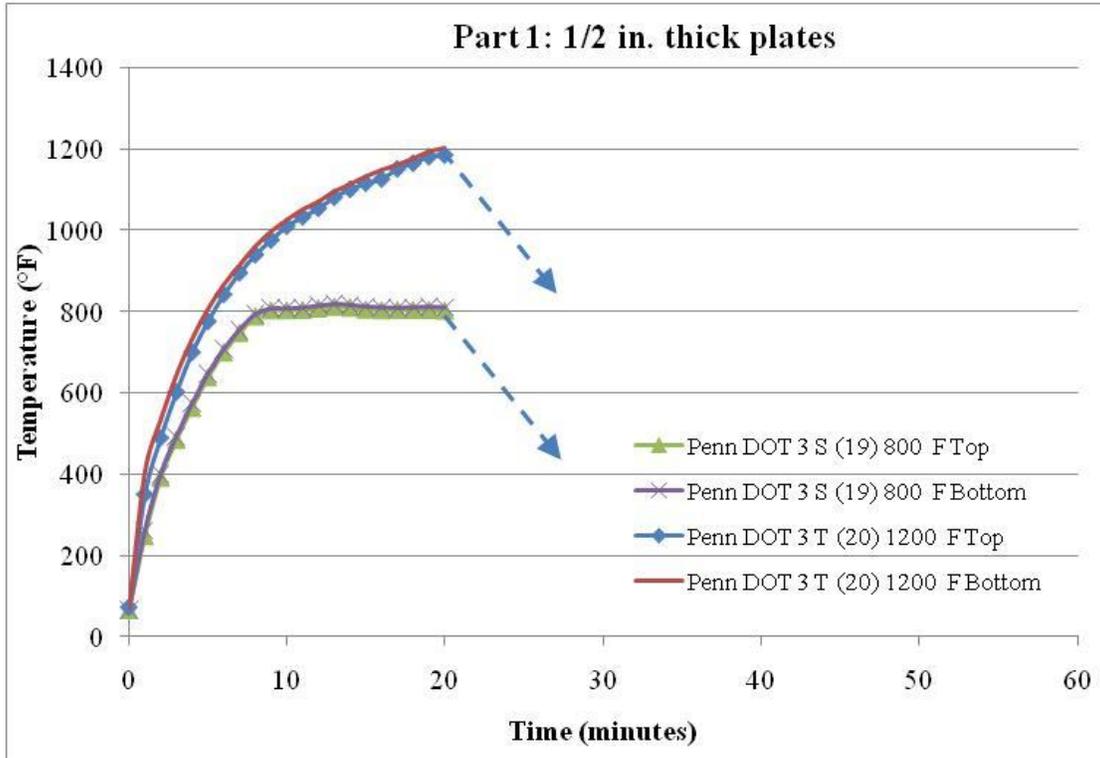
Figure 5.1-5 Measured Temperature-Time Curves for 1/2 in. Thick Part 1 Plate Specimens

Figures 5.1-5 and 5.1-6 show the measured temperature-time (T-t) curves for these plate specimens with ½ in. and ¾ in. thickness, respectively. As shown the target temperatures were achieved and maintained for 20 minutes before cooling. The target time of 20 minutes is representative of the typical fire duration that can cause collapse of a bridge; for example, consider the Oakland, California bridge discussed earlier in Section 2.0.

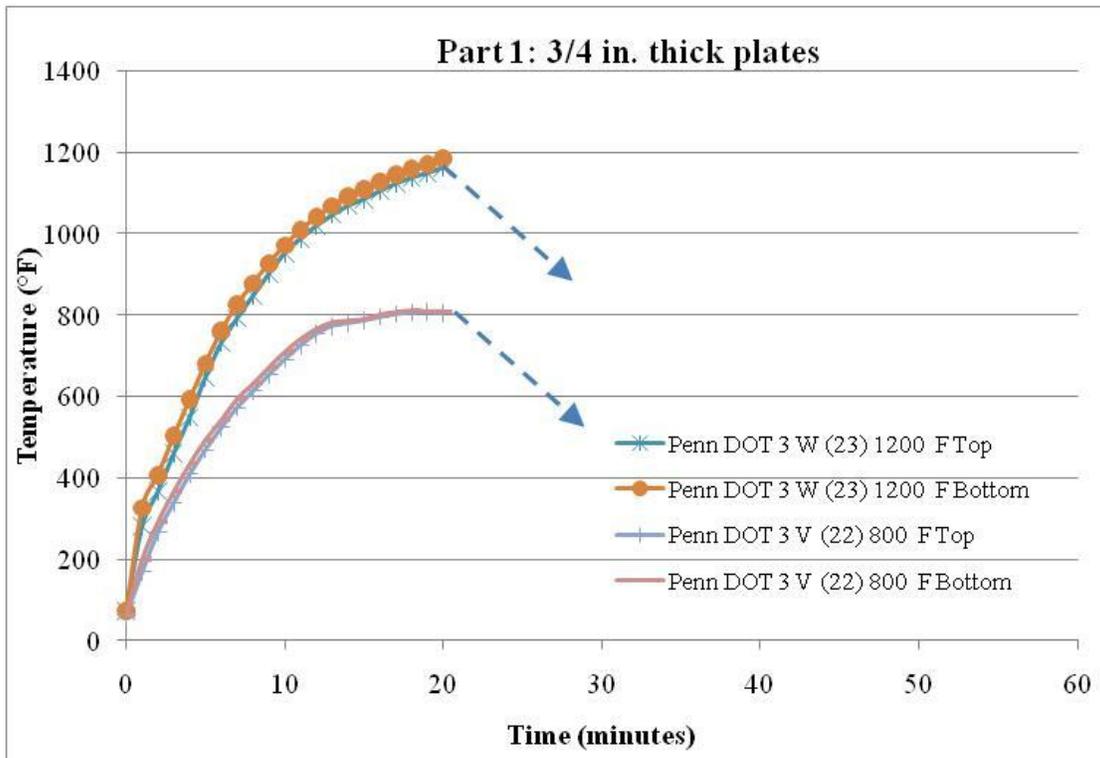
Figure 5.1-6. Measured Temperature-Time Curves for 3/4 in. Thick Part 1 Plate Specimen

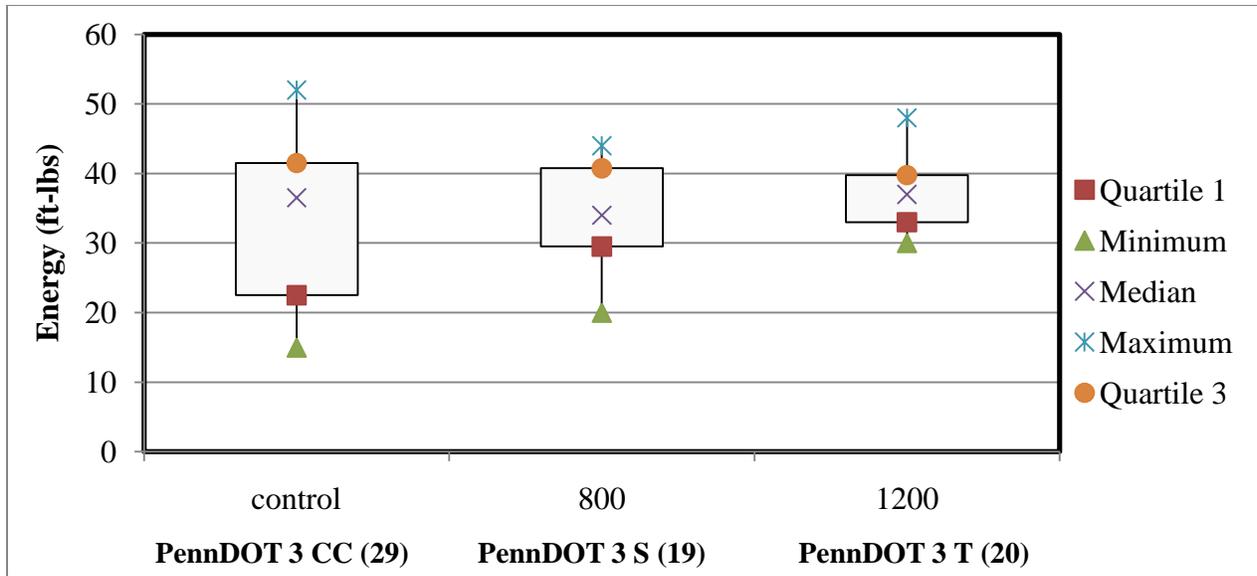
Figure 5.1-7. Statistical Evaluation of CVN Fracture Toughness Values for 1/2 in. thick Plate Specimens (Part 1)

Figures 5.1-7 and 5.1-8 shows box plots that can be used to more comprehensively evaluate the effects of fire exposure on the CVN fracture toughness of steels. These figures focus on ½ in. thick and ¾ in. thick steel plates that had been subjected to controlled fire exposure using the flame jet setup. The box plots include for each plate specimen: (i) the minimum, maximum, and median values of fracture toughness, and (ii) the first and third quartile fracture toughness values. The first quartile means that 25% of the values will be lower than this value, and third quartile means 75% of the values will be lower than this value. These Figures 5.1-7 and 5.1-8 show that the fire exposures do not have a statistically significant effect on the CVN fracture toughness of steels, which numerically still satisfies the 15 ft-lb limit for Zone 2 (AASHTO 2010 §6.6.2).

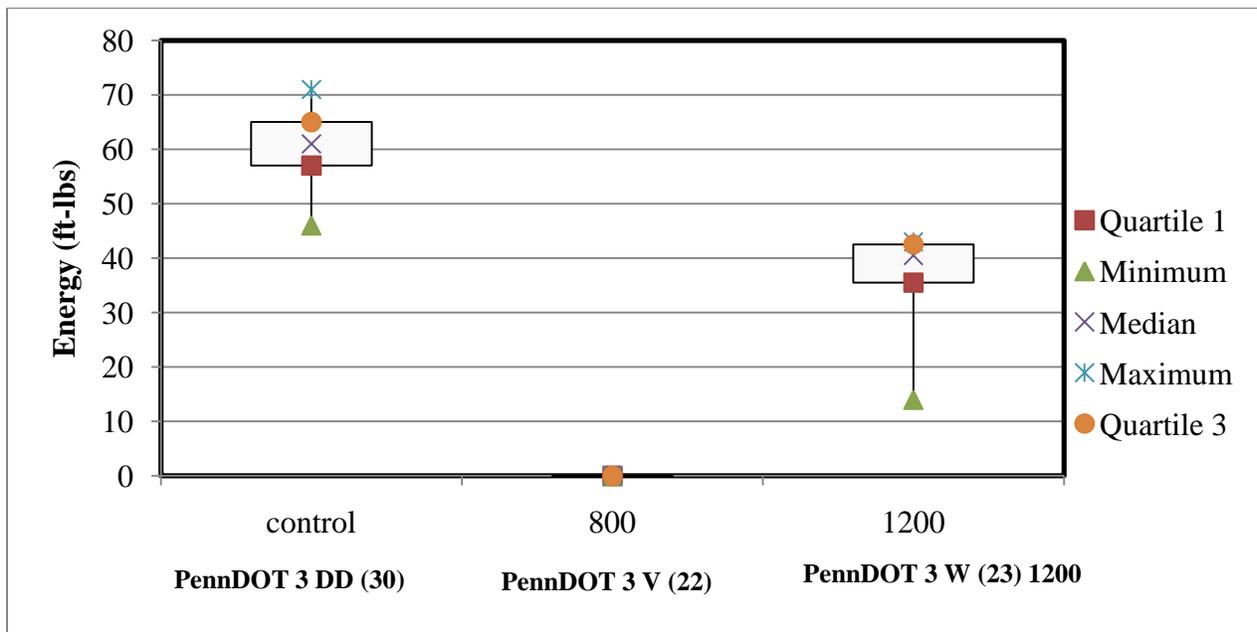
Figure 5.1-8. Statistical Evaluation of CVN Fracture Toughness Values for 3/4 in. thick Plate Specimens (Part 1)

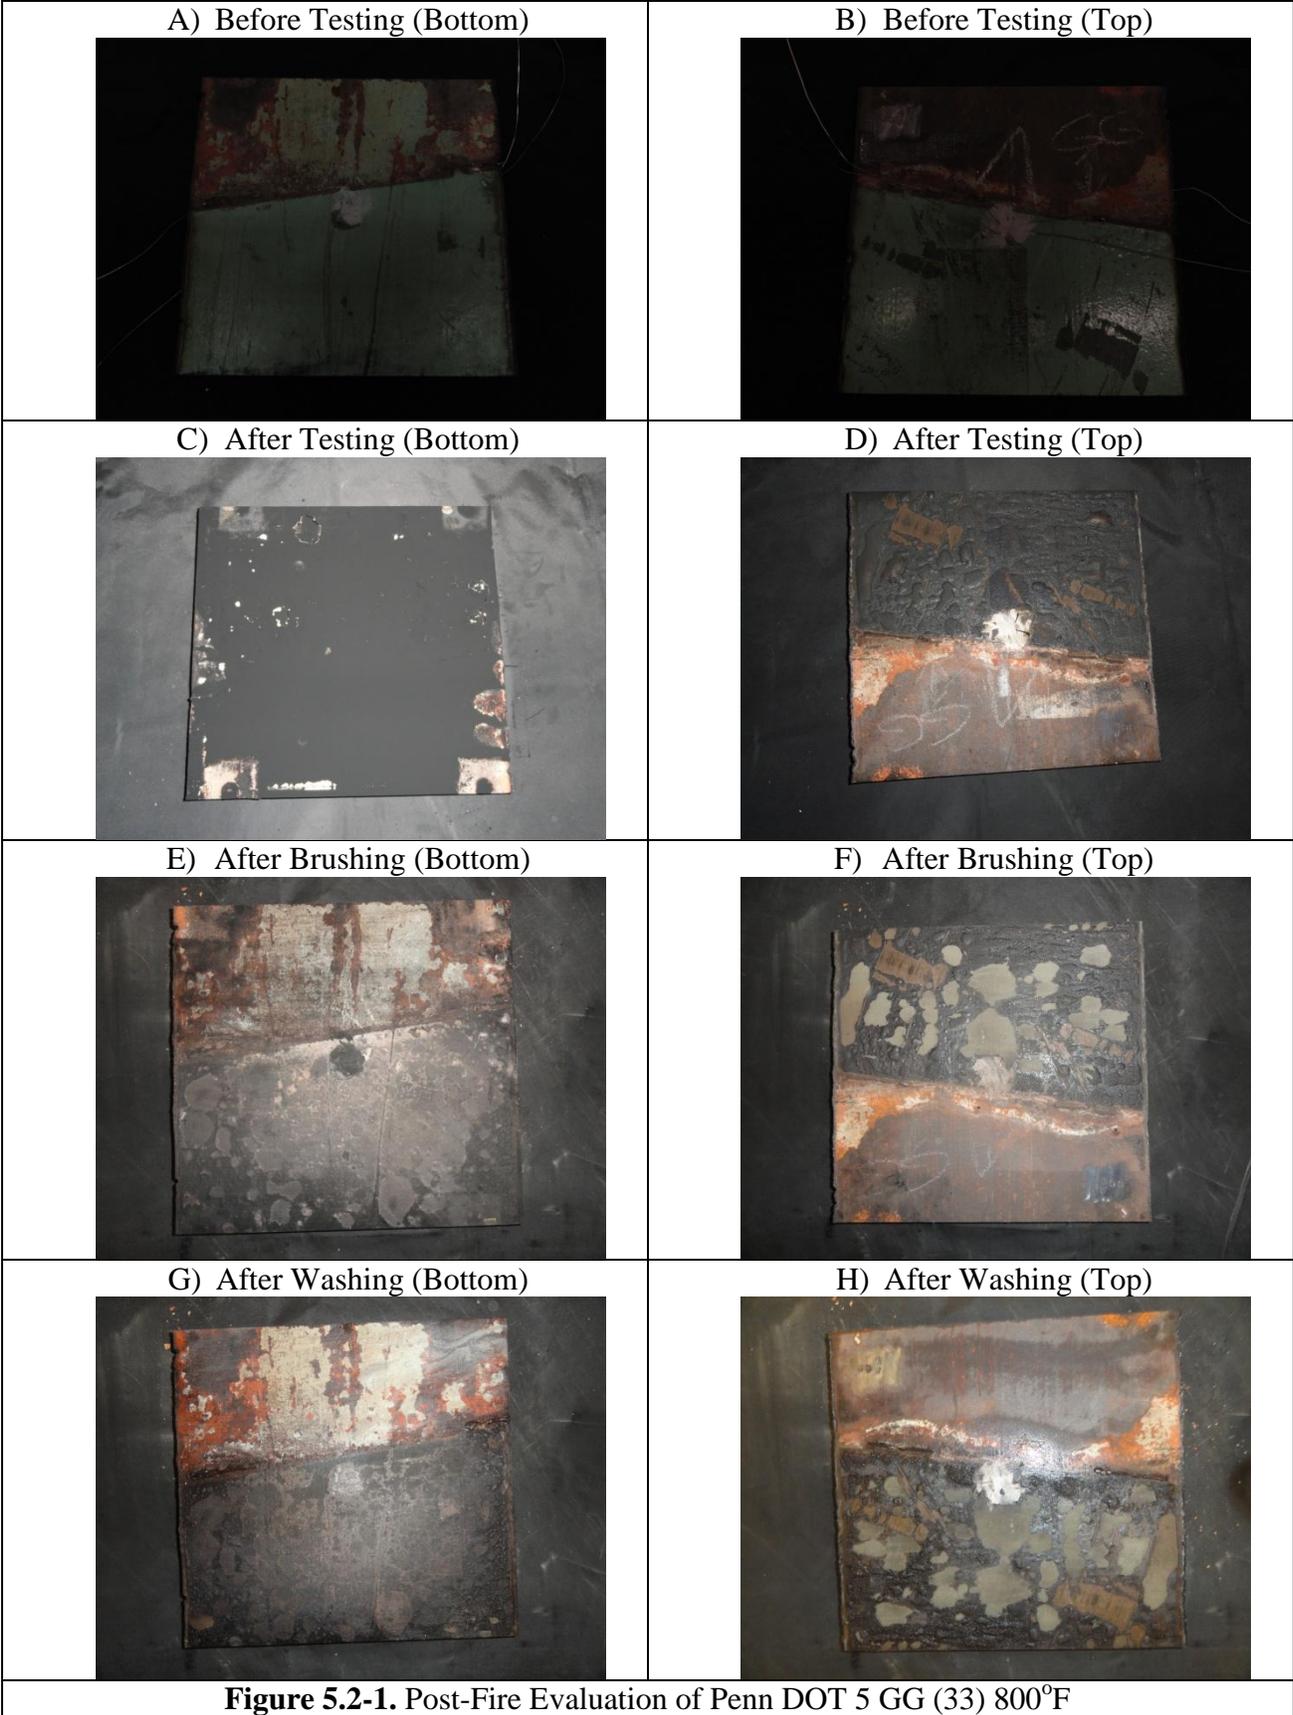
Figure 5.2-1. Post-Fire Evaluation of Penn DOT 5 GG (33) 800°F

Figures 5.2-1 to 5.2-4 show photographs of the post-fire evaluation of the plate specimens (Part 2) identified in Table 4.2-1 and listed below. These include photographs taken as described in Section 4.4.

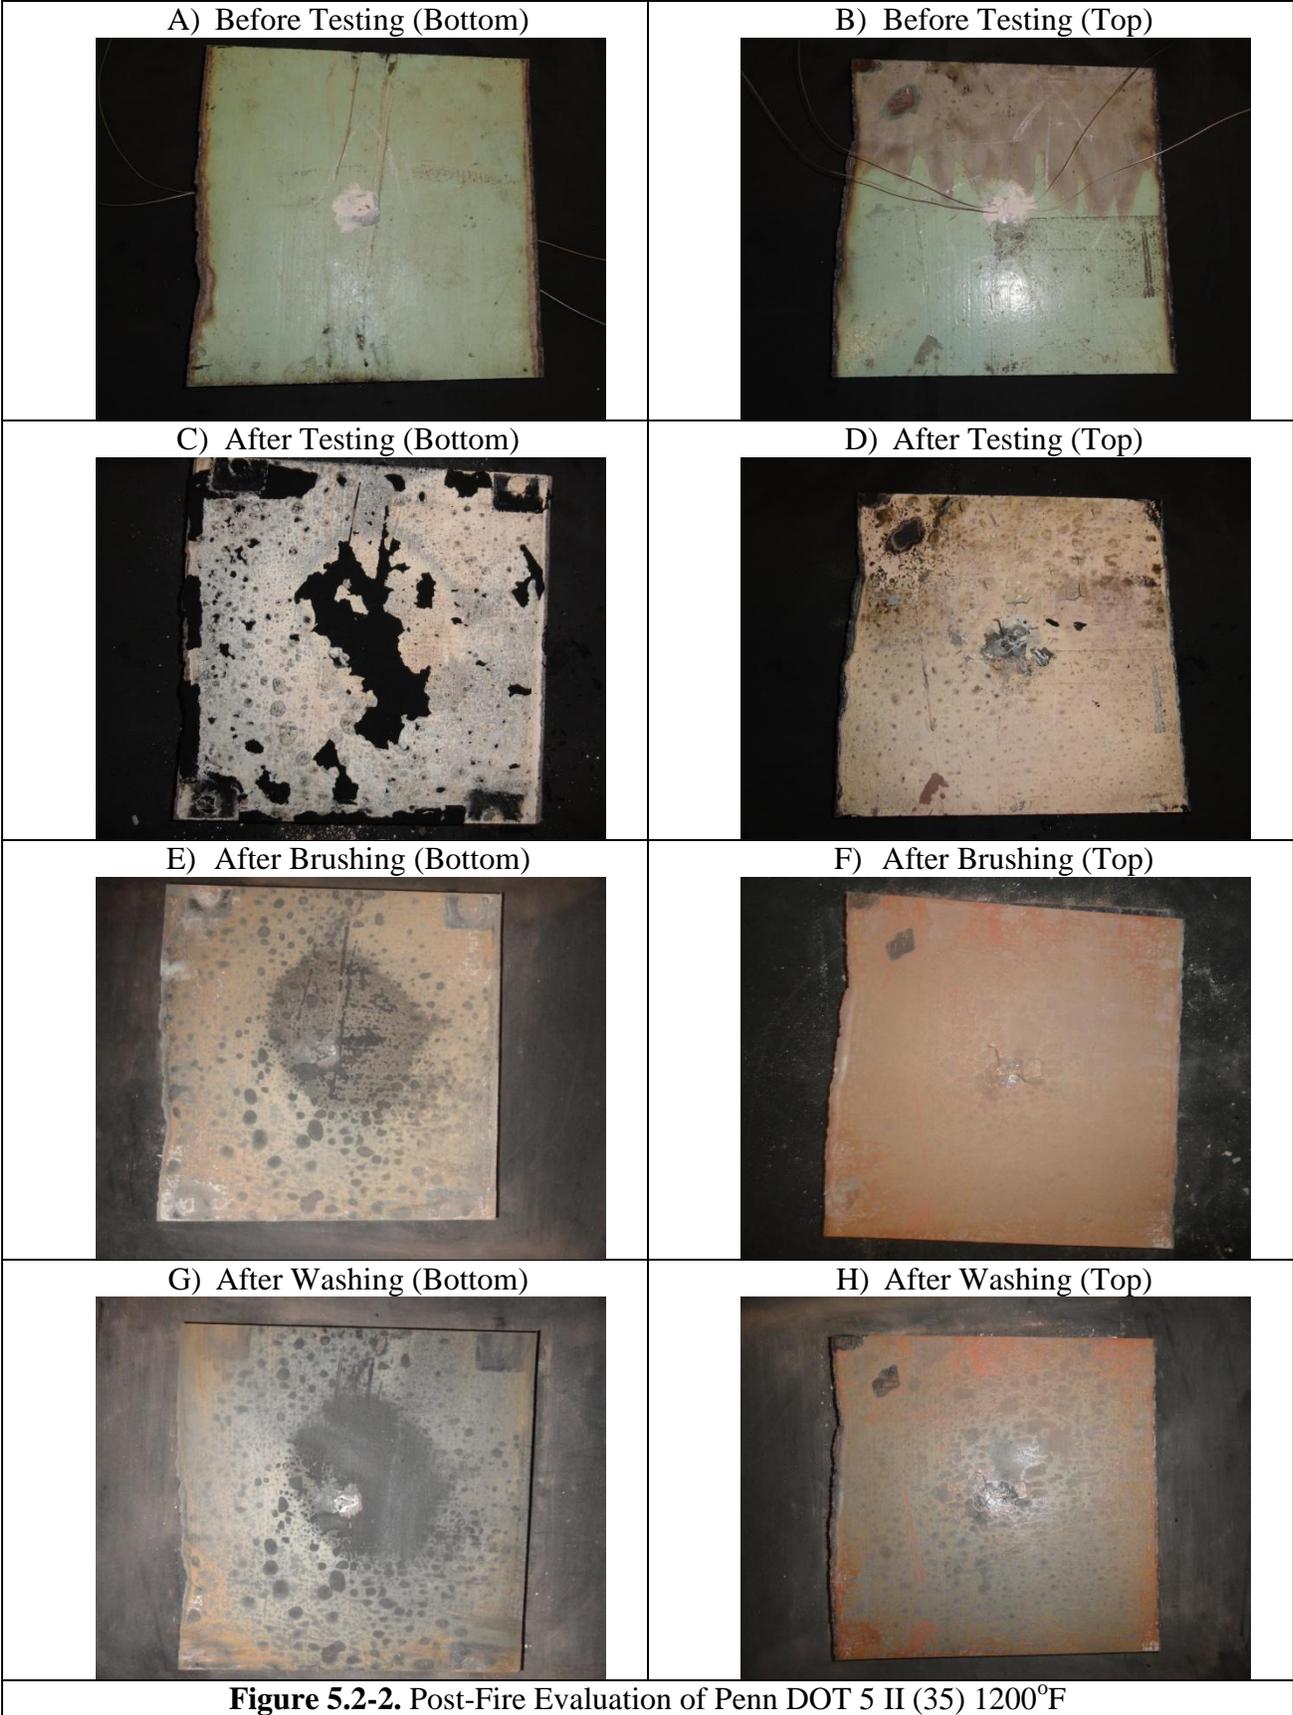
Figure 5.2-2. Post-Fire Evaluation of Penn DOT 5 II (35) 1200°F
