Effects of Fire Damage on the Structural Properties of Steel Bridge Elements

FINAL REPORT

University of Pittsburgh

1. Report No. FHWA-PA-2011-009-PIT011		2. Government Accession No.		3. Recipient's Catalog No.	
4. Title and Subtitle Effects of Fire Damage on the Structural Properties of Steel Bridge Elements				5. Report Date April 30, 2011

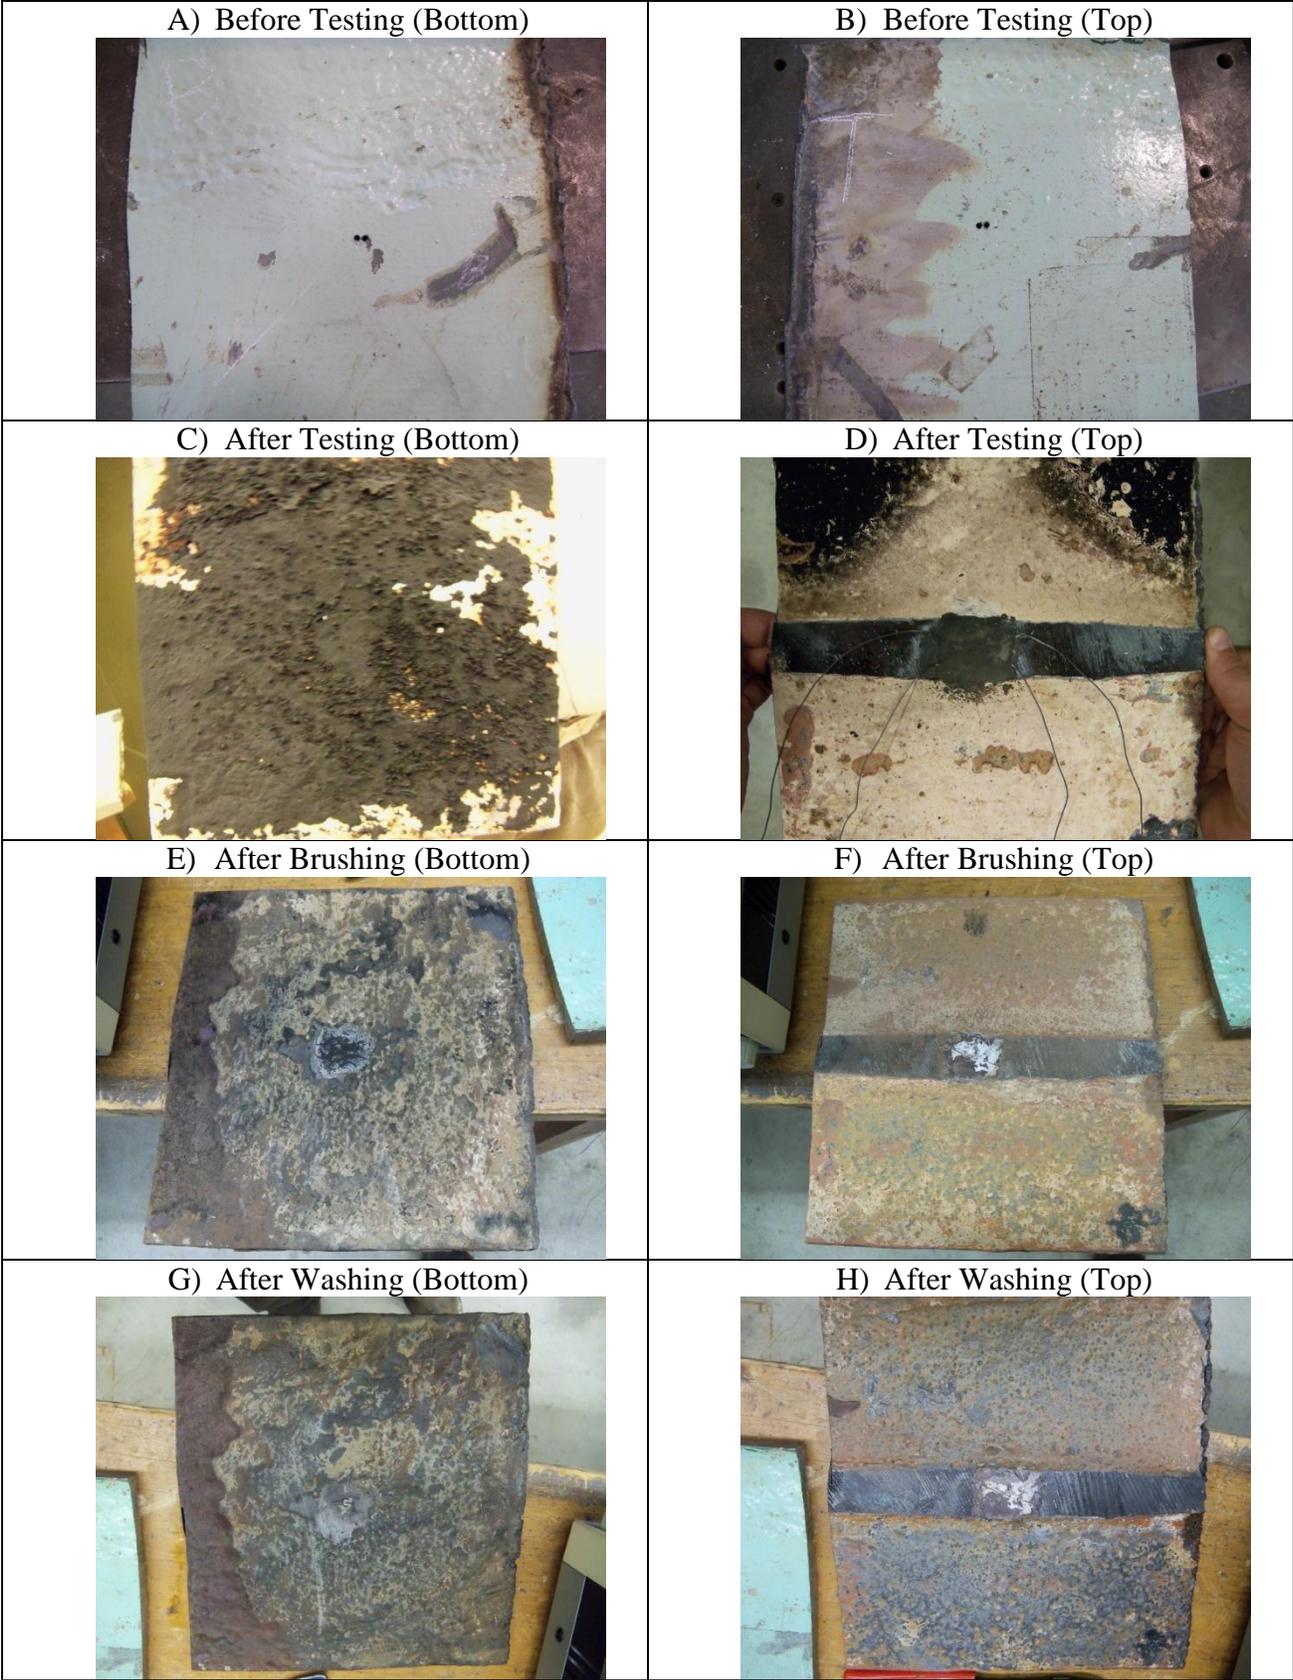
Figure 5.2-3. Post-Fire Evaluation of Penn DOT 5 HH (34) 1200°F

Figures 5.2-1 to 5.2-4 show photographs of the post-fire evaluation of the plate specimens (Part 2) identified in Table 4.2-1 and listed below. These include photographs taken as described in Section 4.4.

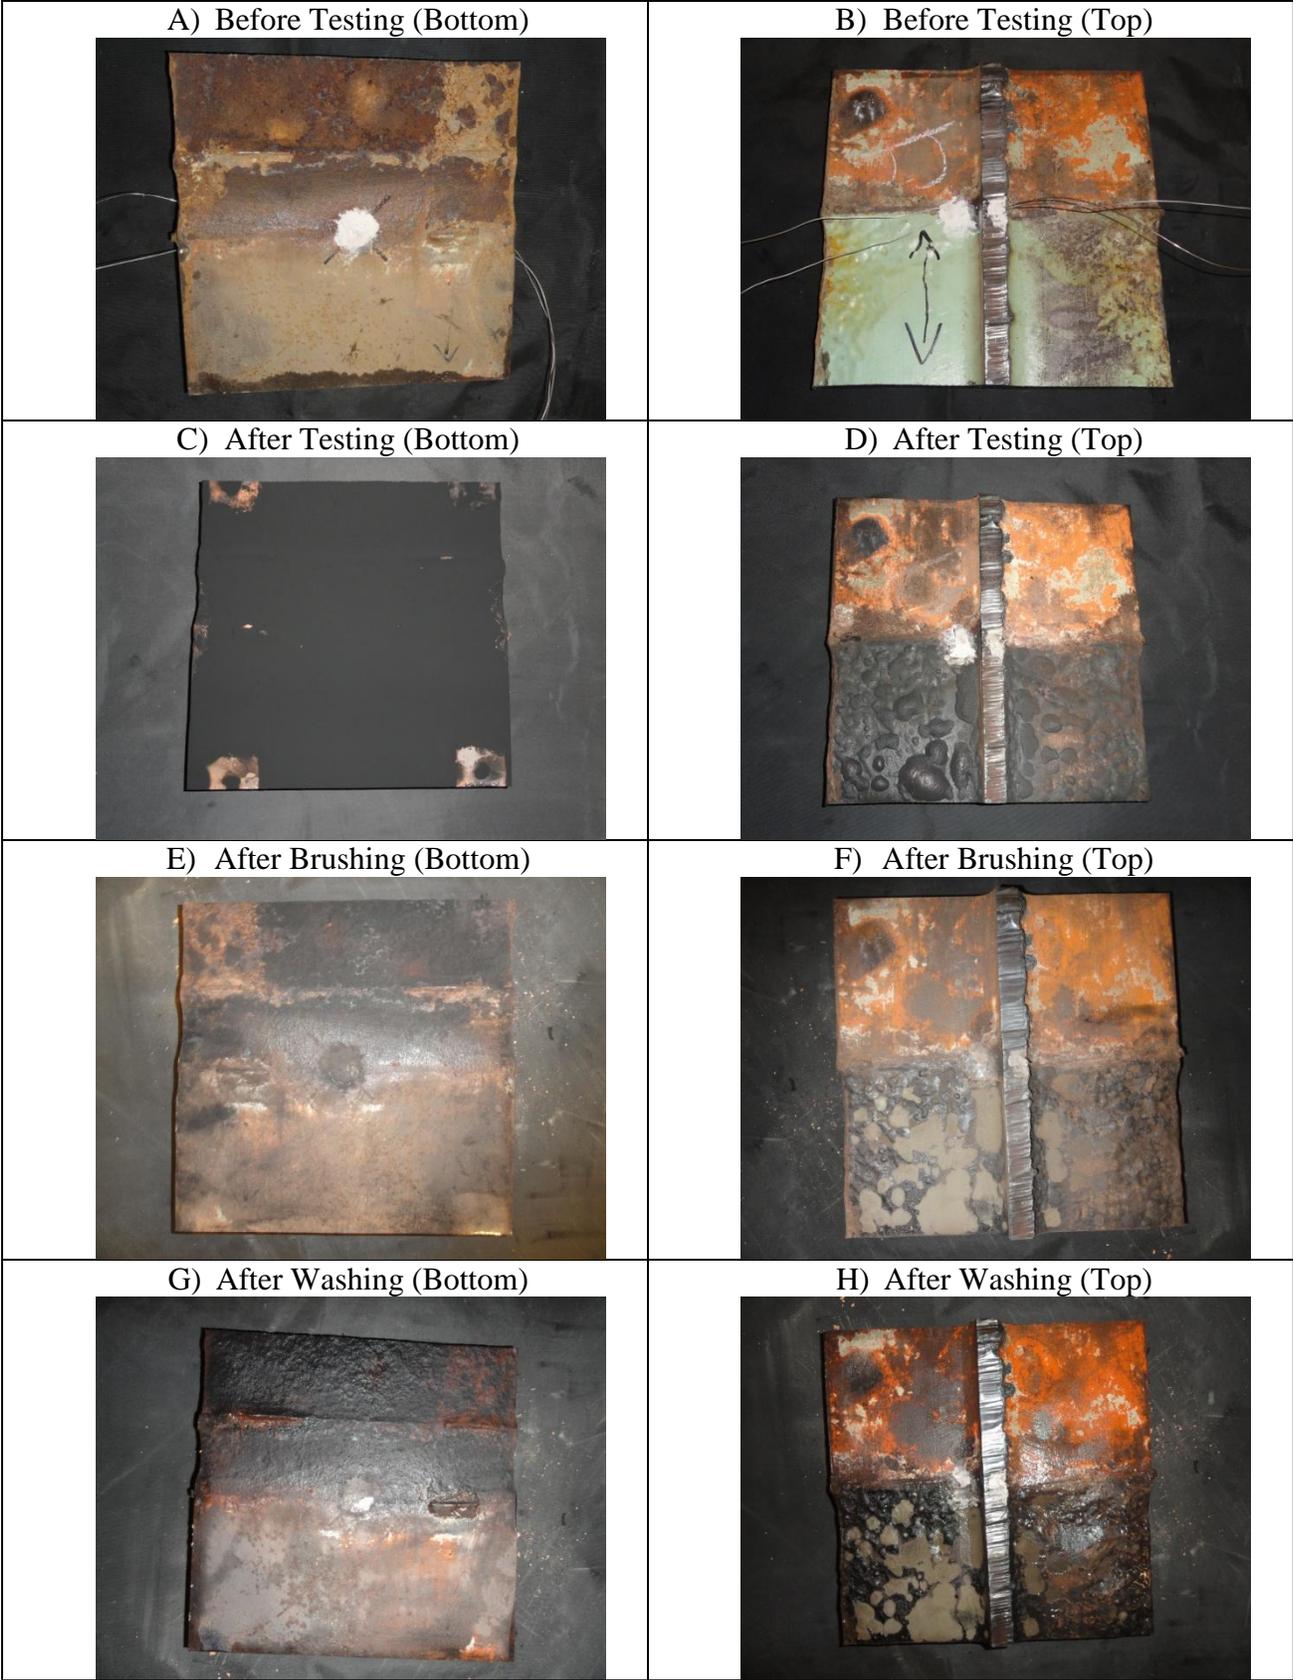
Figure 5.2-4. Post-Fire Evaluation of Penn DOT 5 JJ (36) 800°F

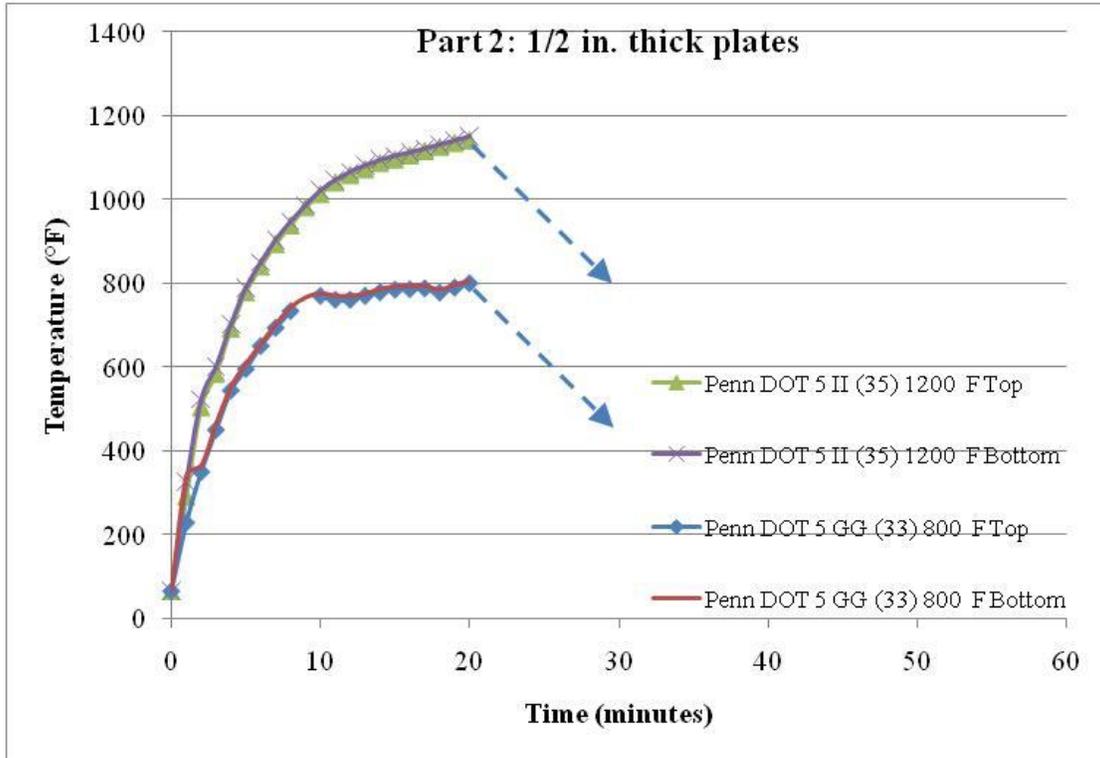
Figure 5.2-5 Measured Temperature-Time Curves for 1/2 in. Thick Part 2 Plate Specimens (Web)

Figures 5.2-5 and 5.2-6 show the measured temperature-time (T-t) curves for these plate specimens with ½ in. thick webs and flanges, respectively. As shown the target temperatures were achieved and maintained for 20 minutes before cooling.

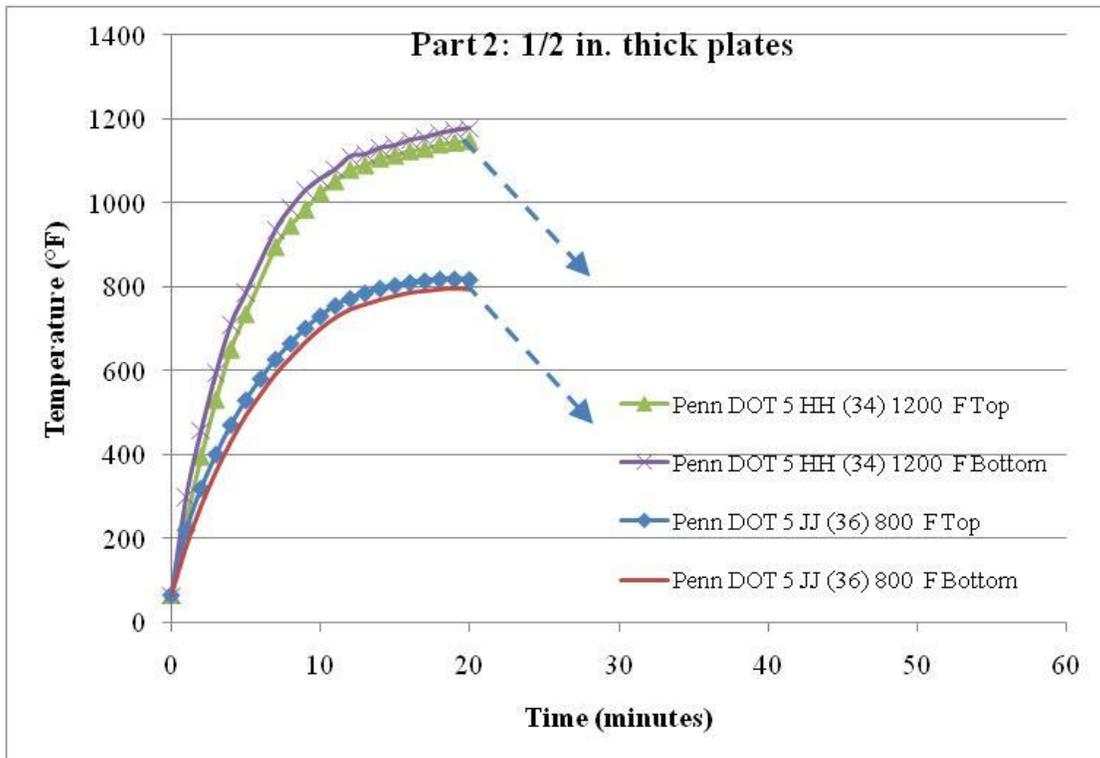
Figure 5.2-6. Measured Temperature-Time Curves for 1/2 in. Thick Part 2 Plate Specimens (Flanges)

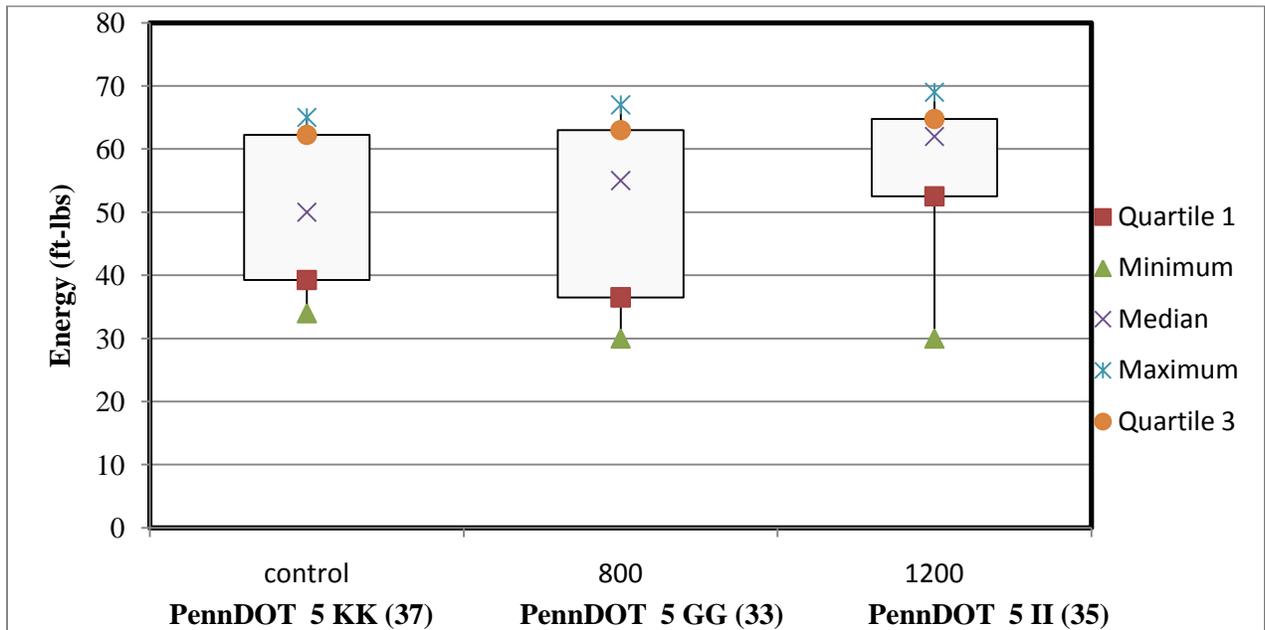
Figure 5.2-7. Statistical Analysis of CVN Fracture Toughness for Part 2 Plate Specimens (1/2 in. thick webs)

Figures 5.2-7 and 5.2-8 shows box plots that can be used to more comprehensively evaluate the effects of fire exposure on the CVN fracture toughness of steels. These figures focus on ½ in. thick webs and the 1/2 in. thick flange steel plates that had been subjected to controlled fire exposure using the flame jet setup. The box plots include for each plate specimen: (i) the minimum, maximum, and median values of fracture toughness, and (ii) the first and third quartile fracture toughness values. The first quartile means that 25% of the values will be lower than this value, and third quartile means 75% of the values will be lower than this value. These Figures show that the fire exposures do not have a statistically significant effect on the CVN fracture toughness of steels, which numerically still satisfies the 15 ft-lb limit for Zone 2 (AASHTO 2010 §6.6.2).

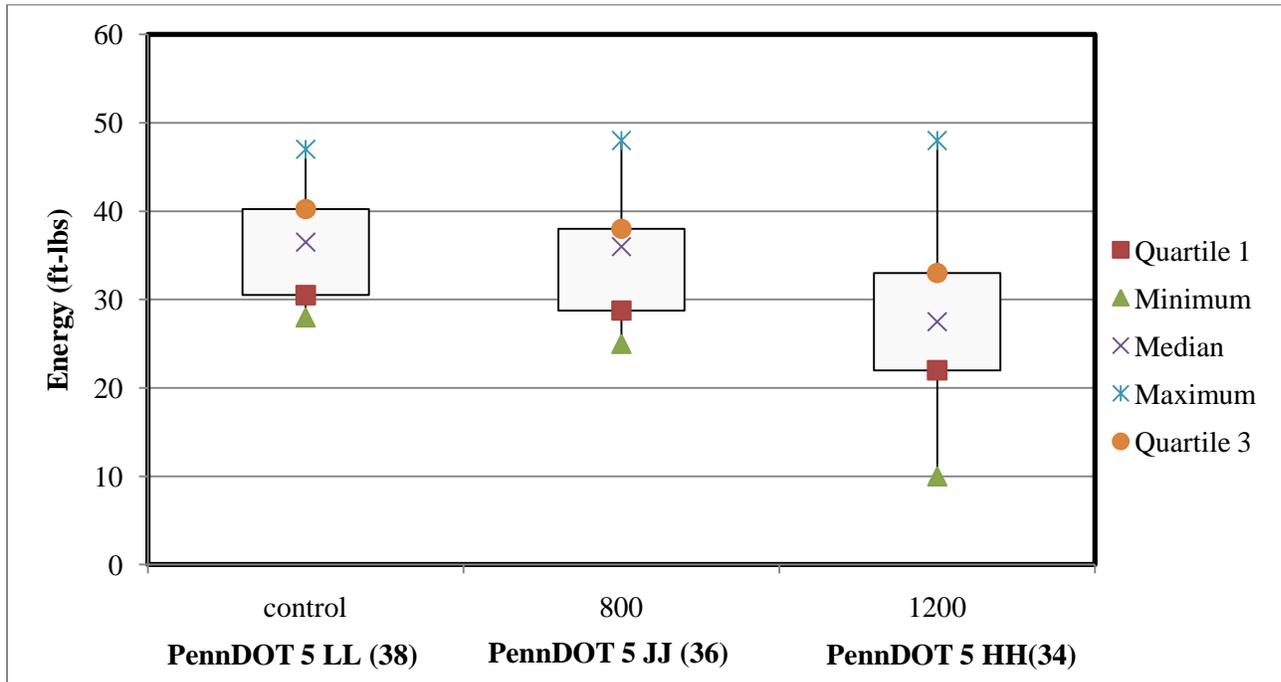
Figure 5.2-8. Statistical Analysis of CVN Fracture Toughness for Part 2 Plate Specimens (1/2 in. thick flanges)

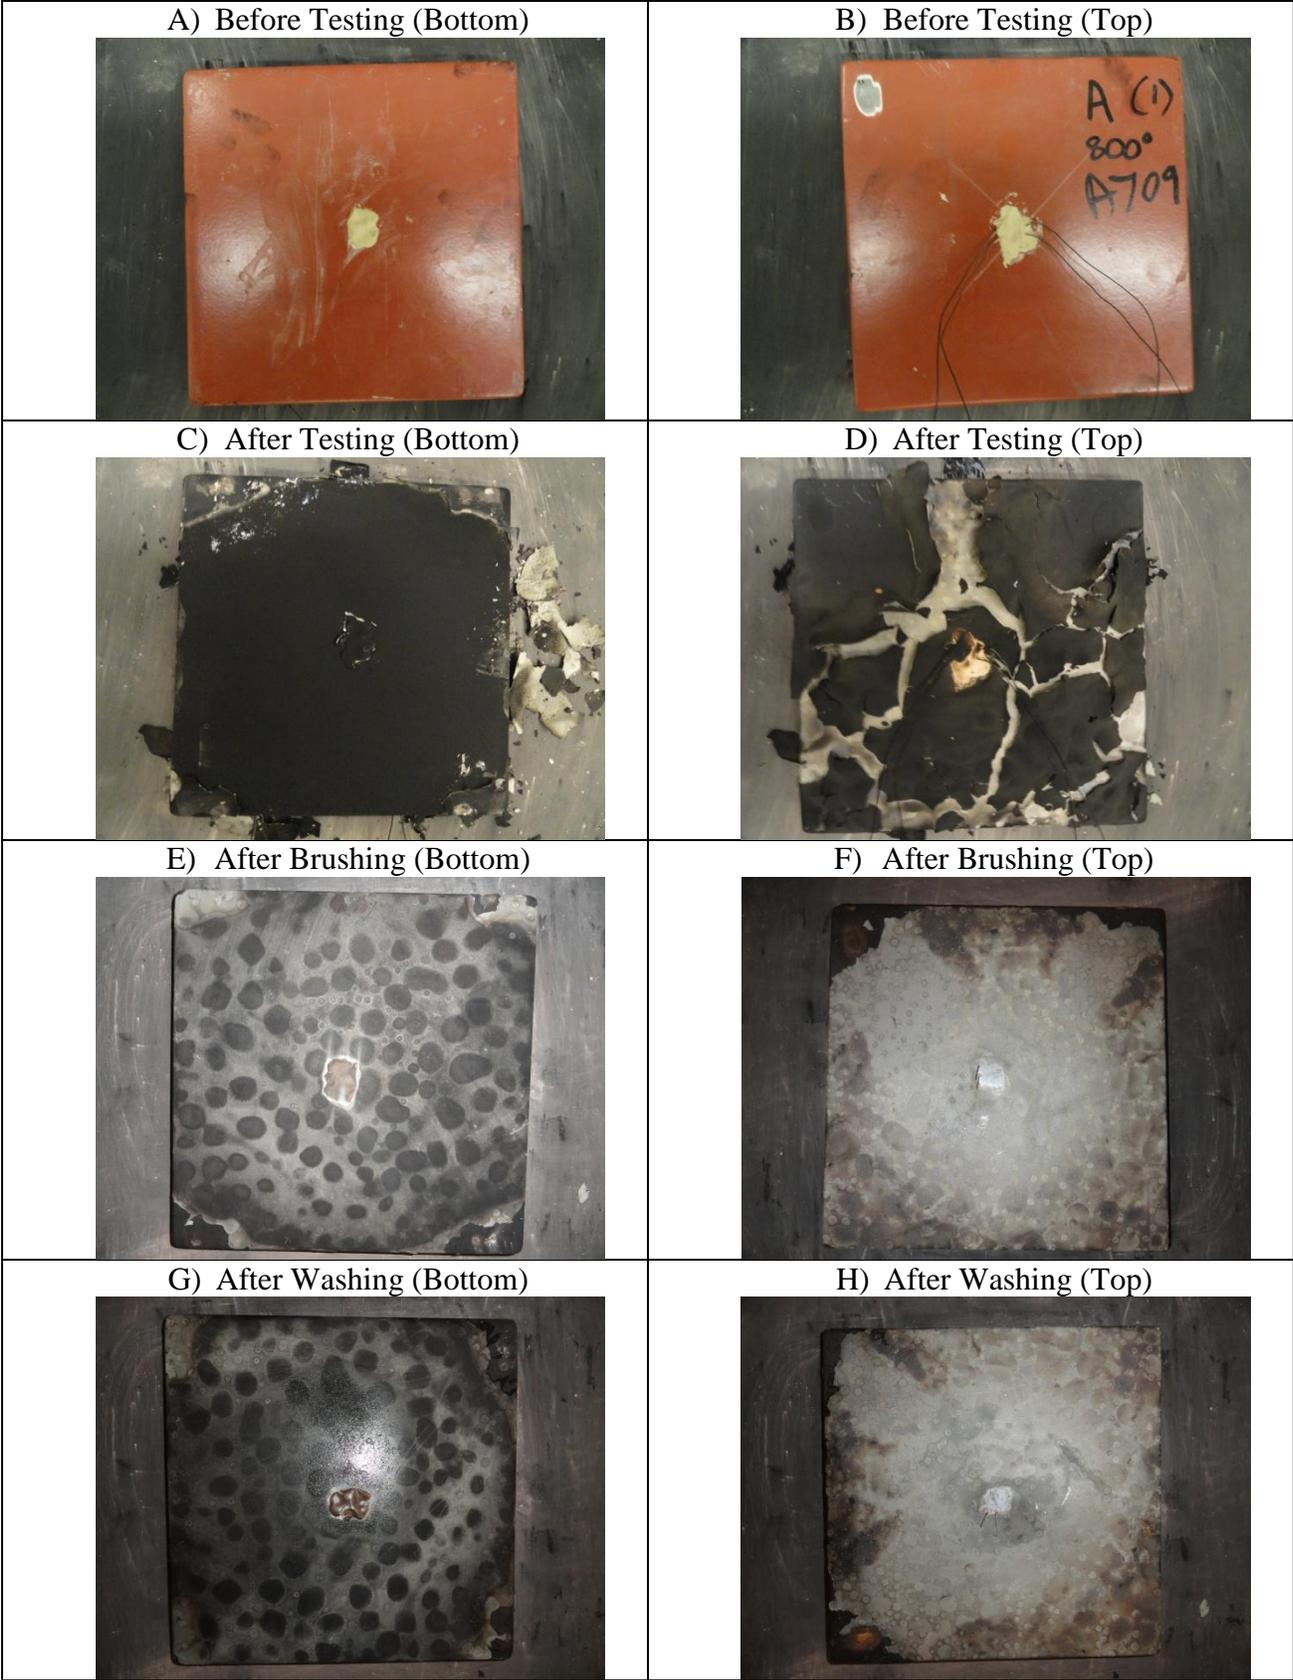
Figure 5.3-1. Post-Fire Evaluation of Acrolon A (1) 800°F

Figures 5.3-1 to 5.3-8 show photographs of the post-fire evaluation of the plate specimens (Part 3) identified in Table 4.2-1 and listed below. These include photographs taken as described in Section 4.4.

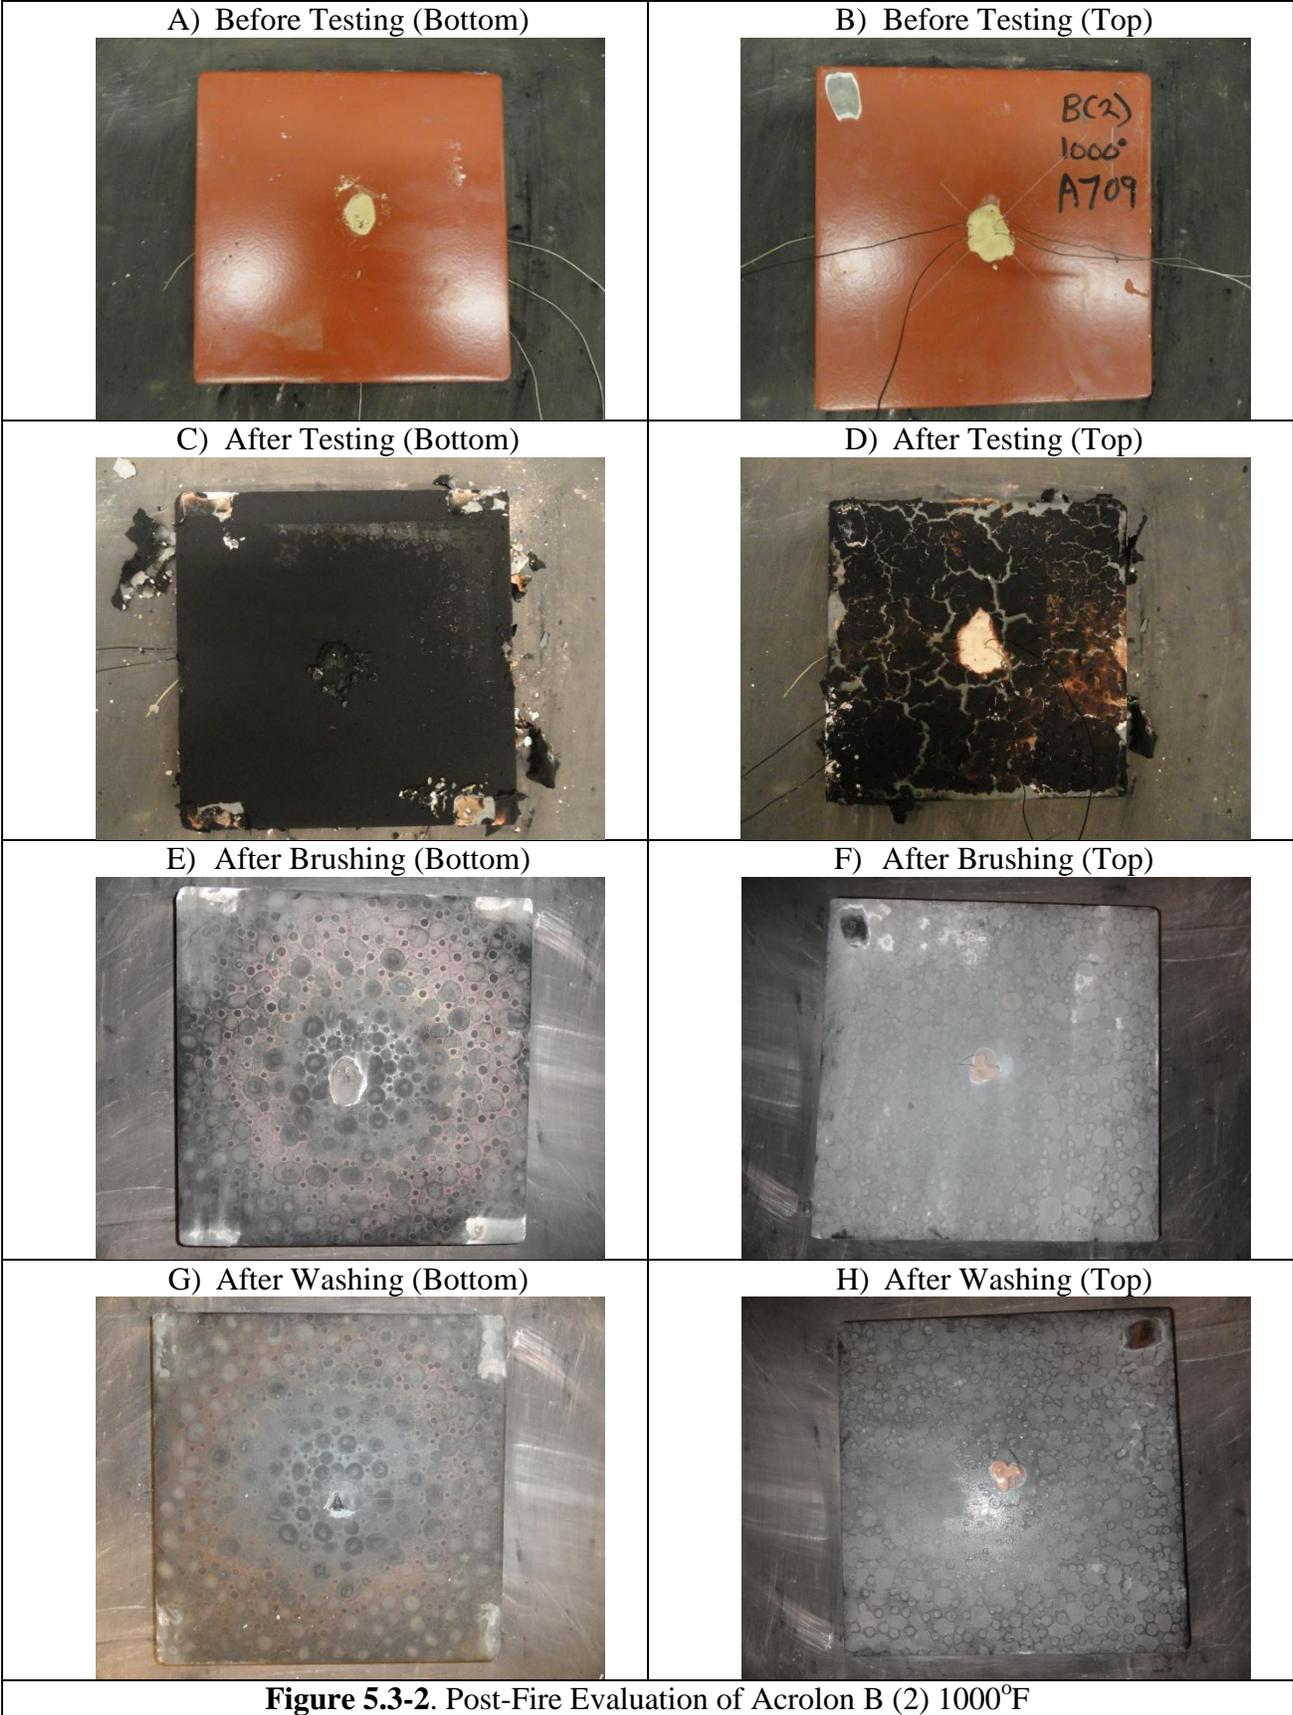
Figure 5.3-2. Post-Fire Evaluation of Acrolon B (2) 1000°F

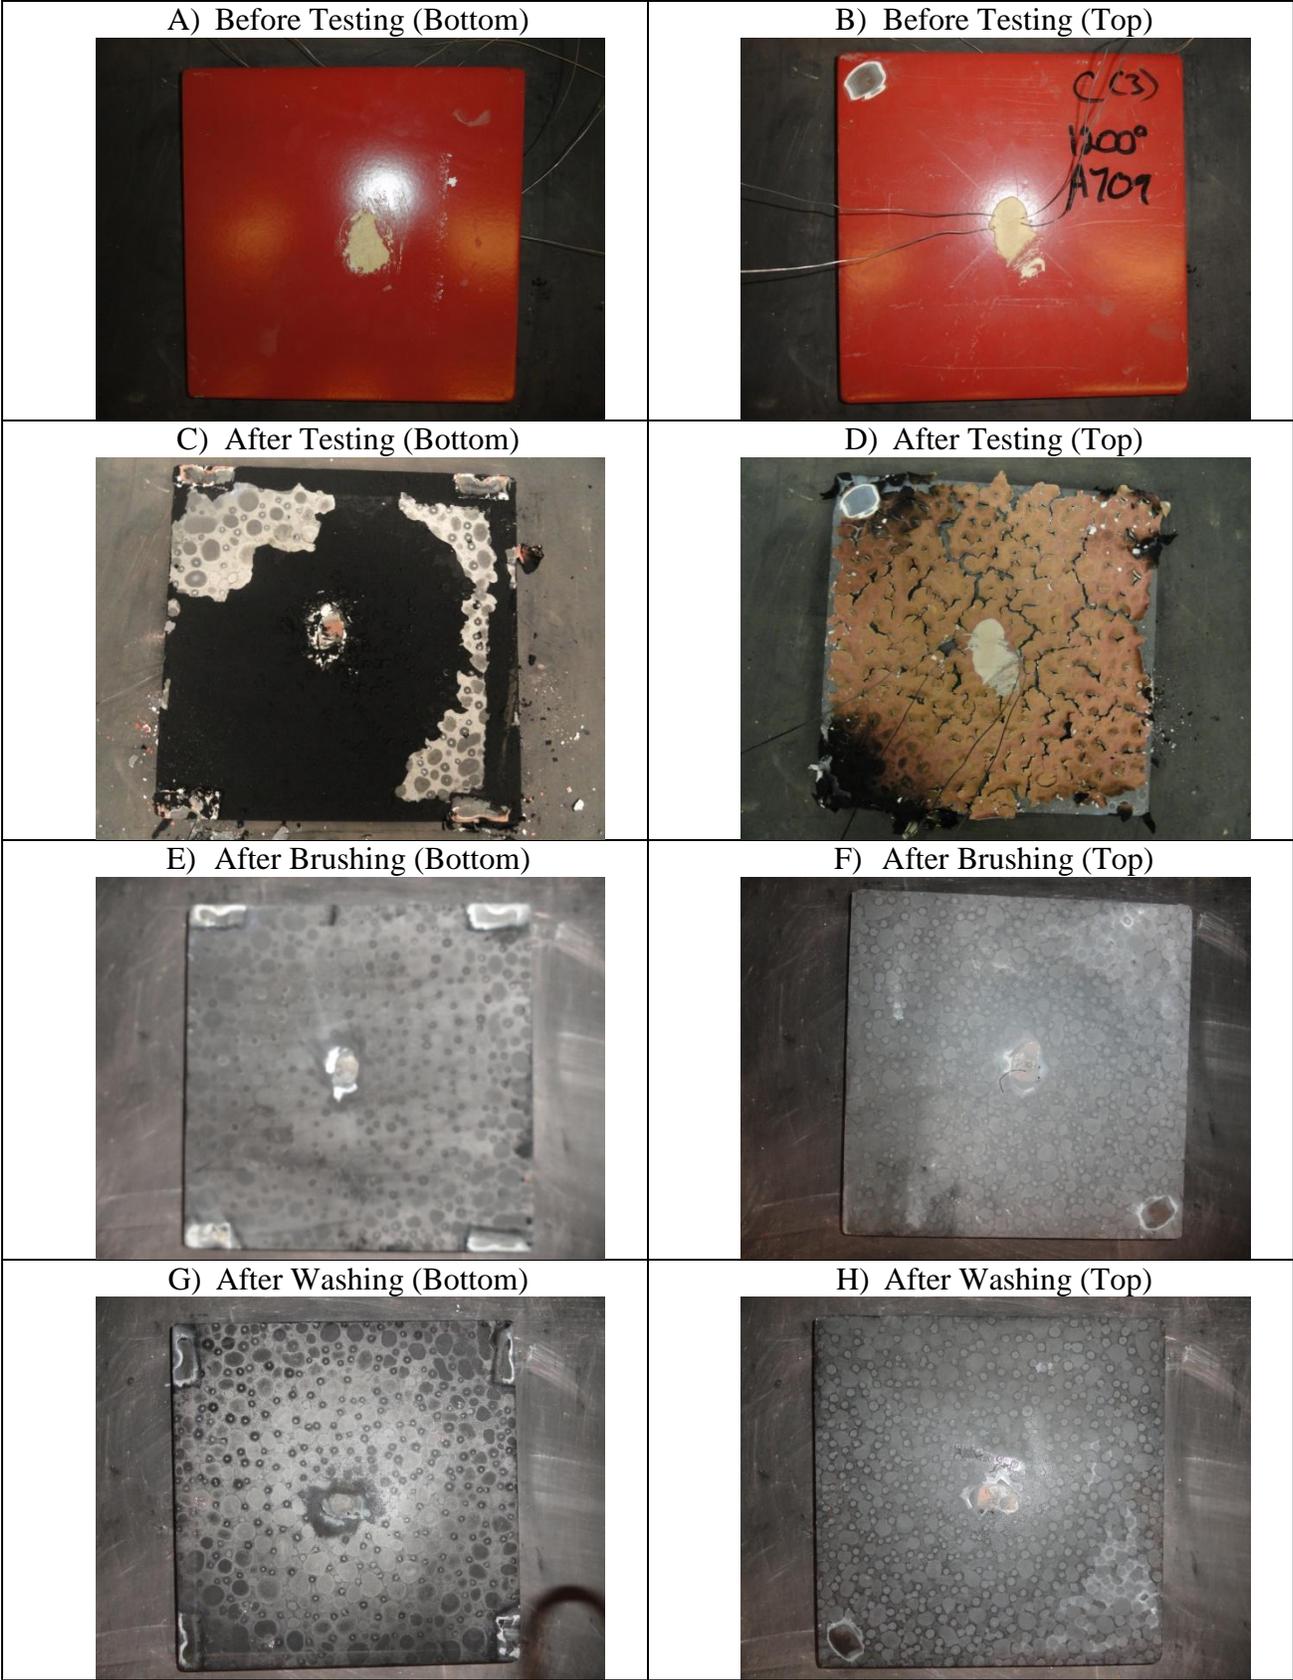
Figure 5.3-3. Post-Fire Evaluation of Acrolon C (3) 1200°F

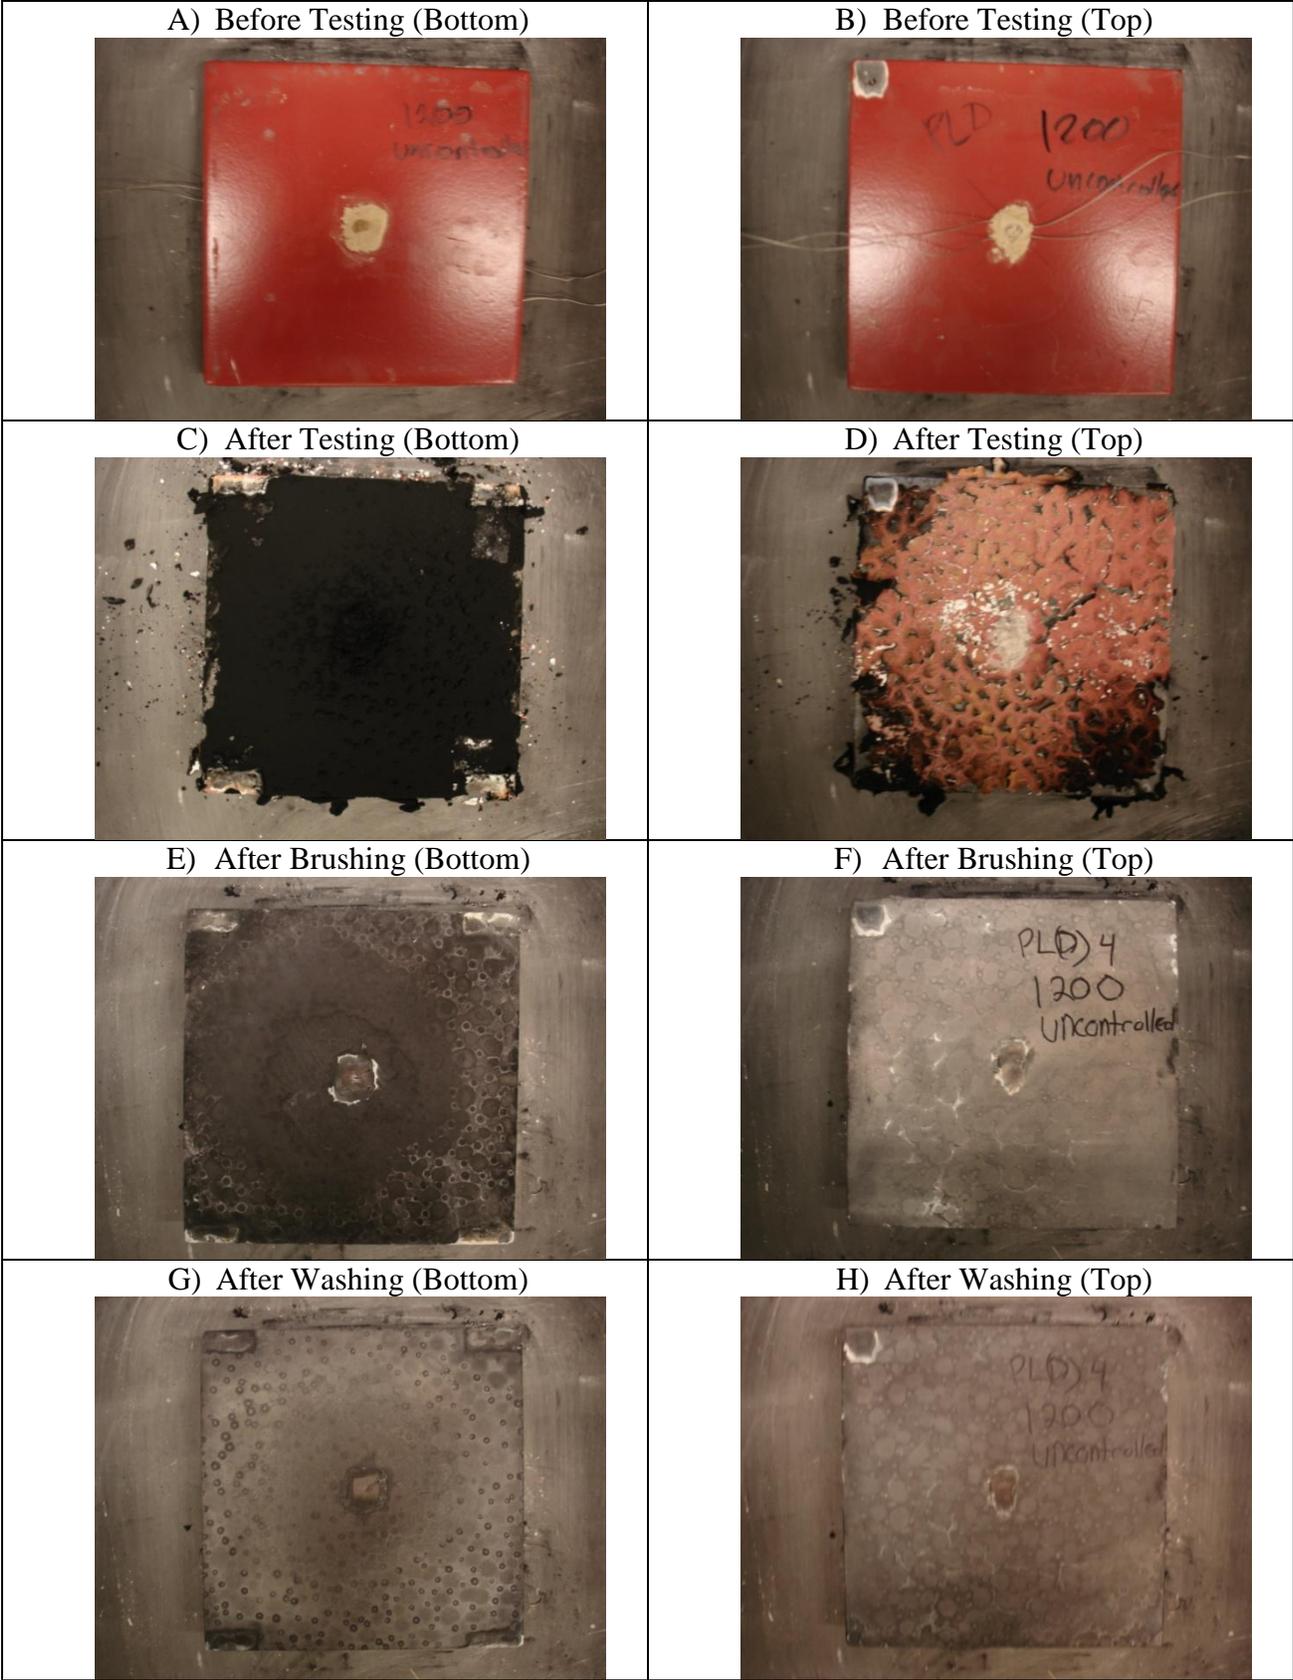
Figure 5.3-4. Post-Fire Evaluation of Acrolon D (4) Uncontrolled 1200°F

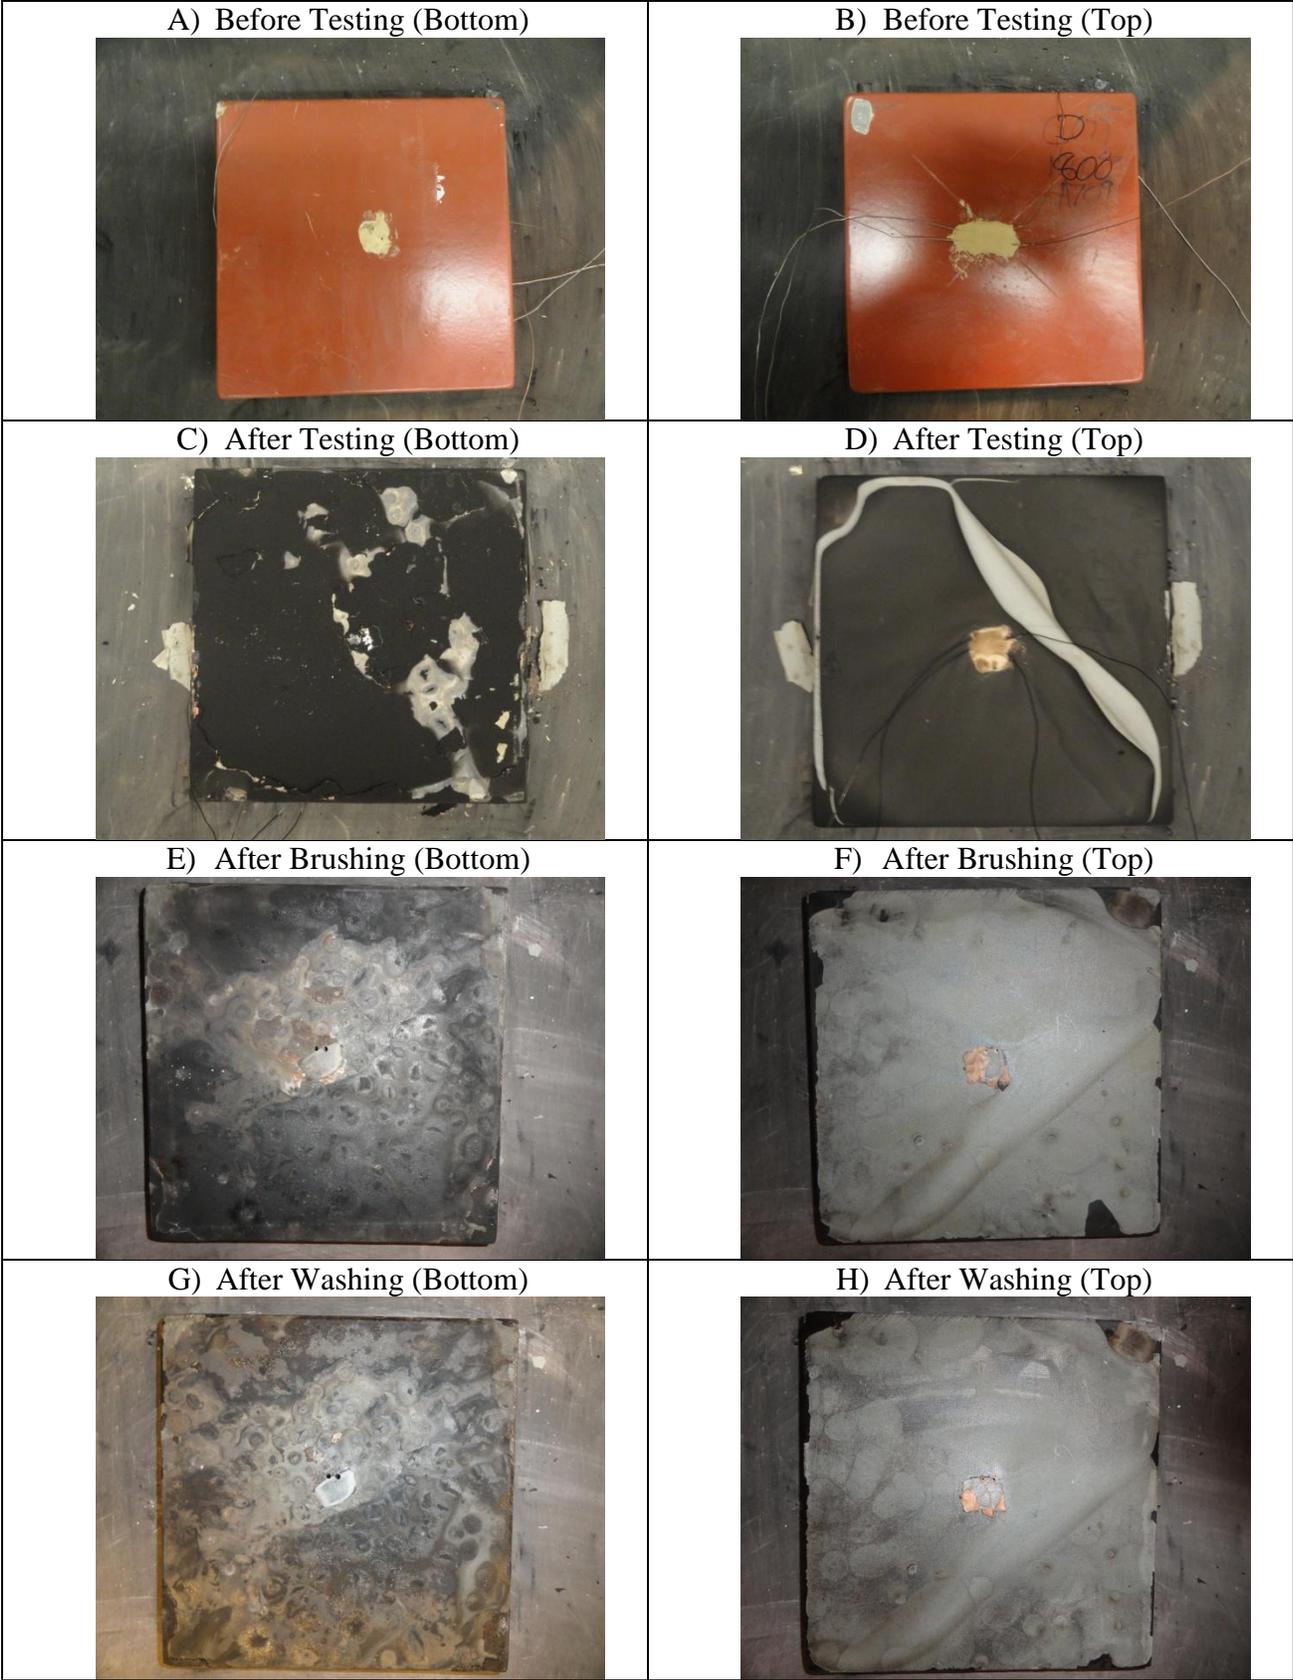
Figure 5.3-5. Post-Fire Evaluation of Acrolon E (5) 800°F

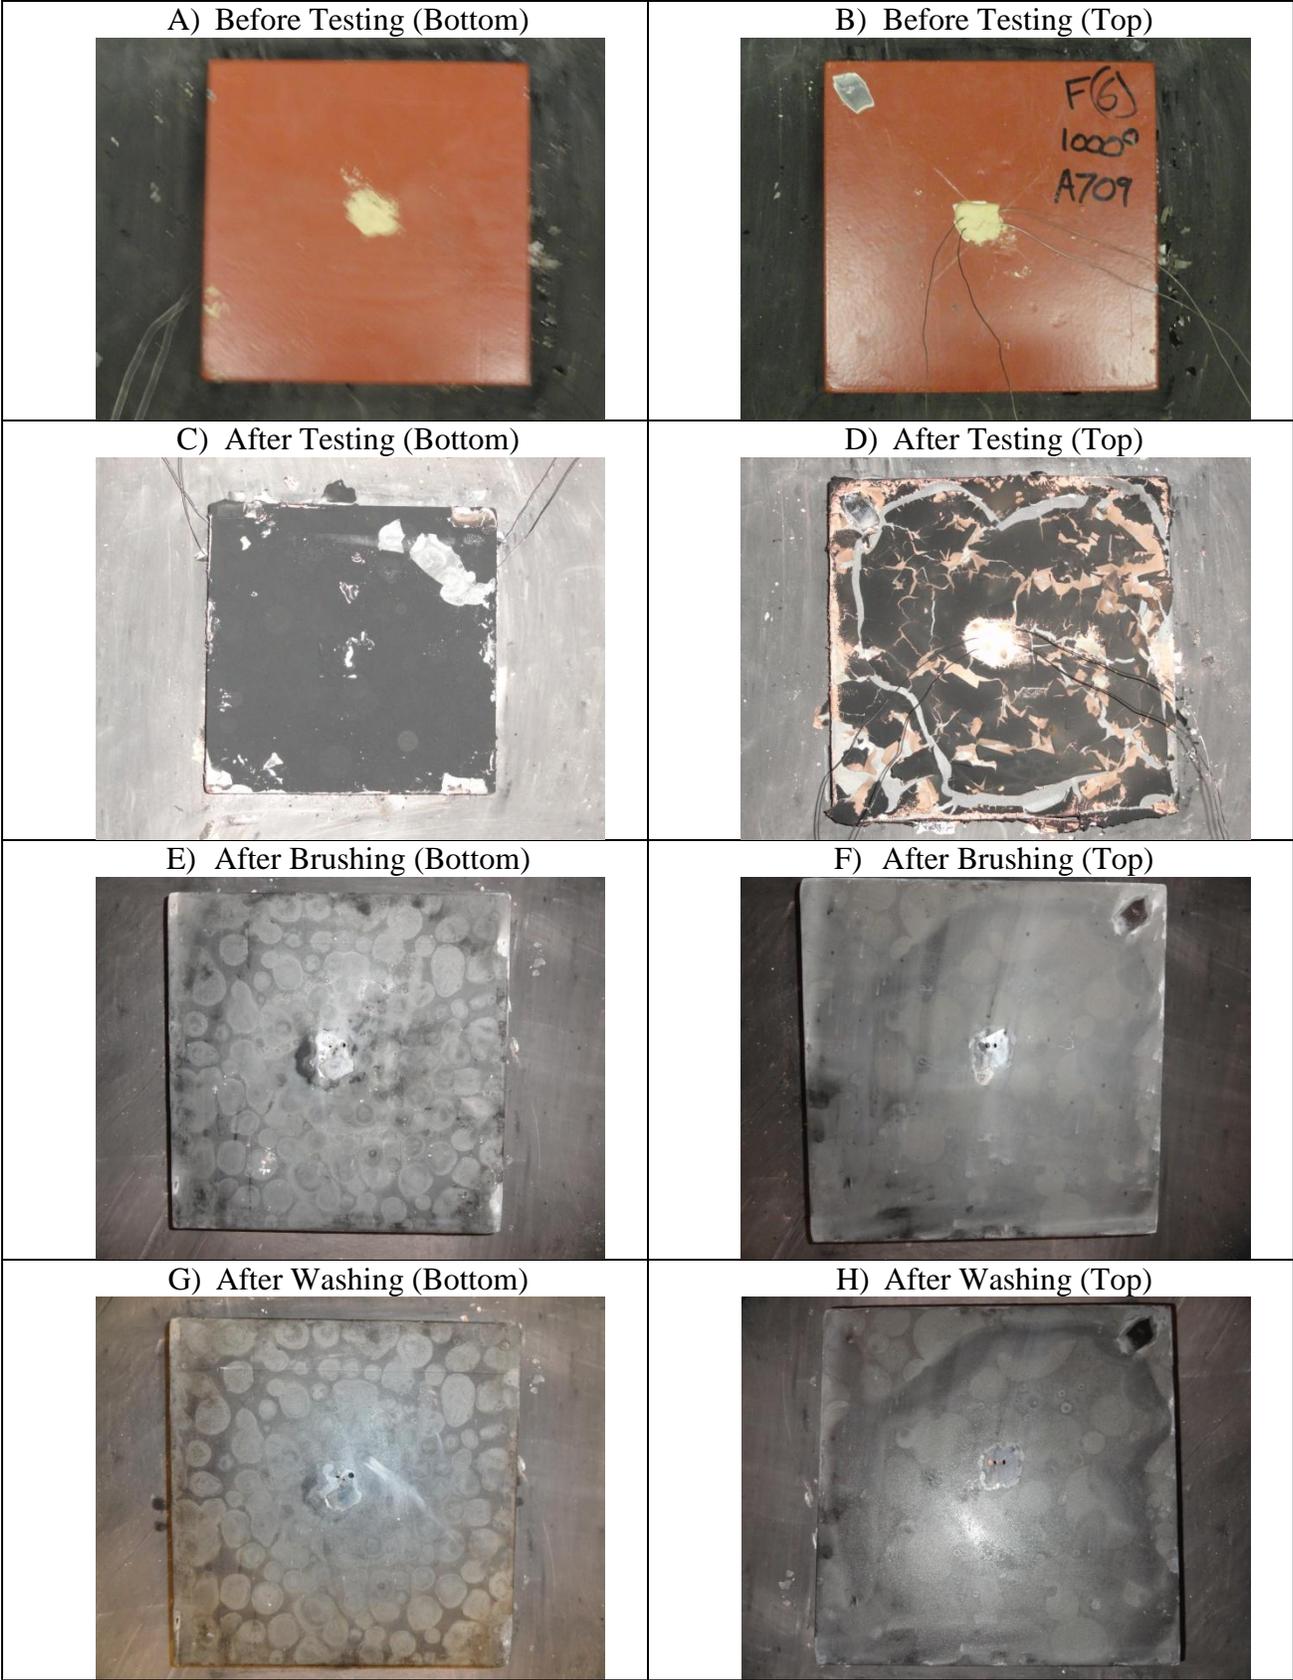
Figure 5.3-6. Post-Fire Evaluation of Acrolon F (6) 1000°F
