Effects of Fire Damage on the Structural Properties of Steel Bridge Elements

FINAL REPORT

University of Pittsburgh

1. Report No. FHWA-PA-2011-009-PIT011		2. Government Accession No.		3. Recipient's Catalog No.	
4. Title and Subtitle Effects of Fire Damage on the Structural Properties of Steel Bridge Elements				5. Report Date April 30, 2011

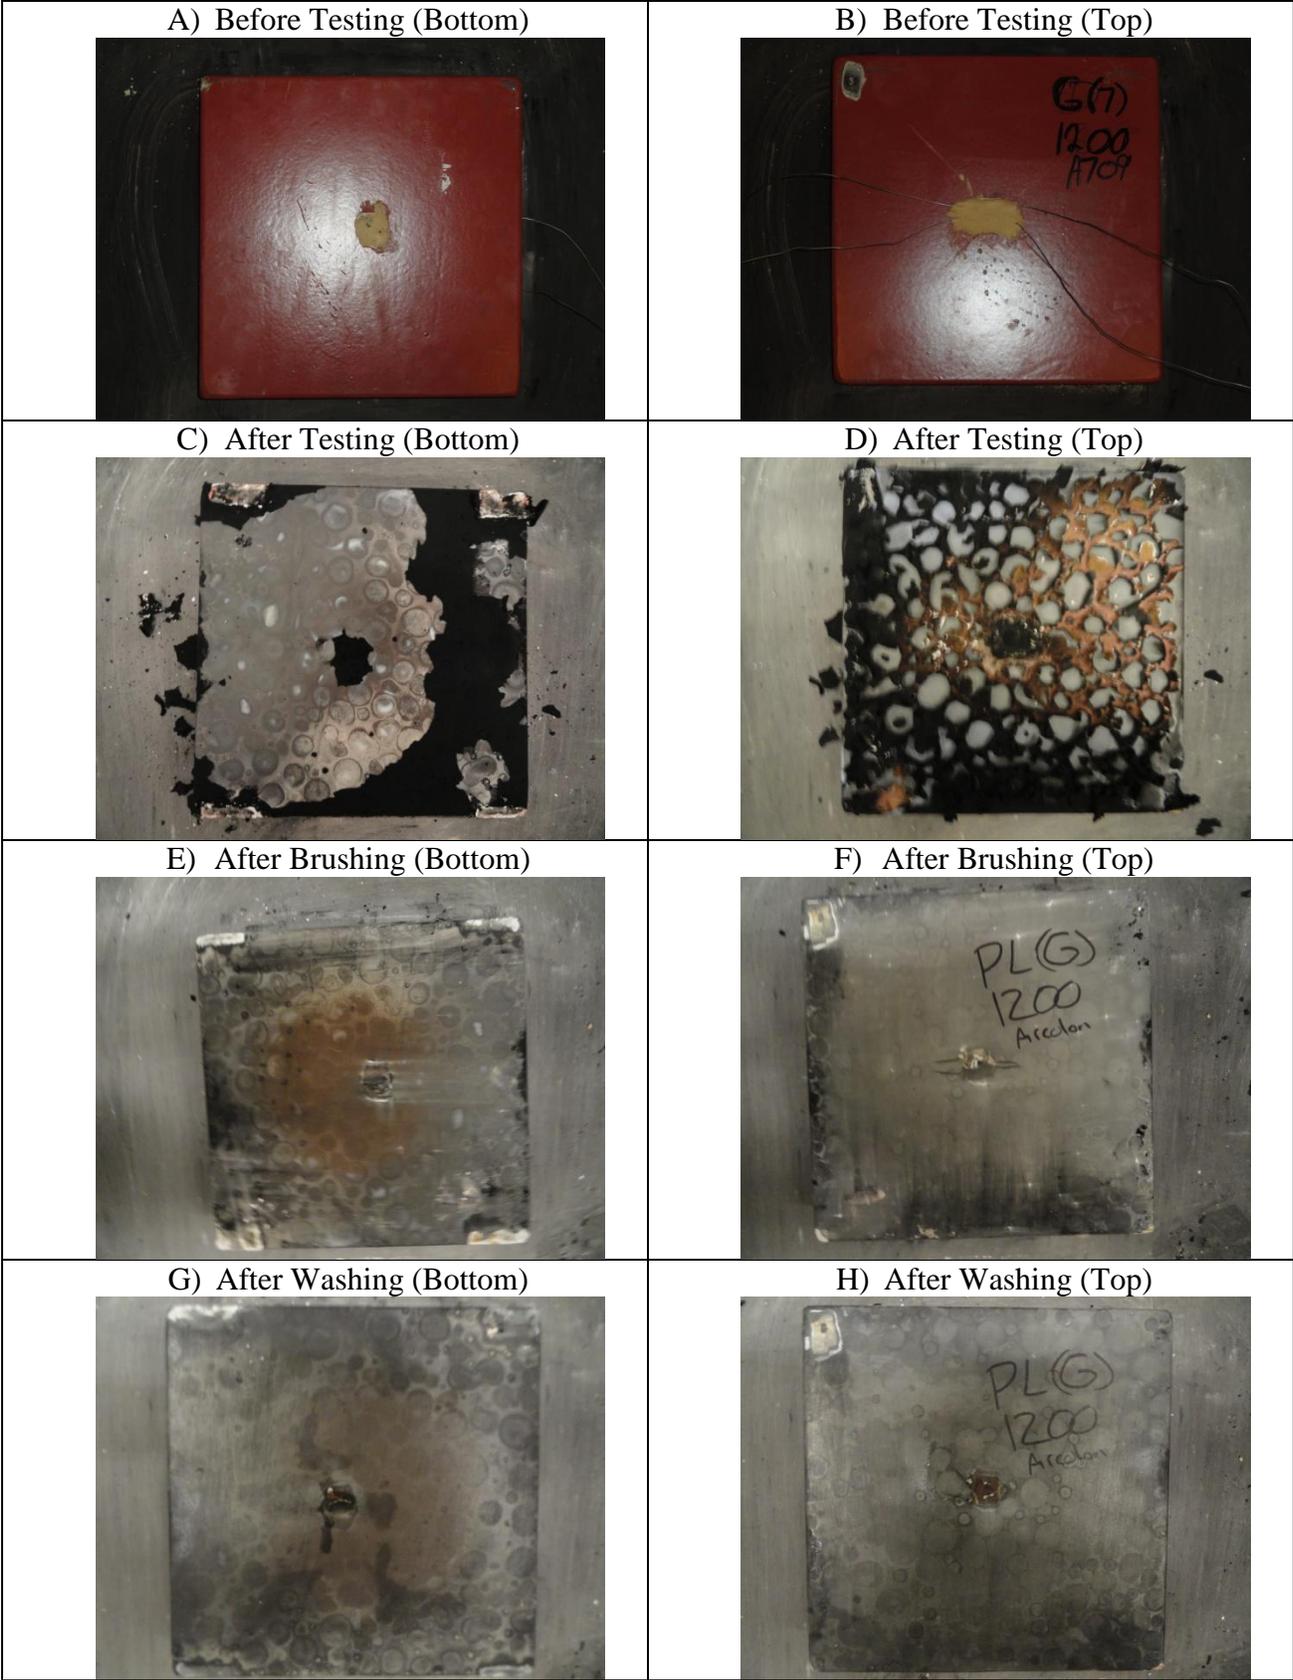
Figure 5.3-7. Post-Fire Evaluation of Acrolon G (7) 1200°F

Figures 5.3-1 to 5.3-8 show photographs of the post-fire evaluation of the plate specimens (Part 3) identified in Table 4.2-1 and listed below. These include photographs taken as described in Section 4.4.

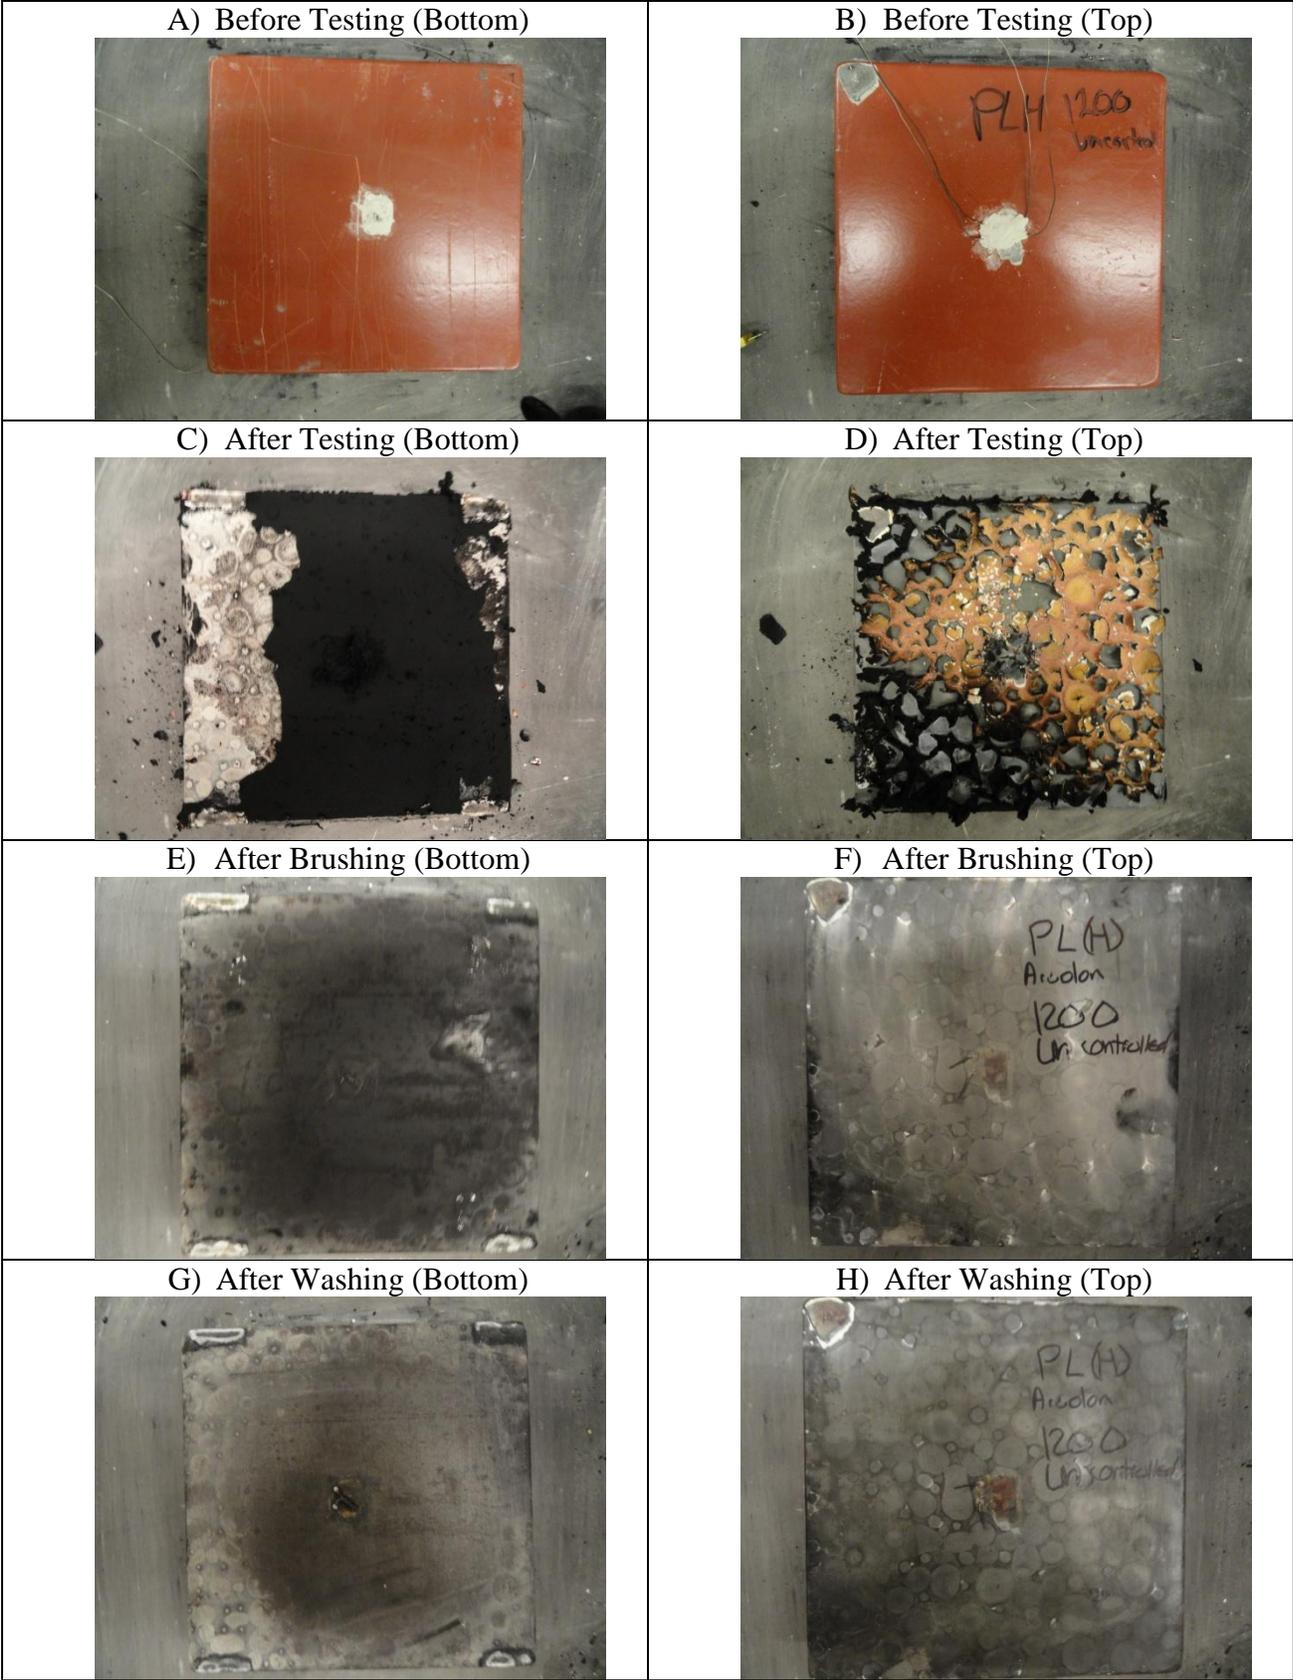
Figure 5.3-8. Post-Fire Evaluation of Acrolon H (8) Uncontrolled 1200°F

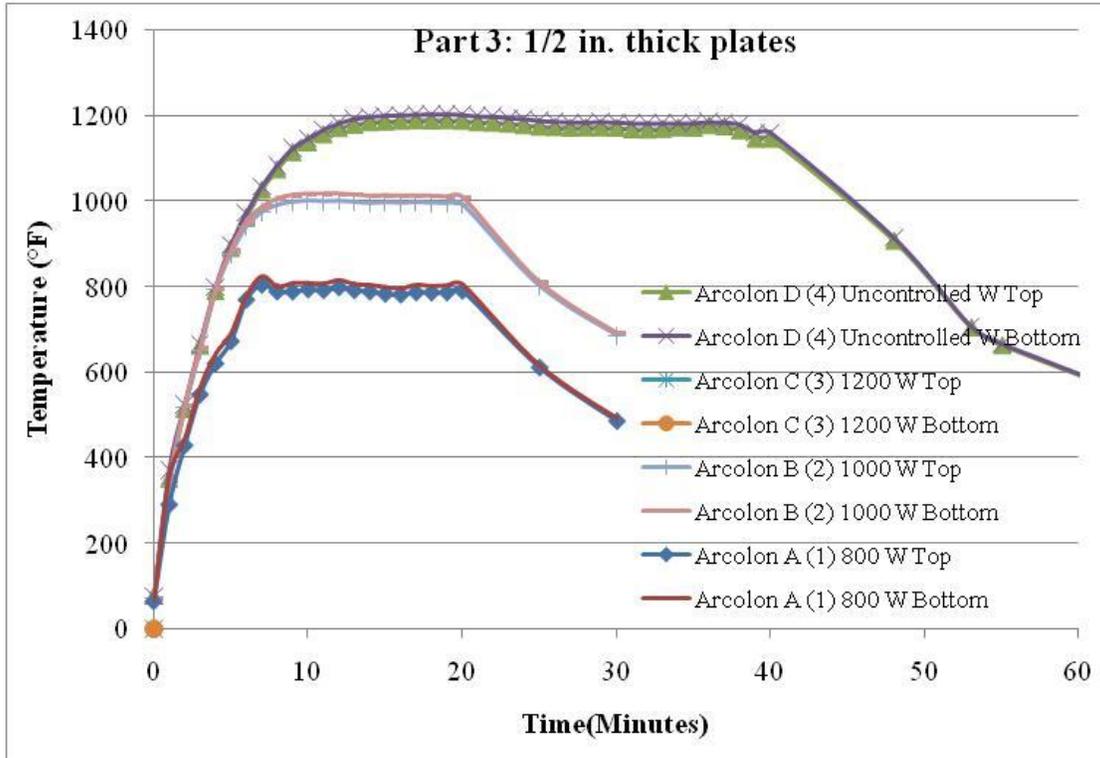
Figure 5.3-9. Measured Temperature-Time Curves for ½ in. Plate Specimens with Arcolon coating (Part 3).

Figures 5.3-9 and 5.3-10 show the measured temperature-time (T-t) curves for the ½ in. thick and 1 in. thick plate specimens, respectively. As shown the target temperatures of 800, 1000, and 1200 °F were achieved and maintained for 20 minutes before cooling. The uncontrolled fire test reached a maximum temperature of 1200 °F also, and was allowed to continue (burn out) for 40 minutes before cooling.

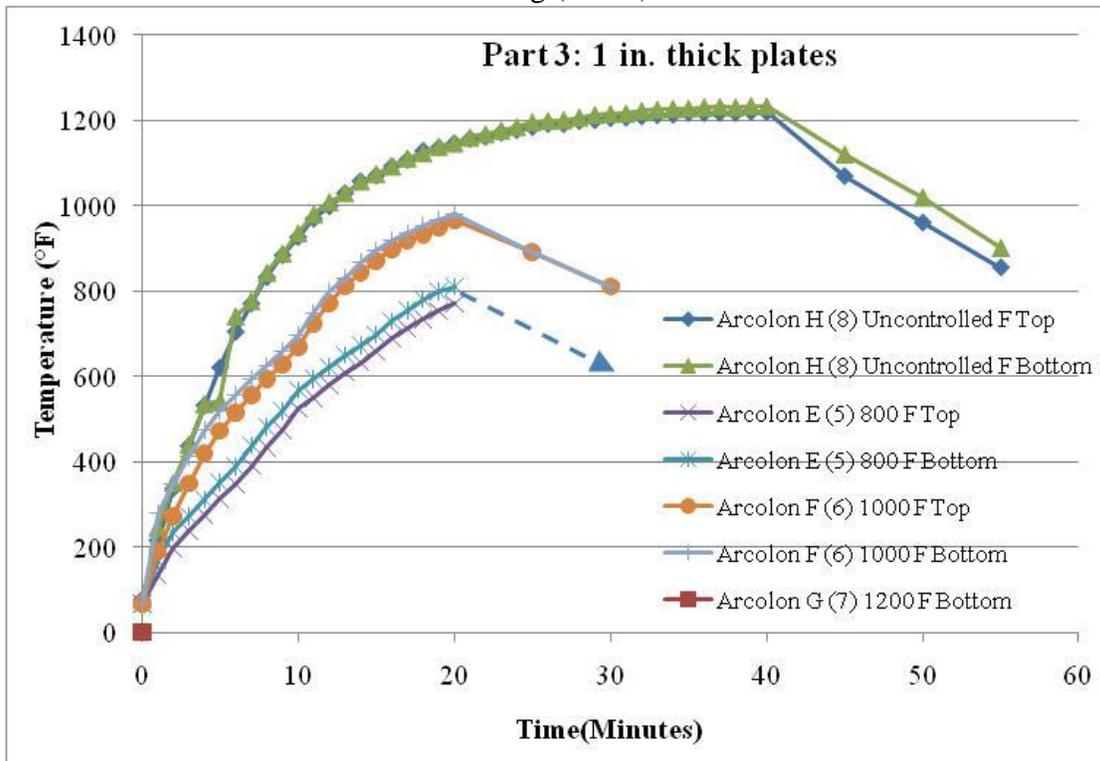
Figure 5.3-9. Measured Temperature-Time Curves for 1 in. Plate Specimens with Arcolon coating (Part 3).

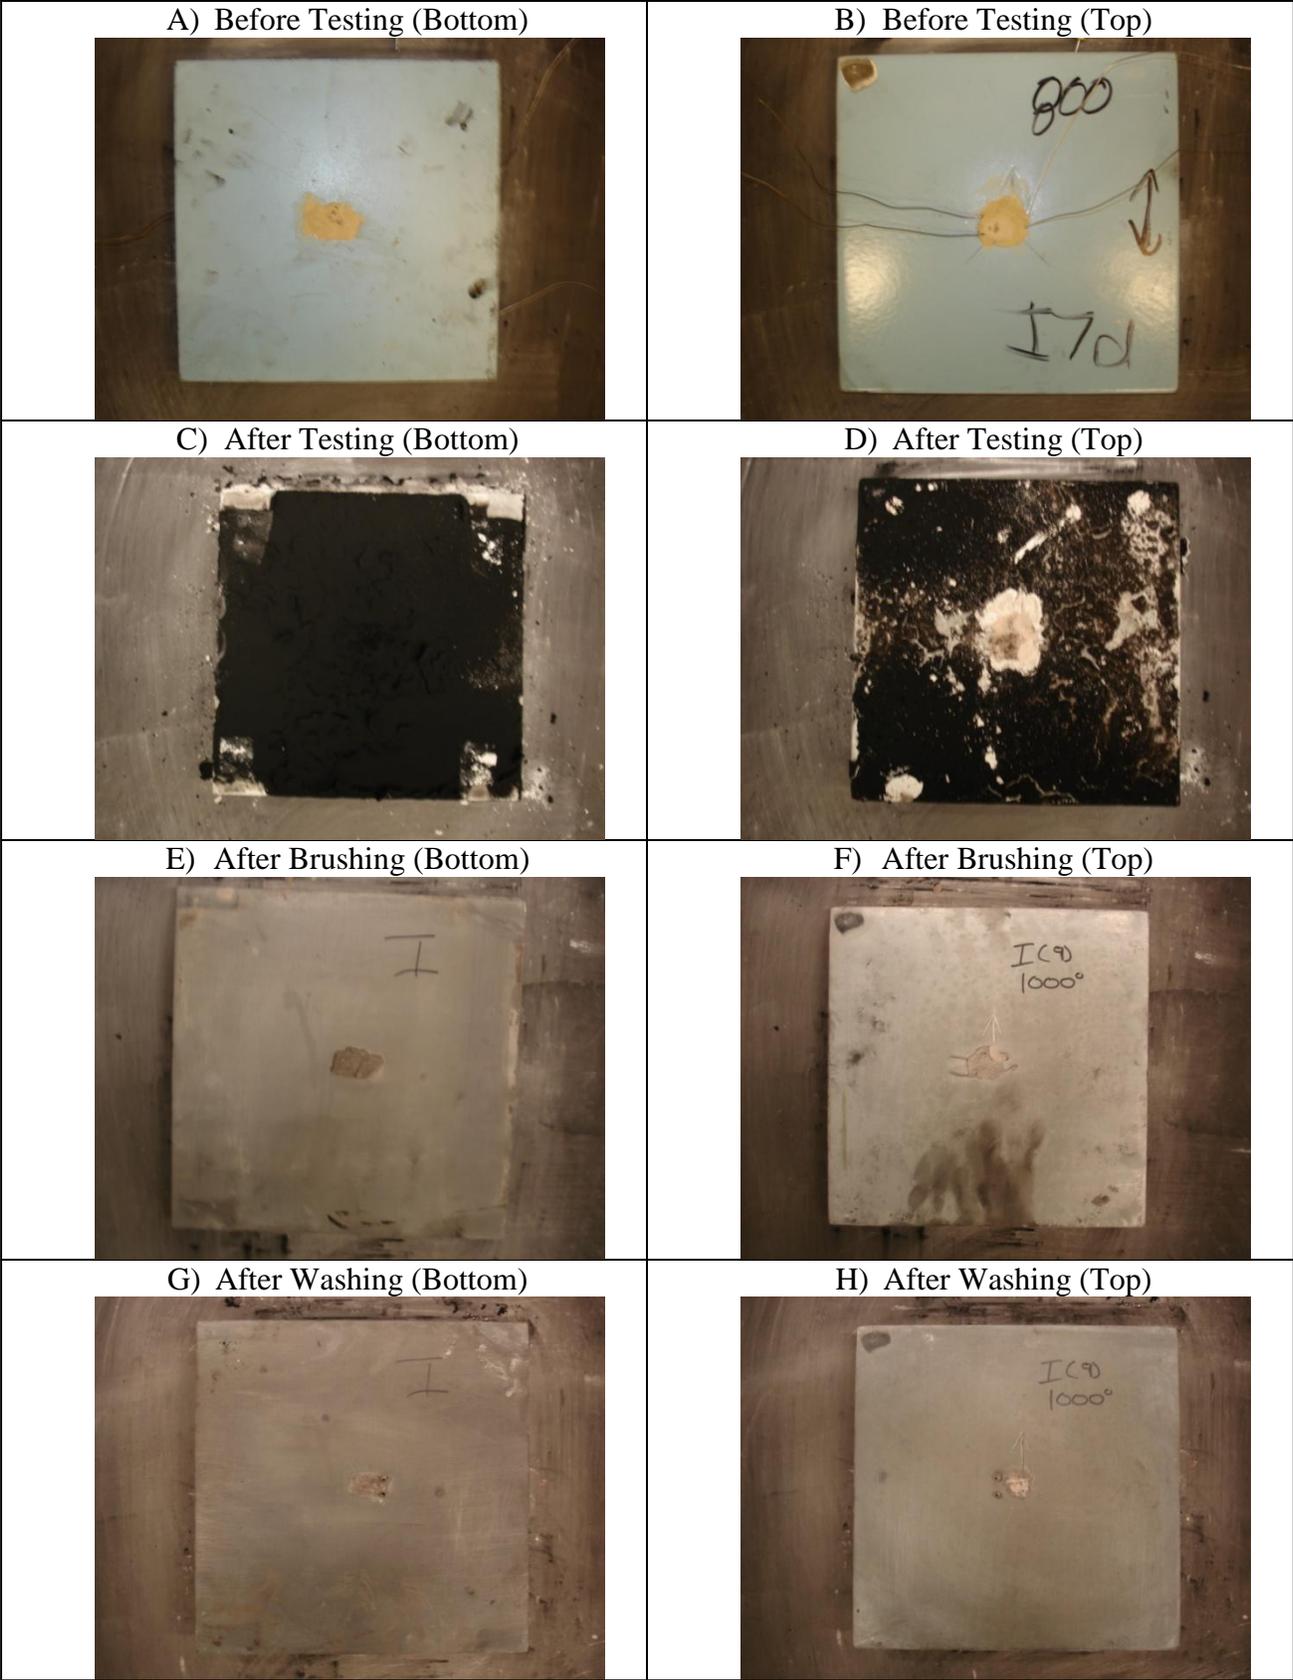
Figure 5.4-1. Post-Fire Evaluation of Carbothane I (9) 1000°F

Figures 5.4-1 to 5.4-6 show photographs of the post-fire evaluation of the plate specimens (Part 4) identified in Table 4.2-1 and listed below. These include photographs taken as described in Section 4.4.

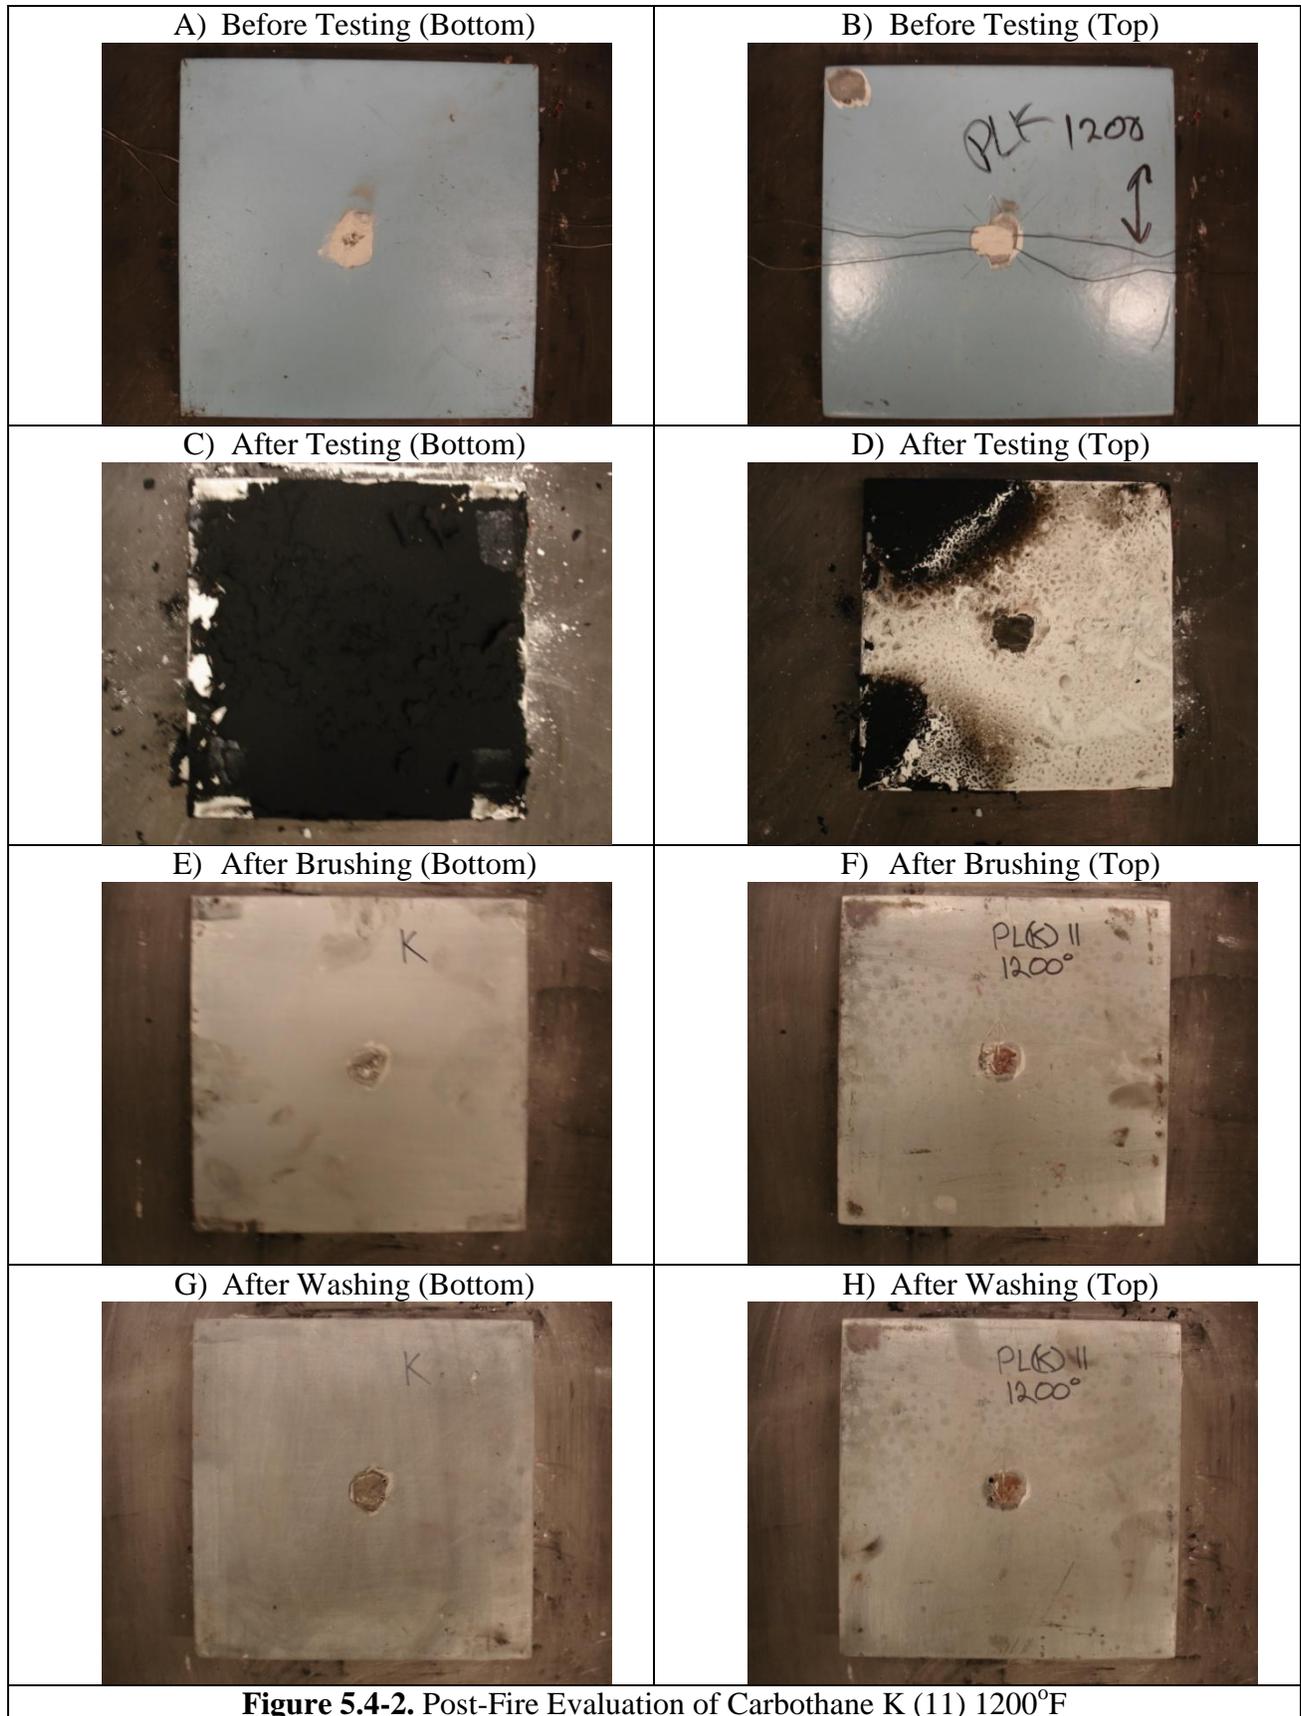
Figure 5.4-2. Post-Fire Evaluation of Carbothane K (11) 1200°F

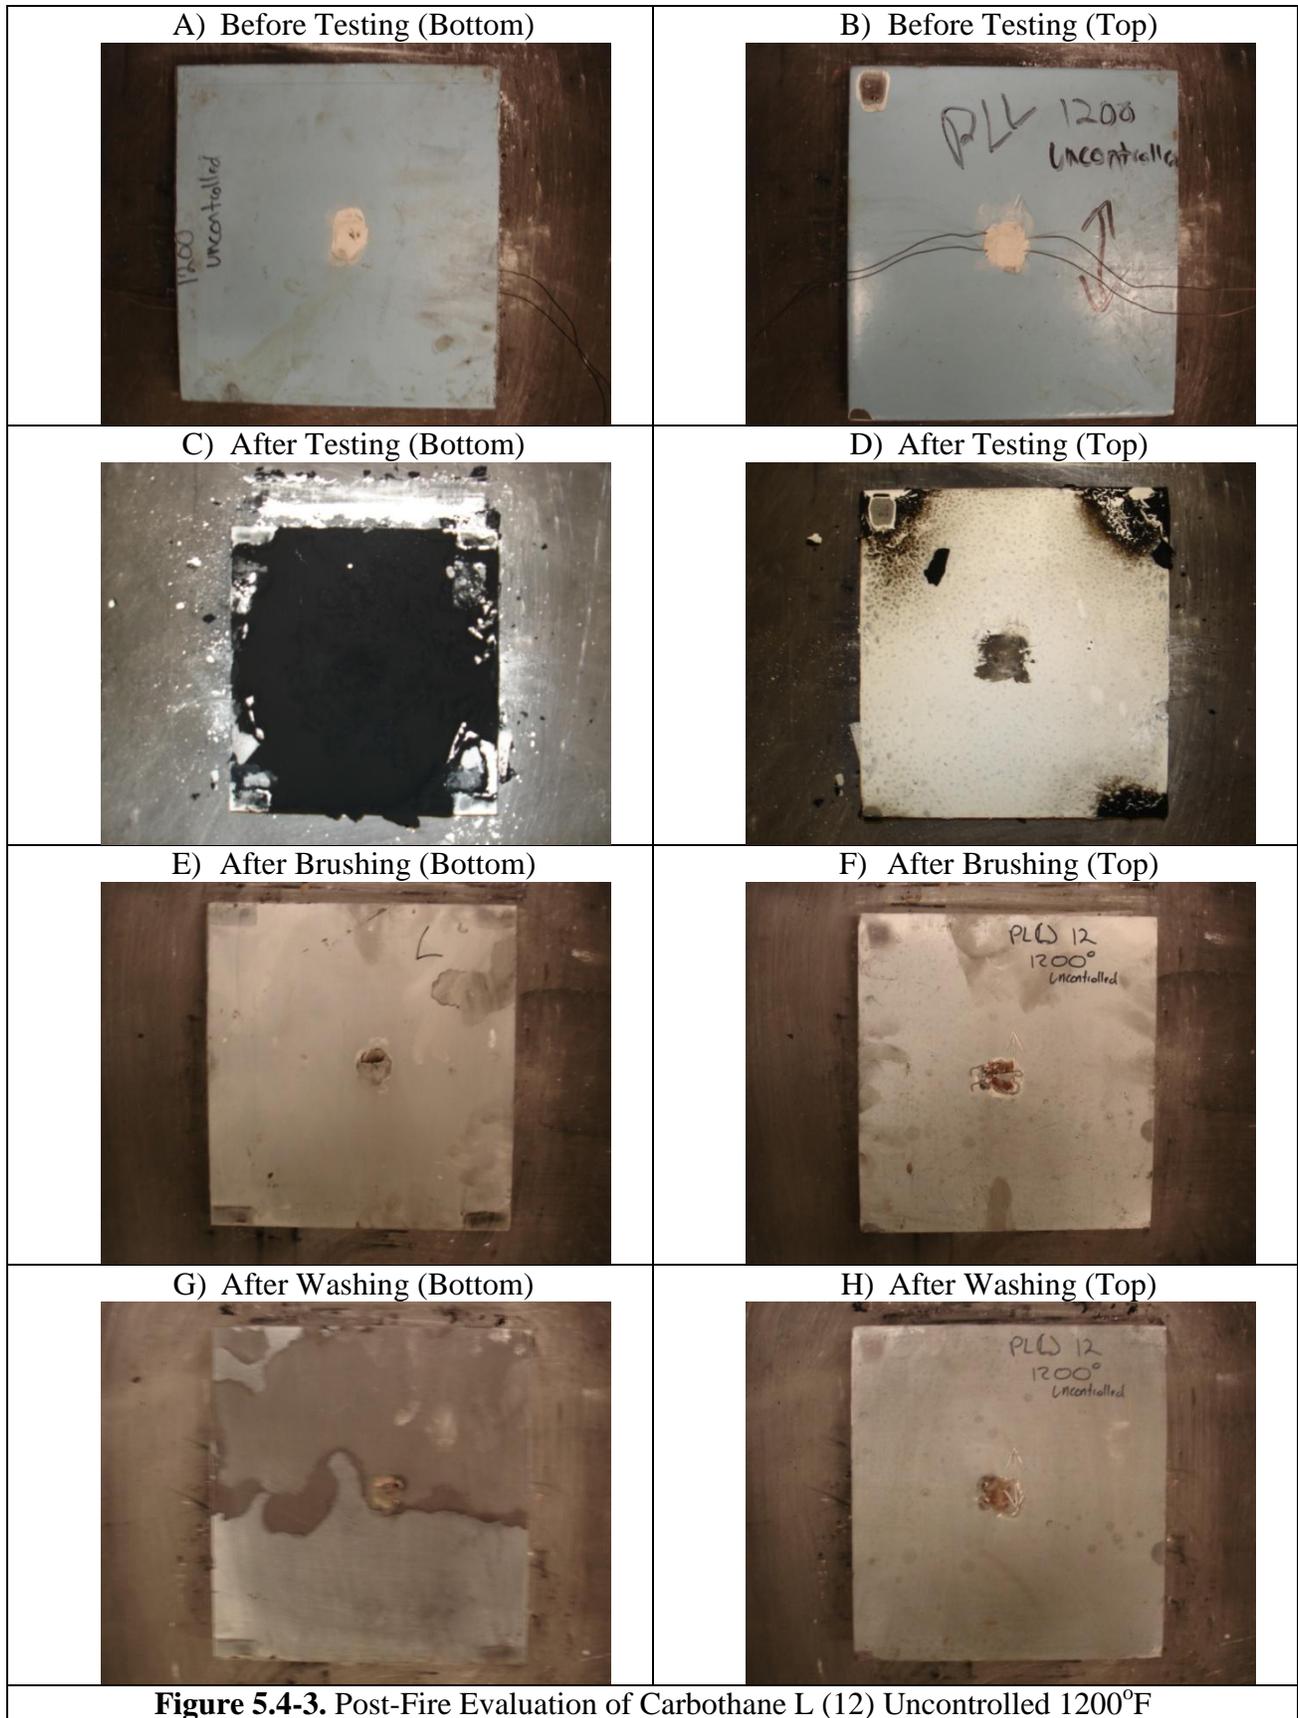
Figure 5.4-3. Post-Fire Evaluation of Carbothane L (12) Uncontrolled 1200°F

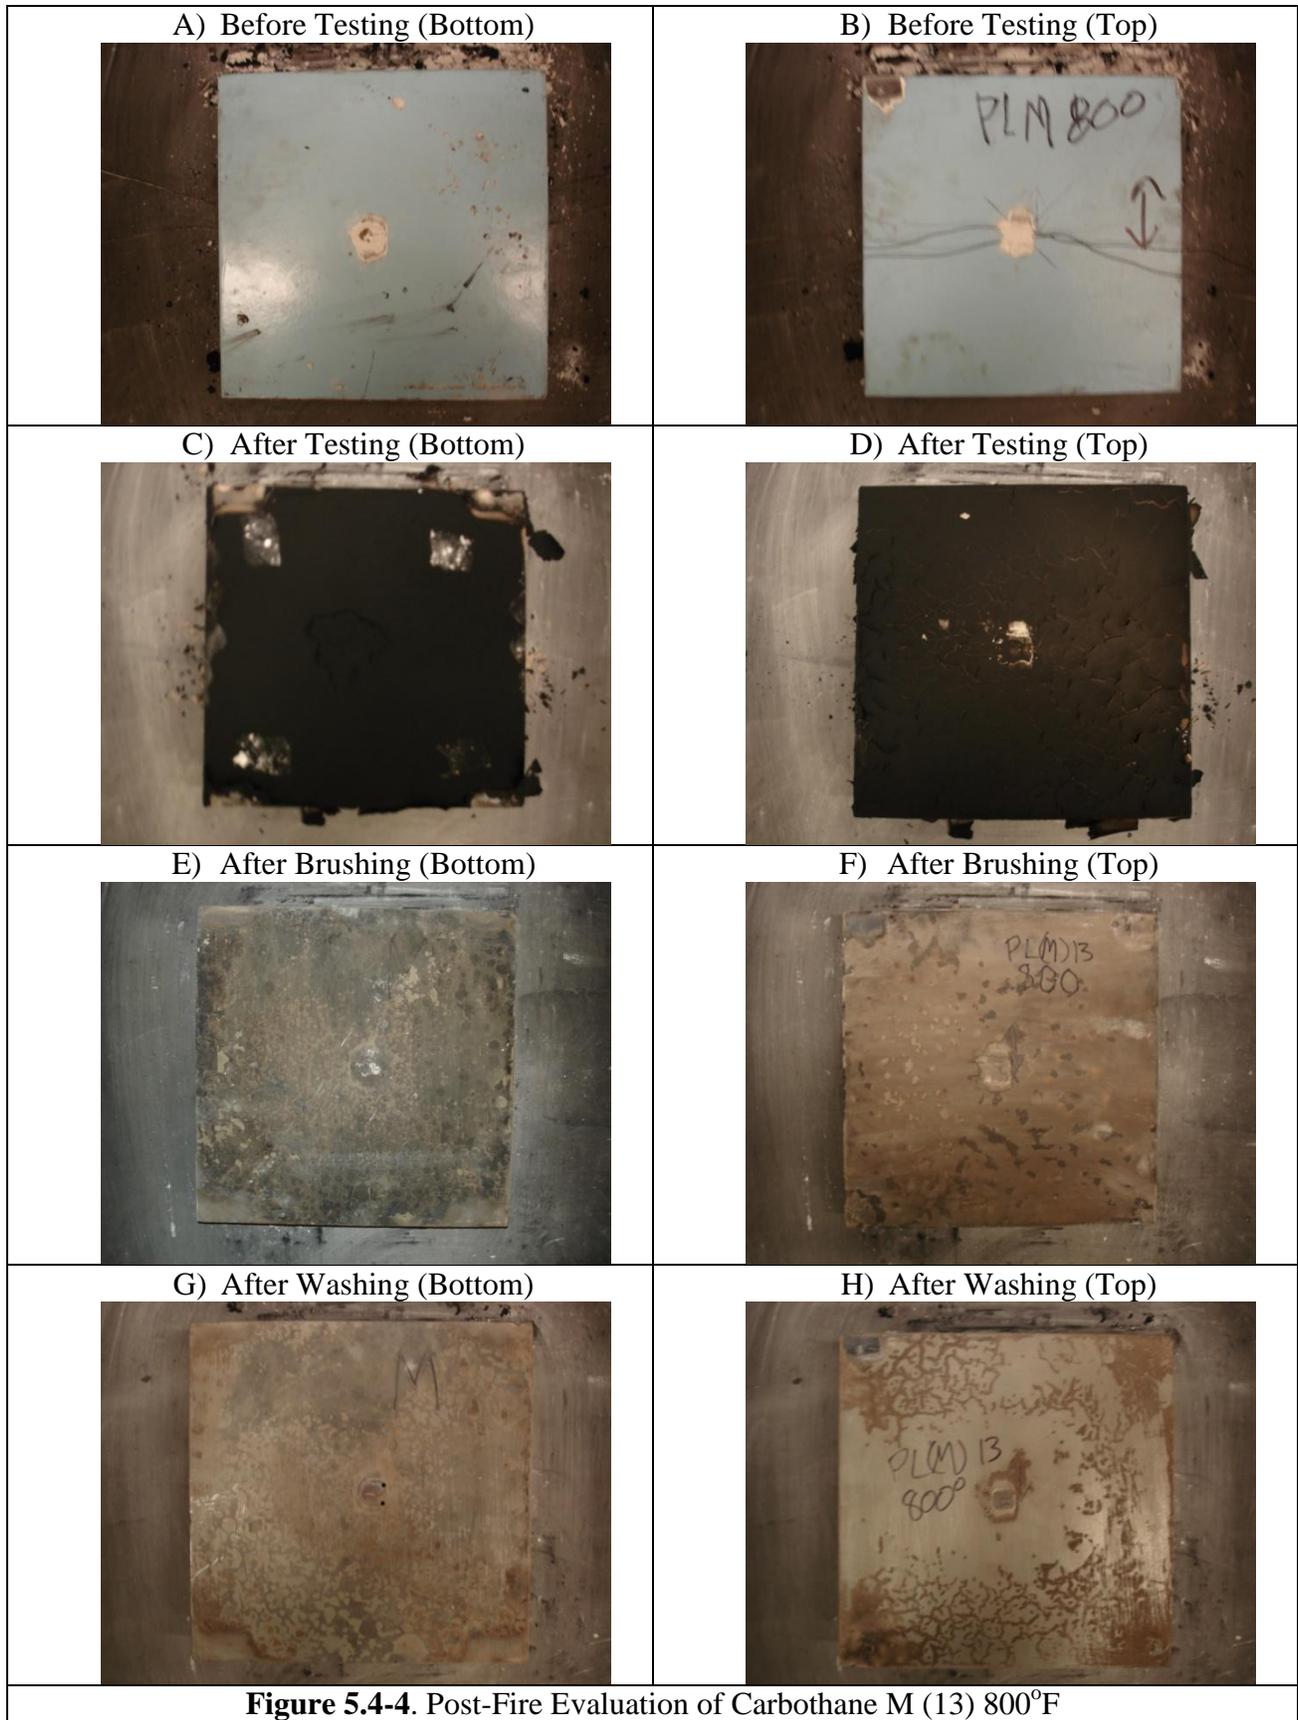
Figure 5.4-4. Post-Fire Evaluation of Carbothane M (13) 800°F

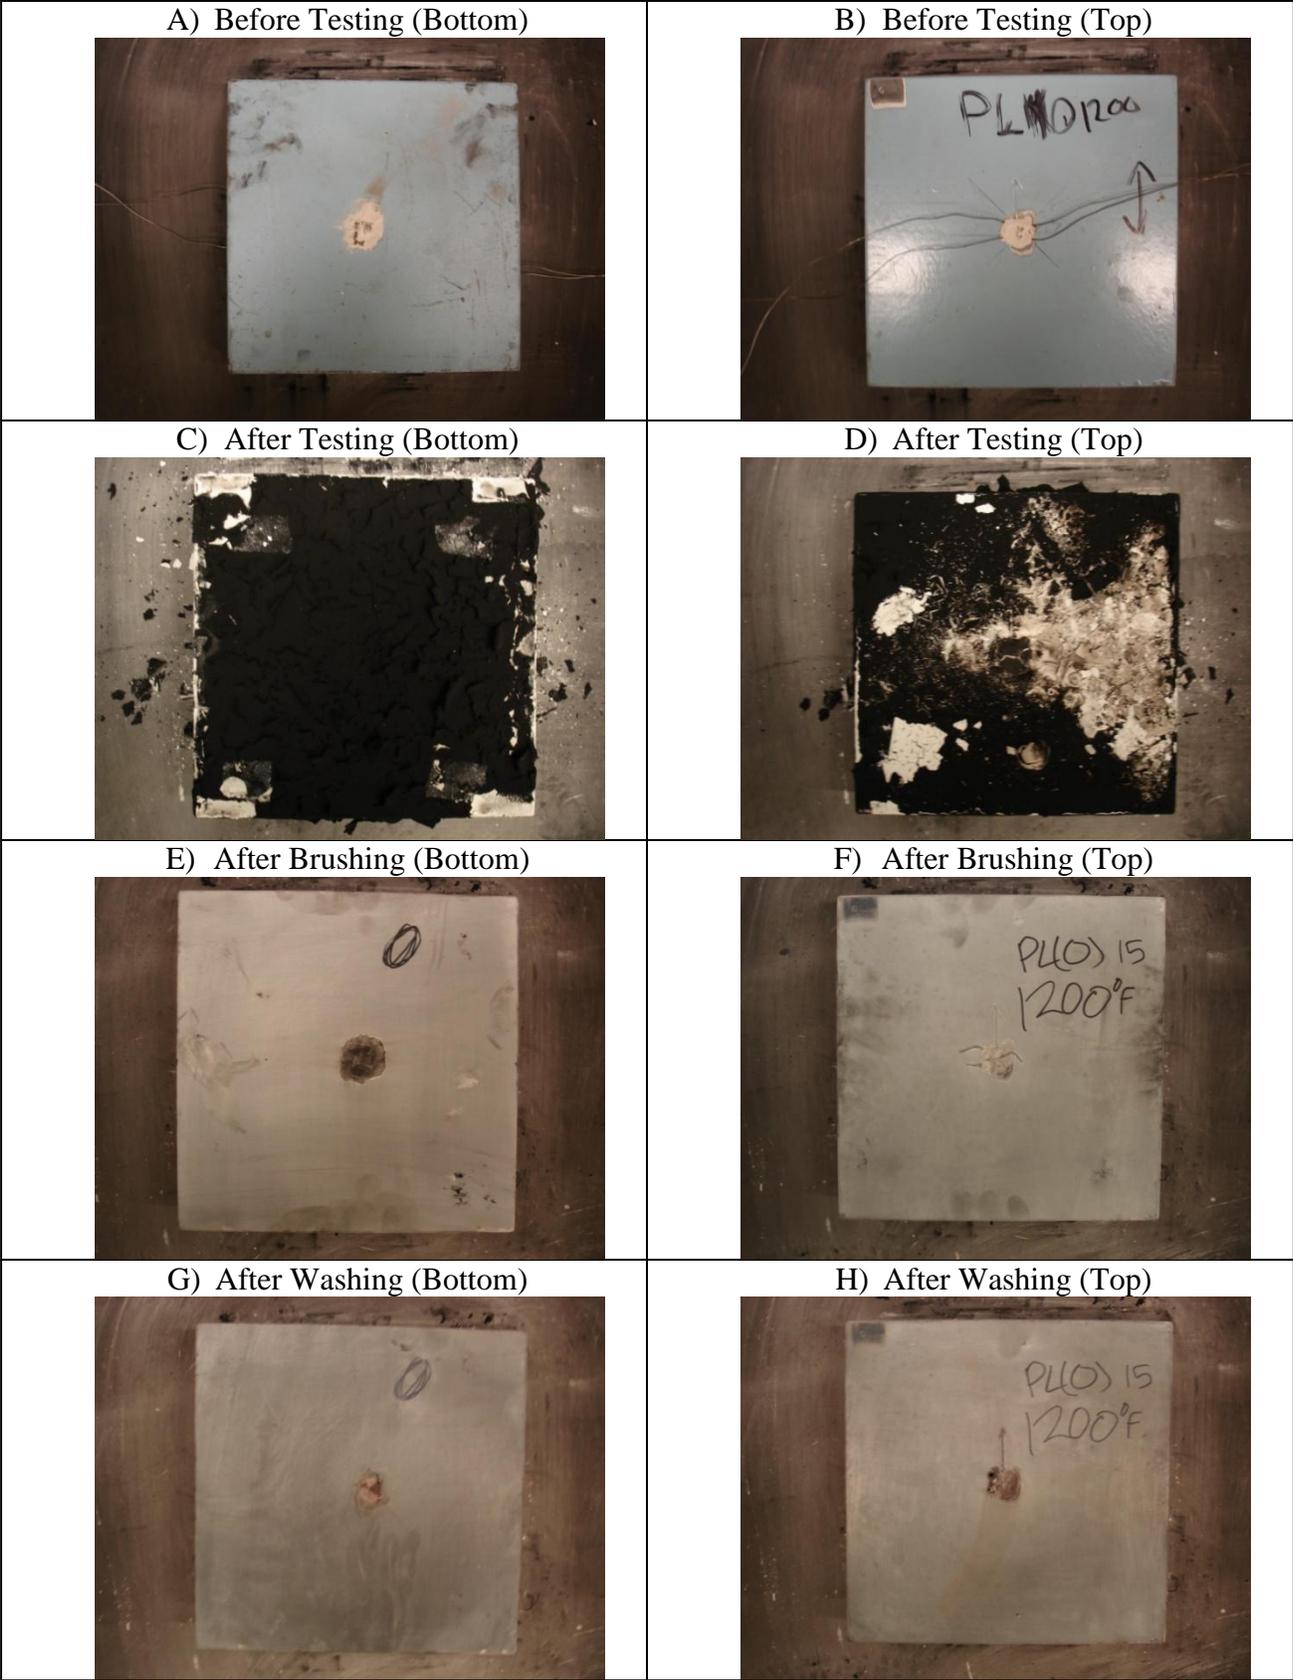
Figure 5.4-5. Post-Fire Evaluation of Carbothane O (15) 1200°F

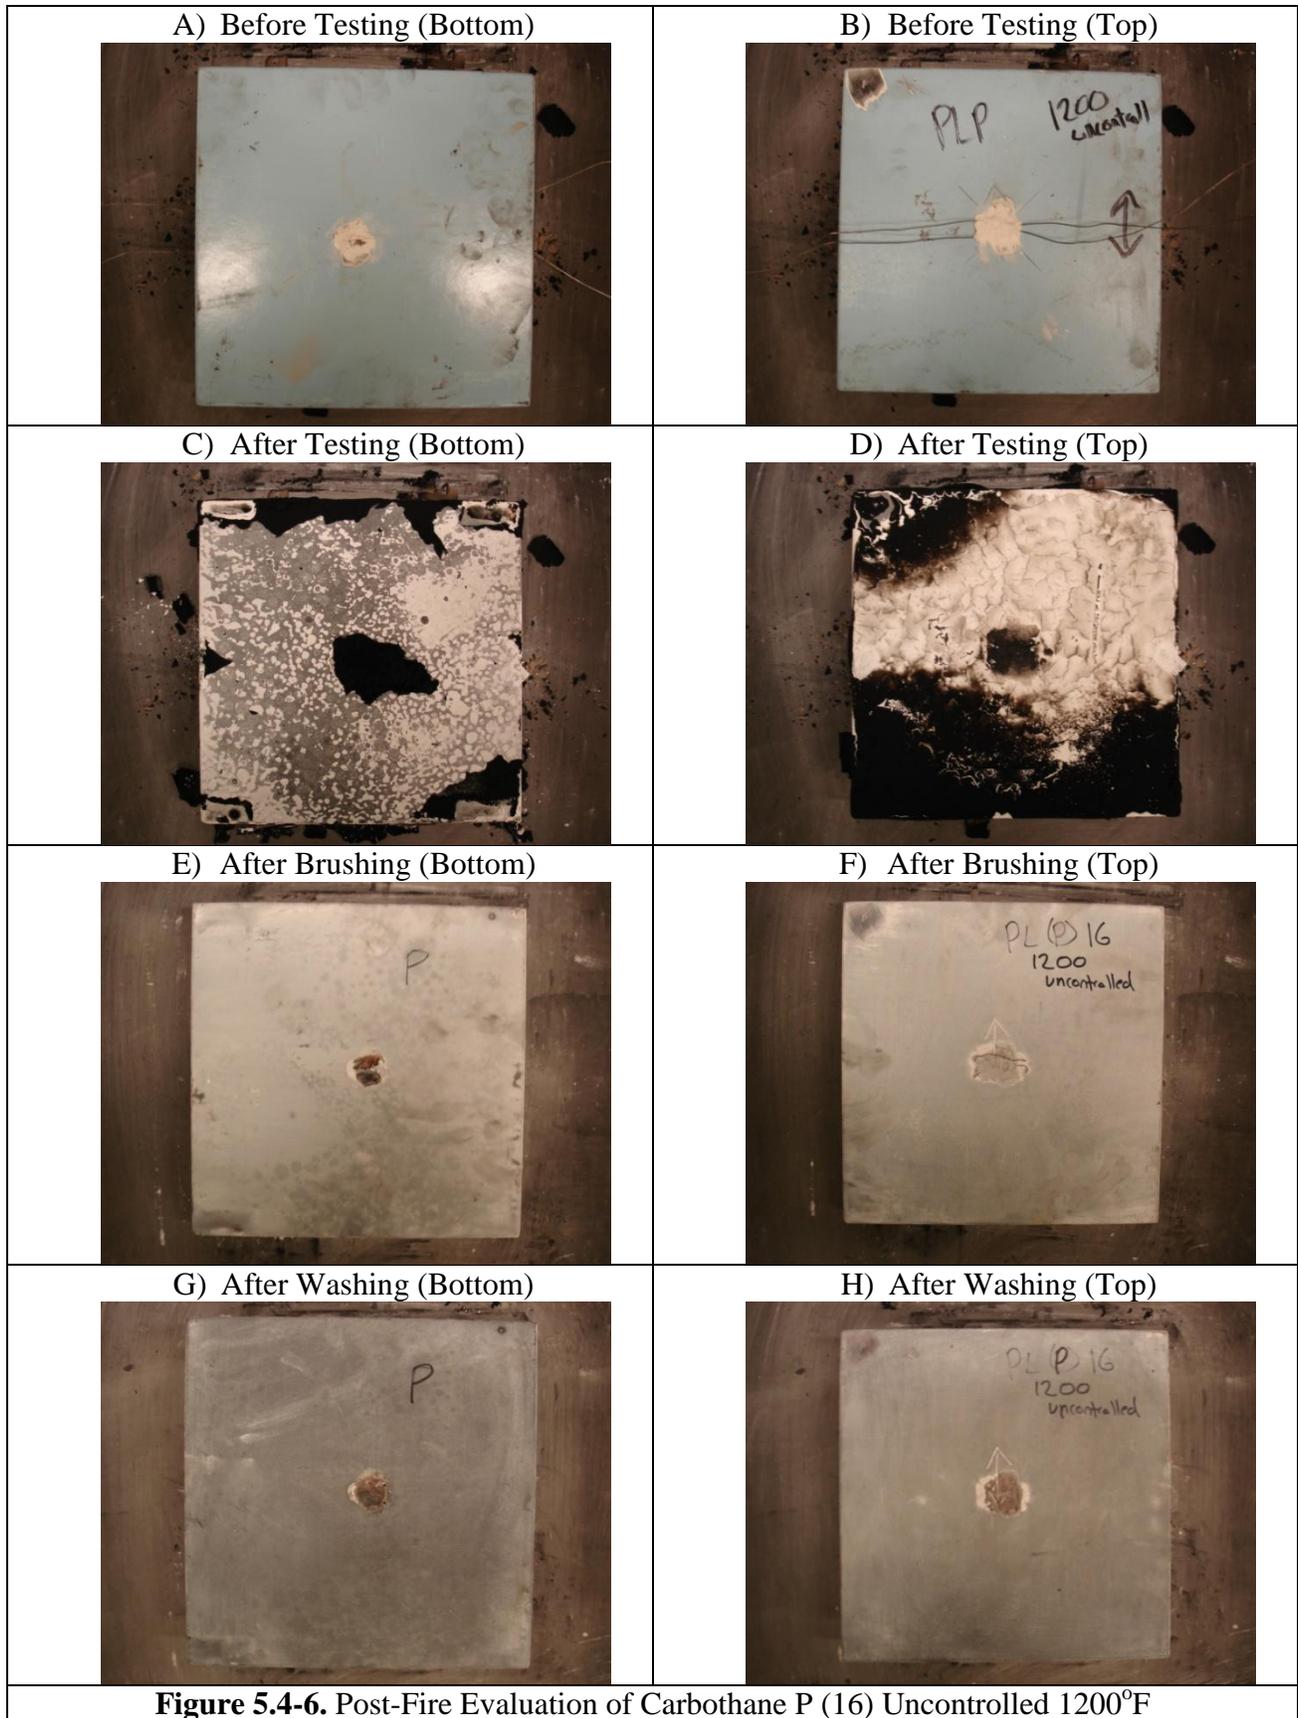
Figure 5.4-6. Post-Fire Evaluation of Carbothane P (16) Uncontrolled 1200°F

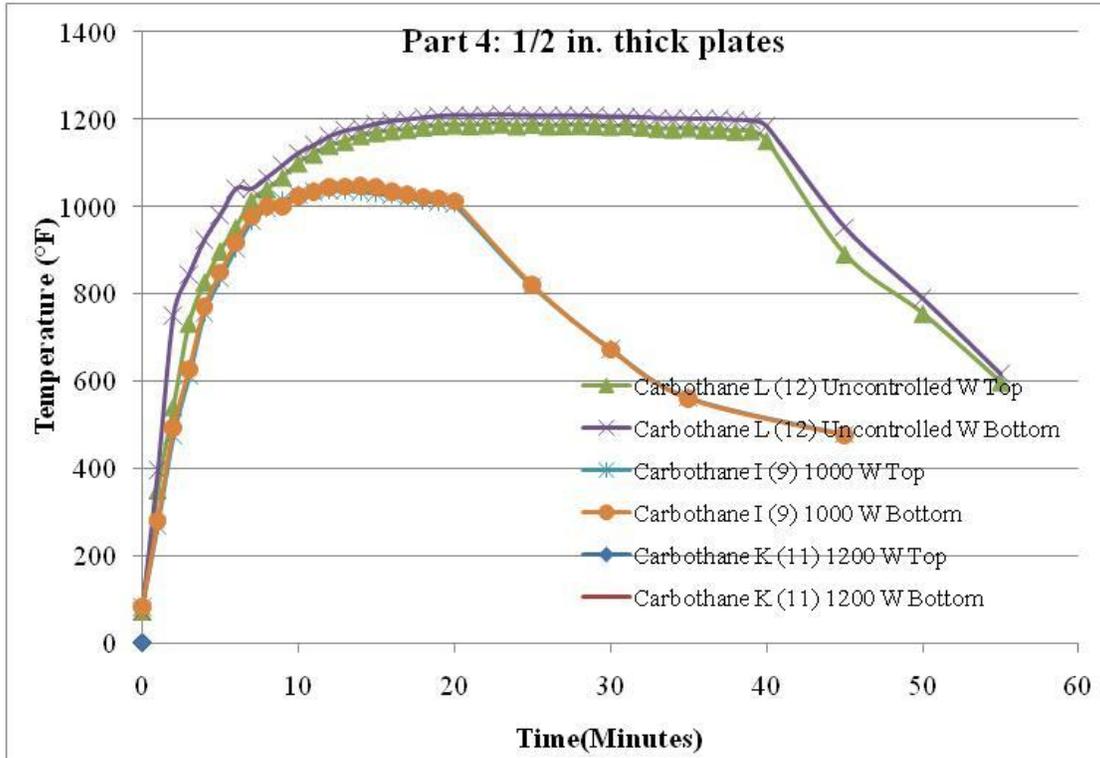
Figure 5.4-7. Measured Temperature-Time Curves for 1/2 in. Thick Carbothane Plates (Part 4).

Figures 5.4-7 and 5.4-8 show the measured temperature-time (T-t) curves for the ½ in. thick and 1 in. thick plate specimens, respectively. As shown the target temperatures of 800, 1000, and 1200°F were achieved and maintained for 20 minutes before cooling. The uncontrolled fire test reached a maximum temperature of 1200°F also, and was allowed to continue (burn out) for 40 minutes before cooling.

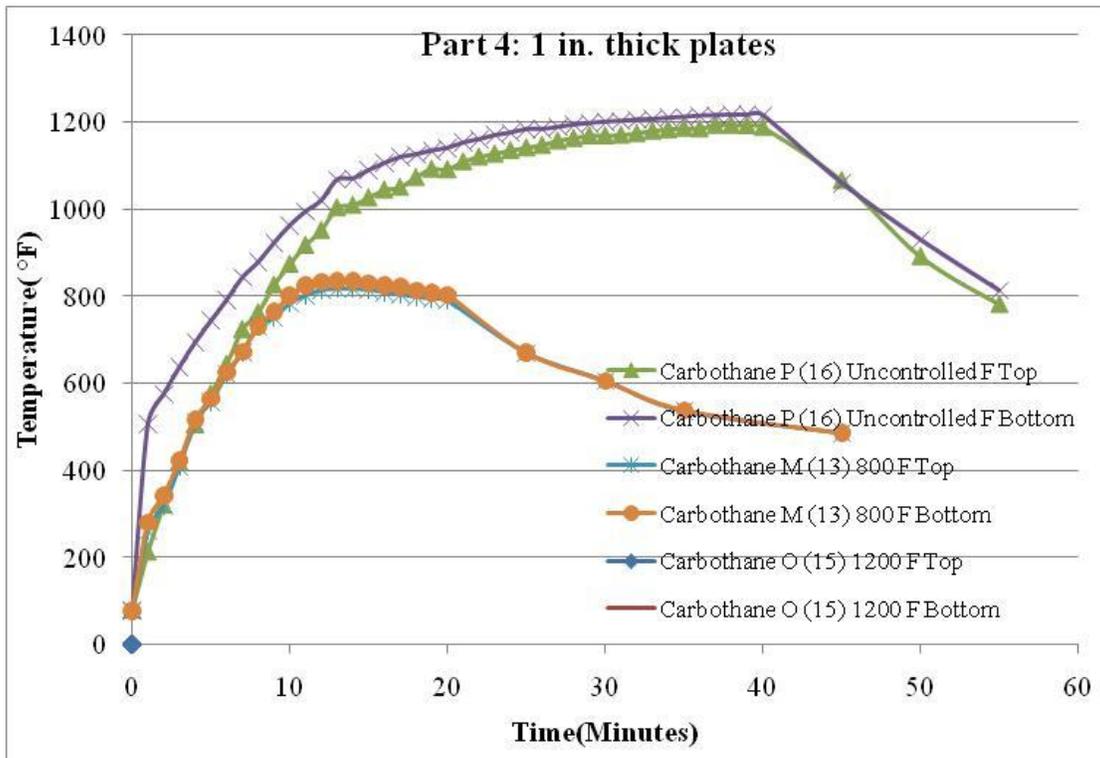
Figure 5.4-8. Measured Temperature-Time Curves for 1 in. Thick Carbothane Plates (Part 4).

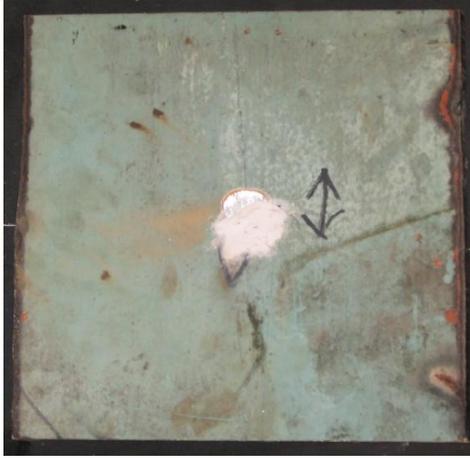
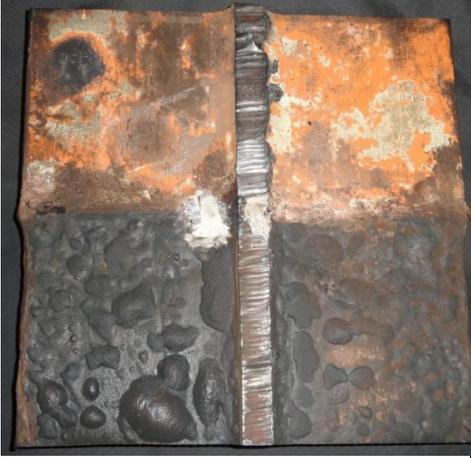
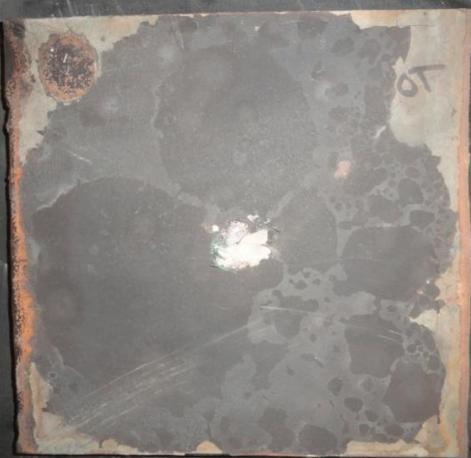
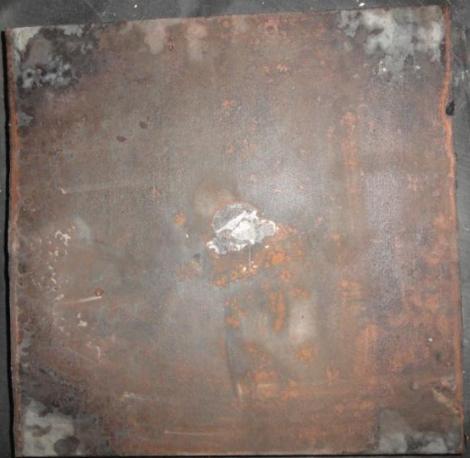
Older steel bridges with indeterminate paint coating systems (Same vintage as steel beams provided by Penn-DOT) (Circa: 1960 – 70)			
Before fire exposure	After fire exposure - 800 °F	After brushing surface	After washing surface

Description:	<i>Non-flame side</i>		
Paint is in reasonable condition. Some scratches, chips, some rust and other typical defects are apparent. (Note: The shiny white patch at plate center was where the paint was scratched off to attach thermocouples)	The plate surface directly exposed to flames will be covered with black soot. Bubbles will be seen in the paint coating on the non-flame side as shown above. Some of these paint bubbles may be cracked, but the material will still be in place.	After hand wire brushing clean, most of the paint will be removed from both the flame and non-flame sides though there may still be some patches of paint. The outline of the bubbles that had formed in the paint may be visible along with discoloration of the plate	After pressure or hand washing clean, all the soot and most of the paint will be removed from both the flame and non-flame sides. Some patches of paint may still be visible.

Material Properties:			
For steel grades with nominal yield stress less than or equal to 50 ksi, fire exposure producing surface conditions as shown above will result in a small (5%) reduction in the material yield strength, ultimate strength, surface hardness, and the CVN fracture toughness. For heat treated steels (e.g., A514, HPS), acquire material samples from the fire-exposed and unexposed portions of the beams. Conduct CVN fracture toughness tests according to ASTM E23 to evaluate the effects of fire on steel.
