Effects of Fire Damage on the Structural Properties of Steel Bridge Elements

FINAL REPORT

University of Pittsburgh

1. Report No. FHWA-PA-2011-009-PIT011		2. Government Accession No.		3. Recipient's Catalog No.	
4. Title and Subtitle Effects of Fire Damage on the Structural Properties of Steel Bridge Elements				5. Report Date April 30, 2011

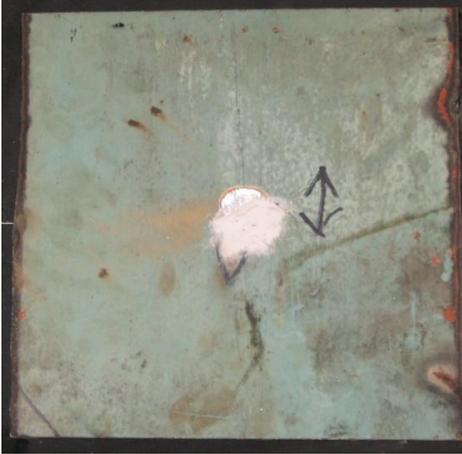
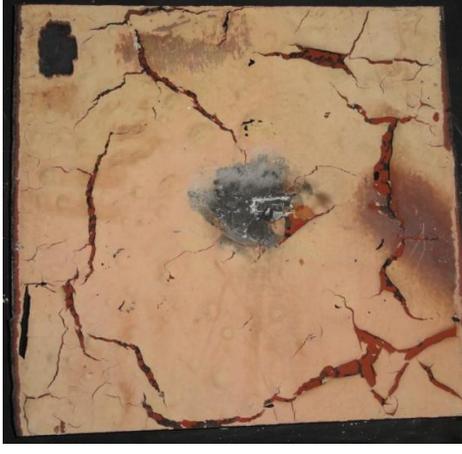
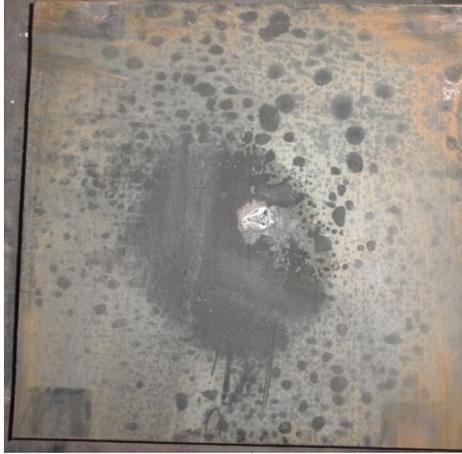
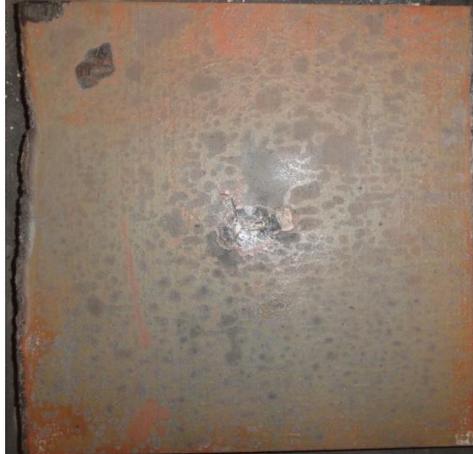
(Same vintage as steel beams provided by Penn-DOT after being exposed to real fire event) (Circa: 1960 – 70)

Before fire exposure	After fire exposure - 1200 °F	After brushing surface	After washing surface

<p>Description:</p> <p>Paint is in reasonable condition. Some scratches, chips, some rust and other typical defects are apparent.</p> <p>(Note: The shiny white patch at plate center was where the paint was scratched off to attach thermocouples)</p>	<p><i>Non-Flame Side</i></p> <p>The plate surface directly exposed to flames will be covered with black soot. The paint coating on the non-flame side will be cracked, but the material will still be in place as shown above.</p>	<p>After hand wire brushing clean, most of the paint will be removed from both the flame and non-flame sides though there may still be some patches of paint. The outline of the bubbles that had formed in the paint may be visible along with discoloration of the plate. Larger discolored rings may be seen where flames came in direct contact with steel surfaces.</p>	<p>After pressure or hand washing, all the soot and most of the paint will be removed from both the flame and non-flame sides. Some patches of paint may still be visible.</p>

<p>Material Properties:</p> <p>For steel grades with nominal yield stress less than or equal to 50 ksi, fire exposure producing surface conditions as shown above will result in a small (5%) reduction in the material yield strength, ultimate strength, surface hardness. The influence on the CVN fracture toughness can be more significant (+20 to -40%). Conduct CVN fracture toughness tests on material samples taken from the unexposed steel to evaluate reserve margin with respect to minimum CVN toughness requirements.</p> <p>For heat treated steels (e.g., A514, HPS), acquire material samples from the fire-exposed and unexposed portions of the beams. Conduct CVN fracture toughness tests according to ASTM E23 to evaluate the effects of fire on steel.</p>

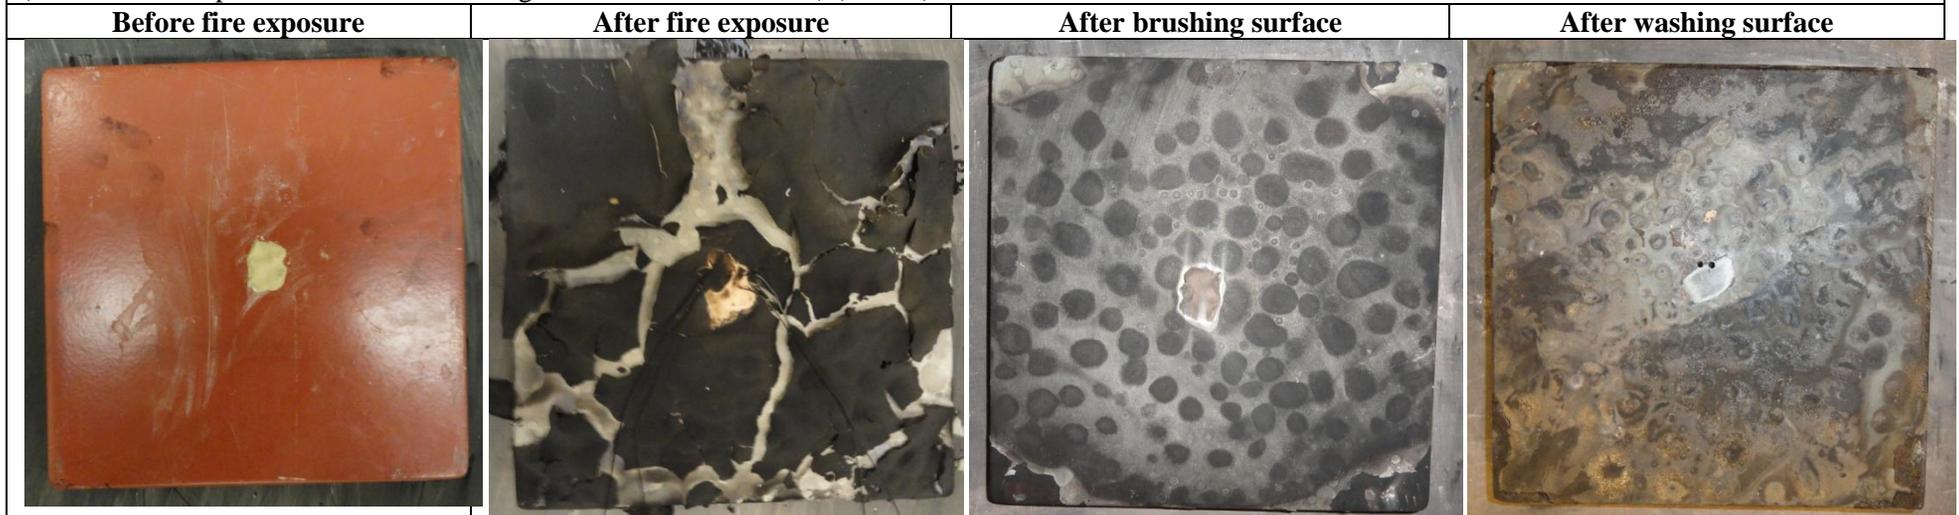
Existing steel bridges with the Sherwin Williams' Acrolon coating system consisting of a primer coat of ZincClad III HS, Macropoxy 646 intermediate coat, and the Acrolon 218 HS top coat. As shown below, this system is rusty red in color.

(A709 beams or plates used in current bridge construction or similar) (Circa:)

Description:	<i>Non-Flame Side</i>		
<p>Paint is in good condition. No significant scratches, chips, rust or other typical defects are apparent.</p> <p>(Note: The shiny white patch at plate center was where the paint was scratched off to attach thermocouples)</p>	<p>The plate surface directly exposed to flames will have little soot because the top-coat of the paint will have fallen off (along with the soot) when the temperature exceeded 700 °F. The paint coating on the non-flame side will have bubbled and cracked, but the paint material will still be in place as shown above.</p>	<p>After hand wire brushing clean, most of the top coat will be eliminated from both sides. The base coat will still be intact. The outline of the bubbles that formed in the paint may be visible with discoloration of the plate.</p>	<p>After washing clean, all the soot and most of the top coat of the paint system will be removed from both the flame and non-flame sides.</p> <p>The base coat of the paint system will likely remain still intact over the plate surfaces.</p>

For steel grades with nominal yield stress less than or equal to 50 ksi, fire exposure producing surface conditions as shown above will result in a small (5%) reduction on the material yield strength, ultimate strength, surface hardness.

The influence on the CVN fracture toughness can be _____. Conduct CVN fracture toughness tests on material samples taken from the unexposed steel to evaluate reserve margin with respect to minimum CVN toughness requirements.

For heat treated steels (e.g., A514, HPS), acquire material samples from the fire-exposed and unexposed portions of the beams. Conduct CVN fracture toughness tests according to ASTM E23 to evaluate the effects of fire on steel.

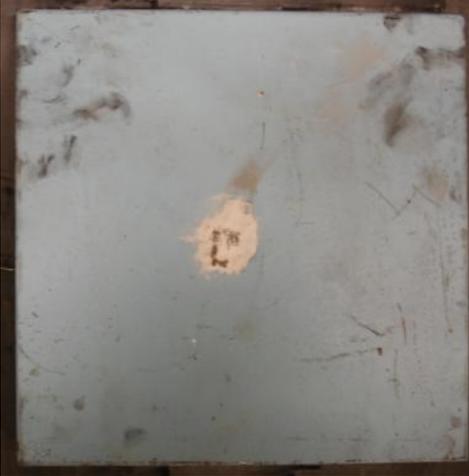
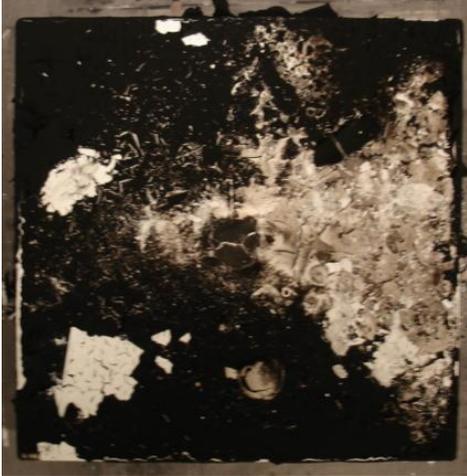
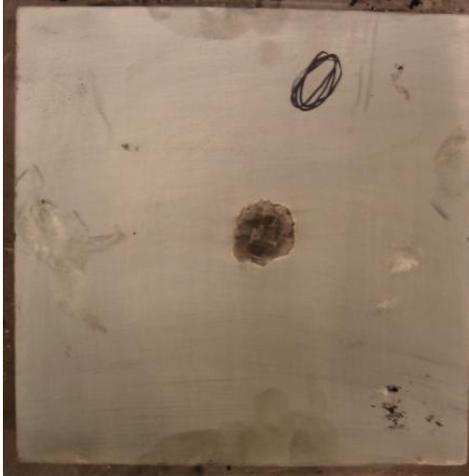
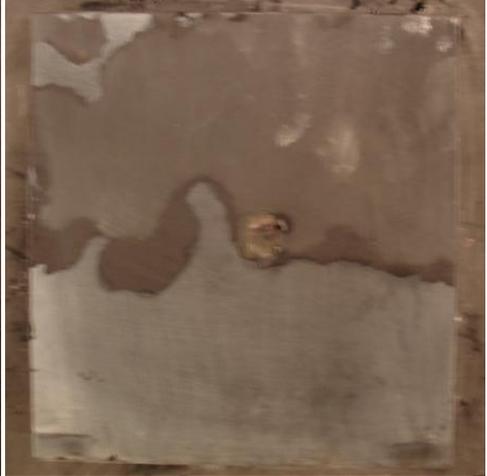
Newly painted steel with the inorganic zinc coating system (*Carbothane*) from Carboline. The first coat is Carbozinc 11 HS, followed by an intermediate Carboguard 893 coat, and a finish coat of Carbothane 133. This system is steel blue in color.
(A709 beams or plates used in current bridge construction) (Circa:)

Before fire exposure	After fire exposure	After brushing surface	After washing surface

<p>Description:</p> <p>Paint is in good condition. No significant scratches, chips, rust or other typical defects are apparent.</p> <p>(Note: The shiny white patch at plate center was where the paint was scratched off to attach thermocouples)</p>	<p><i>Non-Flame Side</i></p> <p>The plate surface directly exposed to flames will have little soot because the top coat of the paint will have fallen off (along with the soot) when the temperature exceeded 700 °F. The paint coating on the non-flame side will have cracked and turned white in color as shown above.</p>	<p>After hand wire brushing clean, most of the top coat will be eliminated from both sides. The base coat will still be intact. There will be no other significant markings (bubbles etc.) visible on the steel surfaces</p>	<p>After washing clean, all the soot and most of the top coat of the paint system will be removed from both the flame and non-flame sides. The base coat of the paint system will remain still intact over the plate surfaces, except for the situation of extremely long duration uncontrolled fires. For such cases, the base coat will also fall off as shown above.</p>

<p>Material Properties:</p>			
<p>For steel grades with nominal yield stress less than or equal to 50 ksi, fire exposure producing surface conditions as shown above will result in a small (5%) influence on the material yield strength, ultimate strength, surface hardness.</p> <p>The influence on the CVN fracture toughness can be _____. Conduct CVN fracture toughness tests on material samples taken from the unexposed steel to evaluate reserve margin with respect to minimum CVN toughness requirements.</p> <p>For heat treated steels (e.g., A514, HPS), acquire material samples from the fire-exposed and unexposed portions of the beams. Conduct CVN fracture toughness tests according to ASTM E23 to evaluate the effects of fire on steel.</p>
