ELECTRIC HEATING OF I-84 IN LADD CANYON, OREGON

Final Report

SPR 304-461

June 2006

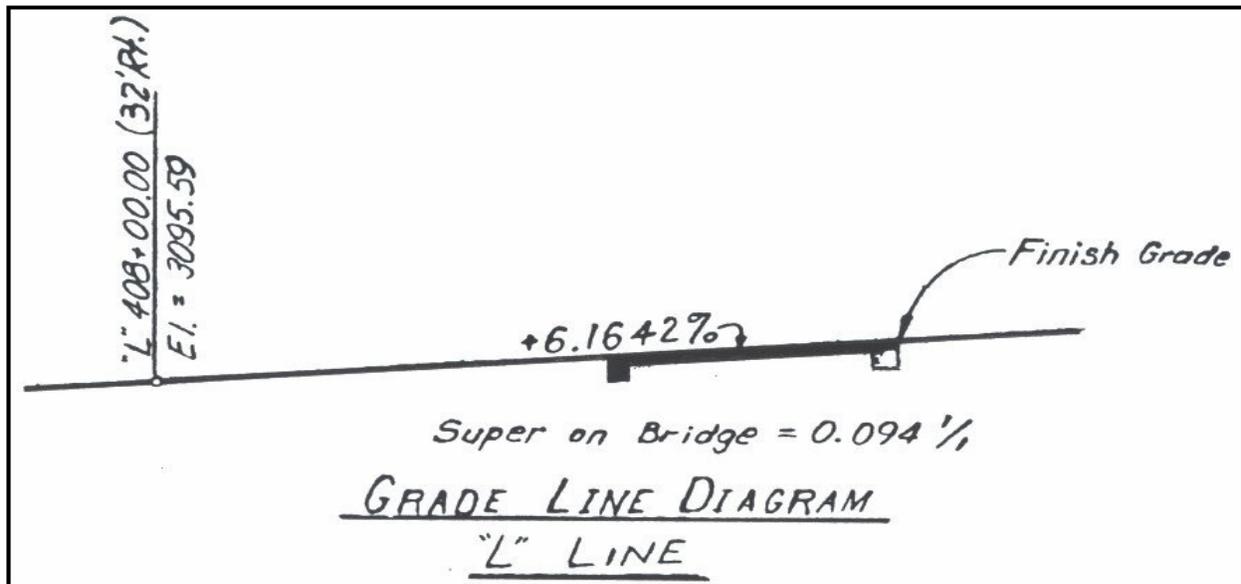
Figure 1.2: Project grade

The lanes are reinforced Portland Cement Concrete (PCC) pavement 12 ft (3.7 m) wide. The left shoulder is made from hot mix asphalt concrete (HMAC) 4 ft (1.2 m) wide. The right shoulder is 10 ft (3.0 m) wide HMAC. The grade throughout the length of the project is very steep and varies only slightly. At the beginning of the project (MP 270.80), the grade is 6.16% (Figure 1.2). At MP 271.05 there is a change to 5.88%, and at MP 271.39 another change to 6.05%. At MP 271.93 the transition from 6.05% to an almost flat grade of 0.82% begins. This transition is 1,200 ft (365.8 m) long and ends at MP 272.16. The average grade for the project is 6.03%.

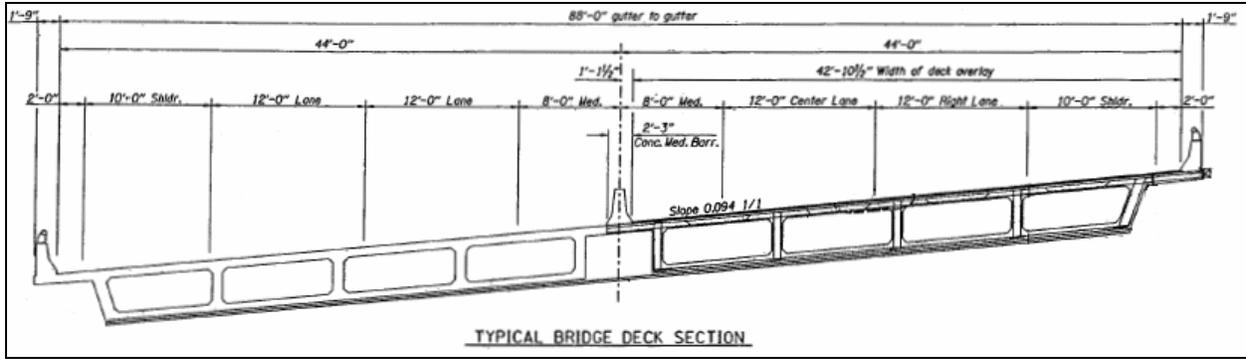
Figure 1.3: Bridge cross-section showing superelevation

A box girder structure (Bridge No. 09686) is located at the bottom of the hill (MP 270.87). This structure is 179 ft (54.5 m) in length and 91.5 ft (27.9 m) wide. The depth of the box girders is 4 ft (1.2 m). The bridge is located in the center of a 1,332 ft (406 m) radius turn and has a superelevation across the surface of the deck of 9.4% constant throughout its length. Design speed is 55 MPH. The uphill grade on the structure is 6.16%, which presents a problem for loaded trucks, as they may not be able to meet the design speed. See Figure 1.3 below.

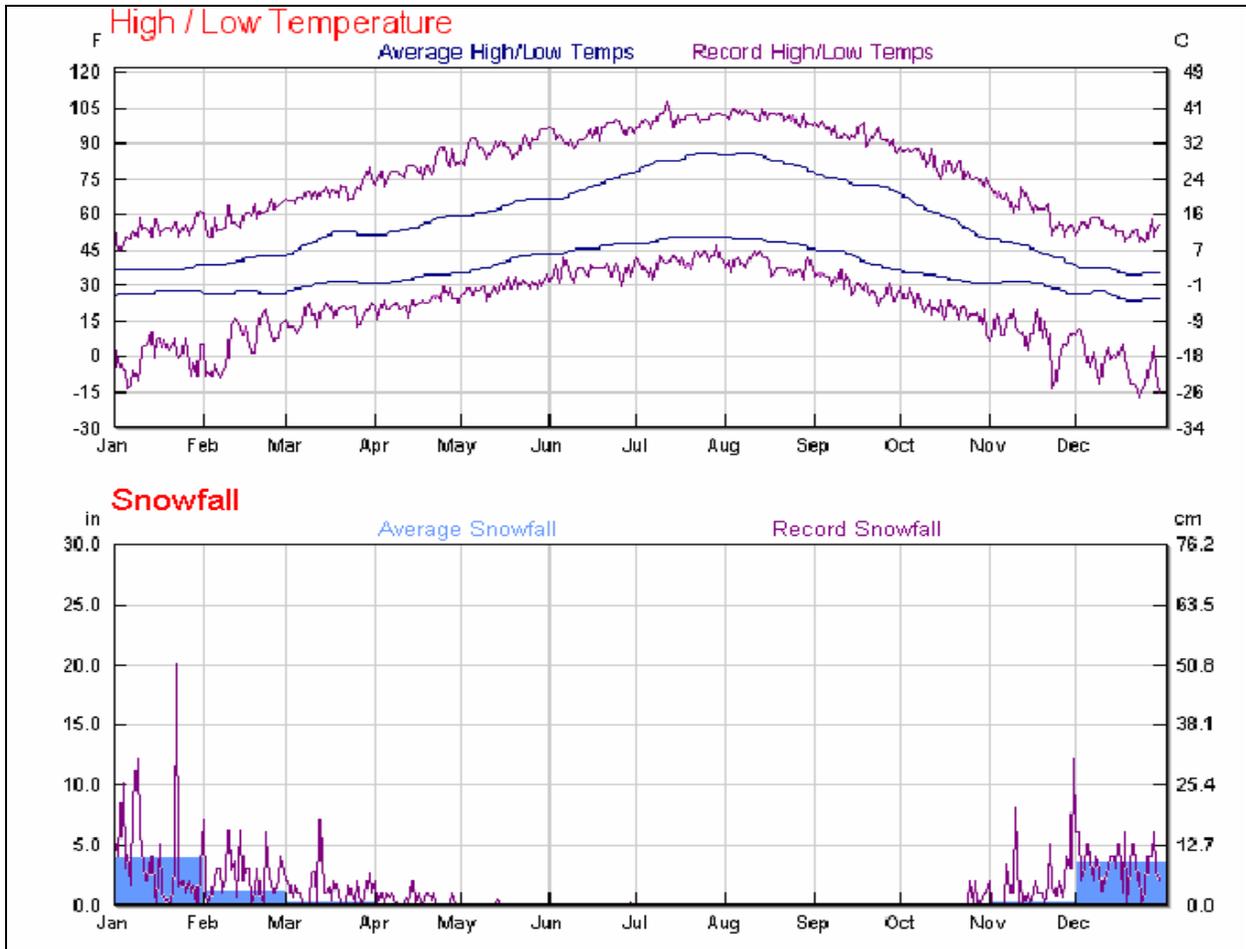
Figure 1.4: Weather conditions in the project area

The La Grande weather station, 11 miles (17.7 km) to the north and nearly 400 ft (122 m) lower in elevation (at 2,760 ft (841 m)), reports average low temperatures below freezing from November thru March with average snowfall above 3 inches (7.6 cm) in December and January (see Figure 1.4 below).

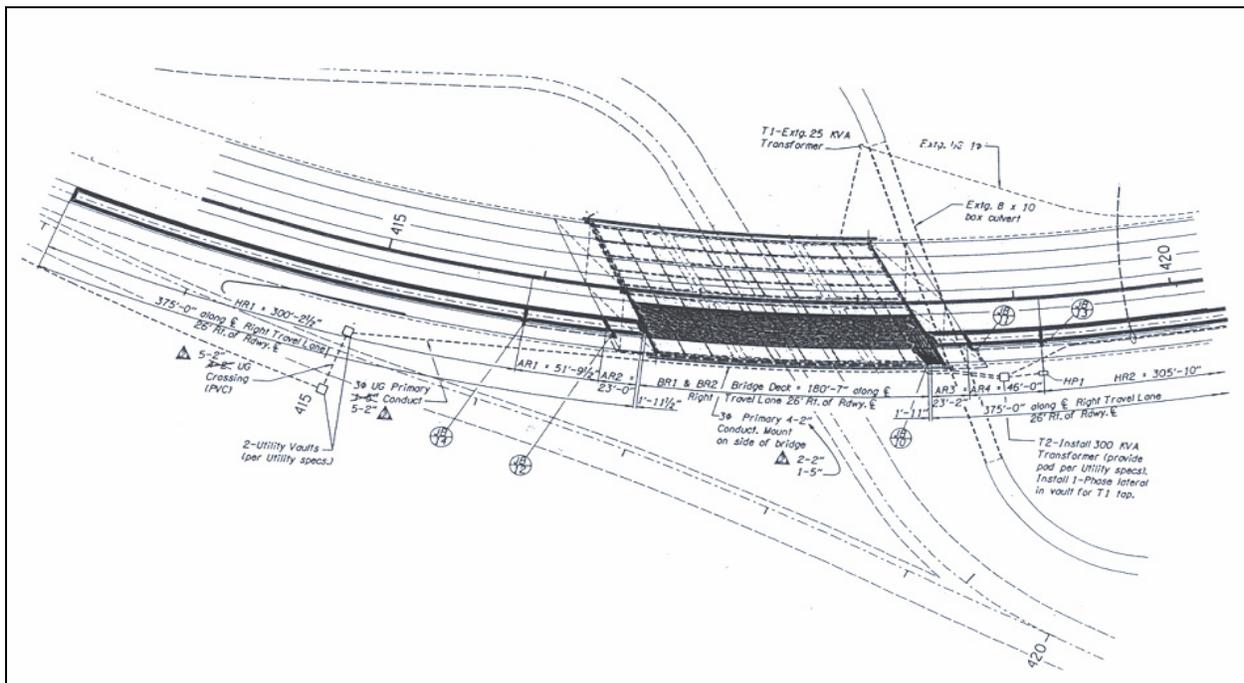
Figure 2.1: Bridge and eastbound approach

The design of the project began with a thermal cable bridge deck microsilica overlay. As the Project Development Team (PDT) looked at the problem in more detail, it became obvious that the heated overlay would only be a partial solution to the problem and that project limits would have to be extended to cover almost the entire length of the steep grade. The bridge and eastbound approach are shown in Figure 2.1.

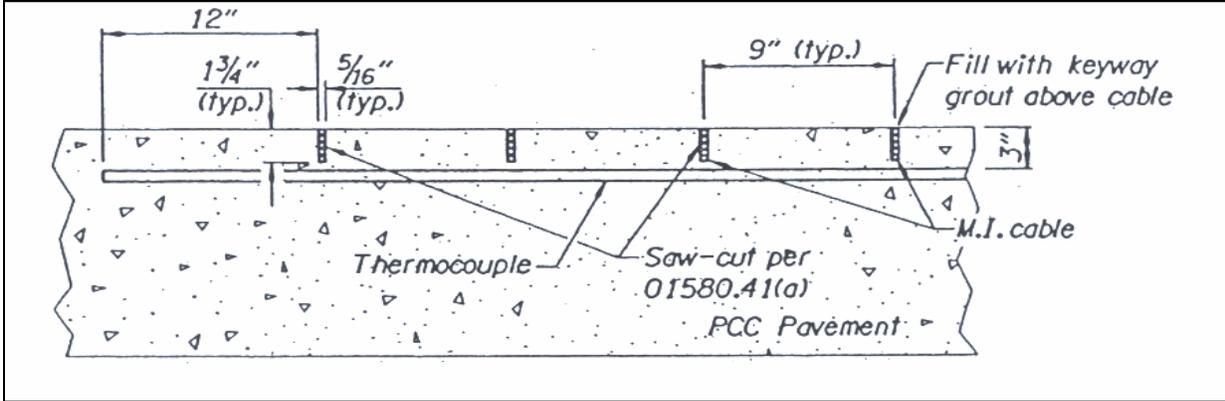
Figure 2.2: Cross-section of roadbed showing saw cuts for cable inlay

For 300 ft (91.4 m) leading up to the bridge, thermal cables were placed into grooves cut into the concrete surface within each wheel track and sealed in place with loop detector sealant (Figure 2.2). This same cabling technique continued for 7,700 ft (2,347 m) beyond the bridge. The project originally called for use of keyway grout to hold the cables in place, but the grout was difficult to work with on the grade, and testing showed that this material was inadequate in completely encapsulating the cable.

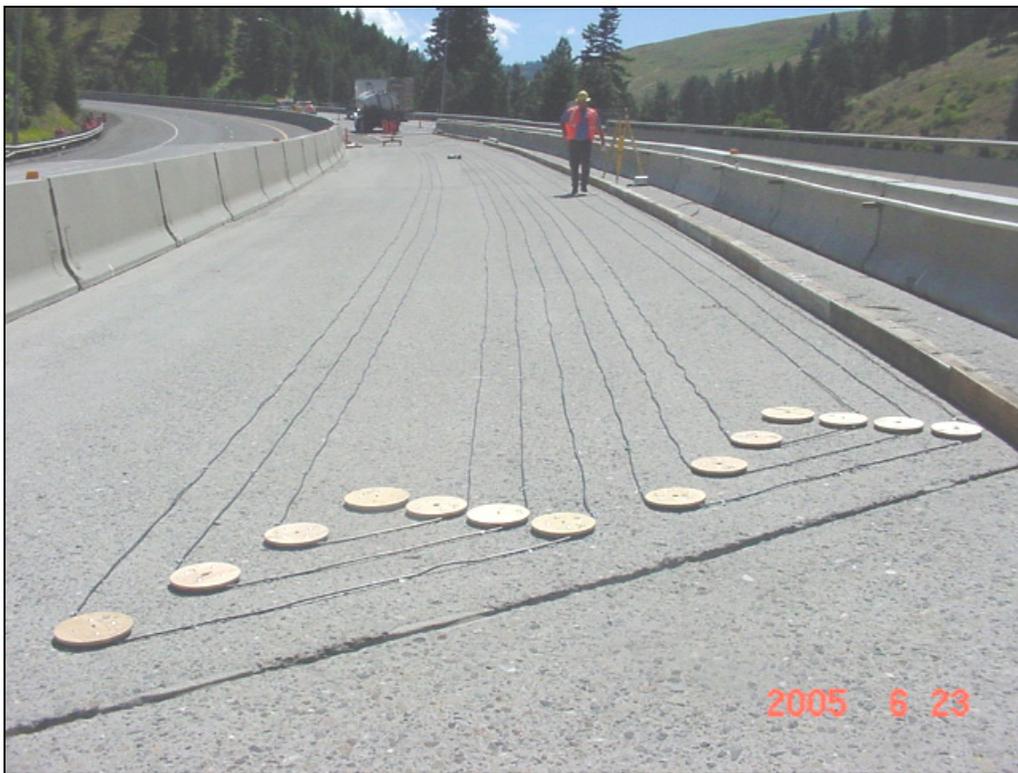
Figure 3.1: Electric heating cables on bridge deck

Electric thermal cables were laid-out on the bridge deck in non-overlapping rectangular serpentine loops on 9 in (22.9 cm) centers across both eastbound travel lanes. A 1.75 in (4.45 cm) microsilica overlay was placed on top.

The deck preparation went well, although there were some loose areas of PCC, and some rebar ends had to be removed before the microsilica was placed. Some areas of the existing deck showed delamination, particularly along the edge of the pour. Figures 3.1 and 3.2 show the placement of the electric heating cables.

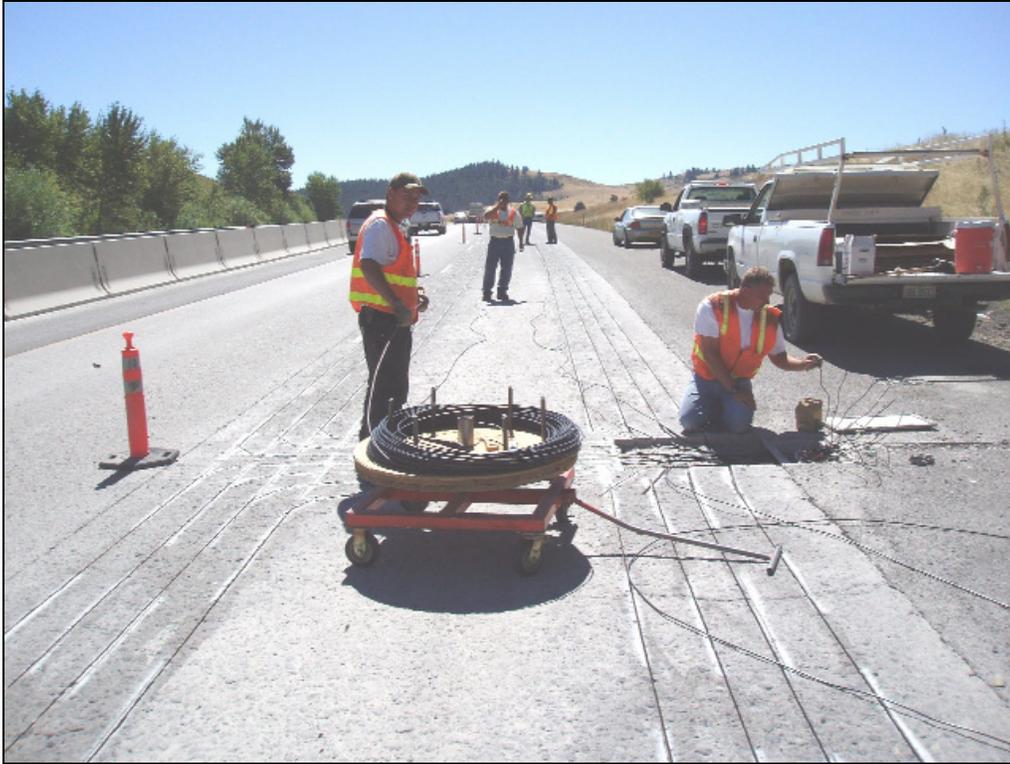
Figure 3.2: Electric heating cables in tire paths

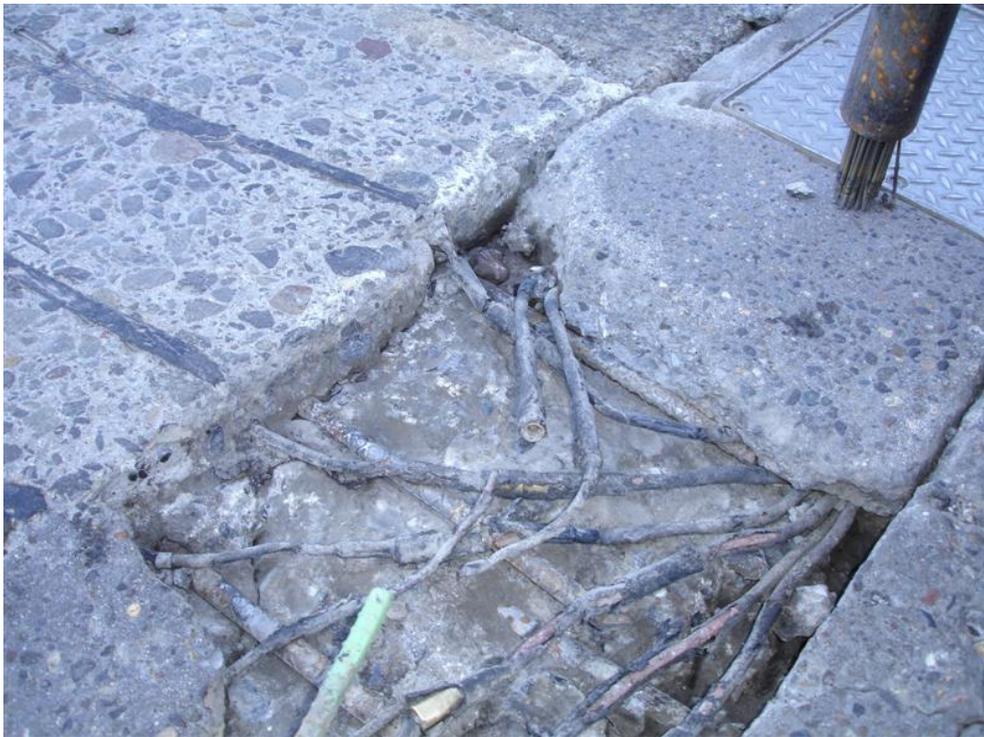
Figure 4.1: Damaged heating cables

- Junction boxes have proved difficult to seal and require frequent inspection. Placement of the junction boxes has proven to be problematic, but this is in part a function of the topology of the installation site.
- Two of the four heating cables in the short section north of the bridge are currently non-functional because of traffic damage to the replacement concrete where heat cables enter the junction box (Figure 4.1).
- One of the junction boxes in the roadway was steaming and the heat cable circuit breaker was open. The suspected cause was water permeation of an electrical connection. This junction box will be repaired this summer.
- Thermocouple sensors in the pavement have proven to be difficult to calibrate and are unreliable. The master roadway information system is being used to turn the entire system on and off, resulting in wasted energy.

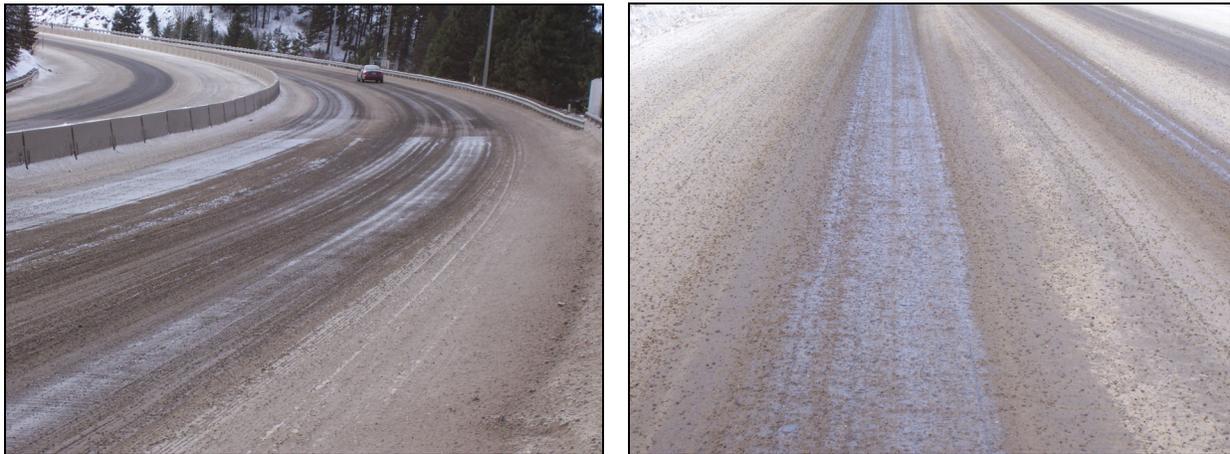
Figure 5.1: Melted snow on tire paths due to heating cables

Figure 5.1 shows the system in operation. The system currently has no data logging capability, so the times and lengths of operation are not known. A data recorder is planned for next season. The cost of electricity for operation during the winter months averages slightly over \$5,000 per month with a peak electric bill of about \$9,000.
