Arizona Department of Transportation Research Center

# **Performance Evaluation of Arizona's LTPP SPS-6 Project: Strategic Study of Rehabilitation Techniques**

**Final Report 396-6  
October 2013**

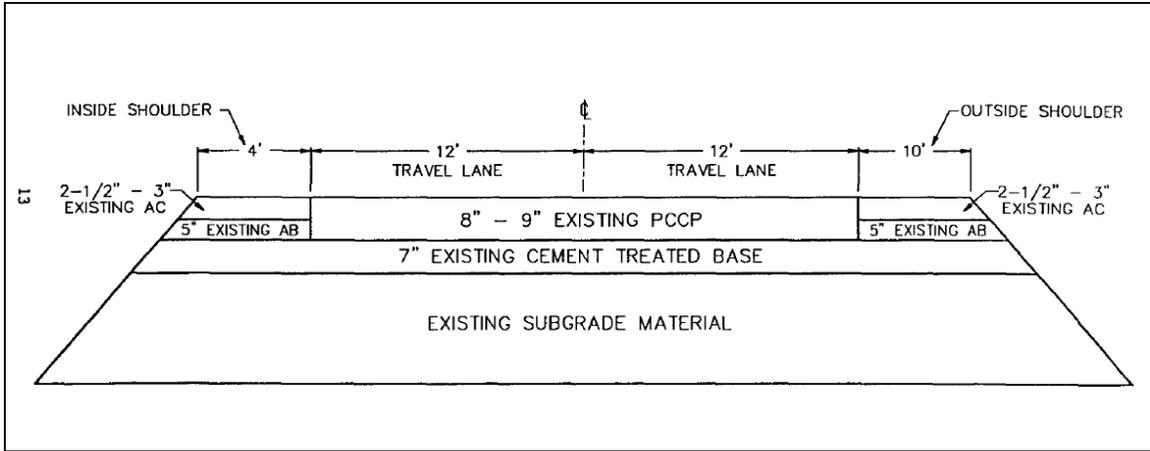
**Figure 2. Existing Concrete Pavement Section Before SPS-6 Project Construction.**

Prior to the construction of the SPS-6 project, the roadway was 38 ft wide with two travel lanes that were each 12 ft wide bounded by a 10 ft outside shoulder and a 4 ft inside shoulder. The lanes had an 8 to 9 inch thick portland cement concrete (PCC) pavement layer, and the shoulders had 2.5 to 3 inches of AC. Figure 2 shows a typical cross section of the road prior to construction.

The SPS-6 project was constructed in a 2.7 mi segment of this 10 mi rehabilitation project and extends from MP 202.16 to MP 204.86 (Figure 3). The site is located in a forested, mountainous area on a longitudinal grade that varies from shallow fill to sandstone cut, to deep fill over a culvert, and back to an increasingly deep sandstone cut. The average length of each test section is approximately 500 ft, which does not include transitional segments between sections. The average elevation of the project is 6900 ft, with a latitude of 35° 13' and longitude of -111°34'. The location and layout of the SPS-6 project are shown in Figures 2 and 3. The test section properties are shown in Table 1.

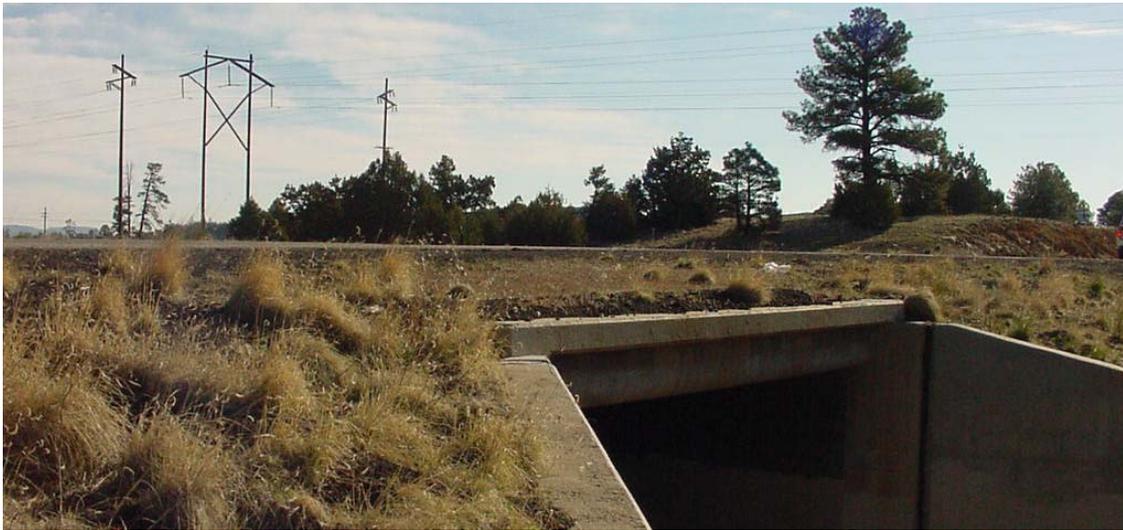
**Figure 4. Box Culvert in Section 040660.**

The photographs in Figures 4 through 8 show the terrain of the SPS-6 project site. Figure 4 shows a box culvert in Section 040660, the first test section on the west end of the project site. Fill material is on both sides of the culvert, and the grade transitions from fill to cut near the end of the test section (as shown in the right side of the photo).

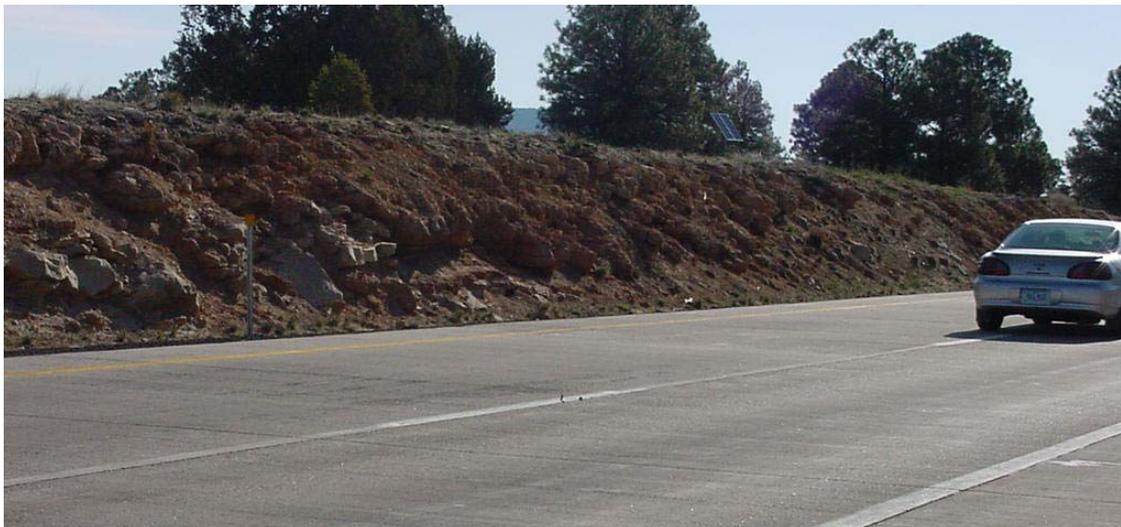
**Figure 5. Shallow Sandstone Cut in Unbonded Overlay Section 040663.**

Figure 5 shows the unbonded overlay section (040663), the next test section at the west end of the site, in a shallow cut. As the photo indicates, the sandstone is not solid rock, but rather considerably weathered material. The LTPP database does not report that bedrock was encountered within the depth to which borings were obtained. Figure 6 is a photograph taken in Section 040662, the ninth test section along the project length, located over a substantial fill.

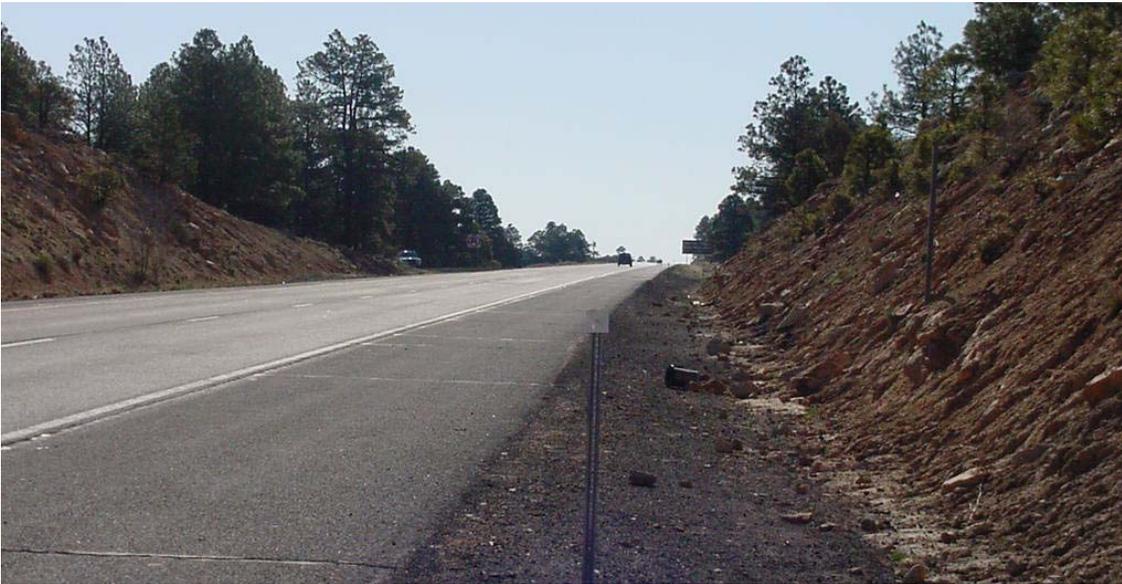
**Figure 7. Cut and Grade in Section 040605.**

Figure 7 shows the depth of fill and uphill grade in Section 040605, the 11th test section along the project length.

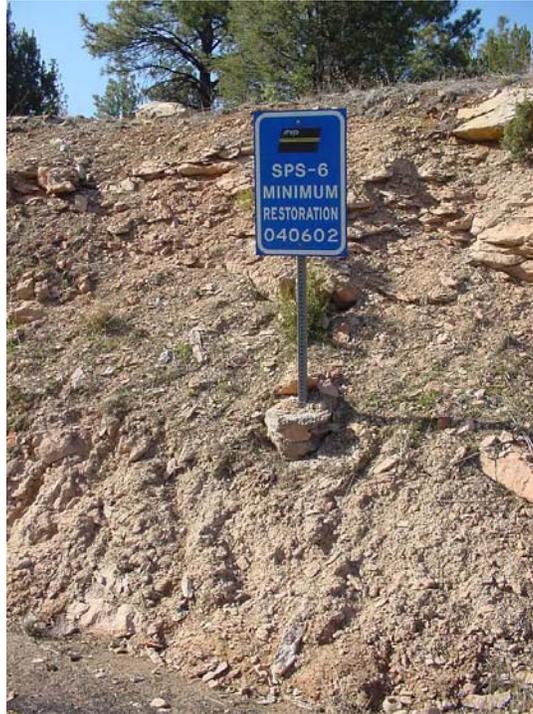
**Figure 8. Cut in Section 040602.**

The photograph in Figure 8 was taken in Section 040602, the 12th test section along the project length, and shows the depth of cut and the weathering of the sandstone.

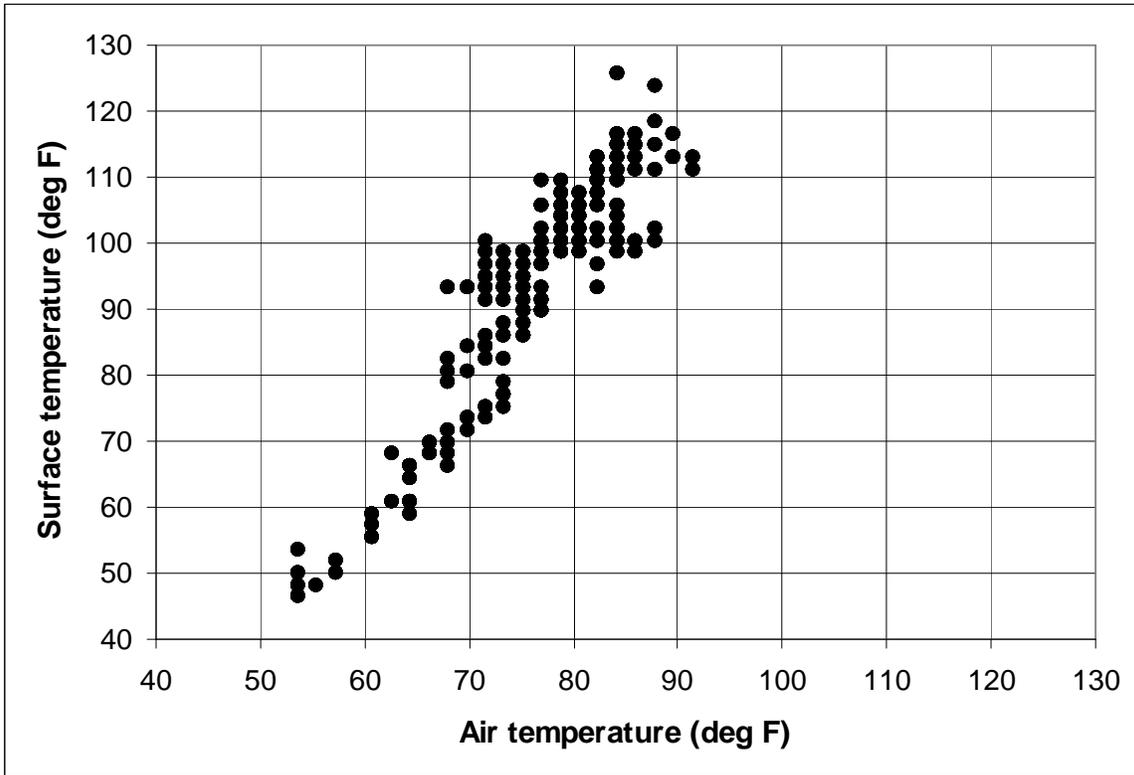
Figure 9. Air and Concrete Surface Temperatures, June 1990.

In-pavement temperatures (at various depths in the concrete slab) were apparently not measured during the June 1990 testing or at least are not in the LTPP database. Air temperatures and pavement surface temperatures were measured with the falling weight deflectometer (FWD), and the latter give an approximate indication of the concrete slab temperatures. Figure 9 shows how the air and surface temperature measurements from the four days of testing in June 1990 compared. There is a strong correlation between the two sets of temperature measurements.

Figure 9 suggests, and Figure 10 further illustrates, that most of the joint load transfer measurements were made at fairly high temperatures. Over the four days of testing, only 21 percent of the joints were tested when the air temperature was at or below 70 °F.

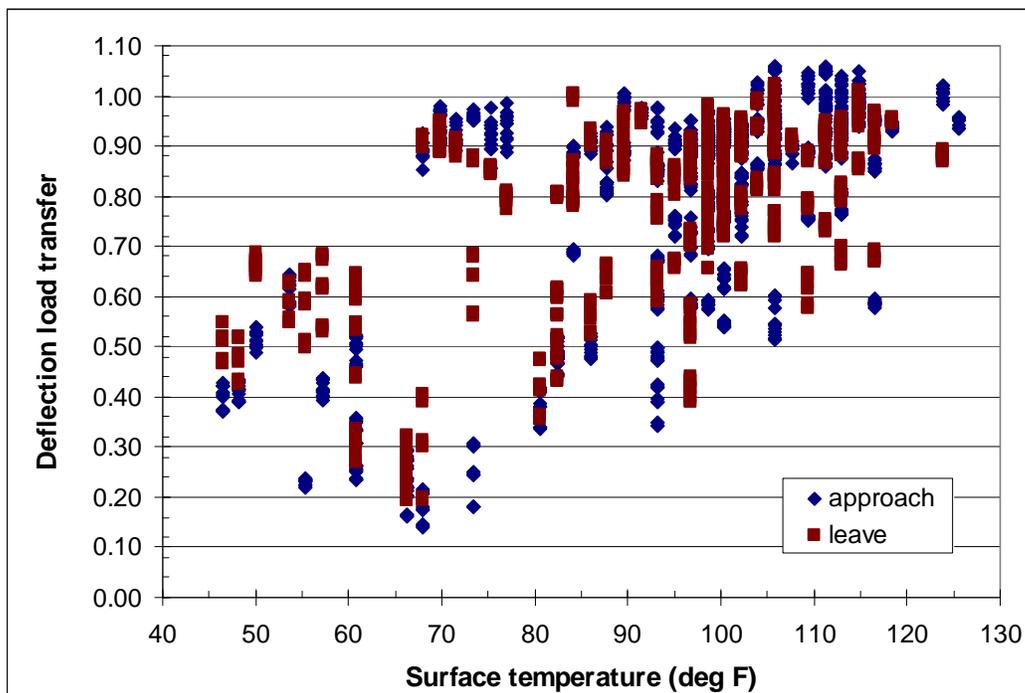
**Figure 11. Joint Deflection Load Transfer as a Function of Pavement Surface Temperature, June 1990.**

Given the approximate nature of the FWD's air and surface temperature measurements, the large percentage of load transfer measurements that were obtained at high temperatures, and the likely contribution of numerous working midslab cracks to variation in joint opening as a function of temperature, it is not surprising that the measured approach and leave joint load transfers show considerable variability as a function of temperature. The graph in Figure 11, which illustrates this variability, suggests three groups of data points:

- Points that follow an upward trend from about 20 percent load transfer at surface temperatures of 70 °F and below, up to load transfers in excess of 80 percent at surface temperatures above about 95 °F.
- A cluster of points with load transfer above 80 percent at surface temperatures in the range of 65 °F to 75 °F.
- A cluster of points with load transfer of about 40 percent to 70 percent at surface temperatures in the range of 45 °F to 60 °F.

Most of the data points in the first group probably represent working joints. The data points in the second group (and perhaps some in the first group as well) represent joints that are not working much at all, perhaps because of the proximity of midslab cracks. The data points in the third group probably represent joints that are working to some degree, but are not opening and closing in response to temperature changes as much as the joints in the first group.

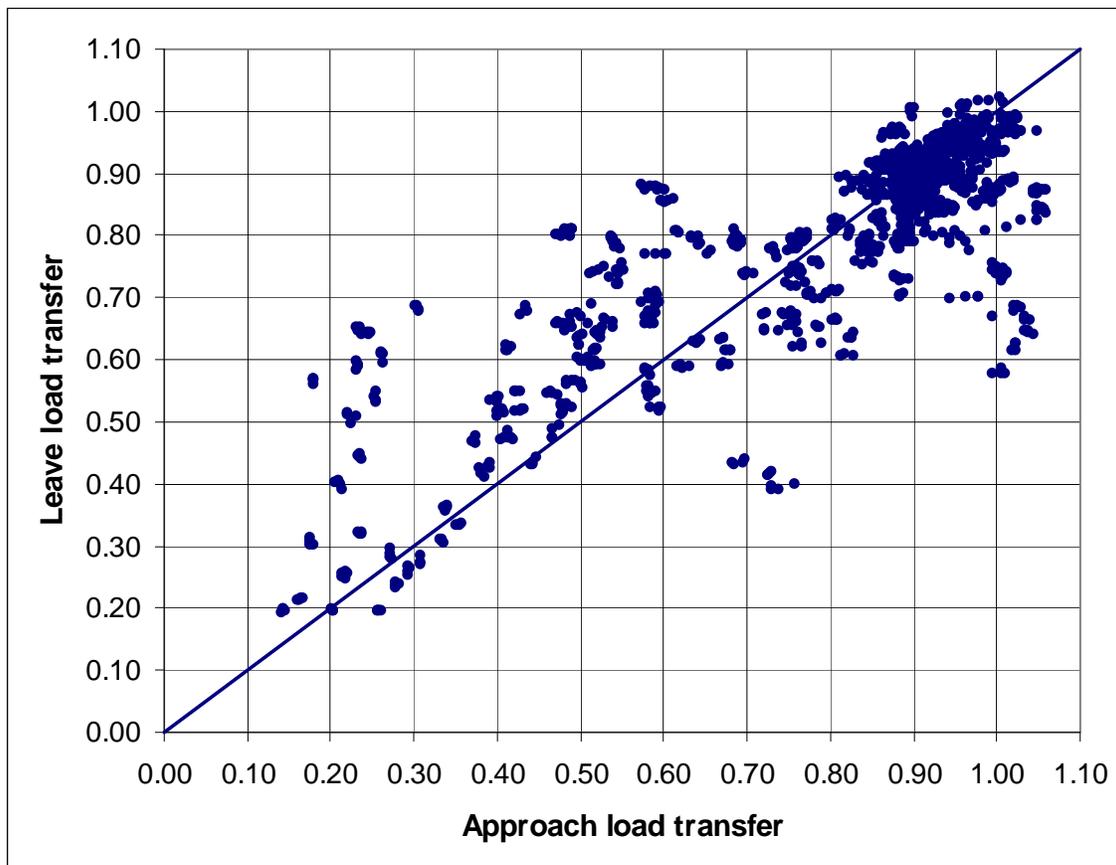
**Figure 12. Approach Versus Leave Joint Load Transfer, June 1990.**

Another aspect of load transfer to consider is how approach side and leave side load transfers compare, joint by joint, at this site. As illustrated in Figure 12:

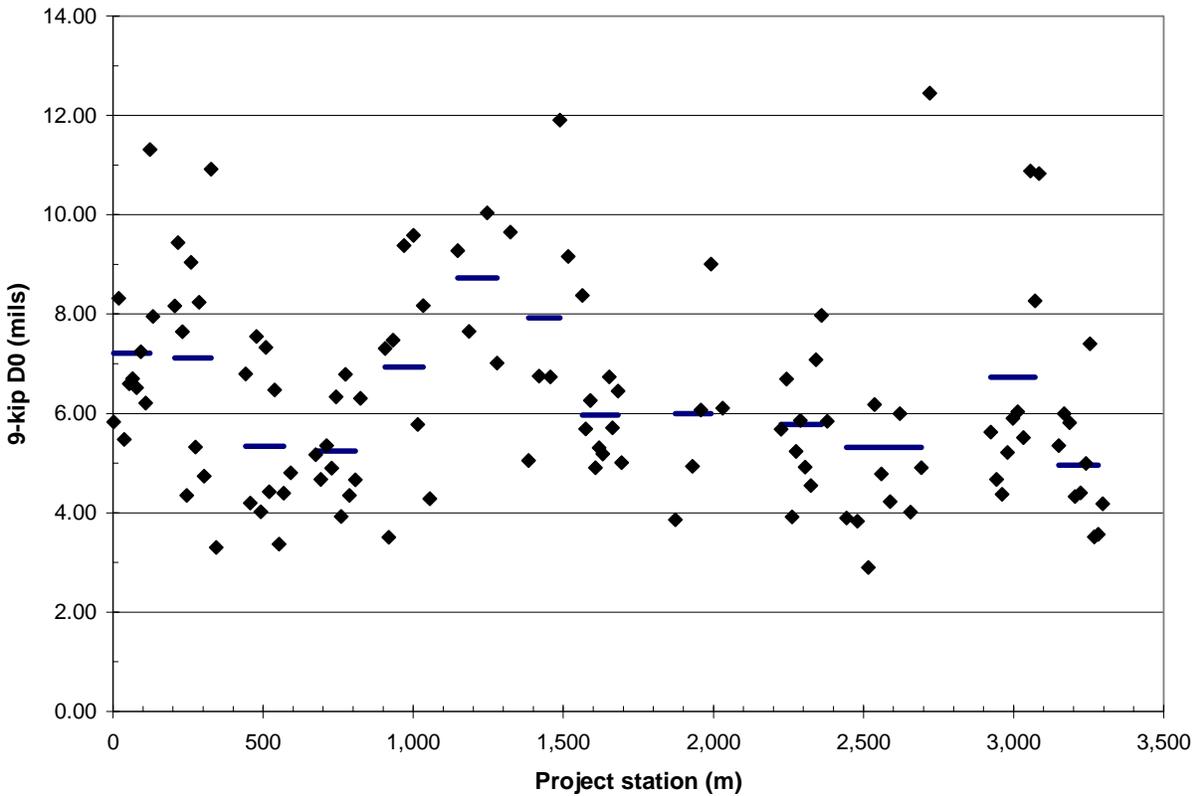
**Figure 13. Maximum Deflection at 9000 Pounds along the Project Length, June 1990.**

Figure 13 shows the midslab D0 deflections along the length of the project. Each point represents the average D0 from four load drops at the 9000 pound target load level, where each of the four individual D0 measurements have been normalized to 9000 pounds. The horizontal bars in Figure 13 represent the average D0 for each test section.

The upward and downward shifts in the test section average D0 deflections are expected, since the first test sections on the west end of the project are in fill, followed by a slight cut, followed by a large fill, followed by an increasingly deep cut. The variation in foundation stiffness due to differences between cut and fill appear to play a large role in the variation in maximum deflection from one test section to the next. The average for the second-to-last test section (040602) deviates from the trend of decreasing average maximum deflection with increasing depth of cut near the east end of the site.

consistent from test section to test section than the prerehabilitation maximum deflections shown in Figure 13.

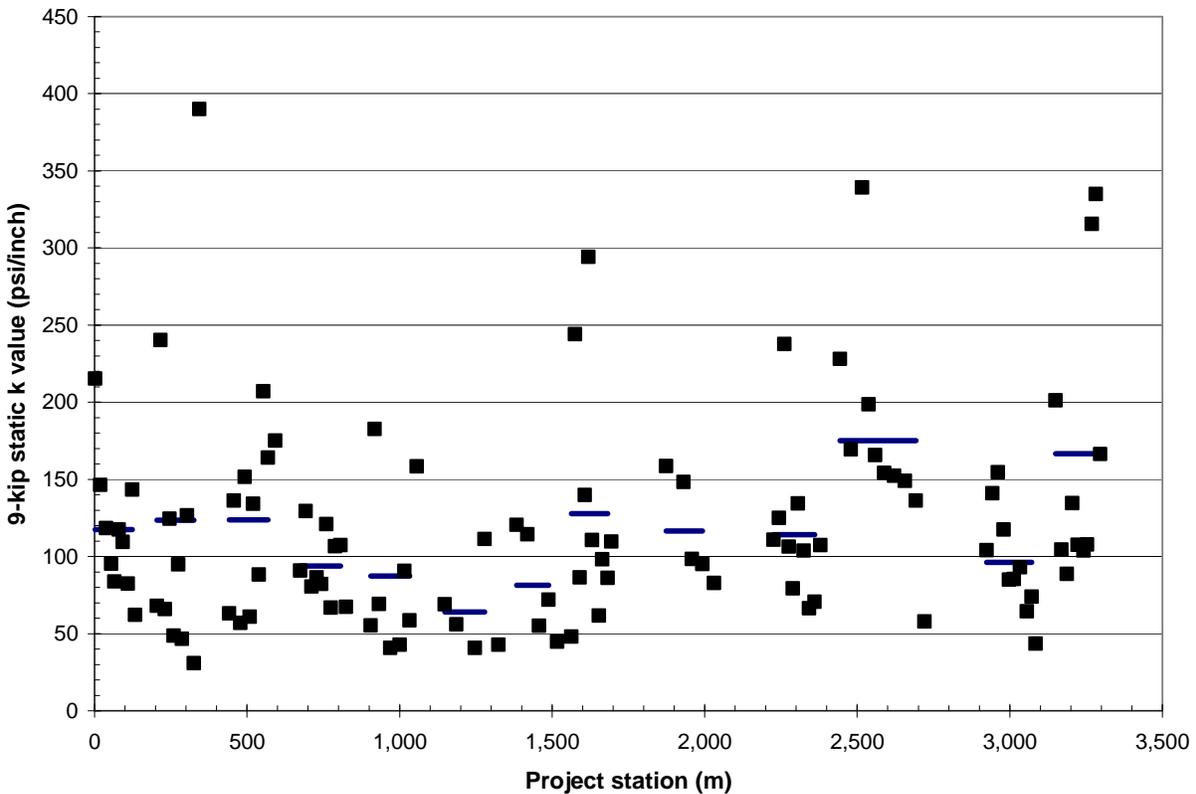
**Figure 14. Estimated Static k Value at 9000 Pounds along Project Length, June 1990.**

The estimated static k values along the length of the project are shown in Figure 14. Each point represents the average k value from four load drops at the 9000 pound target load level. The horizontal bars represent the average estimated static k value for each test section. These k values are referred to here as estimated static k values because the backcalculated (dynamic) k value at each point was divided by two to obtain an estimate of the static k value.

Where the average  $D_0$  shifts up or down from one test section to the next, the average k value shifts in the opposite direction, as expected. In general (except for the second-to-last section in cut), the test sections with higher k values are those in cut, and the test sections with lower k values are those in fill.

The k value results in Figure 14 show the prevalence of very low estimated static k values. Forty-seven percent of the values are less than 100 psi/inch. Over the length of the project, the average estimated static k value is 119 psi/inch and the median is 106 psi/inch. Even in the cut sections, no test section has a mean estimated static k value greater than 175 psi/inch. These k values are not typical of subgrade soils reported to be silty sand with gravel, clayey sand with gravel, or clayey gravel with sand, much less sandstone bedrock. According to the American Association of State Highway and Transportation Officials (AASHTO) Soil Classification System, the first three are descriptors of A-2 soils—soils that include various granular materials and typically have California Bearing Ratio (CBR) values between 10 percent and 80 percent, and static k values between 150 and 500 psi/inch. However, most of the static k values estimated from the backcalculation results would be typical of fine-grained soils with CBR values of less than 10 percent.

Also, the k value results in Figure 14 indicate the lack of uniformity of foundation stiffness along the length of the project. A foundation that could be considered fairly consistent over the length of a project would have a coefficient of variation (standard deviation as a percentage of the mean) of no more than 20 percent. The coefficient of variation of the Arizona SPS-6 site k values (at least, for the 13 sections deflection tested in June 1990) is 57 percent. Even within the individual test sections (that is, discounting the influence of changes between cut and fill), the coefficients of variation of the estimated static k values range from 23 percent to 90 percent.

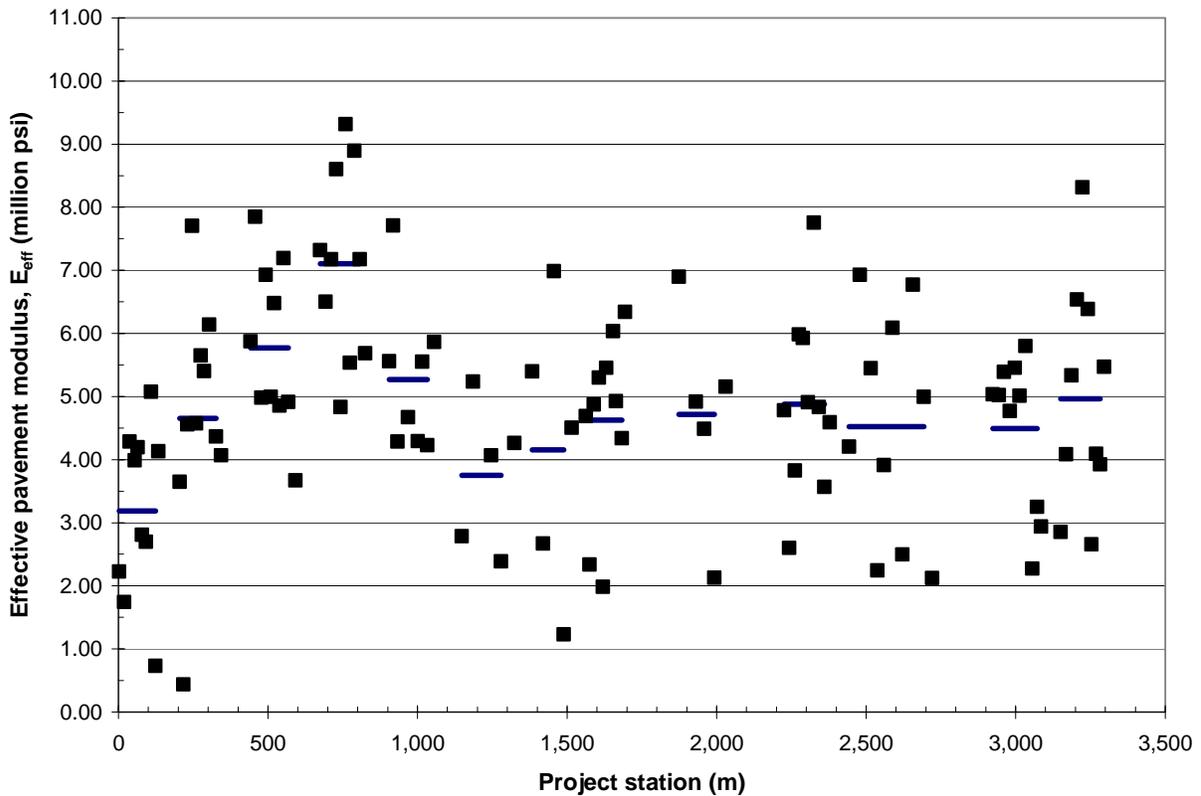
**Figure 15. Effective Pavement Modulus at 9000 Pounds along Project Length for Test Sections’ Average As-Built Thicknesses.**

Figure 15 shows the effective pavement modulus values along the length of the project. Each point represents the average effective pavement modulus from four load drops at the 9000 pound target load level. The horizontal bars represent the average effective pavement modulus for each test section.

The overall average effective pavement modulus over the length of the project was 4.84 million psi. The average in Section 040660, the first test section, was 3.18 million psi—considerably lower than the overall project average. The effective pavement modulus values increase in the next three test sections, to an average high of 7.10 million psi in Section 040607, then drop again, and in the last seven of the 13 sections tested in June 1990, level off between 4 million and 5 million psi.

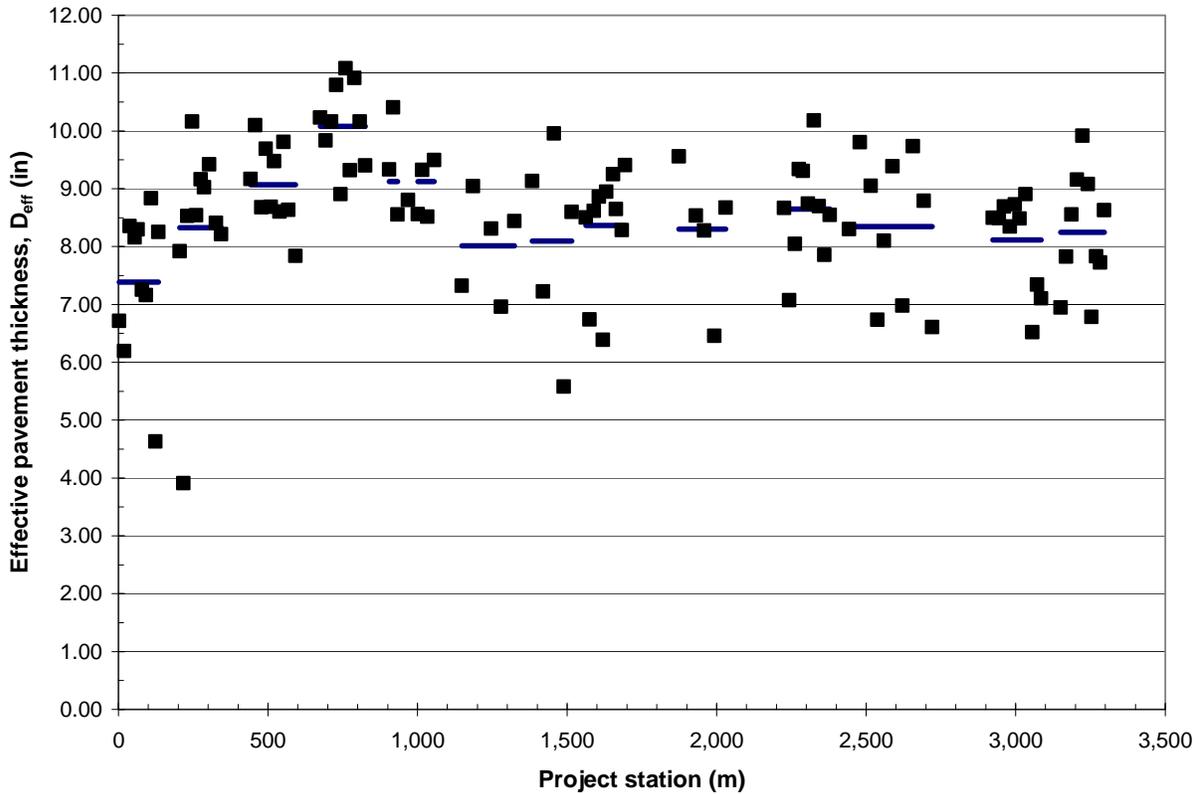
**Figure 16. Effective Thickness along Project Length  
(Assuming 4.2 Million psi Modulus).**

In this analysis, the effective thickness of the pavement structure at each deflection testing point was calculated assuming a concrete slab elastic modulus of 4.2 million psi. This modulus value was chosen because ADOT's past experience suggests that 28-day compressive strengths of about 5000 to 6000 psi are typical, which correspond to elastic modulus values in the range of about 4.0 million to 4.4 million psi. The effective thickness results are shown in Figure 16.

The effective thicknesses ranged from 3.91 to 11.55 inches, with most values in the range of 7 to 10 inches, and the overall project average was 8.5 inches. This means that the existing pavement had the same average bending stiffness as an 8.5 inch pavement with a concrete modulus of 4.2 million psi; it doesn't mean that the existing pavement had the same remaining structural life as an 8.5 inch pavement with a concrete modulus of 4.2 million psi.

Given that the overall average as-constructed thickness of the concrete was 8.25 inches, the calculated overall average effective thickness of 8.5 inches for the concrete and underlying stabilized and unstabilized base layers together suggests that the base layers contribute only about a quarter of an inch to the bending stiffness of the pavement structure.

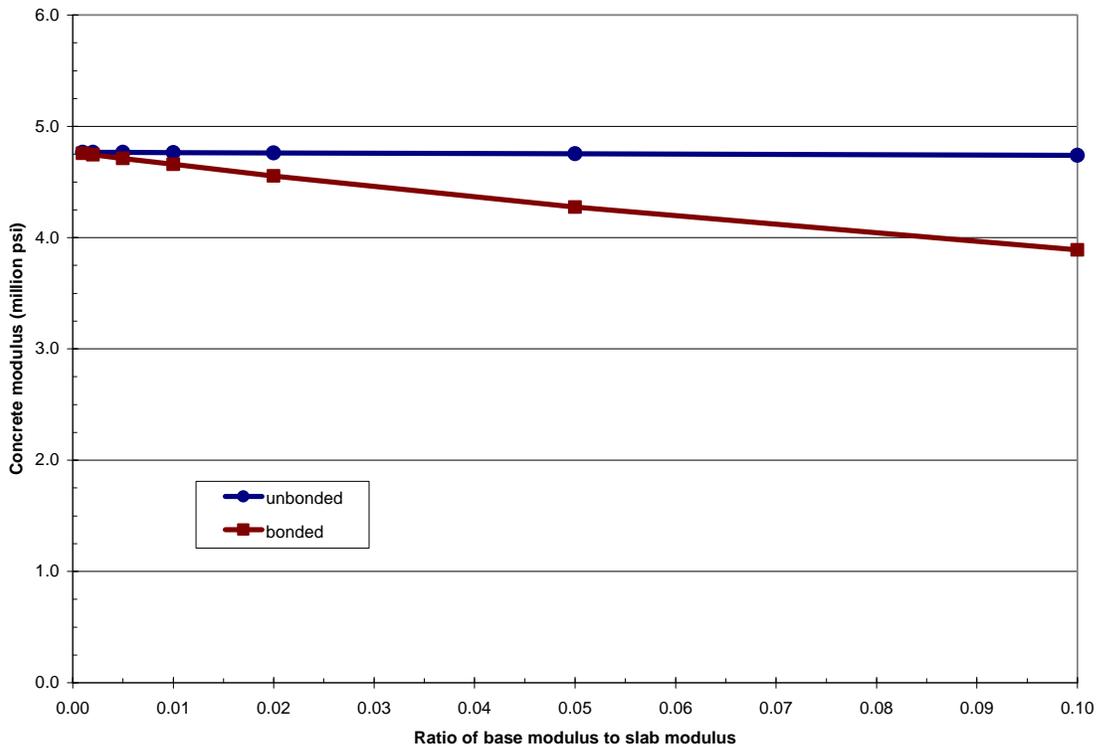
**Figure 17. Concrete Elastic Modulus as a Function of Interface Condition and Modular Ratio.**

Investigators obtained a range of solutions for this analysis to assess which were most realistic. Figure 17 shows the overall average concrete elastic modulus, calculated for both the unbonded and bonded interface cases, and as a function of assumed values of the ratio of base modulus to slab modulus. The corresponding base elastic modulus results are shown in Figure 18.

The concrete elastic modulus results show relatively little sensitivity to either the interface condition or the modular ratio. The results suggest that the true overall average concrete elastic modulus is somewhere between about 4.25 and 4.75 million psi. The base elastic modulus results appear to show greater sensitivity, however Figures 17 and 18 have different vertical scales: psi in millions and thousands, respectively. There appears to be almost no difference between the unbonded and bonded solutions for base modulus values up to 225,000 psi, but the true base modulus could be as low as about 25,000 psi or as high as about 250,000 psi. It is difficult to know any more about the stiffness of the base from the deflection results alone. Additional information about the strength or stiffness of the base obtained from laboratory testing or even visual examination in the field would make it easier to determine the elastic modulus of the base and, as a consequence, of the concrete, although as Figures 17 and 18 show, the degree of friction between the slab and the base probably does not matter much.

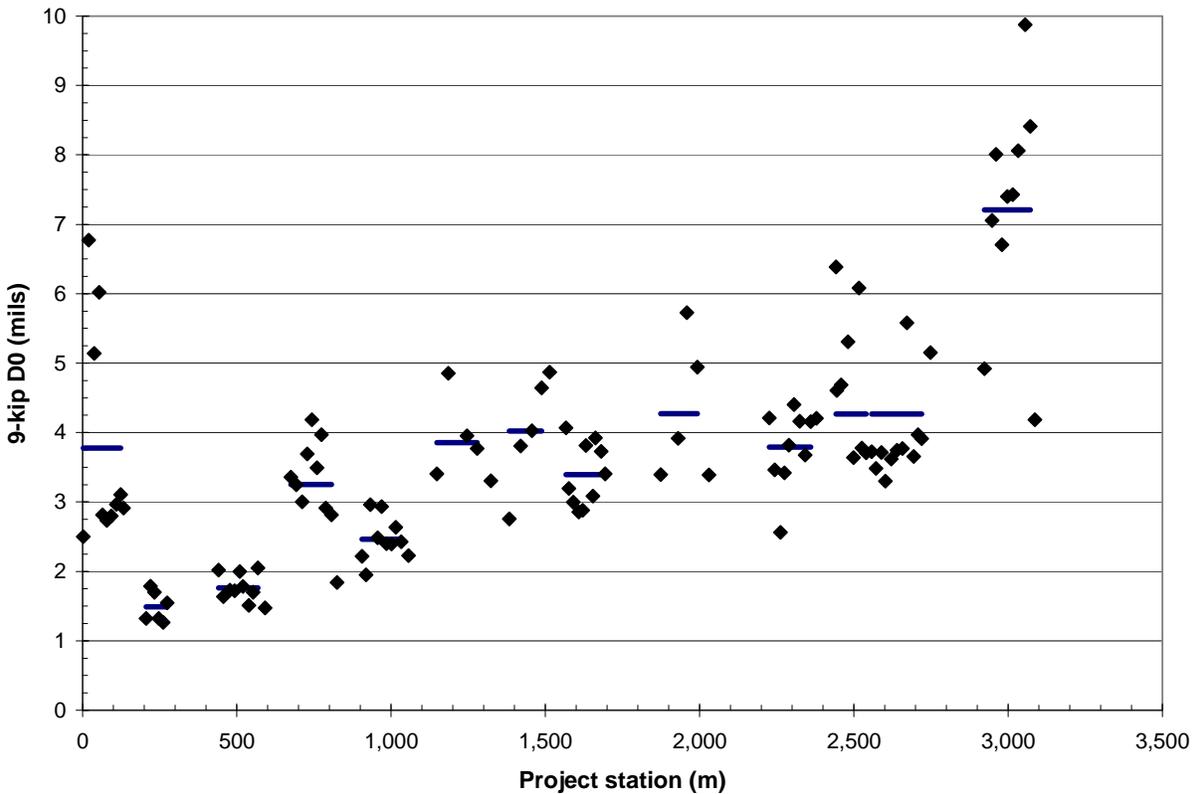
**Figure 19. Maximum Deflections along Project Length, April 1991.**

The April 1991 midslab D0 deflections along the length of the project are shown in Figure 19. Each point represents the average D0 from four load drops at the 9000 pound target load level, where each of the four individual D0 measurements have been normalized to 9000 pounds. In addition, D0 deflections measured on asphalt-surfaced test sections were normalized to 68 °F using a regression equation based on the 1993 AASHTO Guide's temperature adjustment factor for asphalt surfaces on cement- or pozzolan-treated bases. The horizontal bars in Figure 19 represent the average D0 for each test section. With the exception of the control section (040601, the last section plotted), the first set of post-rehabilitation maximum deflections are lower, more consistent within test sections, and more

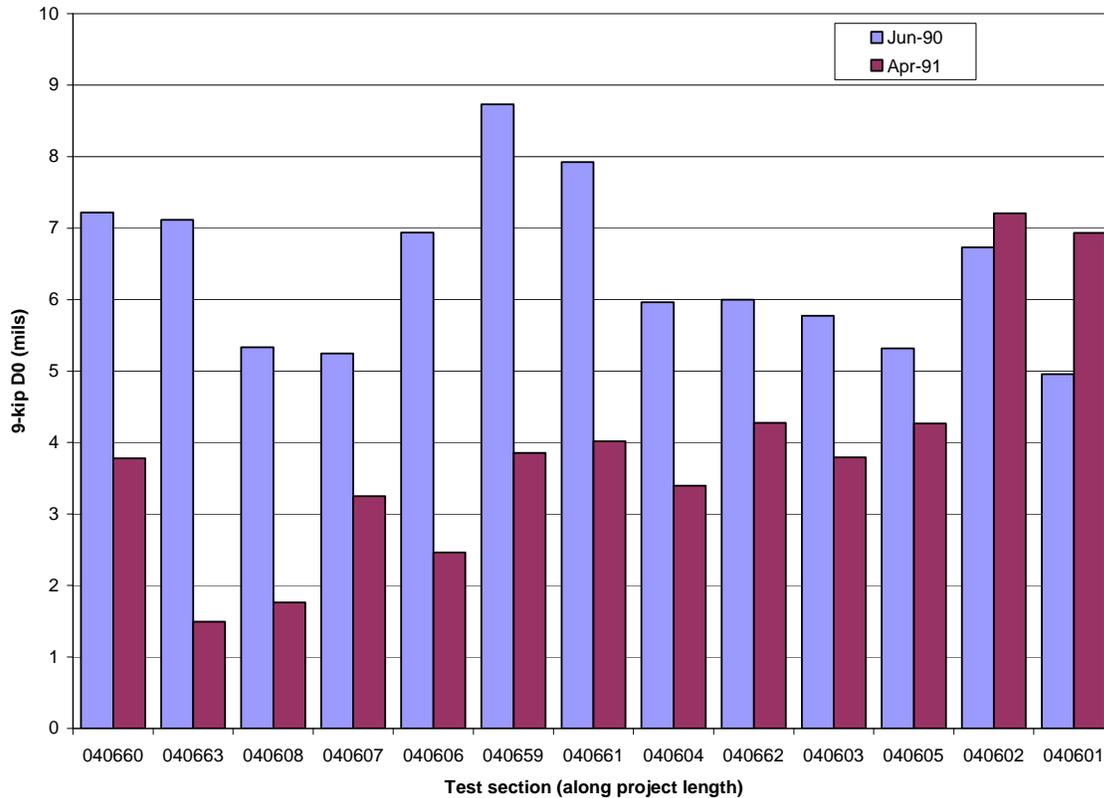
The effect of rehabilitation on the mean maximum deflection in each test section is illustrated in Figure 20. The changes in mean maximum deflection, as a percentage of the prerehabilitation mean, can be examined by rehabilitation treatment group:

- Bare concrete pavement: Mean maximum deflection increased 40 percent in Section 040601, the untreated control; increased 7 percent in Section 040602, which received minimal repair; and decreased 20 percent in Section 040605, in which the entire outer lane was replaced.
- Asphalt overlay of intact concrete pavement: Mean maximum deflection decreased 34 percent in Section 040603 and 43 percent in Section 040604. Both sections received minimal repair; Section 040603 received a 3.4 inch overlay, and Section 040604 received a 3.6 inch overlay along with sawing and sealing of transverse joints. Mean maximum deflection decreased more dramatically (64 percent) in Section 040606, which received a 4.3 inch overlay after complete replacement of the outer lane.

**Figure 20. Mean Maximum Deflection Before and After Rehabilitation, April 1991.**

- Asphalt overlay of cracked and seated concrete pavement: In Section 040607, which received a 4.3 inch overlay after cracking and seating of the concrete pavement, the decrease in mean maximum deflection (34 percent) was comparable to that of the sections that received an asphalt overlay of comparable thickness without slab fracturing (Sections 040603 and 040604). Mean maximum deflection was more dramatically reduced (67 percent) in the section that received an 8.4 inch overlay after cracking and seating. In Section 040659, in which a fabric was placed on the cracked and seated concrete prior to the overlay, mean maximum deflection was reduced by 56 percent. In Sections 040661 and 040662, the two other cracked and seated sections tested in April 1991, dissimilar reductions in mean maximum deflection were achieved (49 percent versus 29 percent). Both received a 4 inch overlay and no apparent difference in treatment other than that Section 040662 also had subdrains retrofitted.

- Asphalt overlay of rubblized concrete pavement: In Section 040660, which received an 8 inch overlay after rubblizing the existing concrete slab, the mean maximum deflection was reduced 49 percent.
- Unbonded concrete overlay of cracked and seated concrete pavement: The initial result of cracking and seating, a 2 inch asphalt separation layer, and a 10 inch concrete overlay was a 79 percent reduction in mean maximum deflection.

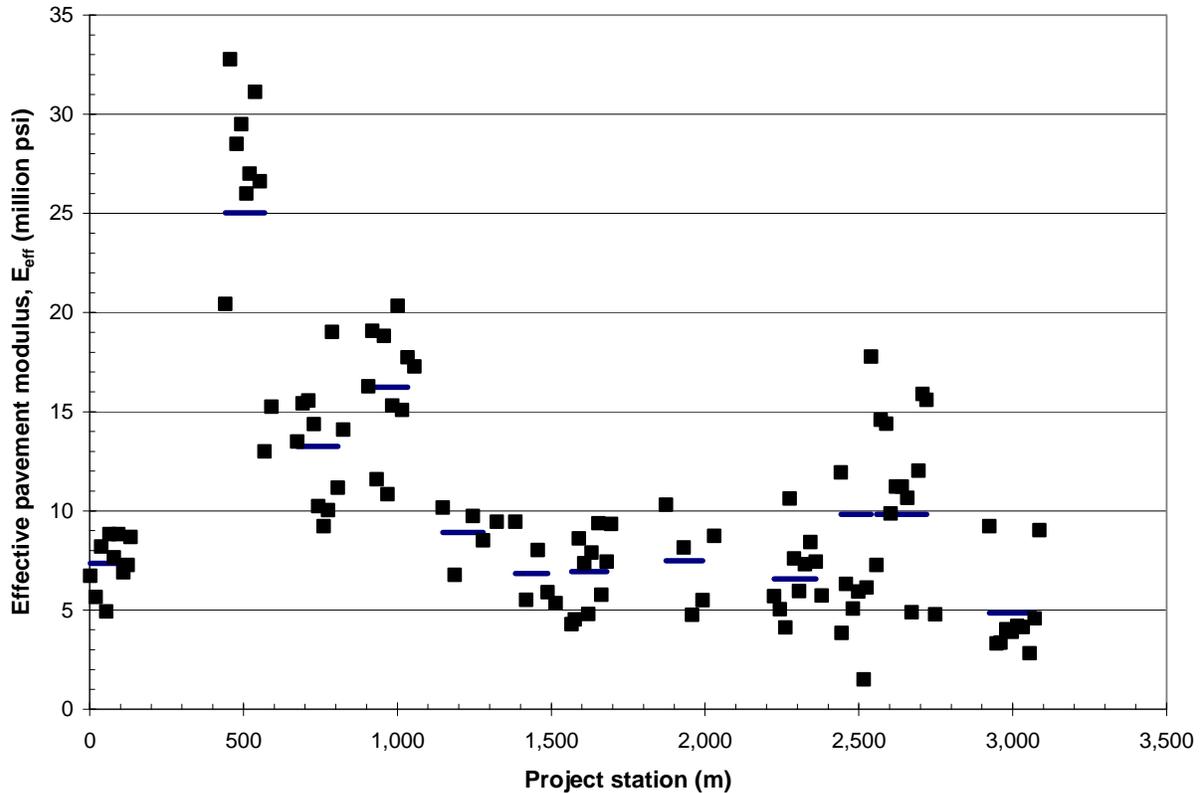
Figure 21 shows effective pavement modulus values along the length of the project after rehabilitation. Each point represents the average effective pavement modulus from four load drops at the 9000 pound target load level. The horizontal bars in Figure 21 represent the average effective pavement modulus for each test section. These values were calculated as a function of the thickness of the original concrete slab, as was done with the prerehabilitation deflections, to illustrate the relative effects of different rehabilitation treatments. For example, if an 8 inch concrete slab with a 4 inch asphalt overlay has an effective pavement modulus of 7 million psi, that does not mean that either the concrete or the asphalt has a modulus of 7 million psi, but rather that the asphalt-overlaid concrete structure has the same bending stiffness as an 8 inch slab of 7 million psi concrete.

**Figure 21. Effective Pavement Modulus along Project Length After Rehabilitation as a Function of Prerehabilitation As-Built Concrete Slab Thicknesses.**

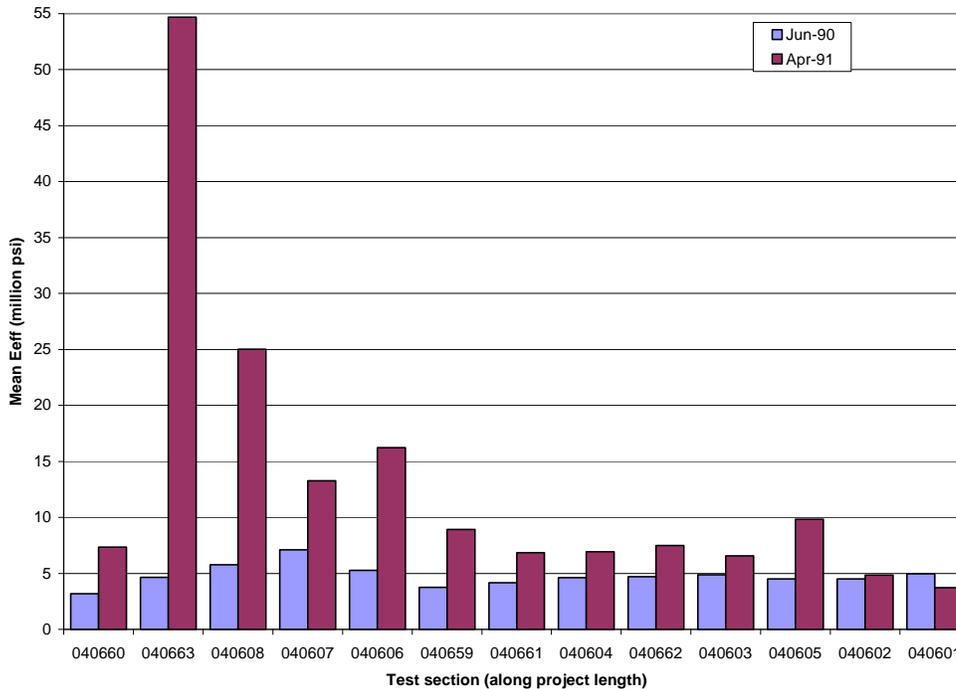
The effect of rehabilitation on effective pavement modulus is illustrated in Figure 22. The changes in mean effective pavement modulus, as a percentage of the prerehabilitation mean, can be examined by rehabilitation treatment group:

- Bare concrete pavement: The mean effective pavement modulus decreased by 25 percent in Section 040601, the untreated control section; increased 8 percent in Section 040602, which received minimal repair; and increased 118 percent in Section 040605, in which the entire outer lane was replaced.
- Asphalt overlay of intact concrete pavement: The mean effective pavement modulus increased 35 percent in Section 040603 and 50 percent in Section 040604. Both sections received minimal repair; Section 040603 received a 3.4 inch overlay, and Section 040604 received a 3.6 inch overlay along with sawing and sealing of transverse joints. Mean effective pavement modulus increased more dramatically (208 percent) in Section 040606, which received a 4.3 inch overlay after complete replacement of the outer lane.

**Figure 22. Effective Pavement Modulus Before and After Rehabilitation as a Function of Prerehabilitation As-Built Concrete Slab Thicknesses.**

- Asphalt overlay of cracked and seated concrete pavement: The mean effective pavement modulus increased by 87 percent and 333 percent in Sections 040607 and 040608, respectively. Section 040607 received a 4.3 inch overlay, and Section 040608 received an 8.4 inch overlay after cracking and seating of the concrete pavement. In Section 040659, in which a fabric was placed on the cracked and seated concrete prior to the overlay, mean effective pavement modulus increased 138 percent. In Sections 040661 and 040662, the two other cracked and seated supplemental sections tested in April 1991, similar increases in mean effective pavement modulus were 65 percent and 59 percent, respectively. Both sections received a 4 inch overlay.

- Unbonded concrete overlay of cracked and seated concrete pavement: In Section 040663, the initial result of cracking and seating, a 2 inch asphalt separation layer, and a 10 inch concrete overlay was a greater than tenfold (1075 percent) increase in effective pavement modulus.

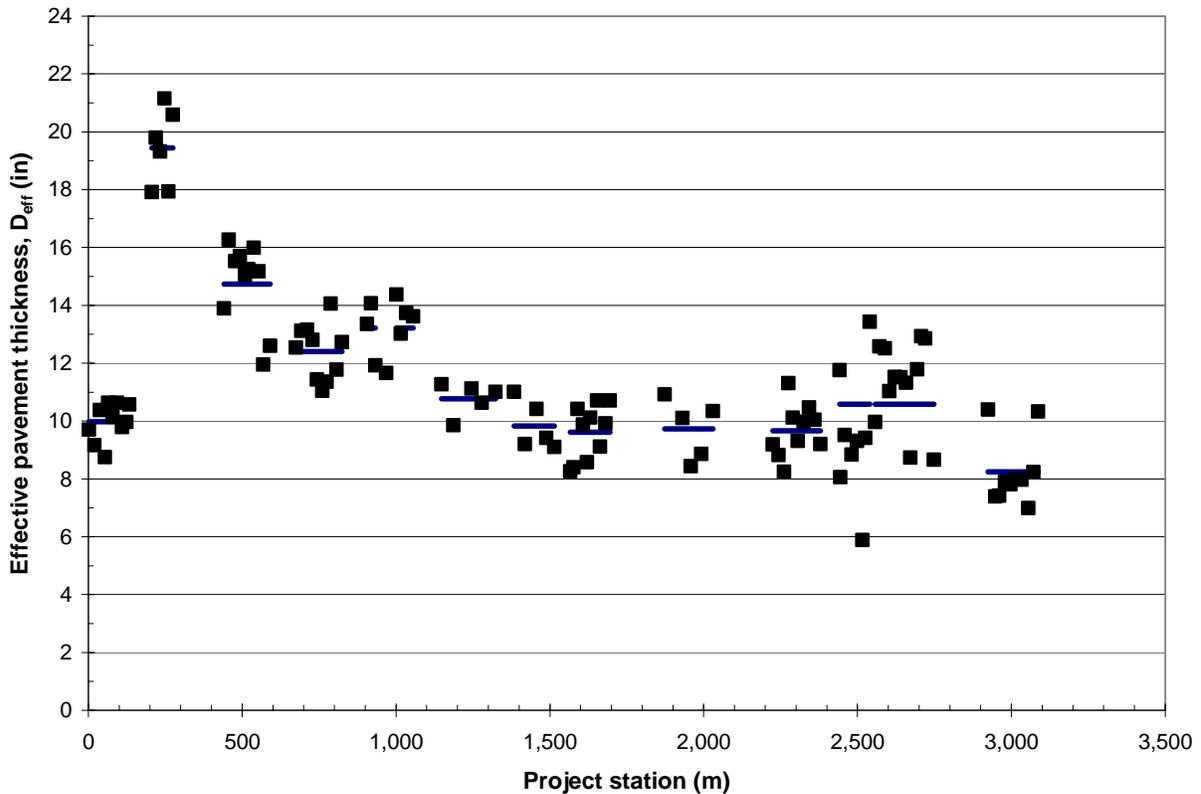
The post-rehabilitation effective thickness values along the length of the project are shown in Figure 23. These values were calculated assuming a concrete slab elastic modulus of 4.2 million psi. The pre- and post-rehabilitation mean effective thickness values are compared in Figure 24.

**Figure 23. Post-Rehabilitation Effective Pavement Thickness along Project Length (Assuming 4.2 Million psi Modulus).**

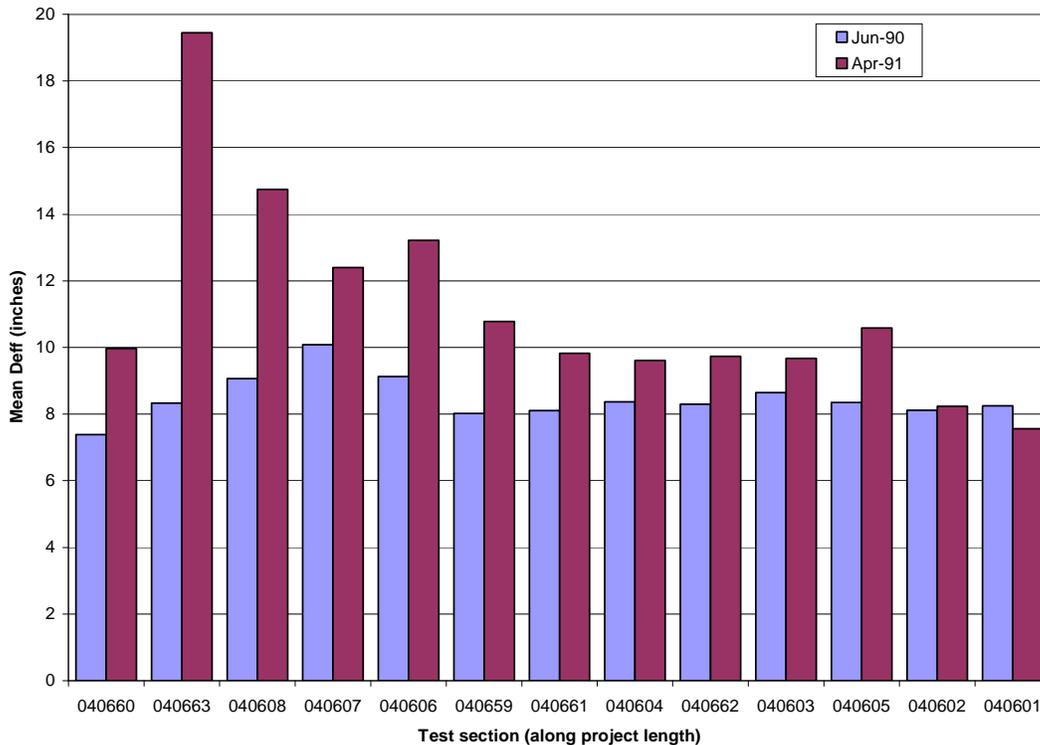
- Bare concrete pavement: The mean effective pavement thickness decreased 8 percent in Section 040601, the untreated control; increased 2 percent in Section 040602, which received minimal repair; and increased 27 percent in Section 040605, in which the entire outer lane was replaced.
- Asphalt overlay of intact concrete pavement: The mean effective pavement thickness increased 12 percent in Section 040603 and 15 percent in Section 040604. Both sections received minimal repair; Section 040603 received a 3.4 inch overlay and Section 040604 received a 3.6 inch overlay along with sawing and sealing of transverse joints. Mean effective pavement thickness increased more dramatically (45 percent) in Section 040606, which received a 4.3 inch overlay after complete replacement of the outer lane.

**Figure 24. Effective Pavement Thickness Before and After Rehabilitation (Assuming 4.2 Million psi Modulus).**

- Asphalt overlay of cracked and seated concrete pavement: The mean effective pavement thickness increased by 23 percent and 63 percent in Sections 040607 and 040608, respectively. Section 040607 received a 4.3 inch overlay and Section 040608 received an 8.4 inch overlay after cracking and seating of the concrete pavement. In Section 040659, in which a fabric was placed on the cracked and seated concrete prior to the overlay, mean effective pavement thickness increased 34 percent. In Sections 040661 and 040662, the two other cracked and seated sections tested in April 1991, both of which received a 4 inch overlay, similar increases in mean effective pavement thickness were observed (21 percent and 17 percent, respectively).

- Unbonded concrete overlay of cracked and seated concrete pavement: In Section 040663, the initial result of cracking and seating, a 2 inch asphalt separation layer, and a 10 inch concrete overlay was a 133 percent increase in effective pavement thickness.

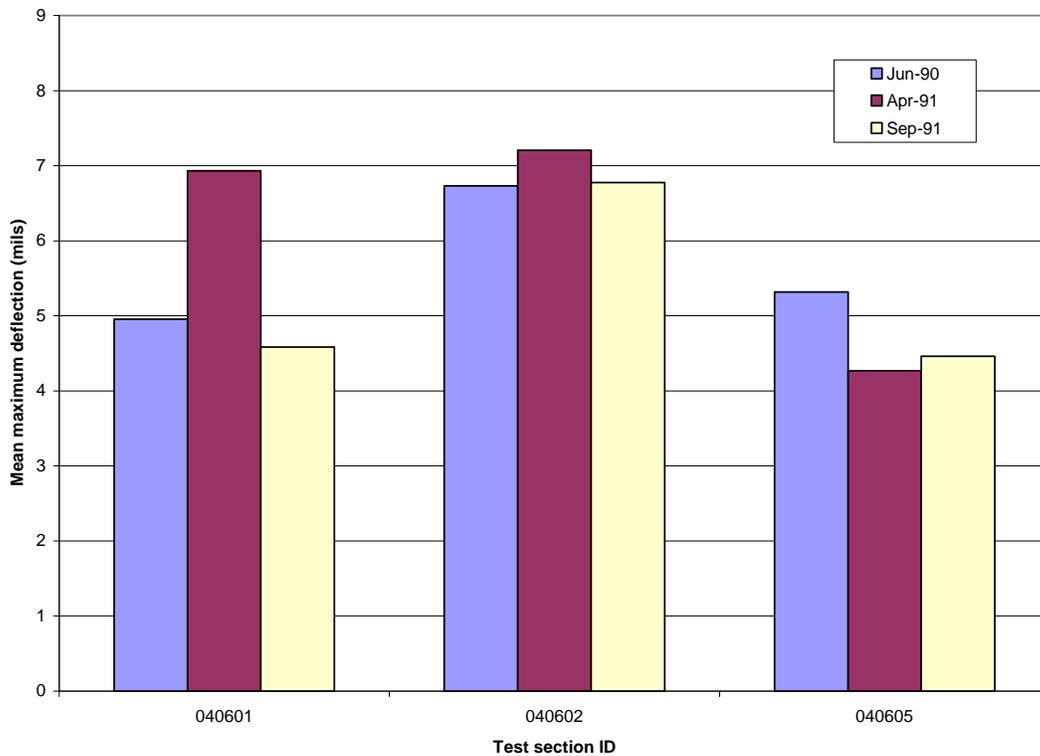
Figure 25 show the mean maximum deflections at the 9 kip loading level for the three bare concrete test sections. In September 1991 the deflections in Sections 040601 and 040602 were at nearly the same levels as in June 1990. In Section 040605, on the other hand, the mean maximum deflections in September 1991 were slightly higher than in April 1991, which may be due to seasonal variation in the foundation stiffness or simply a slight random variation.

**Figure 25. Mean Maximum Deflection Over Time in Bare Concrete Pavement Sections.**
