Arizona Department of Transportation Research Center

# **Performance Evaluation of Arizona's LTPP SPS-6 Project: Strategic Study of Rehabilitation Techniques**

**Final Report 396-6  
October 2013**

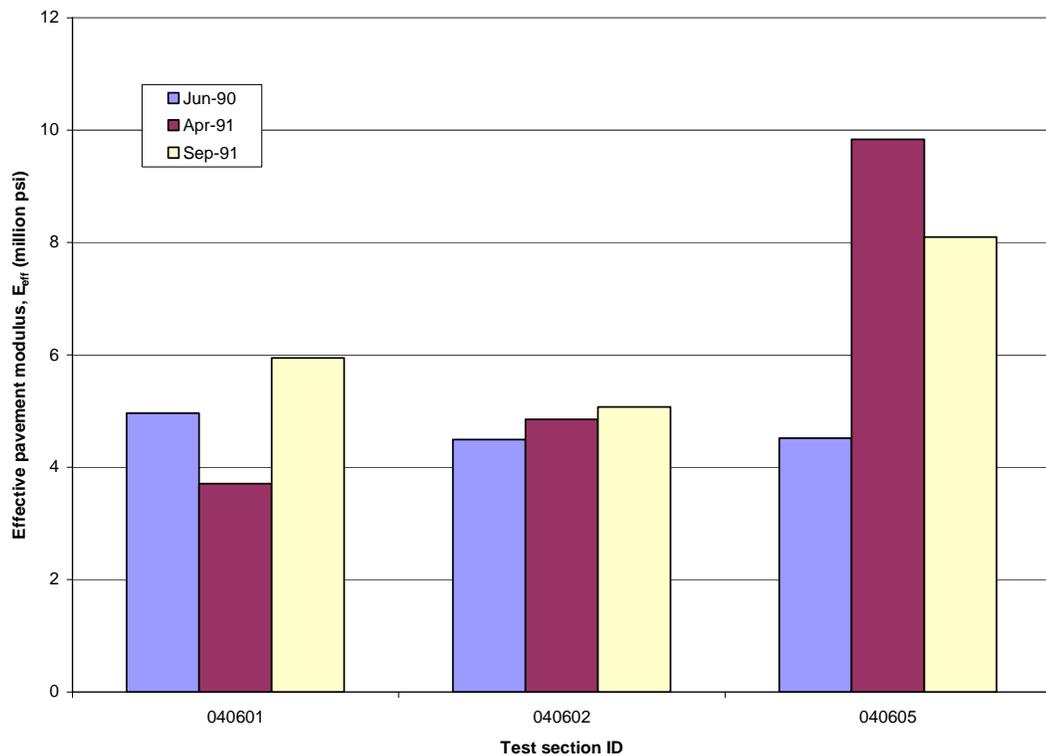
Figure 26 shows effective pavement modulus over time for three bare concrete test sections. As noted earlier, the effective pavement modulus decreased by 25 percent between June 1990 and April 1991 in Section 040601; increased by 8 percent in Section 040602, which received minimal repair; and increased by 118 percent in Section 040605, where the entire outer lane was replaced. Five months later, in September 1991, the effective pavement modulus was 20 percent higher than the April 1991 level in the Section 040601, 12 percent higher in Section 040602, and 79 percent higher in Section 040605.

Since there is no ready physical explanation for fluctuations of  $\pm 25$  percent in the effective pavement modulus over a five-month period, variations of this magnitude from year to year are probably nothing more than random variation. In that context, the relative increases in effective pavement modulus seen in Section 040605 might not be statistically significant. Nonetheless, both the April 1991 and September 1991 results indicate an effective pavement modulus for the new concrete in Section 040605 (9.84 million psi and 8.10 million psi, respectively) that is considerably higher than would be expected in such young concrete. These results suggest that the concrete thickness in the replaced outer lane is greater than the as-constructed thickness (8.3 inches) of the old concrete that was replaced.

**Figure 26. Effective Pavement Modulus Over Time in Bare Concrete Pavement Sections as a Function of Prerehabilitation As-Built Concrete Slab Thickness.**

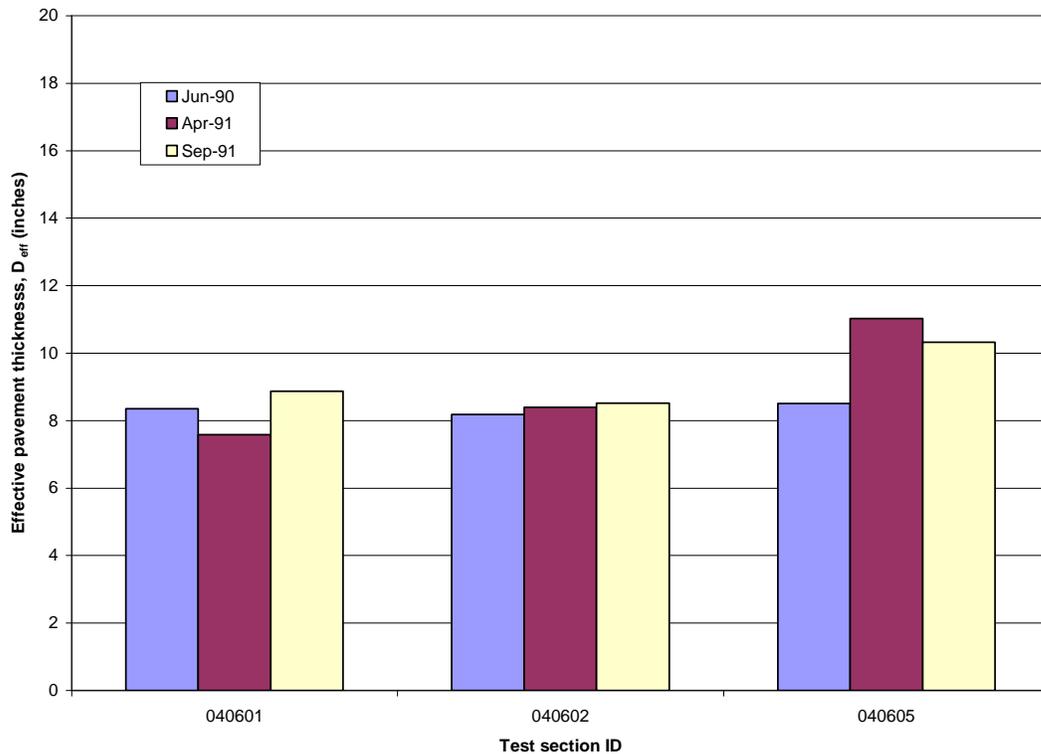
The mean effective thicknesses of the three bare concrete pavement sections, from the three sets of deflection data available, assuming a concrete modulus of 4.2 million psi, are shown in Figure 27. This comparison reinforces the notion that the pavement structures in Sections 040601 and 040602 were essentially unchanged, while the replacement of the outer lane in Section 040605 produced a notable improvement in the structure. The April 1991 data suggest a 27 percent increase in the effective thickness as a result of the outer lane replacement, and the data from five months later suggest that the effective thickness was 21 percent higher than before the replacement. The difference between the April and September 1991 results is probably not significant. Both results, however, reinforce the impression that the new concrete placed in the outer lane was significantly greater than 8.3 inches thick and/or had an elastic modulus significantly greater than 4.2 million psi within a year after placement.

**Figure 27. Effective Thickness Over Time in Bare Concrete Pavement Sections (Assuming 4.2 Million psi Modulus).**

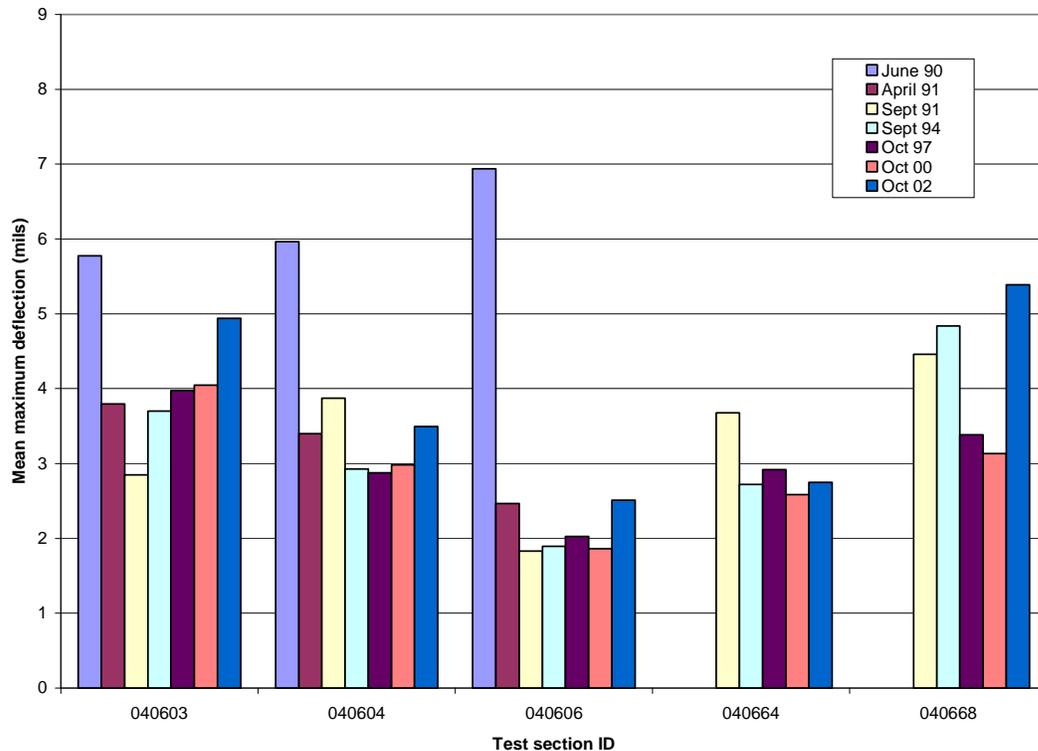
Figure 28 shows the mean maximum deflections at the 9 kip loading level for the asphalt-overlaid concrete sections. No deflections were measured in Sections 040664 or 040668 before September 1991, so pretreatment versus long-term deflection comparisons are not possible for these sections.

**Figure 28. Mean Maximum Deflection Over Time in Asphalt-Overlaid Concrete Sections.**

For the three asphalt-overlaid concrete sections for which pretreatment deflections are available, the mean maximum deflection plot illustrates that the deflection reductions were achieved by the overlay treatments. Among the three sections, the most dramatic deflection reductions occurred in Section 040606, where the concrete in the outer traffic lane was replaced before the asphalt overlay was placed. Deflections in all three sections have remained fairly consistent in the 12 years since.

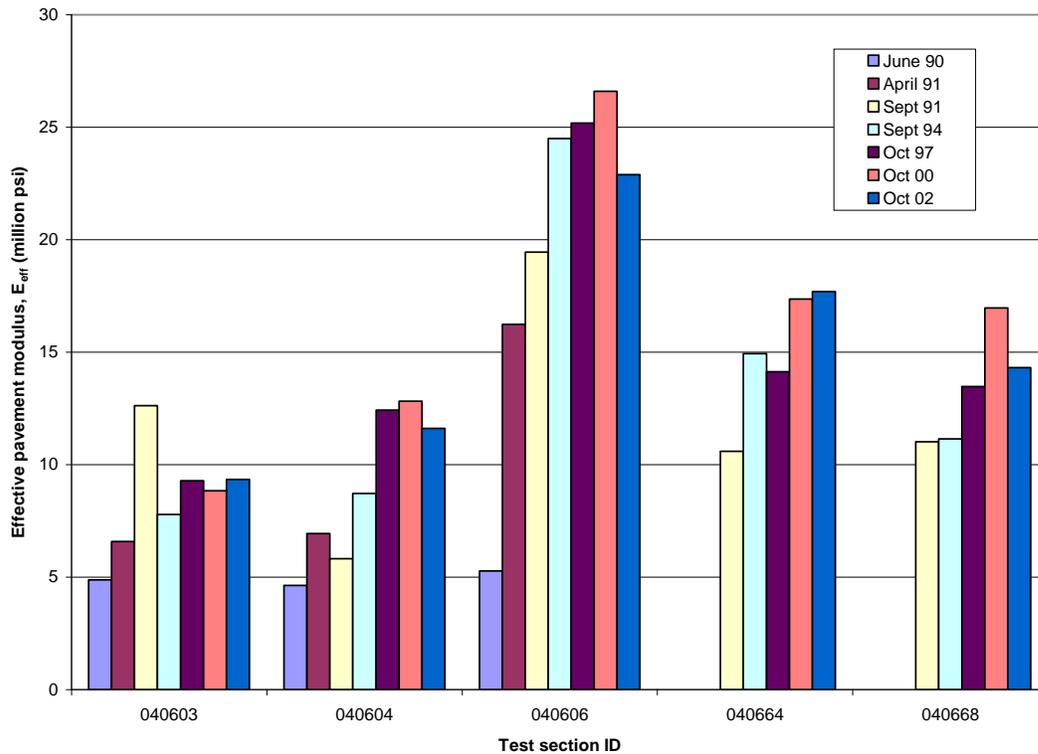
Figure 29 shows the effective pavement modulus over time for the three asphalt-overlaid concrete test sections. This plot illustrates, more clearly than the maximum deflection plot, the relative structural capacity improvements achieved by these different overlay treatments.

**Figure 29. Effective Pavement Modulus Over Time in Asphalt-Overlaid Concrete Pavement Sections as a Function of Prerehabilitation As-Built Concrete Slab Thickness.**

Twelve years after the rehabilitation, Section 040606 (4.3 inch overlay of the replaced concrete) remains the section with the highest effective pavement modulus, followed by Sections 040664 and 040668 (6 inch asphalt overlays of the original concrete), which are then followed by Section 040603 (4.5 inch overlay of the original concrete) and Section 040604 (4 inch overlay of the original concrete).

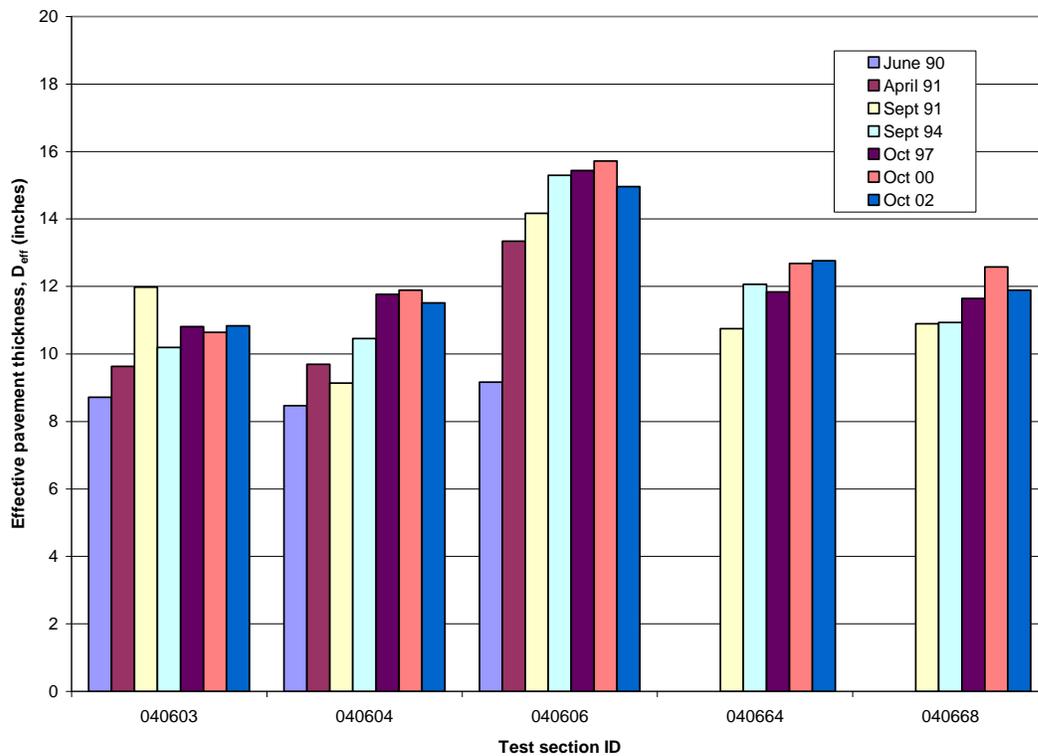
The effective pavement thickness over time is shown for the three asphalt-overlaid concrete test sections in Figure 30. This plot also illustrates the relative structural capacity improvements achieved by these different overlay treatments. The greatest effective thickness corresponds to Section 040606 (4.5 inch overlay over replaced concrete). Sections 040664 and 040668 (6 inch asphalt overlay) have the next largest effective thicknesses, and Sections 040603 and 040604 (4.5 inch and 4 inch overlays, respectively) have lesser effective thicknesses. In each case, the effective thicknesses have remained fairly consistent between the years 1994 and 2002.

**Figure 30. Effective Thickness Over Time in Bare Concrete Pavement Sections (Assuming 4.2 Million psi Modulus).**

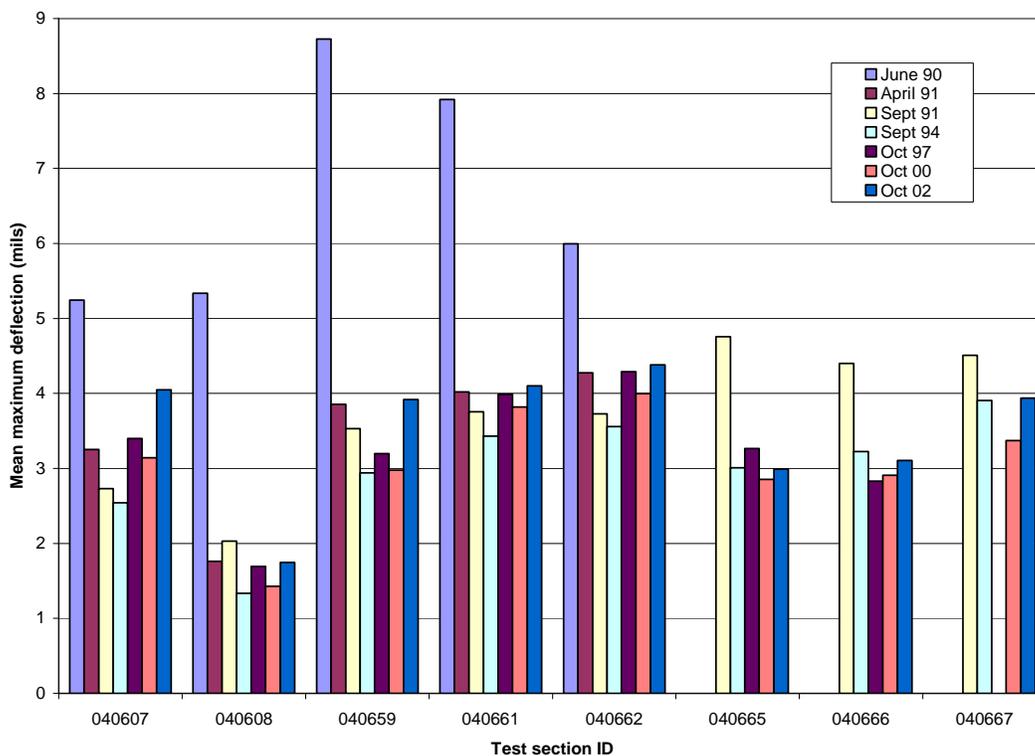
Figure 31 shows the mean maximum deflections at the 9 kip loading level for the sections with asphalt overlays of cracked and seated concrete. No deflections were measured in Sections 040665, 040666, or 040667 before September 1991, so pretreatment versus long-term deflection comparisons are not possible for these sections.

Figure 31. Mean Maximum Deflection Over Time in Crack and Seat Sections.

The 4.3 inch overlay in Section 040607 reduced deflections by about 40 percent, although in the last five years of monitoring, the deflections appear to have been increasing again. The 8.4 inch overlay in Section 040608 reduced deflections by about 66 percent, and the deflections in subsequent years have so far remained steadier.

Section 040659, where a fabric was placed on the cracked and seated concrete before placing the 4 inch overlay, had the highest mean maximum deflection among the sections with pretreatment data available, but the rehabilitation brought deflections down about 50 percent, to about the same level as in Section 040607. The post-overlay deflections in Sections 040661 and 040662 are similar, which suggests that for these sections, the magnitude of deflections after overlay depended more on the thickness of the overlay than on the magnitude of deflections before the overlay.

The plot in Figure 31 shows that in Sections 040665 and 040666, the mean maximum deflections were considerably higher in September 1991 than in subsequent years (during which deflections have remained fairly steady). In Section 040667, the September 1991 deflections were also somewhat higher than the 1994 deflections, but not to the degree seen in Sections 040665 and 040666. This decline in deflections soon after placement of an asphalt overlay, when traffic is still compacting the mix and volatile compounds are still evaporating, is not that uncommon, and is in fact a reason not to read too much into deflections measured soon after asphalt overlay placement. However, if this is the reason that the September 1991 deflections are higher than later deflections in these three sections, it would suggest something different about the AC mix in these sections than in the other sections in this group.

Figure 31 also shows that since 1994, mean maximum deflections have been lower in Sections 040665 and 040666 than in 040667. Given that all three sections had retrofit subdrains and the same overlay thickness, the difference may be due either to differences in foundation stiffness or differences in slab stiffness as a result of different cracking patterns.

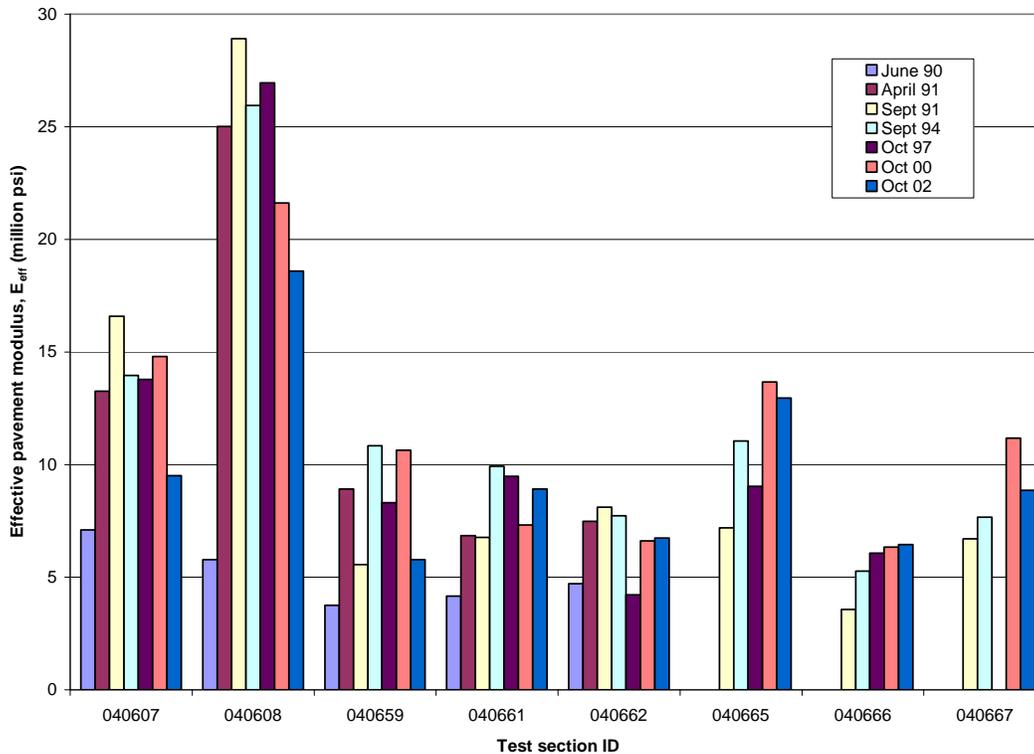
Figure 32 shows the effective pavement modulus over time for the crack and seat sections. This plot shows the dramatic difference in structural improvement achieved by Section 040608 (the 8.4 inch overlay) versus the 4 inch and even the 5.5 inch overlays in the other test sections. The effective modulus has since declined somewhat in this section, but even 12 years after the rehabilitation, is still considerably greater than in the other crack and seat sections. The next highest effective pavement modulus levels over time have been in Section 040607 (the 4.3 inch overlay) and 040665 (one of the 6 inch overlays). The remaining 4- and 5.5 inch overlay sections have exhibited similar effective pavement modulus levels. However, the effective pavement modulus levels in the 5.5 inch overlay sections do seem to have increased during the time period monitored.

**Figure 32. Effective Pavement Modulus Over Time for Crack and Seat Sections as a Function of Prerehabilitation As-Built Concrete Slab Thickness.**

Figure 35 shows the effective pavement modulus values over time for the two rubblized sections. This chart is plotted with the same vertical scale as in Figure 32 to illustrate the lower levels of effective modulus obtained for the rubblized sections compared to the crack and seat sections. However, the effective pavement moduli in both rubblized test sections do appear to have increased over time.

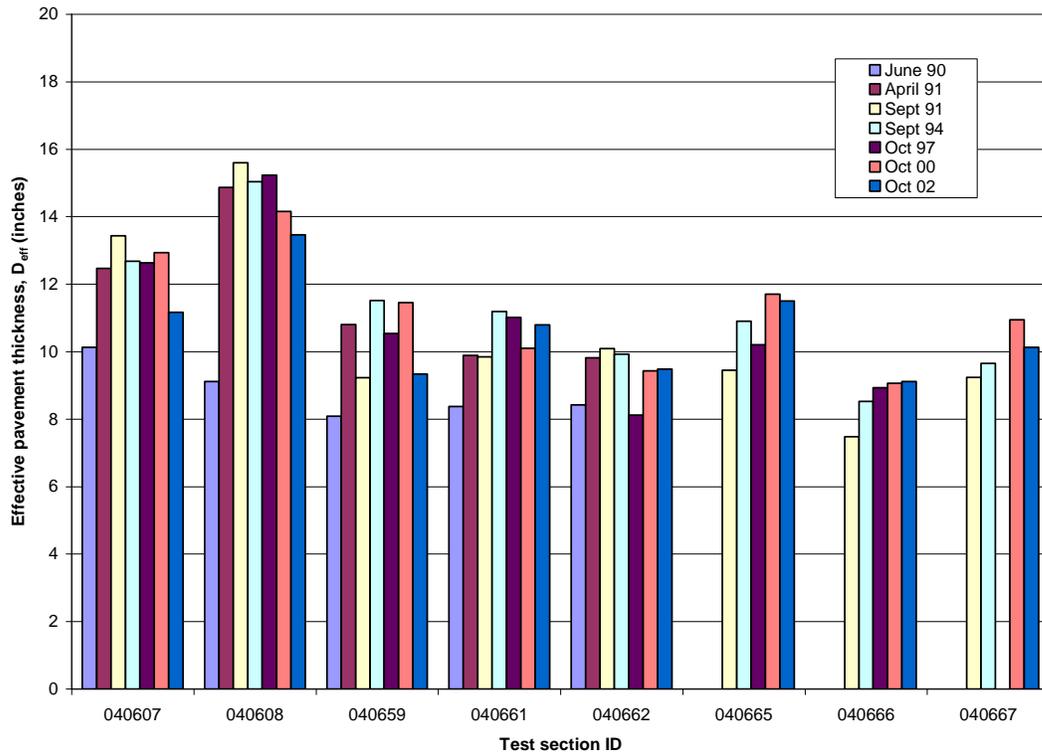
Figure 33 shows the effective thickness over time for the crack and seat sections. This plot illustrates, like the effective modulus plot, the greater structural improvement achieved by the 8.4 inch overlay compared to the overlays in the other test sections. Surprisingly, the effective pavement thicknesses are not, in general, higher in the 5.5 inch overlay sections than in the 4 inch overlay sections. They do, however, seem to be increasing over time in these sections.

**Figure 33. Effective Thickness Over Time for Crack and Seat Sections (Assuming 4.2 Million psi Modulus).**

Figure 36 shows the effective thickness values over time for the two rubblized sections. These are plotted with the same vertical scale as in Figure 33 to illustrate the smaller increases in effective thickness achieved by rubblizing plus overlay compared to crack and seat plus overlay. However, the effective thicknesses do appear to have increased over time.

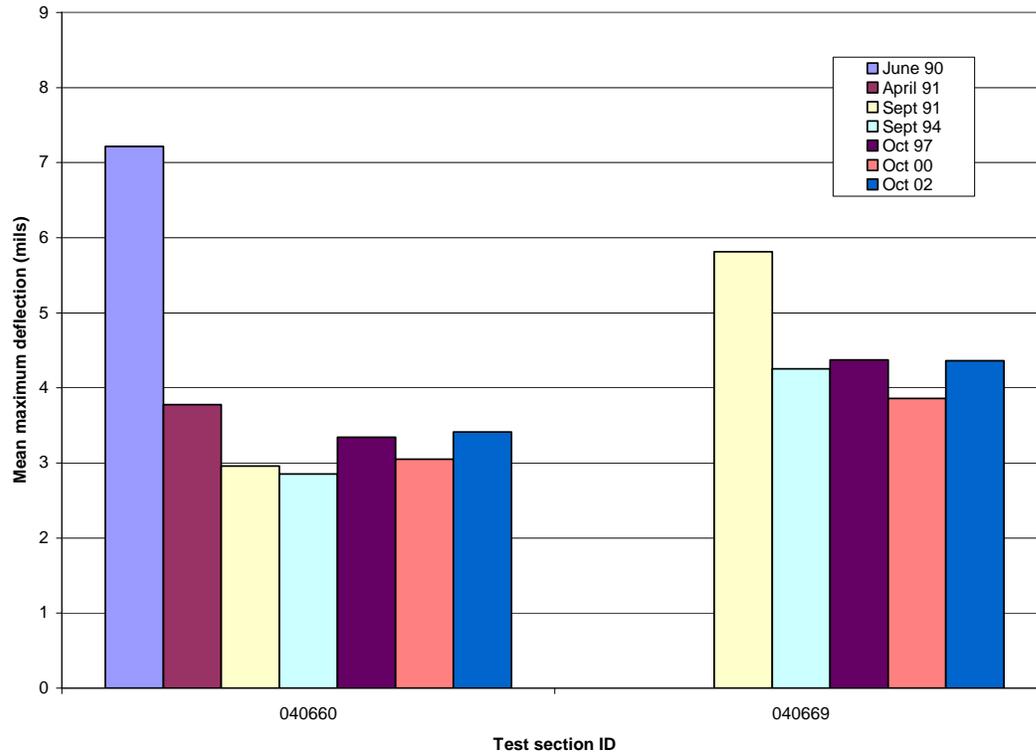
Figure 34 shows the mean maximum deflections over time in the two rubblized sections. Pretreatment deflection measurements are only available for Section 040660. The plot illustrates the substantial reduction in mean maximum deflection—about 50 percent—achieved by the 8 inch overlay, even after rubblizing of the original concrete.

**Figure 34. Mean Maximum Deflection Over Time in Rubblized Sections.**

In Section 040669, like the nearby crack and seat sections, the September 1991 deflections were higher than in subsequent years. In both of the rubblized test sections, the mean maximum deflections have held fairly steady since 1994. The effect of the thicker overlay in Section 040660 is illustrated by its lower mean maximum deflection levels.

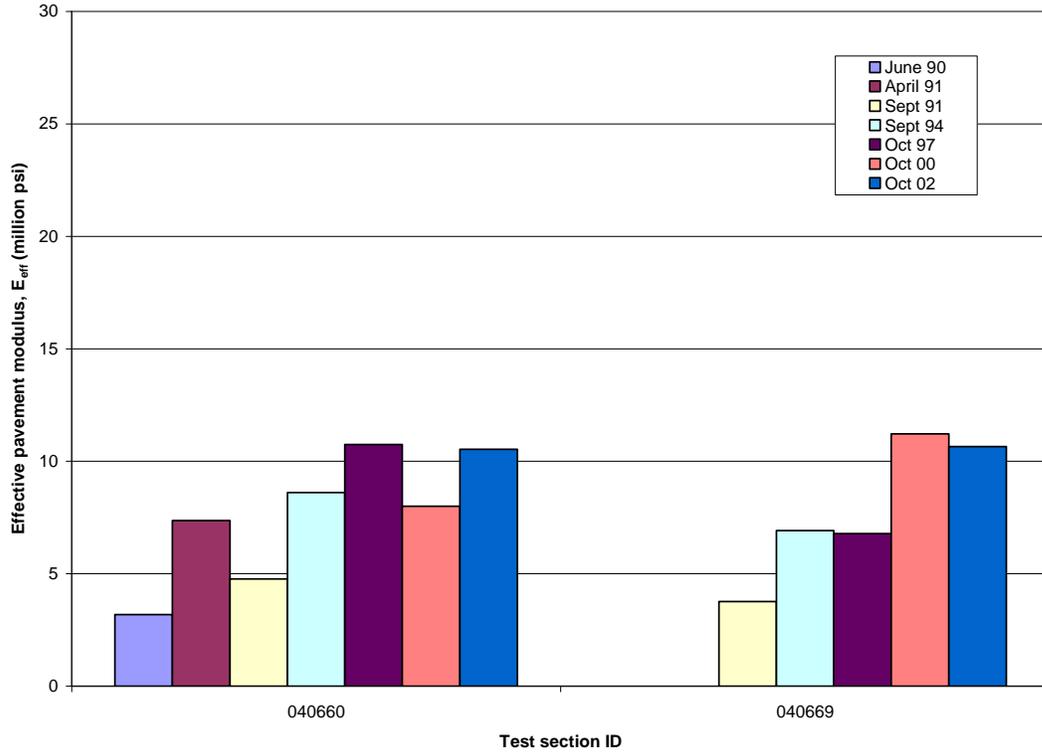
**Figure 35. Effective Pavement Modulus Over Time in Rubblized Sections as a Function of Prerehabilitation As-Built Concrete Slab Thickness.**

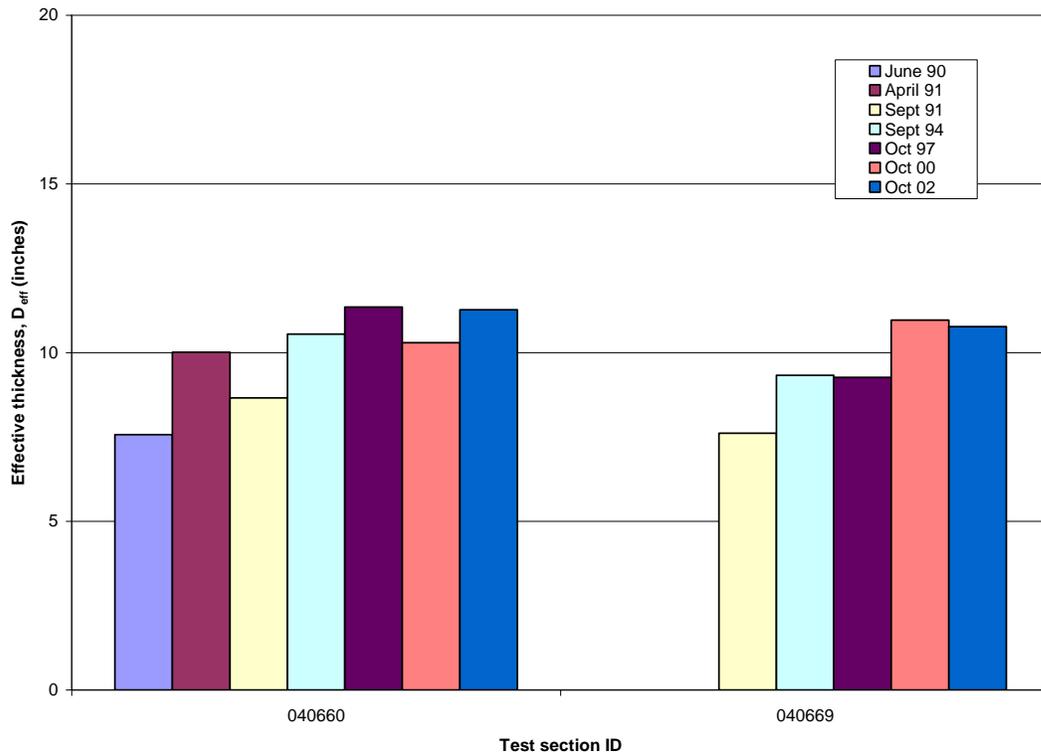
**Figure 36. Effective Thickness of Rubblized Sections (Assuming 4.2 Million psi Modulus).**

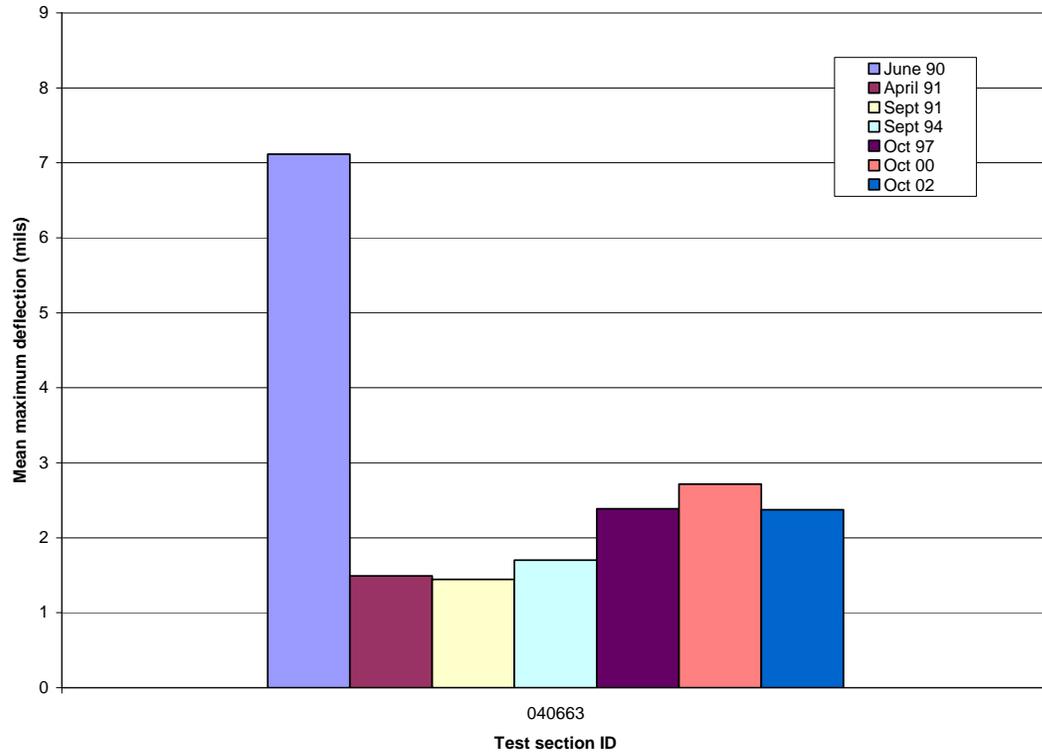
The mean maximum deflections over time in the unbonded overlay section are plotted in Figure 37. The deflections were dramatically reduced by the rehabilitation, although mean maximum deflection appears to have increased slightly in recent years.

**Figure 37. Mean Maximum Deflection Over Time in Unbonded Overlay Section.**

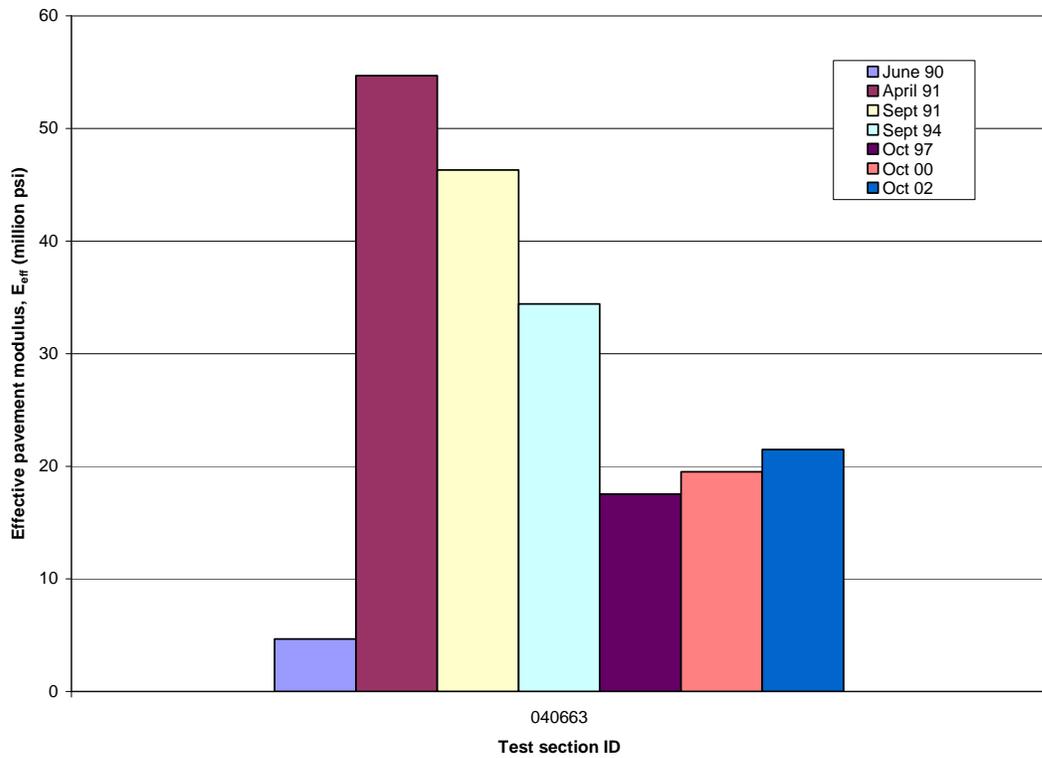
Figure 38 shows the section's effective pavement modulus over time. This plot illustrates the dramatic structural improvement achieved by the rehabilitation, although there has been some decrease in the effective pavement modulus in recent years.

**Figure 38. Effective Pavement Modulus Over Time in Unbonded Overlay Section as a Function of Prehabilitation As-Built Concrete Slab Thickness.**

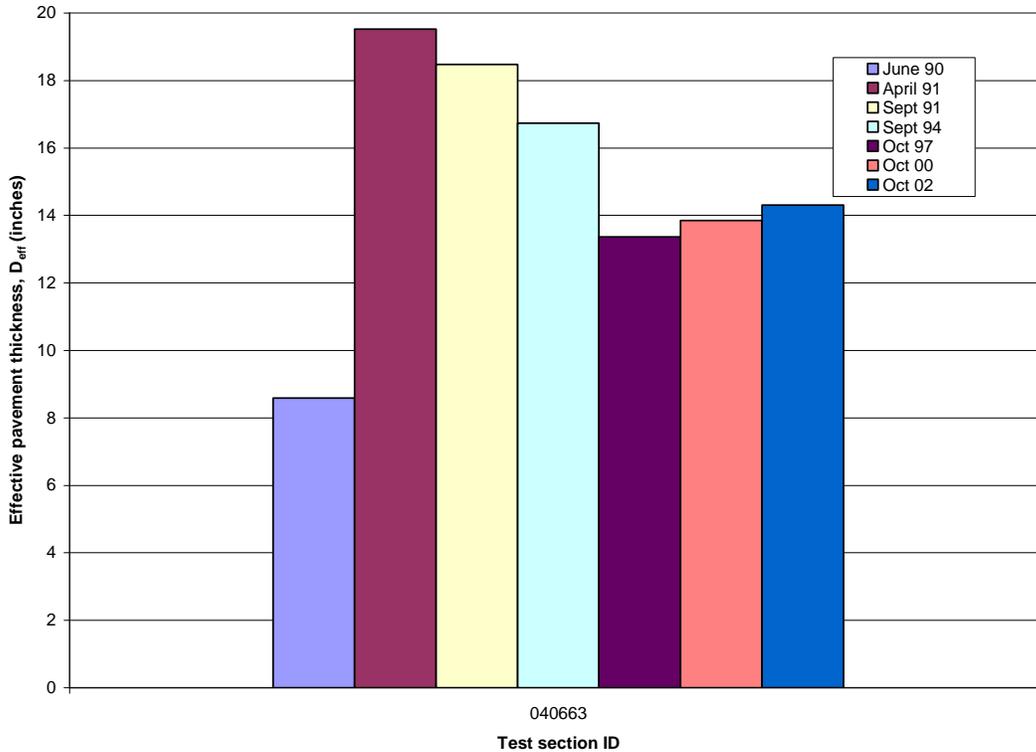
Figure 39 shows the effective pavement thickness over time for the unbonded overlay section. The rehabilitation more than doubled the effective thickness of the pavement structure, and while there has been some decrease in the effective pavement thickness in recent years, after 12 years it is still almost twice the effective thickness of the pavement prior to rehabilitation.

**Figure 39. Effective Pavement Thickness Over Time in Unbonded Overlay Section (Assuming 4.2 Million psi Modulus).**

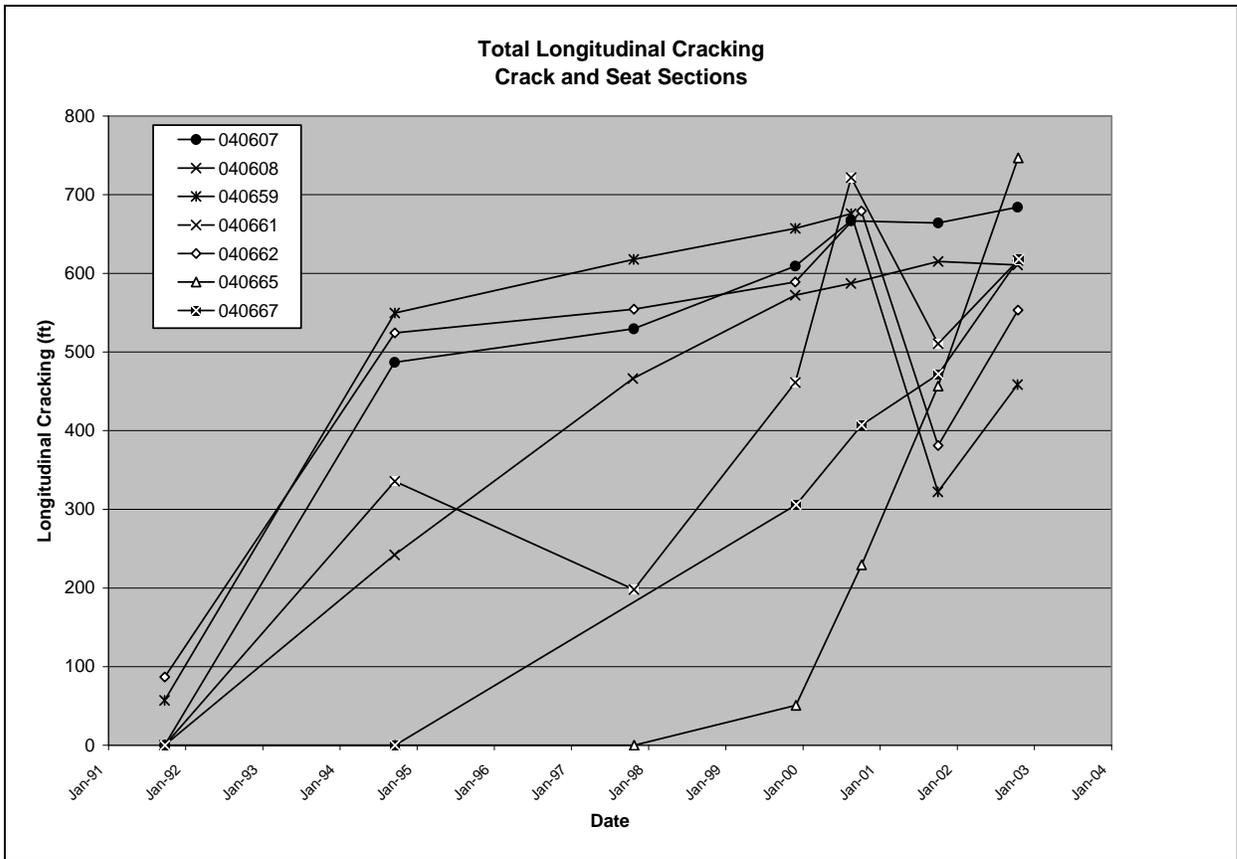
The overall longitudinal cracking trends are plotted in Figure 40 (crack and seat test sections) and Figure 41 (no preparation, minimum/maximum restoration, and rubblized test sections). The performance trends are relatively consistent and within the expected range of variation. Drops in the longitudinal distress graph are indicative of the maintenance that was performed on the test sections, which masked the distress. A full list of the work history of each site is given in Appendix B.

**Figure 40. Longitudinal Cracking Trends of the Crack and Seat Test Sections.**

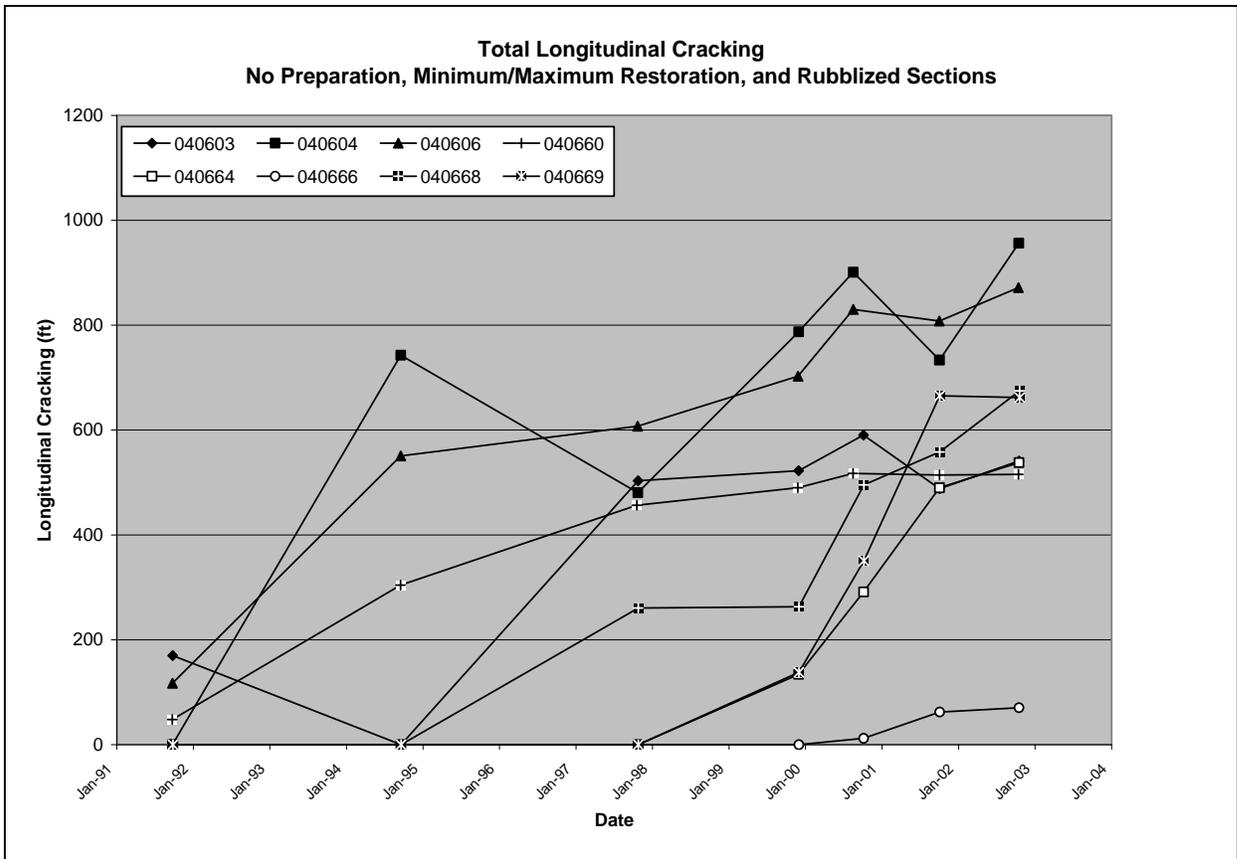
**Figure 41. Longitudinal Cracking Trends of the No Preparation, Minimum/Maximum Restoration, and Rubblized Test Sections.**

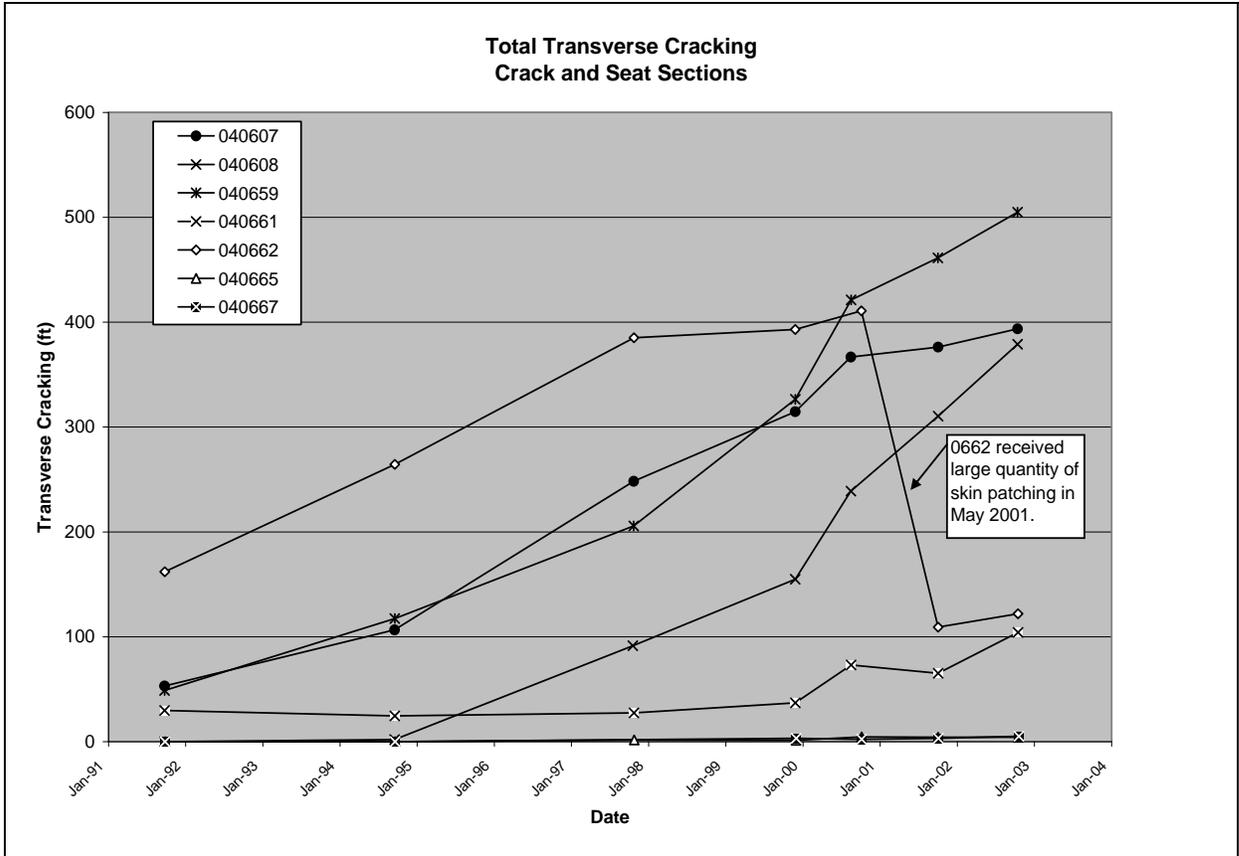
The overall transverse cracking trends are plotted in Figure 42 (crack and seat test sections) and Figure 43 (no preparation, minimum/maximum restoration, and rubblized test sections). The performance trends are relatively consistent and within the expected range of variation. The drop of longitudinal distress for Sections 040603 and 040662 are indicative of large areas of skin patching, which masked the distress.

**Figure 42. Transverse Cracking Trends of the Crack and Seat Test Sections.**

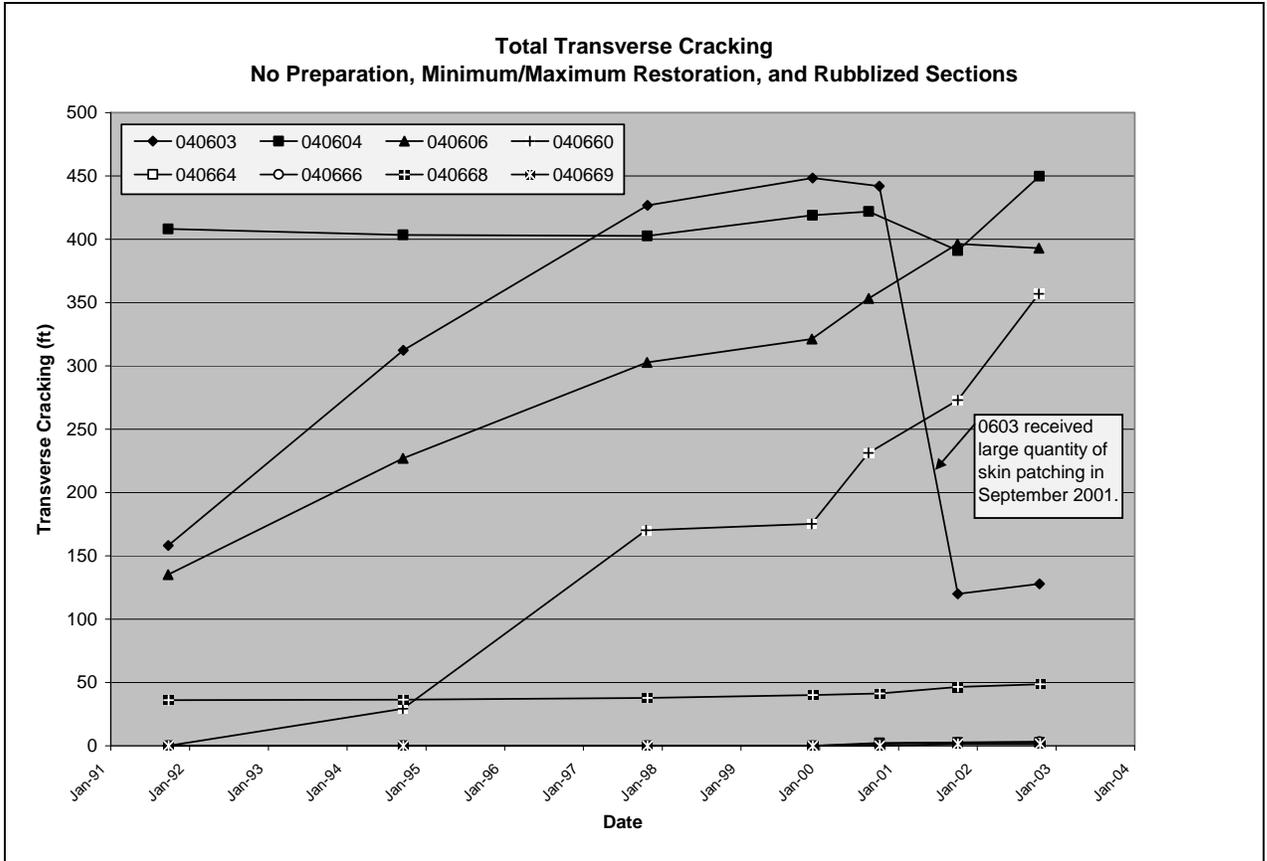
**Figure 43. Transverse Cracking Trends of the No Preparation, Minimum/Maximum Restoration, and Rubblized Test Sections.**

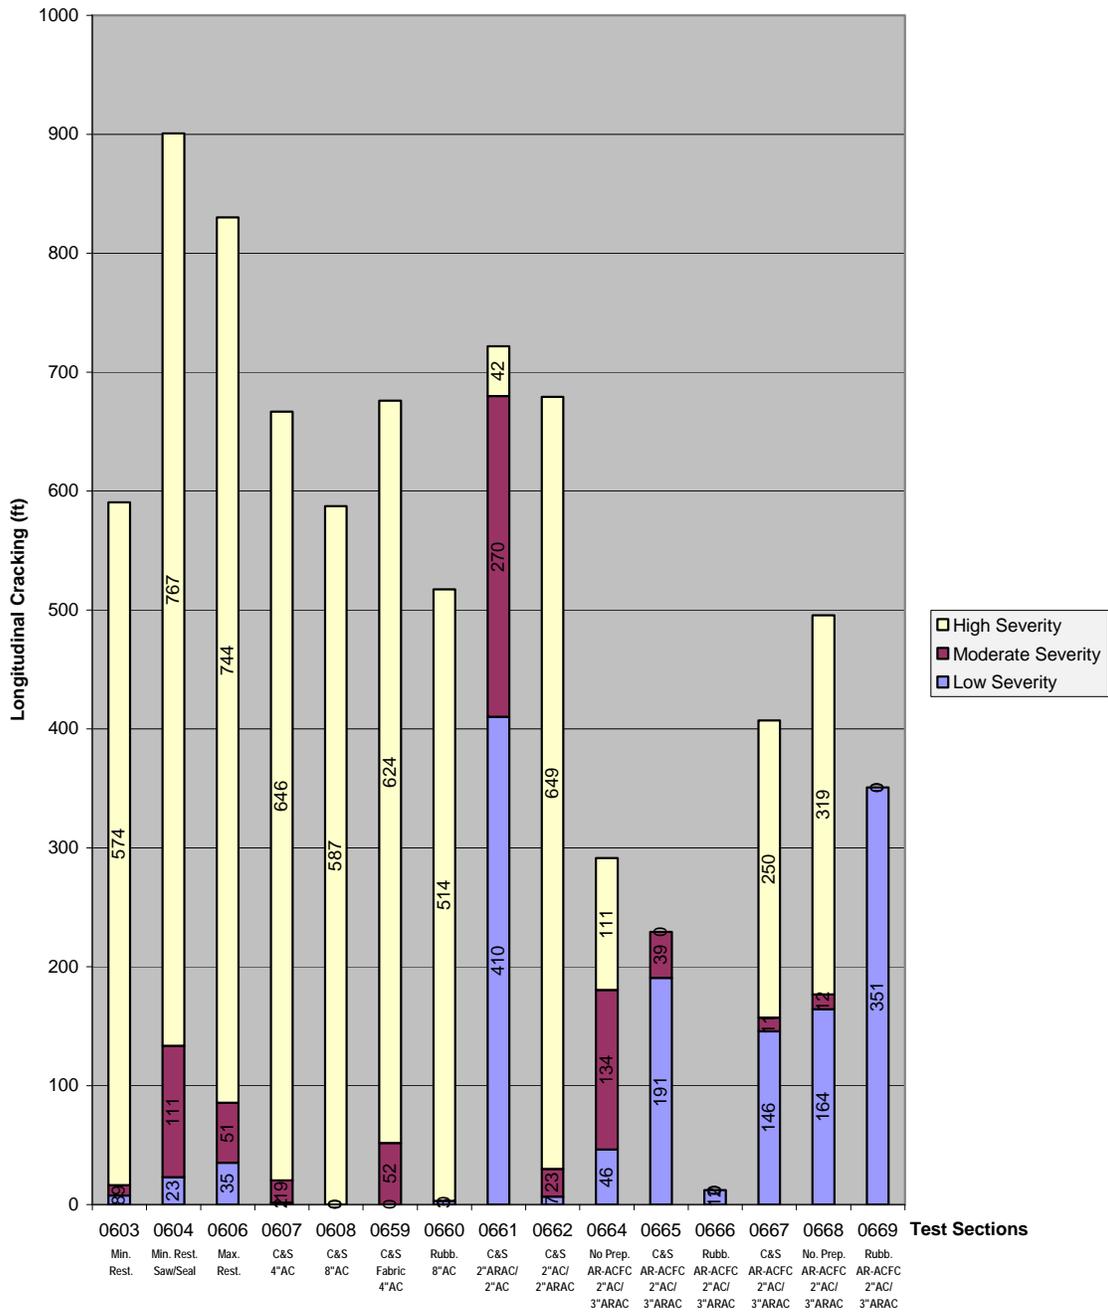
In-depth analyses and comparisons were conducted for all of the SPS-6 test sections that were rehabilitated with AC overlays. Figure 44 provides a summary of the longitudinal cracking for each section; Figure 45 provides a summary of transverse cracking. Data for both distress charts were collected in October 2000 to avoid confounding the data with large skin patching that was performed on Sections 040603 and 040662 in 2001.

Figure 44. Longitudinal Cracking Summary.

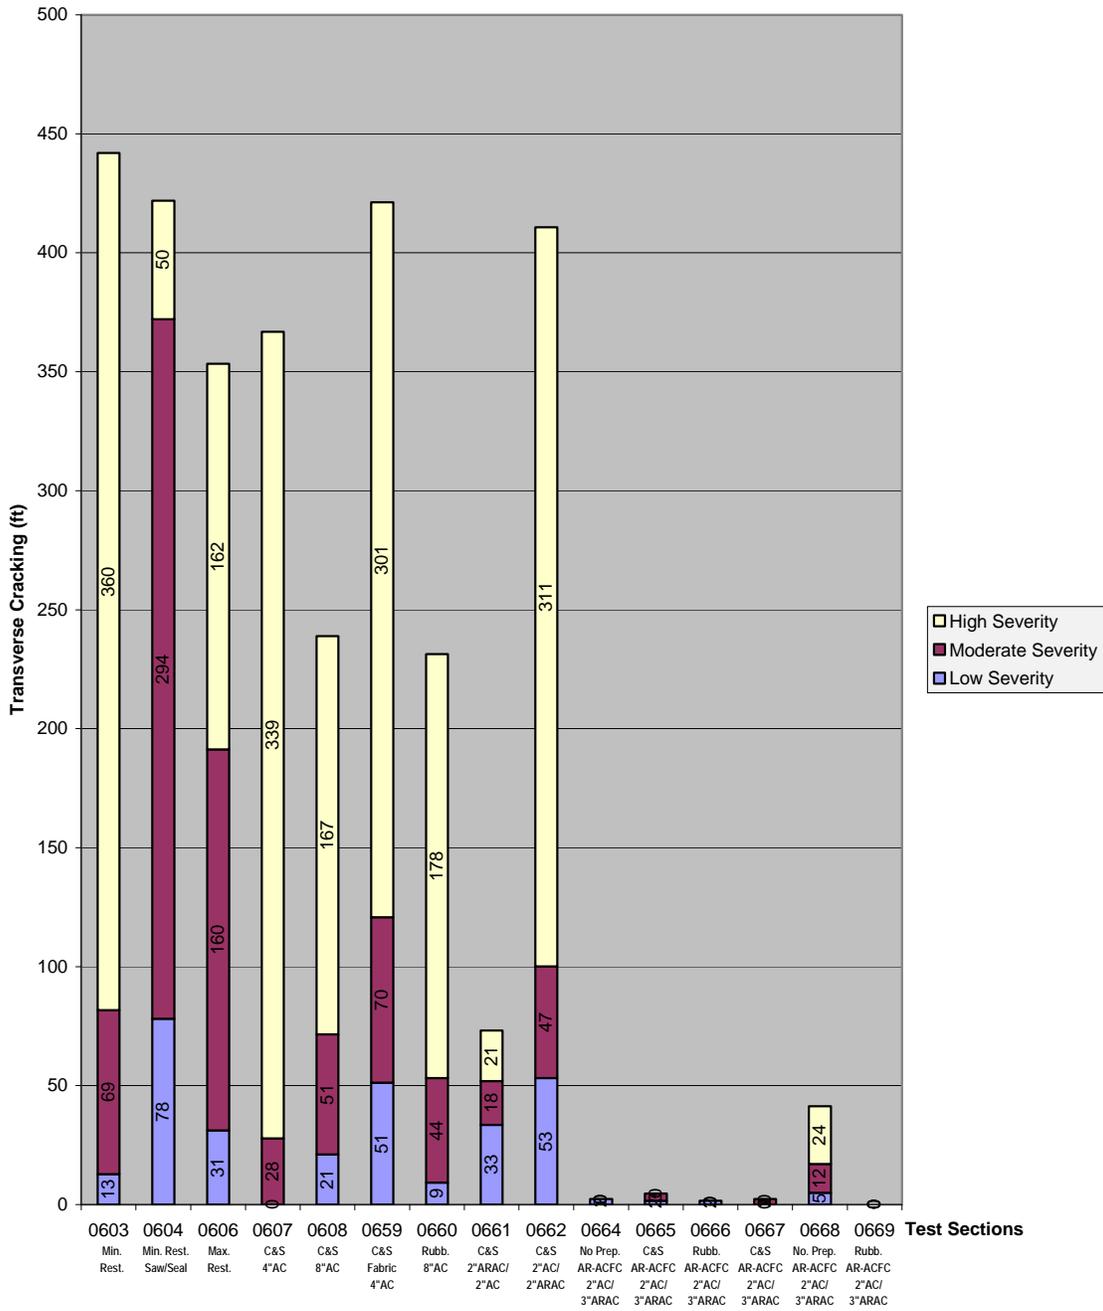
**Figure 45. Transverse Cracking Summary.**
