Arizona Department of Transportation Research Center

# **Performance Evaluation of Arizona's LTPP SPS-6 Project: Strategic Study of Rehabilitation Techniques**

**Final Report 396-6  
October 2013**

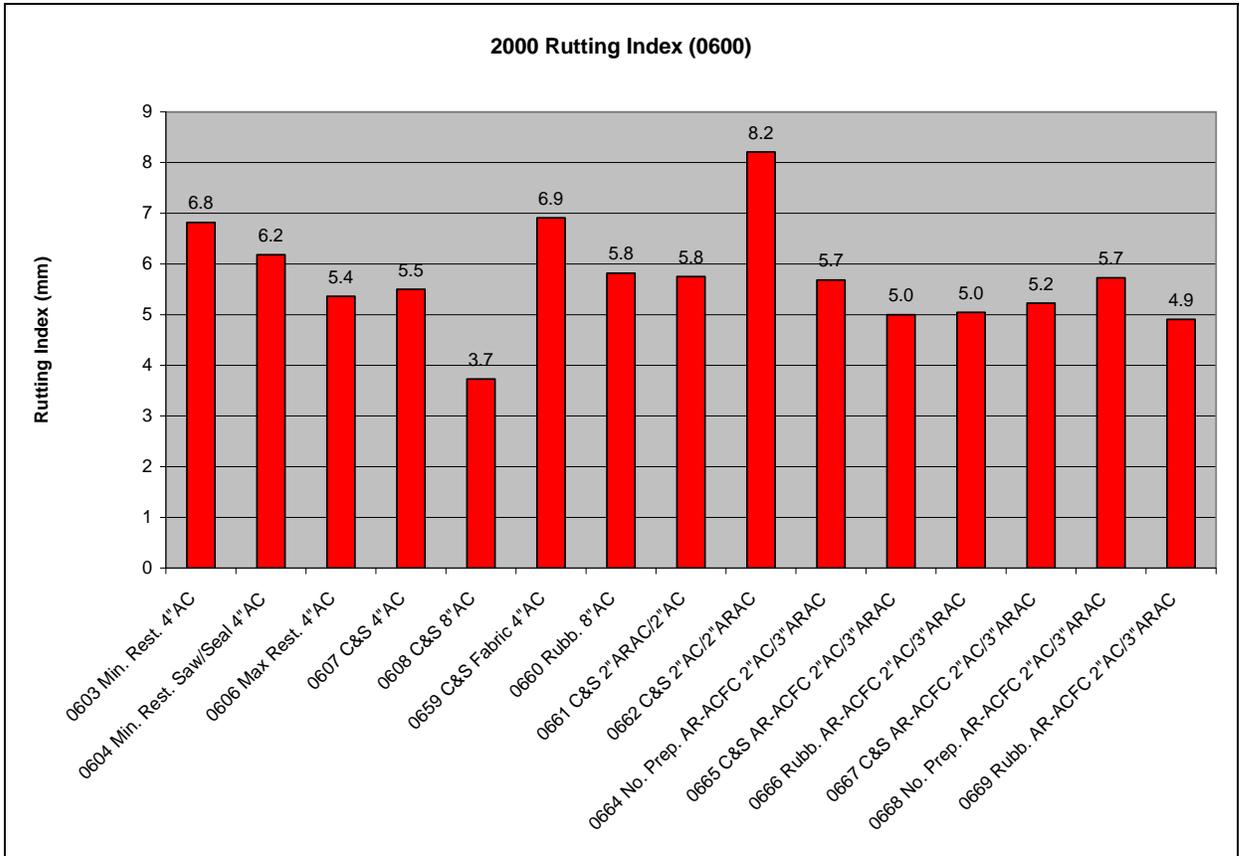
Figure 46 provides a summary of rutting for each section. Section 040608, which received a crack and seat treatment with an 8 inch overlay, experienced the least amount of rutting among all the test sections. However, all sections exhibited less than 9 mm of rutting after more than seven years in service, which is well below the level required to trigger improvements in most pavement management systems. Therefore, rutting was not the driving factor in the overall condition of the pavement.

**Figure 46. Rutting Index Summary.**

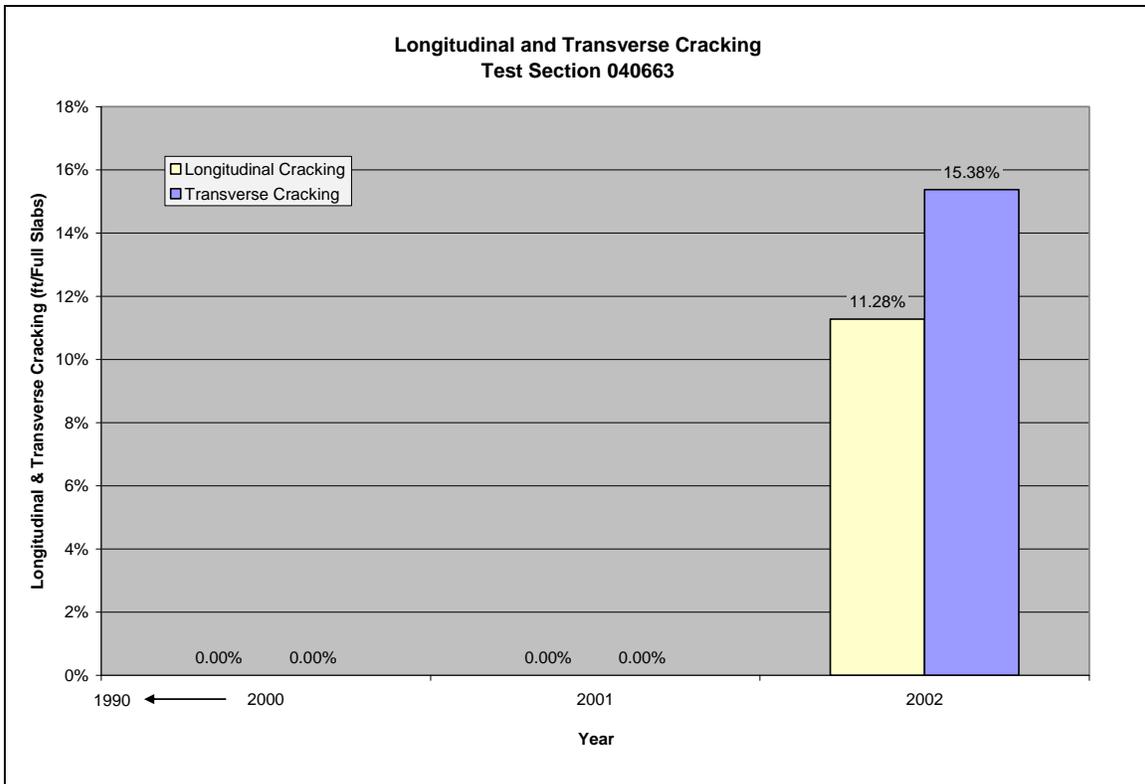
Researchers also conducted in-depth analyses and comparisons of the SPS-6 test sections with PCC surfaces. Due to early structural failure of Sections 040601, 040602, and 040605, longitudinal and transverse cracking charts were only generated for Section 040663 (Figure 47).

**Figure 47. Summary of Longitudinal and Transverse Cracking in Section 040663.**

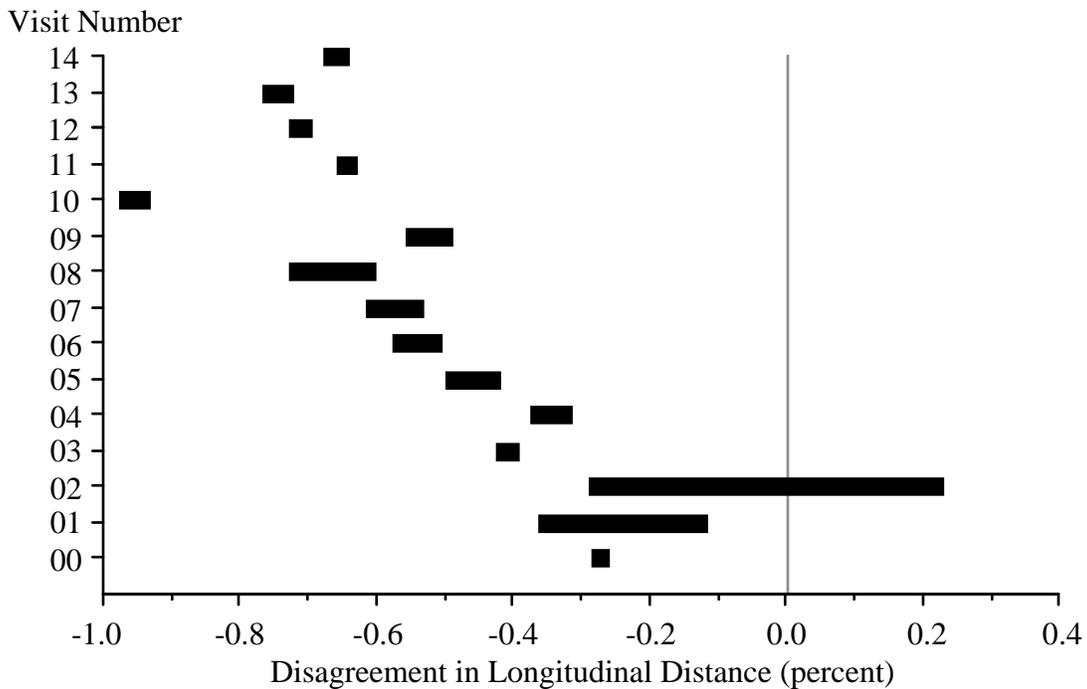
Figure 48 shows the disagreement in longitudinal distance measurement for each visit of the leading group of sections, using the event markers from repeat 1 of visit 02 as a reference. The leading group terminates at the end of Section 040601 for visits 00 through 04, and at the end of Section 040603 for the other visits. In the figure, a range of disagreement for each visit exists because up to nine repeat profile measurements were made. The variation between repeat

measurements from the same visit appears as the width of each bar in the figure. Since the longitudinal distance measurement was based on the rotation of a drive wheel, the variations were most likely caused by variations in speed, lateral wander, and tire inflation pressure (Karamihas et al. 1999). If tire inflation pressure were the dominant cause, the disagreement would grow more negative (or less positive) with each successive repeat measurement as the tire heated up because the tire rolling radius would increase; the profiler would register less wheel rotation for the same travel distance. This appeared to be the case for visits 08 through 13. However, the effect was weak, which indicates that the tires were warmed up to some extent before the measurements began. Only visit 02 exhibited a level of disagreement between repeat measurements that may interfere with the analyses described in this report.

The variation between visits in Figure 48 is caused by differences in distance measurement instrument calibration. The longitudinal distance measured by a profiler is not true horizontal distance. It always includes some additional component because the profiler must travel up and down the undulations in the road. This component can be minimized by calibrating the profiler to true horizontal distance. However, if a profiler operates on a road with grade changes and

**Figure 48. Consistency in Longitudinal Distance in the Leading Sections.**

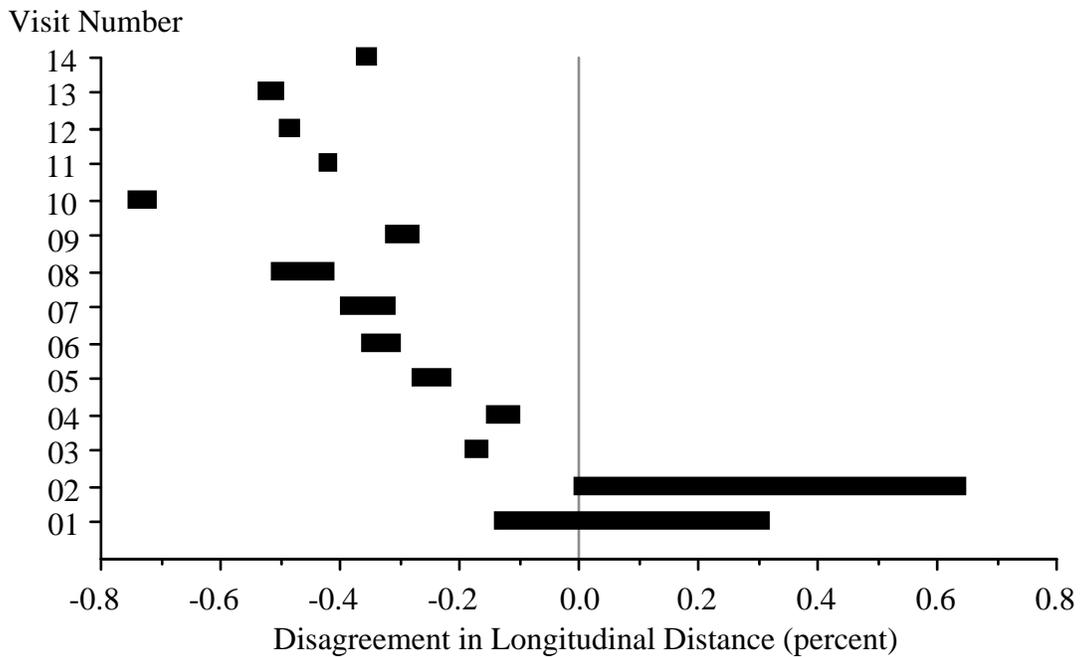
Figure 49 shows the disagreement in longitudinal distance measurement for the trailing group of sections (040664 through 040669). Overall, the disagreement is similar to that observed for the leading group with the exception that earlier visits were less repeatable.

**Figure 49. Consistency in Longitudinal Distance in the Trailing Sections.**

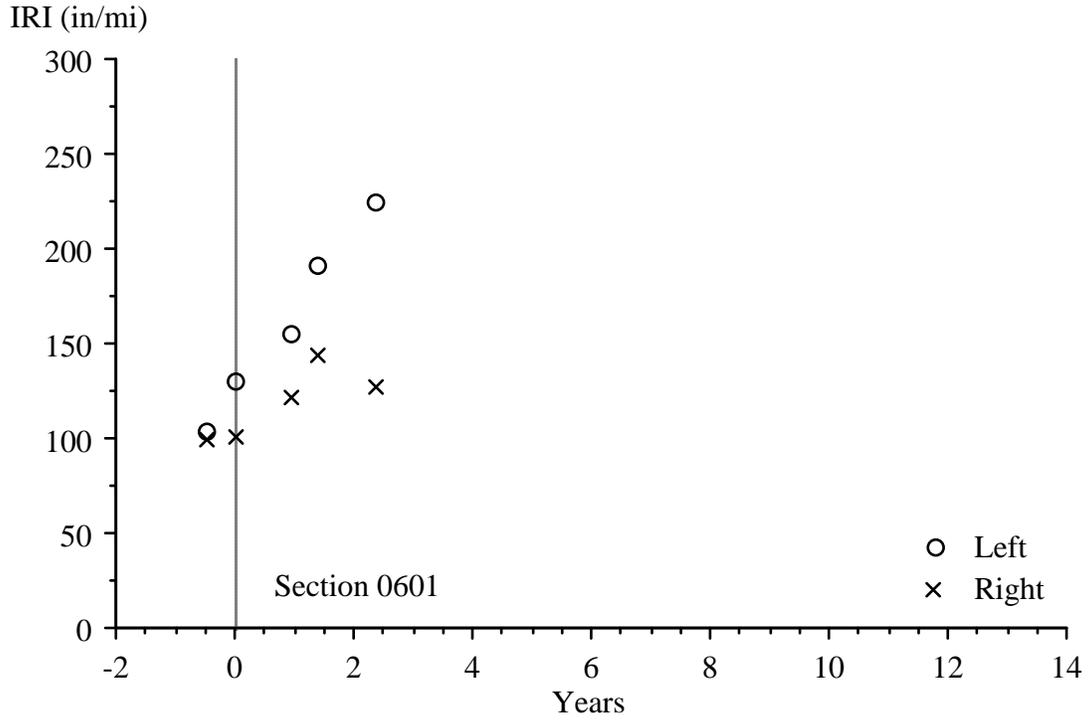
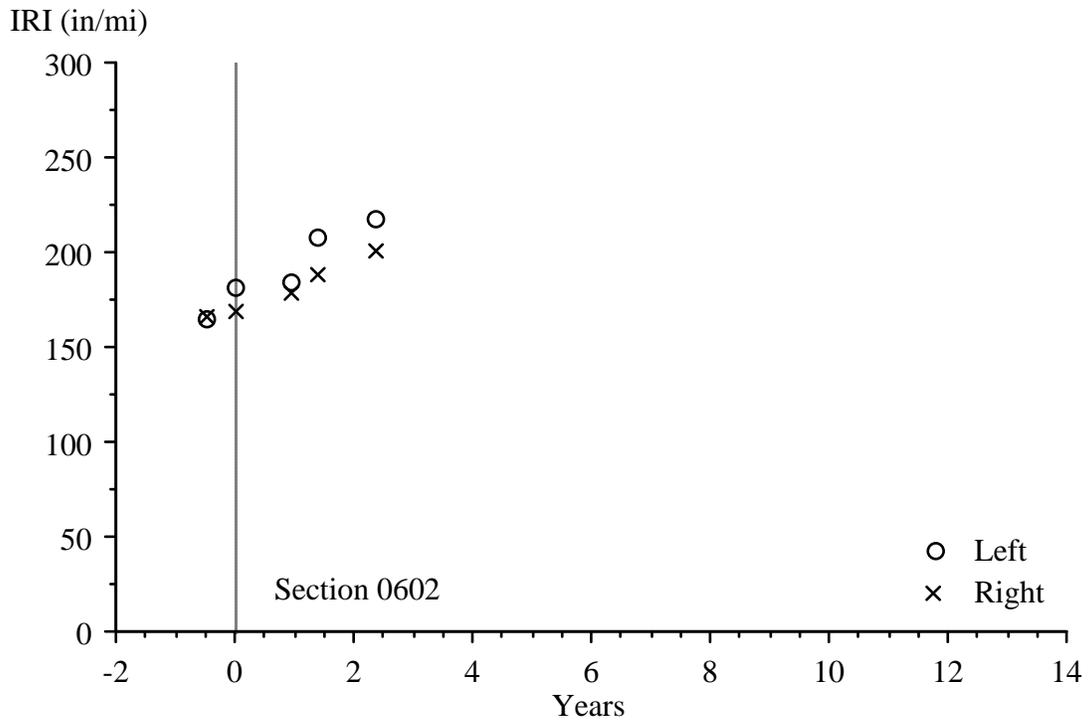
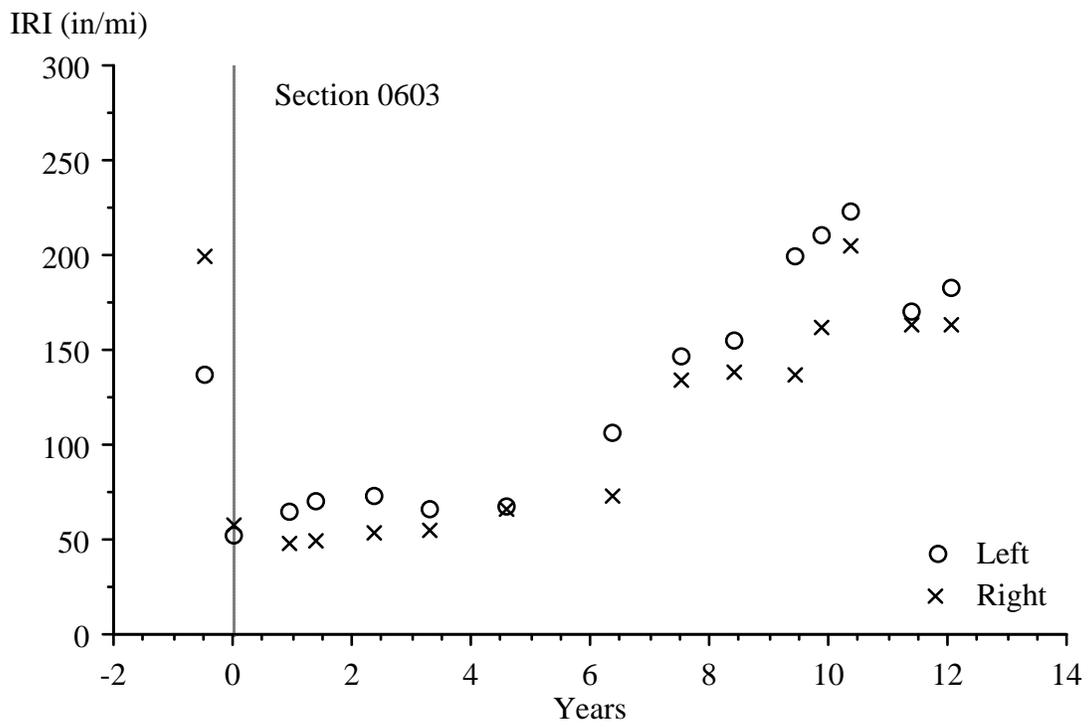
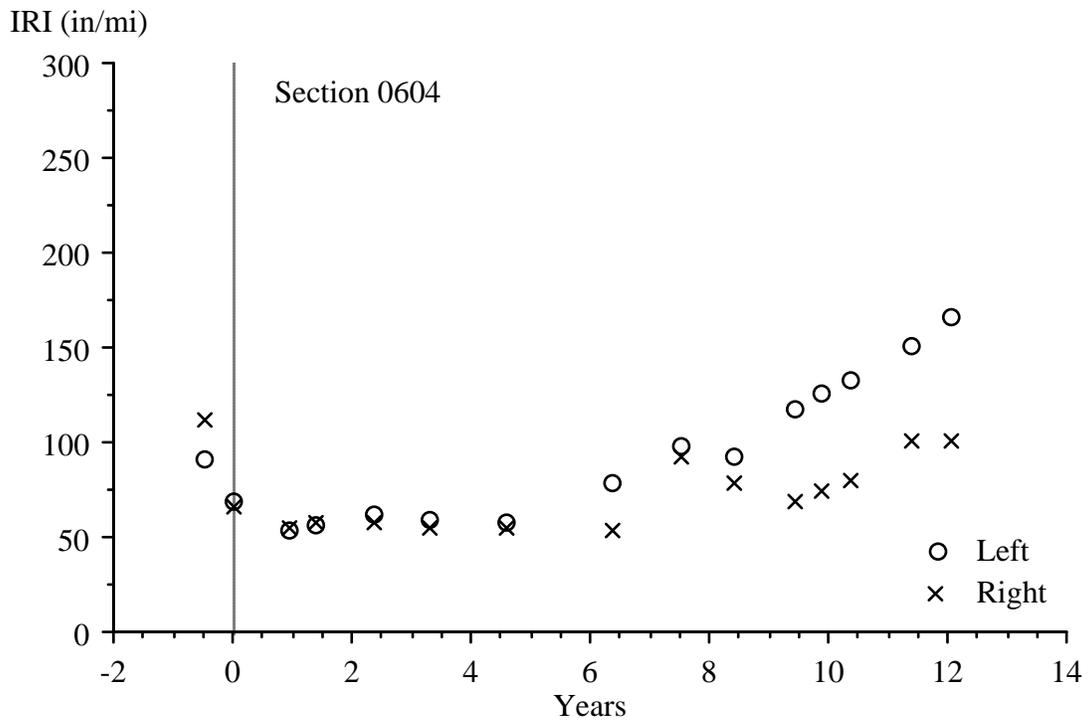
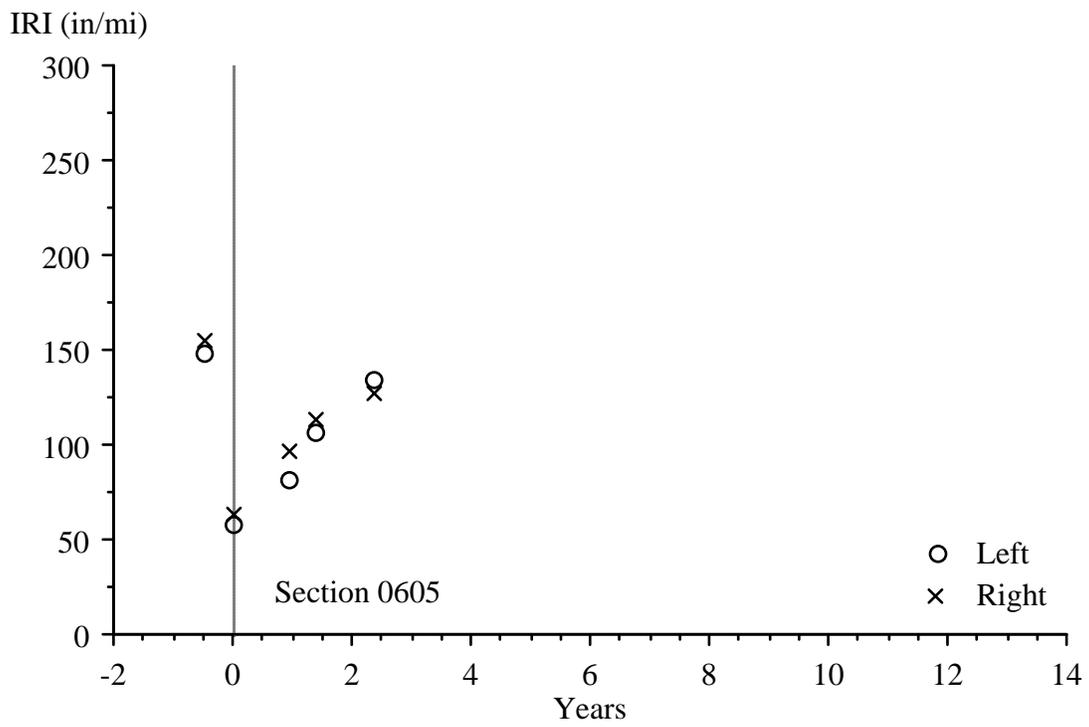
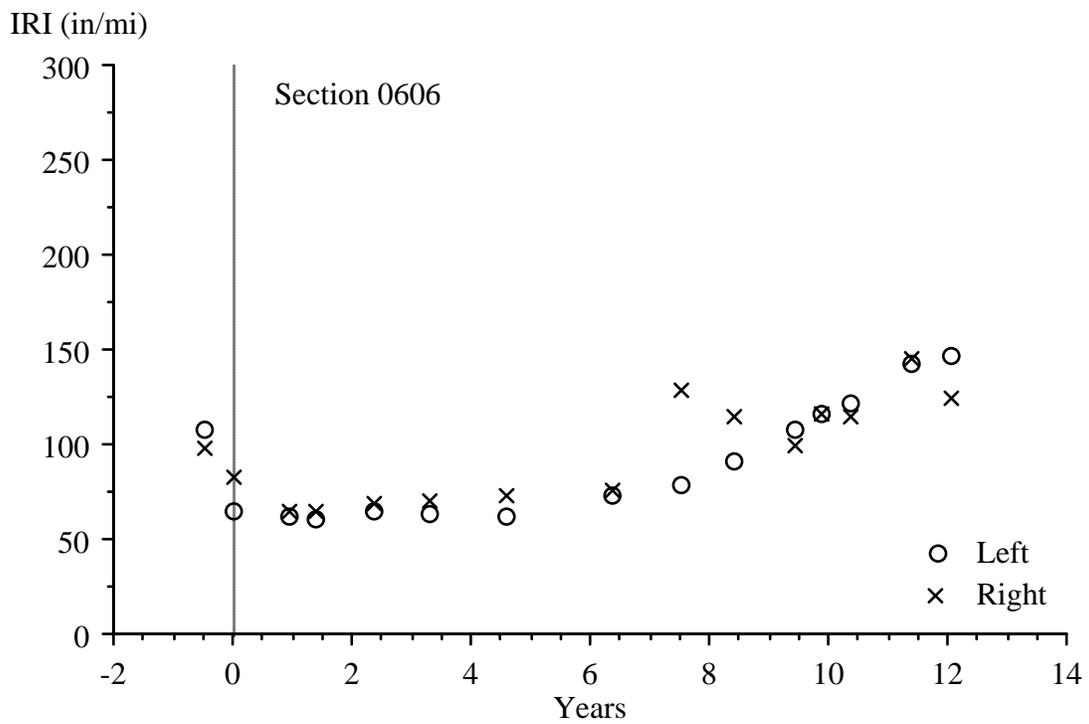
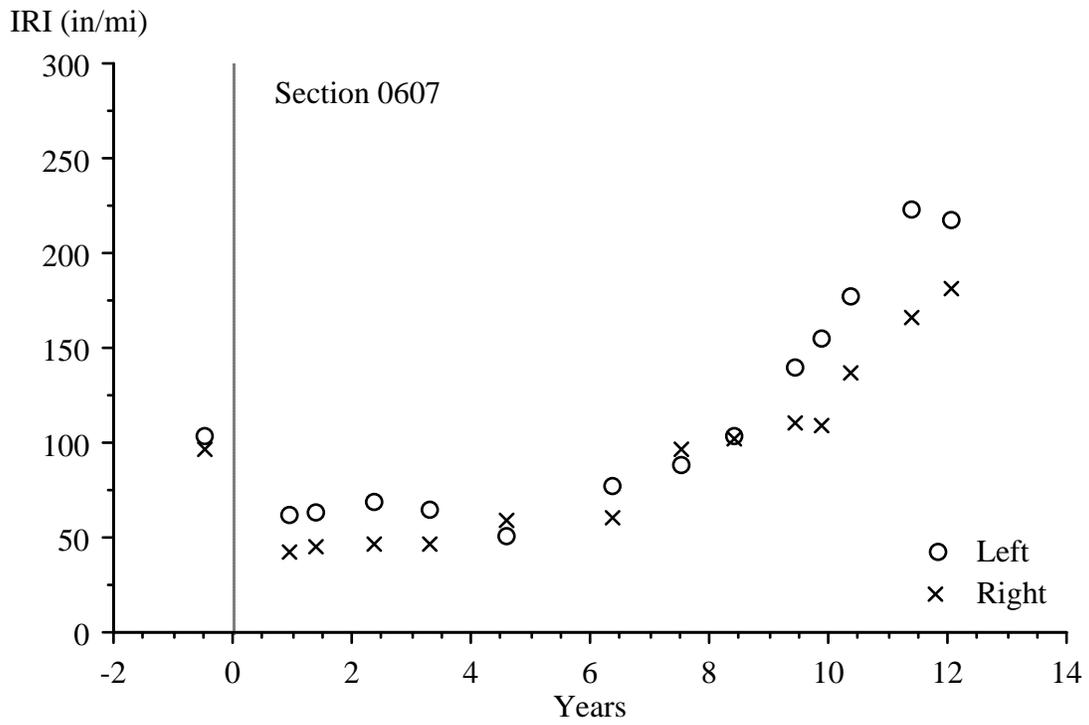
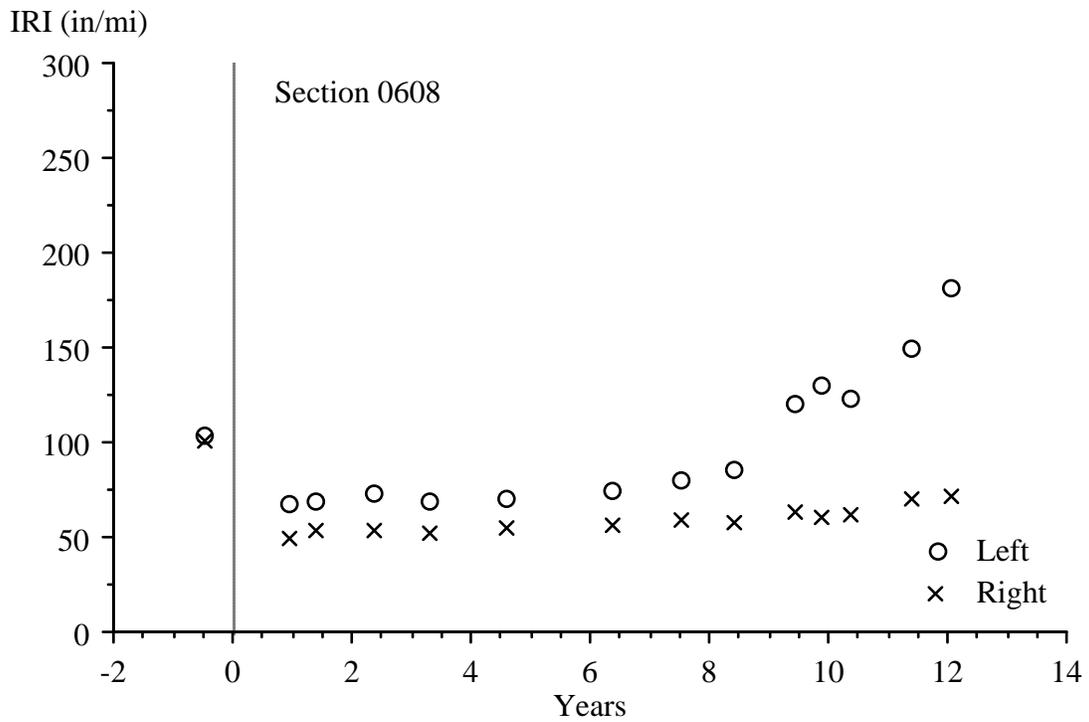
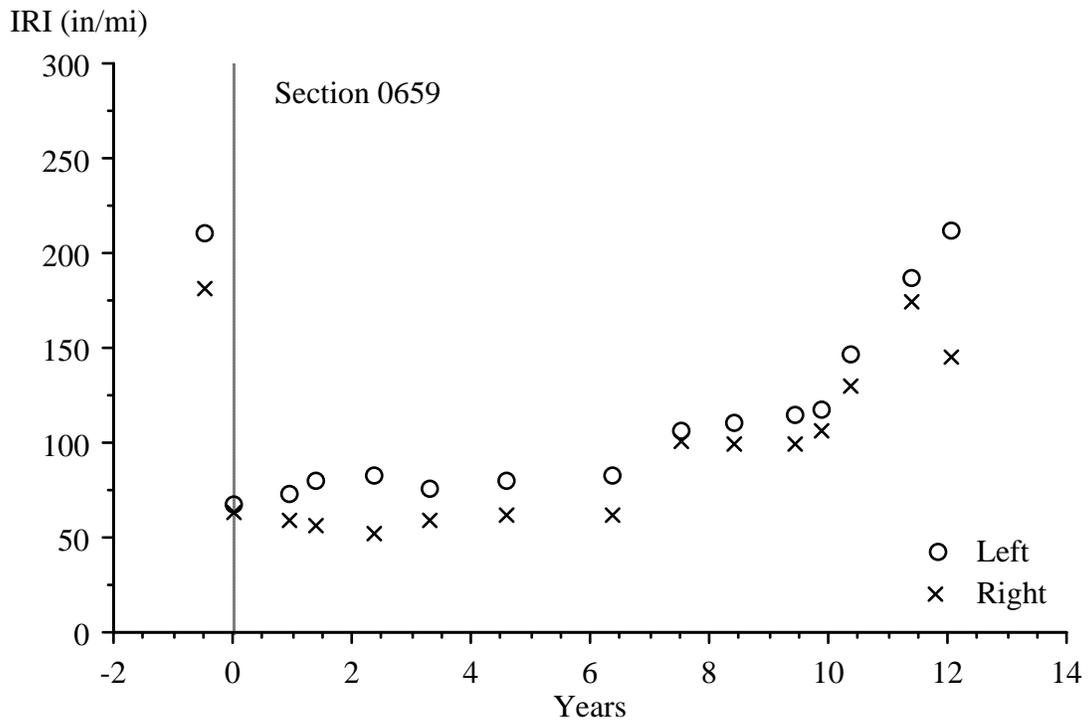
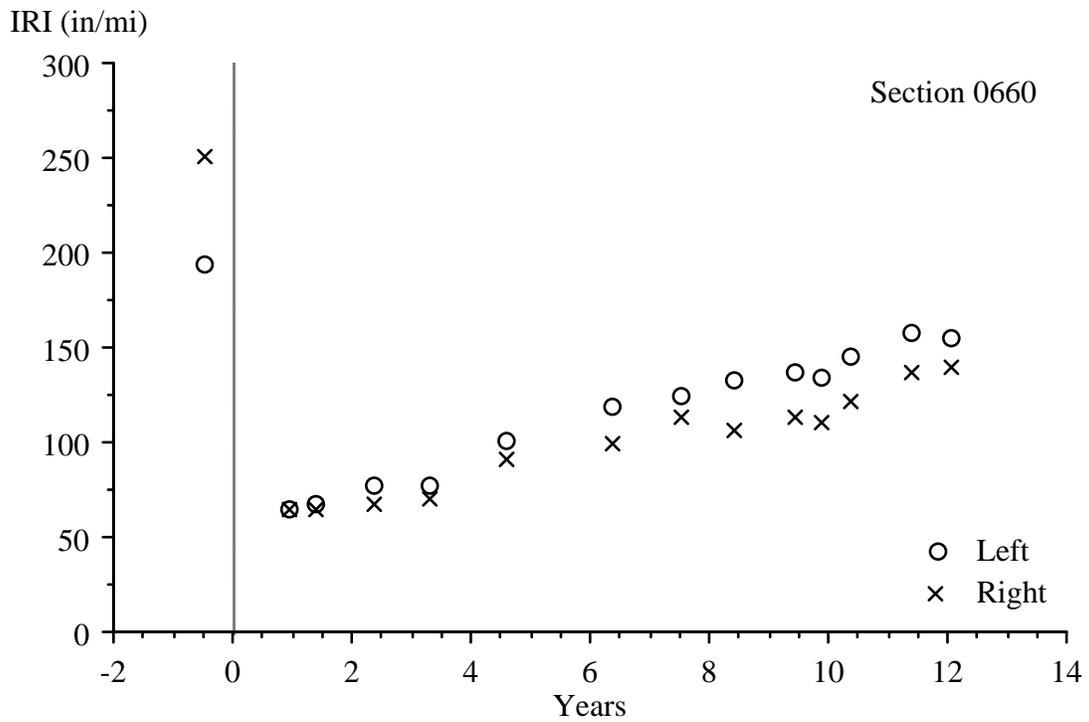
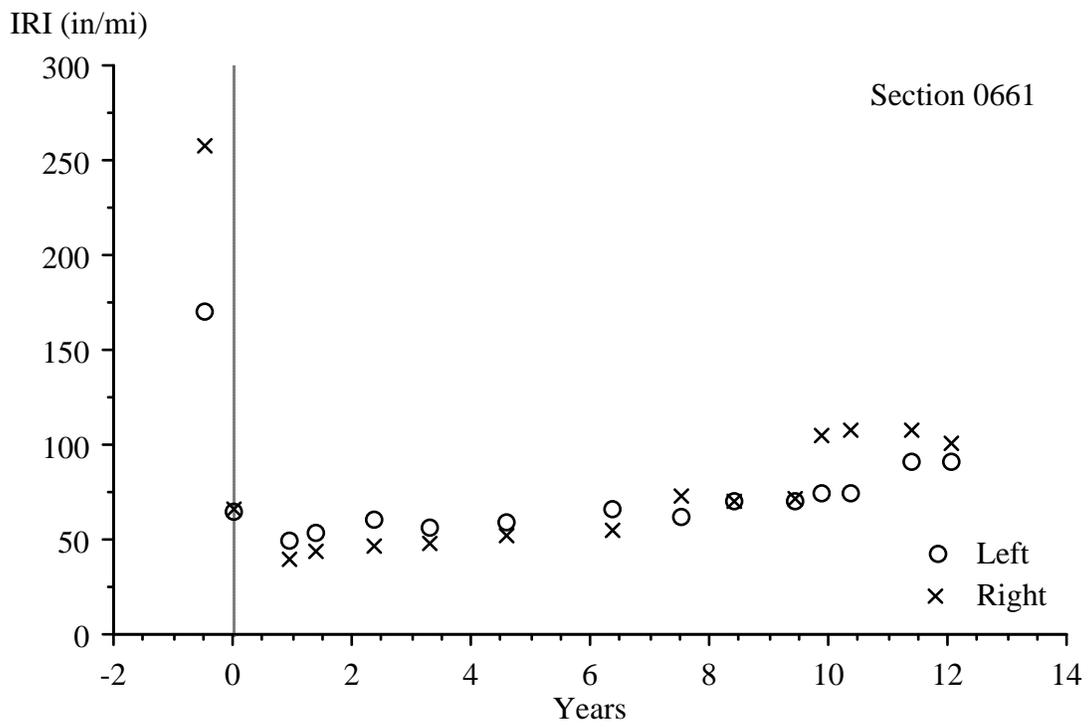
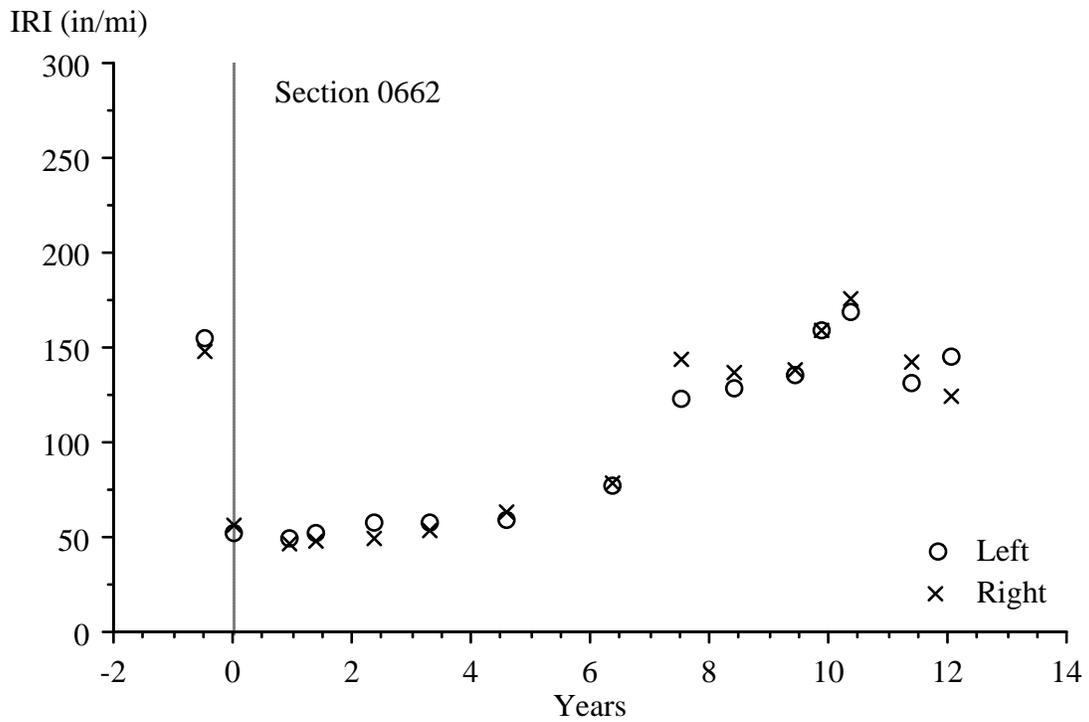
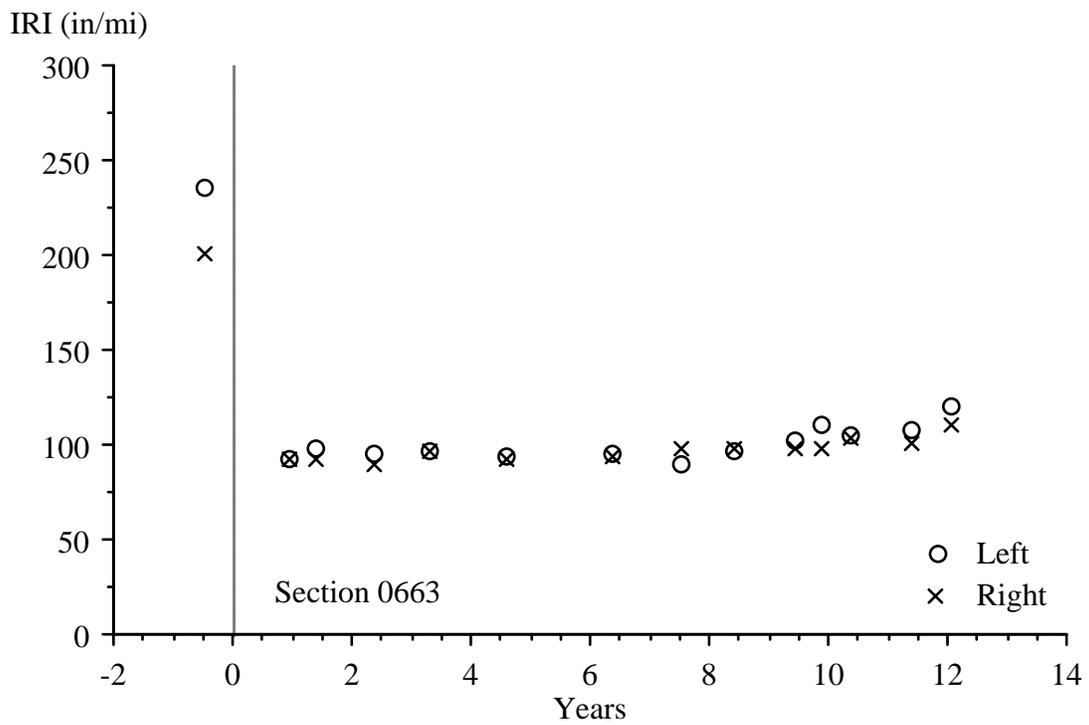
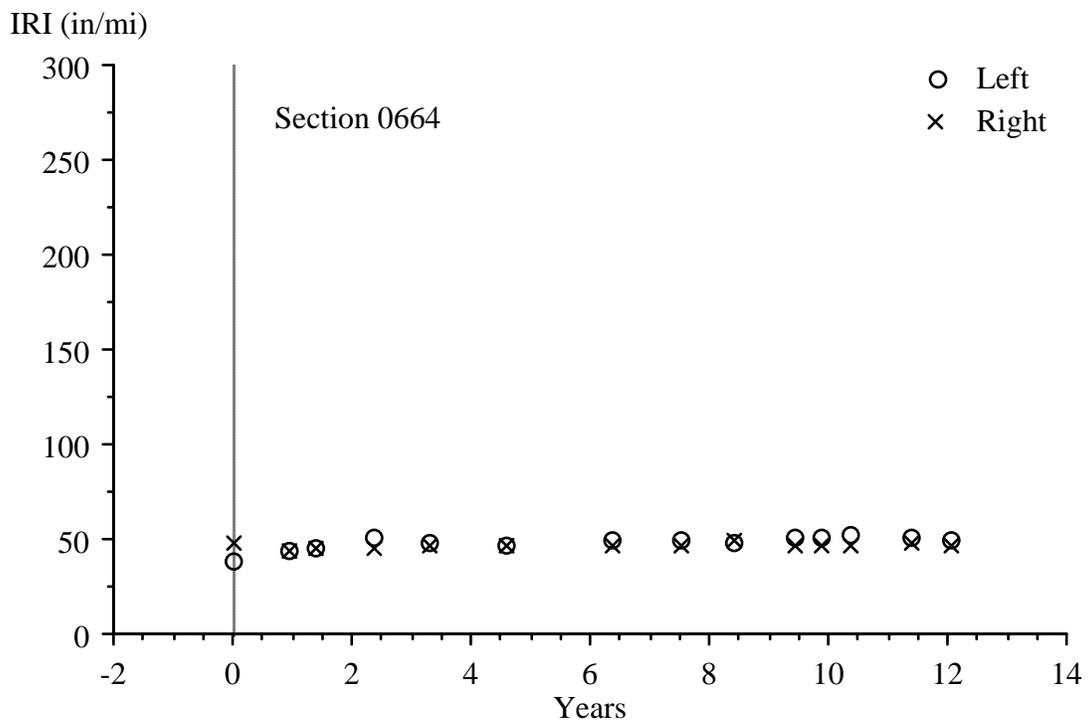
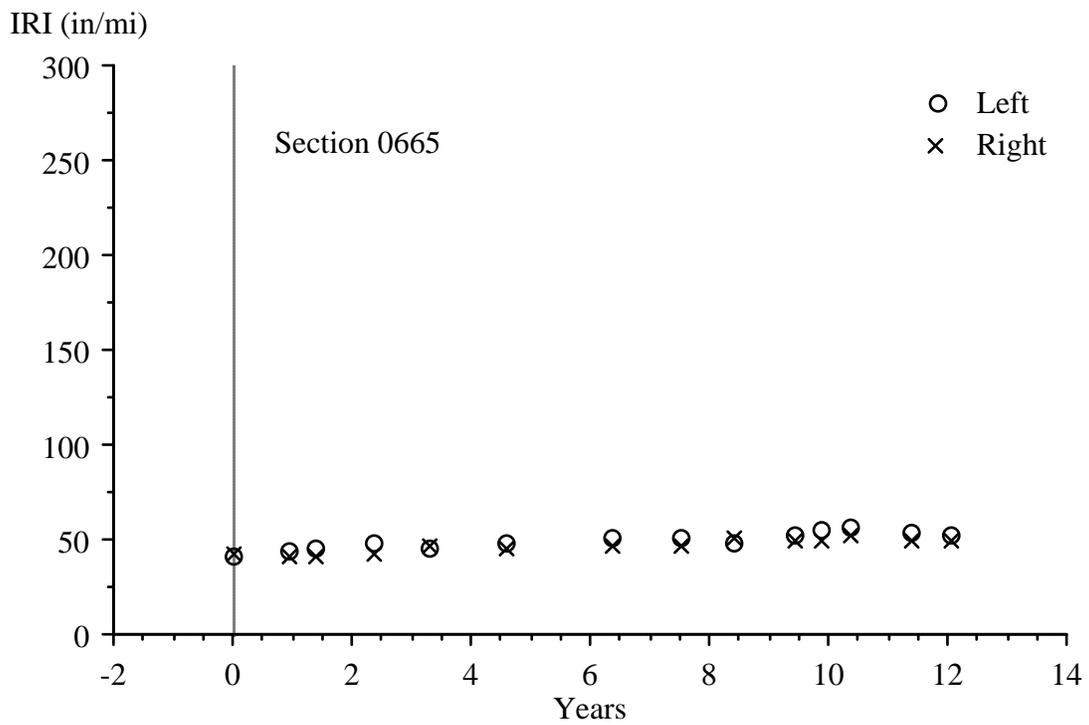
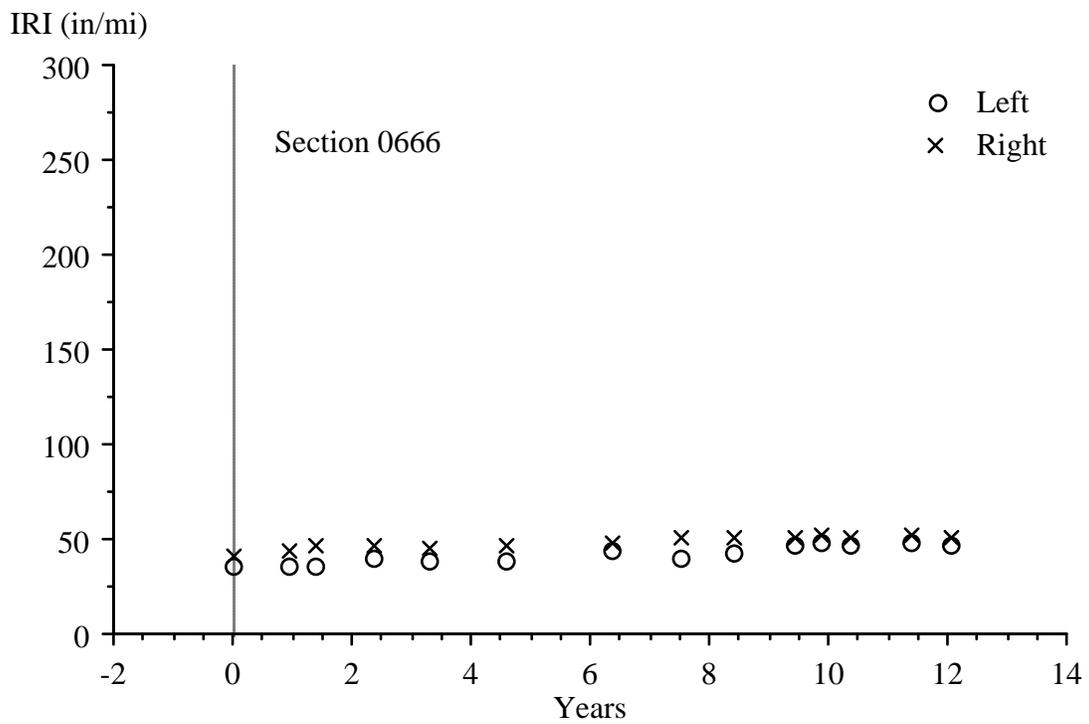
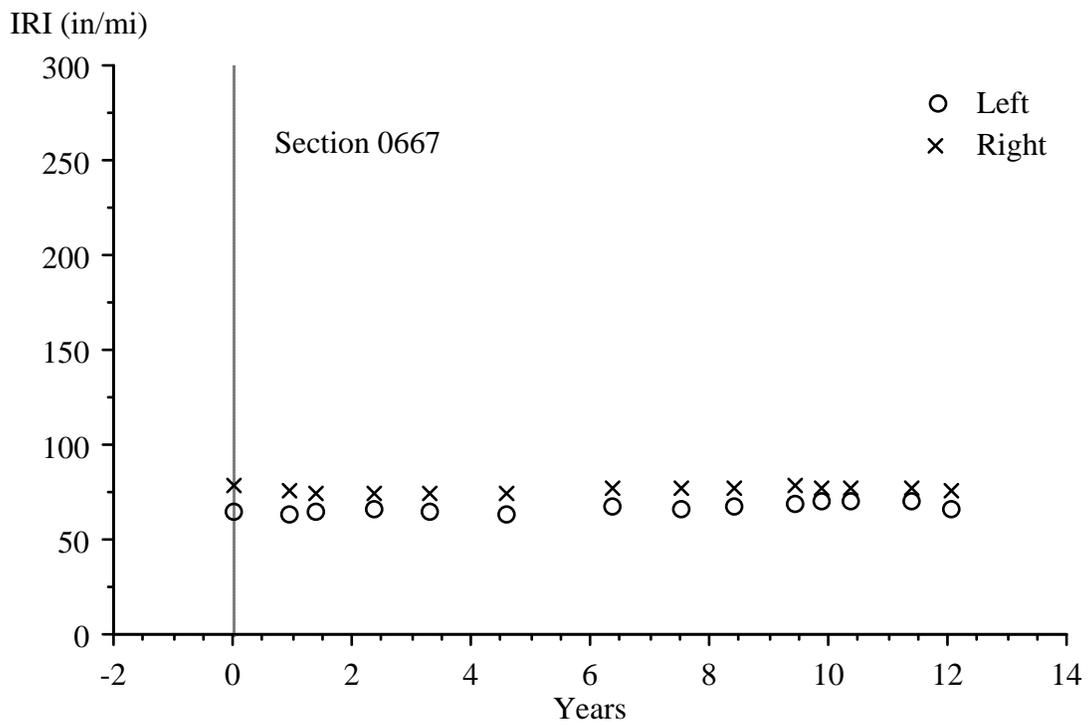
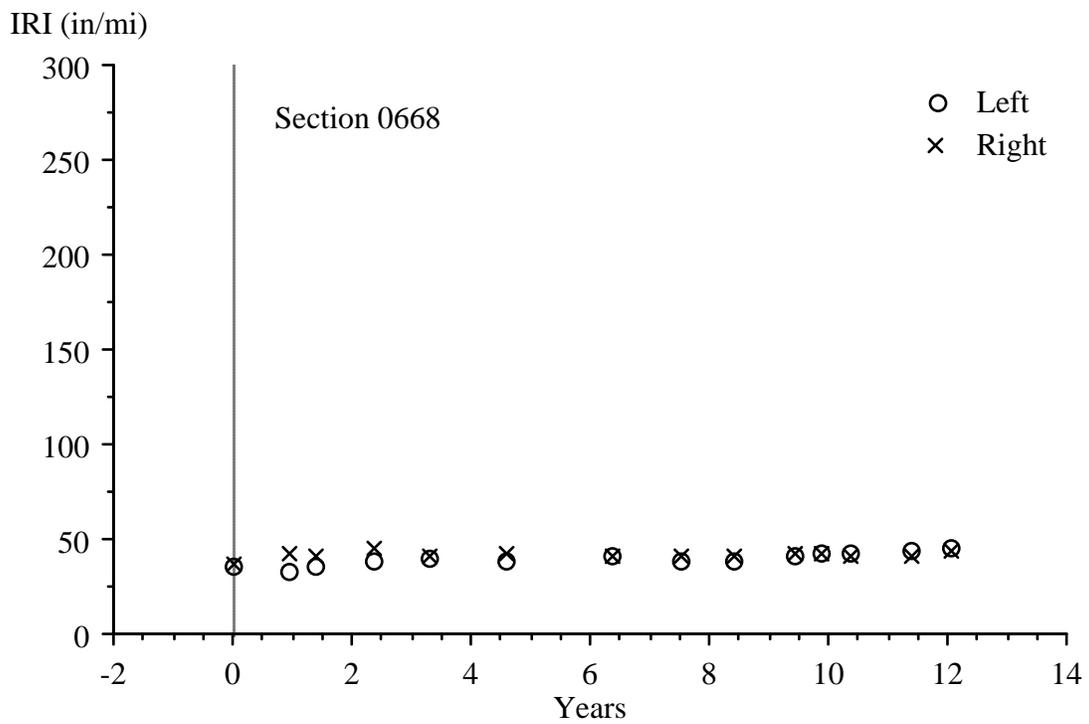
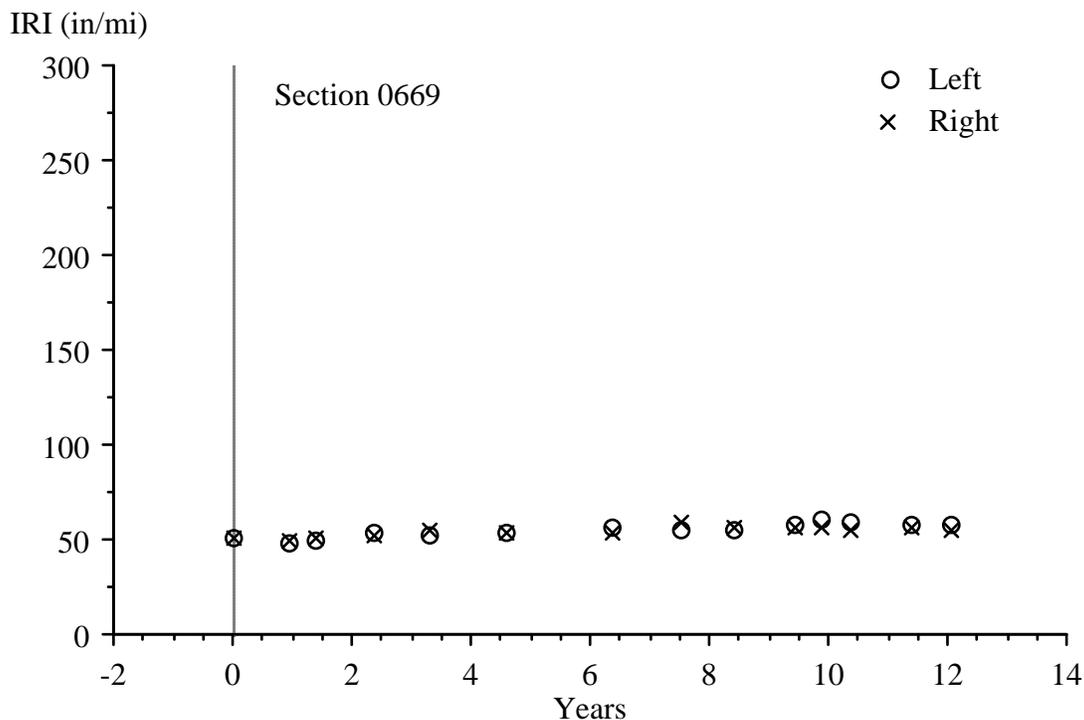
Figures 50 through 68 show the left and right IRI values for each pavement section over its monitoring period. For most of the sections, this includes at least 28 summary IRI values: two per visit over 14 visits (Table 14). The figures show the IRI values versus time in years. In this case, “years” refers to the number of years between the measurement date and the date that the site was opened to traffic after rehabilitation (October 6, 1990). Fractions of a year are estimated to the nearest day.

Figures 50 through 68 provide a snapshot of the roughness history of each pavement section. The remainder of this report is devoted to characterizing the profile content that made up the roughness and explaining the profile features that contributed to roughness progression.

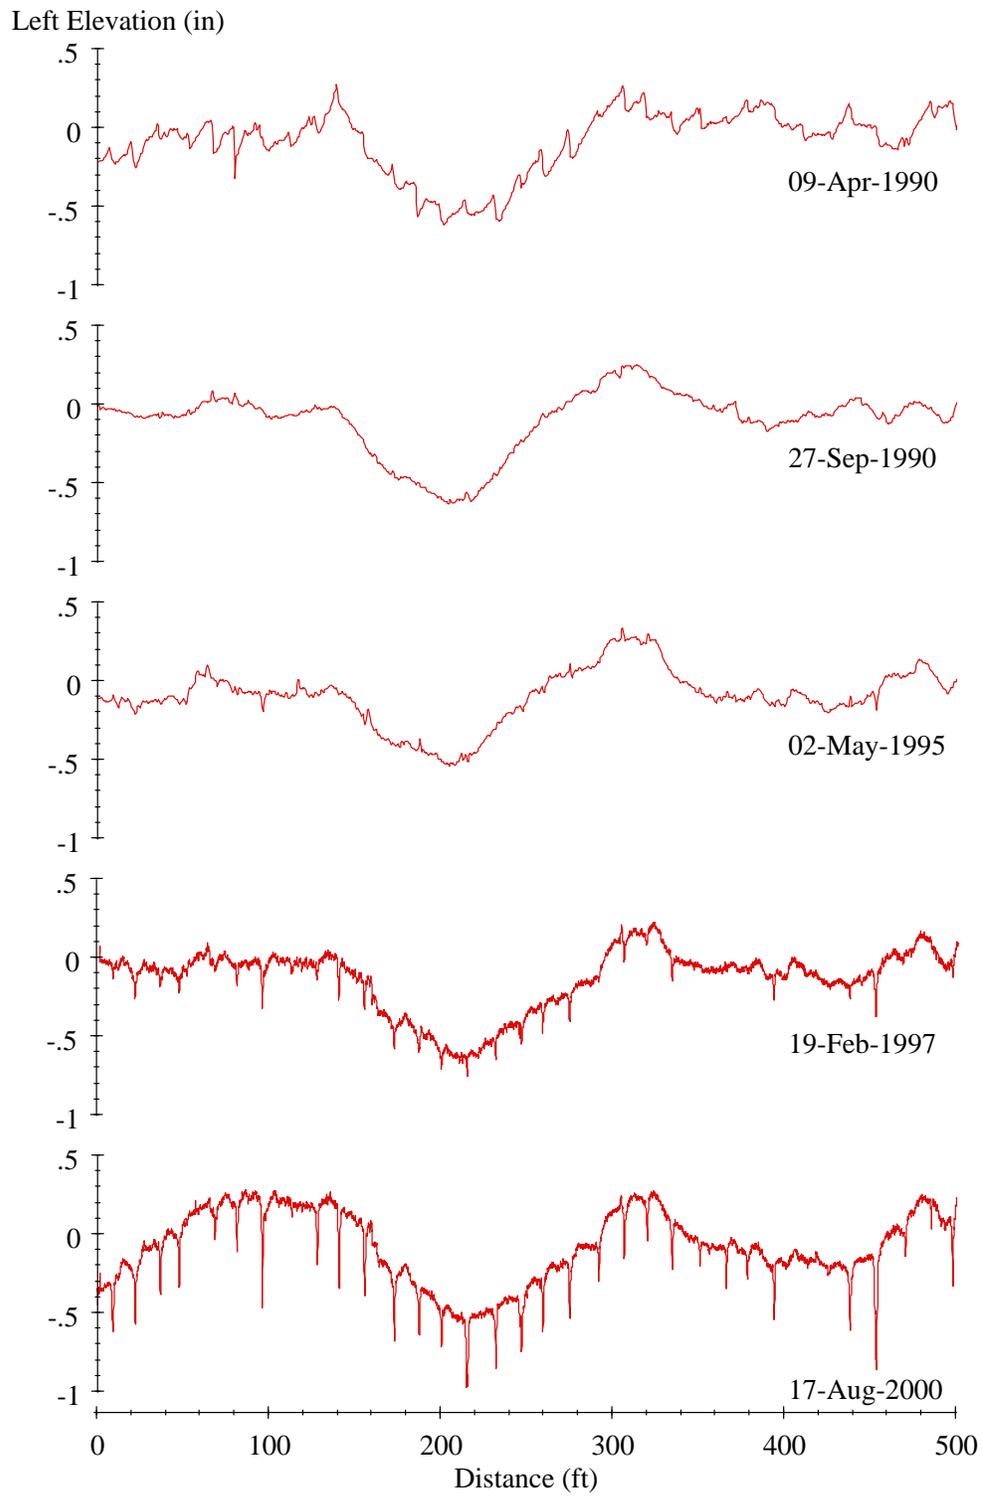
A simple way to learn about the type of roughness that exists within a profile is to view the trace. For example, Figure 69 shows the raw profile trace for five visits of Section 040603 throughout its monitoring history. The plot shows that the long wavelength content, or the trend, in each plot is quite consistent with time. Of particular interest is the consistency in long wavelength content between the profile measured in April 1990, which occurred before rehabilitation, and the profile measured in September 1990, which occurred after placement of a 4 inch AC overlay.

Figure 69 illustrates some features of the roughness and its progression on Section 040603. The profile measured before rehabilitation includes multiple disturbances in a saw-tooth shape. The downward steps at the trailing edge of each “tooth” are joint faults, and the saw-tooth shape is present as a result of the associated slab tilt.

Several short-duration disturbances such as bumps and dips appear in the profile measured in May 1995 that do not appear in the September 1990 profile. In the two subsequent visits shown, roughness progresses with time in the form of narrow dips. Transverse cracking and the associated surface deformation at the borders of the cracks caused most of the narrow dips and small bumps.

**Figure 69. Raw Profiles of Section 040603.**

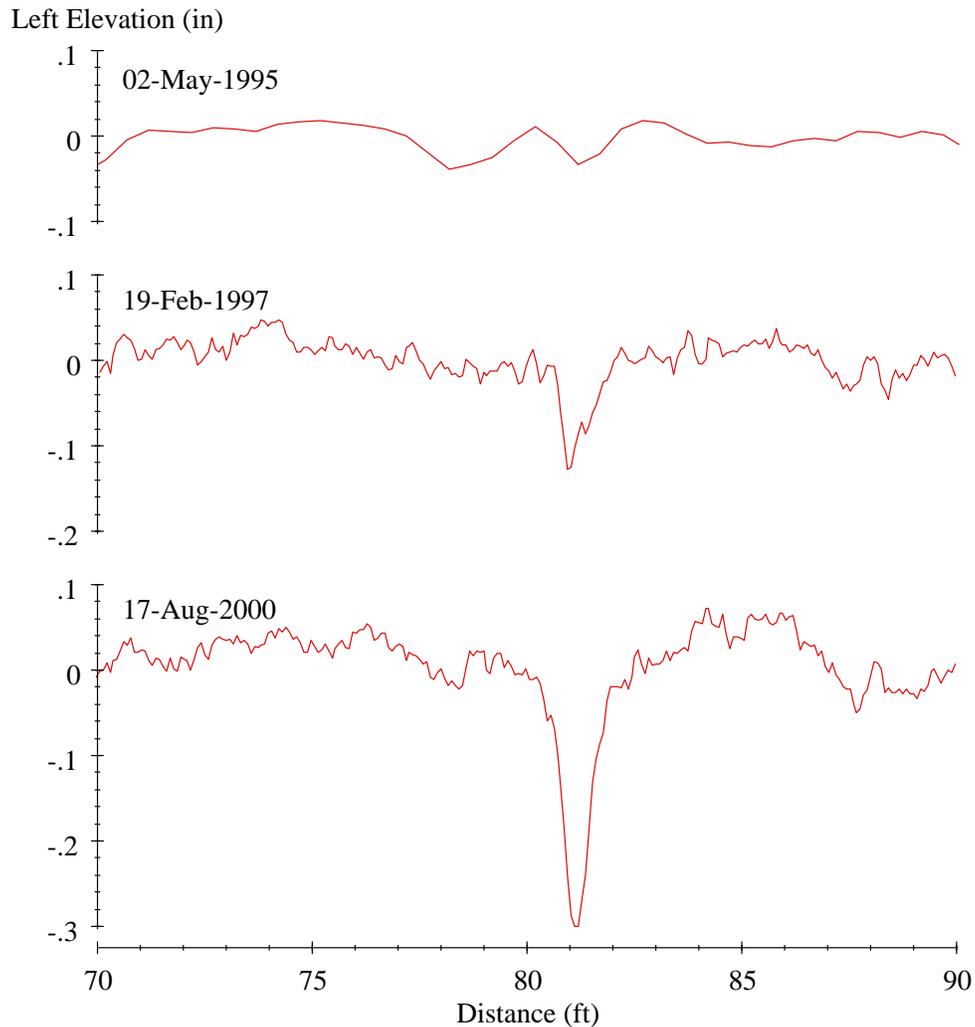
characterizing their shape and width. Figure 70 provides a closer look at one of the dips after a moving average anti-smoothing filter is applied using a base length of 10 ft. This high-pass filter removes much of the roughness in the profile associated with changes in elevation over distances longer than 10 ft (including the long trends visible in Figure 69) and leaves most of the very short duration changes in elevation intact.

**Figure 70. High-Pass Filtered Profiles of Section 040603.**

Figure 70 shows a clear progression in the depth of the dip—from a small ripple in May 1995 to a deep, narrow dip in August 2000. An important feature of the dip is its width. The dip is about 1 ft wide, which is much wider than the crack that caused it. This dip is likely to degrade ride quality and penalize the IRI value much more than a narrower dip with the same depth.
