Arizona Department of Transportation Research Center

# **Performance Evaluation of Arizona's LTPP SPS-6 Project: Strategic Study of Rehabilitation Techniques**

**Final Report 396-6  
October 2013**

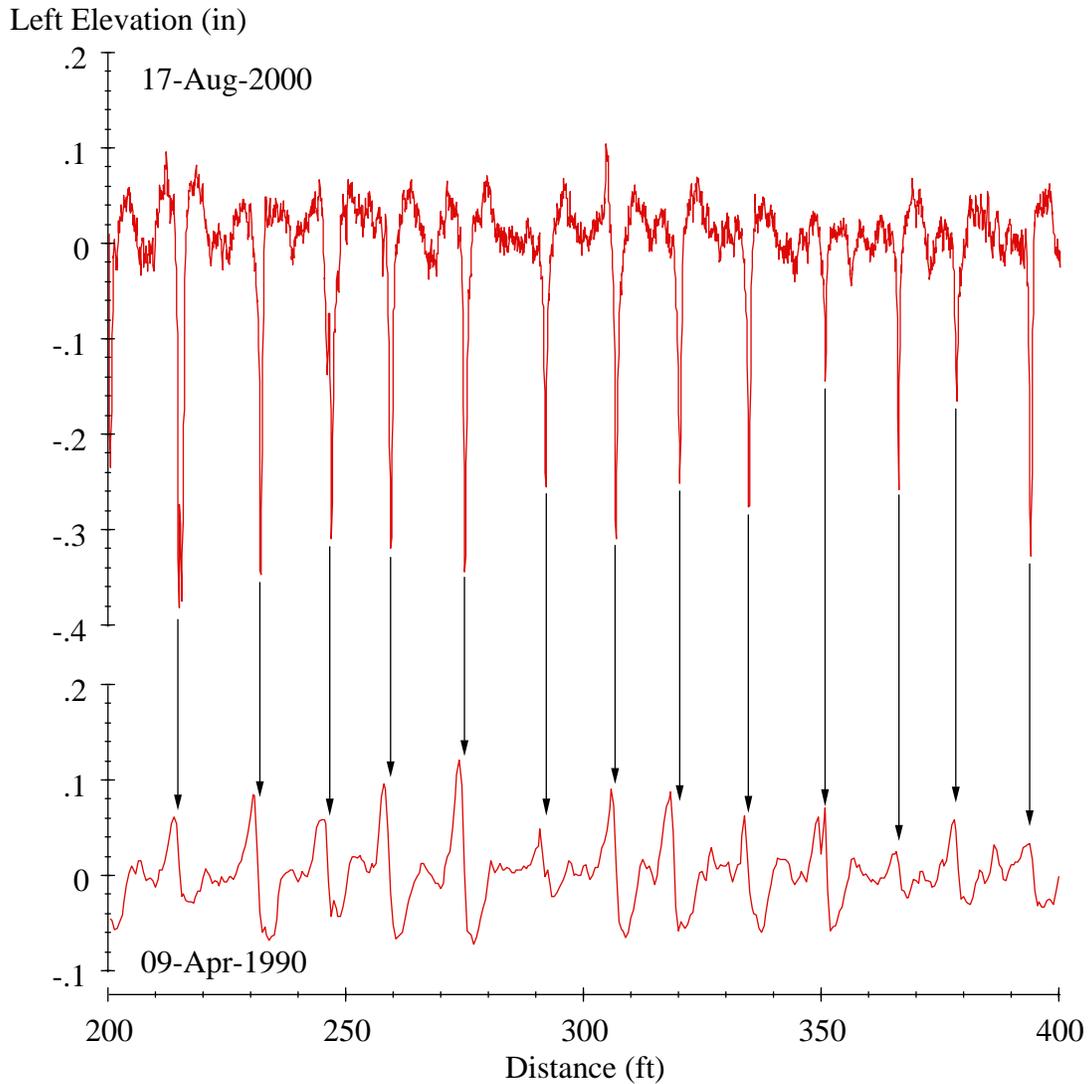
Profiles of Section 040603 late in the monitoring history (starting in August 2000) included narrow dips throughout the entire section and in the same locations where joint faults appeared in the prerehabilitation profiles. Figure 71 illustrates the close relationship. The figure shows segments from both profiles after application of a moving average anti-smoothing filter with a base length of 10 ft. In the faulted profile of April 1990, the filter distorts the faults, and they appear as abrupt downward changes in elevation that follow each upward spike. However, the filter makes the faults easier to see.

Figure 71 shows that the narrow dips in Section 040603 appear in the same pattern and in the same locations as the faults on the left side of the lane, which occurred in a pattern that approximated the original joint spacing of 15-13-15-17 ft. On the right side (not shown), the same pattern of faults before rehabilitation and narrow dips caused by transverse cracks late in the monitoring history is also present. However, the pattern is shifted about 1 ft downstream because of the skewed saw cuts. The synchronization process itself did not guarantee this alignment. Profiles collected before rehabilitation were only aligned to those afterward using data within Section 040601 and extrapolation over the rest of the site.

**Figure 71. Joint and Crack Locations on Section 040603.**

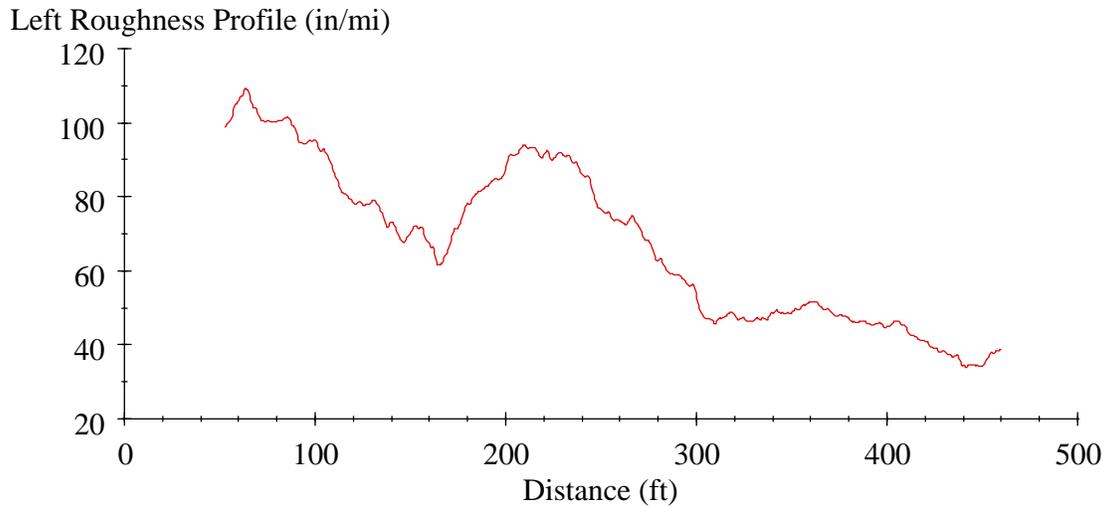
Figure 72 is a roughness profile of Section 040660 measured in September 1991. The roughness profile was generated using a base length of 100 ft, that is, every point in the plot shows the IRI of a 100 ft segment of road, starting 50 ft upstream and ending 50 ft downstream. No data are shown over the 50 ft at each end of the section because the plot was generated using a profile that terminated at the section boundaries. The plot shows that the first 250 ft of the section are more than twice as rough as the last 200 ft.

The profile featured in Figure 72 was measured shortly after rehabilitation, and it represents the status of the section just after rehabilitation. The construction process itself caused the roughness in the first half of the section. Figure 73 is an elevation profile that corresponds to Figure 72 after application of a moving average anti-smoothing filter with a base length of 100 ft. This figure shows that the roughness is caused by some very long duration features. The long dip running 30 to 90 ft from the start of the section deteriorated over time, and eventually became so rough by growing in depth that a skin patch was placed over it.

**Figure 72. Roughness Profile of Section 040660 (100 ft Base Length, September 1991).**

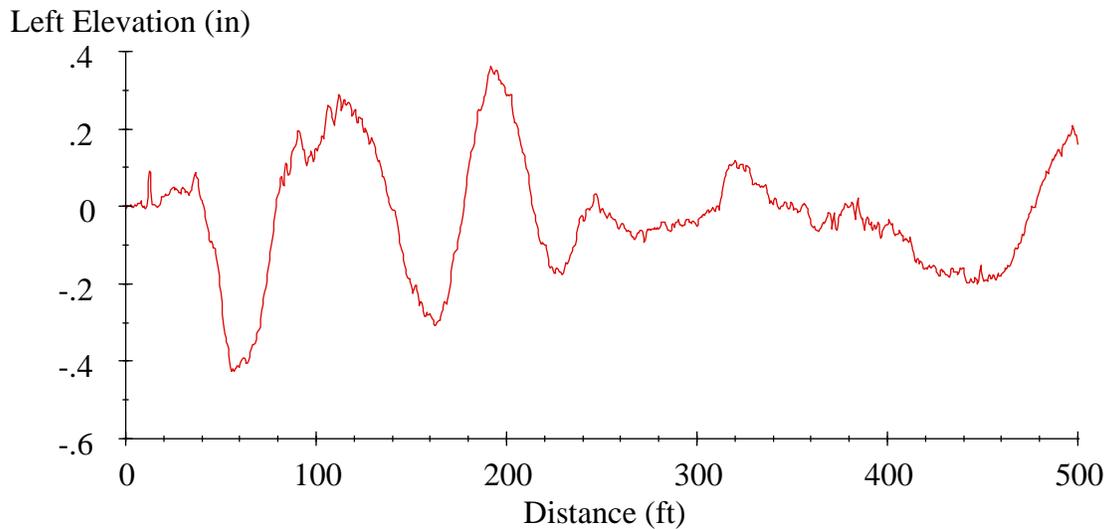
**Figure 73. Elevation Profile of Section 040660 (September 1991).**

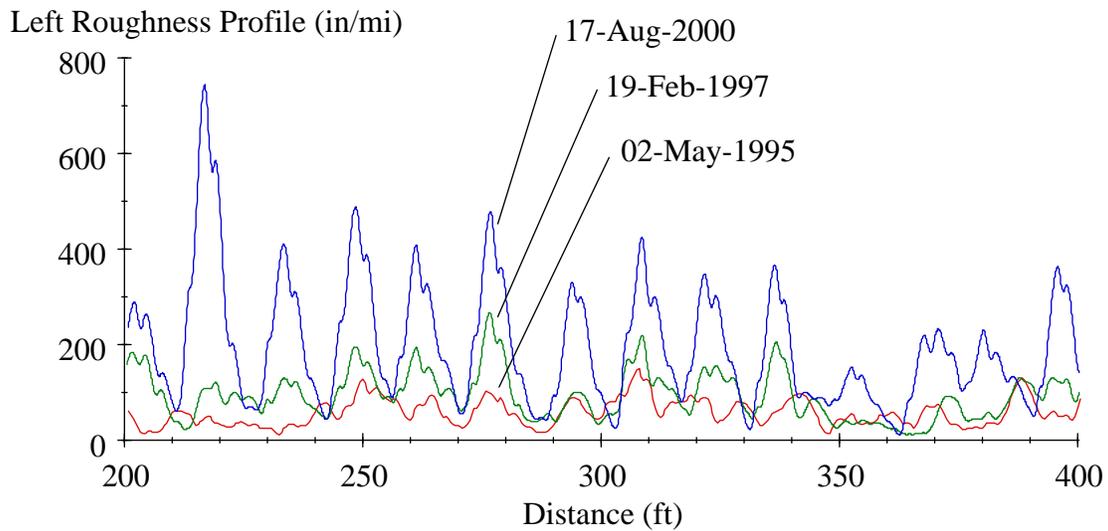
Figure 74 shows how a roughness profile can help find localized roughness and quantify its impact on the overall roughness of a test section. This figure shows the roughness profile of Section 040603 for the three most recent profiles given in Figure 69. The plot was generated using a 5 ft base length, so each point shows the contribution to the IRI that has accumulated over 5 ft. A base length of 25 ft is more standard for the purpose of seeking localized roughness (AASHTO 2008; Swan and Karamihas 2003). But a short base length was required to isolate the closely spaced dips in this section and easily identify roughness. For example, many of the dips highlighted in Figure 71 produced peak values greater than 400 inches/mi in Figure 74. Since

these peaks correspond to roughness over 1 percent of the test section length, they each account for more than 4 inches/mi of the section's overall IRI.

**Figure 74. Roughness Profiles of Section 040603 (5 ft Base Length).**

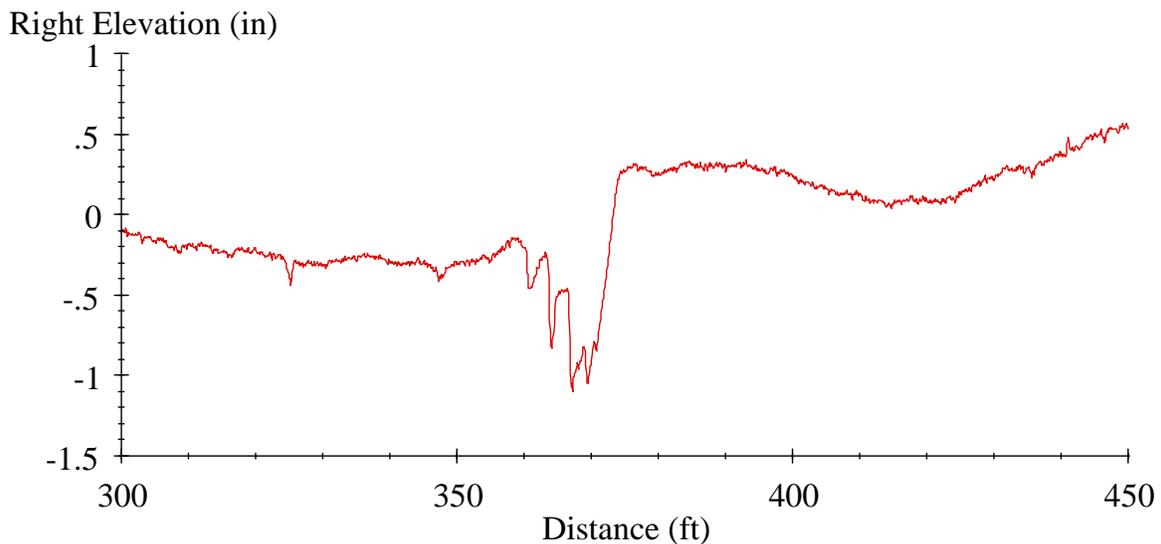
**Figure 75. Right Side Roughness Profile of Section 040661 (August 2000).**

Figure 75 shows how a roughness profile can help find and quantify isolated roughness. The figure shows the right roughness profile of Section 040661 from August 2000 using a 25 ft base length. With this base length, the area of concern about 375 ft from the start of the section is easy to identify. The peak value there is about 678 inches/mi, which is more than 575 inches/mi above the prevailing roughness level surrounding it. This is a difference of 575 inches/mi over 25 ft. Since that value represents the roughness over just 5 percent of the segment, it suggests that a rough feature here increased the overall IRI of the section by nearly 29 inches/mi.

Figure 76 shows the elevation profile of Section 040661 that produced the roughness profile in Figure 75. The profile includes a significant dip and significant disturbances within the dip. Figure 77 is a photograph of the distress that caused the disturbance. Significant localized fatigue is present between the fog line and about 5 ft into the section from the right side. This fatigue cracking developed in the winter and spring of 1999–2000 and is consistent with a “soft spot” in the pavement structure, possibly caused by excessive water buildup in the unbound layers. Many of the fines have pumped up to the pavement surface and are visible in Figure 77.
