# Post-Tensioning Technologies

# JOINT TRANSPORTATION RESEARCH PROGRAM

INDIANA DEPARTMENT OF TRANSPORTATION  
AND PURDUE UNIVERSITY

<b>16. Abstract</b> <p>Post-tensioned bridge construction has become increasingly popular and financially competitive with traditional prestressed concrete and steel plate girder bridges. Unfortunately, Indiana has experienced several construction-related problems in the few post-tensioned structures built, some of which have caused significant long-term durability concerns. Indiana's problems have generally been attributed to a lack of a standard set of specifications for post-tensioned construction as well as inexperience and inadequate training of contractors and inspectors. These types of issues, however, were once more prevalent throughout the industry and much work has been accomplished in recent years to address these issues. This research program had two primary objectives: (1) to improve the quality of post-tensioned bridge construction in Indiana and (2) to provide the State with more confidence when using this type of construction. First, past problems related to post-tensioned construction were identified, and for each, case studies were

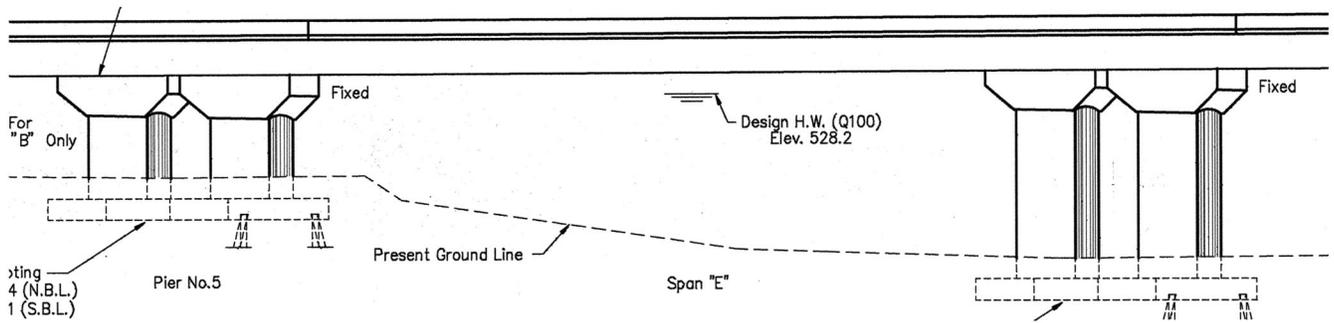
Figure 2.1 Perspective view of US 231 over the Wabash River.

This bridge structure, completed in 1995, consists of two separate bridges and carries US 231 over the Wabash River in Lafayette, IN. The identical structures are composed of four three-span continuous girders with individual span lengths of approximately 175 ft. Each superstructure width is 44 ft-2 in. from outside to outside of coping. Figure 2.1 shows a partial perspective view of the bridges.

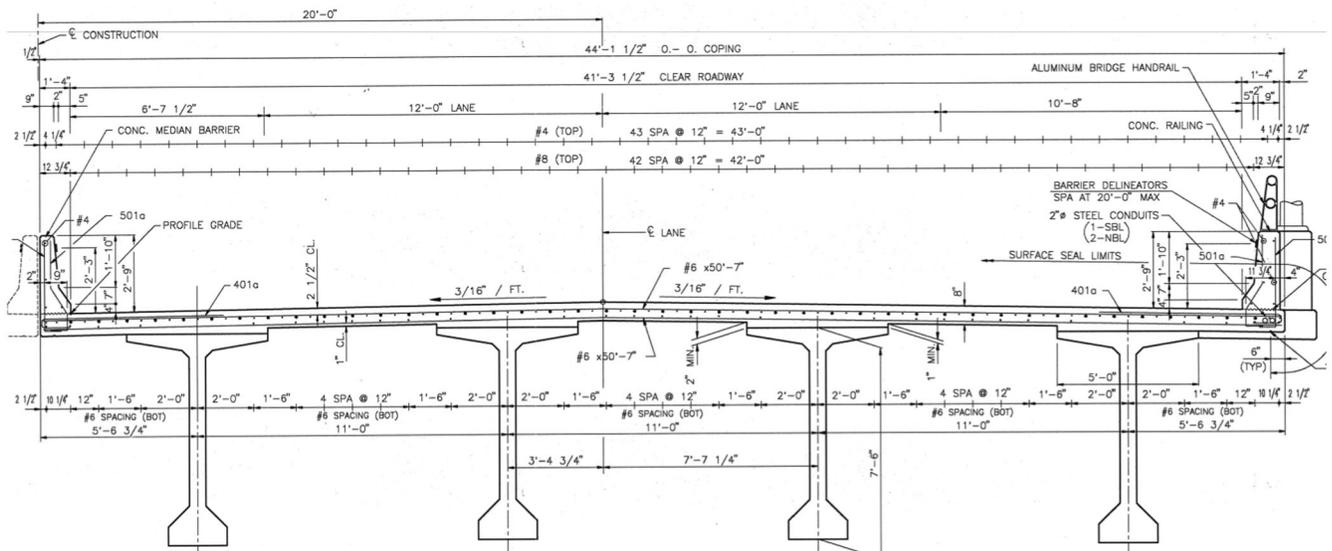
Figure 2.2 Cross-sectional view of US 231 over the Wabash River.

The bridges were constructed using hybrid pre- and post-tensioned 90-in. deep Indiana bulb tee sections. Each superstructure span consists of four bulb tee beams, and each precast beam spans between supports (175 ft). Beams were post-tensioned to create a three-span continuous girder. Figure 2.2 shows a cross-sectional view.

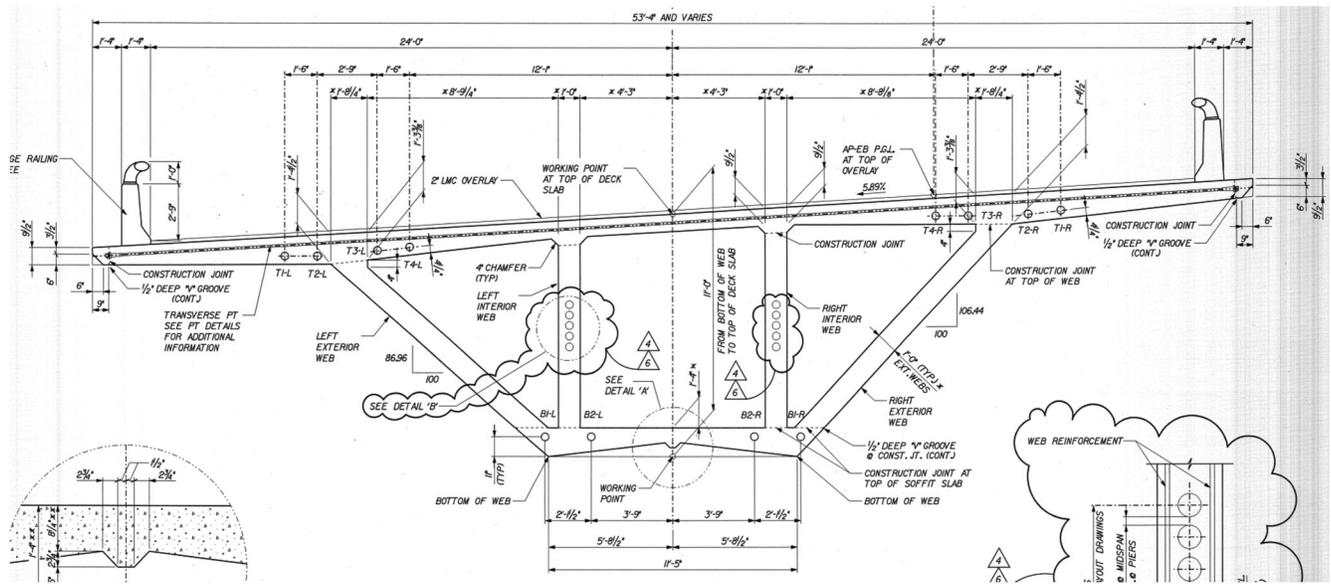
Figure 2.4 Cross-sectional view of the I-70 airport interchange bridge.

The cast-in-place bridges were constructed on temporary falsework. The bridges were also cast in stages: first the bottom slab, then the web and diaphragm walls, and finally the top slab. The top slab was post-tensioned transversely. Figure 2.4 shows a cross-sectional view of the larger bridge.

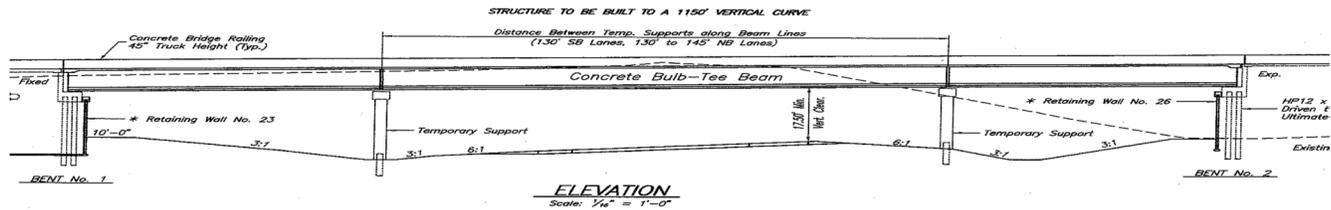
Figure 2.5 Partial elevation view of northbound portion of bridge no. 13.

lanes and two 14-ft shoulders. Next, the southbound bridge was constructed with a variable span length of approximately 191 to 237 ft and a variable skew of 52 to 58 degrees. The southbound bridge consists of two-12 ft lanes, a variable width ramp lane, and two 12-ft shoulders. Figure 2.5 shows a partial elevation view of the twin bridges.

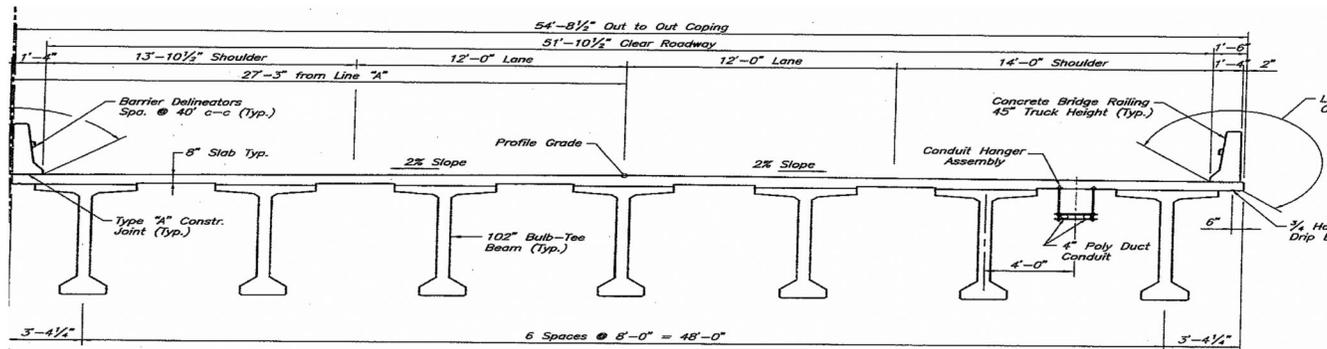
Figure 2.6 Cross-sectional view of northbound portion of bridge no. 13.

The bridges were constructed using hybrid pre- and post-tensioned 102-in. Indiana bulb tee sections. The northbound structure consists of seven girder lines, and the southbound structure consists of nine girder lines. Using temporary supports, the bridges were erected as three pre-tensioned spans ranging from 44 to 130 ft and then post-tensioned to form a continuous single-span structure. The post-tensioning was designed to be completed in phases, before and after deck placement, to provide proper counteracting forces. Each beam has six tendons. Figure 2.6 shows a cross-sectional view of the northbound bridge.
