FINAL REPORT

CORROSION CHARACTERISTICS OF UNPROTECTED POST-TENSIONING STRANDS UNDER STRESS

**Contract No. BDK84-977-22
Final Report to Florida Department of Transportation**

**UNIVERSITY OF
SOUTH FLORIDA**

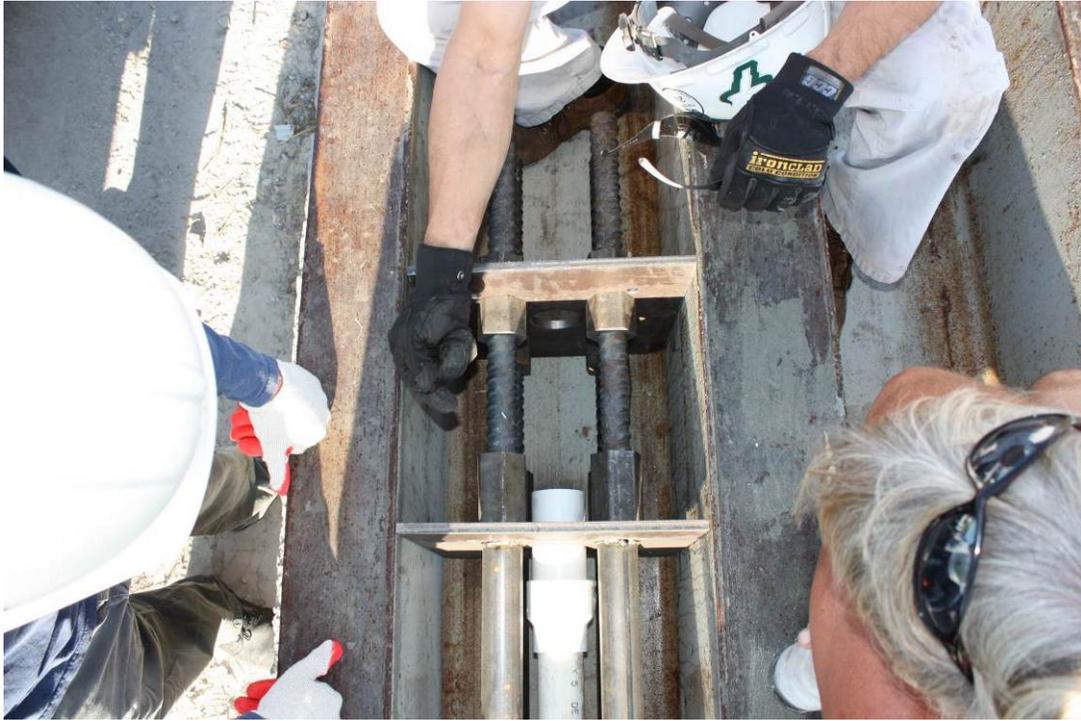
The casting of the piles was performed at Henderson Prestress in Tarpon Springs, FL (Figures 2 through 6). Henderson Prestress provided access to a 14-inch casting bed to the University of South Florida as well as materials and labor for pile construction. After one week, the piles were removed from the casts and transported to both the inland location (USF) and the marine location (SSK). Piles were arranged in an alternating pattern to allow better access to the de-tensioning mechanism. Piles were placed on two dunnage piles provided by Henderson Prestress to allow the small portion of the pile to move per the design, and the piles were made level using concrete blocks.

Figure 2 Setup for Casting of De-Tensioning Piles

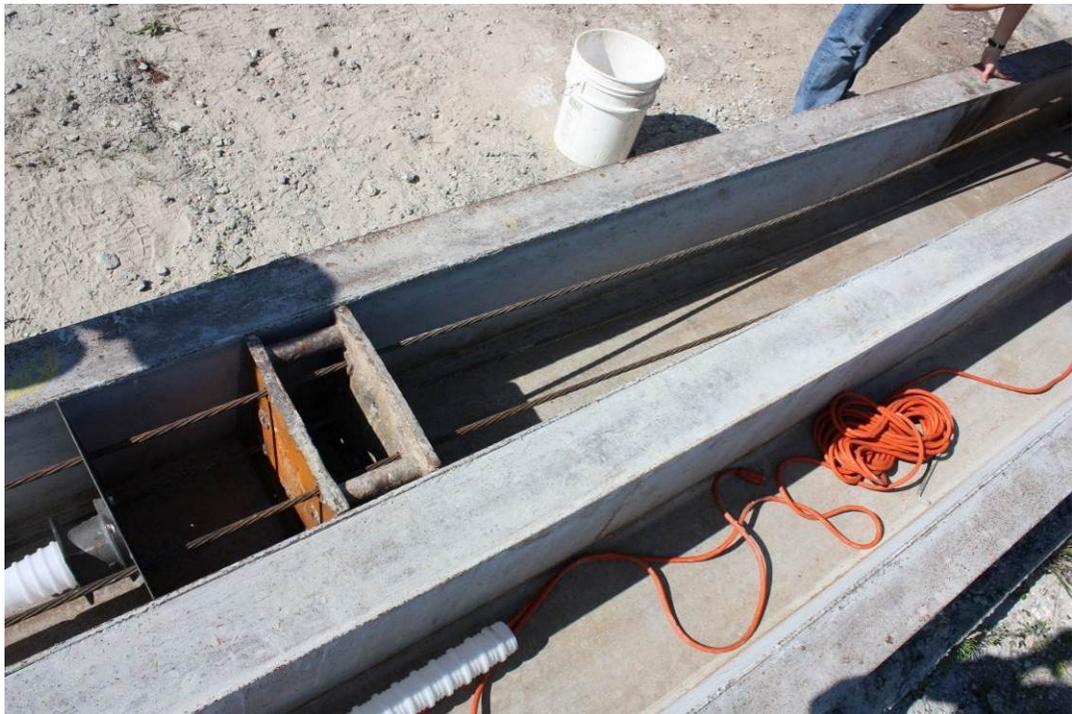
Figure 3 Prestressing Strand for Casting of De-Tensioning Piles

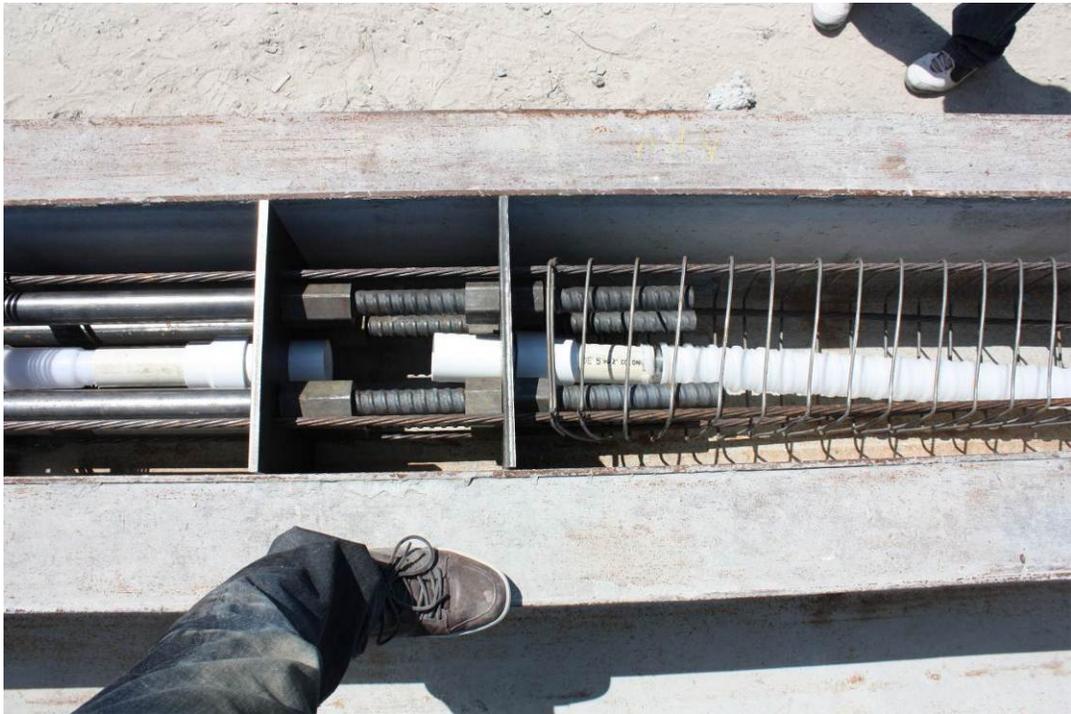
Figure 4 Spiral Wire for Casting of De-Tensioning Piles

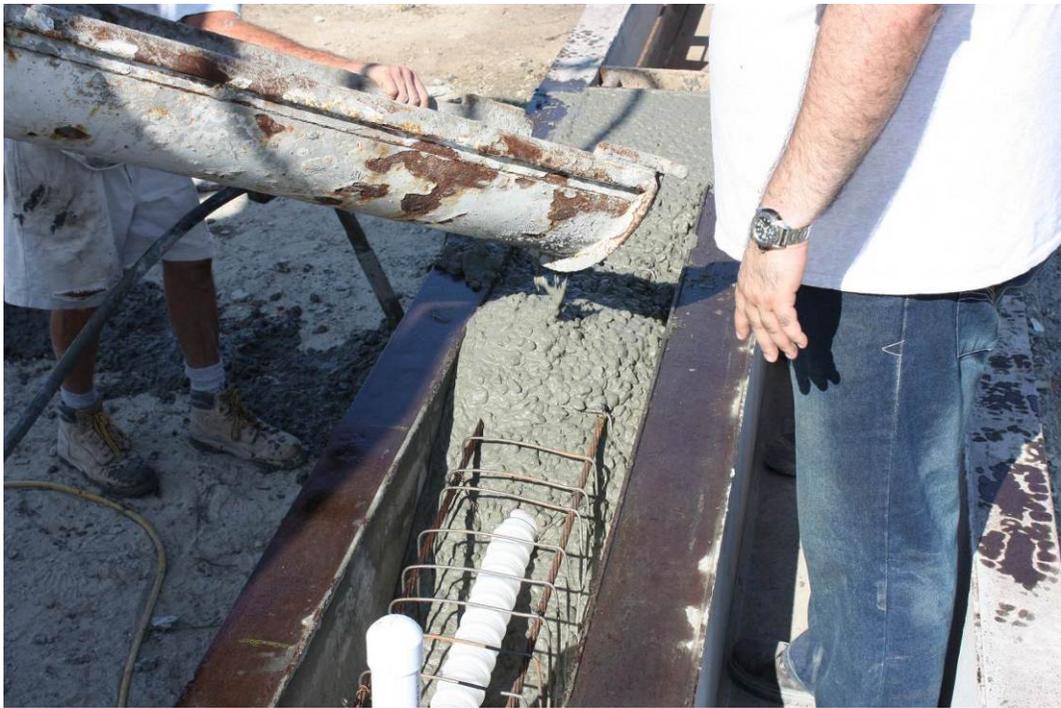
Figure 5 Concrete Pouring for Casting of De-Tensioning Piles

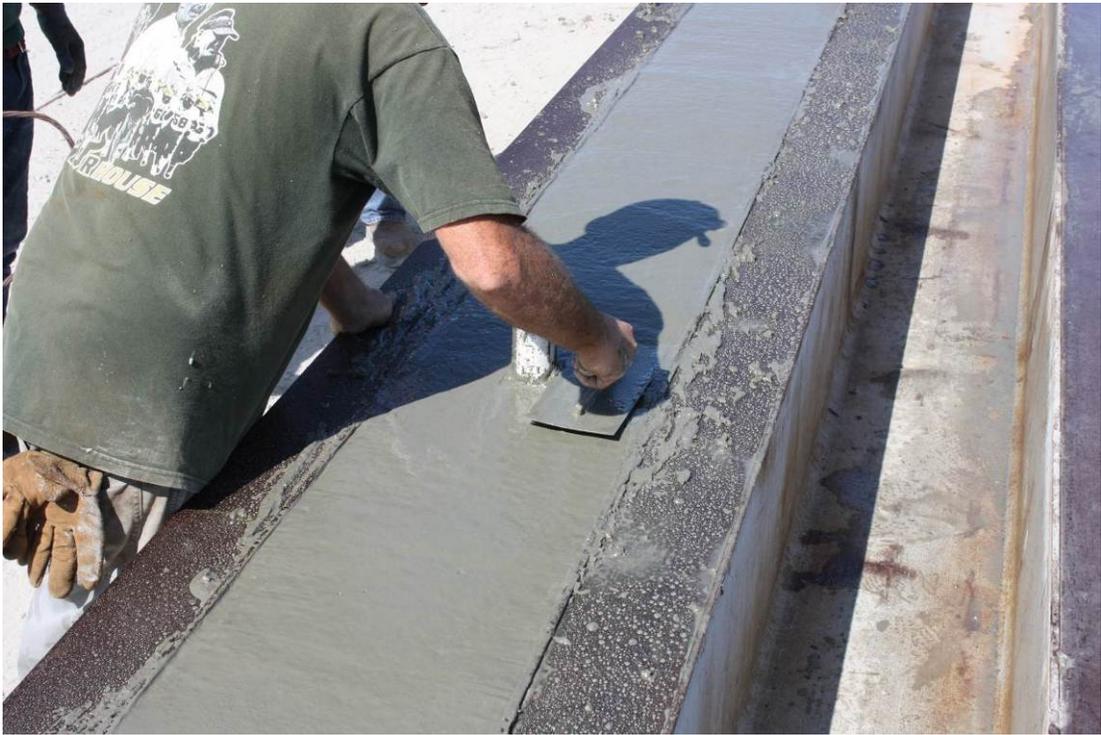
Figure 6 Smoothing of Poured Concrete De-Tensioning Piles

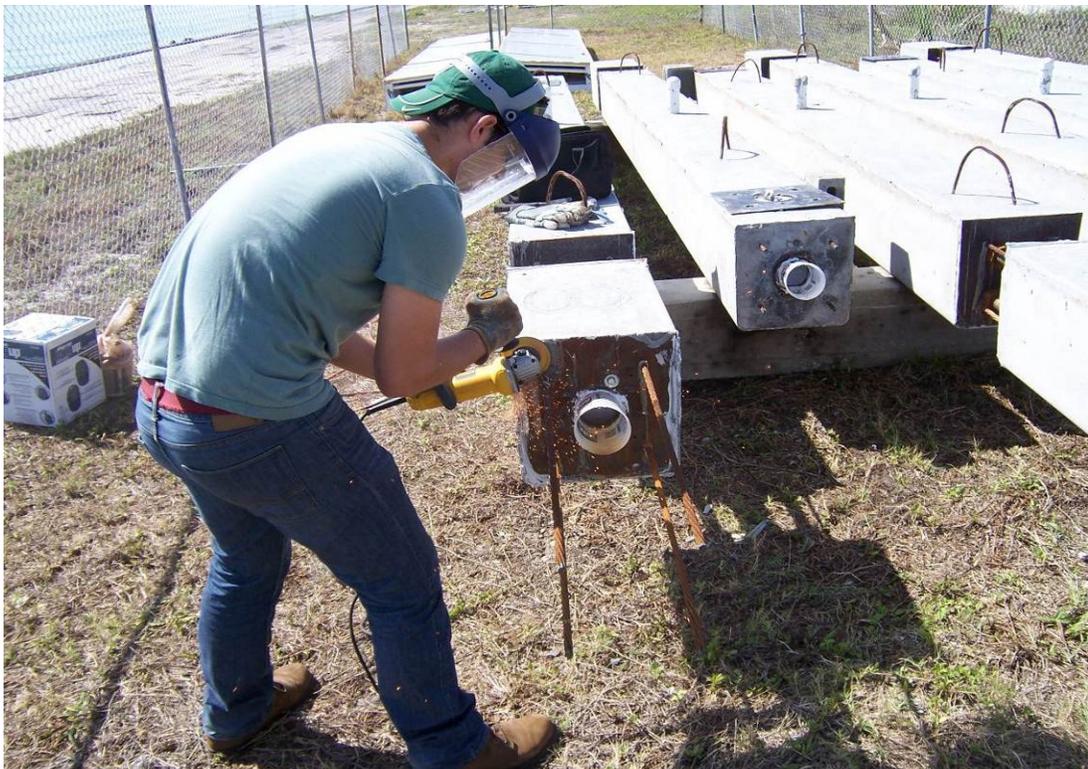
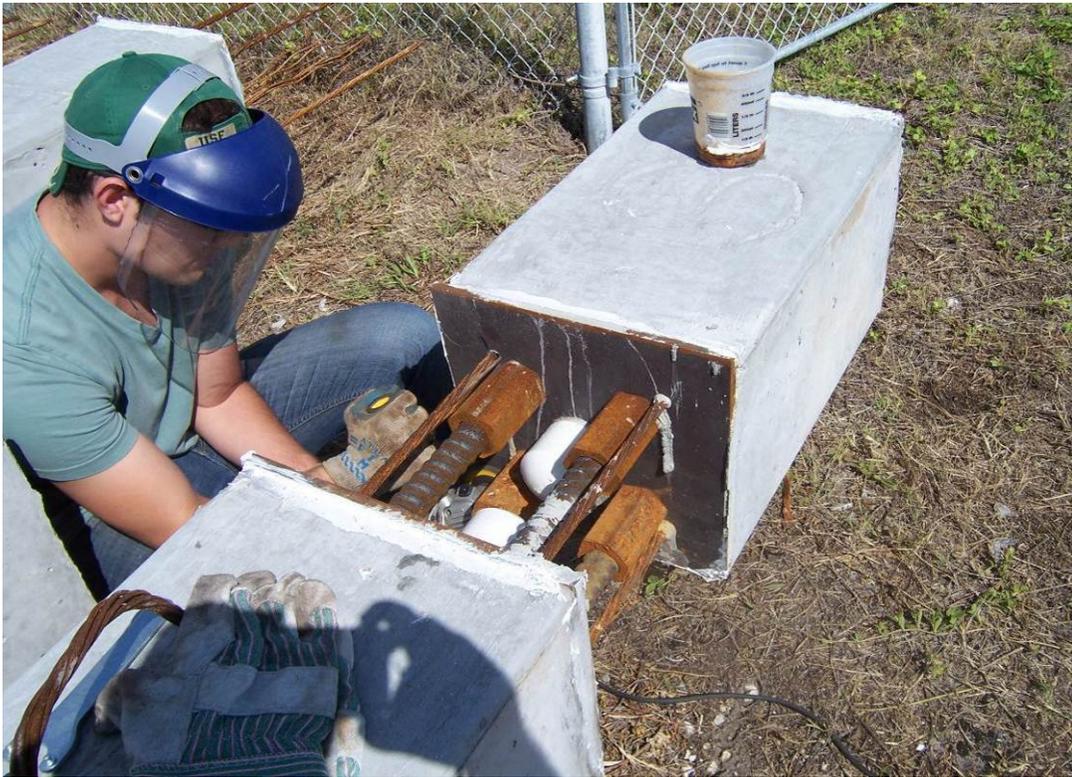
Once the piles were in place, a series of maintenance and cleanup steps were done (Figures 7 and 8). First, the extra prestressing strand material for the strengthening of the piles was removed. Then, the steel plates used to hold the anchor assemblies were removed from the ends where possible. The ducts were cleared out by blowing air through them to remove any water or dirt that may have entered into the ducts. The open points on the ducts were closed with plastic caps and sealed with weatherproof silicon. Rust inhibitor was applied to the exposed metal. Weatherproof silicon was applied to any joints of metal to concrete to prevent crevice corrosion. The layout of the piles at USF location is shown in Figures 9 and 10. The layout of the piles at SSK location is shown in Figures 11 and 12.

Figure 7 Cutting of Excess Strand Material

Figure 8 Cutting of Excess Strand Material

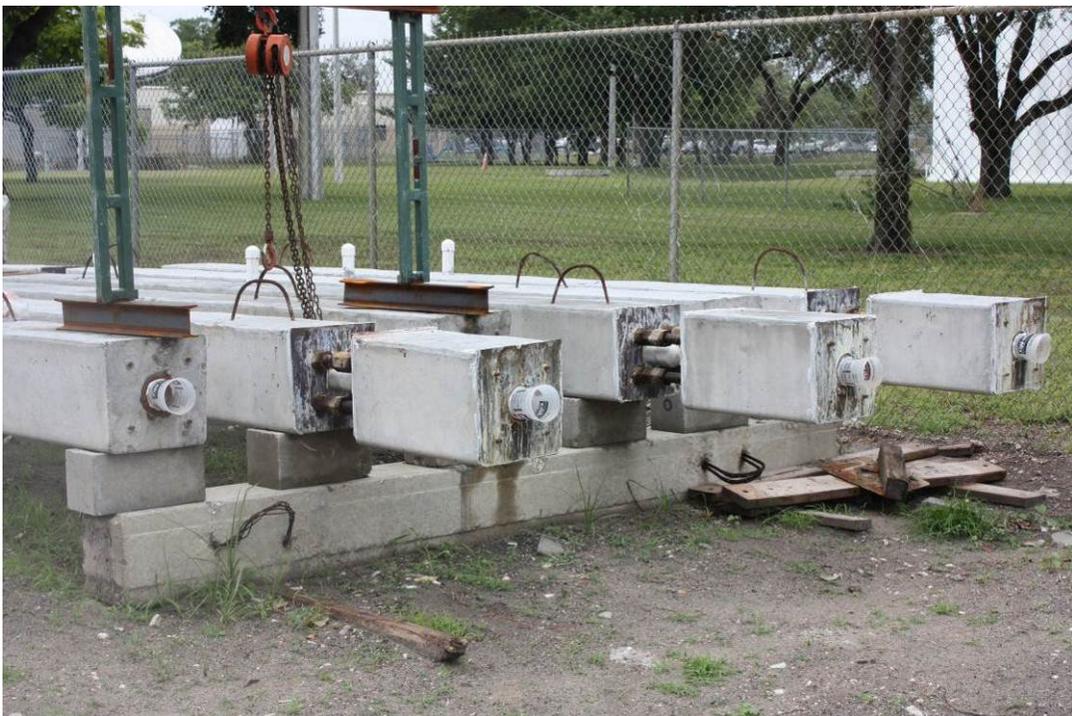
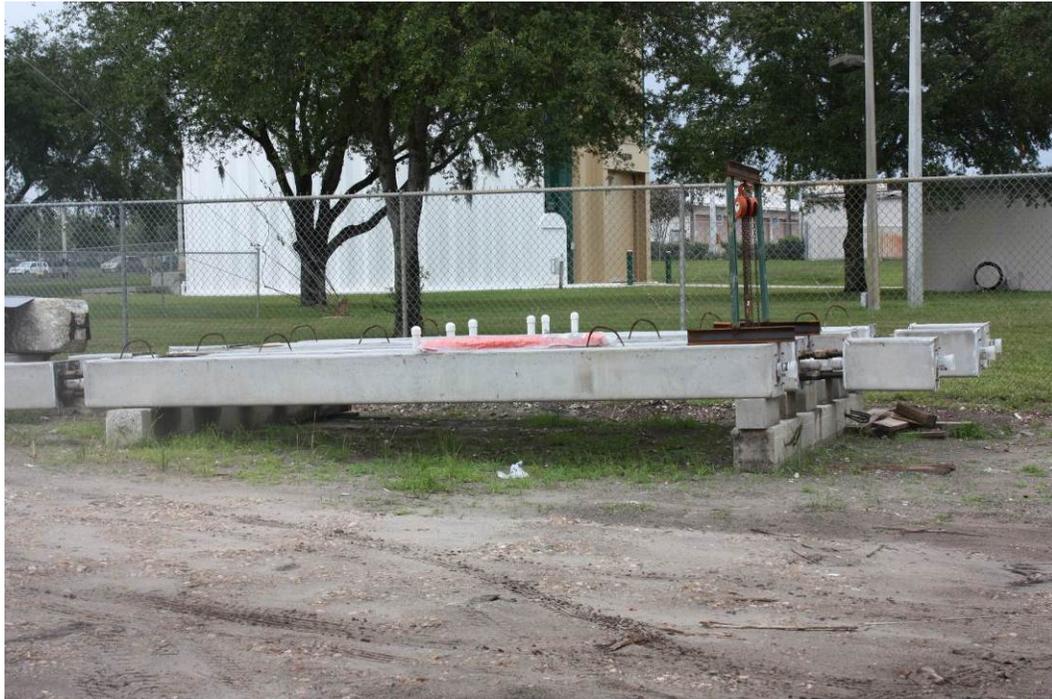
Figure 9 De-Tensioning Pile System at Inland Location (USF)

Figure 10 De-Tensioning Pile System at Inland Location (USF)

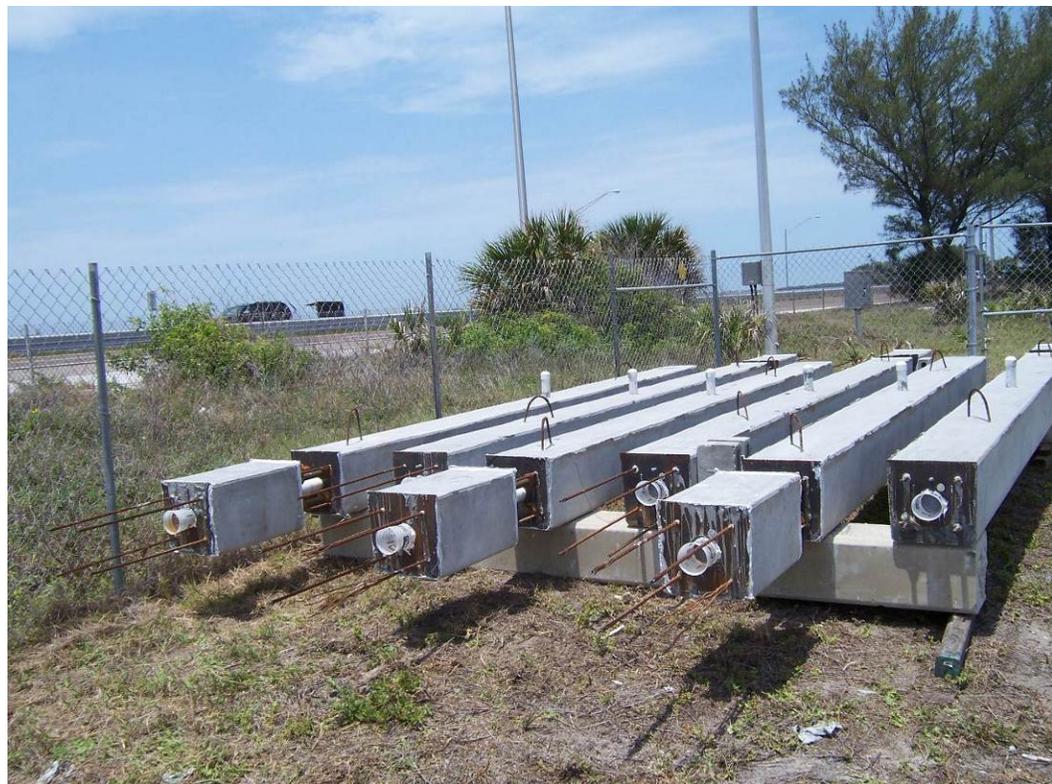
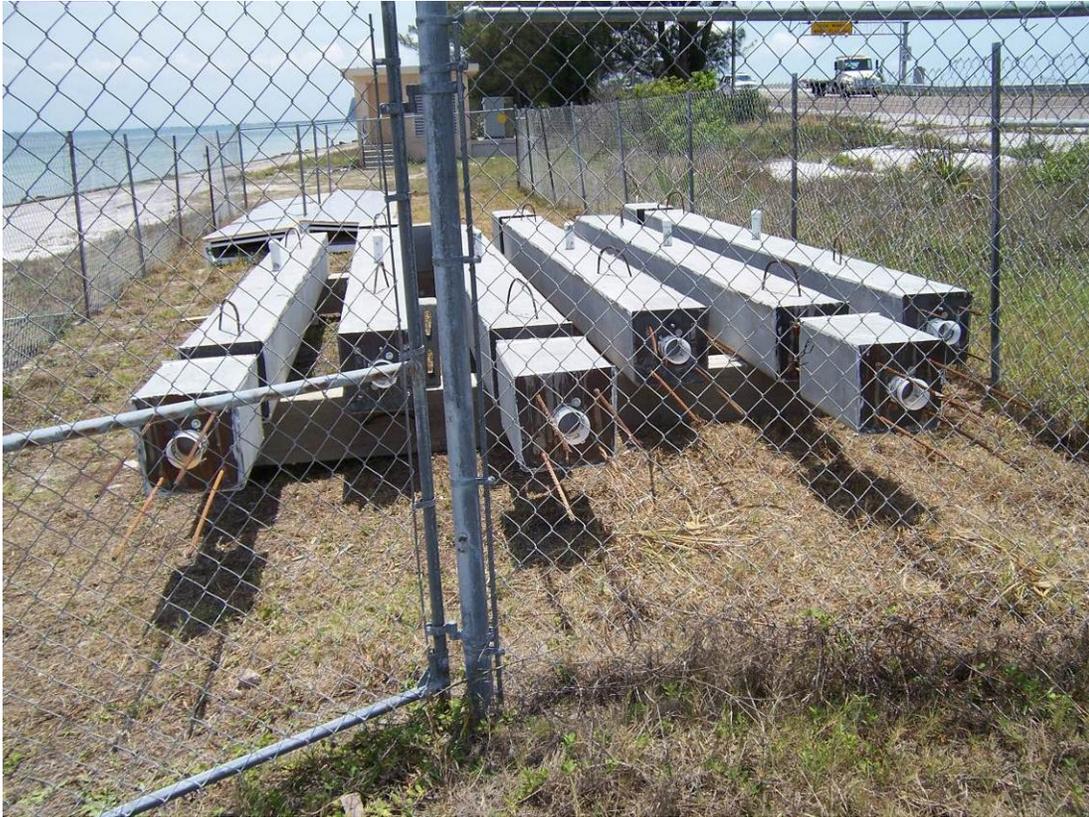
Figure 11 De-tensioning Pile System at Marine Location (SSK)

Figure 12 De-tensioning Pile System at Marine Location (SSK)

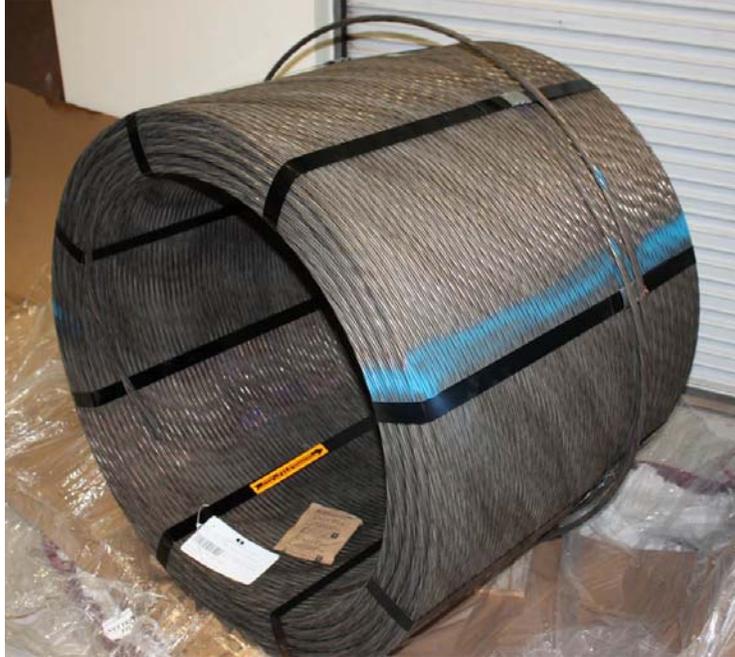
The material used was ASTM A416 7-wire steel strand. The diameter of the strand is nominally ~0.5 inches and has estimated yield strength of 270,000 psi. Steel strand was delivered on 07/18/12 rolled as shown Figure 13.

Figure 13 ASTM A416 270 Kilo-Pounds per Square Inch (ksi) Yield Strength Prestressing Steel Strand

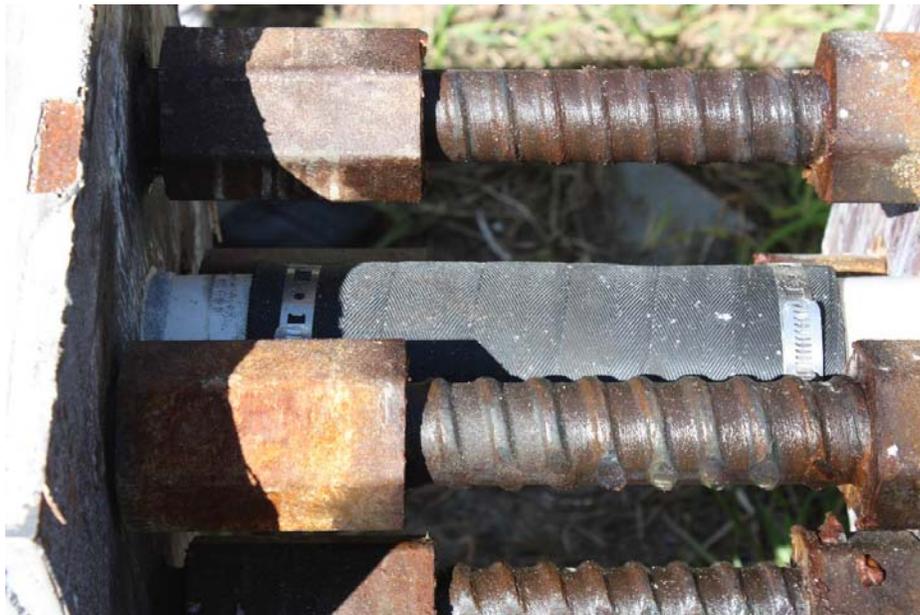
The temporary PVC slip-cap connections were replaced with a flexible bellows connection as shown in Figure 14. Furthermore, the slip-cap connection for the RH access port was deemed inadequate for proper sealing of the ducts, and was replaced with a threaded cap, shown below in Figure 15.

Figure 14 Installed "Bellows" Connection for Pile Segment Break

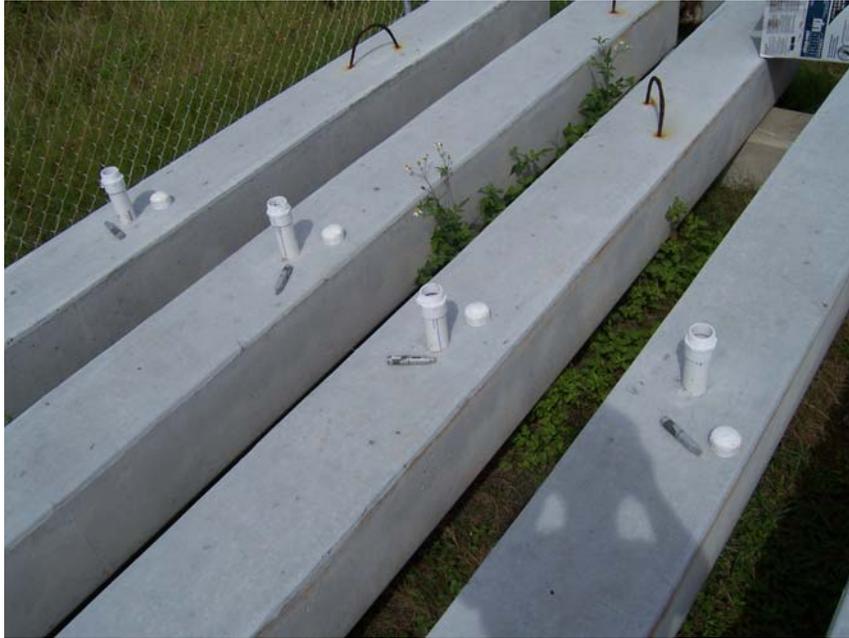
Figure 15 Threaded Caps for Relative Humidity Probes Access Port

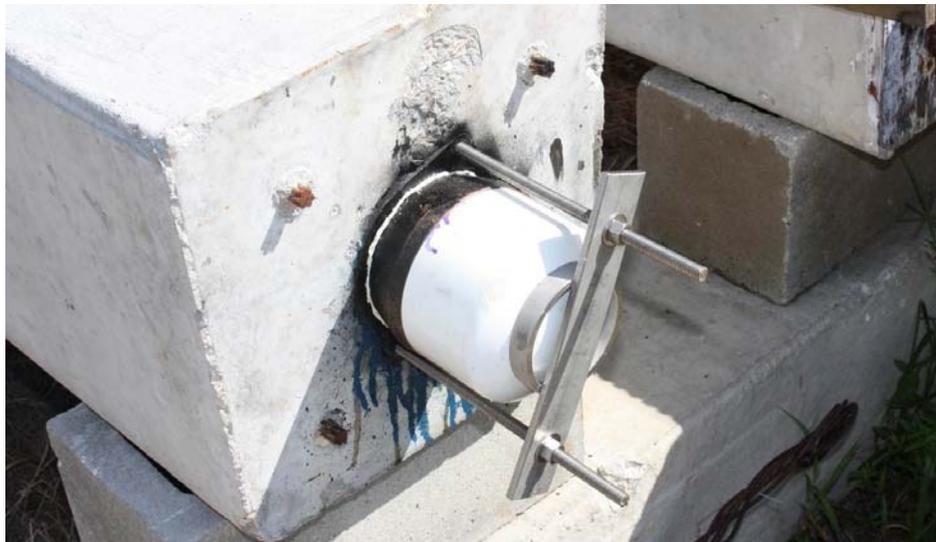
End-caps from the PT anchor body manufacturer were not compliant with FDOT specifications in terms of corrosion resistance. A custom end-cap design was proposed to provide both adequate seal and corrosion protection in lieu of employing the manufacturer's cap. The design includes a standard 4-in PVC slip cap held by a retaining bar and ring which are secured by threaded rods to the anchor body. All metallic elements of the end-cap are stainless steel. A rubber O-ring seal is machined between the PVC cap and the cast-iron wedge plate. The End Cap assembly is shown in Figure 16.

Figure 16 Custom End Cap installed on East End of Duct 6 at USF Facility

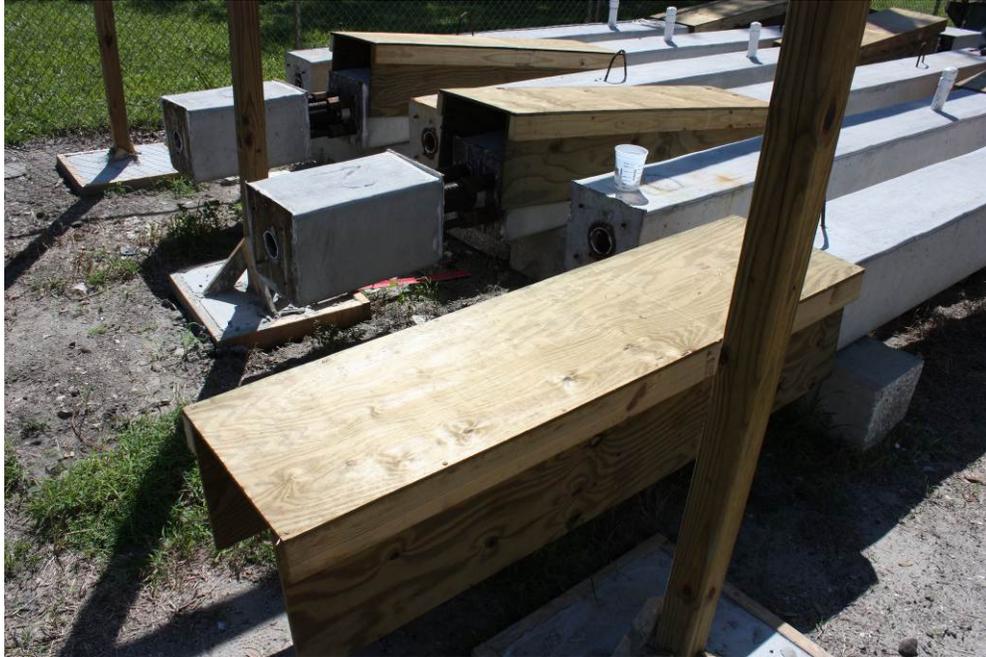
To protect the end caps and pile break steel bars/nuts from undue environmental exposure, wooden cowls fitting over the pile ends were designed, produced, and installed. Figure 17 illustrates the cowls both installed and partially removed.

Figure 17 Wooden End Cowls at USF Facility

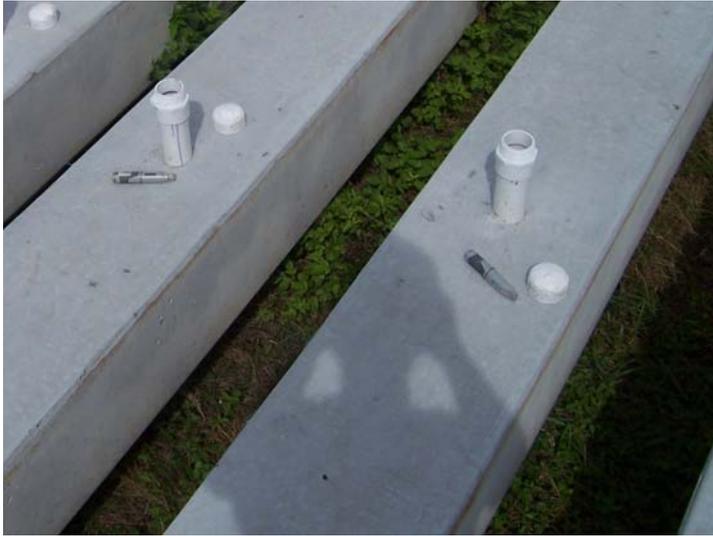
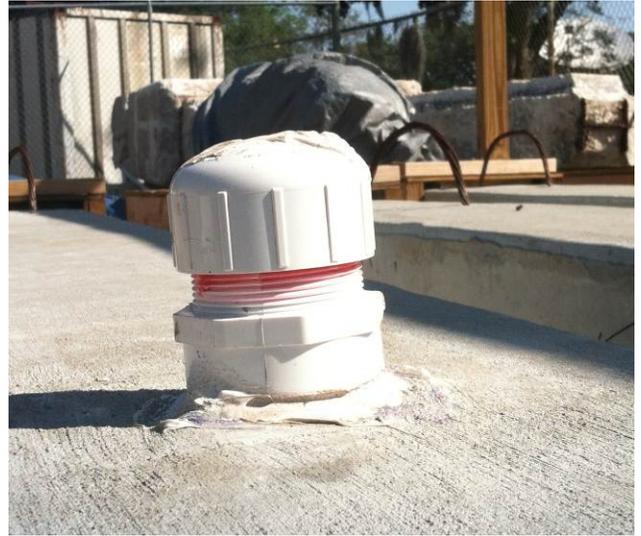
The relative humidity (RH) probe access port was cut to a shorter height (Figures 18 & 19) to reduce the possible reflux in the ducts from the convection of air on the surface of the access port PVC tube.

Figure 18 RH Probe Access Port Tube before Height Reduction

Figure 19 RH Probe Access Port Tube after Height Reduction

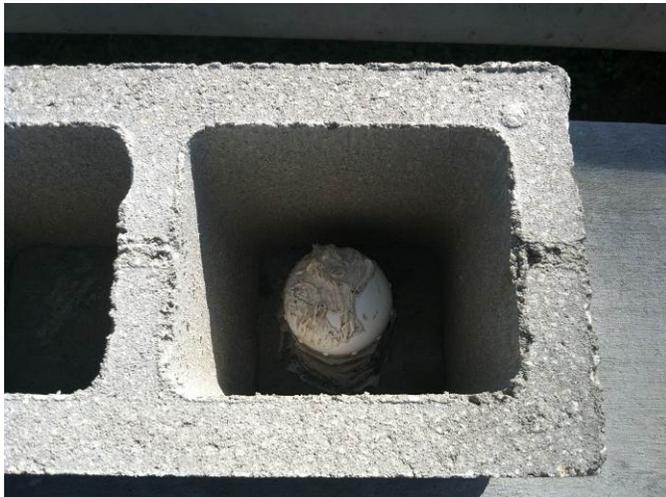
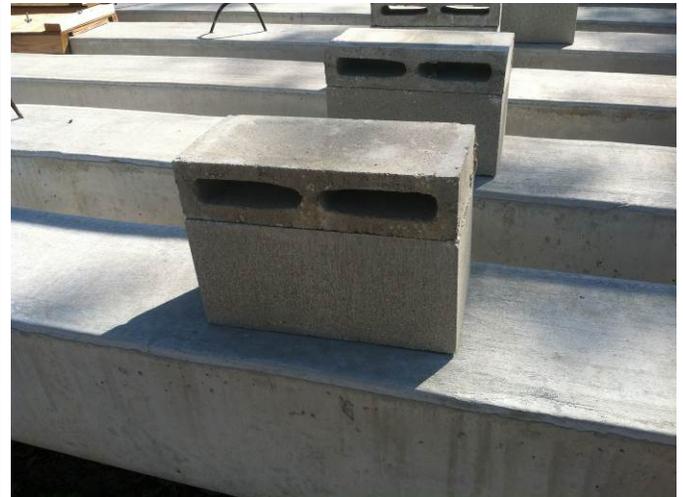
In an effort to further reduce the local environment disparity between the internal duct embedded within the concrete and the portion of duct at the RH probe access port, concrete cinder blocks (Figures 20 and 21) were used to cover the access port thus relieving them from direct exposure to the external environment. At this point, no further alterations were done to the piles, and stressing of the strand commenced.

Figure 20 RH Access Port Cinder Block Covers, without Lid

Figure 21 RH Access Port Cinder Block Covers, with Lid

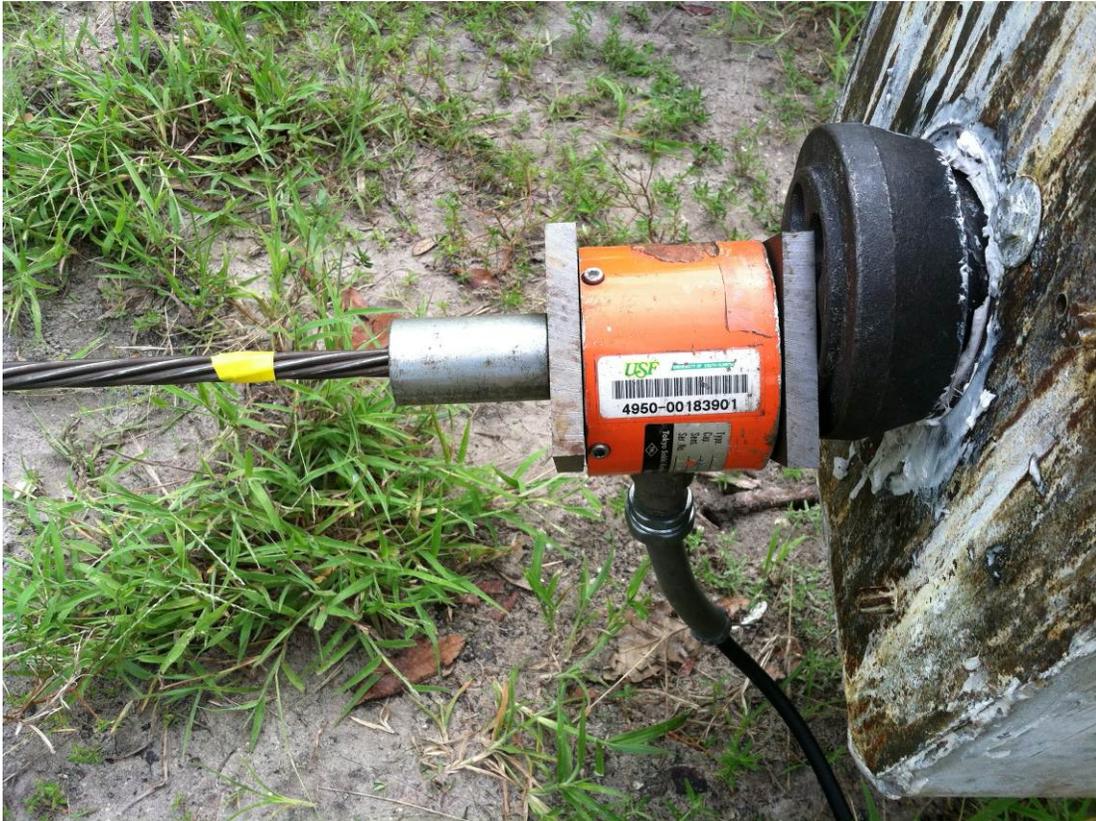
Evaluation of the jack pressure required for appropriate strand stressing and determination of stressing procedure was performed on 07/25/12. A strand sample was paid out from the delivered spool and stressed to various levels. The load cell and jack used, as well as the testing setup are illustrated below in Figures 22, 23 & 24.

Figure 22 Load Cell Setup for Stressing Operation Test

Colored electrical tape (yellow – see Figure 22) was used to measure slippage of the strand. The load cell was placed at the dead end and used to measure the force applied to the strand so as to calibrate the hydraulic system. The calibration consisted of measuring the force on the strand as function of the hydraulic system pressure. The force on the strand was divided by the nominal cross-sectional area of the strand (0.144 inches^2) to obtain the stress on the strand, and plotted as function of the pressure from the hydraulic system. The plot was found to be highly linear as expected. The ratio of the stress on the strand to pressure in the hydraulic pump was found to be 0.0304 ksi/psi. Elongation measurements were in general agreement with the stress levels thus estimated. The jack was fitted with a custom collar to ensure adequate wedge set. Applying pressure to obtain a strand stress of 229.2 ksi and removing jack pressure resulted in a final stress of 220.8 ksi or $0.82 f_{pu}$. It was decided to use for the regular stressing procedures an initial pressurization of 1,000 psi to remove any slack from the strand, and then increase the pressure to 8,000 psi (a nominal stress of 243.9 ksi, or $0.90 f_{pu}$) so that upon removal of the pressure and subsequent wedge set a final stress level of about $0.87 f_{pu}$ would exist. While the code recommended jacking load should not exceed $0.94 f_{py}$ or $0.8 f_{pu}$, (which should then result in a final stress of $0.7 f_{pu}$), all specimens were jacked to a level high enough to overcome large wedge seating losses (due to short strands) and to leave the strand at a higher than normal stress during the exposure ($>0.8 f_{pu}$ instead of $0.7 f_{pu}$). This resulted in a more aggravated stress state that offered a greater opportunity of revealing any adverse effect of stress-corrosion interactions during the ungrouted period.

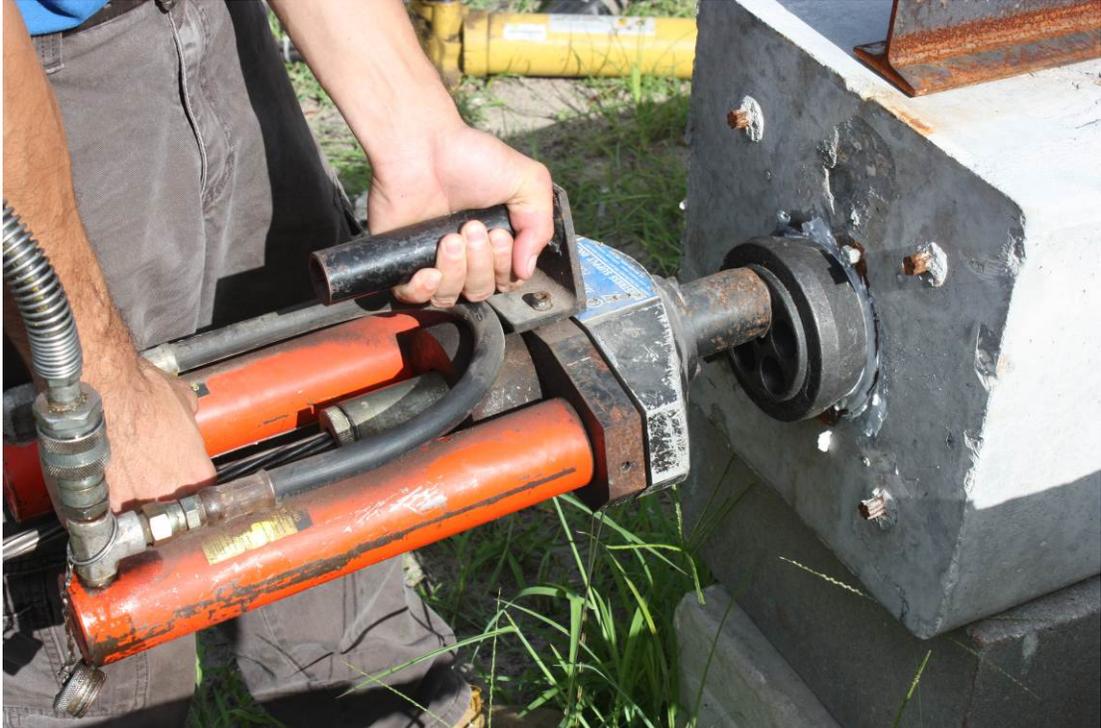
Figure 23 Hydraulic Jack Setup for Stressing Operation Test

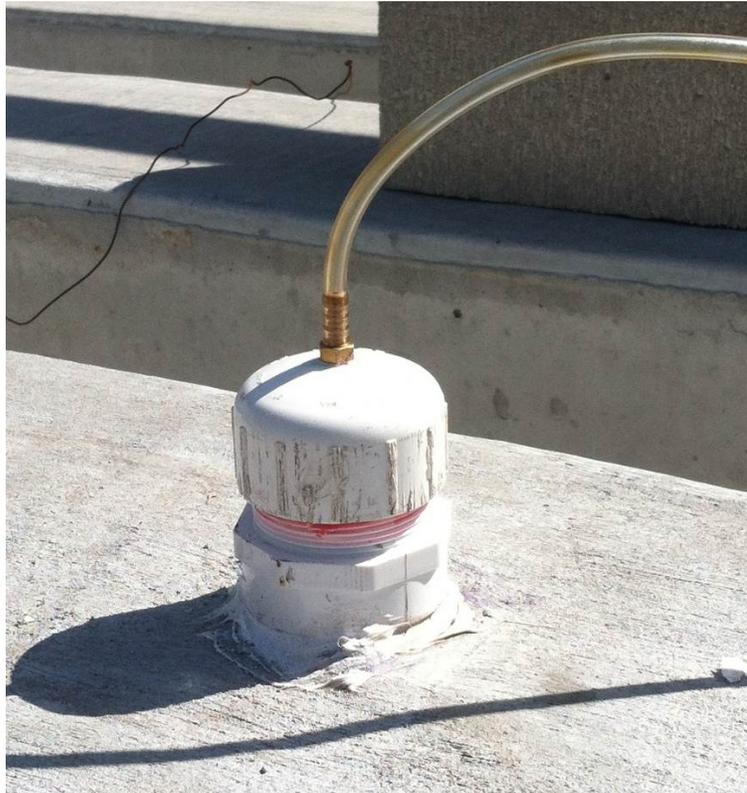
In order to verify the validity of the seal offered by the end caps and flexible bellows connections, a vacuum test was performed on Duct 6 at the USF facility. A threaded cap with a small hole was placed over the RH access port, and a vacuum hose was attached to the cap at the hole, then vacuumed down to 15 inches Hg, and the vacuum level was subsequently measured (see Figure 25). The results of the test showed that the duct can hold vacuum pressure, indicating a sealed system with the bellows and custom end caps.

Figure 25 Vacuum Hose Attached to RH Access Port for Vacuum Pressure Testing

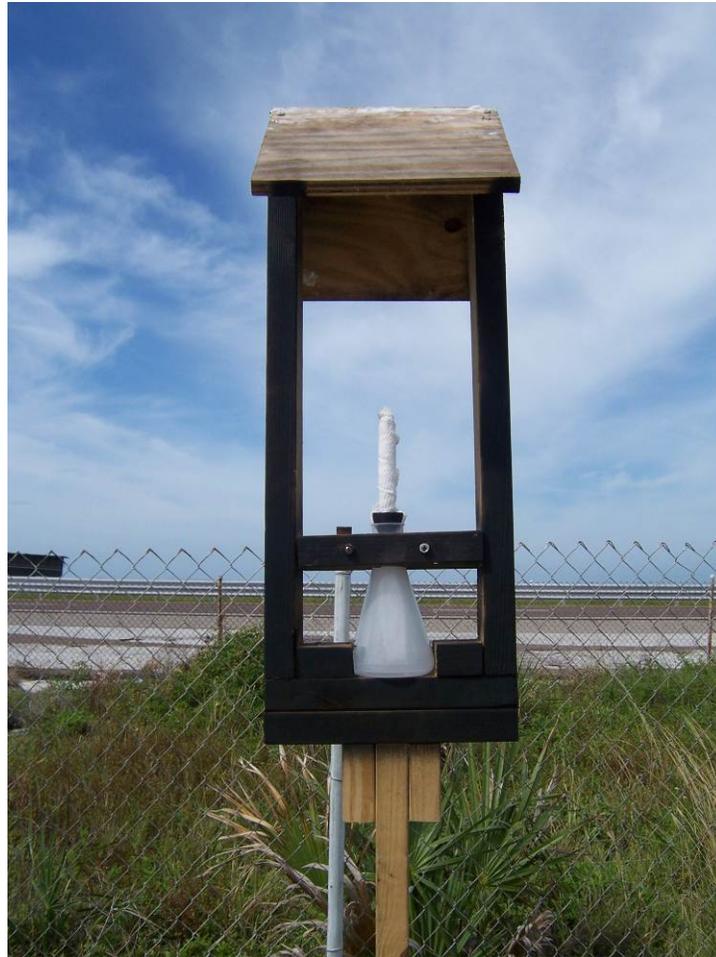
In lieu of an external strand exposure to the environment, the ‘exposed to the environment’ strands were subjected to a controlled laboratory salt spray delivery, thus eliminating the need to circumvent rainfall events in an external environmental exposure. The atmospheric chloride deposition rate was measured at both facilities using a wet candle method conforming to ASTM G140 specifications; the SSK facility wet candle setup is shown in Figure 26.

Figure 26 Wet Candle Setup for Determining Atmospheric Cl⁻ Deposition Rate at SSK Facility

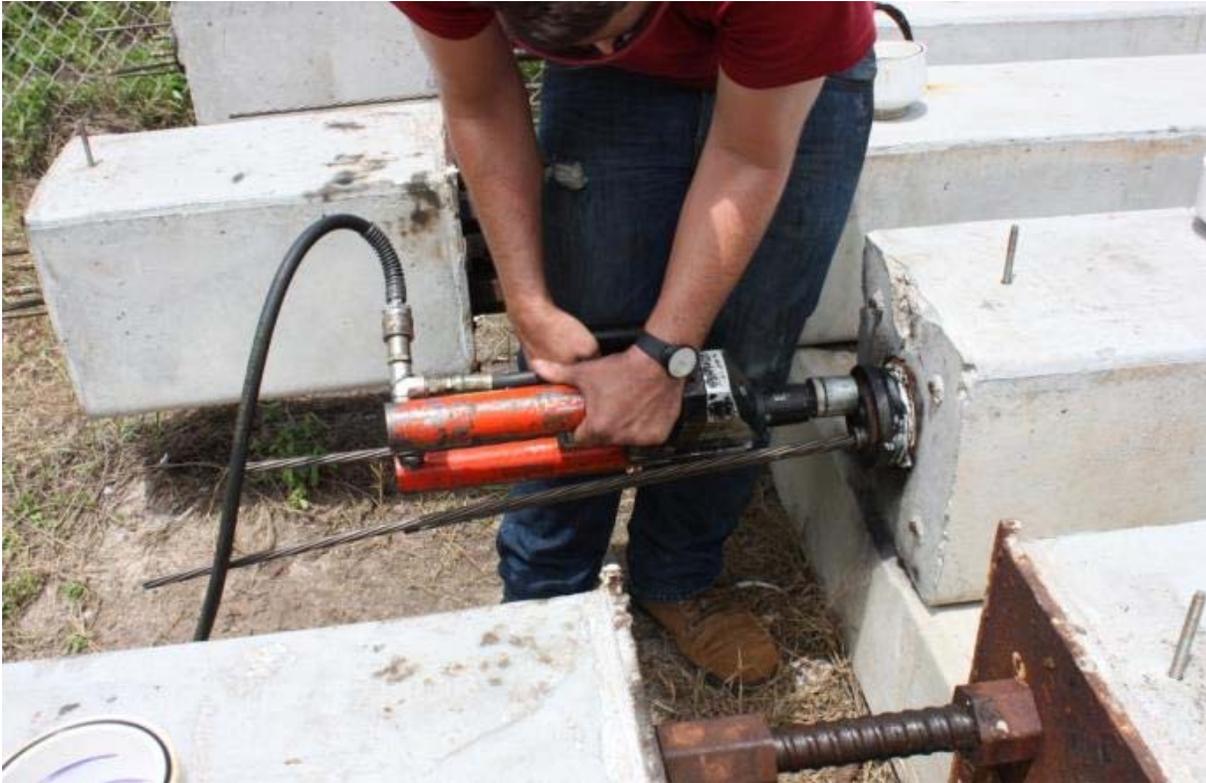
Figure 31 Mono-Strand Jack Used to Stress Strand

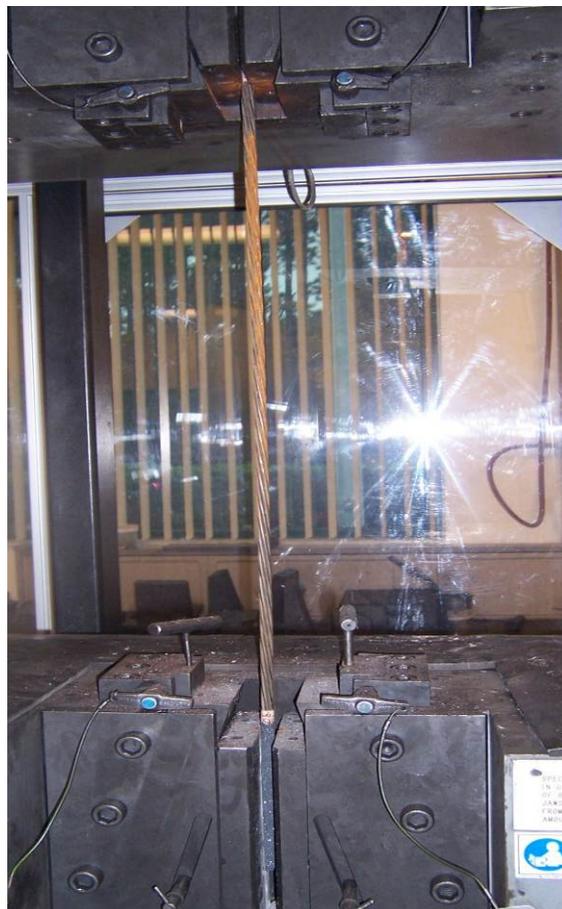
Figure 35 Typical Strand Placements in Tensile Testing Machine at the FDOT SMO

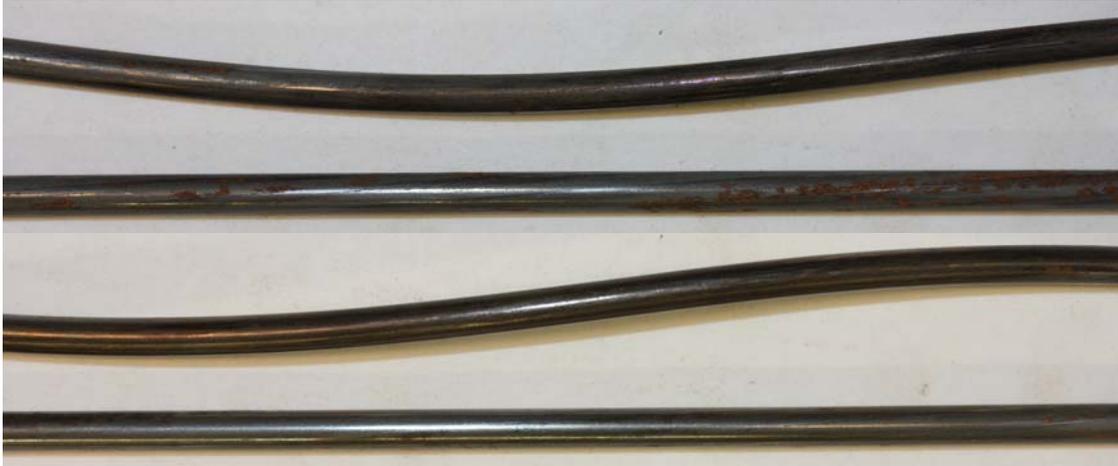
Figure 61 Specimen 97a 4 Week not Salted but Wet Exposed (Top) and after Cleaning (Bottom)

Figures 61 and 62 exemplify wire appearances before and after light surface cleaning, resulting in ratings of 2 and 4 respectively. The picture scale used is given in (Sason, 1992). The summary of all results are shown previously in Table 5.

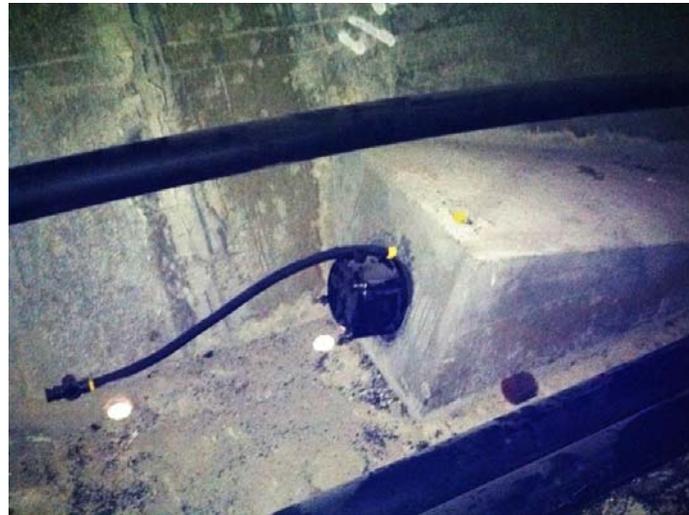
Figure A3 Permanent plastic end cap and grouting port in span 10-8

Two probes, placed in span 10-8, were placed together next to each other in a completed duct with permanent plastic caps and awaiting strand placement. Probes installed were PT 0, and PT 7. Figure A3 shows the end cap inside of which the probes were placed. Figure A4 shows the labeling of the segment within the span, which was already placed at its service elevation.

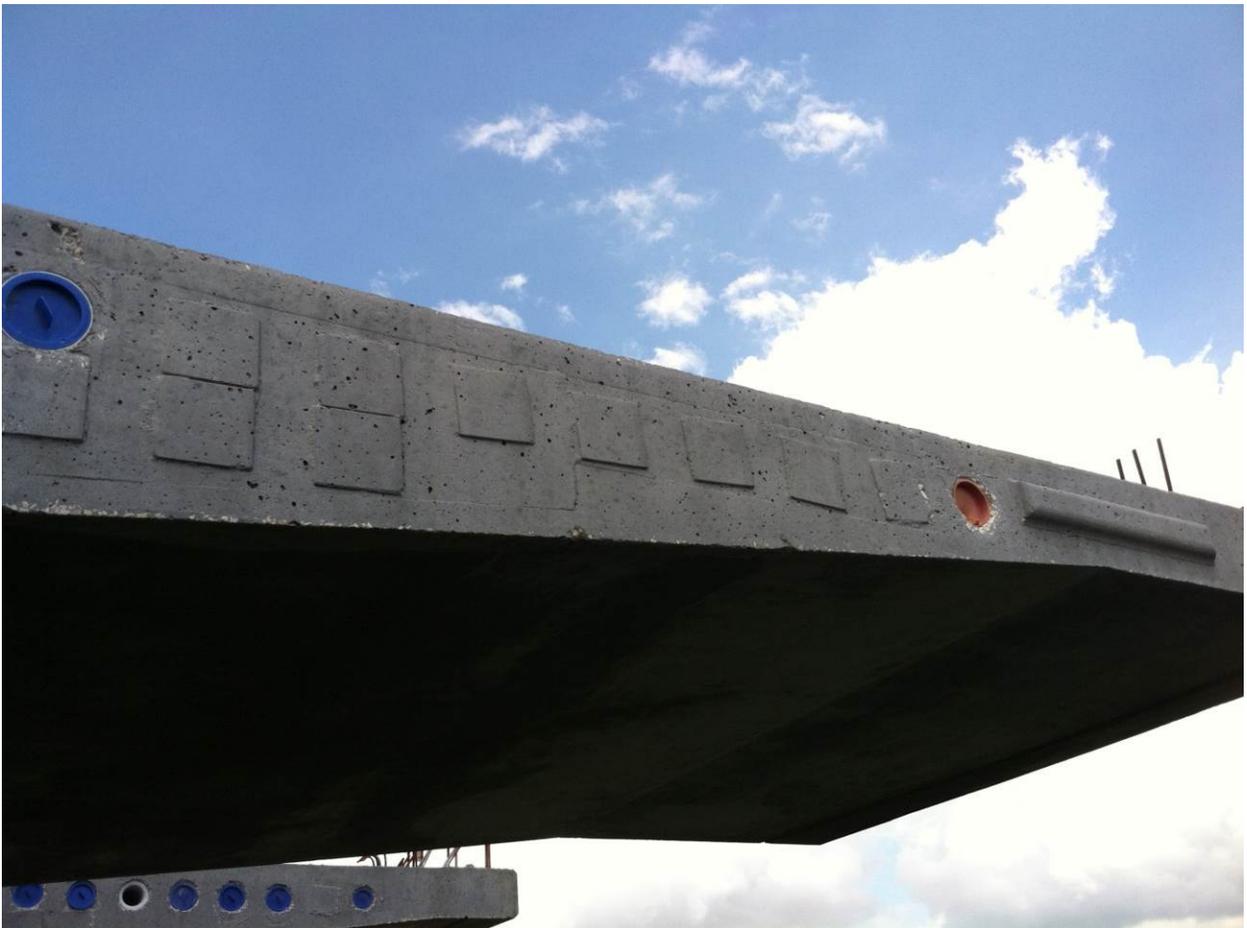
Figure A6 PT strand (left) and PT bar ducts (right) with temporary end caps in casting yard (14U, used for PT bar duct RH record). Note uncapped duct in nearby segment. No picture for 13U

Two (2) box girder segments from the casting yard, both to be installed in span (10-11), were chosen for probe insertion. These segments were still on the ground. During span erection, these segments were to sequentially follow the cantilevered segment mentioned previously. The upper ducts near the inside of the segment wings (left side in Figure A6) had probes positioned within to emulate similar concrete cover as in experiments that are part of an ongoing investigation at USF. Segment 13U (PT 2 & 9) had probes placed within PT strand ducts, where segment 14U had probes placed in PT bar ducts (PT 3 & 10). Some ducts were found to have the caps open upon inspections (Figure A7).
