FINAL REPORT

CORROSION CHARACTERISTICS OF UNPROTECTED POST-TENSIONING STRANDS UNDER STRESS

**Contract No. BDK84-977-22
Final Report to Florida Department of Transportation**

**UNIVERSITY OF
SOUTH FLORIDA**

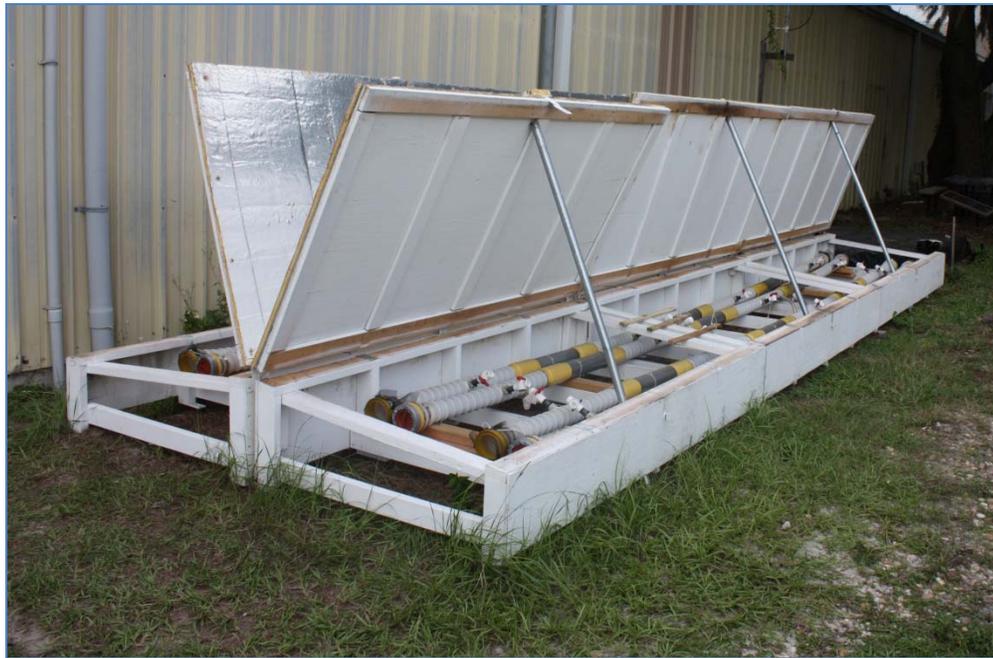
Figure C1 USF Duct Facility in the Open Position

Two facilities were available from the previous investigation (Sagüés et al., 2011) and used for the present unstressed strand study. The facilities were designed to house eight (8) full sized ducts currently used in practice albeit shorter in length than PT duct used in actual bridges. Each facility consists of a hinged roofing enclosure which house eight (8) ducts each. The ducts were sheltered from direct rain on the top and sides, but open to the outside at the ends. The duct segments consisted of polypropylene corrugated sections (PPEX3 3-in internal diameter, 3.6-in external diameter) and transparent polyvinyl chloride (PVC) sections (3-in Sch-40 Harvel™ Clear PVC). The transparent portions were added for in situ visual inspection. Ducts were approximately 20 feet in length and the roof enclosure extended two feet on each side, Figure C1 and Figure C2 display the facility design. Duct sections contained a sag in the center to reproduce conditions used in external PT tendons which have intentional sags secured by deviator blocks. Four vent ports (used in construction for grouting purposes) for each duct was installed at fifth points. One of these central vent ports for each duct housed a relative humidity and temperature probe (Omega OM-EL-USB-2-LCD) as shown in Figure C3.

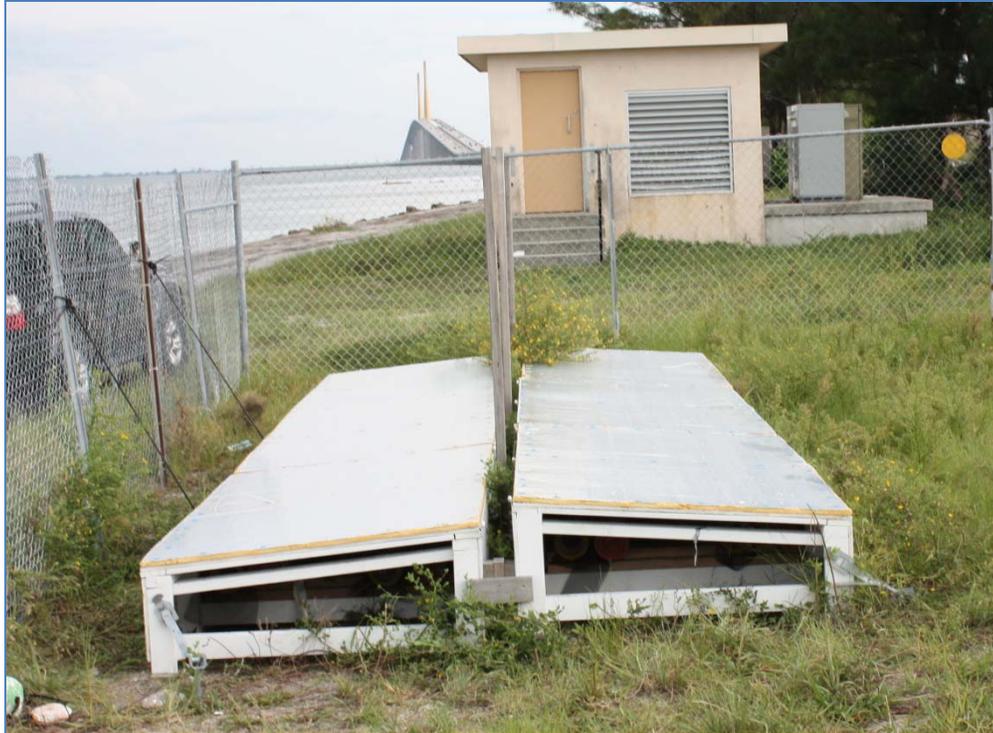
Figure C2 SSK Duct Facility in the Closed Position - Sunshine Skyway Bridge Main Span and Generator Control Room in the Background

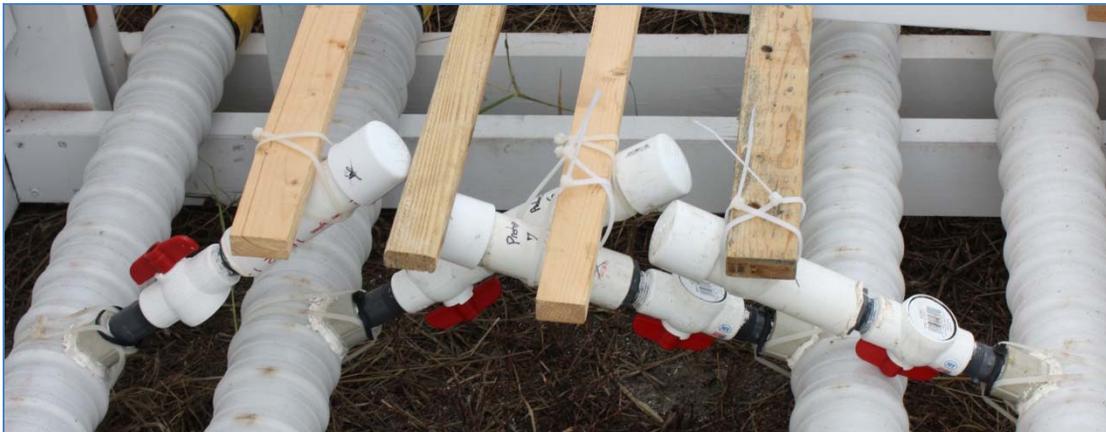
Figure C3 Relative Humidity & Temperature Probe Housings Attached to Ducts via Vent Port and Secured with Wood Boards and Zip-Ties

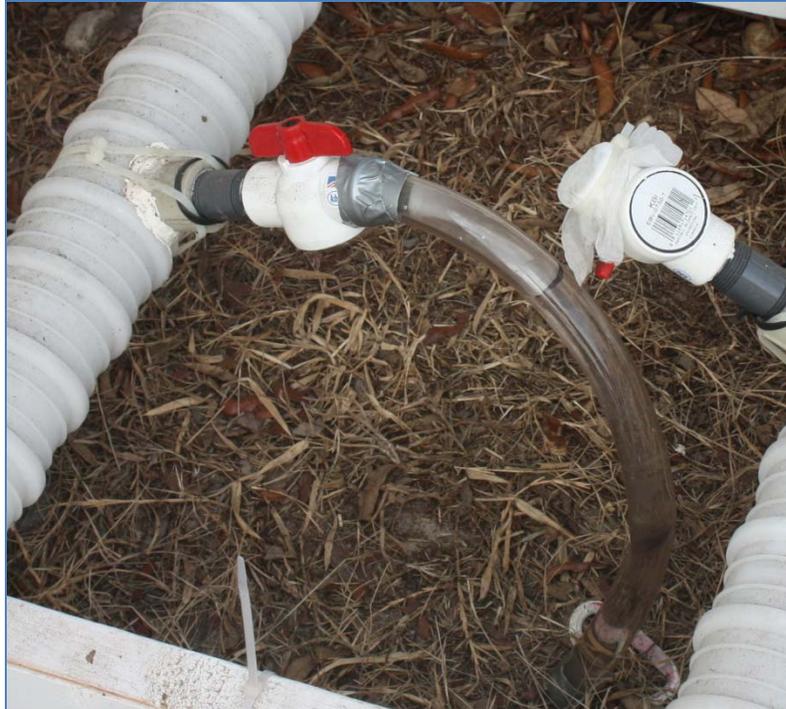
Figure C4 Water Reservoir Attached via Vent Port (left) and Closed Vent Port Covered with Bug Shield (Right)

The other would house a separate water reservoir for the ducts which required it. Water level was marked and refilled as needed, as seen in Figure C4.

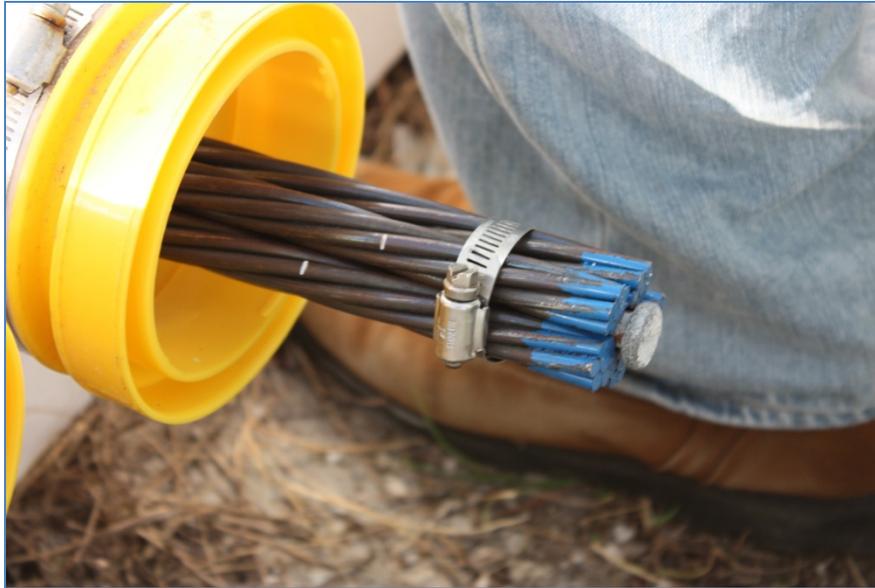
Figure C5 Strand Group Ready for Duct Insertion with Galvanized Spike Secured with Stainless Steel Hose Clamp

A galvanized nail was attached via a stainless steel hose clamp (Figure C5) to simulate the effects (if any) of a galvanized anchorage system on the corrosion propagation of the strands.

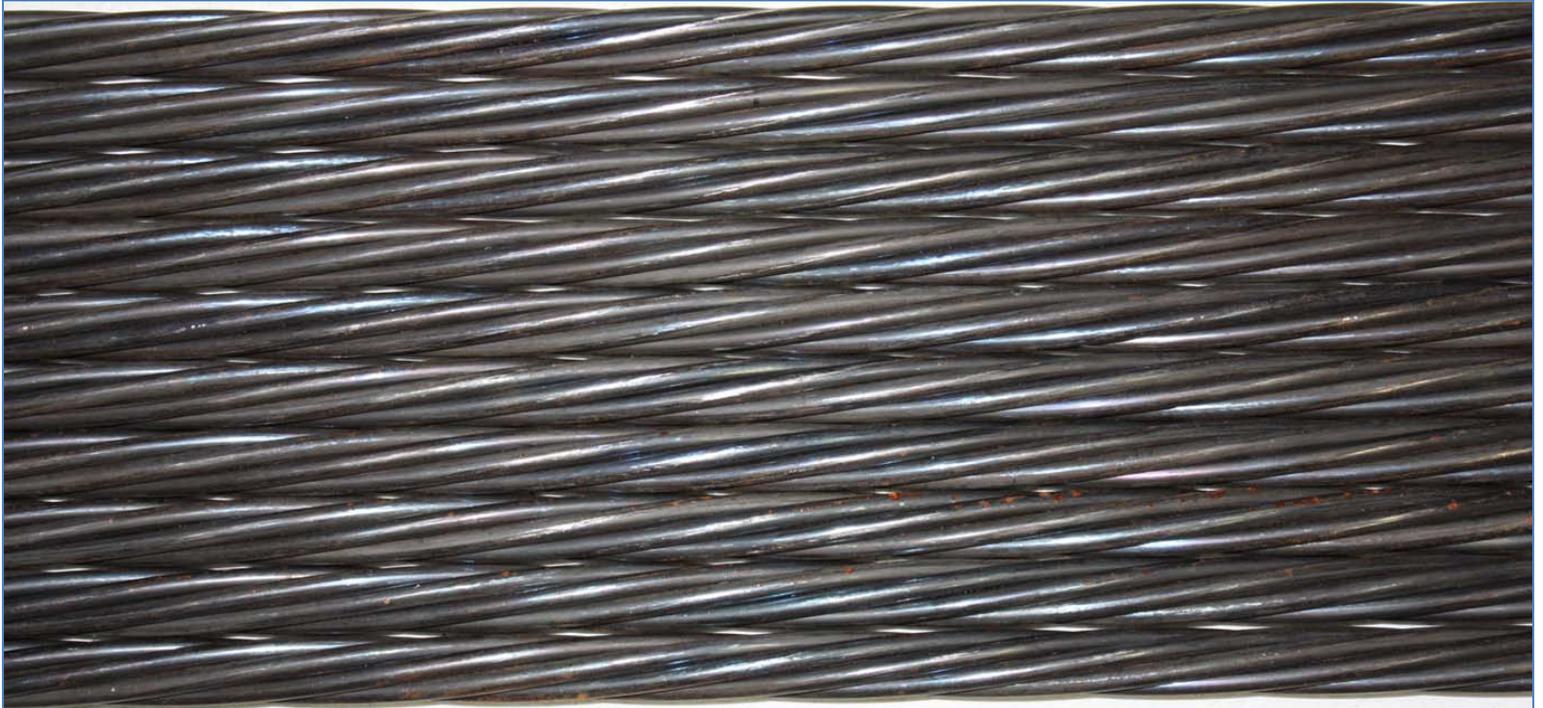
Figure C6 Typical As Received Condition of Strands Prior to Exposure

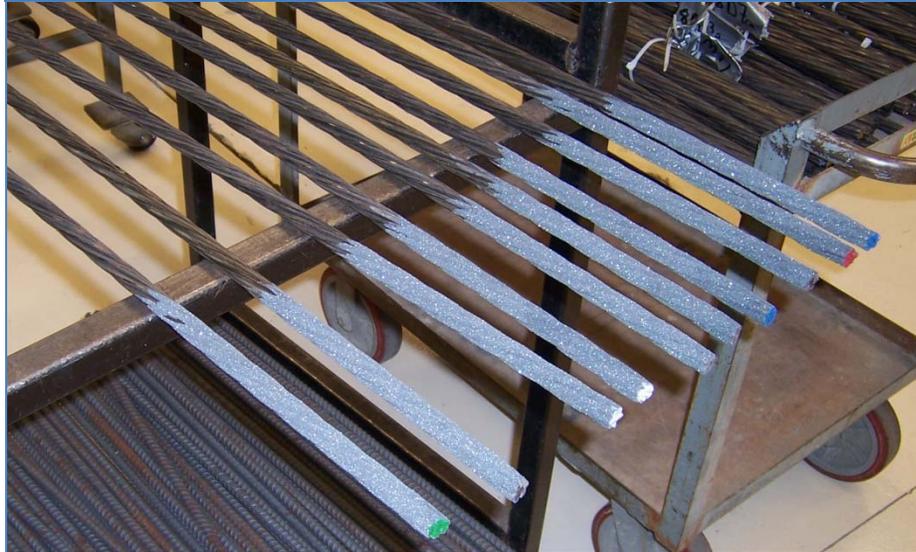
Figure C13 Sample Strands' Ends Coated in Grit Material Awaiting Tensile Testing

C.3 Tensile Testing
