ADA Access to Passenger Vessels: Finding Safety Equivalence Solutions for Weathertight Doors with Coamings

Phase 2: A Risk Management Approach to Reconfiguration Design Solutions

March 2005

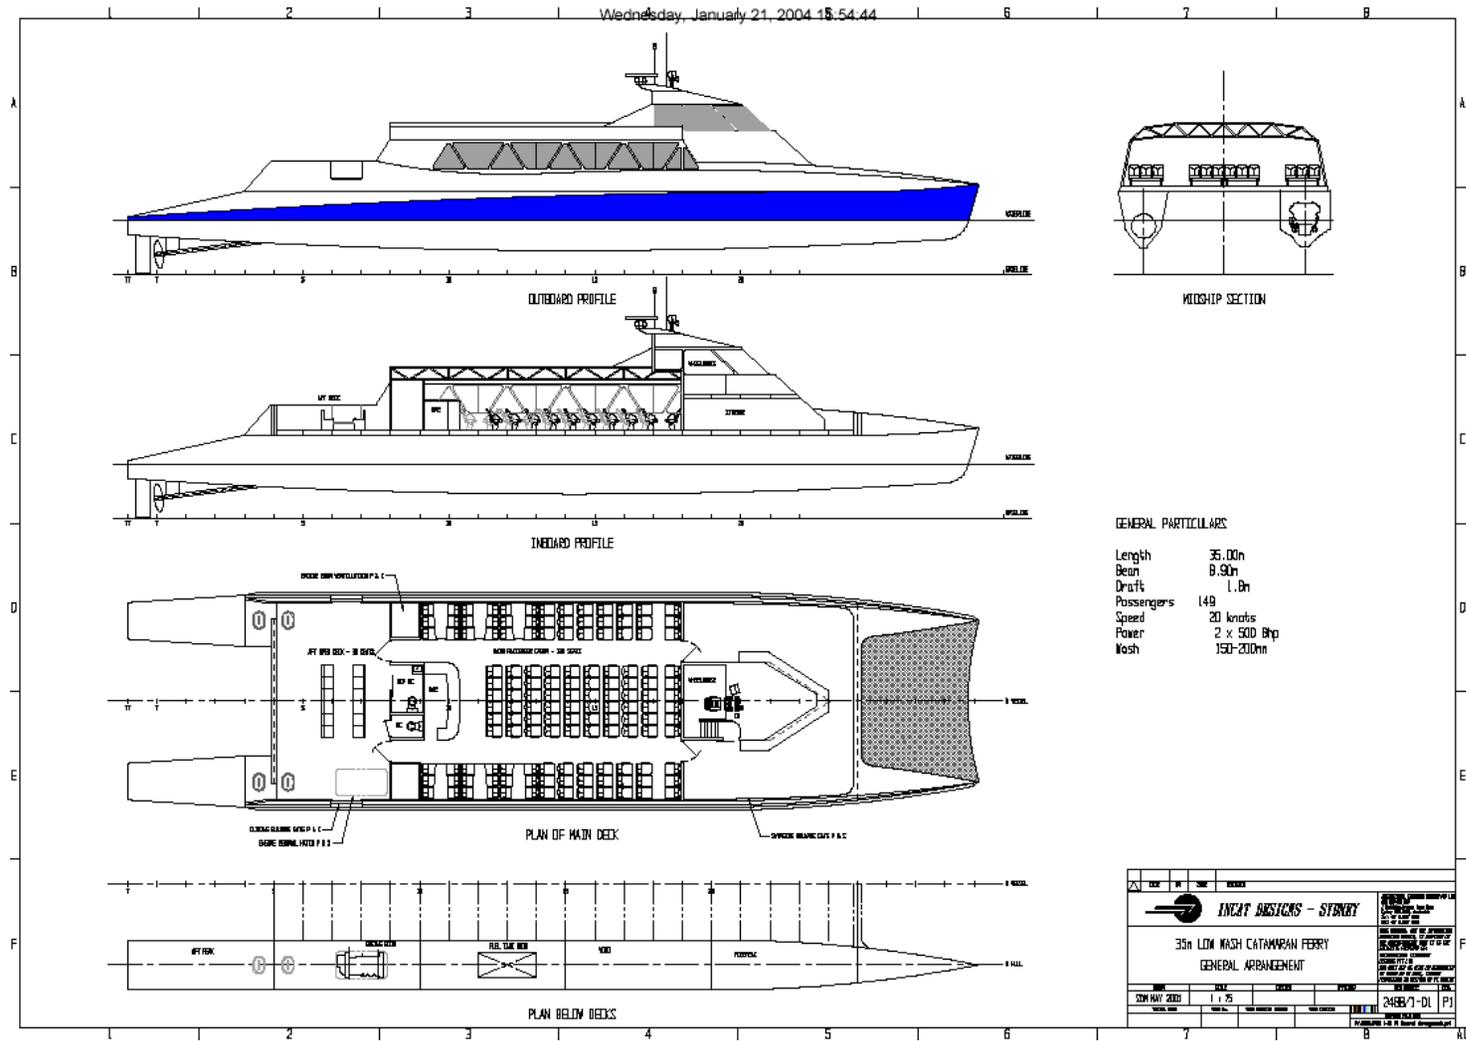
Figure 1. General plans, Gladding –Hearn/INCAT 35 meter catamaran

The particulars of the case for this Gladding-Hearn and INCAT Designs (GH-ICD) boat (deck plan, Figure 1) are:

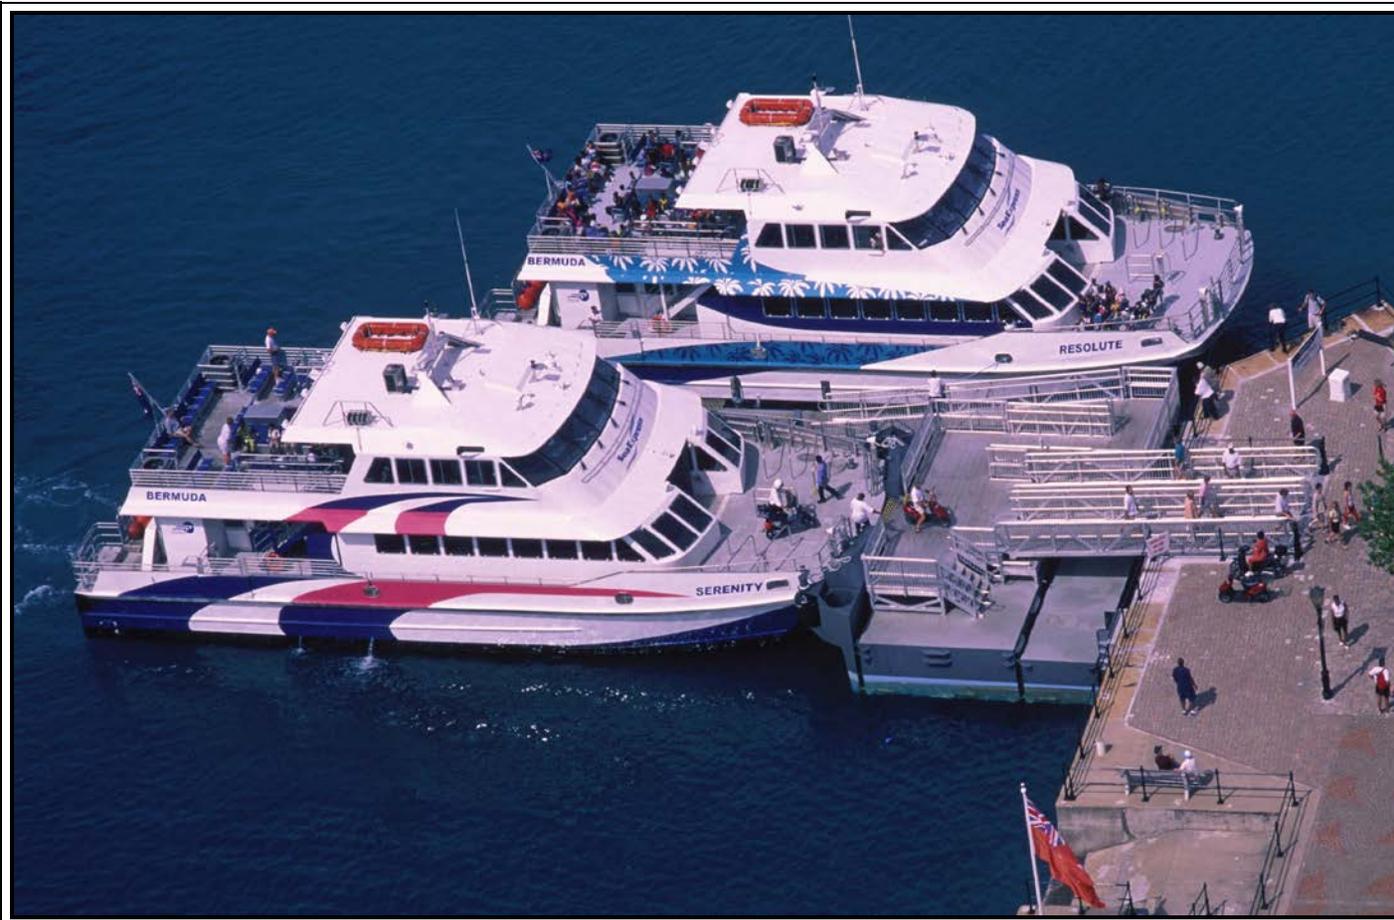
Figure 2. Gladding-Hearn INCAT Design boats 331 and 332 at dock.

NOTE: These boats are not identical to the design chosen for this example and shown in Figure 1. The photograph shows how bow doors and bow loading reconfigure the design (boat at bottom of photograph) of the passenger cabin. The configuration of the side loader (at top) has different doors into aft area of the passenger cabin, which are not part of the configuration for this example, as shown in Figure 1.

- Embarkation access may be via the bow to the forward deckhouse doors, or via bulwark gates near the stern to the aft deckhouse doors. Figure 2 shows GH-ICD boats of similar, but not identical, design to the 35-meter boat considered herein, one each with the bow and stern embarkation access points.

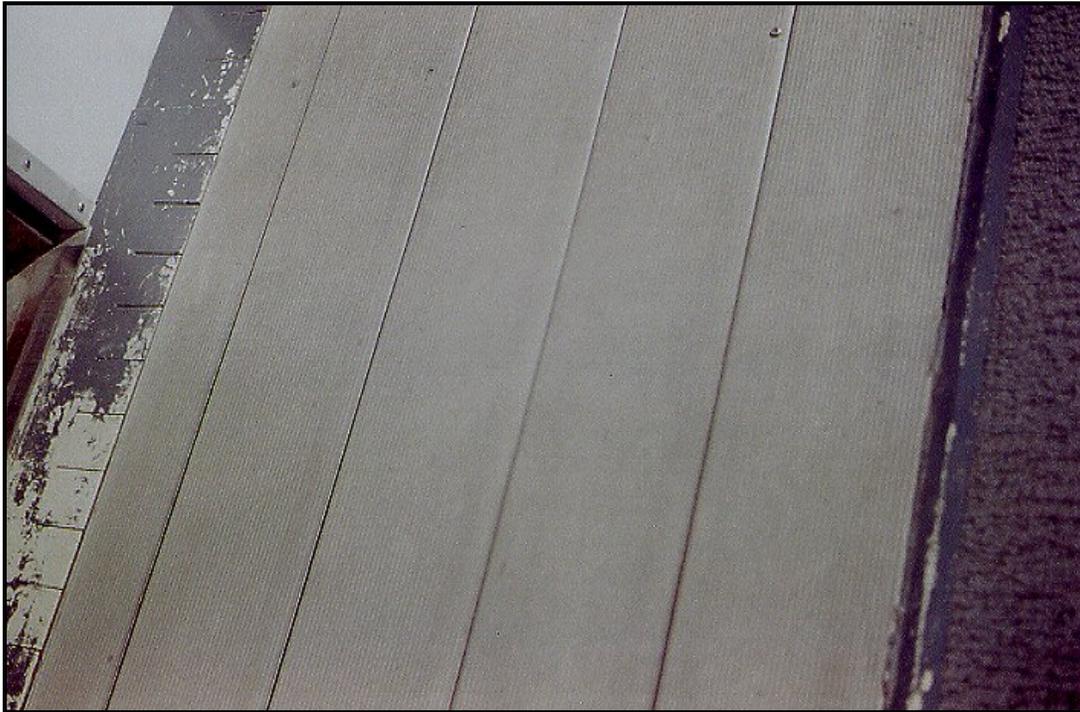
FIGURE 3. DRAINAGE DETAIL, GH-ICB BOAT *FLYING CLOUD*, FORWARD EMBARKATION DOORS

- “Concept A” or B” exterior drains (see figures, Appendix A)
 - Gladding – Hearn exterior drainage detail on *Flying Cloud* (Appendix B, Figure 3)
 - Bulwarks, bulkheads, deck overhangs, etc. preventing passage of water to the door, especially from the direction of exposure, for example, from the bow for forward facing doors or from the stern for aft facing doors.
- Weathertight door with removable regulation height coaming -

With or without the floating deck, in protected water service, the solution indicated would be a coaming-less weathertight door (possibly similar to the GH-ICB sliding doors found on the *Flying Cloud*) or a watertight door with minimal height sill, as allowed by the CFR for operation by able-bodied crew. The risk for this design could be further reduced with protective drainage features against water on deck (e.g., the GH-ICB drainage detail for *Flying Cloud*, Figure 3).

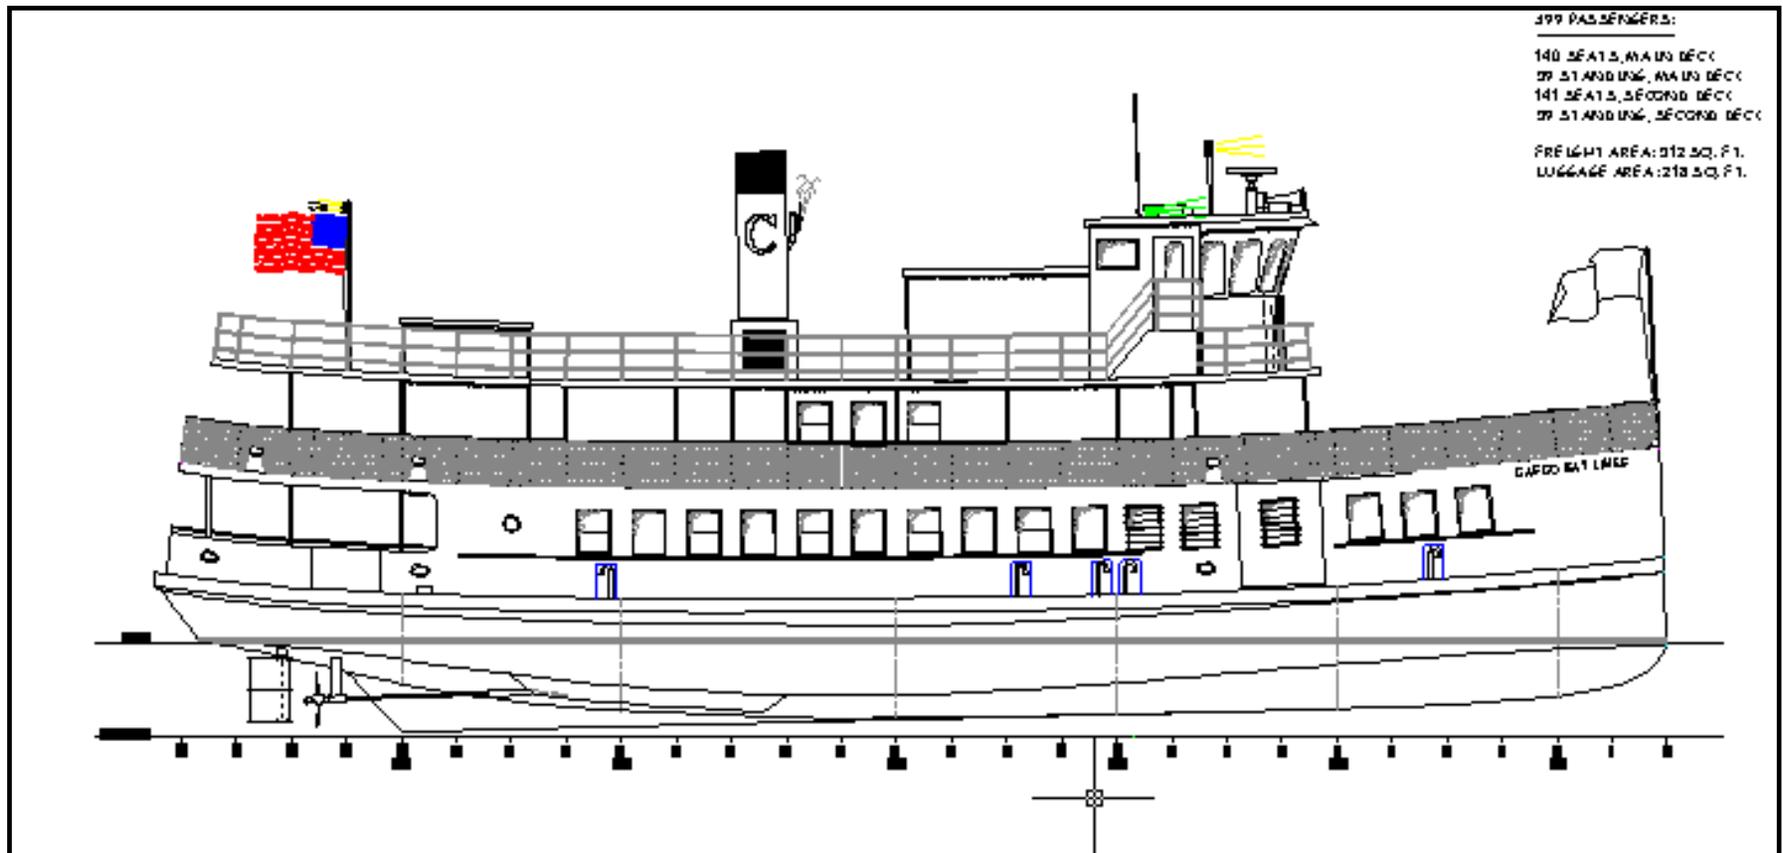
Figure 1. Casco Bay Line boat –Profile

- This is a new design for a Subchapter K boat, capacity of 399 passengers, operating in protected waters (Figure 1: Profile, and Figure 2: Main Deck Plan).
- Sliding weathertight doors on the main deck, port and starboard, for embarkation access, located forward (approximately 0.25L from the bow) at the deck edge.
- Doors have 3” coamings (designed per Subchapter S watertight integrity regulations for vessels less than 100 GT).
- This exercise is to ascertain whether the coamings could be eliminated on a risk management basis as suggested by the Phase 2 report (footnote #1). The designer states that elimination of the coamings at those points would improve embarkation access and simplify the design of the gangways from the shoreside piers used by Casco Bay Line.

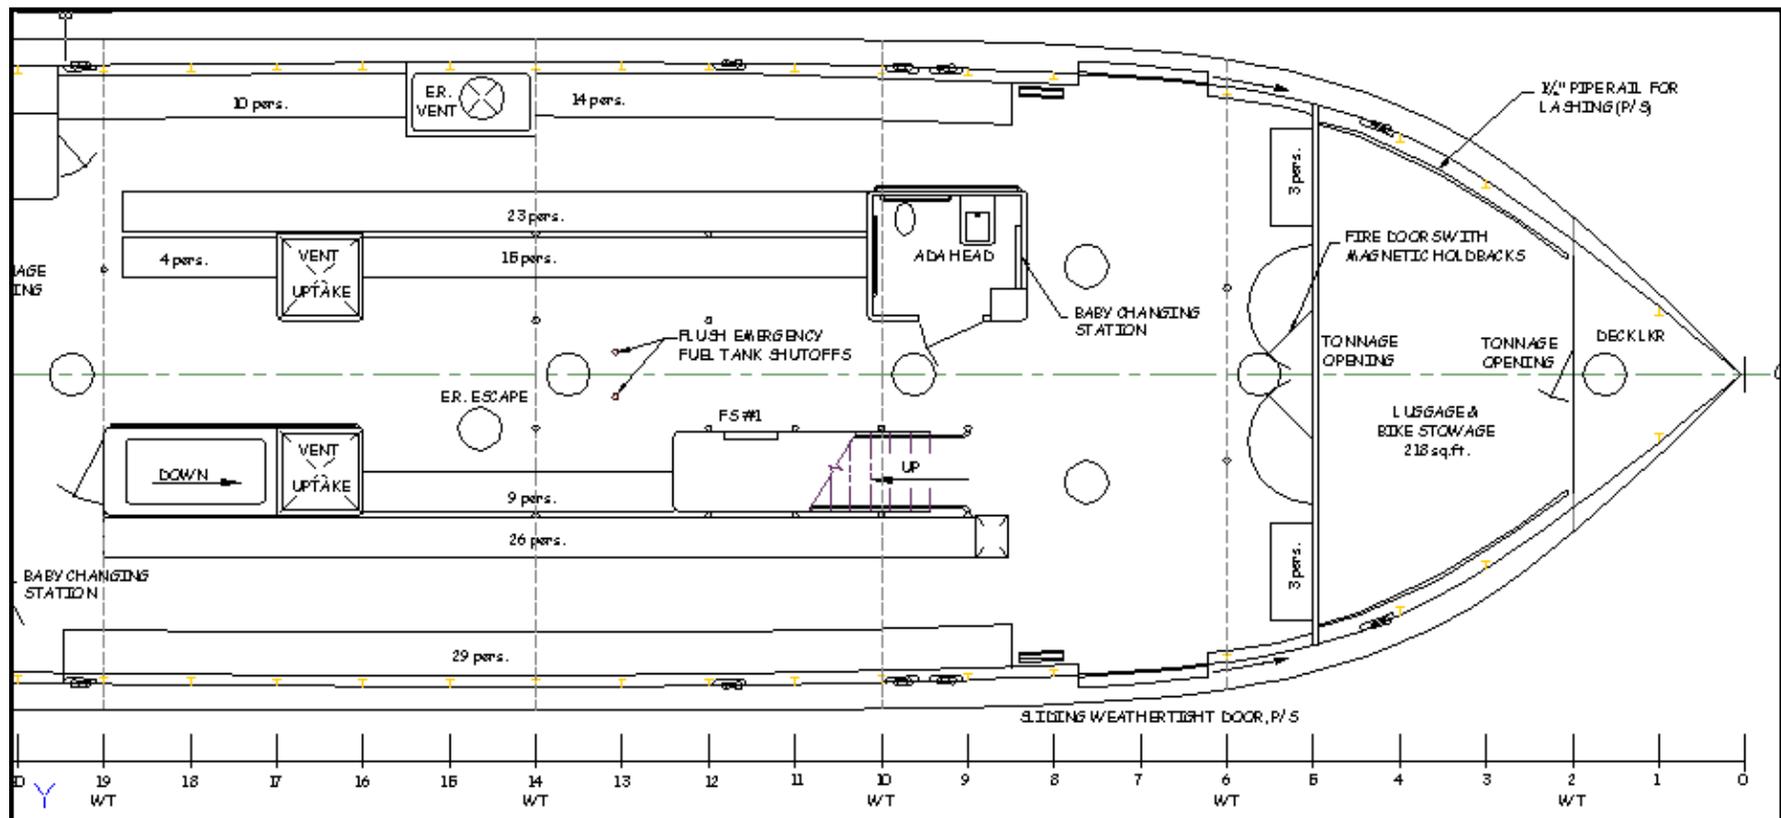
Figure 2. Casco Bay Line boat – Main Deck Plan

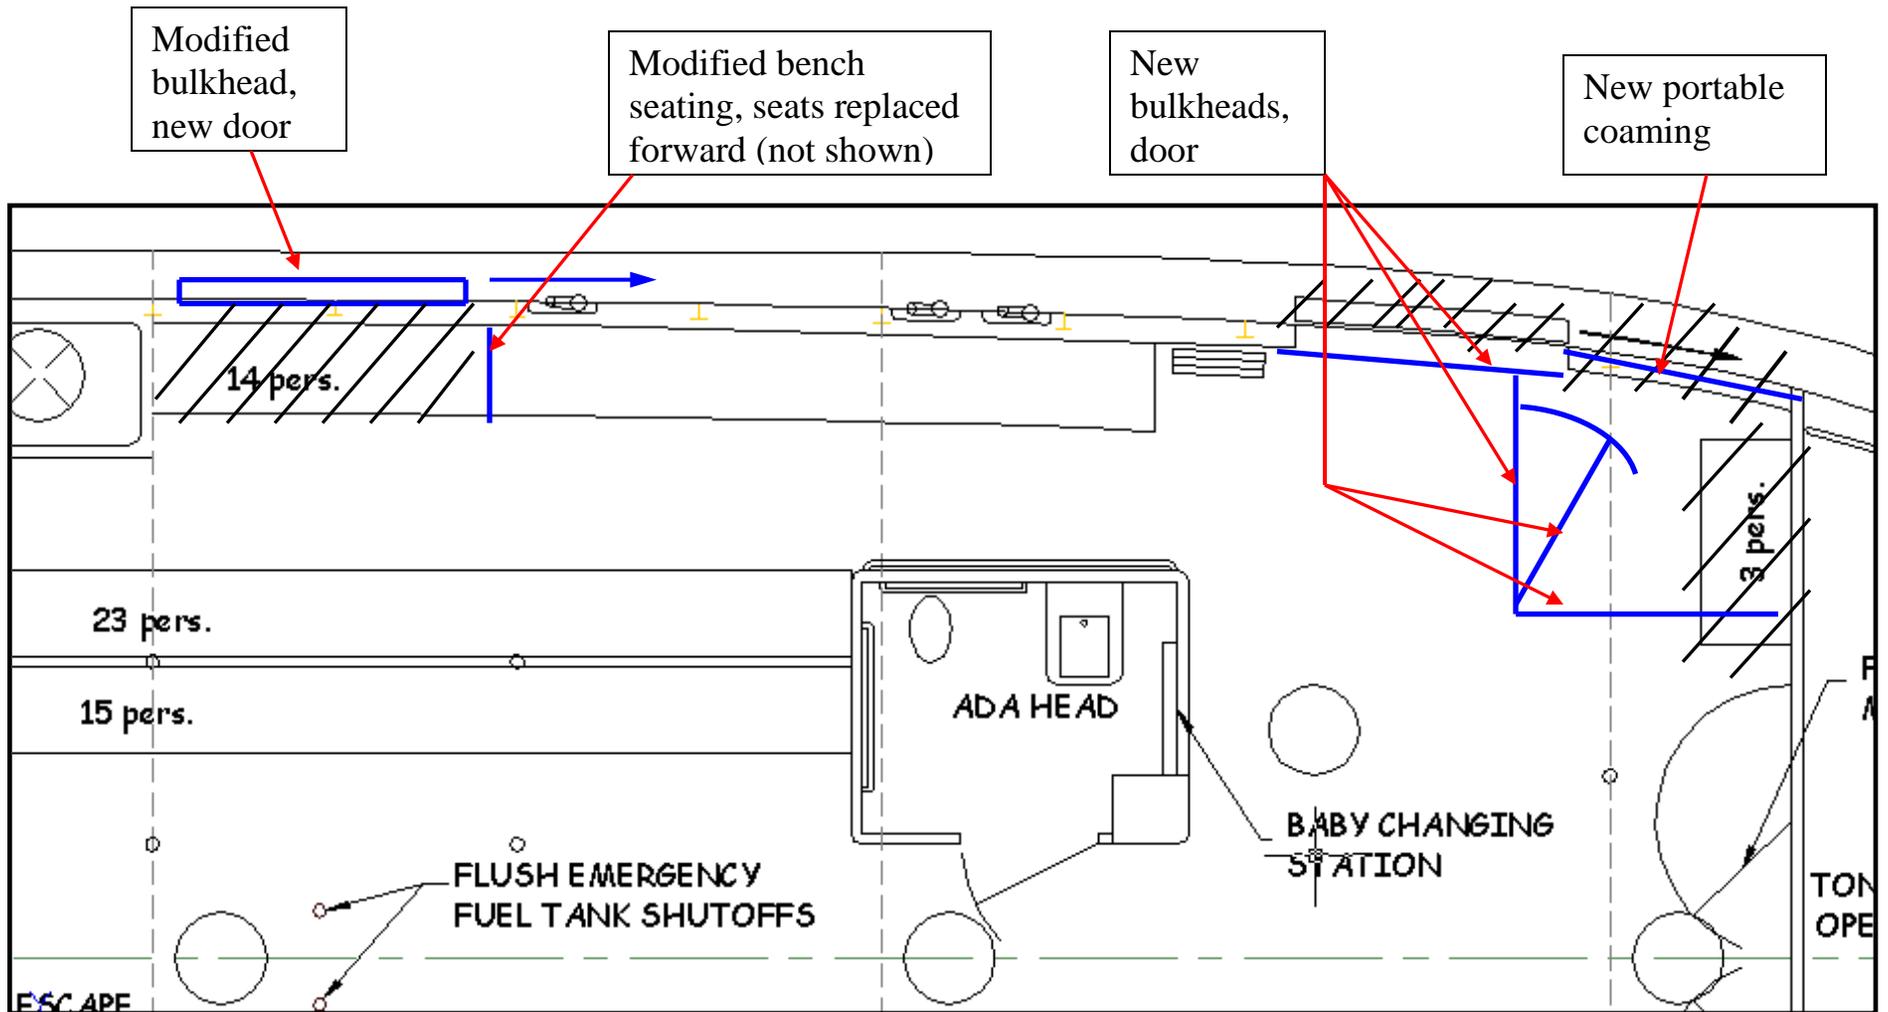
Figure 2. Door reconfigurations.

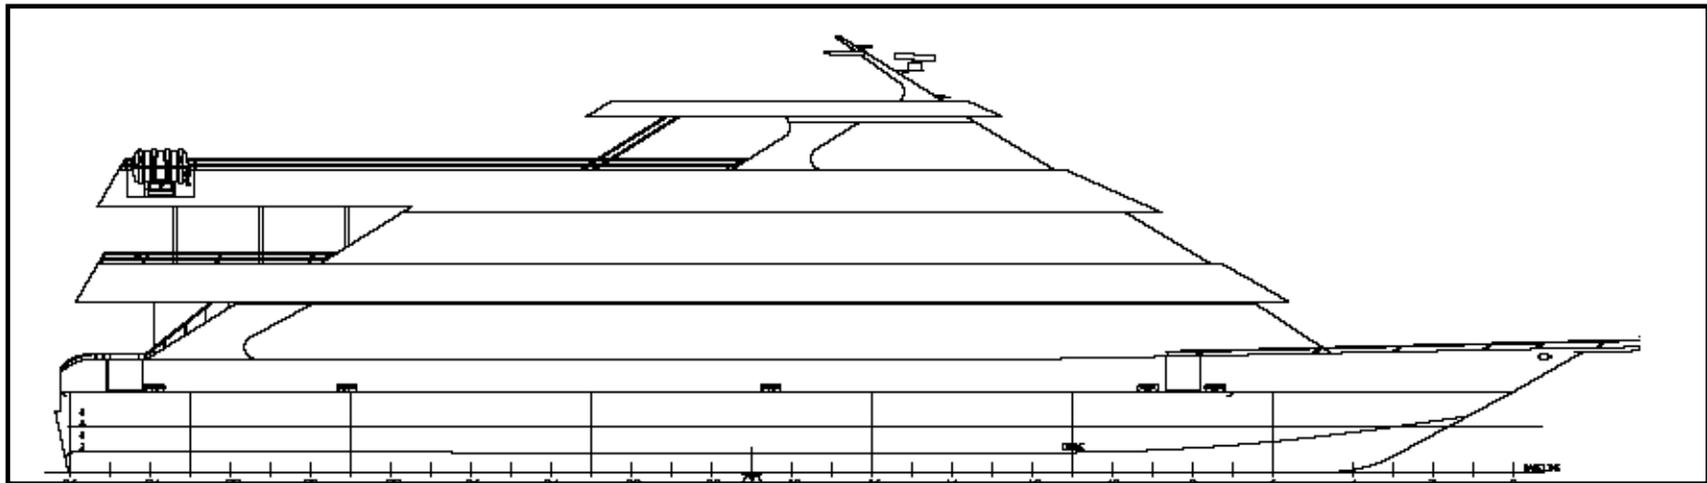
Figure 1. 127'/368 passenger dinner boat, outboard profile

- This is a new design for a Subchapter K boat, capacity of 368 passengers, operating in protected waters but designed for partially protected waters (Figures 1 and 2).
- Hinged weathertight doors in the passenger cabin on the main deck, forward to starboard for weather deck access, and aft to port for embarkation and weather deck access.
- Doors have 6" coamings, designed for partially protected waters service per 46 CFR Subchapters K and S watertight integrity regulations for vessels less than 100 GT (Parts 116.1160 and 171.124, respectively).
- This exercise is to ascertain whether the coamings could be eliminated or reduced on a risk management basis as suggested by the proposed approach.

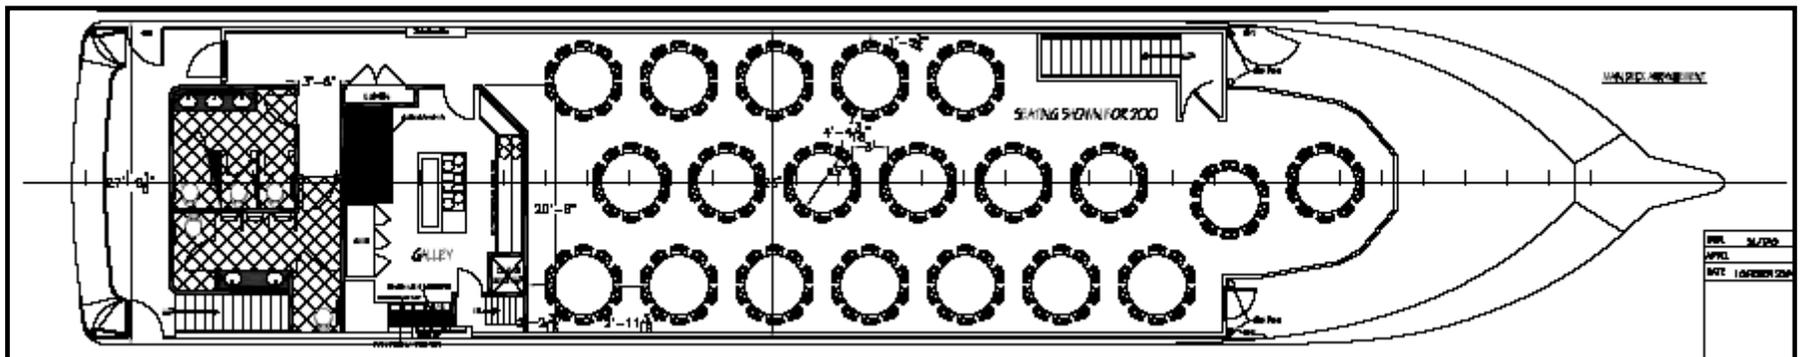
Figure 2. 127'/368 passenger dinner boat, main deck plan
