NATIONAL HIGHWAY SYSTEM CONNECTORS TO FREIGHT FACILITIES

IN THE DELAWARE VALLEY REGION

DELAWARE VALLEY REGIONAL PLANNING COMMISSION

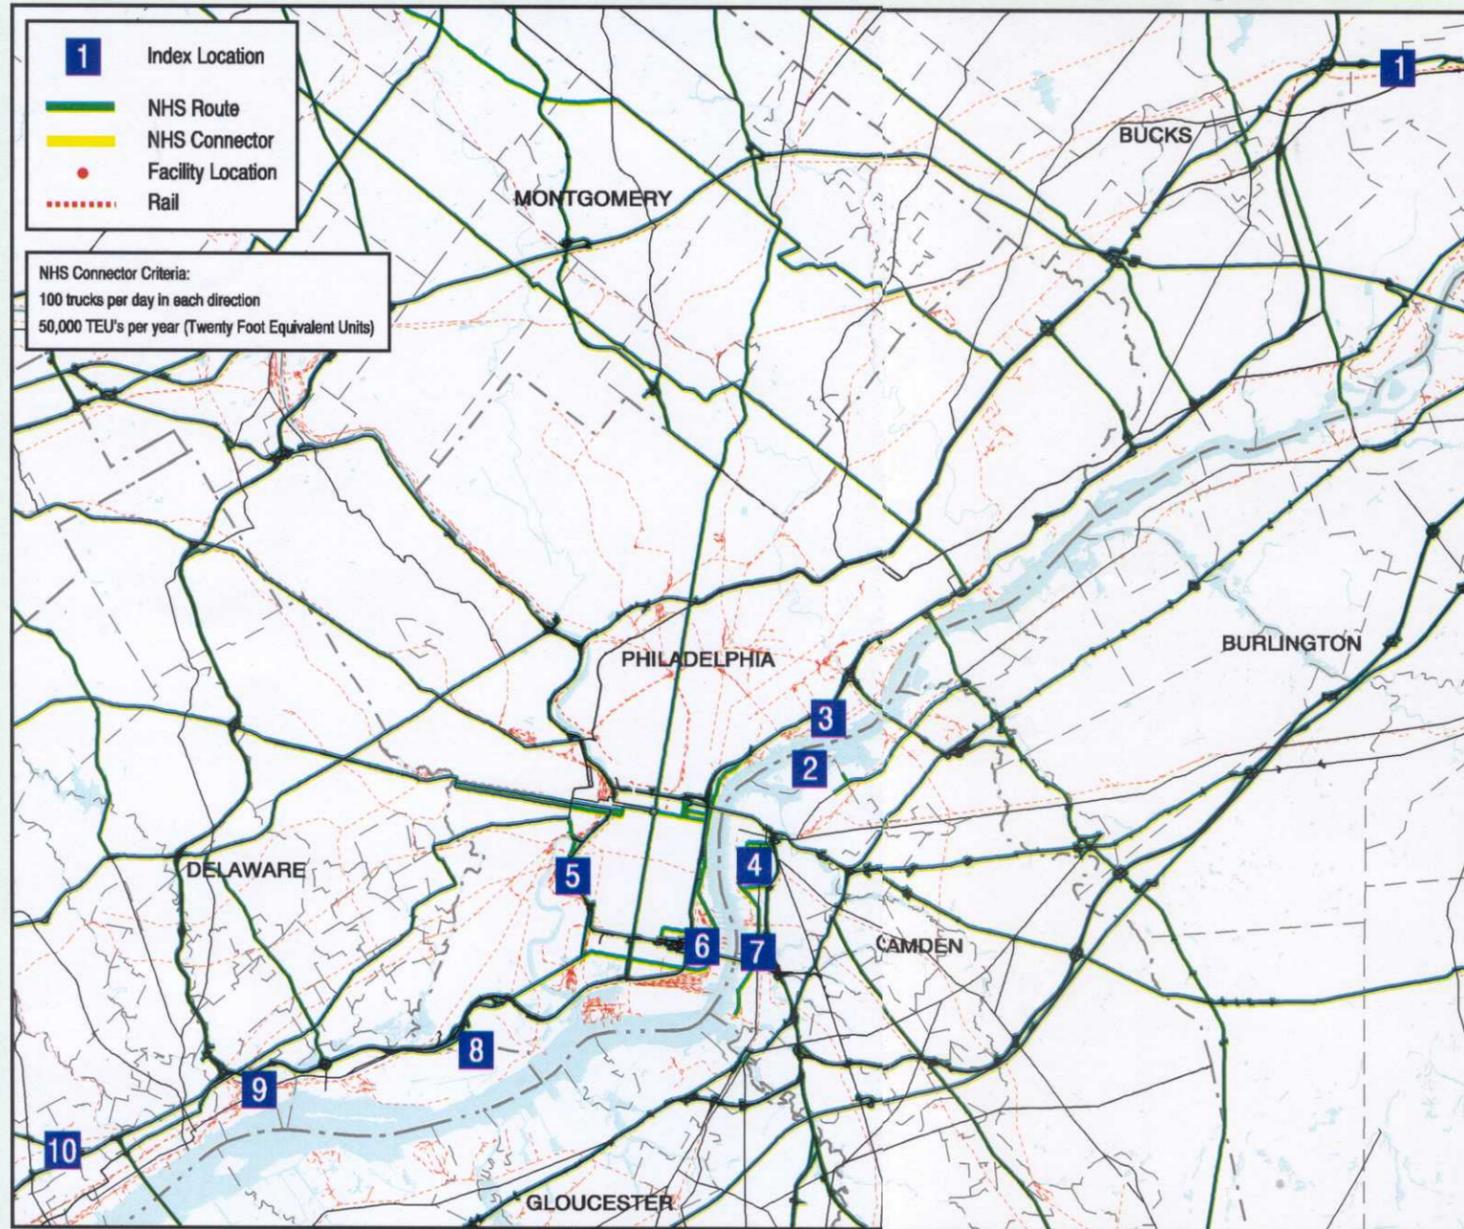
FIGURE 1 : LOCATION MAP

Figure 1 displays a broad view of the existing NHS (shown as green lines) and the ten key intermodal freight locations where local access is supported by an officially designated connector highway. Insets are provided at a larger scale for each freight center to highlight the connector highways (shown in yellow). Fact sheets addressing traffic, physical and operating conditions along the connectors are included in the Appendix to this report. Each fact sheet provides a (still) larger scale map of the connector highway.

- 1** Index Location
- NHS Route
- NHS Connector
- Facility Location
- Rail

NHS Connector Criteria:
 100 trucks per day in each direction
 50,000 TEU's per year (Twenty Foot Equivalent Units)

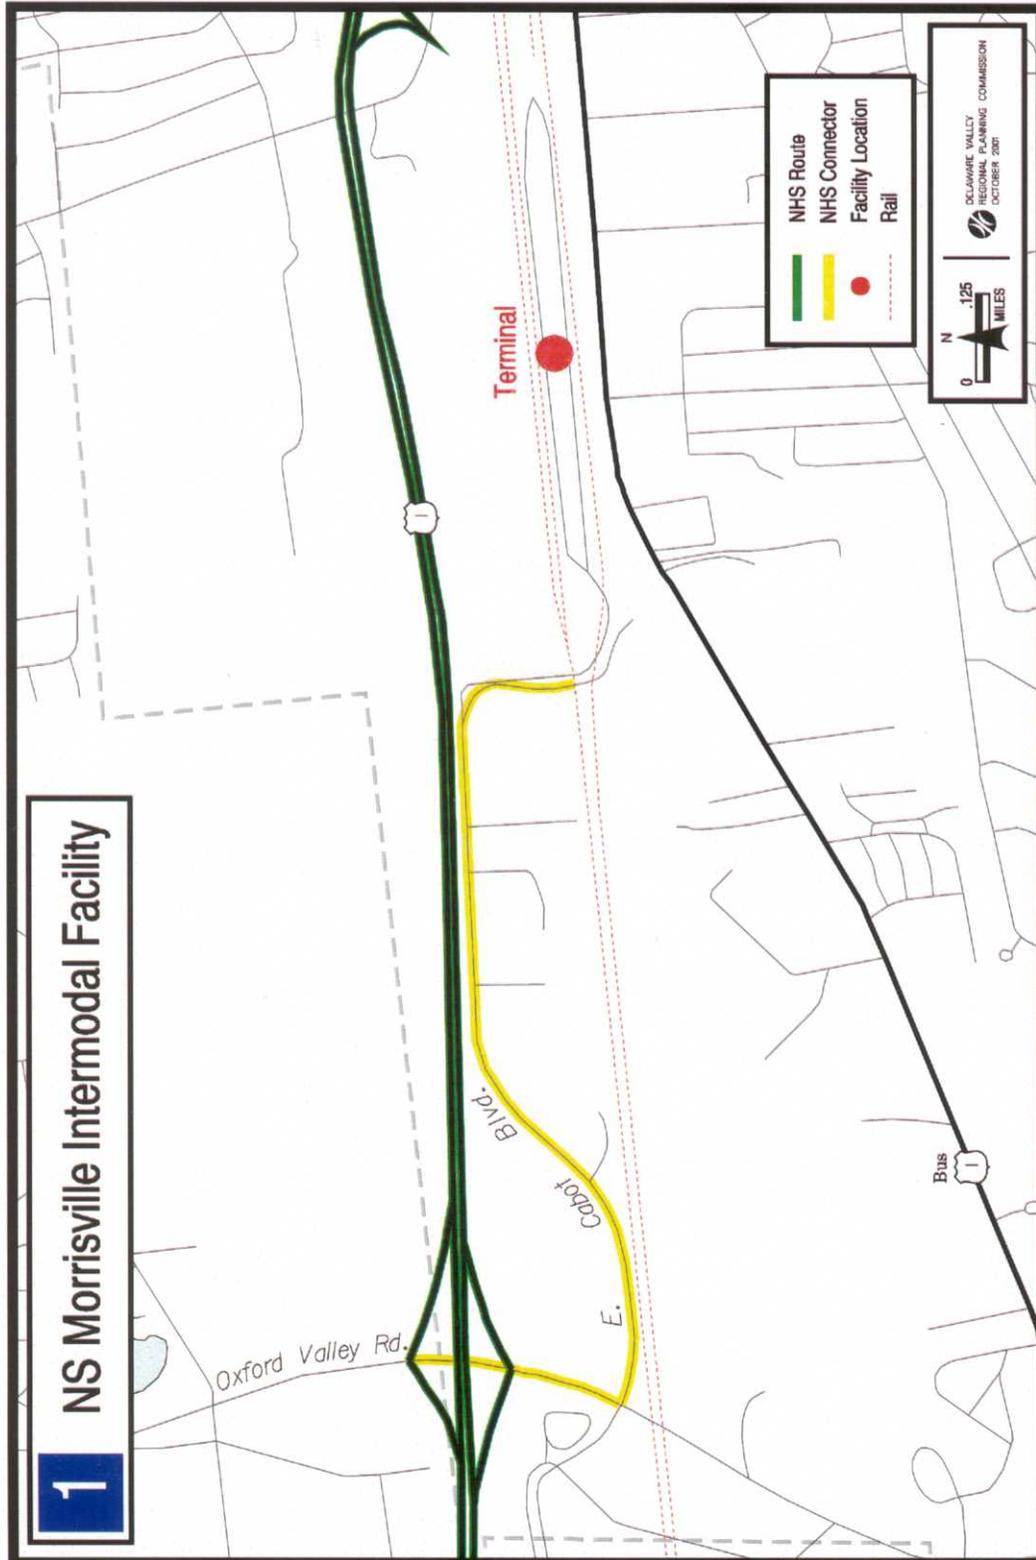
From terminal to US 1 via E. Cabot Blvd. & Oxford Valley Rd.
1.884 miles

Condition	Description	Percent	Location
Very Good	Newly built or resurfaced and distress free.		
Good	Smooth surface with little to no cracking or rutting.	20 %	Oxford Valley Rd.
Fair	Serviceable with shallow rutting and moderate cracks beginning to occur, but does not affect travel speed.		
Poor	Same problems as fair but worse, cause some reduction in speed.	40 %	East Cabot Blvd.
Very Poor	Major problems with potholes, etc., causing substantial reductions in speed.	40%	East Cabot Blvd.

Problem	No Problem	Short Section	Most of Length	Description
Inadequate Travelway Width	✓			
Inadequate Shoulder Width	✓			
Lack of Stabilized Shoulder	✓			
Tight Turning Radii at Intersection	✓			
Road Not Paved	✓			
Bridge / Overpass Vertical Clearance	✓			
Weight Limitation on Road / Bridge	✓			
Narrow Bridge / Tunnel	✓			
Rough Abandoned Railroad Crossing	✓			
Drainage / Flooding				Unknown
Other <u>No pavement markings</u>		✓		At E. Cabot Blvd. / Oxford Valley Rd. intersection

Destination Signing / Trailblazers	
Is there adequate signing from the mainline NHS to the terminal; and from the terminal back to the mainline NHS? Yes _____ No <input checked="" type="checkbox"/>	
New / Replacement Signs Recommended	Location
Sign with terminal name	At intersection of Oxford Valley Rd. and E. Cabot Blvd.
Sign for US 1	At Intersection of E. Cabot Blvd. and Oxford Valley Rd.
Signs for terminal	On US 1

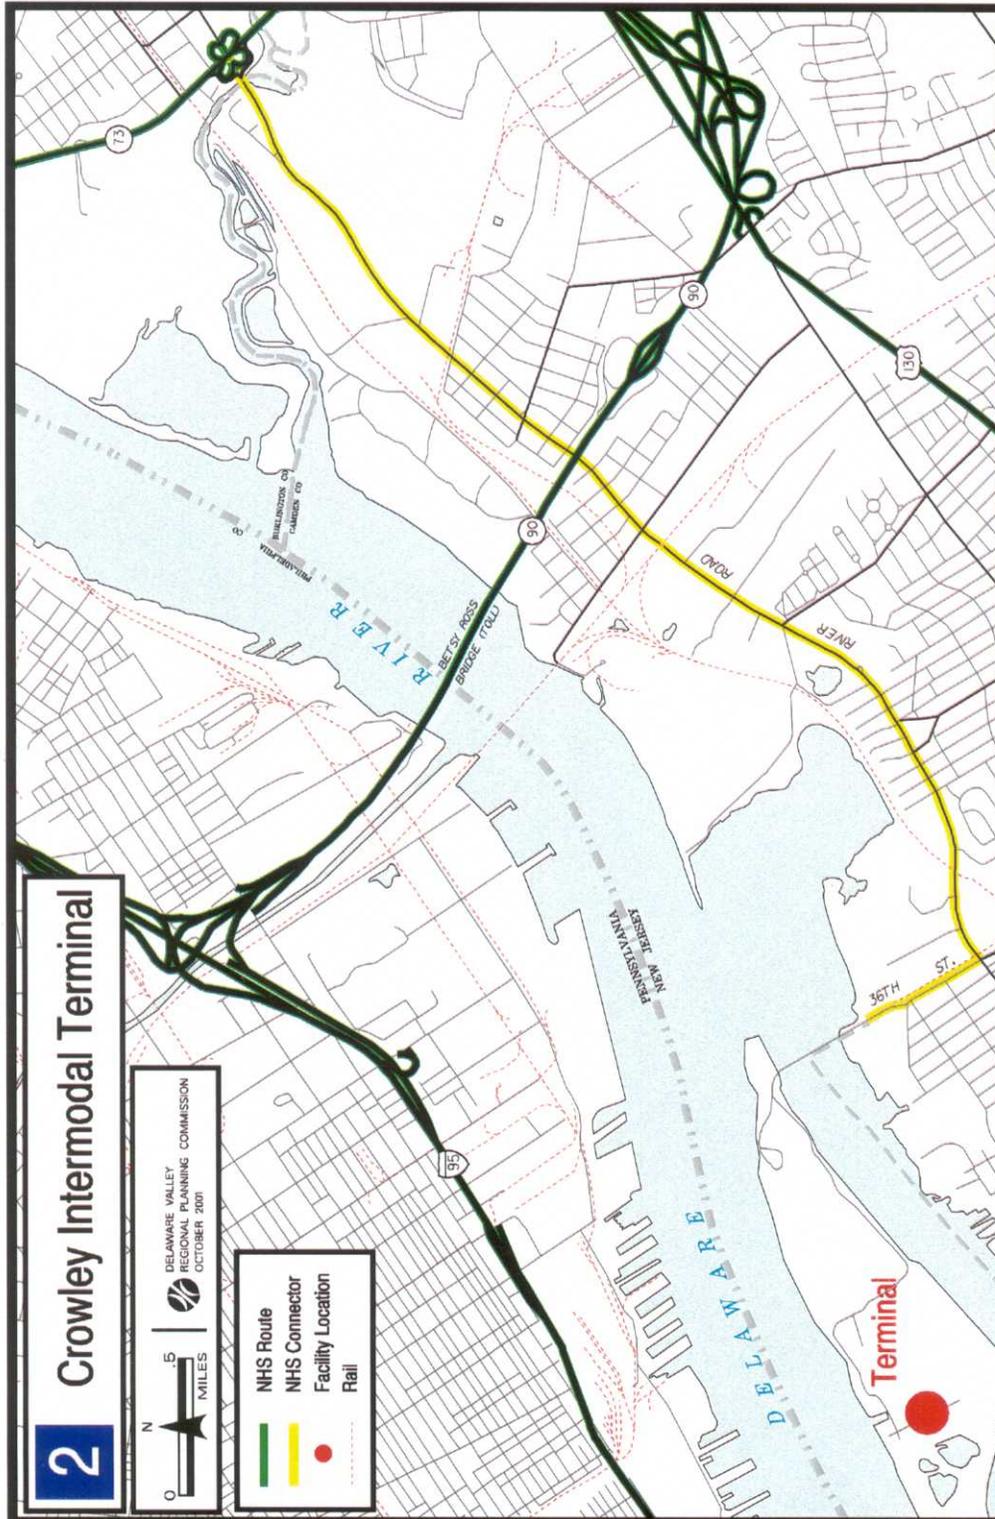
2

From terminal to NJ 73 via 36th St. & River Rd. (CR 543)
4.125 miles

Problem	1	Description
Delays at Railroad Crossing		
Switching / Make-up Operations		
Crossing Warning Devices	✓	Crossbucks, but no flashing lights
Inadequate Sight Distance at Crossing		
Rough Railroad Crossing Surface	✓	
Vehicle Underclearance (Humped Crossing)		
Lack of Alternate Route		
Other <u>crossing located at intersection</u>	✓	train may interrupt traffic at intersection; traffic signal must protect traffic

Condition	Description	Percent	Location
Very Good	Newly built or resurfaced and distress free.	65%	River Rd. (NJ 73 to Cove Rd.)
Good	Smooth surface with little to no cracking or rutting.	20%	River Rd. (Cove Rd. to 36 th St.)
Fair	Serviceable with shallow rutting and moderate cracks beginning to occur, but does not affect travel speed.	10%	36 th Street
Poor	Same problems as fair but worse, cause some reduction in speed.		
Very poor	Major problems with potholes, etc., causing substantial reductions in speed	5%	Bridge at River Rd. / NJ 73 interchange

Geometric / Physical Features				
Problem	No Problem	Short Section	Most of Length	Description
Inadequate Travelway Width		✓		36 th Street
Inadequate Shoulder Width	✓			
Lack of Stabilized Shoulder		✓		36 th Street East side
Tight Turning Radii at Intersections		✓		At River Rd./ 36 th Street intersection
Road Not Paved	✓			
Bridge / Overpass Vertical Clearance		✓		13'8" under Delair Bridge
Weight Limitation on Road / Bridge	✓			
Narrow Bridge / Tunnel	✓			
Rough Abandoned Railroad Crossing		✓		At John Tiptoe Blvd.
Drainage / Flooding		✓		Under Delair Bridge
Other <u>No Pavement Markings</u>		✓		On 36 th Street

New / Replacement Signs Recommended	Location
Trailblazer to Petty's Island	From both directions on NJ 73 and along the connector where applicable
Trailblazers to NJ 73	From the facility to NJ 73 where applicable

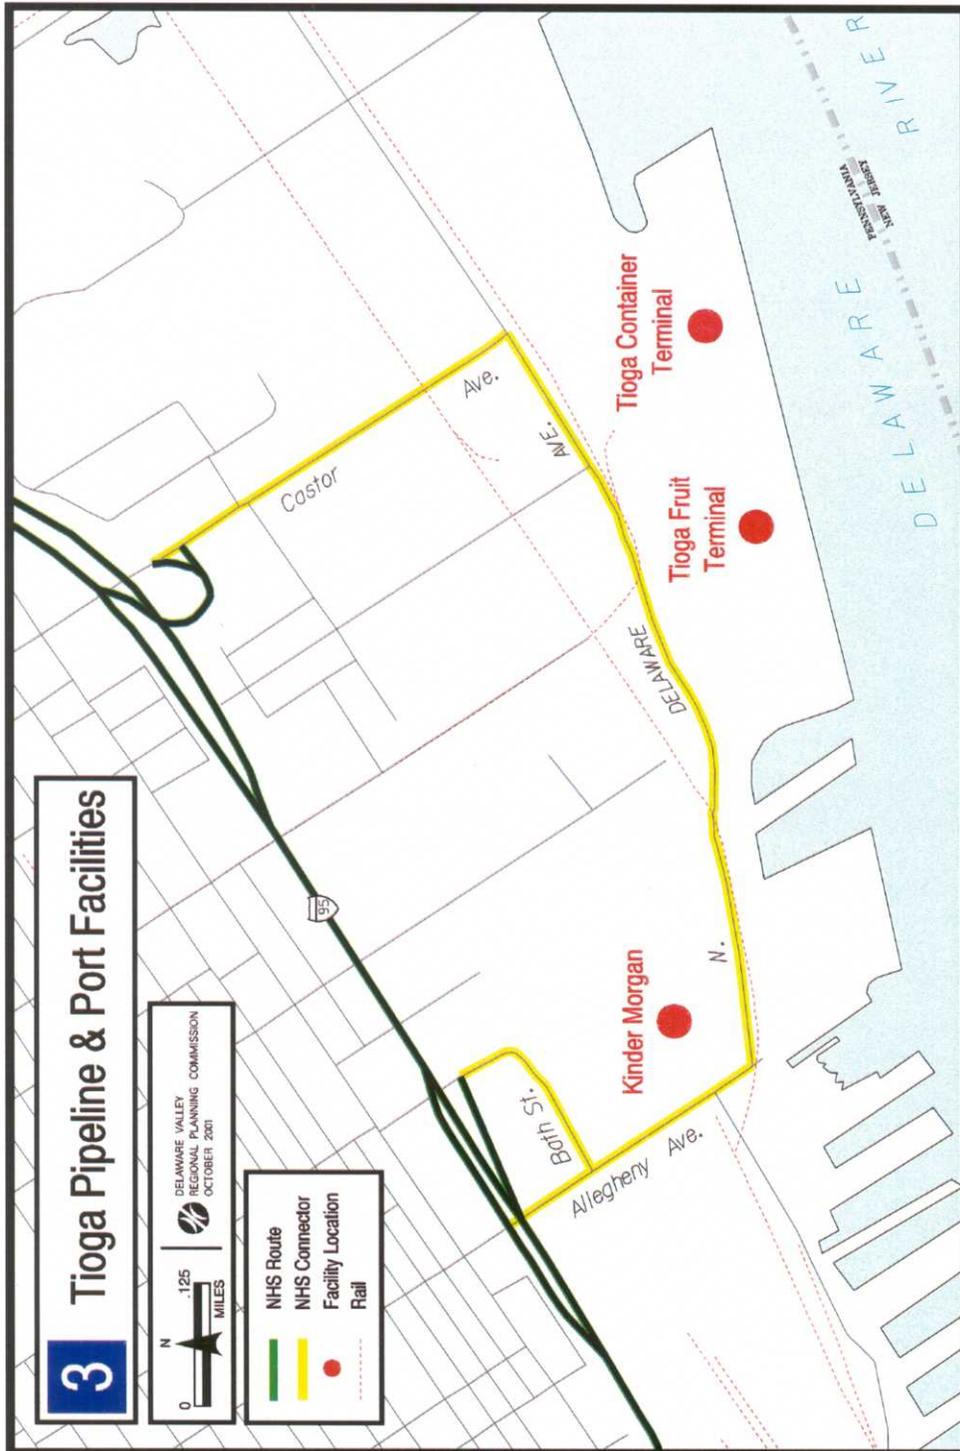
Problem	1	2	3	Description
Delays at Railroad Crossing				
Switching / Make-up Operations				
Crossing Warning Devices		✓	✓	on Castor Ave.
Inadequate Sight Distance at crossing				
Rough Railroad Crossing Surface	✓	✓	✓	on Delaware Ave. and Castor Ave.
Vehicle Underclearance (Humped Crossing)				
Lack of Alternate Route				
Other _____

Pavement Conditions			
Condition	Description	Percent	Location
Very Good	Newly built or resurfaced and distress free.		
Good	Smooth surface with little to no cracking or rutting.	80%	Bath, Allegheny, and Delaware, except at railroad crossings.
Fair	Serviceable with shallow rutting and moderate cracks beginning to occur, but does not affect travel speed.		
Poor	Same problems as fair but worse, cause some reduction in speed	20%	Castor Ave.
Very Poor	Major problems with potholes, etc., causing substantial reductions in speed

Geometric / Physical Features				
Problem	No Problem	Short Section	Most of Length	Description
Inadequate Travelway Width	✓			
Inadequate Shoulder Width	✓			
Lack of Stabilized Shoulder	✓			
Tight Turning Radii at Intersections		✓		Bath St. at I-95 sb off ramp
Road Not Paved	✓			
Bridge / Overpass Vertical Clearance	✓			No sign posted, but I-95 over pass bridge on Allegheny Ave. shows signs of impact.
Weight Limitation on Road / Bridge	✓			
Narrow Bridge / Tunnel	✓			
Rough Abandoned Railroad Crossing		✓		On Delaware Ave.
Drainage / Flooding		✓		On Delaware Ave.
Other _____

Is there adequate signing from the mainline NHS to the terminal: and from the terminal back to the mainline NHS? Yes _____ No ✓	
New / Replacement Signs Recommended	Location
Sign to I-95 nb on ramp	Delaware Ave. and Castor Ave.
Larger and more complete signs to terminals	I-95 and sb off ramps, at Bath St. / Allegheny Ave. intersection

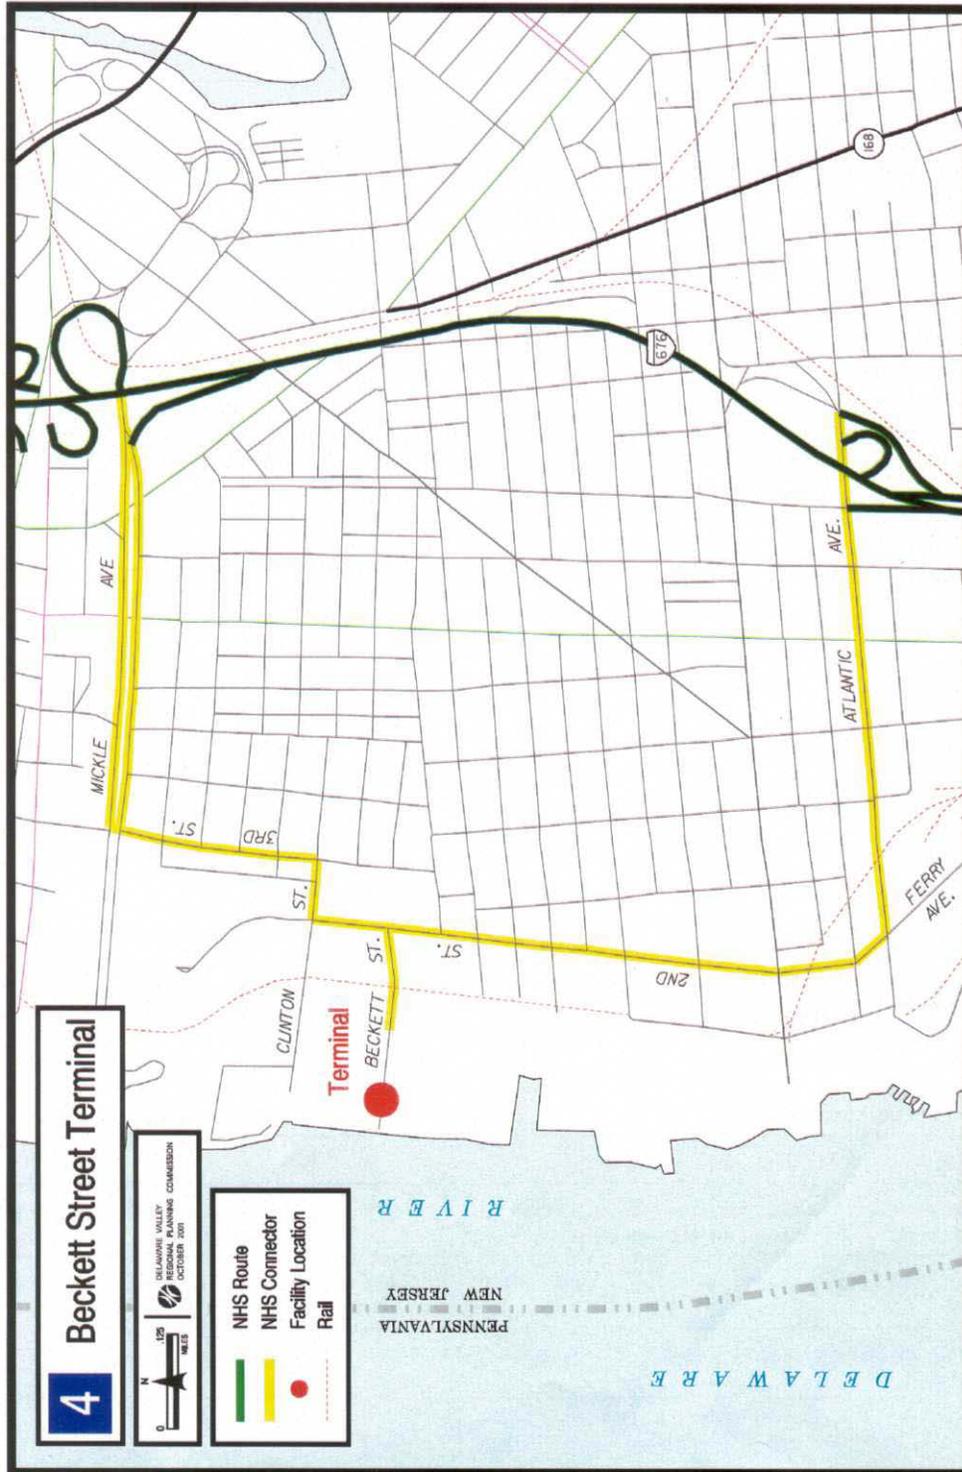
4

Problem	1	2	3	Description
Delays at Railroad Crossing				
Switching / Make-up Operations				
Crossing Warning Devices	✓	✓	✓	There are no warning devices at all of the crossings
Inadequate Sight Distance at Crossing				
Rough Railroad Crossing Surface	✓	✓	✓	All of the crossing are very rough
Vehicle Underclearance (Humped Crossing)				
Lack of Alternate Route				
Other <u>No pavement markings</u>

Condition	Description	Percent	Location
Very Good	Newly built or resurfaced and distress free.		
Good	Smooth surface with little to no cracking or rutting.		
Fair	Serviceable with shallow rutting and moderate cracks beginning to occur, but does not affect travel speed.	50 %	Mickle Ave. Atlantic ave (Ferry Ave. to Broadway)
Poor	Same problems as fair but worse, cause some reduction in speed.	40%	3 rd Street, Clinton St., 2 nd Street, Beckett St.
Very Poor	Major problems with potholes, etc., causing substantial reductions in speed	10 %	Atlantic Ave. (Broadway to I-676)

Geometric / Physical Features				
Problem	No Problem	Short Section	Most of Length	Description
Inadequate Travelway Width	✓			
Inadequate Shoulder Width	✓			
Lack of Stabilized Shoulder	✓			
Tight Turning Radii at intersection		✓		At Beckett St. / 2 nd St. Intersection
Road not Paved	✓			
Bridge / Overpass Vertical Clearance	✓			
Weight Limitation on Road / Bridge	✓			
Narrow Bridge / Tunnel	✓			
Rough Abandoned Railroad Crossing		✓		Possibility that the rough grade crossing are abandoned
Drainage / Flooding		✓		Flood Area on Atlantic Ave.
Other _____

Destination Signing / Trailblazers	
Is there adequate signing from the mainline NHS to the terminal; and from the terminal back to the mainline NHS? Yes ____ No <input checked="" type="checkbox"/>	
New / Replacement Signs Recommended	Location
Trailblazers from I-676 and NJ 30 to terminal	All appropriate intersections
Trailblazers from terminal to I-676	All appropriate intersections
Trailblazers from terminal to NJ 30	All appropriate intersections
Consistent signing for Mickie Blvd. / Martin Luther King Blvd. / Alicia Santos Blvd.	Along Mickie Blvd.
Larger street name signs - current signs are very small	Along all connector roadways

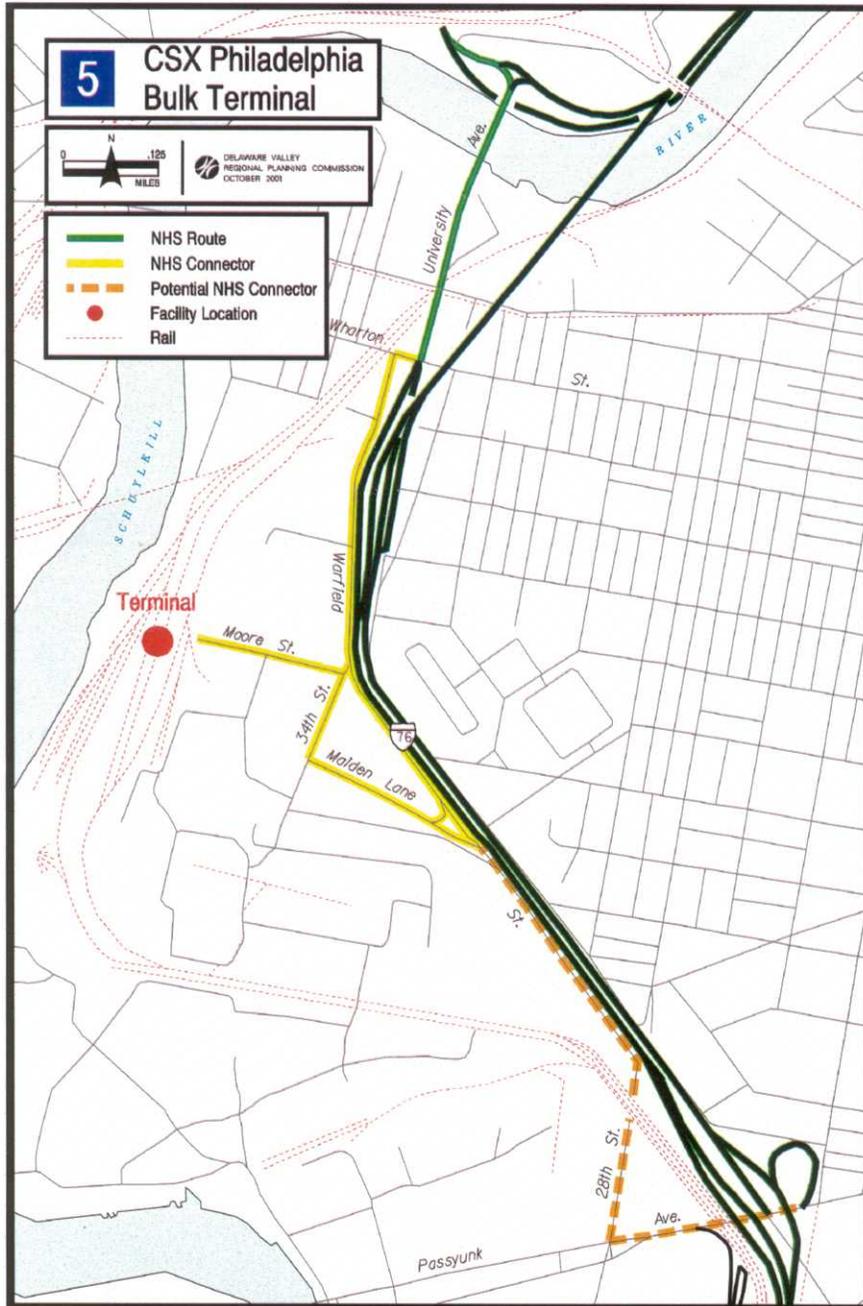
5

¹ Access to I-76 wb is missing in FHWA's approved connector network supporting the CSX Philadelphia Bulk Terminal. The linkage described above is DVRPC staff's recommended connection to serve the movement. The total additional mileage to complete the connection (0.833 mile) has been included in the Connector Length shown above.

Condition	Description	Percent	Location
Very good	Newly built or resurfaced and distress free.		
Good	Smooth surface with little to no cracking or rutting		
Fair	Serviceable with shallow rutting and moderate cracks beginning to occur, but does not affect travel speed	85%	Wharton St., Warfield St., 34 th St., Passyunk Ave.
Poor	Same problems as fair but worse, cause some reduction in speed.	15%	Moore St.
Very Poor	Major problems with potholes, etc., causing substantial reductions in speed

Problem	No Problem	Short Section	Most of Length	Description
Inadequate Travelway Width		✓		Wharton St.
Inadequate Shoulder Width		✓		Wharton St., Warfield St., Moore St.
Lack of Stabilized Shoulder	✓			
Tight Turning Radii at Intersection		✓		Wharton St., Warfield St., and Moore St. intersections
Road Not Paved	✓			
Bridge / Overpass Vertical Clearance	✓			
Weight Limitation on Road / Bridge	✓			
Narrow Bridge / Tunnel	✓			
Rough Abandoned Railroad Crossing	✓			
Drainage / Flooding		✓		At the Maiden Lane / Warfield St. intersection
Other <u>No pavement markings</u>				Warfield St., and 28 th St.

Destination Signing / Trailblazers	
Is there adequate signing from the mainline NHS to the terminal; and from the terminal back to the mainline NHS? Yes _____ No <input checked="" type="checkbox"/>	
New / Replacement Signs Recommended	Location
Trailblazers to facility from the mainline NHS	At all intersections leading to the facility
Directional signs from facility to mainline NHS	At all intersections from the facility to I-76
Replace old overhead sign reading "Schuylkill Expressway North" with "I-76 West" overhead mast arm	Passyunk Ave. and I-76 interchange

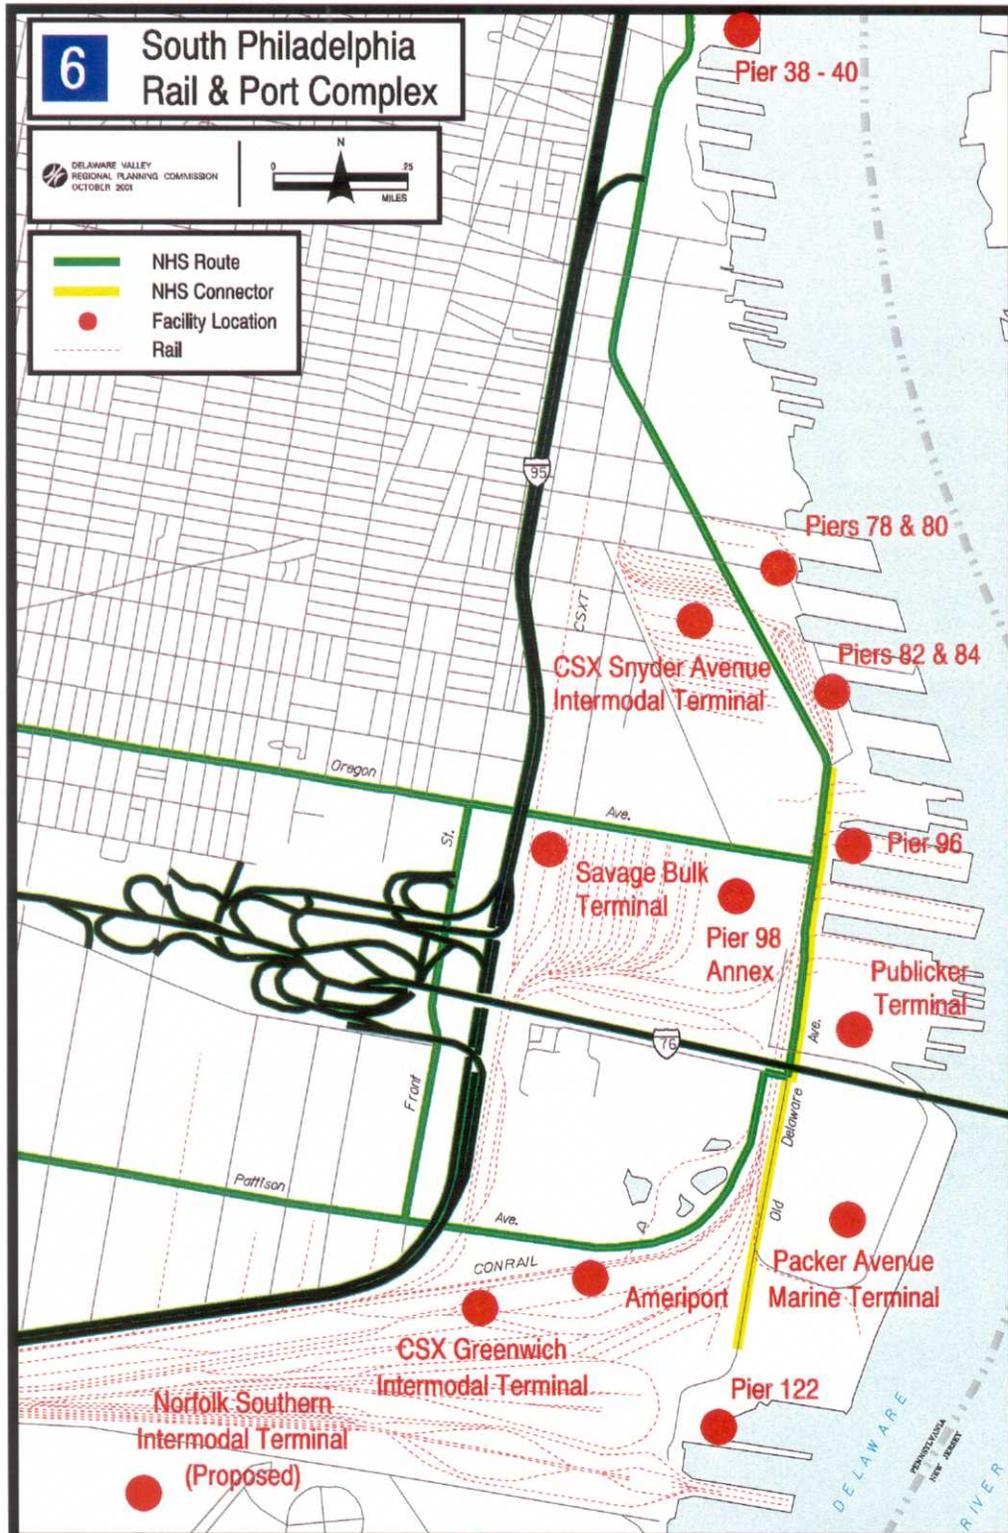
6

Connector Description: From Packer Ave. Marine Terminal's southern driveway to Columbus Blvd. via: Old Delaware Ave.
Connector Length: 1.074 miles

Problem	1	2	3	Description
Delayed at Railroad Crossing	✓			
Switching / Make-up Operations				
Crossing warning Devices	✓	✓	✓	
Inadequate Sight Distance at Crossing	✓			
Rough Railroad Crossing Surface				
Vehicle Underclearance (Humped Crossing)				
Lack of Alternate Route				
Other <u>No pavement markings</u>	✓			Intersection of Old Delaware Ave. and Oregon: There is no defined stop bar for the traffic signal at the intersection. Some trucks could stop across the railroad tracks.

Pavement Conditions			
Condition	Description	Percent	Location
Very Good	Newly built or resurfaced and distress free.		
Good	Smooth surface with little to no cracking or rutting.	100%	All connector roadways
Fair	Serviceable with shadows rutting and moderate cracks beginning to occur, but does not affect travel speed.		
Poor	Same problems as fair but worse, cause some reduction in speed.		
Very Poor	Major problems with potholes, ect., causing substantial reductions in speed

Geometric / Physical Features				
Problem	No problem	Short Section	Most of Length	Description
Inadequate Travelway Width	✓			
Inadequate Shoulder Width	✓			
Lack of Stabilized Shoulder	✓			
Tight Turning Radii at Intersections		✓		At intersection of Oregon Ave. and Columbus Blvd. and the short stacking area from Old Delaware Ave. to those roadways.
Road Not Paved	✓			
Bridge / Overpass Vertical Clearance	✓			
Weight Limitation on Road / Bridge	✓			
Narrow Bridge / Tunnel	✓			
Rough Abandoned Railroad Crossing	✓			
Drainage / Flooding				Unknown
Other <u>No pavement markings</u>		✓		At the intersection of Old Delaware Ave. and Oregon Ave., see description under Railroad Crossing Problems

New / Replacement Signs Recommended	Location
Consolidated directory of showing the locations of all the facilities within the South Philadelphia Port and Rail Complex.	At the base of Oregon Ave. at Old Delaware Ave.

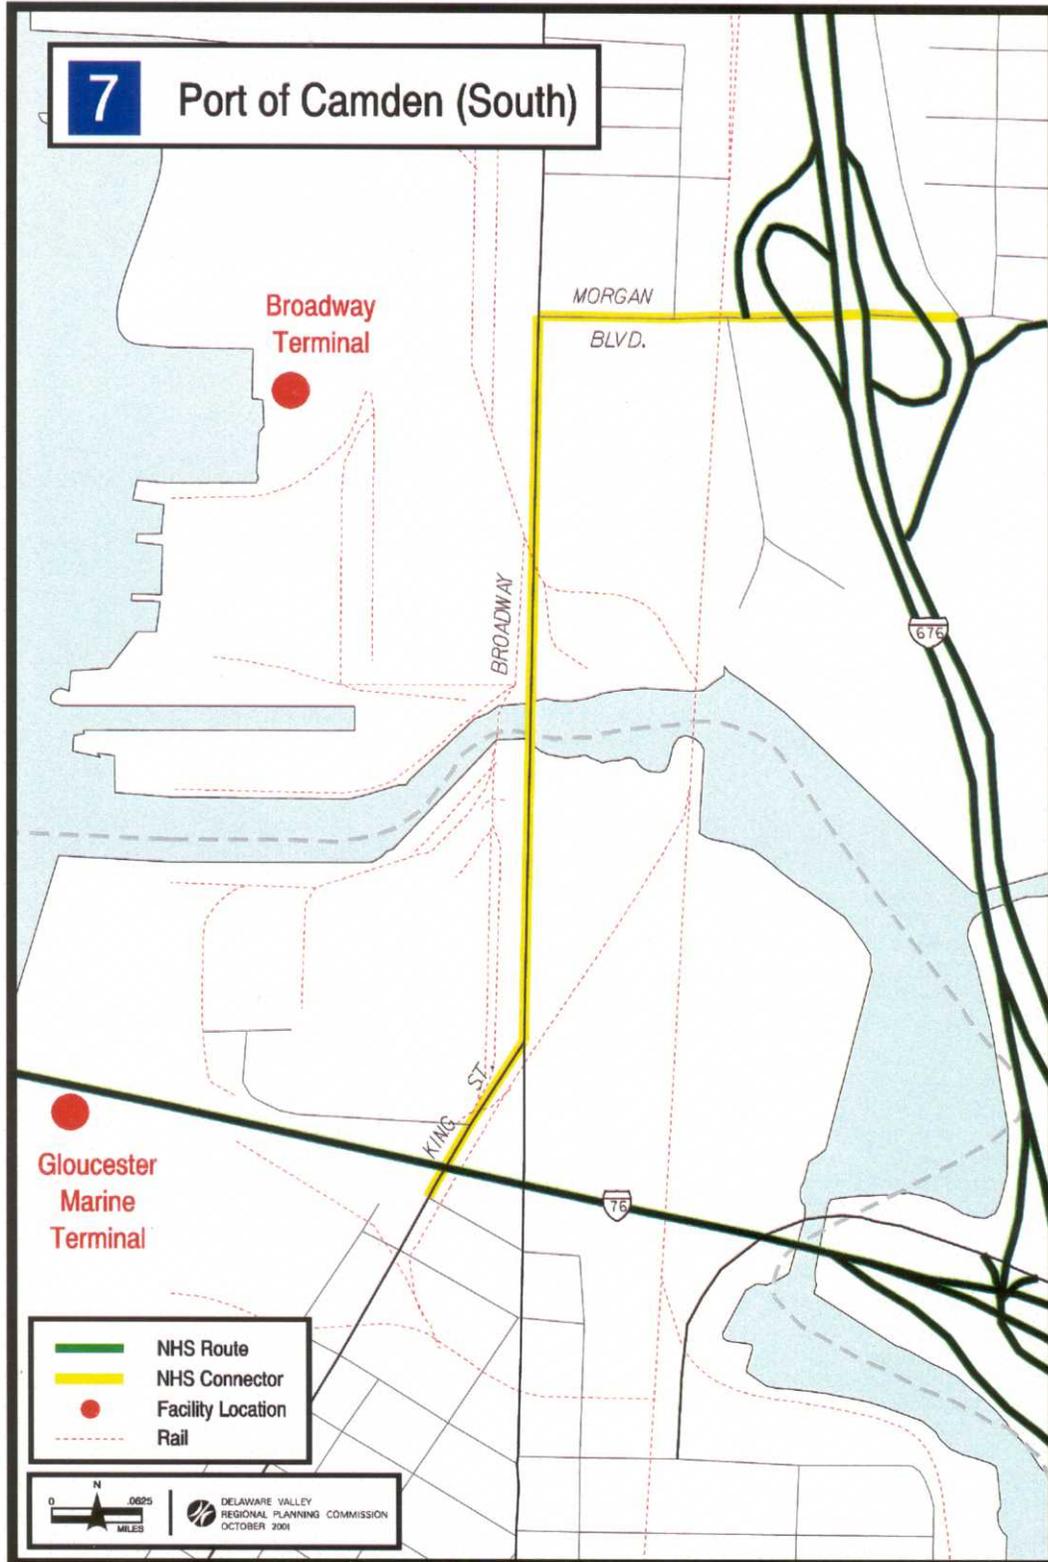
7

From I-676 to the terminals via: Morgan Blvd., Broadway, King St.
0.890 miles

Railroad Crossing Problems					
Problem	1	2	3	4	Description
Delays at Railroad Crossing					
Switching / Make-up Operations					
Crossing warning Devices	✓	✓	✓	✓	There are no warning devices at any of the crossings
Inadequate Sight Distance at Crossing					
Rough Railroad Crossing Surface	✓	✓	✓	✓	All of the crossings are very rough
Vehicle Underclearance (Humped Crossing)					
Lack of Alternate Route					
Other _____

Pavement Conditions			
Condition	Description	Percent	Location
Very Good	Newly built or resurfaced and distress free.		
Good	Smooth surface with little to no cracking or rutting.		
Fair	Serviceable with shallow rutting and moderate cracks beginning to occur, but does not affect travel speed.	100%	All connector roadways
Poor	Same problems at fair but worse, cause some reduction in speed.		
Very Poor	Major problems with potholes, ect., causing substantial reductions in speed

Geometric / Physical Features				
Problem	No Problem	Short Section	Most of Length	Description
Inadequate Travelway Width	✓			
Inadequate Shoulder Width		✓		On King St. and Morgan Blvd.
Lack of Stabilized Shoulder	✓			
Tight Turning Radii at intersections	✓			
Road Not Paved	✓			
Bridge / Overpass Vertical Clearance	✓			
Weight Limitation on Road / Bridge		✓		10 ton weight limit - sign has been pushed over
Narrow Bridge / Tunnel	✓			
Rough Abandoned Railroad Crossing		✓		
Drainage / Flooding				Unknown
Other _____

Destination Signing / Trailblazers	
Is there adequate signing from the mainline NHS to the terminal; and from the terminal back to the mainline NHS? Yes _____ No <input checked="" type="checkbox"/>	
New / Replacement Signs Recommended	Location
Trailblazers to the facilities	At the end of I-676 ramps, at Morgan Blvd./ Broadway Intersection
Sign to identify Broadway Terminal	At the facility

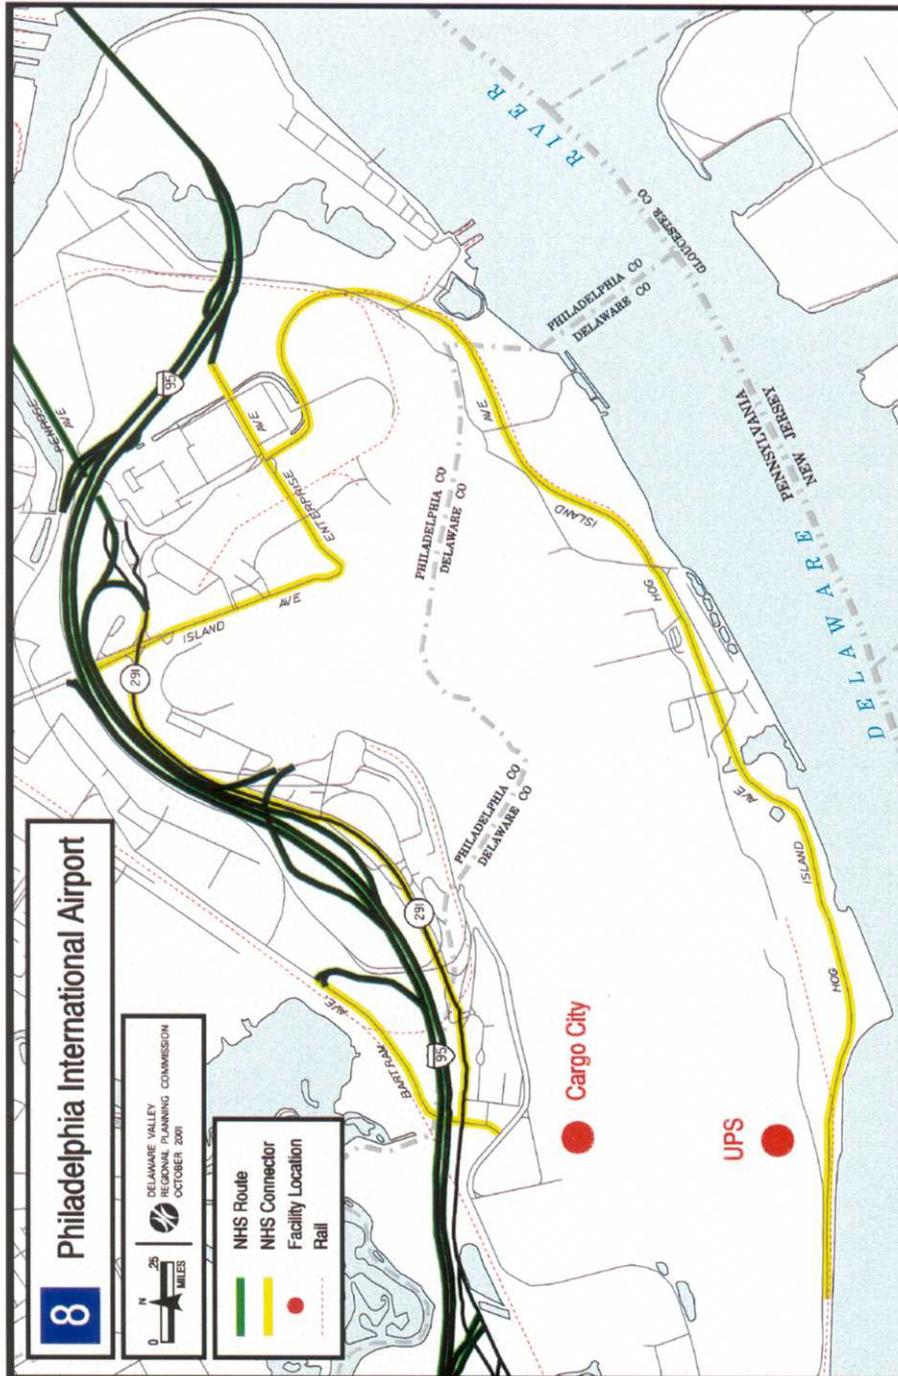
8

Condition	Description	Percent	Location
Very Good	Newly built or resurfaced and distress free.	25%	Bartram Ave., Enterprise Ave.
Good	Smooth surface with little to no cracking or rutting	45%	Scott Way, PA 291, Island Ave., Hog Island Ave. (Enterprise Ave. to Tunnel)
Fair	Serviceable with shallow rutting and moderate cracks beginning to occur, but does not affect travel speed.	30%	Hog Island Ave. (Tunnel to UPS facility)
Poor	Same problems as fair but worse, cause some reduction in speed.		
Very Poor	Major problems with potholes, etc., causing substantial reductions in speed

Geometric / Physical Features				
Problem	No Problem	Short Section	Most of Length	Description
Inadequate Travelway Width	✓			
Inadequate Shoulder Width		✓		Scott Way, Hog Island Ave., Enterprise Ave.
Lack of Stabilized Shoulder		✓		Scott Way, Hog Island Ave., Enterprise Ave.
Tight Turning Radii at Intersections	✓			
Road Not Paved	✓			
Bridge / Overpass Vertical Clearance	✓			
Weight Limitation on Road / Bridge	✓			
Narrow Bridge / Tunnel	✓			
Rough Abandoned Railroad Crossing	✓			
Drainage / Flooding				Unknown - possible due to proximity to river
Other

New / Replacement Signs Recommended	Location
Trailblazers to facilities (UPS, Sunoco), directional sign to I-95	Intersection of enterprise Ave. and Hog Island Ave
Directional signs to I-95	Enterprise Ave, Fort Mifflin Ave, Cargo City

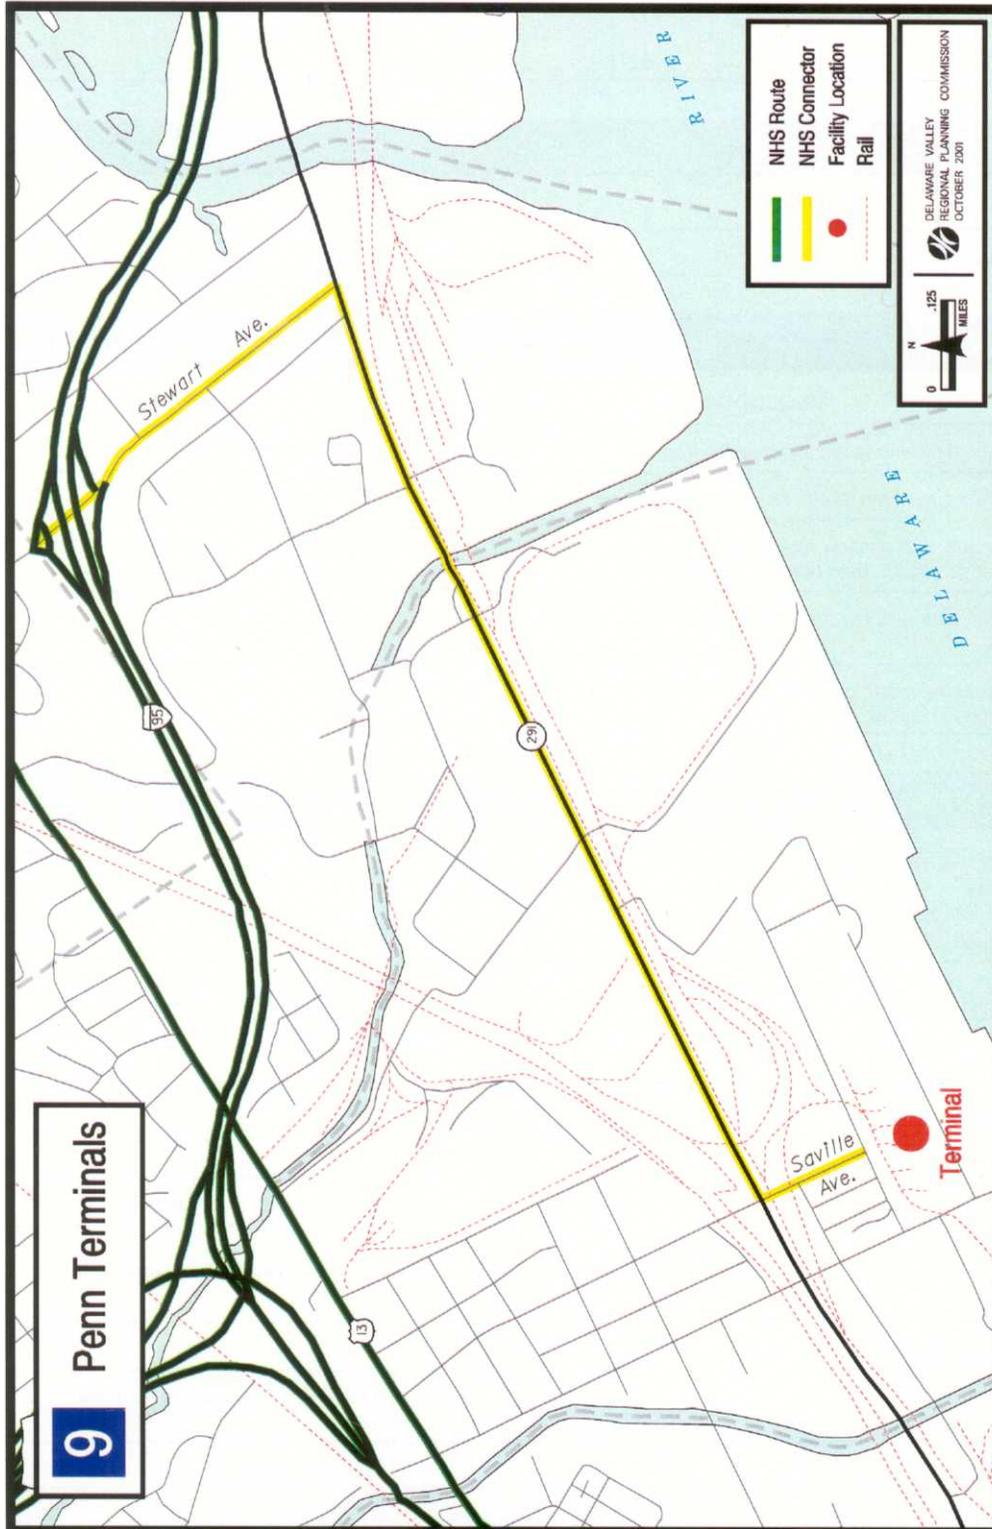
9

Condition	Description	Percent	Location
Very	Newly built or resurfaced and distress free.		
Good	Smooth surface with little to no cracking or rutting.	100%	All connector roadways
Fair	Serviceable with shallow rutting moderate cracks beginning to occur, but does not travel speed.		
Poor	Same problems as fair but worse, cause some reduction in speed.		
Very Poor	Major problems with potholes, ect., causing substantial reductions in speed

Problem	No problem	Short Section	Most of Length	Location
Inadequate Travelway Width	✓			
Inadequate Shoulder		✓		PA 291 is curbed with intermittent shoulders
Lack of Stabilized Shoulder	✓			
Tight Turning Radii at Intersections		✓		Saville Ave. nb to PA 291 eb
Road not Paved	✓			
Bridge / Overpass Vertical Clearance		✓		Railroad bridge over Saville Ave; 14'0"
Weight Limitation on Road / Bridge	✓			
Narrow Bridge / Tunnel	✓			
Rough Abandoned Railroad Crossing	✓			
Drainage / Flooding				Unknown - possible due to proximity to river
Other <u>No pavement markings</u>		✓		Saville Ave. and PA 291

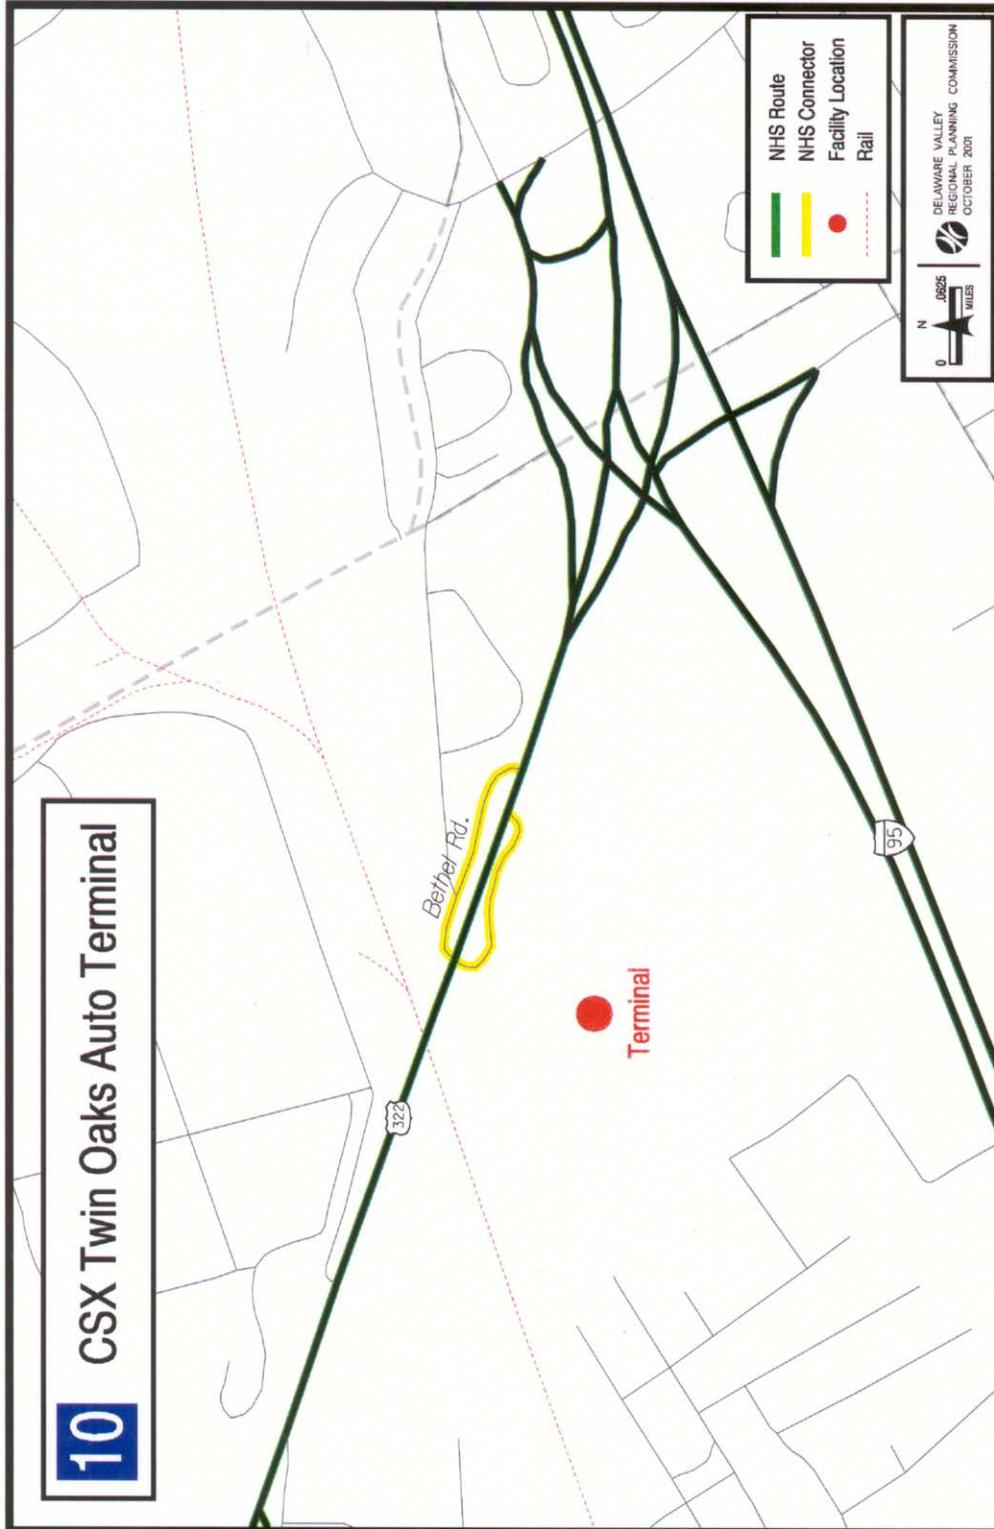
10

From terminal to US 322 (Conchester Highway) via Bethel Rd.
0.492 miles

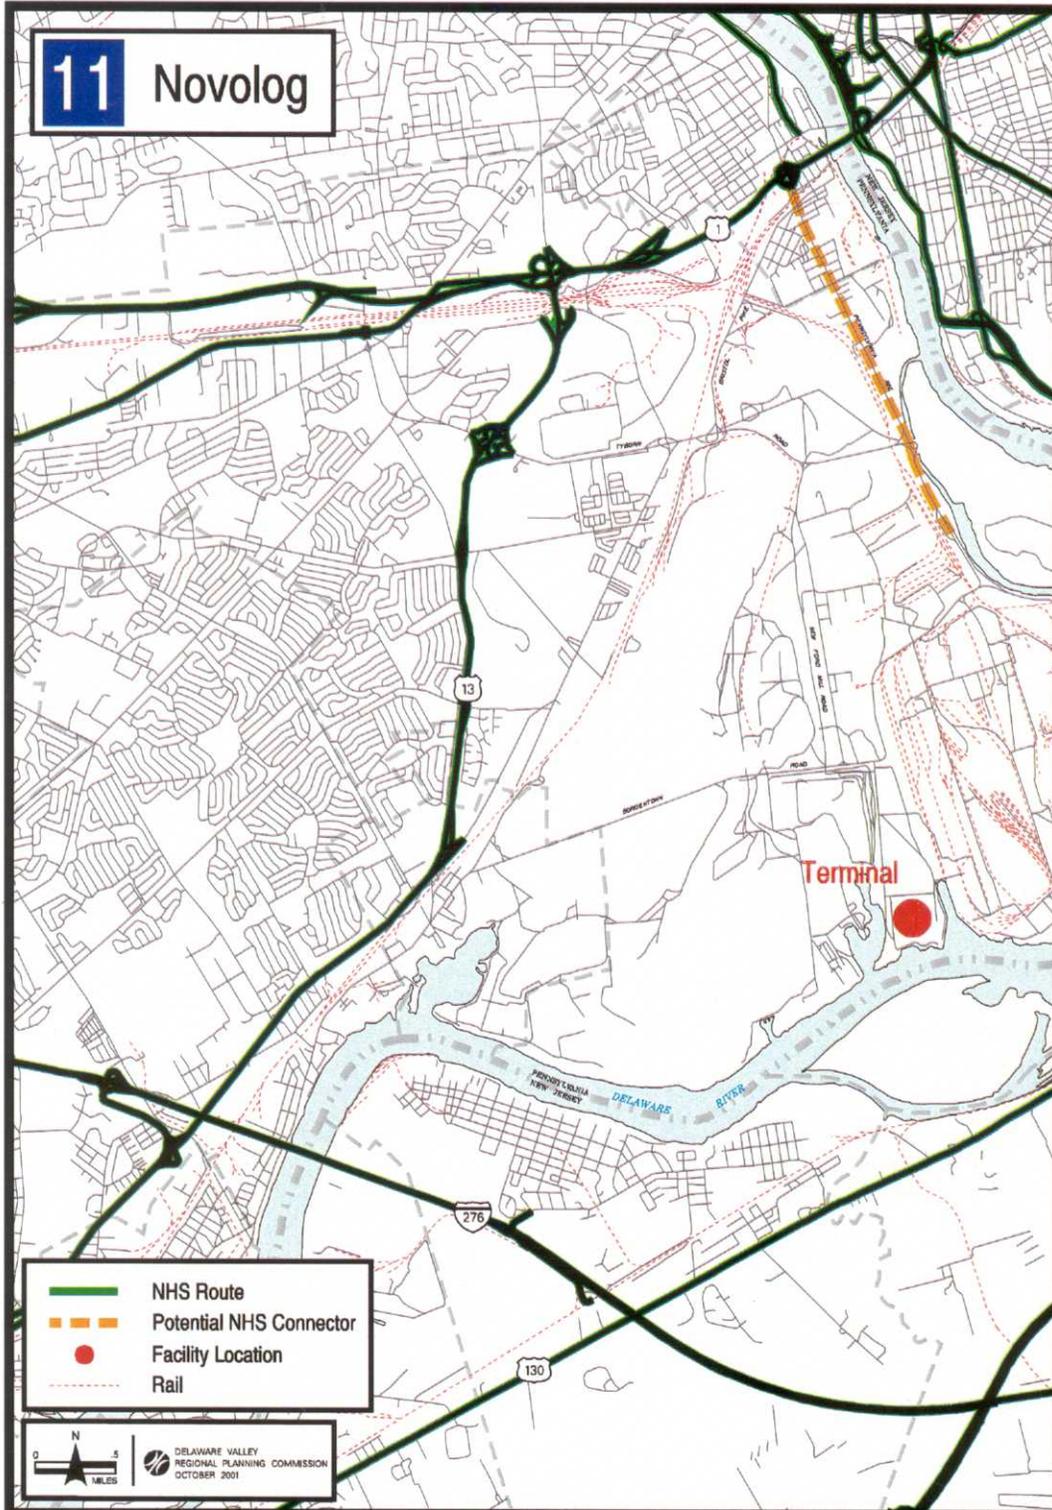
11

From US 1: S. Pennsylvania Ave.
2.575 miles
